Fatal Accident Investigation Team

MECHANICAL INSPECTION REPORT OF MOTOR VAN GBE 8998T

1. I refer to your request on 14th April 2022 to conduct a physical inspection of a Motor Van bearing registration number GBE 8998T (herein referred to as "**Motor Van**"), which was involved in a road traffic accident on 13th January 2022.
2. The objective of this inspection is to determine if there was any possible mechanical failure to the Motor Van that may have contributed to the accident.
3. Following the request, I had carried out a physical inspection of the Motor Van on 12th January 2022 at the premises of Traffic Police vehicle pound, 517 Airport Road Singapore 539942. I now set out below my observations and comments with respect to this inspection.

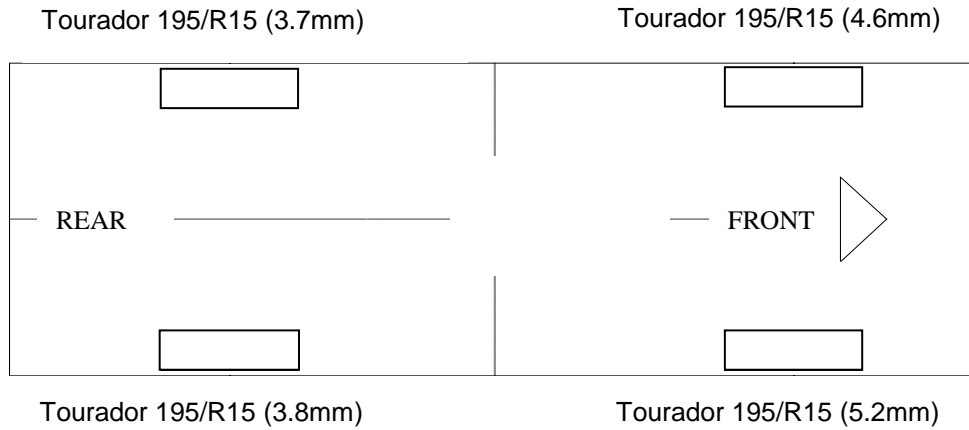
6. The 4 tyres of the Motor Van were observed to be in serviceable condition and sufficiently inflated for vehicular operation. I did not find any tear, cut or burst mark(s) on the outer and the inner sidewalls as well as across the tread of the 4 tyres. The tyre brand, tyre size and remaining tread depth of the 4 tyres of the Motor Van were recorded as follows:-

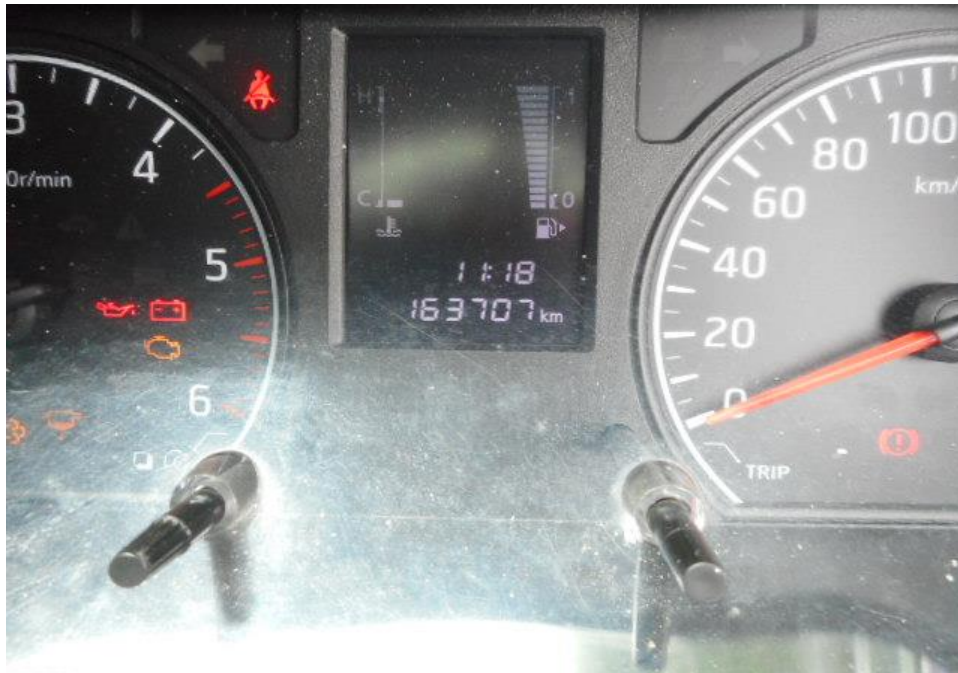
4. The mileage of the Motor Van at the time of my inspection was 163,707km.
5. The Motor Van appeared to have sustained damage at its frontal portion. Its front body panel was damaged at the time of my inspection.

Photo 1 shows a general view of the instrument cluster of the Motor Van at the time of my inspection. The mileage of the Motor Van was 163,707km

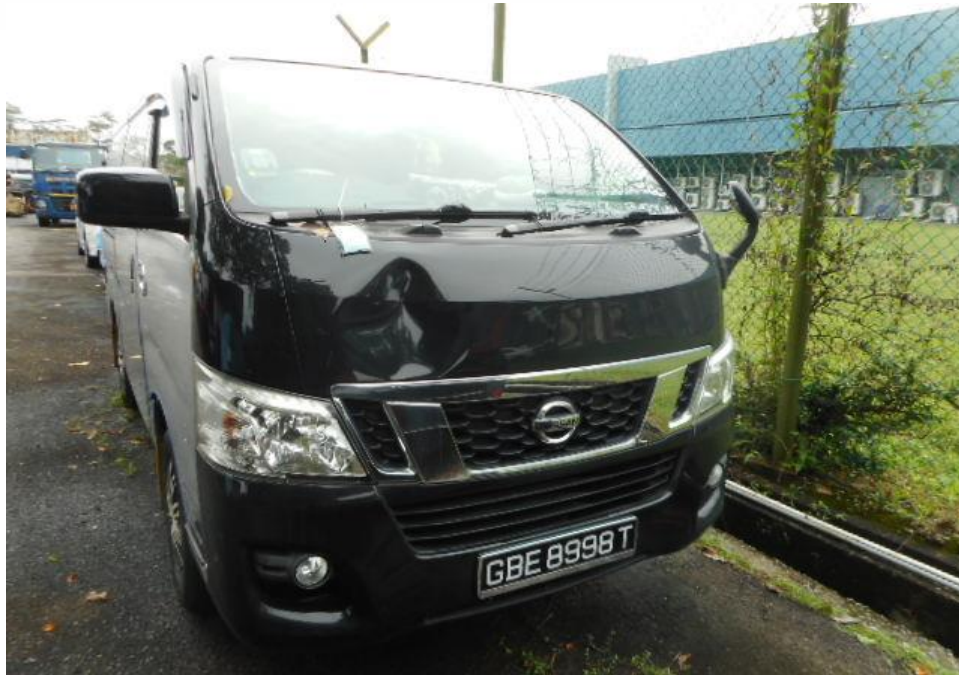
Photo 2 shows a general view of the Motor Van's frontal portion at the time of my inspection. It appeared to have sustained damage at its frontal portion. Its front body panel and front bumper were also damage at the time of my inspection.

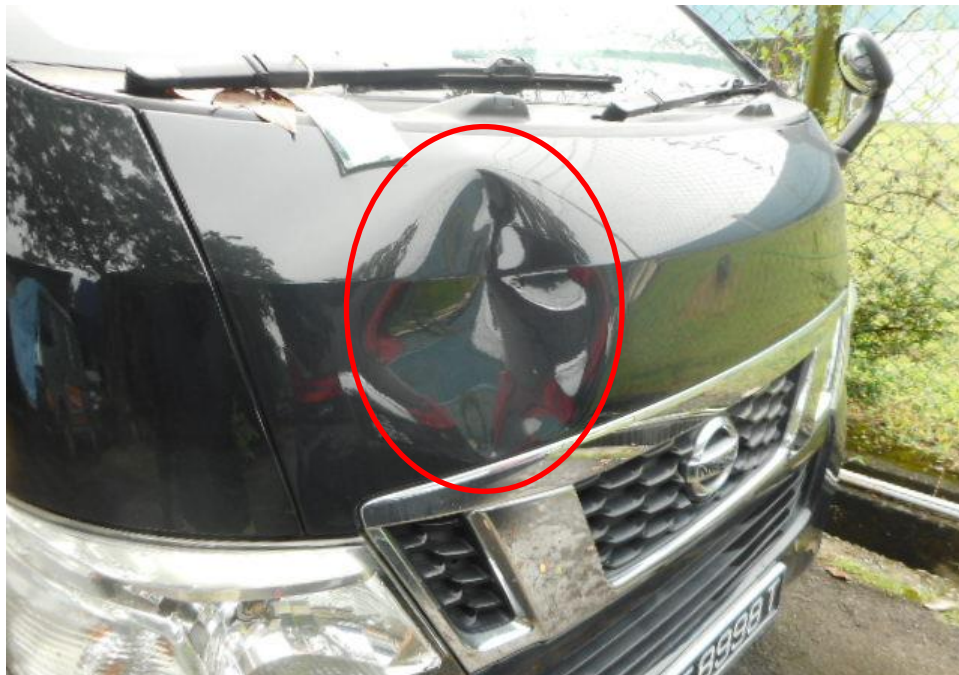
Photo 3 shows a close up view of the Motor Van's frontal portion at the time of my inspection. It appeared to have sustained damage at its frontal portion. Its front body panel (circled) was damage at the time of my inspection as a result of the accident.

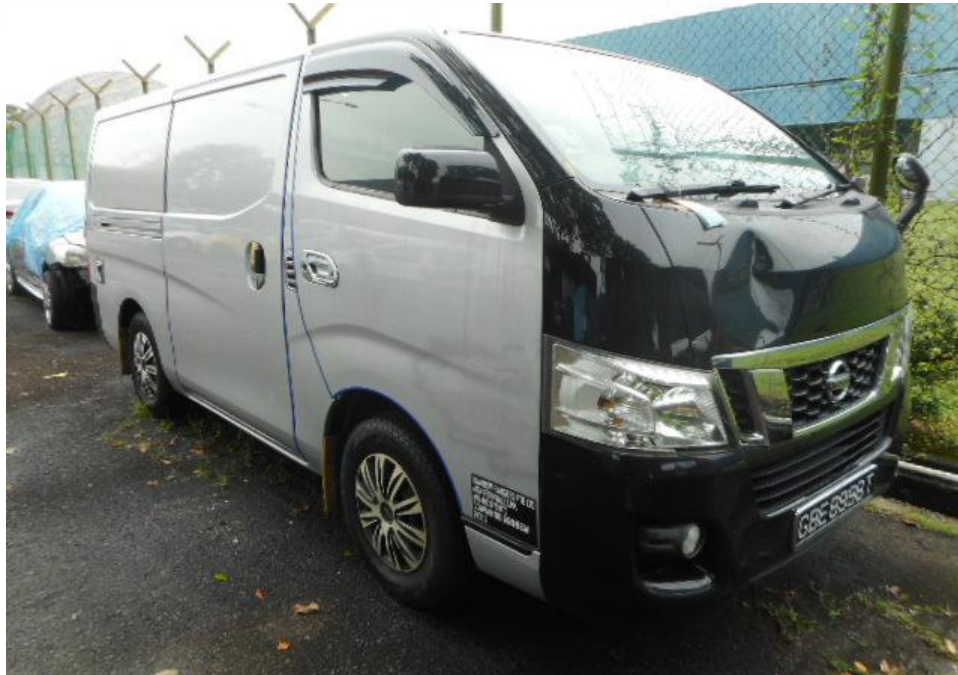
Photo 4 shows a general view of the right body of the Motor Van at the time of my inspection. The Motor Van was observed to be intact and unaffected by the accident.

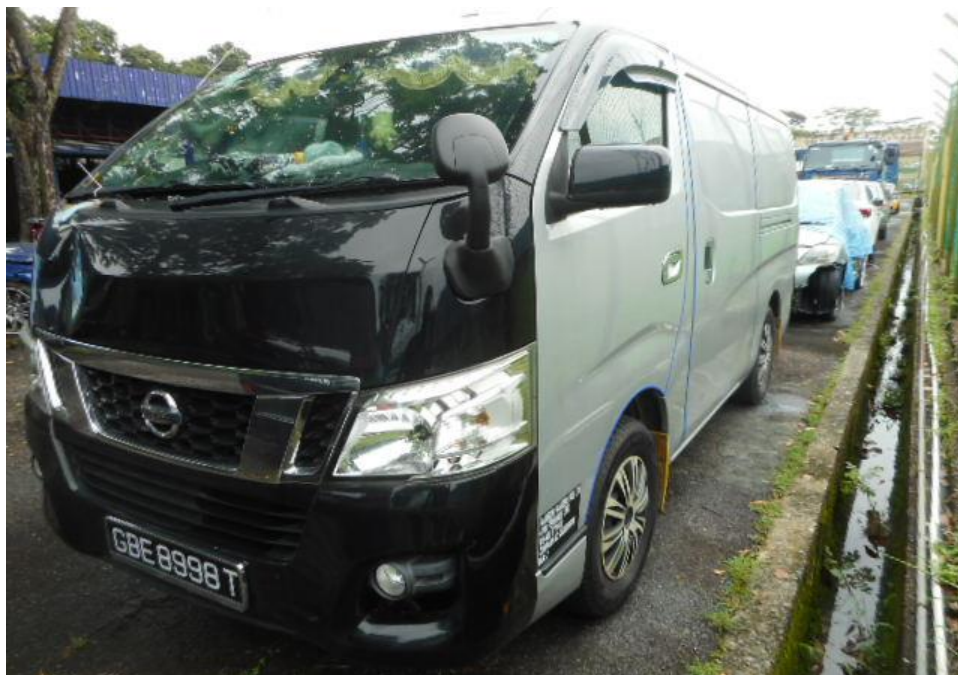
Photo 5 shows a general view of the left body of the Motor Van at the time of my inspection. The Motor Van was observed to be intact and unaffected by the accident.

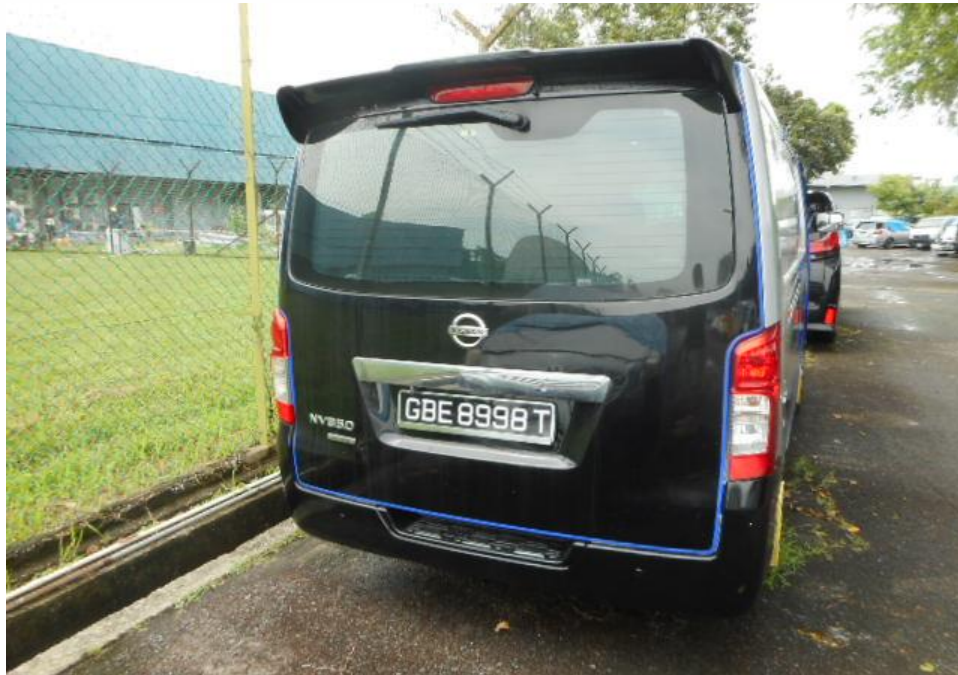
Photo 6 shows a general view of the rear body of the Motor Van at the time of my inspection. The Motor Van was observed to be intact and unaffected by the accident.

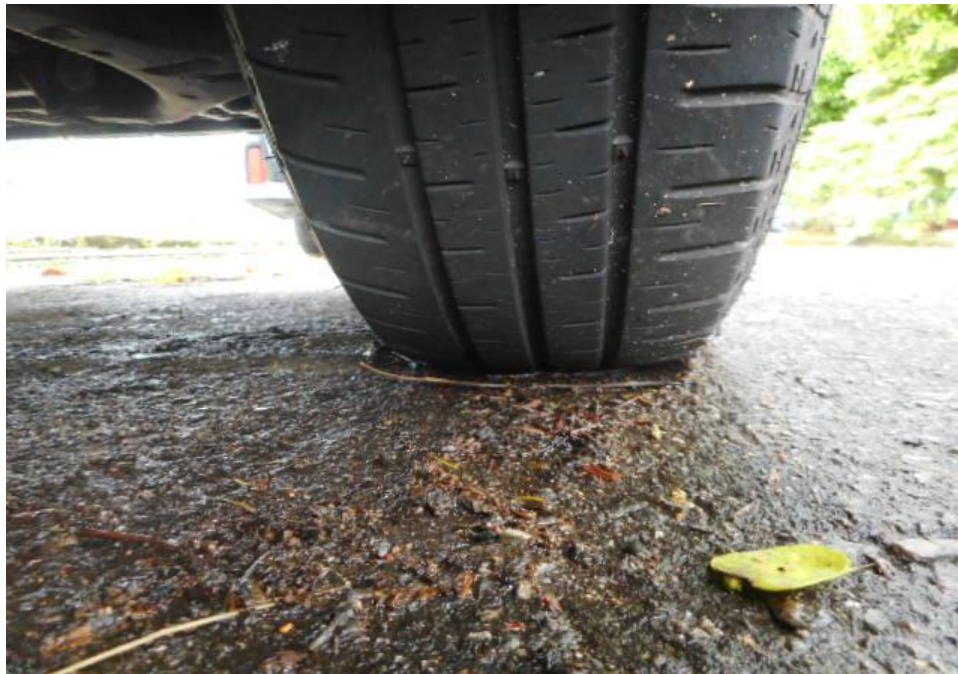
Photo 7 shows the condition of the front right tyre of the Motor Van, which was observed to be in serviceable condition with remaining tread depth of approximately 5.2mm. The tyre, which was wrapped around standard steel wheel rim, was also observed to be sufficiently inflated for vehicular operation. There was no tear, cut or burst mark(s) on the outer and the inner sidewalls as well as across the tread of the 4 tyres that were fitted on the Motor Van.

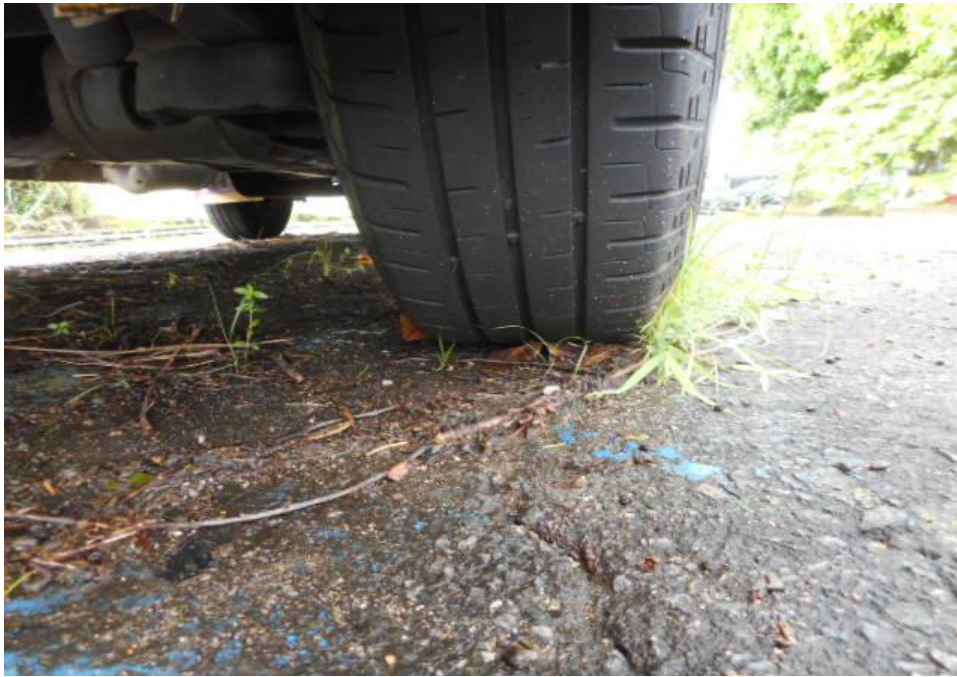
Photo 8 shows the condition of the rear right tyre of the Motor Van, which was observed to be in serviceable condition with remaining tread depth of approximately 3.8mm. The tyre, which was wrapped around standard steel wheel rim, it was observed to be sufficiently inflated for vehicular operation.

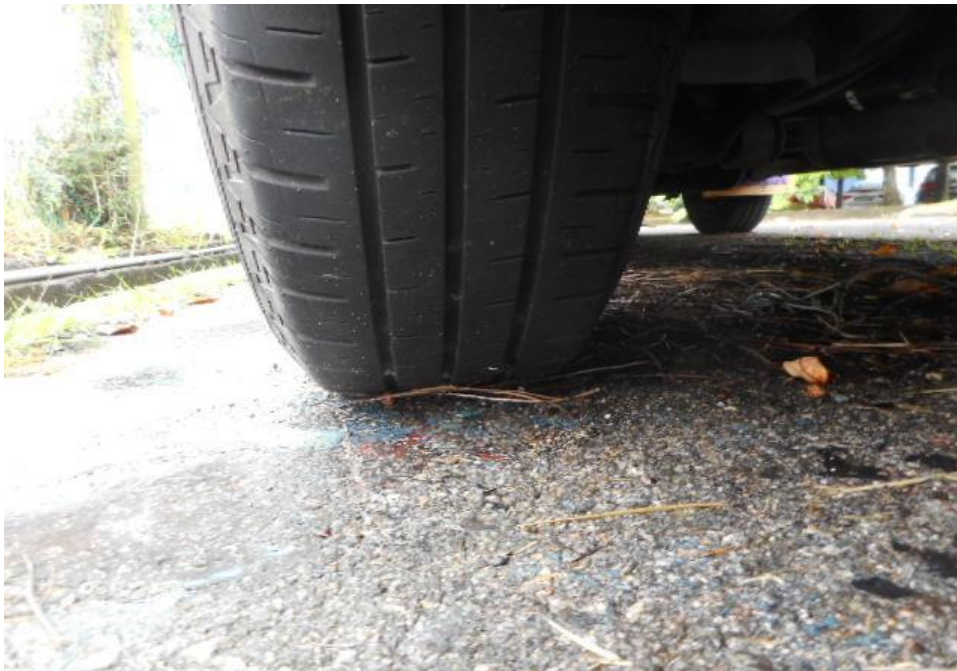
Photo 9 shows the condition of the rear left tyres of the Motor Van, which was observed to be in serviceable condition with remaining tread depth of approximately 3.7mm. The tyres, which were wrapped around standard steel wheel rim, were also observed to be sufficiently inflated for vehicular operation. There was also no damage found on all 4 steel wheel rims of the Motor Van.

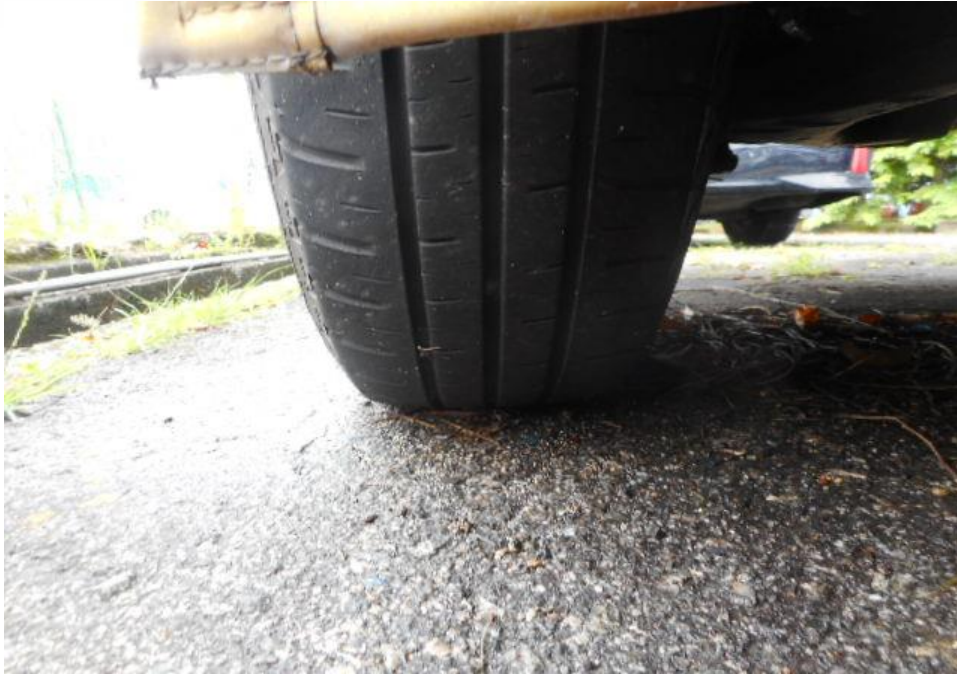
Photo 10 shows the condition of the rear right tyres of the Motor Van, which were observed to be in serviceable condition with remaining, tread depth of approximately 4.4mm. There was also no tear, cut or burst mark(s) on the outer and the inner sidewalls as well as across the tread of the 4 tyres that were fitted on the Motor Van.

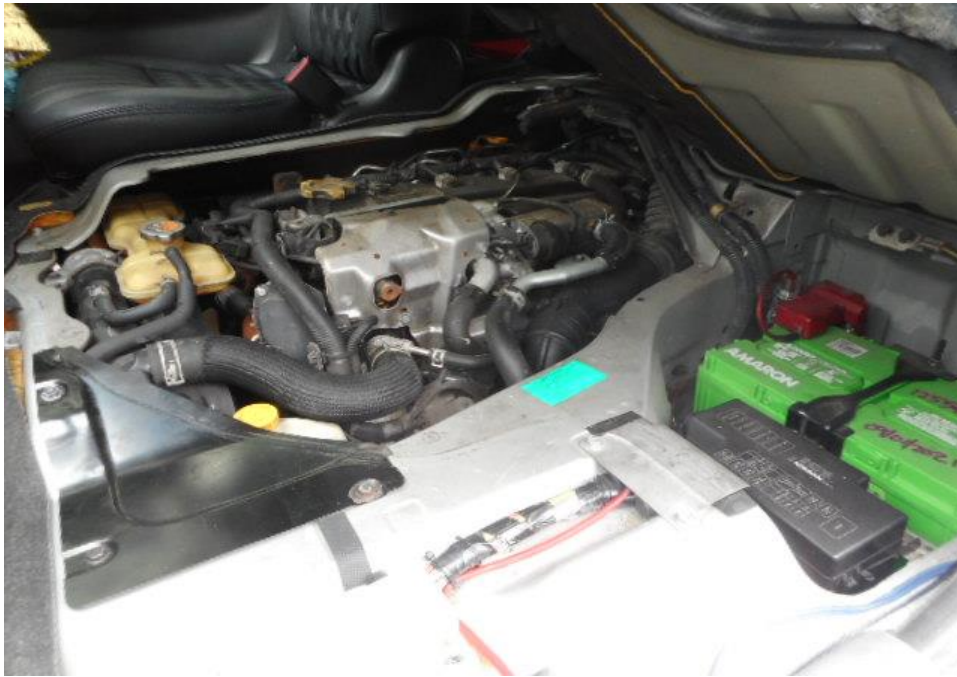
Photo 11 shows a general view of the Motor Van's engine compartment, which was accessed by lifting the front cabin of the Motor Van. The various parts and components inside the engine compartment were unaffected by the accident. There was also no sign(s) or indication(s) of fresh fluid leakage and/or fluid stain within the engine compartment

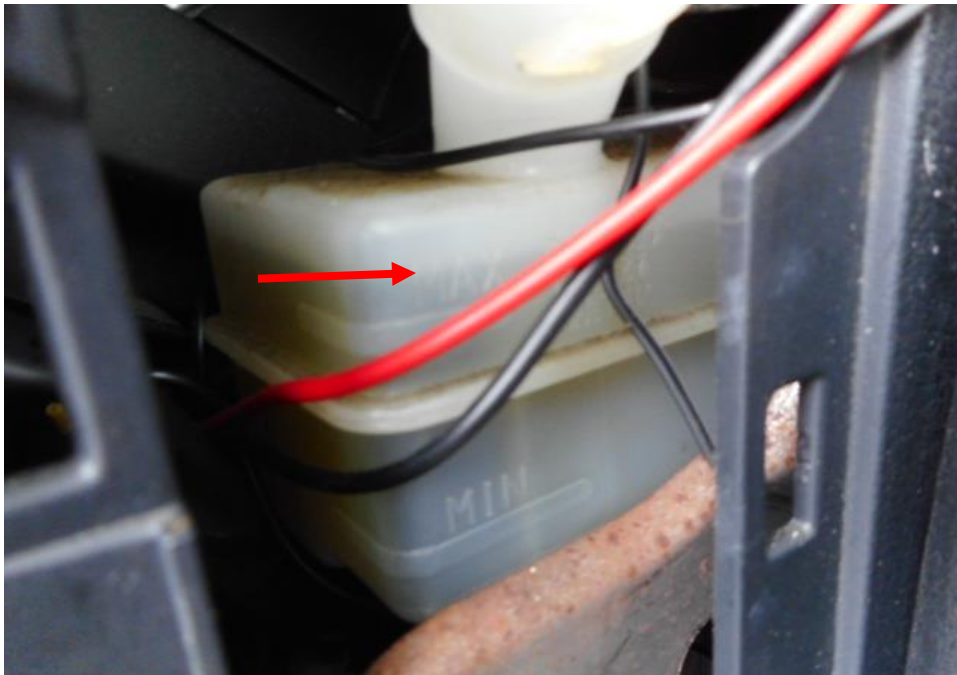
Photo 12 shows the brake fluid reservoir of the Motor Van at the time of my inspection. The brake fluid was observed to be of sufficient level (arrowed) and without any visible contamination.

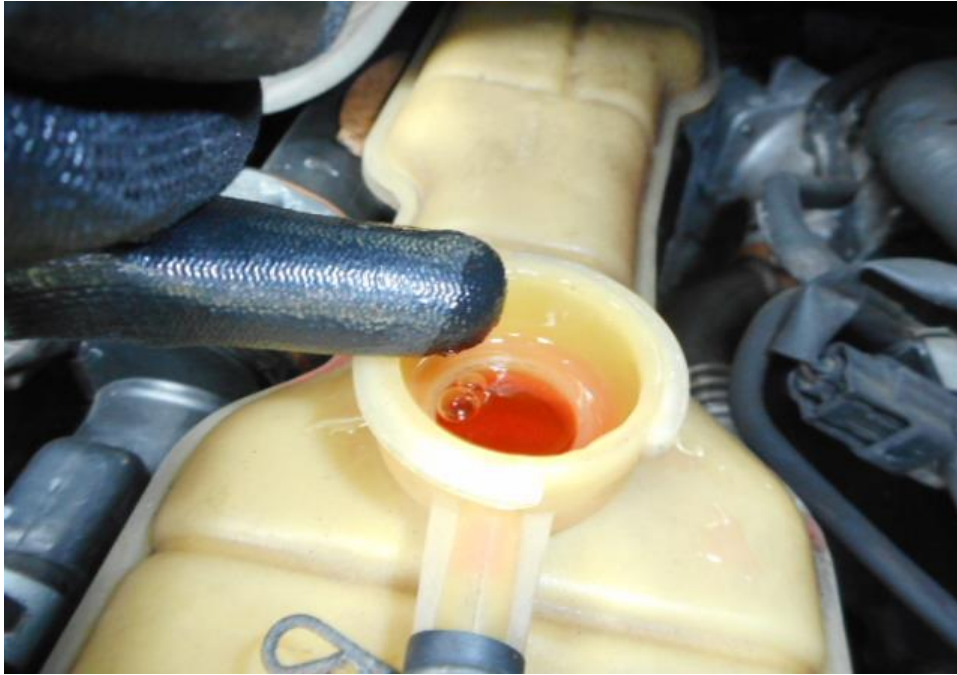
Photo 13 shows the engine coolant of the Motor Van at the time of my inspection. The engine coolant was observed to be of sufficient level and without any visible contamination.

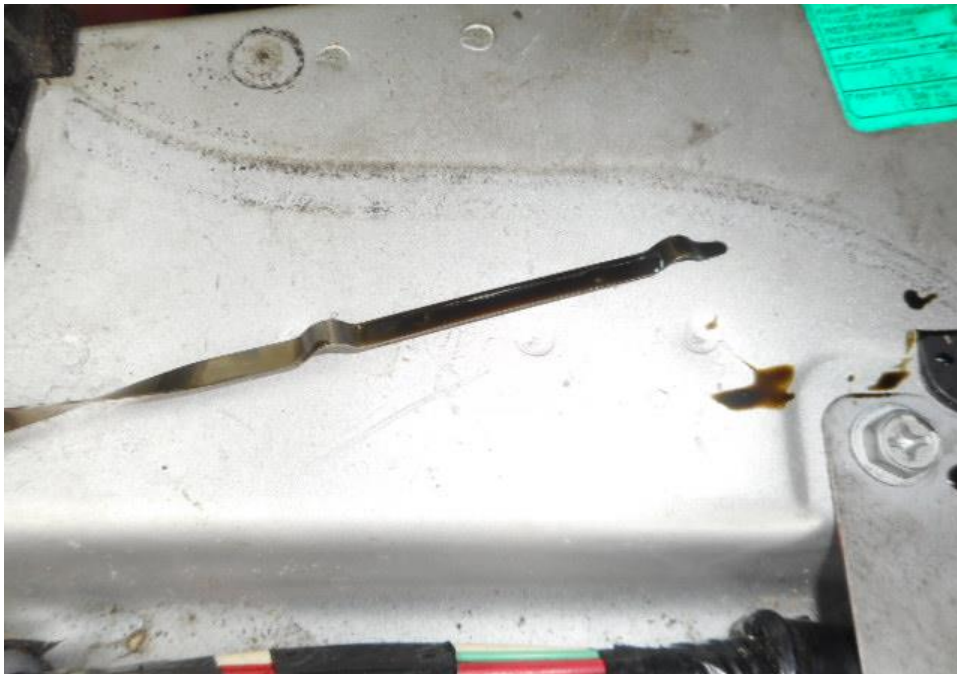
Photo 14 shows the engine oil dip stick of the Motor Van at the time of my inspection. The engine oil was observed to be of sufficient level and without any visible contamination.

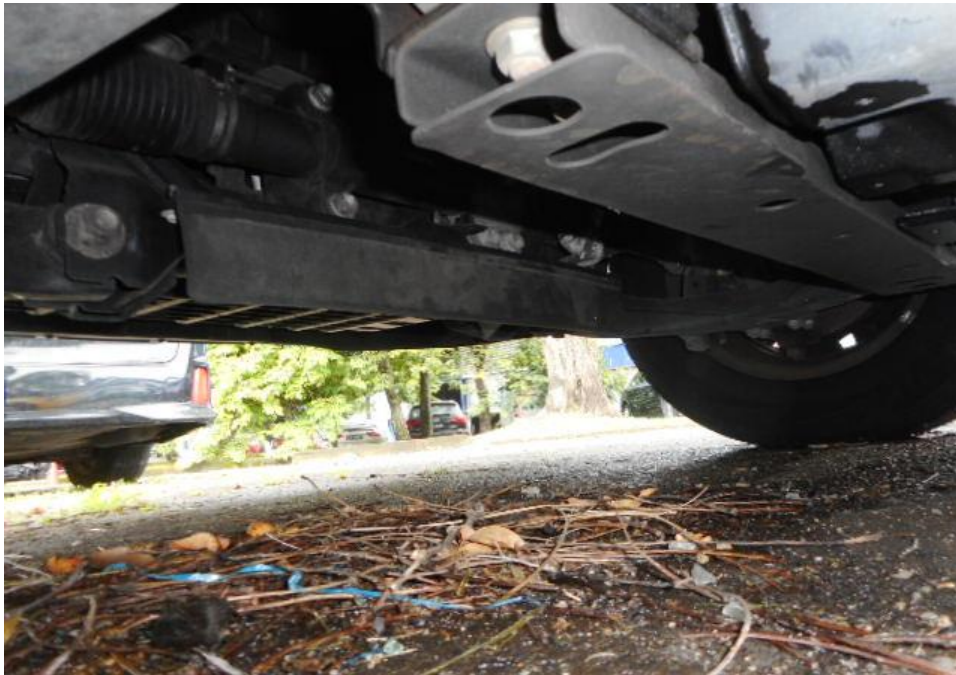
Photo 15 shows the undercarriage of the Motor Van, at the area where the engine housing and transmission housing are located. . I did not find any sign(s) or indication(s) of fluid leak and/or fluid stain(s) on the underside of the Motor Van.

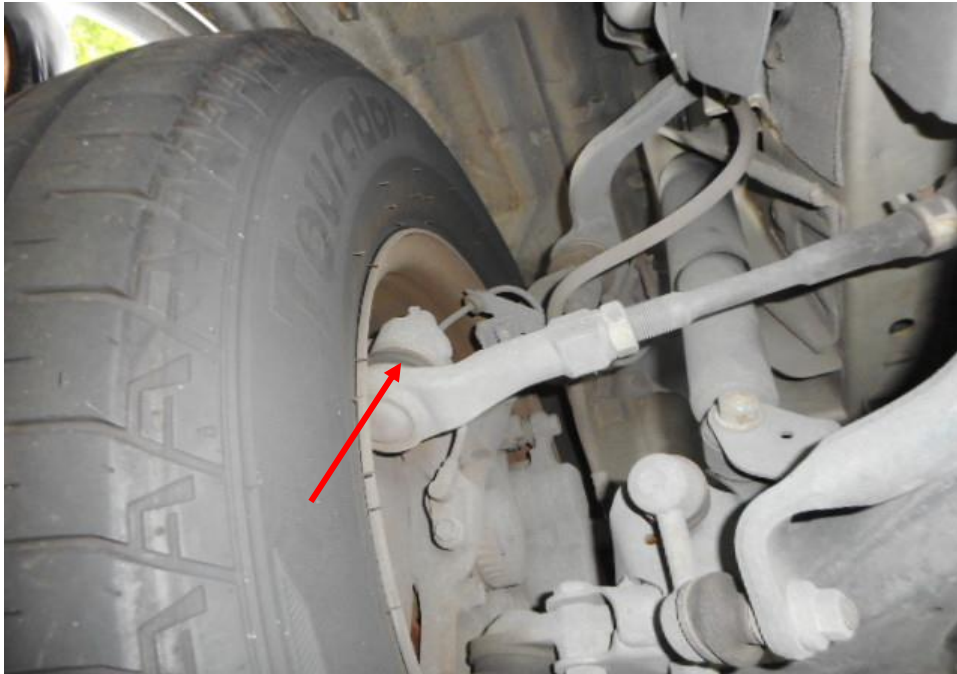
Photo 16 shows the various undercarriage components at the front right wheel of the Motor Van, in particular the steering tie rod end (arrowed). The various steering components were all found to be intact, suggesting that the steering system of the Motor Van was likely to be in serviceable condition at the material time of accident. There was also no sign of fluid stain(s) observed on the various undercarriage components.

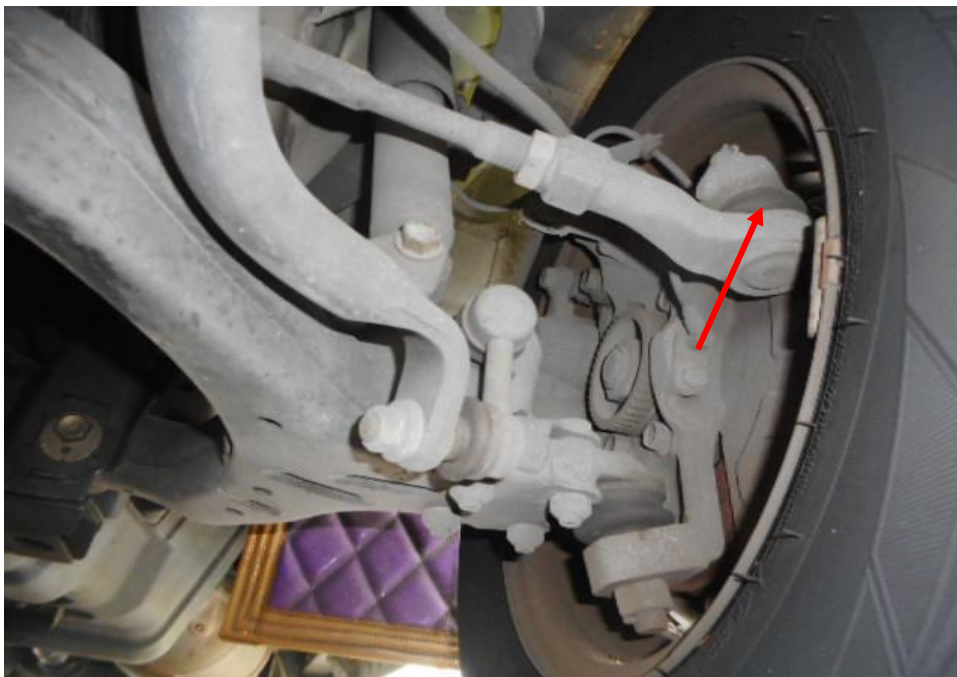
Photo 17 shows the various undercarriage components at the front left wheel of the Motor Van, in particular the steering tie rod end (arrowed). The various undercarriage components of the Motor Van were all found to be intact without any visible damage. There was also no sign of fluid stain(s) observed on the various undercarriage components.

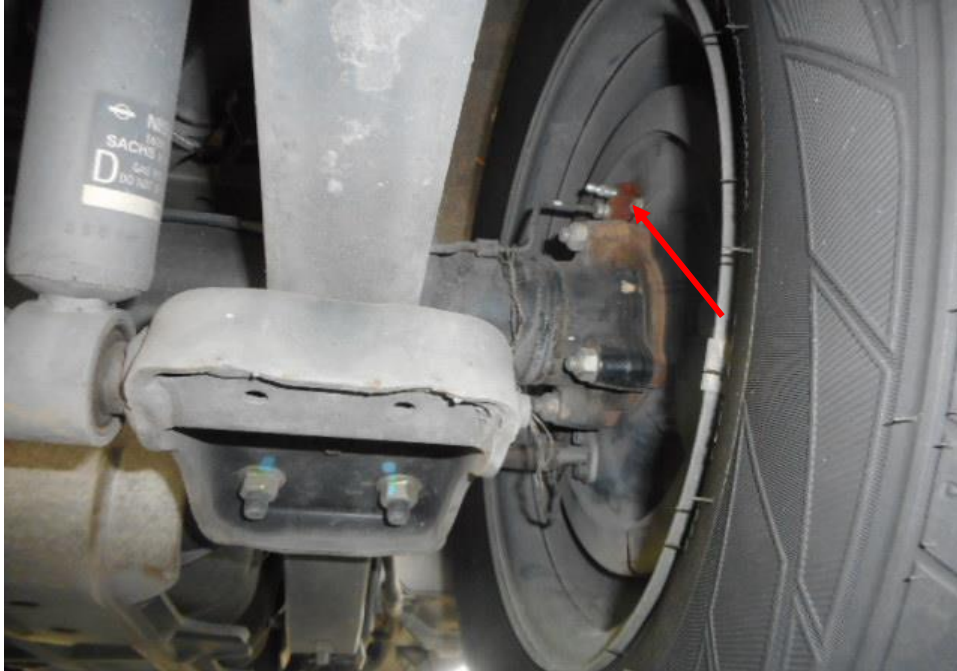
Photo 18 shows the brake pipe (arrowed) at the rear right wheel of the Motor Van. I did not observe any leakage of brake fluid at the time of my inspection of the Motor Van. My static tests of the Motor Van's braking system, along with my visual examination of the various mechanical components in the braking system, had indicated that there was no internal leakage of pressure/vacuum. Hence the braking system of the Motor Van was likely to be in serviceable condition at the material time of accident.

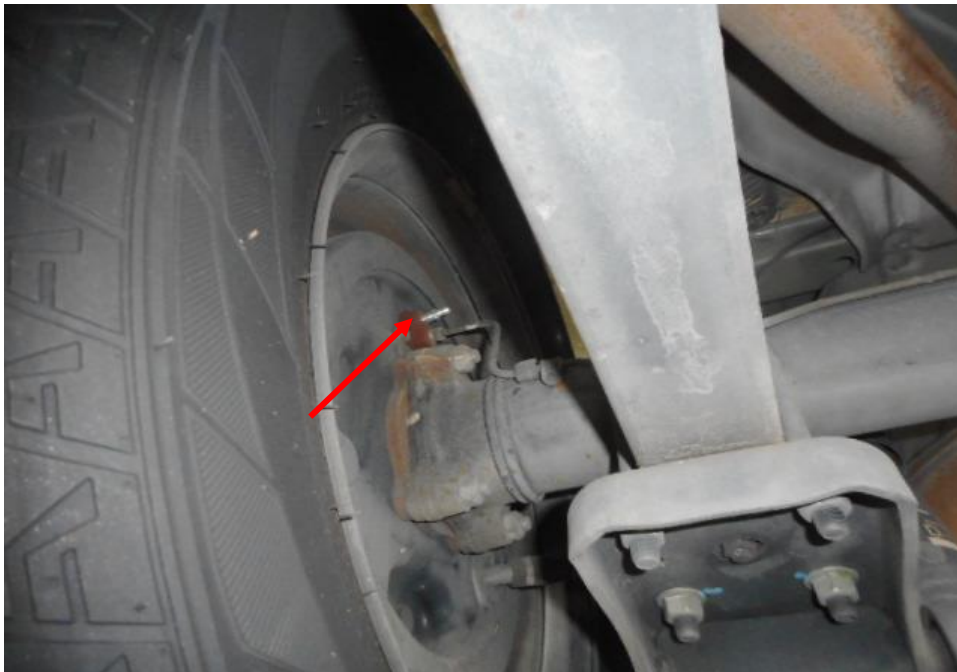
Photo 19 shows the brake pipe (arrowed) at the rear left wheel of the Motor Van. I did not observe any leakage of brake fluid at the time of my inspection of the Motor Van. My static tests of the Motor Van's braking system, along with my visual examination of the various mechanical components in the braking system had indicated that there was no internal leakage of pressure/vacuum. Hence the braking system of the Motor Van was likely to be in serviceable condition at the material time of accident.

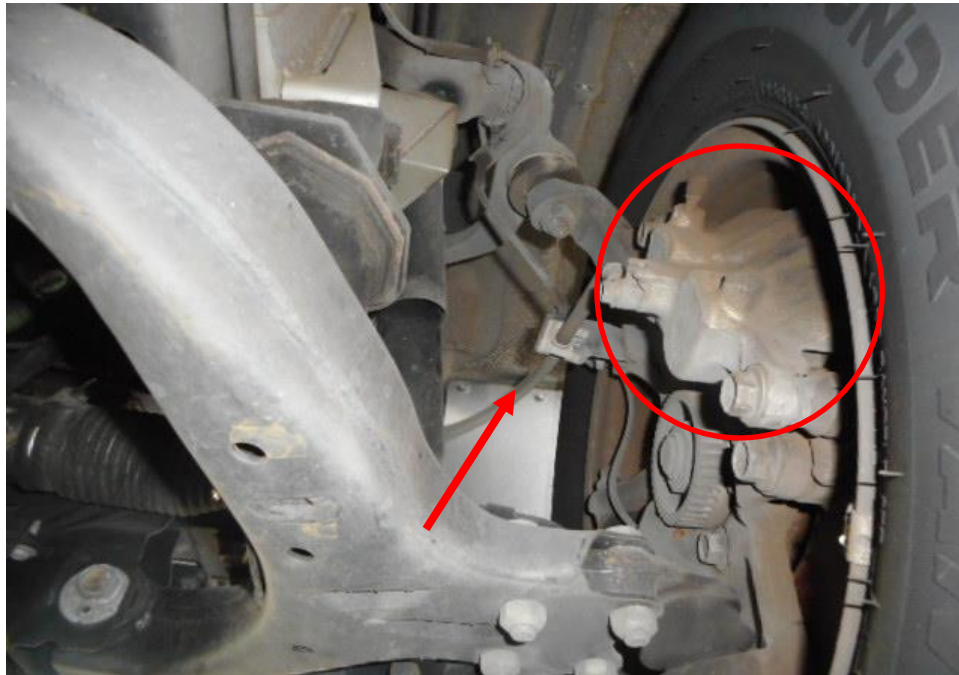
Photo 20 shows the brake hose/pipe (arrowed) at the front right wheel of the Motor Van. No leakage of brake fluid was observed. Visual examination of the various components of the braking system like the brake caliper (circled), brake booster, brake pedal etc had revealed all to be intact and without visible damage at the time of accident. There was also no sign of fluid stain(s) observed on the various undercarriage components.

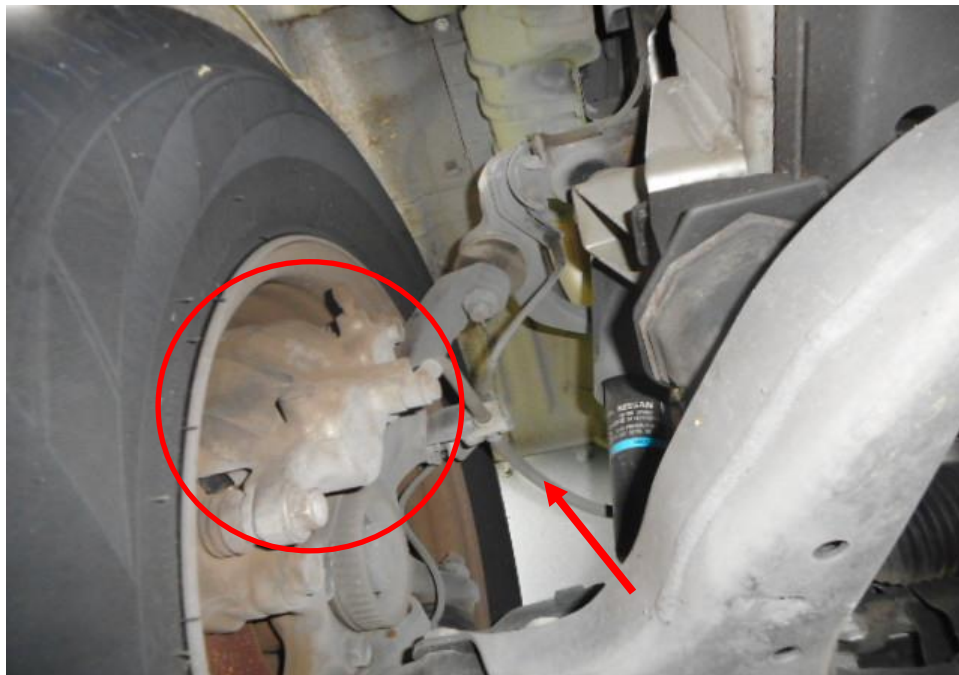
Photo 21 shows the brake hose/pipe (arrowed) at the front left wheel of the Motor Van. No leakage of brake fluid was observed. Visual examination of the various components of the braking system like the brake caliper (circled), brake booster, brake pedal etc had revealed all to be intact and without visible damage at the time of accident. There was also no sign of fluid stain(s) observed on the various undercarriage components.

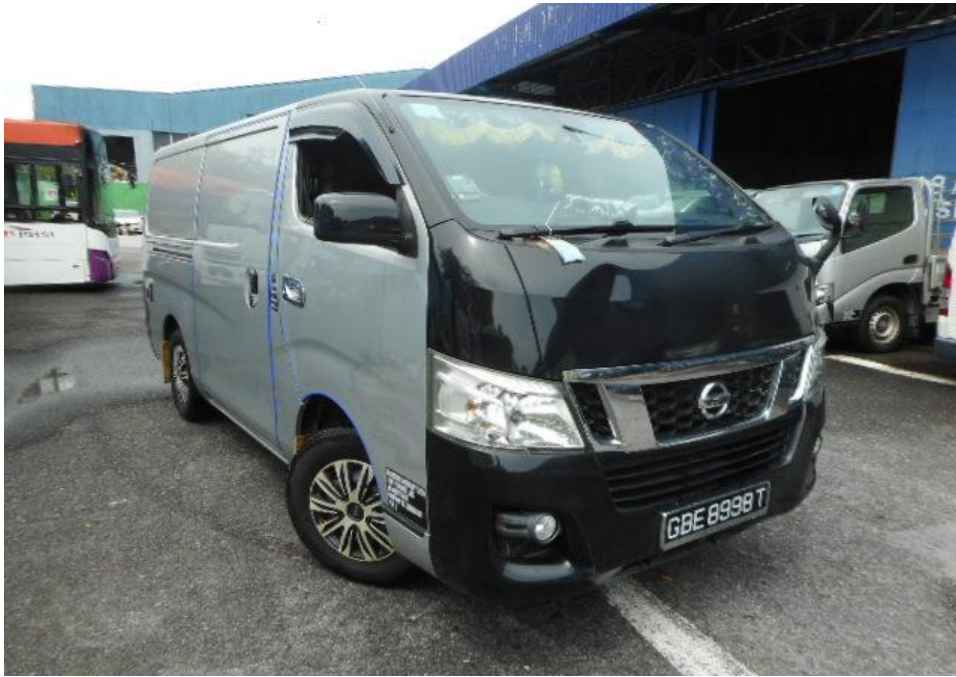
Photo 22 shows the front right wheel of the Motor Van turned to its full left. During my steering system test, I did not experience any abnormal free play and/or resistance when I had turned the steering wheel towards full left and full right. This would suggest that the steering system of the Motor Van was likely to be in serviceable condition at the material time of accident.

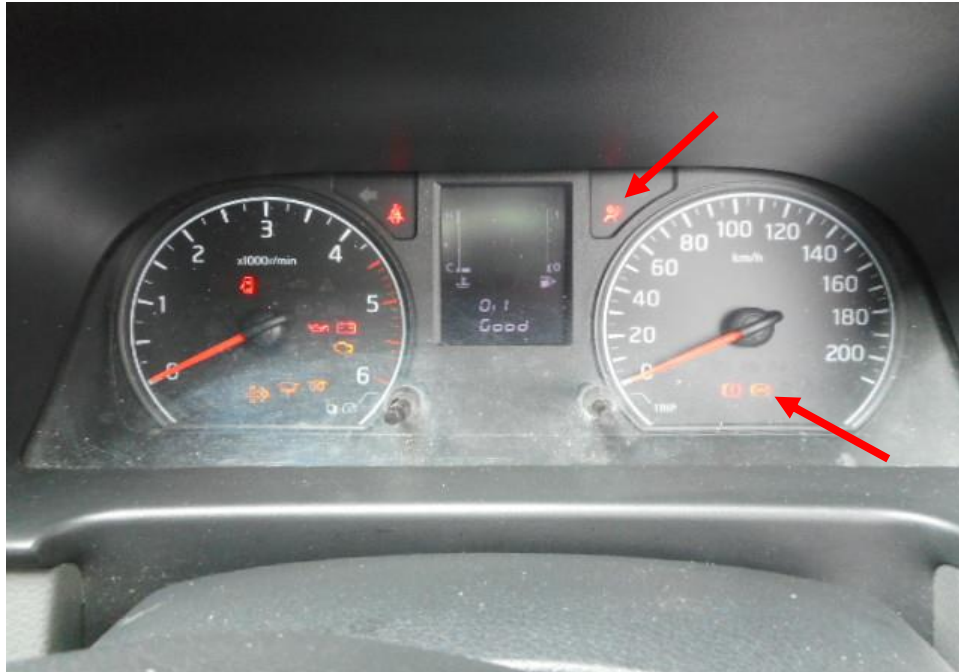
Photo 23 shows the warning light for Anti-Lock Brake System (ABS) and Supplemental Restraint System (SRS) (arrowed) appearing on the instrument panel of the Motor Van during the self-test of its various electronic operating systems when its engine was cranked.

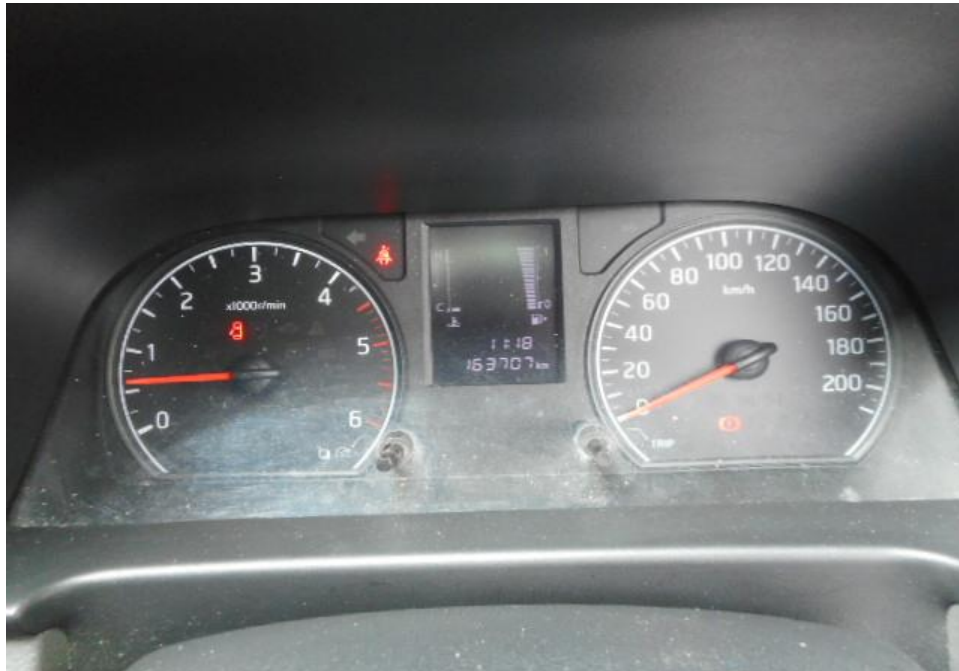
Photo 24 shows no warning lights illuminated on the instrument panel of the Motor Van after the engine was cranked. This would suggest that there was no abnormality to the electronic operating system of the Motor Van, like the ABS, SRS and etc.
