You're Ref: TP/IP/02937/2022  
Our Ref: CI/TPD22003618/P

**Fatal Accident Investigation Team**

**MECHANICAL INSPECTION REPORT OF MOTOR CAR SJL 7003P**

1. I refer to your request on 14<sup>th</sup> April 2022 to conduct a physical inspection of a Motor Car bearing registration number SJL 7003P (herein referred to as "**Motor Car**"), which was involved in a road traffic accident on 7<sup>th</sup> February 2022.
2. The objective of the inspection is to determine if there was any possible mechanical failure to the Motor Car that may have contributed to the accident.
3. Following the request, I had carried out a physical inspection of the Motor Car on 18<sup>th</sup> April 2022 at the premises of Traffic Police vehicle pound, 517 Airport Road Singapore 539942. I now set out below my observations and comments with respect to this inspection.

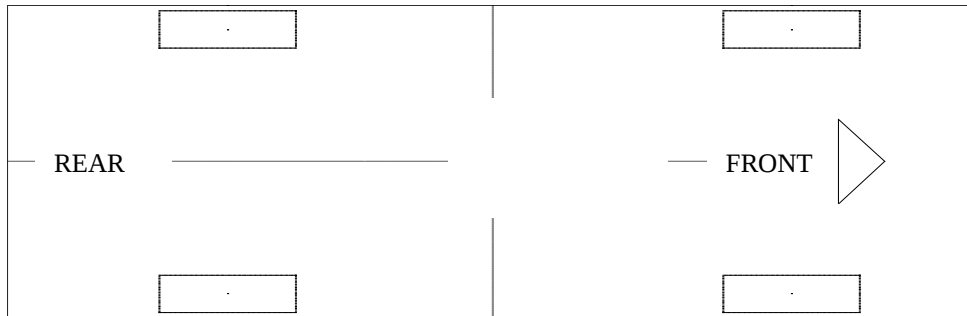
6. The condition of the Motor Car's 4 tyres was observed to be in serviceable condition. I did not find any tear, cut or burst mark(s) on the outer and the inner sidewalls as well as across the tread of the 4 tyres. The 4 tyres were also observed to be sufficiently inflated for vehicular operation. The tyre brand, tyre size and remaining tread depth of the 4 tyres were recorded as follows:-

Yokohama 185/65R15 (4.7mm)

Continental 185/65R15 (5.7mm)

Yokohama 185/65R15 (4.6mm)

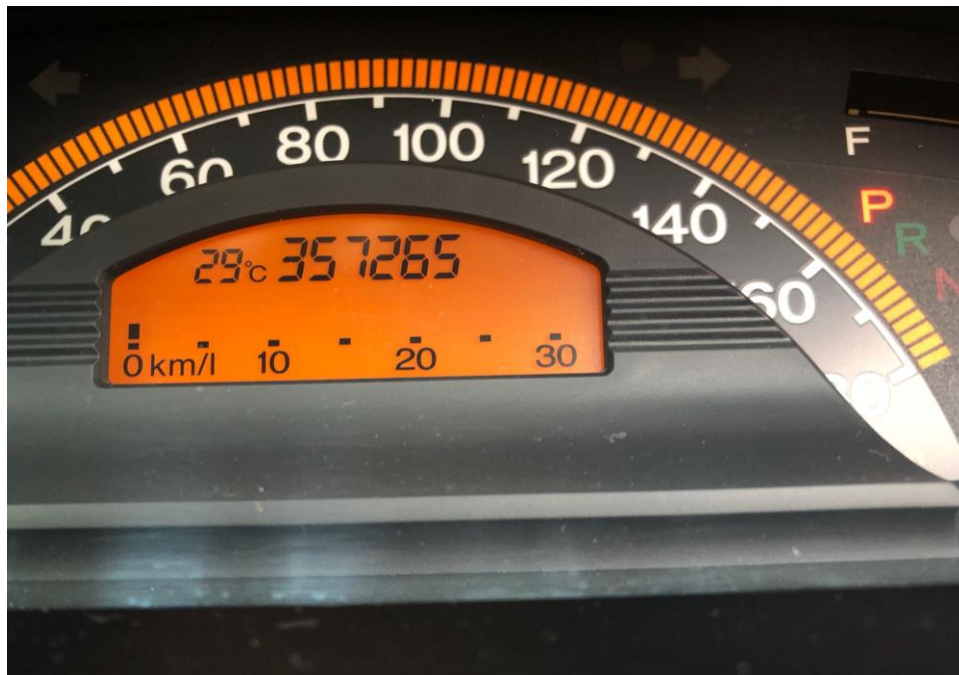
4. The mileage of the Motor Car at the time of my inspection was 357,265km.
5. The Motor Car was observed to have sustained damage at its rear portion. Its rear bumper, rear body panel and rear bumper was the body parts that were damaged as a result of the accident.

**Photo 1** shows the mileage of the Motor Car at the time of my inspection. The mileage observed was 357,265km.

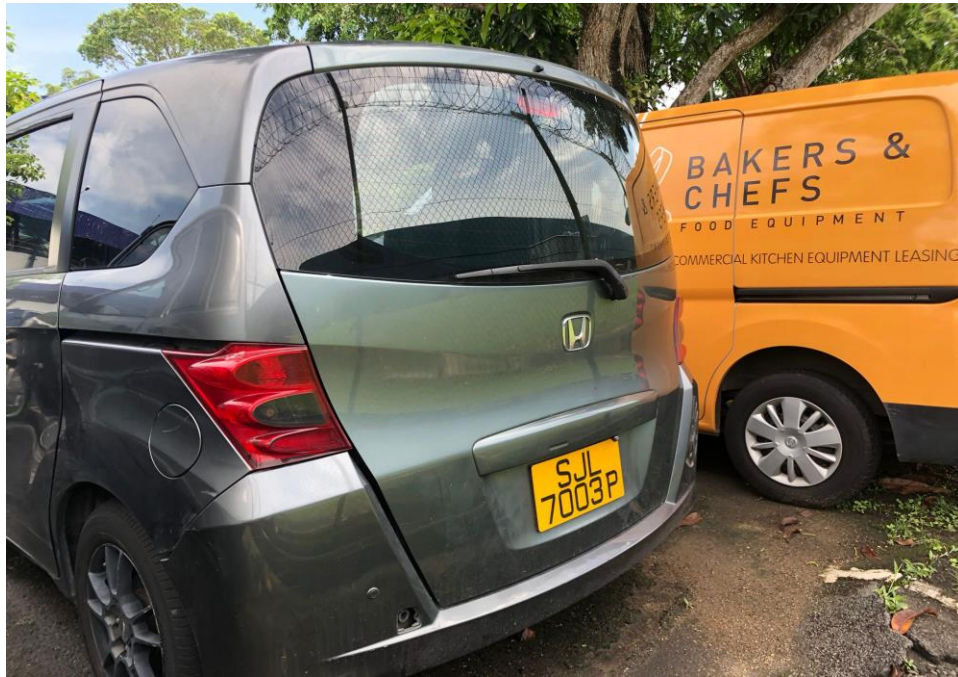
**Photo 2** shows a general view of the Motor Car's rear body at the time of my inspection. The rear portion. Its rear body panel and rear bumper was the body parts that were damaged as a result of the accident.

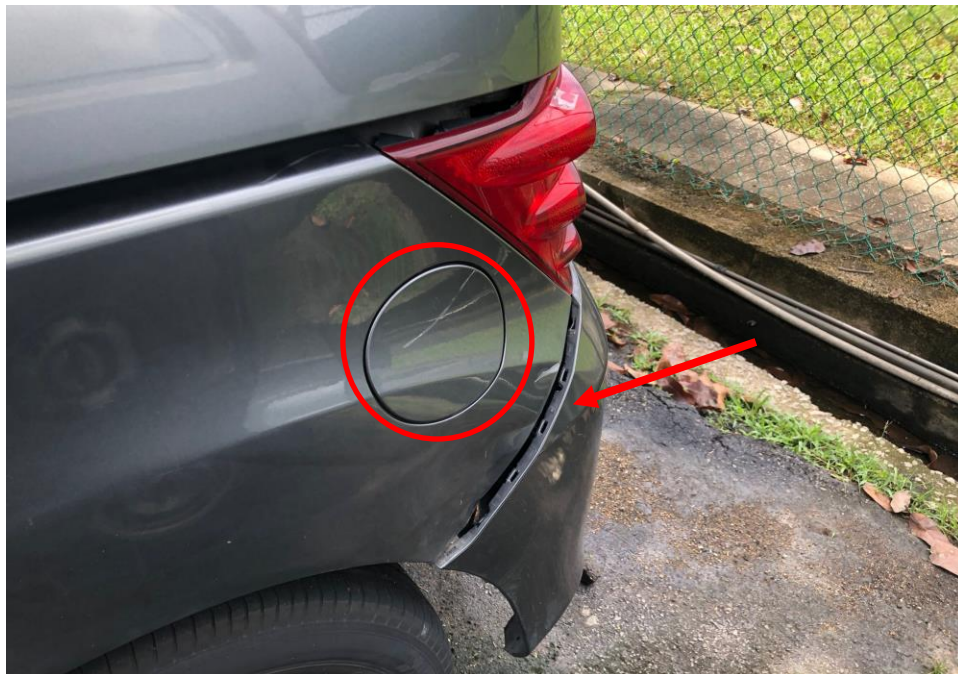
**Photo 3** shows a close up view of the Motor Car's rear body at the time of my inspection. The rear portion of the Motor Car was observed to have sustained damage. Its rear body panel (circled), and rear bumper (arrowed) was the body parts that were damaged as a result of the accident.

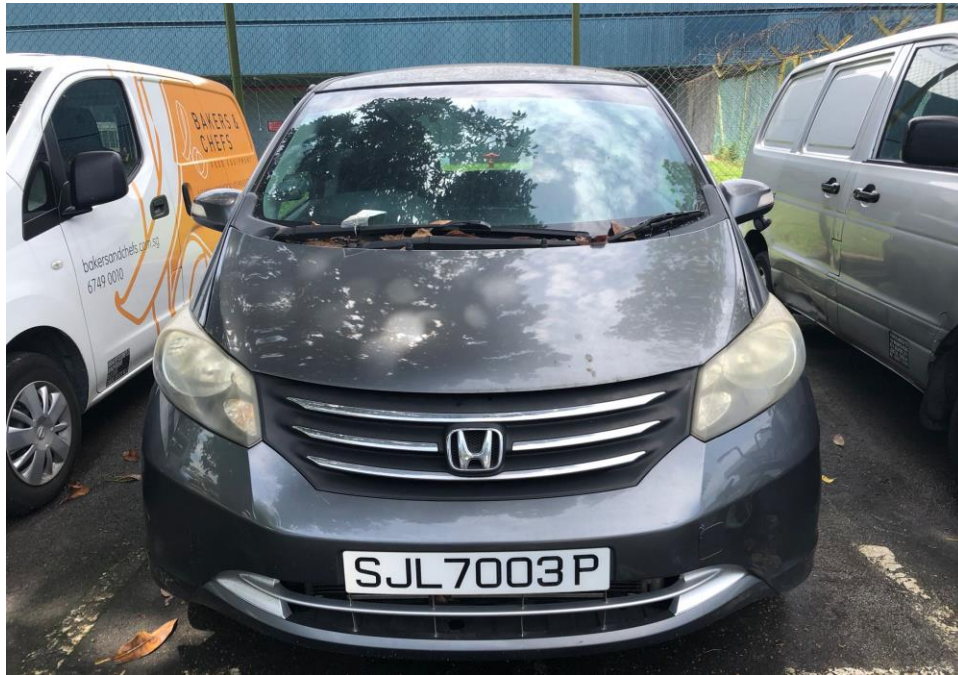
**Photo 4** shows a general view of the Motor Car's front body at the time of my inspection. The front portion of the Motor Car was observed to have been unaffected by the accident.

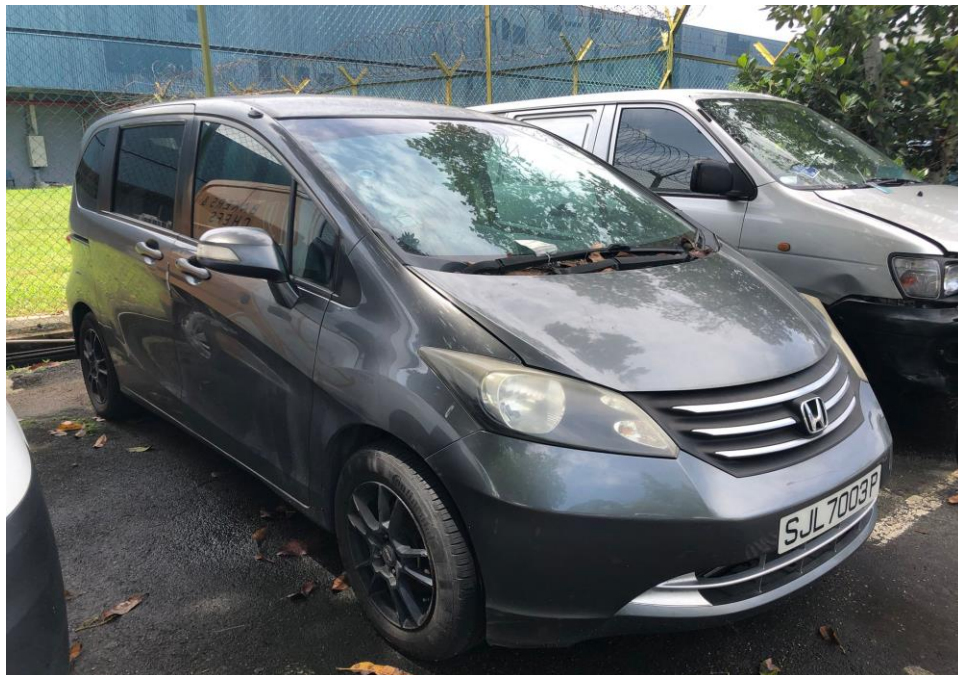
**Photo 5** shows a general view of the Motor Car's right body at the time of my inspection. The right portion of the Motor Car was observed to have been unaffected by the accident.

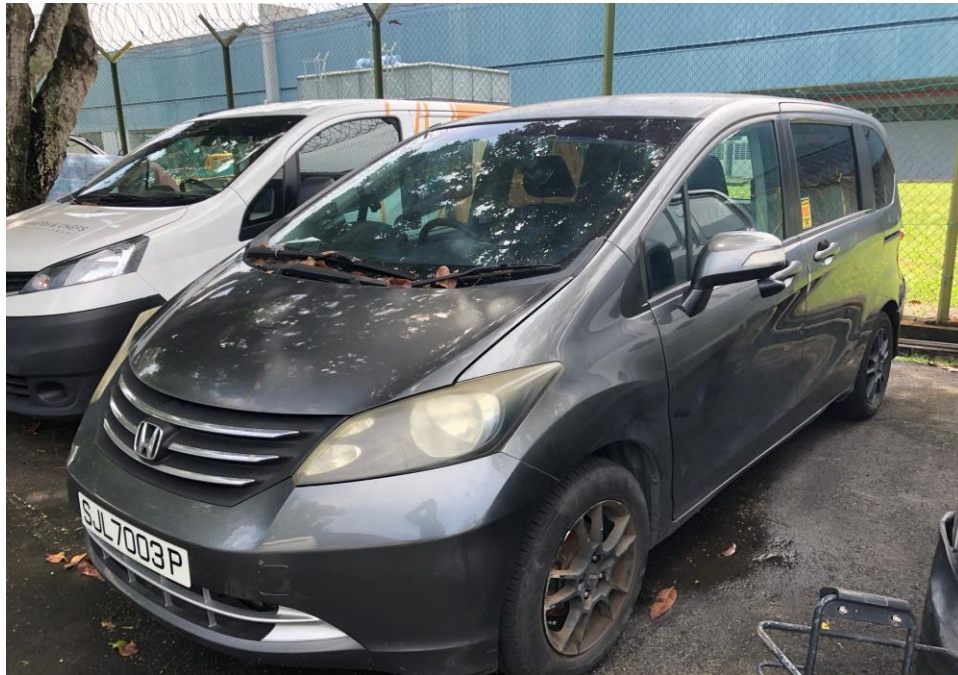
**Photo 6** shows a general view of the Motor Car's left body at the time of my inspection. The left portion of the Motor Car was observed to have been unaffected by the accident.

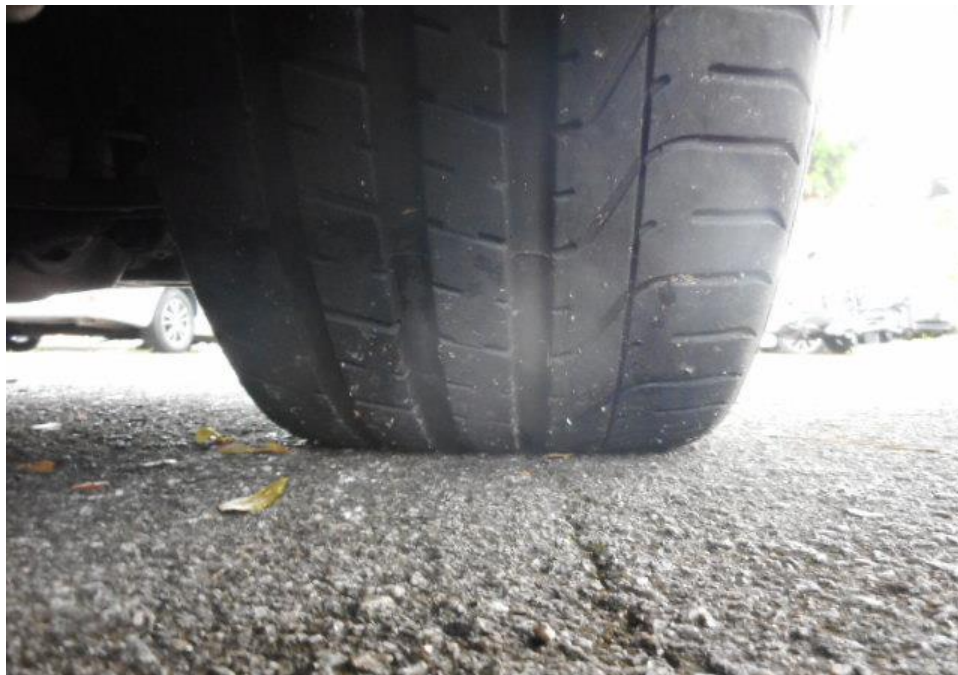
**Photo 7** shows the condition of the front right tyre of the Motor Car, which was observed to be in serviceable condition with remaining tread depth of approximately 5.7mm. The tyre was sufficiently inflated for vehicular operation with no tear, cut or burst mark(s) on the outer and the inner sidewalls as well as across the tread. The 4 tyres of the Motor Car were wrapped around standard steel wheel rims without any damage.

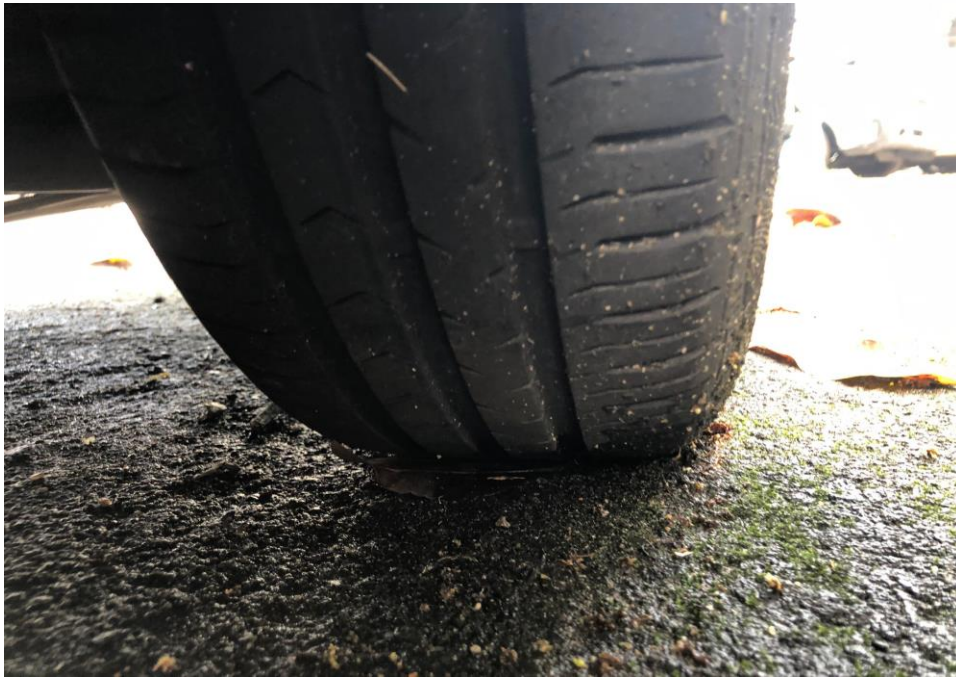
**Photo 8** shows the condition of the rear right tyre of the Motor Car, which was observed to be in serviceable condition with remaining tread depth of approximately 4.6mm. The tyre was also observed to be sufficiently inflated for vehicular operation with no tear, cut or burst mark(s).

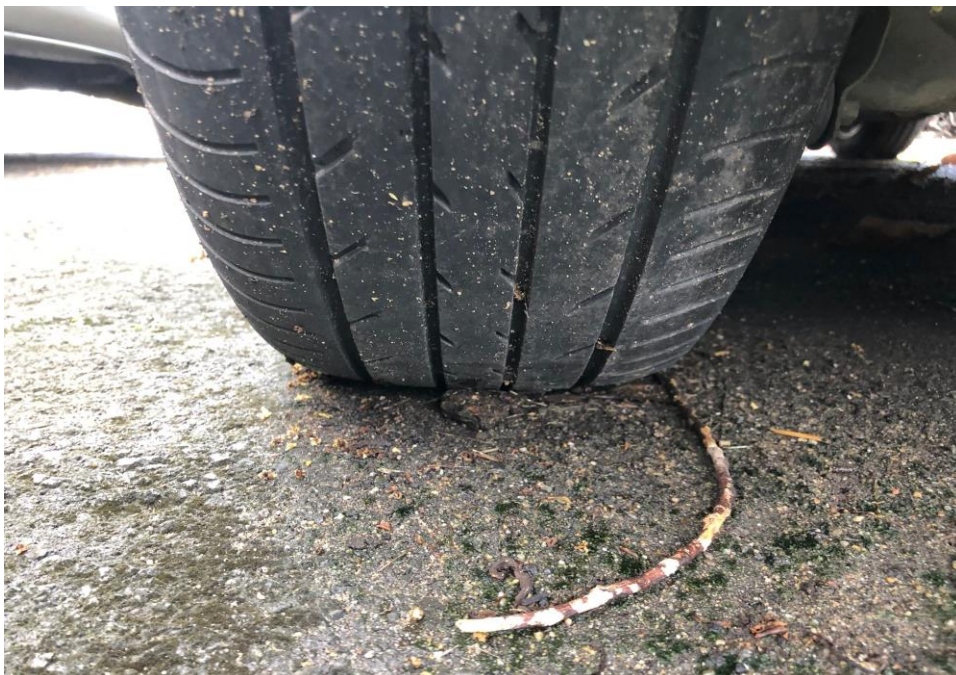
**Photo 9** shows the condition of the rear left tyre of the Motor Car, which was observed to be in serviceable condition with remaining tread depth of approximately 4.7mm. The tyre, which was wrapped around steel wheel rim, was also observed to be sufficiently inflated for vehicular operation. The 4 tyres of the Motor Car were wrapped around standard steel wheel rims.

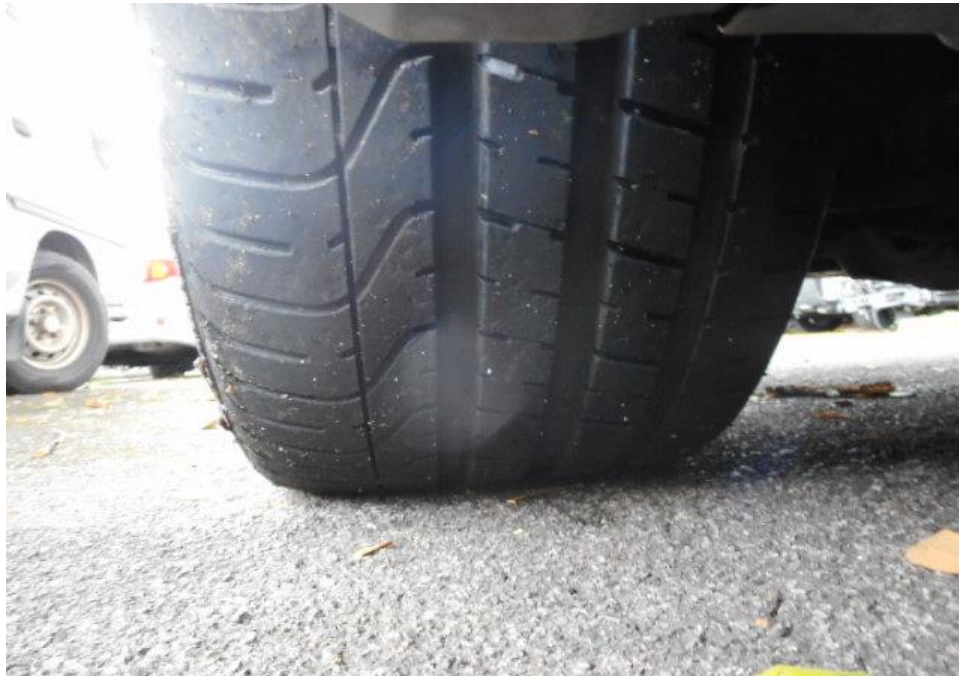
**Photo 10** shows the condition of the front left tyre of the Motor Car, which was observed to be in serviceable condition with remaining tread depth of approximately 5.7mm. There was also no tear, cut or burst mark(s) on the outer and the inner sidewalls as well as across the tread of the Motor Car's 4 tyres.

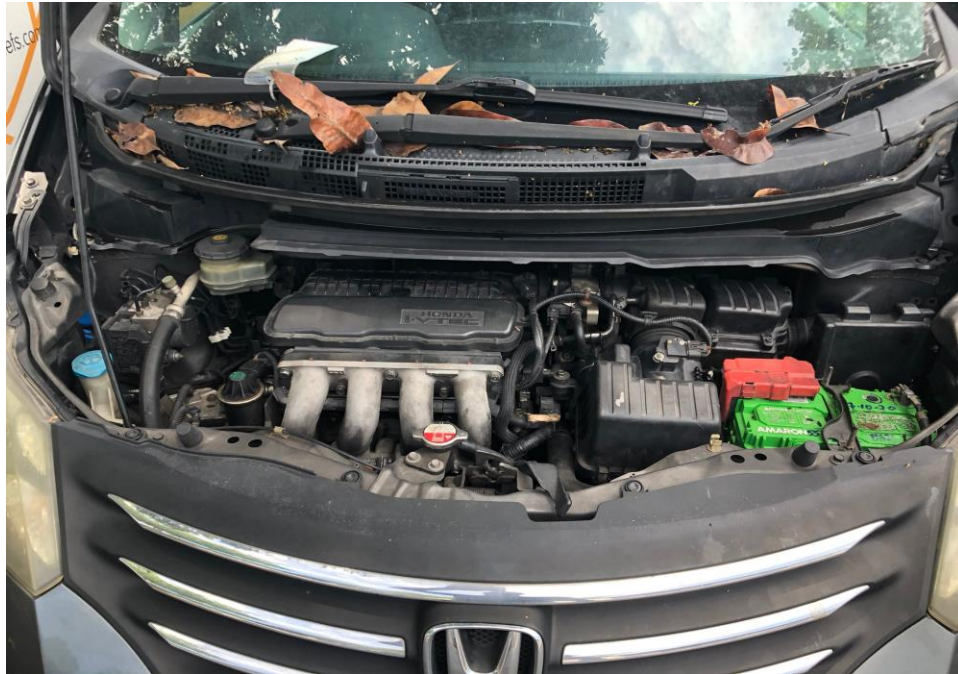
**Photo 11** shows a general view of the Motor Car's engine compartment. The various parts and components inside the engine compartment were unaffected by the accident. There was also no sign(s) or indication(s) of fluid leakage and/or fluid stain within the engine compartment.

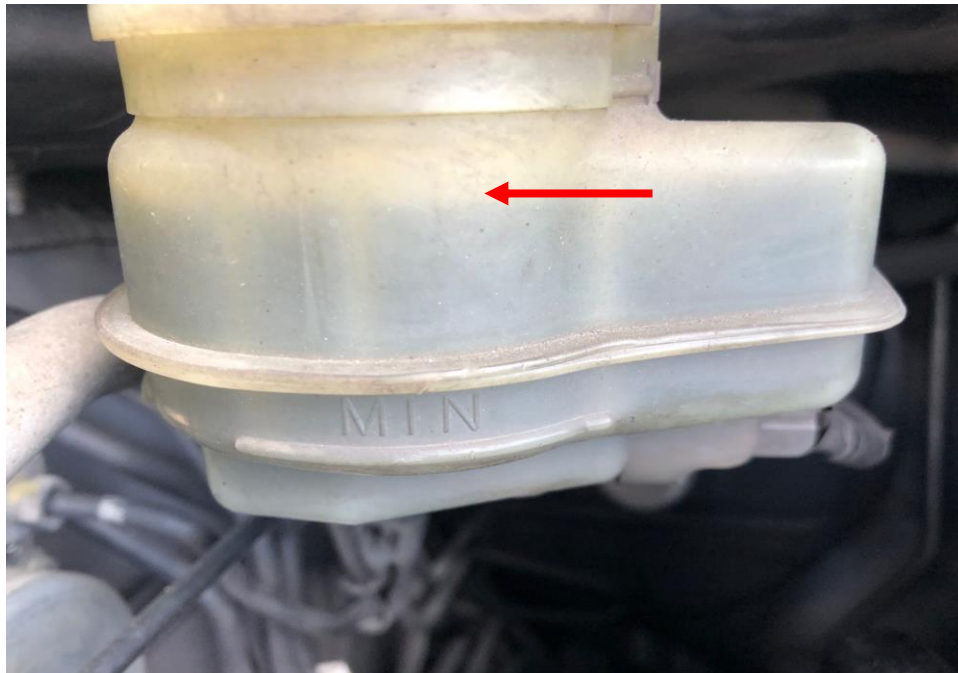
**Photo 12** shows the brake fluid reservoir of the Motor Car at the time of my inspection. The brake fluid was observed to be of sufficient level (arrowed) and without any visible contamination.

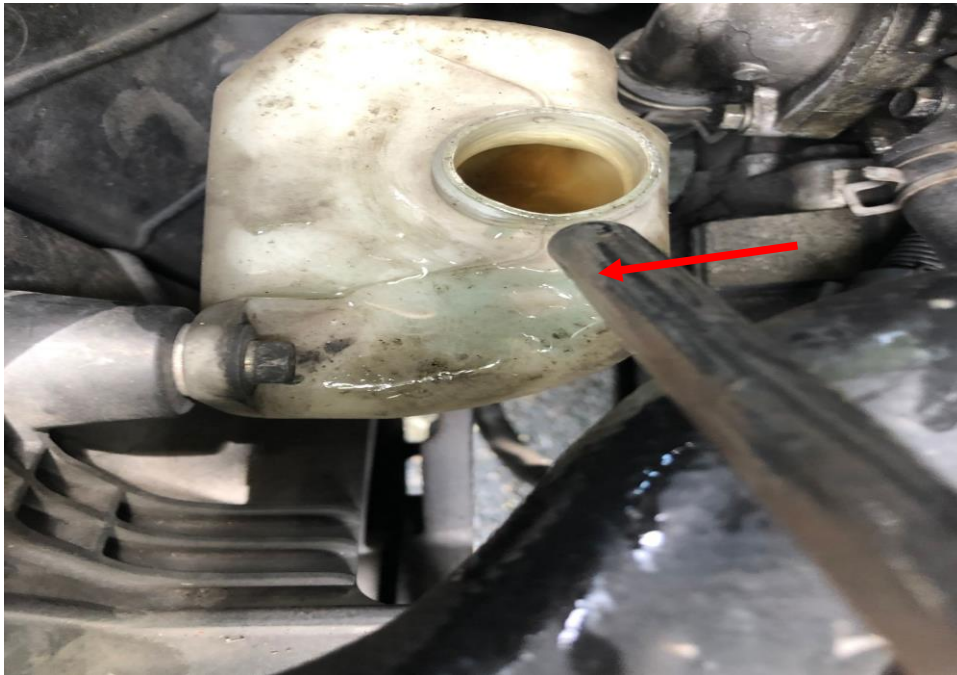
**Photo 13** shows checks being carried out to the engine coolant of the Motor Car at the time of my inspection. The engine coolant was observed to be of sufficient level (arrowed) and without any visible contamination.

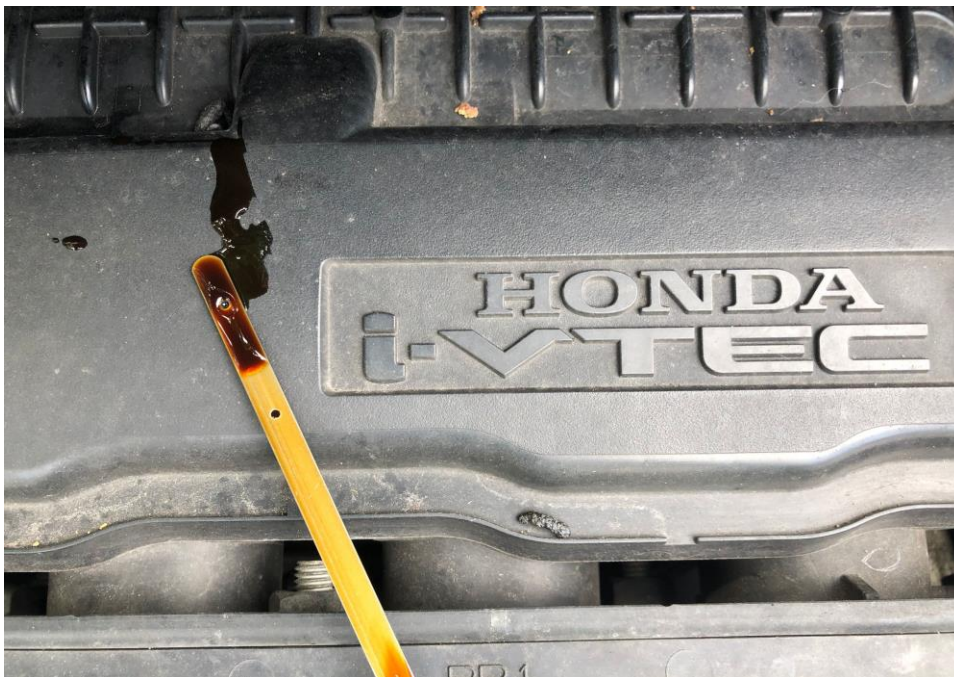
**Photo 14** shows the engine oil dipstick of the Motor Car at the time of my inspection. The engine oil was observed to be of sufficient level and without any visible contamination.

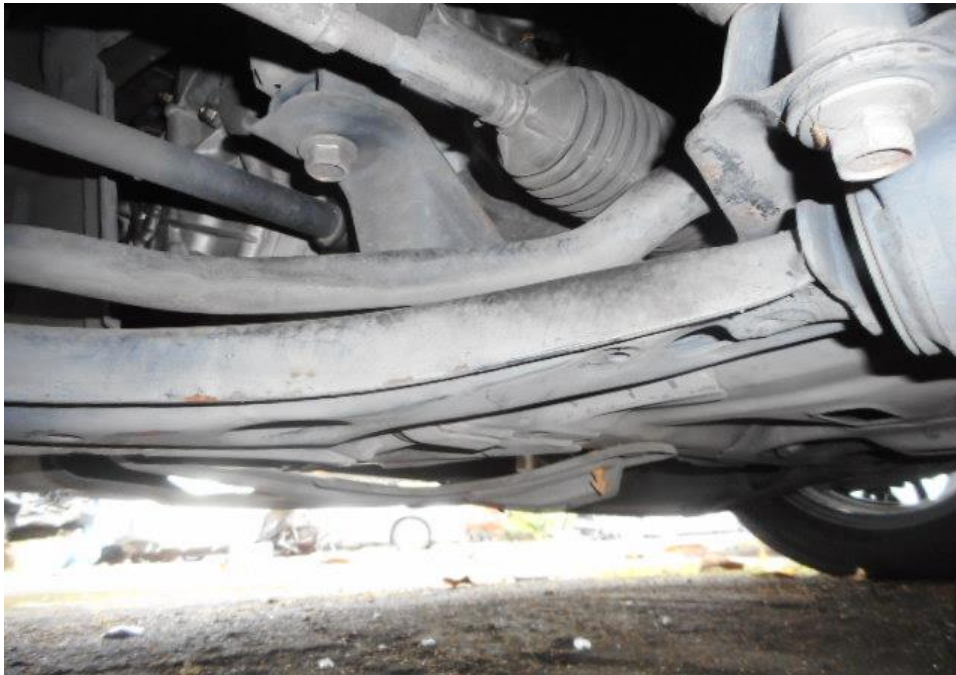
**Photo 15** shows the undercarriage of the Motor Car, at the area where the engine housing and transmission housing are located. I did not find any sign(s) or indication(s) of fluid leak and/or fluid stain(s) on the underside of the Motor Car.

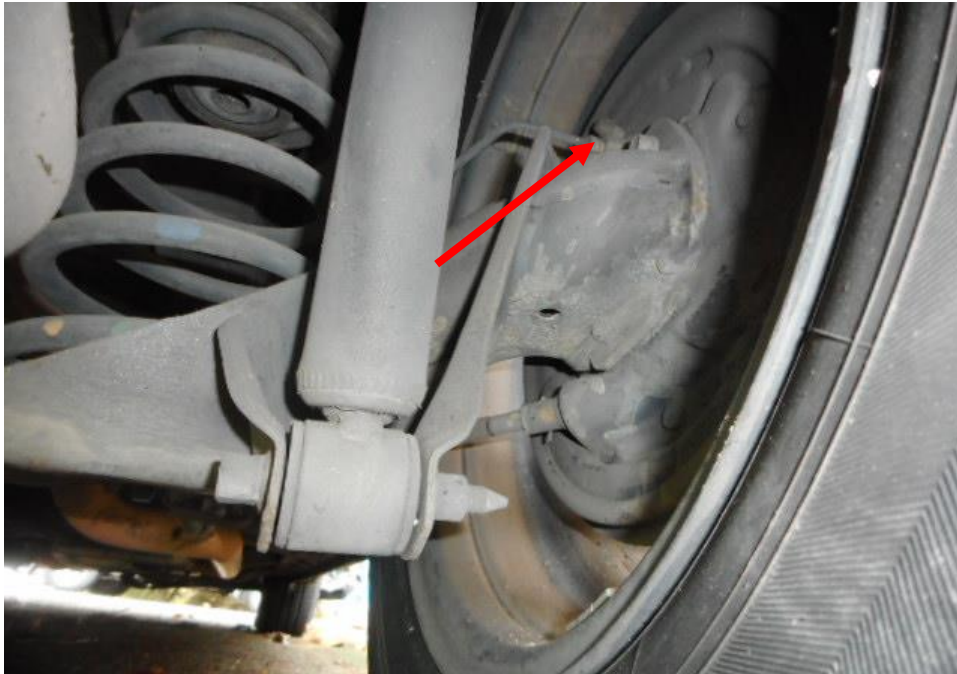
**Photo 16** shows the brake hose/pipe (arrowed) at the rear right wheel of the Motor Car. No leakage of brake fluid was observed. Visual examination of the various components of the braking system like the drum brake, brake booster, brake pedal etc. had revealed all to be intact and without visible damage.

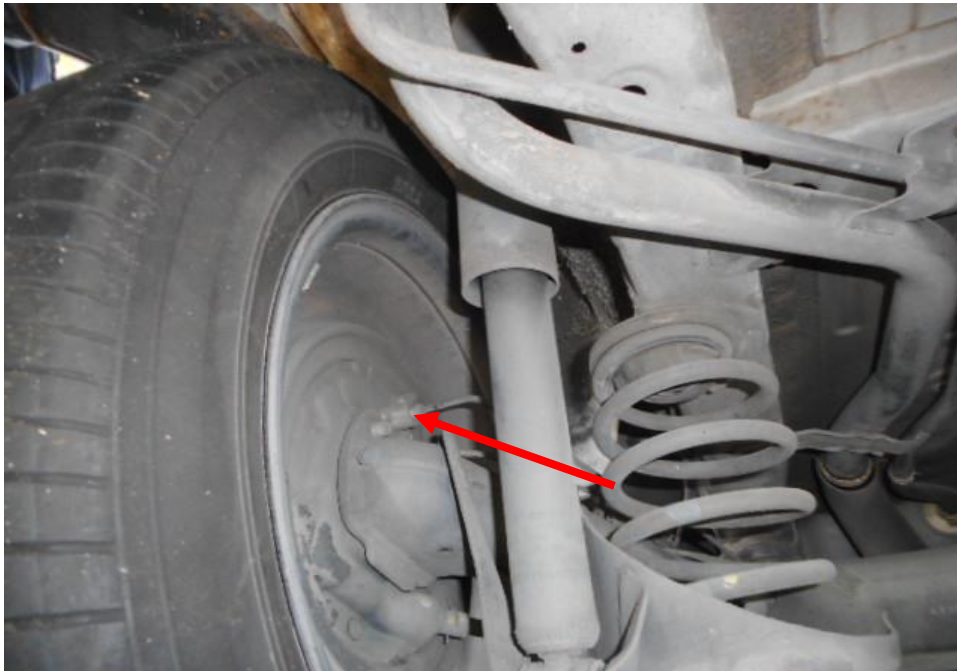
**Photo 17** shows the brake hose/pipe (arrowed) at the rear left wheel of the Motor Car. I did not observe any leakage of brake fluid at the time of my inspection of the Motor Car. Static tests of the Motor Car's braking system had indicated that there was no internal leakage of pressure/vacuum. The undercarriage components of the Motor Car were also all found to be intact and without any visible damage.

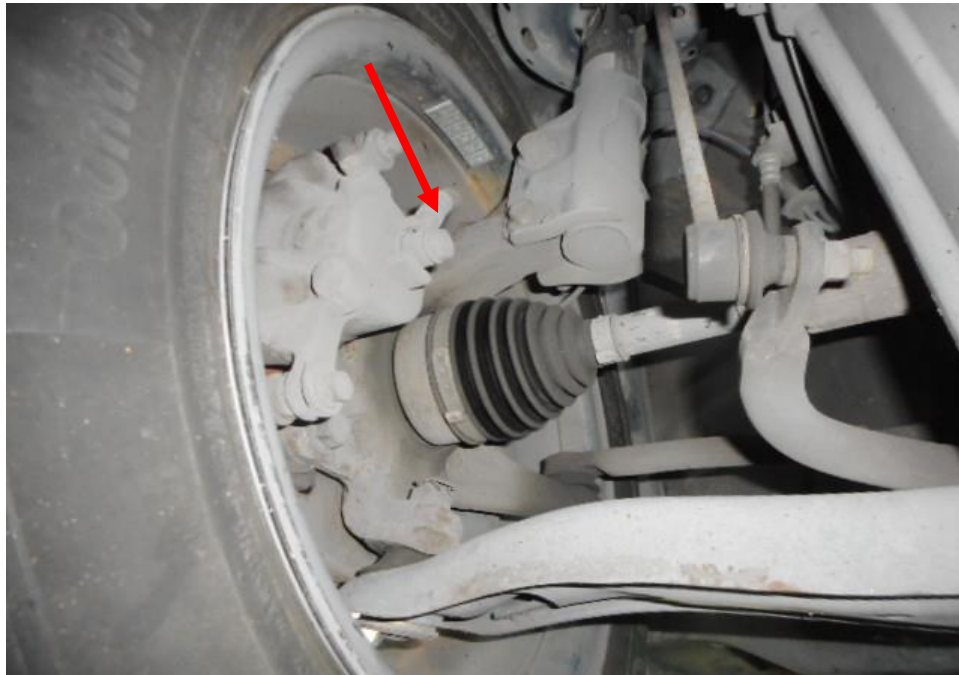
**Photo 18** shows the brake hose/pipe (arrowed) at the front right wheel of the Motor Car. I did not observe any leakage of brake fluid at the time of my inspection of the Motor Car. Static tests of the Motor Car's braking system had indicated that there was no internal leakage of pressure/vacuum. The undercarriage components of the Motor Car were also all found to be intact and without any visible damage.

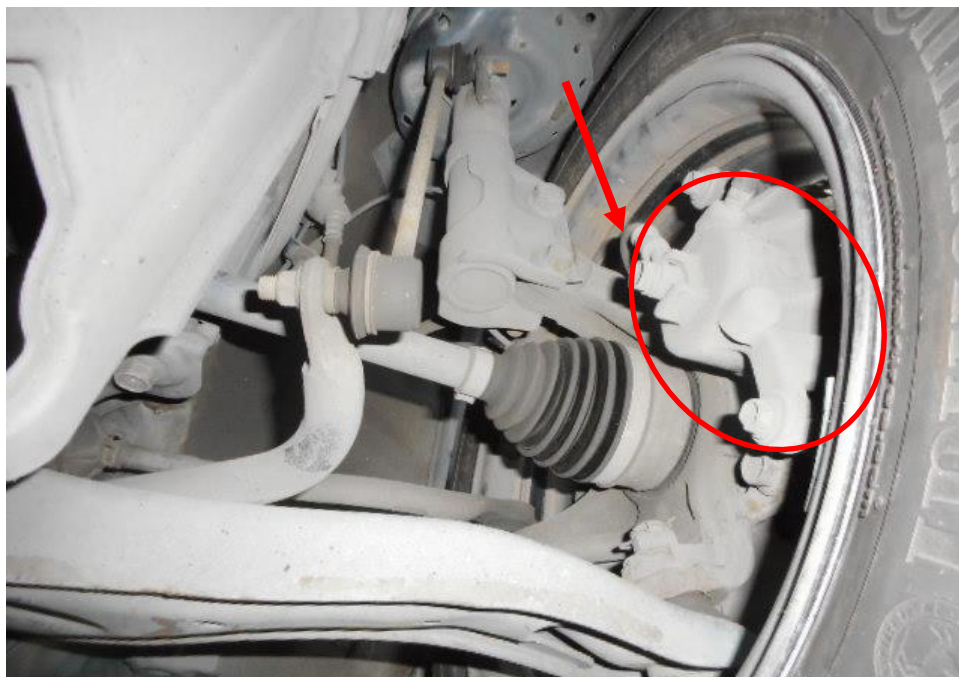
**Photo 19** shows the brake hose/pipe (arrowed) at the front left wheel of the Motor Car. No leakage of brake fluid was observed. Visual examination of the various components of the braking system like the brake caliper (circled), brake booster, brake pedal etc had revealed all to be intact and without visible damage.

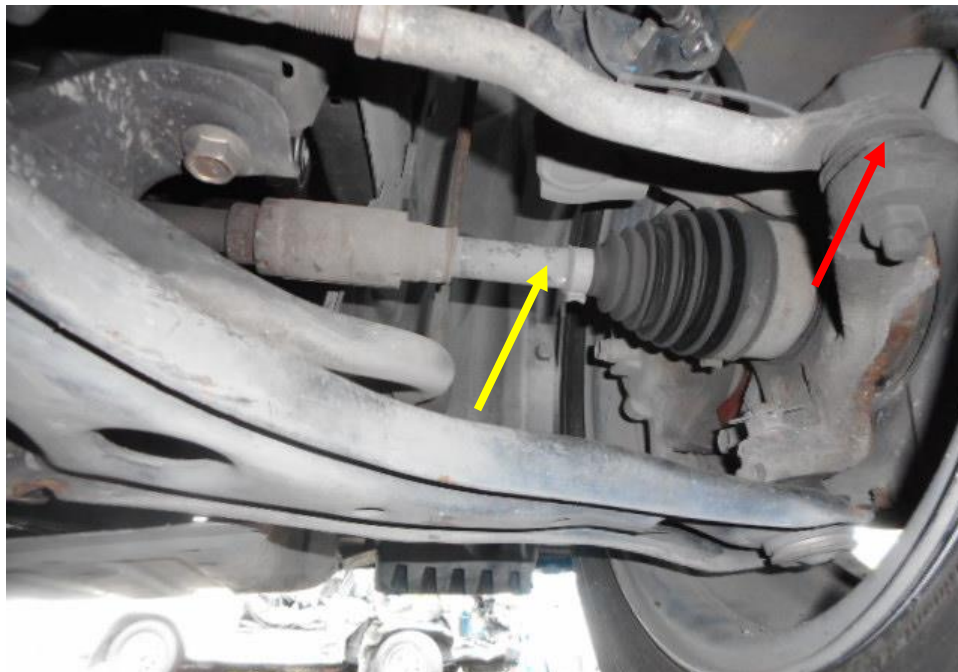
**Photo 21** shows the various undercarriage components at the front right wheel of the Motor Car, in particular the steering tie rod (red arrow) and its driveshaft (yellow arrow). The various steering components were all found to be intact, suggesting that the steering system of the Motor Car was likely to be in serviceable condition at the material time of accident. There was also no sign of fluid stain observed on the various undercarriage components at the front right wheel of the Motor Car.

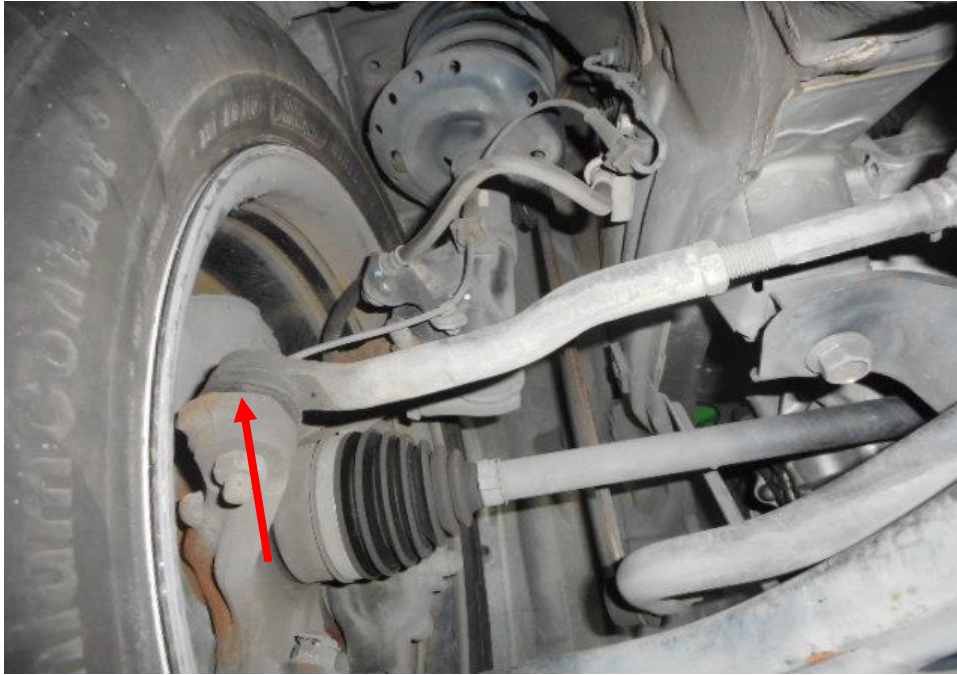
**Photo 22** shows the various undercarriage components at the front left wheel of the Motor Car, which had included the steering tie rod (red arrow). The various undercarriage components of the Motor Car were all found to be intact without any visible damage.

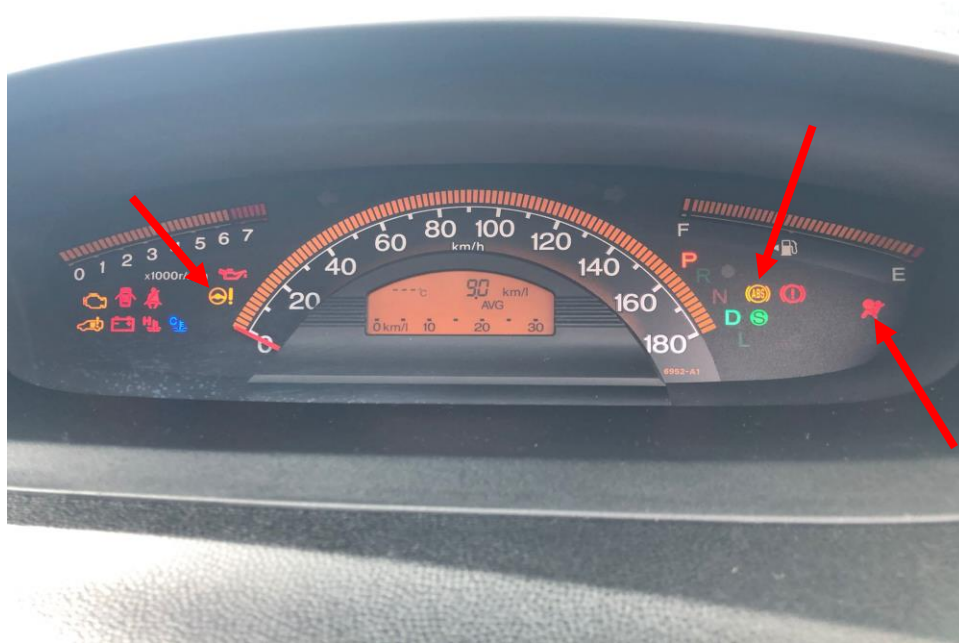
**Photo 23** shows the warning light for Anti-Lock Brake System (ABS), Traction Control System (TCS) and Supplemental Restraint System (SRS) (arrowed) appearing on the instrument panel of the Motor Car during the self-test of its various electronic operating systems when its engine was cranked.

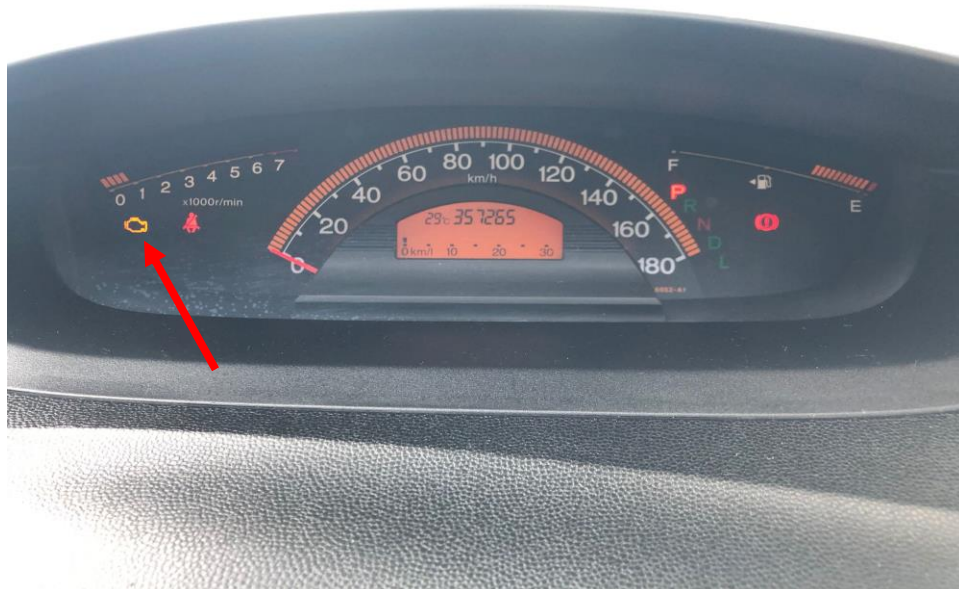
**Photo 24** shows no warning lights illuminated on the instrument panel of the Motor Car after the engine was cranked. Only the engine light (arrowed) remained illuminated on, this is due to a pre-existing fault in the system and did not affect the Motor Car in its operational test. However, this would suggest that there was no abnormality to the other electronic operating system of the Motor Car, like the ABS, TCS and SRS etc.
