Your Ref: TP/IP/08075/2022
Our Ref : CI/TPD22003619/P

Fatal Accident Investigation Team

MECHANICAL INSPECTION REPORT OF TIPPER TRUCK XE 3002P

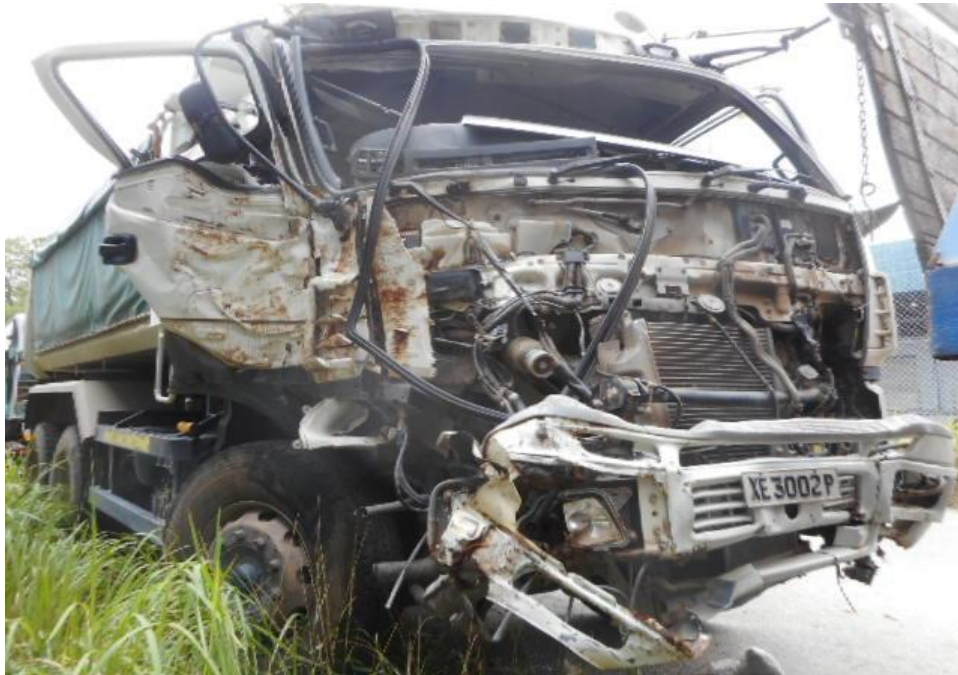
Photo 1 shows a general view of the front body of the Tipper Truck at the time of my inspection. The Tipper Truck was observed to have sustained damage at its frontal portion. Its front cabin, front windscreen, front body panel, front bumper, front left and right doors were amongst the body parts that were damaged as a result of the accident.

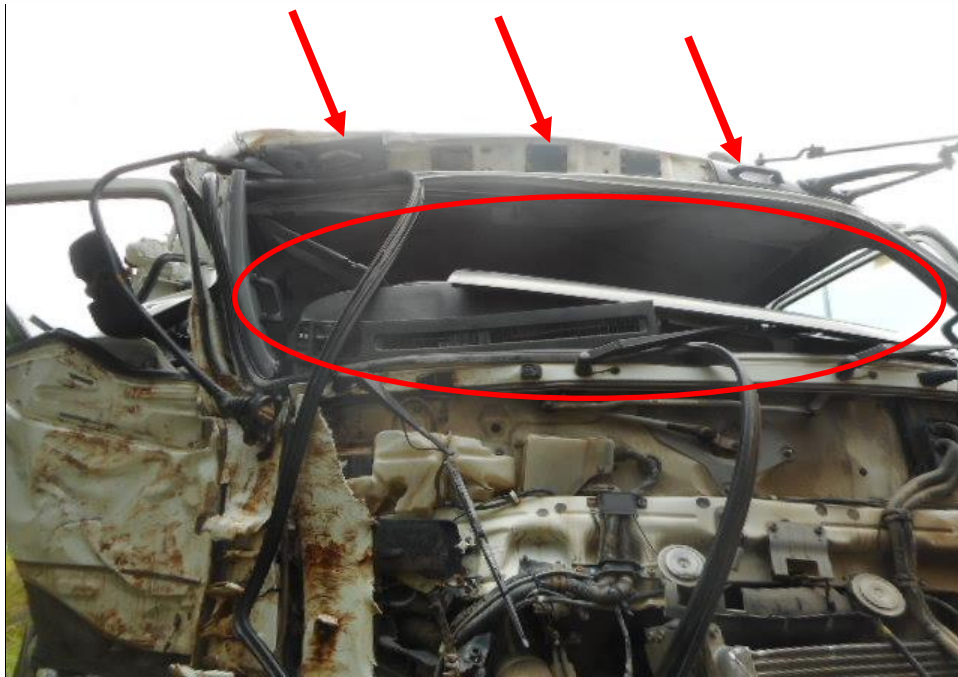
Photo 2 shows the close up view of the Tipper Truck front body at the time of my inspection. The Tipper Truck was observed to have sustained damage at its front cabin (arrowed) and front windscreen (circled), as a result of the accident.

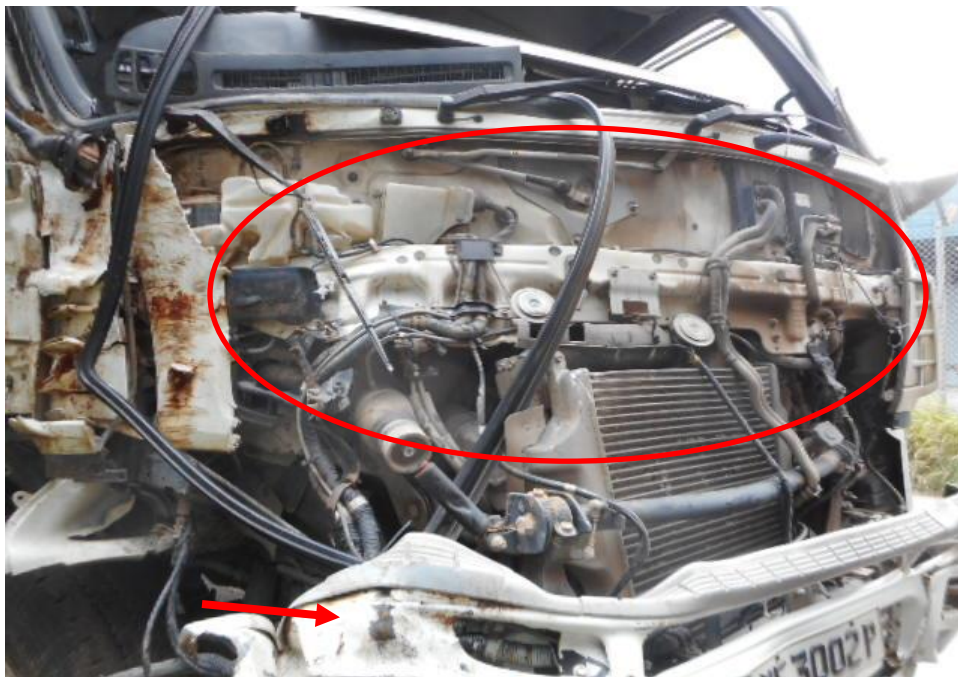
Photo 3 shows the close up view of the Tipper Truck front body at the time of my inspection. The Tipper Truck was observed to have sustained damage at its front body panel (circled) and front bumper (arrowed) was also damaged as a result of the accident.

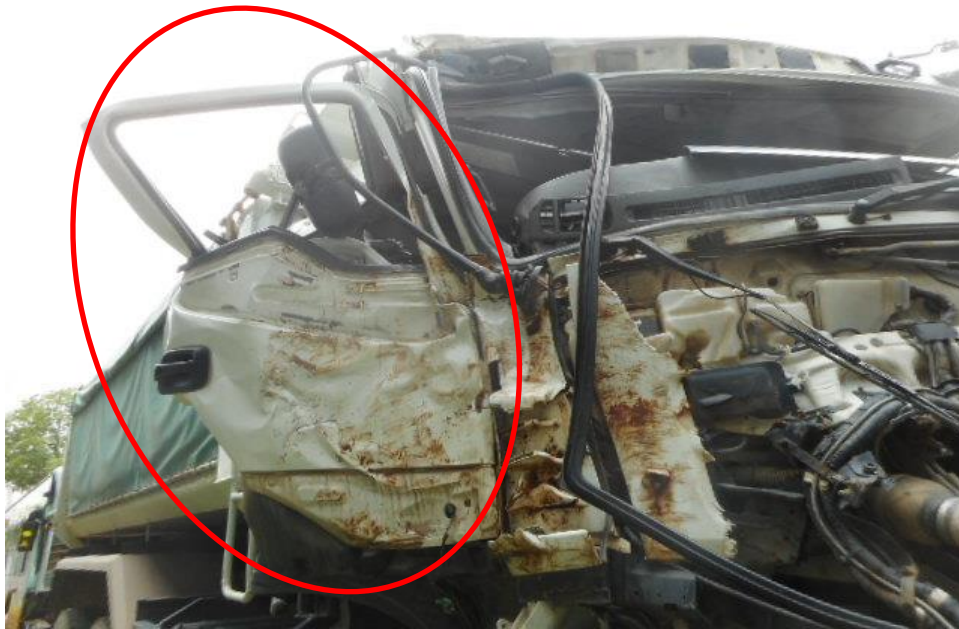
Photo 4 shows the close up view of the Tipper Truck front body at the time of my inspection. The Tipper Truck was observed to have sustained damage at its front right door (circled) as a result of the accident.

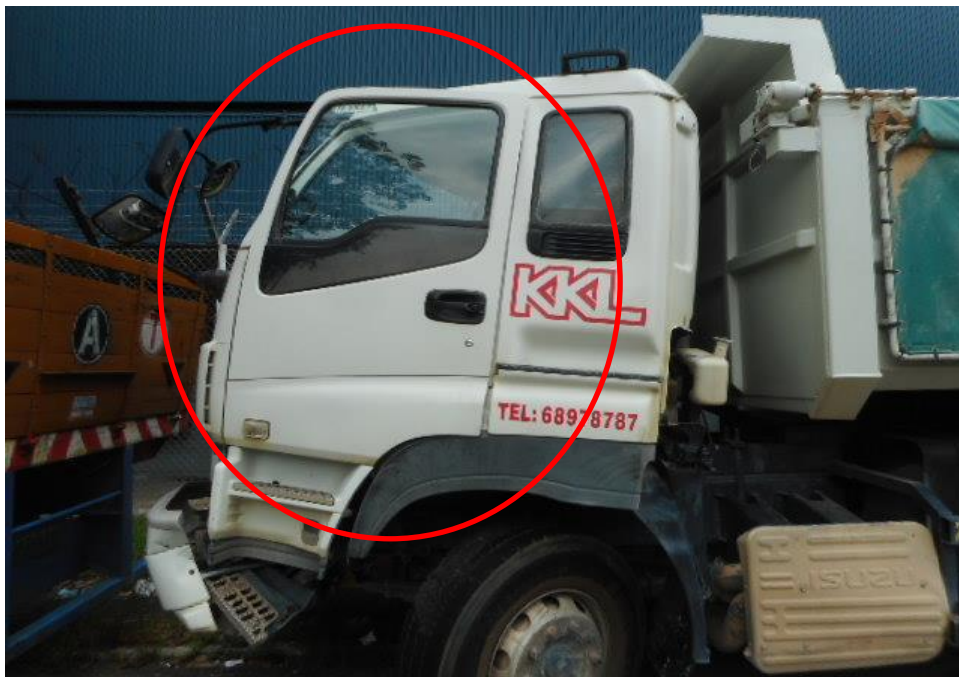
Photo 5 shows the close up view of the Tipper Truck front body at the time of my inspection. The Tipper Truck was observed to have sustained damage at its front left door (circled) as a result of the accident.

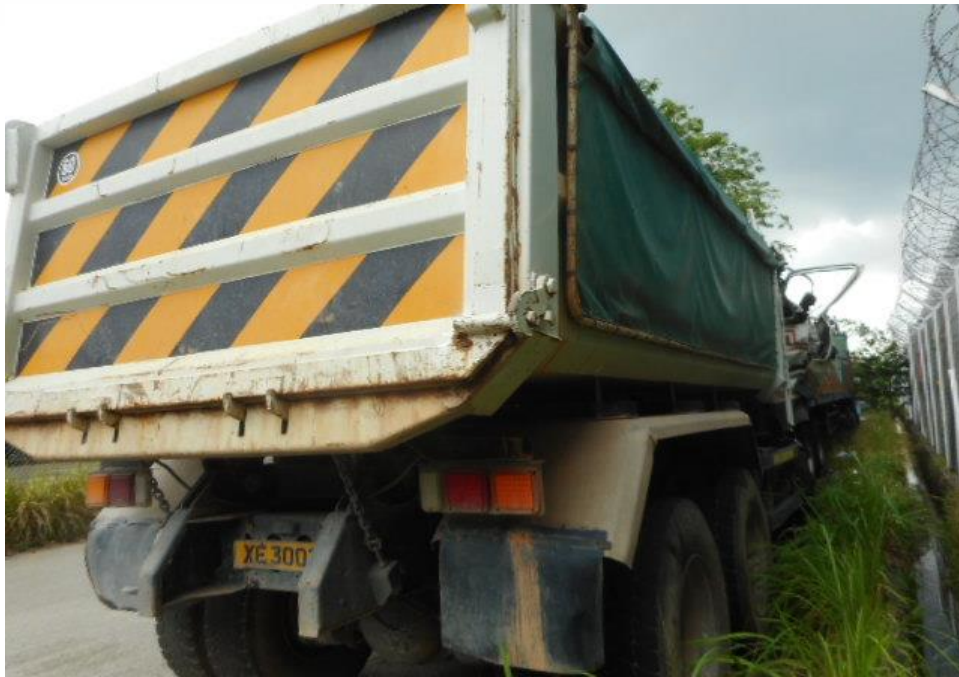
Photo 6 shows a general view of the right body of the Tipper Truck at the time of my inspection, it was observed to have been unaffected by the accident.

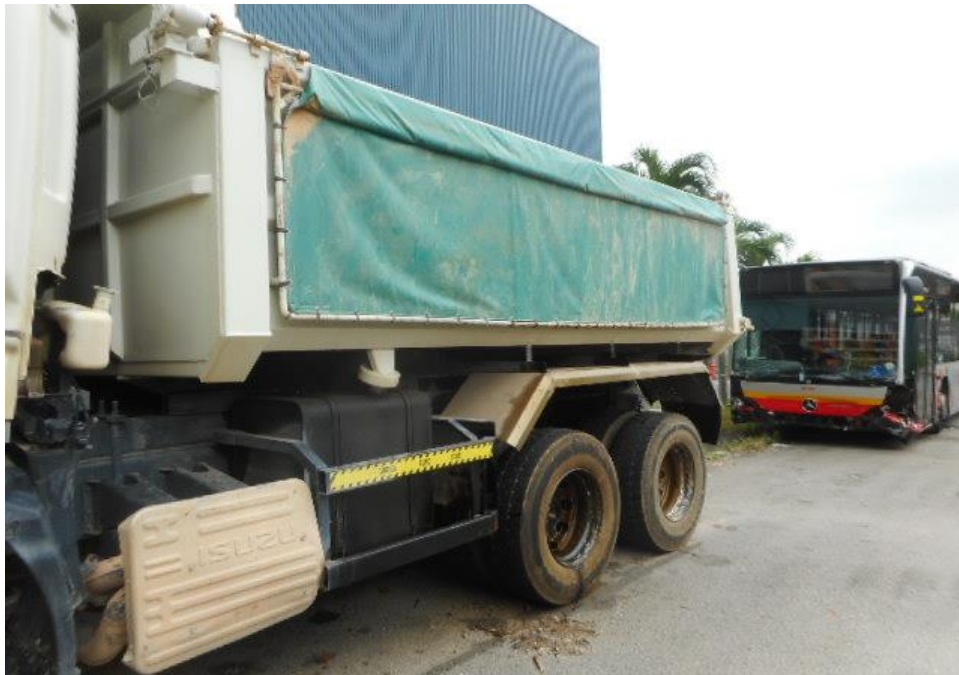
Photo 7 shows a general view of the left body of the Tipper Truck at the time of my inspection, it was observed to have been unaffected by the accident.

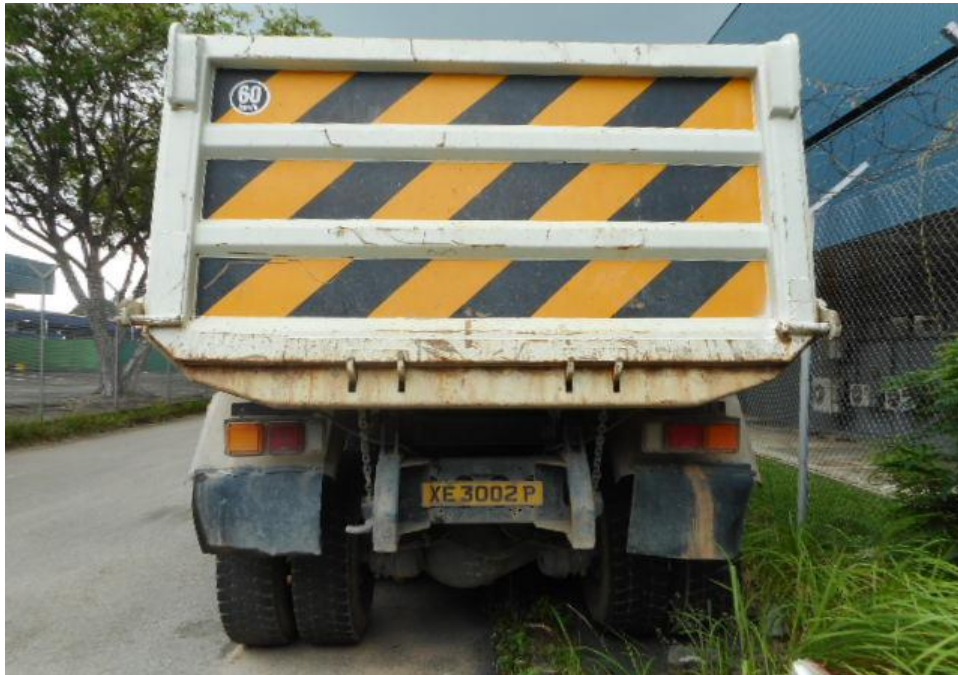
Photo 8 shows a general view of the Tipper Truck's rear body at the time of my inspection. There was no damage found to the rear portion of the Tipper Truck.

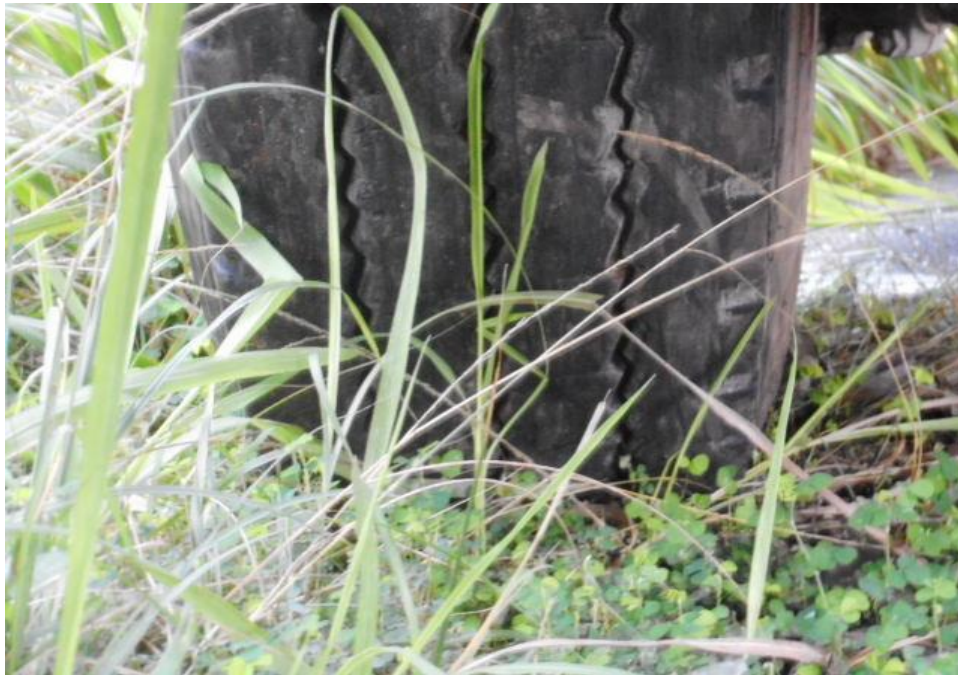
Photo 9 shows the condition of the front right tyre of the Tipper Truck, which was observed to be in serviceable condition with remaining tread depth of approximately 8.7 mm. The tyre, which was wrapped around standard steel wheel rim, was also observed to be sufficiently inflated for vehicular operation. There was no tear, cut or burst mark(s) on the outer and the inner sidewalls as well as across the tread of the 10 tyres that were fitted on the Tipper Truck.

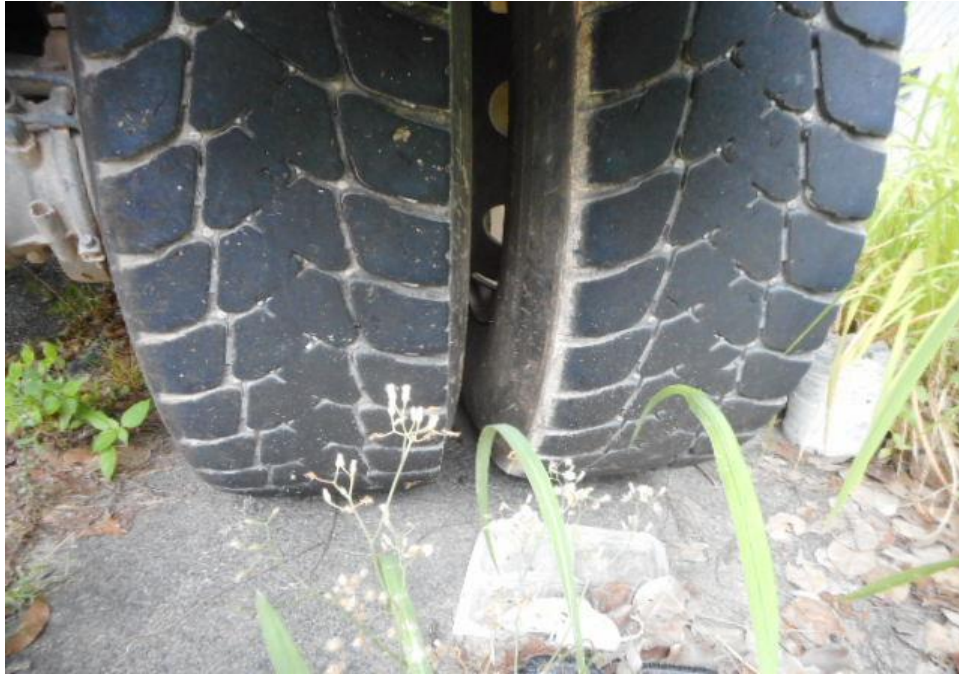
Photo 10 shows the condition of the rear right tyre of the Tipper Truck, which was observed to be in serviceable condition with remaining tread depth of approximately 6.1mm. The tyre, which was wrapped around standard steel wheel rim, was also observed to be sufficiently inflated for vehicular operation.

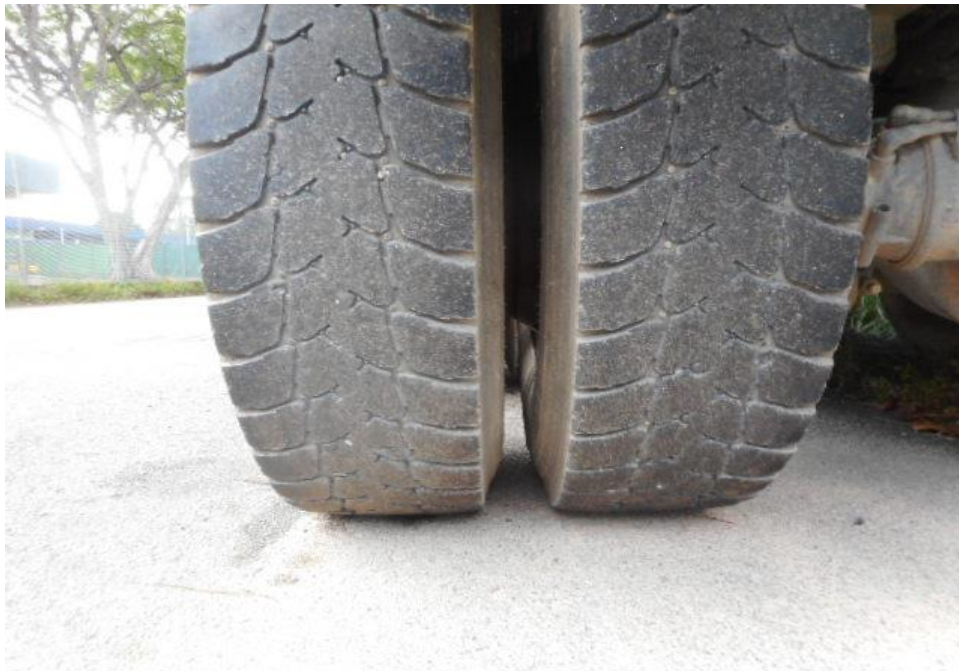
Photo 11 shows the condition of the rear left tyres of the Tipper Truck, which was observed to be in serviceable condition with remaining tread depth of approximately 5.8mm. The tyres, which were wrapped around standard steel wheel rim, were also observed to be sufficiently inflated for vehicular operation. There was also no damage found on all 10 steel wheel rims of the Tipper Truck.

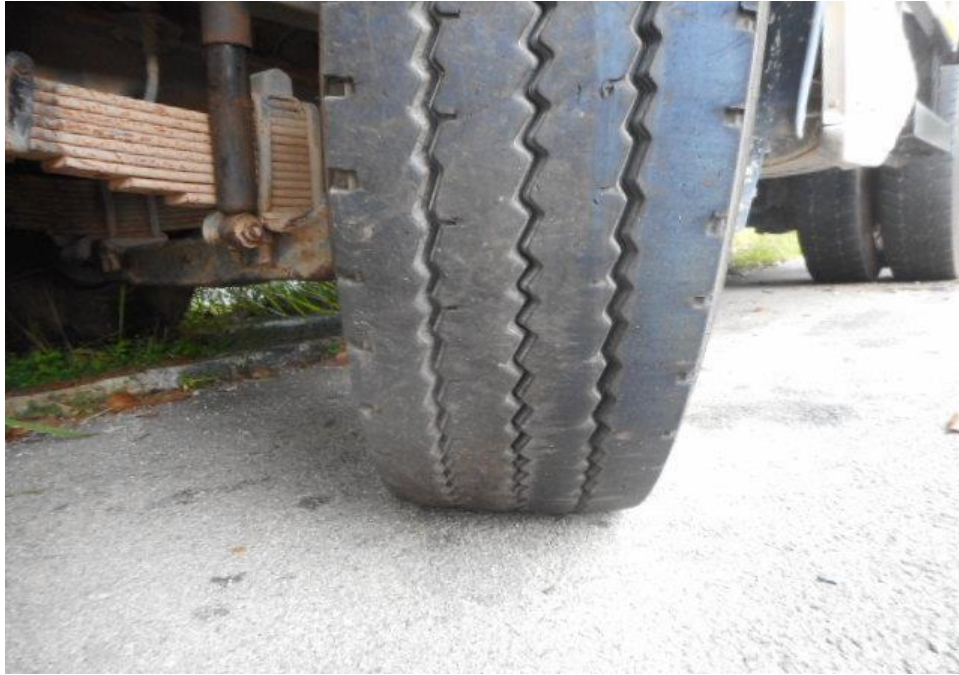
Photo 12 shows the condition of the front left tyres of the Tipper Truck, which were observed to be in serviceable condition with remaining tread depth of approximately 11.7mm. There was also no tear, cut or burst mark(s) on the outer and the inner sidewalls as well as across the tread of the 10 tyres that were fitted on the Tipper Truck.

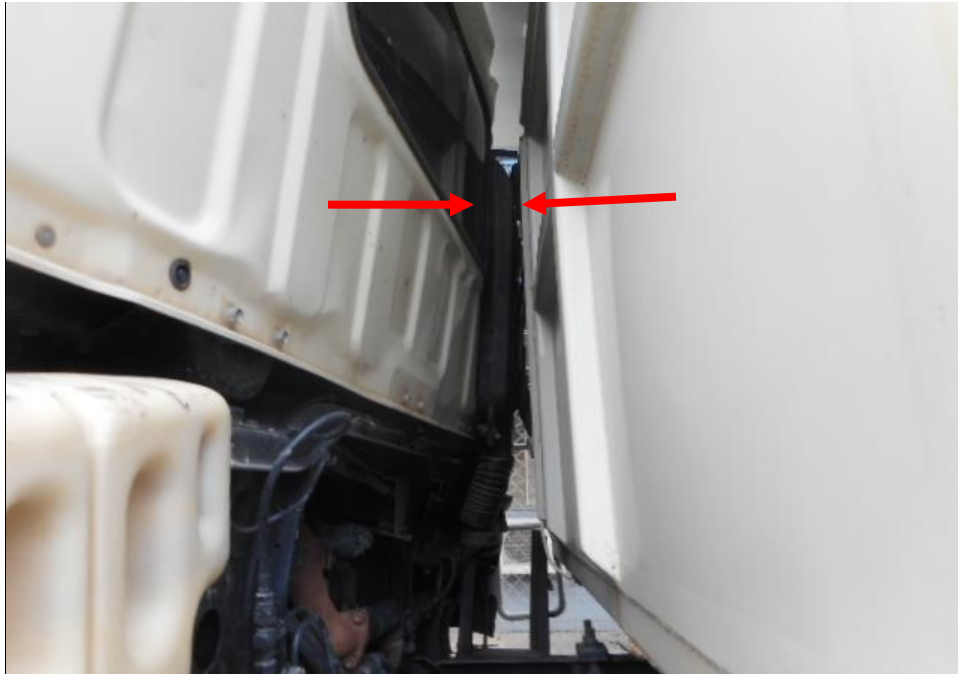
8. The engine compartment of the Tipper Truck was located below the front cabin of the Tipper Truck. I was not able to carry out any checks on the engine compartment as the cabin of the Tipper Truck was not able to be lifted to view the engine compartment as the cabin is damaged as a result of the accident.
9. However, we were able to view the engine coolant and the power steering fluid which were located outside of the engine compartment. They were observed to be sufficient level for operating purposes and there was no contamination found to these fluids See photo 13 - 15 below.

Photo 13 shows the close up view of the Tipper Truck front underside at the time of my inspection. The Tipper Truck was observed to have sustained damage at its engine, its oil hoses (red arrow) and radiator (yellow arrow) was also damaged as a result of the accident.

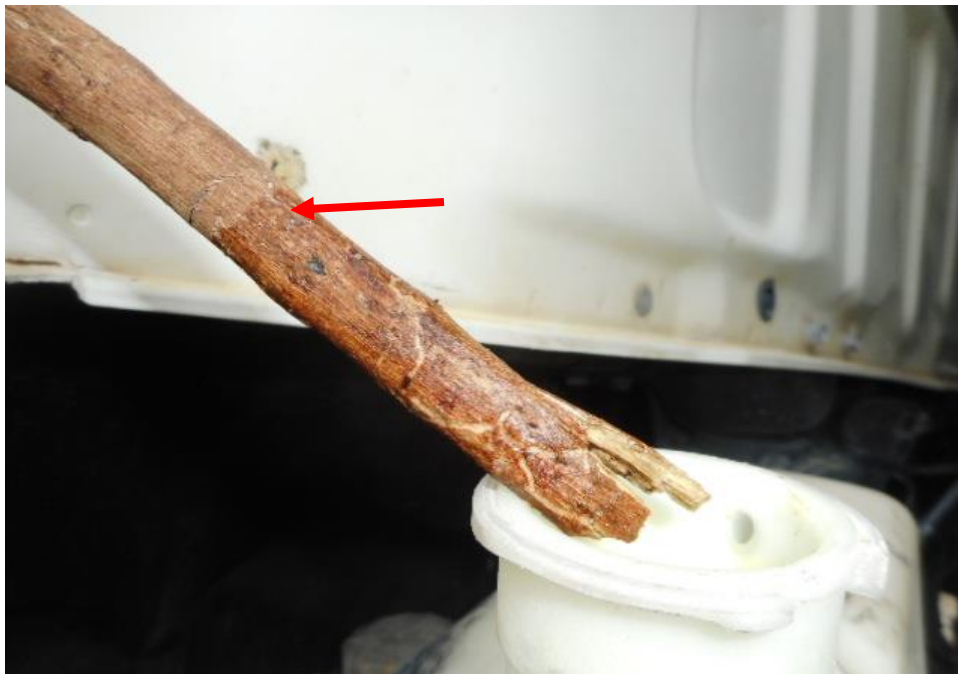
Photo 14 shows checks being carried out to the engine coolant of the Tipper Truck at the time of my inspection. The engine coolant was observed to be of sufficient level (arrowed) and without any visible contamination.

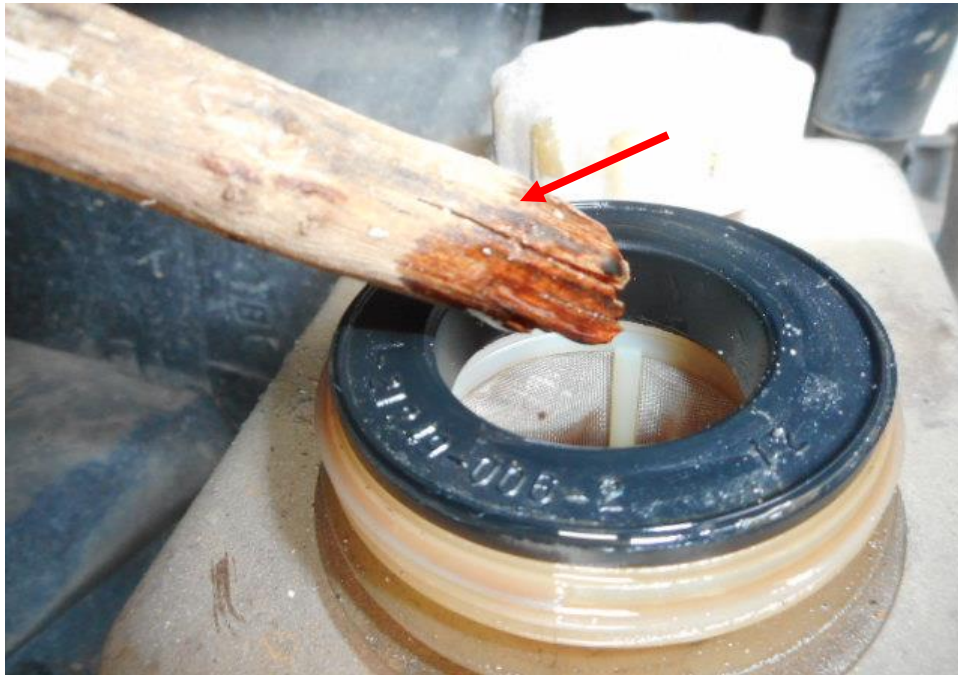
Photo 15 shows checks being carried out to the power steering fluid of the Tipper Truck at the time of my inspection. The power steering fluid was observed to be of sufficient level (arrowed) and without any visible contamination.

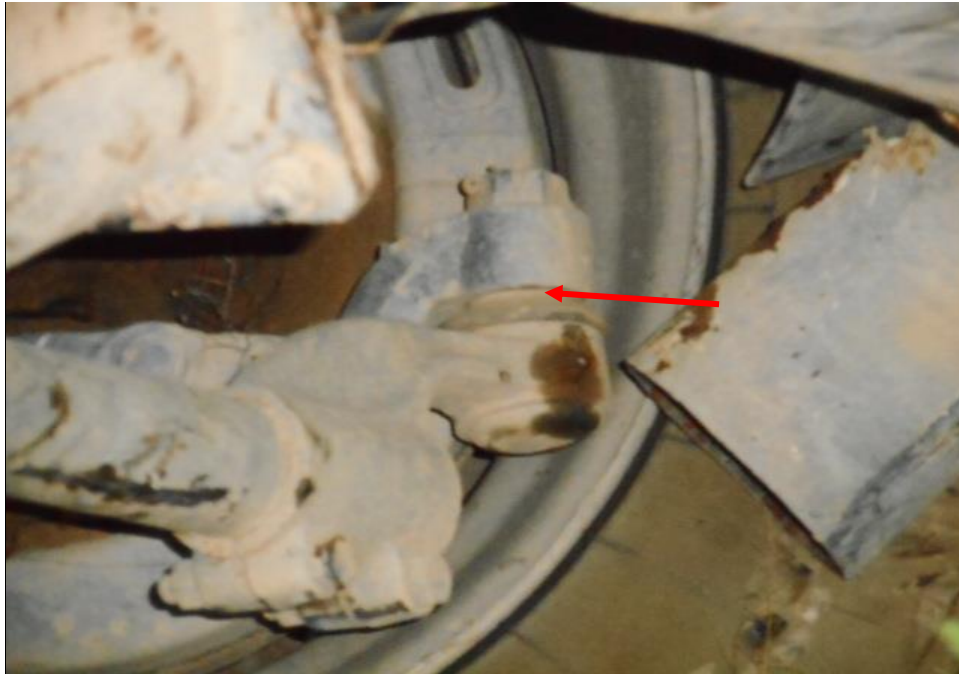
Photo 16 shows the various undercarriage components at the front right wheel of the Tipper Truck, in particular the steering tie rod end (arrowed). The various steering components were all found to be intact, suggesting that the steering system of the Tipper Truck was likely to be in serviceable condition at the material time of accident. There was also no sign of fluid stain(s) observed on the various undercarriage components.

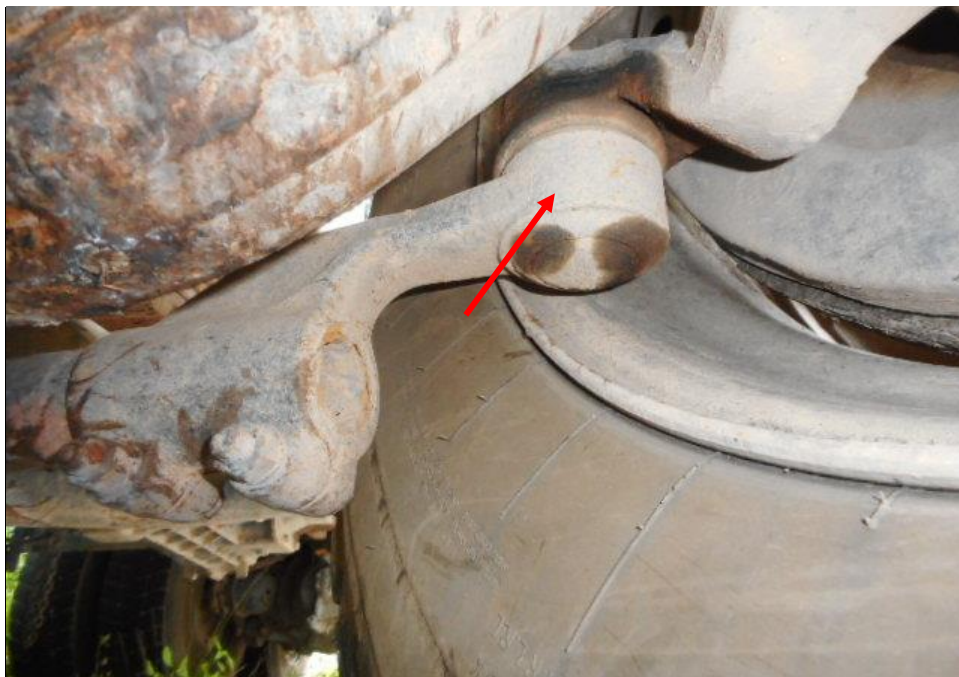
Photo 17 shows the various undercarriage components at the front left wheel of the Tipper Truck, in particular the steering tie rod end (arrowed). The various undercarriage components of the Tipper Truck were all found to be intact without any visible damage. There was also no sign of fluid stain(s) observed on the various undercarriage components.

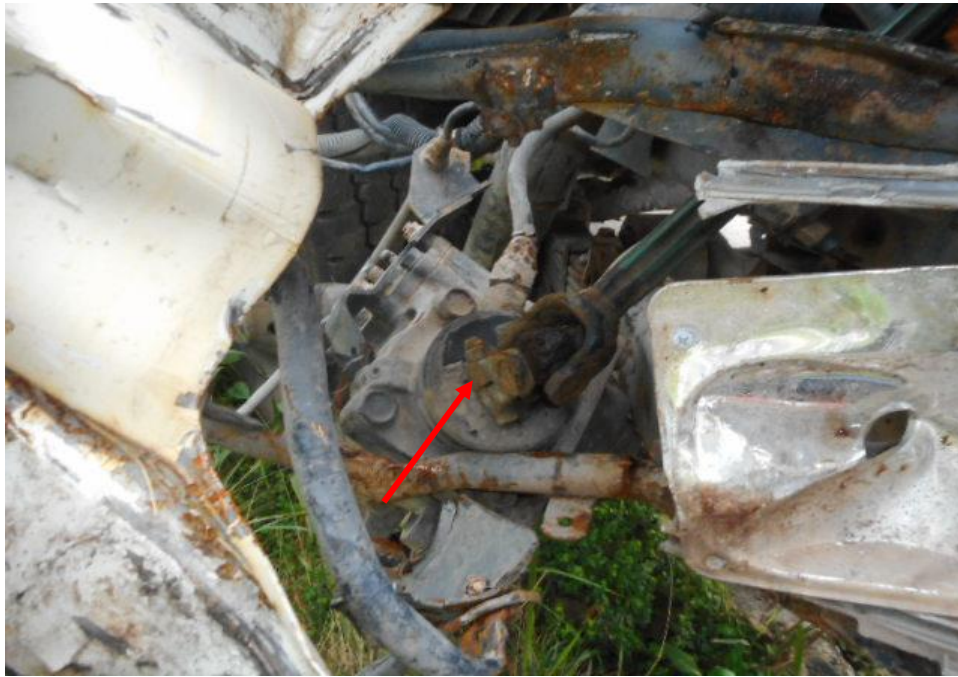
10. The steering box component was observed to be damaged as a result of the accident. However, the steering shaft and steering rack of the Tipper Truck were observed to be intact and securely attached to the front left wheel and front right wheel. The steering ball joints were also observed to be in a serviceable condition.
11. The steering system could not be tested at the time of my inspection, due to the block access to the cabin and the damaged steering box component. See photo 16 - 18 below.

Photo 18 shows the steering box component (arrowed) at the undercarriage of the Tipper Truck was found to be damaged as a result of the accident.

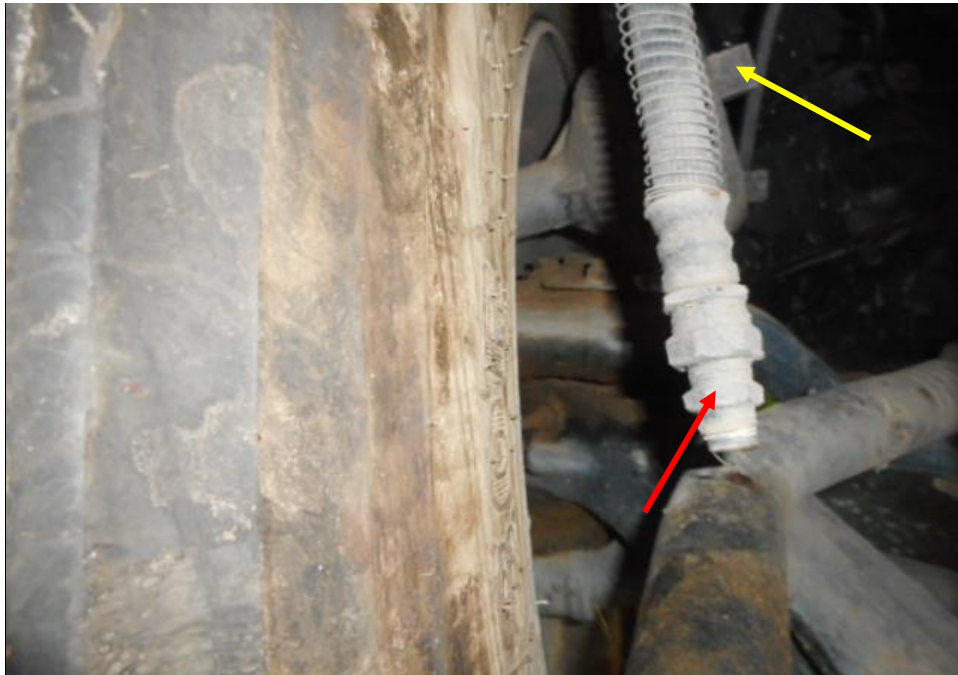
Photo 19 shows the brake pipe (red arrow) and the air brake unit (yellow arrow) of the front right wheel of the Tipper Truck, it was observed to be damaged and broken off as a result of the accident.

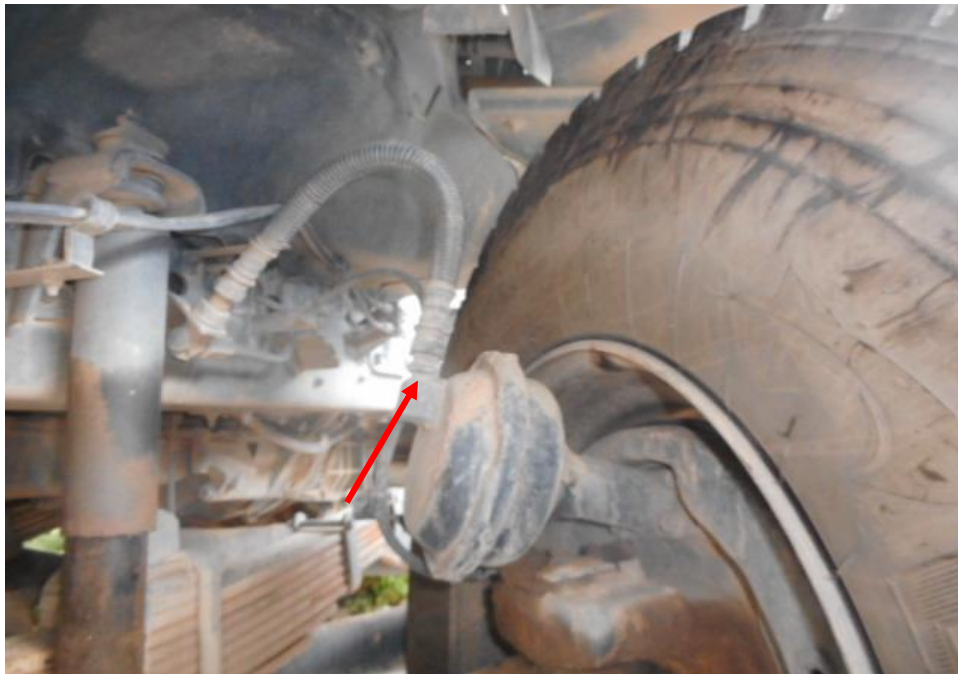
Photo 20 shows the brake pipe (arrowed) at the front left wheel of the Tipper Truck. I did not observe any leakage of brake fluid at the time of my inspection of the Tipper Truck and the various mechanical components was observed to be intact.

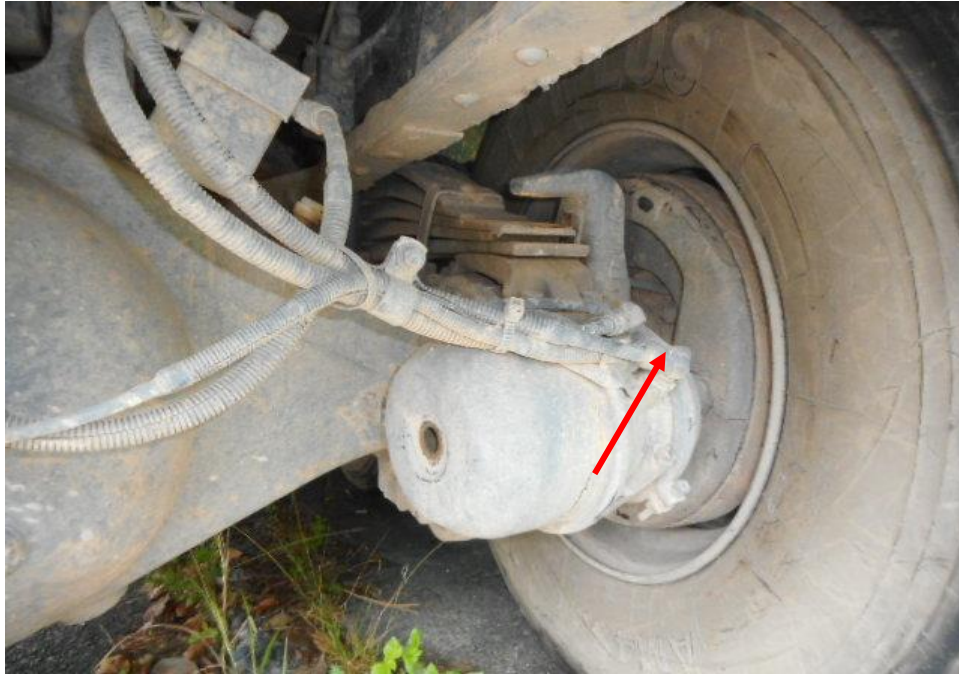
Photo 21 shows the brake pipe (arrowed) at the rear right wheel of the Tipper Truck. I did not observe any leakage of brake fluid at the time of my inspection of the Tipper Truck and the various mechanical components was observed to be intact.

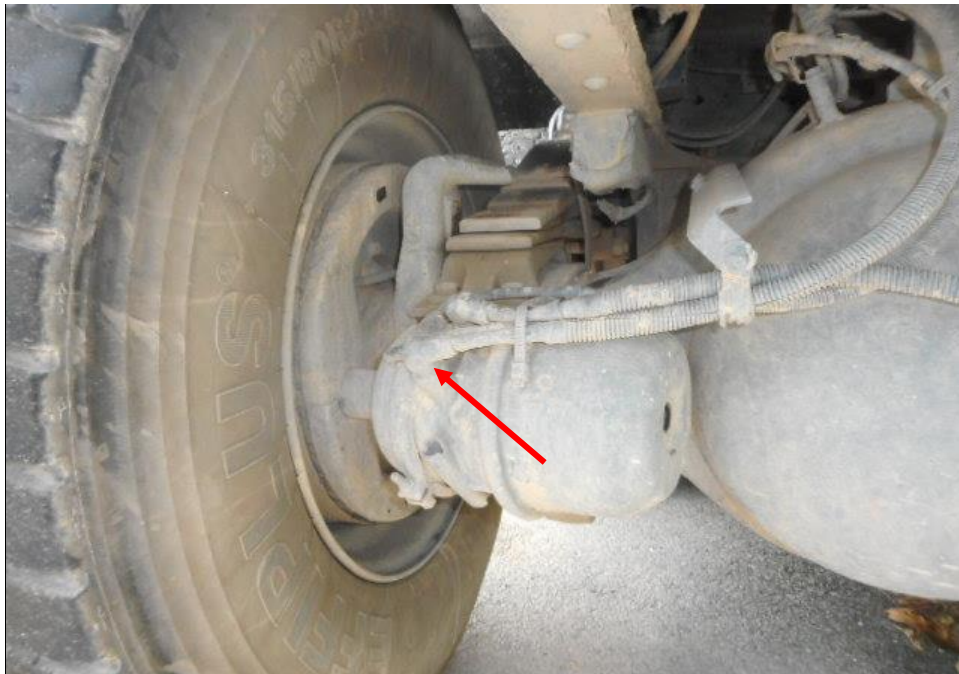
Photo 22 shows the brake pipe (arrowed) at the rear left wheel of the Tipper Truck. I did not observe any leakage of brake fluid at the time of my inspection of the Tipper Truck and the various mechanical components was observed to be intact.

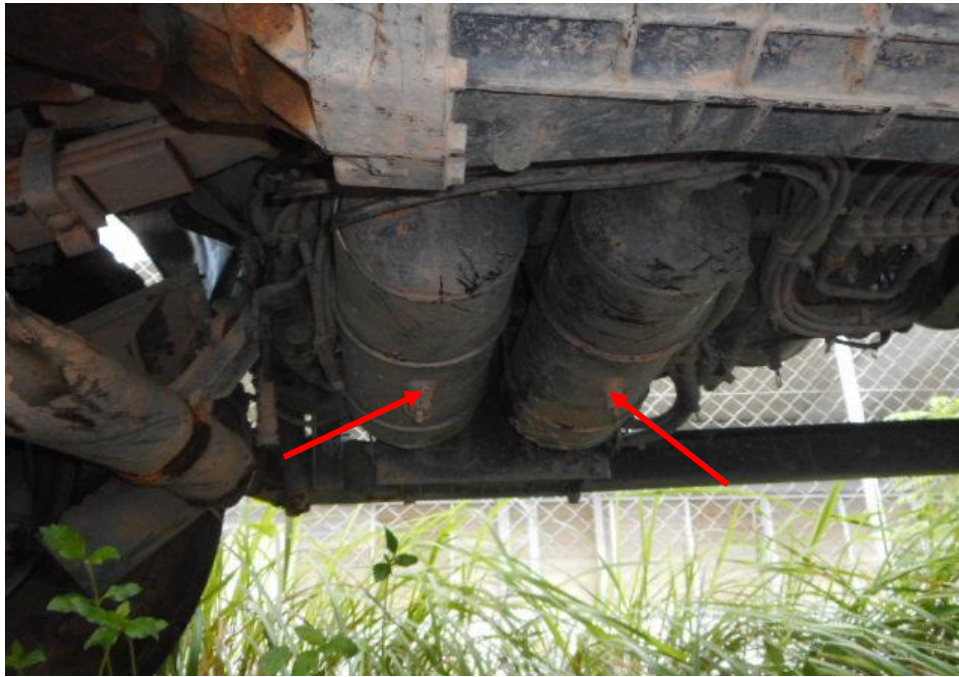
Photo 23 shows the air brake cylinders (arrowed) at the undercarriage of the Tipper Truck. I did not observe any leakage of brake fluid at the time of my inspection of the Tipper Truck and the various mechanical components was observed to be intact.
