Your Ref: TP/IP/59995/2021
Our Ref : CI/TPD22003621/P

MECHANICAL INSPECTION REPORT OF MOTOR VAN GBC 8355J

1. I refer to your request on 14th April 2022 to conduct a physical inspection of a Motor Van bearing registration number GBC 8355J (herein referred to as "**Motor Van**"), which was involved in a road traffic accident on 27th December 2022.
2. The objective of this inspection is to determine if there was any possible mechanical failure to the Motor Van that may have contributed to the accident.
3. Following the request, I had carried out a physical inspection of the Motor Van on 31st May 2022 at the premises of Traffic Police vehicle pound, 517 Airport Road Singapore 539942. I now set out below my observations and comments with respect to this inspection.

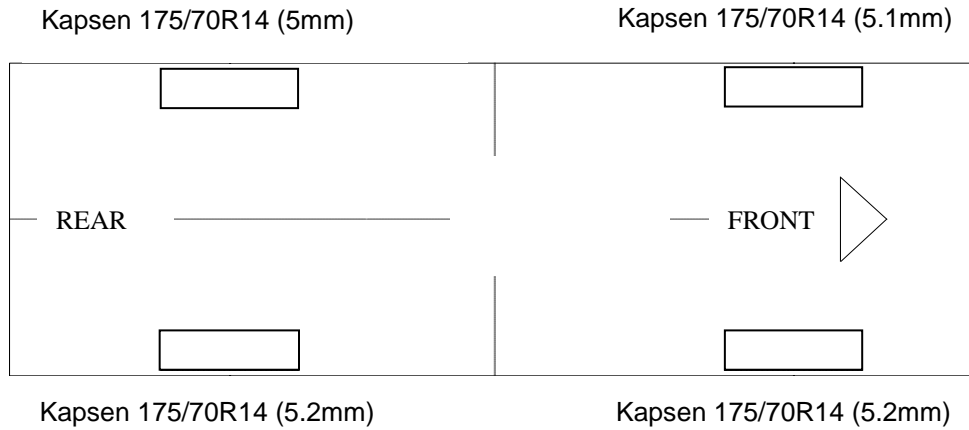
6. The 4 tyres of the Motor Van were observed to be in serviceable condition and sufficiently inflated for vehicular operation. I did not find any tear, cut or burst mark(s) on the outer and the inner sidewalls as well as across the tread of the 4 tyres. The tyre brand, tyre size and remaining tread depth of the 4 tyres of the Motor Van were recorded as follows:-

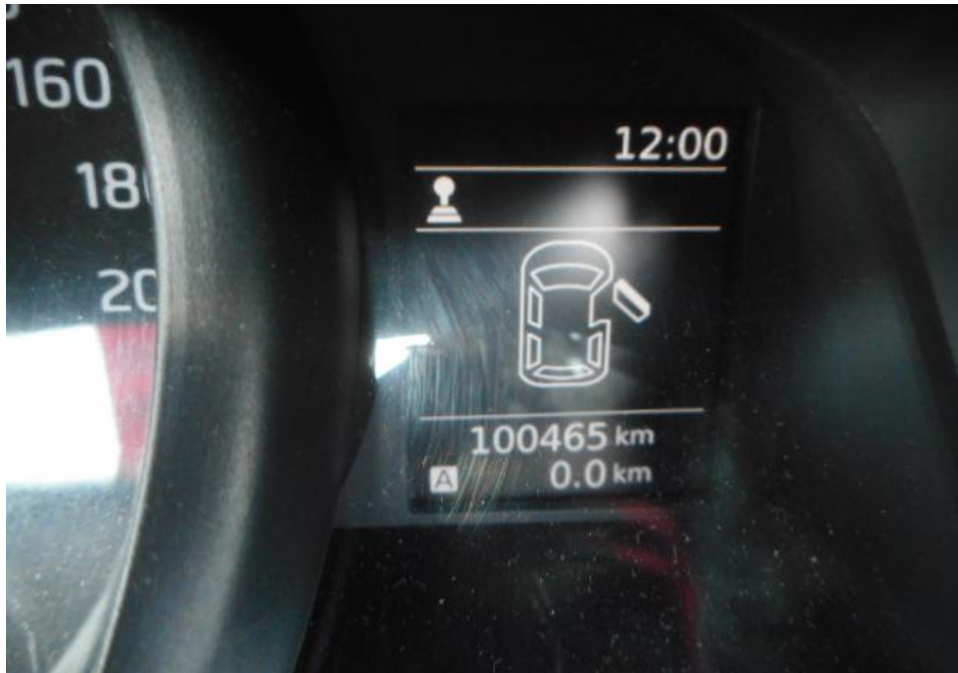
Photo 1 shows a general view of the instrument cluster of the Motor Van at the time of my inspection. The mileage of the Motor Van was 100,465km

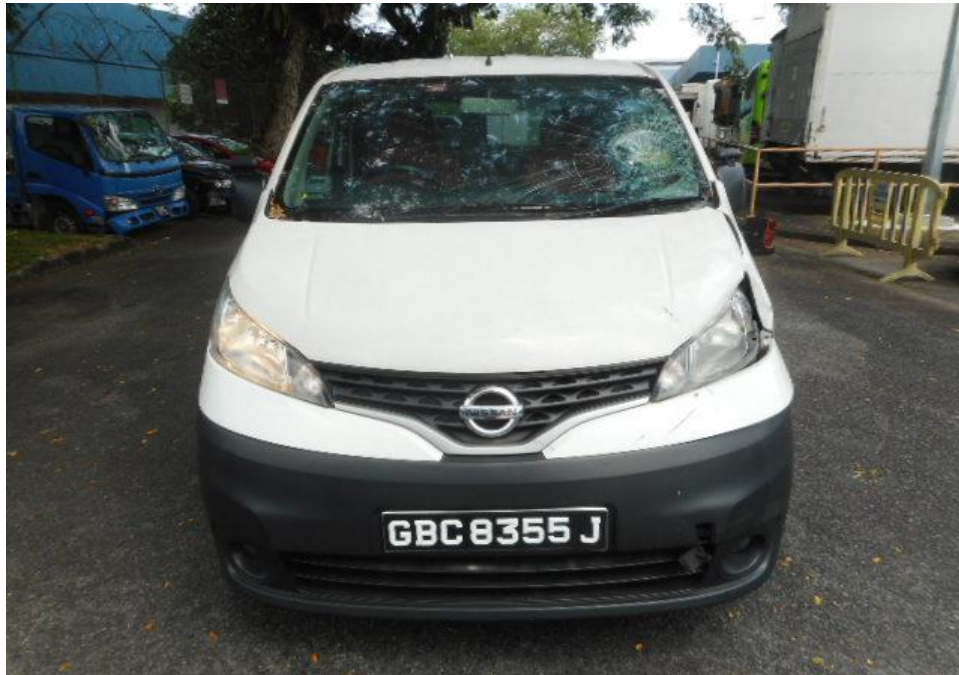
4. The mileage of the Motor Van at the time of my inspection was 100,465km.
5. The Motor Van appeared to have sustained damage at its frontal portion. Its front windscreen, front bonnet, front left headlamp and front bumper were damaged at the time of my inspection.

Photo 2 shows a general view of the Motor Van's frontal portion at the time of my inspection. It appeared to have sustained damage at its frontal portion. Its front windscreen, front bonnet, front left headlamp and front bumper were damage at the time of my inspection.

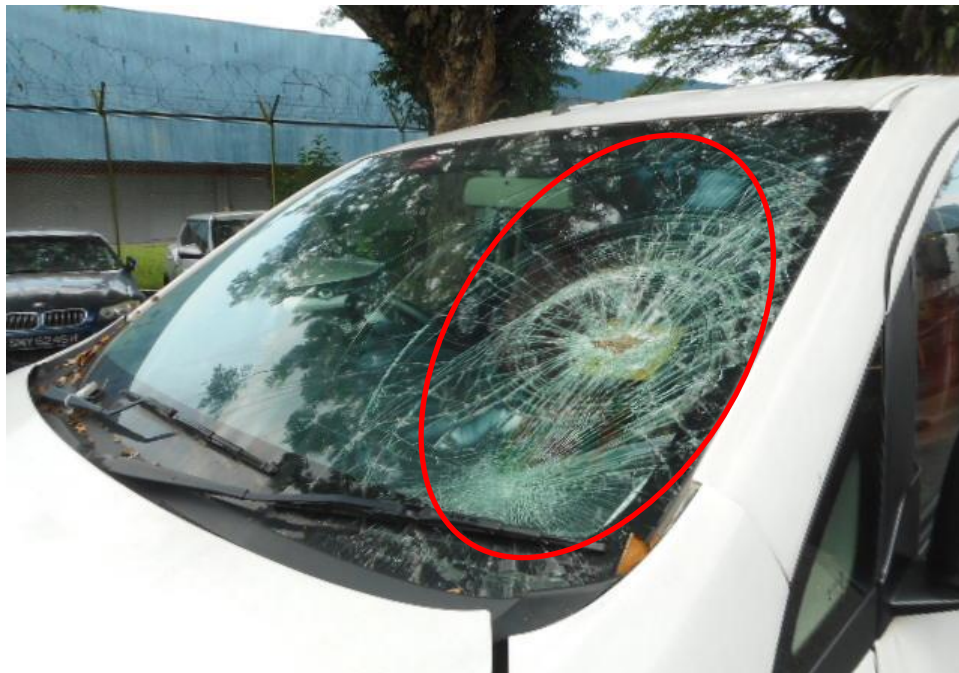
Photo 3 shows a close up view of the Motor Van's frontal portion at the time of my inspection. It appeared to have sustained damage at its frontal portion. Its front windscreen (circled) was damage at the time of my inspection as a result of the accident.

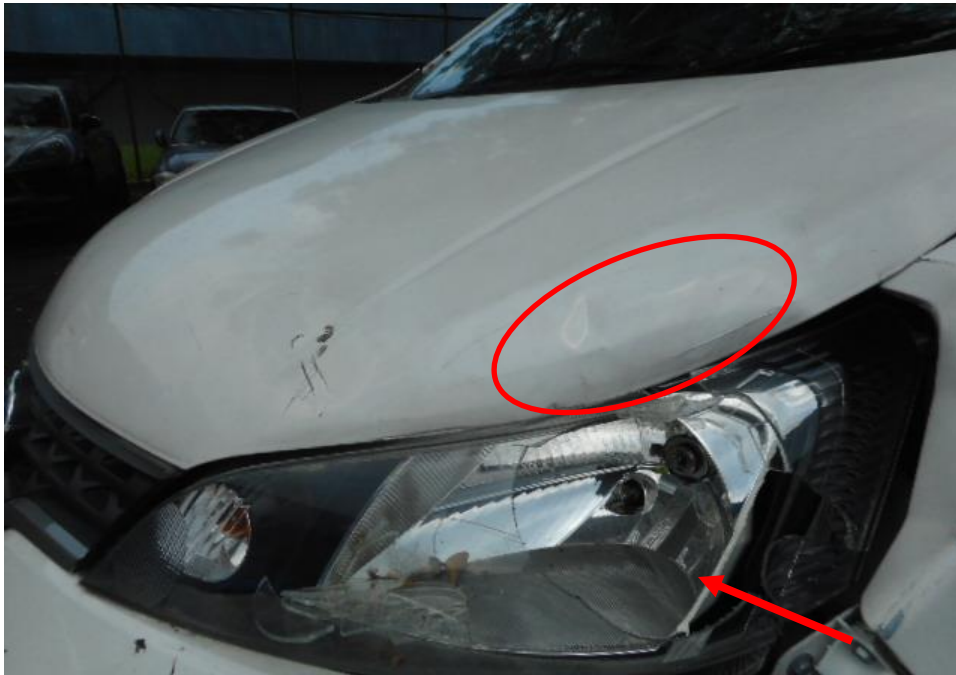
Photo 4 shows a close up view of the Motor Van's frontal portion at the time of my inspection. It appeared to have sustained damage at its frontal portion. Its front bonnet (circled) and front left headlamp (arrowed) was damage at the time of my inspection as a result of the accident.

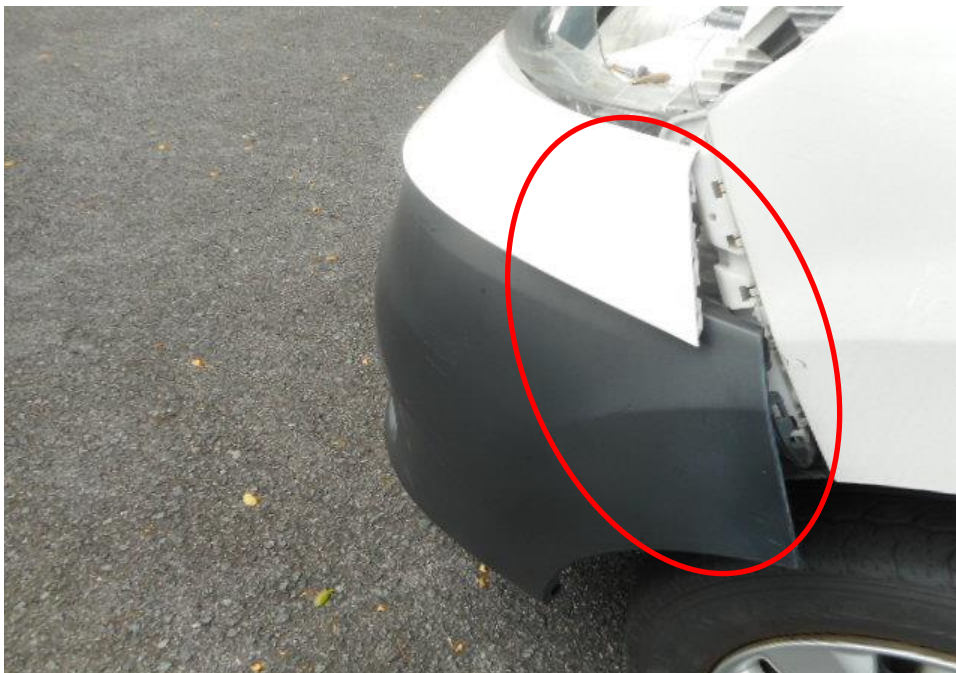
Photo 5 shows a close up view of the Motor Van's frontal portion at the time of my inspection. It appeared to have sustained damage at its frontal portion. Its front bumper (circled) was damage at the time of my inspection as a result of the accident.

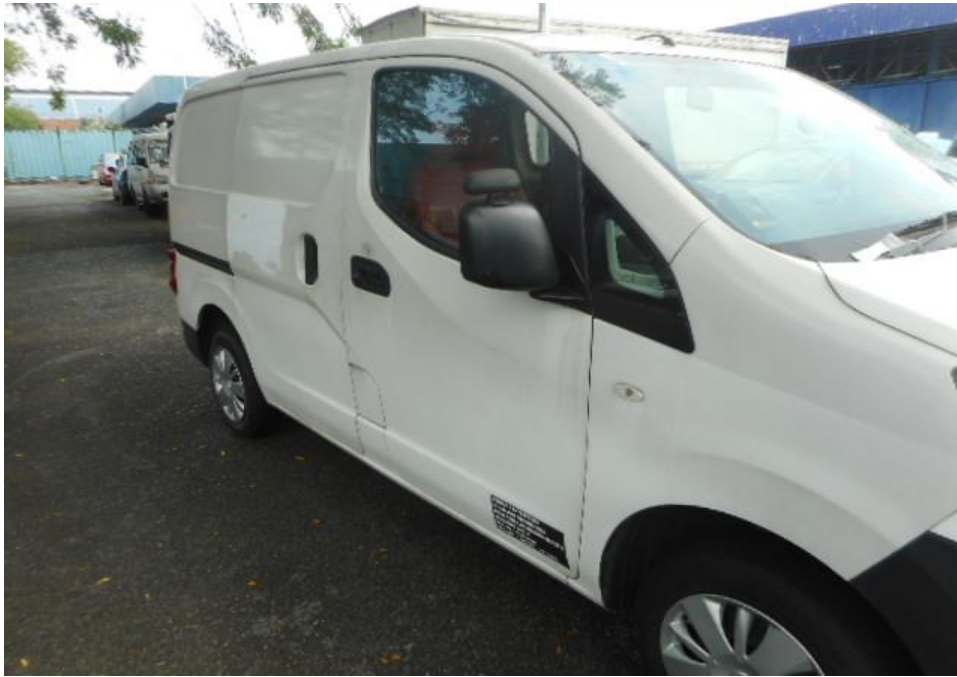
Photo 6 shows a general view of the right body of the Motor Van at the time of my inspection. The Motor Van was observed to be intact and unaffected by the accident.

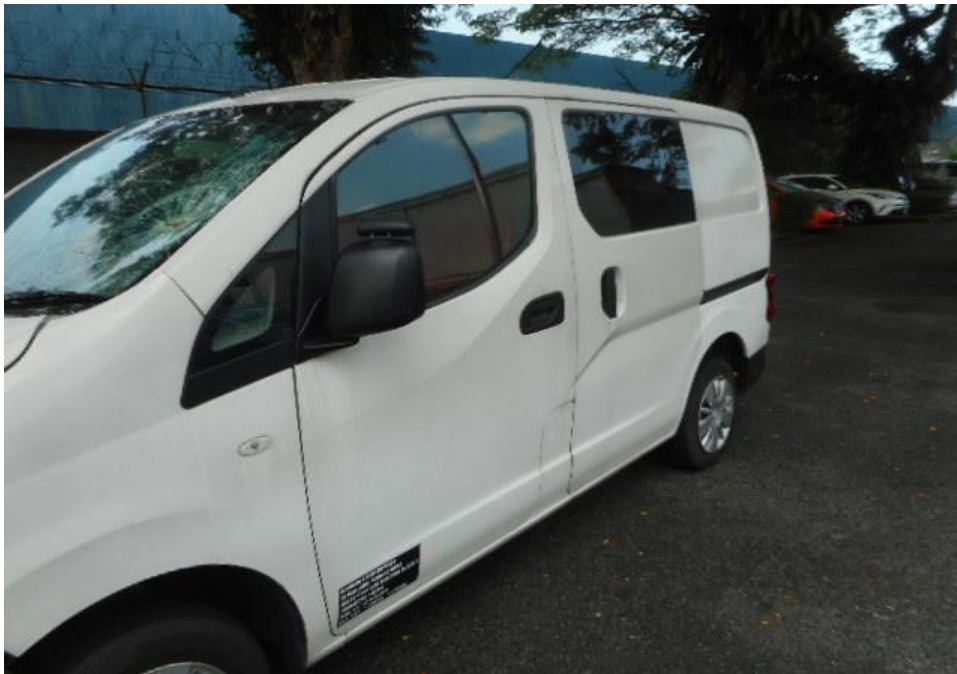
Photo 7 shows a general view of the left body of the Motor Van at the time of my inspection. The Motor Van was observed to be intact and unaffected by the accident.

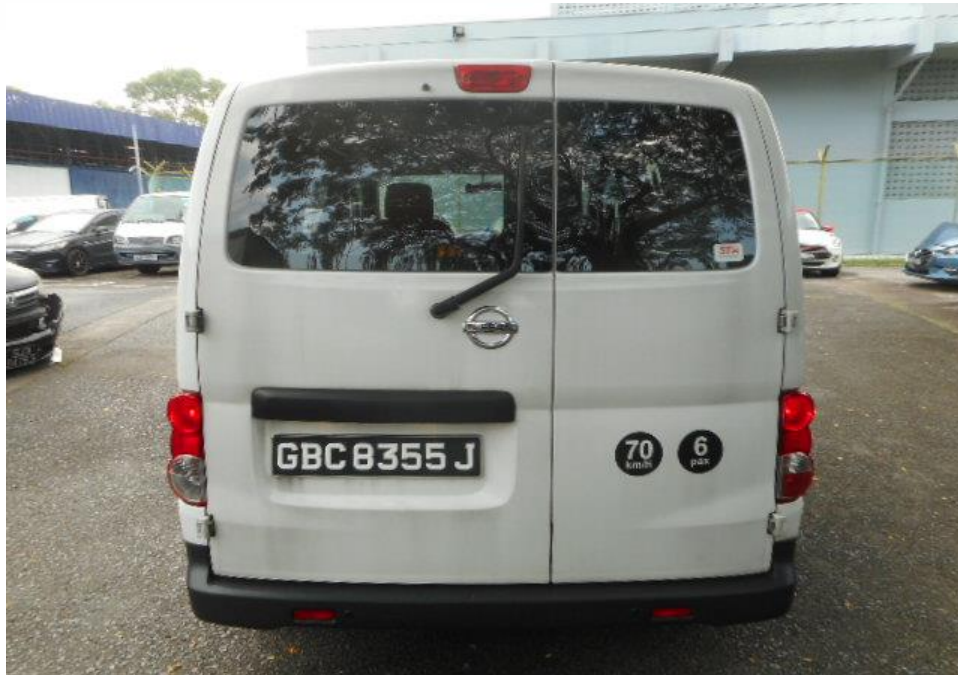
Photo 8 shows a general view of the rear body of the Motor Van at the time of my inspection. The Motor Van was observed to be intact and unaffected by the accident.

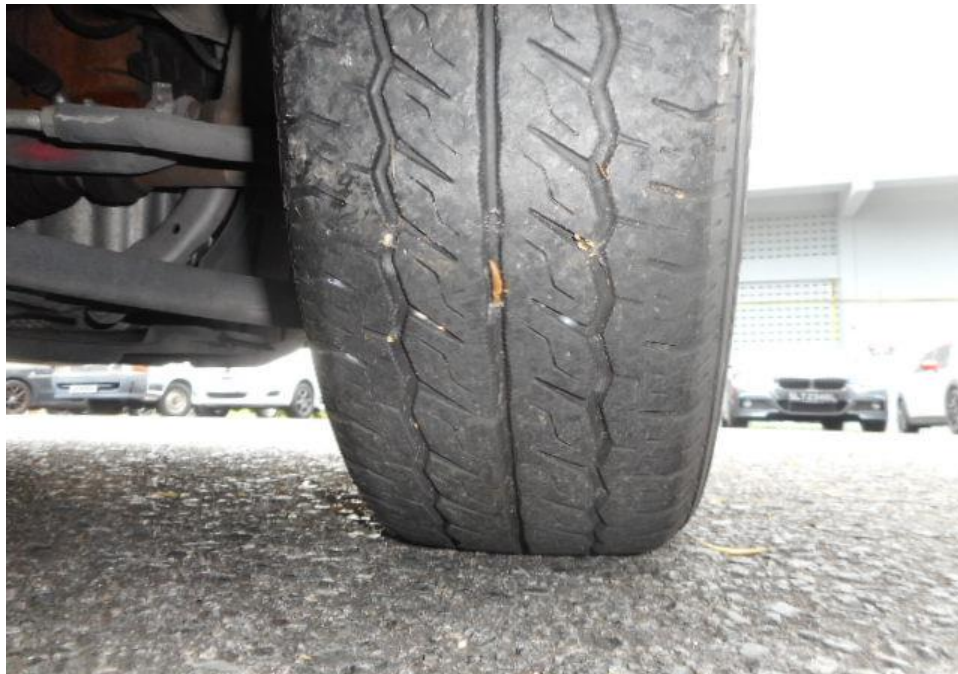
Photo 9 shows the condition of the front right tyre of the Motor Van, which was observed to be in serviceable condition with remaining tread depth of approximately 5.2mm. The tyre, which was wrapped around standard steel wheel rim, was also observed to be sufficiently inflated for vehicular operation. There was no tear, cut or burst mark(s) on the outer and the inner sidewalls as well as across the tread of the 4 tyres that were fitted on the Motor Van.

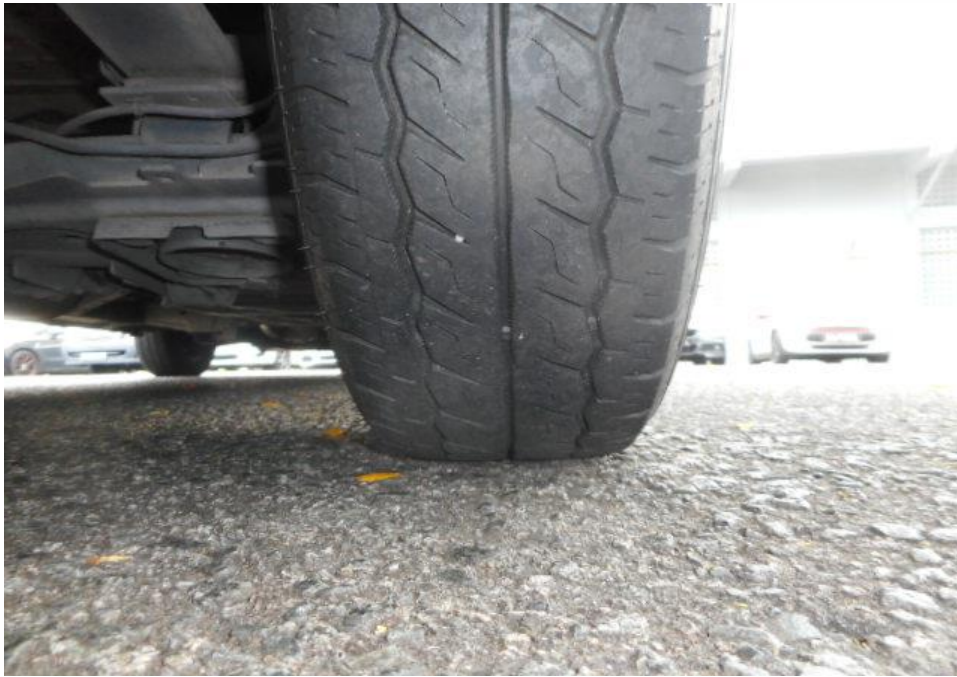
Photo 10 shows the condition of the rear right tyre of the Motor Van, which was observed to be in serviceable condition with remaining tread depth of approximately 5.2mm. The tyre, which was wrapped around standard steel wheel rim, it was observed to be sufficiently inflated for vehicular operation.

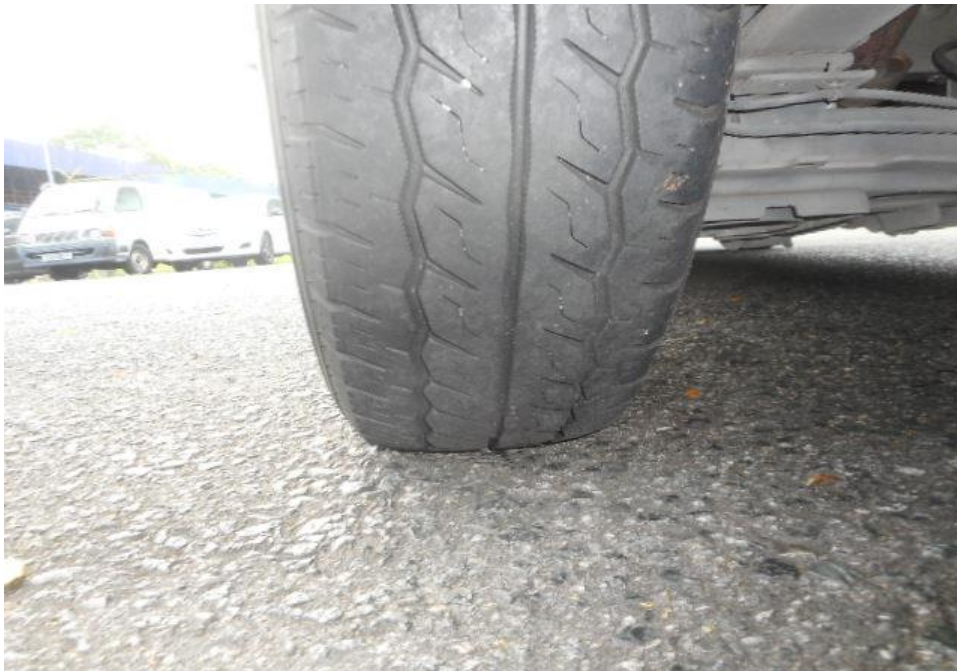
Photo 11 shows the condition of the rear left tyres of the Motor Van, which was observed to be in serviceable condition with remaining tread depth of approximately 5mm. The tyres, which were wrapped around standard steel wheel rim, were also observed to be sufficiently inflated for vehicular operation. There was also no damage found on all 4 steel wheel rims of the Motor Van.

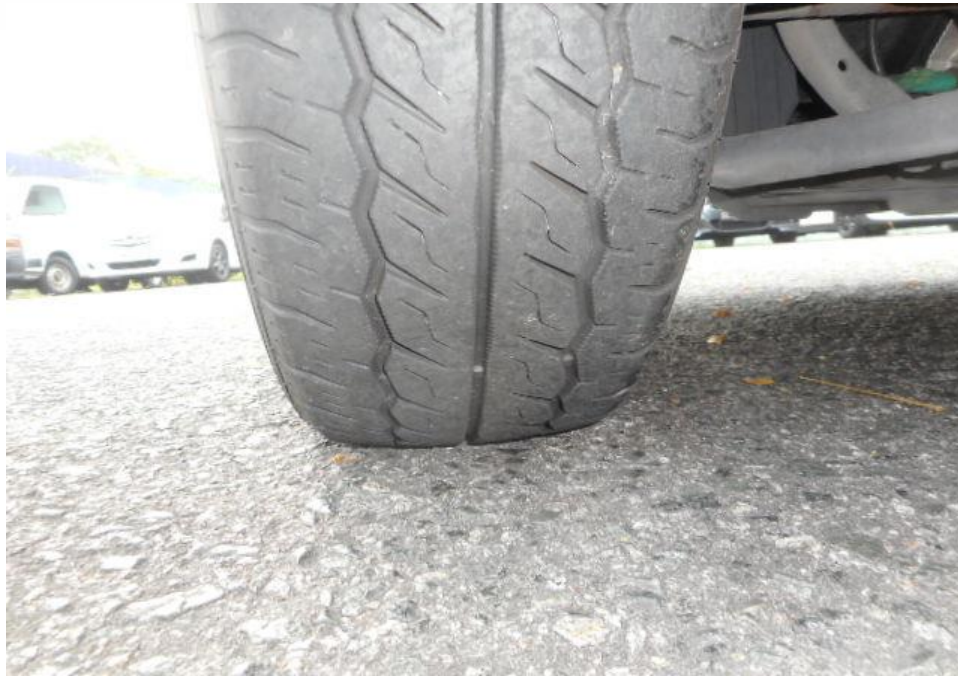
Photo 12 shows the condition of the rear right tyres of the Motor Van, which were observed to be in serviceable condition with remaining, tread depth of approximately 5.2mm. There was also no tear, cut or burst mark(s) on the outer and the inner sidewalls as well as across the tread of the 4 tyres that were fitted on the Motor Van.

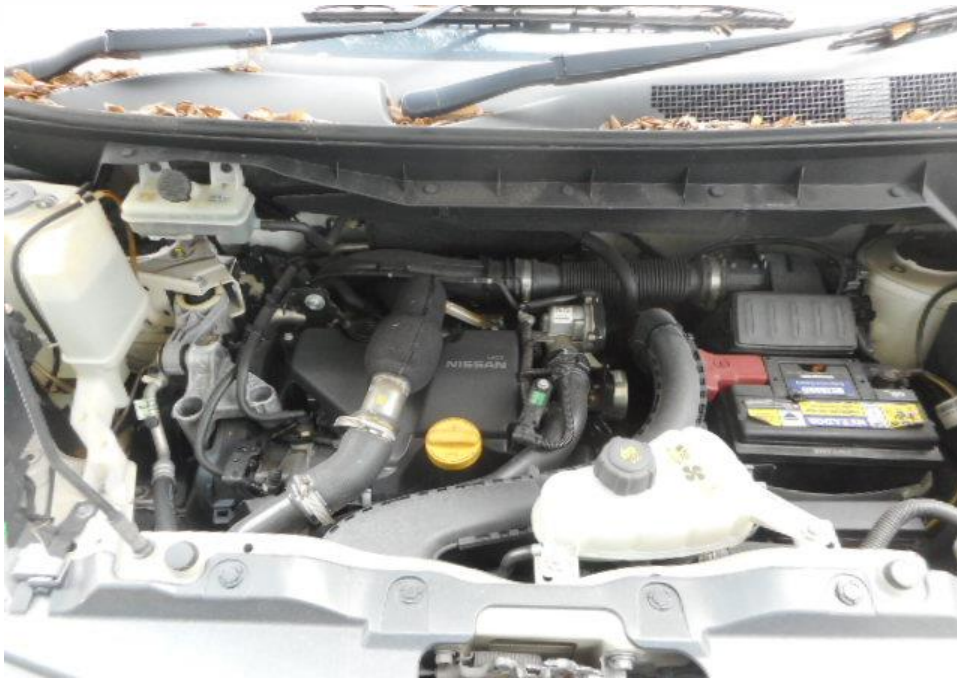
Photo 13 shows a general view of the Motor Van's engine compartment, which was accessed by lifting the front cabin of the Motor Van. The various parts and components inside the engine compartment were unaffected by the accident. There was also no sign(s) or indication(s) of fresh fluid leakage and/or fluid stain within the engine compartment

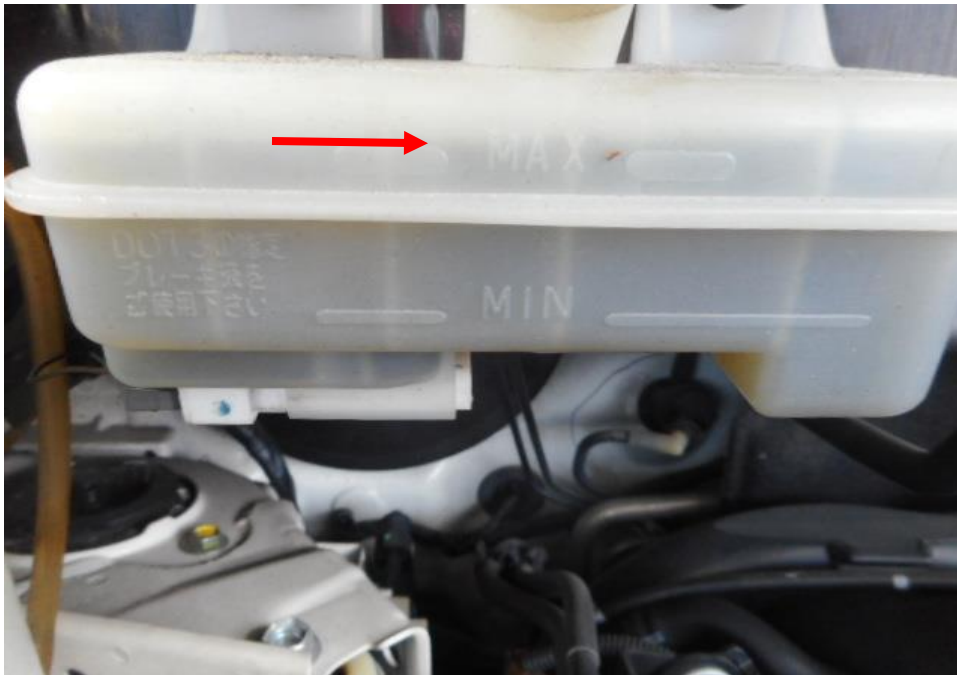
Photo 14 shows the brake fluid reservoir of the Motor Van at the time of my inspection. The brake fluid was observed to be of sufficient level (arrowed) and without any visible contamination.

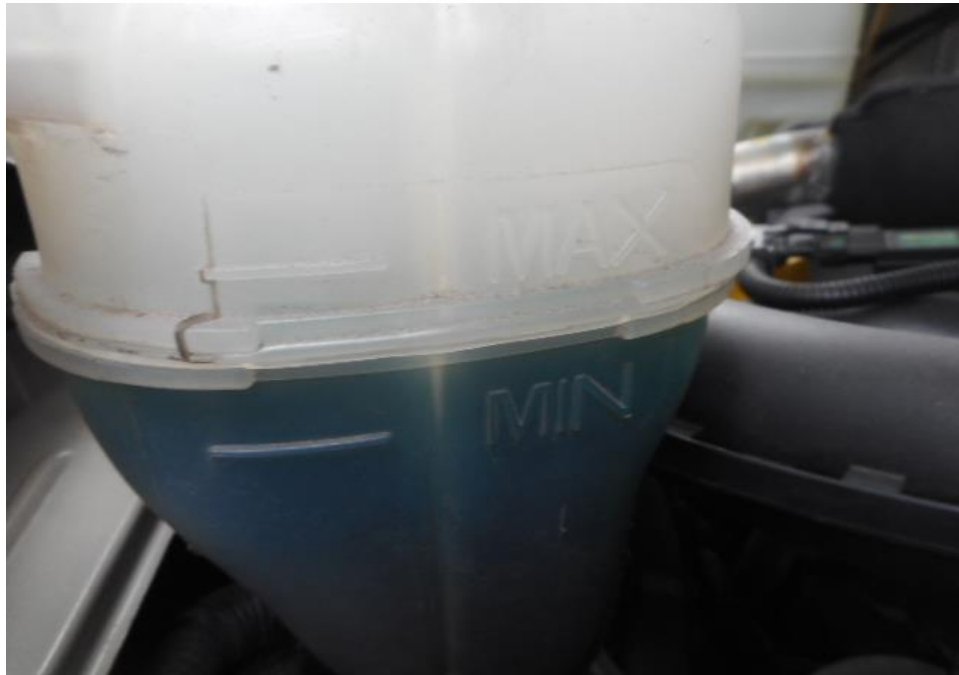
Photo 15 shows the engine coolant of the Motor Van at the time of my inspection. The engine coolant was observed to be of sufficient level and without any visible contamination.

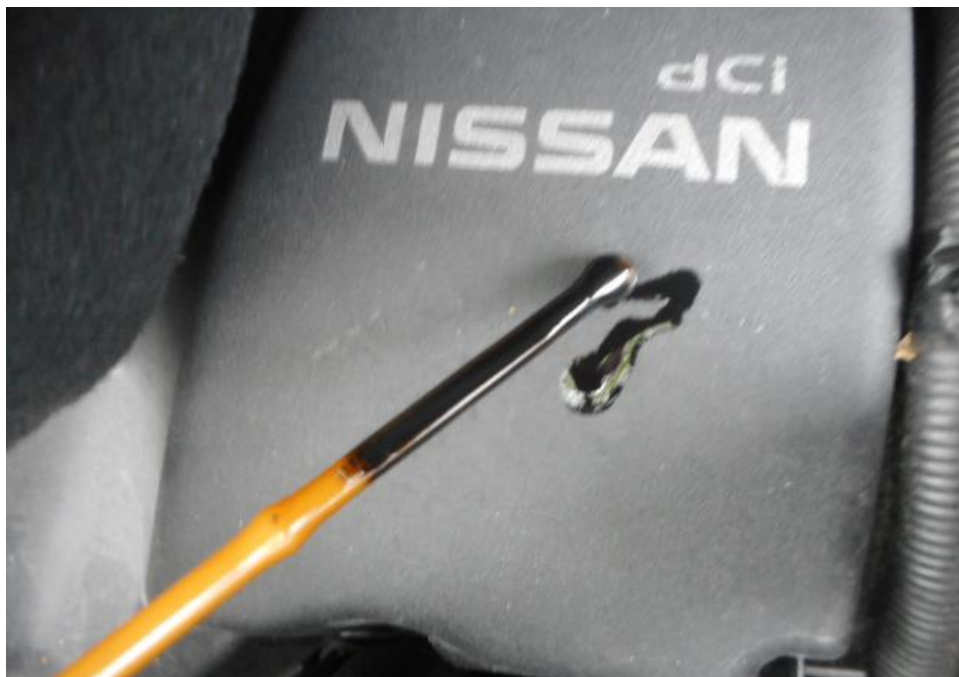
Photo 16 shows the engine oil dip stick of the Motor Van at the time of my inspection. The engine oil was observed to be of sufficient level and without any visible contamination.

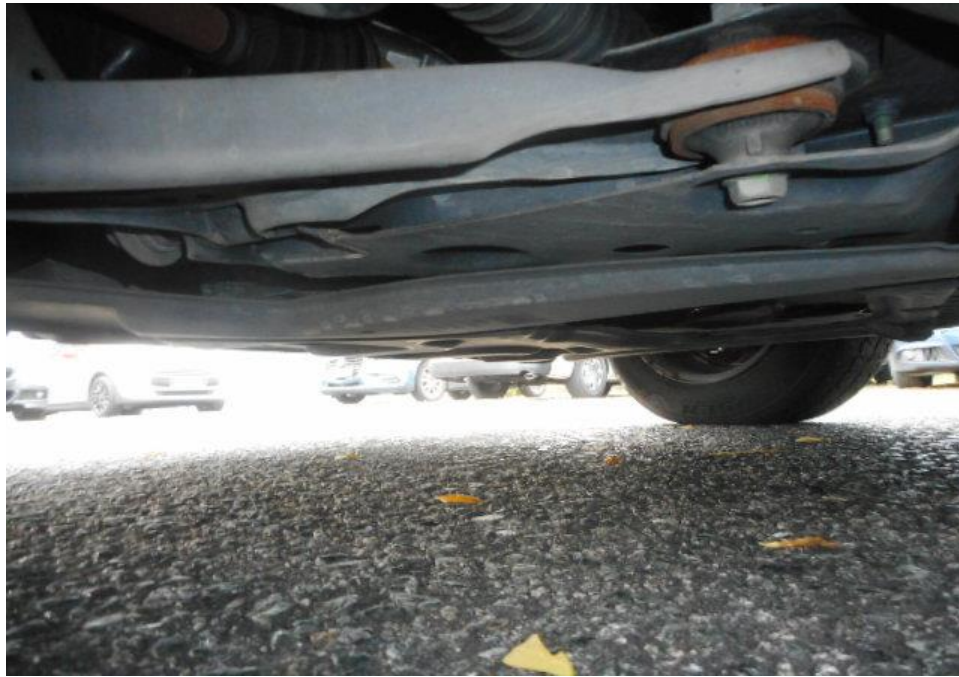
Photo 17 shows the undercarriage of the Motor Van, at the area where the engine housing and transmission housing are located. . I did not find any sign(s) or indication(s) of fluid leak and/or fluid stain(s) on the underside of the Motor Van.

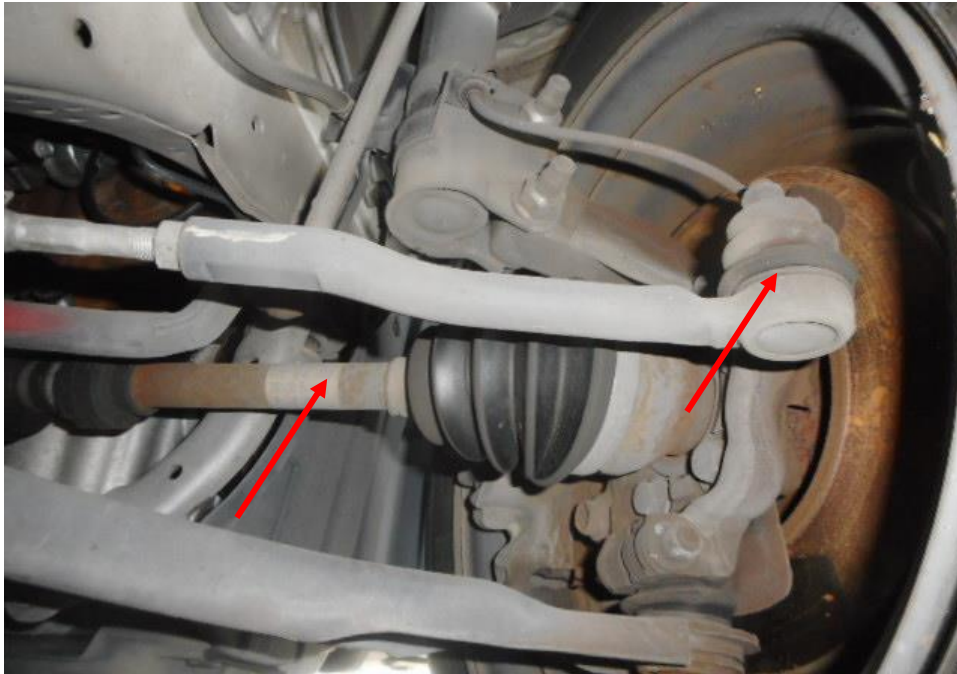
Photo 18 shows the various undercarriage components at the front right wheel of the Motor Van, in particular the steering tie rod end (red arrow) and driveshaft (yellow arrow). The various steering components were all found to be intact, suggesting that the steering system of the Motor Van was likely to be in serviceable condition at the material time of accident. There was also no sign of fluid stain(s) observed on the various undercarriage components.

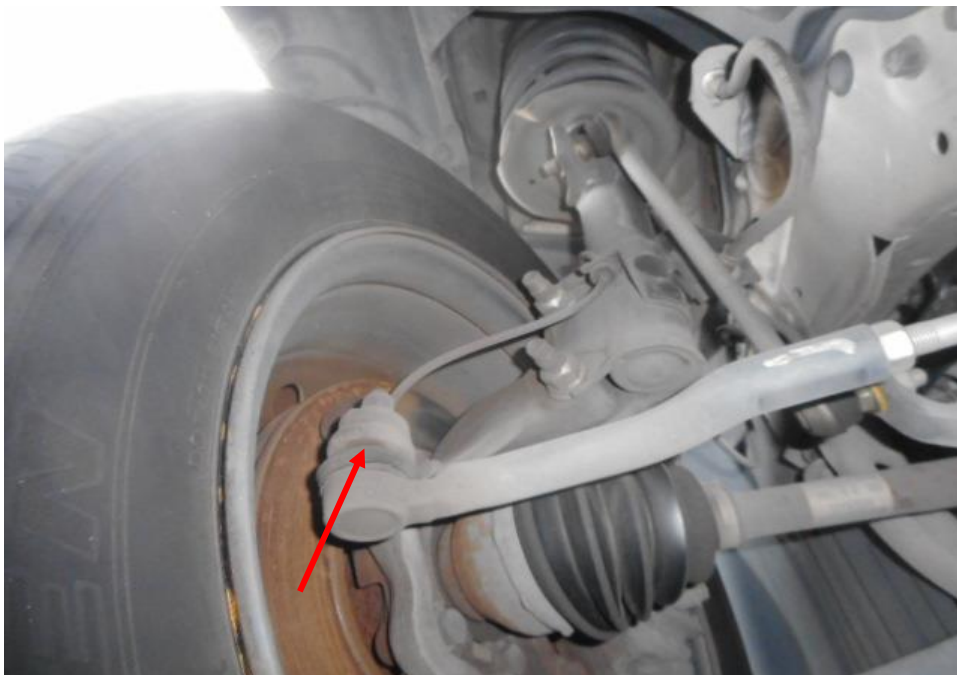
Photo 19 shows the various undercarriage components at the front left wheel of the Motor Van, in particular the steering tie rod end (arrowed). The various undercarriage components of the Motor Van were all found to be intact without any visible damage. There was also no sign of fluid stain(s) observed on the various undercarriage components.

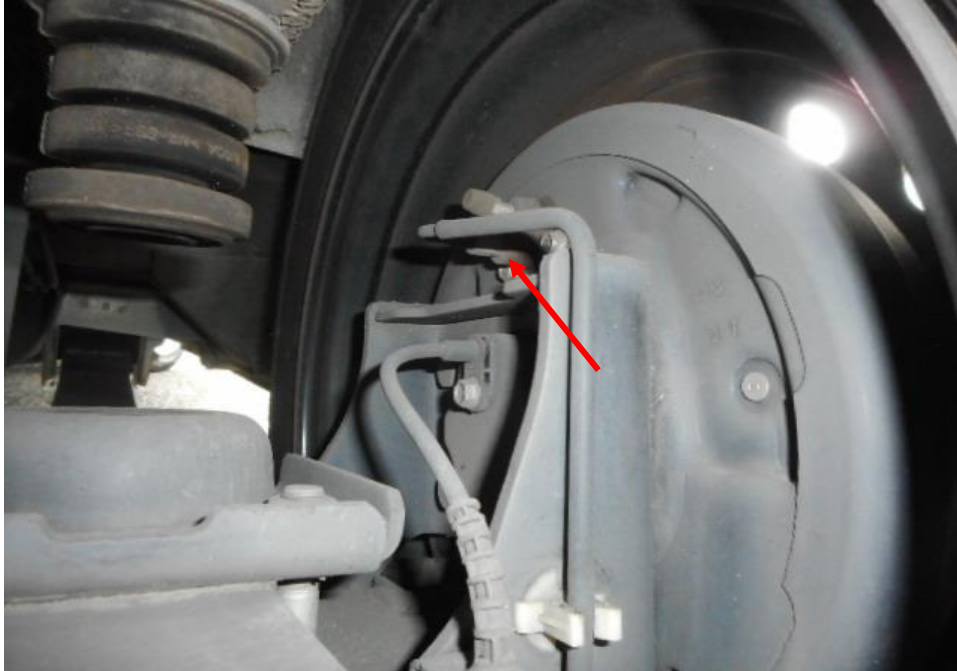
Photo 20 shows the brake pipe (arrowed) at the rear right wheel of the Motor Van. I did not observe any leakage of brake fluid at the time of my inspection of the Motor Van. My static tests of the Motor Van's braking system, along with my visual examination of the various mechanical components in the braking system, had indicated that there was no internal leakage of pressure/vacuum. Hence the braking system of the Motor Van was likely to be in serviceable condition at the material time of accident.

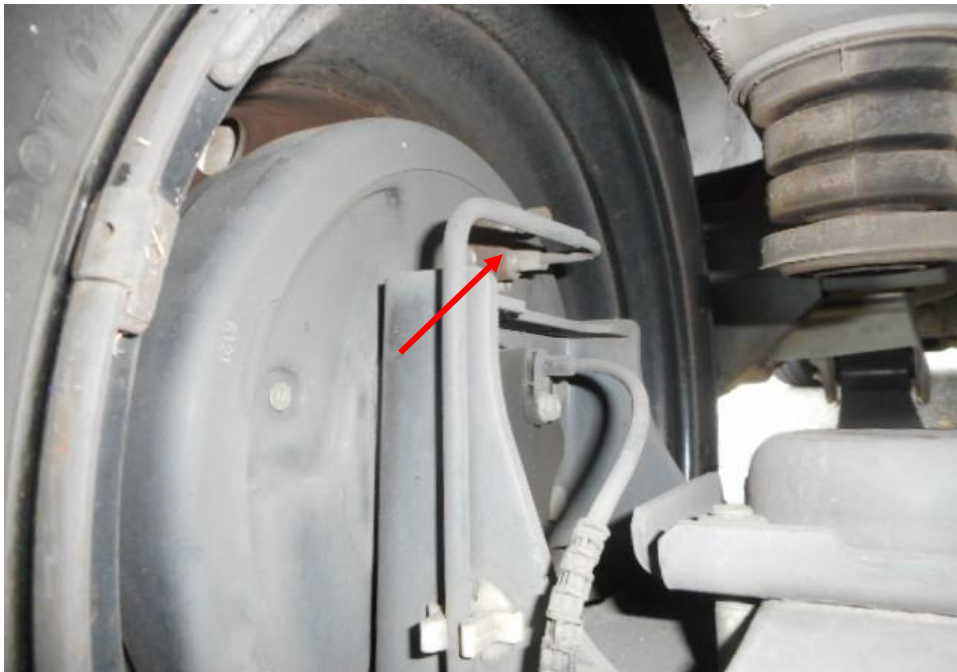
Photo 21 shows the brake pipe (arrowed) at the rear left wheel of the Motor Van. I did not observe any leakage of brake fluid at the time of my inspection of the Motor Van. My static tests of the Motor Van's braking system, along with my visual examination of the various mechanical components in the braking system had indicated that there was no internal leakage of pressure/vacuum. Hence the braking system of the Motor Van was likely to be in serviceable condition at the material time of accident.

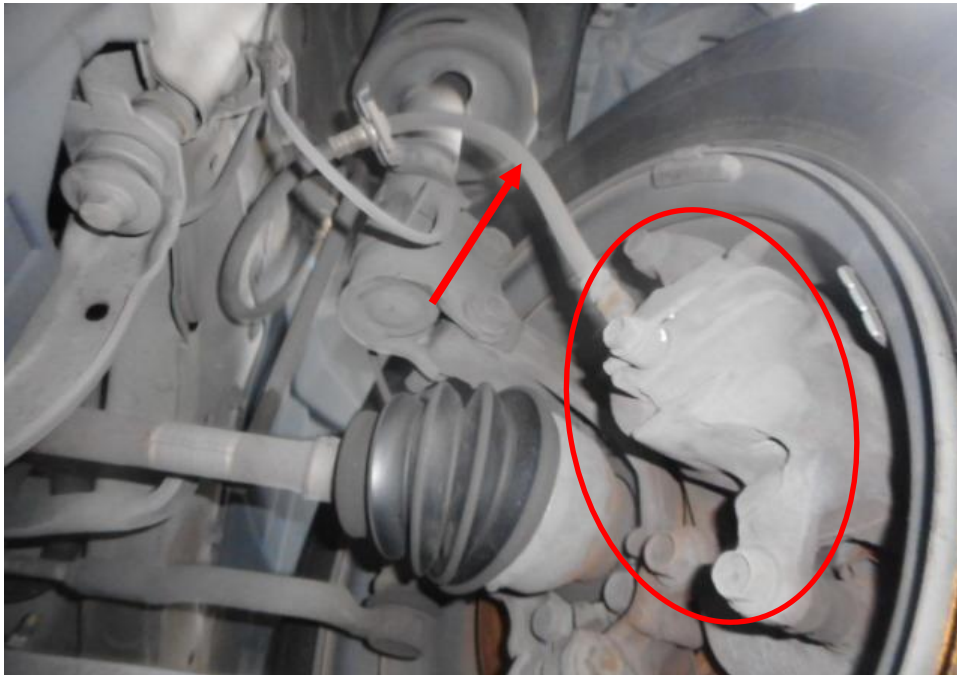
Photo 22 shows the brake hose/pipe (arrowed) at the front right wheel of the Motor Van. No leakage of brake fluid was observed. Visual examination of the various components of the braking system like the brake caliper (circled), brake booster, brake pedal etc had revealed all to be intact and without visible damage at the time of accident. There was also no sign of fluid stain(s) observed on the various undercarriage components.

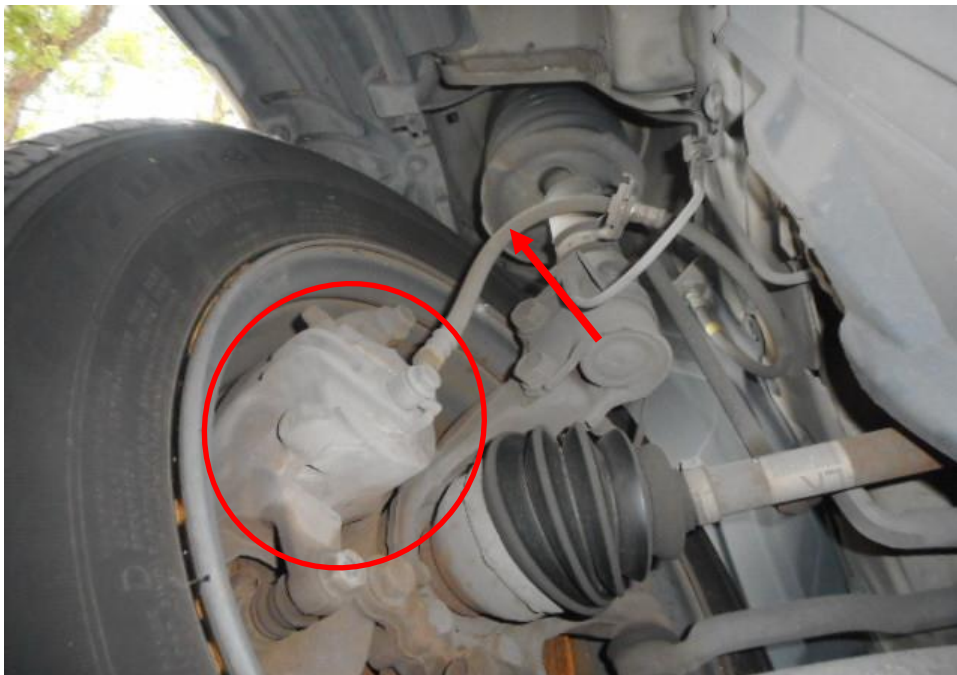
Photo 23 shows the brake hose/pipe (arrowed) at the front left wheel of the Motor Van. No leakage of brake fluid was observed. Visual examination of the various components of the braking system like the brake caliper (circled), brake booster, brake pedal etc had revealed all to be intact and without visible damage at the time of accident. There was also no sign of fluid stain(s) observed on the various undercarriage components.

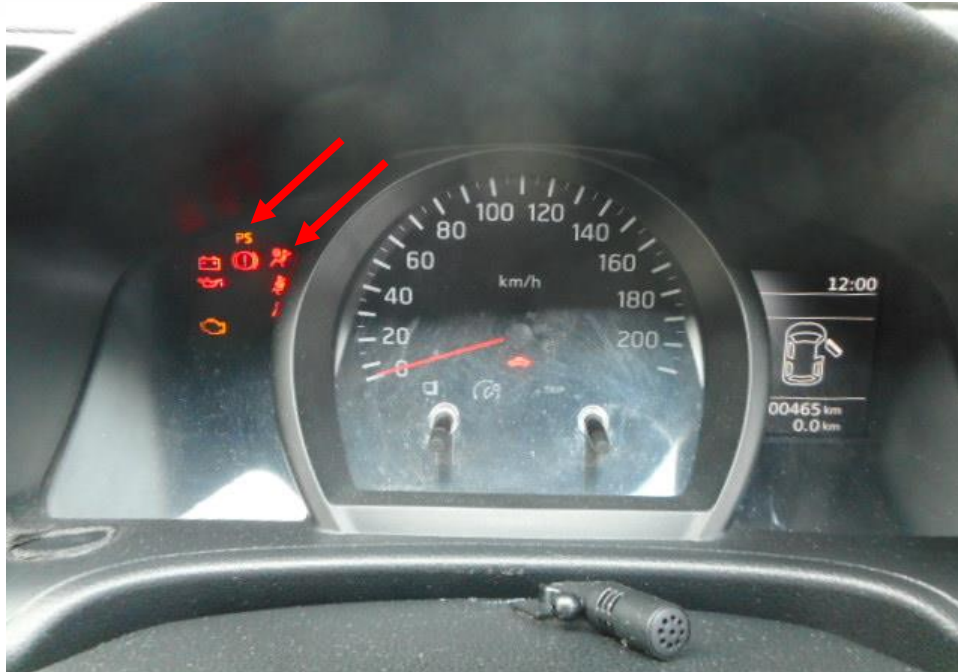
Photo 25 shows the warning light for Electric Power Steering System (EPS) and Supplemental Restraint System (SRS) (arrowed) appearing on the instrument panel of the Motor Van during the self-test of its various electronic operating systems when its engine was cranked.

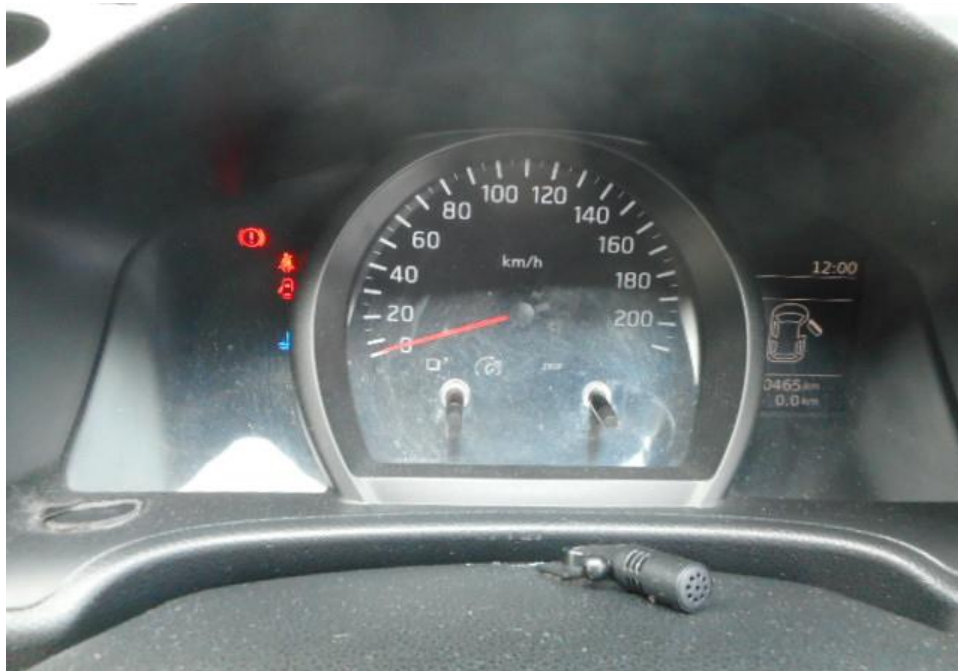
Photo 26 shows no warning lights illuminated on the instrument panel of the Motor Van after the engine was cranked. This would suggest that there was no abnormality to the electronic operating system of the Motor Van, like the EPS, SRS and etc.
