Your Ref: TP/IP/08101/2022  
Our Ref : CI/TPD22003623/P

**Fatal Accident Investigation Team**

**MECHANICAL INSPECTION REPORT OF MOTOR VAN GBL 5950M**

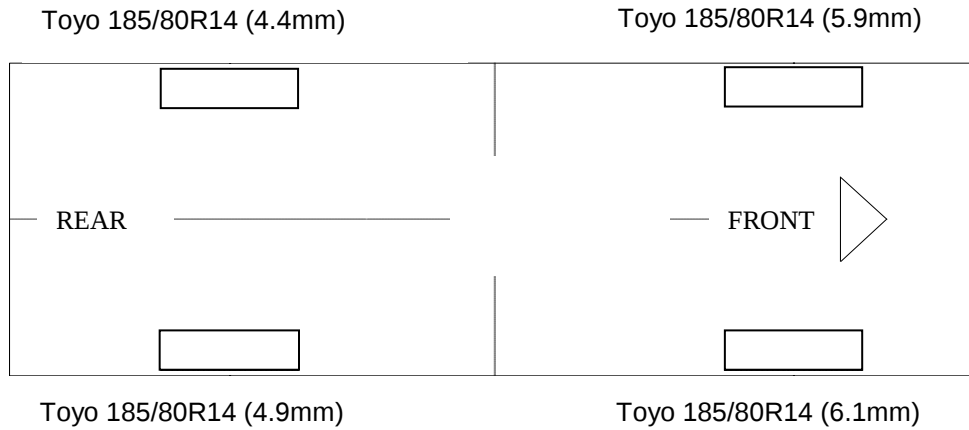
6. The 4 tyres of the Motor Van were observed to be in serviceable condition and sufficiently inflated for vehicular operation. I did not find any tear, cut or burst mark(s) on the outer and the inner sidewalls as well as across the tread of the 4 tyres. The tyre brand, tyre size and remaining tread depth of the 4 tyres of the Motor Van were recorded as follows:-

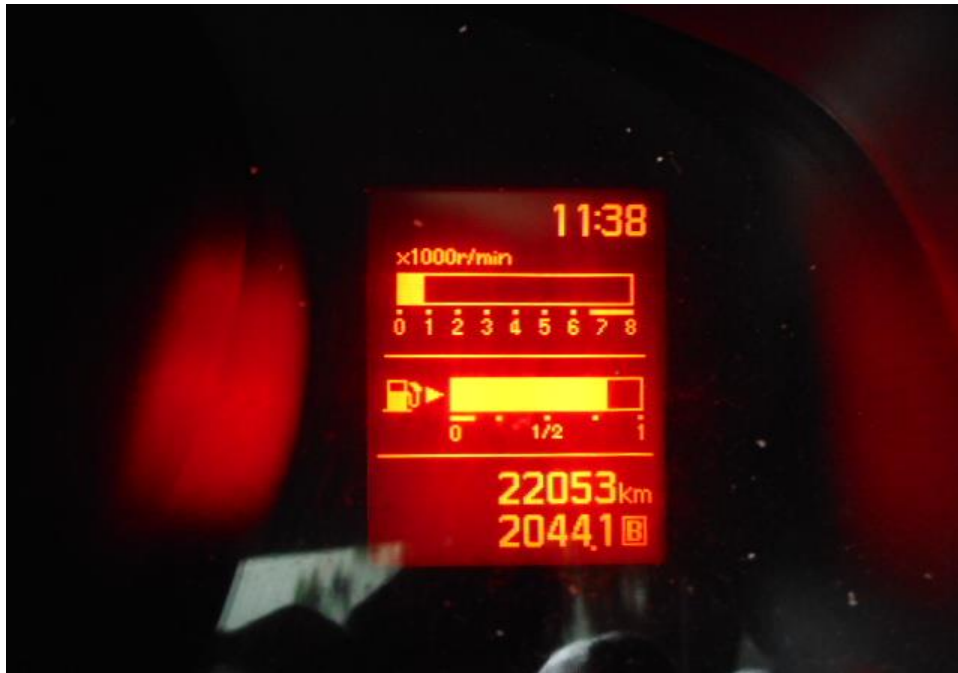
4. The mileage of the Motor Van at the time of my inspection was 22,053km.
5. The Motor Van appeared to have sustained damage at its rear portion. Its rear body panel was damaged at the time of my inspection.

**Photo 1** shows a general view of the instrument cluster of the Motor Van at the time of my inspection. The mileage of the Motor Van was 22,053km

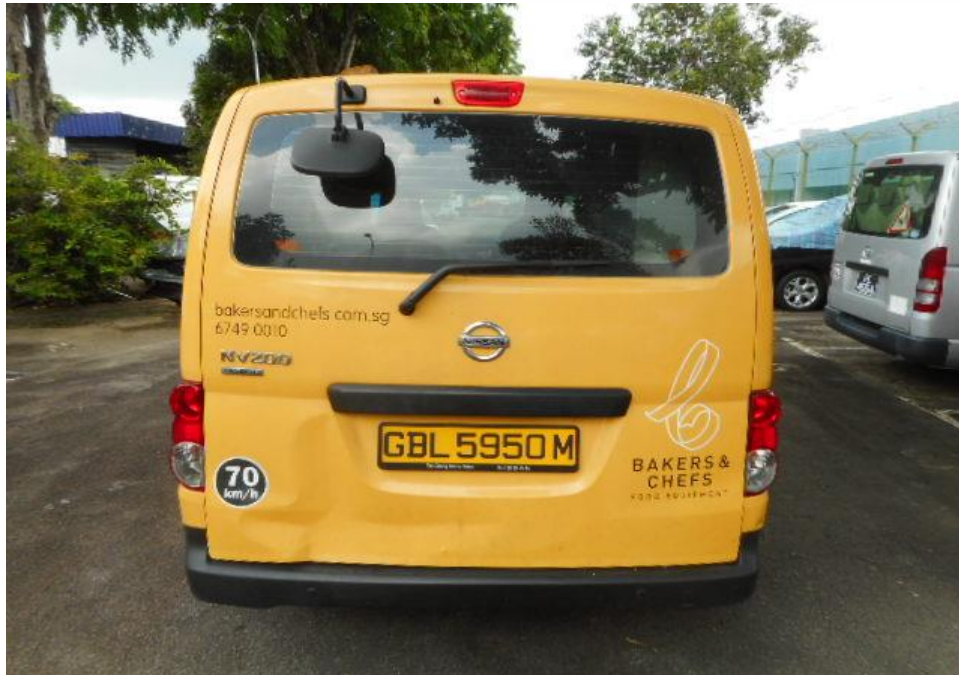
**Photo 2** shows a general view of the Motor Van's rear portion at the time of my inspection. It appeared to have sustained damage at its rear portion. Its rear body panel were damage at the time of my inspection.

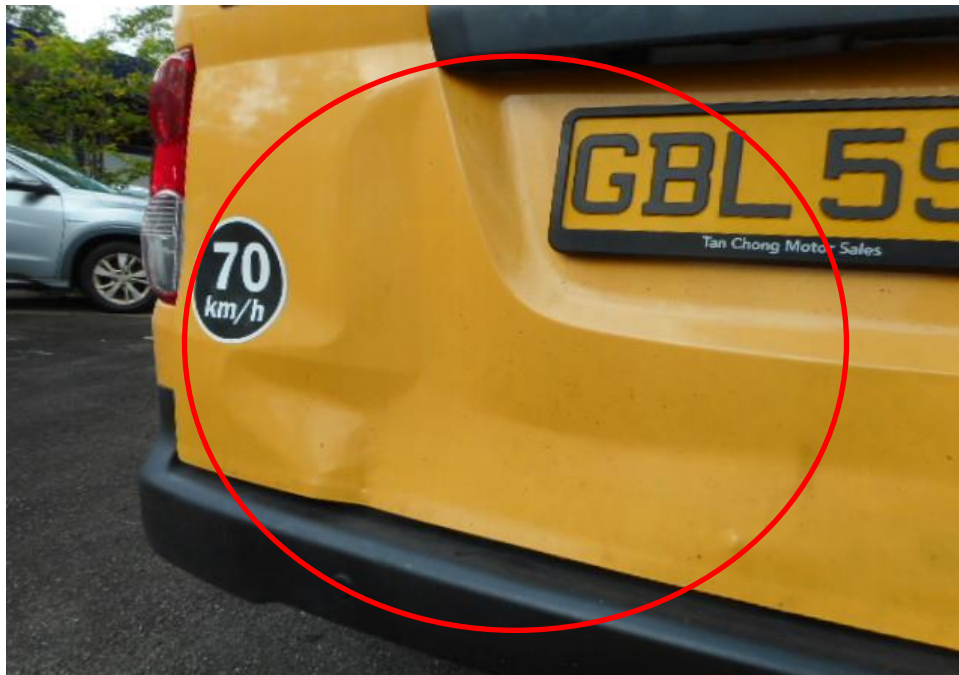
**Photo 3** shows a close up view of the Motor Van's rear portion at the time of my inspection. It appeared to have sustained damage at its rear portion. Its rear body panel (circled) was damage at the time of my inspection as a result of the accident.

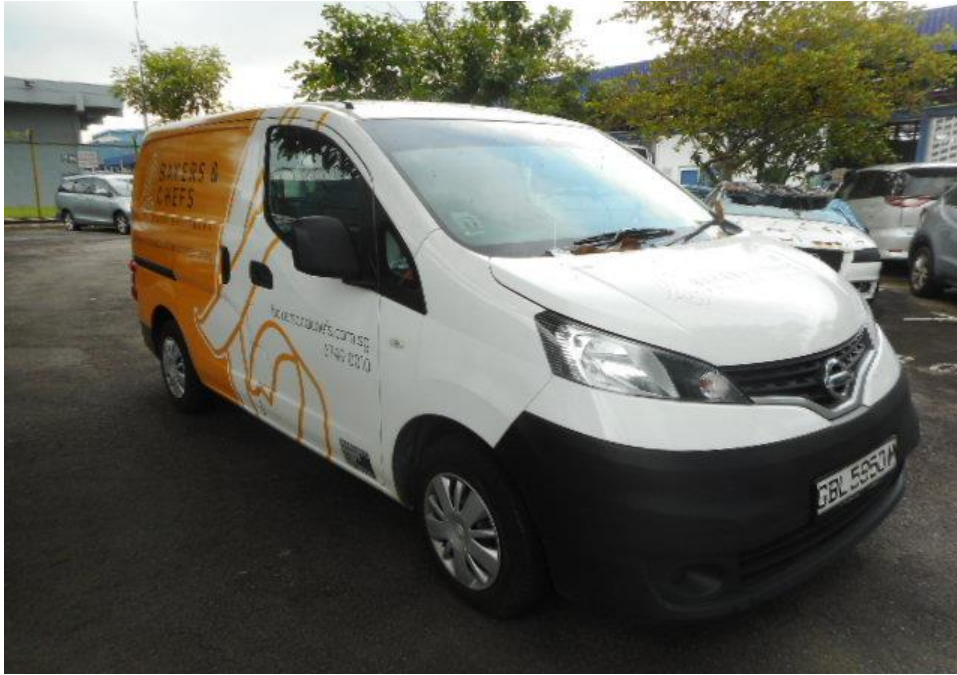
**Photo 4** shows a general view of the right body of the Motor Van at the time of my inspection. The Motor Van was observed to be intact and unaffected by the accident.

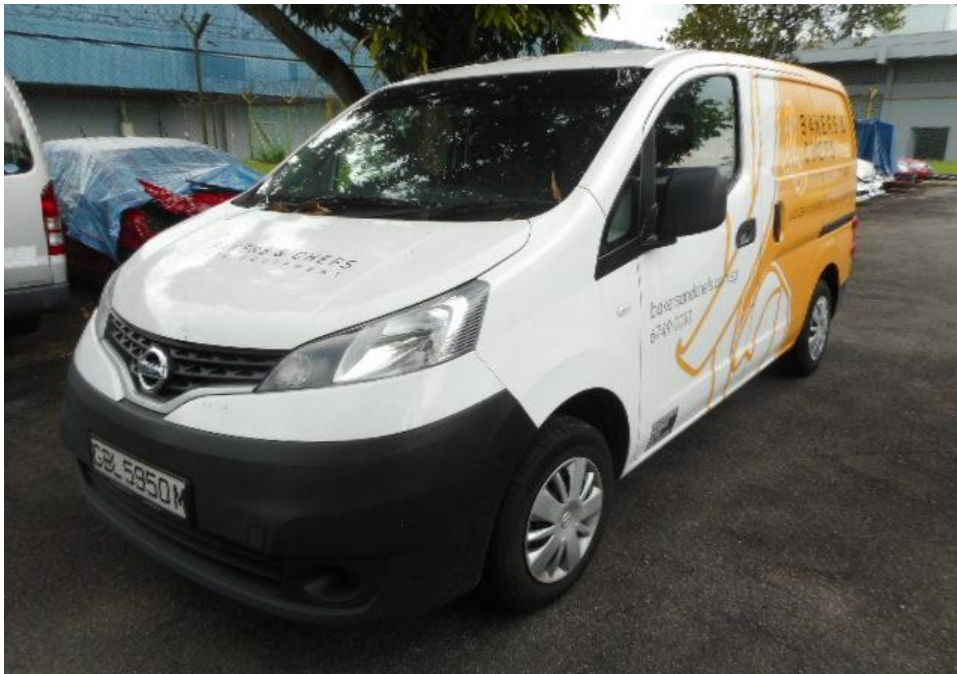
**Photo 5** shows a general view of the left body of the Motor Van at the time of my inspection. The Motor Van was observed to be intact and unaffected by the accident.

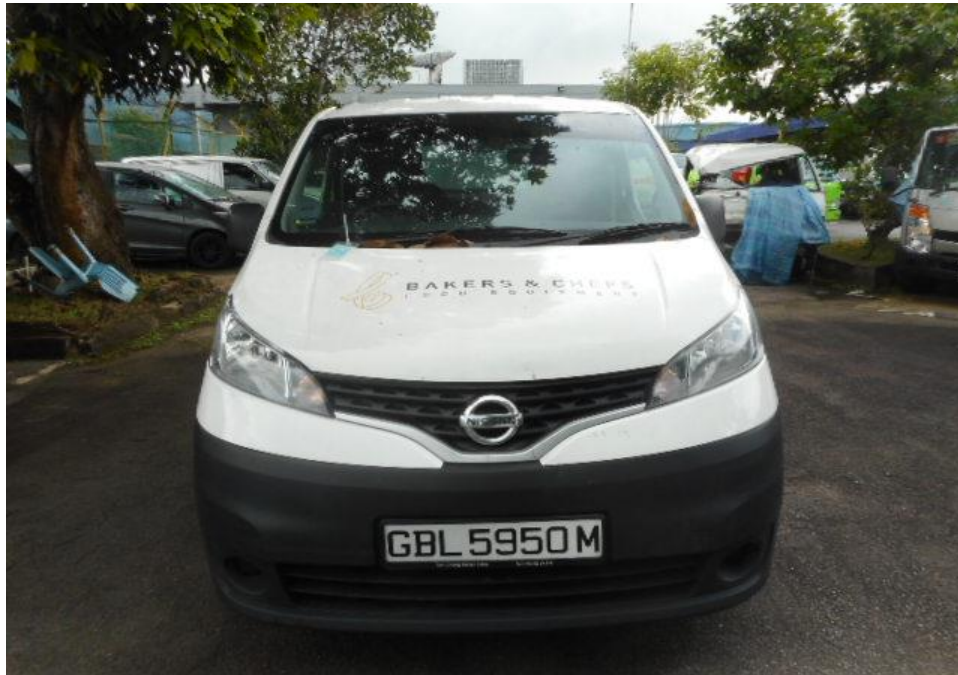
**Photo 6** shows a general view of the front body of the Motor Van at the time of my inspection. The Motor Van was observed to be intact and unaffected by the accident.

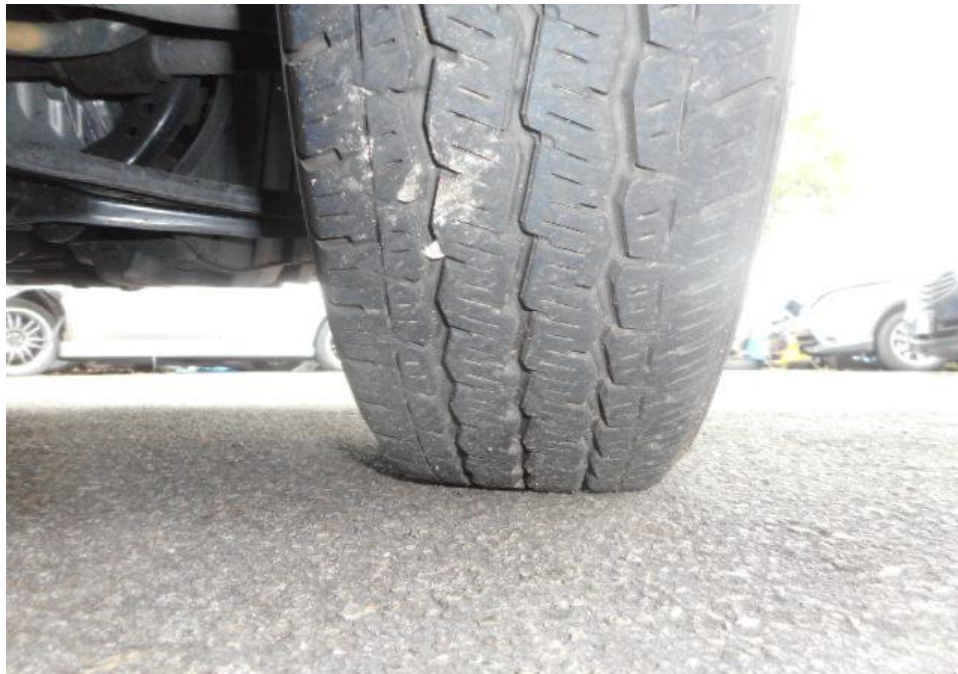
**Photo 7** shows the condition of the front right tyre of the Motor Van, which was observed to be in serviceable condition with remaining tread depth of approximately 6.1mm. The tyre, which was wrapped around standard steel wheel rim, was also observed to be sufficiently inflated for vehicular operation. There was no tear, cut or burst mark(s) on the outer and the inner sidewalls as well as across the tread of the 4 tyres that were fitted on the Motor Van.

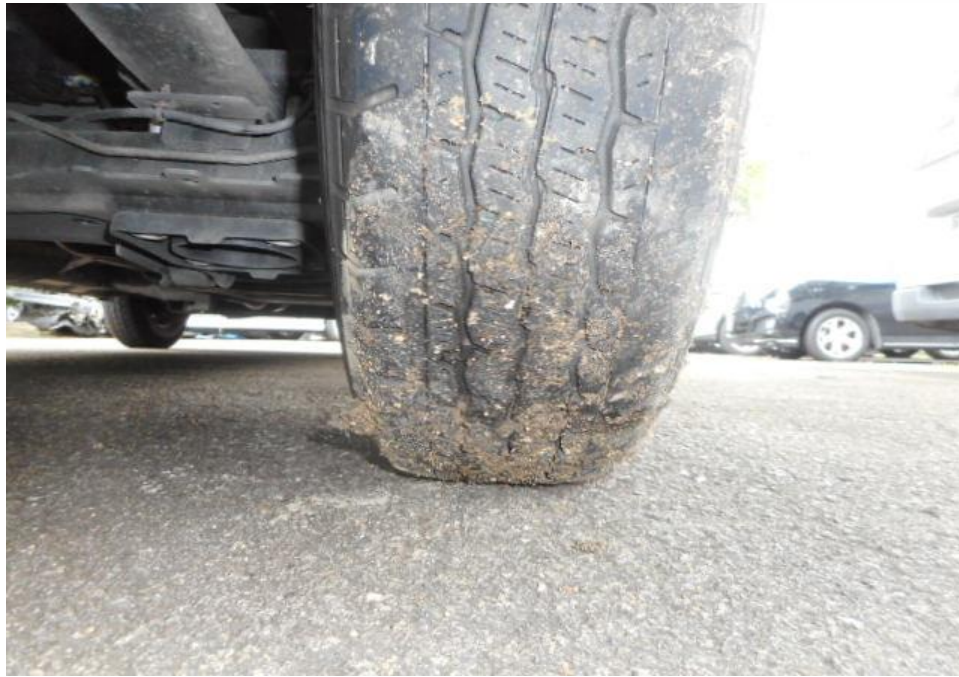
**Photo 8** shows the condition of the rear right tyre of the Motor Van, which was observed to be in serviceable condition with remaining tread depth of approximately 4.9mm. The tyre, which was wrapped around standard steel wheel rim, it was observed to be sufficiently inflated for vehicular operation.

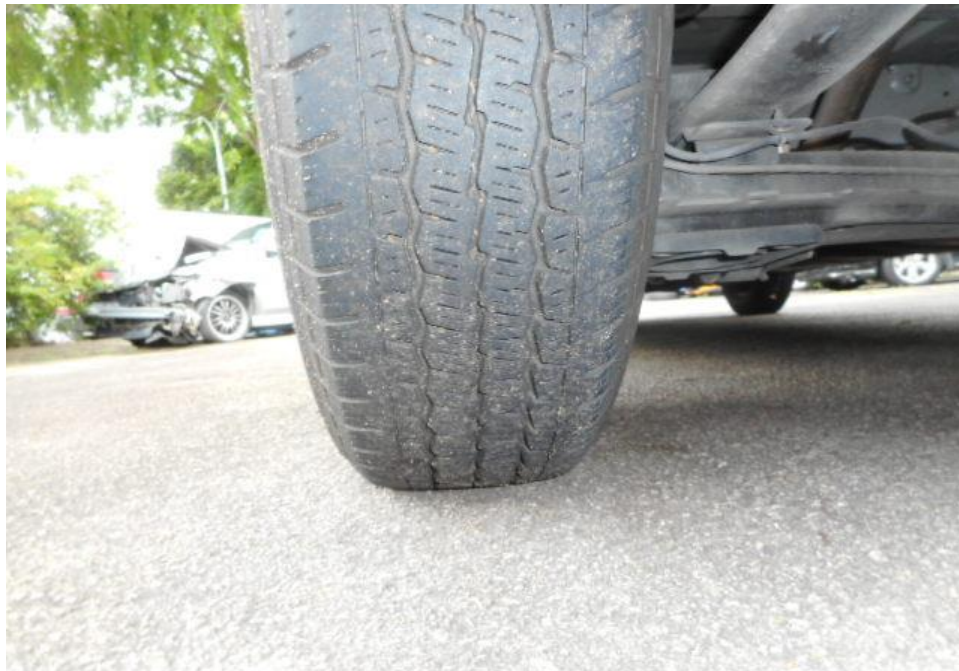
**Photo 9** shows the condition of the rear left tyres of the Motor Van, which was observed to be in serviceable condition with remaining tread depth of approximately 4.4mm. The tyres, which were wrapped around standard steel wheel rim, were also observed to be sufficiently inflated for vehicular operation. There was also no damage found on all 4 steel wheel rims of the Motor Van.

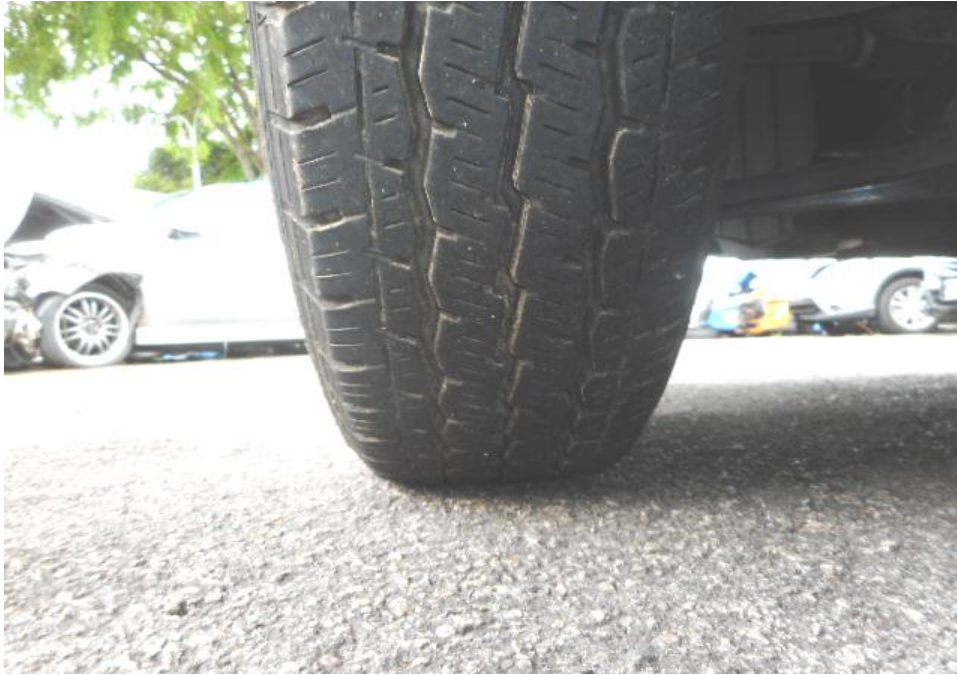
**Photo 10** shows the condition of the rear right tyres of the Motor Van, which were observed to be in serviceable condition with remaining, tread depth of approximately 5.9mm. There was also no tear, cut or burst mark(s) on the outer and the inner sidewalls as well as across the tread of the 4 tyres that were fitted on the Motor Van.

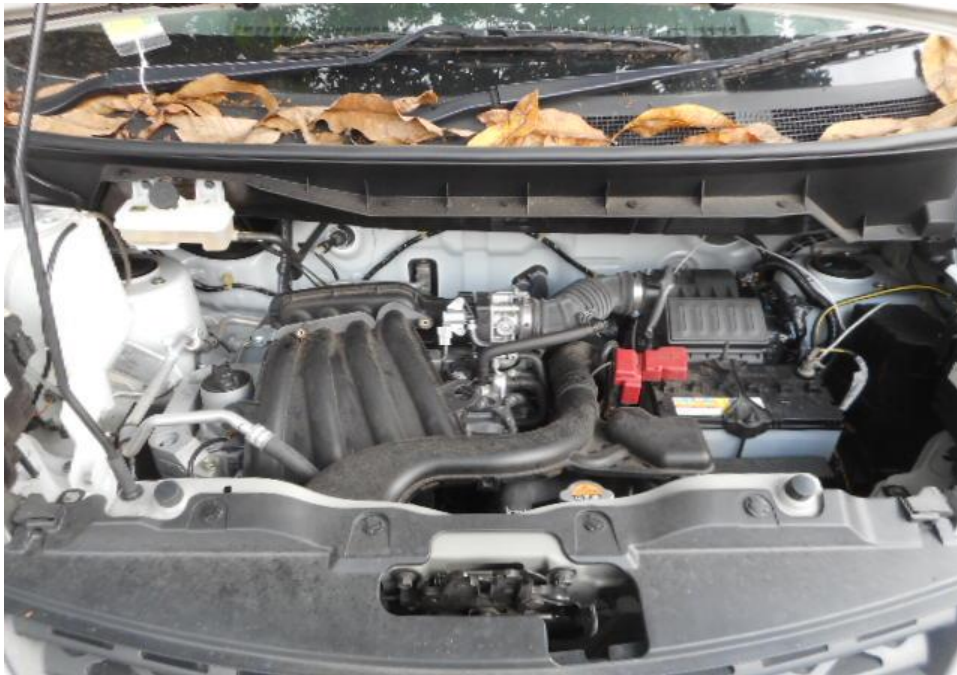
**Photo 11** shows a general view of the Motor Van's engine compartment, which was accessed by lifting the front cabin of the Motor Van. The various parts and components inside the engine compartment were unaffected by the accident. There was also no sign(s) or indication(s) of fresh fluid leakage and/or fluid stain within the engine compartment

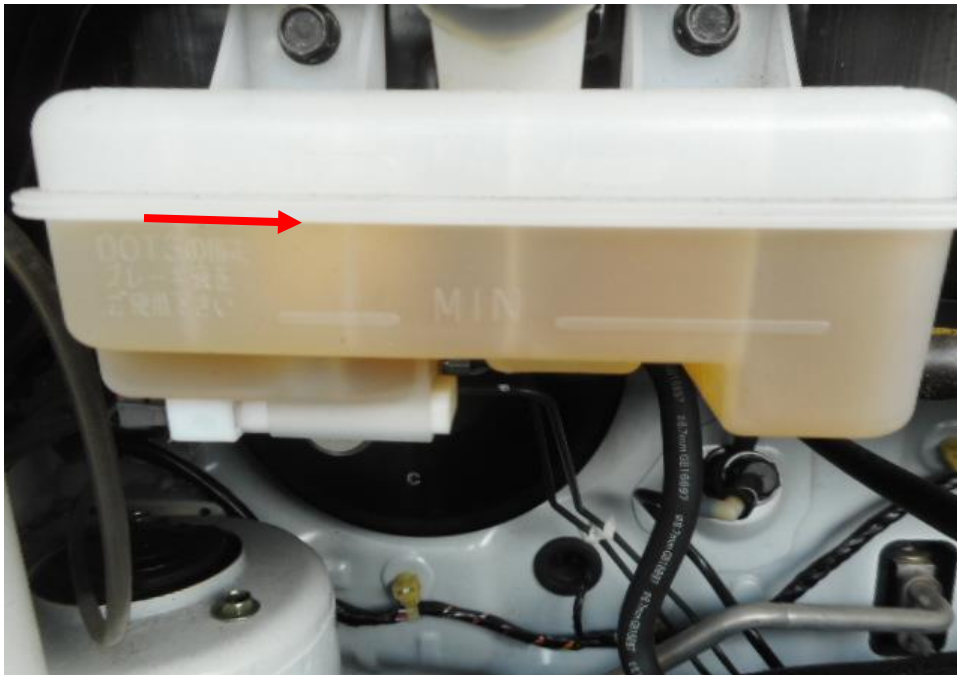
**Photo 12** shows the brake fluid reservoir of the Motor Van at the time of my inspection. The brake fluid was observed to be of sufficient level (arrowed) and without any visible contamination.

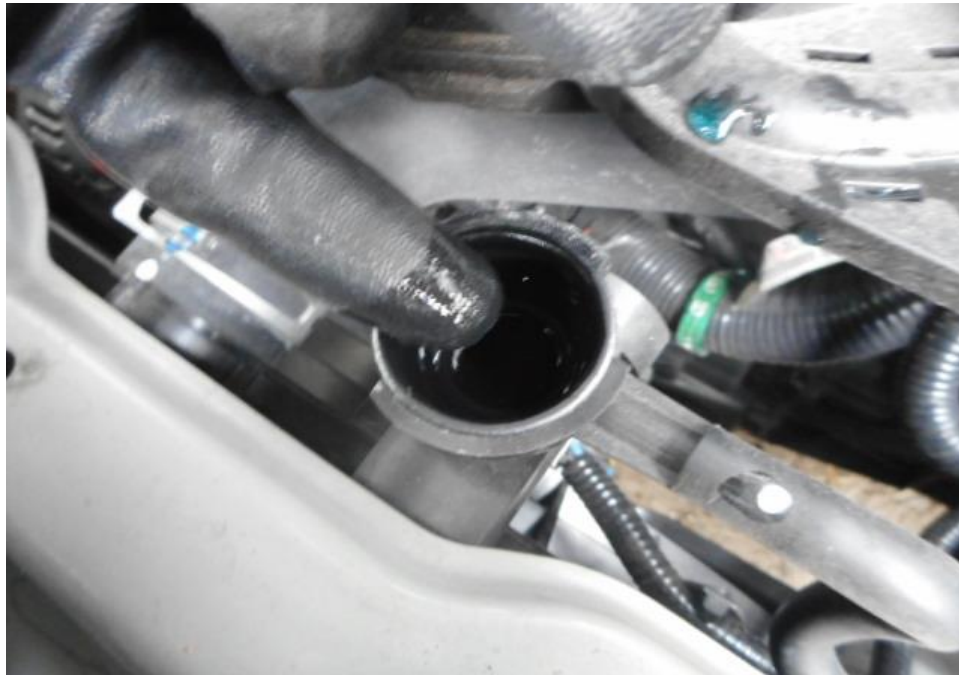
**Photo 13** shows the engine coolant of the Motor Van at the time of my inspection. The engine coolant was observed to be of sufficient level and without any visible contamination.

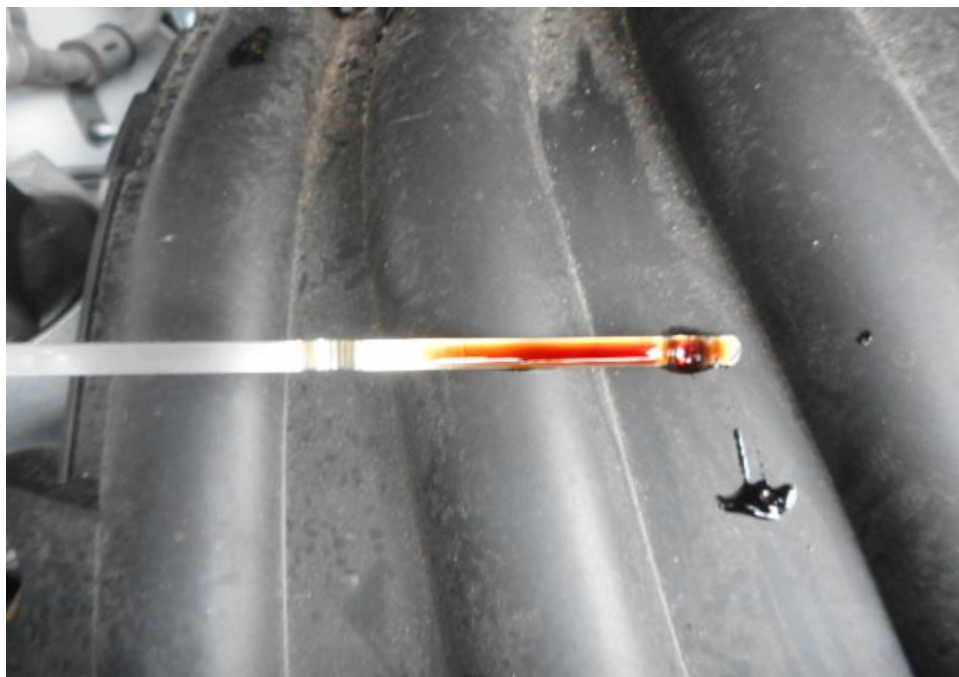
**Photo 14** shows the engine oil dip stick of the Motor Van at the time of my inspection. The engine oil was observed to be of sufficient level and without any visible contamination.

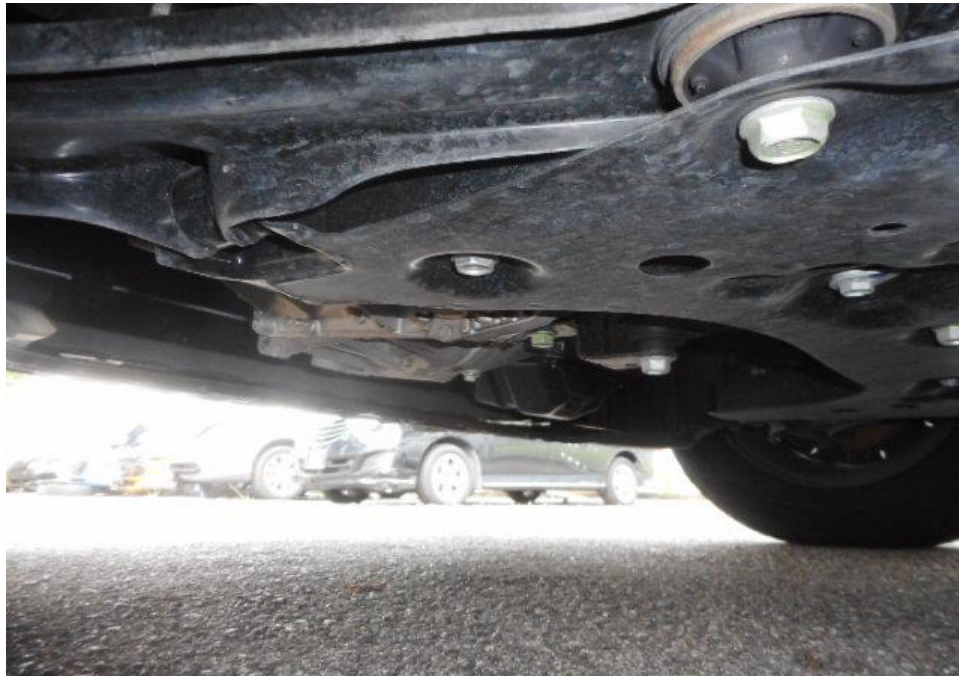
**Photo 15** shows the undercarriage of the Motor Van, at the area where the engine housing and transmission housing are located. I did not find any sign(s) or indication(s) of fluid leak and/or fluid stain(s) on the underside of the Motor Van.

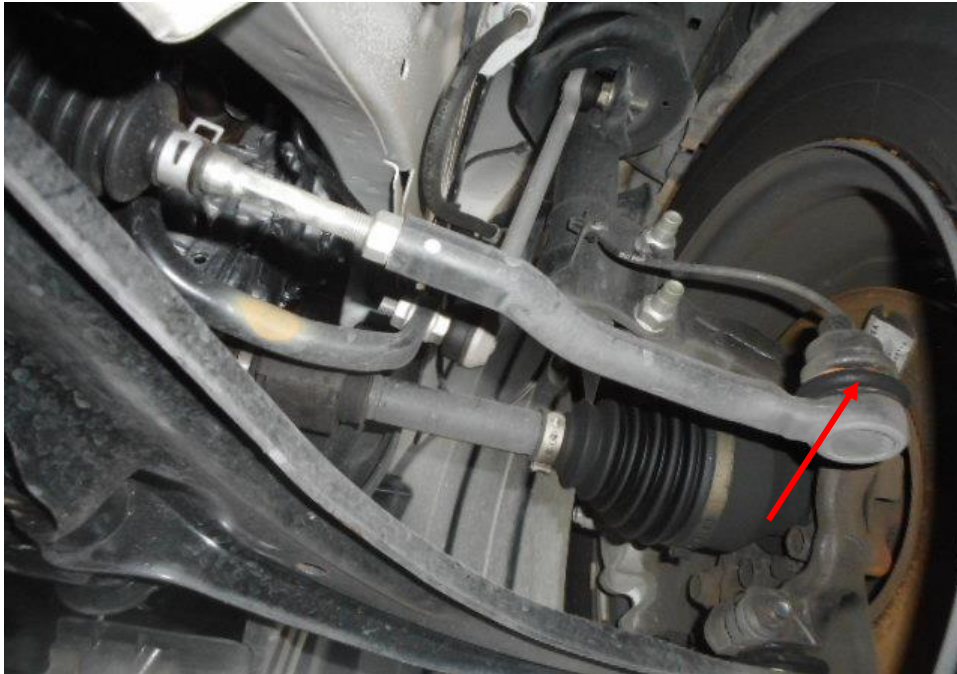
**Photo 16** shows the various undercarriage components at the front right wheel of the Motor Van, in particular the steering tie rod end (arrowed). The various steering components were all found to be intact, suggesting that the steering system of the Motor Van was likely to be in serviceable condition at the material time of accident. There was also no sign of fluid stain(s) observed on the various undercarriage components.

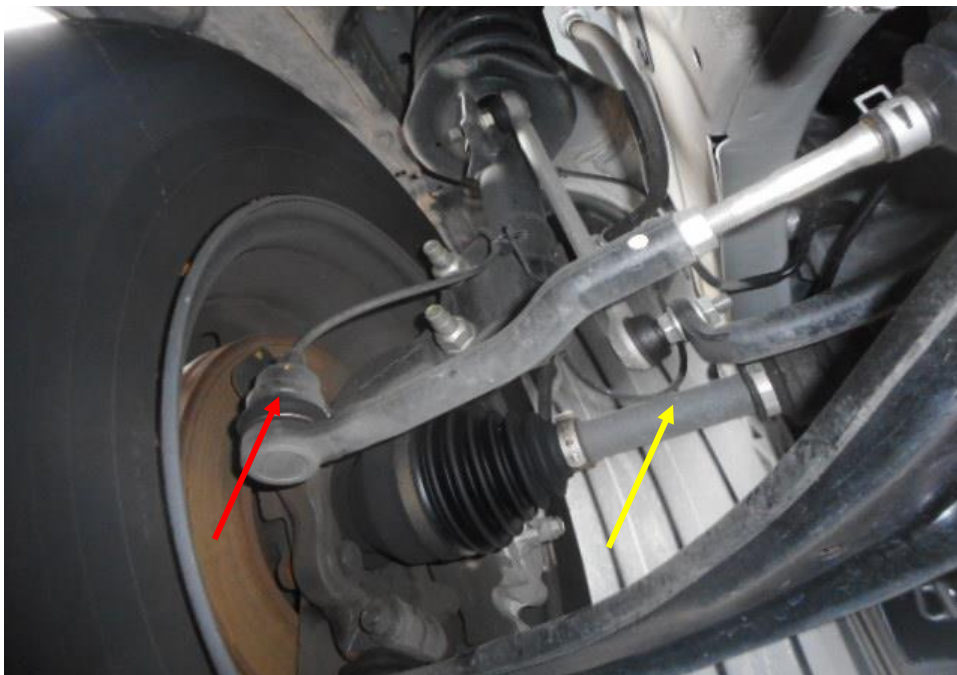
**Photo 17** shows the various undercarriage components at the front left wheel of the Motor Van, in particular the steering tie rod end (red arrow) and the driveshaft (yellow arrow). The various undercarriage components of the Motor Van were all found to be intact without any visible damage. There was also no sign of fluid stain(s) observed on the various undercarriage components.

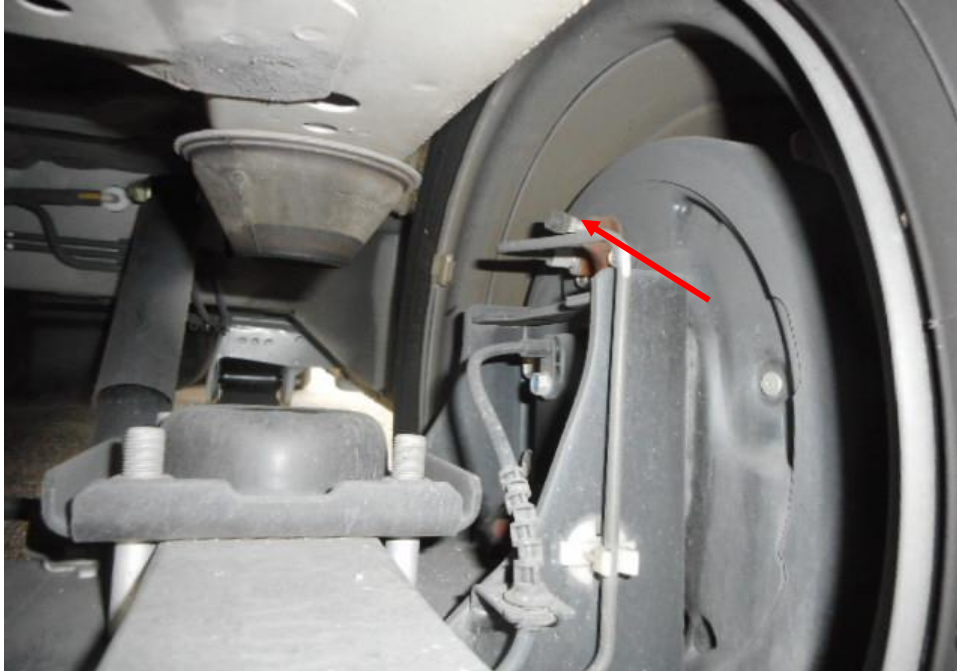
**Photo 18** shows the brake pipe (arrowed) at the rear right wheel of the Motor Van. I did not observe any leakage of brake fluid at the time of my inspection of the Motor Van. My static tests of the Motor Van's braking system, along with my visual examination of the various mechanical components in the braking system, had indicated that there was no internal leakage of pressure/vacuum. Hence the braking system of the Motor Van was likely to be in serviceable condition at the material time of accident.

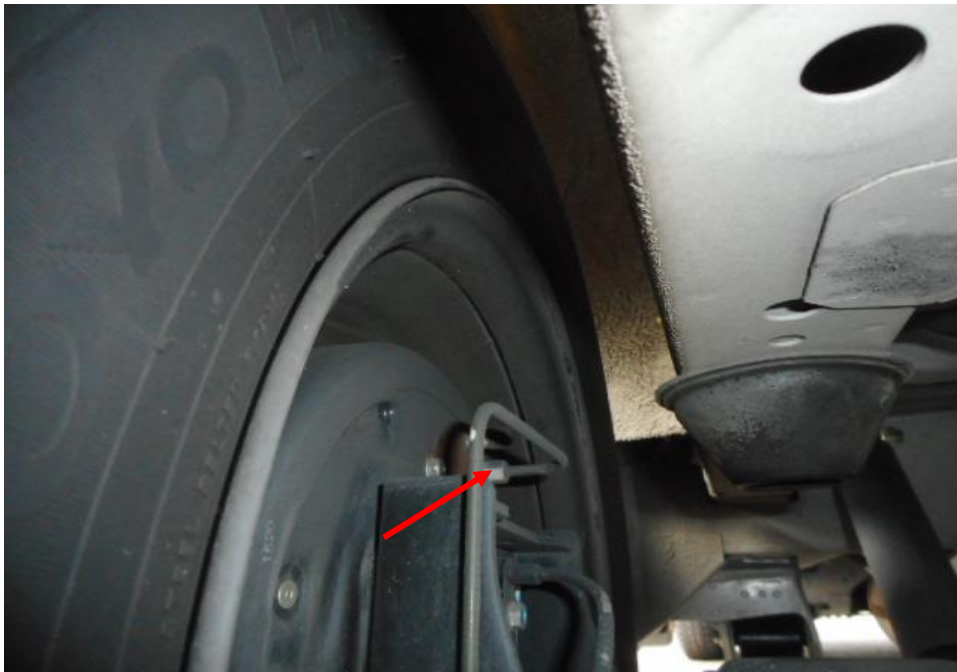
**Photo 19** shows the brake pipe (arrowed) at the rear left wheel of the Motor Van. I did not observe any leakage of brake fluid at the time of my inspection of the Motor Van. My static tests of the Motor Van's braking system, along with my visual examination of the various mechanical components in the braking system had indicated that there was no internal leakage of pressure/vacuum. Hence the braking system of the Motor Van was likely to be in serviceable condition at the material time of accident.

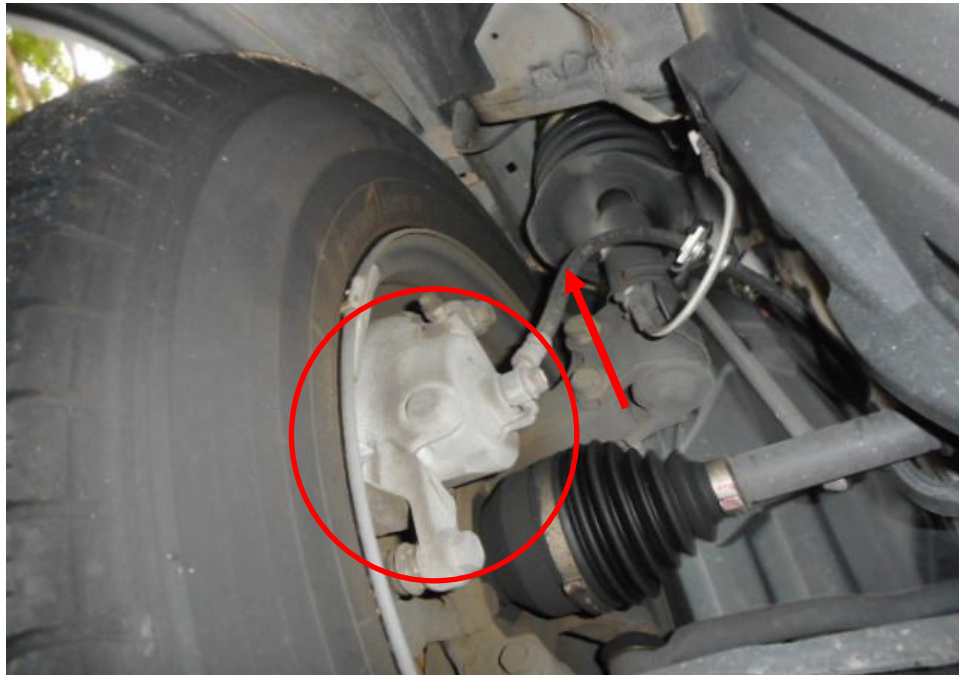
**Photo 20** shows the brake hose/pipe (arrowed) at the front right wheel of the Motor Van. No leakage of brake fluid was observed. Visual examination of the various components of the braking system like the brake caliper (circled), brake booster, brake pedal etc had revealed all to be intact and without visible damage at the time of accident. There was also no sign of fluid stain(s) observed on the various undercarriage components.

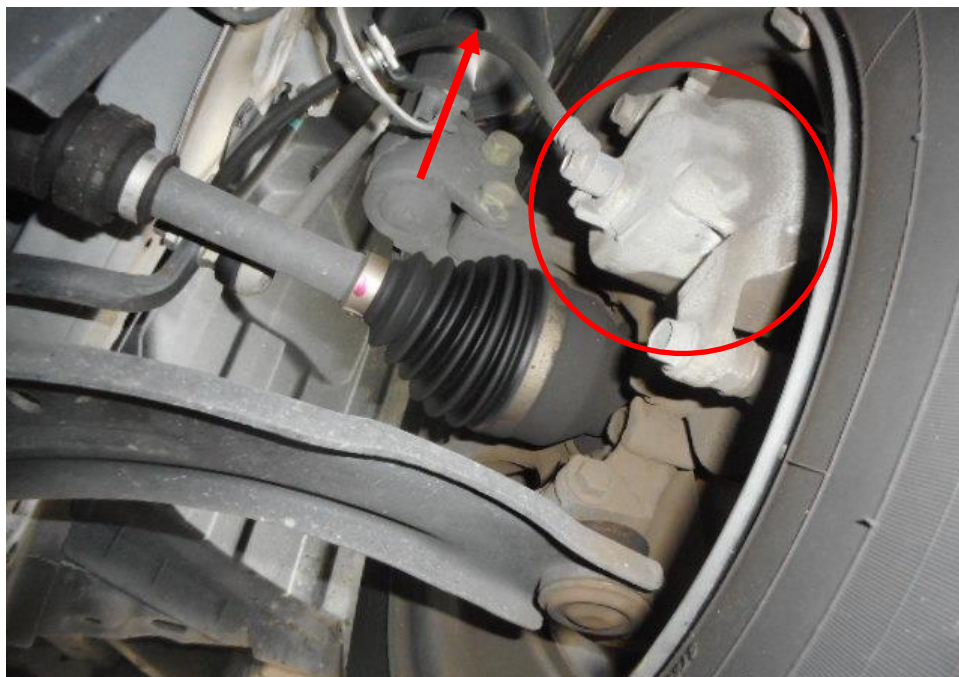
**Photo 21** shows the brake hose/pipe (arrowed) at the front left wheel of the Motor Van. No leakage of brake fluid was observed. Visual examination of the various components of the braking system like the brake caliper (circled), brake booster, brake pedal etc had revealed all to be intact and without visible damage at the time of accident. There was also no sign of fluid stain(s) observed on the various undercarriage components.

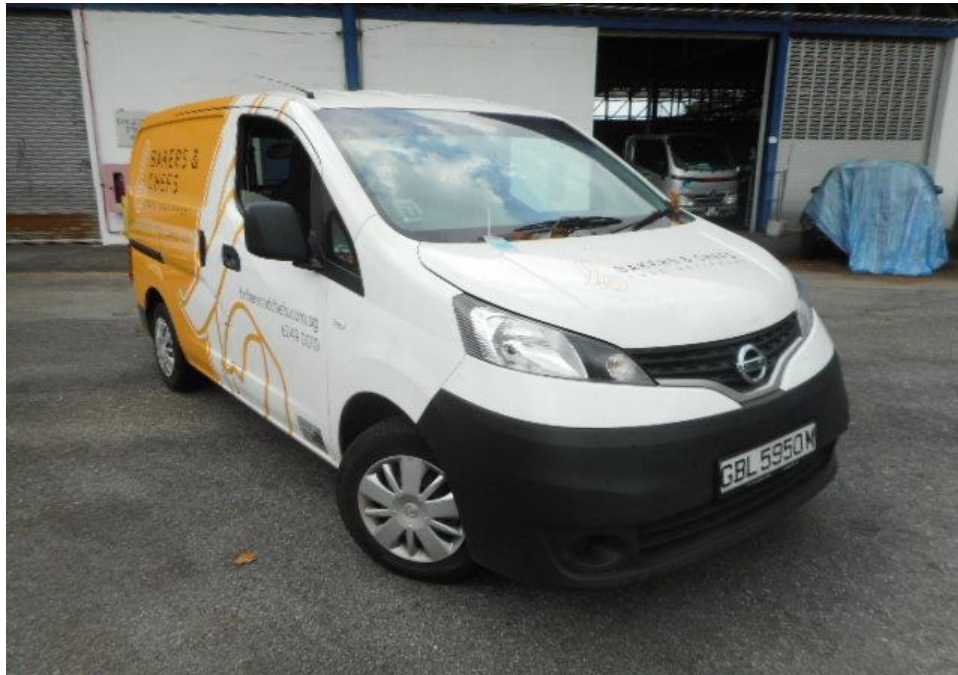
**Photo 22** shows the front right wheel of the Motor Van turned to its full left. During my steering system test, I did not experience any abnormal free play and/or resistance when I had turned the steering wheel towards full left and full right. This would suggest that the steering system of the Motor Van was likely to be in serviceable condition at the material time of accident.

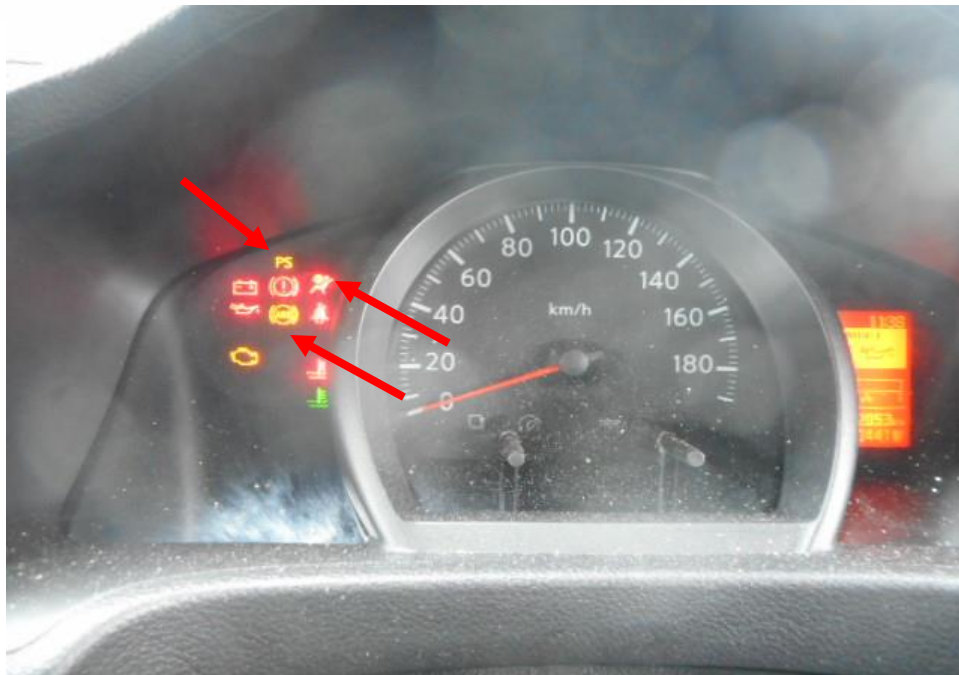
**Photo 23** shows the warning light for Anti-Lock Brake System (ABS), Electrical Power Steering System (EPS) and Supplemental Restraint System (SRS) (arrowed) appearing on the instrument panel of the Motor Van during the self-test of its various electronic operating systems when its engine was cranked.

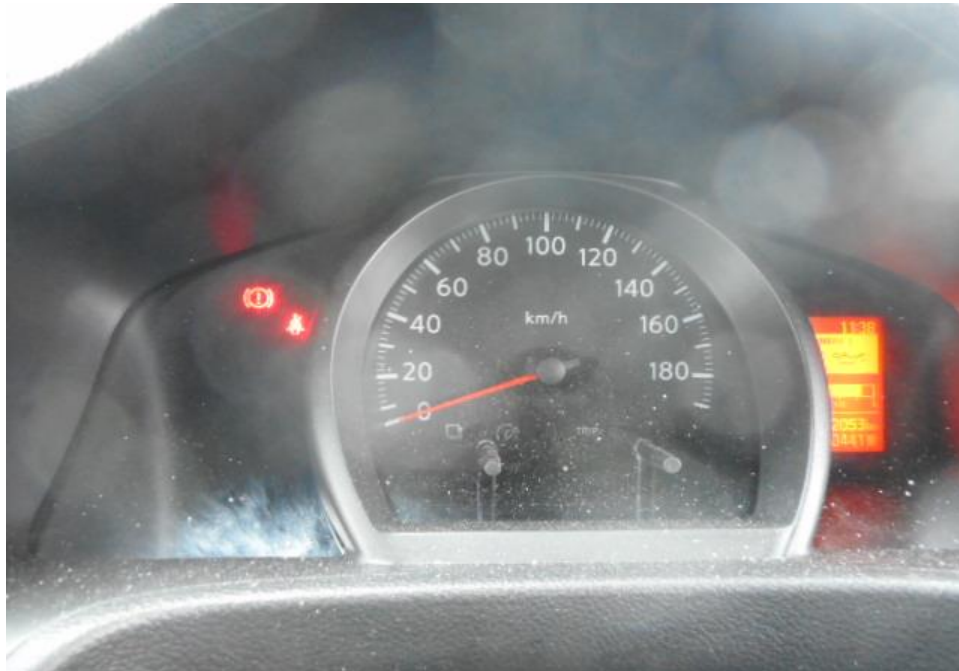
**Photo 24** shows no warning lights illuminated on the instrument panel of the Motor Van after the engine was cranked. This would suggest that there was no abnormality to the electronic operating system of the Motor Van, like the ABS, EPS, SRS and etc.
