You're Ref: TP/IP/07267/2022  
Our Ref: CI/TPD22003626/P

**General Investigation Team**

**MECHANICAL INSPECTION REPORT OF PRIME MOVER XE 1942P**

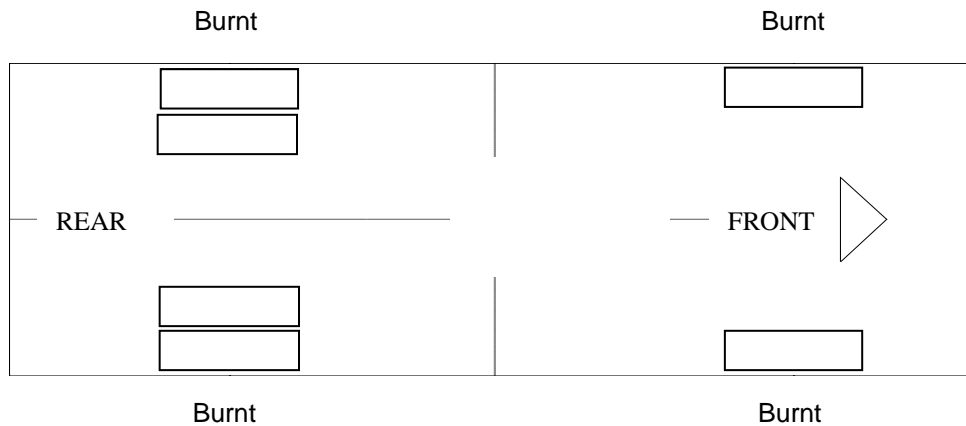
6. The 6 tyres of the Prime Mover were observed to be unserviceable condition as they were all burnt as a result of the fire.

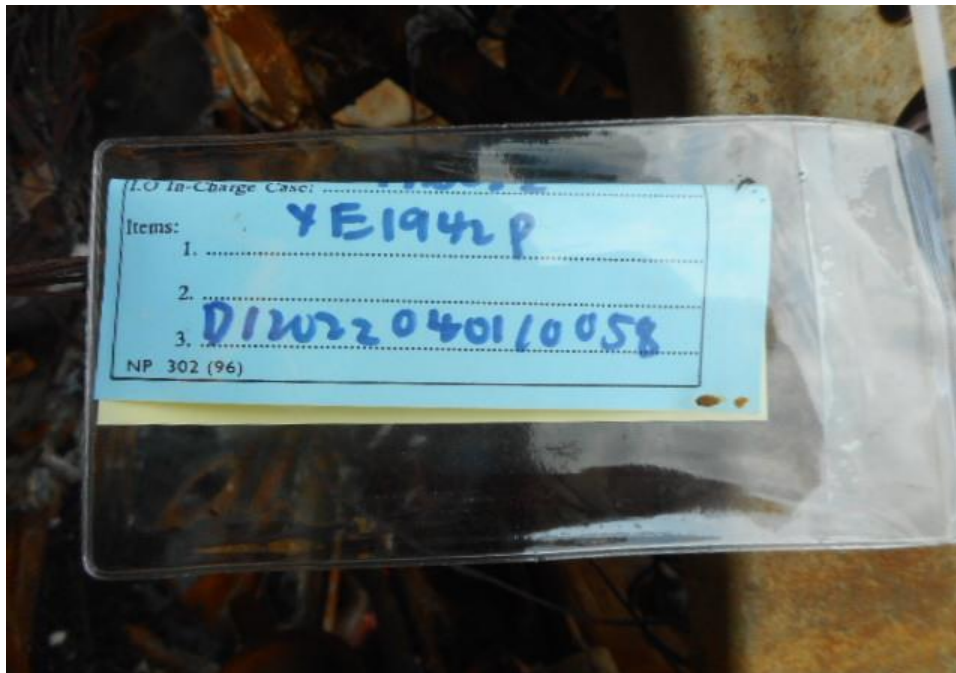
**Photo 1** shows the identification number of the Prime Mover's front body at the time of my inspection.

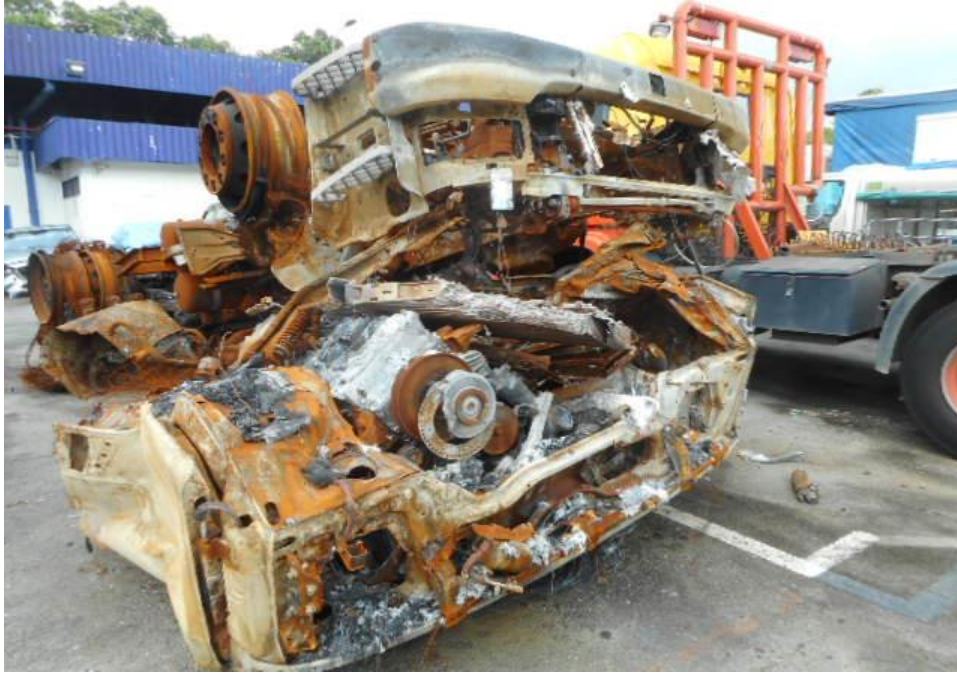
**Photo 2** shows a general view of the Prime Mover's front body at the time of my inspection. The front cabin of the Prime Mover was observed to be damaged as a result of the accident and fire.

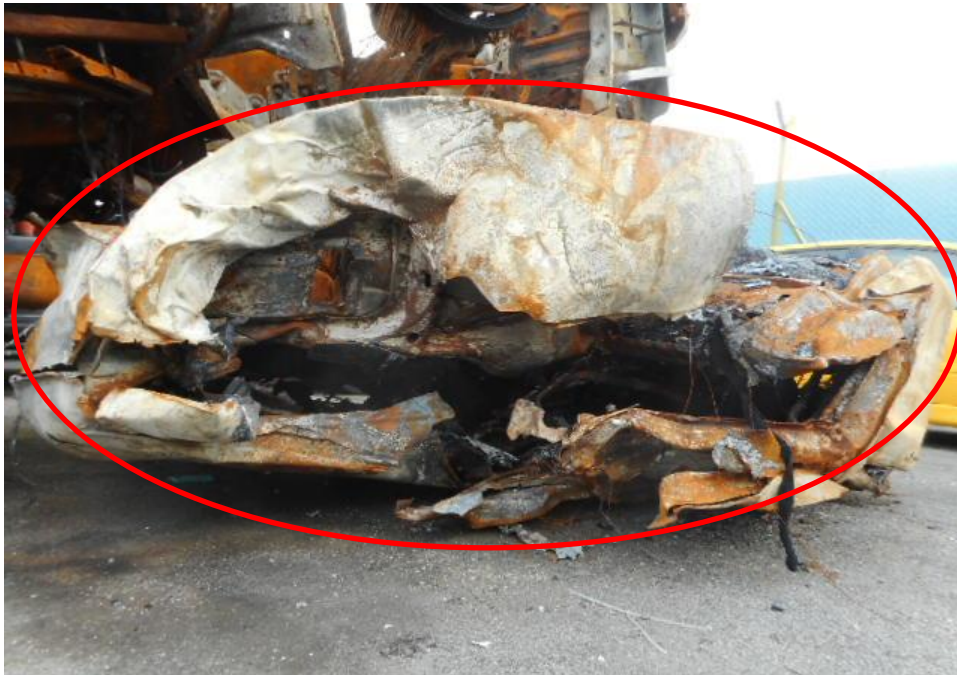
**Photo 3** shows a close up view of the Prime Mover's front body at the time of my inspection. The front cabin (circled) of the Prime Mover was observed to be damaged as a result of the accident and fire.

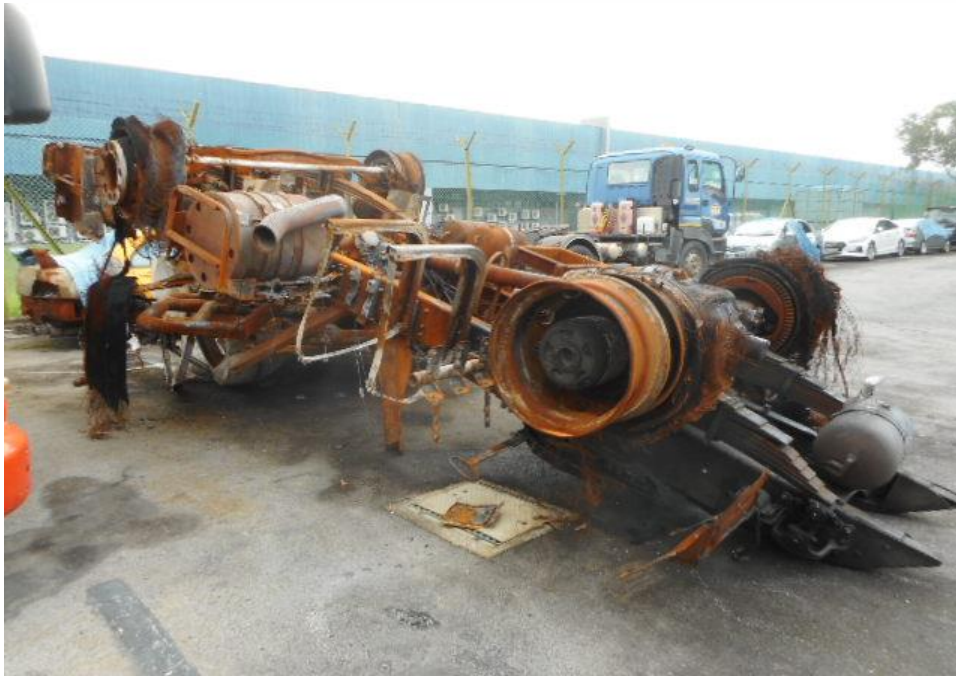
**Photo 4** shows a general view of the Prime Mover's right body at the time of my inspection. The right portion of the Prime Mover was observed to be damaged as a result of the accident and fire.

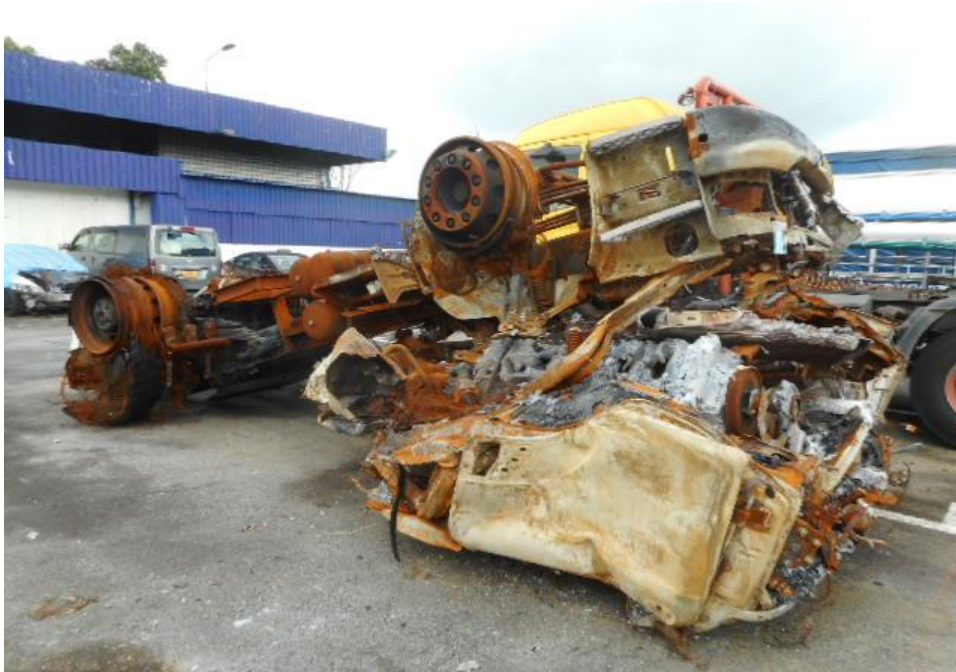
**Photo 5** shows a general view of the Prime Mover's left body at the time of my inspection. The left portion of the Prime Mover was observed to be damaged as a result of the accident and fire.

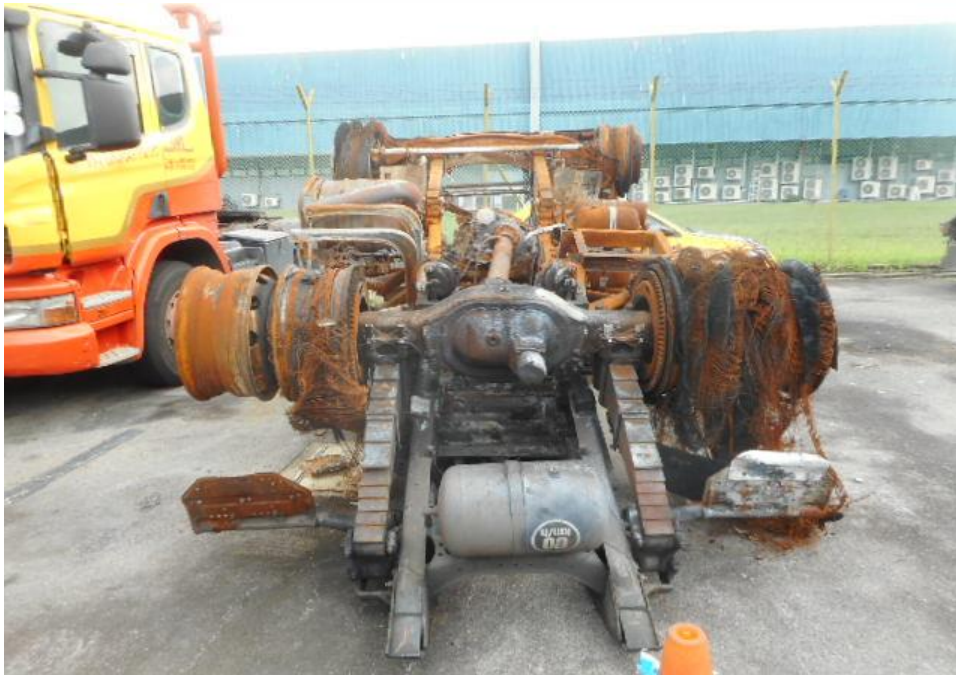
**Photo 6** shows a general view of the Prime Mover's rear body at the time of my inspection. The rear portion of the Prime Mover was observed to be damaged as a result of the accident and fire.

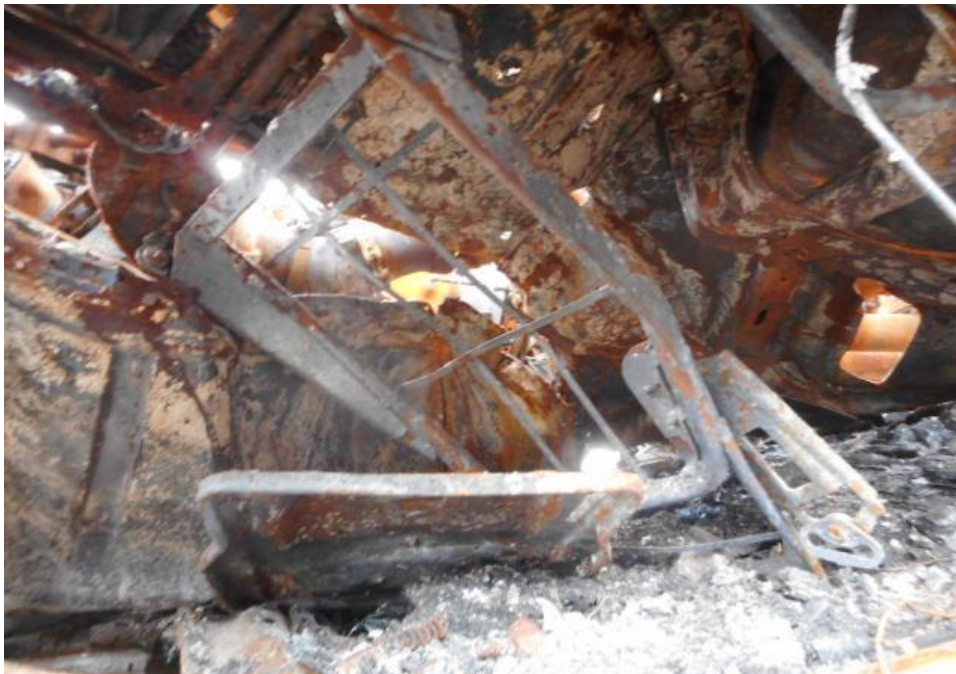
**Photo 7** shows the general view of the interior compartment of the Prime Mover at the time of our inspection. Its interior compartment was completely burnt and damaged as a result of the fire and accident.

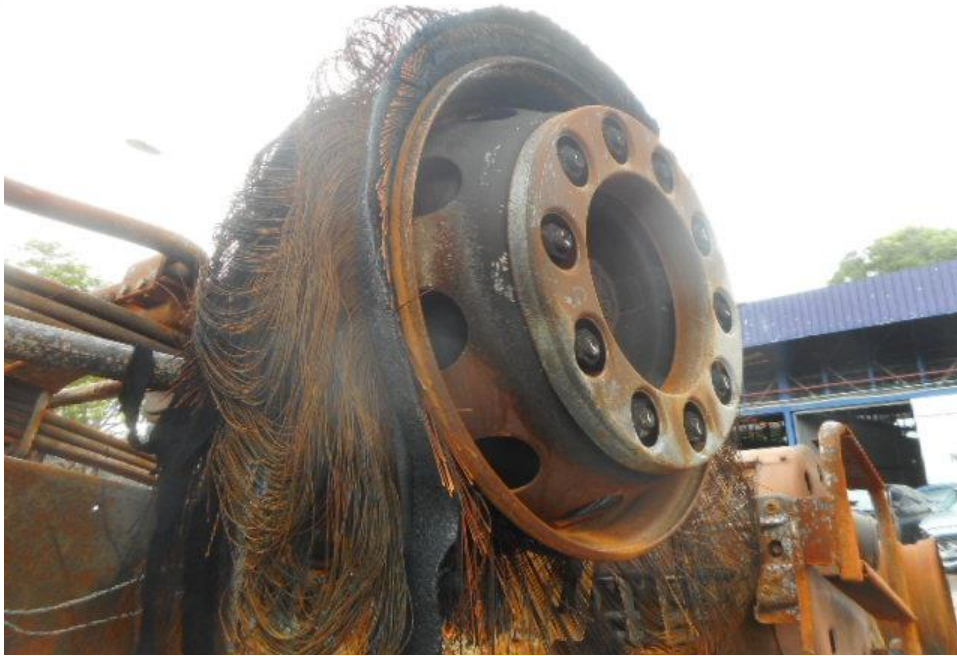
**Photo 8** shows the condition of the front right tyre of the Prime Mover, which were observed to be in unserviceable condition as it was badly burnt as a result of the fire.

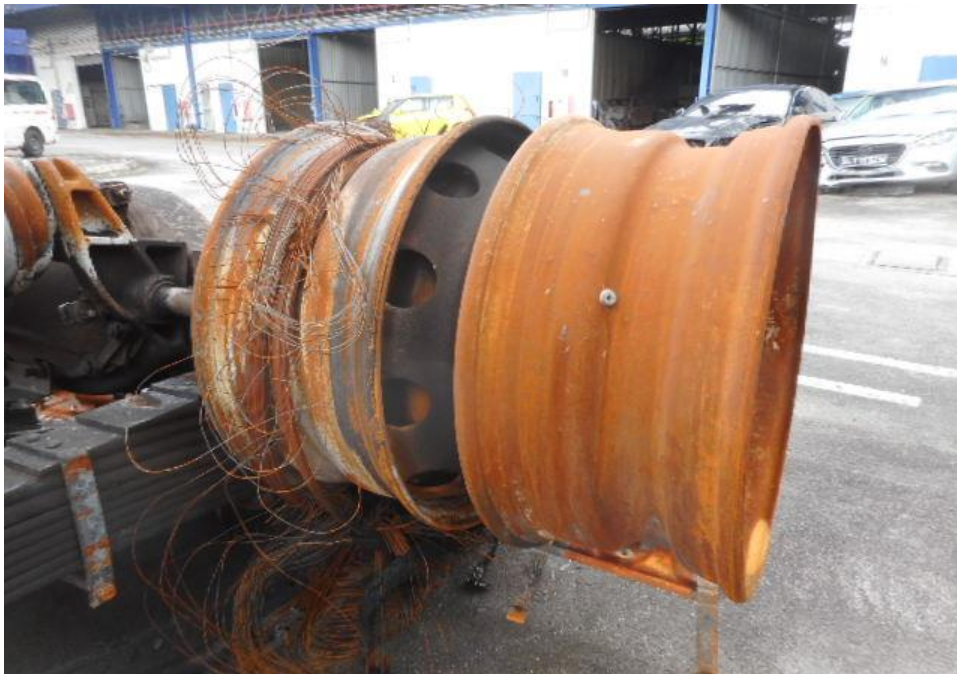
**Photo 9** shows the condition of the rear right tyres of the Prime Mover, which were observed to be in unserviceable condition as it was badly burnt as a result of the fire.

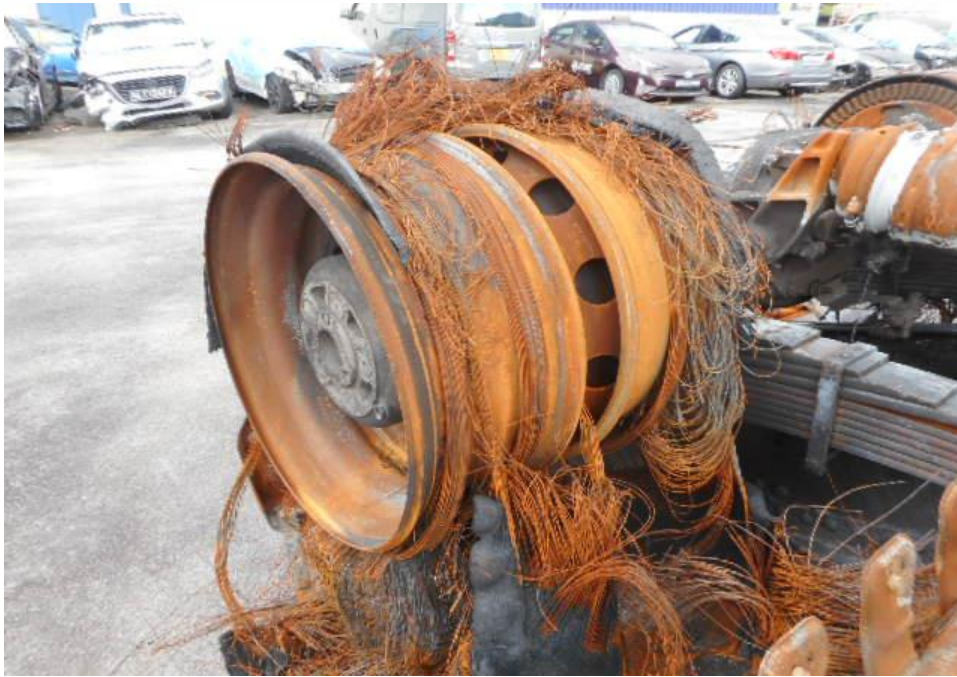
**Photo 10** shows the condition of the rear left tyre of the Prime Mover, which were observed to be in unserviceable condition as it was badly burnt as a result of the fire.

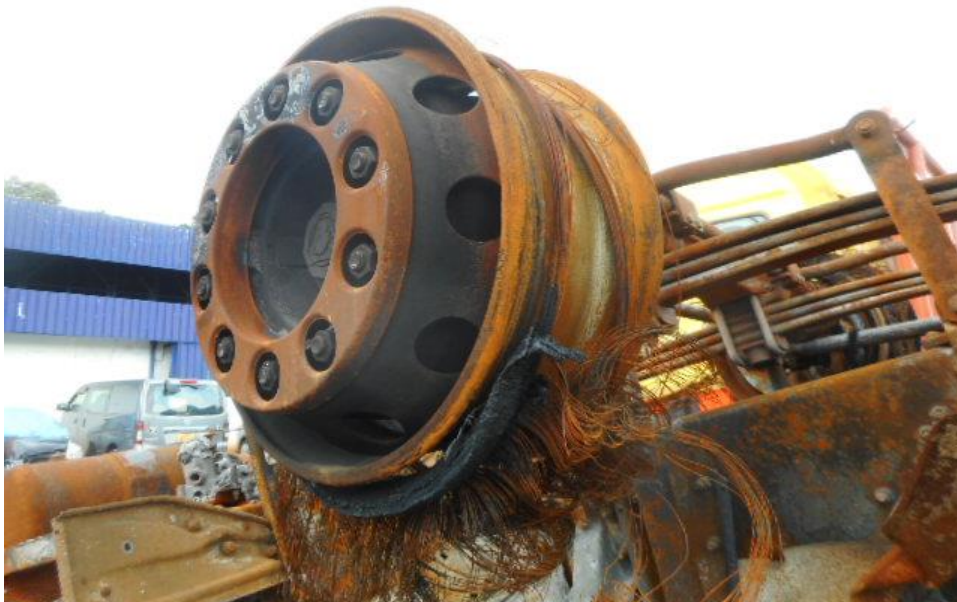
**Photo 11** shows the condition of the front left tyre of the Prime Mover, which were observed to be in unserviceable condition as it was badly burnt as a result of the fire.

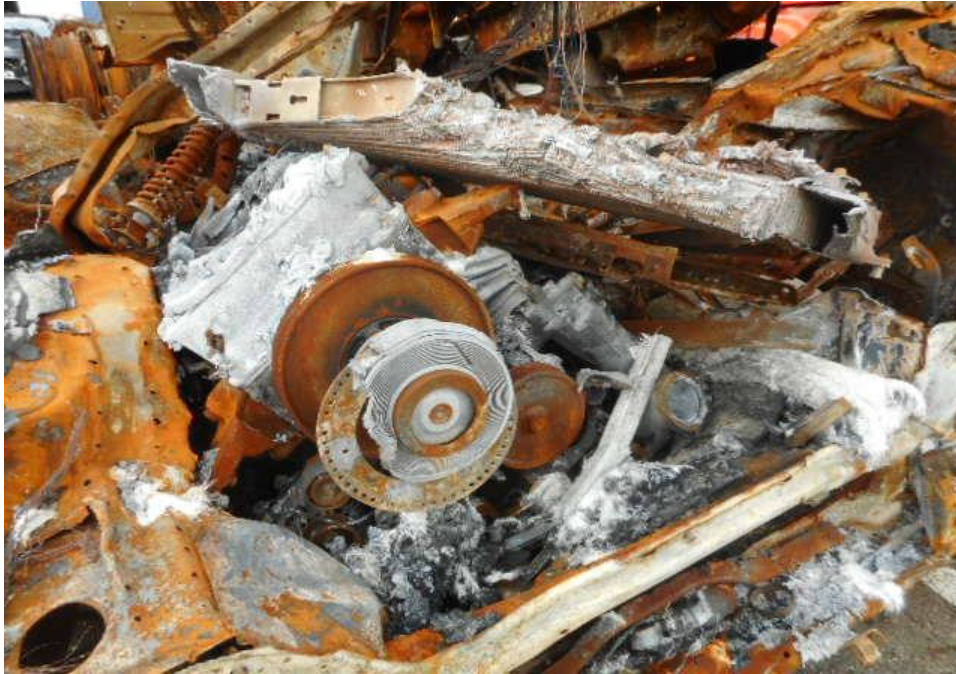
8. Upon examination of the Prime Mover's engine compartment, we were unable to conduct a check as all the engine components in the engine compartment had been burnt as a result of the fire. See photo 12 below.

**Photo 12** shows the engine compartment (arrowed) of the Prime Mover, all the engine components had been burnt as a result of the fire.

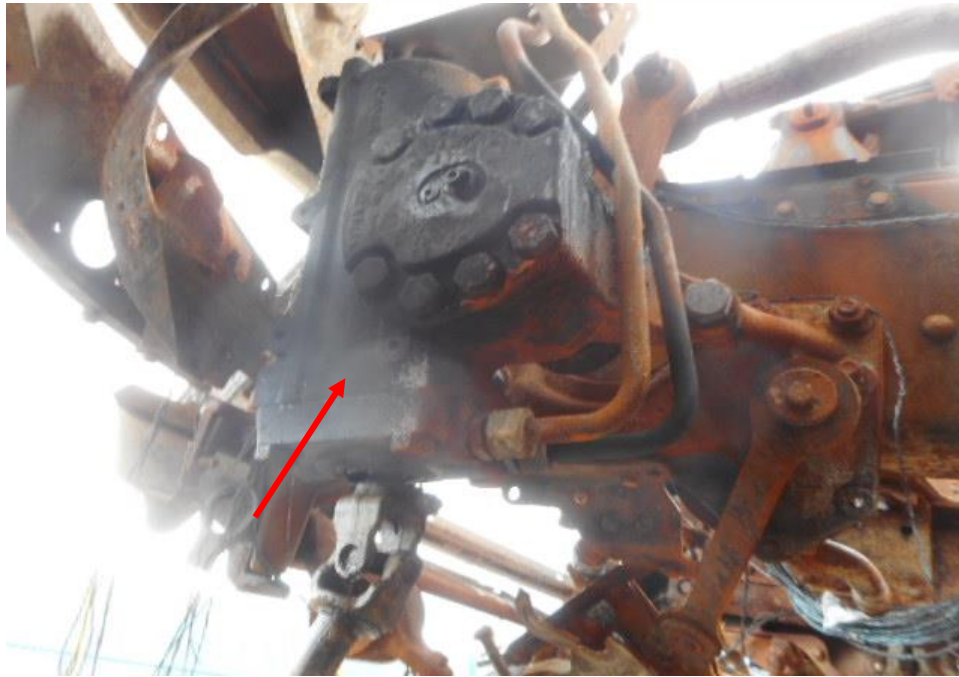
9. Static braking and steering tests were not conducted on the Prime Mover as the braking and steering controls were burnt as a result of the fire. Our visual inspection of the mechanical components of the Prime Mover observed that its undercarriage braking and steering system components were all burnt by the fire. See photo 13 - 15 below.

**Photo 13** shows the steering box component (arrowed) at the front of the Prime Mover, it was observed to be burnt as a result of the fire.

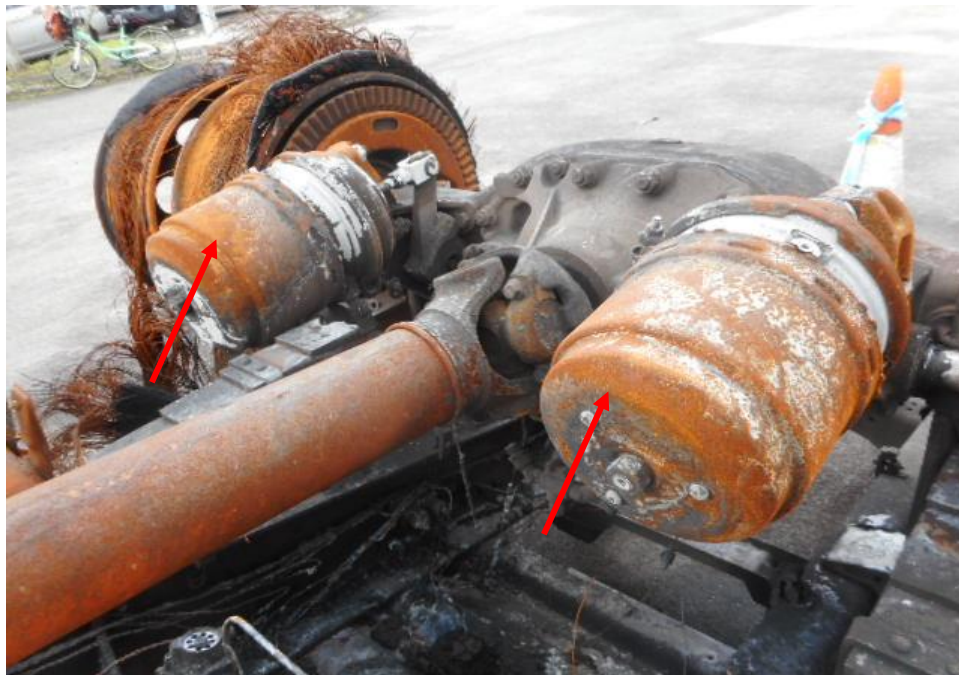
**Photo 14** shows the air brake component (arrowed) at the rear of the Prime Mover, it was observed to be burnt as a result of the fire.

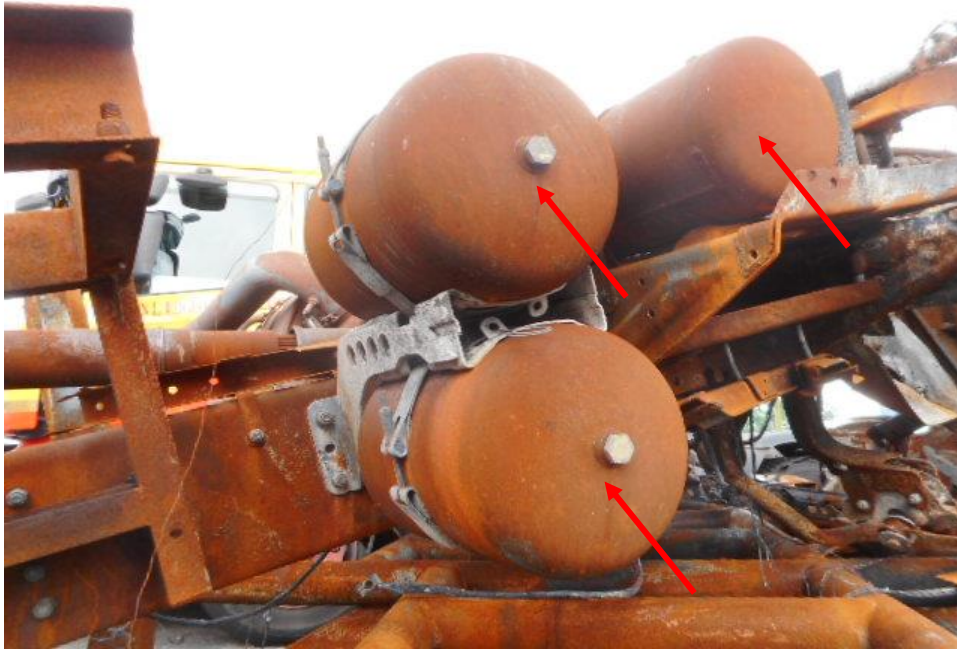
**Photo 15** shows the air brake component (arrowed) at the left of the Prime Mover, it was observed to be burnt as a result of the fire.
