Your Ref: McLaren GT  
(chassis number SBM22GCC6LW000594)  
Our Ref : CI/TP22003705/D

22 April 2022

**INSPECTION REPORT OF AN UNREGISTERED MCLAREN GT MOTOR CAR  
WITH CHASSIS NUMBER SBM22GCC6LW000594**

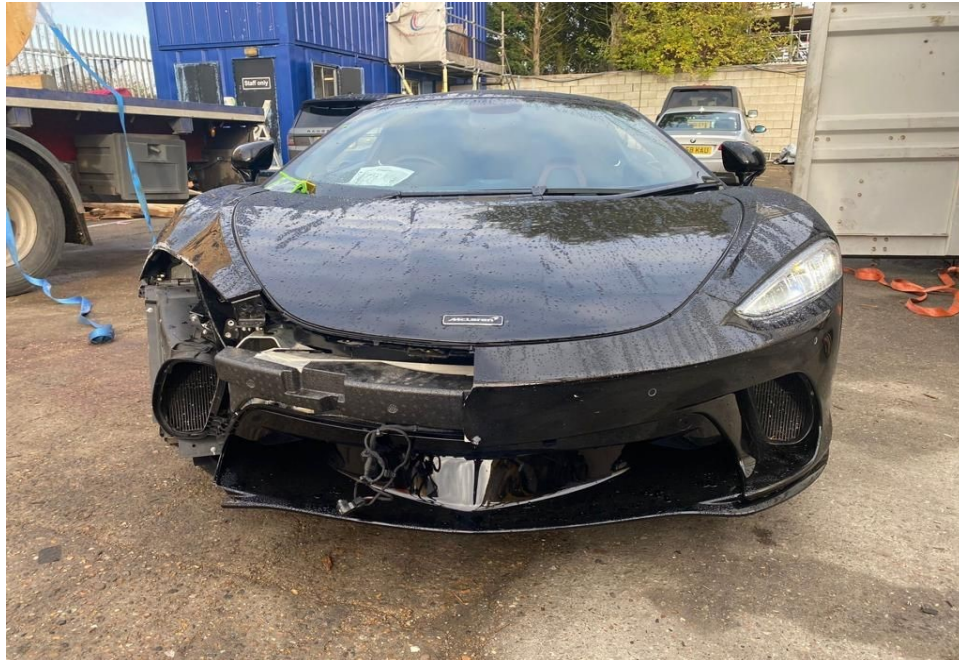
**Photo 1** shows the frontal body of the Motor Car (photograph provided to me). The photographs provided to me had showed damage to the front right portion of the Motor Car. The front bumper, front bumper right sensors, front bumper right air duct and front right fender were amongst the body parts that were observed to have been damaged. The front right headlamp was also observed to be dislodged/missing/damaged.

22. The body parts at the front right portion of the Motor Car were visually examined and it was noted that the repair/restoration works carried out to the damaged area of the Motor Car (refer to photograph 1 & 2 above) were reasonably adequate and in order.

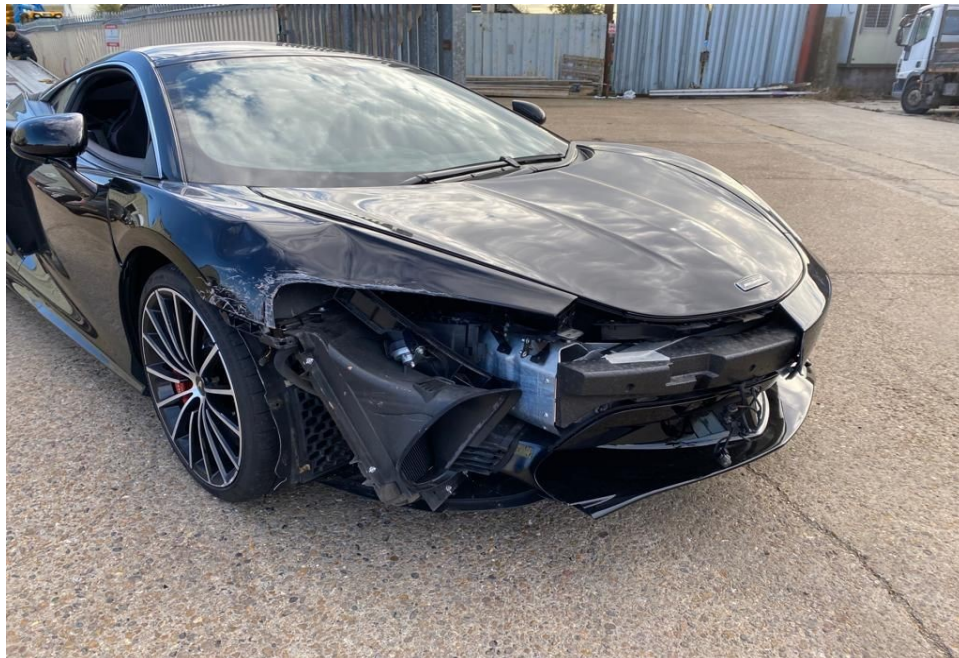
**Photo 2** shows the front right body of the Motor Car (photograph provided to me). The photographs provided to me had showed damage to the front right portion of the Motor Car. The front bumper, front bumper right bracket, front bumper right reflector, front bumper right air duct, front right fender and front right fender inner shield were amongst the body parts that were observed to have been damaged. The front right headlamp was also observed to be dislodged/missing/damaged.

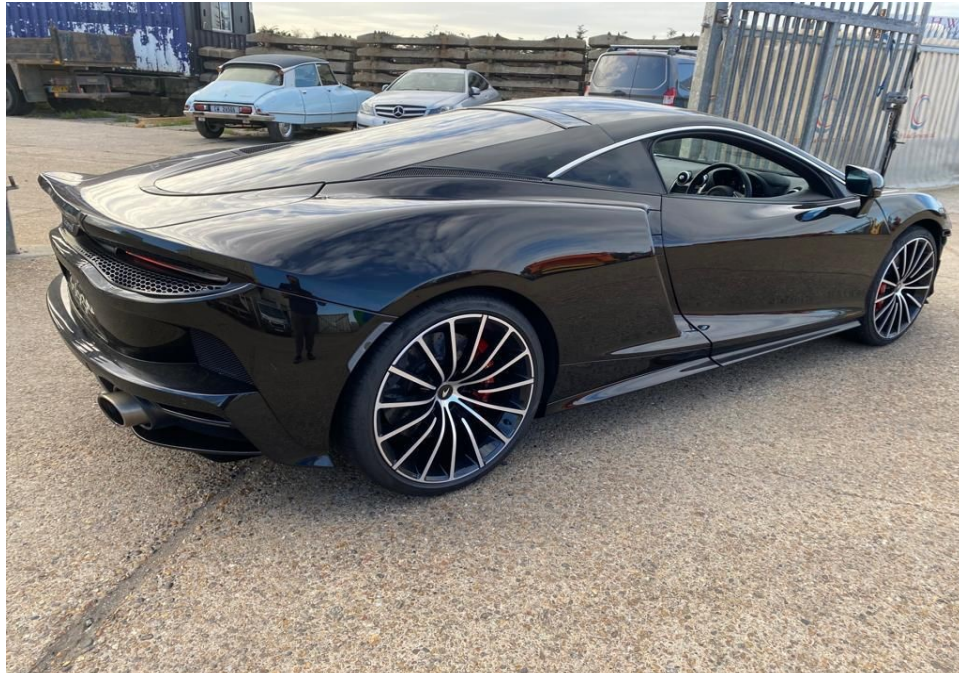
**Photo 3** shows the rear right body of the Motor Car (photograph provided to me). Apart for the front right portion, there was no physical damage observed to other areas of the Motor Car.

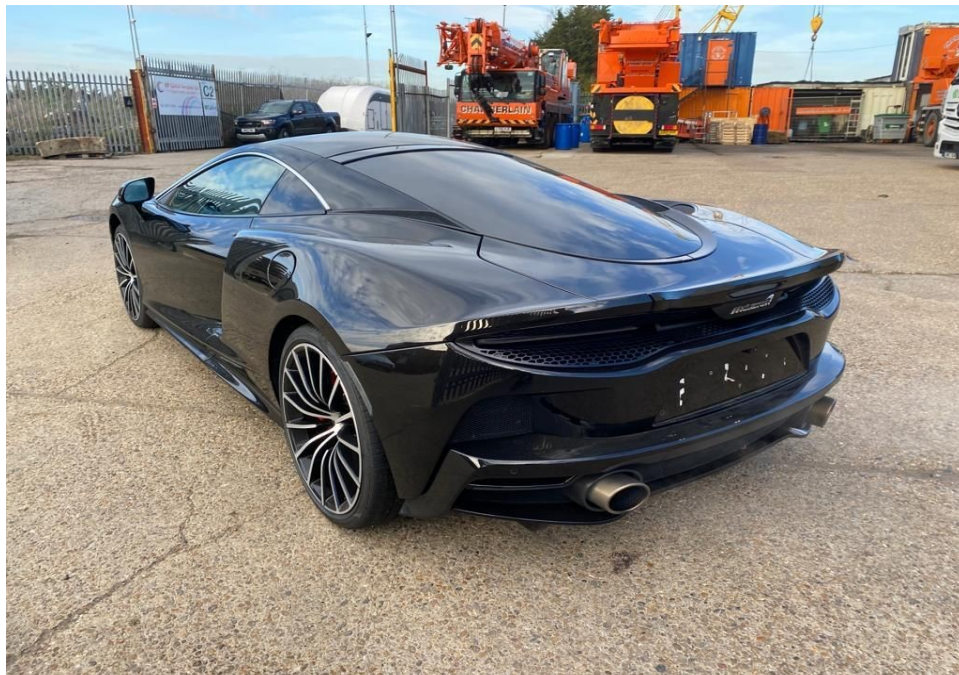
**Photo 4** shows the rear left body of the Motor Car (photograph provided to me). Apart for the front right portion, there was no physical damage observed to other areas of the Motor Car.

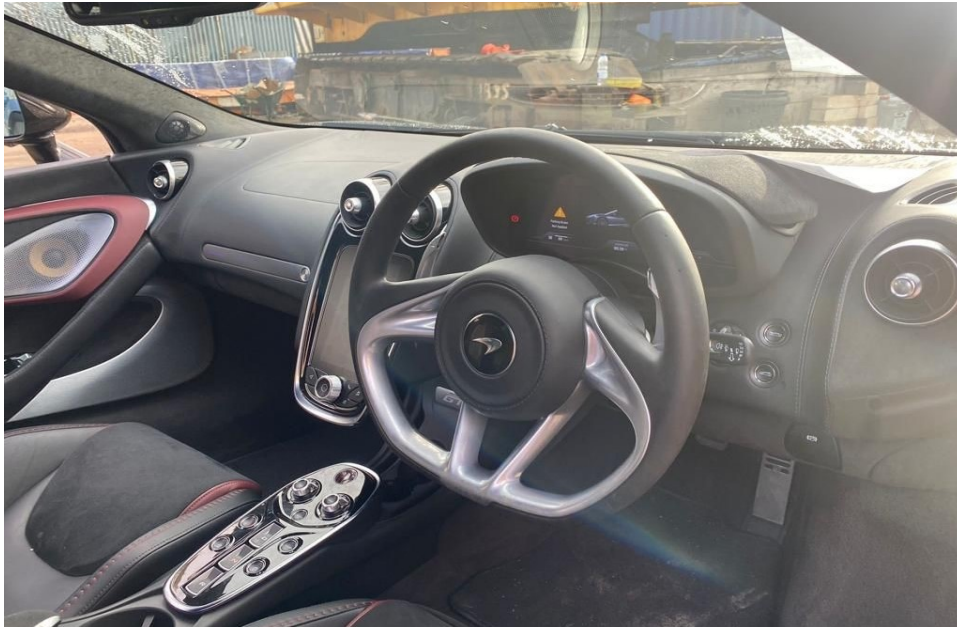
**Photo 5** shows the interior compartment of the Motor Car (photograph provided to me). The various parts and components within the interior compartment were all intact and unaffected. The airbag(s) was not deployed as seen from the photographs that were provided to me.

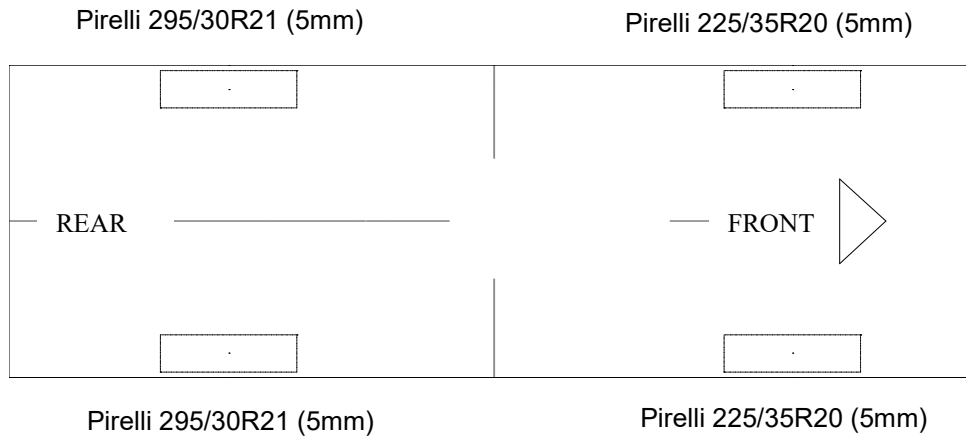
8. It was fitted with 20inch (front) and 21inch (rear) sport wheel rims that were wrapped with tyres that were observed to be of serviceable condition. The tyres were also sufficiently inflated for vehicular operation. The tyre brand, tyre size and approximate remaining tread depth of the 4 tyres of the Motor Car were recorded as follows: -

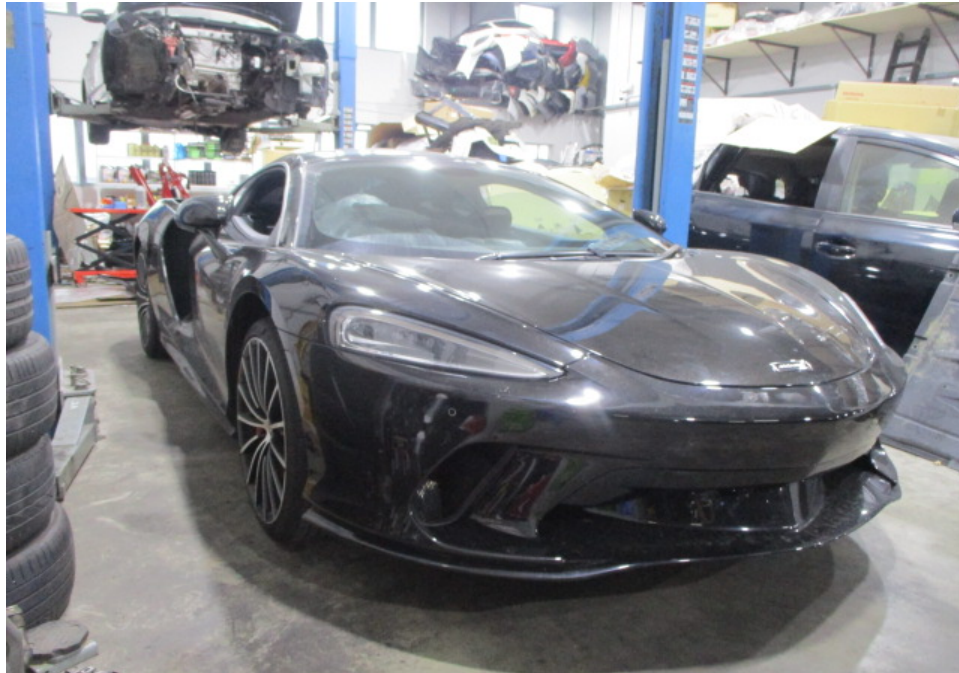
**Photo 6** shows a general view of the front right body of the Motor Car at the time of my inspection. The Motor Car was observed to be in a relatively good general condition with no loose exterior fittings observed. The body parts at the front right portion of the Motor Car were visually examined and it was observed that the repair/restoration works carried out to the damaged area of the Motor Car (refer to photograph 1 & 2 above) were reasonably adequate and in order.

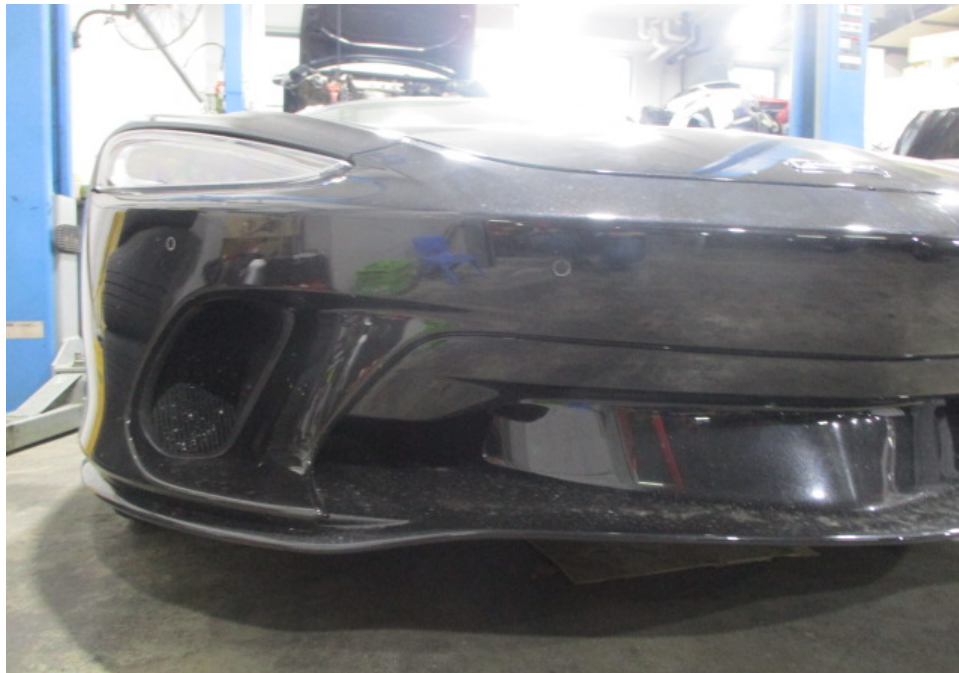
**Photo 7** shows a closer view of the Motor Car's front bumper, front bumper sensors and front bumper right air duct. The body parts at the front right portion of the Motor Car were visually examined and it was observed that the repair/restoration works carried out to the damaged area of the Motor Car (refer to photograph 1 & 2 above) were reasonably adequate and in order.

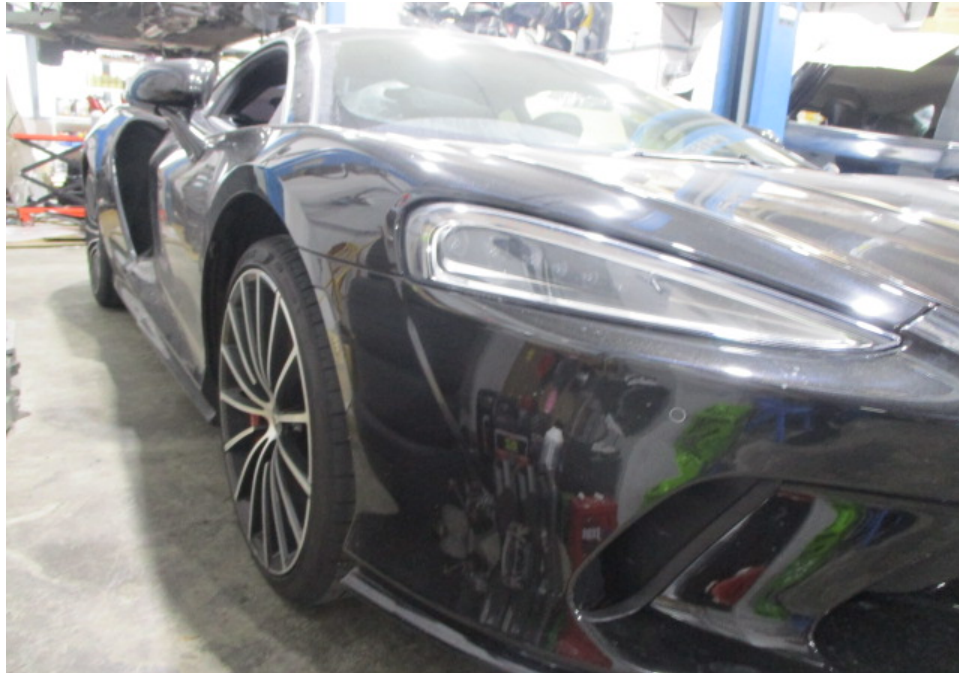
**Photo 8** shows a closer view of the Motor Car's front bumper, front right fender and front right headlamp at the time of my inspection. The body parts at the front right portion of the Motor Car were visually examined and it was observed that the repair/restoration works carried out to the damaged area of the Motor Car (refer to photograph 1 & 2 above) were reasonably adequate and in order.

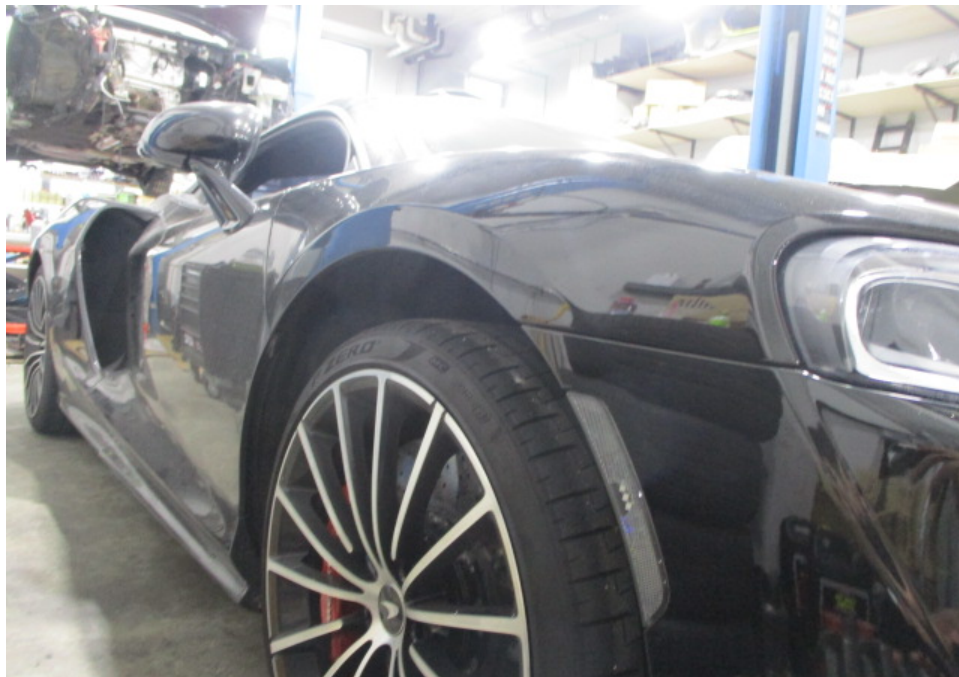
**Photo 9** shows a closer view of the Motor Car's front bumper, front bumper right reflector, front right fender and front right wheel rim at the time of my inspection. The body parts at the front right portion of the Motor Car were visually examined and it was observed that the repair/restoration works carried out to the damaged area of the Motor Car (refer to photograph 1 & 2 above) were reasonably adequate and in order.

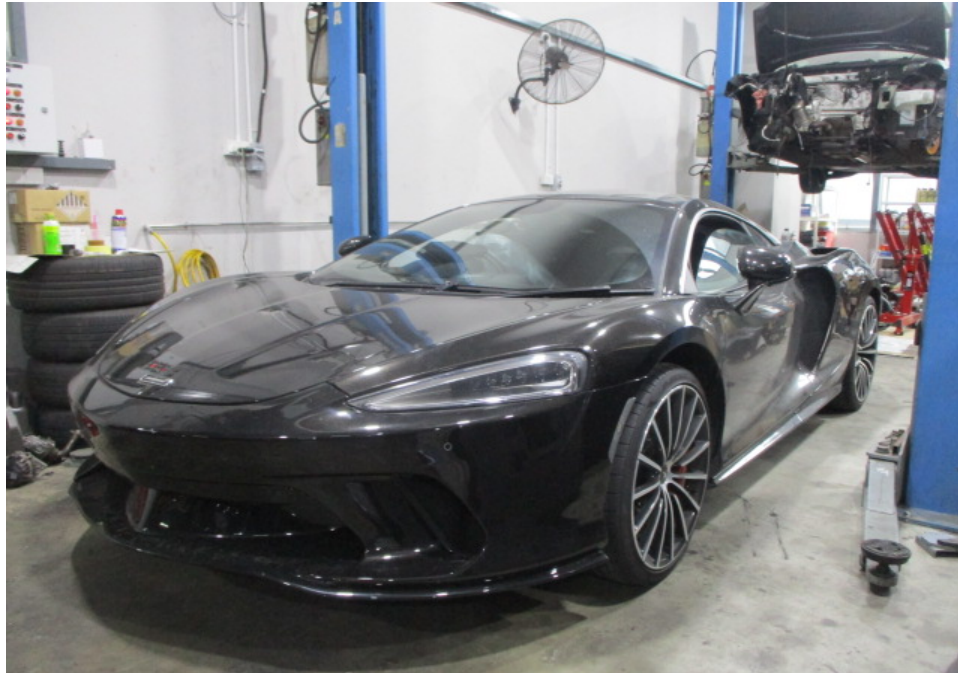
**Photo 10** shows a general view of the front left body of the Motor Car at the time of my inspection. The Motor Car was observed to be in a relatively good general condition with no loose exterior fittings observed. The mileage of the Motor Car recorded at the time of my inspection was 14,326km.

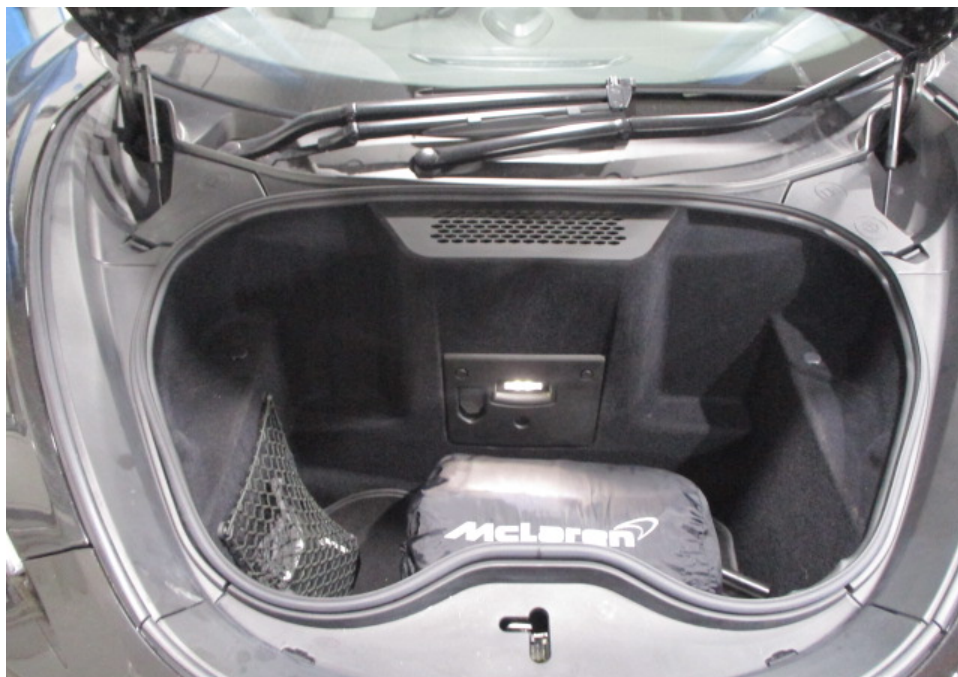
**Photo 11** shows a general of the Motor Car's front bonnet compartment at the time of my inspection. All inner trims, garnishes and upholstery etc were observed to be intact and properly fitted.

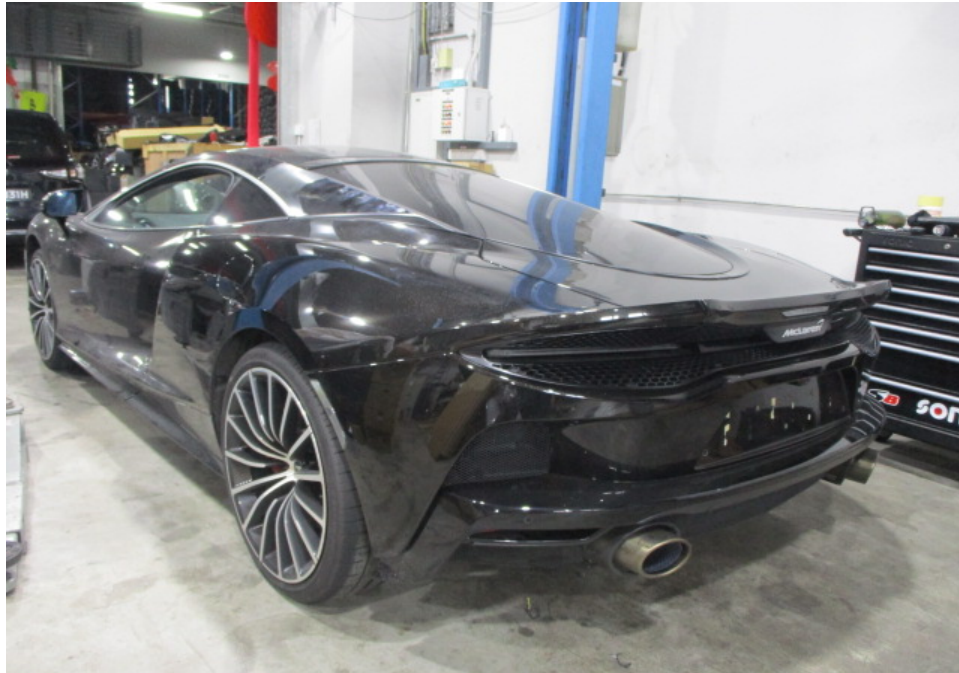
**Photo 12** shows a general view of the rear left body of the Motor Car at the time of my inspection. The Motor Car was observed to be in a relatively good general condition with no loose exterior fittings observed. The mileage of the Motor Car recorded at the time of my inspection was 14,326km.

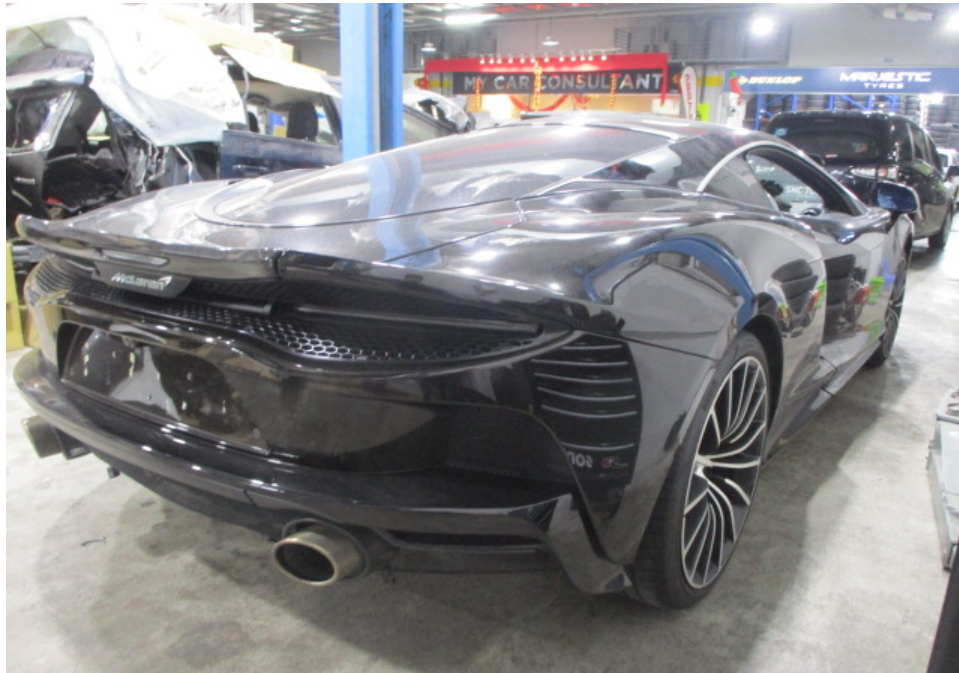
**Photo 13** shows a general view of the rear right body of the Motor Car at the time of my inspection. The Motor Car was observed to be in a relatively good general condition with no loose exterior fittings observed. The mileage of the Motor Car recorded at the time of my inspection was 14,326km.

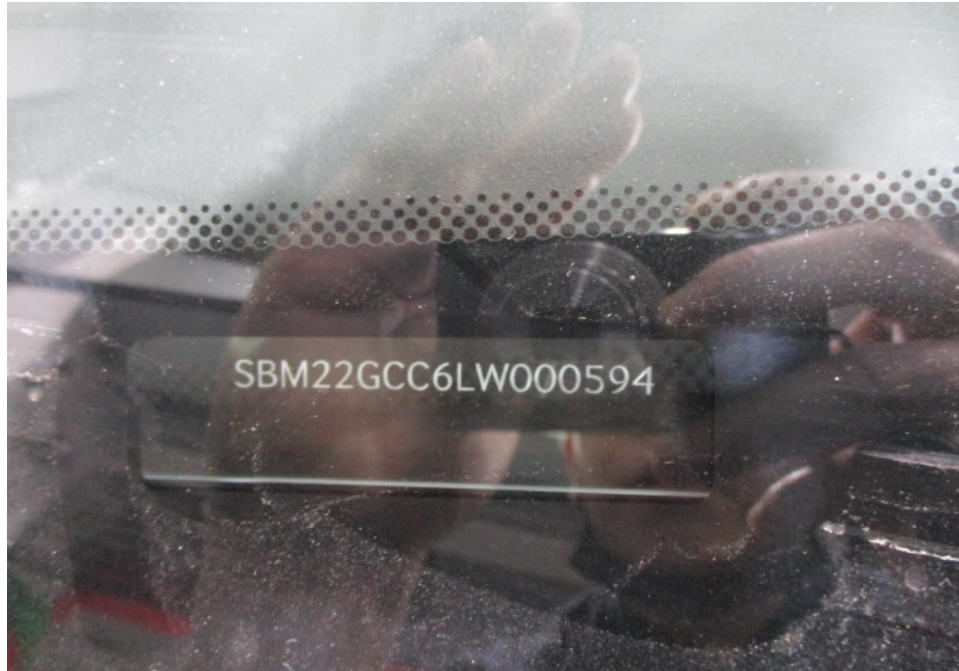
**Photo 14** shows the chassis number of the Motor Car. The chassis number recorded was SBM22GCC6LW000594.

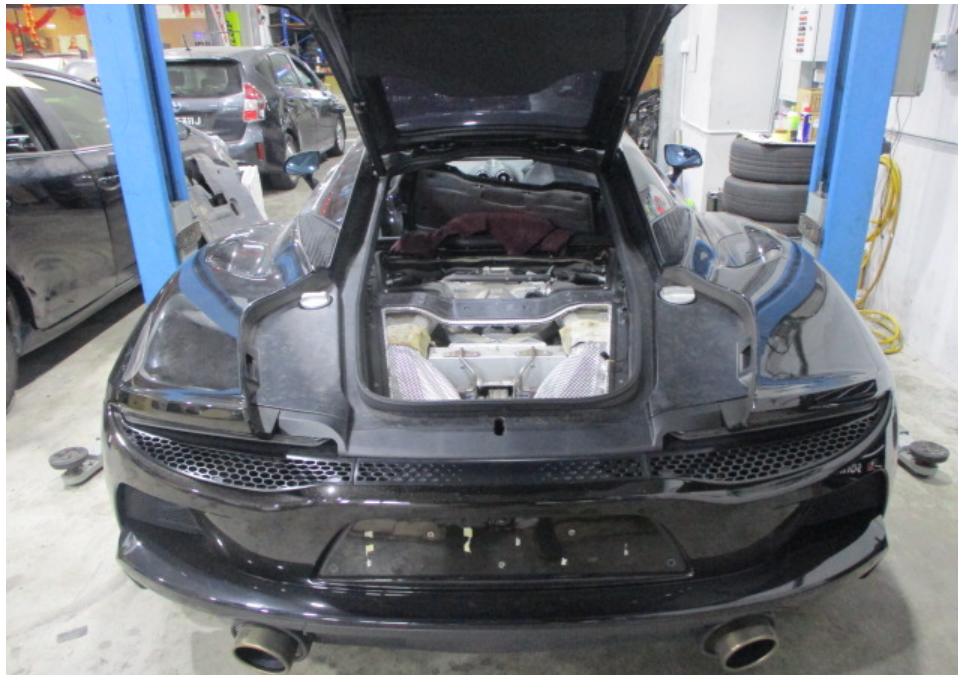
**Photo 15** shows a general of the Motor Car's engine compartment at the time of my inspection. I had found the various parts and components inside the engine compartment to be intact and properly fitted. There was also no sign(s) or indication(s) of fluid leak and/or fluid stain found inside the engine compartment. Refer to photograph 16, 17 & 28 below.

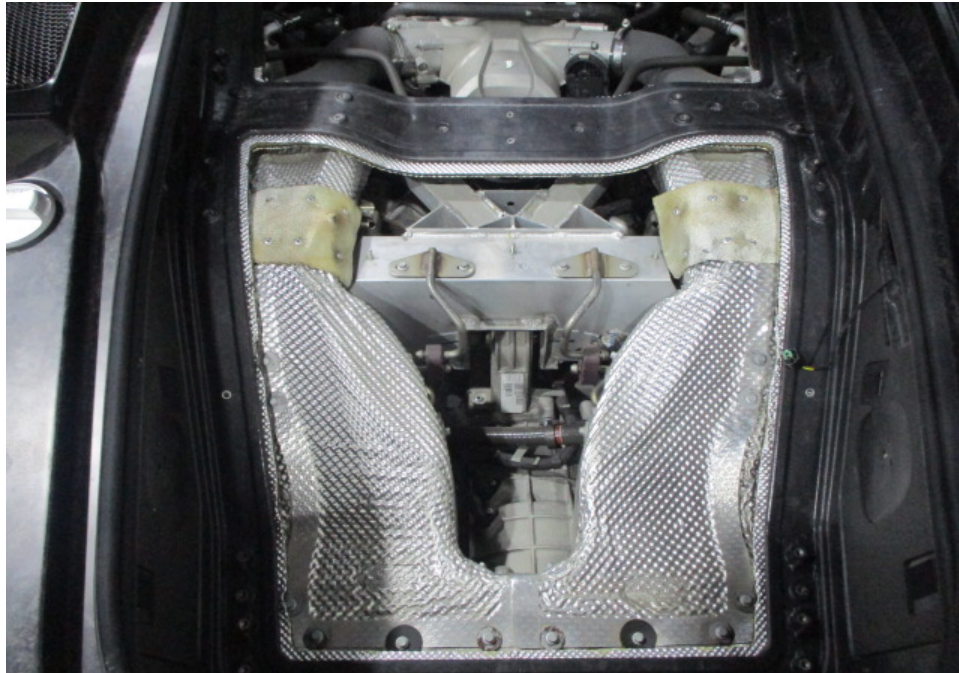
**Photo 16** shows a general view of the engine compartment of the Motor Car at the time of my inspection. The various parts and components inside the engine compartment were all observed to be intact and properly fitted. There was also no sign(s) or indication(s) of fluid leak and/or fluid stain found inside the engine compartment.

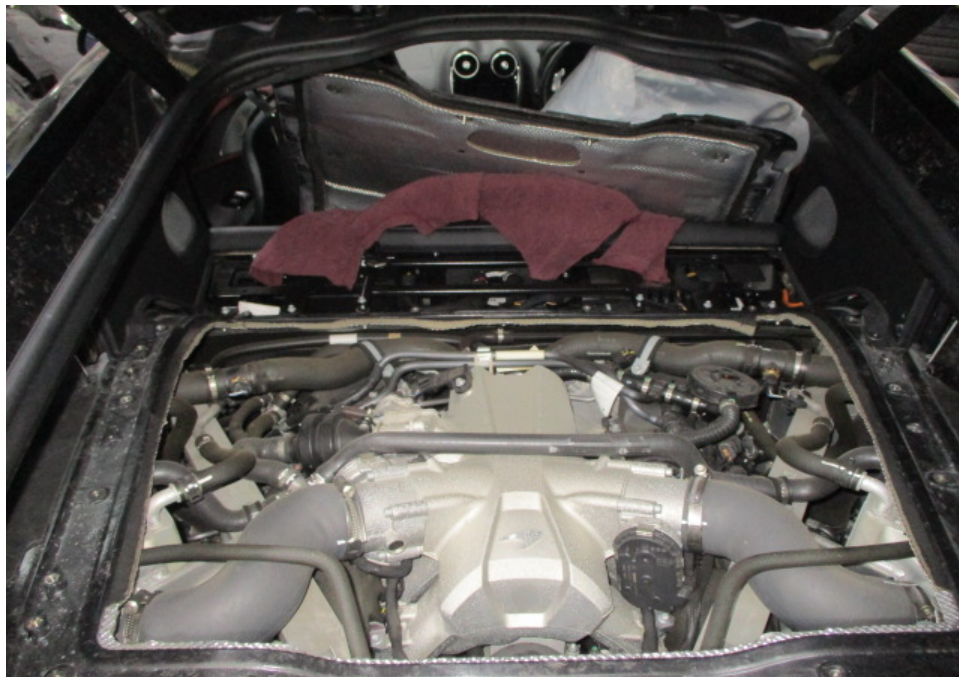
**Photo 17** shows a general view of the engine compartment of the Motor Car at the time of my inspection. The various parts and components inside the engine compartment were all observed to be intact and properly fitted. There was also no sign(s) or indication(s) of fluid leak and/or fluid stain found inside the engine compartment.

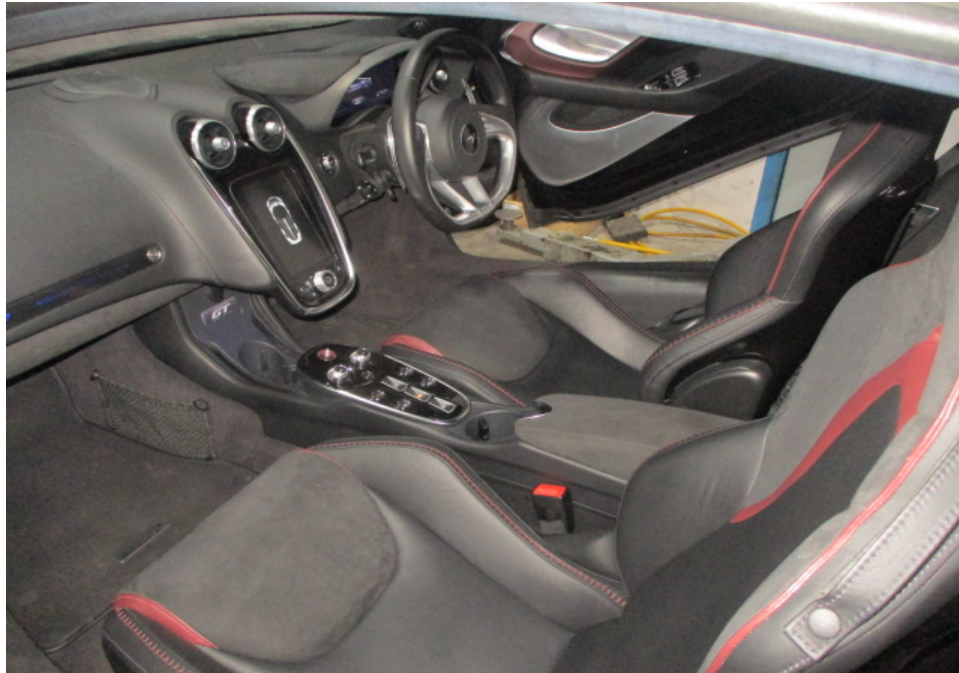
**Photo 18** shows the interior compartment of the Motor Car at the time of my inspection. The various parts and components, trims, carpet, and upholstery inside the interior compartment were all observed to be intact and properly fitted.

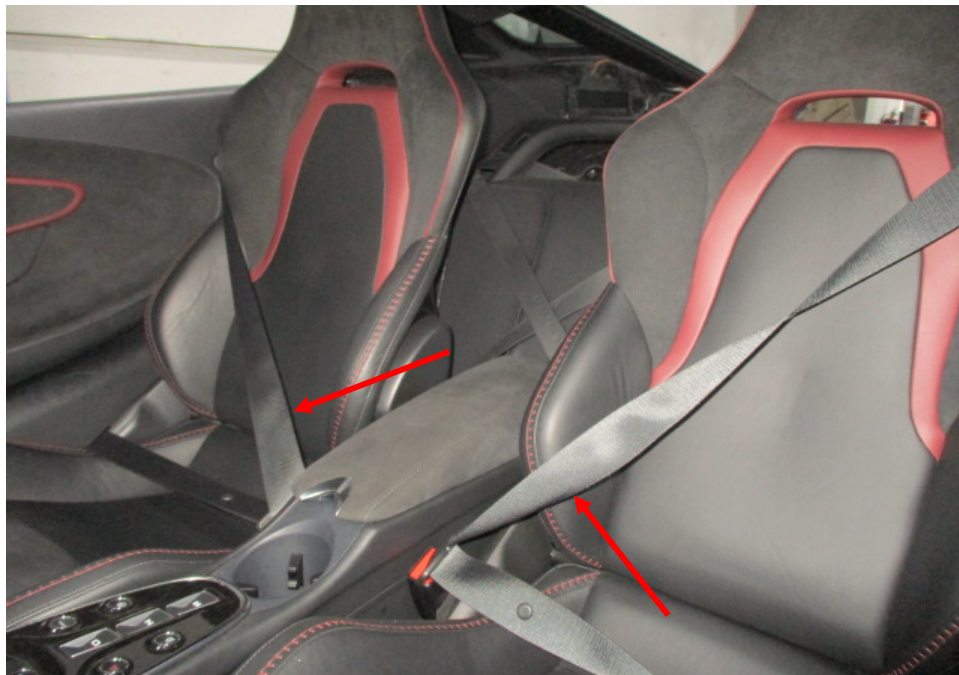
**Photo 19** shows the seats of the Motor Car. All the seats of the Motor Car were secured via seat rails to the floorboard. They were also fitted with a retractable seat belt reel and a pre-tensioner. The seat belts (arrowed) were tested and were able to be fastened into the respective pre-tensions that were fitted on the side of each individual seat.

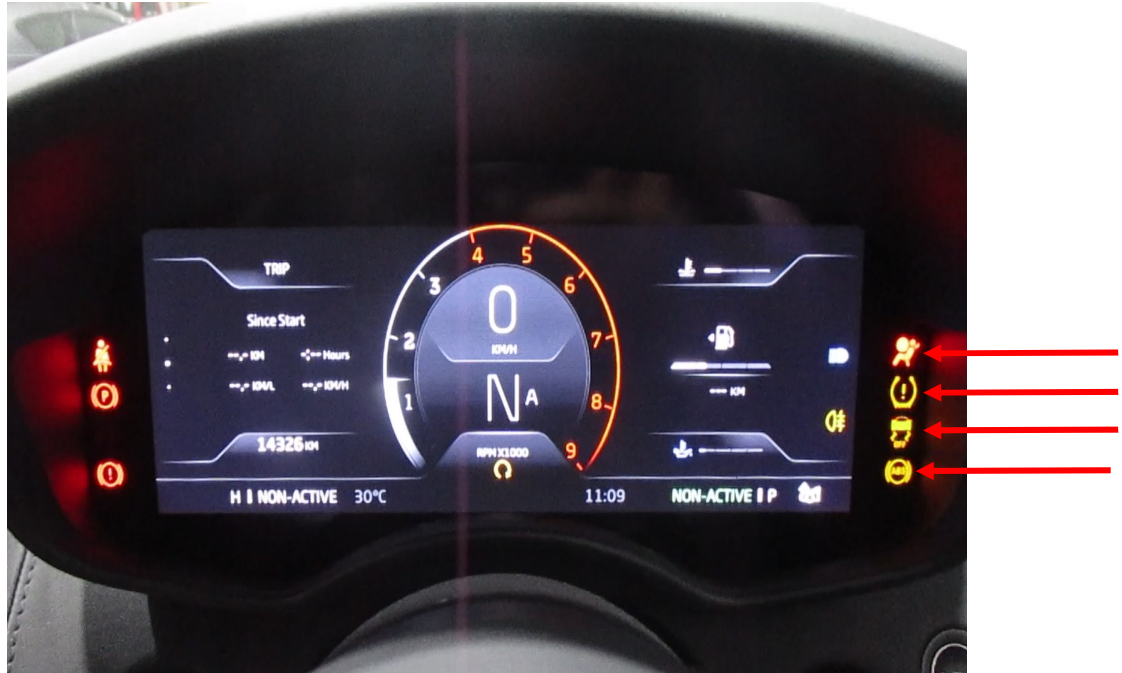
**Photo 20** shows the warning lights for the various electronic safety features appearing on the instrument panel of the Motor Car during its self-test when the engine is cranked, in particular the ABS, SRS, TPM and TCS lights (arrowed).

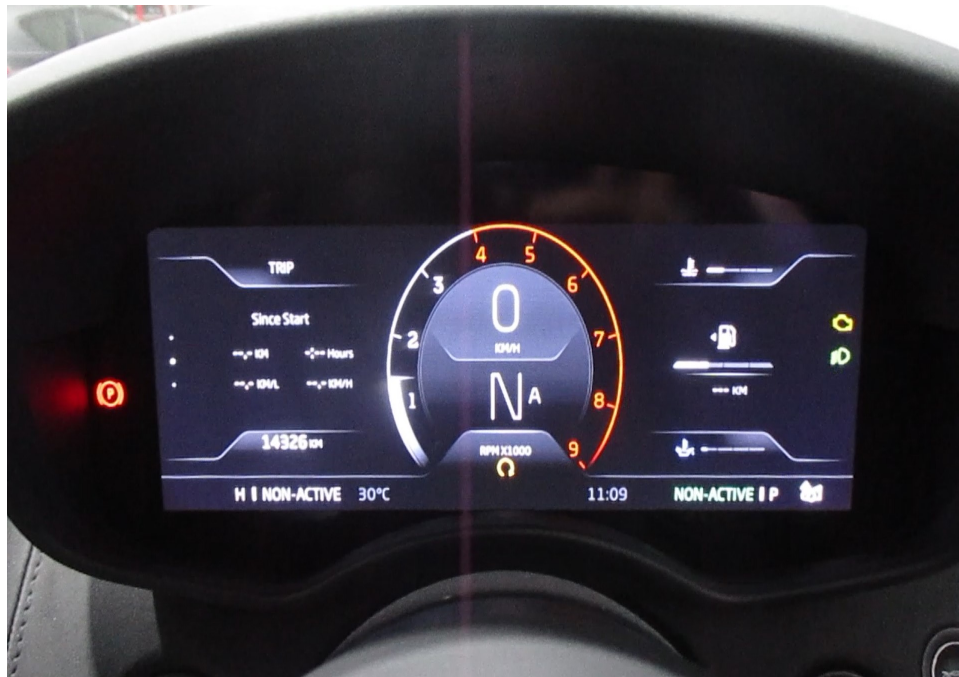
**Photo 21** shows the respective warning lights no longer illuminated, indicating that there is no fault detected to the ABS, SRS, TPM and TCS systems of the Motor Car during the self-test. These electronic systems were hence in working condition at the time of my inspection.

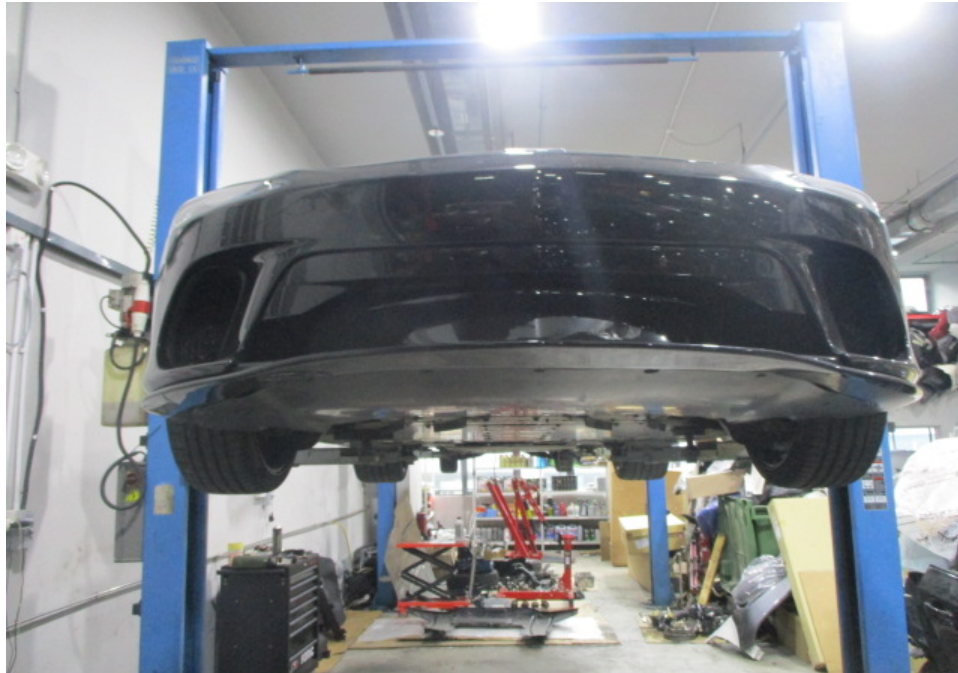
**Photo 22** shows the Motor Car hoisted up for checks on its undercarriage. There was no sign(s) or indication(s) of fluid leakage and/or fluid stain(s) on the underside of the Motor Car. The undercarriage components of the Motor Car were also all observed to be intact and secured in an appropriate manner.

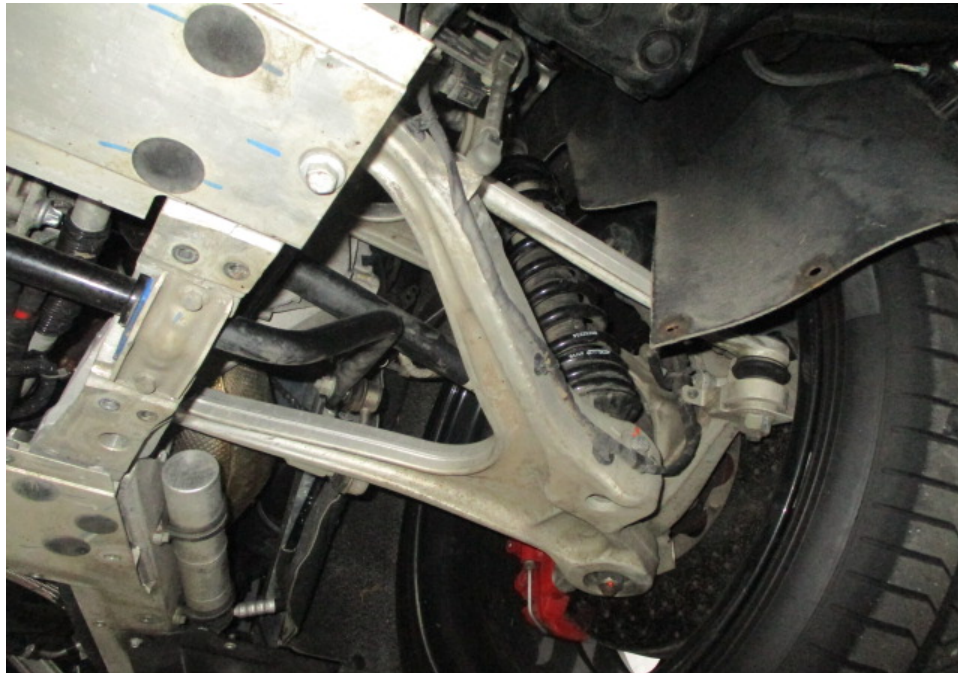
**Photo 23** shows a general view of the control arms and linkages at the rear right wheel of the Motor Car. I did not observe any fluid leak and/or fluid stain on the underside of the Motor Car. All of the Motor Car's undercarriage components were observed to be intact and secured in an appropriate manner.

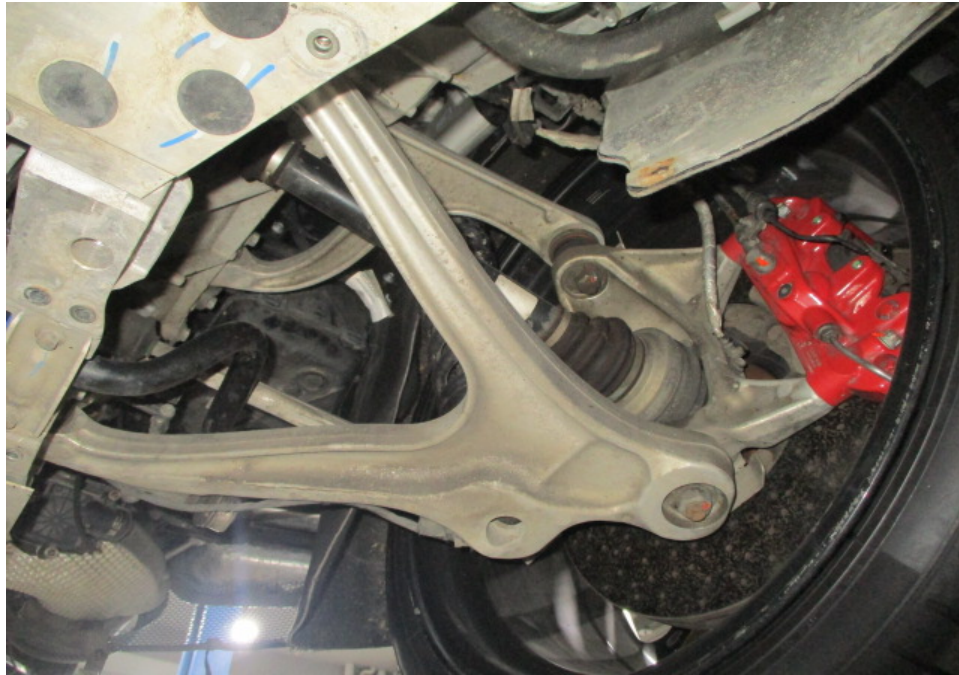
**Photo 24** shows a general view of the control arms and linkages at the rear left wheel of the Motor Car. I did not observe any fluid leak and/or fluid stain on the underside of the Motor Car. All of the Motor Car's undercarriage components were observed to be intact and secured in an appropriate manner.

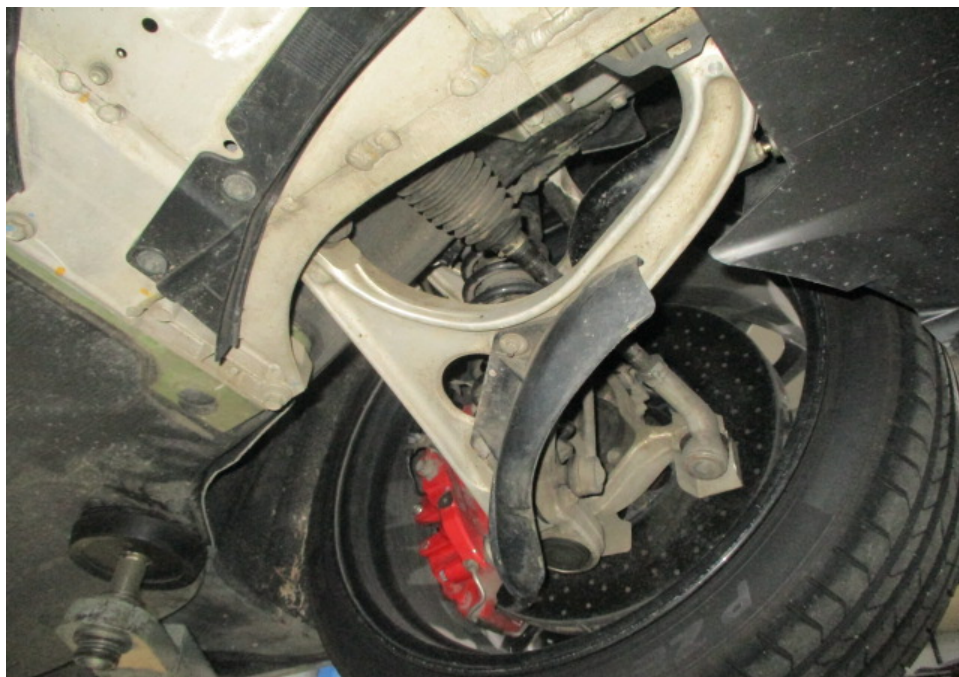
**Photo 25** shows the various undercarriage components at the front left wheel of the Motor Car. The mechanical components, control arms and linkages were all found to be intact and secured in an appropriate manner.

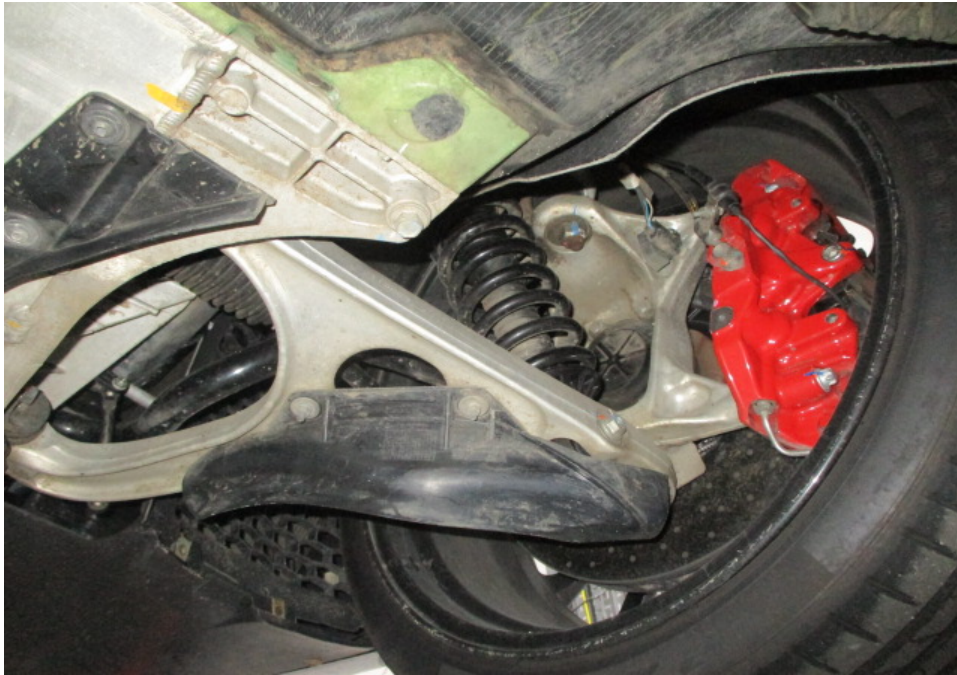
**Photo 26** shows the various undercarriage components at the front right wheel of the Motor Car. The mechanical components, control arms and linkages were all found to be intact and secured in an appropriate manner. I also did not observe any fluid leak and/or fluid stain on the underside of the Motor Car.

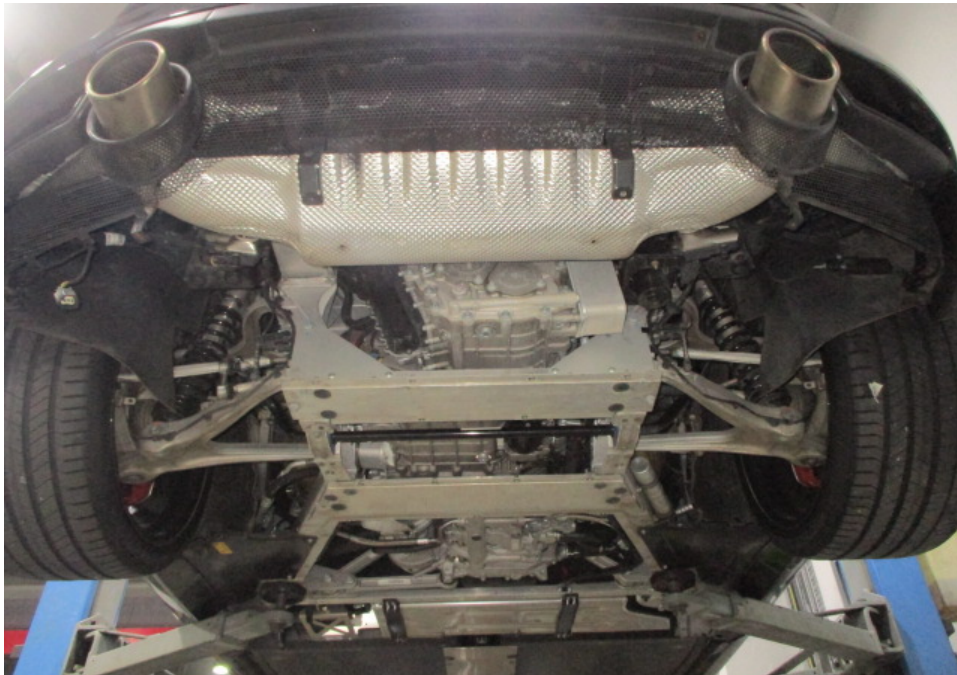
**Photo 27** shows the Motor Car's exhaust system after dismantling of the rear undercovers. In general, my examination of the Motor Car's exhaust system revealed no sign(s) or indication(s) of any cut or weld marks along its exhaust pipes, on its catalytic converters and on its rear muffler.

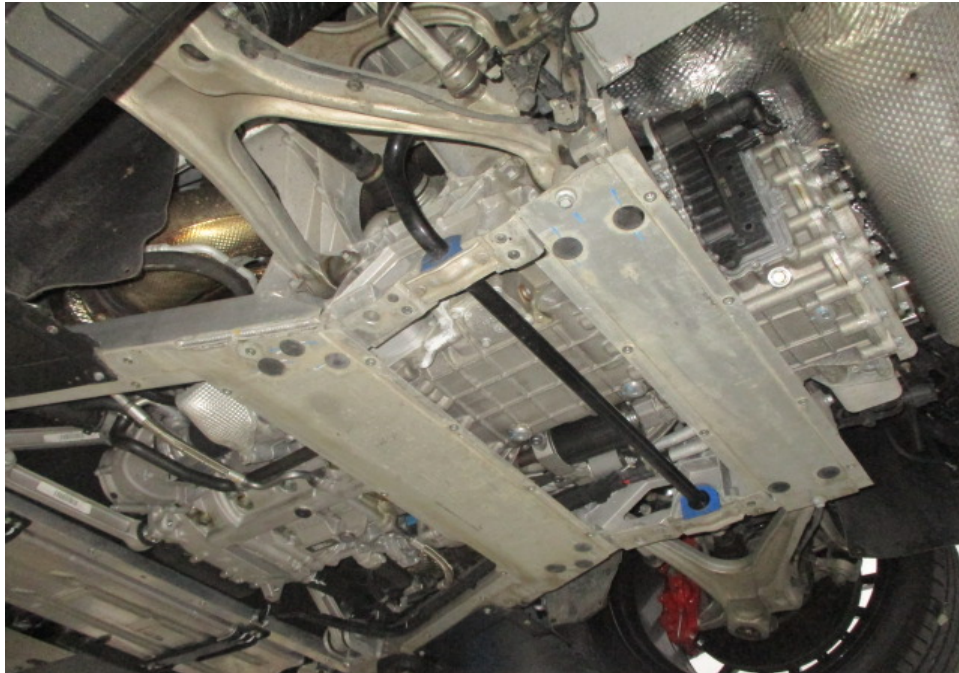
**Photo 28** shows the Motor Car's engine compartment as viewed from the rear underside of the Motor Car. The various parts and components inside the engine compartment were all observed to be intact and properly fitted. There was also no sign(s) or indication(s) of fluid leak and/or fluid stain found inside the engine compartment.

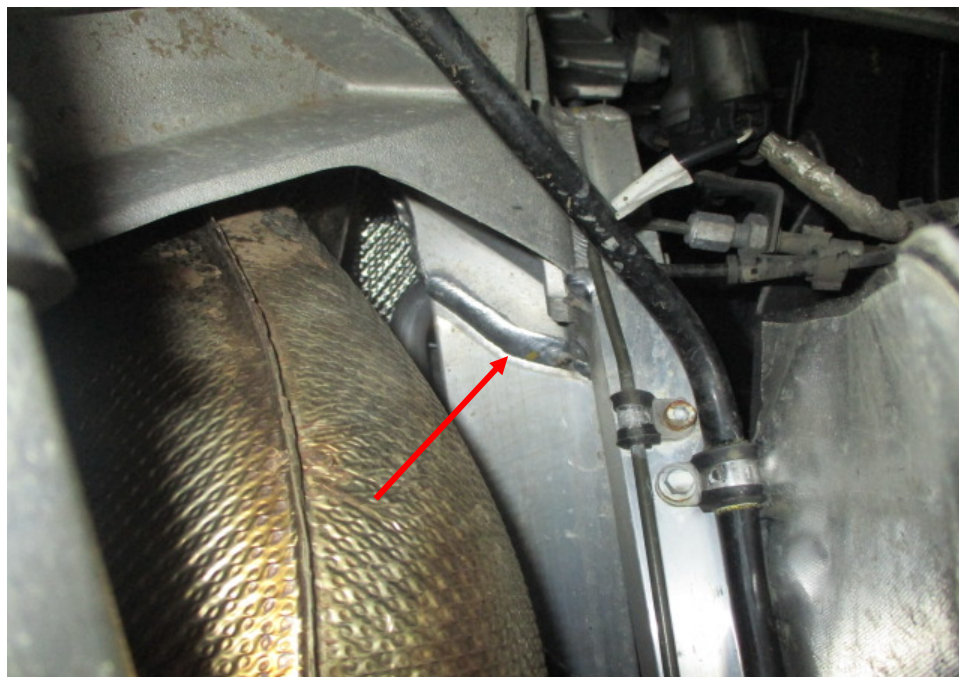
**Photo 29** shows the aluminium chassis/structural body at the underside rear right of the Motor Car. I did not find any weld marks other than original spot weld marks on the chassis/structural body of the Motor Car. The original factory sealant (arrowed) at the joints along the chassis/structural body was untouched, indicating no work was done on the chassis/structural body of the Motor Car and that the chassis/structural body was originally fitted.

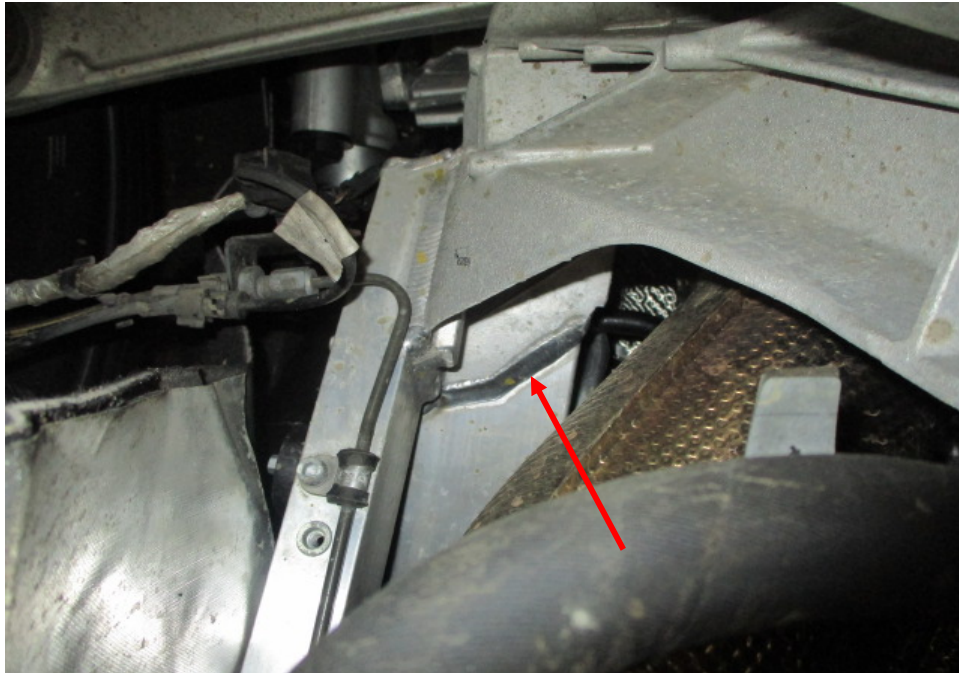
**Photo 30** shows the aluminium chassis/structural body at the underside rear left of the Motor Car. I did not find any weld marks other than original spot weld marks on the chassis/structural body of the Motor Car. The original factory sealant (arrowed) at the joints along the chassis/structural body was untouched, indicating no work was done on the chassis/structural body of the Motor Car and that the chassis/structural body was originally fitted.
