Your Ref: McLaren GT  
(chassis number SBM22GCC6LW000594)  
Our Ref : CI/TP22003705/D

22 April 2022

**INSPECTION REPORT OF AN UNREGISTERED MCLAREN GT MOTOR CAR  
WITH CHASSIS NUMBER SBM22GCC6LW000594**

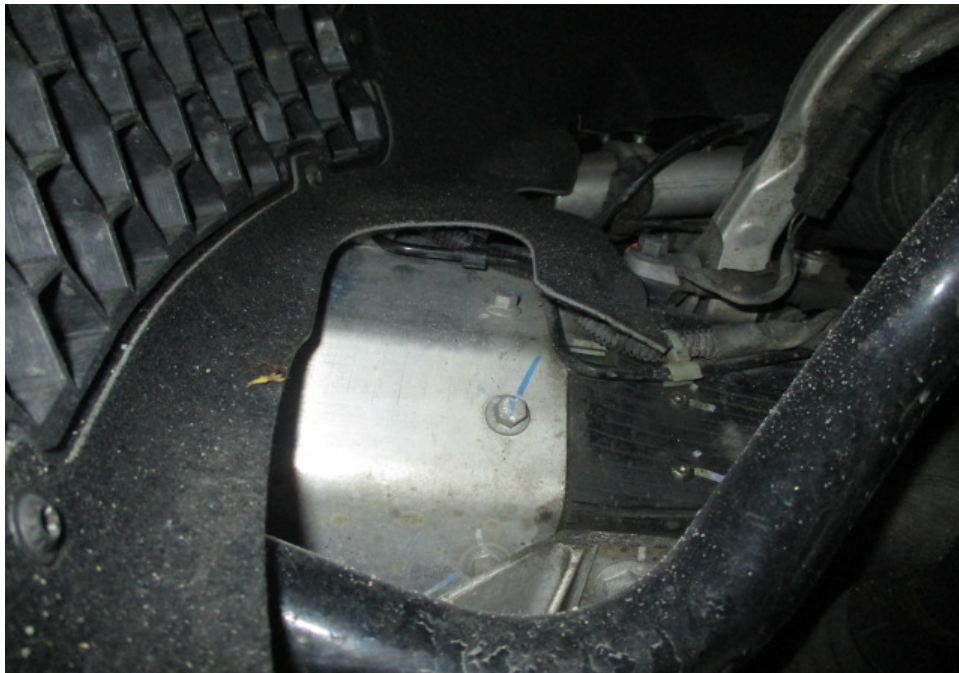
**Photo 31** shows the aluminium chassis/structural body at the underside front left of the Motor Car. The original factory sealant at the joints along the chassis/structural body was observed to be untouched. In general, I had found no work was carried out on the chassis/structural body of the Motor Car. The aluminium chassis/structural body of the Motor Car was originally fitted.

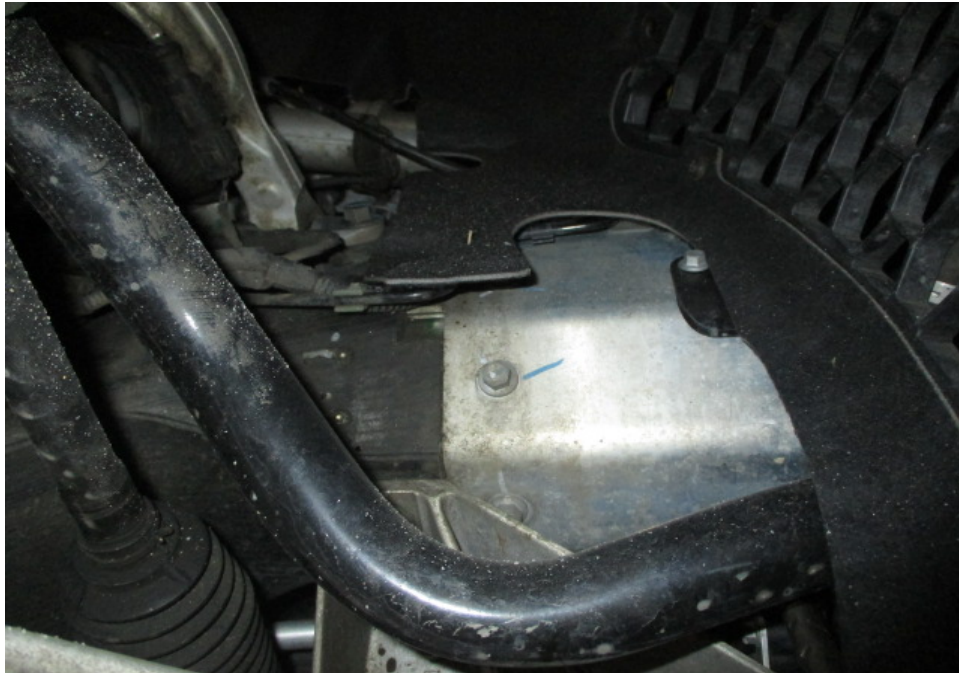
**Photo 32** shows the aluminium chassis/structural body at the underside front right of the Motor Car. I did not find any weld marks other than original spot weld marks on the chassis/structural body of the Motor Car. The original factory sealant at the joints along the chassis/structural body was untouched, indicating no work was done on the chassis/structural body of the Motor Car and that the chassis/structural body was originally fitted.
