Your Ref: SNM22D202713/C01
Our Ref : CS4/CTI22003776/N

**TECHNICAL INVESTIGATION REPORT OF FIRE INCIDENT INVOLVING THE
INSURED VEHICLE GBC 3173A ON 20 APRIL 2022**

Vehicle Registration No.	: GBC 3173A
Make / Model	: Nissan NV200 1.5L MT ABS AIRBAG 2WD 6DR
Chassis No	: VSKYBAM20U0026614
Year of Registration	: November 2011
Mileage	: N.A (wiring affected)

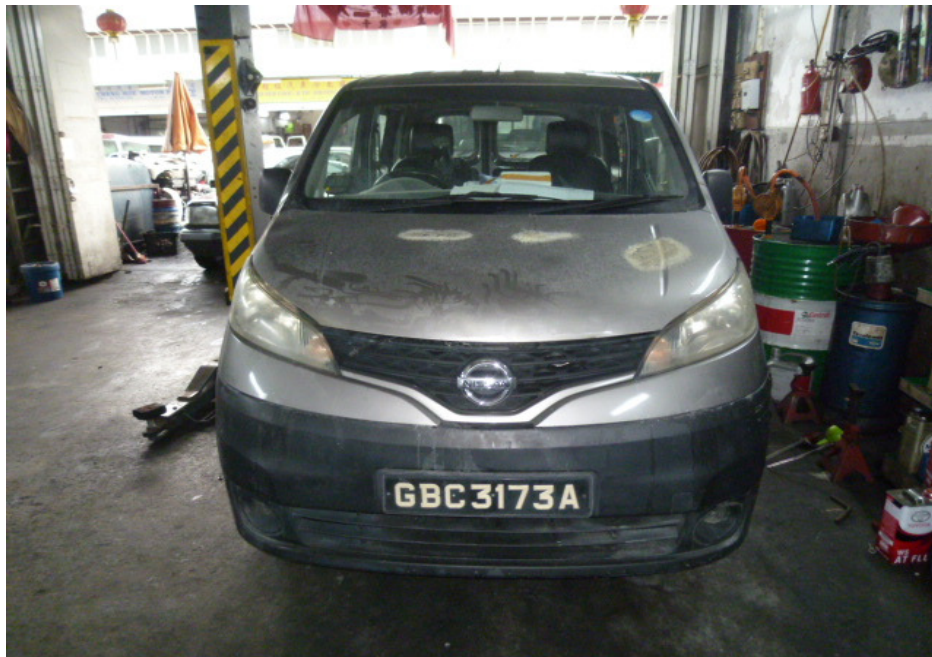
Photo 1 shows the general view of the front portion of the Insured Vehicle at the time of our inspection. The fire damage to the Insured Vehicle was confined to its frontal portion. Its front bonnet and front windscreen were amongst the body parts that were found to have been affected as a result of the fire.

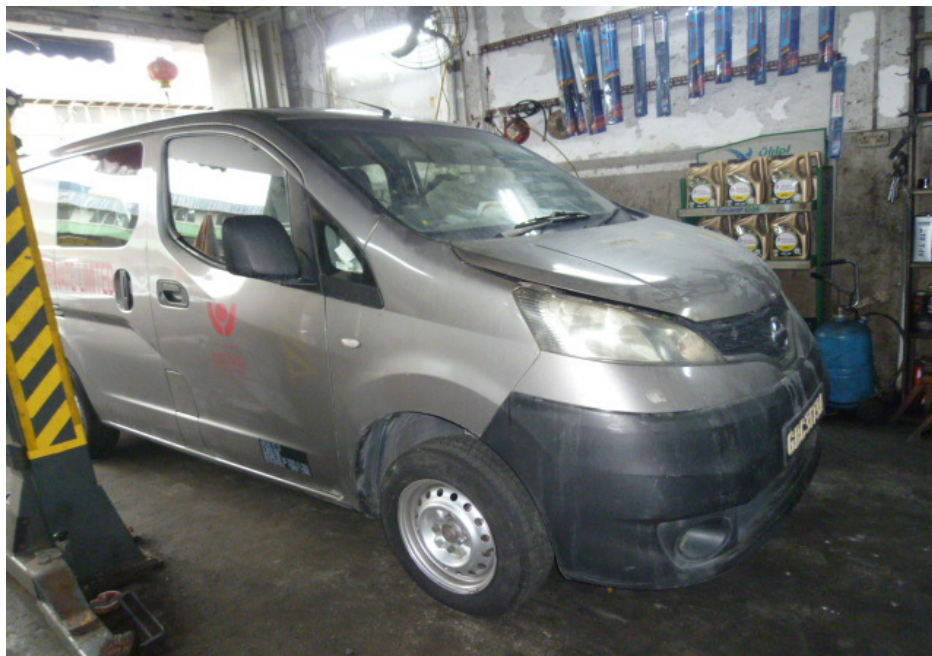
Photo 2 shows the general view of the right body of the Insured Vehicle at the time of our inspection. The fire damage to the Insured Vehicle was confined to its frontal portion. The right body was found to have been relatively unaffected by the fire.

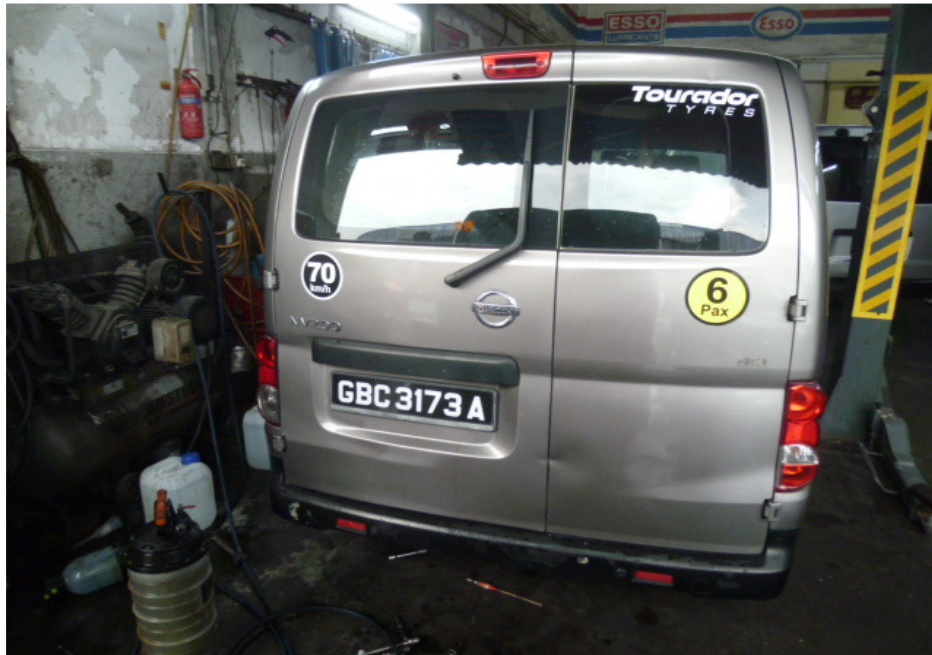
Photo 3 shows the general view of the rear portion of the Insured Vehicle at the time of our inspection. The fire damage to the Insured Vehicle was confined to its frontal portion. The rear portion was found to have been relatively unaffected by the fire.

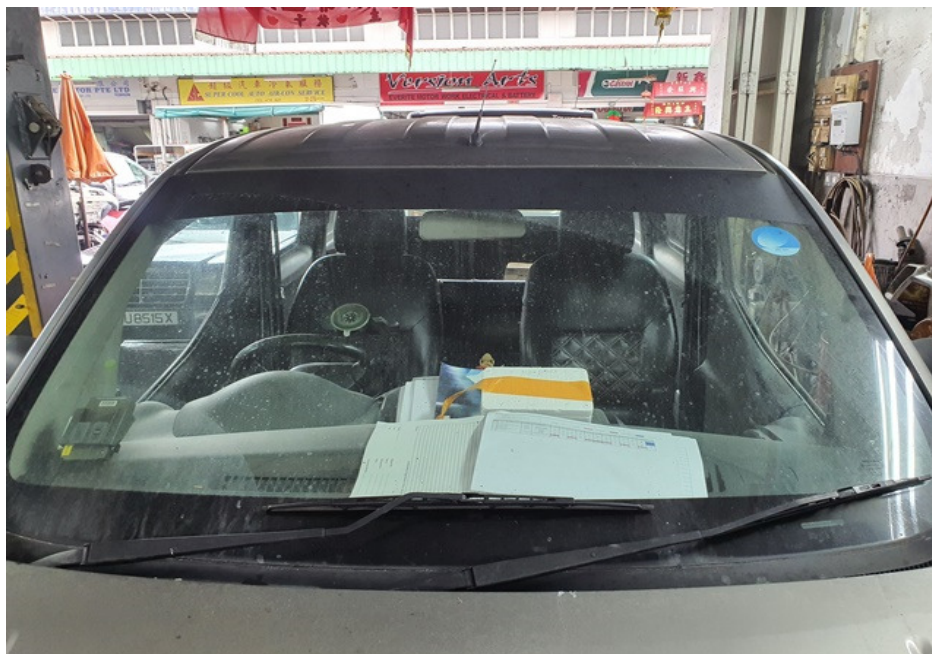
Photo 4 shows the general view of the front windscreen of the Insured Vehicle at the time of our inspection. The fire damage to the front windscreen of Insured Vehicle was minimal.

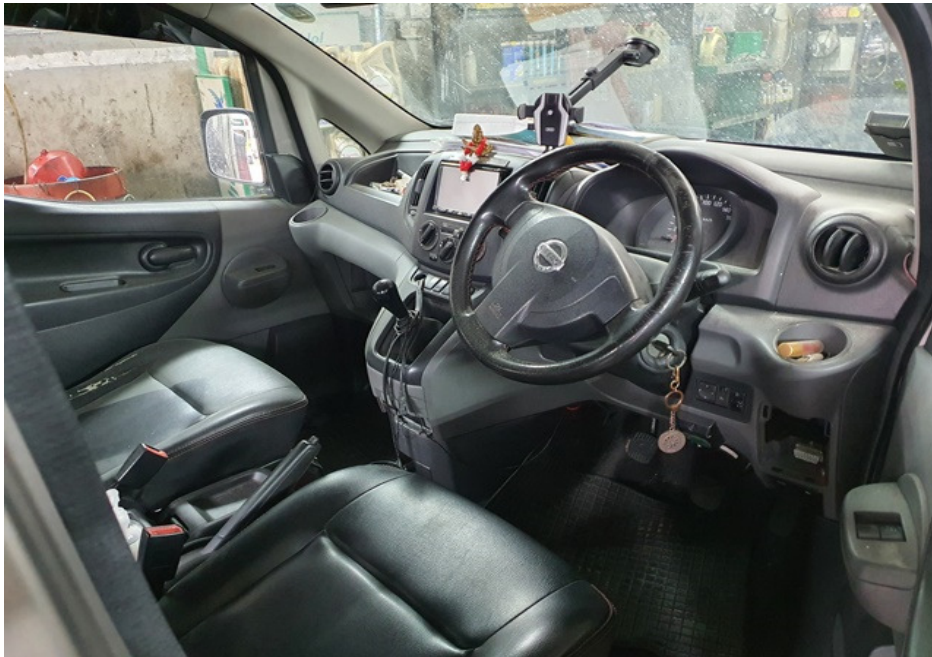
Photo 5 shows the interior compartment of the Insured Vehicle, which was observed to be relatively unaffected by the fire.

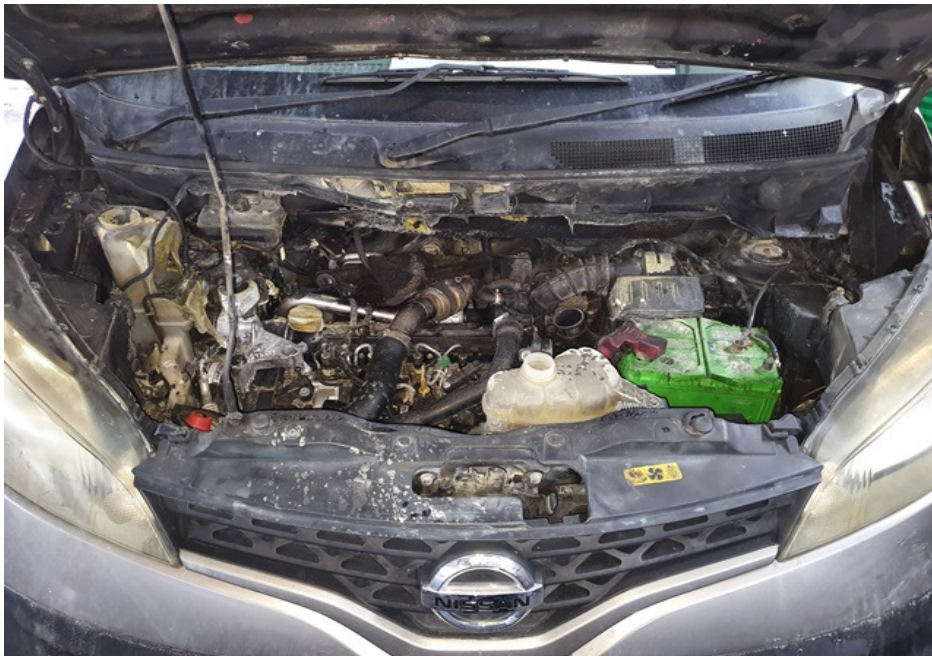
Photo 6 shows a general view of the engine compartment of the Insured Vehicle which was covered in fire extinguisher residue at the time of our inspection. Most of its engine components were found to have been affected as a result of the fire.

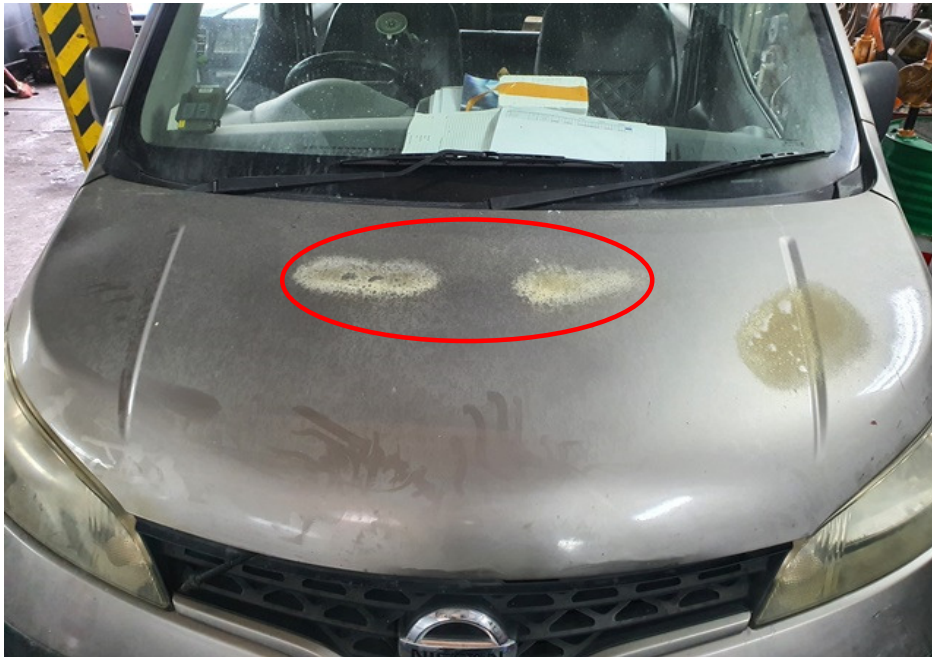
8. For this particular case, the fire appears to have originated within the engine compartment of the Insured Vehicle, somewhere around the centre rear portion of the engine compartment. This can be determined from the burn pattern and the high heat intensity burn marks (whitish burn marks) found on the centre rear of the bonnet of the Insured Vehicle and also the rust that had developed on the underside of the front bonnet, at the rear centre portion.

9. The whitish burn marks are a result of exposure to prolonged heat intensity. Rust would normally start to develop around these areas soon after a fire as prolonged exposure to high heat intensity usually causes steel/metal material body parts to be exposed to natural environmental condition. The rust that had developed on the underside of the front bonnet, around the right side area, is an indication that the right side area of the engine compartment had sustained exposure to prolonged high heat intensity. See photos 7 & 8 below.

Photo 7 shows the burn pattern and whitish burn marks (circled) that were found on the rear centre portion of the front bonnet of the Insured Vehicle. Such whitish burn marks are a result of exposure to prolonged heat intensity, which may indicate where the fire had started. Rust would also begin to develop on these areas soon after the fire.

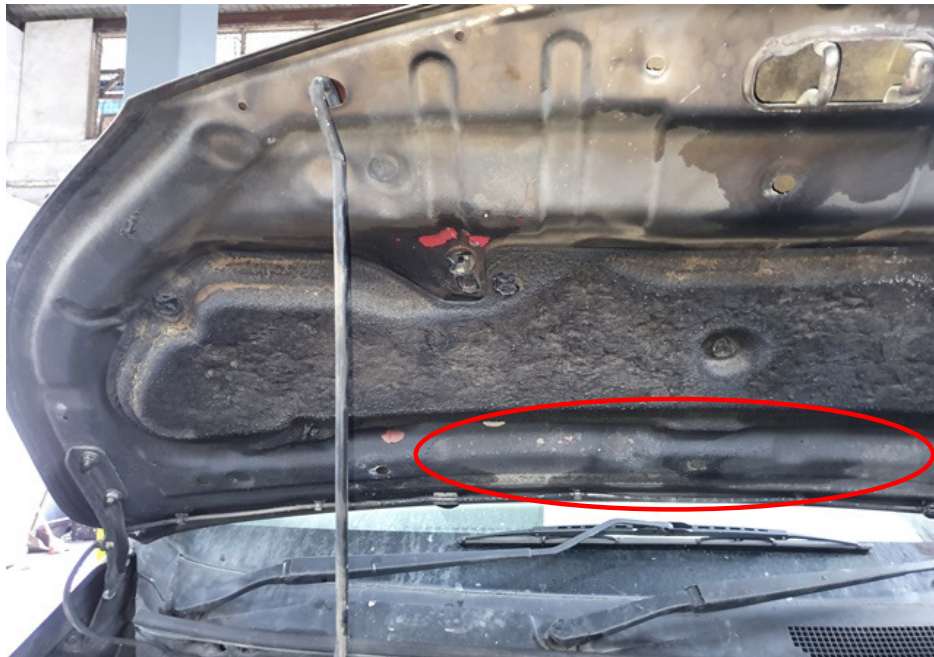
Photo 8 shows the rust that had developed on the underside of the front bonnet, around the rear centre portion (circled). The development of rust is an indication that this area was subjected to prolonged exposure to high heat intensity, which had caused the steel/metal material of the front bonnet to be exposed to natural environmental condition. Hence the fire to the Insured Vehicle can be determined to have originated towards the centre rear portion of the engine compartment.

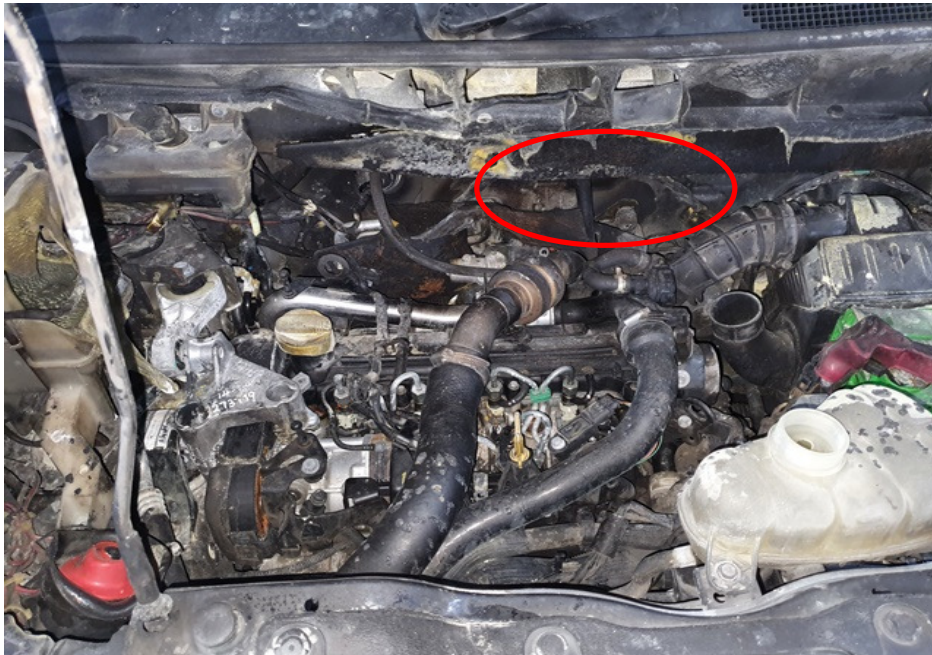
10. Upon closer examination of the engine compartment, in particular to the wire harness closest to the firewall, we had found faint traces of greenish residue on several burnt stretches of original factory fitted wirings around the centre rear portion of the engine compartment. The presence of such greenish residue indicates internal heating of copper wires, a sign of an electrical short circuit occurring. The greenish residue is normally left behind from oxidation as a result of chemical reaction involving the copper wires. We also observed that the negative terminal of the battery had partially melted. These physical evidences would then appear to suggest that the cause of fire to the Insured Vehicle could have possibly been due to electrical in nature. See photos 9 - 13 below.

Photo 9 shows the burnt stretches of original factory fitted wirings near the firewall, which is in the immediate vicinity where the fire to the Insured Vehicle had likely started. Faint traces of greenish residue were found on some of the wirings (circled). The presence of such greenish residue suggests occurrence of an electrical short circuit.

33. Having investigated and technically analysed the damages of burnt nature to the Insured Vehicle, we are of the view that the cause of fire to the Insured Vehicle was of electrical in nature. For this particular case, the fire had originated along the wirings around the engine compartment. The wirings were original factory wirings around the centre rear portion of the engine compartment of the Insured Vehicle.
34. We did not find any evidence which had suggested that the cause of fire to the Insured Vehicle was due to poor maintenance and/or recurring electrical problem.
35. Our investigations had also revealed that at the time of writing this report, there is no manufacturer recall of electrical nature to similar make and model vehicle as the Insured Vehicle that may pose a fire risk.

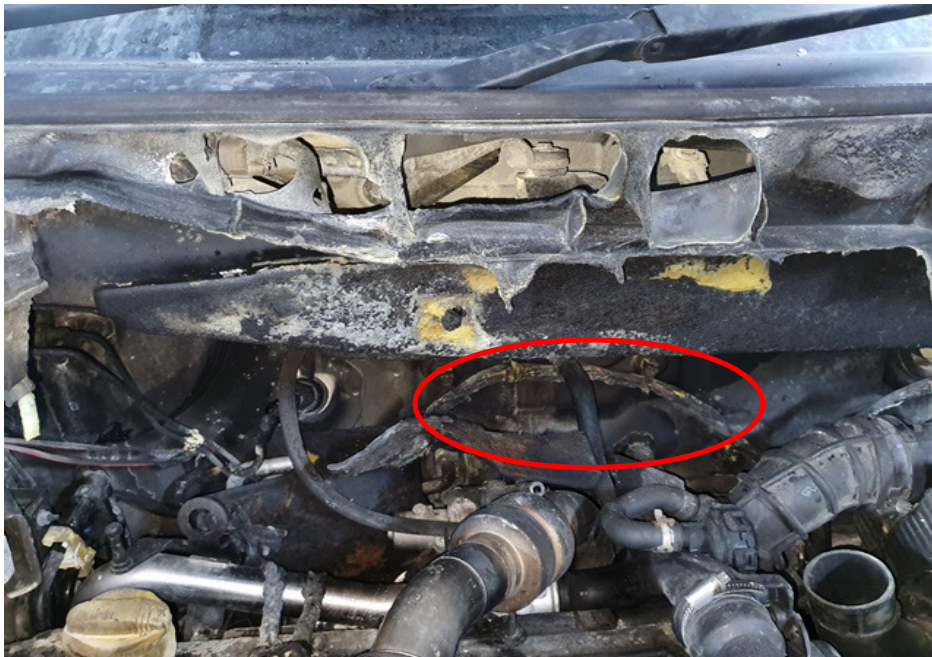
Photo 10 shows a closer view of the burnt stretches of original factory fitted wirings near the firewall, which is in the immediate vicinity where the fire to the Insured Vehicle had likely started (circled).

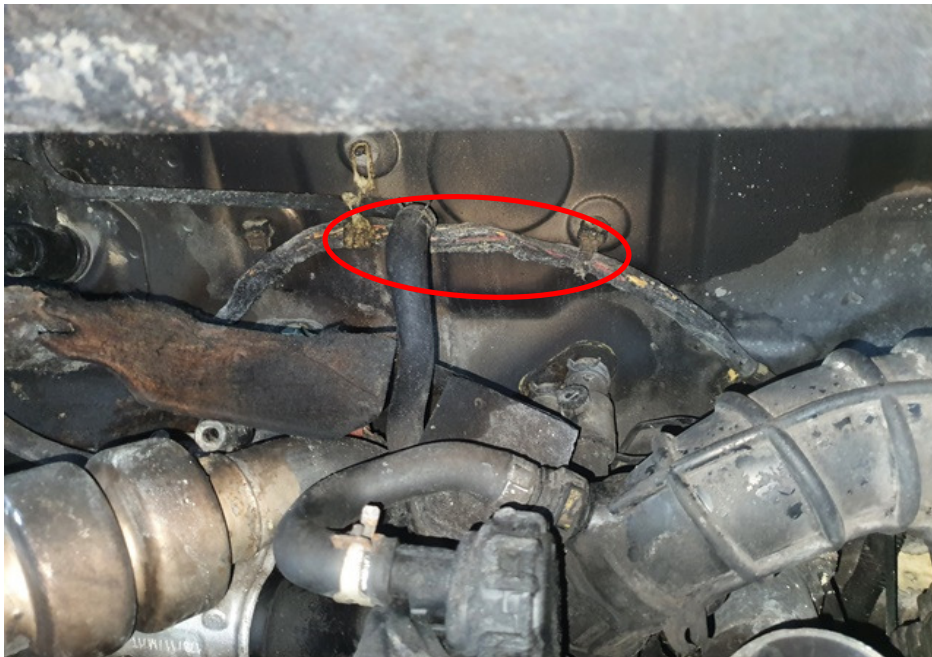
Photo 11 shows a close up view of the burnt stretches of original factory fitted wirings near the firewall, which is in the immediate vicinity where the fire to the Insured Vehicle had likely started. Faint traces of greenish residue were found on some of the wirings (circled).

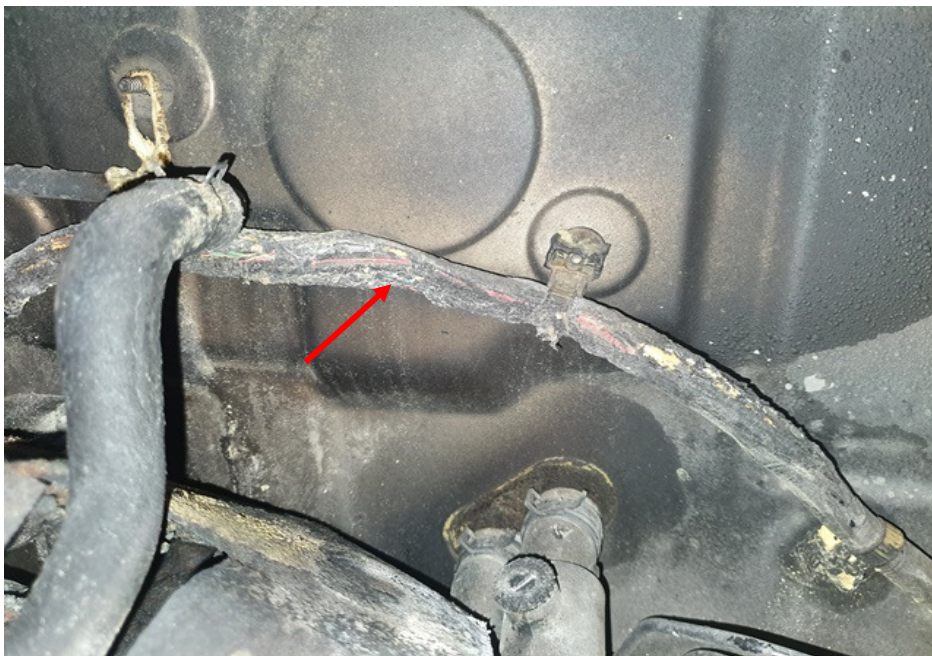
Photo 12 shows a closer view of the wirings around the centre rear portion of the engine compartment which is near to the vicinity where the fire to the Insured Vehicle had likely started. We observed greenish residue on the wirings (arrowed) at the centre rear portion of the engine compartment.

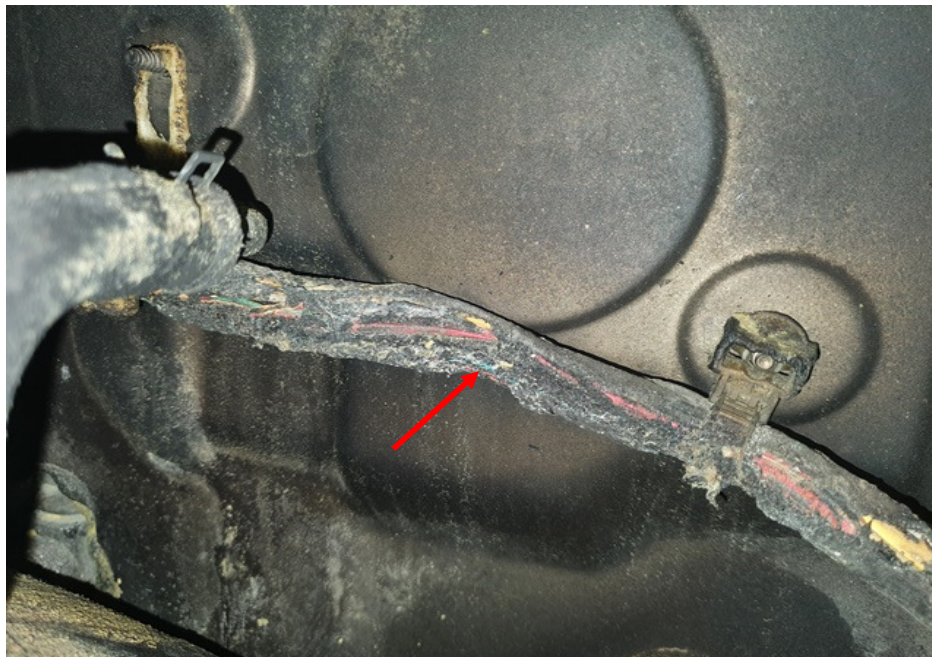
Photo 13 shows a close up view of the wirings around the centre rear portion of the engine compartment which is near to the vicinity where the fire to the Insured Vehicle had likely started. We observed greenish residue on the wirings (arrowed) at the centre rear portion of the engine compartment.

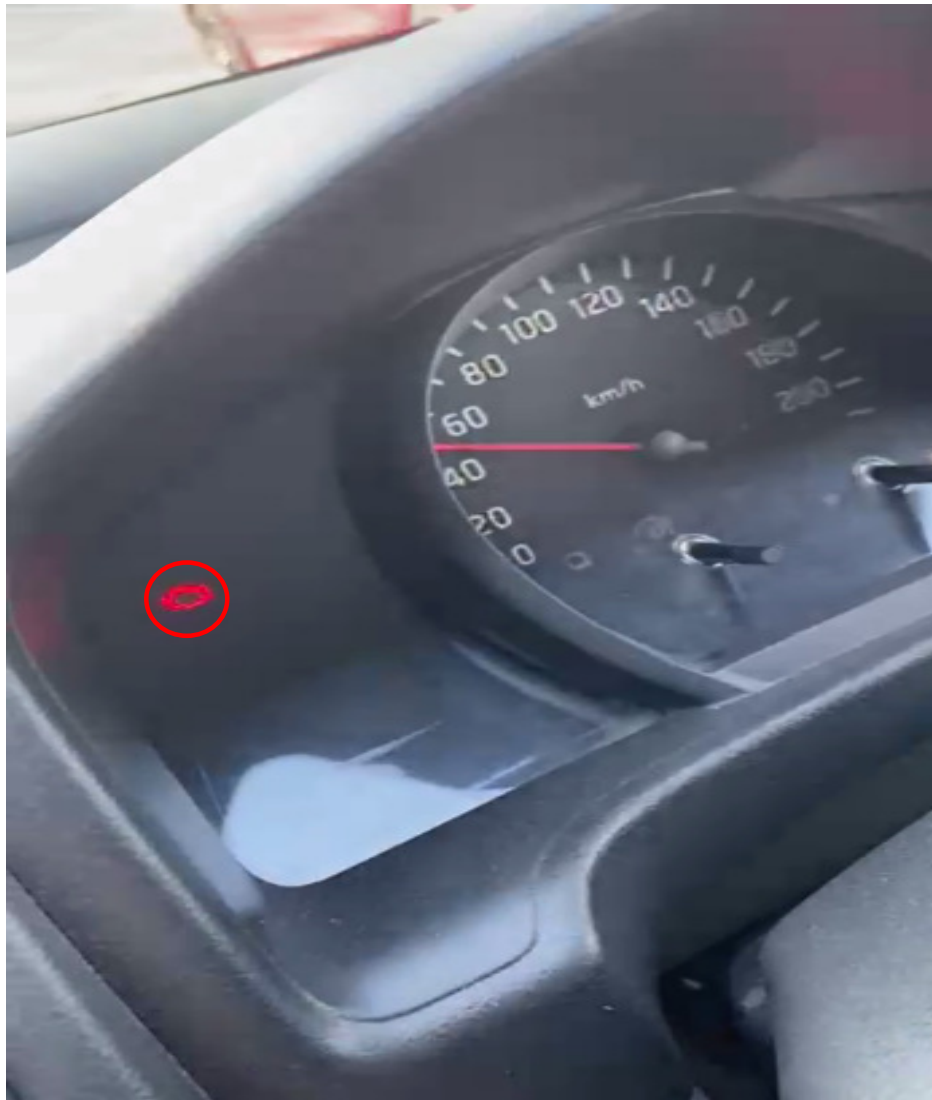
Photo 14 shows the red engine warning light which had been flashing on the dashboard of the Insured Vehicle when Mr Raja was driving along the CTE before it broke down on 28 March 2022.

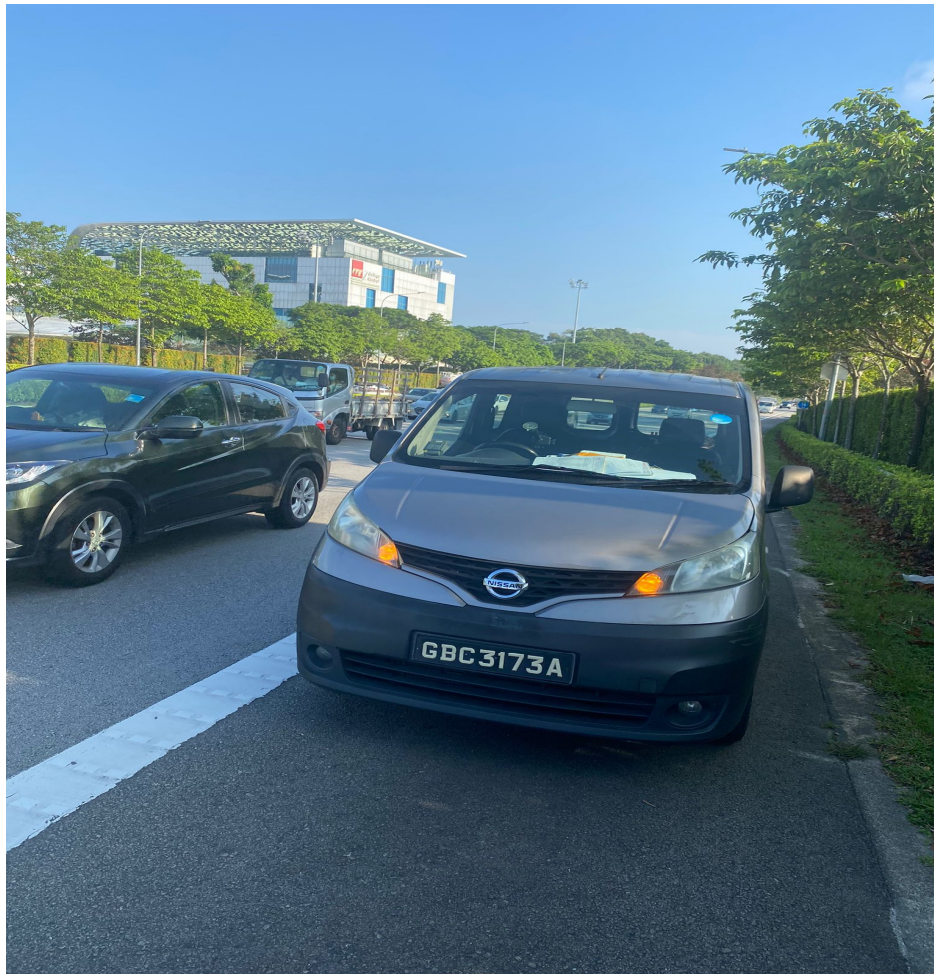
Photo 15 shows the Insured Vehicle which was waiting to be towed along the CTE on 28 March 2022. In general, the information that could be gathered from this photograph had corresponded to the events that were related to us by Mr Yee, which is the Insured Vehicle had broken down along the CTE on 28 March 2022.

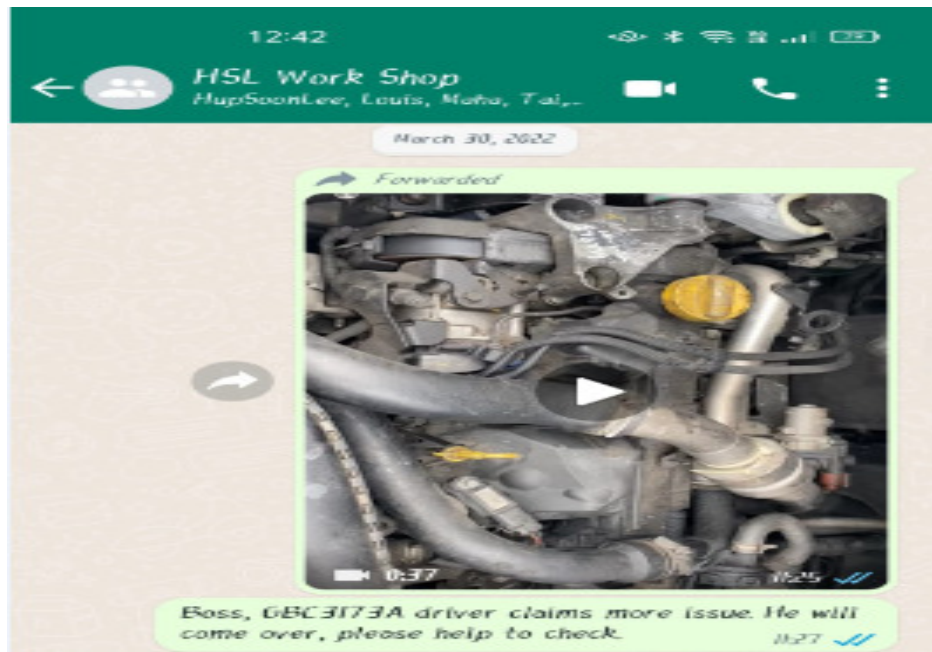
Photo 16 shows the whatsapp message which was sent to HSL by Mr Yee on 30 March 2022 pertaining to the idling issue of the Insured Vehicle's engine (arrowed).

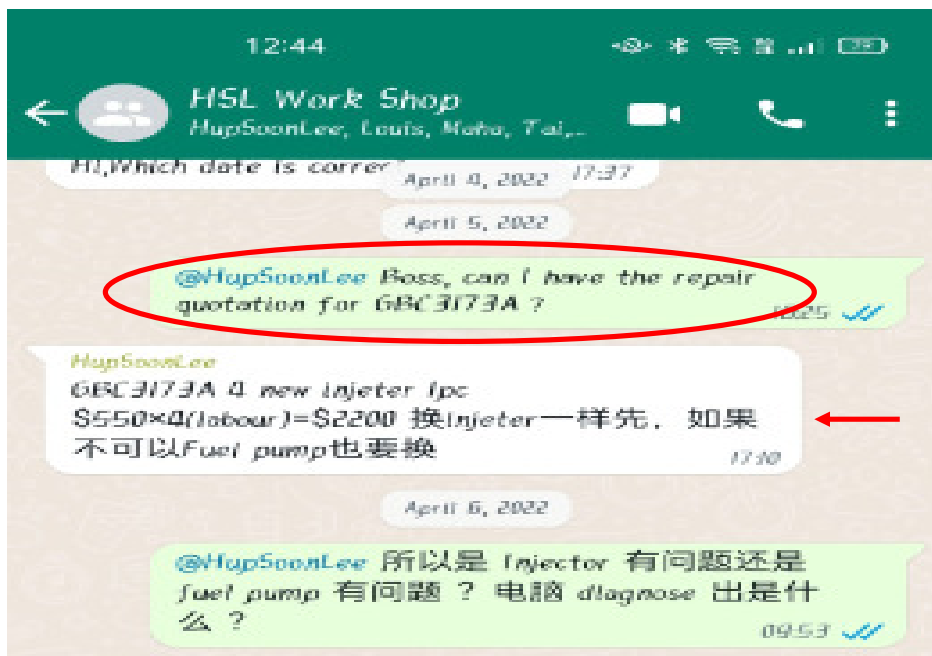
Photo 17 shows the whatsapp message which was sent to HSL by Mr Yee on 4 April 2022 pertaining to repair quotation for the Insured Vehicle (circled). The mechanic of HSL replied stating that the fuel injectors needed to be replaced (arrowed).

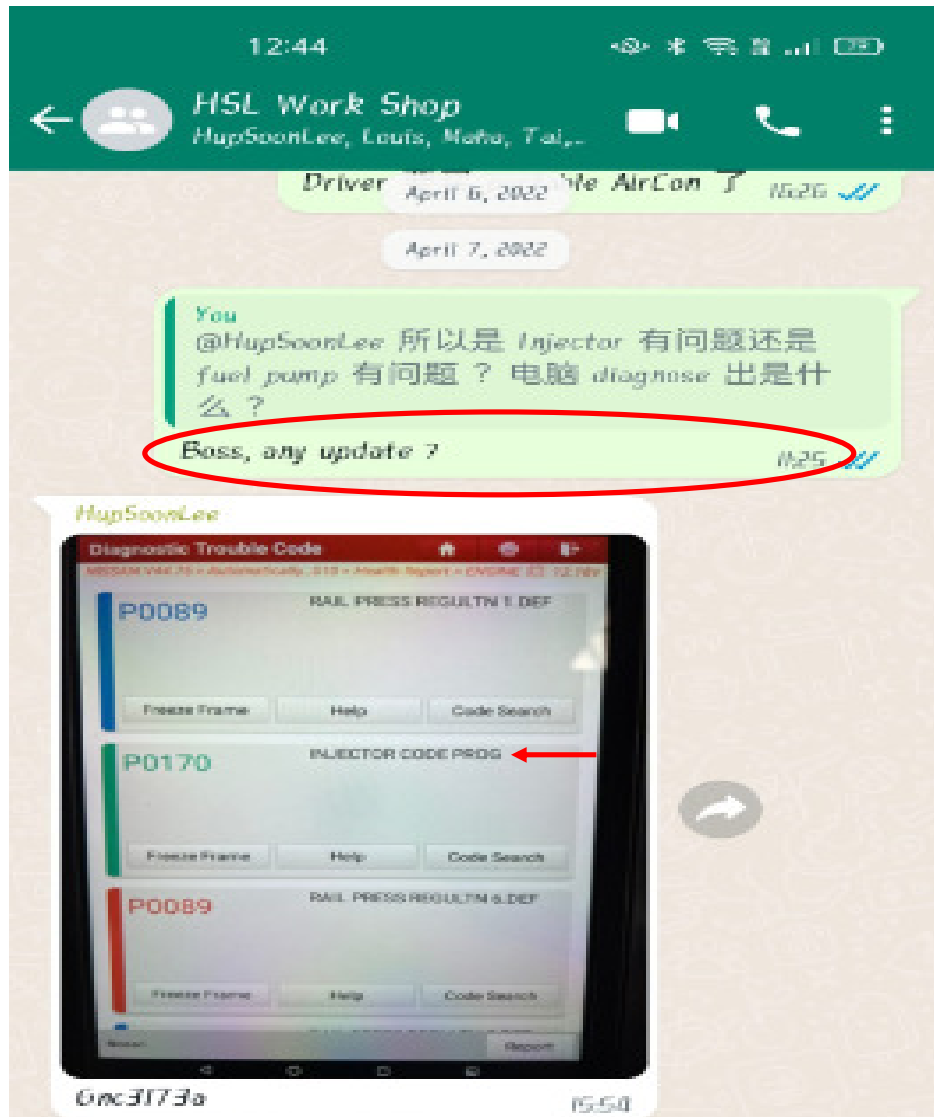
Photo 18 shows the whatsapp message which was sent to HSL by Mr Yee on 7 April 2022 pertaining to the diagnostic check for the Insured Vehicle (circled). The mechanic of HSL replied showing the error codes on the fuel injectors (arrowed).

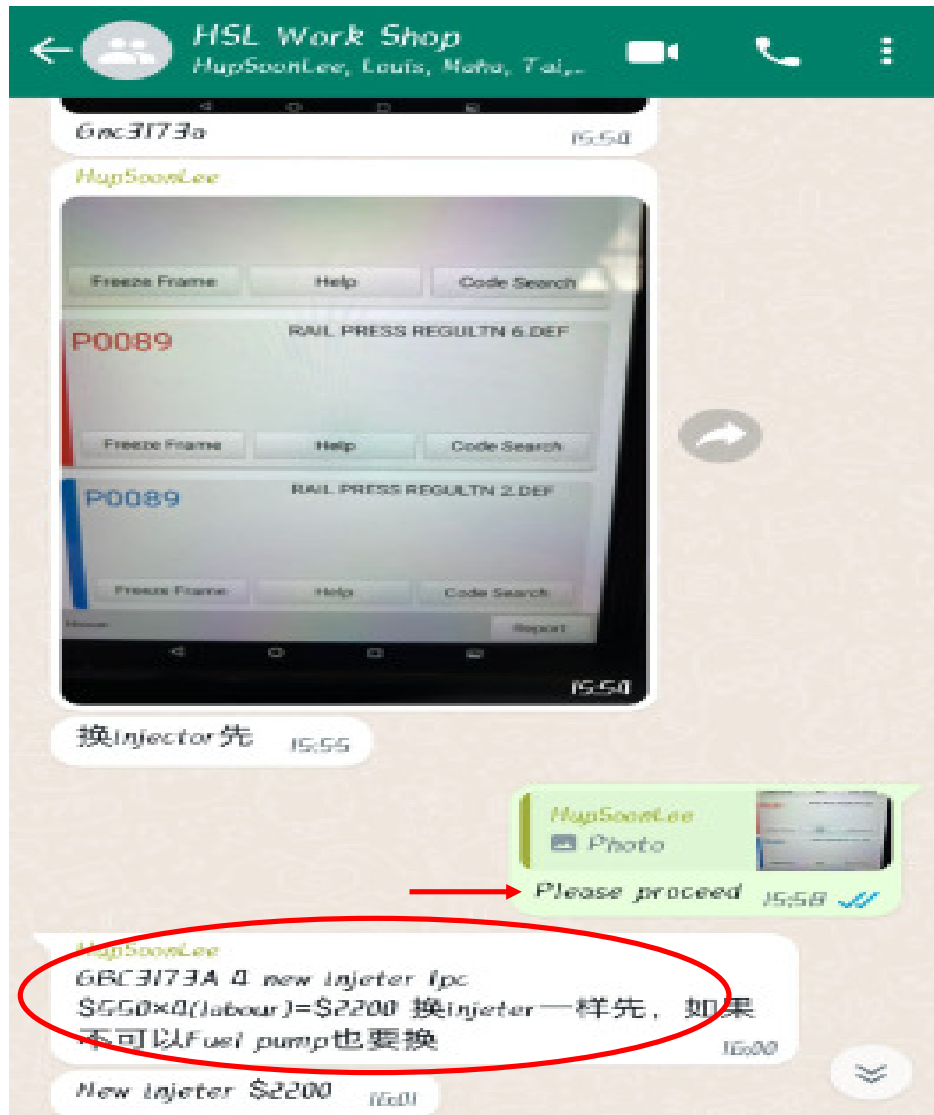
Photo 19 shows the whatsapp message which was sent to HSL by Mr Yee on 7 April 2022 asking the mechanic to proceed with the repairs to replace the fuel injectors on the Insured Vehicle (arrowed). The mechanic of HSL replied with the price breakdown on the fuel injectors (circled).

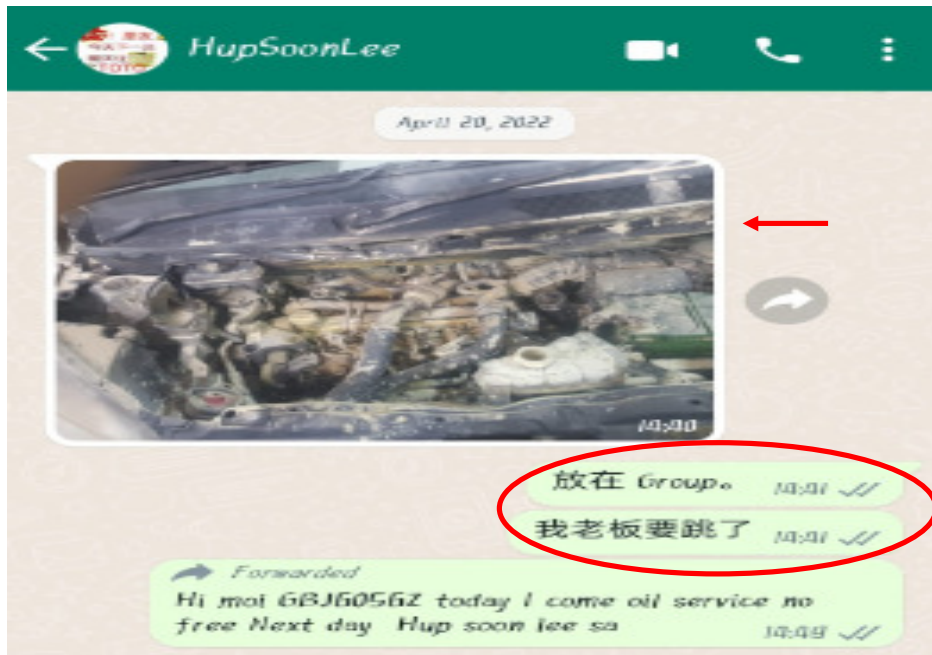
Photo 20 shows the private whatsapp message which was sent to Mr Yee by the mechanic of HSL on 20 April 2022 post- incident (arrowed). Mr Yee replied in Mandarin asking the mechanic of HSL to forward this message to the main chat whatsapp group (circled).

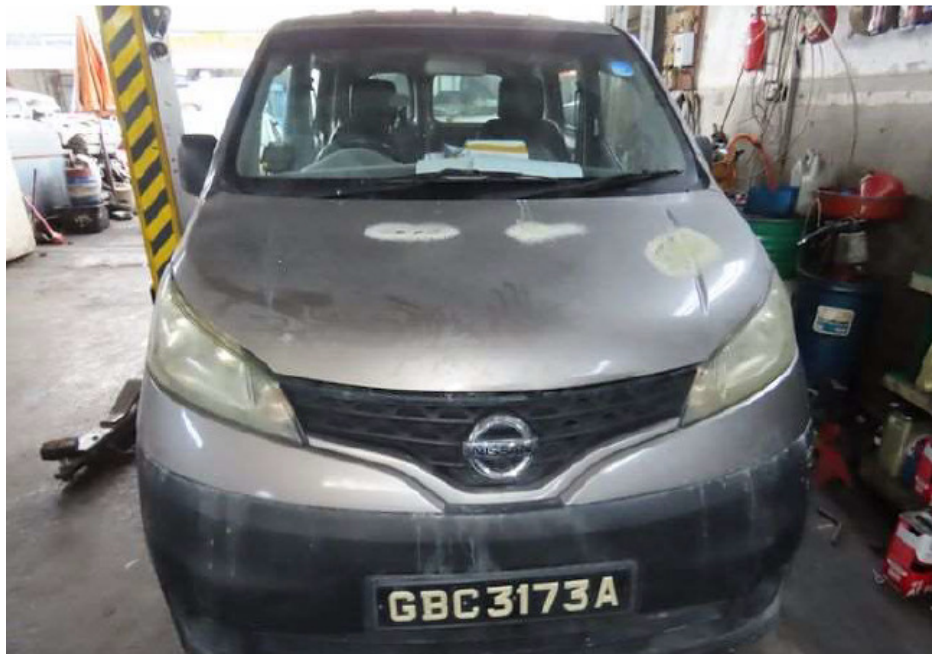
Photo 21 shows the Insured Vehicle at HSL post- incident.

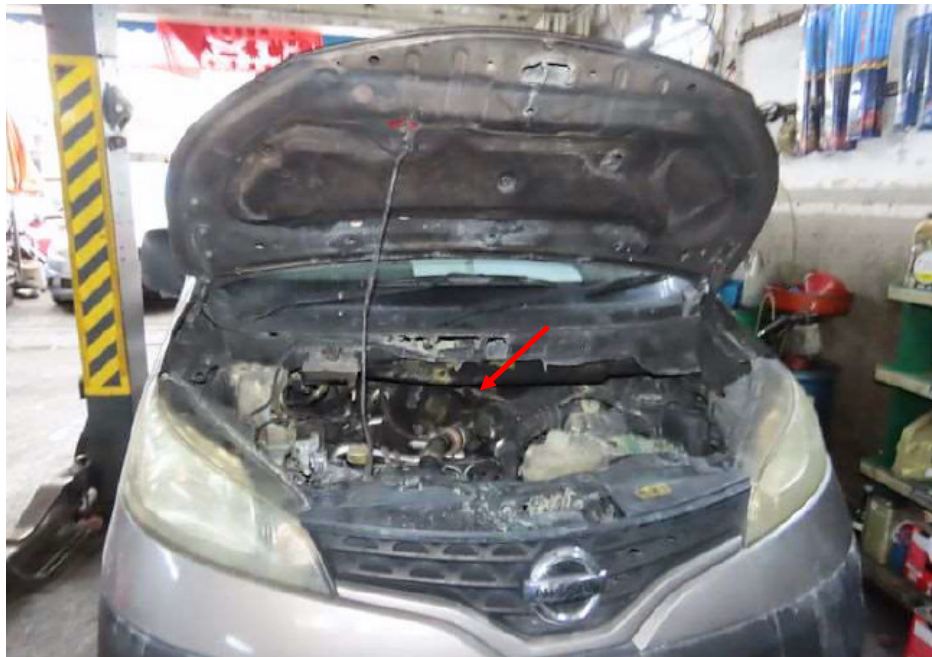
Photo 22 shows the engine compartment of the Insured Vehicle at HSL post-incident. In general, the information that could be gathered from this photograph had corresponded to the events that were related to us by Mr Yee, which is the fire to the Insured Vehicle had started from the engine compartment (arrowed).
