AUTOMOBILE INSPECTION REPORT

Assigned By : As above
Accident Date : 06 April 2022
Assignment Date : 19 April 2022
Inspection Date : 20 April 2022
Our Reference No. : PAS/DT/220213/TP

Registration No.	: CB 7545 C	Mileage	: 349699	Km/h
Make/Model	: MITSUBISHI ROSA BUS BE641JRMDEB 23 Jun	Radio/Cassette	: Fitted	
Yr of Manuf/Regn	: 24 Feb 2015	CD Disc Player	: Fitted	
Carrying Capacity	: 23 Passengers	Air Conditioner	: Fitted	
Chassis No.	: BE641JJ10132	Clock	: Fitted	
Engine No.	: 4P10B26434	Seat Belt	: Fitted	
Colour	: Metallic White	Wing Mirror	: Fitted	
Class	: School Bus	Other Accessories	: Fitted

APPENDIX A

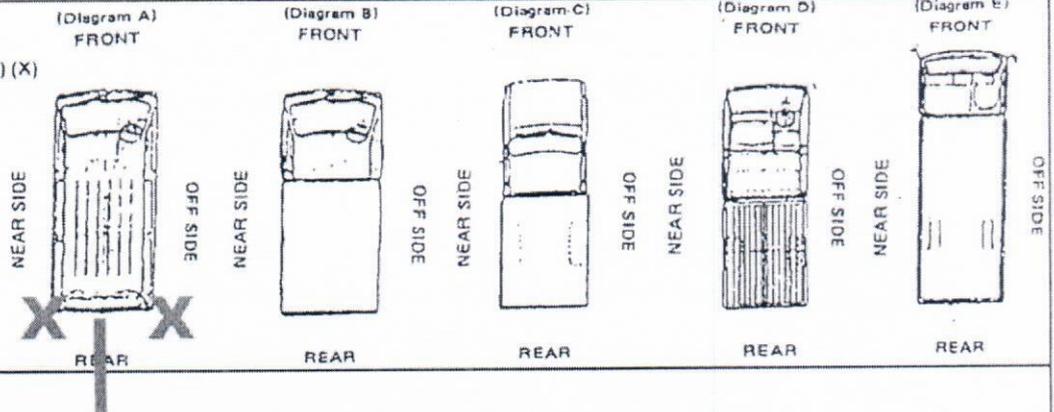
The vehicle sustained impact on its Rear Portion (see Diagram A)

The rear n/s door and lower hinge, rear o/s door and lower hinge, rear bumper and panel, rear panel lower beam were dented.
