Your Ref: MTS2022D0002071
Our Ref : CI/III22003908/P

**TECHNICAL INVESTIGATION REPORT OF WARRARTY CLAIM INVOLVING
THE INSURED VEHICLE SLL 8055J ON 21st April 2022**

Vehicle Registration No.	: SLL 8055J
Make / Model	: MERCEDES BENZ GLB200 AMG LINE
PREMIUM 7 SEATER	
Chassis No	: W1N2476872W031179
Year of Registration	: MAR 2021
Mileage	: 18,253KM

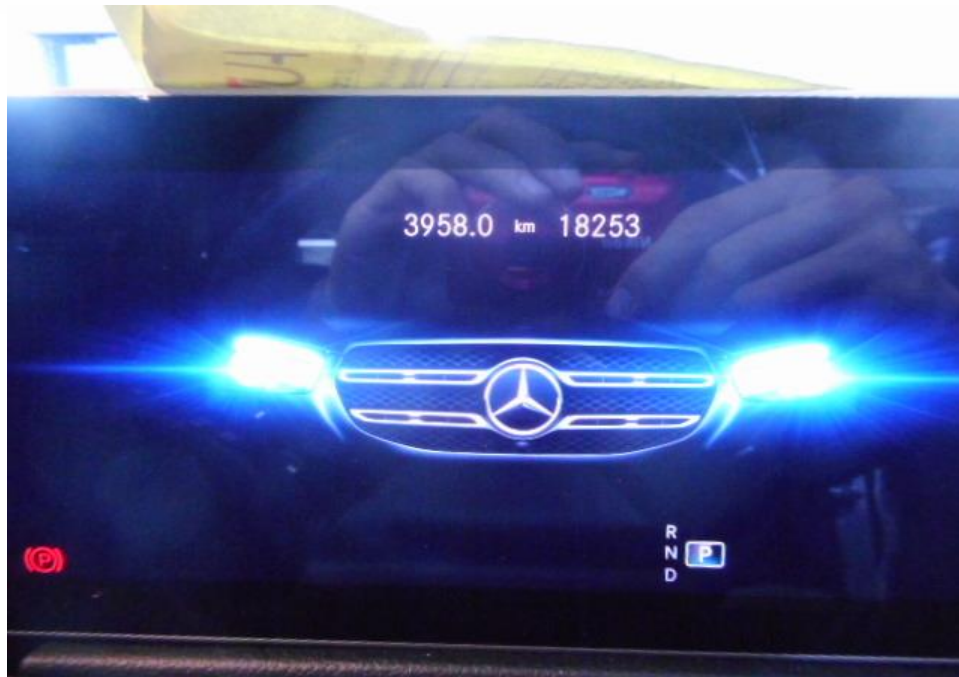
Photo 1 shows the mileage of the Insured Vehicle recorded at the time inspection at 18,253KM

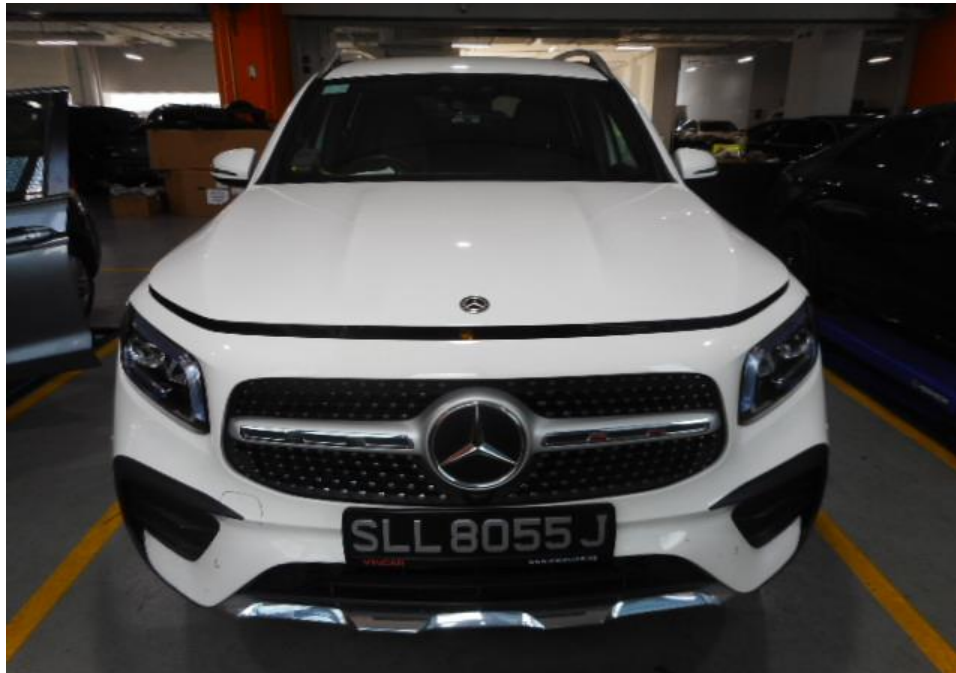
Photo 2 shows the general view of the front portion of the Insured Vehicle at the time of our inspection. The Insured Vehicle is observed to be unaffected by any signs of accident.

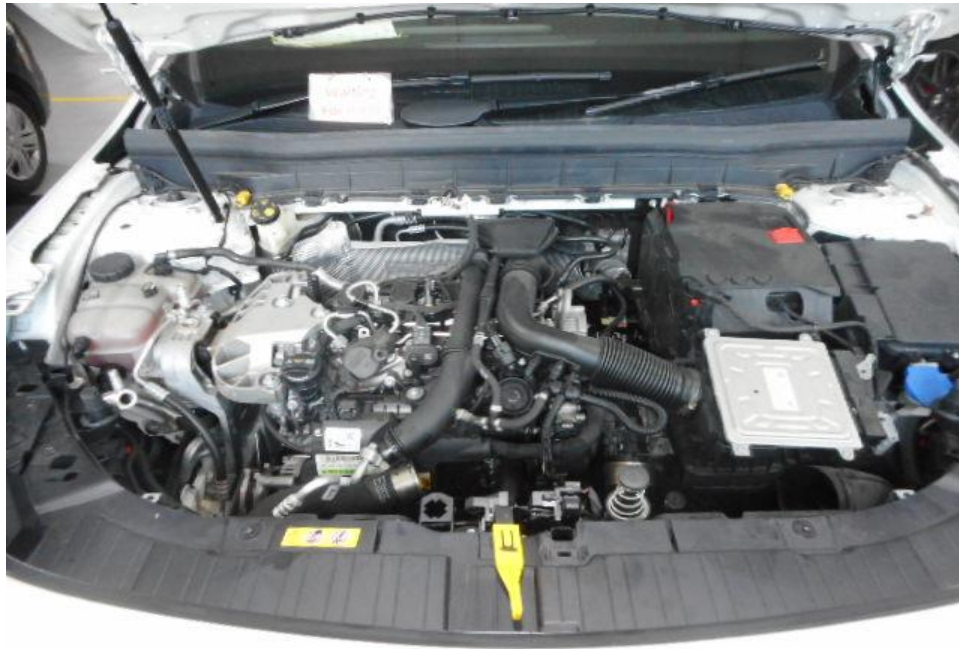
Photo 3 shows the general view of the engine portion of the Insured Vehicle at the time of our inspection. The engine compartment is observed to be unaffected by any signs of accident.

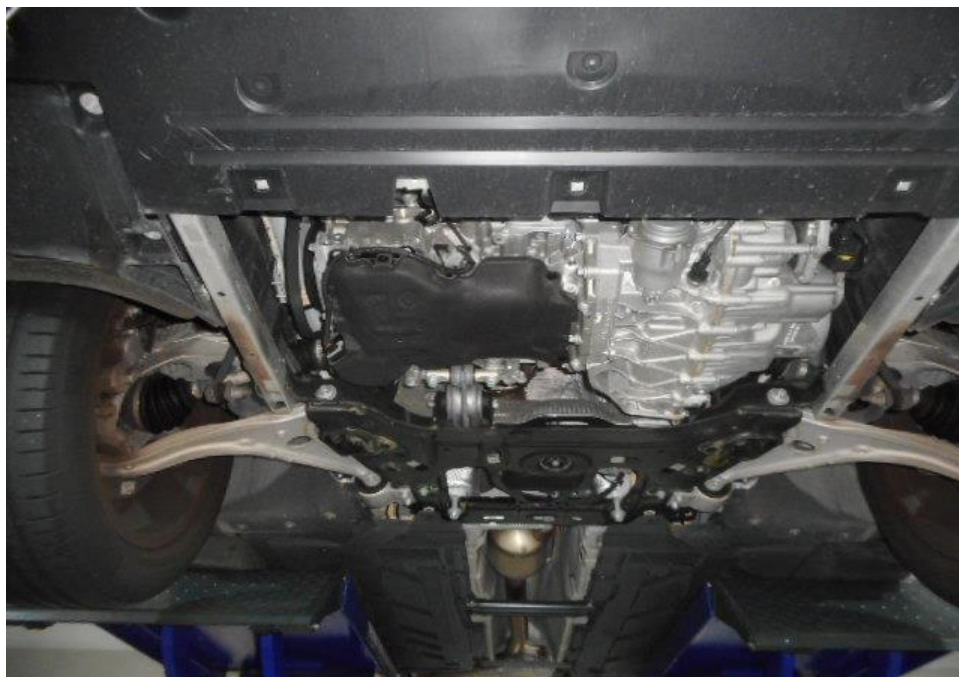
Photo 4 shows the general view of the engine underside portion of the Insured Vehicle at the time of our inspection. The engine underside compartment is observed to be unaffected and by any signs of accident.

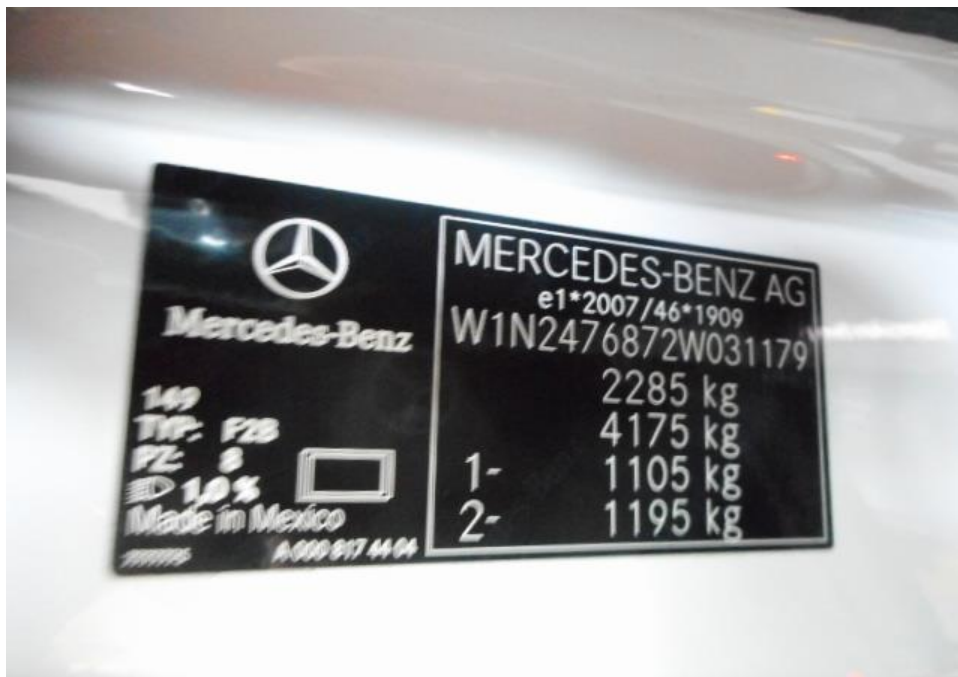
Photo 5 shows the chassis number of the Insured Vehicle at the time of our inspection.

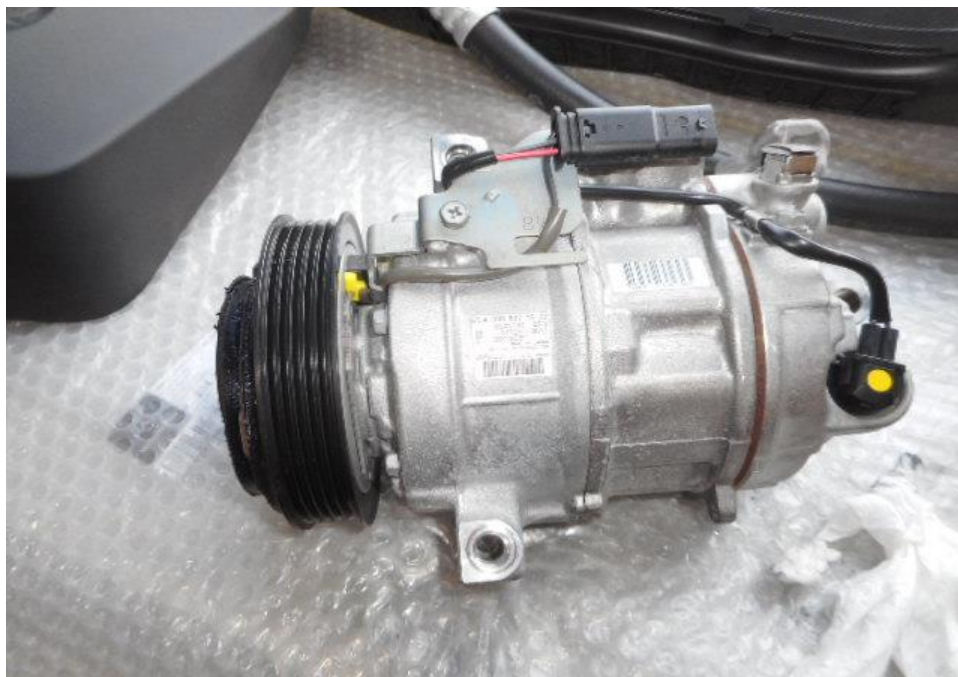
Photo 6 shows the aircon compressor unit of the Insured Vehicle at the time of our inspection. The aircon compressor unit is observed to be taken out of the Insured Vehicle and inspected.

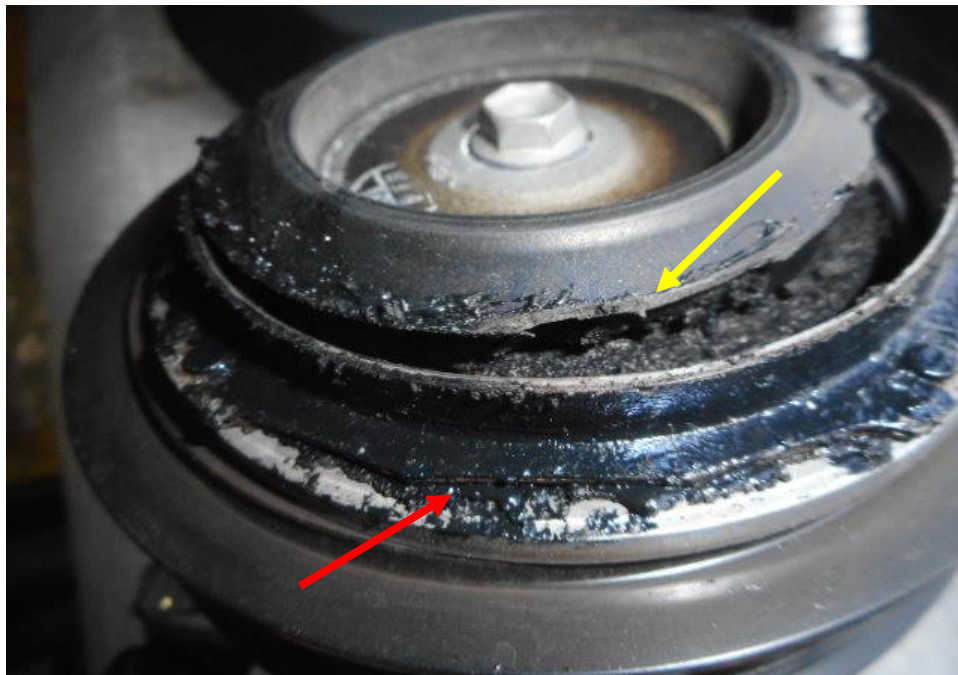
Photo 7 shows the aircon compressor unit portion of the Insured Vehicle at the time of our inspection. The bearing (yellow arrow) of the aircon compressor unit is observed to be damaged and the grease (red arrow) inside it has leaked out.

7. We did not find any evidence which had suggested that the cause of abnormalities to the Insured Vehicle was due to poor maintenance and/or recurring problem. And the damaged to the aircon compressor bearing was likely due to material stress which caused it to be broken and resulting to the damages to the aircon compressor, causing in the metal fillings and black liquid to flow around in the aircon system affecting the aircon condenser, aircon cooling coil and its components.
8. Our investigations had also revealed that at the time of writing this report, there is no manufacturer recall to similar make and model vehicle as the Insured Vehicle that may possibly be related to this incident.
9. The recommendation to replace the aircon compressor, aircon condenser, aircon cooling coil and its components at \$3,737.00 is justifiable as all the relevant checks has been conducted.

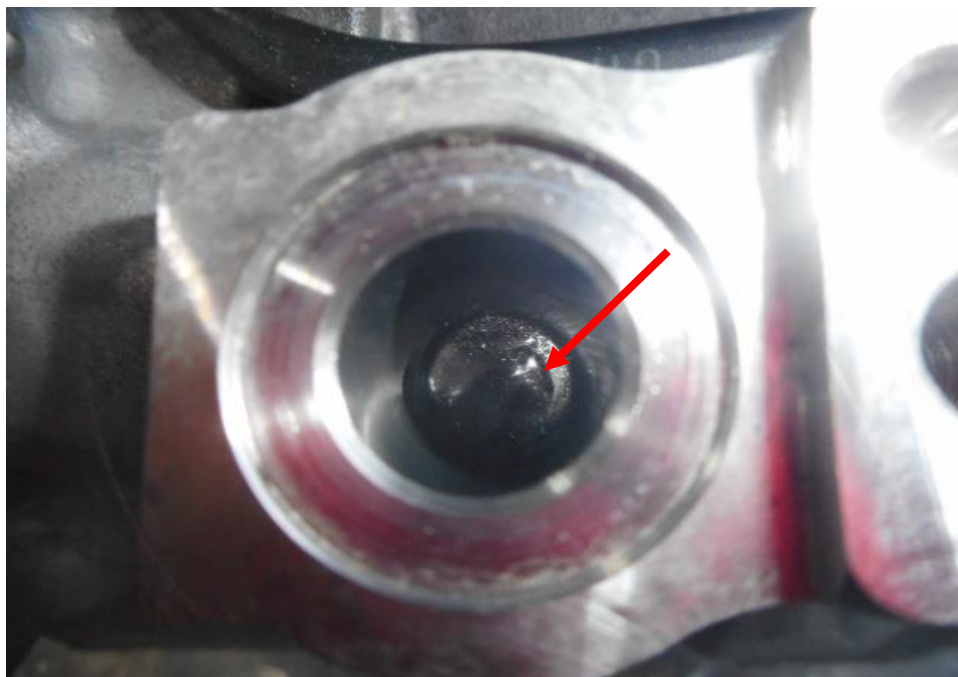
Photo 8 shows the close up view of the aircon compressor of the Insured Vehicle at the time of our inspection. The internals of the aircon compressor was observed to be filled up with black liquid and metal fillings (arrowed) which was caused by the damaged aircon compressor bearing at the time of inspection.

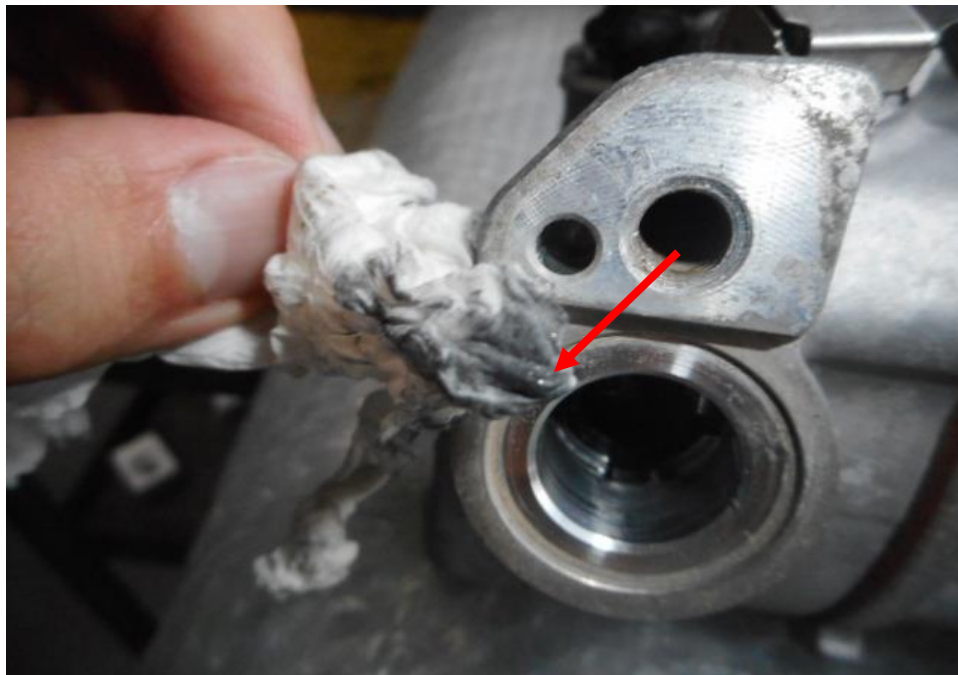
Photo 9 shows the close up view of the aircon compressor of the Insured Vehicle at the time of our inspection. The internals of the aircon compressor was observed to be filled up with black liquid and metal fillings (arrowed) which was caused by the damaged aircon compressor bearing at the time of inspection.
