## LKK Auto Consultants Pte Ltd

Affiliated to Federation Internationale Des Experts En Automobile				
CHINA TAIPING INSURANCE (S) PTE LTD 3 ANSON ROAD #16-00 SPRINGLEAF TOWERS SINGAPORE 079909			Ref: CC3/CTI22004019/Kpa3q2	
			Date: 09/06/2022	
			Code: CTI	
<b>1. Policy Particulars :- THIRD PARTY CLAIM</b>				
Insured Veh.	GBD 2236D	Veh. Inspected	SHD 145A	
Policy No.	DMCVSNW00073452100	Coverage (\$)	0.00	
Claim No.	SNM22D202892/C02	Excess (\$)	0.00	
Assign From		Assign Date	27/04/2022	
<b>2. Vehicle Particulars &amp; Condition</b>				
Make & Model	RENAULT LATITUDE (A)	c.c	1995	
Engine No.	HIDDEN	Year of Reg.	2015	
Chassis No.	VF1ABL15AUC282250	Colour	METALLIC WHITE/RED	
Odometer	302546 KM	Steering	IN ORDER	
Brakes	IN ORDER	Modification	NIL	
General	GOOD			
<b>3. Conditions of Tyres</b>				
	Size	Make	Balance	
R/H Front Tyre	215/60 R16	SAILUN	7 mm	
L/H Front Tyre	215/60 R16	SAILUN	7 mm	
R/H Rear Tyre	215/60 R16	SAILUN	8 mm	
L/H Rear Tyre	215/60 R16	SAILUN	8 mm

### ADJUSTMENT ON REPAIR COST FOR VEHICLE NO. SHD 145A

### PHOTOGRAPHS FOR VEHICLE NO. SHD 145A

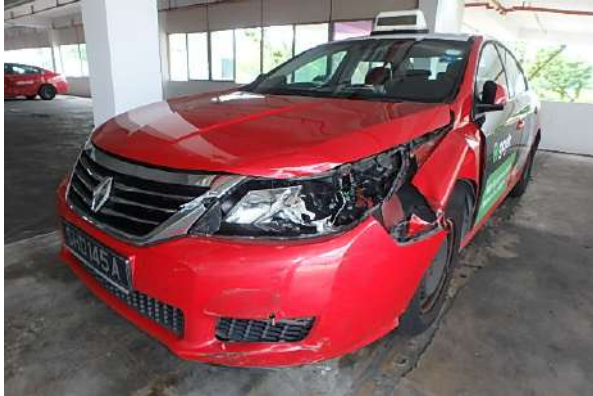
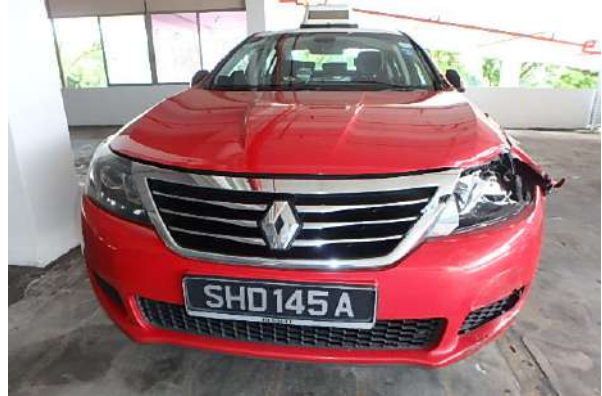
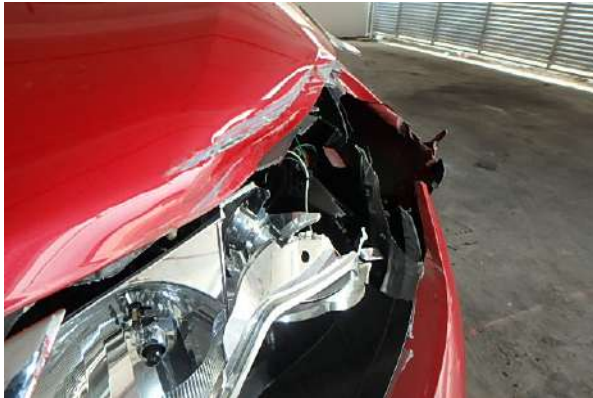
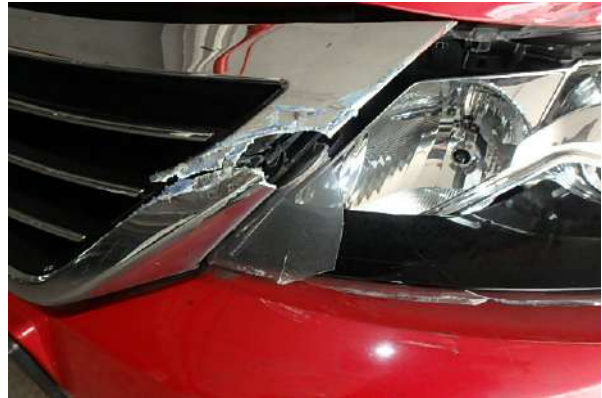
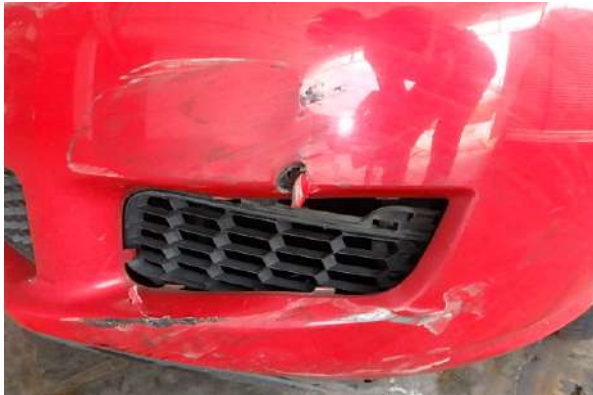
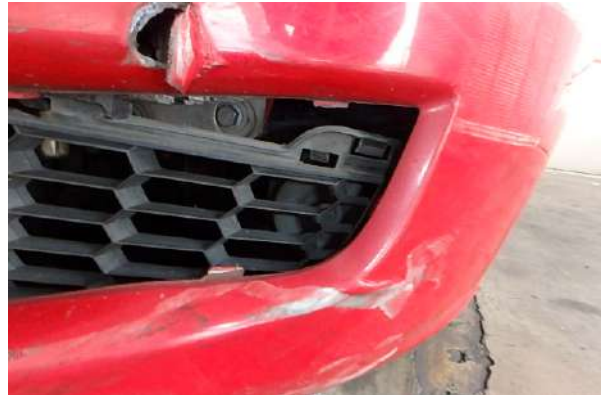
### INSPECTION

<b>4. Description of Damages</b>				
THE VEHICLE SUSTAINED DAMAGES AT THE FRONT N/S PORTION.  DAMAGES SEE DETAILS.				
<b>5. General Information</b>				
Accident Date	26/04/2022	Inspection Date	27/04/2022	
Survey held at	TRANS-CAB AUTO SERVICES PTE LTD NO.2 ANG MO KIO ST 63 SINGAPORE 569111			
<b>5a. Remarks</b>

<b>RECOMMENDED COST OF LUMP SUM REPAIRS (TO ITS PRE-ACCIDENT CONDITION)</b>			<b>5,100.00</b>
---	--	--	-----------------
