Your Ref: Mercedes Benz C63 Coupe  
(chassis number WDD2053872F950728)  
Our Ref : CI/TP22004078/D

26 April 2022

**INSPECTION REPORT OF AN UNREGISTERED MERCEDES BENZ C63  
COUPE MOTOR CAR WITH CHASSIS NUMBER WDD2053872F950728**

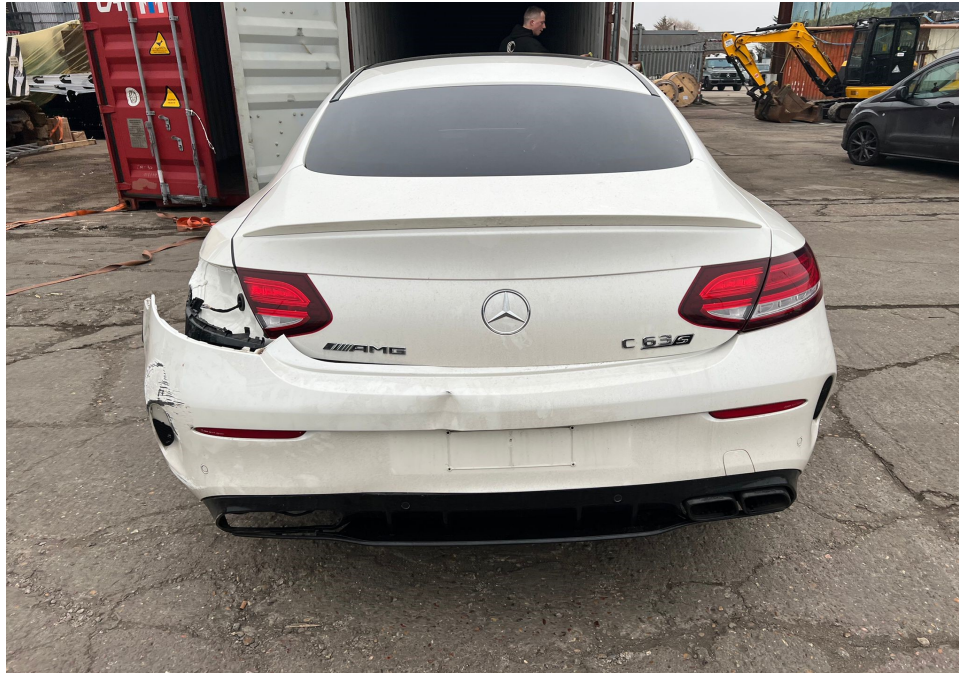
**Photo 1** shows the rear body of the Motor Car (photograph provided to me). The Motor Car was observed to have sustained damage at its rear left portion. The rear bumper, rear bumper lower cover and rear left taillamp were amongst the body parts that were observed to have been damaged.

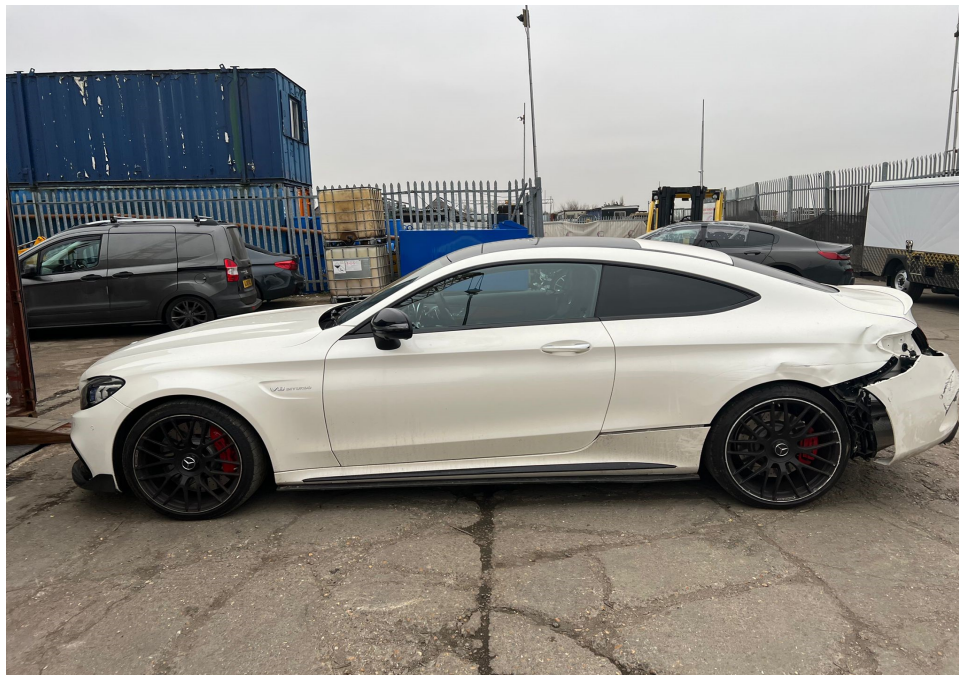
**Photo 2** shows the left side body of the Motor Car (photograph provided to me). The Motor Car was observed to have sustained damage at its rear left portion. The rear bumper, rear left taillamp, rear left fender and rear left wheel rim were amongst the body parts that were observed to have been damaged. The airbag(s) was not deployed as seen from the photographs that were provided to me.

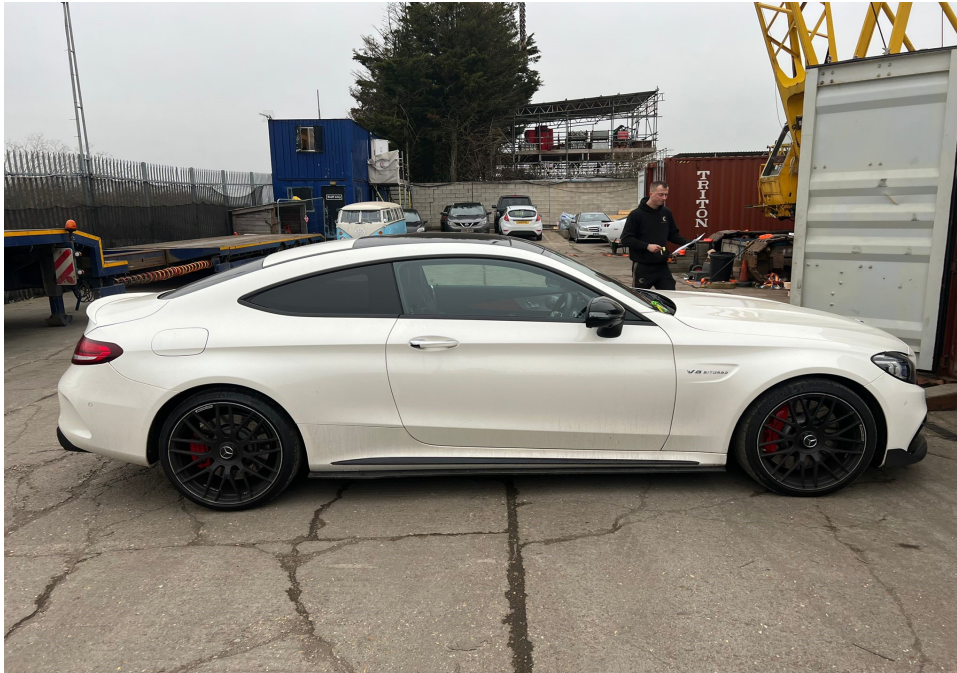
**Photo 3** shows the right side body of the Motor Car (photograph provided to me). Apart for the rear left portion, there was no physical damage observed to other areas of the Motor Car. The airbag(s) was not deployed as seen from the photographs that were provided to me.

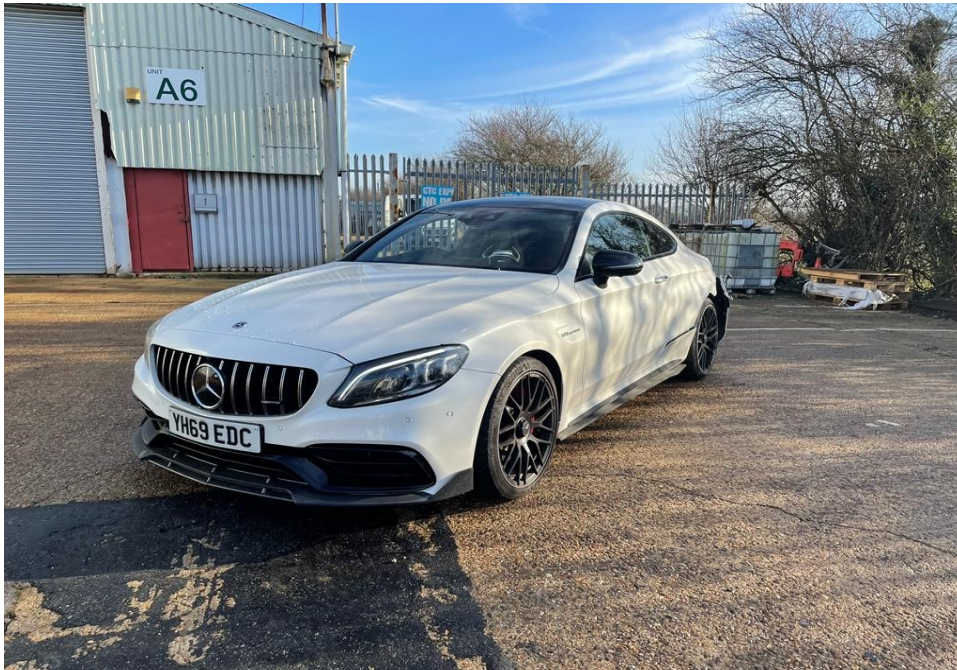
**Photo 4** shows the front left body of the Motor Car (photograph provided to me). Apart for the rear left portion, there was no physical damage observed to other areas of the Motor Car. The airbag(s) was not deployed as seen from the photographs that were provided to me.

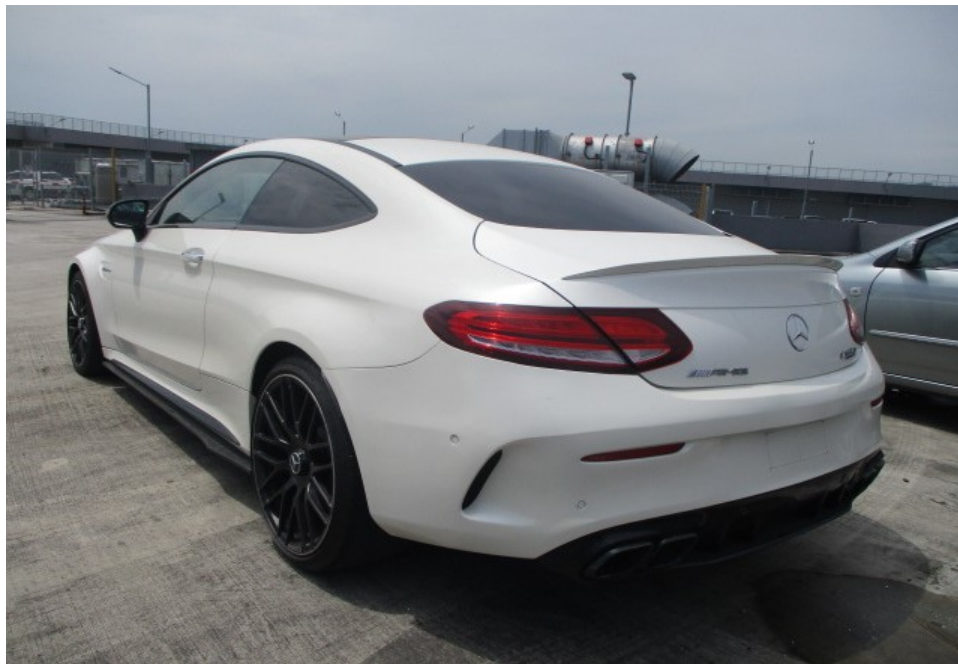
**Photo 5** shows a general view of the rear left body of the Motor Car at the time of my inspection. The Motor Car was observed to be in a relatively good general condition with no loose exterior fittings observed. The body parts at the rear left portion of the Motor Car were visually examined and it was observed that the repair/restoration works carried out to the damaged area of the Motor Car (refer to photograph 1 & 2 above) were reasonably adequate and in order.

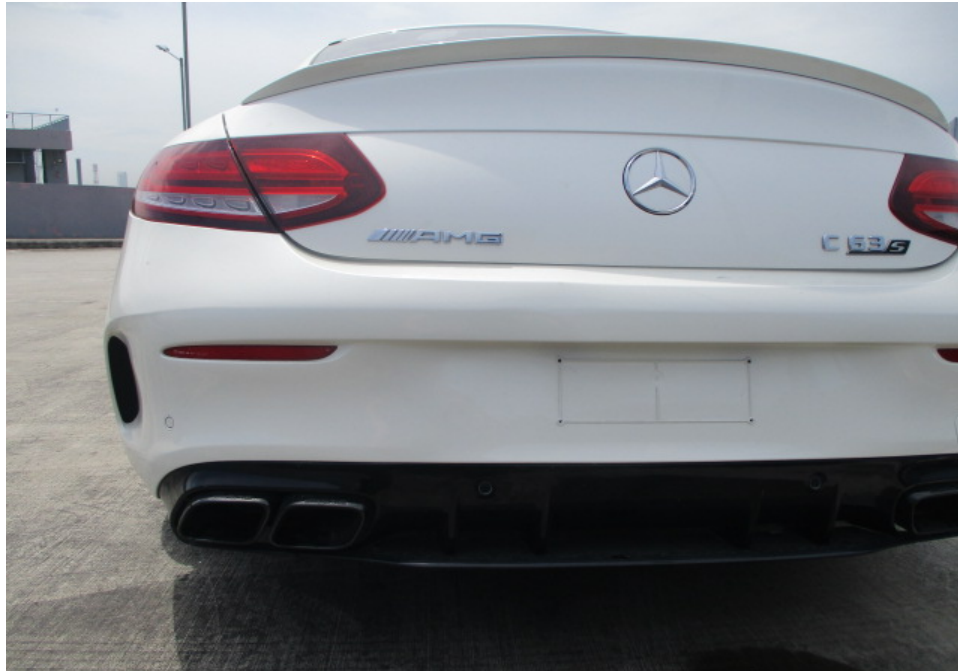
**Photo 6** shows a closer view of the Motor Car's rear bumper, rear bumper lower cover, rear bumper sensors and rear bumper left reflector at the time of my inspection. The body parts at the rear left portion of the Motor Car were visually examined and it was observed that the repair/restoration works carried out to the damaged area of the Motor Car (refer to photograph 1 & 2 above) were reasonably adequate and in order.

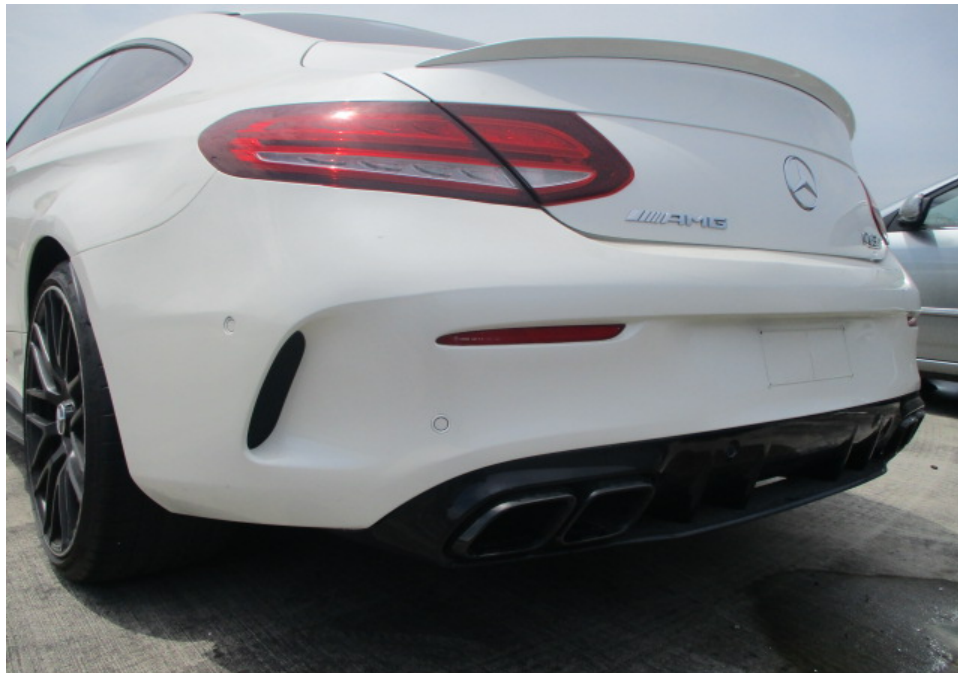
**Photo 7** shows a closer view of the Motor Car's rear bumper, rear bumper lower cover and rear left taillamp at the time of my inspection. The body parts at the rear left portion of the Motor Car were visually examined and it was observed that the repair/restoration works carried out to the damaged area of the Motor Car (refer to photograph 1 & 2 above) were reasonably adequate and in order.

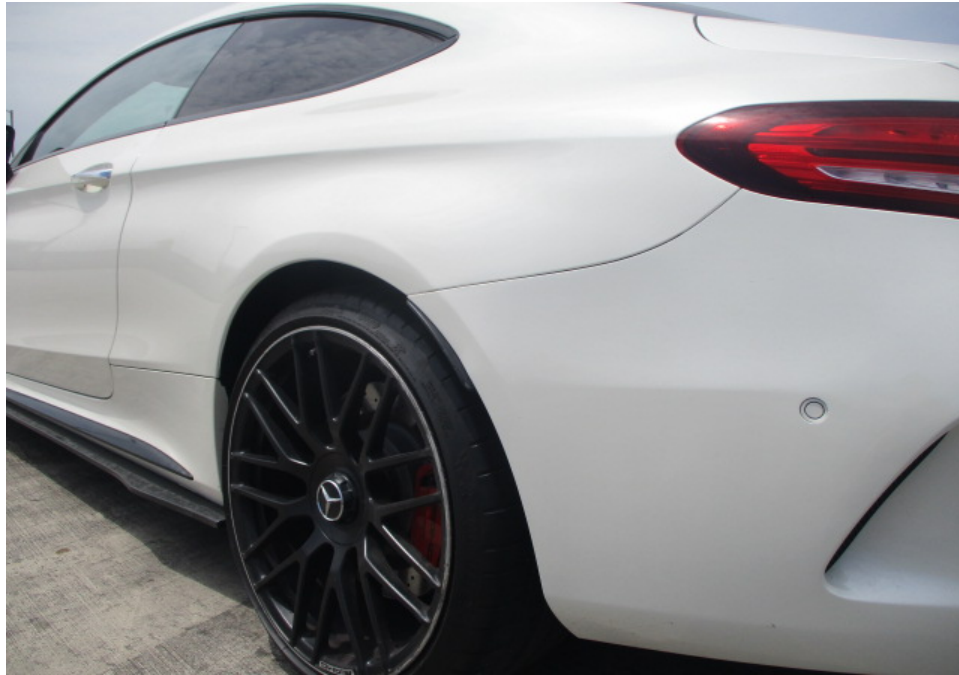
**Photo 8** shows a closer view of the Motor Car's rear bumper, rear bumper left sensor, rear left taillamp, rear left fender and rear left wheel rim at the time of my inspection. The body parts at the rear left portion of the Motor Car were visually examined and it was observed that the repair/restoration works carried out to the damaged area of the Motor Car (refer to photograph 1 & 2 above) were reasonably adequate and in order.

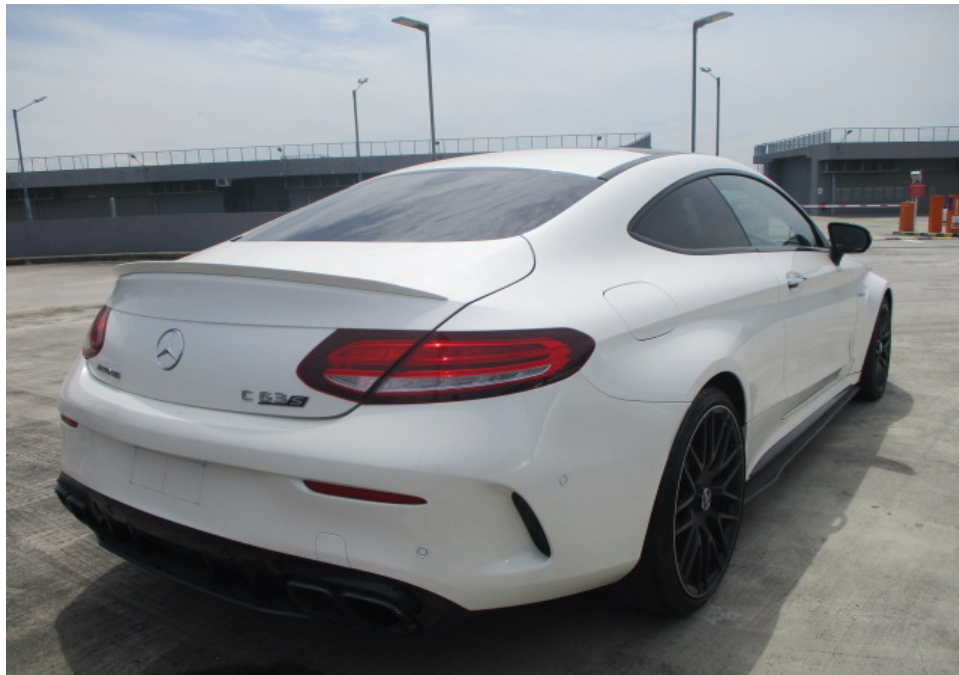
**Photo 9** shows a general view of the rear right body of the Motor Car at the time of my inspection. The Motor Car was observed to be in a relatively good general condition with no loose exterior fittings observed. The mileage of the Motor Car recorded at the time of my inspection was 6,213km.

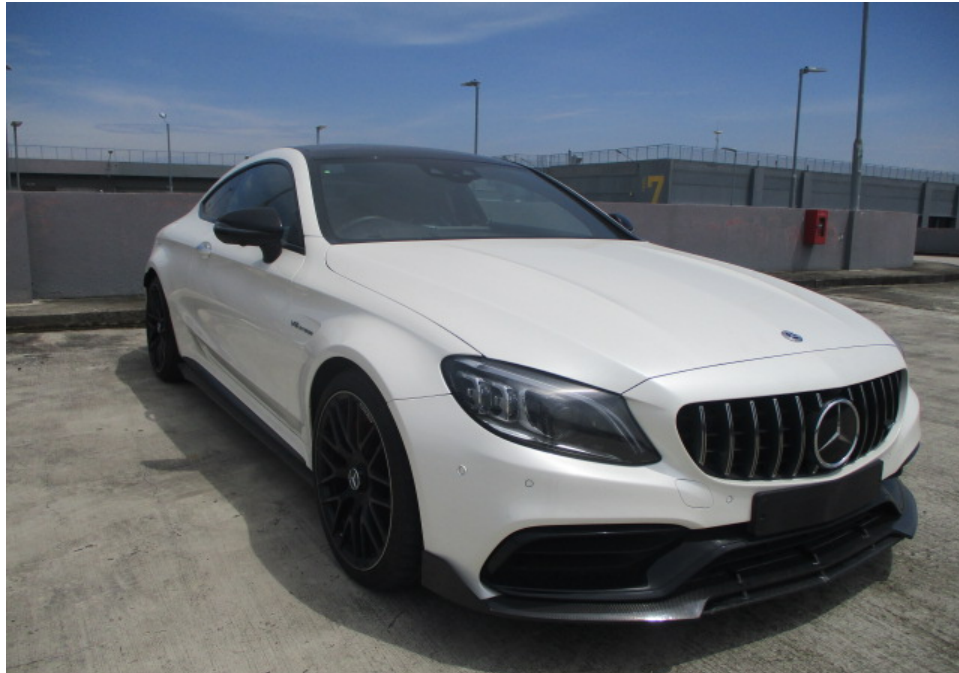
**Photo 10** shows a general view of the front right body of the Motor Car at the time of my inspection. The Motor Car was observed to be in a relatively good general condition with no loose exterior fittings observed. The mileage of the Motor Car recorded at the time of my inspection was 6,213km.

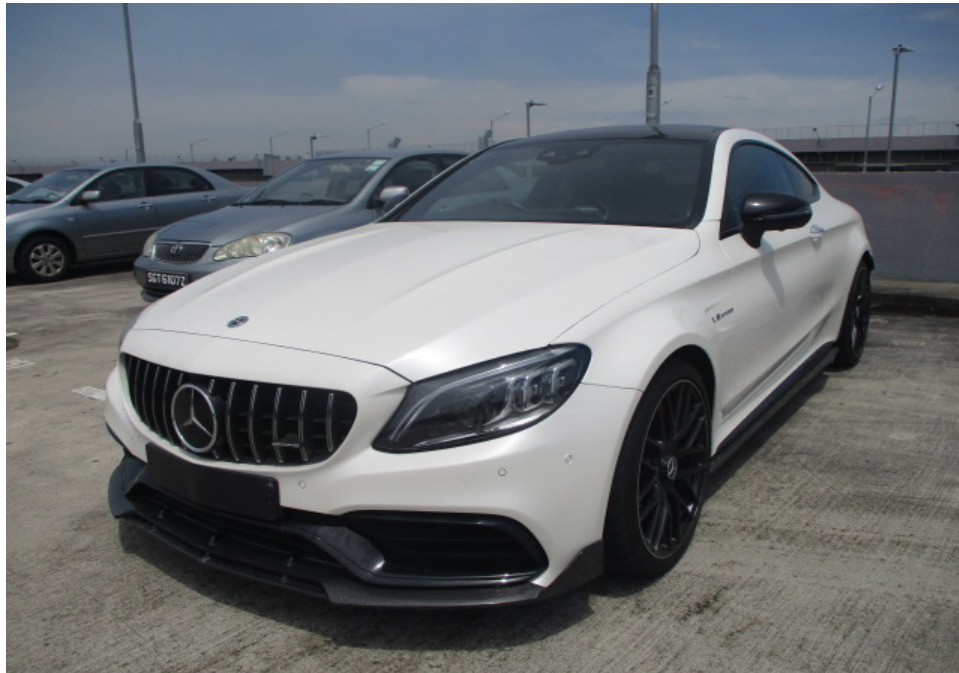
**Photo 11** shows a general view of the front left body of the Motor Car at the time of my inspection. The Motor Car was observed to be in a relatively good general condition with no loose exterior fittings observed. The mileage of the Motor Car recorded at the time of my inspection was 6,213km.

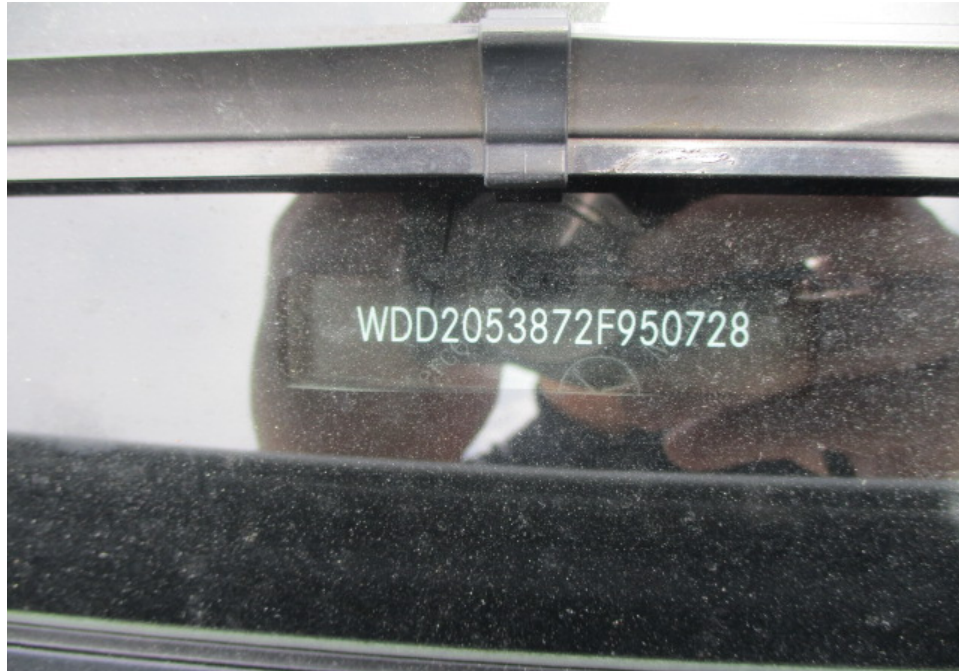
**Photo 12** shows the chassis number of the Motor Car. The chassis number recorded was WDD2053872F950728.

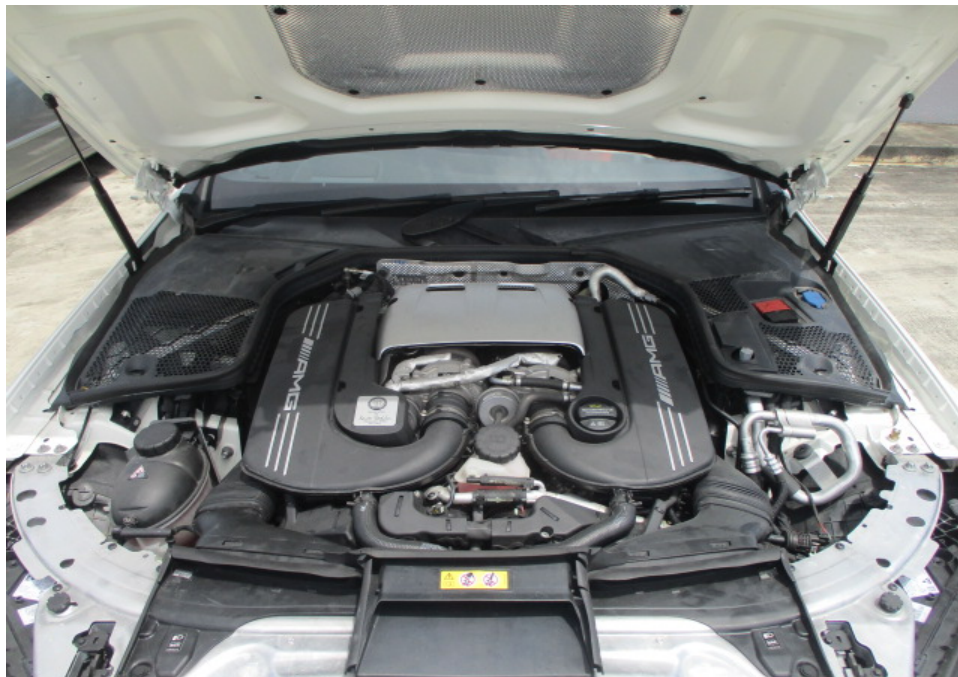
**Photo 13** shows a general view of the engine compartment of the Motor Car at the time of my inspection. The various parts and components inside the engine compartment were all observed to be intact and properly fitted. There was also no sign(s) or indication(s) of fluid leak and/or fluid stain found inside the engine compartment.

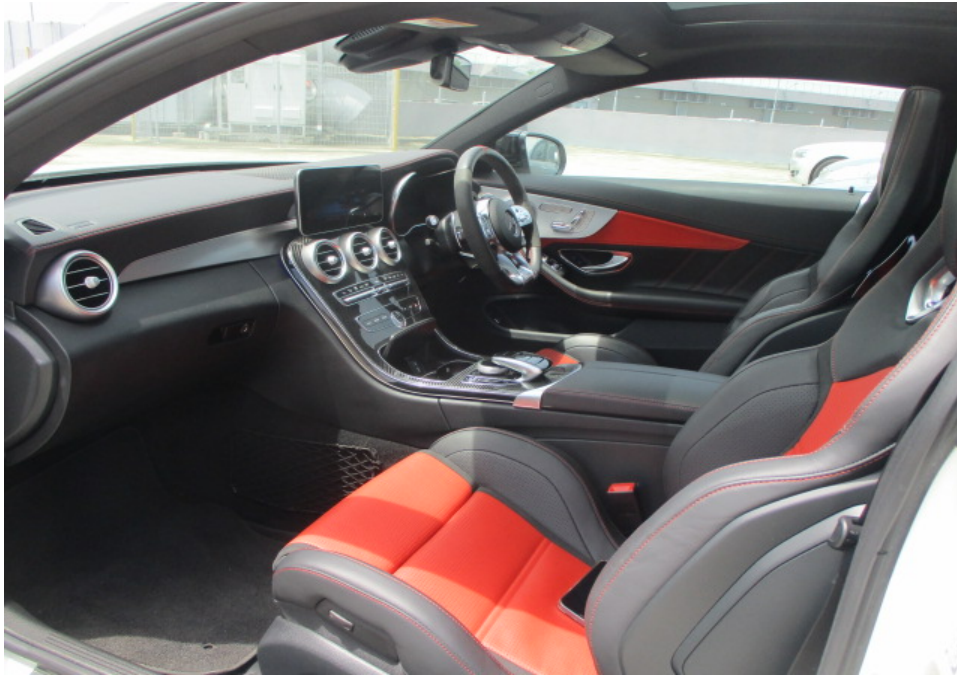
**Photo 14** shows the interior compartment of the Motor Car at the time of my inspection. The various parts and components, trims, carpet, and upholstery inside the interior compartment were all observed to be intact and properly fitted.

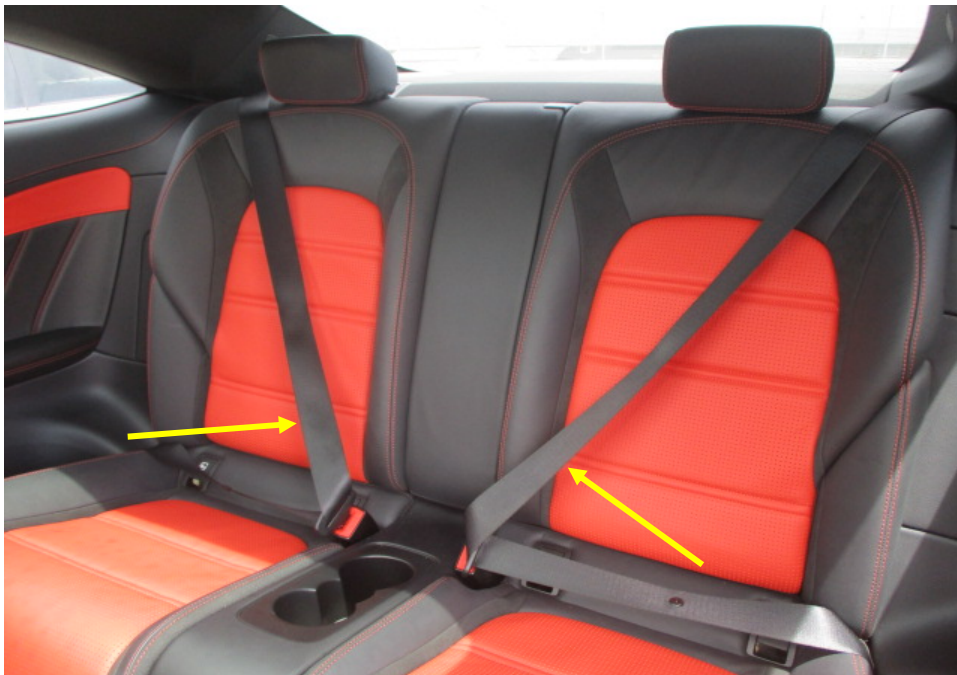
**Photo 15** shows the rear seats of the Motor Car. All the seats of the Motor Car were secured via seat rails to the floorboard. They were also fitted with a retractable seat belt reel and a pre-tensioner. The seat belts (arrowed) were tested and were able to be fastened into the respective pre-tensions that were fitted on the side of each individual seat.

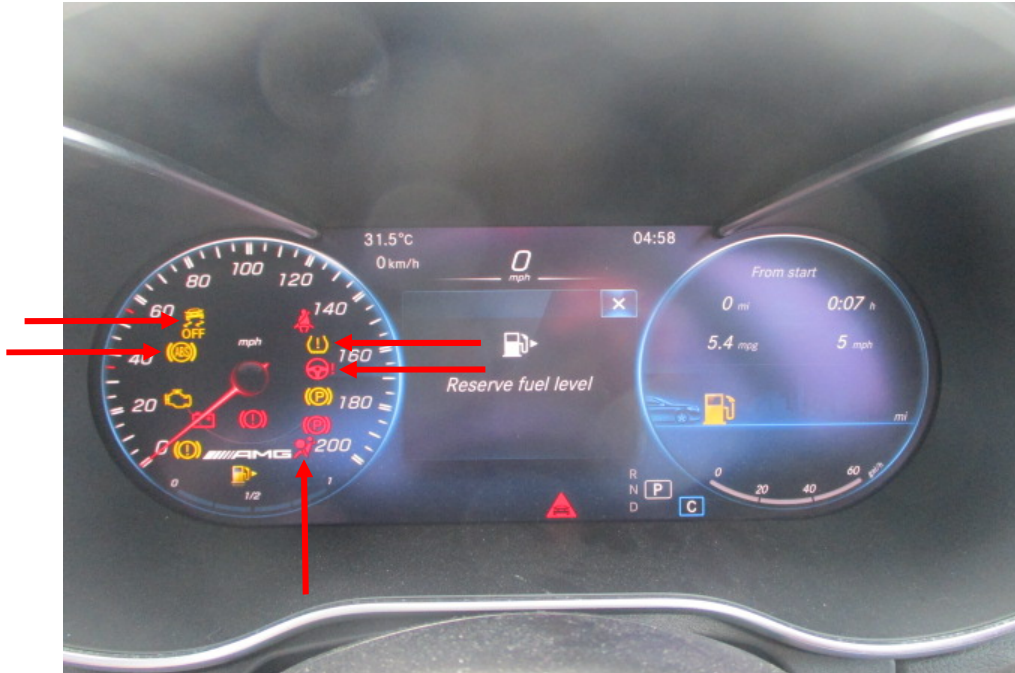
**Photo 16** shows the warning lights for the various electronic safety features appearing on the instrument panel of the Motor Car during its self-test when the engine is cranked, in particular the ABS, SRS, EPS, TPM and TCS lights (arrowed).

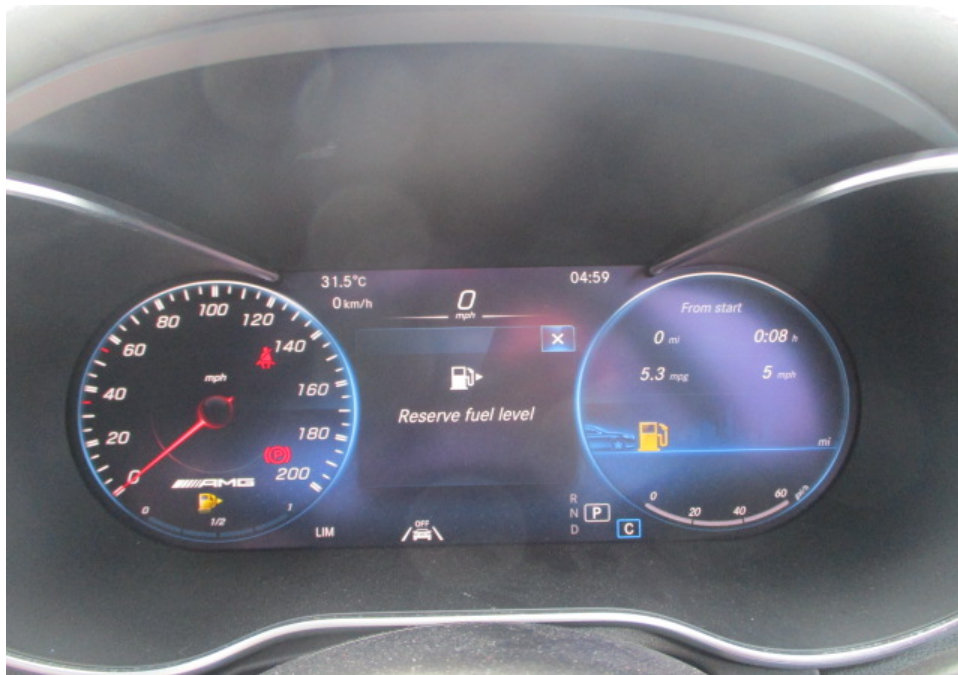
**Photo 17** shows the respective warning lights no longer illuminated, indicating that there is no fault detected to the ABS, SRS, EPS, TPM and TCS systems of the Motor Car during the self-test. These electronic systems were hence in working condition at the time of my inspection.

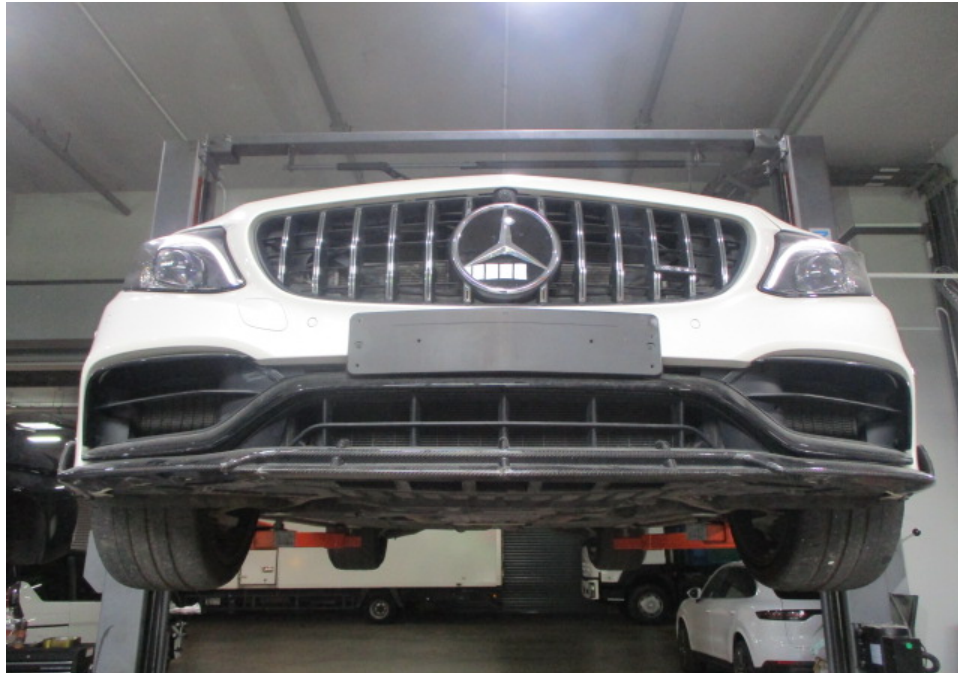
**Photo 18** shows the Motor Car hoisted up for checks on its undercarriage. There was no sign(s) or indication(s) of fluid leakage and/or fluid stain(s) on the underside of the Motor Car. The undercarriage components of the Motor Car were also all observed to be intact and secured in an appropriate manner.

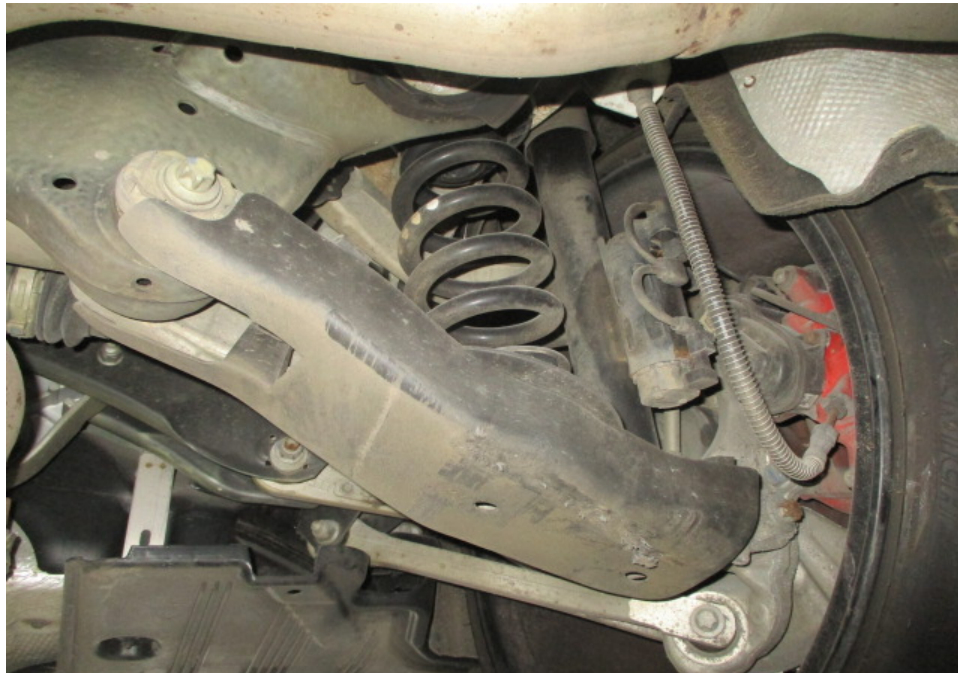
**Photo 19** shows a general view of the control arms and linkages at the rear right wheel of the Motor Car. I did not observe any fluid leak and/or fluid stain on the underside of the Motor Car. All of the Motor Car's undercarriage components were observed to be intact and secured in an appropriate manner.

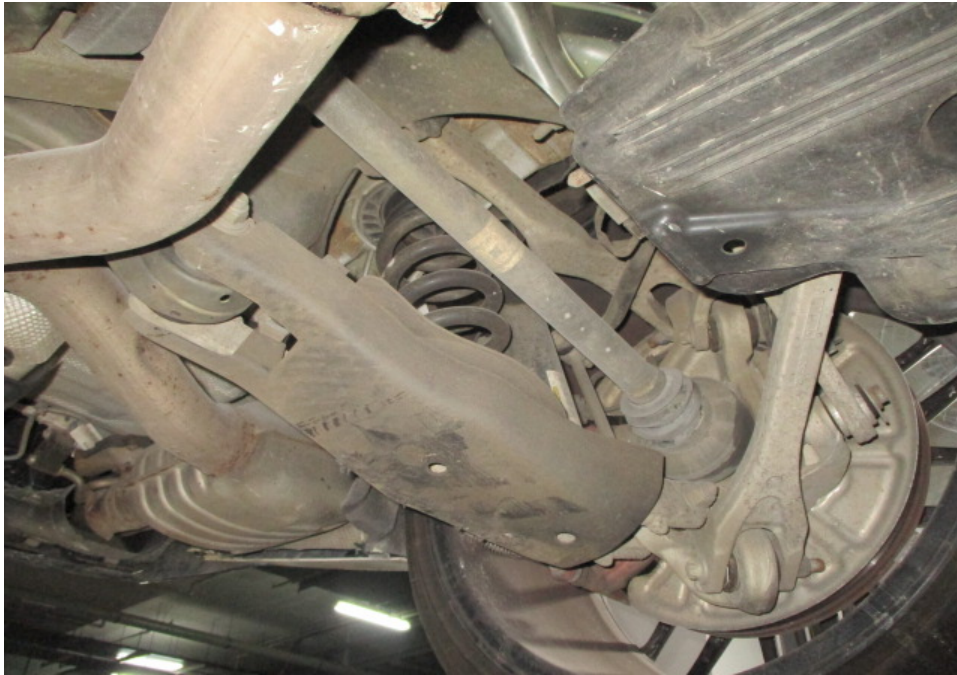
**Photo 20** shows a general view of the control arms and linkages at the rear left wheel of the Motor Car. I did not observe any fluid leak and/or fluid stain on the underside of the Motor Car. All of the Motor Car's undercarriage components were observed to be intact and secured in an appropriate manner.

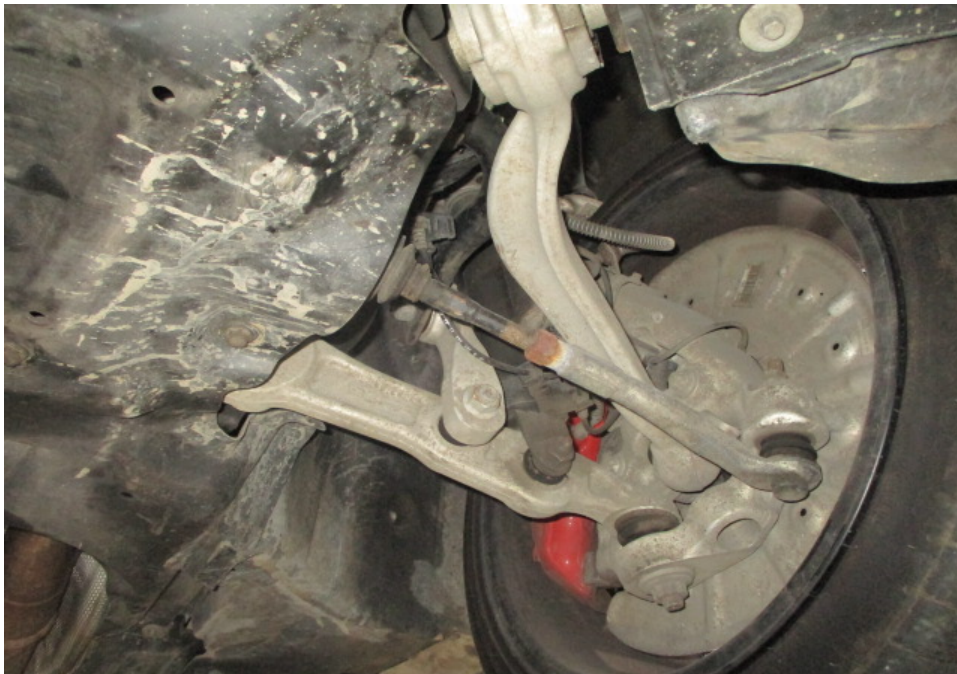
**Photo 21** shows the various undercarriage components at the front left wheel of the Motor Car. The mechanical components, control arms and linkages were all found to be intact and secured in an appropriate manner.

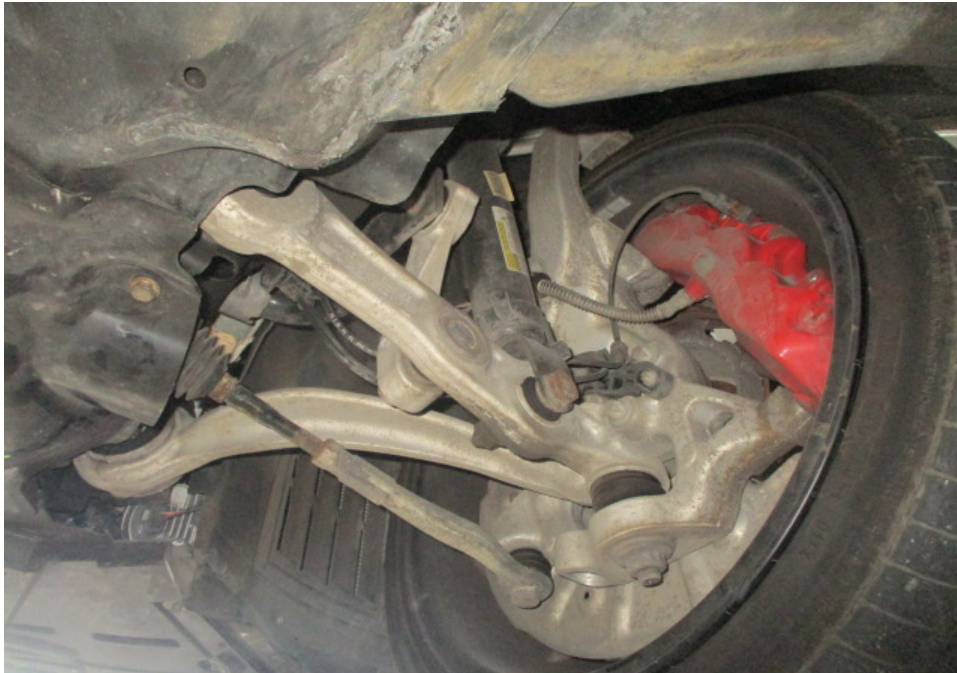
**Photo 22** shows the various undercarriage components at the front right wheel of the Motor Car. The mechanical components, control arms and linkages were all found to be intact and secured in an appropriate manner. I also did not observe any fluid leak and/or fluid stain on the underside of the Motor Car.

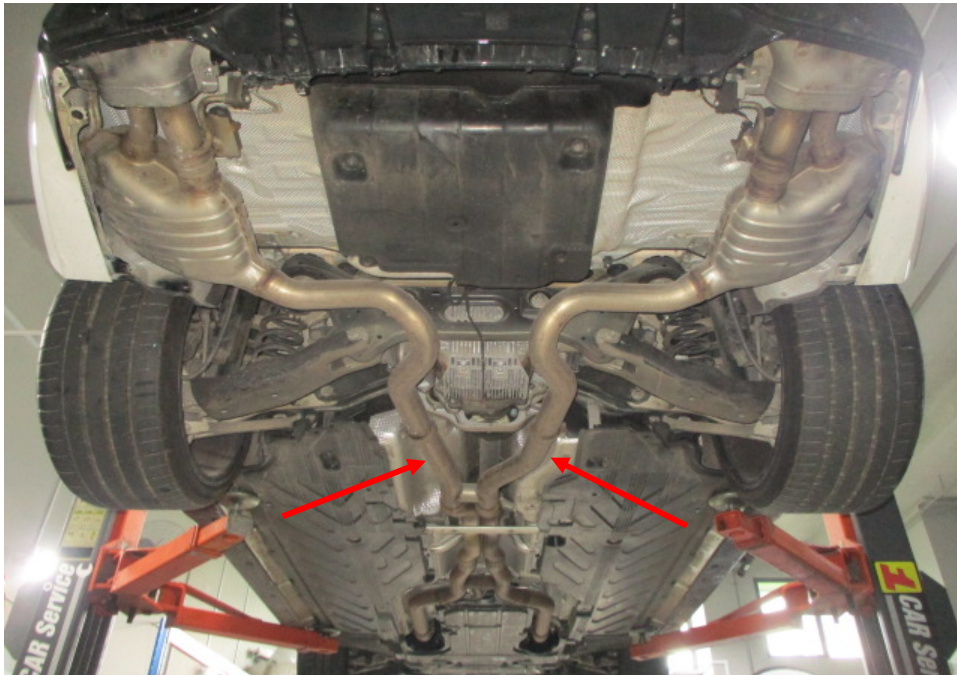
**Photo 23** shows the rear section of the Motor Car's exhaust system. My examination of the Motor Car's exhaust system revealed no sign(s) or indication(s) of any cut or weld marks along its exhaust pipes (arrowed), on its rear mufflers and on its catalytic converters.

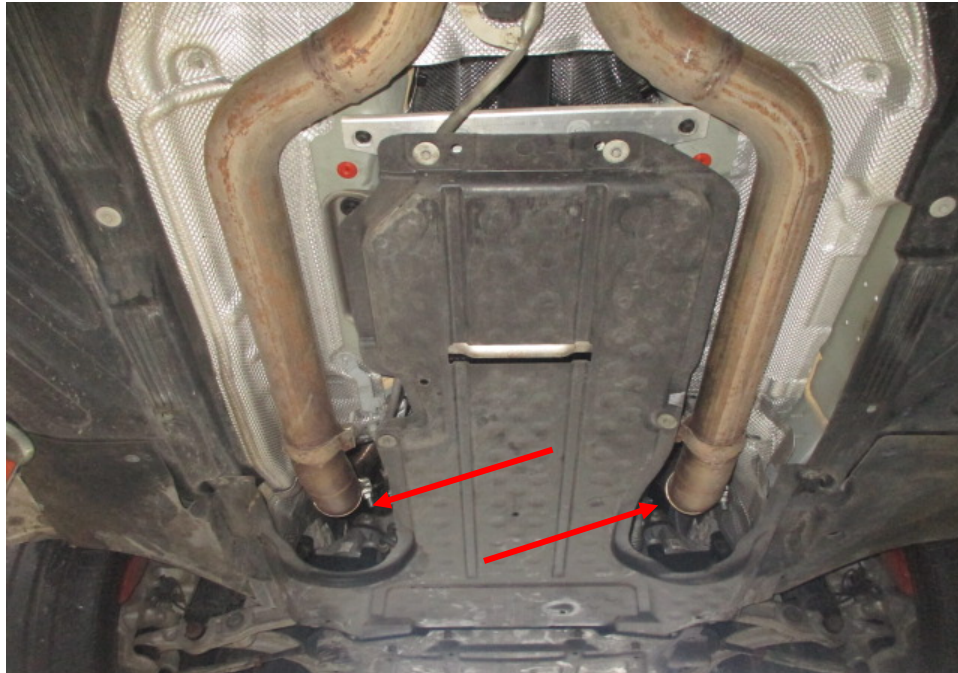
**Photo 24** shows the front section of the Motor Car's exhaust system. My examination of the Motor Car's exhaust system revealed no sign(s) or indication(s) of any cut or weld marks along its exhaust pipes, on its rear mufflers, and on its catalytic converters (arrowed).

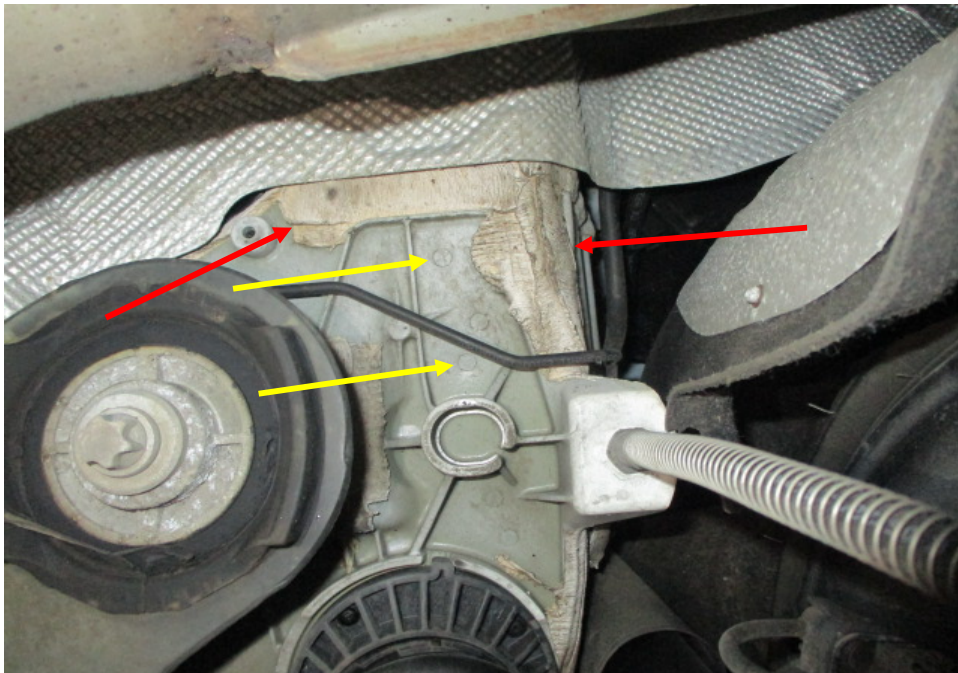
**Photo 25** shows the chassis/structural body at the underside rear right of the Motor Car. I did not find any weld marks other than original spot weld marks (yellow arrow) on the chassis/structural body of the Motor Car. The original factory sealant (red arrow) at the joints along the chassis/structural body was untouched, indicating no work was done on the chassis/structural body of the Motor Car and that the chassis/structural body was originally fitted.

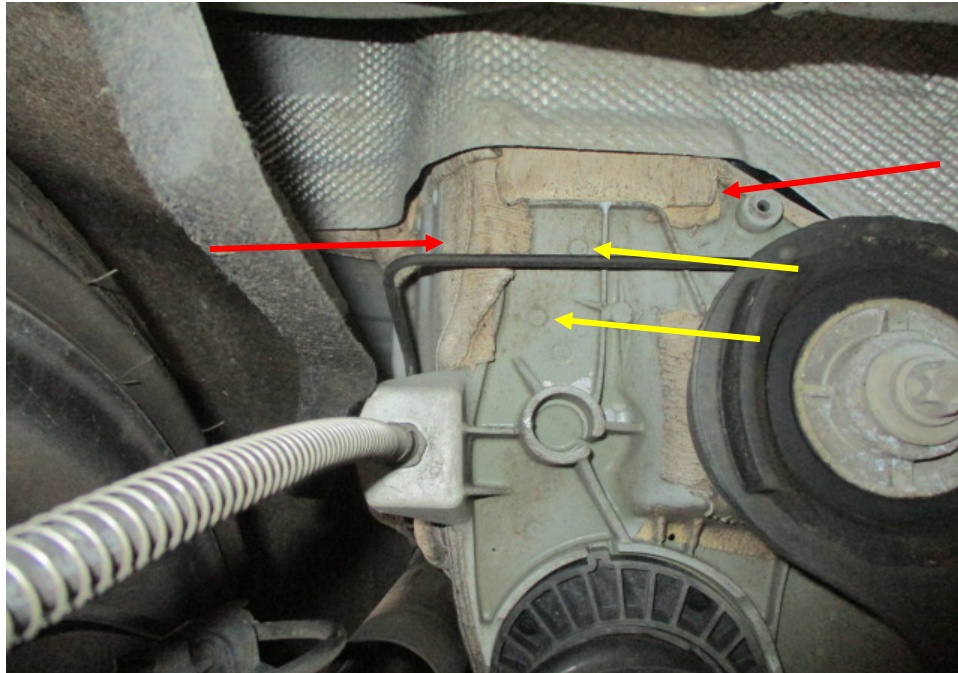
**Photo 26** shows the chassis/structural body at the underside rear left of the Motor Car. I did not find any weld marks other than original spot weld marks (yellow arrow) on the chassis/structural body of the Motor Car. The original factory sealant (red arrow) at the joints along the chassis/structural body was untouched, indicating no work was done on the chassis/structural body of the Motor Car and that the chassis/structural body was originally fitted.

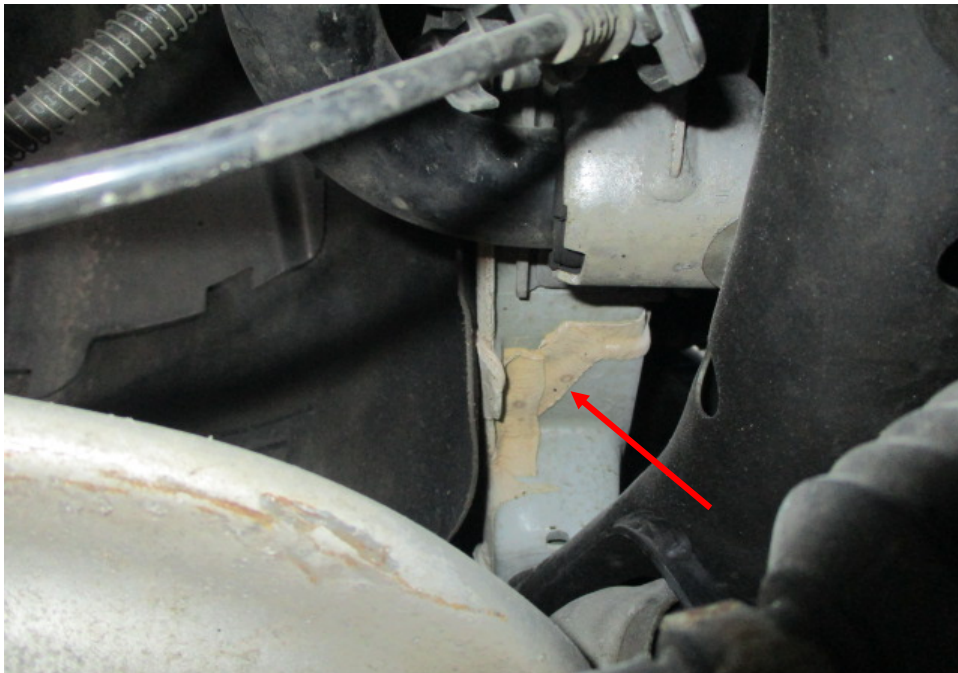
**Photo 27** shows the chassis/structural body at the underside front left of the Motor Car. The original factory sealant (arrowed) at the joints along the chassis/structural body was observed to be untouched. In general, I had found no work was carried out on the chassis/structural body of the Motor Car. The chassis/structural body of the Motor Car was originally fitted.

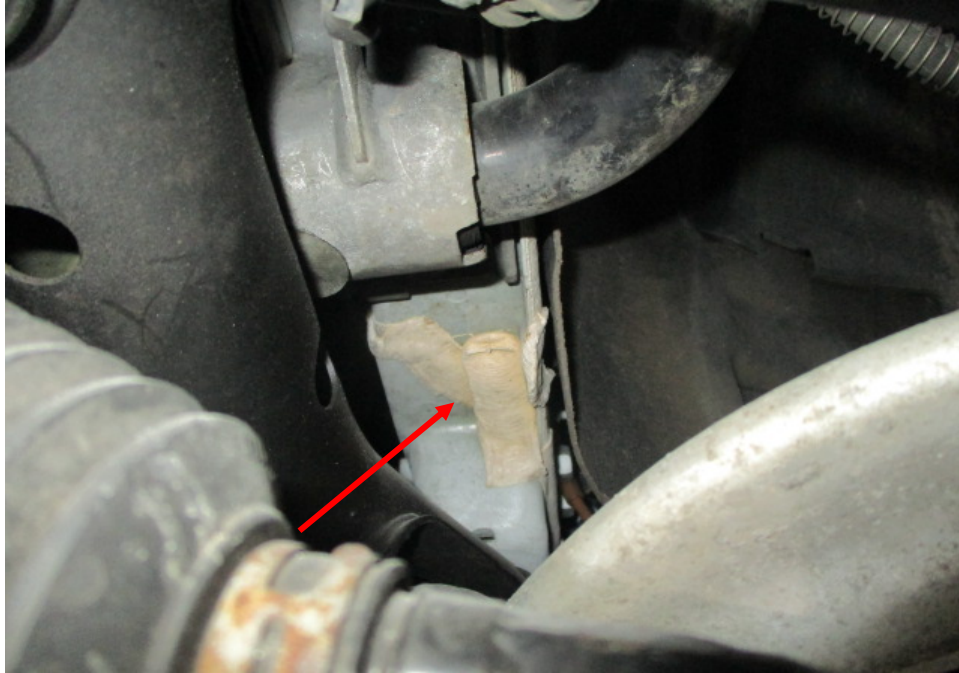
**Photo 28** shows the chassis/structural body at the underside front right of the Motor Car. The original factory sealant (arrowed) at the joints along the chassis/structural body was observed to be untouched. In general, I had found no work was carried out on the chassis/structural body of the Motor Car. The chassis/structural body of the Motor Car was originally fitted.

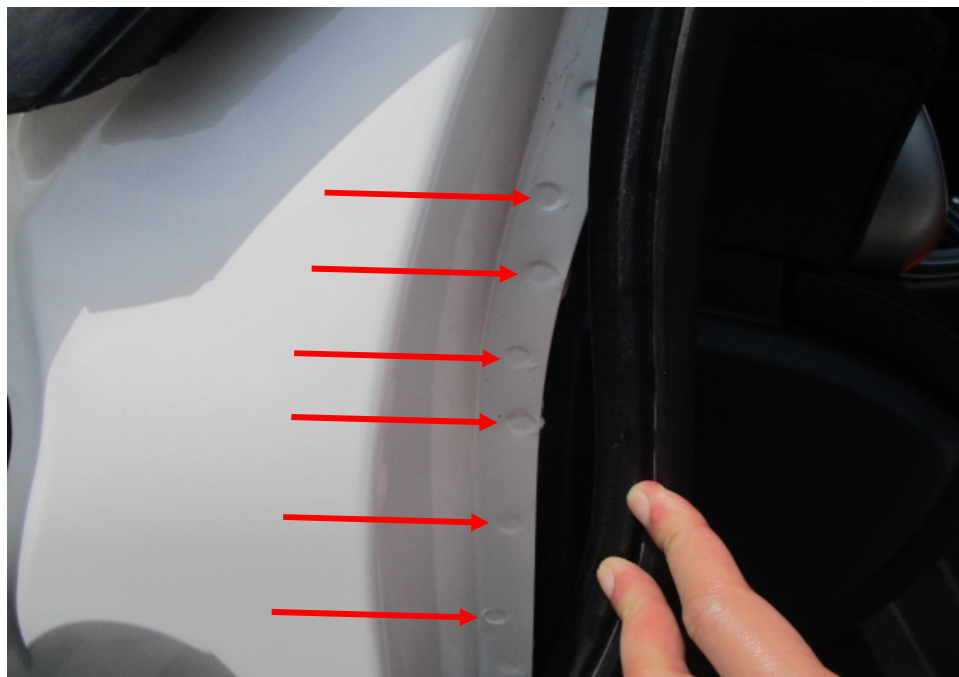
**Photo 29** shows the left side "A" pillar of the Motor Car. I did not find any weld marks other than original spot weld marks (arrowed) on the left side "A" pillar of the Motor Car which, indicates that there was no re-welding works carried out. In general, I had found all the non-detachable body panels of the Motor Car to be originally fitted at the time of my inspection.

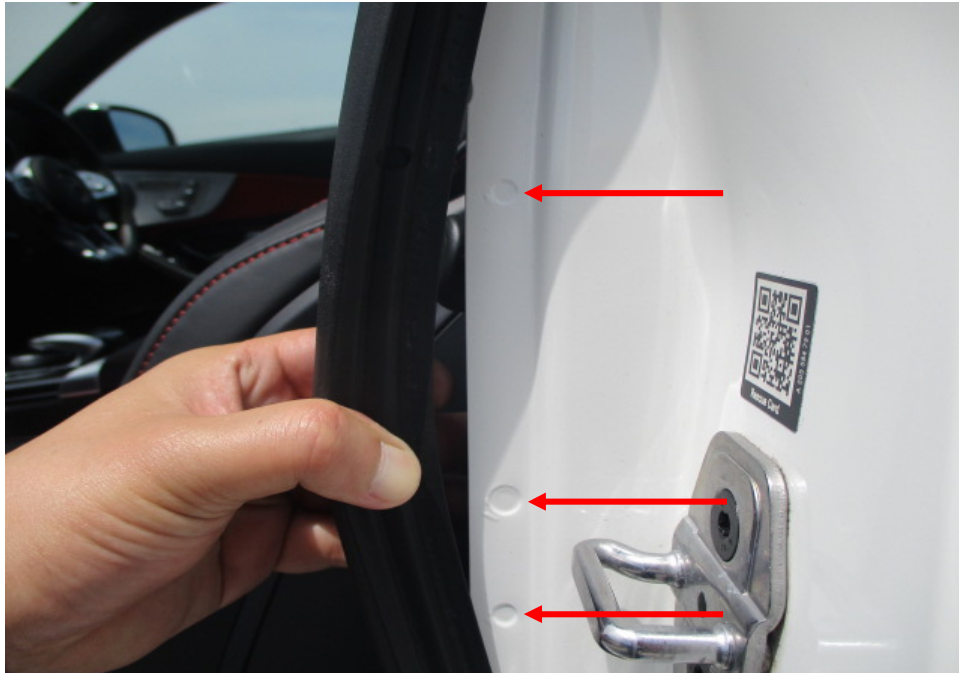
**Photo 30** shows the left rear body panel of the Motor Car. I did not find any weld marks other than original spot weld marks (arrowed) on the left rear body panel of the Motor Car, which indicates that there was no re-welding works carried out. In general, I had found all the non-detachable body panels of the Motor Car to be originally fitted at the time of my inspection.

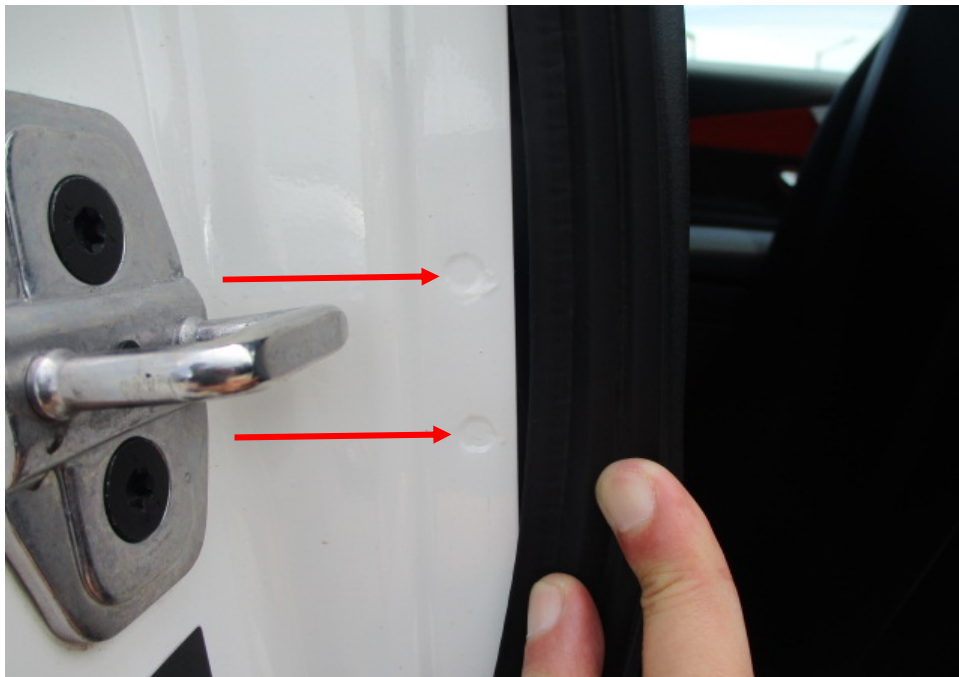
**Photo 31** shows the right rear body panel of the Motor Car. I did not find any weld marks other than original spot weld marks (arrowed) on the right rear body panel of the Motor Car, which indicates that there was no re-welding works carried out. In general, I had found all the non-detachable body panels of the Motor Car to be originally fitted at the time of my inspection.
