Your Ref: Mercedes Benz C63 Coupe  
(chassis number WDD2053872F950728)  
Our Ref : CI/TP22004078/D

26 April 2022

**INSPECTION REPORT OF AN UNREGISTERED MERCEDES BENZ C63  
COUPE MOTOR CAR WITH CHASSIS NUMBER WDD2053872F950728**

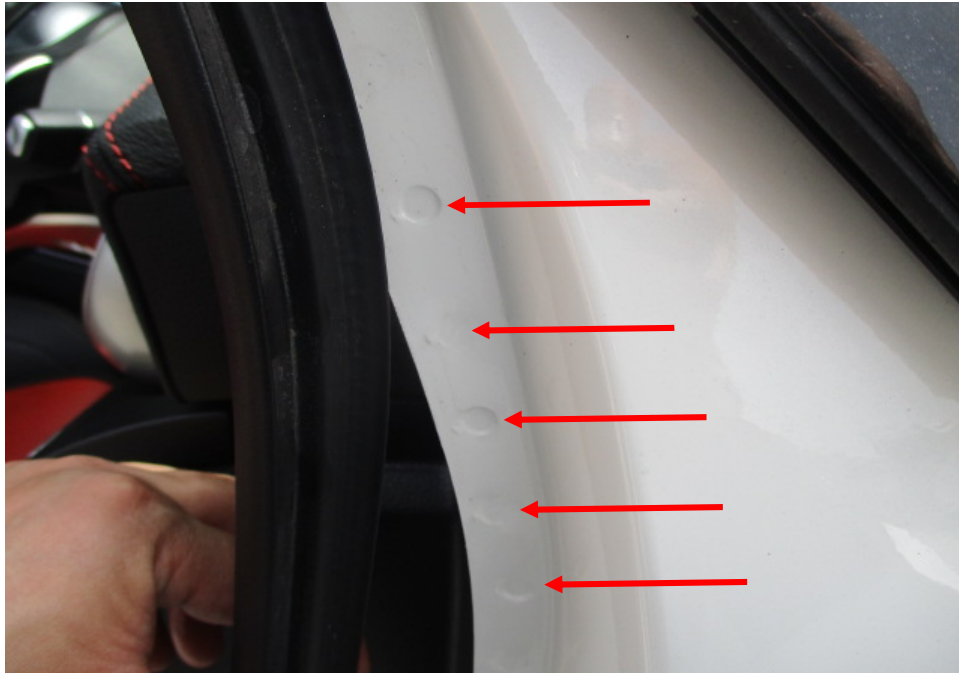
**Photo 32** shows the right side "A" pillar of the Motor Car. I did not find any weld marks other than original spot weld marks (arrowed) on the right side "A" pillar of the Motor Car which, indicates that there was no re-welding works carried out. In general, I had found all the non-detachable body panels of the Motor Car to be originally fitted at the time of my inspection.
