Your Ref: Porsche Macan  
(chassis number WP1ZZZ95ZLLB72426)  
Our Ref : CI/TP22004079/D

30 April 2022

**INSPECTION REPORT OF AN UNREGISTERED PORSCHE MACAN MOTOR CAR WITH CHASSIS NUMBER WP1ZZZ95ZLLB72426**

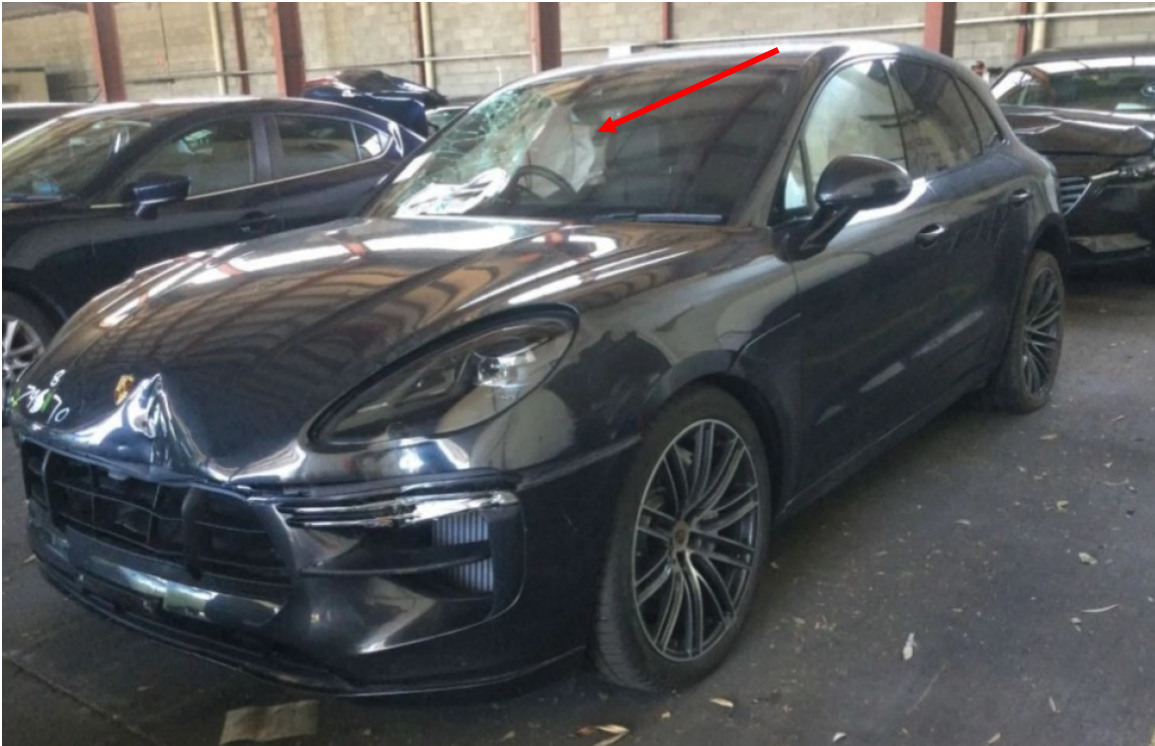
**Photo 1** shows the front left body of the Motor Car (photograph provided to me). The photographs provided to me had showed damage to the front portion of the Motor Car. The front bumper, front bumper lower lip, front bumper left grille, front bumper centre lower grille, radiator grille, front left day light and front bonnet were amongst the body parts that were observed to have been damaged. The right curtain airbag (arrowed) was deployed.

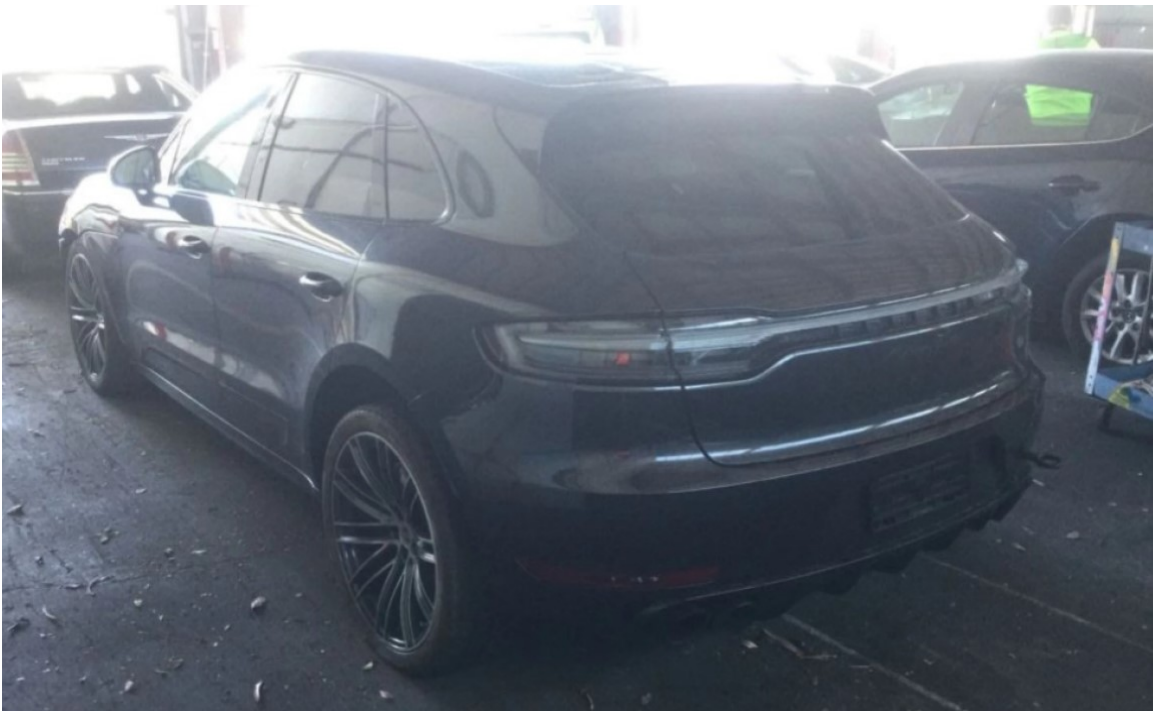
**Photo 2** shows the rear left body of the Motor Car (photograph provided to me). Apart for the front portion, there was no physical damage observed to other areas of the Motor Car.

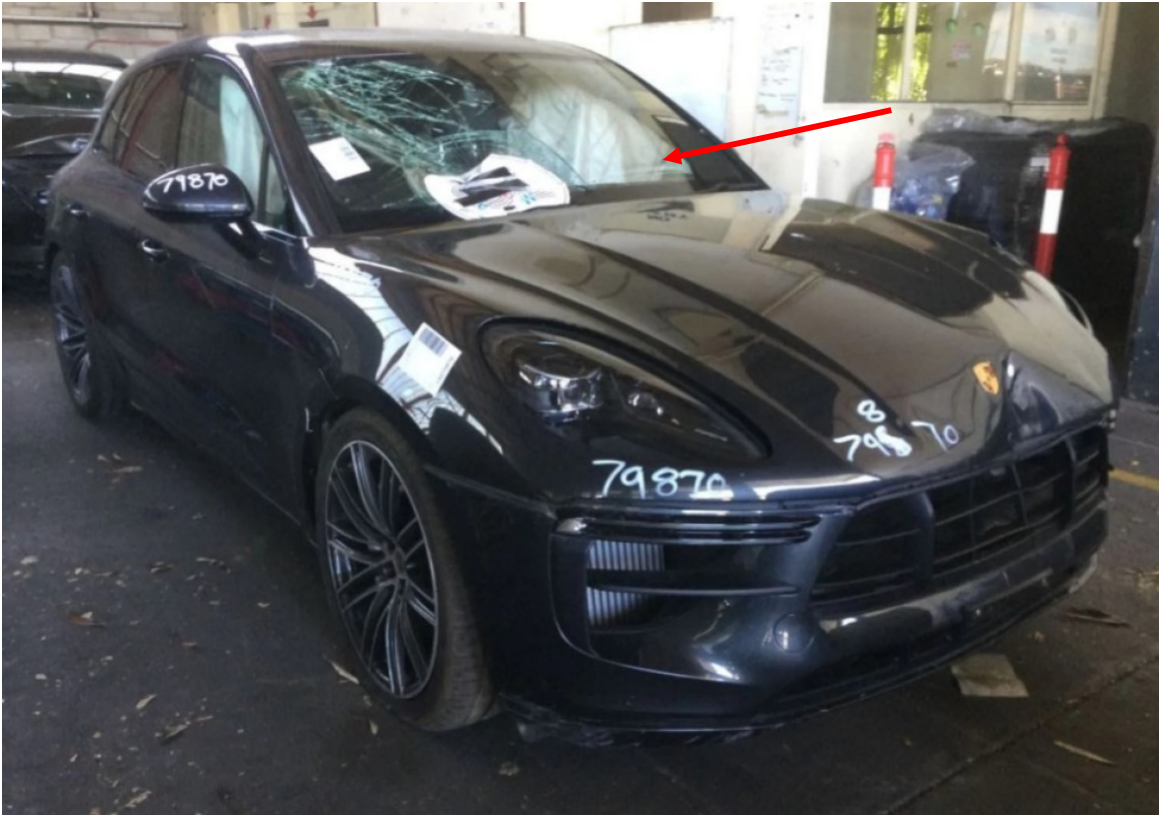
**Photo 3** shows the front right body of the Motor Car (photograph provided to me). The photographs provided to me had showed damage to the front portion of the Motor Car. The front bumper, radiator grille, front bonnet and front windscreen were amongst the body parts that were observed to have been damaged. The left curtain airbag (arrowed) was deployed.

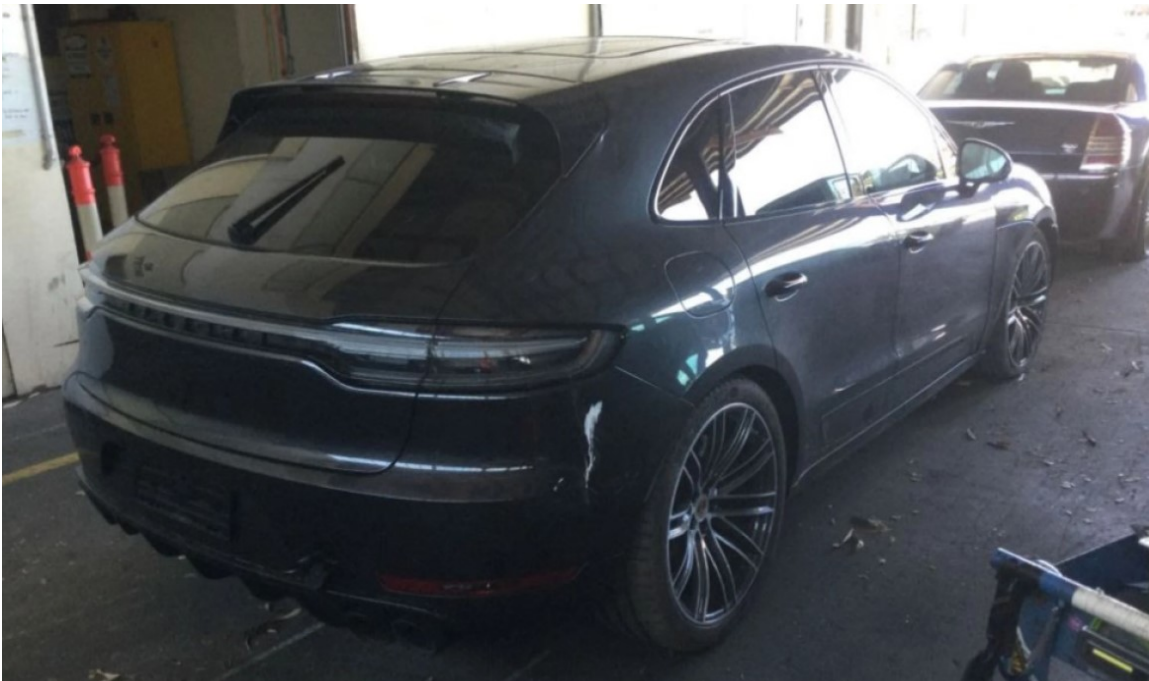
**Photo 4** shows the rear right body of the Motor Car (photograph provided to me). Apart for the front portion, there was no physical damage observed to other areas of the Motor Car.

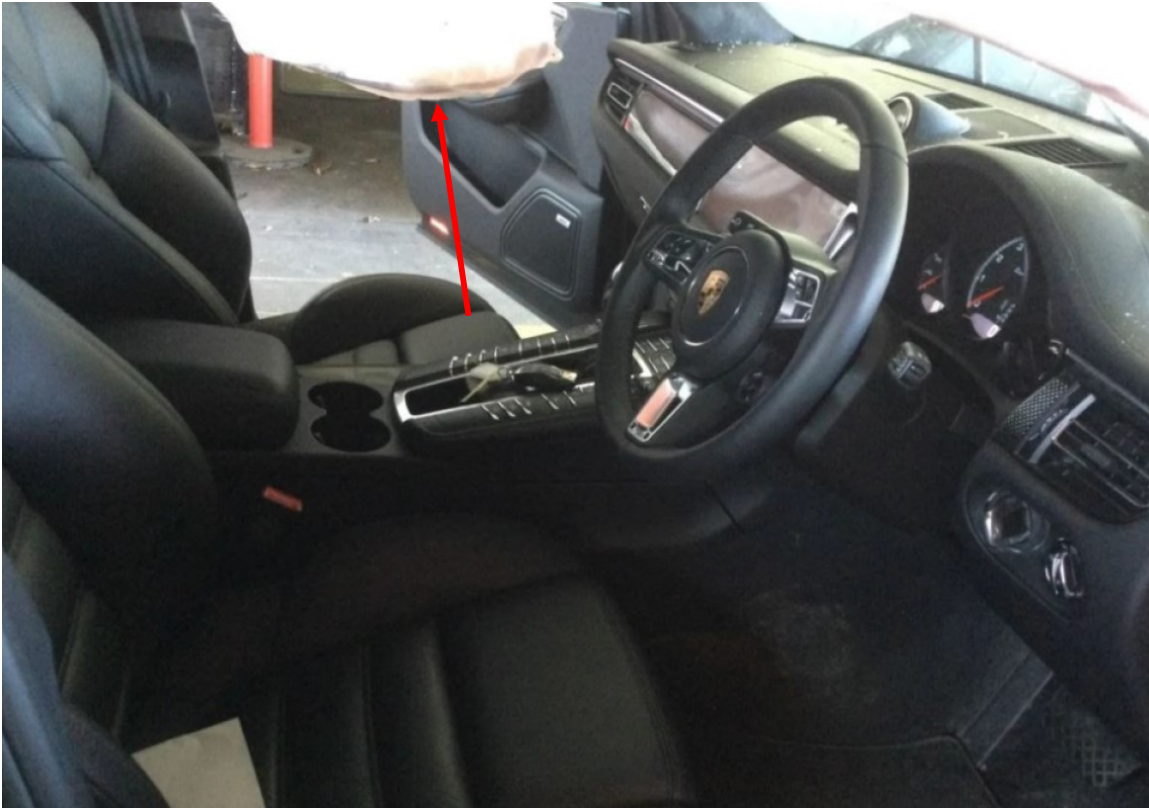
**Photo 5** shows the interior compartment of the Motor Car (photograph provided to me). The various parts and components within the interior compartment were all intact and unaffected. The left curtain airbag (arrowed) and right curtain airbag were deployed as seen from the photographs that were provided to me.

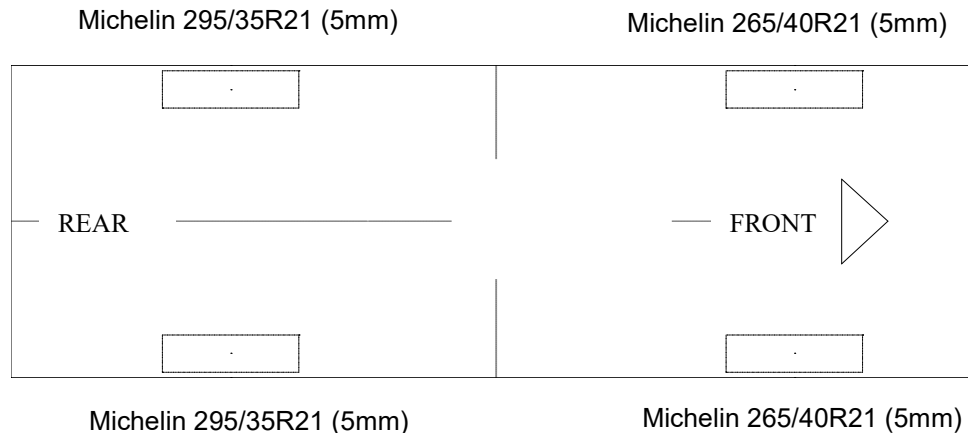
8. The Motor Car was fitted with 21inch sport wheel rims that were wrapped with tyres that were observed to be of serviceable condition. The tyres were also sufficiently inflated for vehicular operation. The tyre brand, tyre size and approximate remaining tread depth of the 4 tyres of the Motor Car were recorded as follows: -

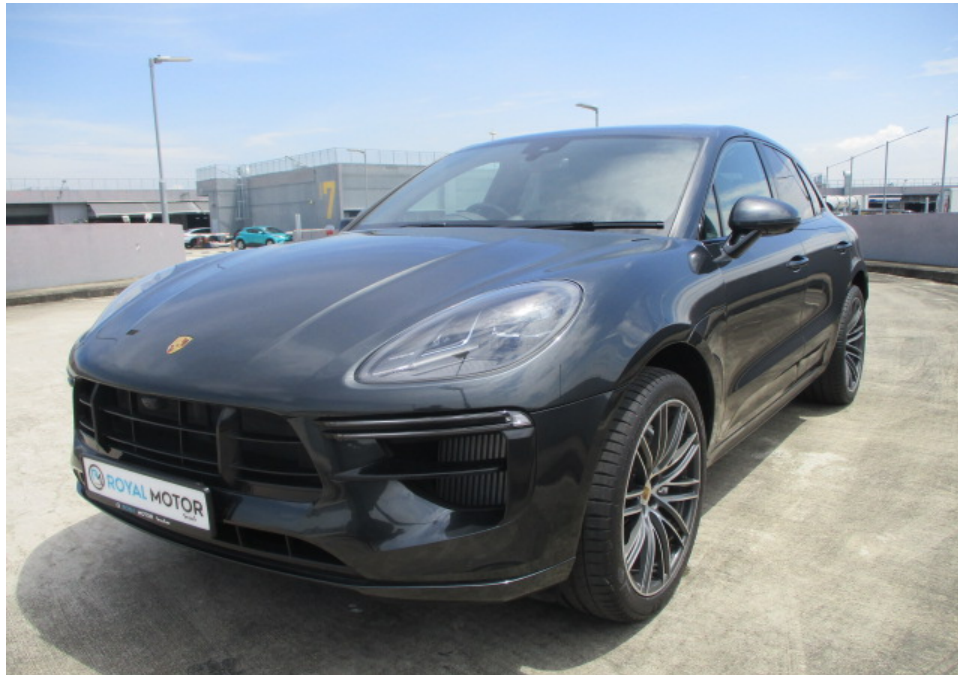
**Photo 6** shows a general view of the front left body of the Motor Car at the time of my inspection. The Motor Car was observed to be in a relatively good general condition with no loose exterior fittings observed. The body parts at the front portion of the Motor Car were visually examined and it was observed that the repair/restoration works carried out to the damaged area of the Motor Car (refer to photograph 1 & 3 above) were reasonably adequate and in order.

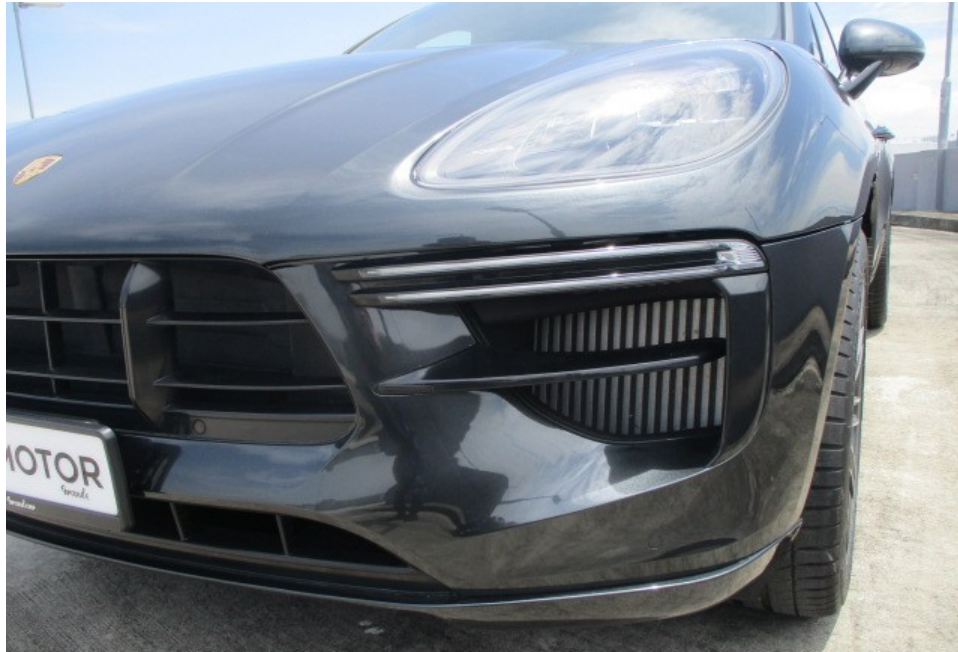
**Photo 7** shows a closer view of the Motor Car's front bumper, front bumper lower lip, front bumper left grille, front left day light and front left headlamp. The body parts at the front portion of the Motor Car were visually examined and it was observed that the repair/restoration works carried out to the damaged area of the Motor Car (refer to photograph 1 & 3 above) were reasonably adequate and in order.

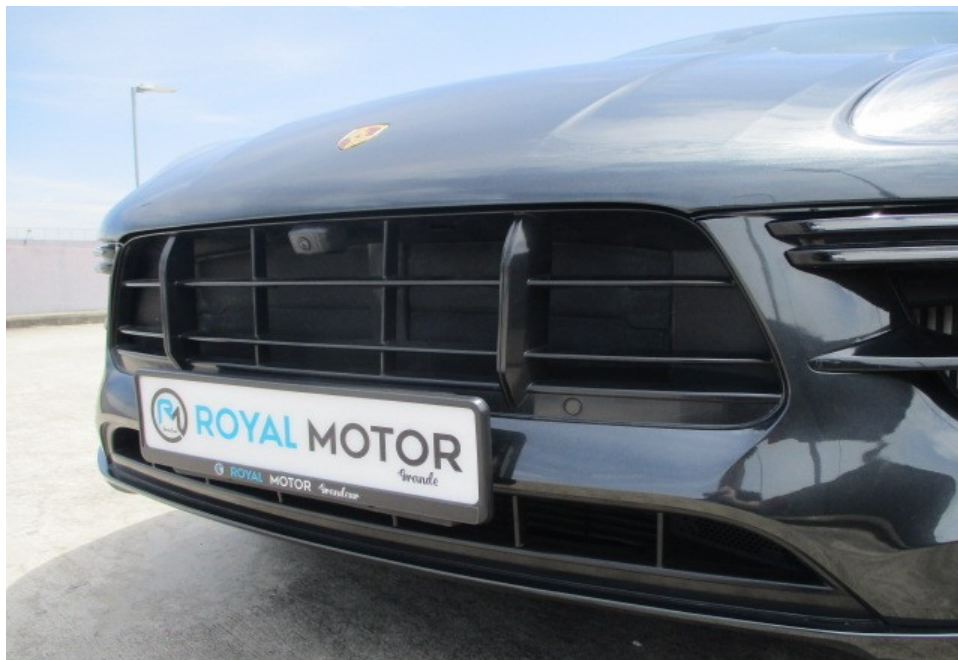
**Photo 8** shows a closer view of the Motor Car's front bumper, front bumper lower lip, front bumper centre lower grille, radiator grille and front sensor. The body parts at the front portion of the Motor Car were visually examined and it was observed that the repair/restoration works carried out to the damaged area of the Motor Car (refer to photograph 1 & 3 above) were reasonably adequate and in order.

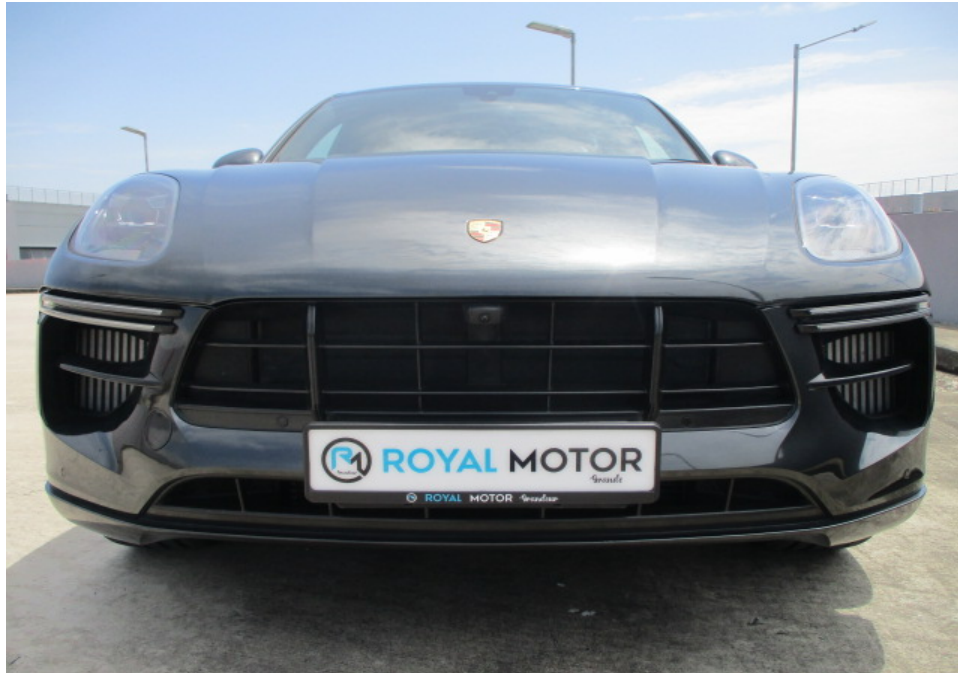
**Photo 9** shows a closer view of the Motor Car's front portion at the time of my inspection. The body parts at the front portion of the Motor Car were visually examined and it was observed that the repair/restoration works carried out to the damaged area of the Motor Car (refer to photograph 1 & 3 above) were reasonably adequate and in order.

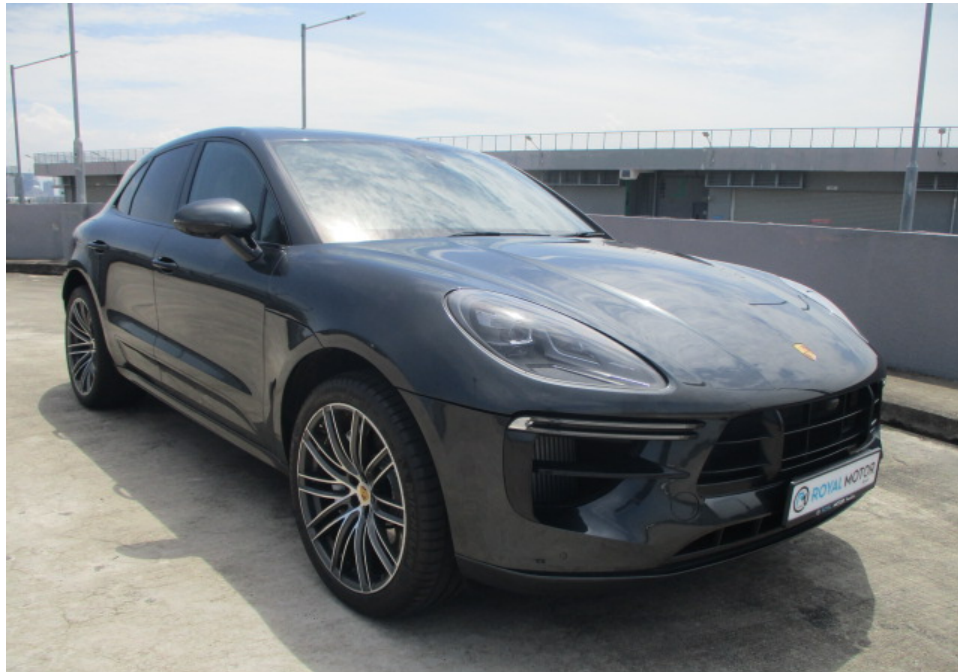
**Photo 10** shows a general view of the front right body of the Motor Car at the time of my inspection. The Motor Car was observed to be in a relatively good general condition with no loose exterior fittings observed. The mileage of the Motor Car recorded at the time of my inspection was 1,596km.

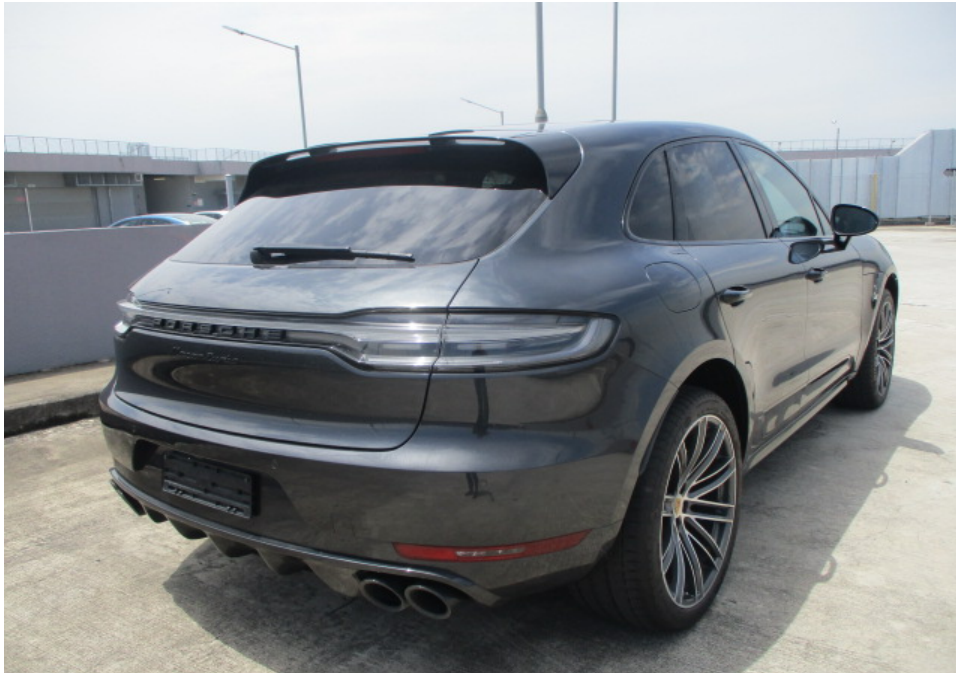
**Photo 11** shows a general view of the rear right body of the Motor Car at the time of my inspection. The Motor Car was observed to be in a relatively good general condition with no loose exterior fittings observed. The mileage of the Motor Car recorded at the time of my inspection was 1,596km.

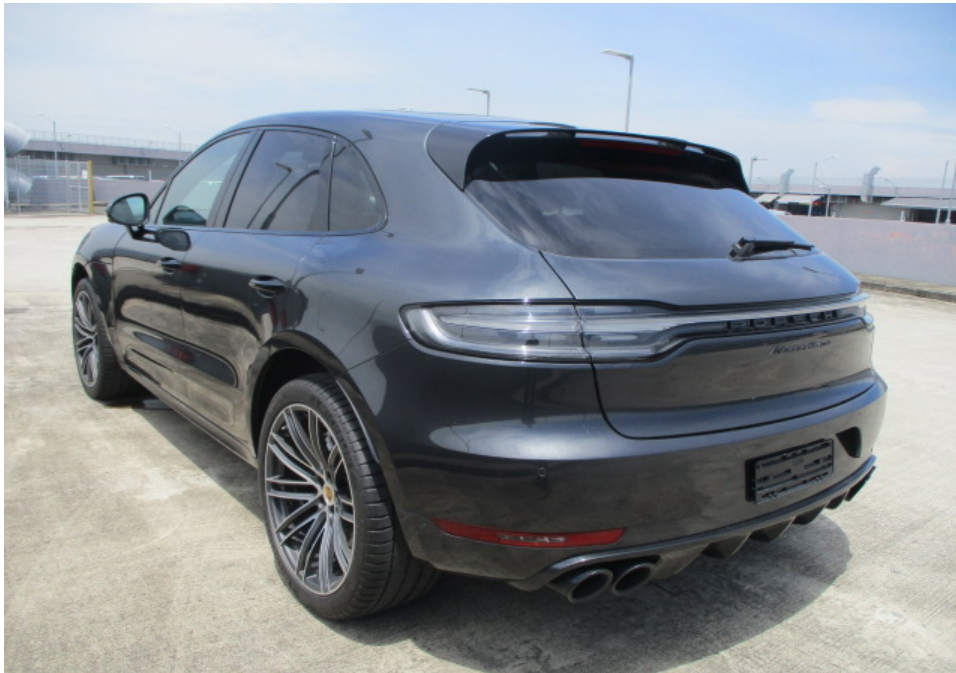
**Photo 12** shows a general view of the rear left body of the Motor Car at the time of my inspection. The Motor Car was observed to be in a relatively good general condition with no loose exterior fittings observed. The mileage of the Motor Car recorded at the time of my inspection was 1,596km.

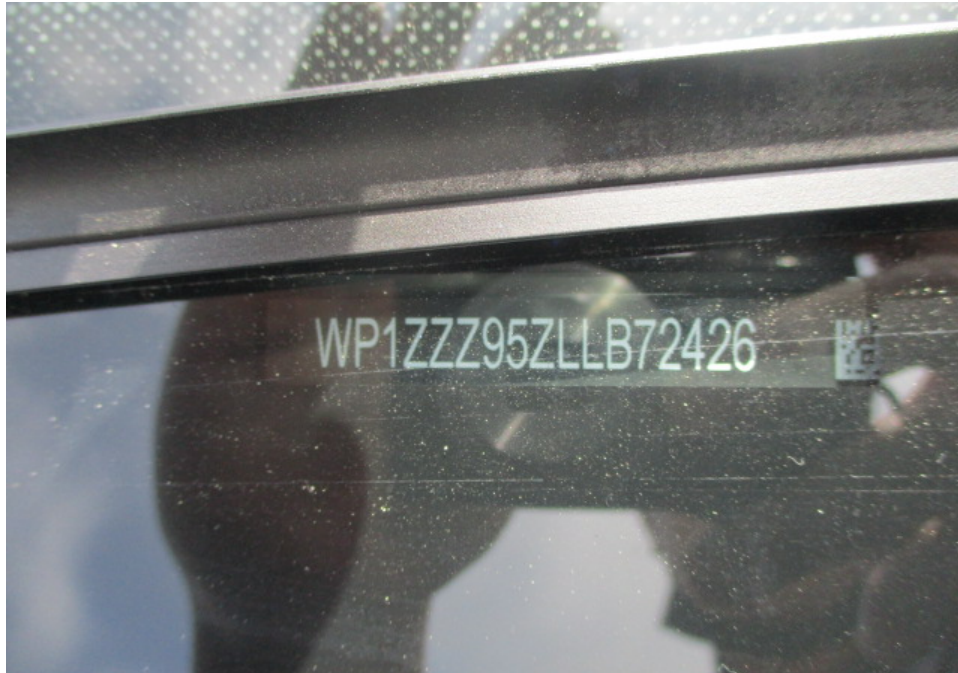
**Photo 13** shows the chassis number of the Motor Car. The chassis number recorded was WP1ZZZ95ZLLB72426.

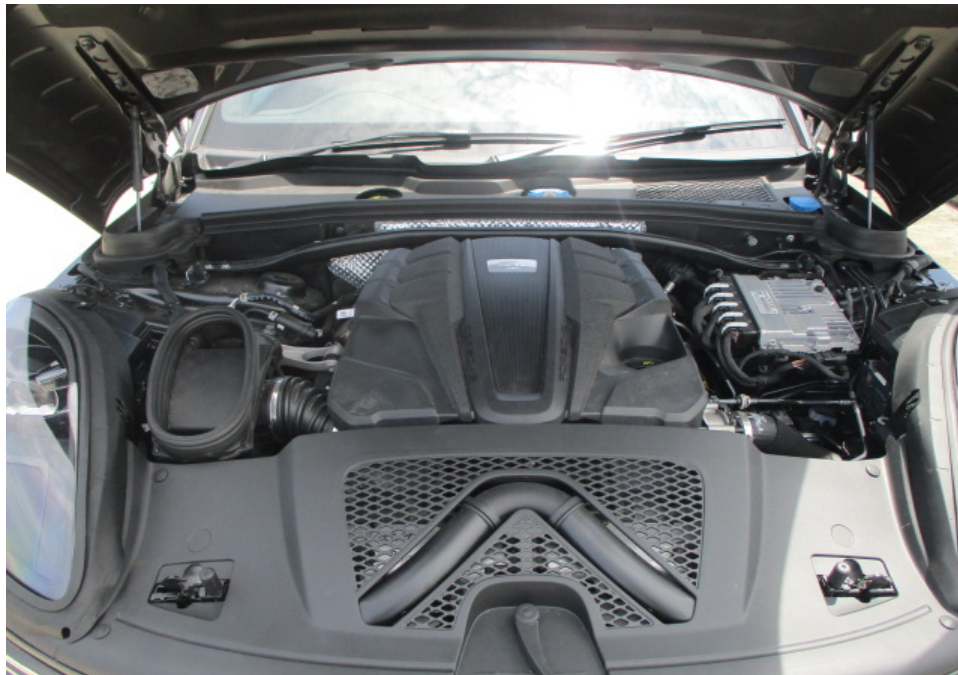
**Photo 14** shows a general view of the engine compartment of the Motor Car at the time of my inspection. The various parts and components inside the engine compartment were all observed to be intact and properly fitted. There was also no sign(s) or indication(s) of fluid leak and/or fluid stain found inside the engine compartment.

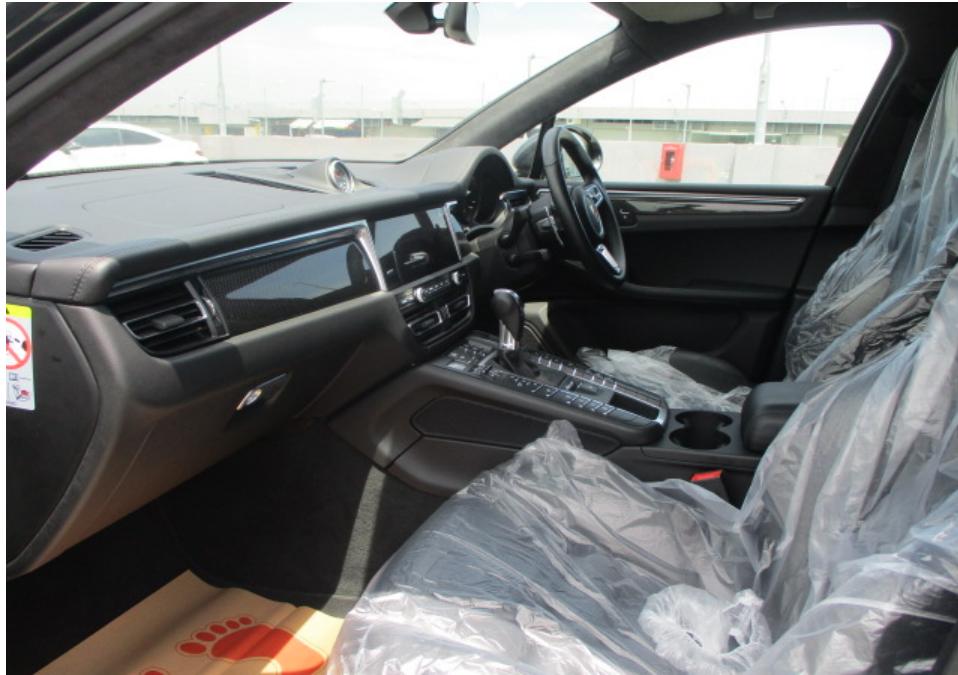
**Photo 15** shows the interior compartment of the Motor Car at the time of my inspection. The various parts and components, trims, carpet, and upholstery inside the interior compartment were all observed to be intact and properly fitted.

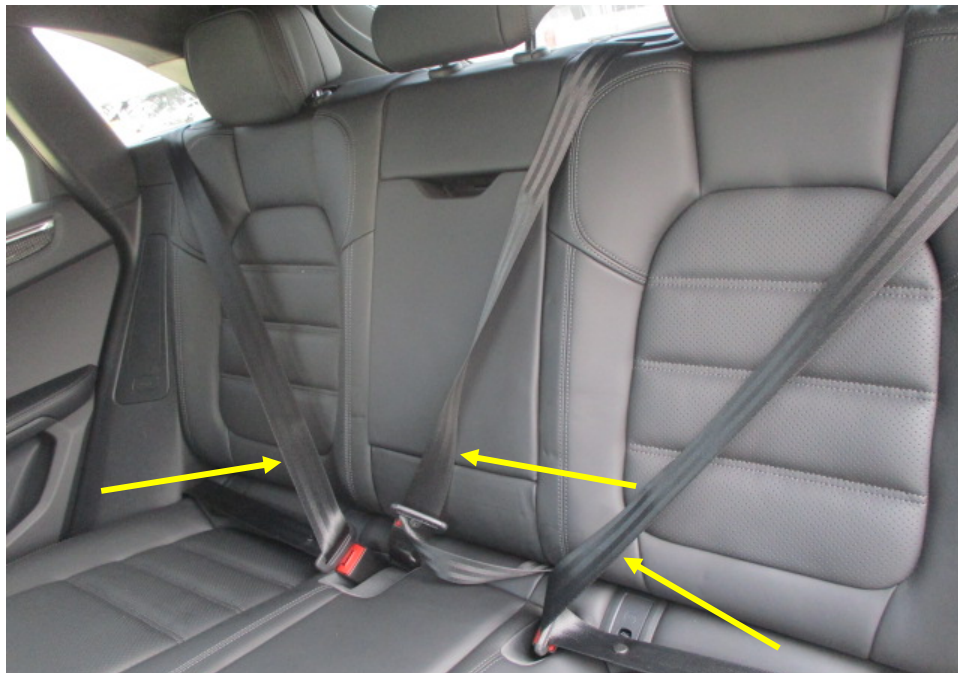
**Photo 16** shows the rear seats of the Motor Car. All the seats of the Motor Car were secured via seat rails to the floorboard. They were also fitted with a retractable seat belt reel and a pre-tensioner. The seat belts (arrowed) were tested and were able to be fastened into the respective pre-tensions that were fitted on the side of each individual seat.

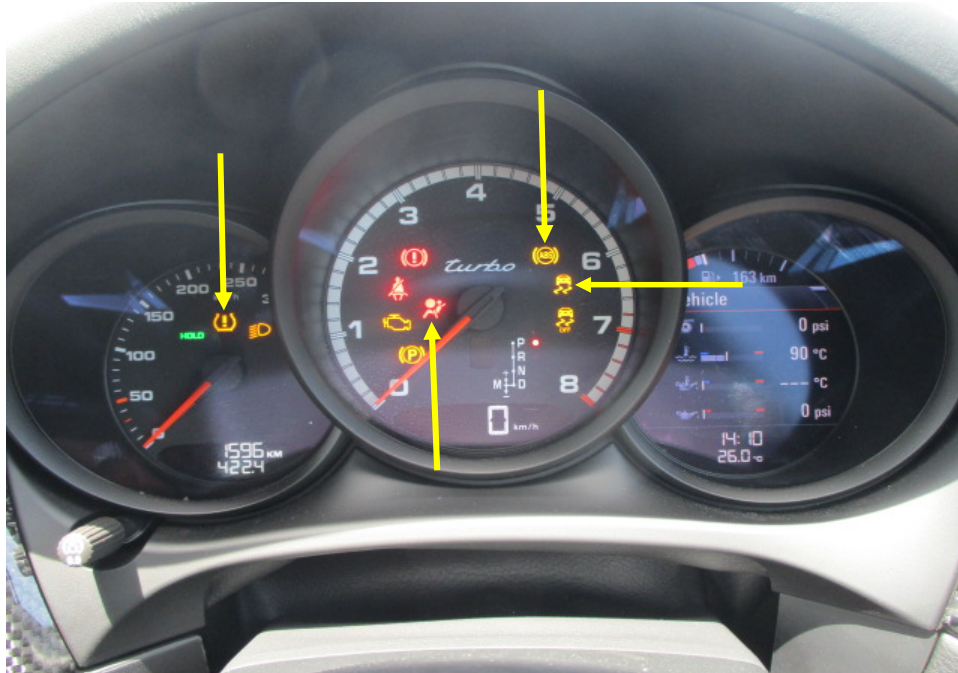
**Photo 17** shows the warning lights for the various electronic safety features appearing on the instrument panel of the Motor Car during its self-test when the engine is cranked, in particular the ABS, SRS, TPM and TCS lights (arrowed).

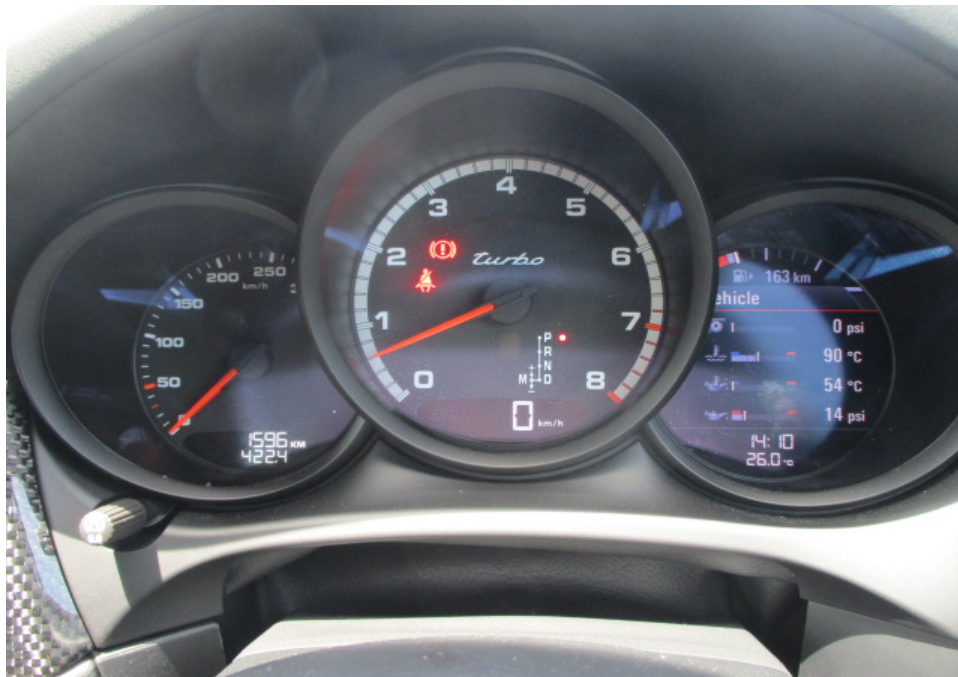
**Photo 18** shows the respective warning lights no longer illuminated, indicating that there is no fault detected to the ABS, SRS, TPM and TCS systems of the Motor Car during the self-test. These electronic systems were hence in working condition at the time of my inspection.

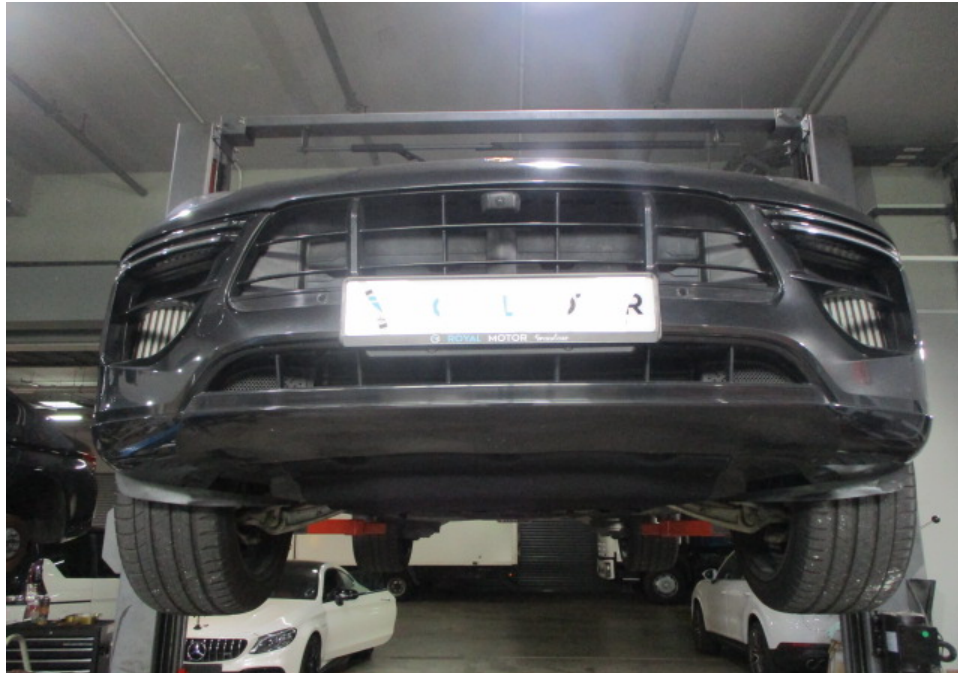
**Photo 19** shows the Motor Car hoisted up for checks on its undercarriage. There was no sign(s) or indication(s) of fluid leakage and/or fluid stain(s) on the underside of the Motor Car. The undercarriage components of the Motor Car were also all observed to be intact and secured in an appropriate manner.

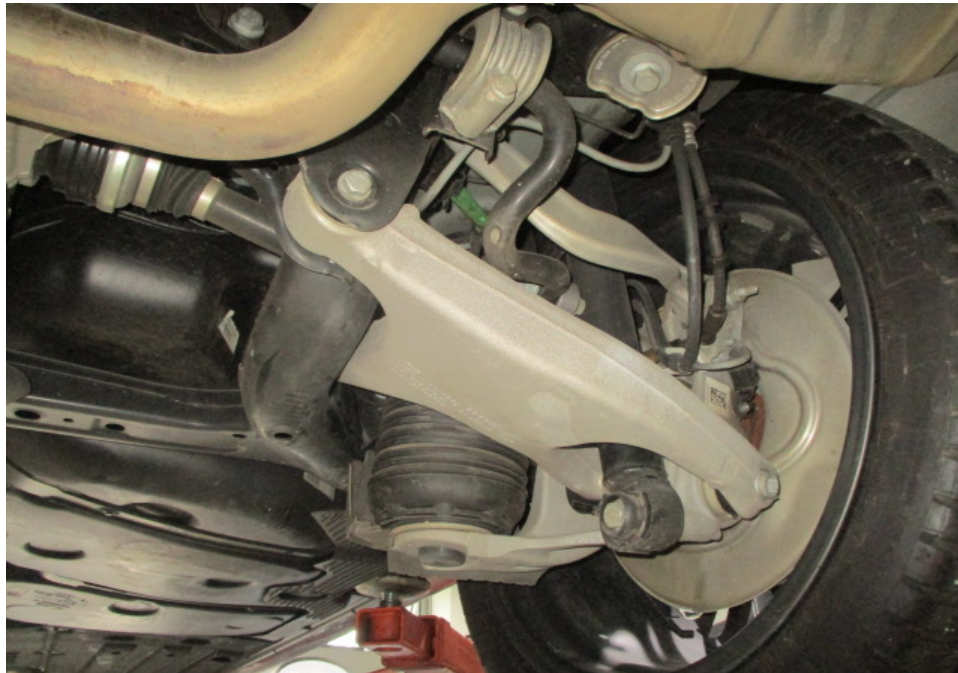
**Photo 20** shows a general view of the control arms and linkages at the rear right wheel of the Motor Car. I did not observe any fluid leak and/or fluid stain on the underside of the Motor Car. All of the Motor Car's undercarriage components were observed to be intact and secured in an appropriate manner.

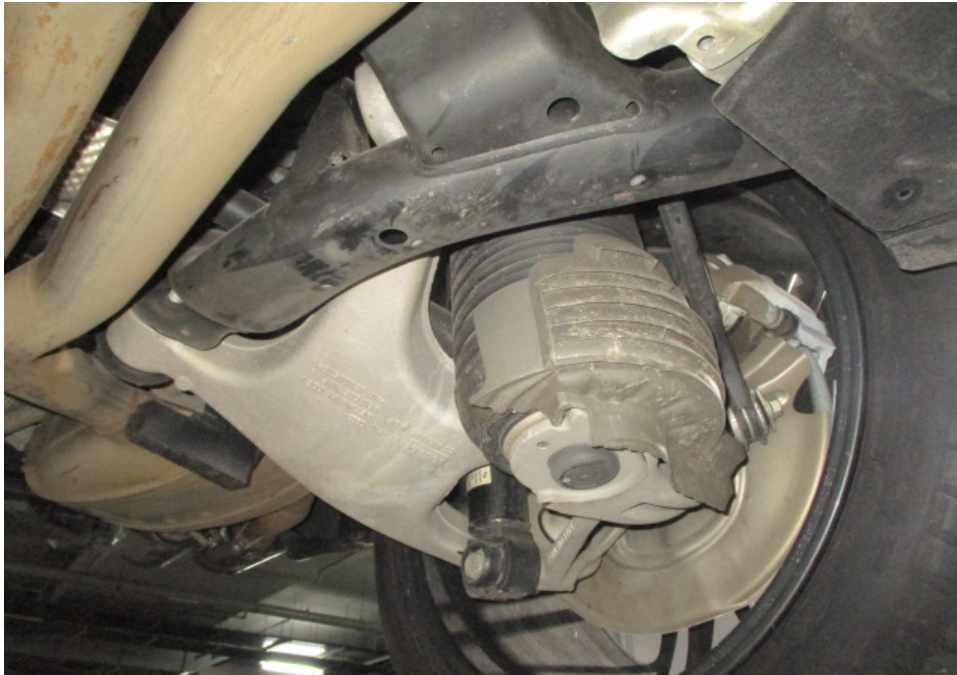
**Photo 21** shows a general view of the control arms and linkages at the rear left wheel of the Motor Car. I did not observe any fluid leak and/or fluid stain on the underside of the Motor Car. All of the Motor Car's undercarriage components were observed to be intact and secured in an appropriate manner.

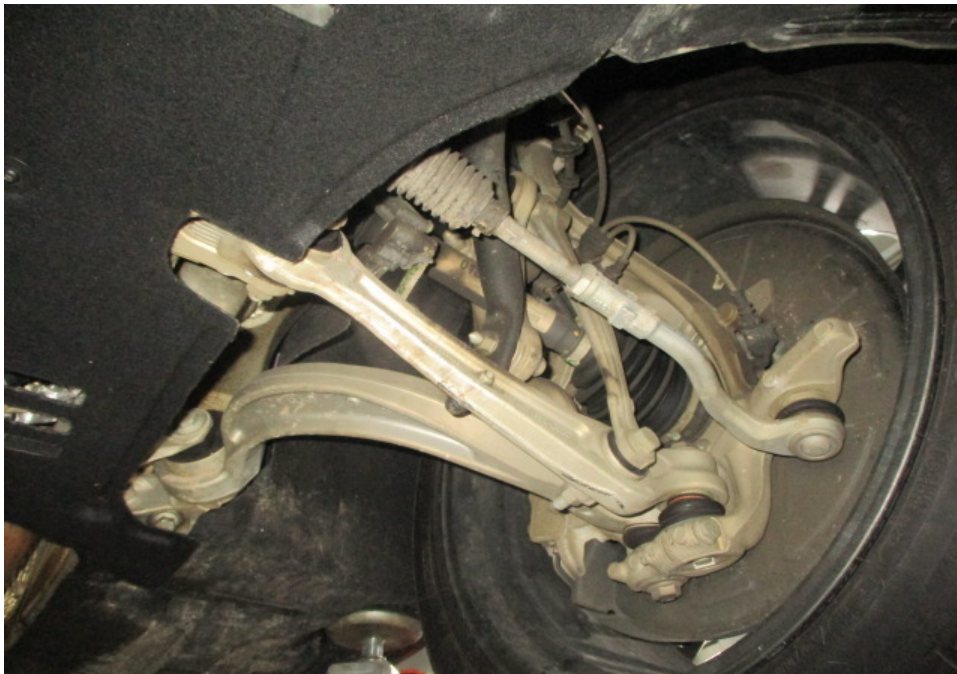
**Photo 22** shows the various undercarriage components at the front left wheel of the Motor Car. The mechanical components, control arms and linkages were all found to be intact and secured in an appropriate manner.

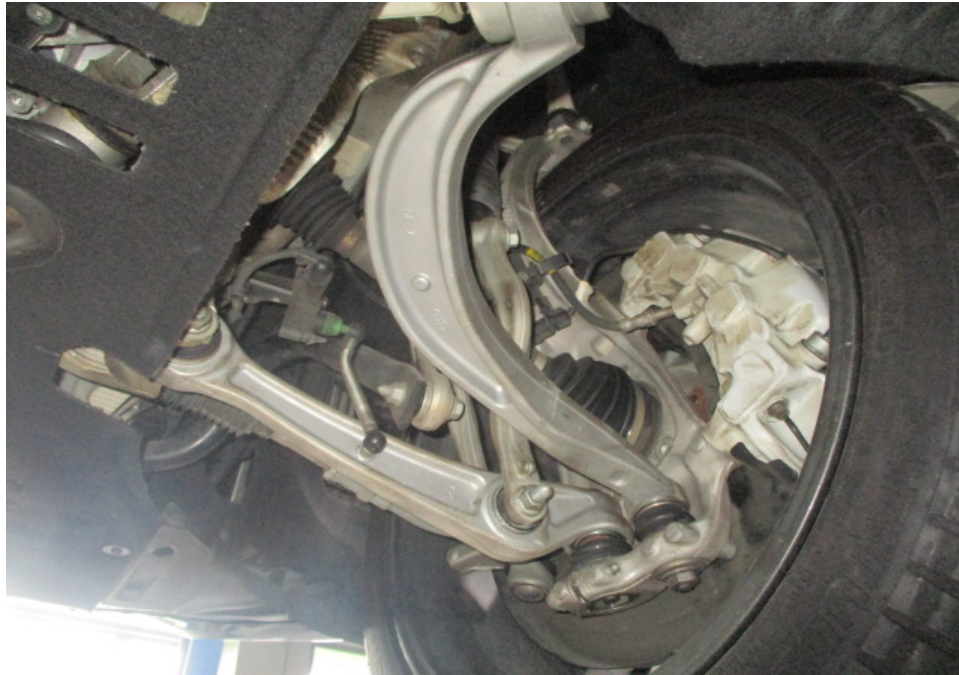
**Photo 23** shows the various undercarriage components at the front right wheel of the Motor Car. The mechanical components, control arms and linkages were all found to be intact and secured in an appropriate manner. I also did not observe any fluid leak and/or fluid stain on the underside of the Motor Car.

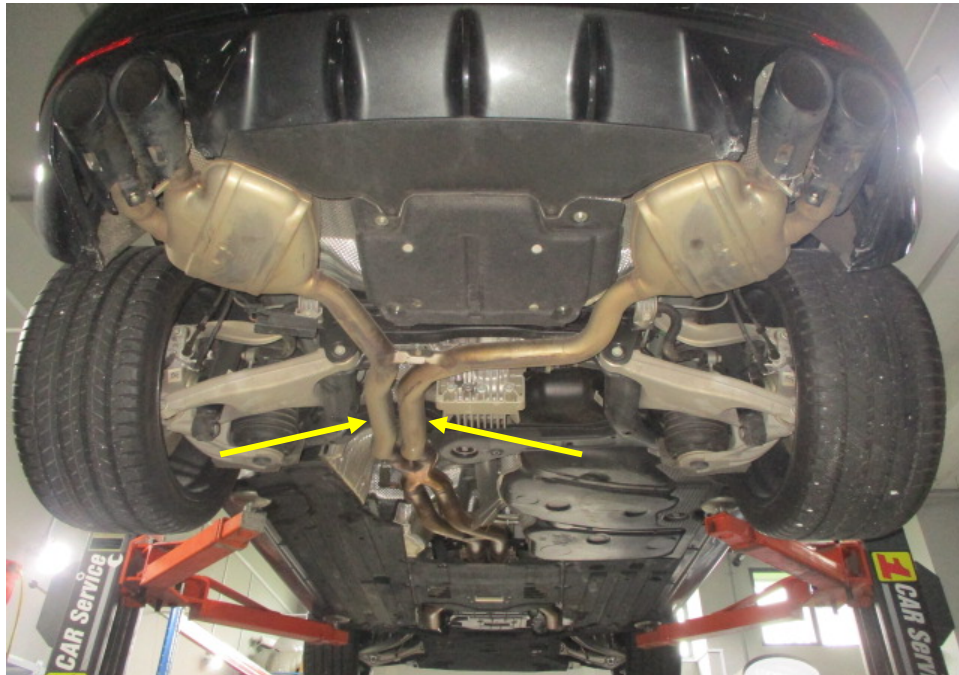
**Photo 24** shows the rear section of the Motor Car's exhaust system. My examination of the Motor Car's exhaust system revealed no sign(s) or indication(s) of any cut or weld marks along its exhaust pipes (arrowed), on its rear mufflers and on its catalytic converters.

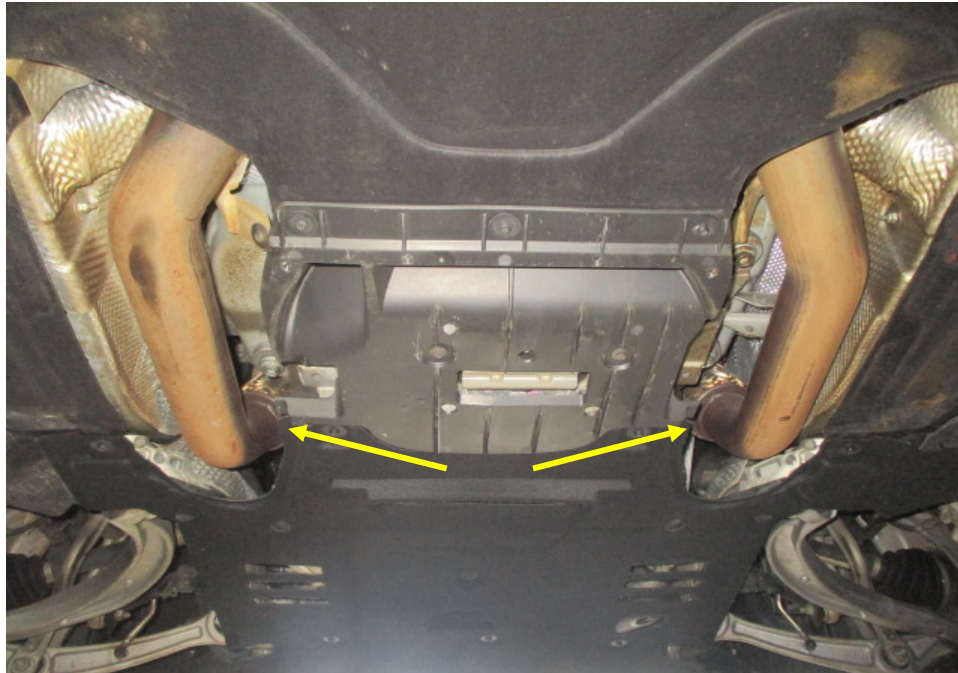
**Photo 25** shows the front section of the Motor Car's exhaust system. My examination of the Motor Car's exhaust system revealed no sign(s) or indication(s) of any cut or weld marks along its exhaust pipes, on its rear mufflers, and on its catalytic converters (arrowed).

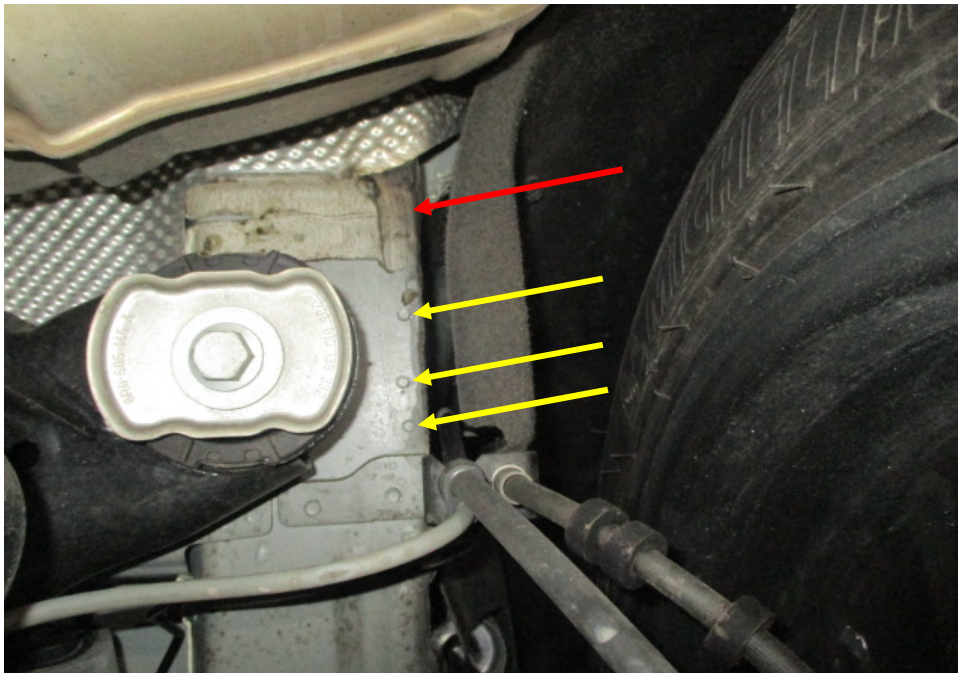
**Photo 26** shows the chassis/structural body at the underside rear right of the Motor Car. I did not find any weld marks other than original spot weld marks (yellow arrow) on the chassis/structural body of the Motor Car. The original factory sealant (red arrow) at the joints along the chassis/structural body was untouched, indicating no work was done on the chassis/structural body of the Motor Car and that the chassis/structural body was originally fitted.

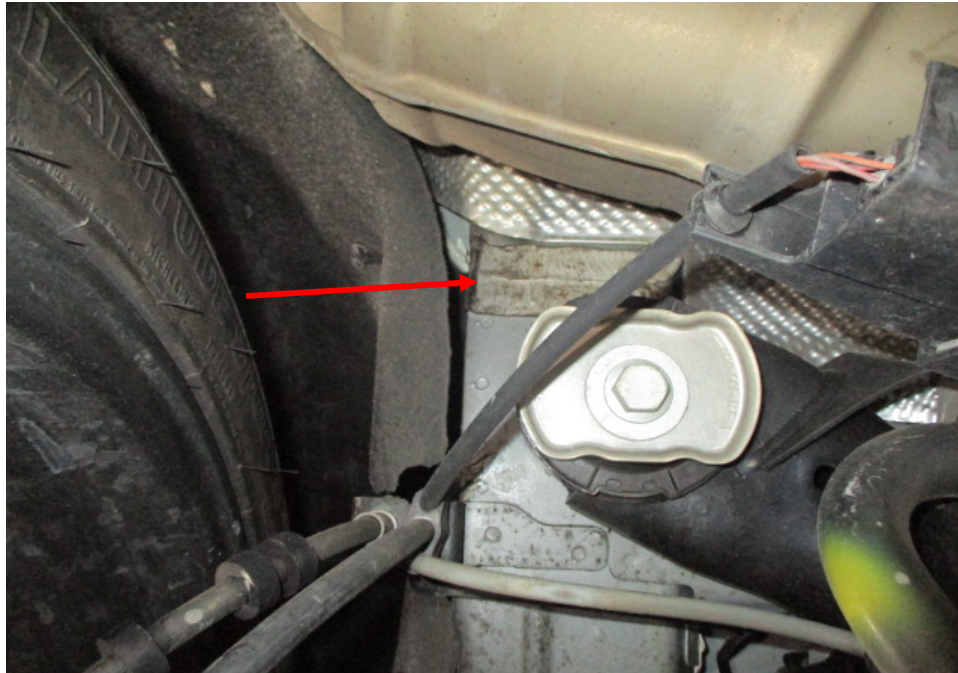
**Photo 27** shows the chassis/structural body at the underside rear left of the Motor Car. The original factory sealant (arrowed) at the joints along the chassis/structural body was observed to be untouched. In general, I had found no work was carried out on the chassis/structural body of the Motor Car. The chassis/structural body of the Motor Car was originally fitted.

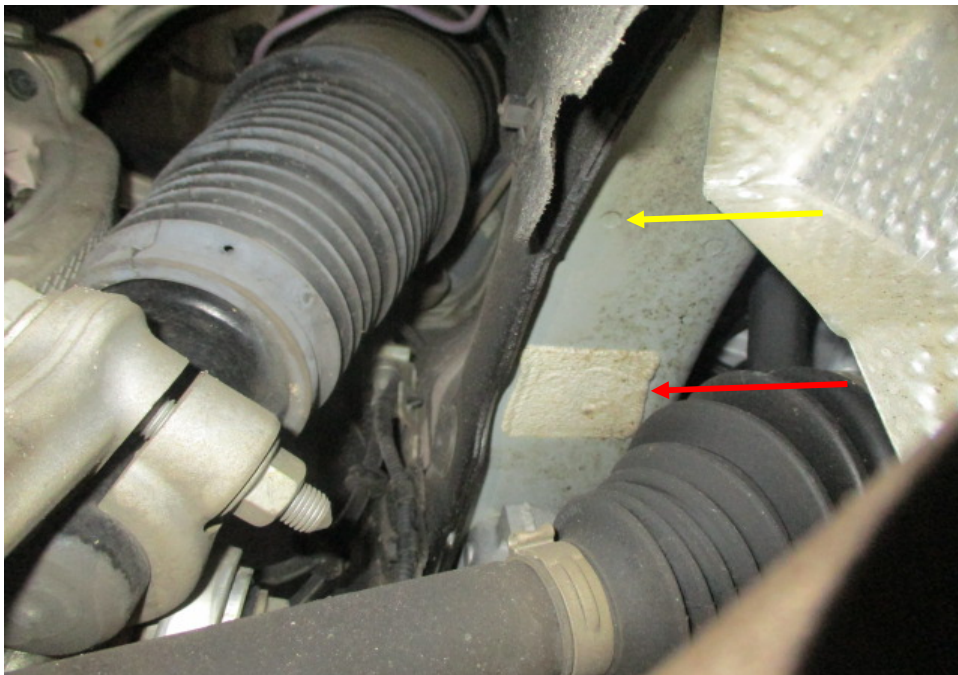
**Photo 28** shows the chassis/structural body at the underside front left of the Motor Car. I did not find any weld marks other than original spot weld marks (yellow arrow) on the chassis/structural body of the Motor Car. The original factory sealant (red arrow) at the joints along the chassis/structural body was untouched, indicating no work was done on the chassis/structural body of the Motor Car and that the chassis/structural body was originally fitted.

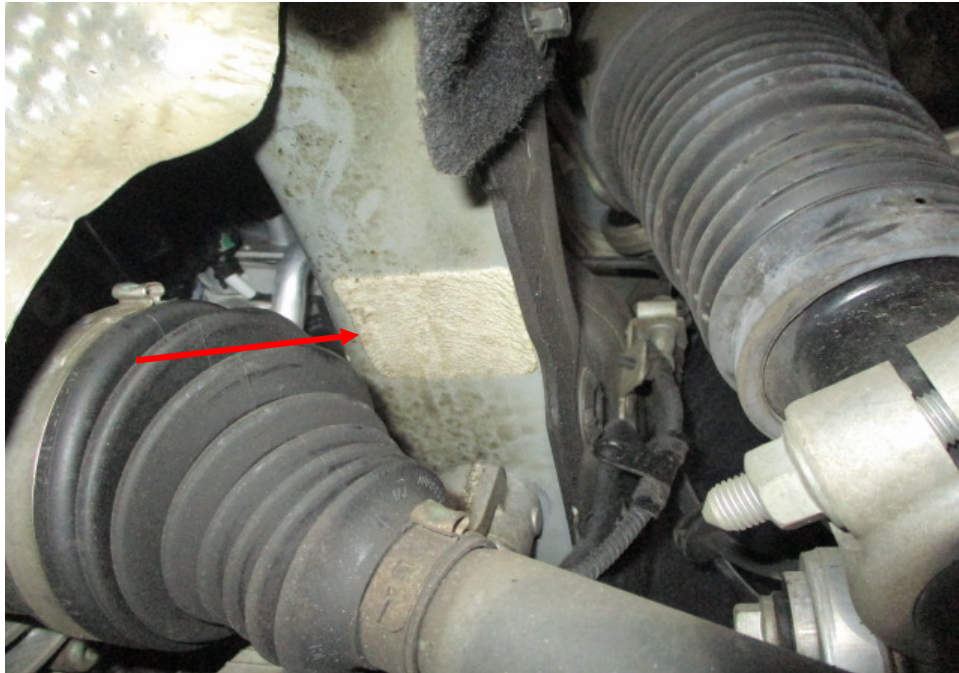
**Photo 29** shows the chassis/structural body at the underside front right of the Motor Car. The original factory sealant (arrowed) at the joints along the chassis/structural body was observed to be untouched. In general, I had found no work was carried out on the chassis/structural body of the Motor Car. The chassis/structural body of the Motor Car was originally fitted.
