Your Ref: Porsche Macan  
(chassis number WP1ZZZ95ZLLB72426)  
Our Ref : CI/TP22004079/D

30 April 2022

**INSPECTION REPORT OF AN UNREGISTERED PORSCHE MACAN MOTOR CAR WITH CHASSIS NUMBER WP1ZZZ95ZLLB72426**

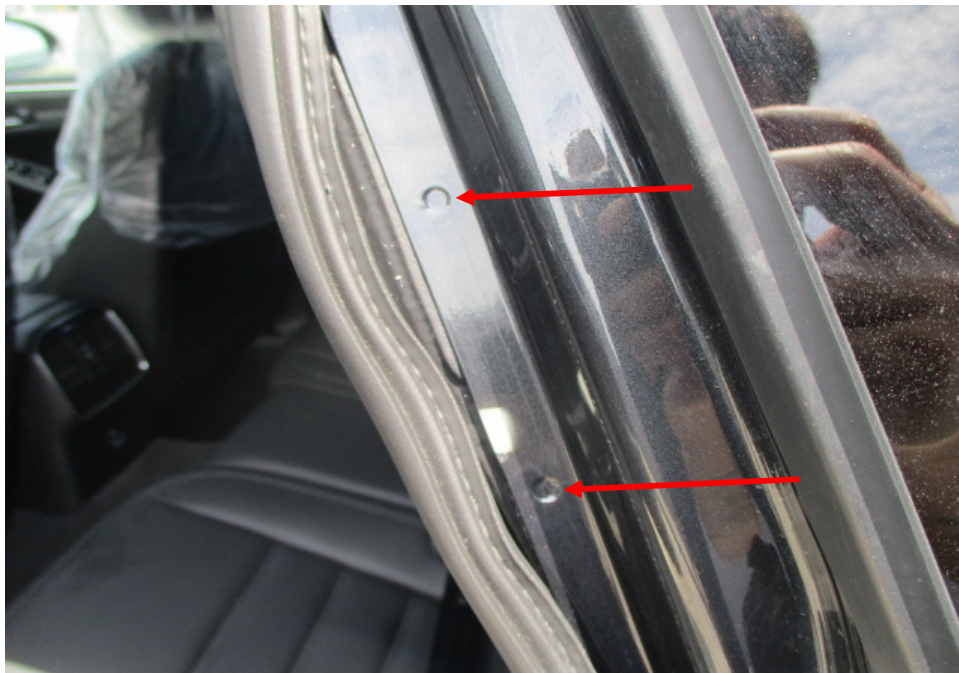
**Photo 30** shows the left side "C" pillar of the Motor Car. I did not find any weld marks other than original spot weld marks (arrowed) on the left side "C" pillar of the Motor Car which, indicates that there was no re-welding works carried out. In general, I had found all the non-detachable body panels of the Motor Car to be originally fitted at the time of my inspection.

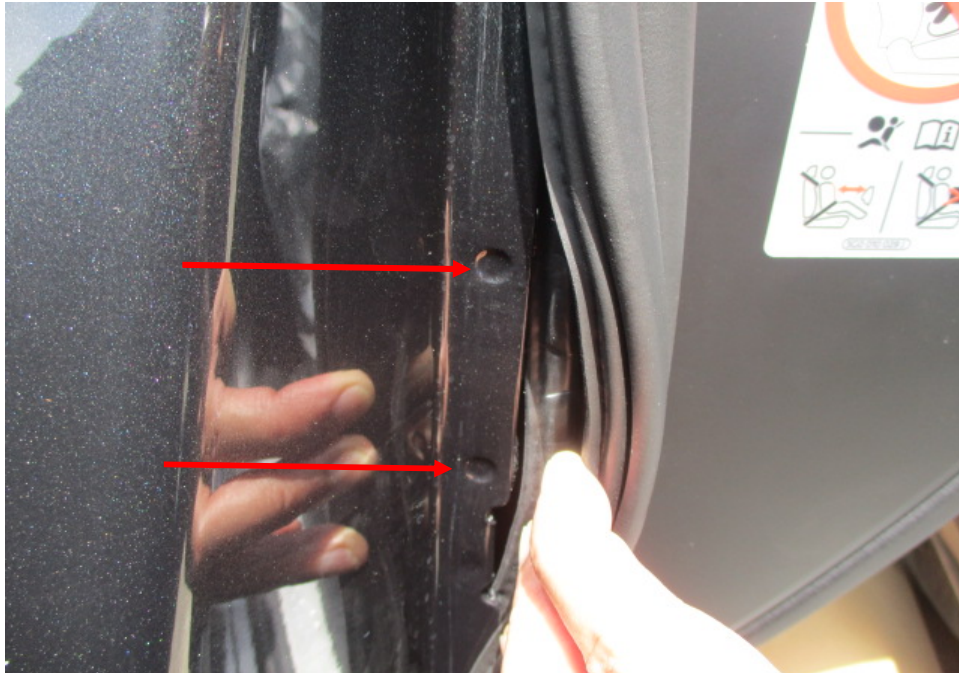
**Photo 31** shows the left side “A” pillar of the Motor Car. I did not find any weld marks other than original spot weld marks (arrowed) on the left side “A” pillar of the Motor Car which, indicates that there was no re-welding works carried out. In general, I had found all the non-detachable body panels of the Motor Car to be originally fitted at the time of my inspection.

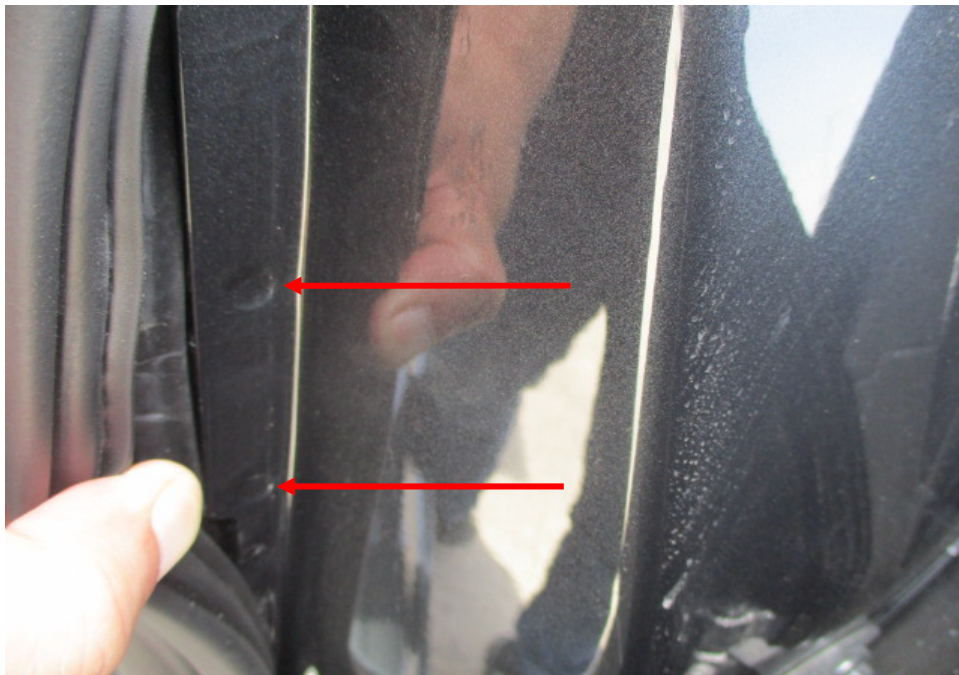
**Photo 32** shows the right side “A” pillar of the Motor Car. I did not find any weld marks other than original spot weld marks (arrowed) on the right side “A” pillar of the Motor Car which, indicates that there was no re-welding works carried out. In general, I had found all the non-detachable body panels of the Motor Car to be originally fitted at the time of my inspection.

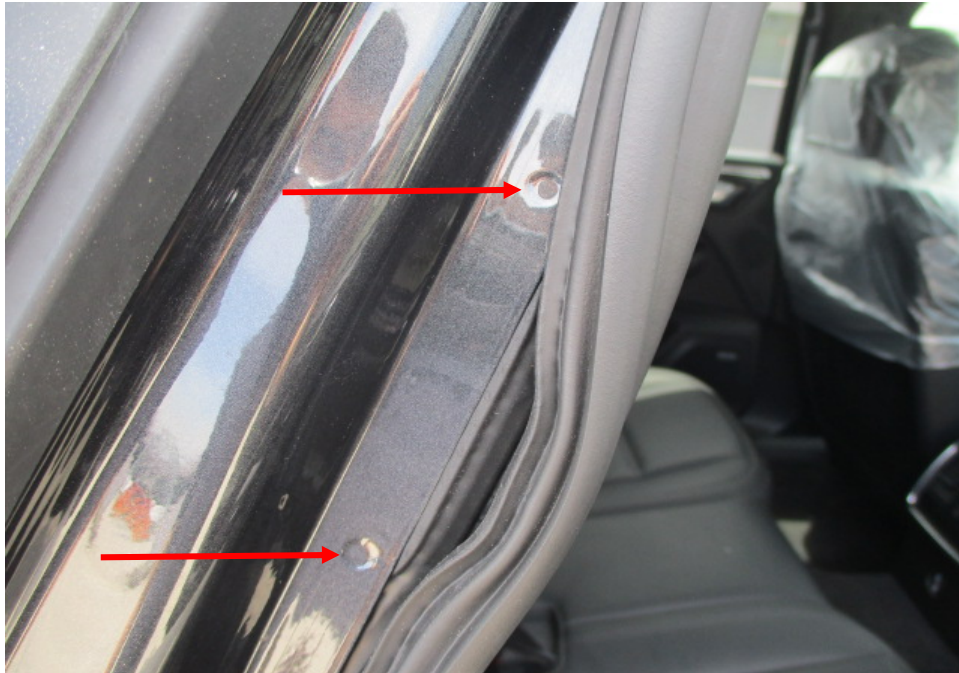
**Photo 33** shows the right side "C" pillar of the Motor Car. I did not find any weld marks other than original spot weld marks (arrowed) on the right side "C" pillar of the Motor Car which, indicates that there was no re-welding works carried out. In general, I had found all the non-detachable body panels of the Motor Car to be originally fitted at the time of my inspection.
