Your Ref: Porsche Macan
(chassis number WP1ZZZ95ZKLB05467)
Our Ref : CI/TP22004080/D

INSPECTION REPORT OF AN UNREGISTERED PORSCHE MACAN MOTOR CAR WITH CHASSIS NUMBER WP1ZZZ95ZKLB05467

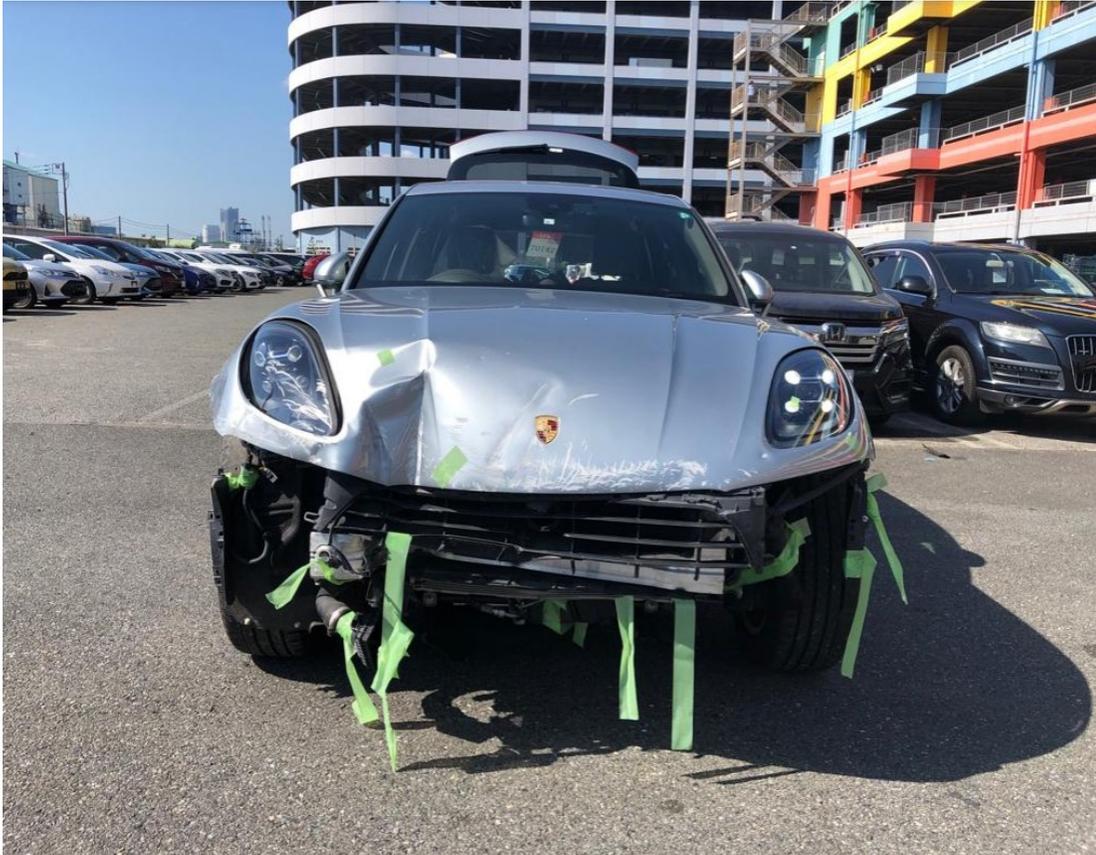
3. The photographs provided to me had showed damage to the Motor Car's frontal portion. Body parts damaged include the front bumper reinforcement, front intercooler, radiator grille, front sensor unit, aircon condenser, front support panel, front support panel top garnish, engine undercover, front bonnet, front right headlamp and front left fender inner shield amongst others.
4. The Motor Car's front bumper and all its related parts and attachments like the front bumper lower lip, front bumper centre lower grille, front bumper right lower grille, front bumper left lower grille, front bumper right upper grille, front bumper left upper grille, front bumper sensors, front bumper brackets and front day lights amongst others were also observed to be damaged/dislodge/missing.

Photo 1 shows the front body of the Motor Car (photograph provided to me). The Motor Car was observed to have sustained damage at its frontal portion. The front bumper reinforcement, front intercooler, radiator grille, front sensor unit, aircon condenser, front support panel, front support panel top garnish, engine undercover, front bonnet, front right headlamp and front left fender inner shield were amongst the body parts that were observed to have been damaged. The Motor Car's front bumper and all its related parts and attachments like the front bumper lower lip, front bumper centre lower grille, front bumper right lower grille, front bumper left lower grille, front bumper right upper grille, front bumper left upper grille, front bumper sensors, front bumper brackets and front day lights amongst others were also observed to be damaged/dislodge/missing.

23. The body parts at the frontal portion of the Motor Car were visually examined and it was noted that the repair/restoration works carried out to the damaged area of the Motor Car (refer to photograph 1 above) were reasonably adequate and in order.

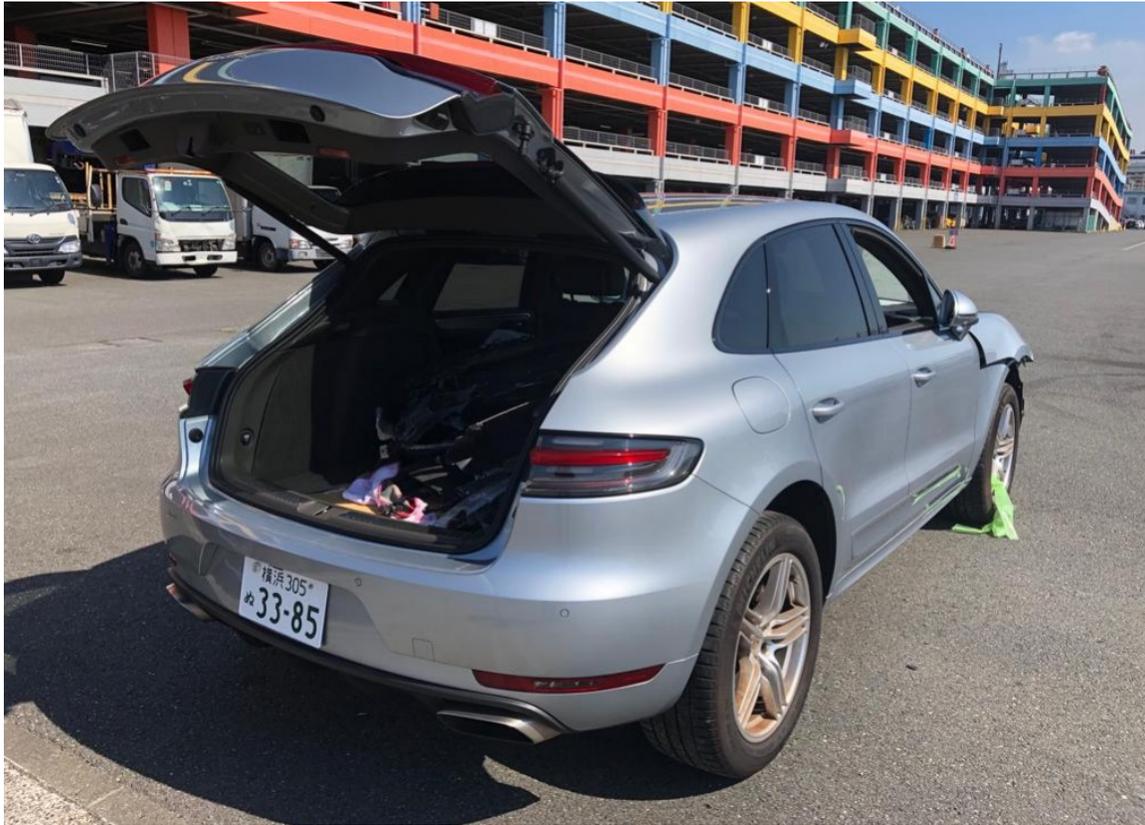
Photo 2 shows the rear right body of the Motor Car (photograph provided to me). Apart for the frontal portion, there was no physical damage observed to other areas of the Motor Car.

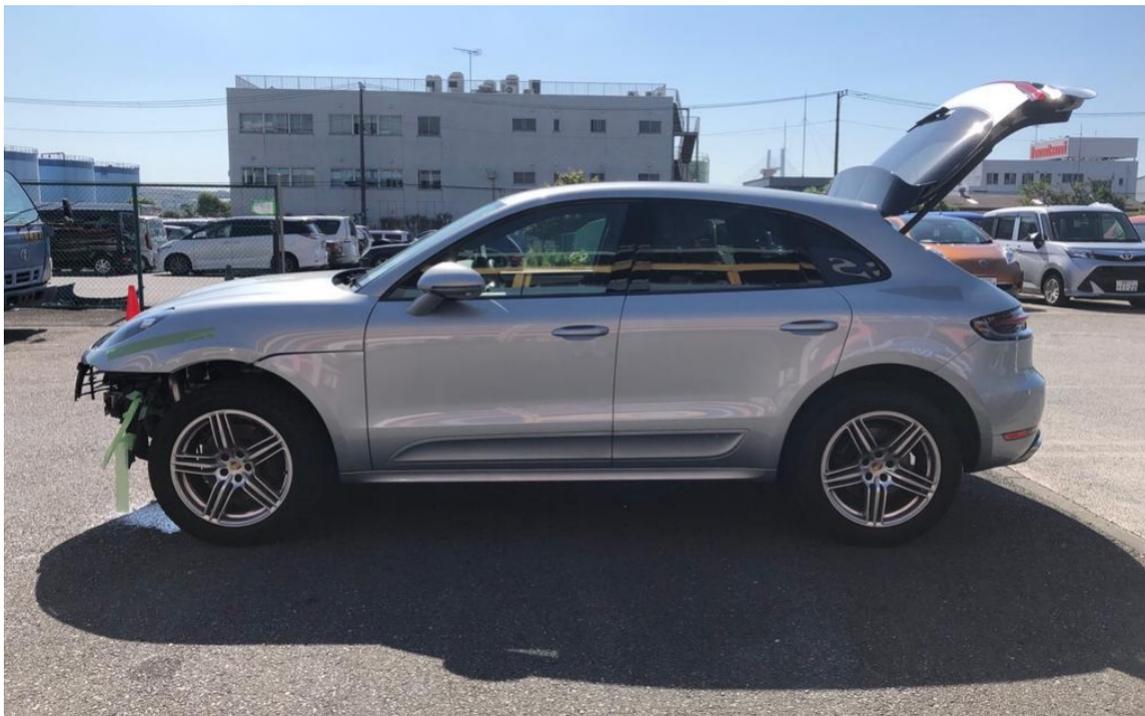
Photo 3 shows the left body of the Motor Car (photograph provided to me). Apart for the frontal portion, there was no physical damage observed to other areas of the Motor Car.

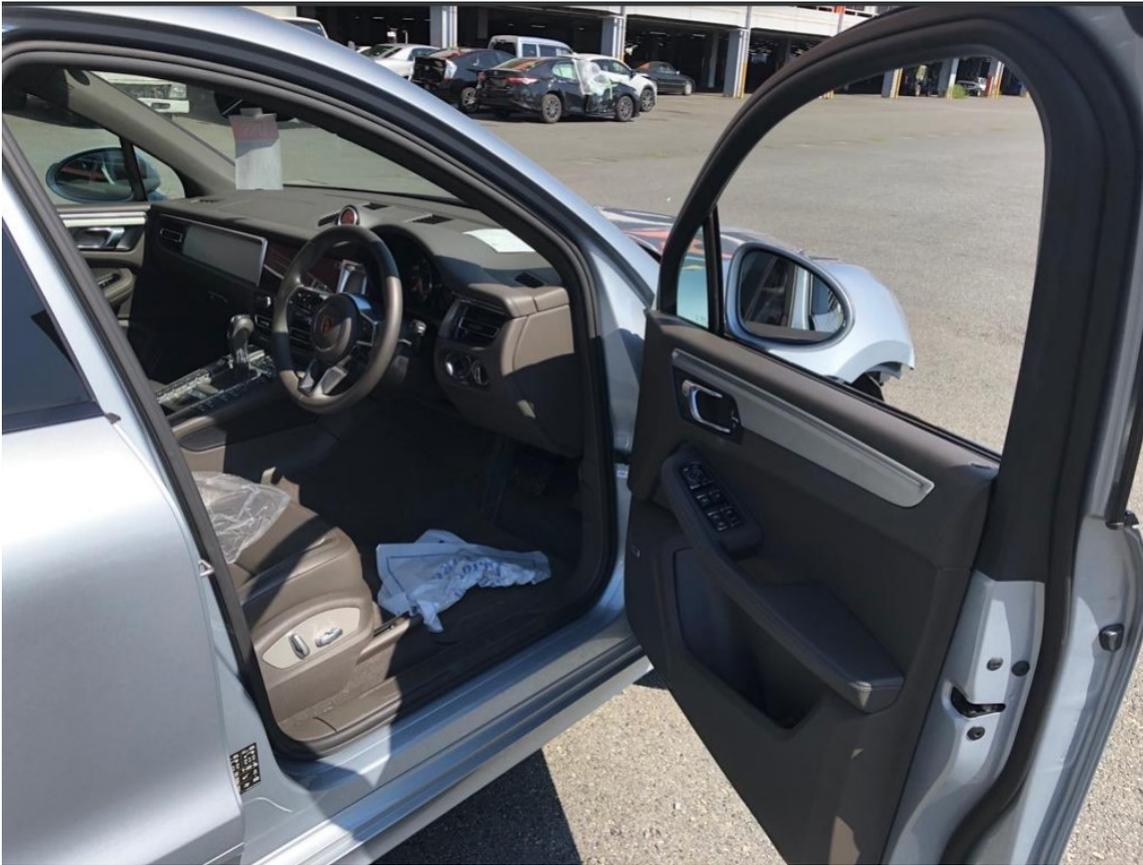
Photo 4 shows the interior compartment of the Motor Car (photograph provided to me). The various parts and components within the interior compartment were all intact and unaffected. The airbag(s) was not deployed as seen from the photographs that were provided to me.

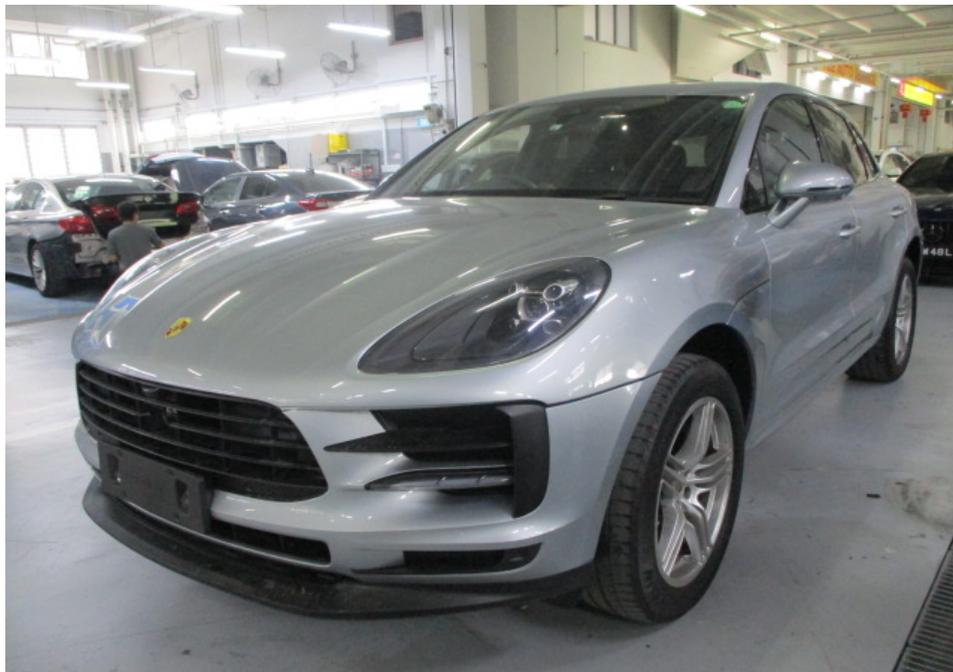
Photo 5 shows a general view of the front left body of the Motor Car at the time of my inspection. The Motor Car was observed to be in a relatively good general condition with no loose exterior fittings observed. The body parts at the frontal portion of the Motor Car were visually examined and it was observed that the repair/restoration works carried out to the damaged area of the Motor Car (refer to photograph 1 above) were reasonably adequate and in order.

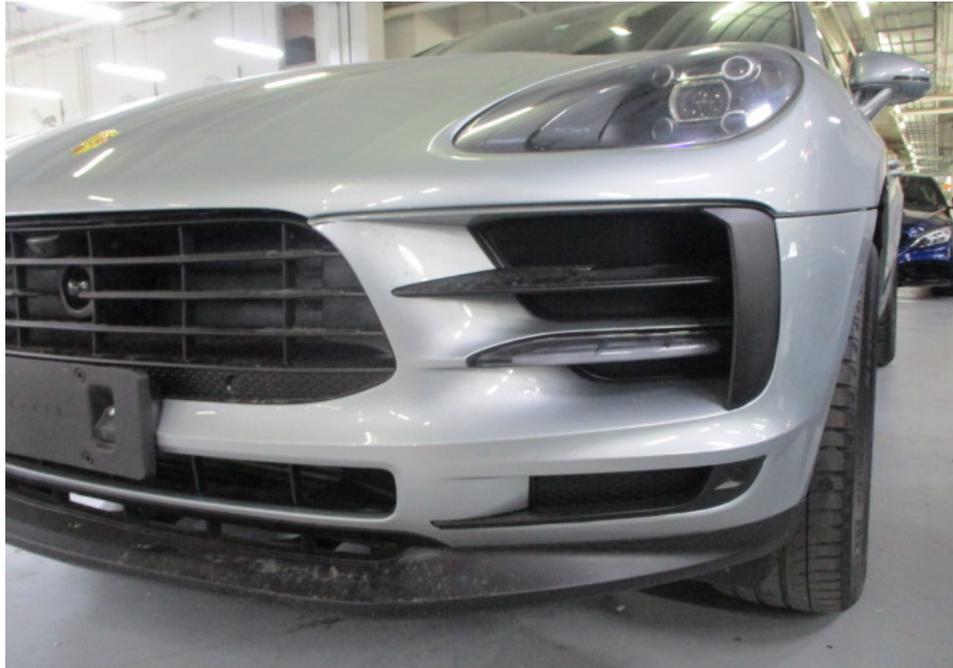
Photo 6 shows a closer view of the Motor Car's front bumper, front bumper lower lip, front bumper left lower grille, front bumper left upper grille and front left day light. The body parts at the frontal portion of the Motor Car were visually examined and it was observed that the repair/restoration works carried out to the damaged area of the Motor Car (refer to photograph 1 above) were reasonably adequate and in order.

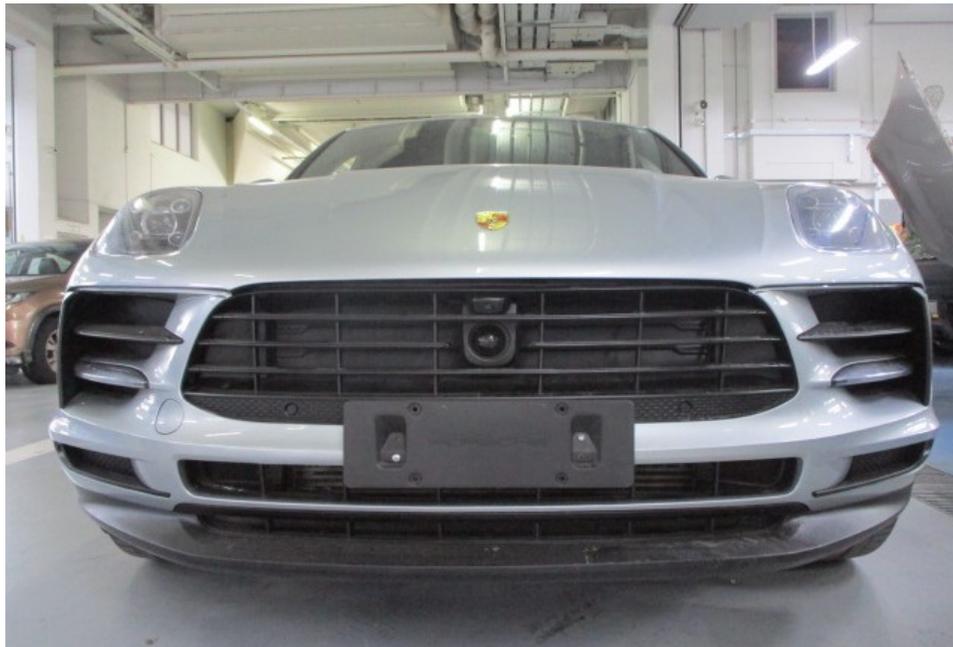
Photo 7 shows a closer view of the Motor Car's front bumper, front bumper centre lower grille, radiator grille, front sensor unit and front bonnet. The body parts at the frontal portion of the Motor Car were visually examined and it was observed that the repair/restoration works carried out to the damaged area of the Motor Car (refer to photograph 1 above) were reasonably adequate and in order.

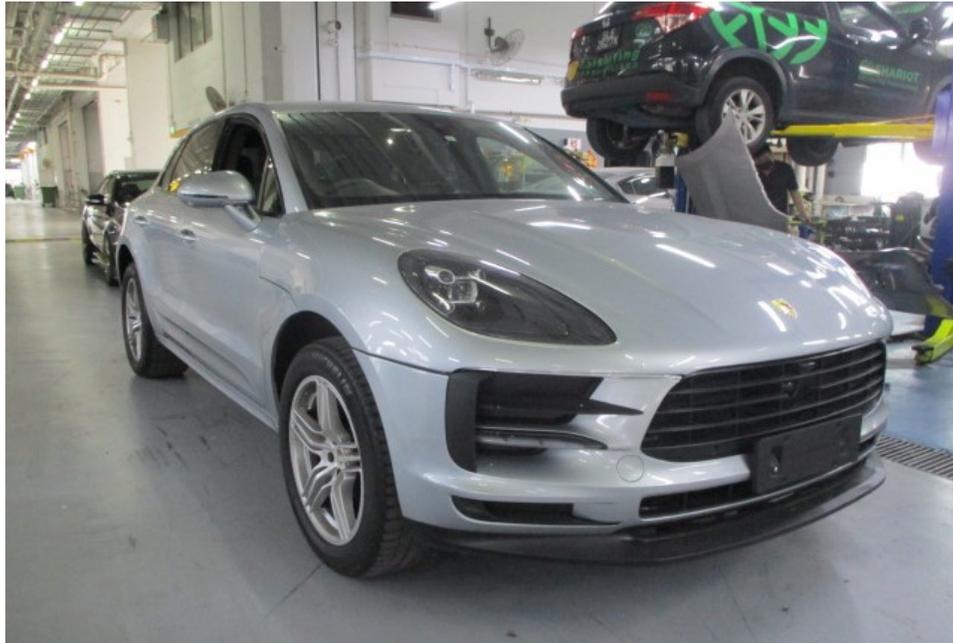
Photo 8 shows a general view of the front right body of the Motor Car at the time of my inspection. The Motor Car was observed to be in a relatively good general condition with no loose exterior fittings observed. The body parts at the frontal portion of the Motor Car were visually examined and it was observed that the repair/restoration works carried out to the damaged area of the Motor Car (refer to photograph 1 above) were reasonably adequate and in order.

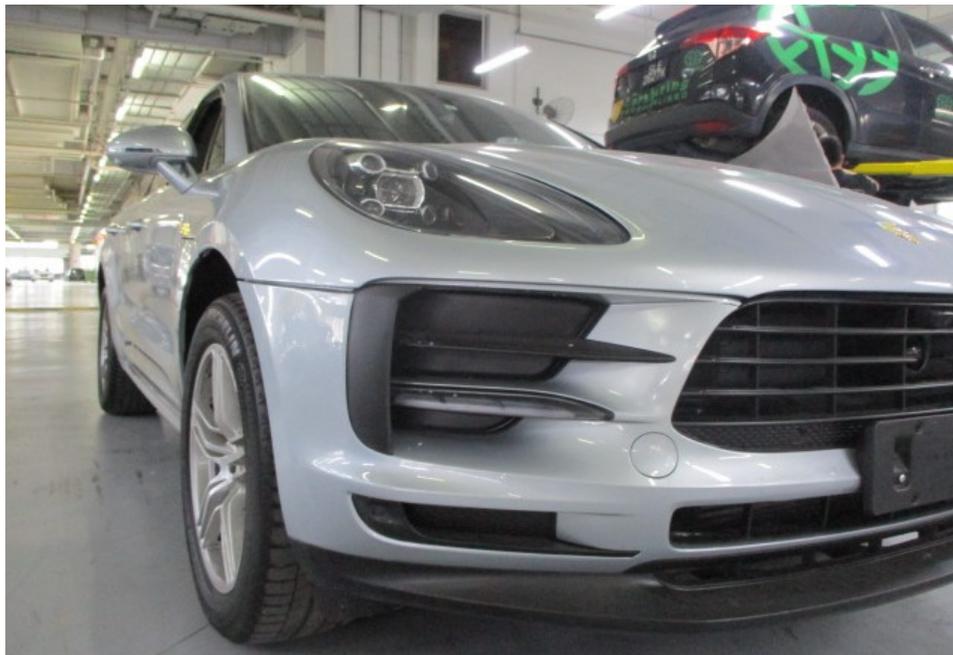
Photo 9 shows a closer view of the Motor Car's front bumper, front bumper tow hook cover, front bumper lower lip, front bumper right lower grille, front bumper right upper grille, front right day light and front right headlamp. The body parts at the frontal portion of the Motor Car were visually examined and it was observed that the repair/restoration works carried out to the damaged area of the Motor Car (refer to photograph 1 above) were reasonably adequate and in order.

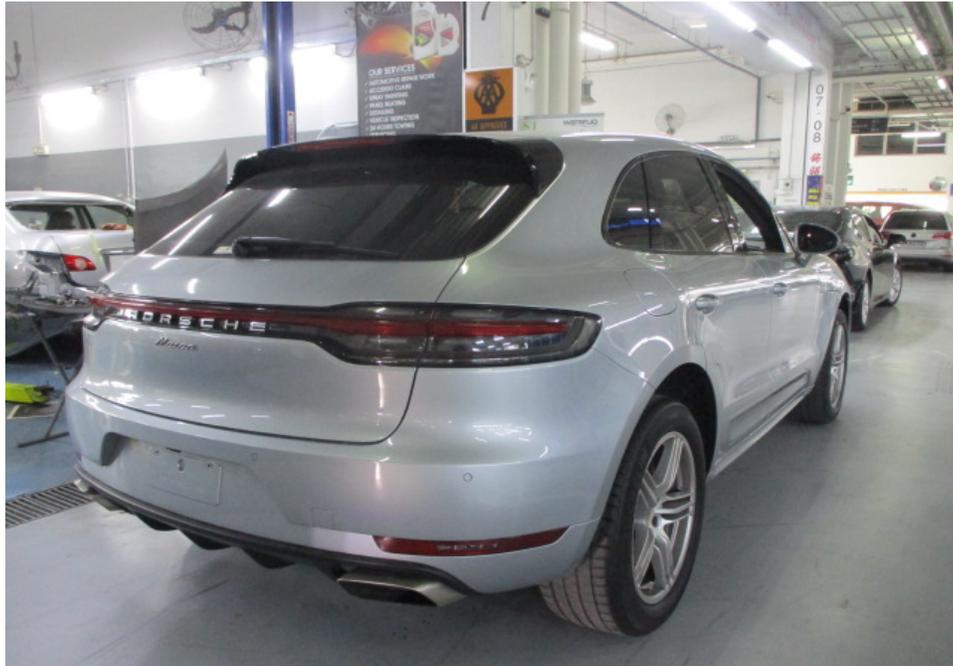
Photo 10 shows a general view of the rear right body of the Motor Car at the time of my inspection. The Motor Car was observed to be in a relatively good general condition with no loose exterior fittings observed. The mileage of the Motor Car recorded at the time of my inspection was 14,137km.

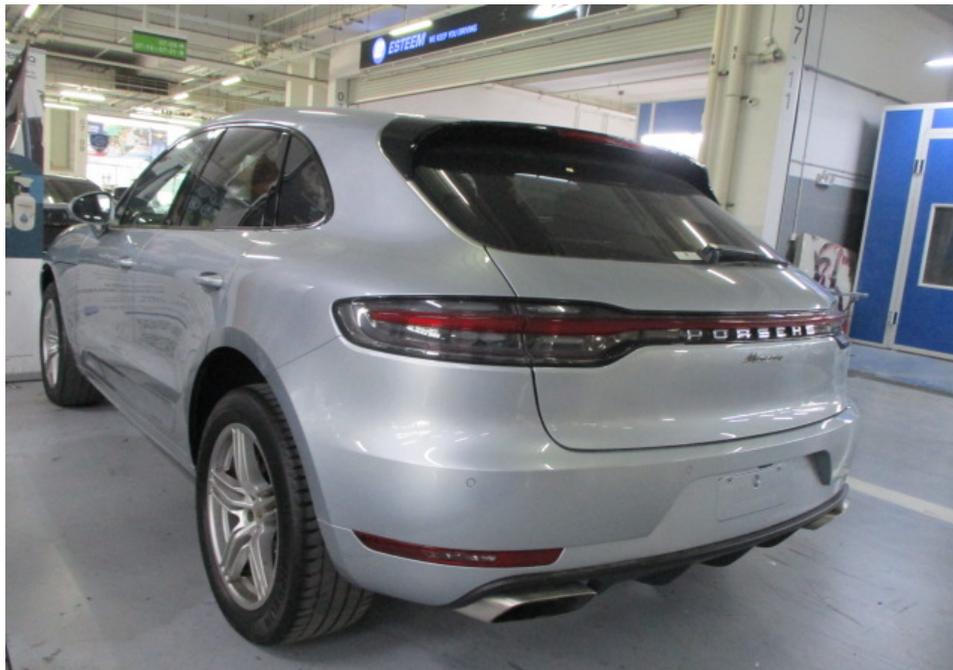
Photo 11 shows a general view of the rear left body of the Motor Car at the time of my inspection. The Motor Car was observed to be in a relatively good general condition with no loose exterior fittings observed. The mileage of the Motor Car recorded at the time of my inspection was 14,137km.

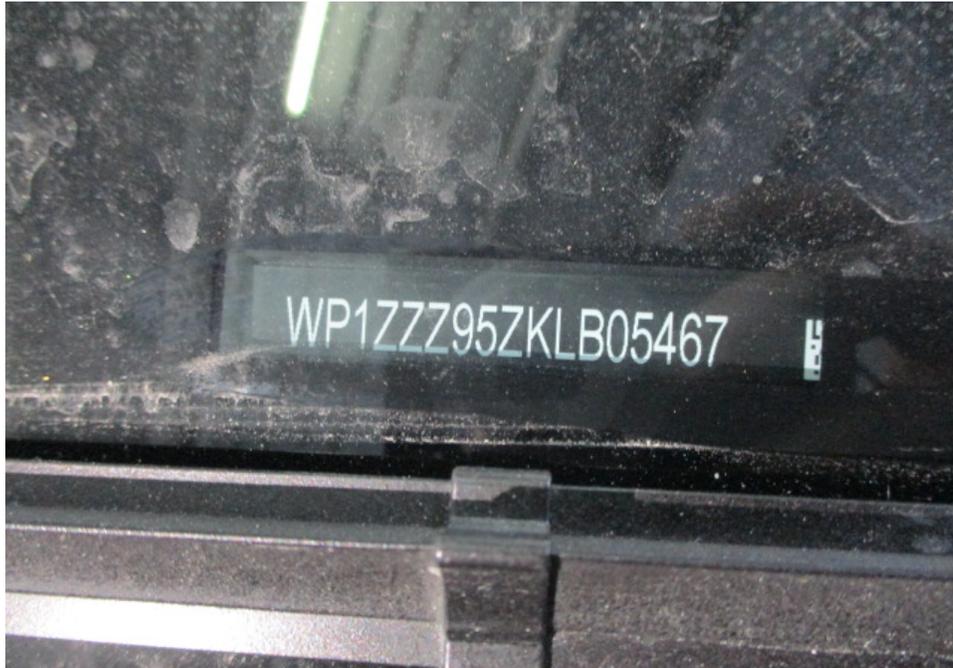
Photo 12 shows the chassis number of the Motor Car. The chassis number recorded was WP1ZZZ95ZKLB05467.

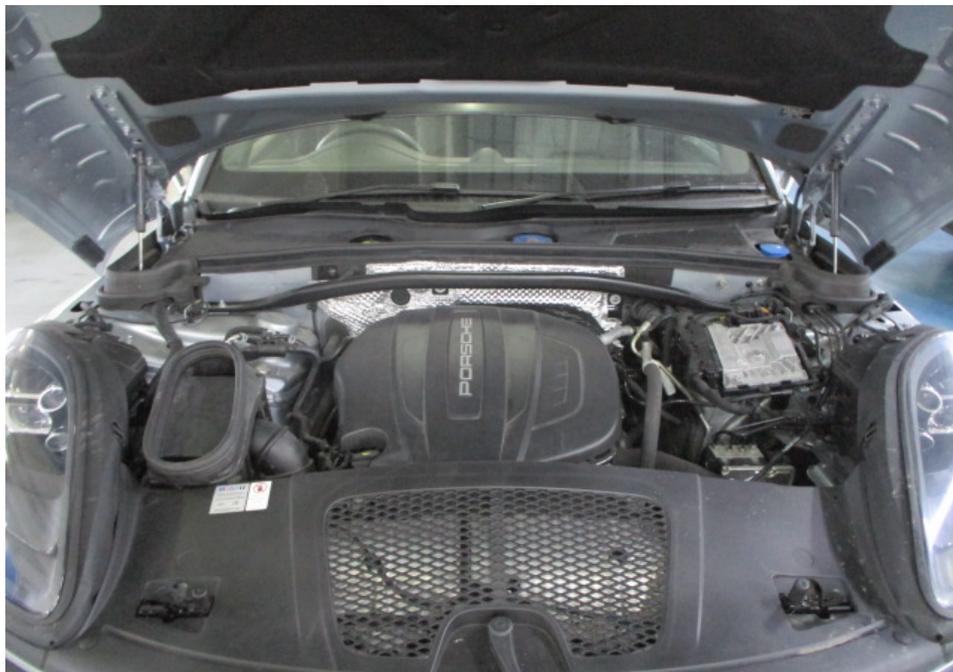
Photo 13 shows a general view of the engine compartment of the Motor Car at the time of my inspection. The various parts and components inside the engine compartment were all observed to be intact and properly fitted. There was also no sign(s) or indication(s) of fluid leak and/or fluid stain found inside the engine compartment. The repair/restoration works carried out to the various parts within the engine compartment like the front support panel, front support panel top garnish, front intercooler and aircon condenser amongst others were reasonably adequate and in order.

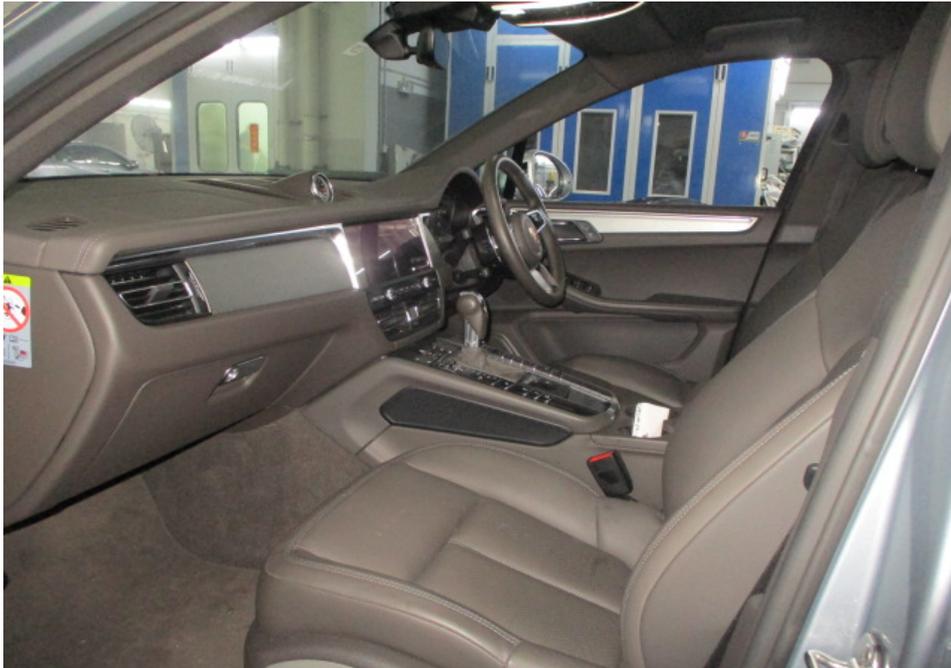
Photo 14 shows the interior compartment of the Motor Car. The front dashboard, steering wheel, seats, upholstery and trims etc were all observed to be intact and properly fitted.

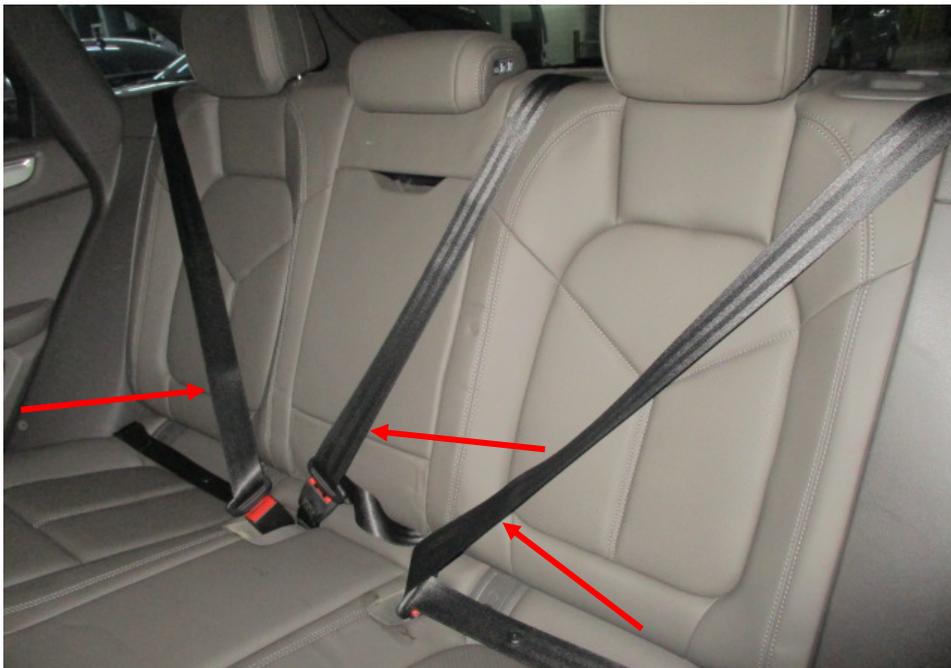
Photo 15 shows the rear seats of the Motor Car. All the seats of the Motor Car were secured via seat rails to the floorboard. They were also fitted with a retractable seat belt reel and a pre-tensioner. The seat belts (arrowed) were tested and were able to be fastened into the respective pre-tensions that were fitted on the side of each individual seat.

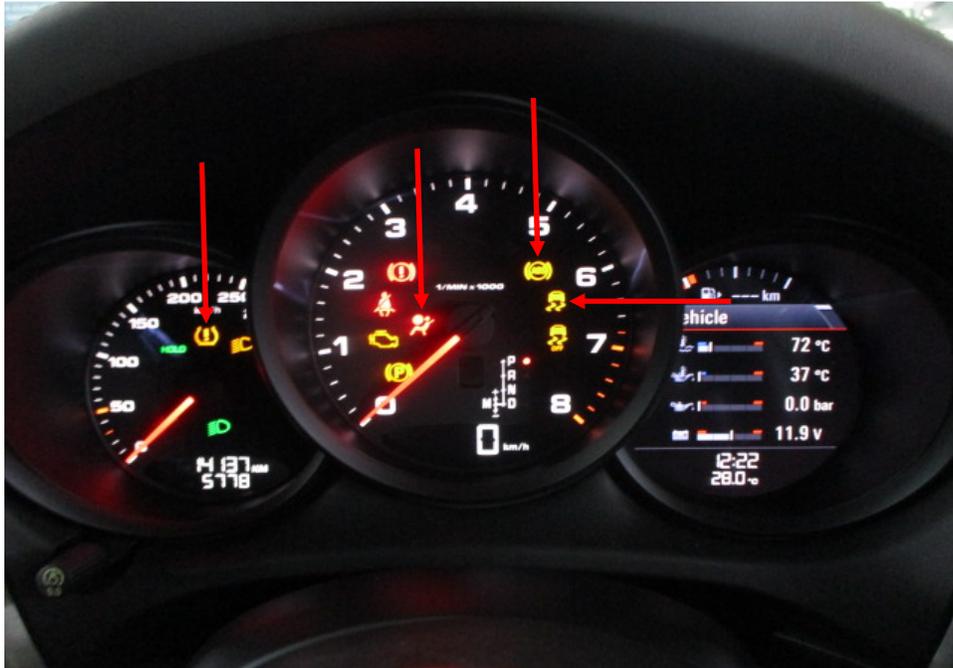
Photo 16 shows the warning lights for the various electronic safety features appearing on the instrument panel of the Motor Car during its self-test when the engine is cranked, in particular the ABS, SRS, TPM and TCS lights (arrowed).

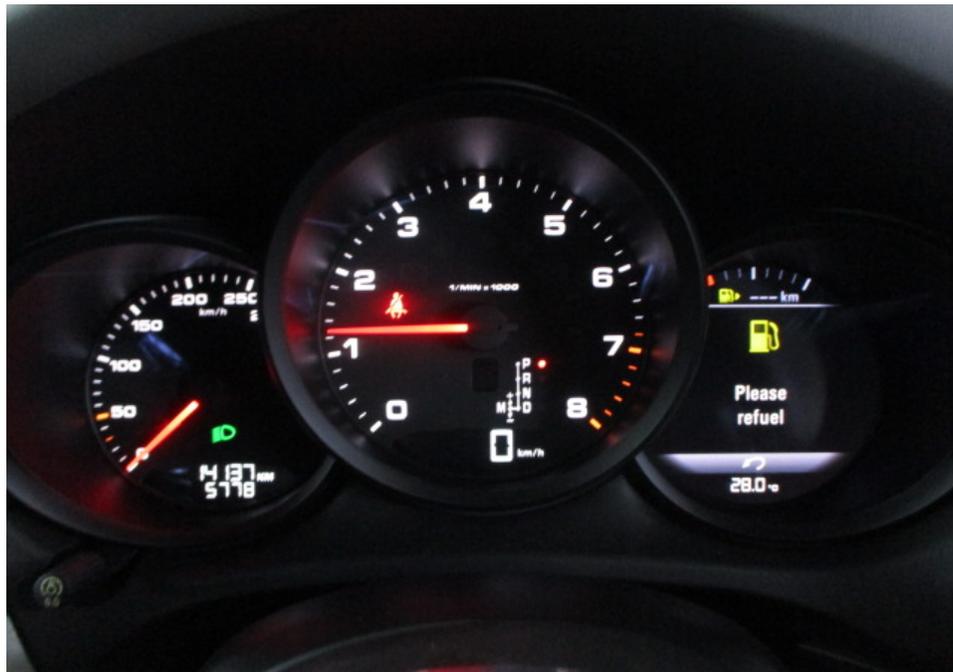
Photo 17 shows the respective warning lights no longer illuminated, indicating that there is no fault detected to the ABS, SRS, TPM and TCS systems of the Motor Car during the self-test. These electronic systems were hence in working condition at the time of my inspection.

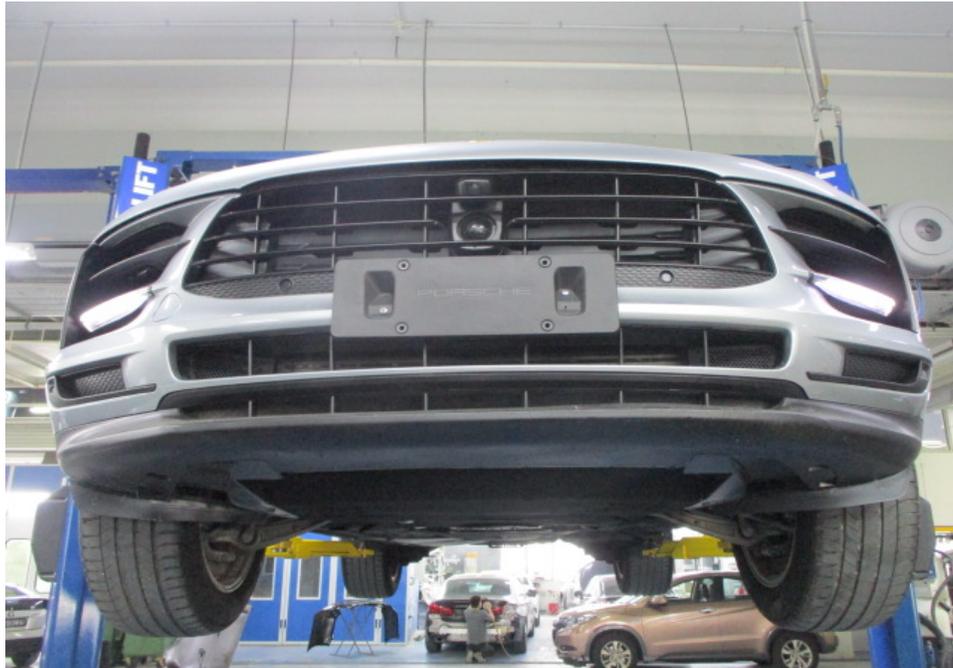
Photo 18 shows the Motor Car hoisted up for checks on its undercarriage. There was no sign(s) or indication(s) of fluid leakage and/or fluid stain(s) on the underside of the Motor Car. The undercarriage components of the Motor Car were also all observed to be intact and secured in an appropriate manner.

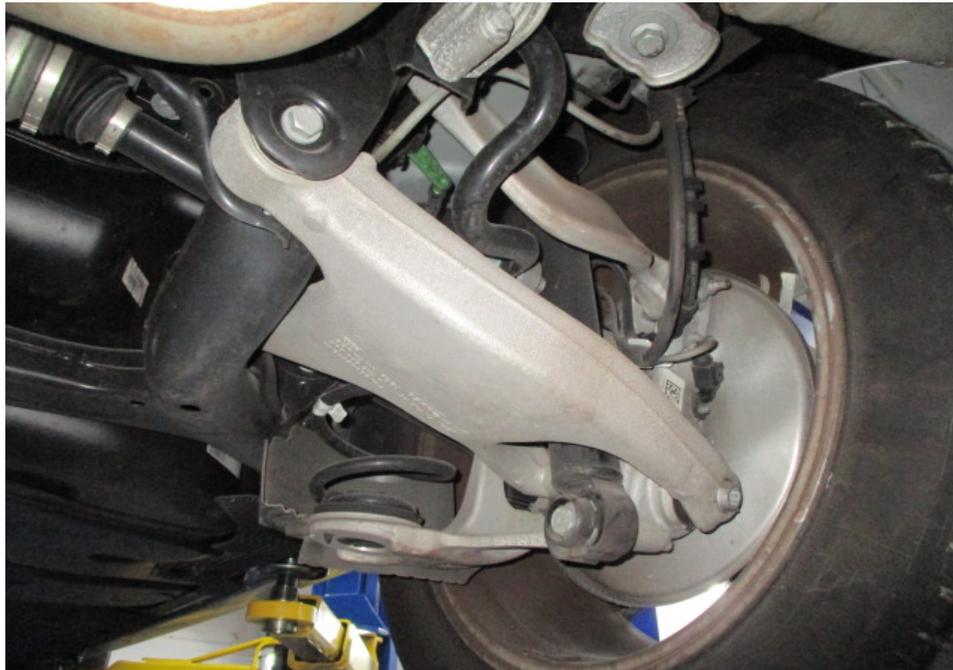
Photo 19 shows a general view of the control arms and linkages at the rear right wheel of the Motor Car. I did not observe any fluid leak and/or fluid stain on the underside of the Motor Car. All of the Motor Car's undercarriage components were observed to be intact and secured in an appropriate manner.

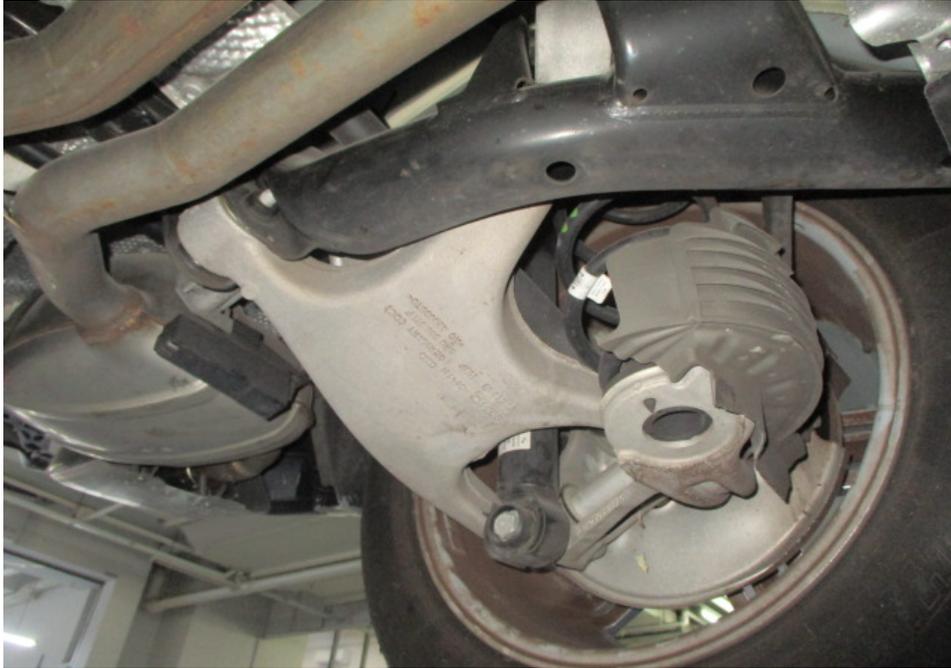
Photo 20 shows a general view of the control arms and linkages at the rear left wheel of the Motor Car. I did not observe any fluid leak and/or fluid stain on the underside of the Motor Car. All of the Motor Car's undercarriage components were observed to be intact and secured in an appropriate manner.

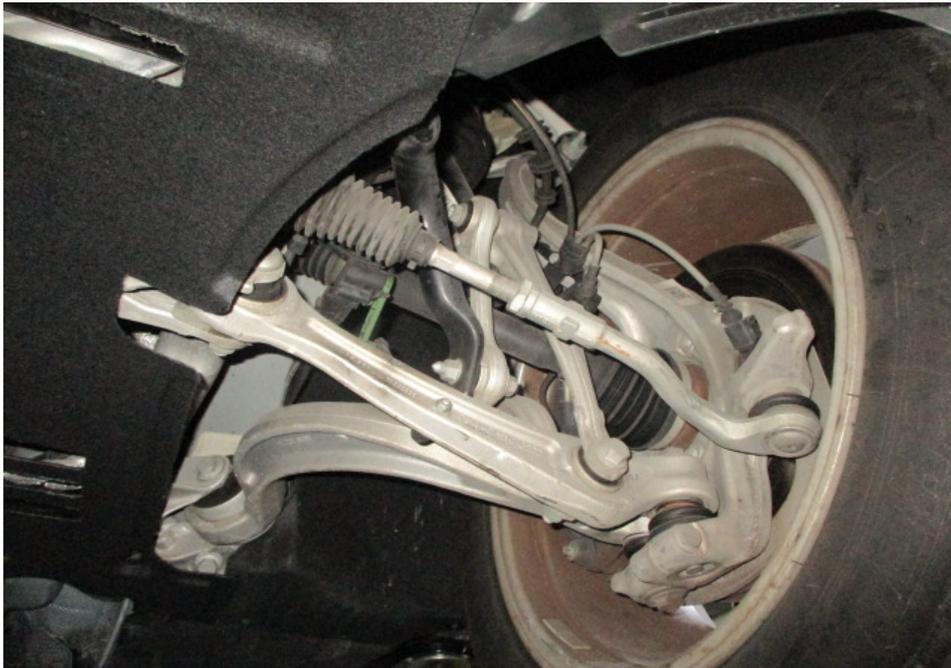
Photo 21 shows a general view of the control arms and linkages at the front left wheel of the Motor Car. I did not observe any fluid leak and/or fluid stain on the underside of the Motor Car. All of the Motor Car's undercarriage components were observed to be intact and secured in an appropriate manner.

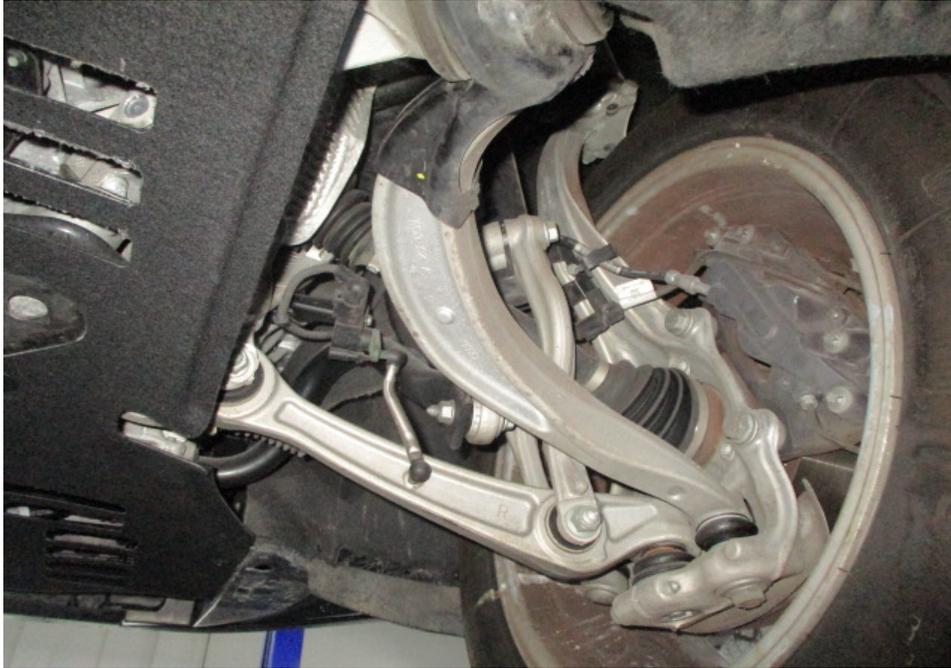
Photo 22 shows the various undercarriage components at the front right wheel of the Motor Car. The mechanical components, control arms and linkages were all found to be intact and secured in an appropriate manner. I also did not observe any fluid leak and/or fluid stain on the underside of the Motor Car.

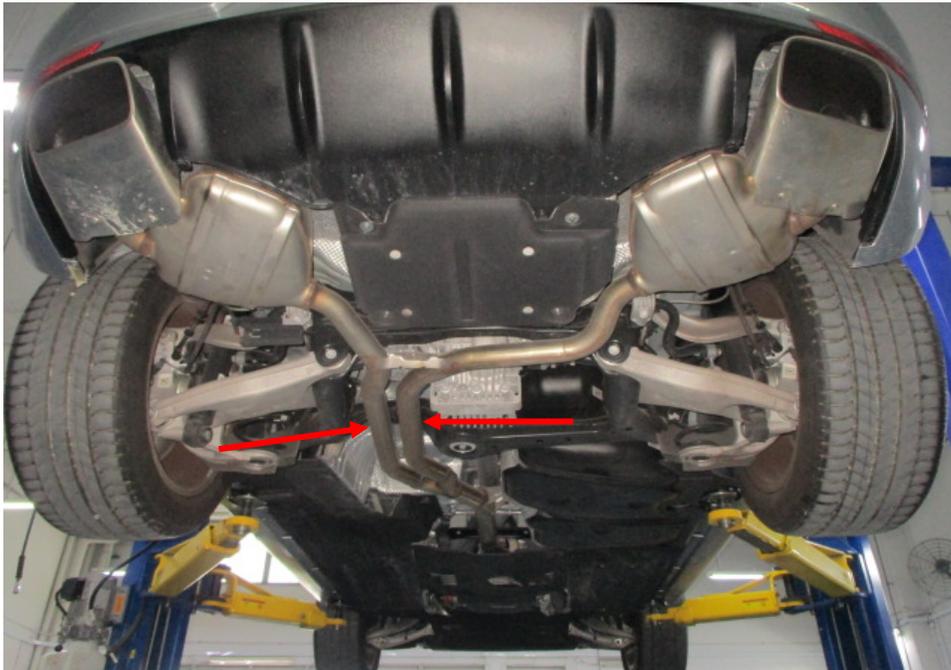
Photo 23 shows the rear section of the Motor Car's exhaust system. My examination of the Motor Car's exhaust system revealed no sign(s) or indication(s) of any cut or weld marks along its exhaust pipes (arrowed), on its rear mufflers and on its catalytic converter.

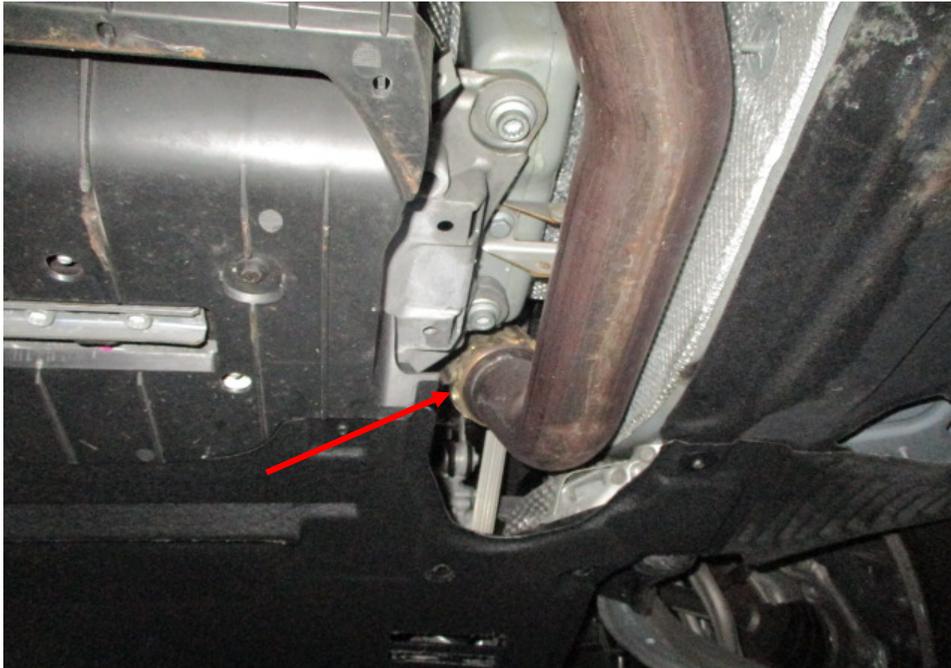
Photo 24 shows the front section of the Motor Car's exhaust system. My examination of the Motor Car's exhaust system revealed no sign(s) or indication(s) of any cut or weld marks along its exhaust pipes, on its rear mufflers and on its catalytic converter (arrowed).

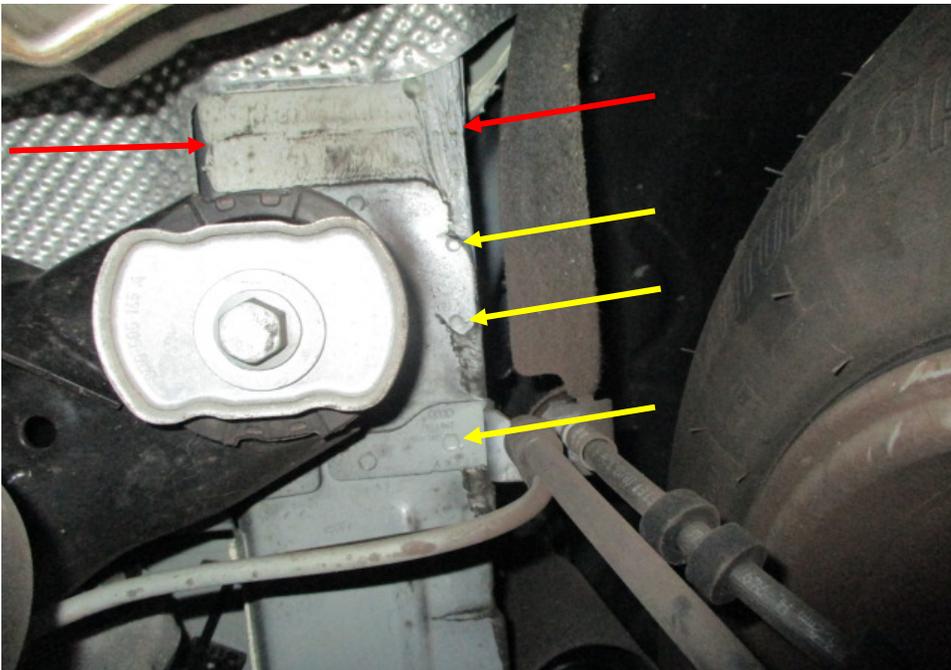
Photo 25 shows the chassis/structural body at the underside rear right of the Motor Car. I did not find any weld marks other than original spot weld marks (yellow arrow) on the chassis/structural body of the Motor Car. The original factory sealant (red arrow) at the joints along the chassis/structural body was untouched, indicating no work was done on the chassis/structural body of the Motor Car and that the chassis/structural body was originally fitted.

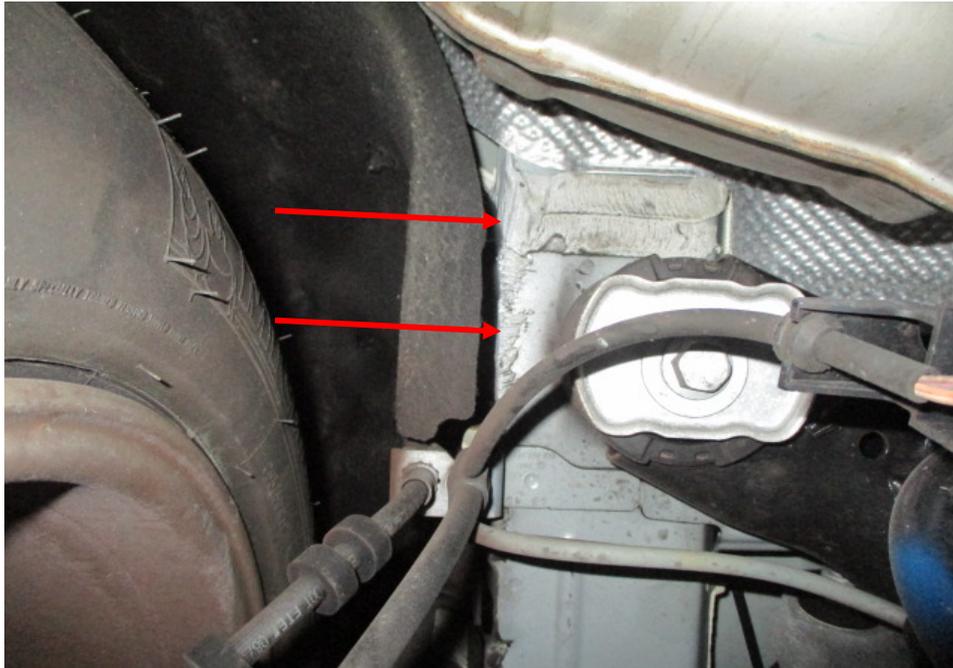
Photo 26 shows the chassis/structural body at the underside rear left of the Motor Car. The original factory sealant (arrowed) at the joints along the chassis/structural body was observed to be untouched. In general, I had found no work was carried out on the chassis/structural body of the Motor Car. The chassis/structural body of the Motor Car was originally fitted.

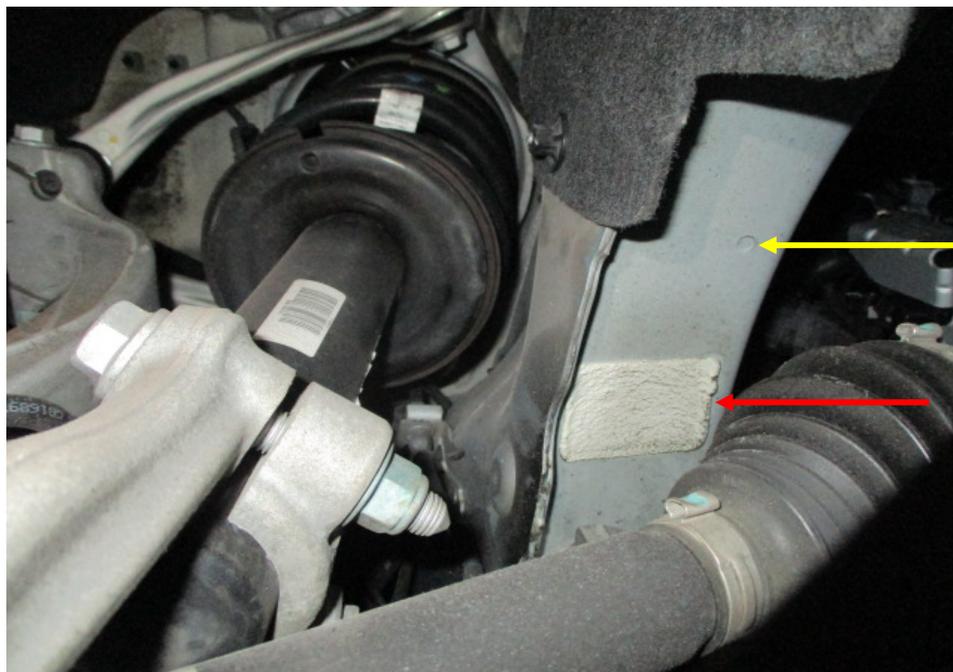
Photo 27 shows the chassis/structural body at the underside front left of the Motor Car. I did not find any weld marks other than original spot weld marks (yellow arrow) on the chassis/structural body of the Motor Car. The original factory sealant (red arrow) at the joints along the chassis/structural body was untouched, indicating no work was done on the chassis/structural body of the Motor Car and that the chassis/structural body was originally fitted.

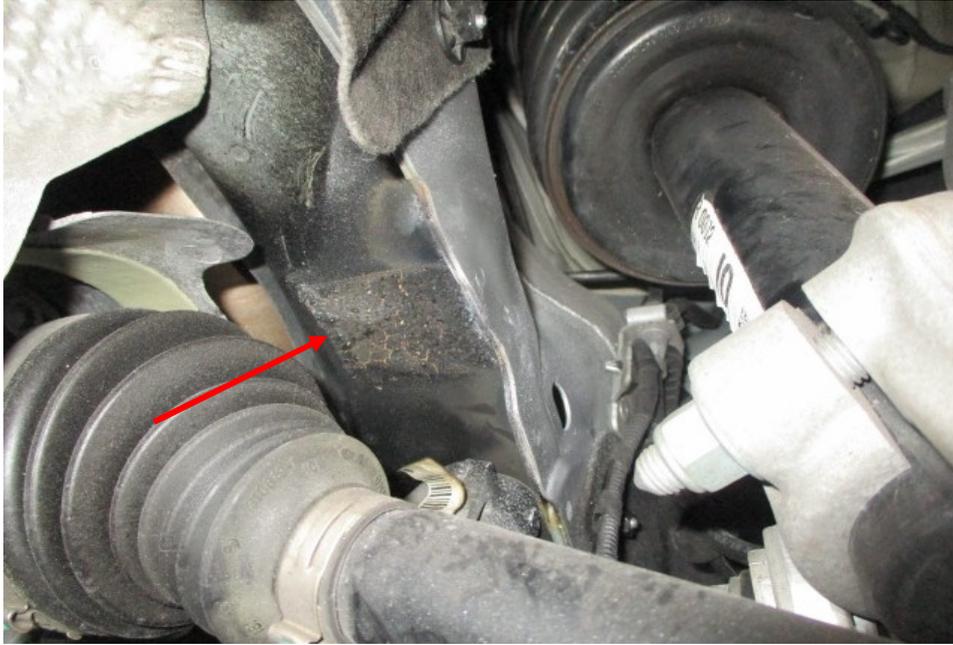
12. Visually, I did not find any weld marks, other than the original spot weld marks, on the chassis/structural body of the Motor Car. The original factory sealant at the joints along the chassis/structural body was also untouched, again indicating that no replacement of the chassis/structural body was carried out; and that the chassis/structural body was originally fitted. I did however find signs of repair work carried out to the front section of the Motor Car's front right chassis (refer to photograph 28 below).

24. I had found signs of repair work carried out to the front section of the Motor Car's front right chassis. The repairs carried out were in order as the repairs did not involve any cutting and/or re-welding of the Motor Car's original chassis/structural body. Furthermore, lower body chassis alignment measurements carried out by STA Inspection Pte Ltd on 14 April 2022 also showed the chassis/structural measurements of the Motor Car to be within acceptable tolerance (refer to Appendix 1 at page 23 and 24 of this report).

Photo 28 shows the chassis/structural body at the underside front right of the Motor Car. The front section of the chassis/structural body at the underside front right was found sprayed with anti-corrosion protection. This is an indication that repair works were carried out at the front section of the chassis/structural body at the underside front right. However, the front right chassis of the Motor Car was still observed to be an originally fitted part given that the original factory sealant (arrowed) was still present.

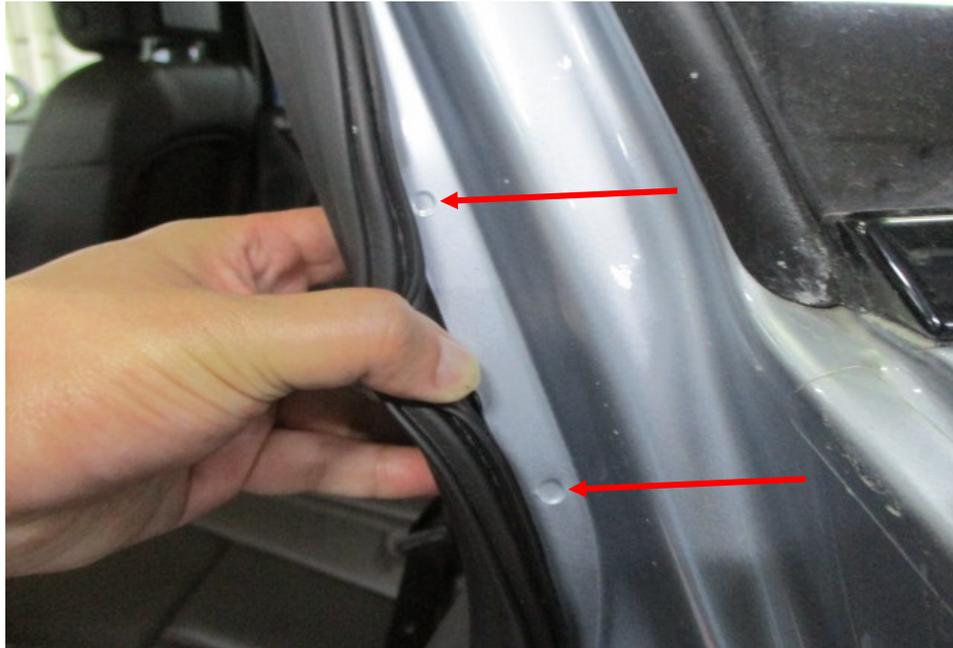
Photo 29 shows the left side "C" pillar of the Motor Car. I did not find any weld marks other than original spot weld marks (arrowed) on the left side "C" pillar of the Motor Car which, indicates that there was no re-welding works carried out. In general, I had found all the non-detachable body panels of the Motor Car to be originally fitted at the time of my inspection.
