Your Ref: Porsche Macan
(chassis number WP1ZZZ95ZKLB05467)
Our Ref : CI/TP22004080/D

INSPECTION REPORT OF AN UNREGISTERED PORSCHE MACAN MOTOR CAR WITH CHASSIS NUMBER WP1ZZZ95ZKLB05467

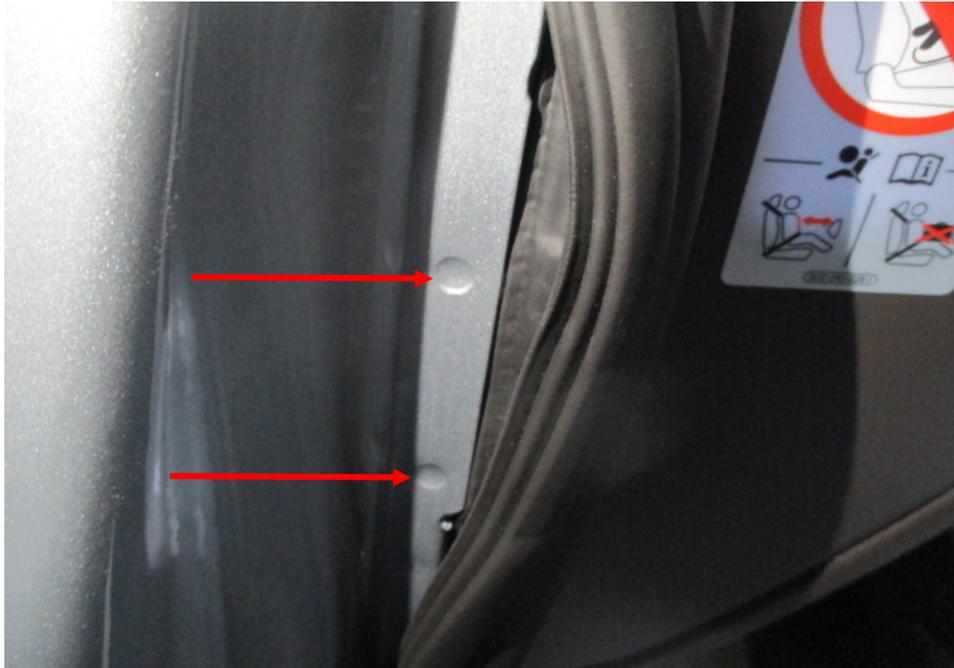
Photo 30 shows the left side “A” pillar of the Motor Car. I did not find any weld marks other than original spot weld marks (arrowed) on the left side “A” pillar of the Motor Car which, indicates that there was no re-welding works carried out. In general, I had found all the non-detachable body panels of the Motor Car to be originally fitted at the time of my inspection.

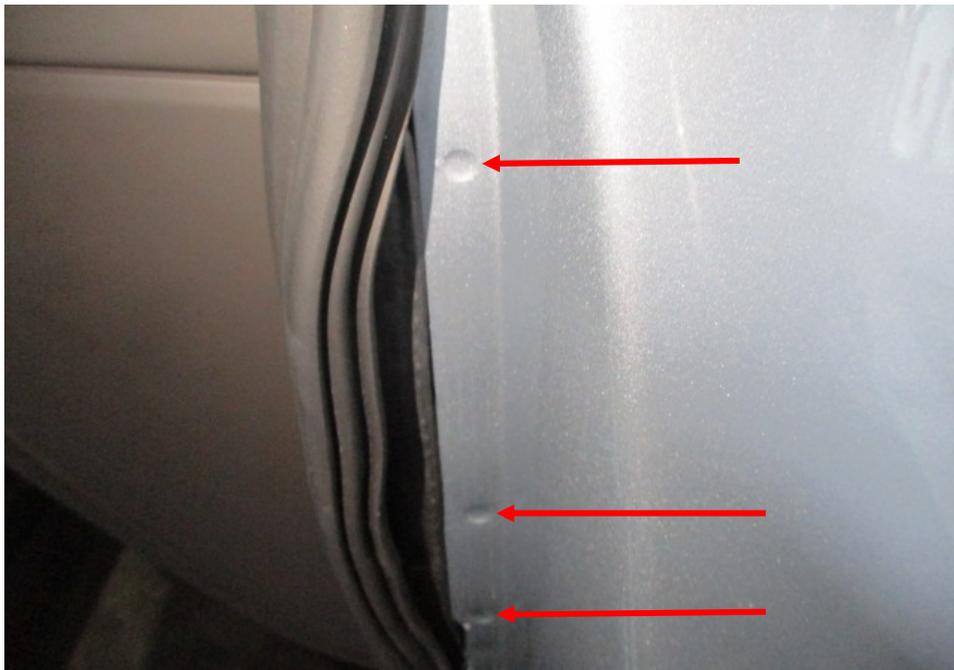
Photo 31 shows the right side “A” pillar of the Motor Car. I did not find any weld marks other than original spot weld marks (arrowed) on the right side “A” pillar of the Motor Car which, indicates that there was no re-welding works carried out. In general, I had found all the non-detachable body panels of the Motor Car to be originally fitted at the time of my inspection.

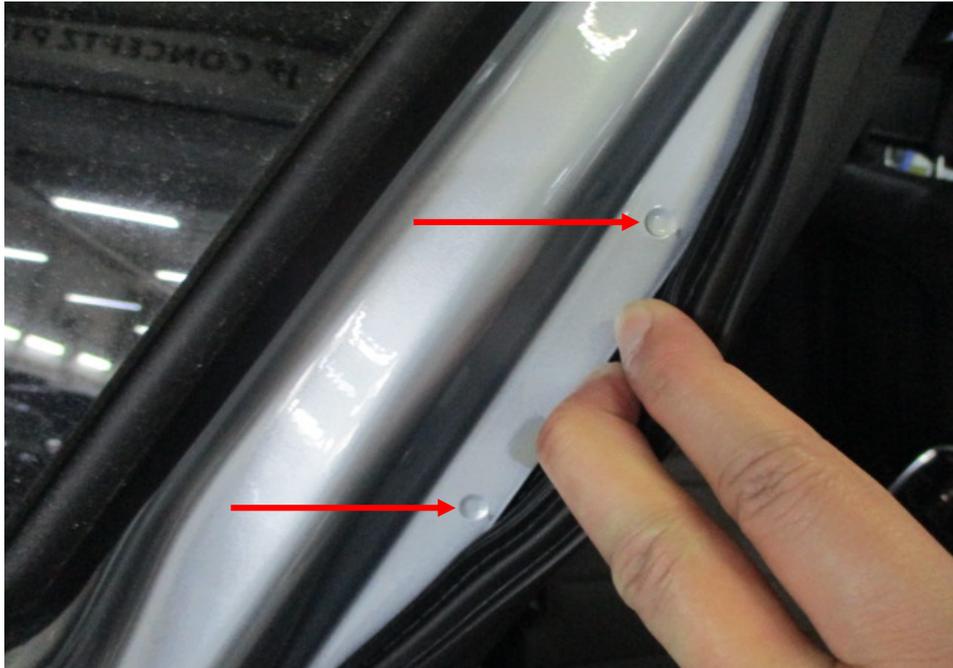
Photo 32 shows the right side “C” pillar of the Motor Car. I did not find any weld marks other than original spot weld marks (arrowed) on the right side “C” pillar of the Motor Car which, indicates that there was no re-welding works carried out. In general, I had found all the non-detachable body panels of the Motor Car to be originally fitted at the time of my inspection.

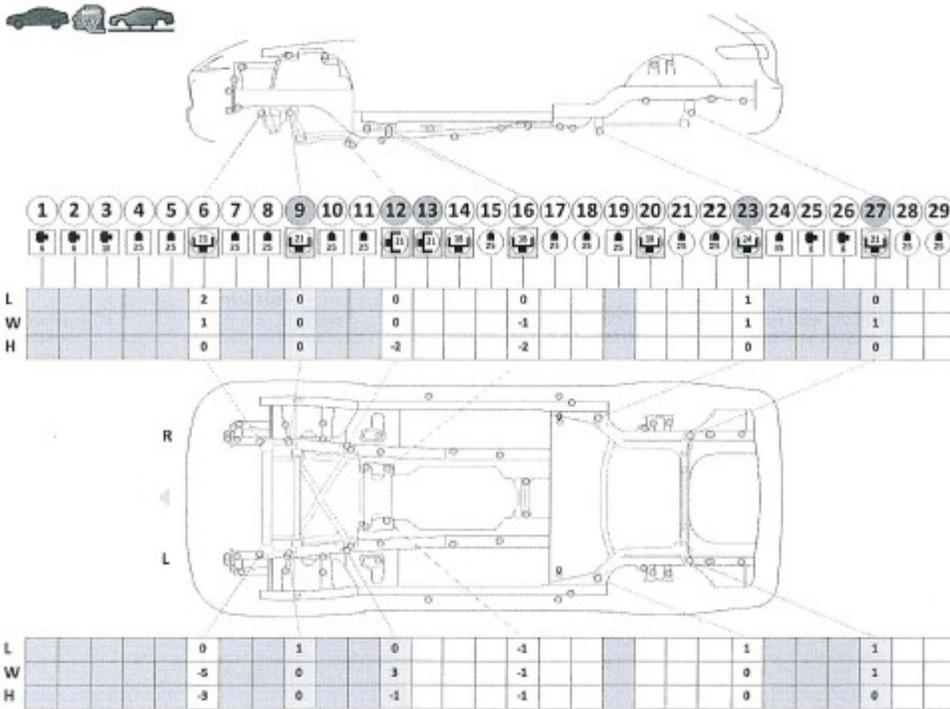
Appendix 1 shows the lower body chassis measurements of the Motor Car that was carried out by STA Inspection Pte Ltd on 14 April 2022. I note that the chassis/structural measurements of the Motor Car were within acceptable tolerance (arrowed).
