Your Ref: Porsche Macan
(chassis number WP1ZZZ95ZKLB09550)
Our Ref : CI/TP22004095/D

05 May 2022

Hong Hin Motor Works

INSPECTION REPORT OF AN UNREGISTERED PORSCHE MACAN MOTOR CAR WITH CHASSIS NUMBER WP1ZZZ95ZKLB09550

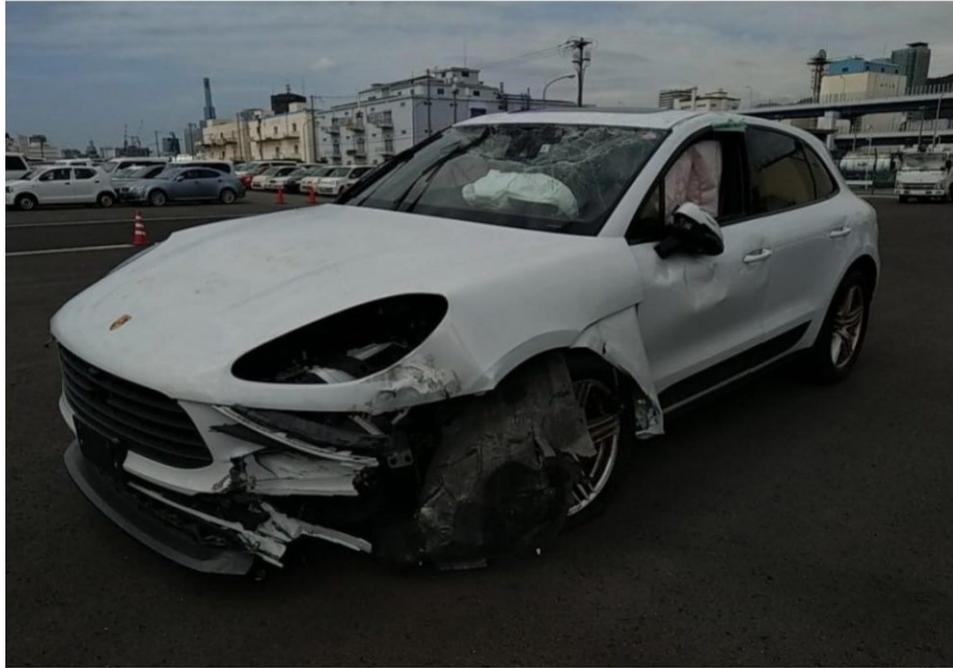
Photo 1 shows the front left body of the Motor Car (photograph provided to me). The photographs provided to me had showed damage to the front left portion and left side centre portion of the Motor Car. The front bumper, front bumper lower lip, front bumper left lower grille, front bumper left upper grille, front bumper centre lower grille, front left day light, front left headlamp, front bonnet, front windscreen front left fender, front left door and left wing mirror were amongst the body parts that were observed to have been damaged.

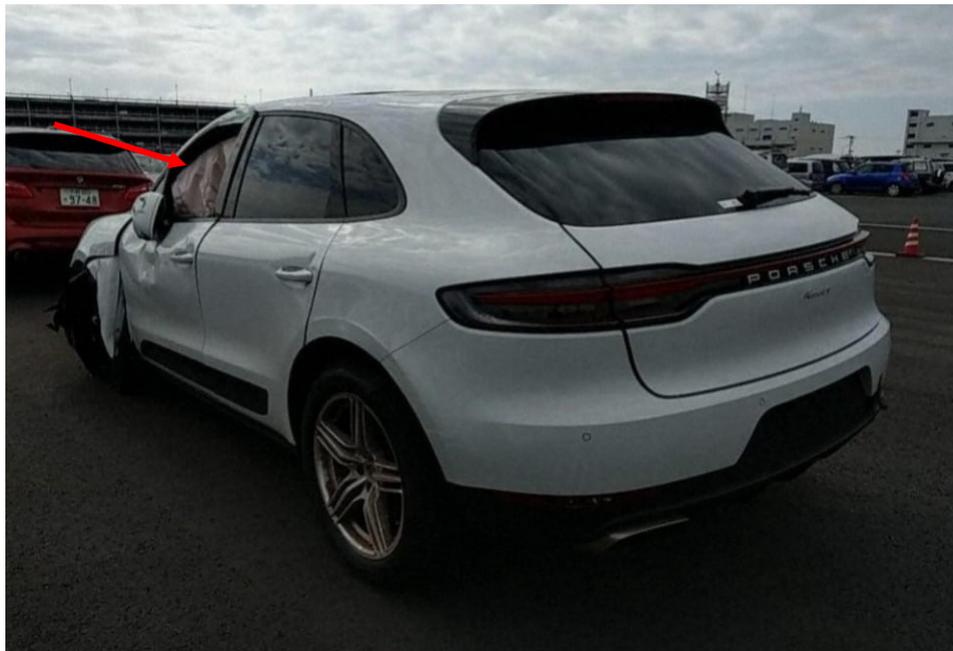
Photo 2 shows the rear left body of the Motor Car (photograph provided to me). The rear left door and front left door were observed to be damaged. The left curtain airbag was (arrowed) deployed. As for the Motor Car's rear portion, it was observed to be without physical damage.

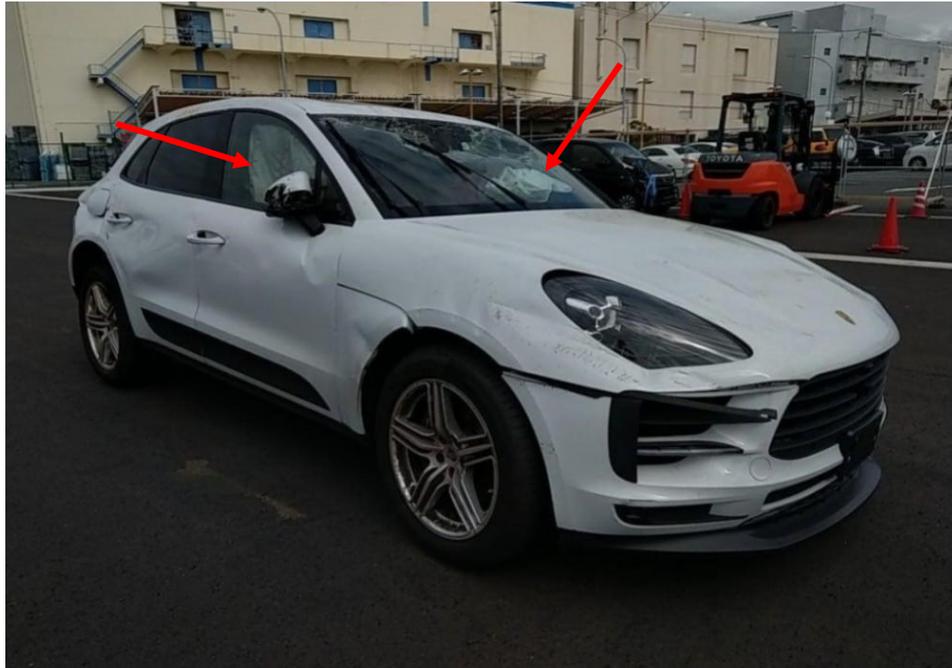
Photo 3 shows the front right body of the Motor Car (photograph provided to me). The photographs provided to me had showed damage to the right side portion of the Motor Car. The front right fender, front right door, front right door handle, rear right door and rear right door handle were amongst the body parts that were observed to have been damaged. The right curtain airbag and front left passenger airbag were deployed (arrowed).

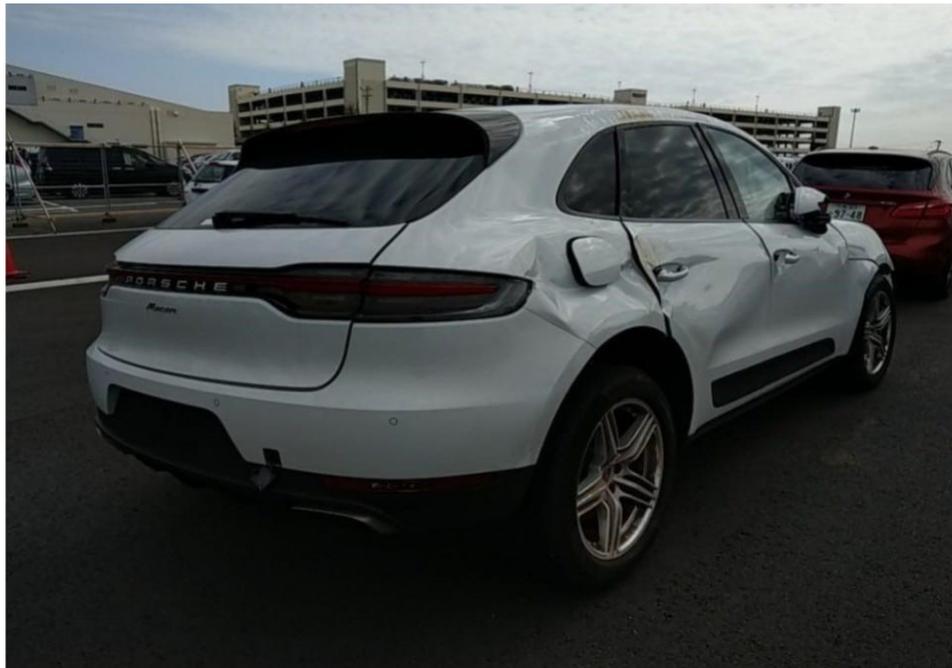
Photo 4 shows the rear right body of the Motor Car (photograph provided to me). The front right door, rear right door, rear right door handle, rear right fender and fuel tank filler cover were amongst the body parts that were observed to have been damaged at the right side portion of the Motor Car.

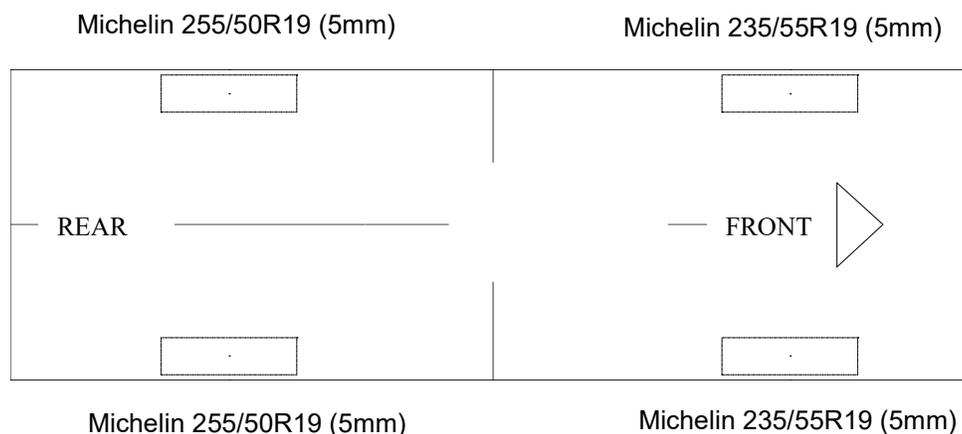
9. The Motor Car was fitted with 19inch sport wheel rims that were wrapped with tyres that were observed to be of serviceable condition. The tyres were also sufficiently inflated for vehicular operation. The tyre brand, tyre size and approximate remaining tread depth of the 4 tyres of the Motor Car were recorded as follows: -

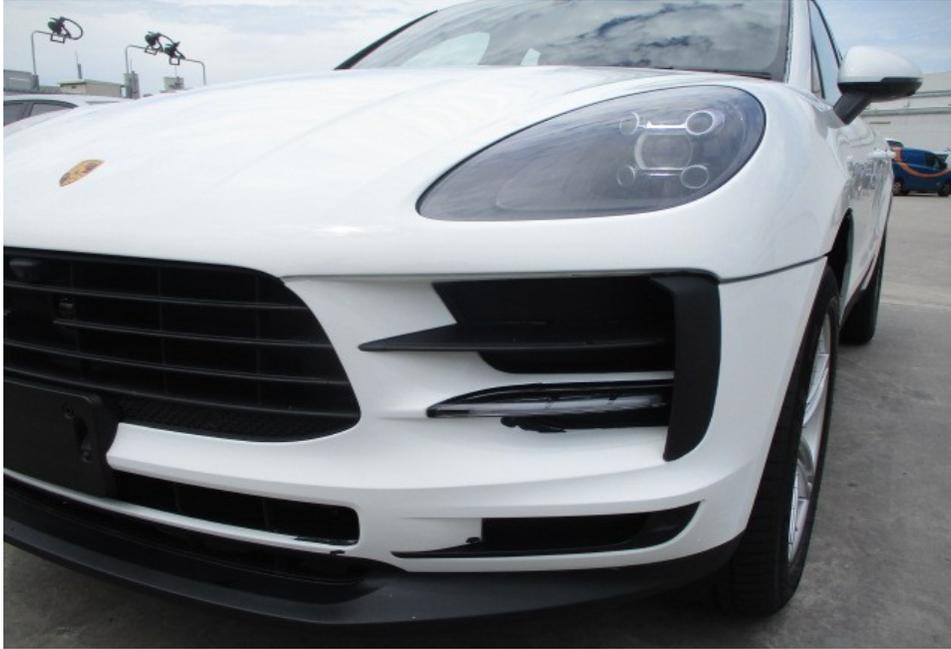
Photo 6 shows a closer view of the Motor Car's front bumper, front bumper lower lip, front bumper left lower grille, front bumper left upper grille, front left day light and front left headlamp. The body parts at the front left portion of the Motor Car were visually examined and it was observed that the repair/restoration works carried out to the damaged area of the Motor Car (refer to photograph 1 above) were reasonably adequate and in order.

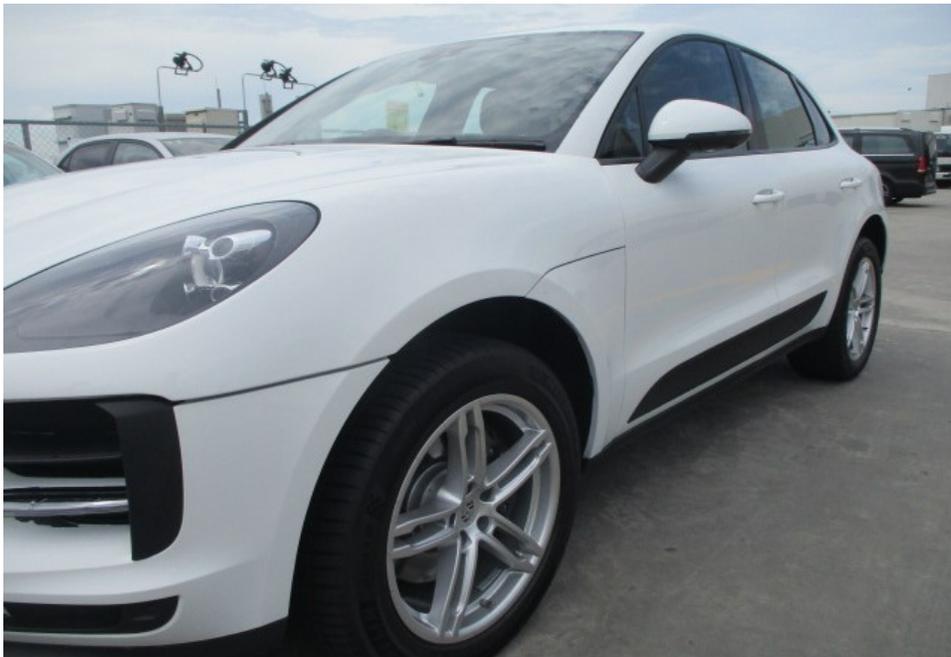
Photo 7 shows a closer view of the Motor Car's front bonnet, front left headlamp, front left fender and front left wheel rim. The body parts at the front left portion and left side centre portion of the Motor Car were visually examined and it was observed that the repair/restoration works carried out to the damaged area of the Motor Car (refer to photograph 1 & 2 above) were reasonably adequate and in order.

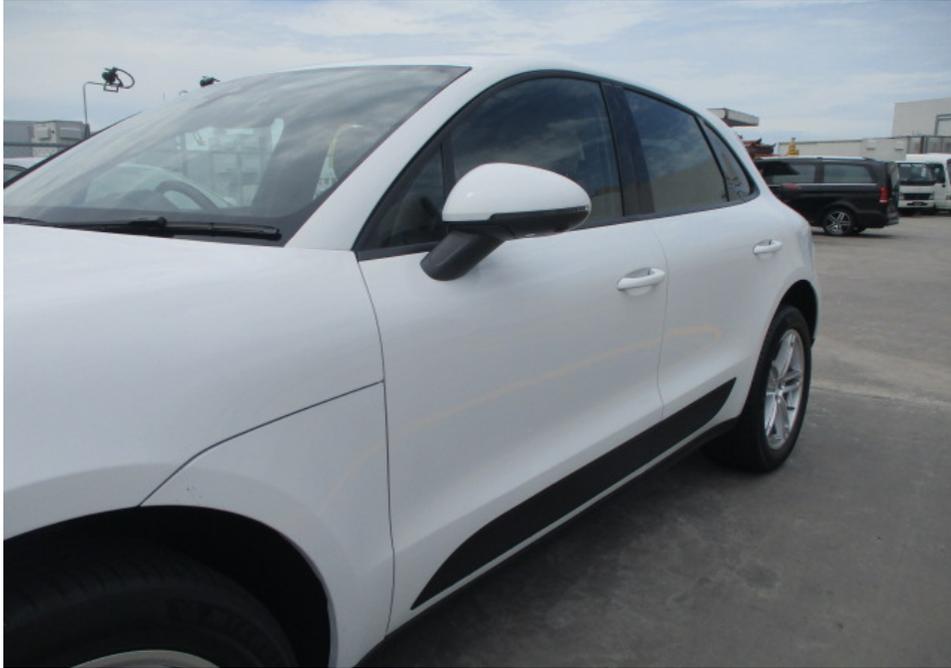
Photo 8 shows a closer view of the Motor Car's front left fender, front left door, front windscreen and left wing mirror. The body parts at the left side centre portion of the Motor Car were visually examined and it was observed that the repair/restoration works carried out to the damaged area of the Motor Car (refer to photograph 1 & 2 above) were reasonably adequate and in order.

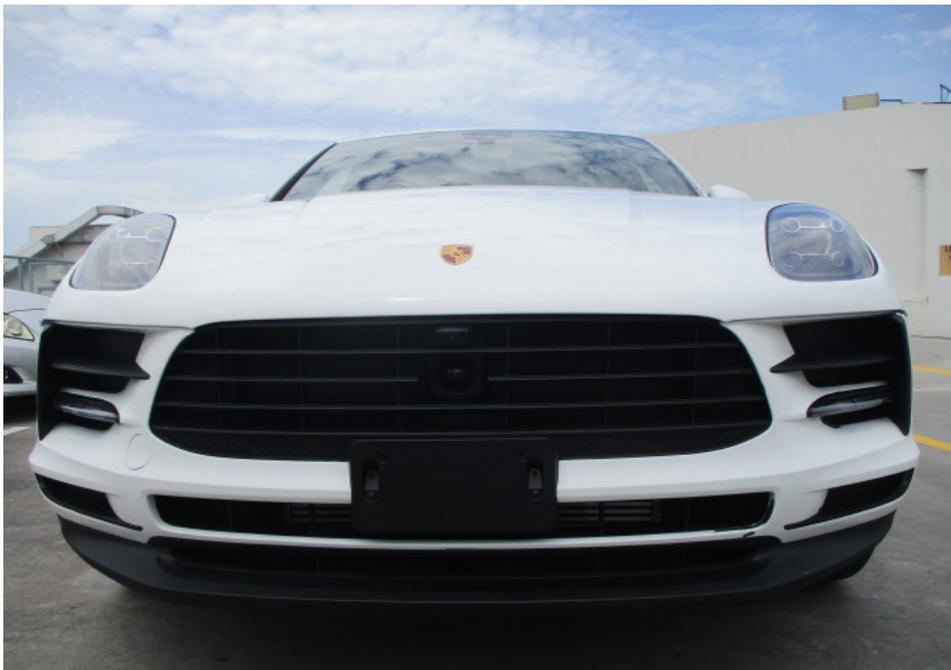
Photo 9 shows a closer view of the Motor Car's front bumper, front bumper centre lower grille, radiator grille, front sensor unit and front bonnet. The body parts at the frontal portion of the Motor Car were visually examined and it was observed that the repair/restoration works carried out to the damaged area of the Motor Car (refer to photograph 1 above) were reasonably adequate and in order.

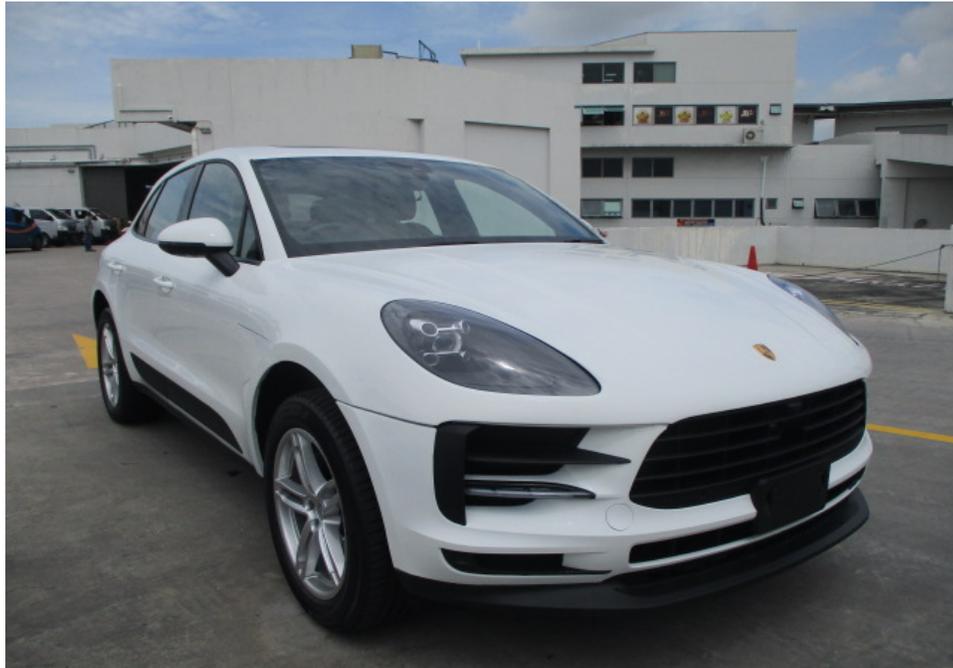
Photo 10 shows a general view of the front right body of the Motor Car at the time of my inspection. The Motor Car was observed to be in a relatively good general condition with no loose exterior fittings observed. The mileage of the Motor Car recorded at the time of my inspection was 22,177km.

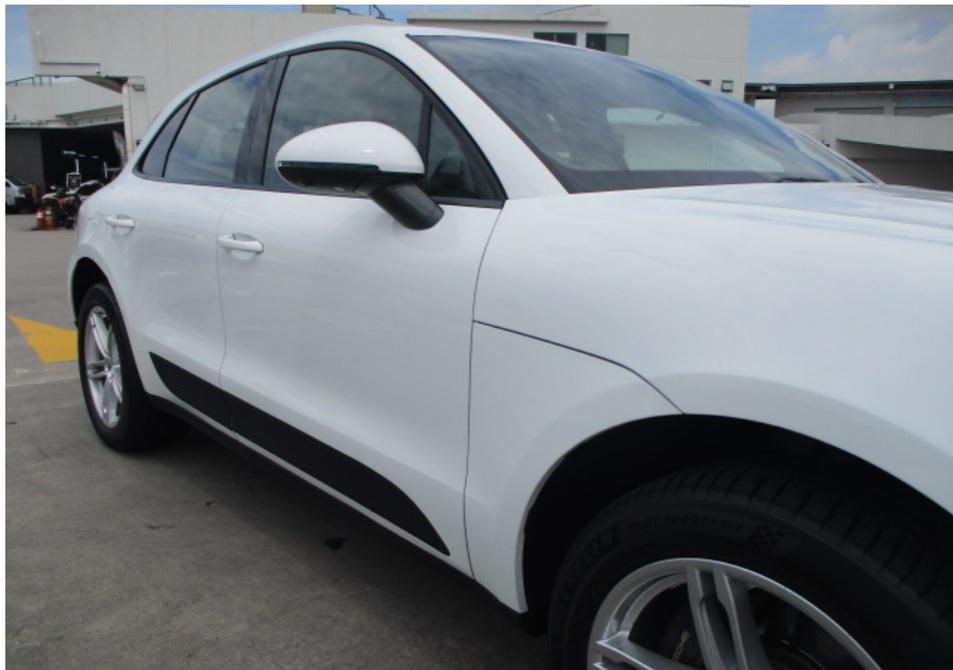
Photo 11 shows a closer view of the Motor Car's front right fender, front right door, front right door handle, front windscreen and right wing mirror. The body parts at the right side portion of the Motor Car were visually examined and it was observed that the repair/restoration works carried out to the damaged area of the Motor Car (refer to photograph 3 above) were reasonably adequate and in order.

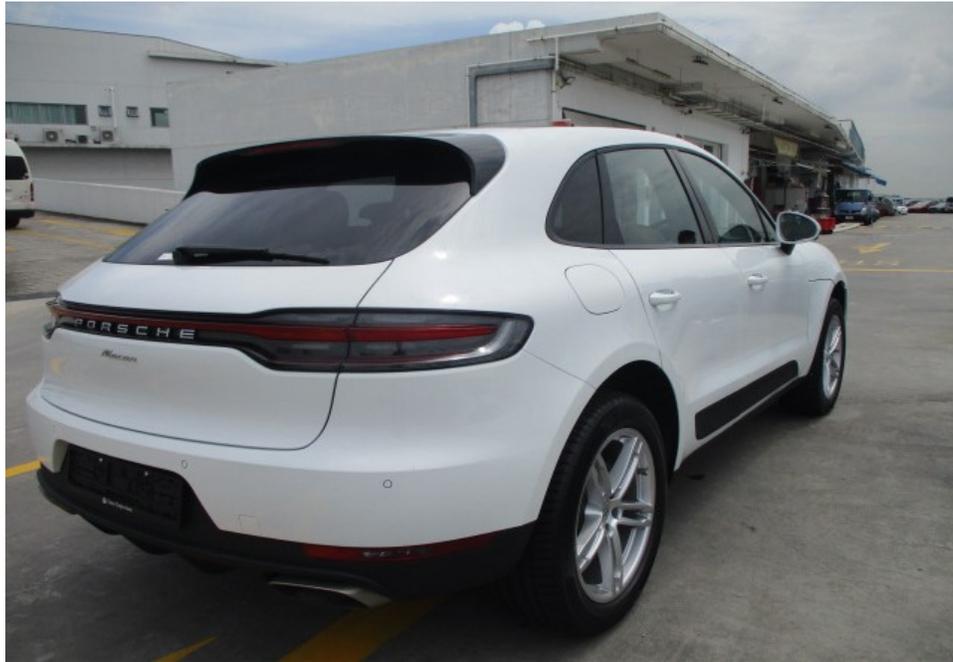
Photo 12 shows a general view of the rear right body of the Motor Car at the time of my inspection. The Motor Car was observed to be in a relatively good general condition with no loose exterior fittings observed. The body parts at the right side portion of the Motor Car were visually examined and it was observed that the repair/restoration works carried out to the damaged area of the Motor Car (refer to photograph 3 & 4 above) were reasonably adequate and in order.

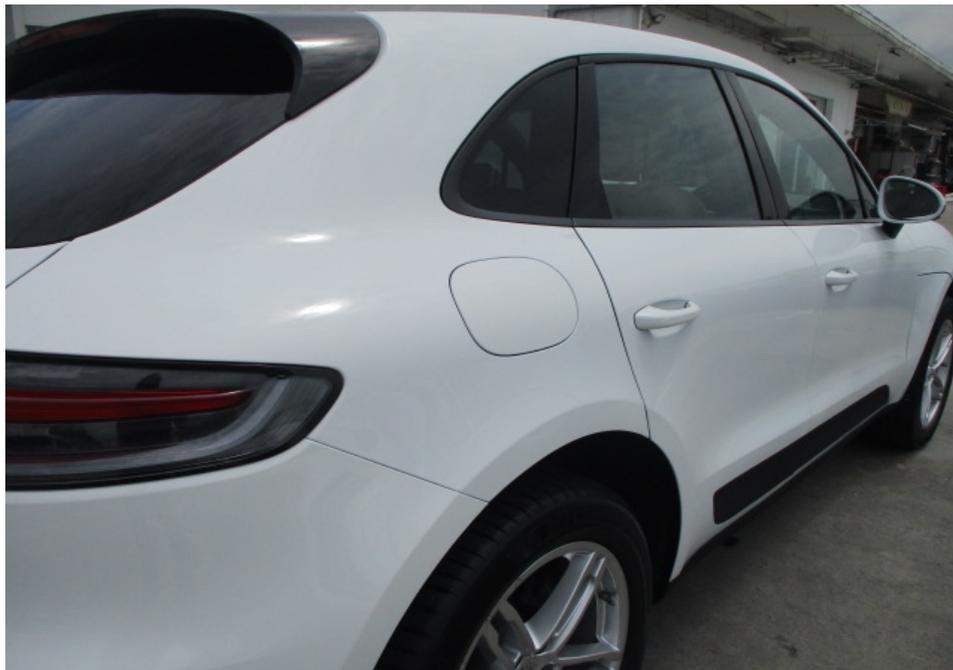
Photo 13 shows a closer view of the Motor Car's rear right fender, rear right door, rear right door handle and fuel tank filler cover. The body parts at the right side portion of the Motor Car were visually examined and it was observed that the repair/restoration works carried out to the damaged area of the Motor Car (refer to photograph 4 above) were reasonably adequate and in order.

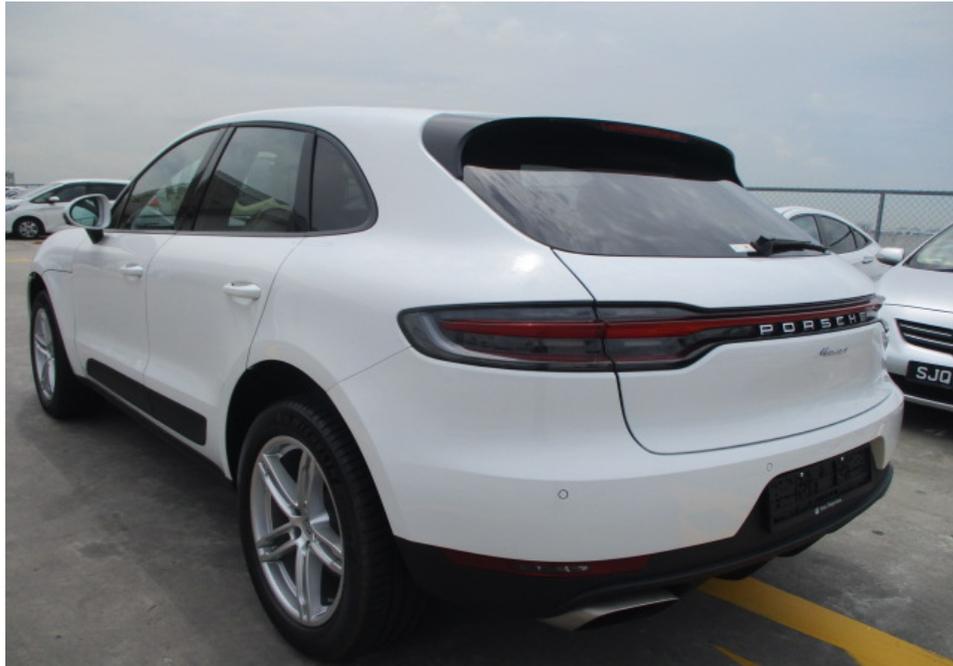
Photo 14 shows a general view of the rear left body of the Motor Car at the time of my inspection. The Motor Car was observed to be in a relatively good general condition with no loose exterior fittings observed. The mileage of the Motor Car recorded at the time of my inspection was 22,177km.

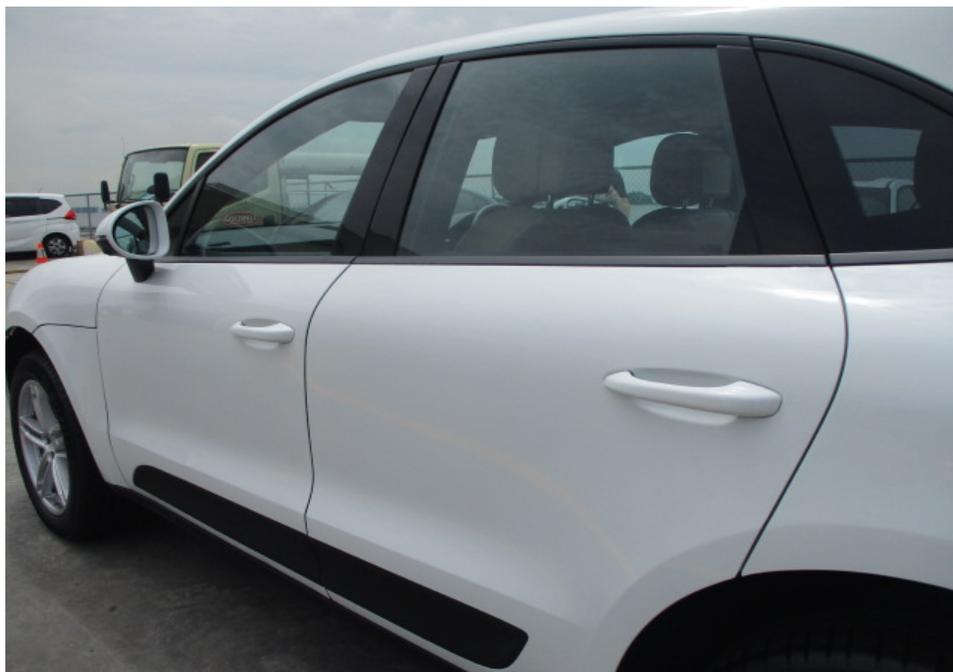
Photo 15 shows a closer view of the Motor Car's rear left door, front left door and left wing mirror. The body parts at the left side centre portion of the Motor Car were visually examined and it was observed that the repair/restoration works carried out to the damaged area of the Motor Car (refer to photograph 2 above) were reasonably adequate and in order.

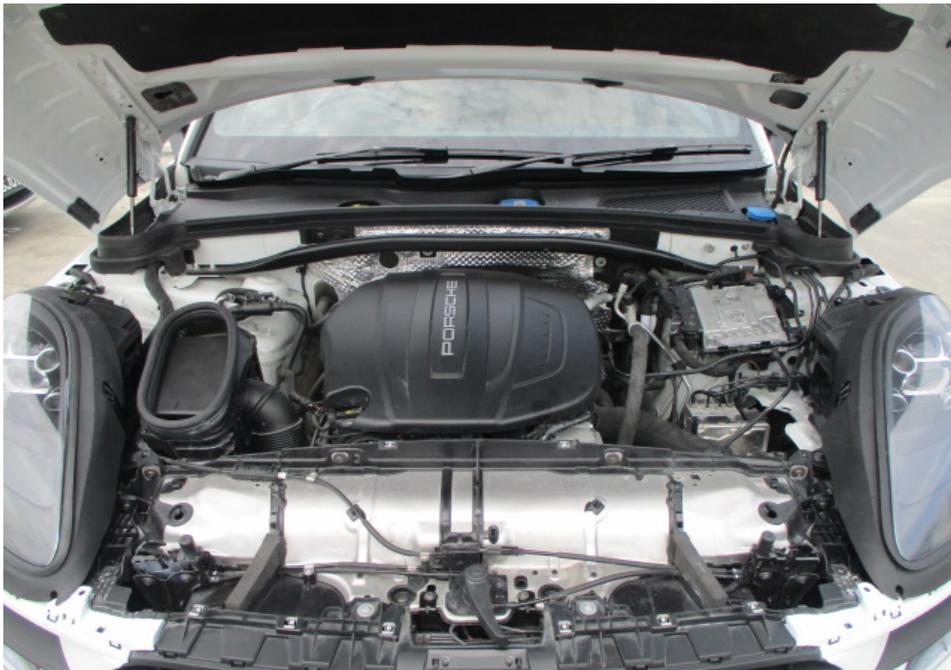
Photo 17 shows a general view of the engine compartment of the Motor Car at the time of my inspection. The various parts and components inside the engine compartment were all observed to be intact and properly fitted. There was also no sign(s) or indication(s) of fluid leak and/or fluid stain found inside the engine compartment.

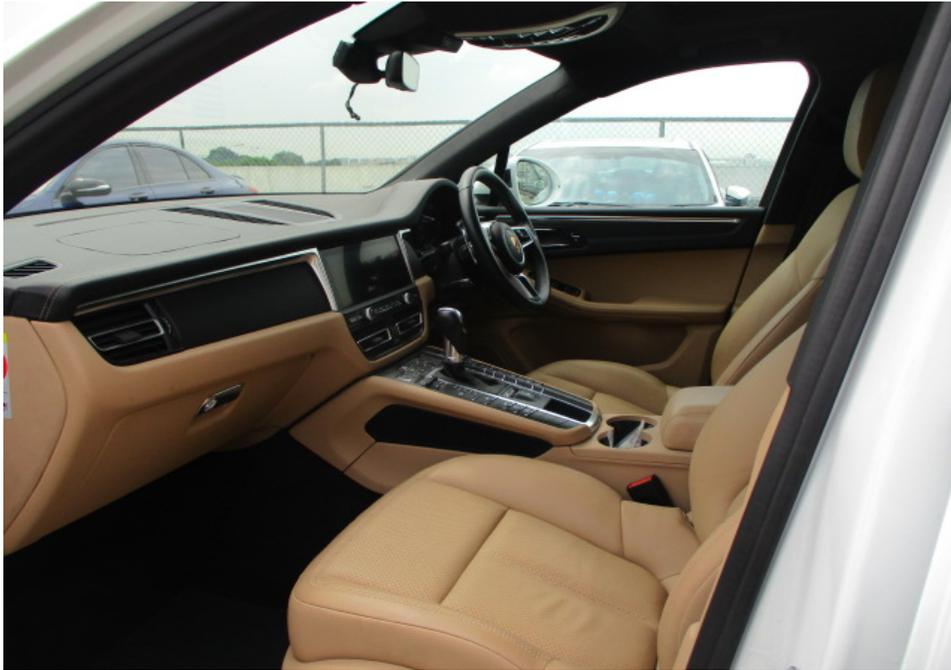
Photo 18 shows the interior compartment of the Motor Car at the time of my inspection. The various parts and components, trims, carpet, and upholstery inside the interior compartment were all observed to be intact and properly fitted.

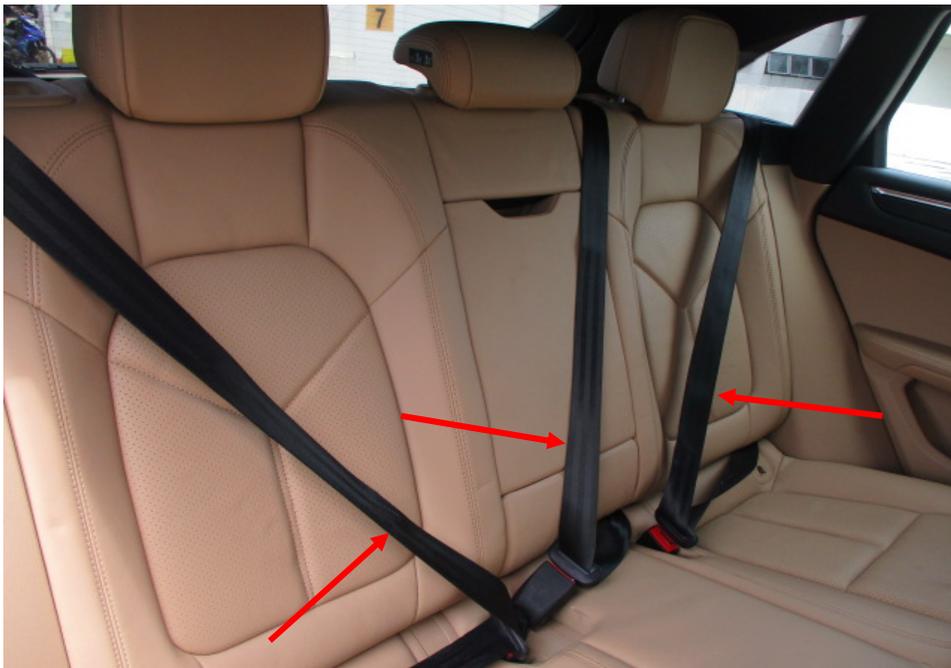
Photo 19 shows the rear seats of the Motor Car. All the seats of the Motor Car were secured via seat rails to the floorboard. They were also fitted with a retractable seat belt reel and a pre-tensioner. The seat belts (arrowed) were tested and were able to be fastened into the respective pre-tensions that were fitted on the side of each individual seat.

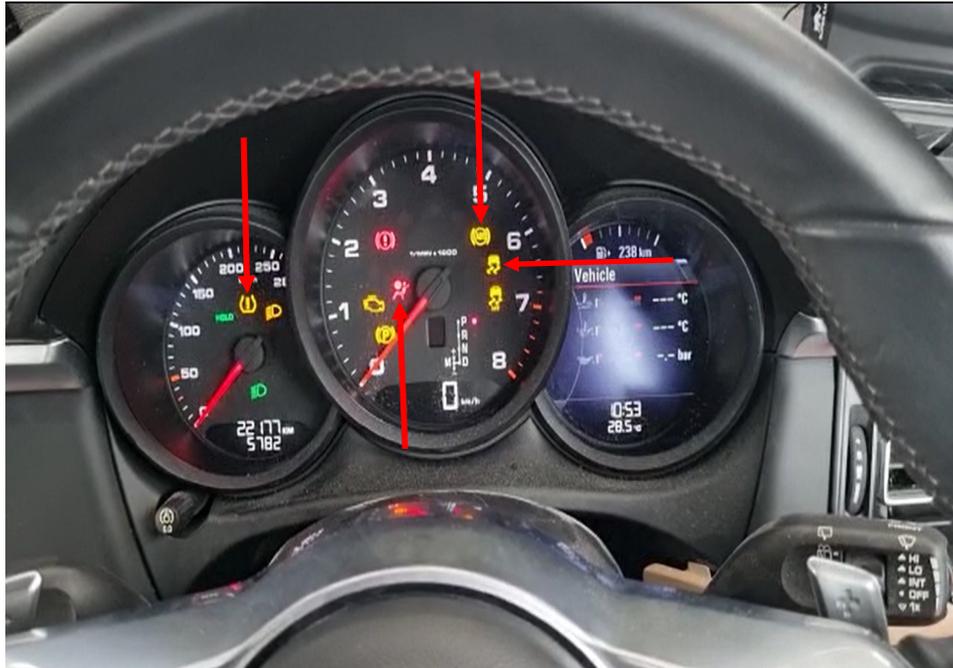
Photo 20 shows the warning lights for the various electronic safety features appearing on the instrument panel of the Motor Car during its self-test when the engine is cranked, in particular the ABS, SRS, TPM and TCS lights (arrowed).

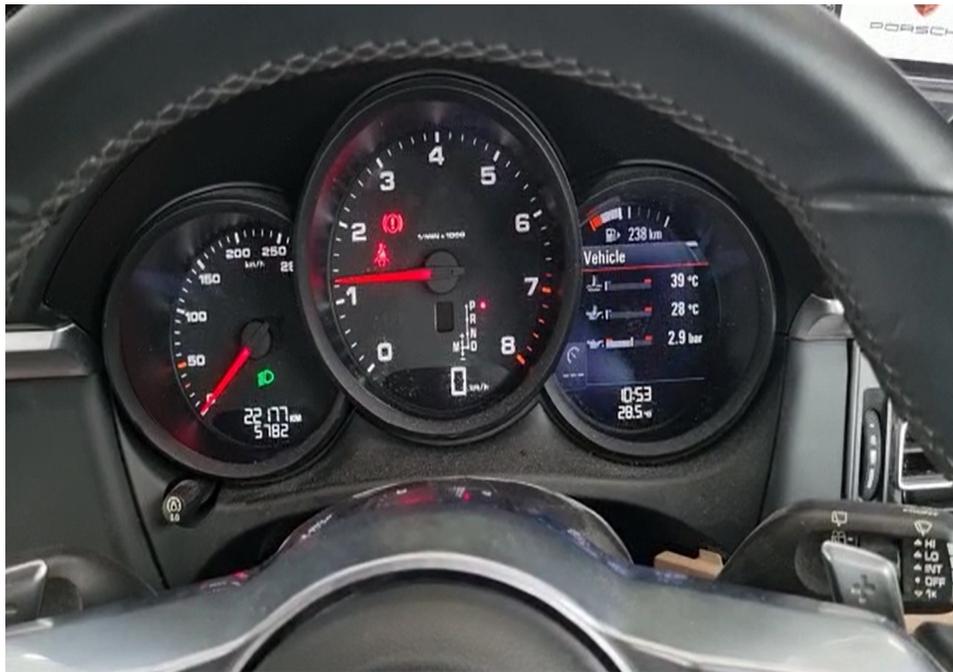
Photo 21 shows the respective warning lights no longer illuminated, indicating that there is no fault detected to the ABS, SRS, TPM and TCS systems of the Motor Car during the self-test. These electronic systems were hence in working condition at the time of my inspection.

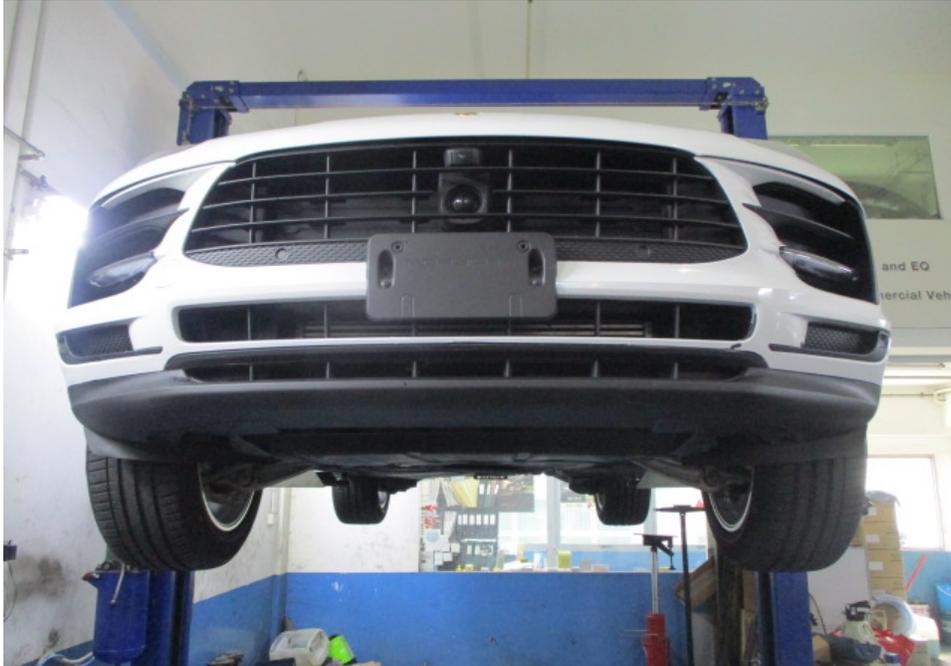
Photo 22 shows the Motor Car hoisted up for checks on its undercarriage. There was no sign(s) or indication(s) of fluid leakage and/or fluid stain(s) on the underside of the Motor Car. The undercarriage components of the Motor Car were also all observed to be intact and secured in an appropriate manner.

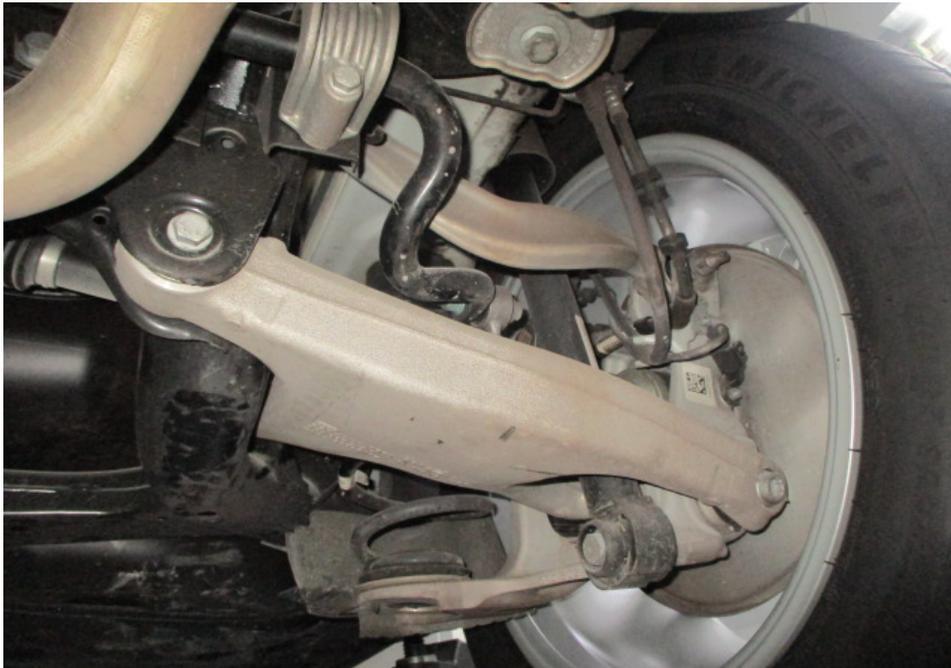
Photo 23 shows a general view of the control arms and linkages at the rear right wheel of the Motor Car. I did not observe any fluid leak and/or fluid stain on the underside of the Motor Car. All of the Motor Car's undercarriage components were observed to be intact and secured in an appropriate manner.

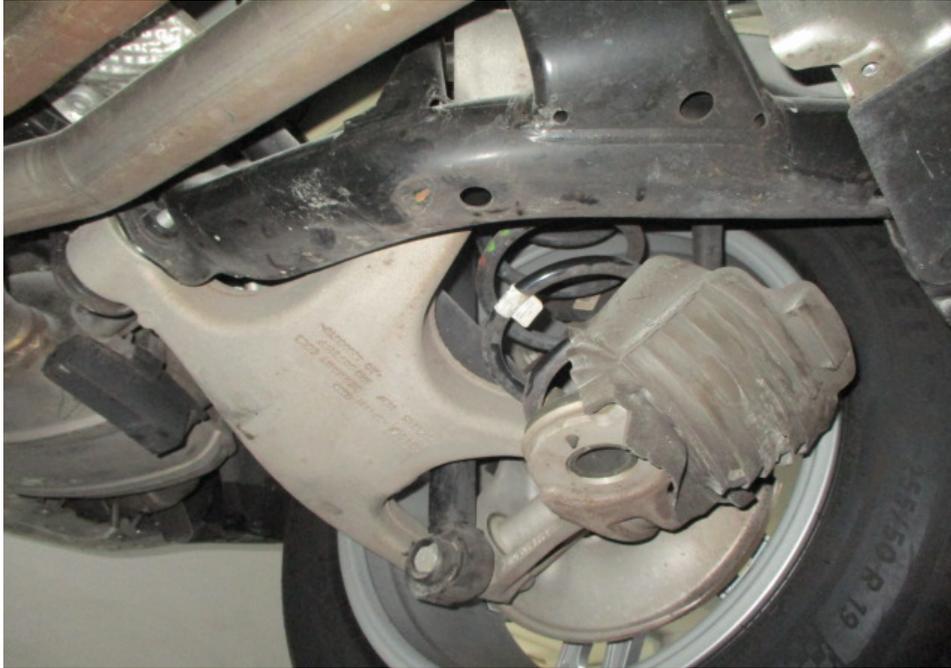
Photo 24 shows a general view of the control arms and linkages at the rear left wheel of the Motor Car. I did not observe any fluid leak and/or fluid stain on the underside of the Motor Car. All of the Motor Car's undercarriage components were observed to be intact and secured in an appropriate manner.

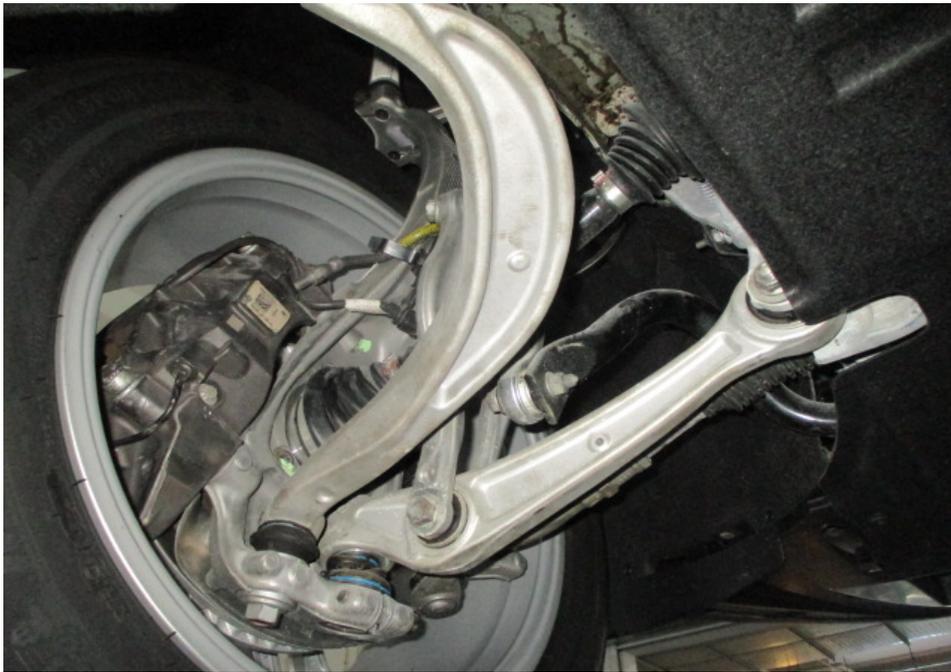
Photo 25 shows the various undercarriage components at the front left wheel of the Motor Car. The mechanical components, control arms and linkages were all found to be intact and secured in an appropriate manner.

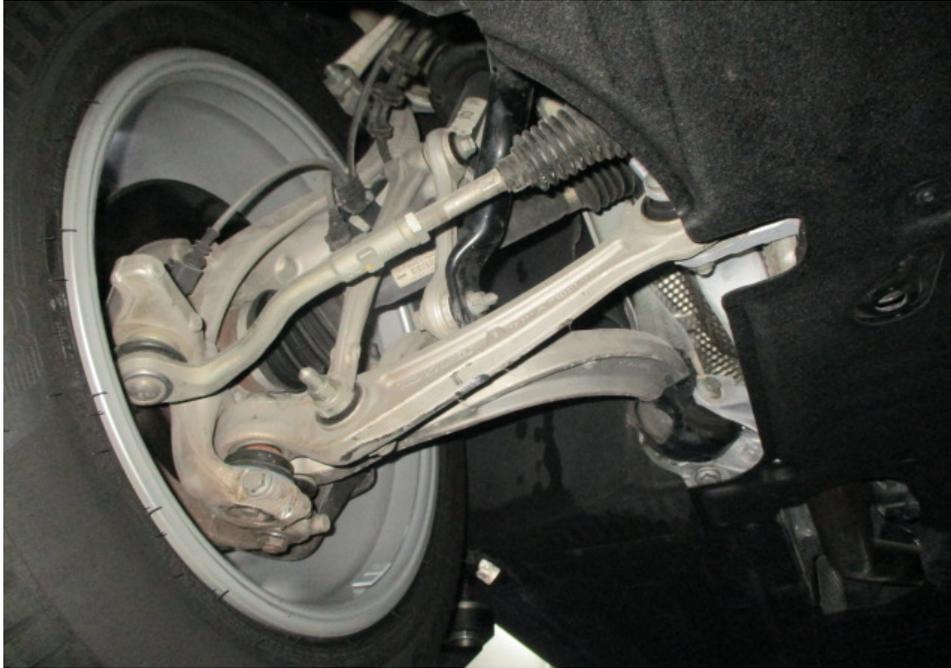
Photo 26 shows the various undercarriage components at the front right wheel of the Motor Car. The mechanical components, control arms and linkages were all found to be intact and secured in an appropriate manner. I also did not observe any fluid leak and/or fluid stain on the underside of the Motor Car.

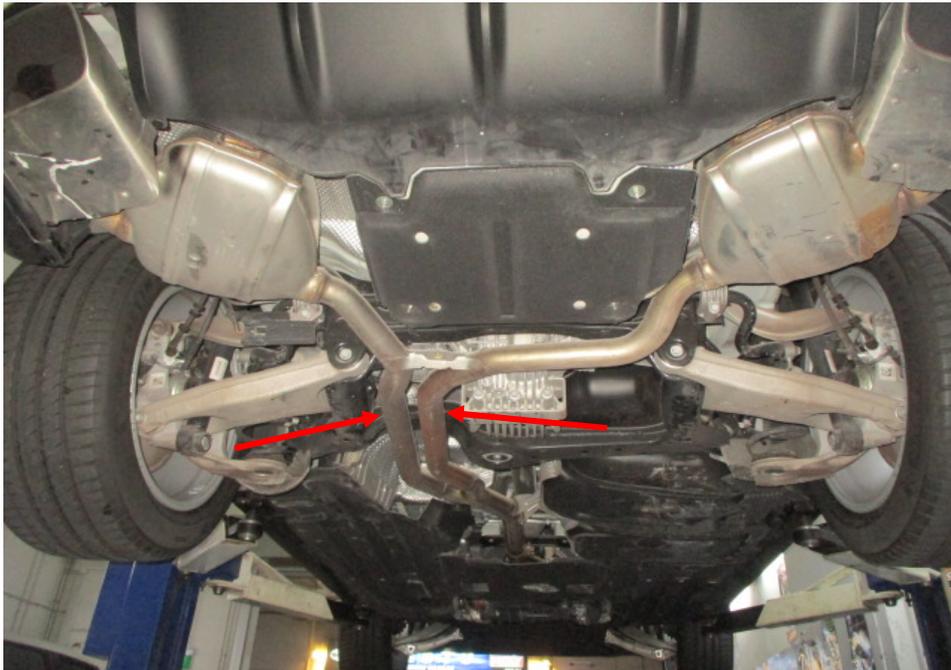
Photo 27 shows the rear section of the Motor Car's exhaust system. My examination of the Motor Car's exhaust system revealed no sign(s) or indication(s) of any cut or weld marks along its exhaust pipes (arrowed), on its rear mufflers and on its catalytic converter.

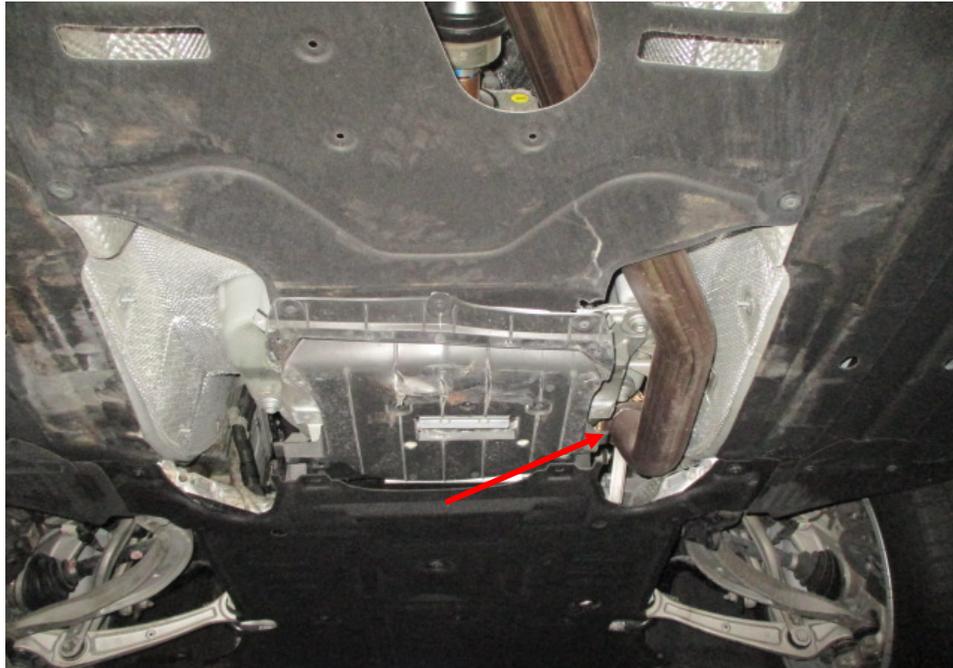
Photo 28 shows the front section of the Motor Car's exhaust system. My examination of the Motor Car's exhaust system revealed no sign(s) or indication(s) of any cut or weld marks along its exhaust pipes, on its rear mufflers, and on its catalytic converter (arrowed).

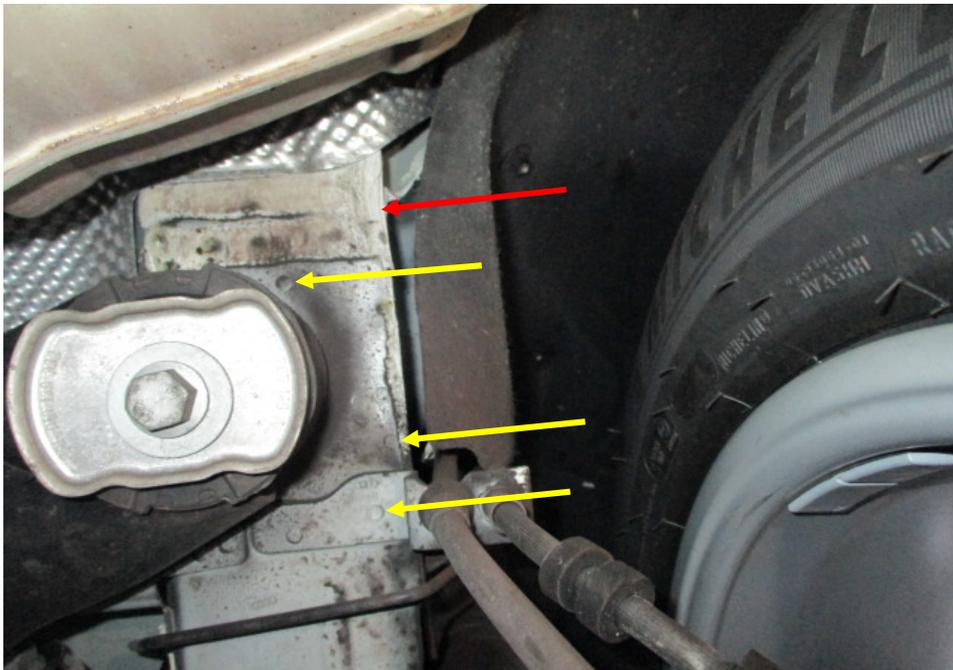
Photo 29 shows the chassis/structural body at the underside rear right of the Motor Car. I did not find any weld marks other than original spot weld marks (yellow arrow) on the chassis/structural body of the Motor Car. The original factory sealant (red arrow) at the joints along the chassis/structural body was untouched, indicating no work was done on the chassis/structural body of the Motor Car and that the chassis/structural body was originally fitted.

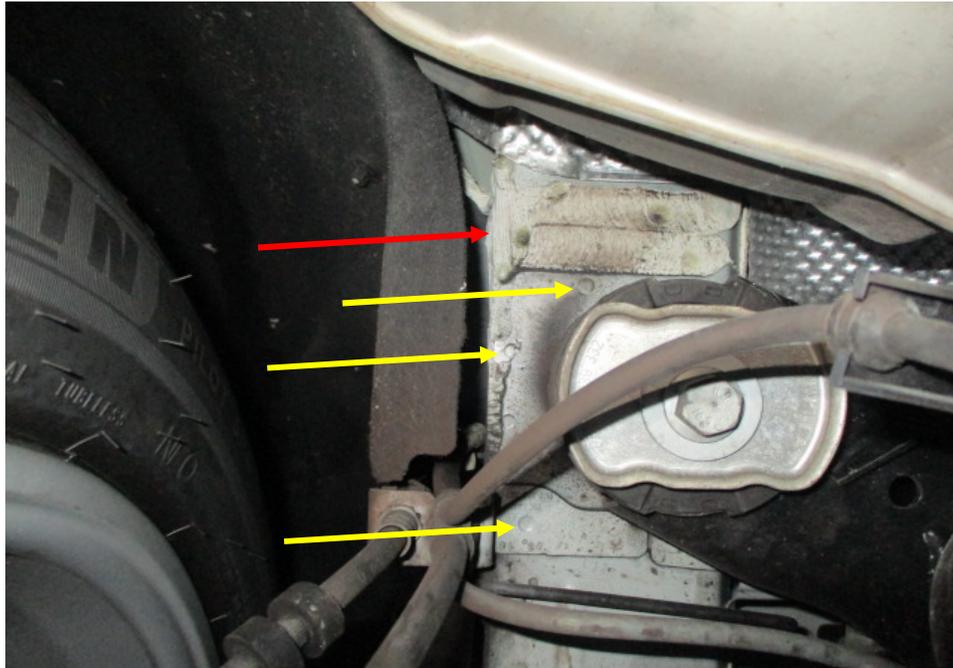
Photo 30 shows the chassis/structural body at the underside rear left of the Motor Car. I did not find any weld marks other than original spot weld marks (yellow arrow) on the chassis/structural body of the Motor Car. The original factory sealant (red arrow) at the joints along the chassis/structural body was untouched, indicating no work was done on the chassis/structural body of the Motor Car and that the chassis/structural body was originally fitted.

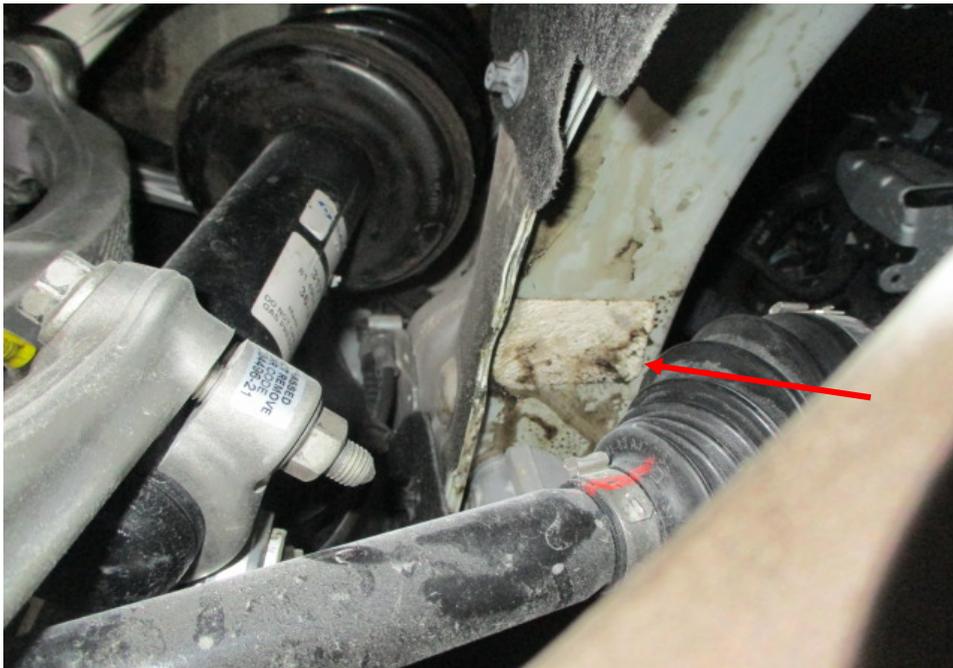
Photo 31 shows the chassis/structural body at the underside front left of the Motor Car. The original factory sealant (arrowed) at the joints along the chassis/structural body was observed to be untouched. In general, I had found no work was carried out on the chassis/structural body of the Motor Car. The chassis/structural body of the Motor Car was originally fitted.

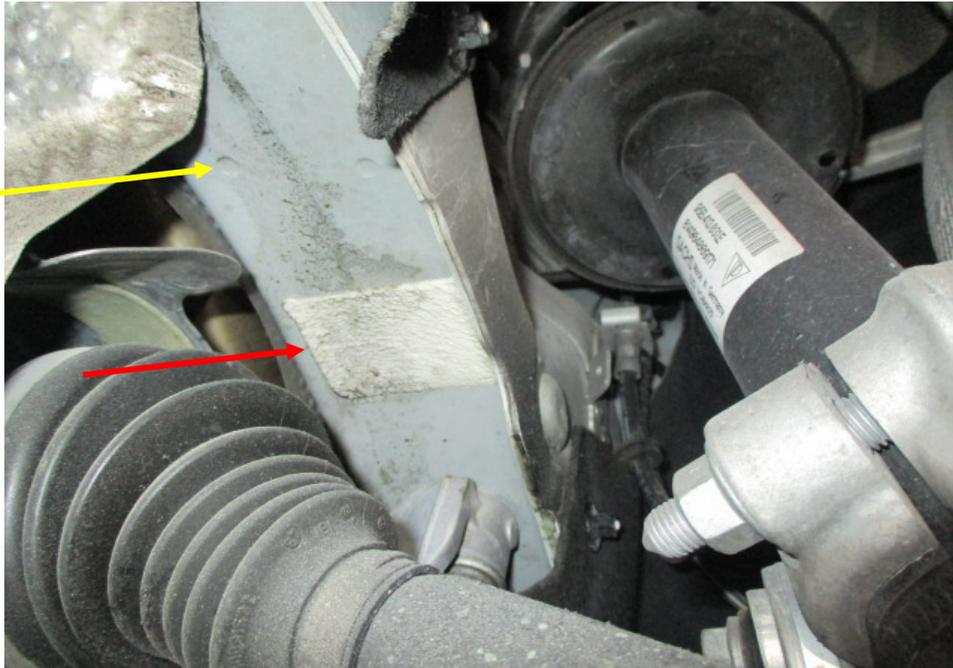
Photo 32 shows the chassis/structural body at the underside front right of the Motor Car. I did not find any weld marks other than original spot weld marks (yellow arrow) on the chassis/structural body of the Motor Car. The original factory sealant (red arrow) at the joints along the chassis/structural body was untouched, indicating no work was done on the chassis/structural body of the Motor Car and that the chassis/structural body was originally fitted.
