Your Ref: Porsche Macan
(chassis number WP1ZZZ95ZKLB09550)
Our Ref : CI/TP22004095/D

05 May 2022

Hong Hin Motor Works

INSPECTION REPORT OF AN UNREGISTERED PORSCHE MACAN MOTOR CAR WITH CHASSIS NUMBER WP1ZZZ95ZKLB09550

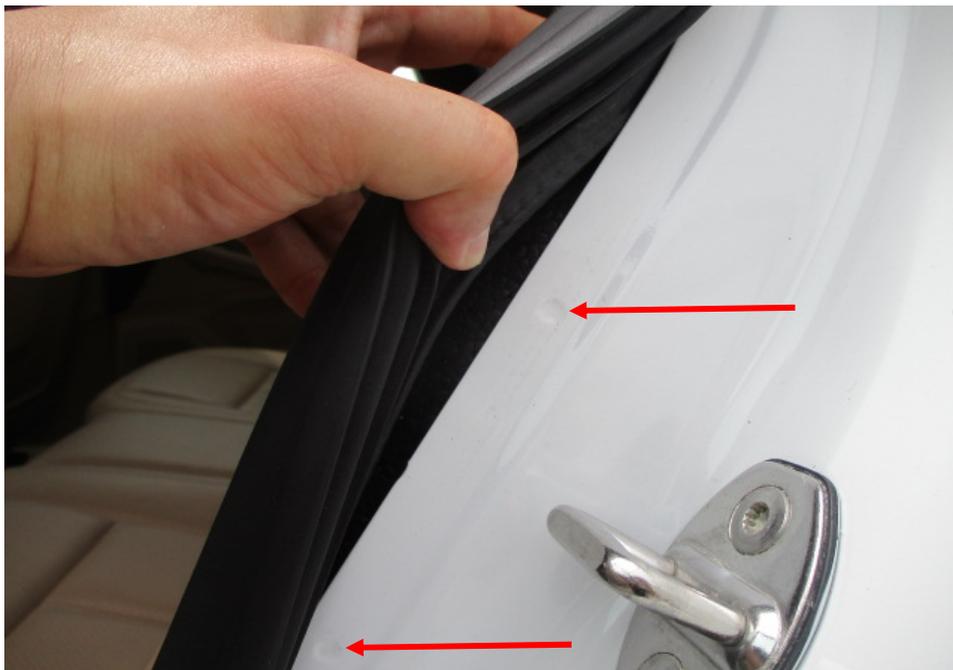
Photo 33 shows the left side "C" pillar of the Motor Car. I did not find any weld marks other than original spot weld marks (arrowed) on the left side "C" pillar of the Motor Car which, indicates that there was no re-welding works carried out. In general, I had found all the non-detachable body panels of the Motor Car to be originally fitted at the time of my inspection.

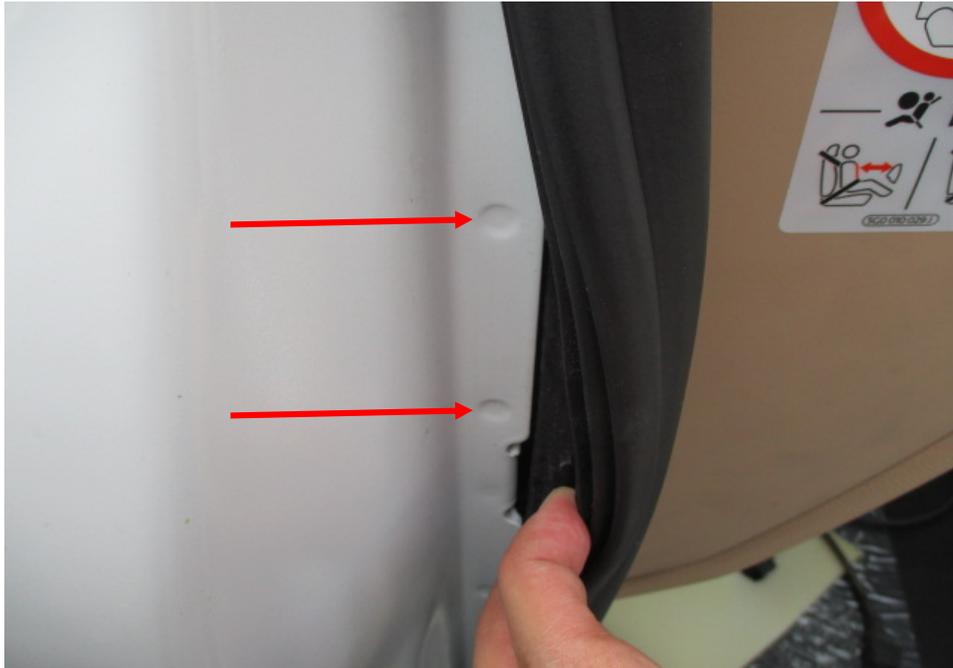
Photo 34 shows the left side "A" pillar of the Motor Car. I did not find any weld marks other than original spot weld marks (arrowed) on the left side "A" pillar of the Motor Car which, indicates that there was no re-welding works carried out. In general, I had found all the non-detachable body panels of the Motor Car to be originally fitted at the time of my inspection.

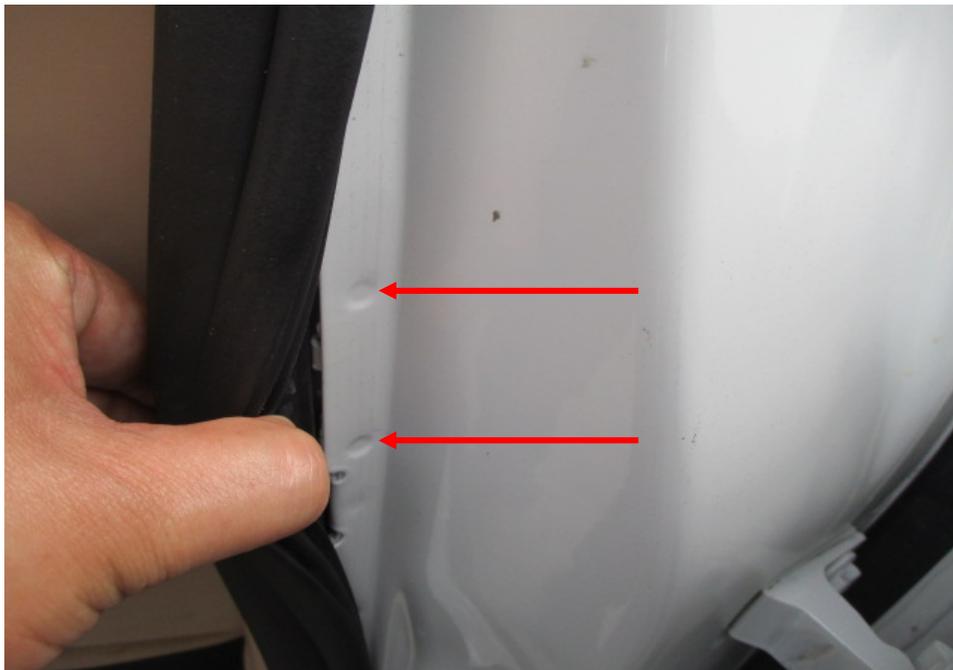
Photo 35 shows the right side "A" pillar of the Motor Car. I did not find any weld marks other than original spot weld marks (arrowed) on the right side "A" pillar of the Motor Car which, indicates that there was no re-welding works carried out. In general, I had found all the non-detachable body panels of the Motor Car to be originally fitted at the time of my inspection.

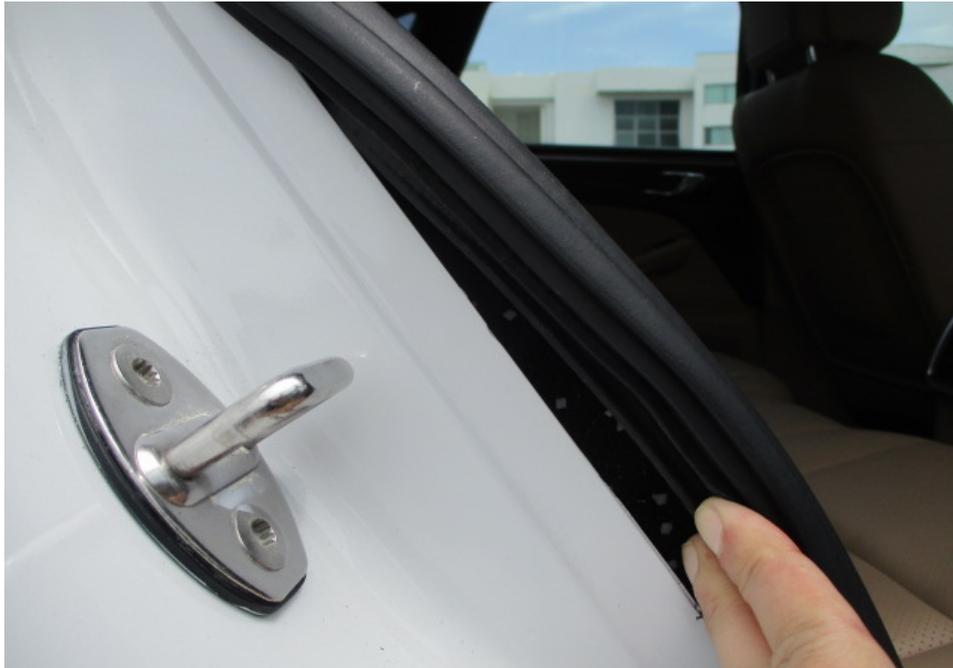
11. Checks on the non-detachable body panels like the rear fenders, floorboard, roof panel, pillars and rocker panels amongst others, revealed that these body panels were spot welded onto the chassis/structural body of the Motor Car. The original factory sealant at the joints of the non-detachable body panels was all untouched indicating no replacement of the non-detachable body panels was carried out; and that these body panels were all originally fitted, except for the rear right fender which was found to be replaced. Refer to photograph 36 below.

Photo 36 shows the right side “C” pillar of the Motor Car. I did not find any original weld marks at the right side “C” pillar of the Motor Car, indicating that the rear right fender of the Motor Car was replaced. The lack of original weld marks seen was due to replacement work when the replaced rear right fender was re-welded onto the Motor Car and smoothen for re-spraying work
