Your Ref : 266146
Our Ref : CI/MSG22004574/D

19 May 2022

**AUTOMOBILE TECHNICAL INVESTIGATION REPORT OF ACCIDENT
INVOLVING YP 6099X AND XD 5502E ON 27 NOVEMBER 2021**

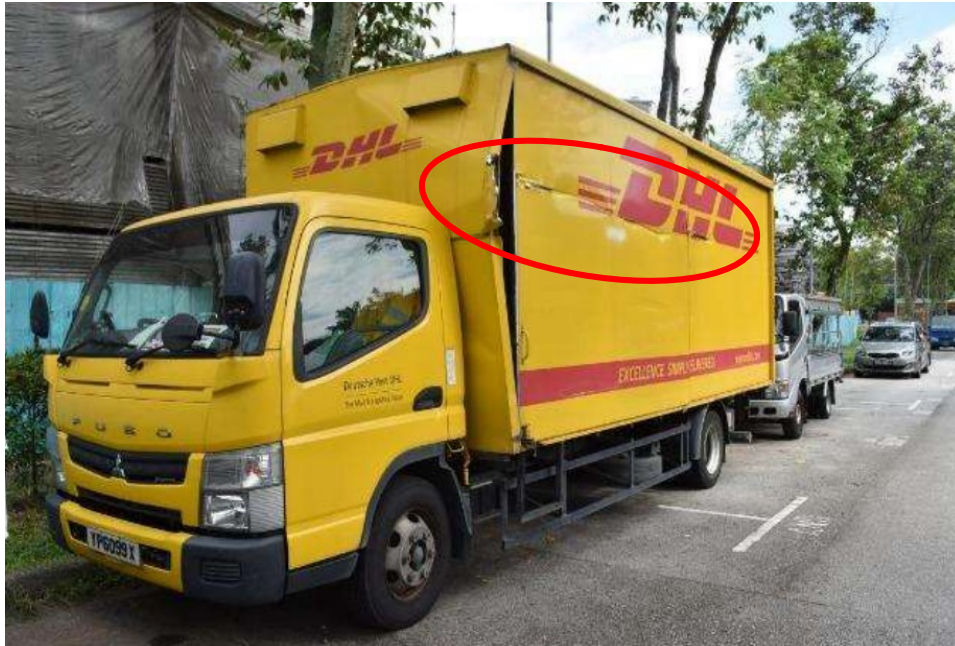
12. The Vehicle Damage Inspection Report of the Insured Vehicle that was provided to me had contain photographs that were taken before the start of its repair. Upon review of these photographs, I note that the Insured Vehicle had sustained damage that was confined to its left centre portion. The cargo box of the Insured Vehicle was observed to be cut at the left sliding door and at the left rear panel, at the area adjacent to the left sliding door. The cut was horizontally across the left sliding door and left rear panel, at a significant height above ground level. The frame at the left side of the front facing panel of the cargo box was also observed to be bent towards the front of the Insured Vehicle.

13. Overall, the damage pattern of the Insured Vehicle suggests that an object with protruding sharp edge(s) had horizontally cut into the left side of the cargo box, in a rear to front direction of the Insured Vehicle. See photo 1 - 3 below.

Photo 1 shows the Insured Vehicle before the start of repair. The photographs contained in the Vehicle Damage Inspection Report of the Insured Vehicle had showed damage that was confined to the left centre portion (circled) of the Insured Vehicle. The left sliding door and left rear panel of the Insured Vehicle's cargo box was observed to be horizontally cut. The frame at the left side of the front facing panel of the cargo box was also observed to be bent.

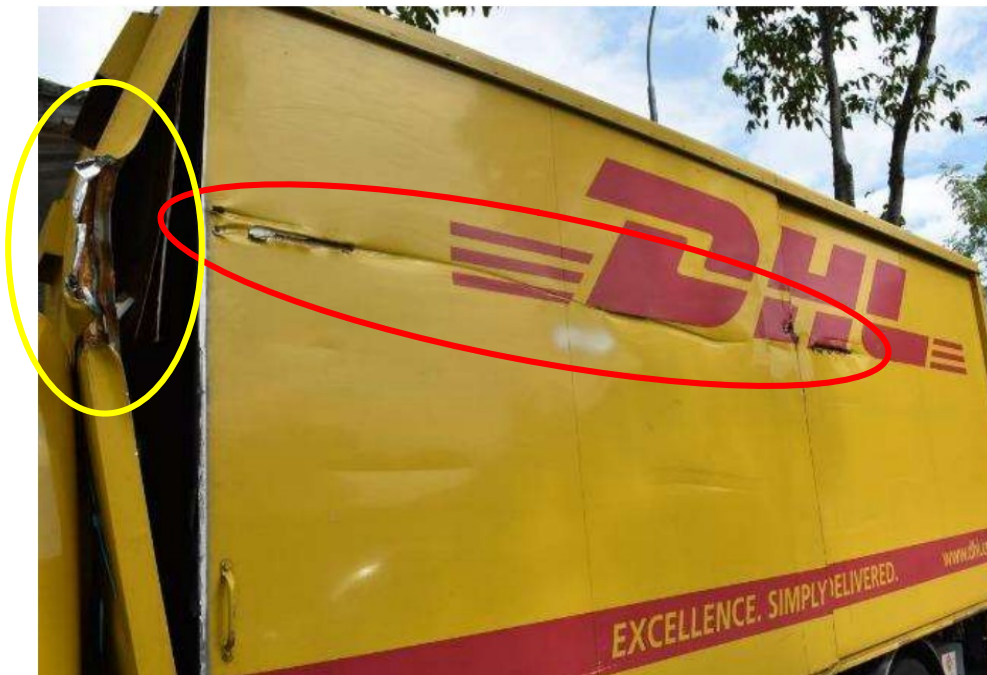
Photo 2 shows a closer view of the damaged cargo box, at the left centre portion of the Insured Vehicle. The cut to the cargo box was horizontally across the left sliding door and left rear panel (red circle), at a significant height above ground level. The frame (yellow circle) at the left side of the front facing panel of the cargo box was also observed to be bent towards the front of the Insured Vehicle.

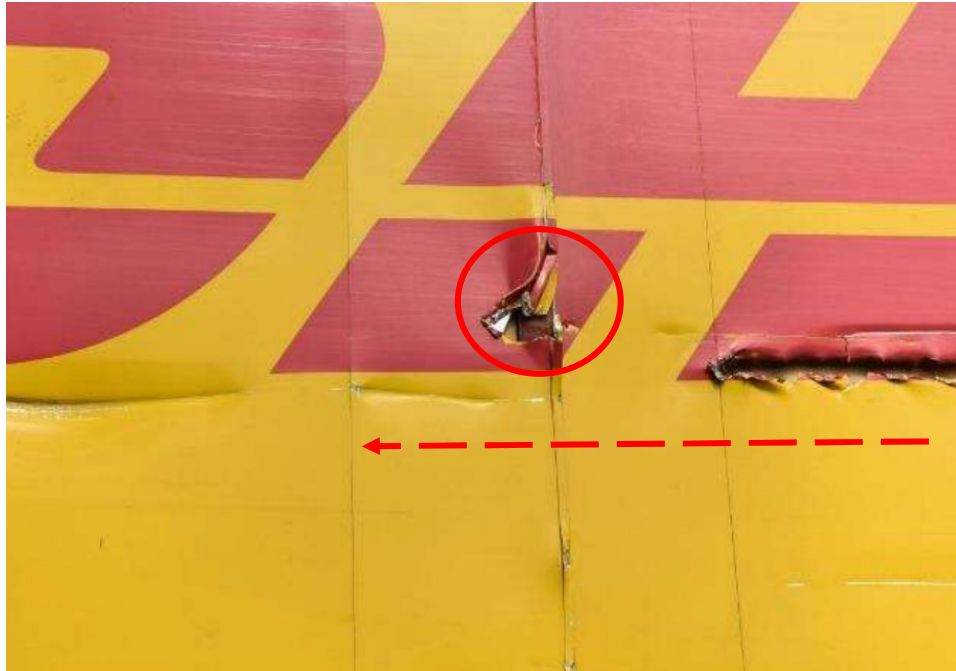
Photo 3 shows a closer view of the damaged cargo box of the Insured Vehicle. This was at the area between the left sliding door and left rear panel of the cargo box. The edge of the sliding door (circled) was dented/pulled towards the front of the Insured Vehicle. This would represent a rear to front directional force (red dotted arrow). Along with the frame at the left side of the front facing panel bending towards the front (refer to yellow circle in photograph 2 above), the damage pattern of the Insured Vehicle suggests that an object with protruding sharp edge(s) had horizontally cut into the left side of the cargo box, in a rear to front direction of the Insured Vehicle.

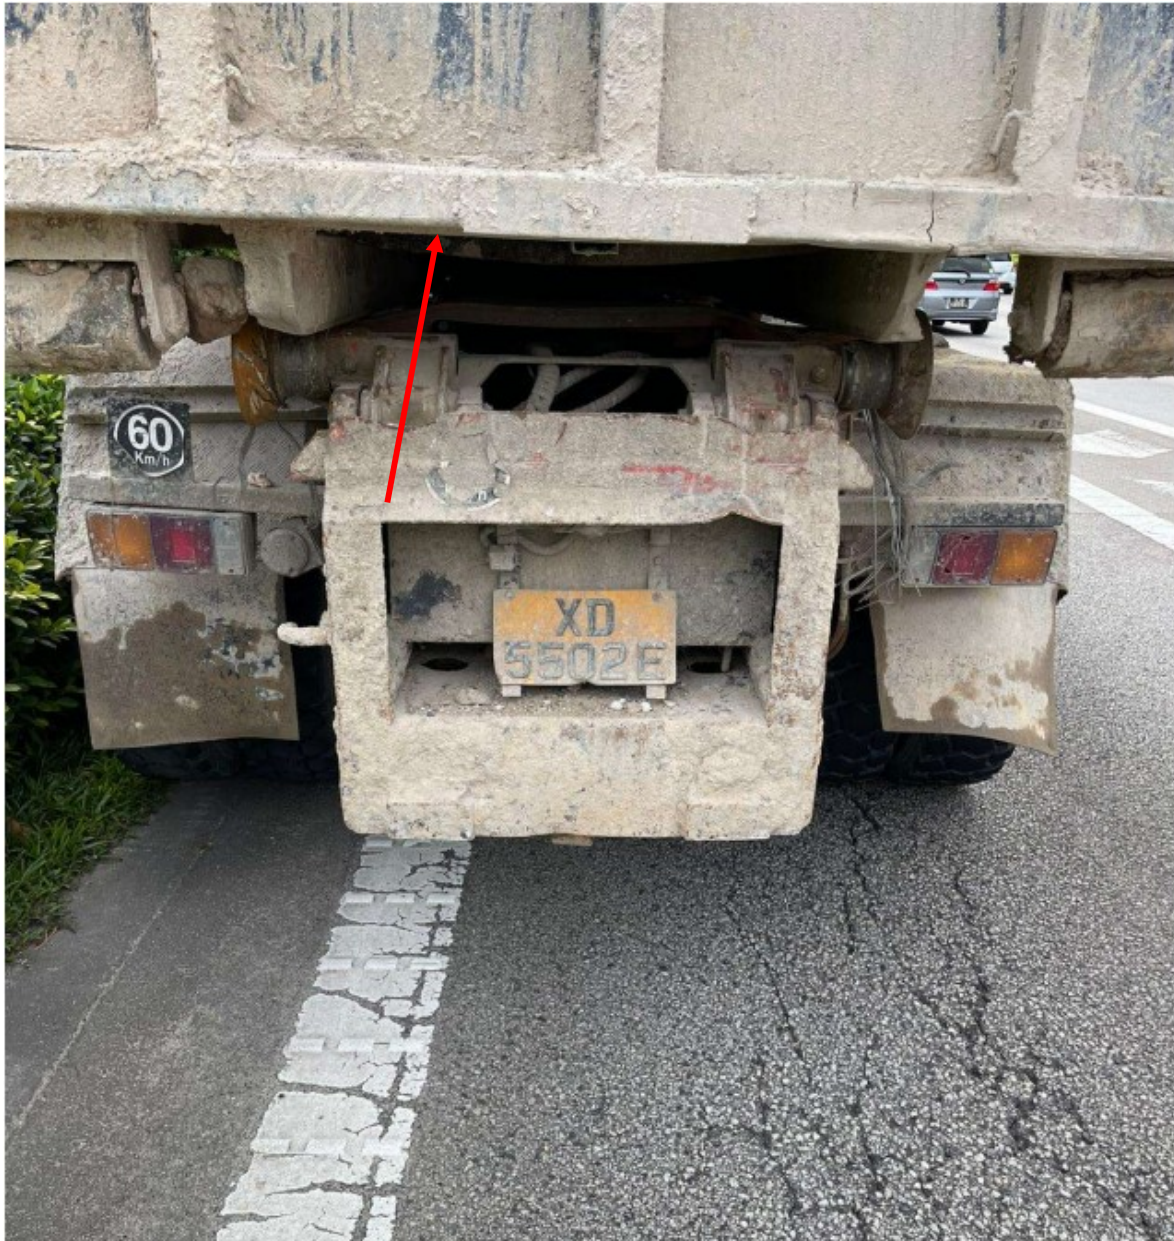
17. The accident scene photographs also appear to show that the Third Party Vehicle was stopped along the left side, towards the end of the slip road entering CTE towards City. This was based on features, like the scrubs on the left side of the Third Party Vehicle and the chevron markings on the right side of the Third Party Vehicle that separates CTE towards City and the slip road entering CTE towards City. See photo 4 below.

Photo 4 shows the Third Party Vehicle at the accident scene. It can be established that the Third Party Vehicle was loaded with a rectangular bin (arrowed) at the material time of accident. The rectangular bin that it was carrying would have been those sand, gravel rubbish carrying rectangular bin often seen on a tipper truck. The Third Party Vehicle was also seen stopped along the left side, towards the end of the slip road entering CTE towards City.

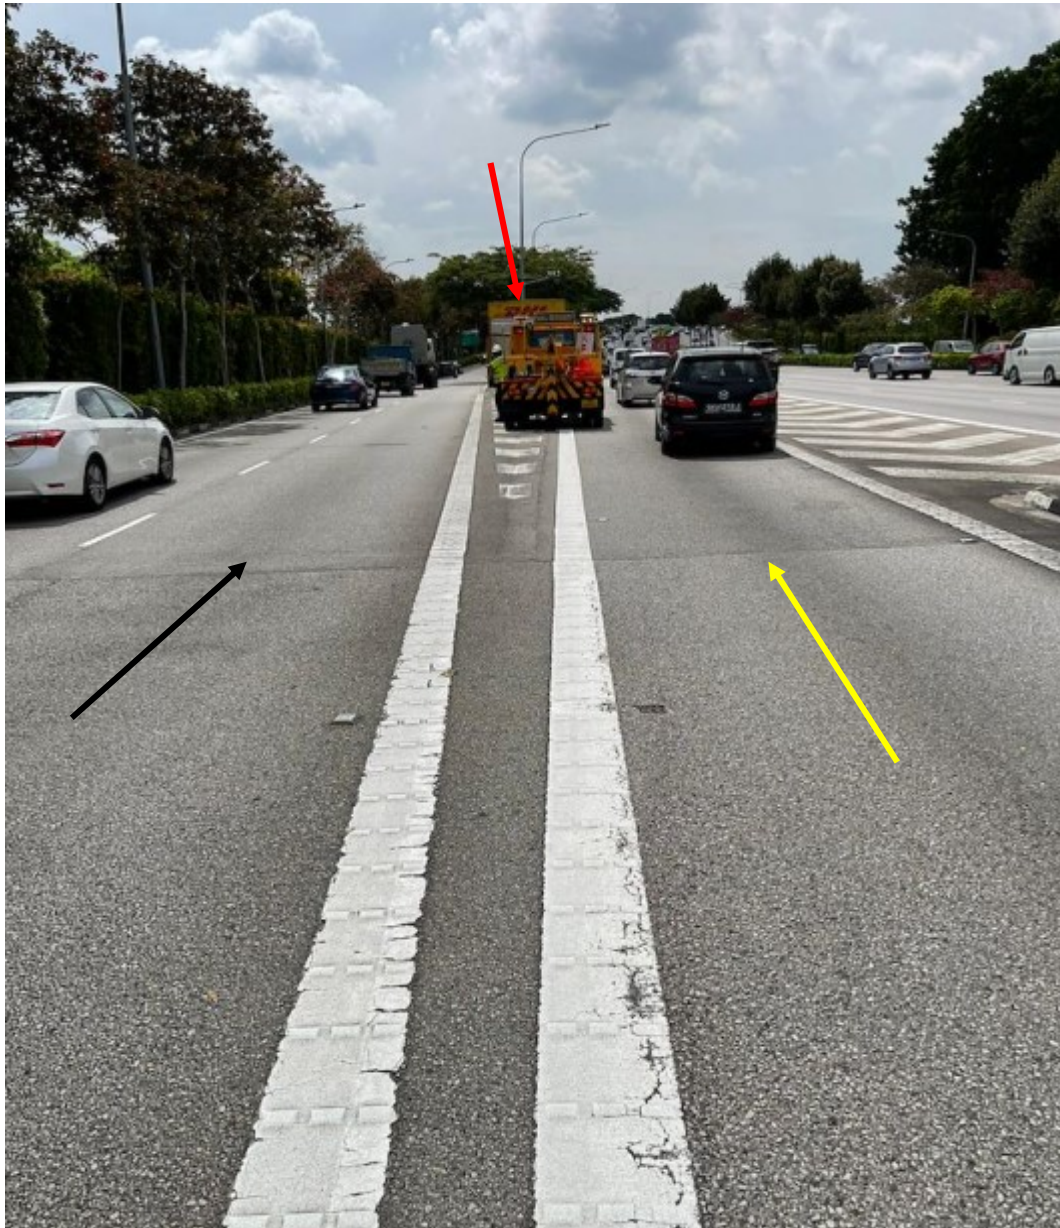
18. As for the Insured Vehicle, it was seen stopped along the chevron markings separating the slip road entering CTE towards City and Ang Mo Kio Avenue 5. Its stopped location was also noted to be behind the Third Party Vehicle. Note also that the slip road entering CTE towards City was single lane. See photo 5 & 6 below.

Photo 5 shows the Insured Vehicle at the accident scene. The Insured Vehicle (red arrow) was stopped along the chevron markings separating the slip road entering CTE towards City and Ang Mo Kio Avenue 5. The slip road entering CTE towards City is highlighted by the yellow arrow while Ang Mo Kio Avenue 5 is highlighted by the black arrow. The Third Party Vehicle (not seen in this photograph) was stopped further in front of the Insured Vehicle, at the end of the slip road entering CTE towards City. Note that the slip road entering CTE towards City was single lane.

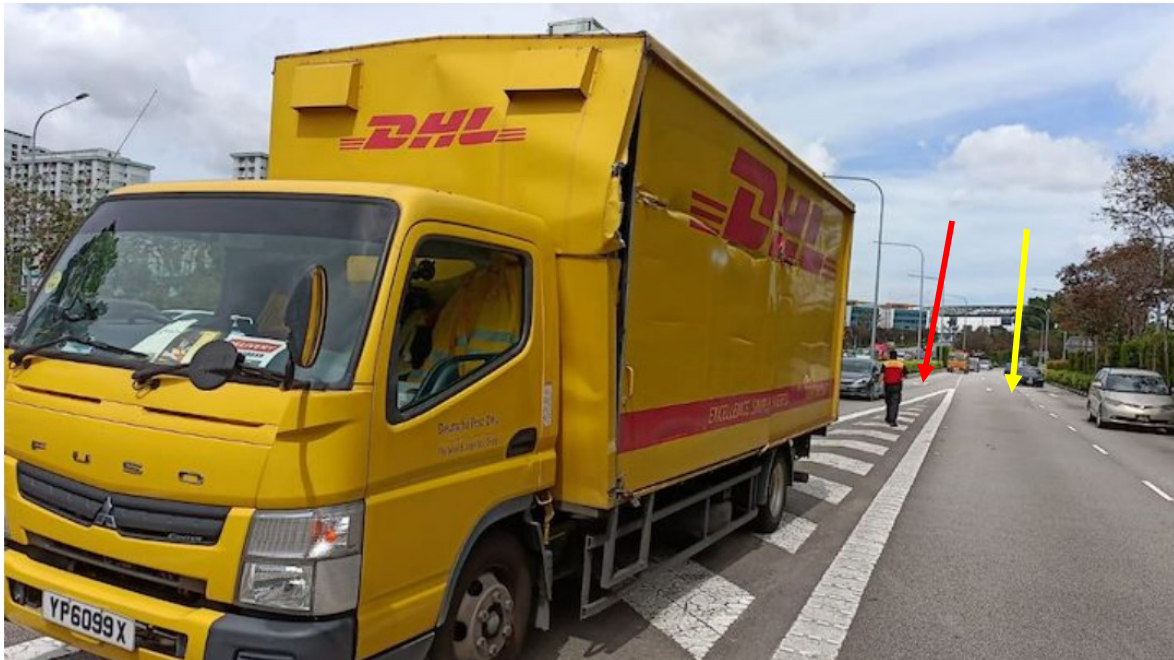
Photo 6 shows another view of the Insured Vehicle at the accident scene. The Insured Vehicle was stopped along the chevron markings separating the slip road entering CTE towards City and Ang Mo Kio Avenue 5. The slip road entering CTE towards City is highlighted by the red arrow while Ang Mo Kio Avenue 5 is highlighted by the yellow arrow. Note that the slip road entering CTE towards City was single lane.

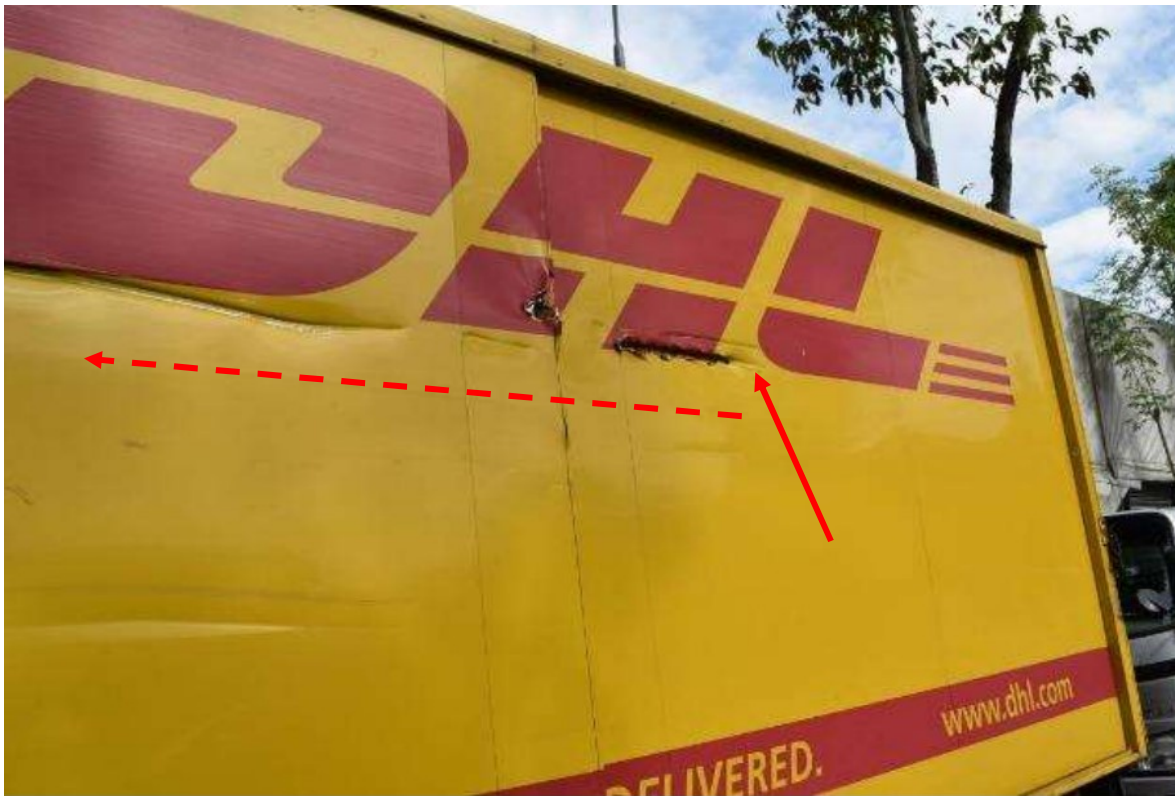
19. Earlier, I had commented in paragraph 13 that the damage pattern of the Insured Vehicle suggests that an object with protruding sharp edge(s) had horizontally cut into the left side of its cargo box, in a rear to front direction of the Insured Vehicle. This would mean that the first point of contact on the Insured Vehicle was at the left side centre portion of your Insured Vehicle, at the left rear panel of the cargo box just after the sliding door. The contact, thereafter, extended towards the left side front portion of the Insured Vehicle.

20. In order to cause a damage pattern that is from rear to front direction on the Insured Vehicle, the Third Party Vehicle would have to be travelling at a higher speed than the Insured Vehicle at the time of contact. Note that the accident scene photographs also indicated that the Third Party Vehicle was stopped ahead of the Insured Vehicle. See photo 7 below.

Photo 7 shows the left centre portion of the Insured Vehicle. The first contact on the Insured Vehicle was at the left side centre portion of your Insured Vehicle, at the left rear panel (arrowed) of the cargo box just after the sliding door. The contact, thereafter, extended towards the left side front portion of the Insured Vehicle, in a rear to front direction (shown by the dotted red arrow).

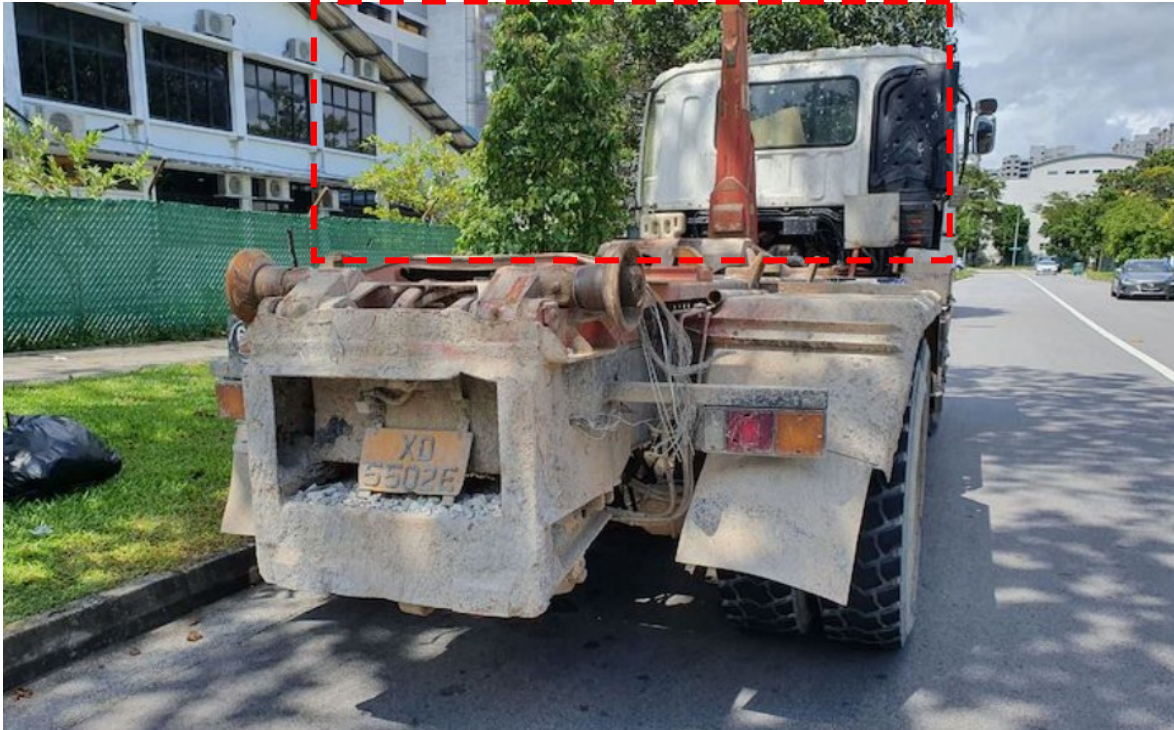
21. The Third Party Vehicle was loaded with a rectangular bin at the material time of accident (refer to photograph 4 above). The object with protruding sharp edge(s) that had horizontally cut into the left side of the Insured Vehicle's cargo box was likely to be the rectangular bin that was loaded on the Third Party Vehicle. Based on this, the point of contact at the Third Party Vehicle would have been at the right side centre portion onwards, which is where the rectangular bin would have been placed when loaded on the Third Party Vehicle. See photo 8 below.

Photo 8 shows the Third Party Vehicle, without any rectangular bin loaded at the time of accident reporting. At the material time of accident, the Third Party Vehicle was loaded with a rectangular bin (refer to photograph 4 above). The object with protruding sharp edge(s) that had horizontally cut into the left side of the Insured Vehicle's cargo box was likely to be the rectangular bin that was loaded on the Third Party Vehicle. Based on this, the point of contact at the Third Party Vehicle would have been at the right side centre portion onwards, which is where the rectangular bin would have been placed, as highlighted by the red dotted lines.

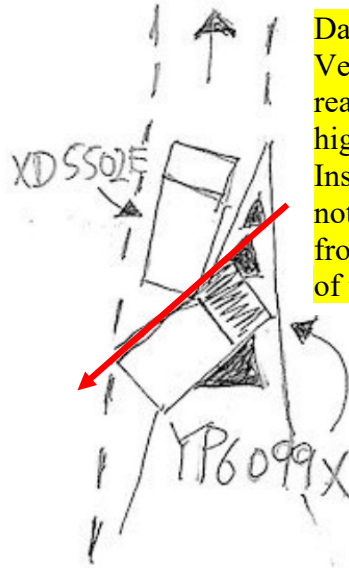
Sketch Plan

23. If following the accident account and sketch plan in the Singapore Accident Statement that was lodged by the driver of the Third Party Vehicle, the damage pattern of the Insured Vehicle would be in a front to rear direction, as the Insured Vehicle would have to be travelling at a higher speed than the Third Party Vehicle in order for contact to occur (travelling at same speed will not result in any contact).

24. First contact would be at left side front portion of the Insured Vehicle before stretching towards the left side centre and left side rear of the Insured Vehicle due to the higher travelling speed of the Insured Vehicle. The sketch plan (refer to page 3 above and shown again below) does not match the damage pattern of the Insured Vehicle.

Damage to the Insured Vehicle would be in a front to rear direction due to the higher travelling speed of the Insured Vehicle, which does not correspond to the rear to front direction damage pattern of the Insured Vehicle

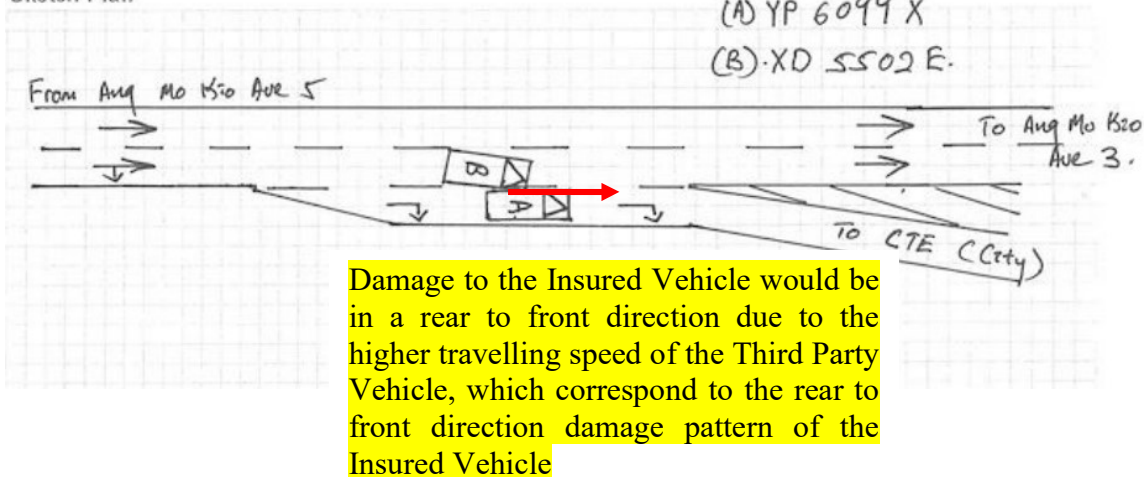
Sketch Plan

26. On the other hand, the accident account and sketch plan in the Singapore Accident Statement that was lodged by the driver of the Insured Vehicle would correspond to the damage pattern of the Insured Vehicle. The first point of contact was on the left side centre portion of the Insured Vehicle and the higher travelling speed of the Third Party Vehicle (travelling at same speed will not result in any contact) would lead to damage on the Insured Vehicle stretching from its left side centre portion to its left side front portion (refer to sketch plan at page 2 and shown again below).
