# T & C AUTOMOBILE ASSESSORS

REF : TC/2019/436

## VEHICLE SURVEY REPORT

Vehicle Registration No : SLV7873T Make & Model : MITSUBISHI  
ATTRAGE 1.2 CVT  
Year Make : 2017 Colour : RED  
Engine No : 3A92UGN9691 Chassis No. : MMBSTA13AJH000894  
Engine Capacity : 1193cc

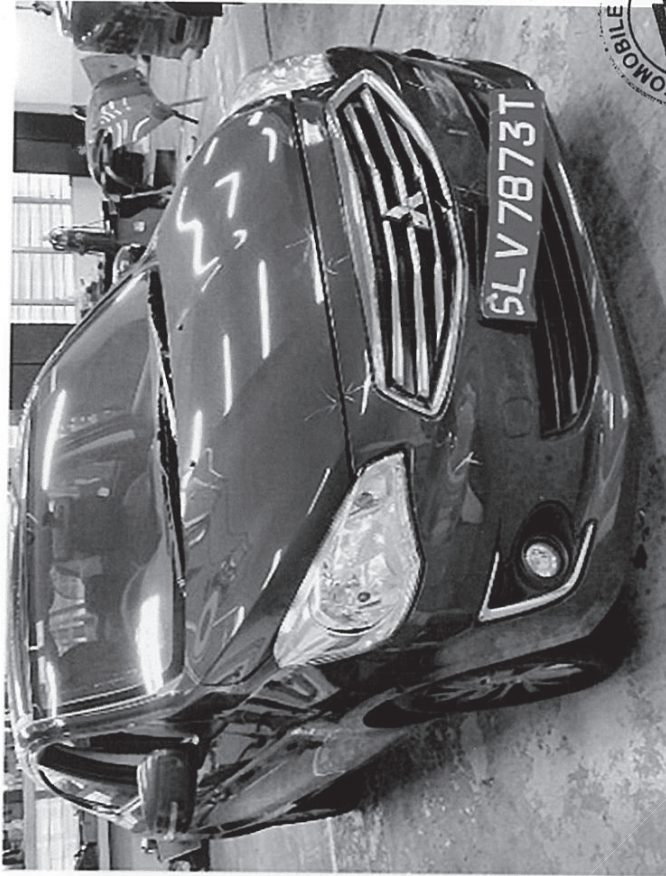
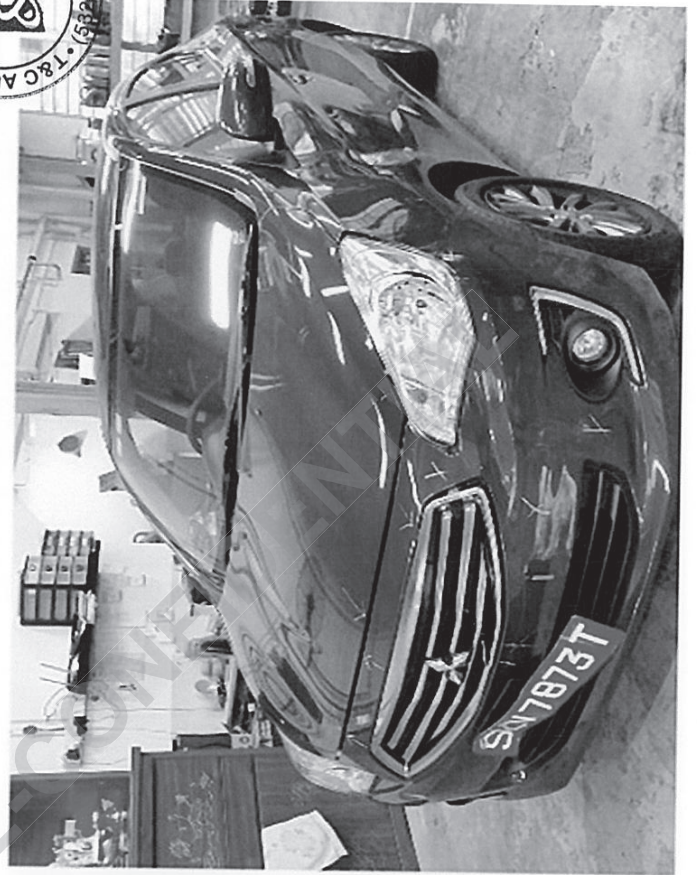
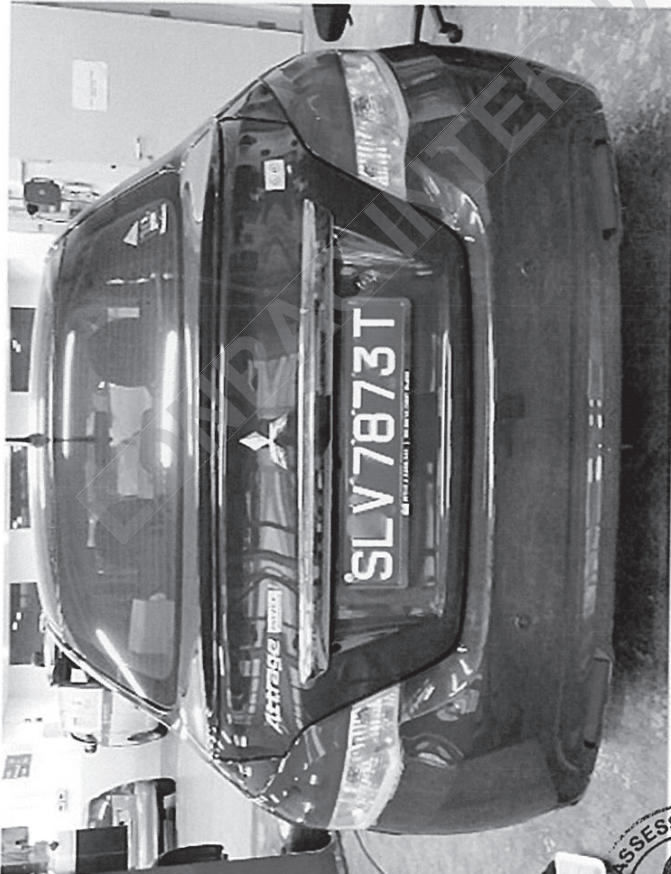
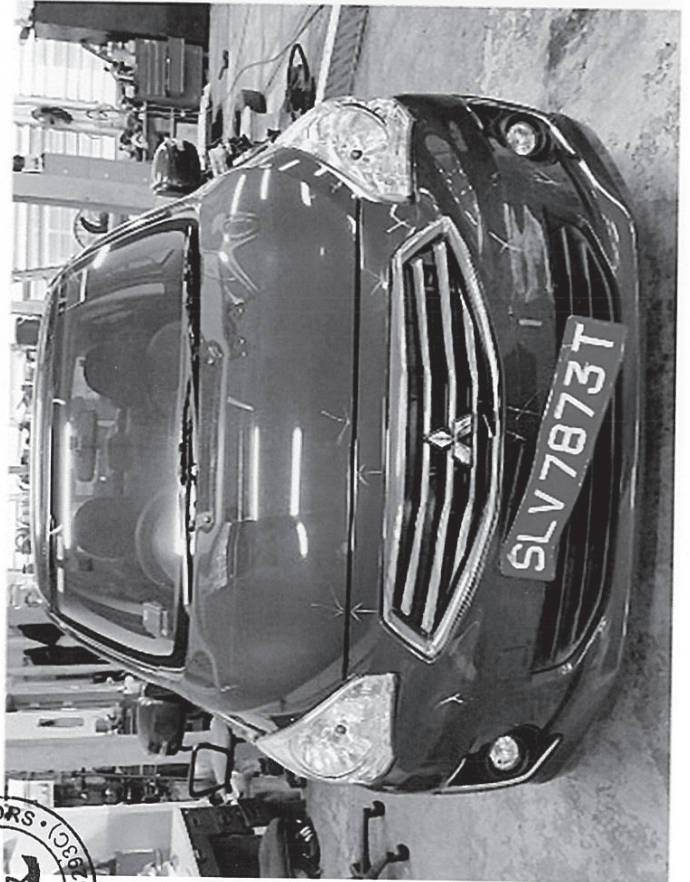
The Vehicle sustained damages at the rear portion.  
(For information of damages, please refer to Parts/Labour/Photographs attached)

<u>S/NO</u>	<u>QTY</u>	<u>DESCRIPTION</u>	<u>CONDITION/ REMARKS</u>	<u>REPAIRER'S ESTIMATES</u> S\$	<u>OUR ASSESSMENT</u> S\$
1	1	Front bumper	Deformed	1,096.40	1,096.40
2	1	Front bumper reinforcement	Bent	216.30	216.30
3	1	Front bumper bracket	Bent	171.50	171.50
4	1	Front bumper side retainer	Broken	86.70	86.70
5	1 set	Front bumper clips	Necessary	60.00	60.00
6	1	Front bumper lower grille	Broken/cut	277.90	277.90
7	1	Front grille	Broken/cut	486.20	486.20
8	1	Front grille badge	Necessary	48.50	48.50
9	1 set	Front grille clips	Necessary	50.00	50.00
10	1	Front support panel	Bent	787.90	787.90
11	1	Front LH foglamp	Cut	169.50	169.50
12	1	Front LH foglamp cover	Necessary	67.90	67.90
13	1	Front LH fender	Deformed	474.20	474.20
14	1	Front LH headlamp	Broken	896.30	896.30
				4,889.30	4,889.30
Less : Discount 10%				-488.93	-488.93
<b>Total :</b>				<b>4,400.37</b>	<b>4,400.37</b>
<b><u>SPECIAL NETT ITEMS</u></b>

<u>S/NO</u>	<u>DESCRIPTION</u>	<u>REPAIRER'S ESTIMATES S\$</u>	<u>OUR ASSESSMENT S\$</u>
1	To remove, cut out damage portion, jack out, straighten, panel beating, welding, align and renew replaced parts.	1,700.00	1,400.00
2	To putty and respray painting on effected areas.	1,500.00	1,200.00
3	To check wiring and lightings.	120.00	80.00
4	To applied LTA permit, and sent vehicle to inspection centre for reseal of front number plate.	150.00	120.00
5	To apply undersealing.	200.00	150.00
<b>Total Labour Charges :</b>		<b>3,670.00</b>	<b>2,950.00</b>
<b>Total Spare Parts :</b>		<b>4,480.37</b>	<b>4,480.37</b>
<b>Total Repair Costs :</b>		<b>8,150.37</b>	<b>7,430.37</b>

The repairer has agreed to undertake the repair of **S\$7,430.37**, with a repair period of 10 working days.
