Your Ref: Porsche 911 Carrera 4S Coupe  
(chassis number WP0ZZZ99ZLS215977)  
Our Ref : CI/TP22004784/D

**INSPECTION REPORT OF AN UNREGISTERED PORSCHE 911 CARRERA 4S  
COUPE MOTOR CAR WITH CHASSIS NUMBER WP0ZZZ99ZLS215977**

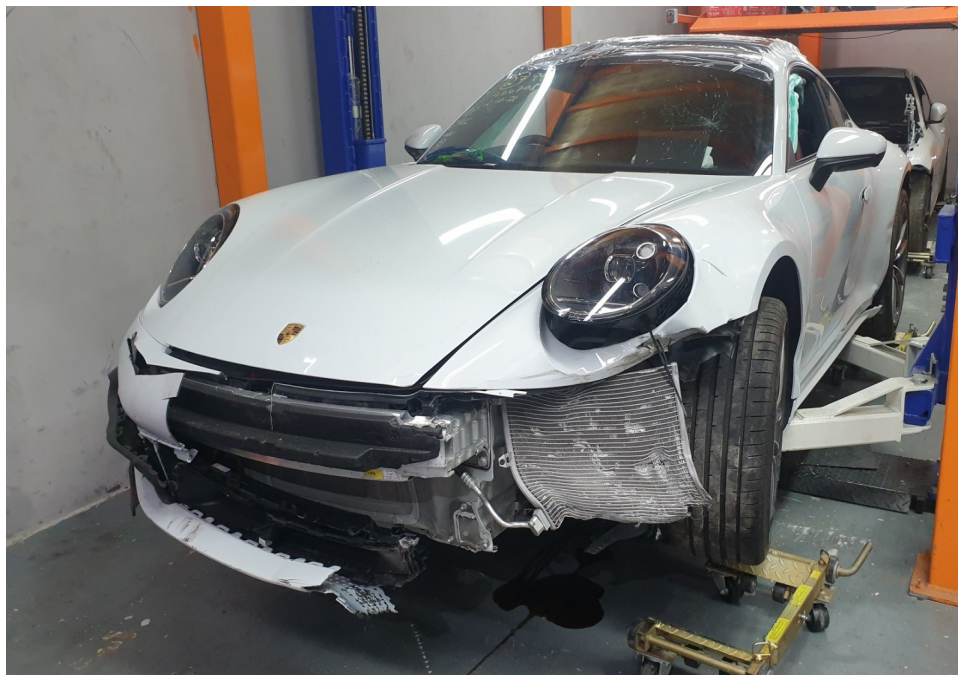
3. The photographs provided to me had showed damage to the frontal portion of the Motor Car. The front bumper, front bumper lower moulding, front bumper left lower grille, front bumper centre lower grille, front bumper sensors, front bumper reinforcement, front bumper sponge, front left day light, front left aircon condenser, front left headlamp, front left signal lamp, front left fender, front left fender inner shield, front bonnet and front windscreen were amongst the body parts that were observed to have been damaged.

**Photo 1** shows the front left body of the Motor Car (photograph provided to me). The photographs provided to me had showed damage to the frontal portion of the Motor Car. The front bumper, front bumper sponge, front bumper reinforcement, front left headlamp, front left aircon condenser and front windscreen were amongst the body parts that were observed to have been damaged. The left curtain airbag and front left passenger airbag were also observed to be deployed.

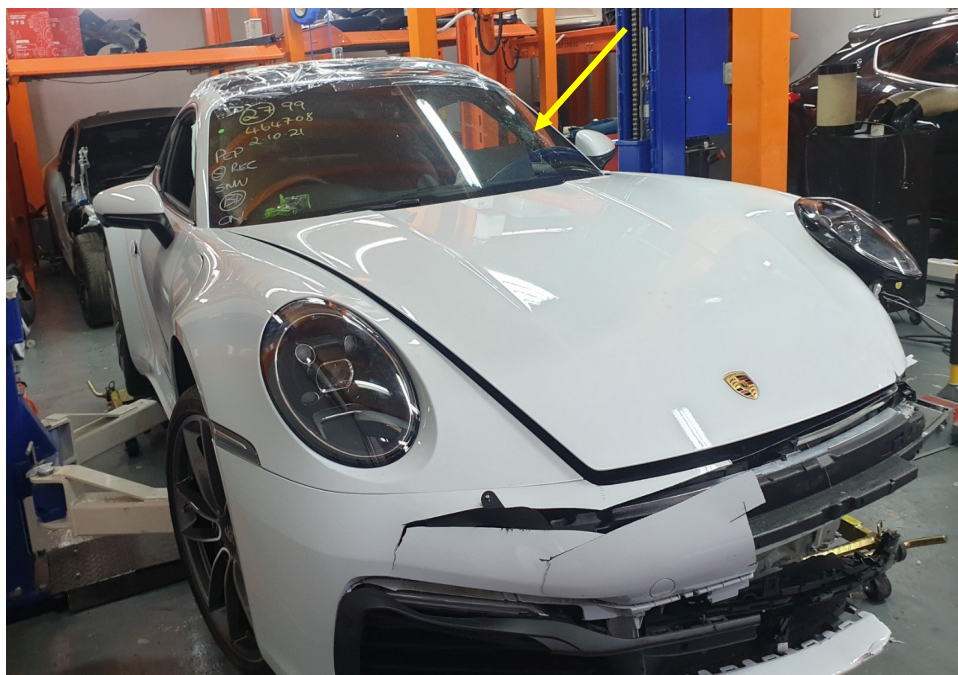
**Photo 2** shows the front right body of the Motor Car (photograph provided to me). The photographs provided to me had showed damage to the frontal portion of the Motor Car. The front bumper, front bumper centre lower grille, front bumper sensors, front bonnet and front windscreen (arrowed) were amongst the body parts that were observed to have been damaged.

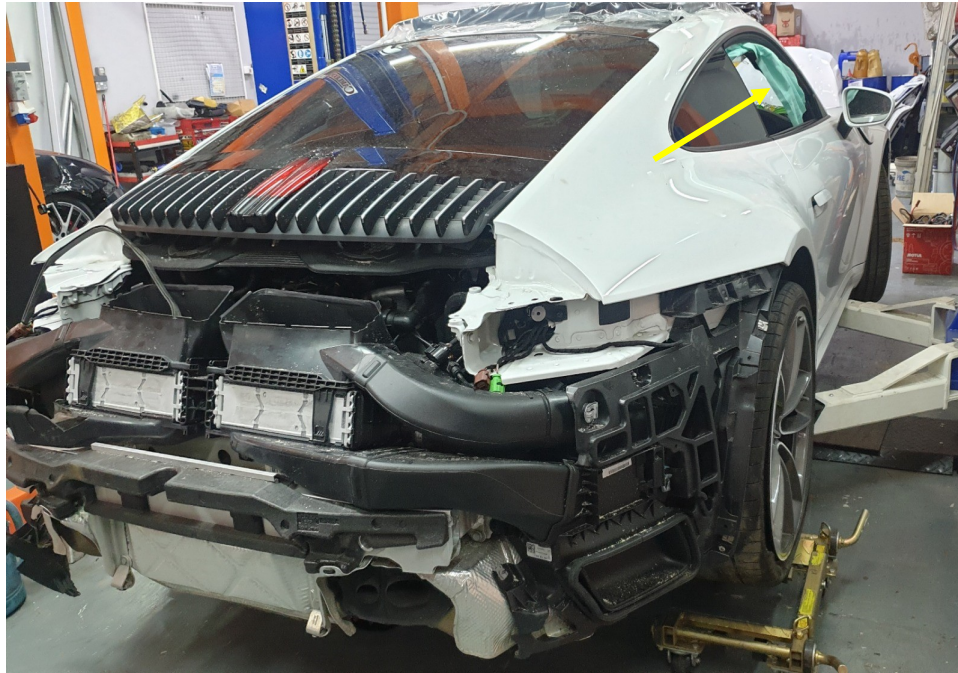
4. Several body parts at the rear portion of the Motor Car were also observed to be missing/dislodged/damaged. These body parts include the rear bumper and all its related parts and attachments, rear taillamps, rear top cover and rear centre lamp amongst others.

**Photo 3** shows the rear right body of the Motor Car (photograph provided to me). Apart for the frontal portion, I had also observed several body parts at the Motor Car's rear portion to be missing/dislodged/damaged. These body parts include the rear bumper and all its related parts and attachments, rear taillamps, rear top cover and rear centre lamp amongst others. The right curtain airbag (arrowed) was deployed.

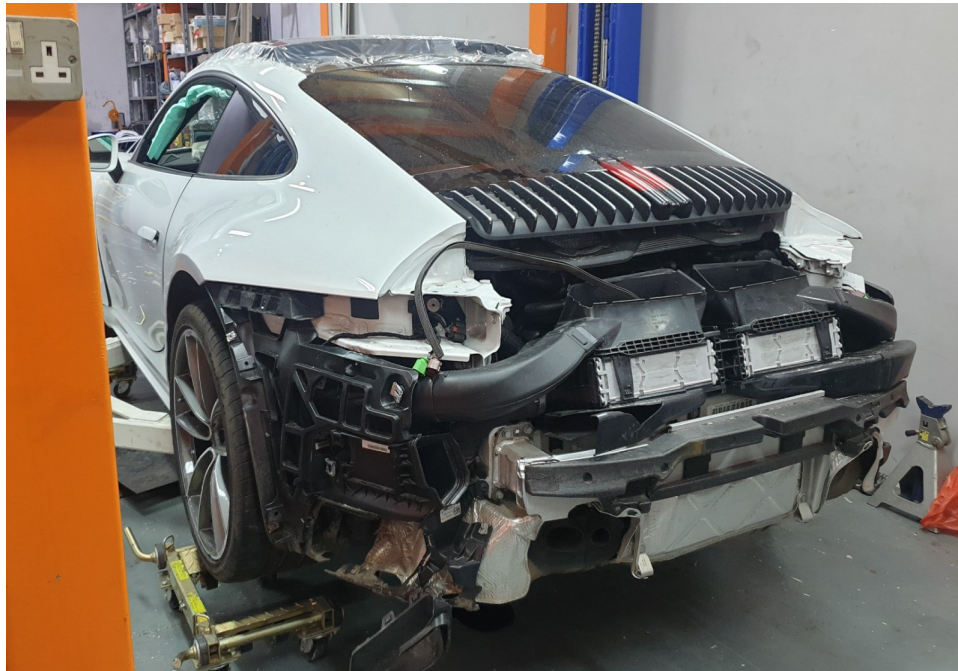
**Photo 4** shows the rear left body of the Motor Car (photograph provided to me). Apart for the frontal portion, I had also observed several body parts at the Motor Car's rear portion to be missing/dislodged/damaged. These body parts include the rear bumper and all its related parts and attachments, rear taillamps, rear top cover and rear centre lamp amongst others.

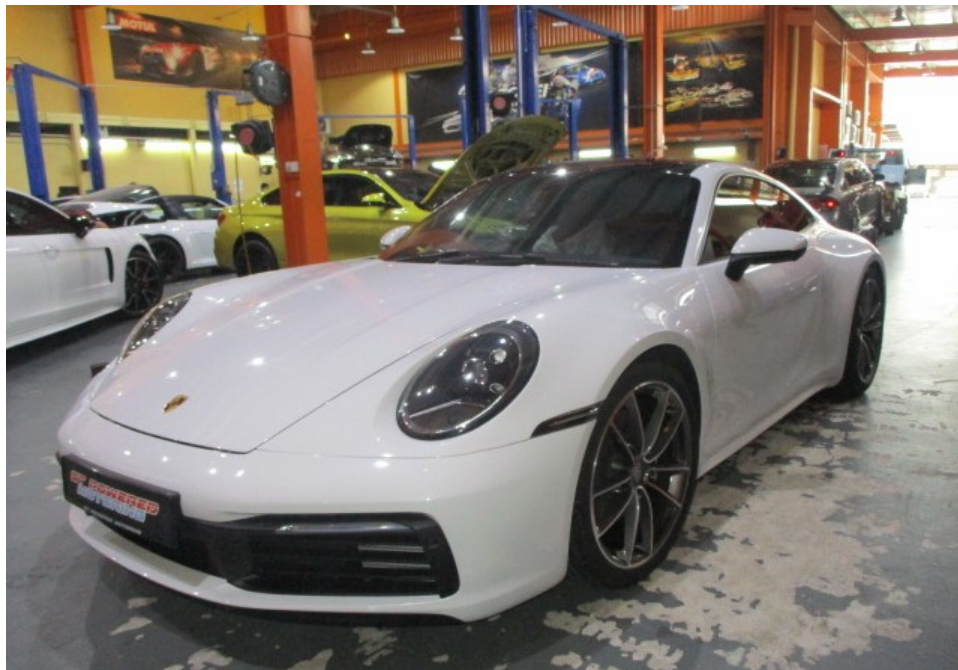
**Photo 5** shows a general view of the front left body of the Motor Car at the time of my inspection. The Motor Car was observed to be in a relatively good general condition with no loose exterior fittings observed. The body parts at the frontal portion of the Motor Car were visually examined and it was observed that the repair/restoration works carried out to the damaged area of the Motor Car (refer to photograph 1 & 2 above) were reasonably adequate and in order.

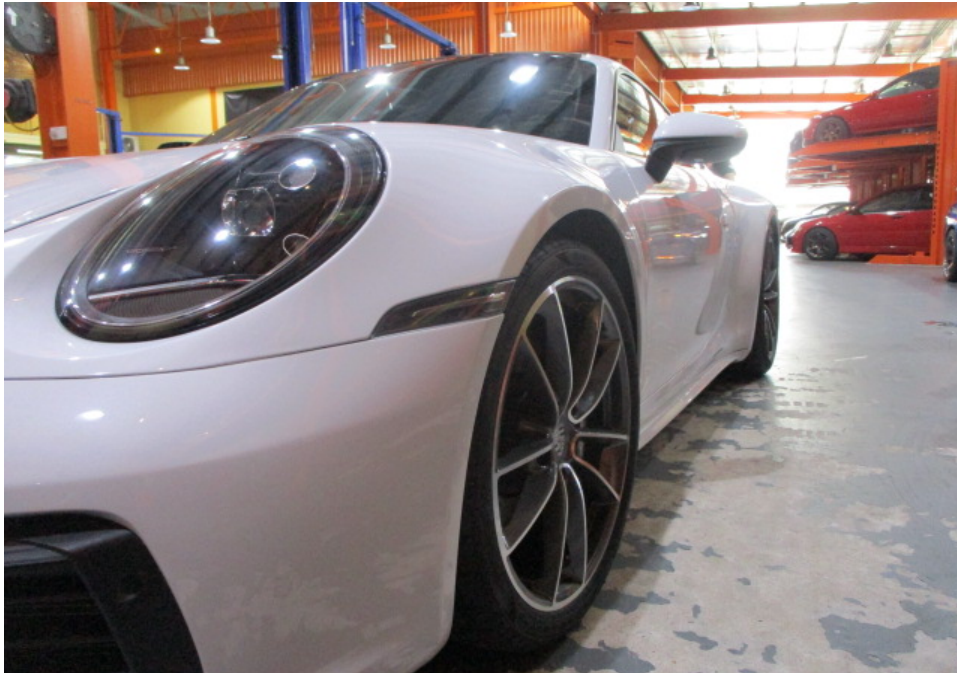
**Photo 6** shows a closer view of the Motor Car's front left signal lamp, front left headlamp, front left fender and front left wheel rim. The body parts at the frontal portion of the Motor Car were visually examined and it was observed that the repair/restoration works carried out to the damaged area of the Motor Car (refer to photograph 1 & 2 above) were reasonably adequate and in order.

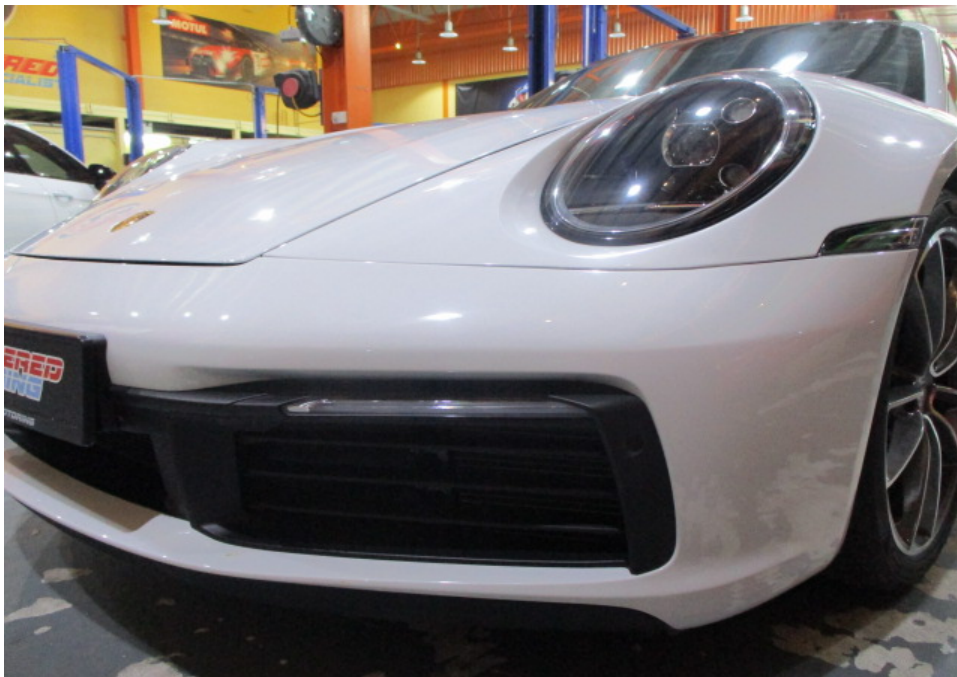
**Photo 7** shows a closer view of the Motor Car's front bumper, front bumper left lower grille, front left day light and front bonnet. The body parts at the frontal portion of the Motor Car were visually examined and it was observed that the repair/restoration works carried out to the damaged area of the Motor Car (refer to photograph 1 & 2 above) were reasonably adequate and in order

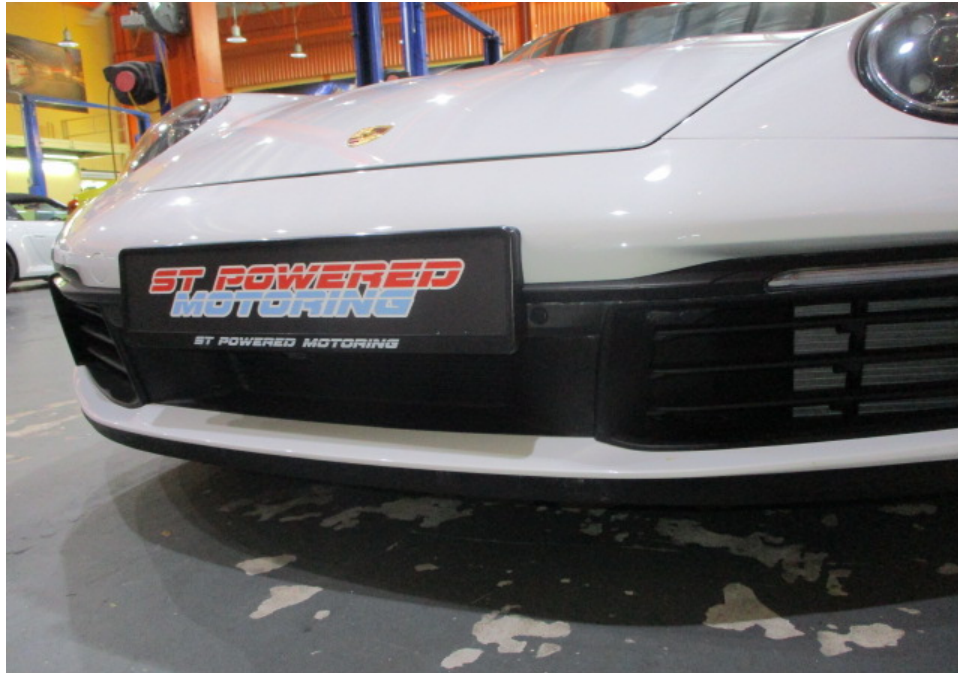
**Photo 8** shows a closer view of the Motor Car's front bumper, front bumper lower moulding, front bumper centre lower grille and front bonnet. The body parts at the frontal portion of the Motor Car were visually examined and it was observed that the repair/restoration works carried out to the damaged area of the Motor Car (refer to photograph 1 & 2 above) were reasonably adequate and in order.

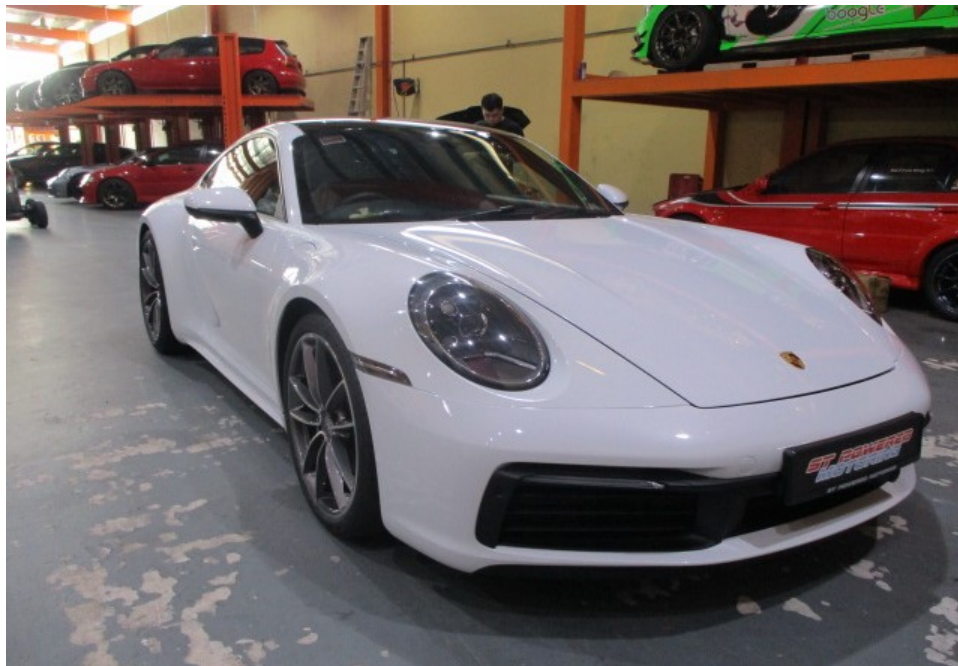
**Photo 9** shows a general view of the front right body of the Motor Car at the time of my inspection. The Motor Car was observed to be in a relatively good general condition with no loose exterior fittings observed. The body parts at the frontal portion of the Motor Car were visually examined and it was observed that the repair/restoration works carried out to the damaged area of the Motor Car (refer to photograph 1 & 2 above) were reasonably adequate and in order.

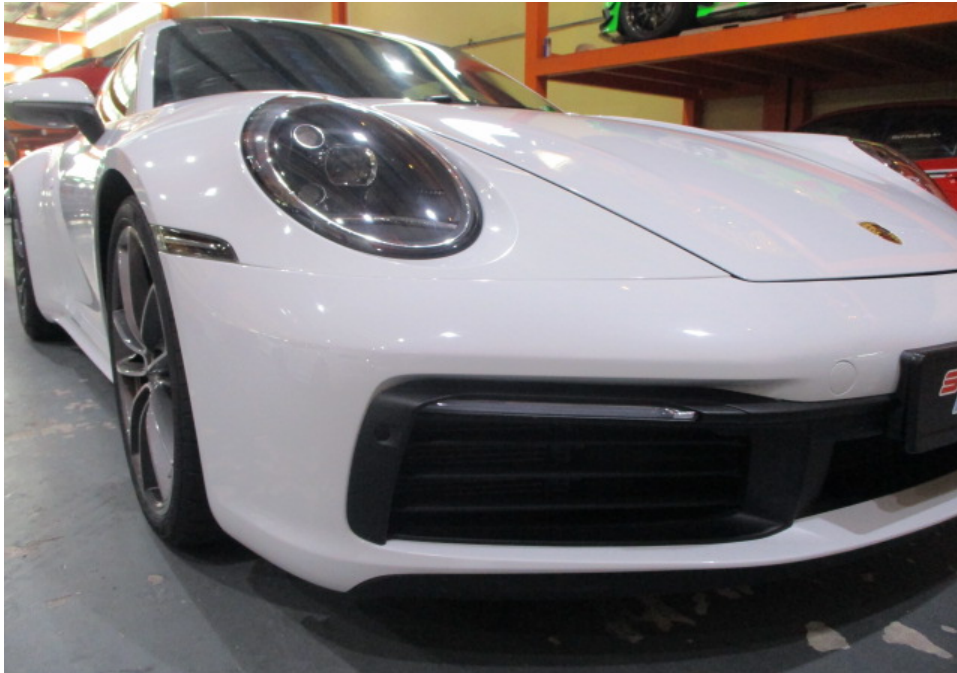
**Photo 10** shows a closer view of the Motor Car's front bumper, front bumper right lower grille, front right day light, front right headlamp and front right signal lamp. The body parts at the frontal portion of the Motor Car were visually examined and it was observed that the repair/restoration works carried out to the damaged area of the Motor Car (refer to photograph 1 & 2 above) were reasonably adequate and in order.

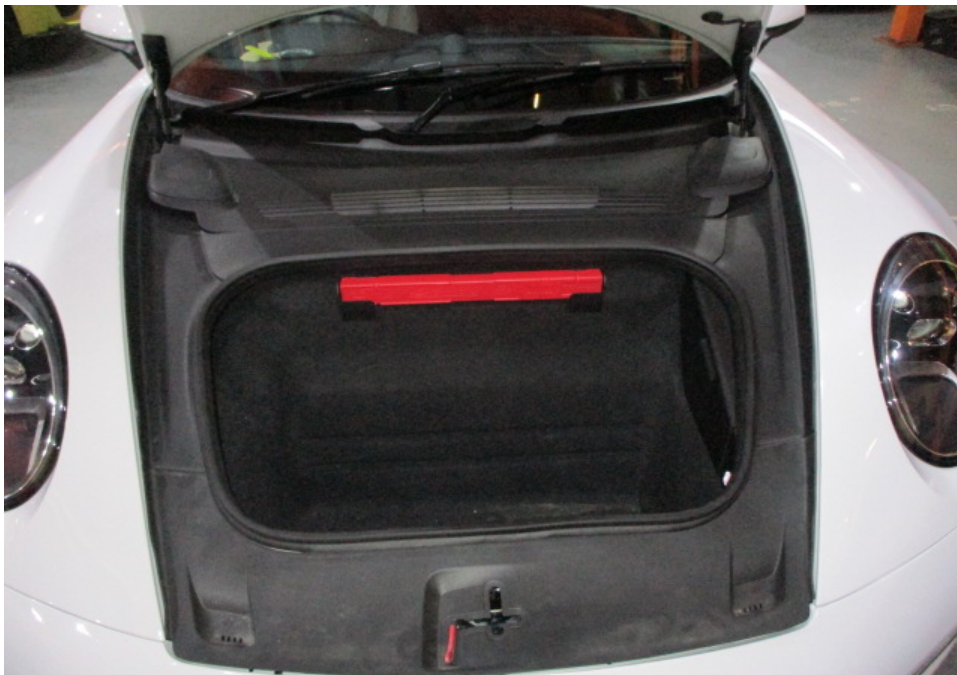
**Photo 11** shows a general view of the Motor Car's front bonnet compartment at the time of my inspection. All inner trims, garnishes and upholstery etc were observed to be properly fitted.

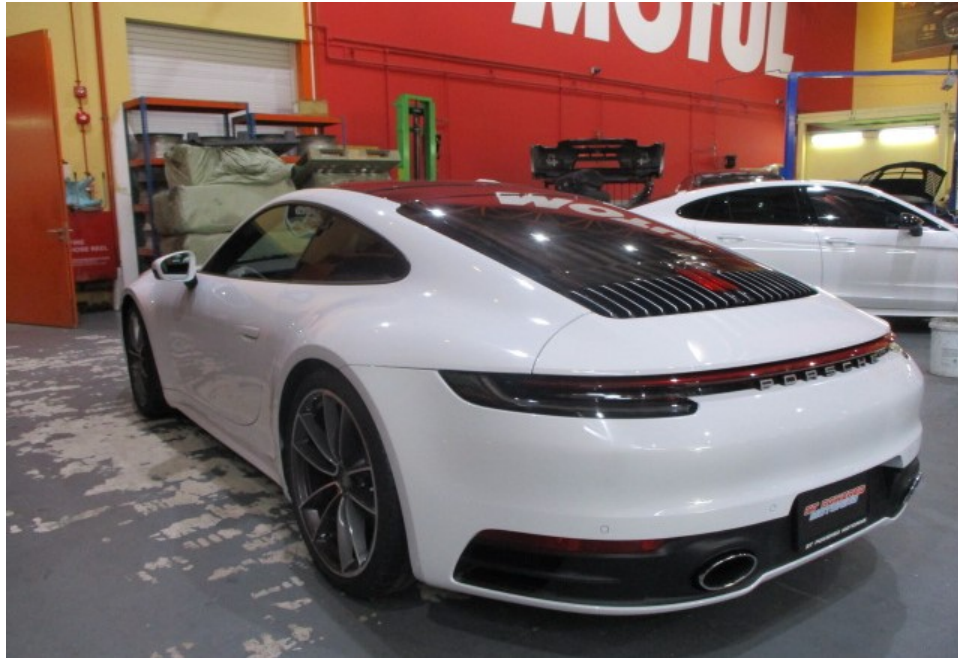
**Photo 12** shows a general view of the rear left body of the Motor Car at the time of my inspection. The Motor Car was observed to be in a relatively good general condition with no loose exterior fittings observed. The body parts at the rear portion of the Motor Car were visually examined and it was observed that the repair/restoration works carried out to the damaged area of the Motor Car (refer to photograph 3 & 4 above) were reasonably adequate and in order.

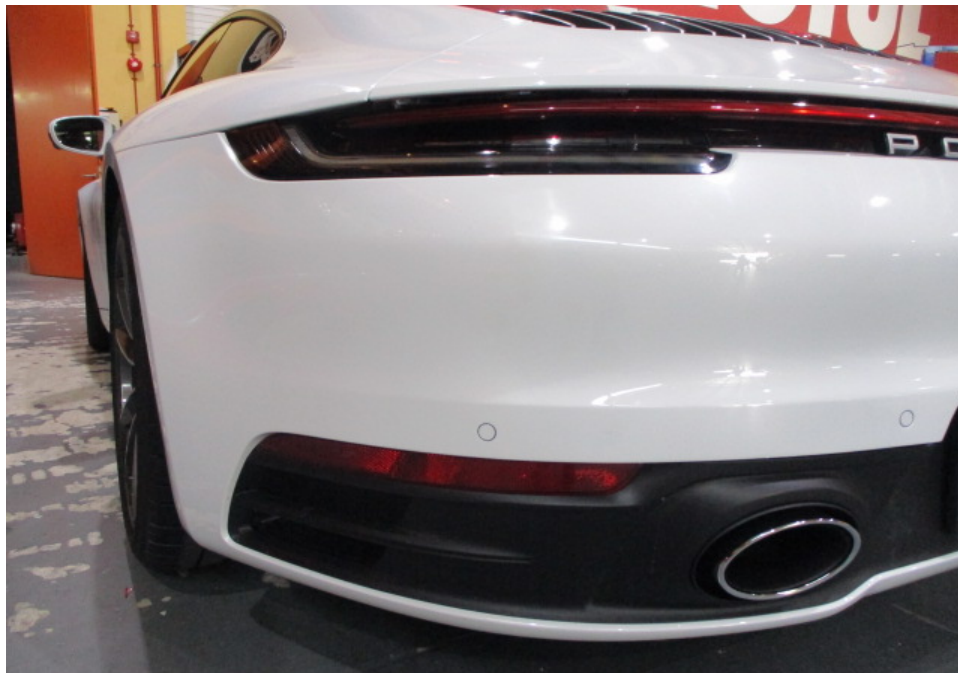
**Photo 13** shows a closer view of the Motor Car's rear bumper, rear bumper lower cover, rear bumper left reflector and rear left taillamp. The body parts at the rear portion of the Motor Car were visually examined and it was observed that the repair/restoration works carried out to the damaged area of the Motor Car (refer to photograph 3 & 4 above) were reasonably adequate and in order.

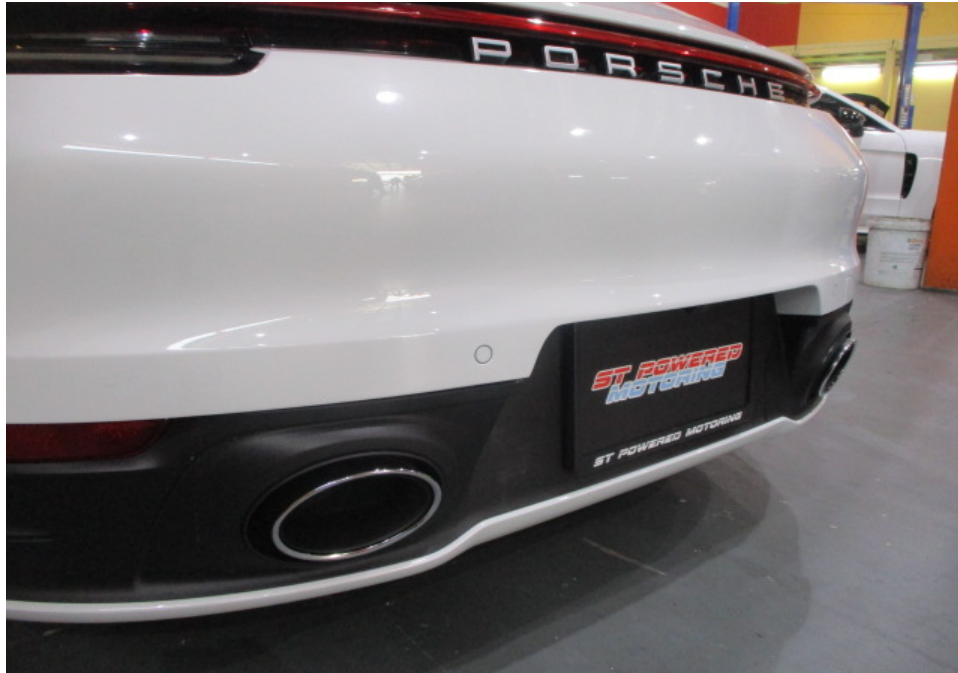
**Photo 14** shows a closer view of the Motor Car's rear bumper, rear bumper lower cover and rear bumper sensors. The body parts at the rear portion of the Motor Car were visually examined and it was observed that the repair/restoration works carried out to the damaged area of the Motor Car (refer to photograph 3 & 4 above) were reasonably adequate and in order.

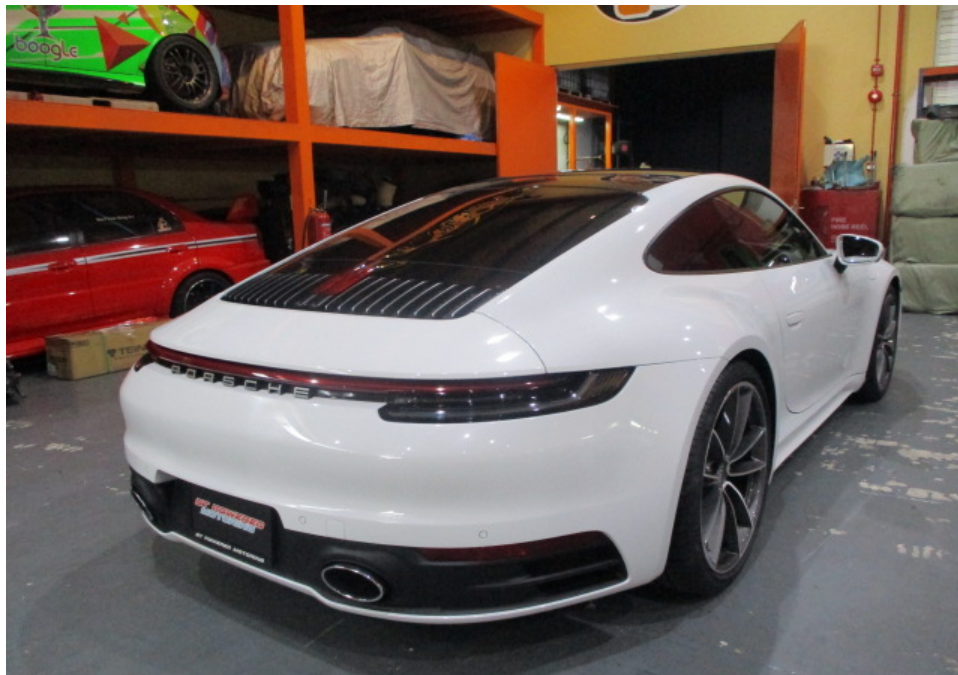
**Photo 15** shows a general view of the rear right body of the Motor Car at the time of my inspection. The Motor Car was observed to be in a relatively good general condition with no loose exterior fittings observed. The body parts at the rear portion of the Motor Car were visually examined and it was observed that the repair/restoration works carried out to the damaged area of the Motor Car (refer to photograph 3 & 4 above) were reasonably adequate and in order.

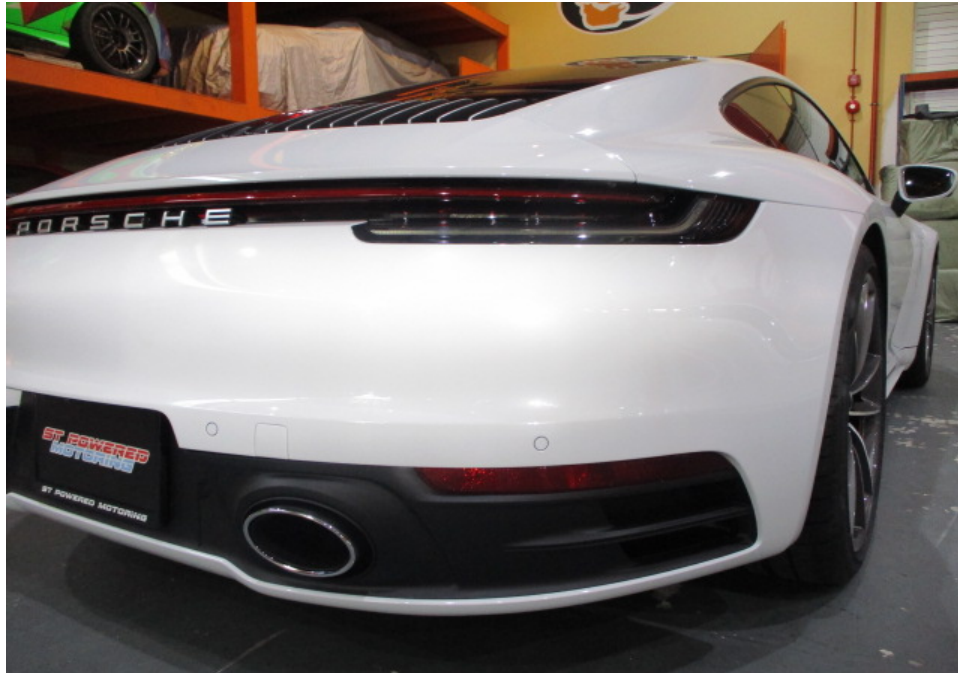
**Photo 16** shows a closer view of the Motor Car's rear bumper, rear bumper lower cover, rear bumper right reflector, rear bumper sensors and rear right taillamp. The body parts at the rear portion of the Motor Car were visually examined and it was observed that the repair/restoration works carried out to the damaged area of the Motor Car (refer to photograph 3 & 4 above) were reasonably adequate and in order.

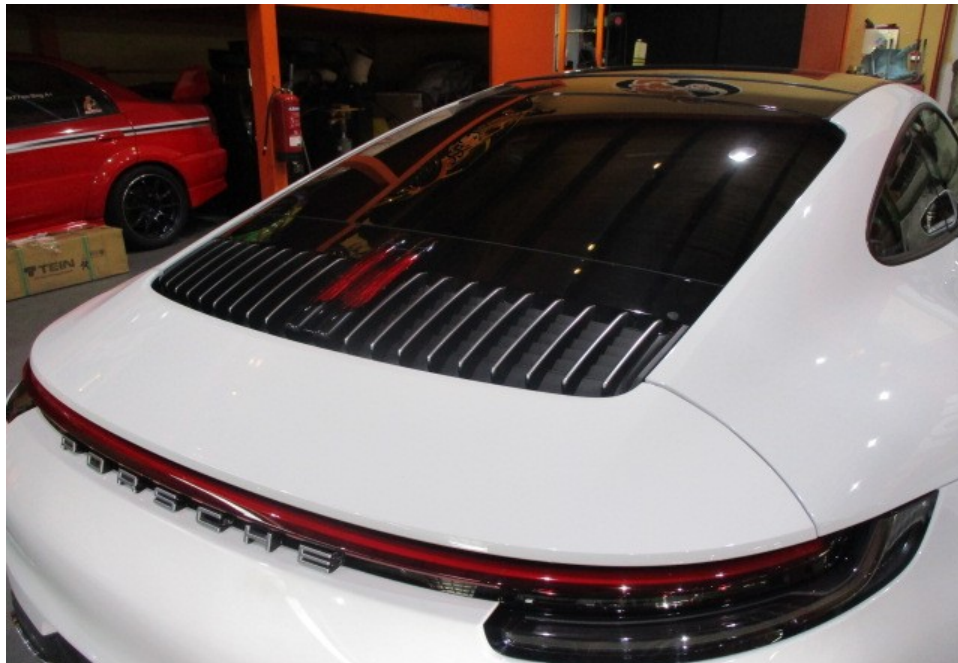
**Photo 17** shows a closer view of the Motor Car's rear top cover and rear centre lamp. The body parts at the rear portion of the Motor Car were visually examined and it was observed that the repair/restoration works carried out to the damaged area of the Motor Car (refer to photograph 3 & 4 above) were reasonably adequate and in order.

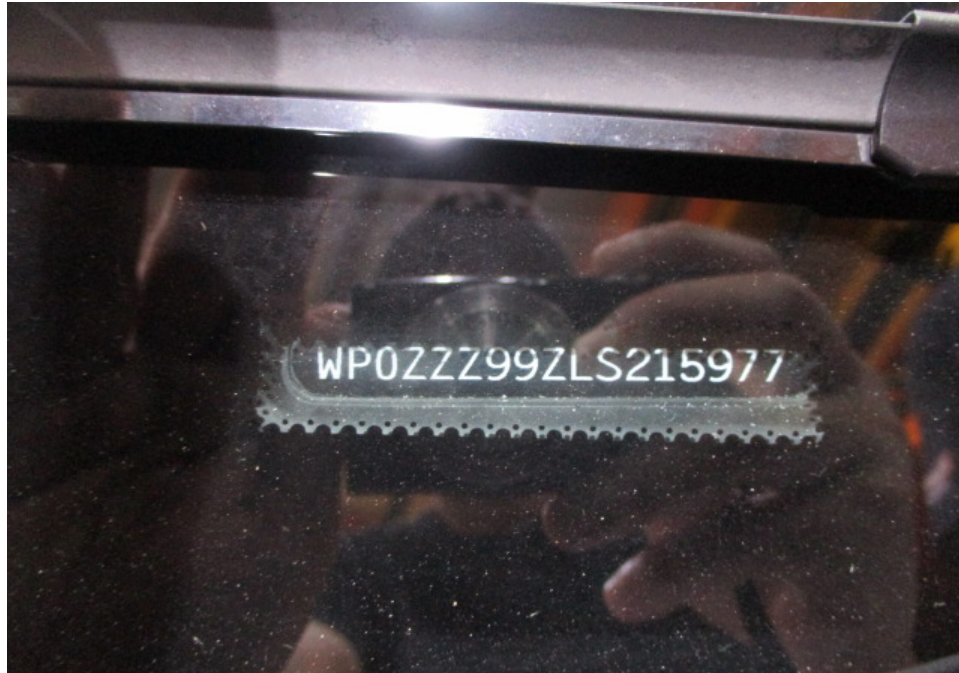
**Photo 18** shows the chassis number of the Motor Car. The chassis number recorded was WP0ZZZ99ZLS215977.

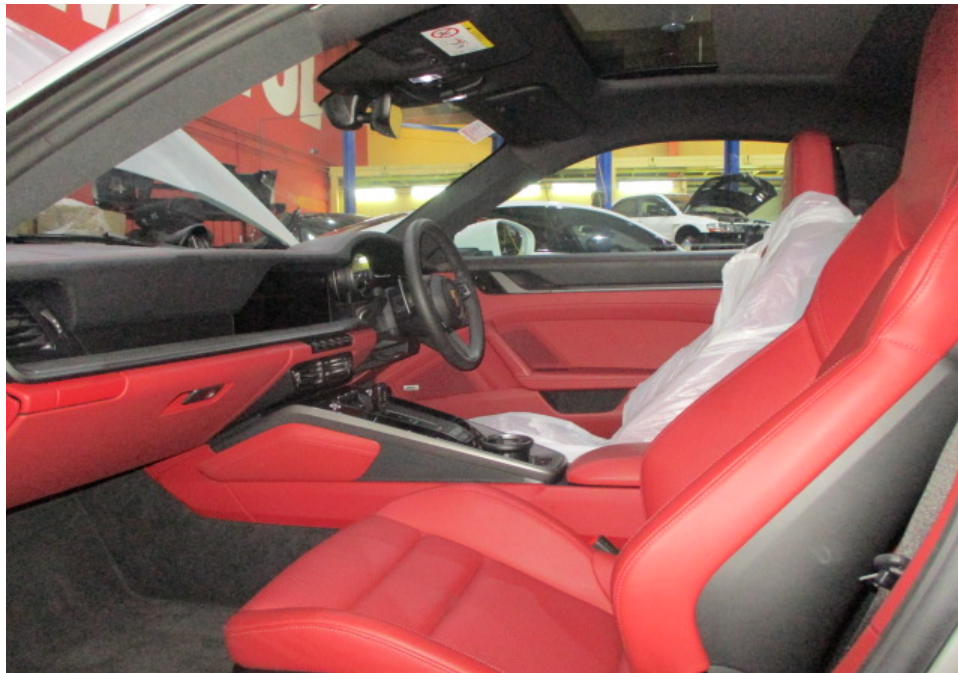
**Photo 19** shows the interior compartment of the Motor Car at the time of my inspection. The various parts and components, trims, carpet, and upholstery inside the interior compartment were all observed to be intact and properly fitted.

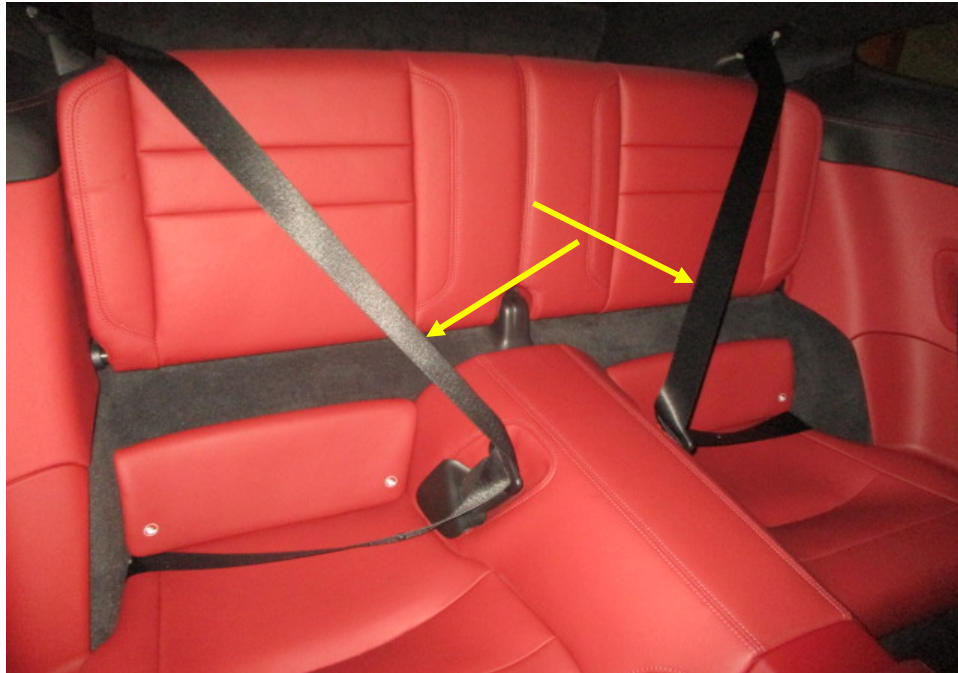
13. The seats of the Motor Car were found to be secured to the floorboard of the Motor Car via seat rails bolted onto the floorboard. Retractable seat belt reels and pre-tensioners were fitted on all seats of the Motor Car. The seat belts were tested and were able to be fastened securely into the respective pre-tensioners that were fixed to the side of all the seats.

**Photo 20** shows the rear seats of the Motor Car. All the seats of the Motor Car were secured via seat rails to the floorboard. They were also fitted with a retractable seat belt reel and a pre-tensioner. The seat belts (arrowed) were tested and were able to be fastened into the respective pre-tensions that were fitted on the side of each individual seat.

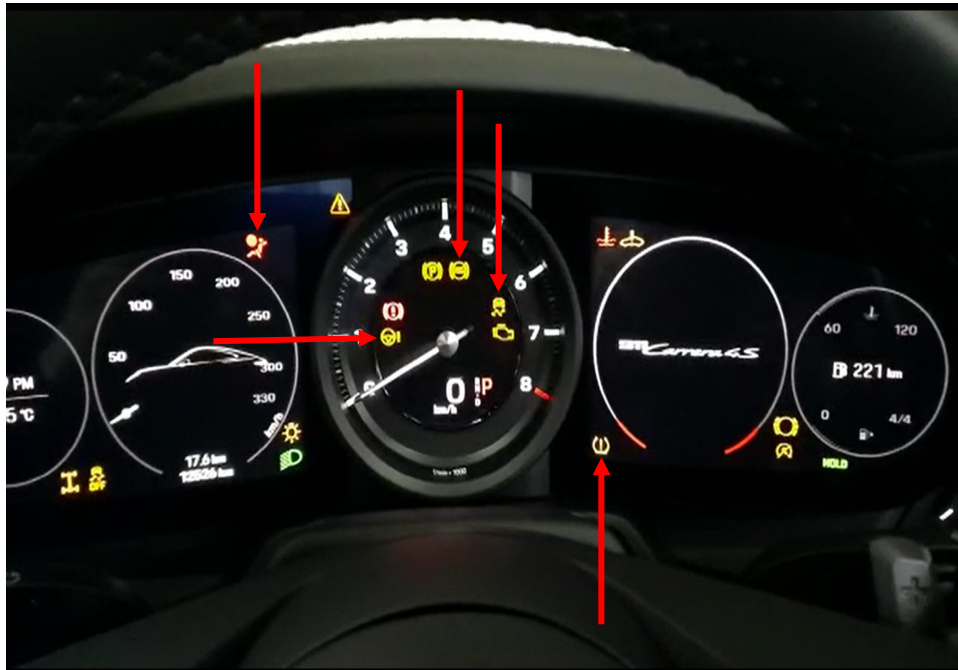
**Photo 21** shows the warning lights for the various electronic safety features appearing on the instrument panel of the Motor Car during its self-test when the engine is cranked, in particular the ABS, SRS, EPS, TPM and TCS lights (arrowed).

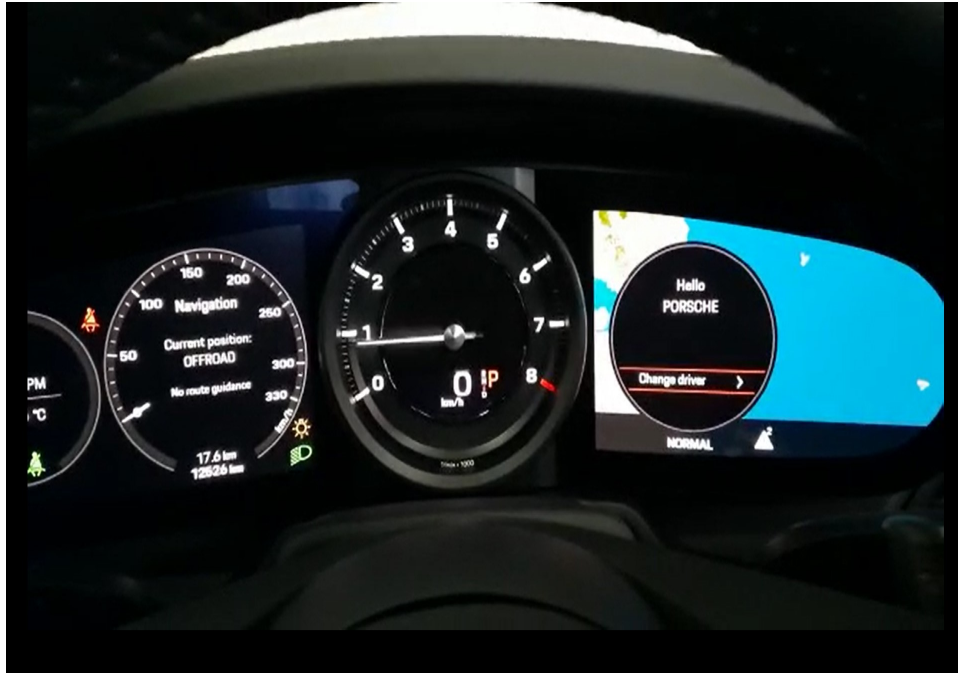
14. The Motor Car's automatic self-test of the functionality of its various electronic safety features like the Anti-Lock Brake System (ABS), Supplemental Restraint System (SRS), Electric Power Steering (EPS), Tyre Pressure Monitor (TPM) and Traction Control System (TCS) during cranking of the engine had indicated that these electronic systems were in working condition. This was determined from the respective warning lights disappearing from the instrument panel after the self-test.

**Photo 22** shows the respective warning lights no longer illuminated, indicating that there is no fault detected to the ABS, SRS, EPS, TPM and TCS systems of the Motor Car during the self-test. These electronic systems were hence in working condition at the time of my inspection.

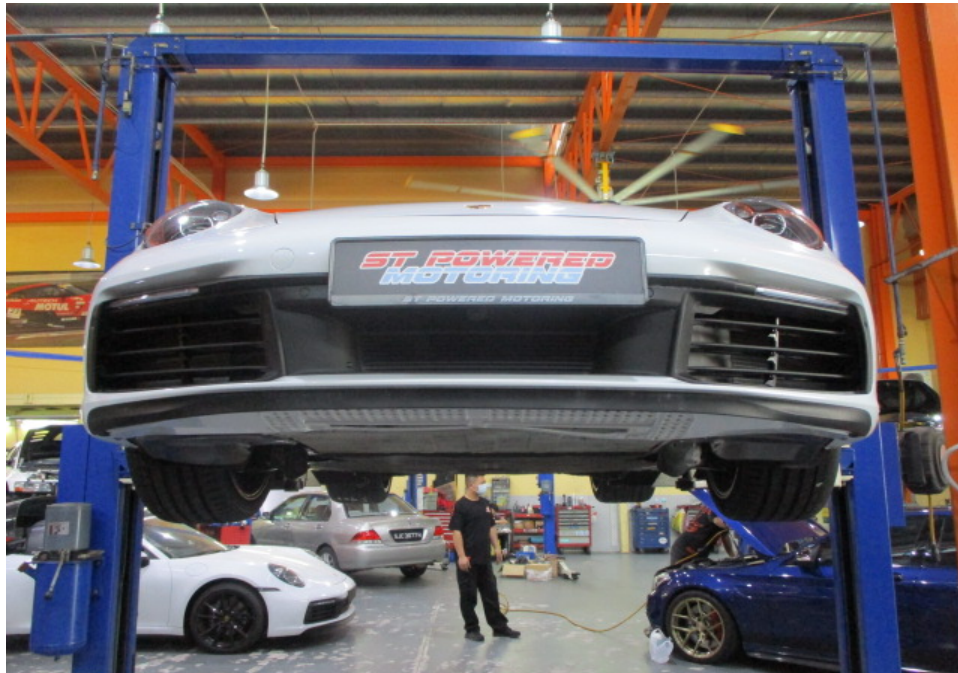
16. My checks on the underside of the Motor Car revealed no sign(s) or indication(s) of fluid leakage and/or fluid stain(s). The engine block and automatic transmission assembly were both secured properly. All undercarriage components of the Motor Car were also observed to be intact and secured in an appropriate manner.

**Photo 23** shows the Motor Car hoisted up for checks on its undercarriage. There was no sign(s) or indication(s) of fluid leakage and/or fluid stain(s) on the underside of the Motor Car. The undercarriage components of the Motor Car were also all observed to be intact and secured in an appropriate manner.

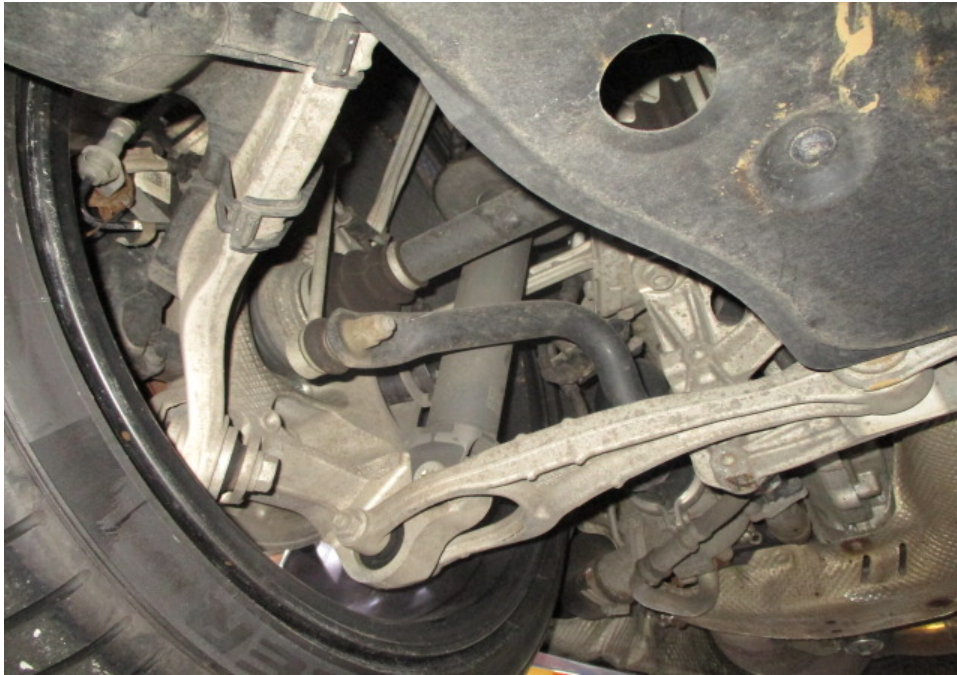
**Photo 24** shows a general view of the control arms and linkages at the rear right wheel of the Motor Car. I did not observe any fluid leak and/or fluid stain on the underside of the Motor Car. All of the Motor Car's undercarriage components were observed to be intact and secured in an appropriate manner.

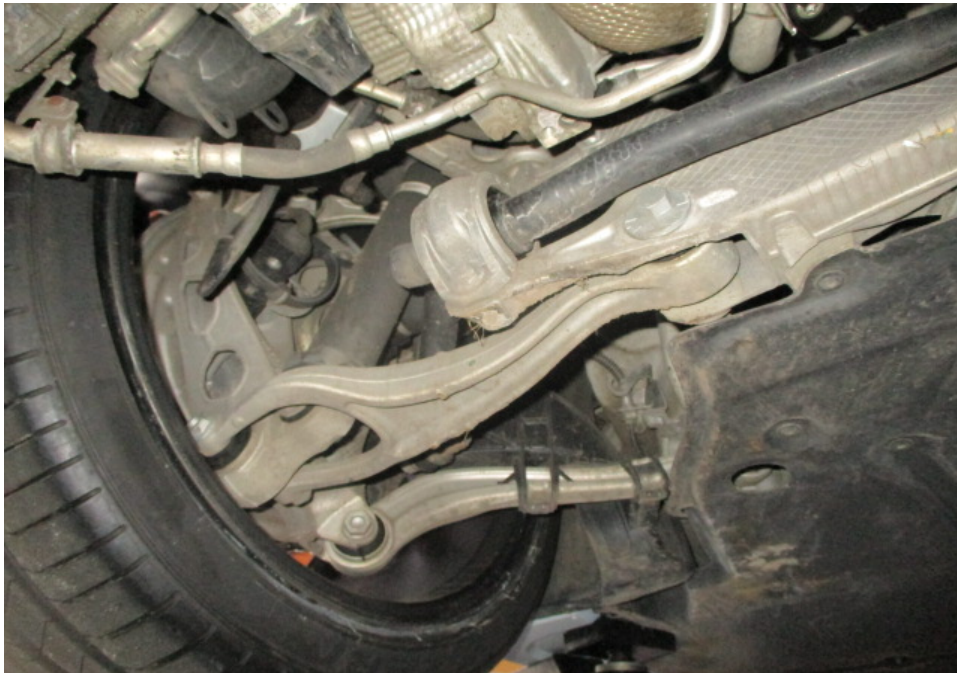
**Photo 25** shows a general view of the control arms and linkages at the rear left wheel of the Motor Car. I did not observe any fluid leak and/or fluid stain on the underside of the Motor Car. All of the Motor Car's undercarriage components were observed to be intact and secured in an appropriate manner.

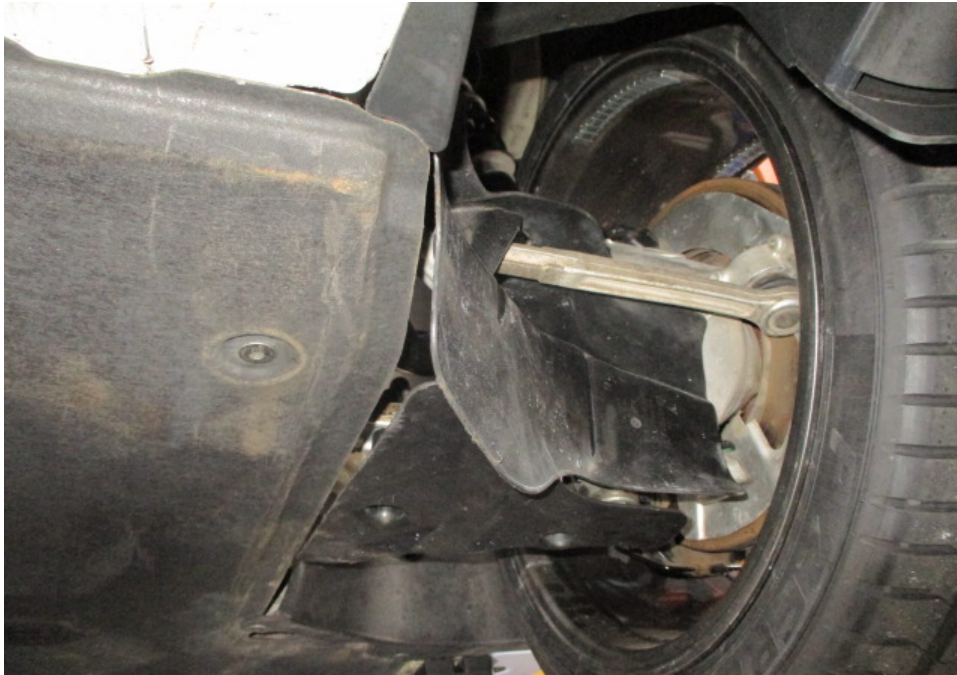
**Photo 26** shows the various undercarriage components at the front left wheel of the Motor Car. The mechanical components, control arms and linkages were all found to be intact and secured in an appropriate manner.

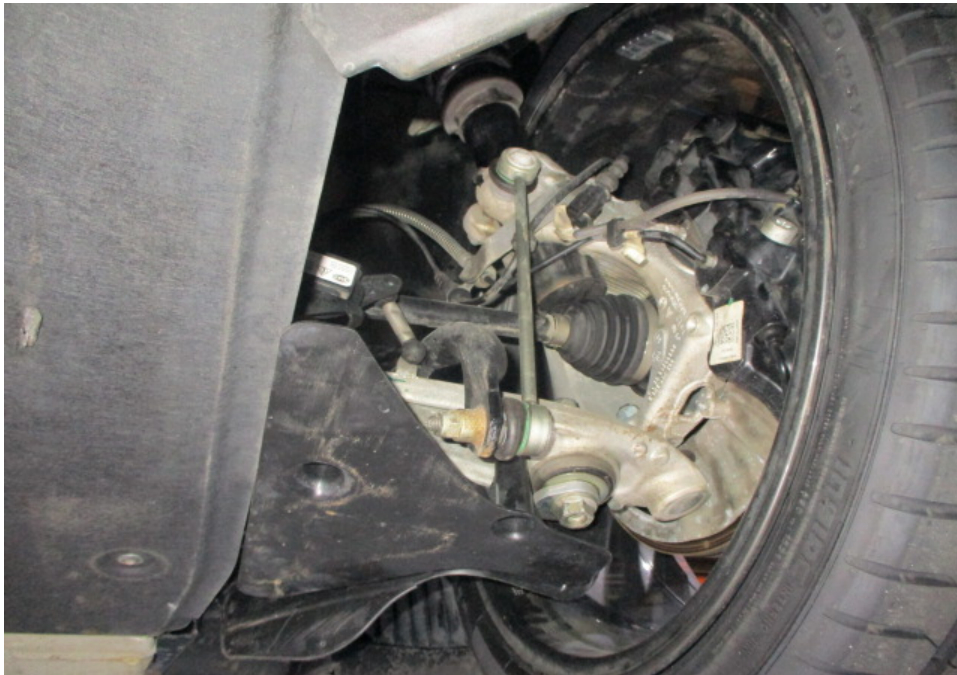
**Photo 27** shows the various undercarriage components at the front right wheel of the Motor Car. The mechanical components, control arms and linkages were all found to be intact and secured in an appropriate manner. I also did not observe any fluid leak and/or fluid stain on the underside of the Motor Car.

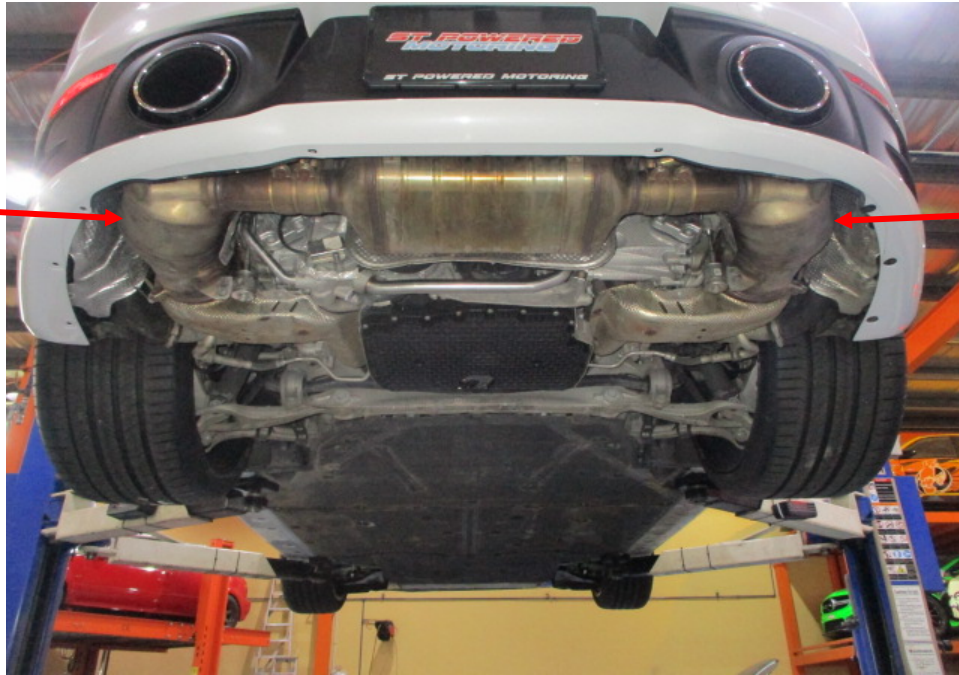
**Photo 28** shows the Motor Car's exhaust system. My examination of the Motor Car's exhaust system revealed no sign(s) or indication(s) of any cut or weld marks along its exhaust pipes, on its catalytic converters (arrowed) and on its rear muffler.

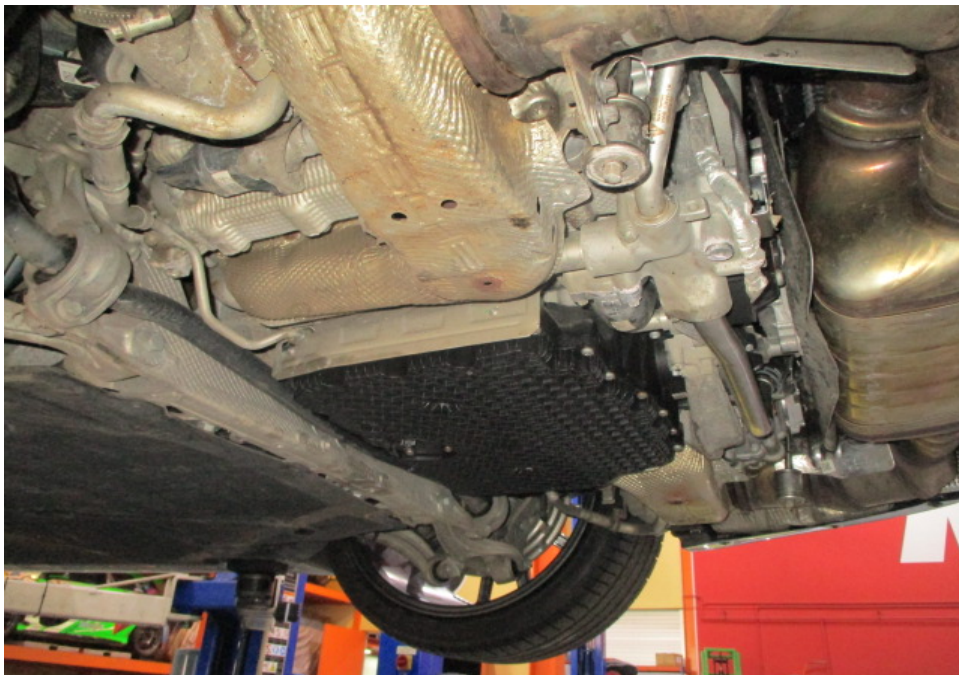
15. My examination of the engine compartment of the Motor Car revealed that the various parts and components inside the engine compartment were all intact and properly fitted. The engine oil, brake fluid and engine coolant were all found to be of sufficient level for operating purposes. Visually, there was also no contamination found to these fluids.

**Photo 29** shows a general view of the Motor Car's engine compartment. The engine compartment was at the rear underside of the Motor Car. The various parts and components inside the engine compartment were all observed to be intact and properly fitted. There was also no sign(s) or indication(s) of fluid leak and/or fluid stain found inside the engine compartment.

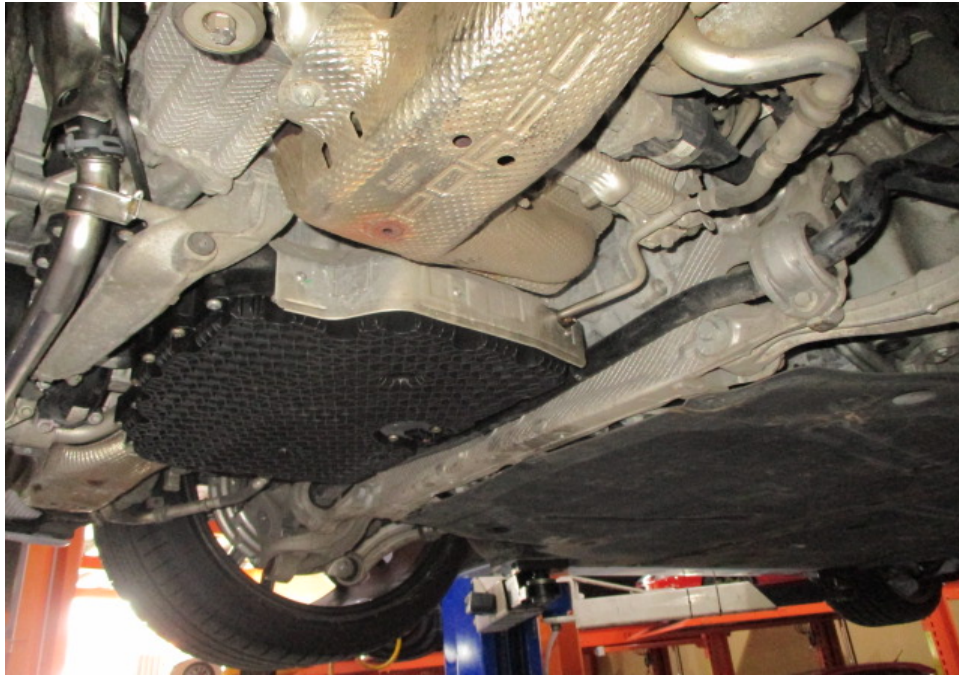
**Photo 30** shows another view of the Motor Car's engine compartment. The engine compartment was at the rear underside of the Motor Car. The various parts and components inside the engine compartment were all observed to be intact and properly fitted. There was also no sign(s) or indication(s) of fluid leak and/or fluid stain found inside the engine compartment.
