Your Ref: Porsche 911 Carrera 4S Coupe  
(chassis number WP0ZZZ99ZLS215977)  
Our Ref : CI/TP22004784/D

**INSPECTION REPORT OF AN UNREGISTERED PORSCHE 911 CARRERA 4S  
COUPE MOTOR CAR WITH CHASSIS NUMBER WP0ZZZ99ZLS215977**

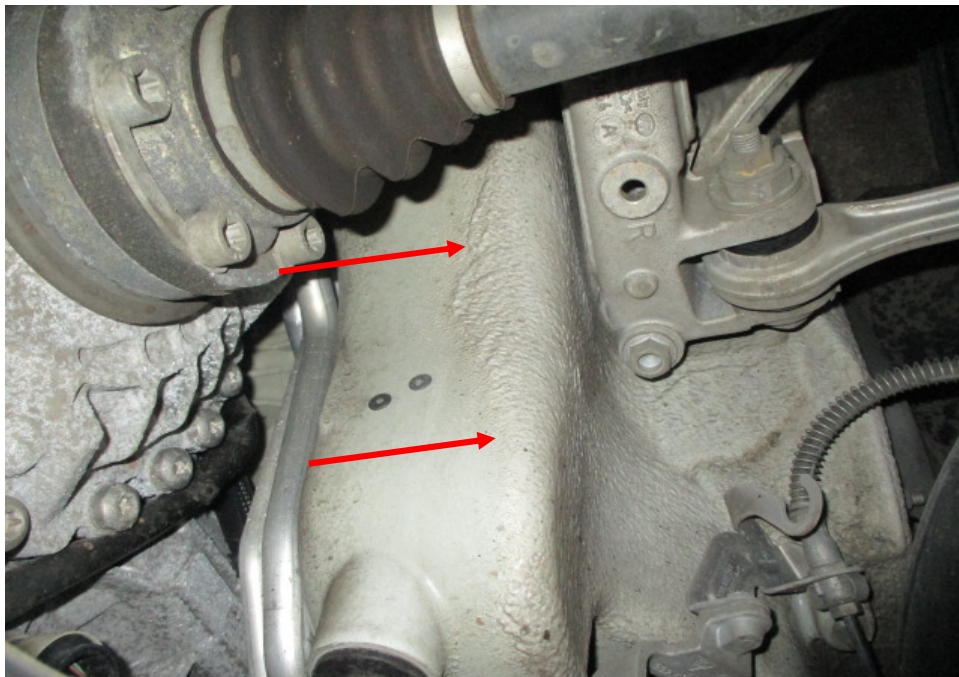
12. Visually, I did not find any weld marks, other than the original spot weld marks, on the chassis/structural body of the Motor Car. The original factory sealant at the joints along the chassis/structural body was also untouched, again indicating that no replacement of the chassis/structural body was carried out; and that the chassis/structural body was originally fitted.

**Photo 31** shows the chassis/structural body at the underside rear right of the Motor Car. I did not find any weld marks other than original spot weld marks on the chassis/structural body of the Motor Car. The original factory sealant (arrowed) at the joints along the chassis/structural body was untouched, indicating no work was done on the chassis/structural body of the Motor Car and that the chassis/structural body was originally fitted.

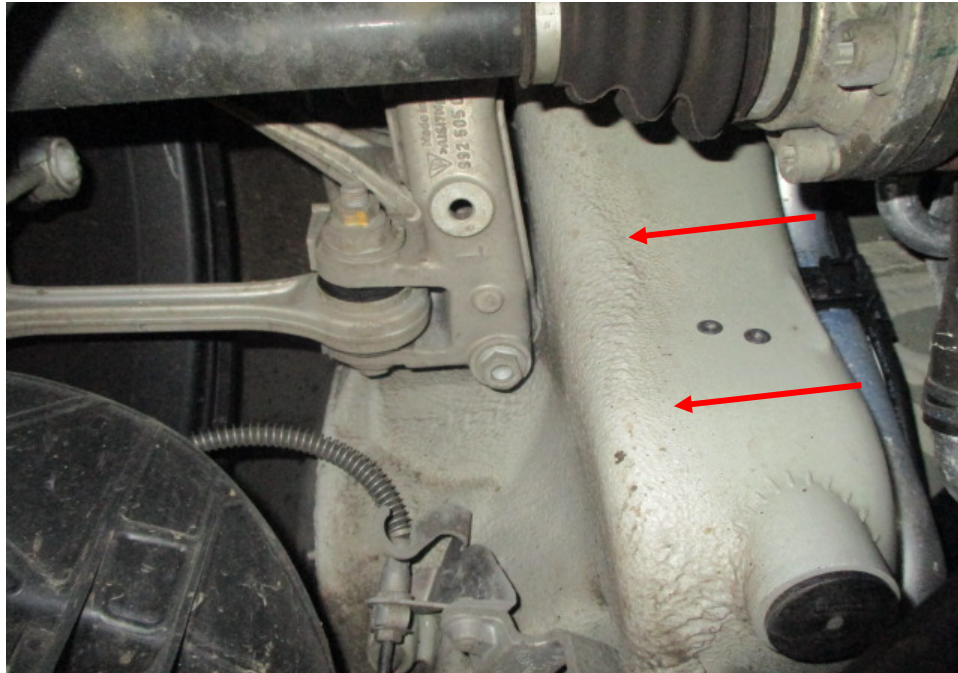
**Photo 32** shows the chassis/structural body at the underside rear left of the Motor Car. The original factory sealant (arrowed) at the joints along the chassis/structural body was observed to be untouched. In general, I had found no work was carried out on the chassis/structural body of the Motor Car. The chassis/structural body of the Motor Car was originally fitted.

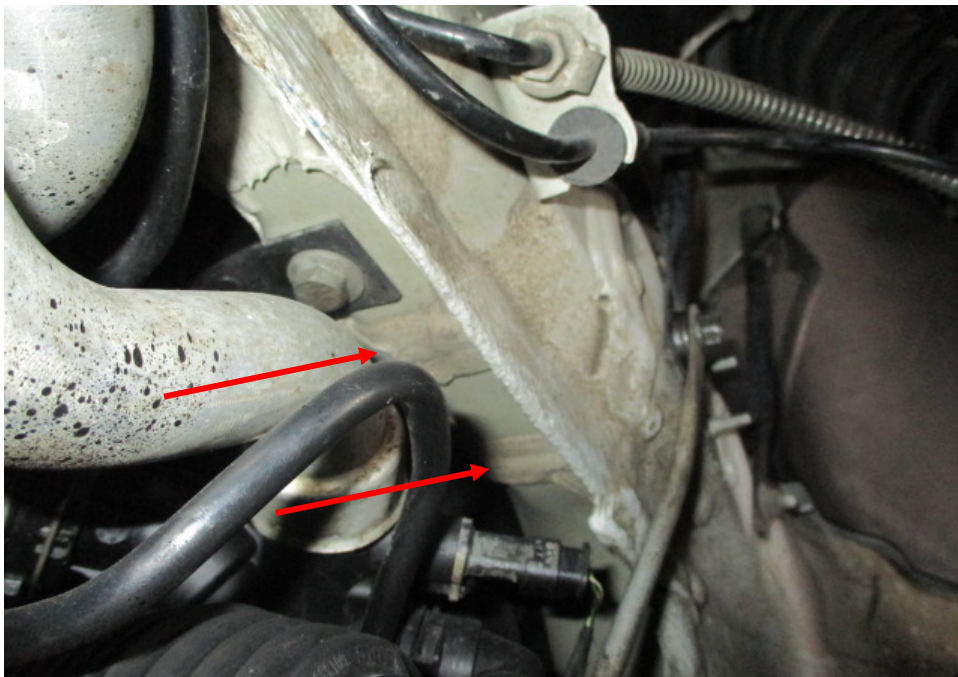
**Photo 33** shows the chassis/structural body at the underside front left of the Motor Car. I did not find any weld marks other than original spot weld marks on the chassis/structural body of the Motor Car. The original factory sealant (arrowed) at the joints along the chassis/structural body was untouched, indicating no work was done on the chassis/structural body of the Motor Car and that the chassis/structural body was originally fitted.

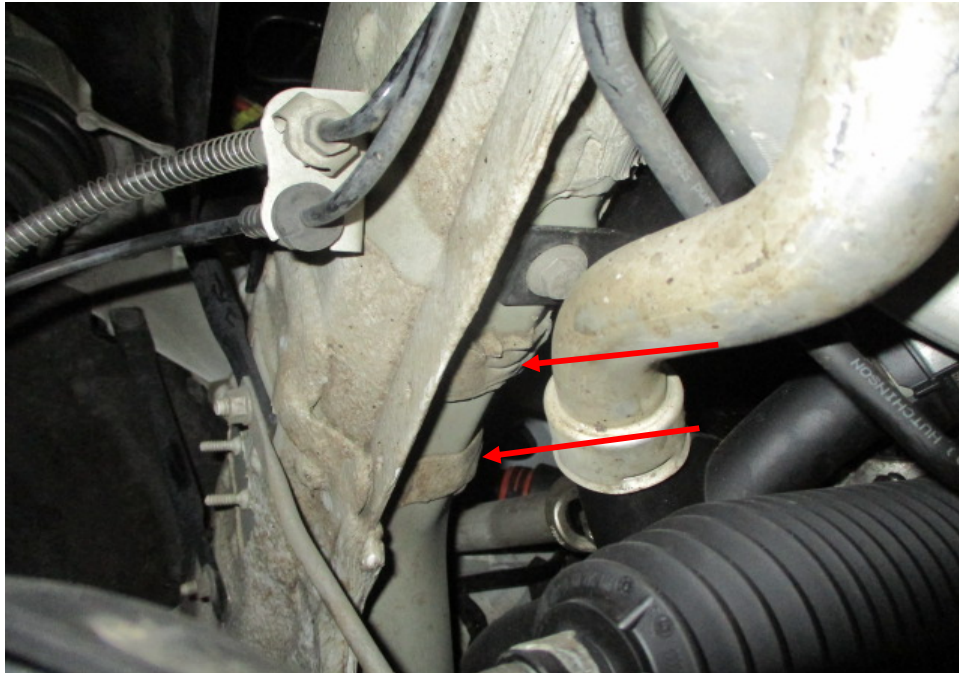
**Photo 34** shows the chassis/structural body at the underside front right of the Motor Car. The original factory sealant (arrowed) at the joints along the chassis/structural body was observed to be untouched. In general, I had found no work was carried out on the chassis/structural body of the Motor Car. The chassis/structural body of the Motor Car was originally fitted.
