Your Ref: BMW Z4 Coupe
(chassis number WBAHF92060WW84064)
Our Ref : CI/TP22004785/D

21 May 2022

INSPECTION REPORT OF AN UNREGISTERED BMW Z4 COUPE MOTOR CAR WITH CHASSIS NUMBER WBAHF92060WW84064

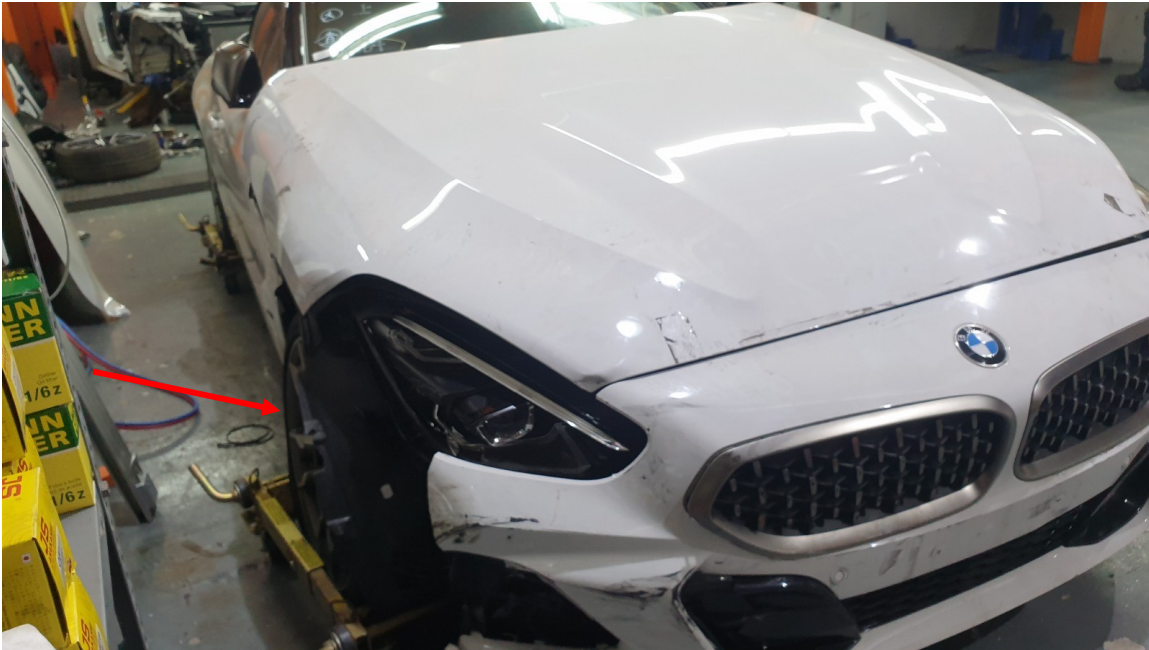
Photo 1 shows the front right body of the Motor Car (photograph provided to me). The photographs provided to me had showed damage to the front right portion of the Motor Car. The front bumper, front bumper right lower grille, front bumper right lower grille garnish, front right headlamp, right radiator grille, front bonnet and front bonnet hinges were amongst the body parts that were observed to have been damaged at the front right portion of the Motor Car. The front right wheel (arrowed) and front left wheel (refer to photograph 2 below) were both orientated inwards. This would indicate damage to the front undercarriage parts of the Motor Car.

24. The body parts at the front right portion and left rear portion of the Motor Car as well as the undercarriage parts at the front wheels of the Motor Car were visually examined and it was noted that the repair/restoration works carried out to the damaged area of the Motor Car (refer to photograph 1 - 3 above) were reasonably adequate and in order.

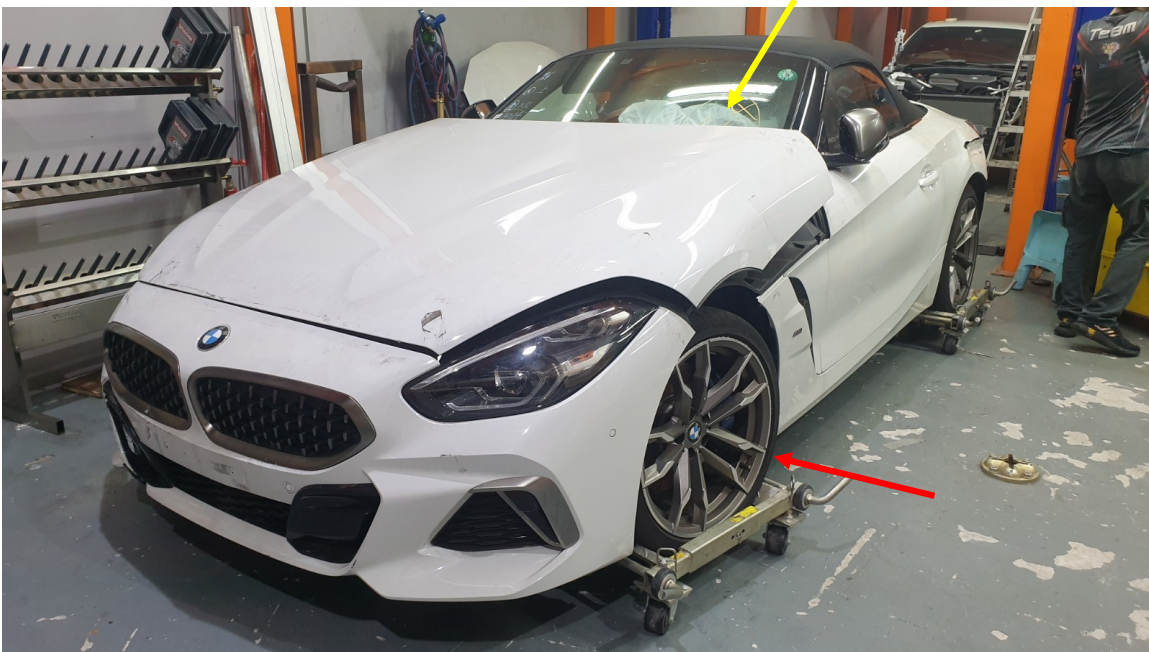
Photo 2 shows the front left body of the Motor Car (photograph provided to me). The front left wheel (red arrow) and front right wheel (refer to photograph 1 above) were both orientated inwards. This would indicate damage to the front undercarriage parts of the Motor Car. The front left passenger airbag (yellow arrow) was also deployed as seen from the photographs that were provided to me.

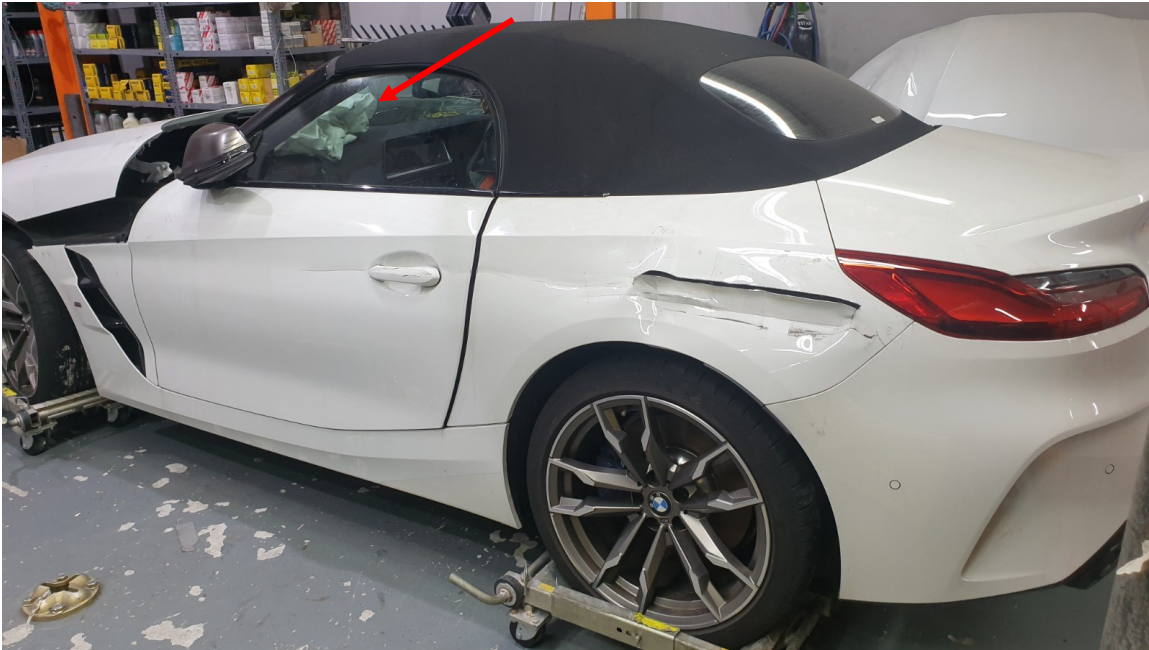
Photo 3 shows the left rear body of the Motor Car (photograph provided to me). Apart for the front right portion, I had also observed damage to the left rear portion of the Motor Car. Body parts damaged include the left rear body panel, front left door and front left door handle. The front left passenger airbag (arrowed) was also deployed.

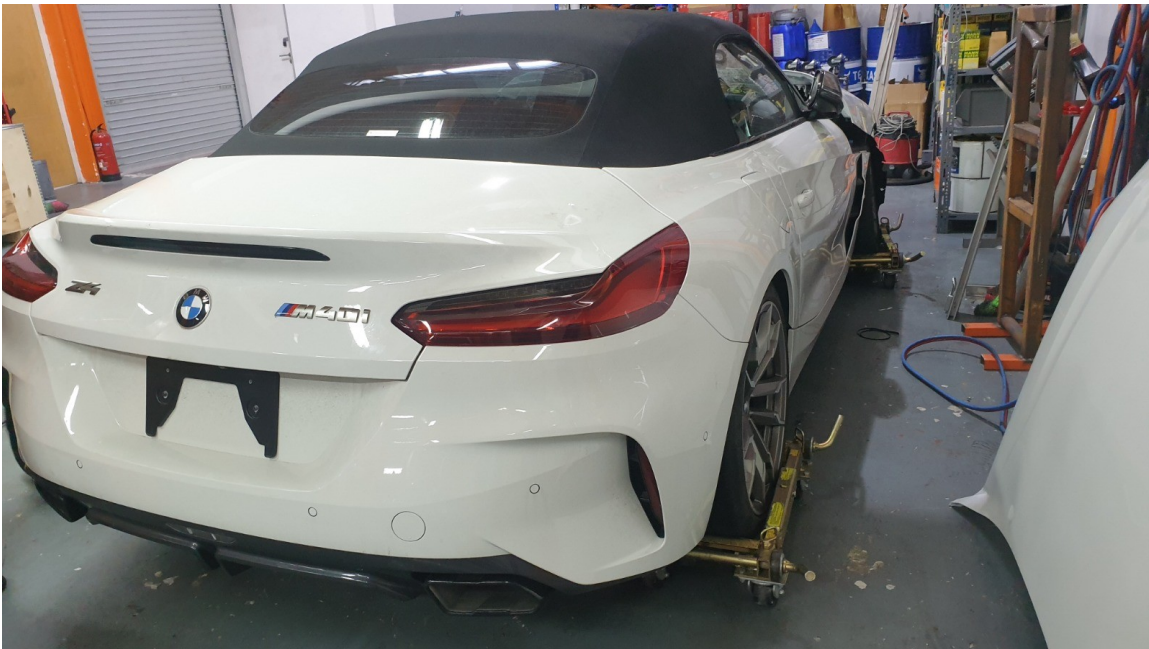
Photo 4 shows the rear right body of the Motor Car (photograph provided to me). No physical damage was observed to the rear right portion of the Motor Car.

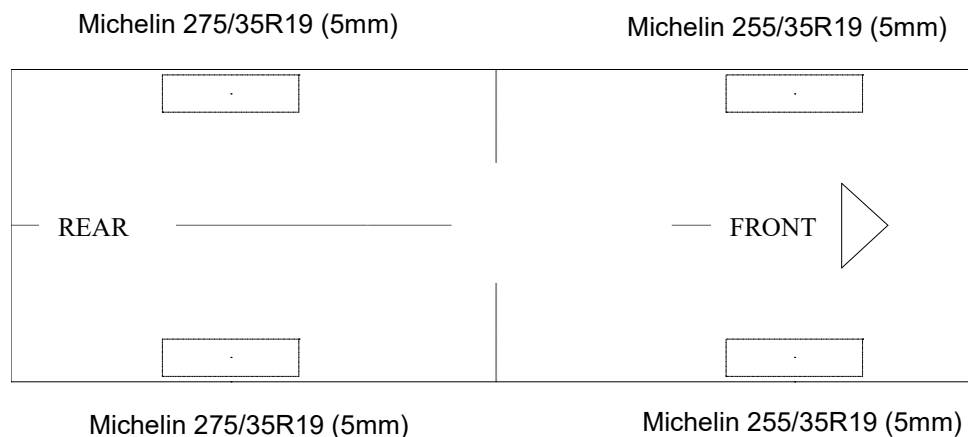
10. The Motor Car was fitted with 19inch sport wheel rims that were wrapped with tyres that were observed to be of serviceable condition. The tyres were also sufficiently inflated for vehicular operation. The tyre brand, tyre size and approximate remaining tread depth of the 4 tyres of the Motor Car were recorded as follows: -

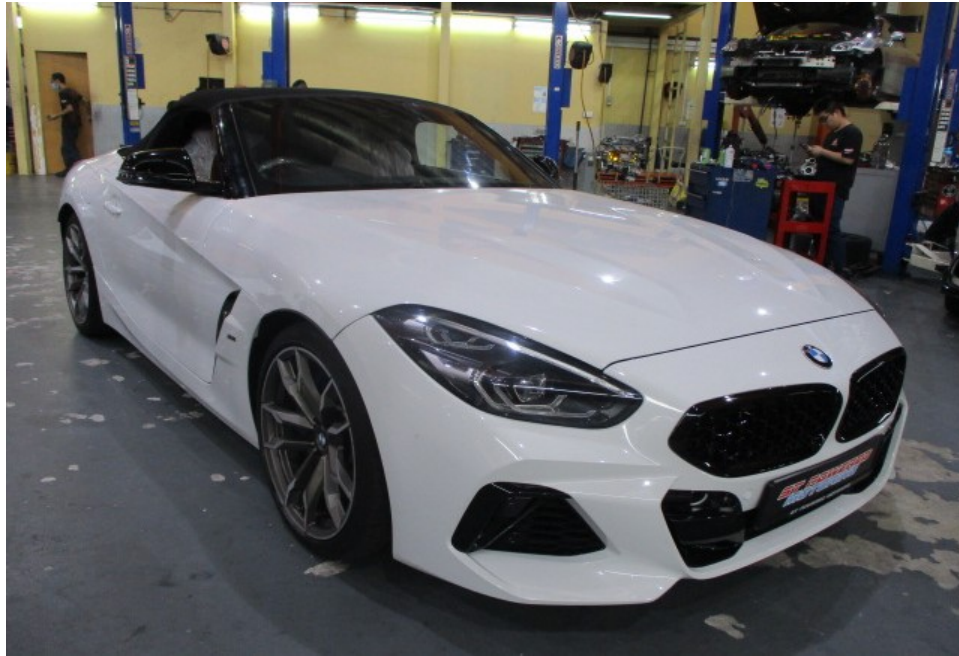
Photo 5 shows a general view of the front right body of the Motor Car at the time of my inspection. The Motor Car was observed to be in a relatively good general condition with no loose exterior fittings observed. The body parts at the front right portion of the Motor Car were visually examined and it was observed that the repair/restoration works carried out to the damaged area of the Motor Car (refer to photograph 1 & 2 above) were reasonably adequate and in order.

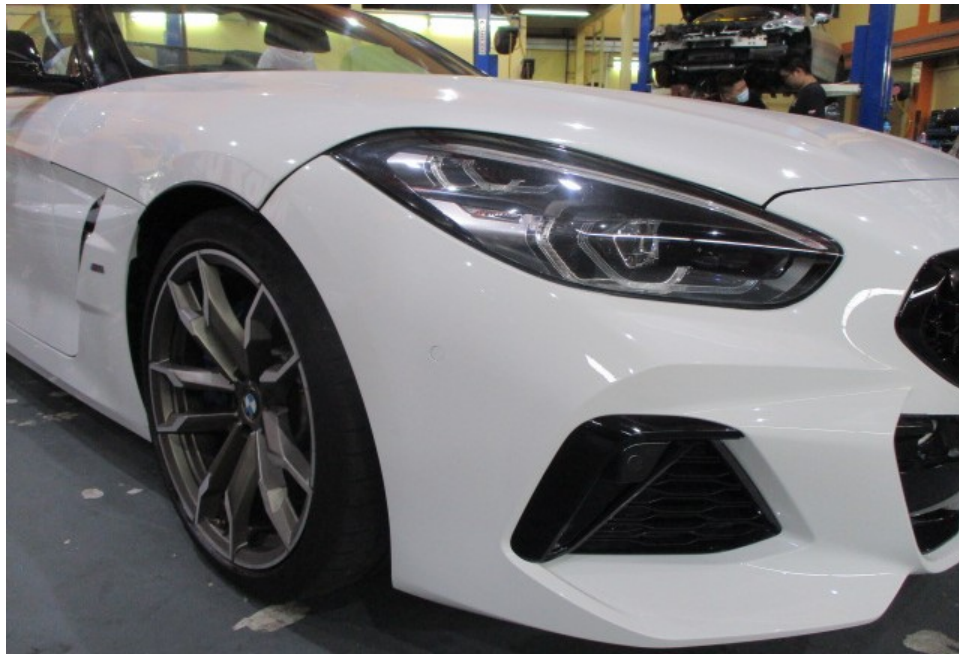
Photo 6 shows a closer view of the Motor Car's front bumper, front bumper right lower grille, front bumper right lower grille garnish, front right headlamp and front bonnet at the time of my inspection. The body parts at the front right portion of the Motor Car were visually examined and it was observed that the repair/restoration works carried out to the damaged area of the Motor Car (refer to photograph 1 & 2 above) were reasonably adequate and in order.

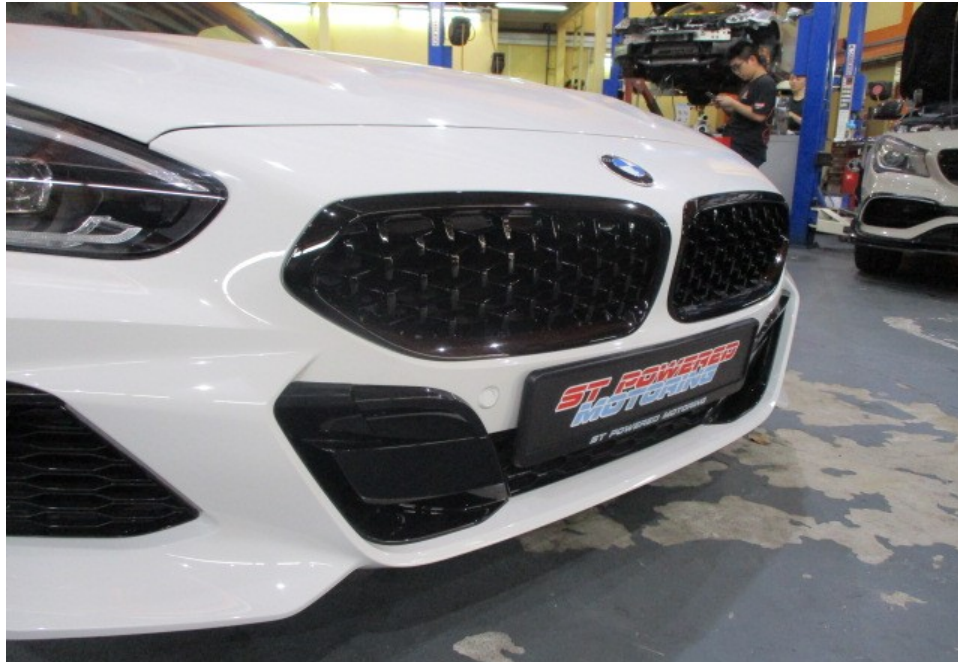
Photo 7 shows a closer view of the Motor Car's front bumper, front bumper sensors, front bumper centre lower grille and radiator grilles at the time of my inspection. The body parts at the front right portion of the Motor Car were visually examined and it was observed that the repair/restoration works carried out to the damaged area of the Motor Car (refer to photograph 1 & 2 above) were reasonably adequate and in order.

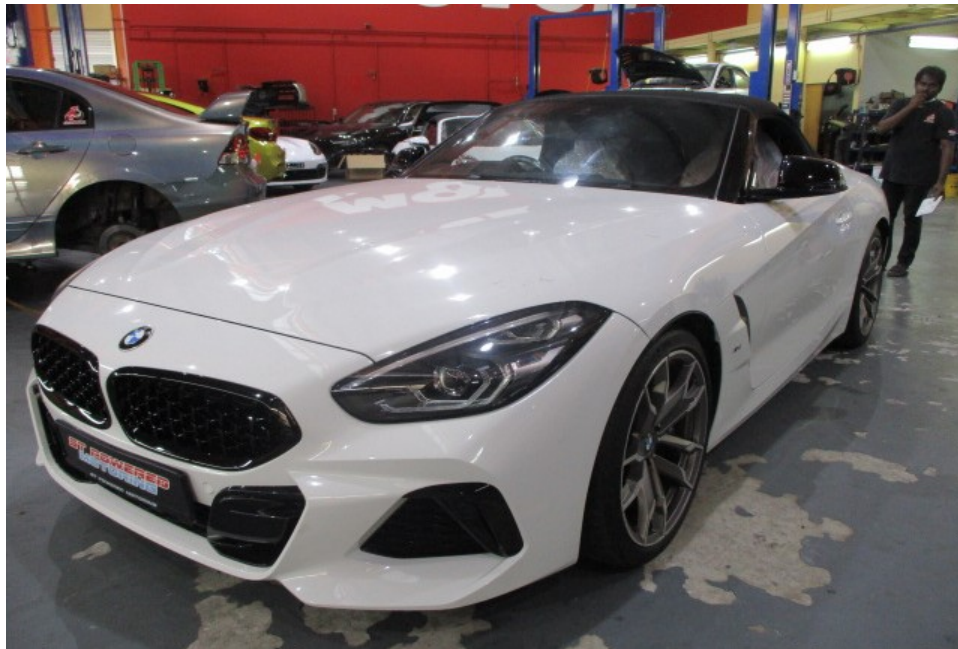
Photo 8 shows a general view of the front left body of the Motor Car at the time of my inspection. The Motor Car was observed to be in a relatively good general condition with no loose exterior fittings observed. The body parts at the frontal portion of the Motor Car were visually examined and it was observed that the repair/restoration works carried out to the damaged area of the Motor Car (refer to photograph 1 & 2 above) were reasonably adequate and in order.

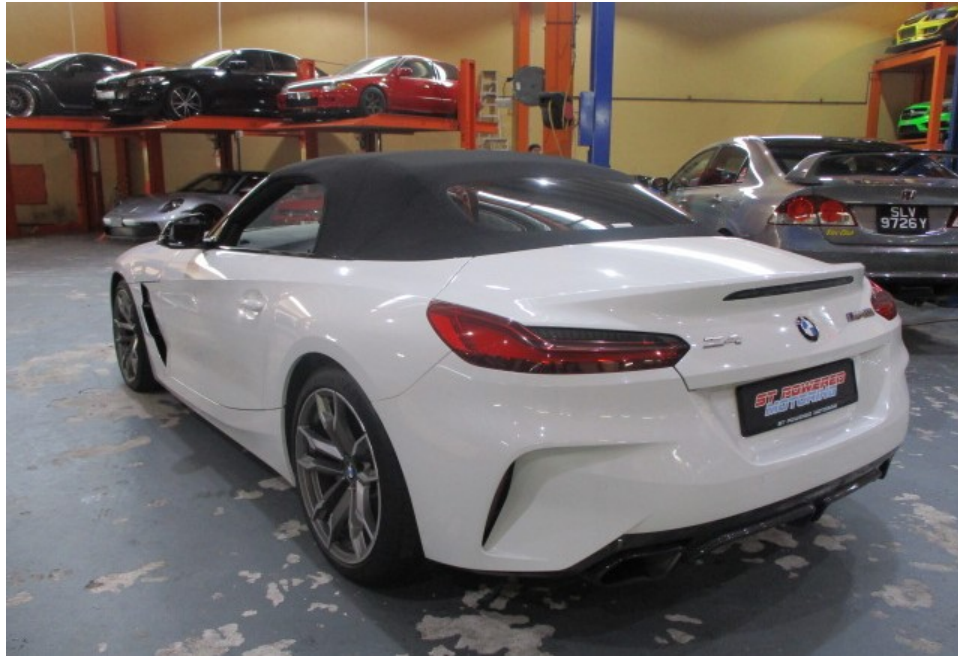
Photo 9 shows a general view of the rear left body of the Motor Car at the time of my inspection. The Motor Car was observed to be in a relatively good general condition with no loose exterior fittings observed. The body parts at the left rear portion of the Motor Car were visually examined and it was observed that the repair/restoration works carried out to the damaged area of the Motor Car (refer to photograph 3 above) were reasonably adequate and in order.

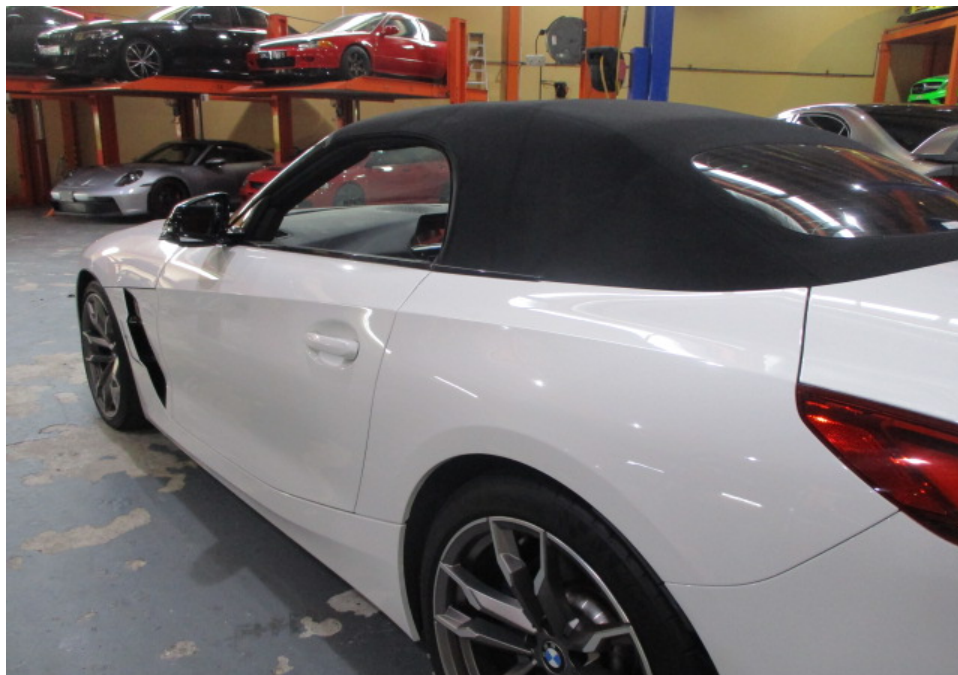
Photo 10 shows a closer view of the Motor Car's left rear body panel, front left door and front left door handle at the time of my inspection. The body parts at the left rear portion of the Motor Car were visually examined and it was observed that the repair/restoration works carried out to the damaged area of the Motor Car (refer to photograph 3 above) were reasonably adequate and in order.

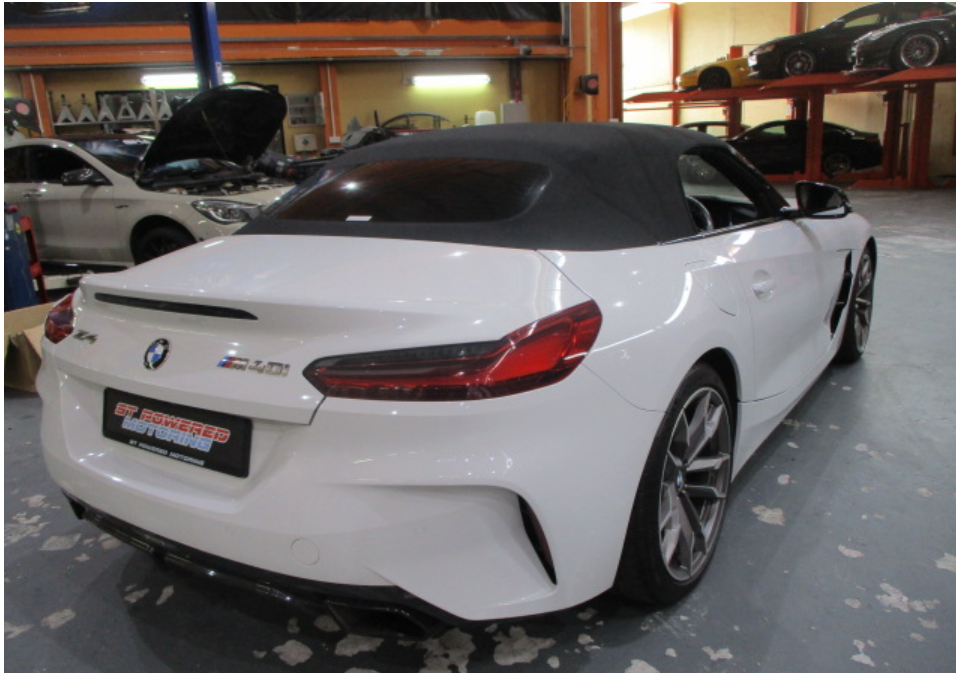
Photo 11 shows a general view of the rear right body of the Motor Car at the time of my inspection. The Motor Car was observed to be in a relatively good general condition with no loose exterior fittings observed. The mileage of the Motor Car recorded at the time of my inspection was 21,123km.

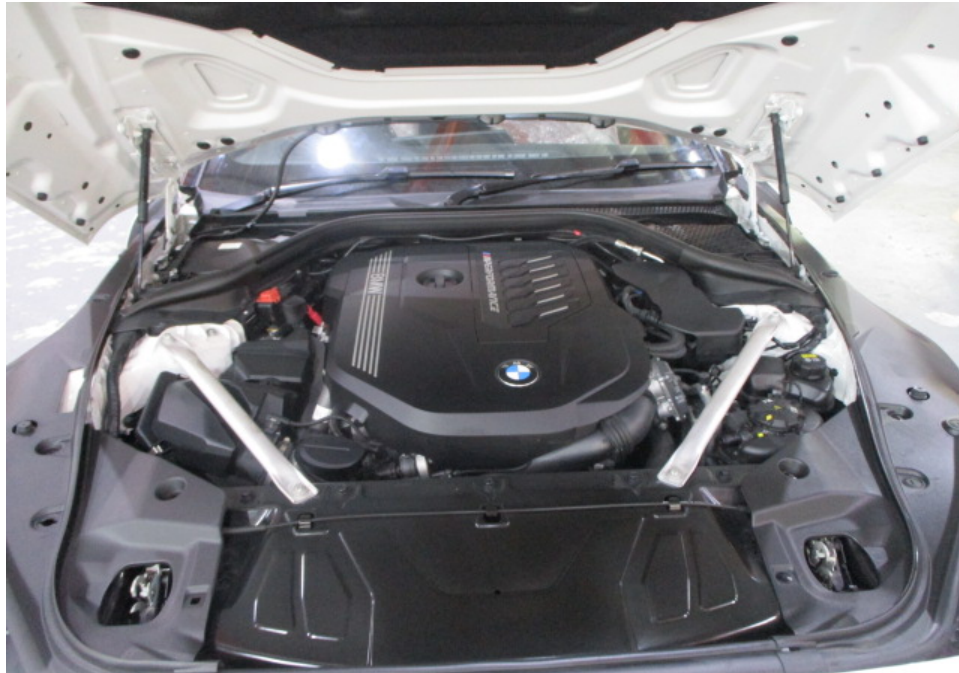
Photo 13 shows a general view of the engine compartment of the Motor Car at the time of my inspection. The various parts and components inside the engine compartment were all observed to be intact and properly fitted. There was also no sign(s) or indication(s) of fluid leak and/or fluid stain found inside the engine compartment.

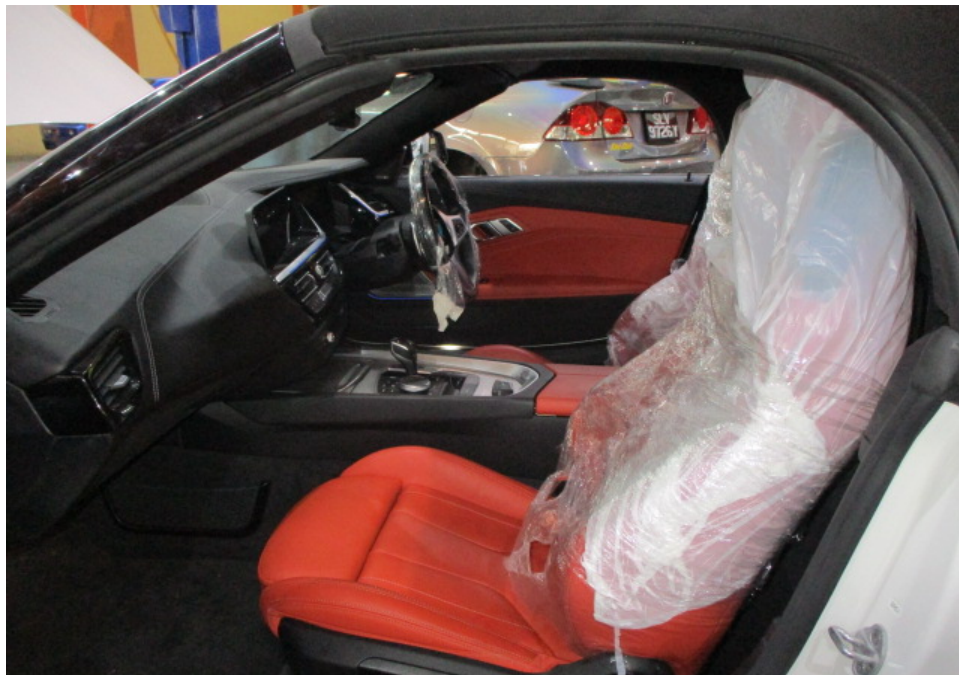
Photo 14 shows the interior compartment of the Motor Car at the time of my inspection. The various parts and components, trims, carpet, and upholstery inside the interior compartment were all observed to be intact and properly fitted.

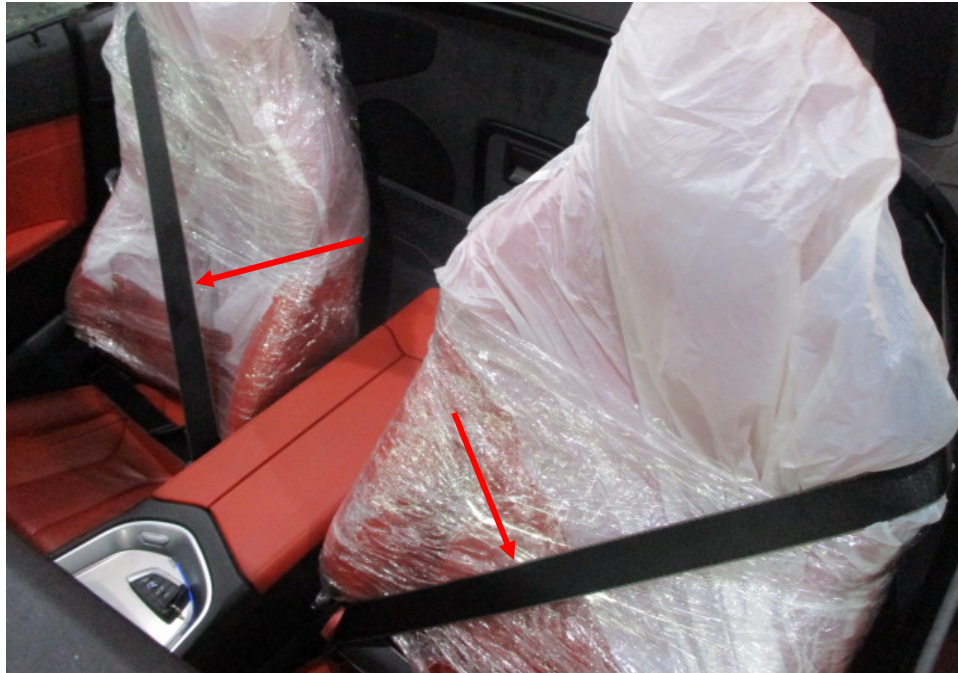
Photo 15 shows the seats of the Motor Car. All the seats of the Motor Car were secured via seat rails to the floorboard. They were also fitted with a retractable seat belt reel and a pre-tensioner. The seat belts (arrowed) were tested and were able to be fastened into the respective pre-tensions that were fitted on the side of each individual seat.

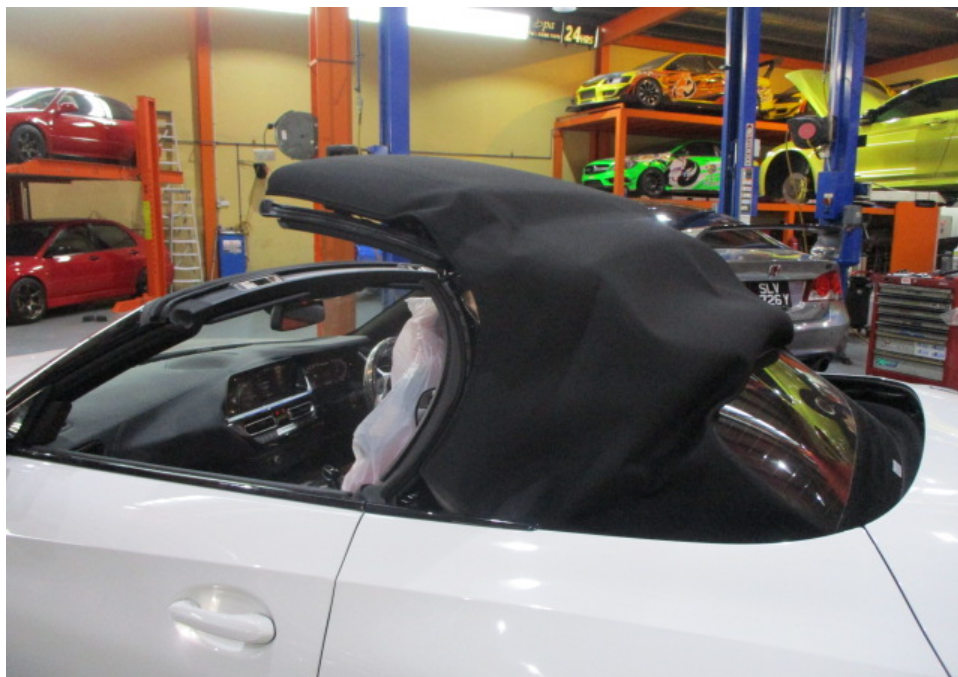
Photo 16 shows the Motor Car's soft top roof being tested. It was observed that as a safety feature, the soft top roof could only open and close when the Motor Car was in a stationary position. When opened, the soft top roof is completely folded into the rear compartment with no parts protruding out of the Motor Car's body. The soft top roof was also found adequately secured to the "A" pillar after closing.

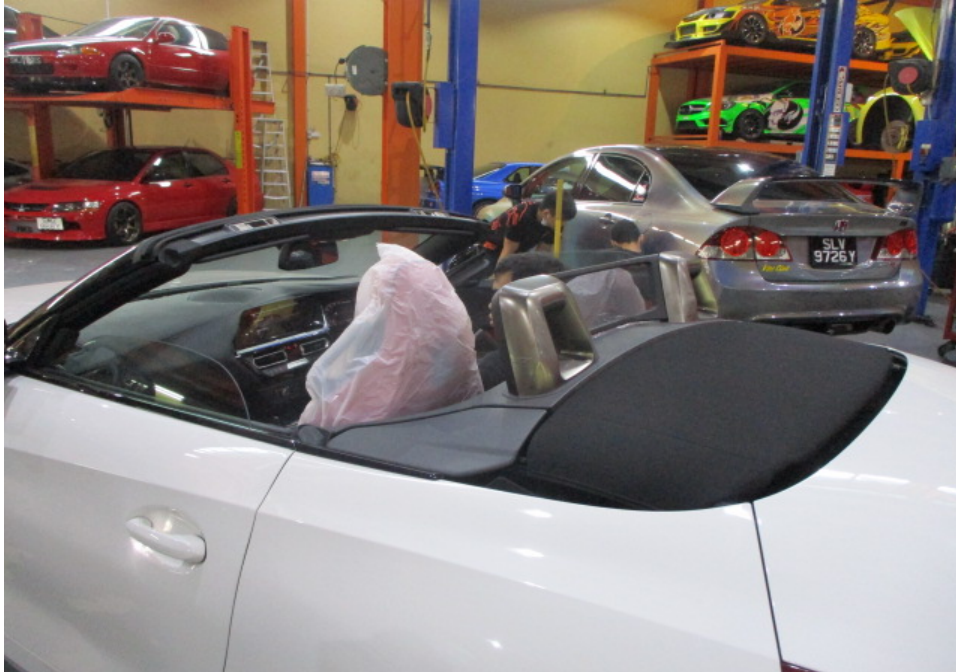
Photo 17 shows the Motor Car with its soft top roof completely folded. It was observed that as a safety feature, the soft top roof could only open and close when the Motor Car was in a stationary position. When opened, the soft top roof is completely folded into the rear compartment with no parts protruding out of the Motor Car's body. The soft top roof was also found adequately secured to the "A" pillar after closing.

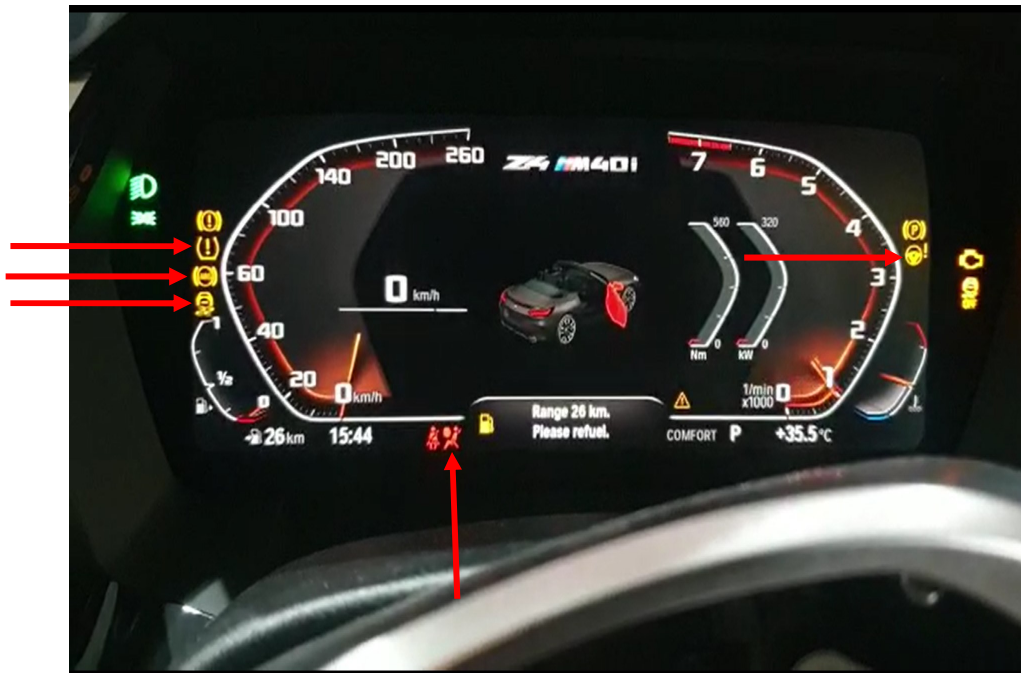
Photo 18 shows the warning lights for the various electronic safety features appearing on the instrument panel of the Motor Car during its self-test when the engine is cranked, in particular the ABS, SRS, IAS, TPM and DSC lights (arrowed).

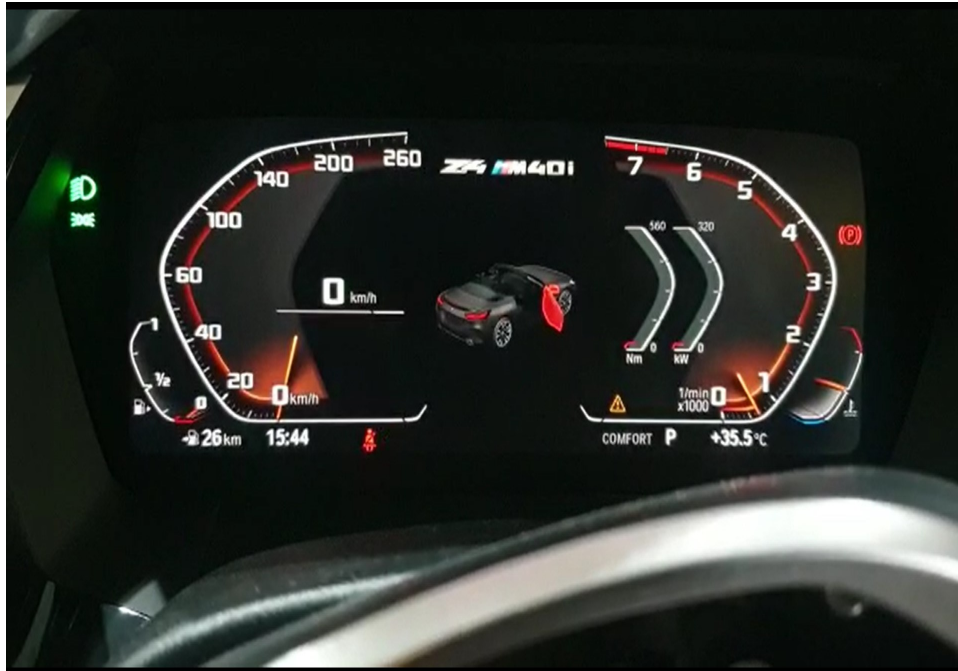
Photo 19 shows the respective warning lights no longer illuminated, indicating that there is no fault detected to the ABS, SRS, IAS, TPM and DSC systems of the Motor Car during the self-test. These electronic systems were hence in working condition at the time of my inspection.

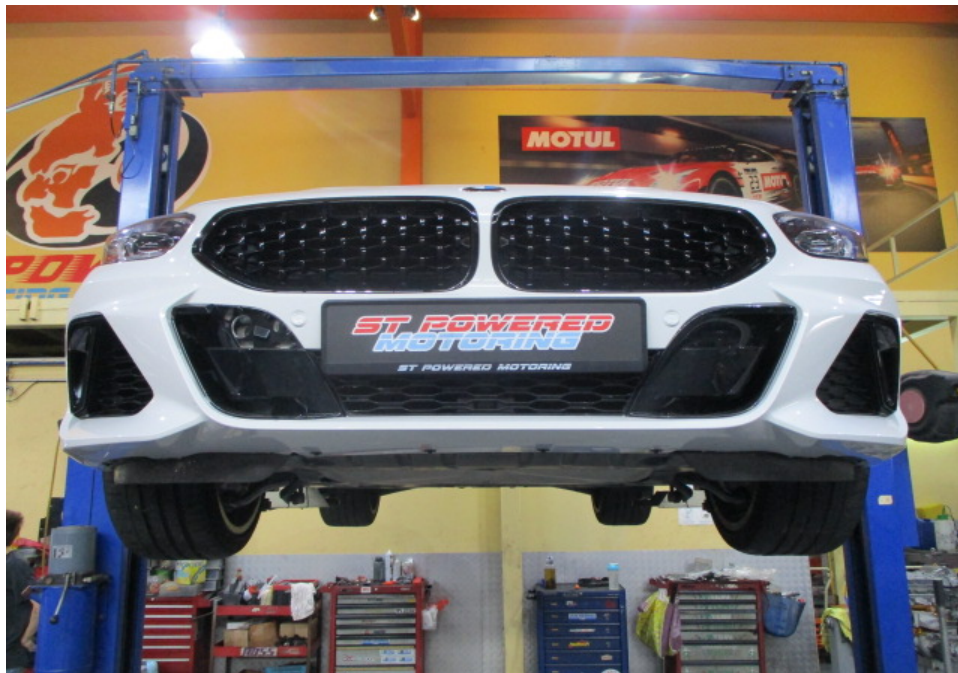
Photo 20 shows the Motor Car hoisted up for checks on its undercarriage. There was no sign(s) or indication(s) of fluid leakage and/or fluid stain(s) on the underside of the Motor Car. The undercarriage components of the Motor Car were also all observed to be intact and secured in an appropriate manner.

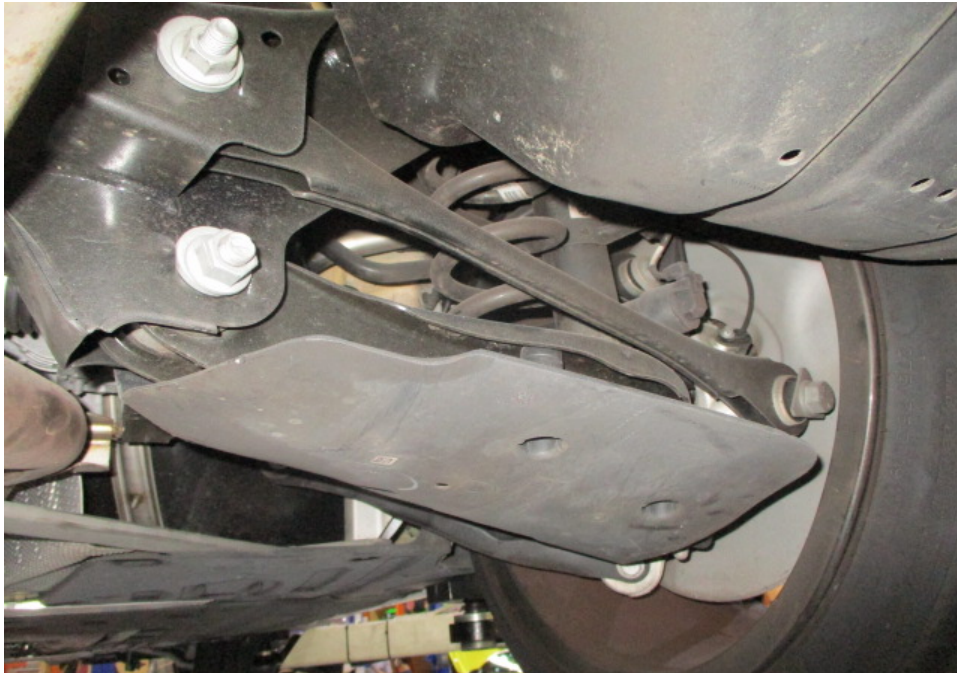
Photo 21 shows a general view of the control arms and linkages at the rear right wheel of the Motor Car. I did not observe any fluid leak and/or fluid stain on the underside of the Motor Car. All of the Motor Car's undercarriage components were observed to be intact and secured in an appropriate manner.

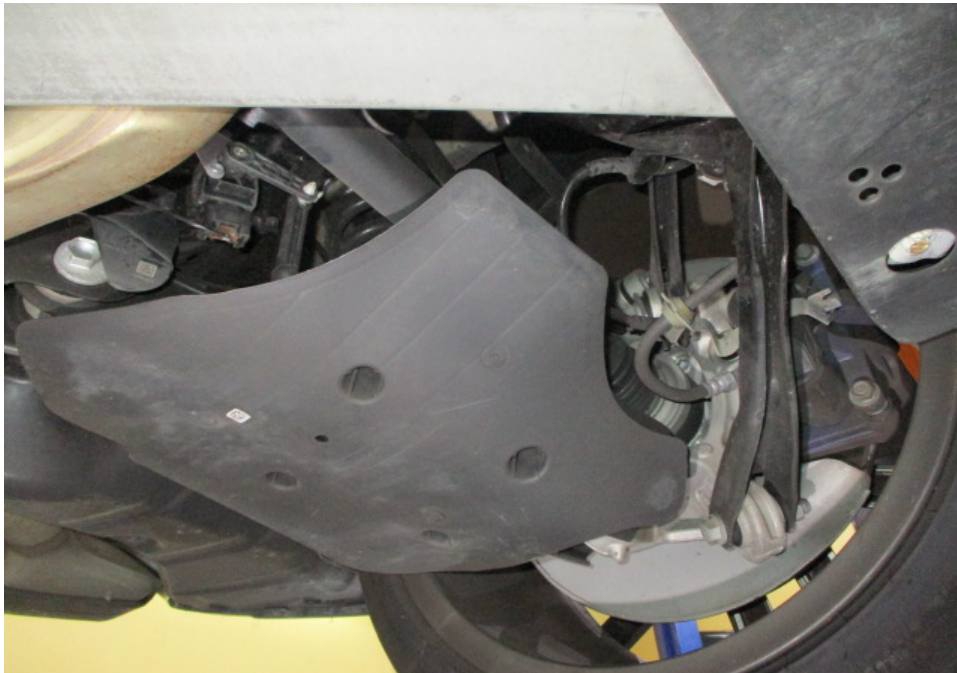
Photo 22 shows a general view of the control arms and linkages at the rear left wheel of the Motor Car. I did not observe any fluid leak and/or fluid stain on the underside of the Motor Car. All of the Motor Car's undercarriage components were observed to be intact and secured in an appropriate manner.

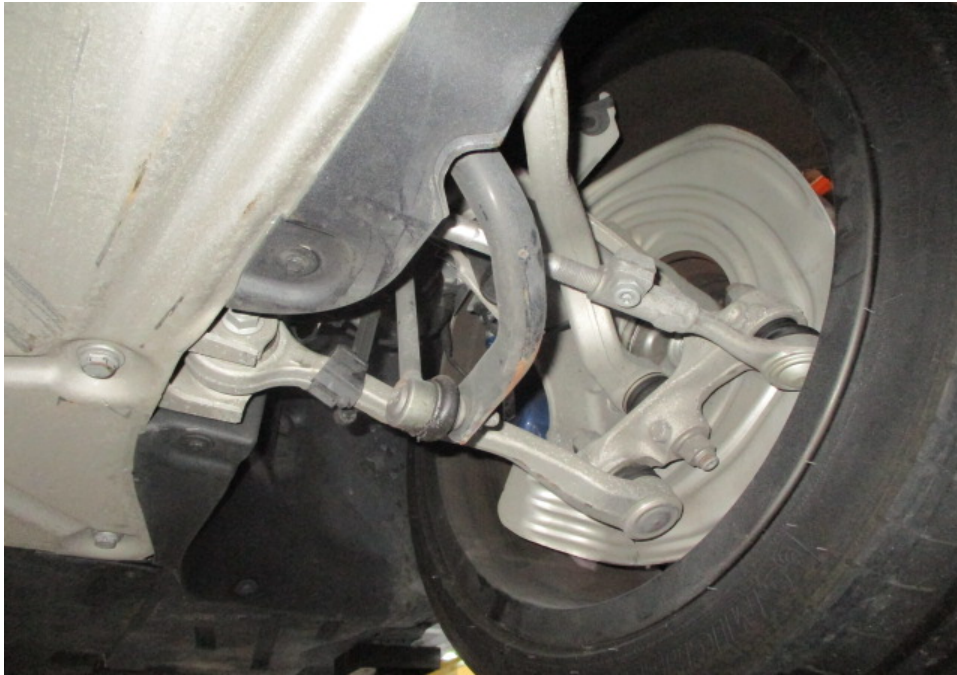
Photo 23 shows the various undercarriage components at the front left wheel of the Motor Car. The mechanical components, control arms and linkages were all found to be intact and secured in an appropriate manner.

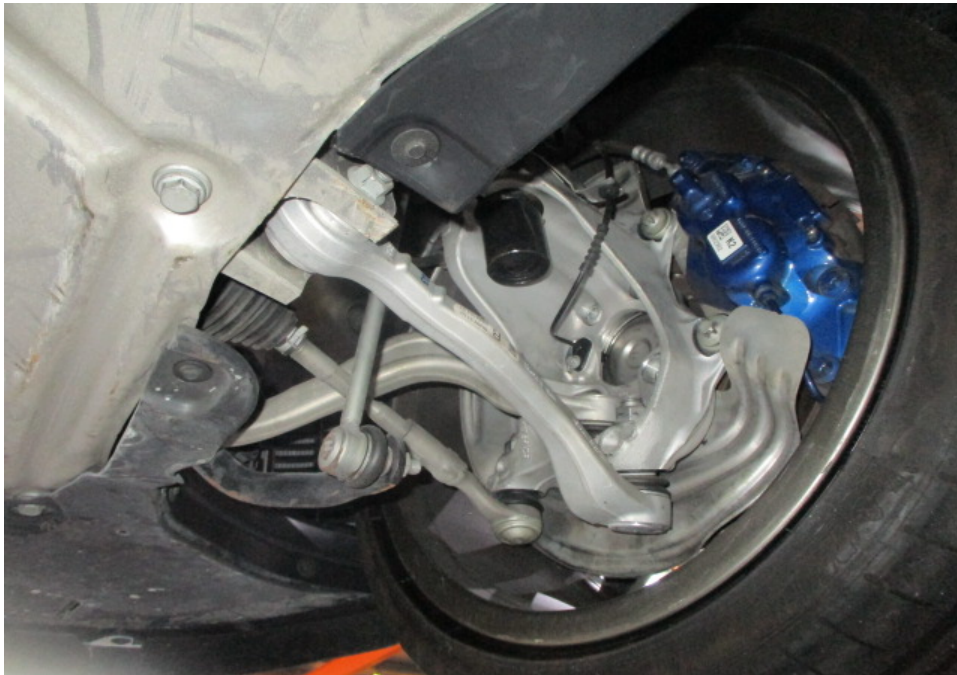
Photo 24 shows the various undercarriage components at the front right wheel of the Motor Car. The mechanical components, control arms and linkages were all found to be intact and secured in an appropriate manner. I also did not observe any fluid leak and/or fluid stain on the underside of the Motor Car.

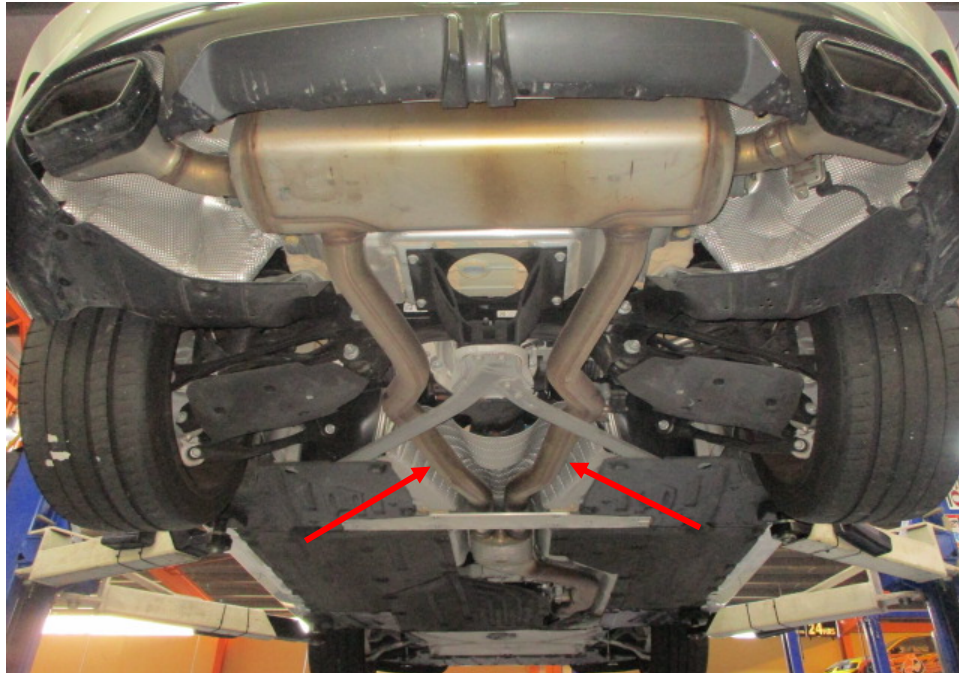
Photo 25 shows the rear section of the Motor Car's exhaust system. My examination of the Motor Car's exhaust system revealed no sign(s) or indication(s) of any cut or weld marks along its exhaust pipes (arrowed), on its rear muffler, on its centre resonator box and on its catalytic converter.

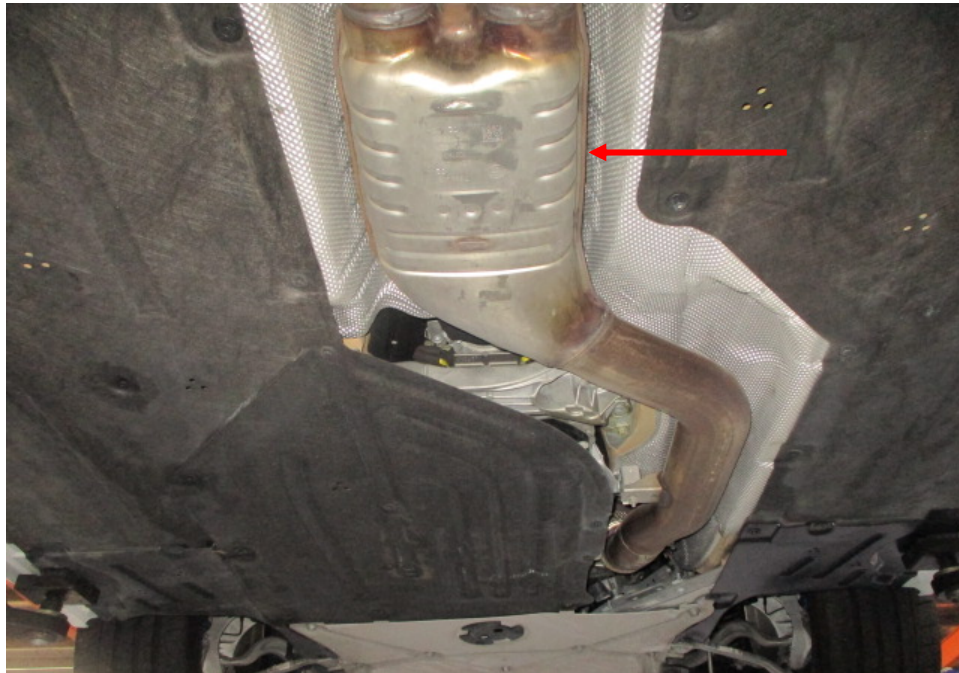
Photo 26 shows the front section of the Motor Car's exhaust system. My examination of the Motor Car's exhaust system revealed no sign(s) or indication(s) of any cut or weld marks along its exhaust pipes, on its rear muffler, on its centre resonator box (arrowed) and on its catalytic converter.

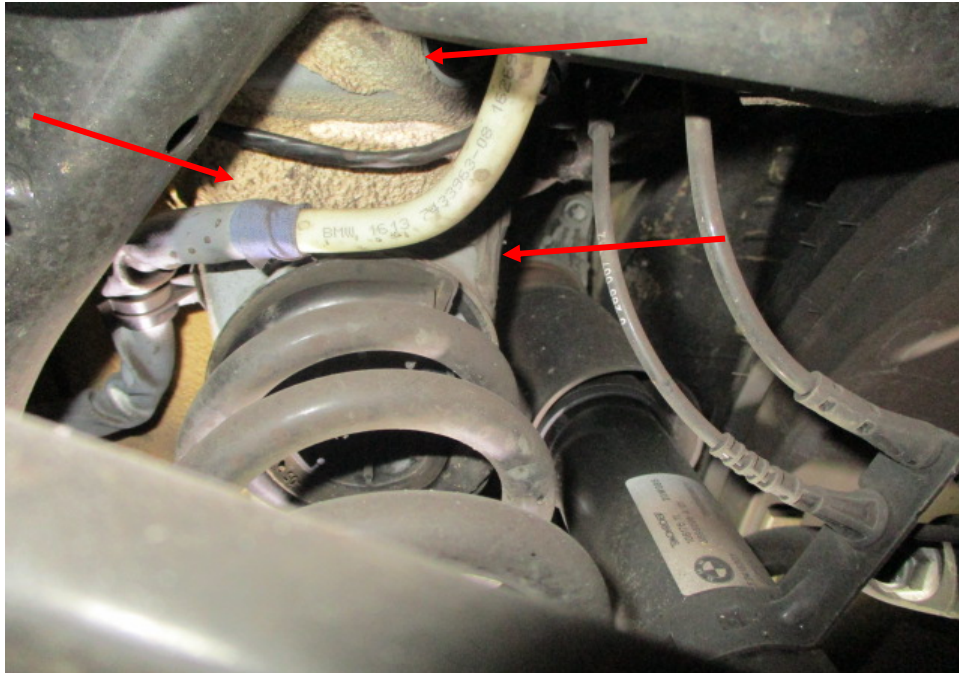
Photo 27 shows the chassis/structural body at the underside rear right of the Motor Car. I did not find any weld marks other than original spot weld marks on the chassis/structural body of the Motor Car. The original factory sealant (arrowed) at the joints along the chassis/structural body was untouched, indicating no work was done on the chassis/structural body of the Motor Car and that the chassis/structural body was originally fitted.

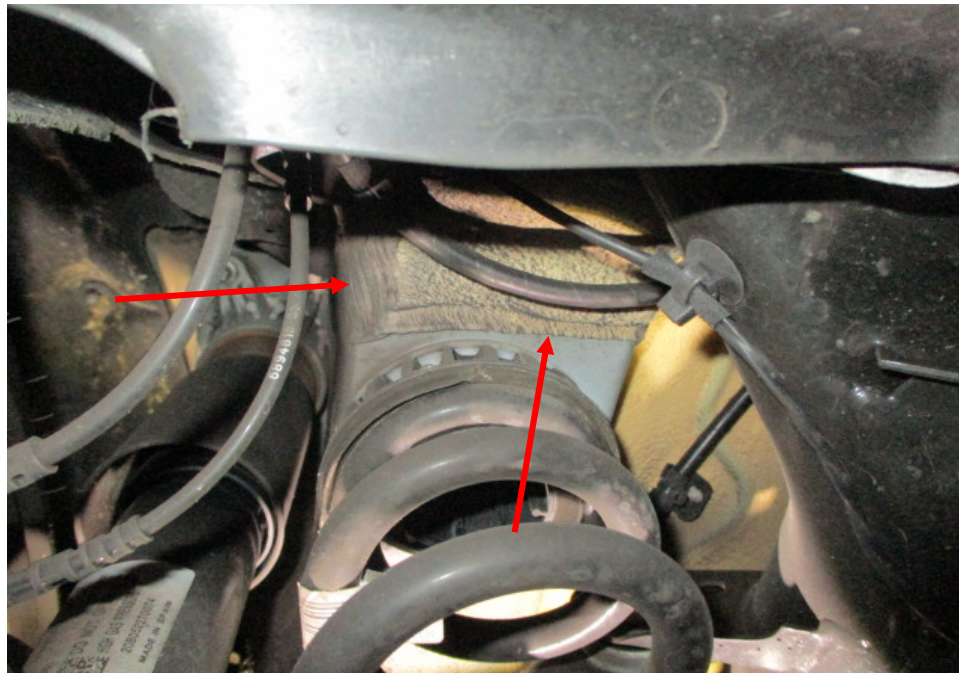
Photo 28 shows the chassis/structural body at the underside rear left of the Motor Car. The original factory sealant (arrowed) at the joints along the chassis/structural body was observed to be untouched. In general, I had found no work was carried out on the chassis/structural body of the Motor Car. The chassis/structural body of the Motor Car was originally fitted.

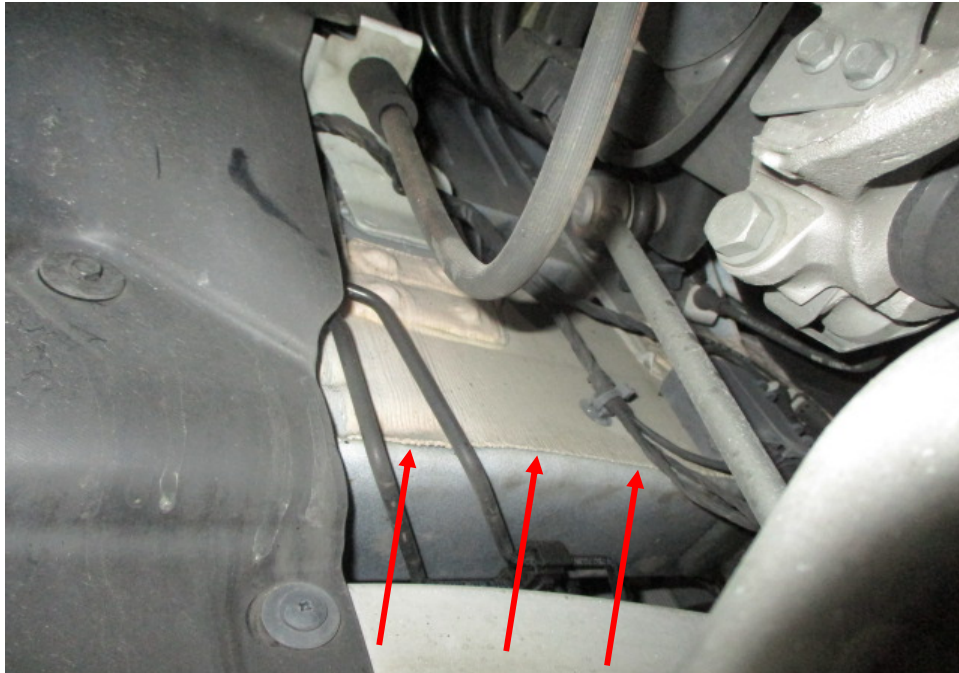
Photo 29 shows the chassis/structural body at the underside front left of the Motor Car. The original factory sealant (arrowed) at the joints along the chassis/structural body was observed to be untouched. In general, I had found no work was carried out on the chassis/structural body of the Motor Car. The chassis/structural body of the Motor Car was originally fitted.

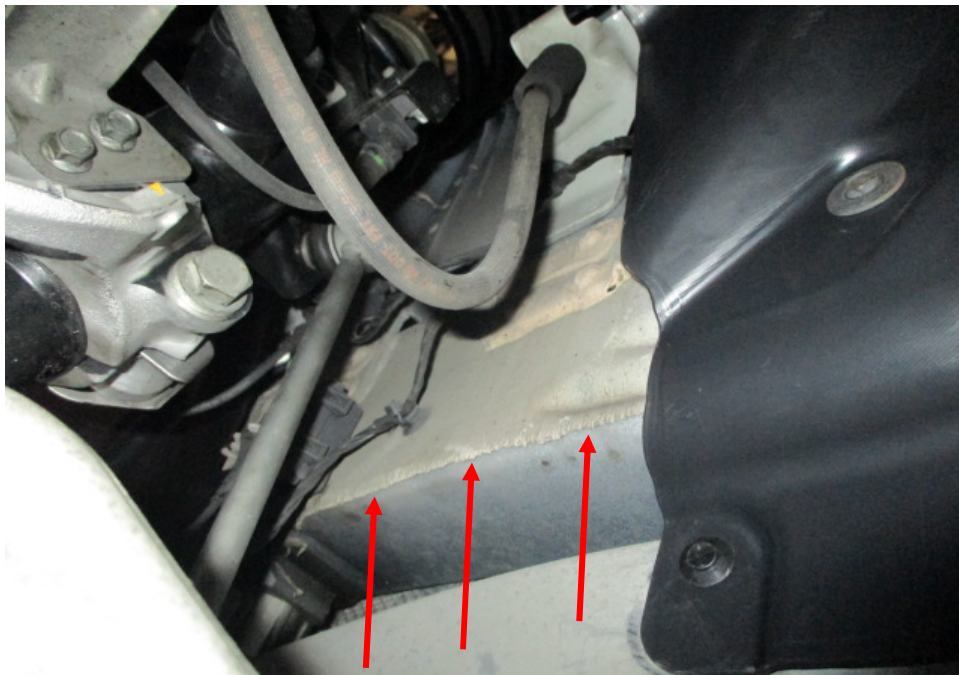
Photo 30 shows the chassis/structural body at the underside front right of the Motor Car. The original factory sealant (arrowed) at the joints along the chassis/structural body was observed to be untouched. In general, I had found no work was carried out on the chassis/structural body of the Motor Car. The chassis/structural body of the Motor Car was originally fitted.
