Your Ref: BMW Z4 Coupe
(chassis number WBAHF92060WW84064)
Our Ref : CI/TP22004785/D

21 May 2022

INSPECTION REPORT OF AN UNREGISTERED BMW Z4 COUPE MOTOR CAR WITH CHASSIS NUMBER WBAHF92060WW84064

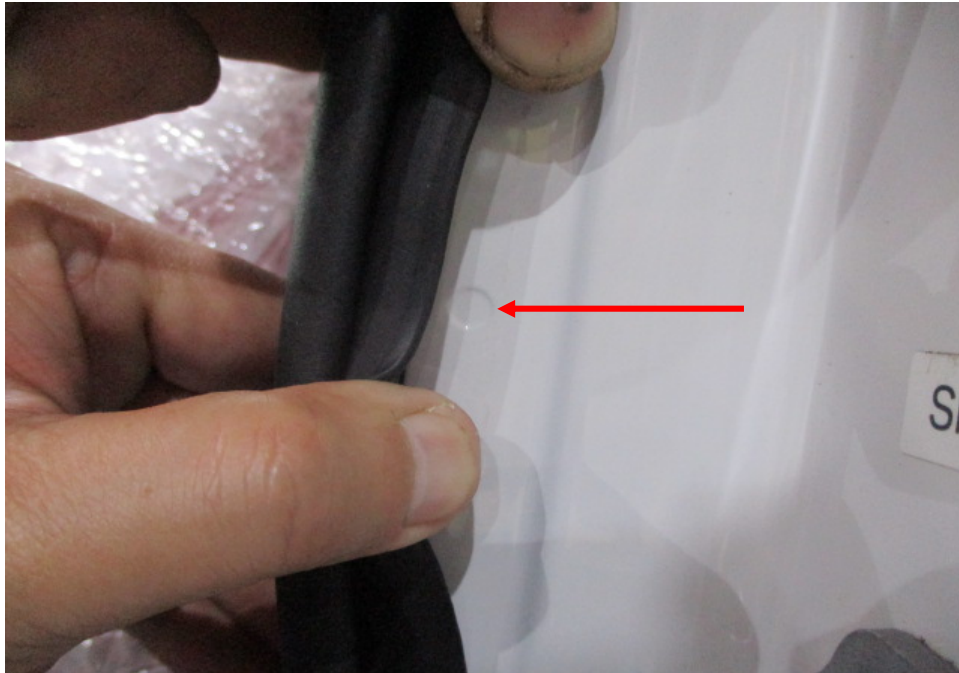
Photo 31 shows the left side rear body panel of the Motor Car. I did not find any weld marks other than original spot weld marks (arrowed) on the left side rear body panel of the Motor Car which, indicates that there was no re-welding works carried out. In general, I had found all the non-detachable body panels of the Motor Car to be originally fitted at the time of my inspection.

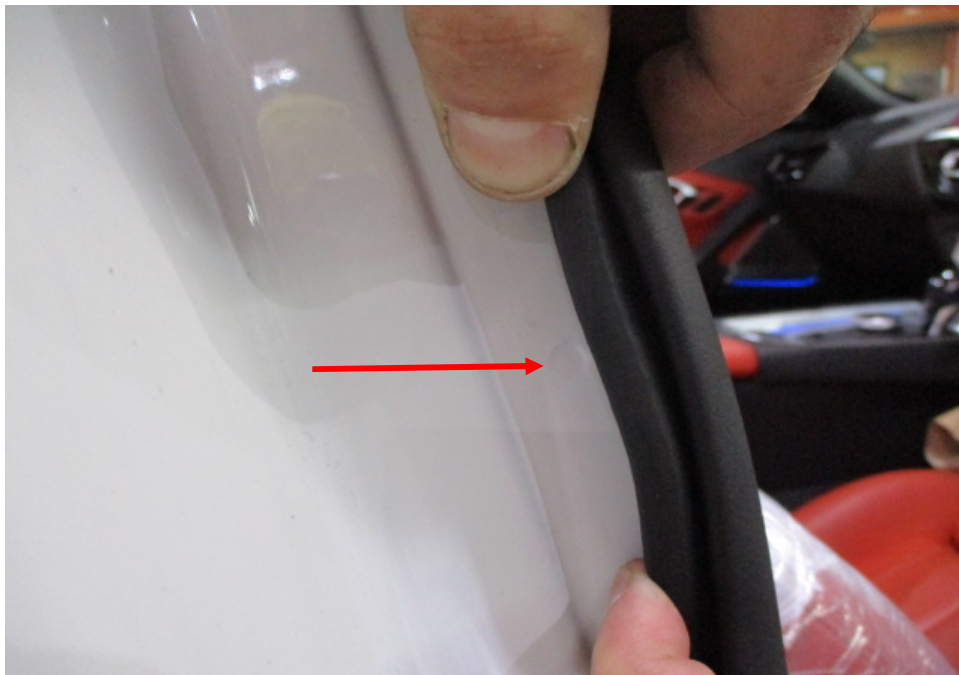
Photo 32 shows the right side rear body panel of the Motor Car. I did not find any weld marks other than original spot weld marks (arrowed) on the right side rear body panel of the Motor Car which, indicates that there was no re-welding works carried out. In general, I had found all the non-detachable body panels of the Motor Car to be originally fitted at the time of my inspection.

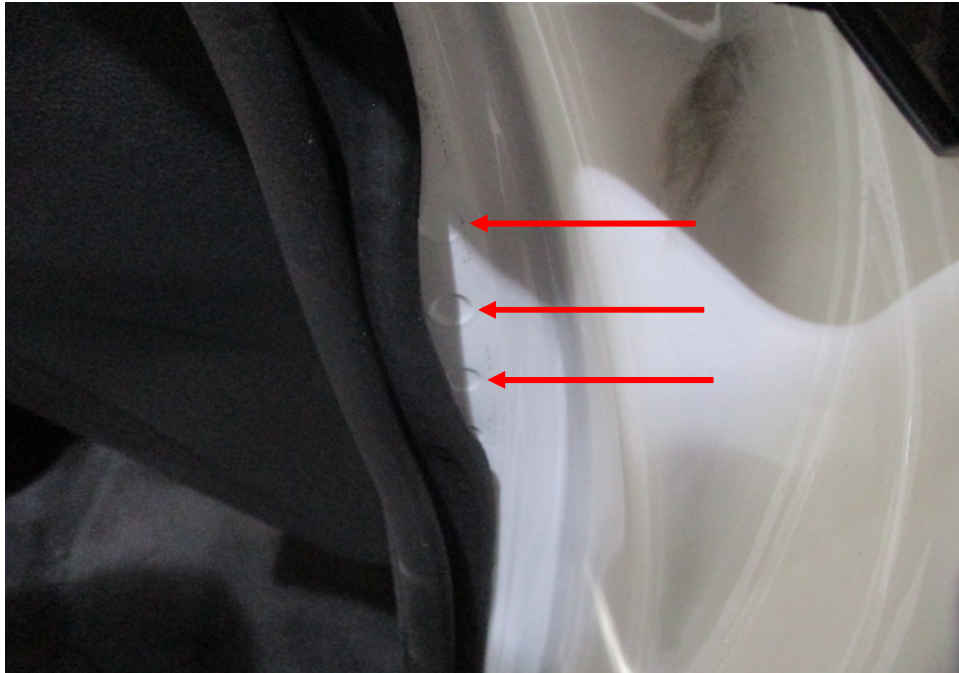
Photo 33 shows the right side "A" pillar of the Motor Car. I did not find any weld marks other than original spot weld marks (arrowed) on the right side "A" pillar of the Motor Car which, indicates that there was no re-welding works carried out. In general, I had found all the non-detachable body panels of the Motor Car to be originally fitted at the time of my inspection.
