INVESTIGATION REPORT:

Our Ref : CS4/CTI22004803/N
Claim No : OD/SNM22D203195/C01/CSC
Insured : SMG 1195Z
Date of Accident : 8 May 2022
Location : Traffic junction of Kitchener Road and Jalan Besar

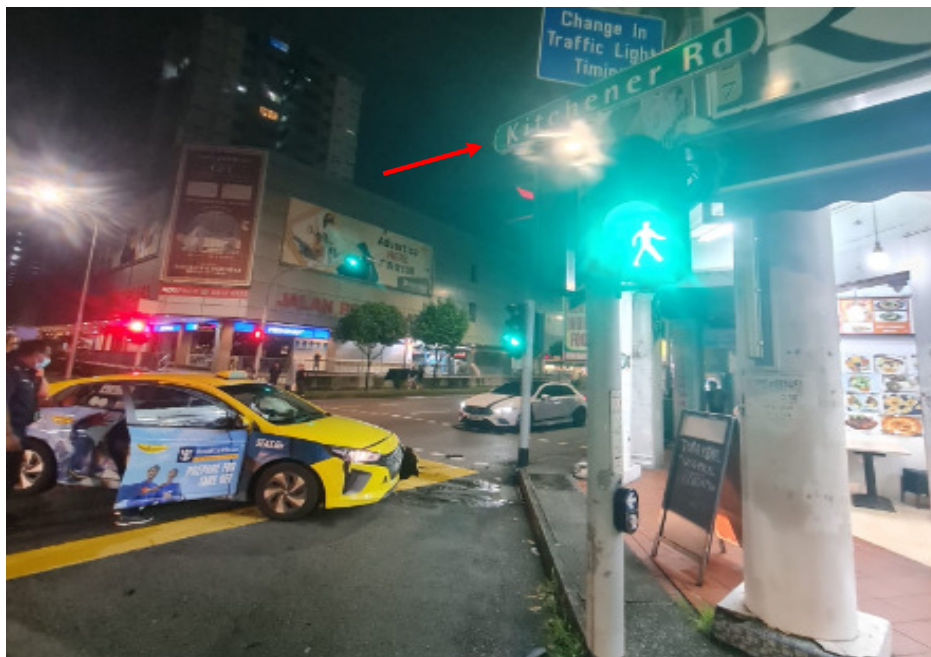
Photo 1 shows the Insured Vehicle at its respective final rest position at the accident scene right after the collision with the Taxi. It seems to correlate with Mr Ong's account of the accident which had occurred when Mr Ong attempted to make a right turn from Kitchener Road (arrowed) into Jalan Besar.

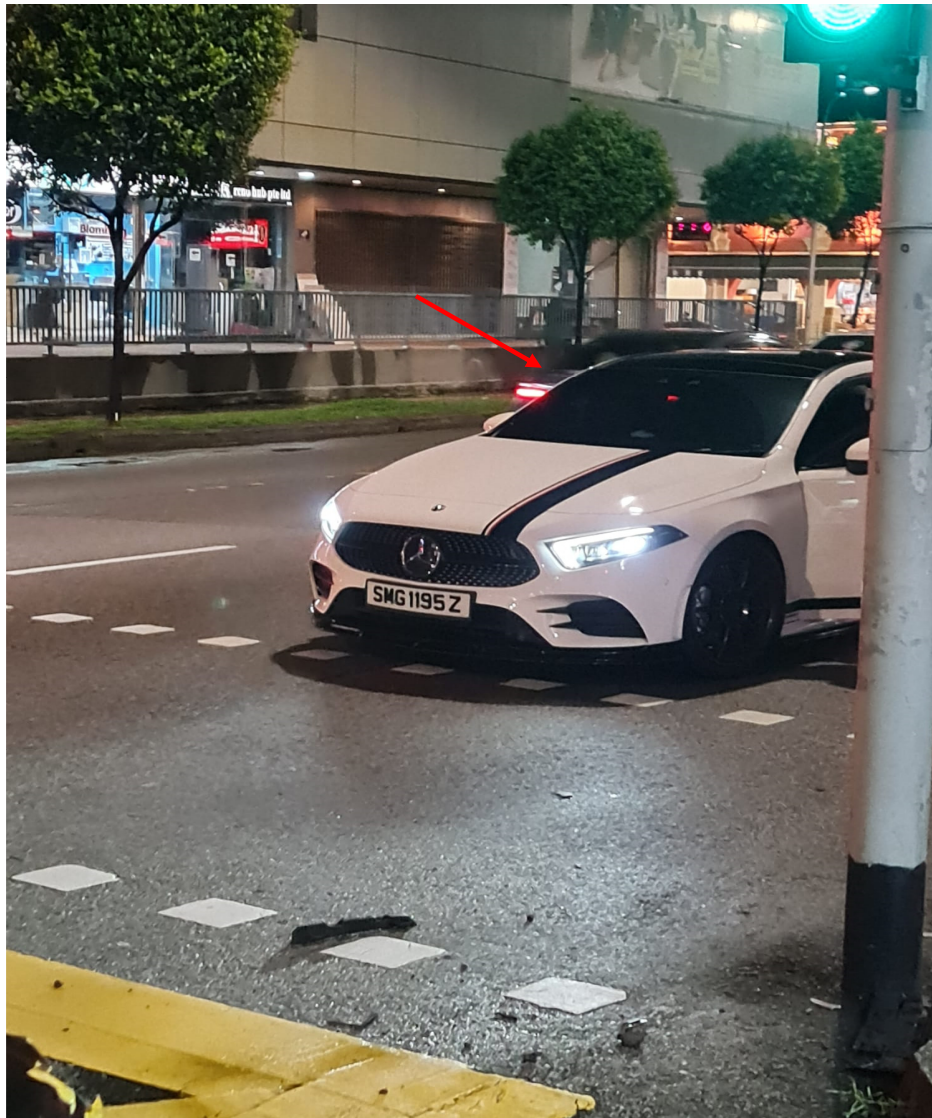
Photo 2 shows the Insured Vehicle at its respective final rest position at the accident scene right after the collision with the Taxi. It seems to correlate with Mr Ong's account of the accident in which upon collision the Insured had spun 180 degrees before coming to a stop facing oncoming traffic along Jalan Besar (arrowed).

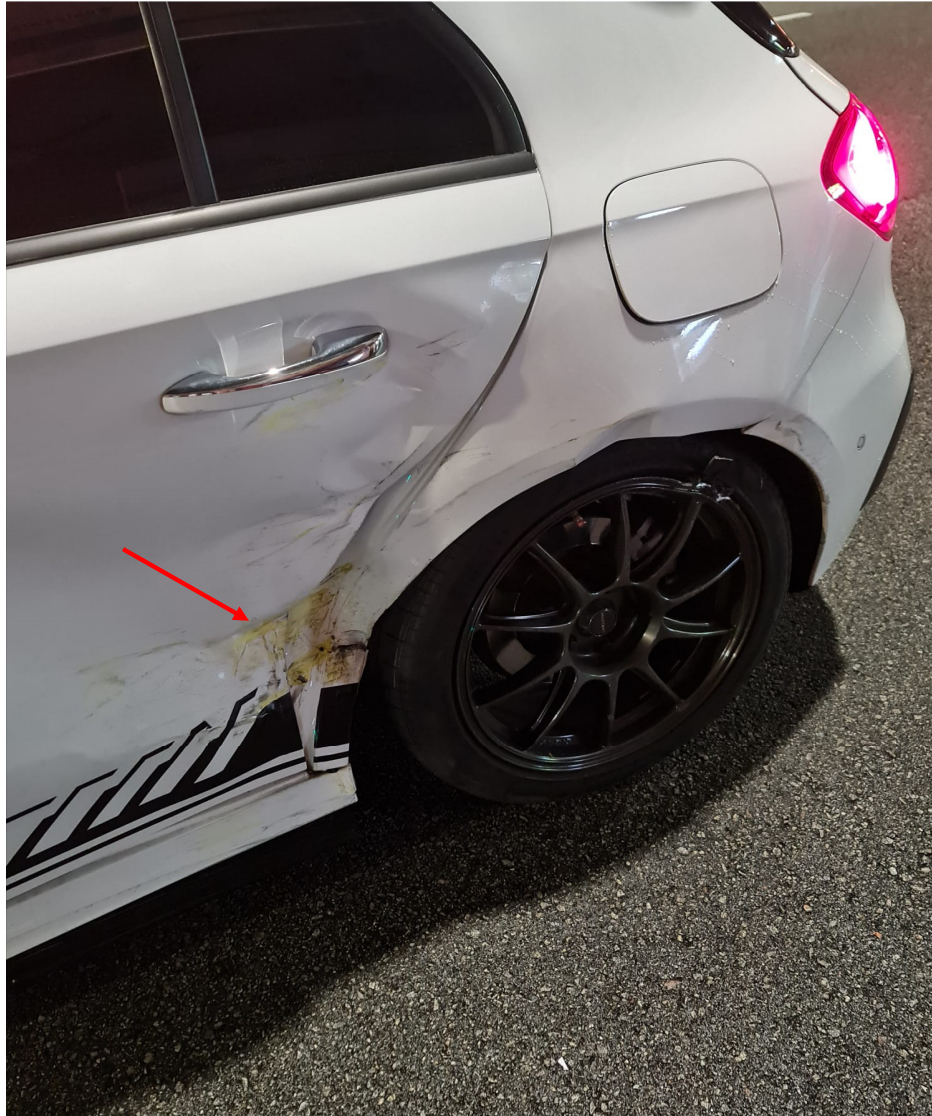
Photo 3 shows a closer view of the damages sustained to the Insured Vehicle as a result of the accident. It seems to correlate with Mr Ong's statement in which the frontal portion of the Taxi had collided into the left rear portion of the Insured Vehicle (arrowed).

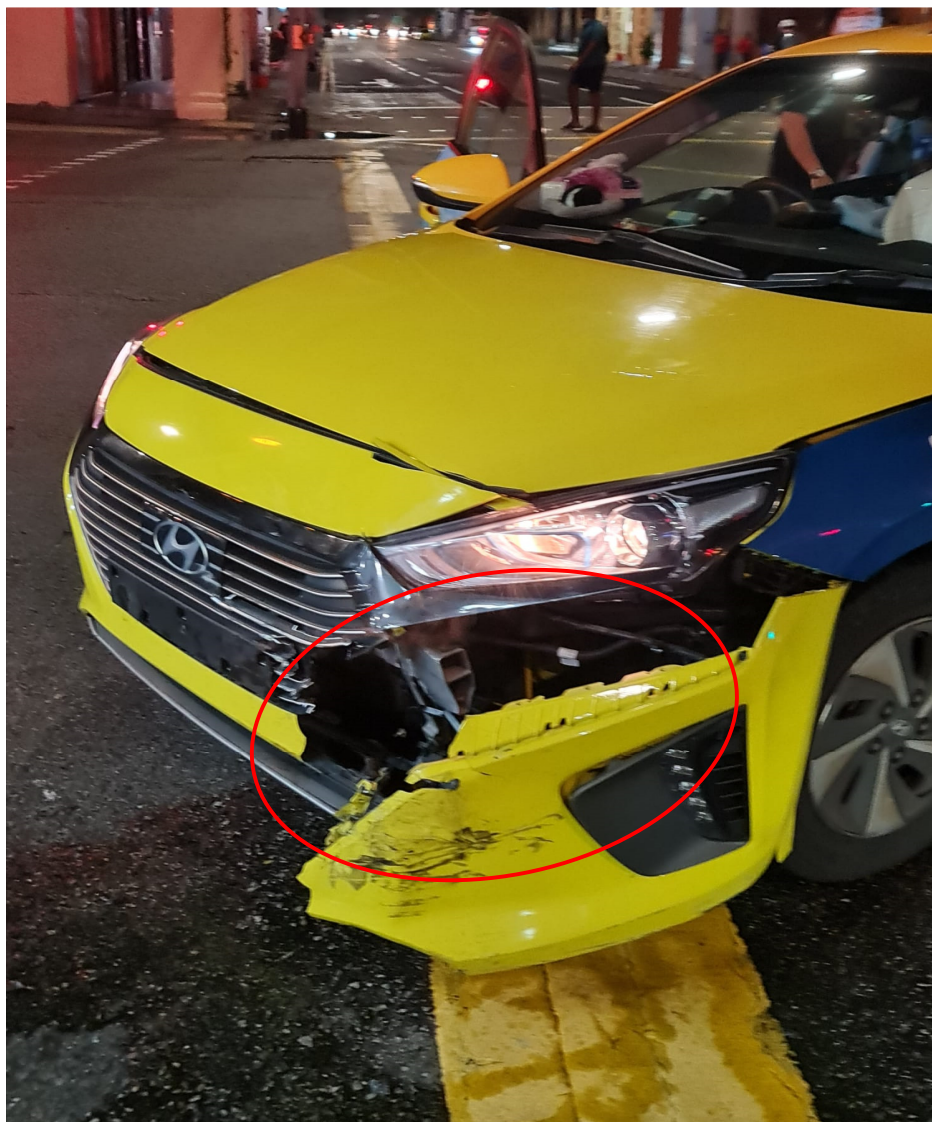
Photo 4 shows a closer view of the damages sustained to the Taxi as a result of the accident (circled). It seems to correlate with Mr Ong's statement in which the frontal portion of the Taxi had collided into the left rear portion of the Insured Vehicle.

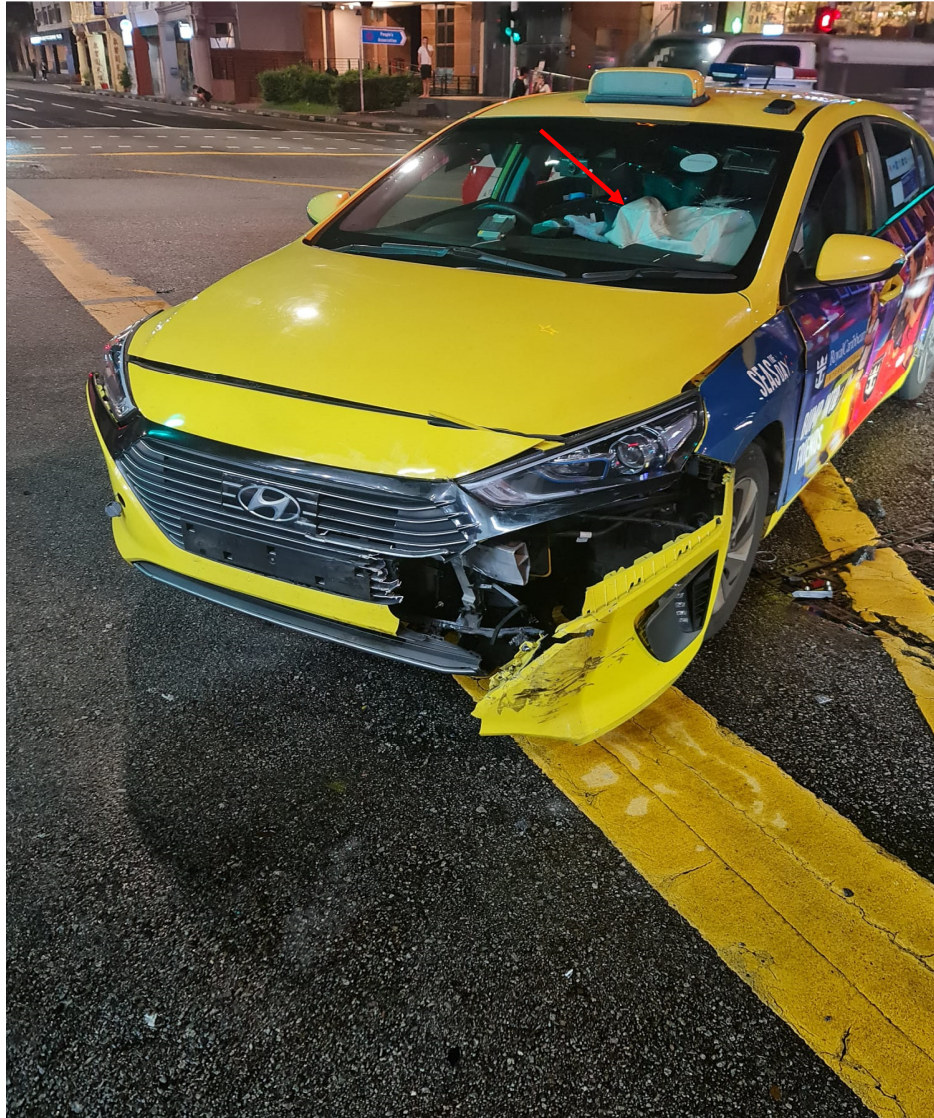
Photo 5 shows a frontal view of the Taxi post- accident. It seems to correlate with Mr Ong's statement in which he mentioned the front passenger airbag of the Taxi had been deployed upon collision (arrowed).

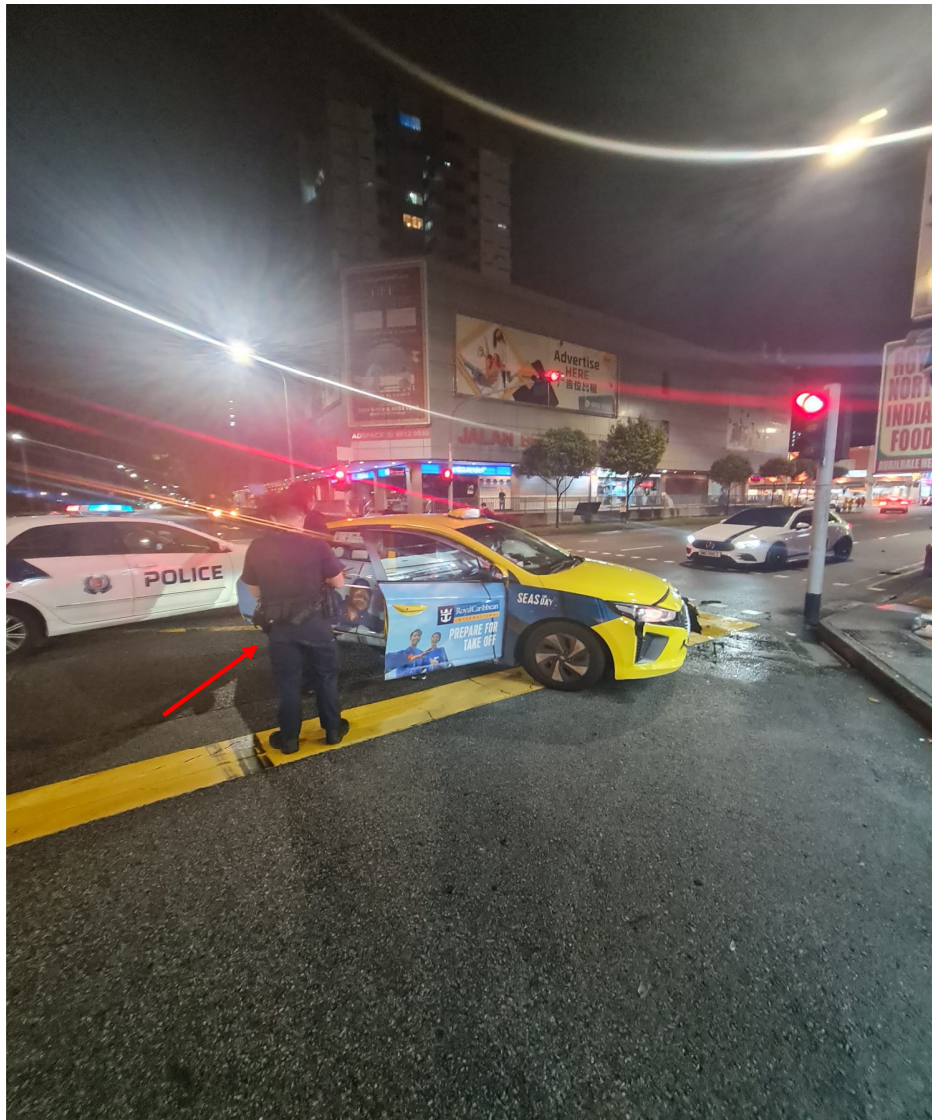
Photo 6 shows the arrival of the police at the accident location. It seems to correlate with Mr Ong's account of the accident in particular, the presence of the police (arrowed) together with the ability of Mr Ong to take clear photographs after the accident would suggest that there was no drink driving involved in this particular accident.

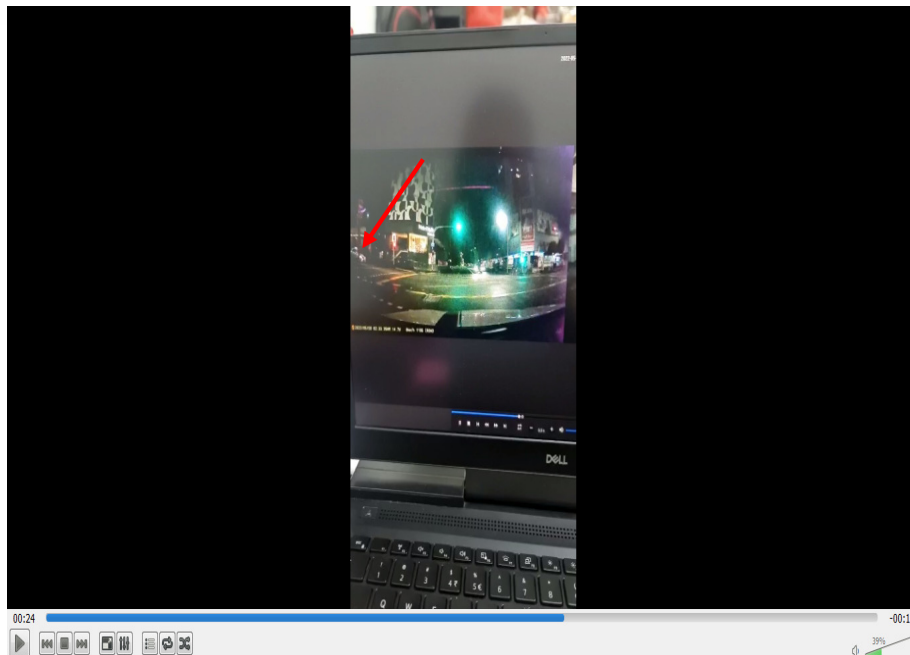
Screenshot 1 of the video recording from the video recording device that was mounted onto the front windscreen of the Insured Vehicle shows at the 24 second mark, Mr Ong driving the Insured Vehicle forward to gradually make a right turn into Jalan Besar. The police car can also be seen along Jalan Besar (arrowed).

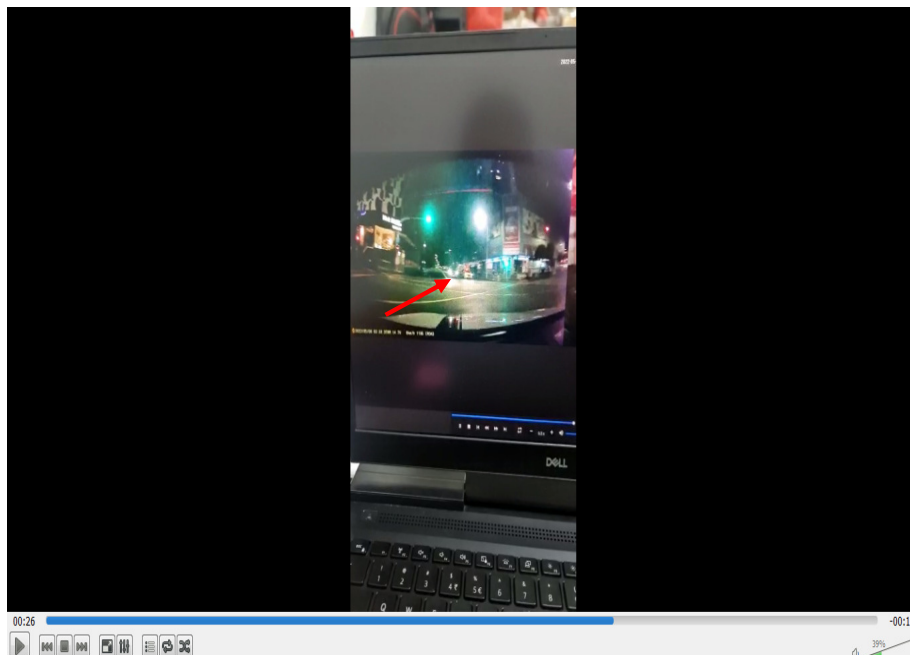
Screenshot 2 shows at the 26- second mark of the video recording, Mr Ong proceeded to turn right after noticing the vehicle at the opposite direction on the 1st lane was stationary with no hazard lights blinking (arrowed).

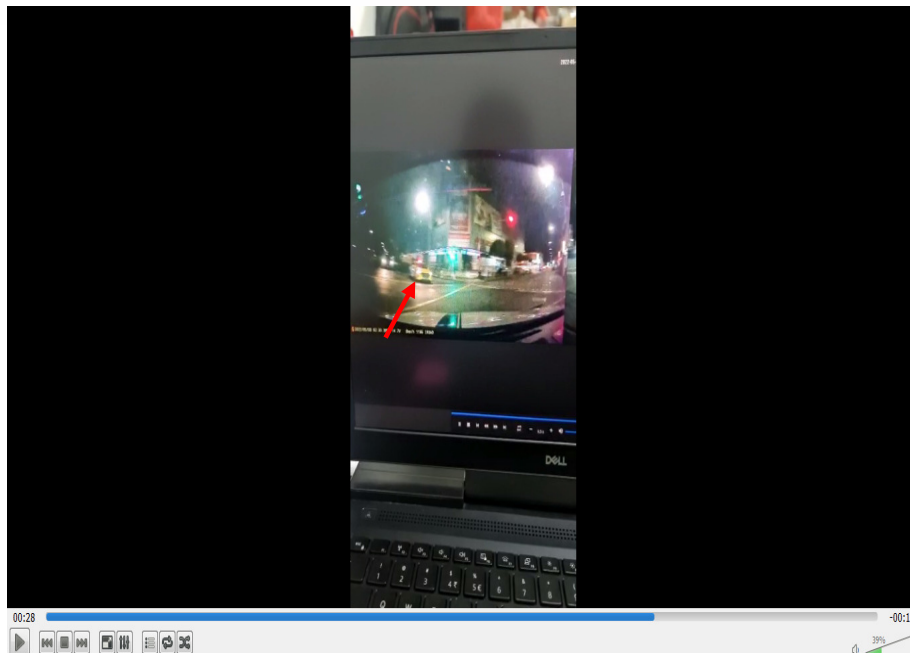
Screenshot 3 At the 28- second mark of the video recording, Mr Ong proceeded to turn right even though there was an approaching Taxi bearing registration number SHC 503E (arrowed).

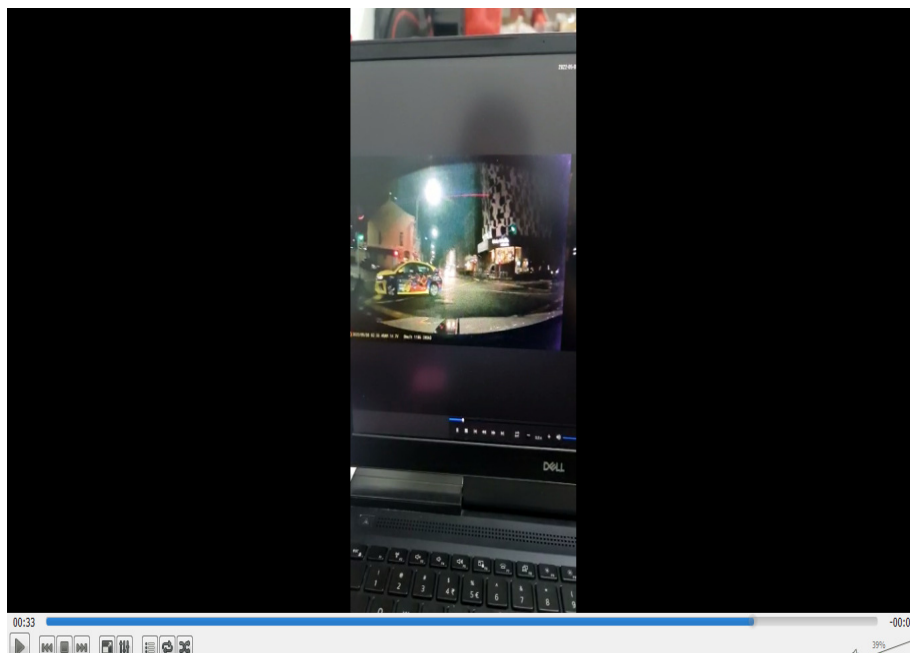
Screenshot 4 shows the collision occurring at the 30- second mark of the video recording, where the frontal portion of the Taxi collided into the left rear portion of the Insured Vehicle, causing the Insured Vehicle to spin 180 degrees before coming to a stop facing oncoming traffic along Jalan Besar.

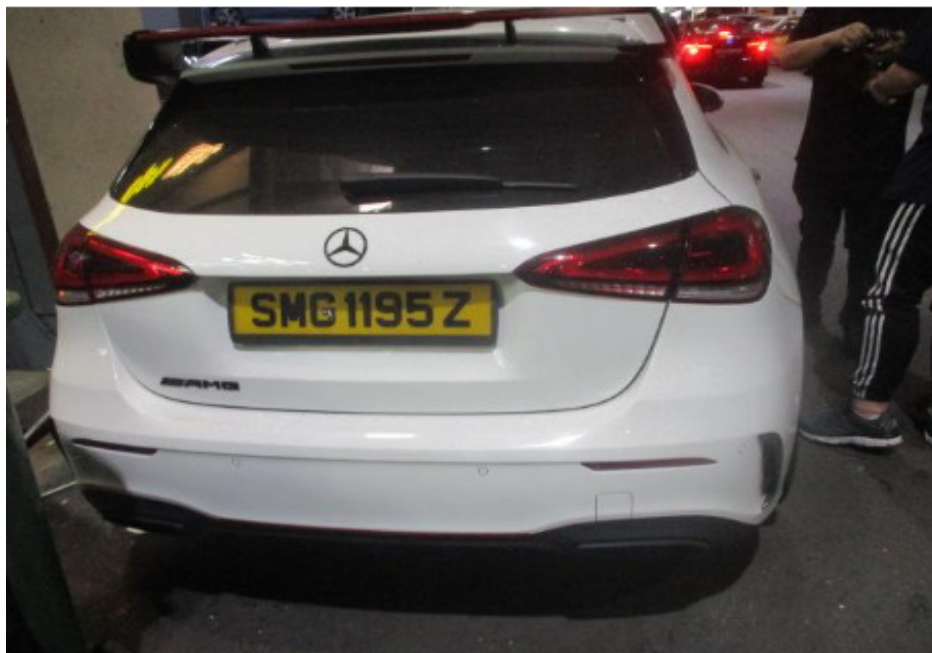
14. Our review of the accident scene photographs provided to us by Mr Ong and subsequent physical inspection of the Insured Vehicle at Teamwork revealed that the Insured Vehicle had sustained damages to its left rear portion as a result of the accident. The left rear door had buckled. There were dents and graze marks on the left rear portion of the Insured Vehicle. There was also a misalignment of the left rear wheel rim. We observed several yellow paint transfer marks on the left rear portion which would appear to correspond to the left rear portion of the Insured Vehicle being hit by the frontal portion of the Taxi. See photos 7 – 10 below.

Photo 7 shows a view of the rear portion of the Insured Vehicle during the physical inspection at Teamwork. The Insured Vehicle had sustained damages to its left rear portion as a result of the accident.

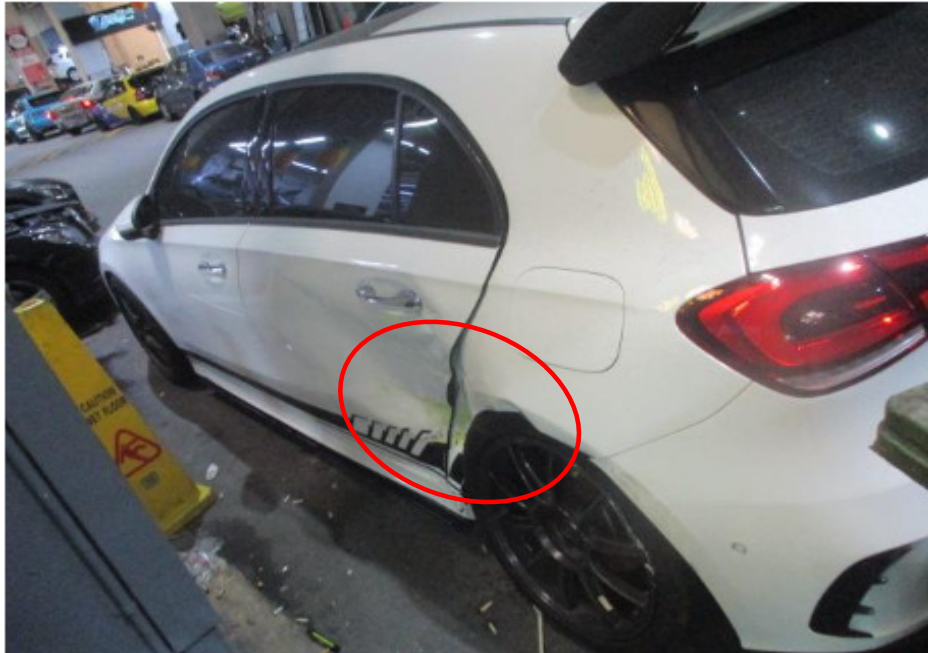
Photo 8 shows a view of the left rear portion of the Insured Vehicle during the physical inspection at Teamwork. The Insured Vehicle had sustained damages to its left rear portion as a result of the accident (circled).

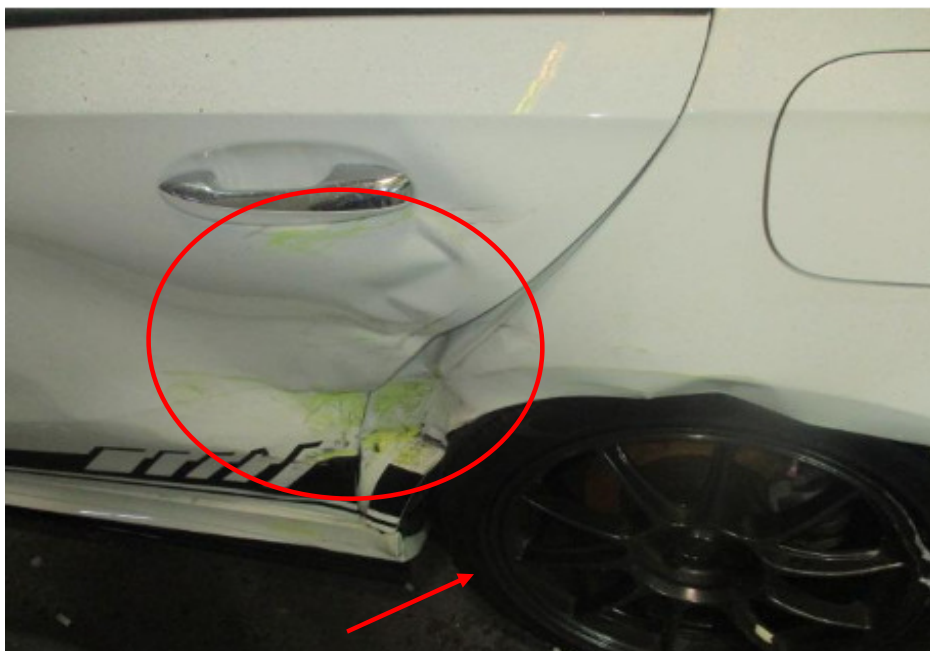
Photo 9 shows a closer view of the dents, yellow paint transfer marks and graze marks on the left rear portion of the Insured Vehicle (circled). There was also a misalignment of the left rear wheel rim (arrowed).

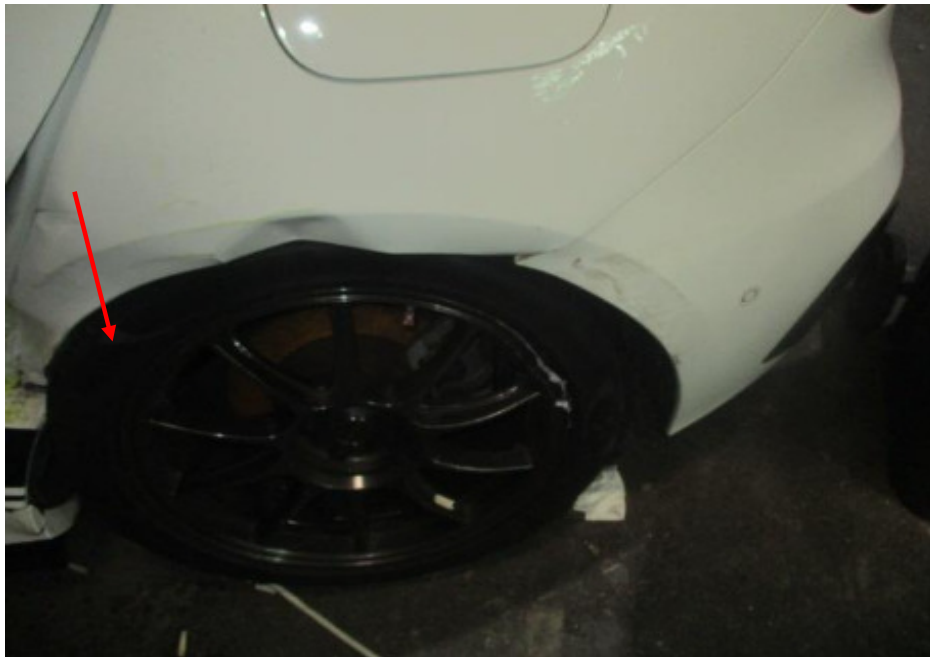
Photo 10 shows the misalignment of the left wheel rim of the Insured Vehicle (arrowed) which would appear to correspond to the left rear portion of the Insured Vehicle being hit by the frontal portion of the Taxi.
