Your Ref: TP/IP/55291/2021
Our Ref : CI/TPD22004867/N

7 July 2022

**INSPECTION REPORT OF BICYCLE (BLUE) - TRAFFIC POLICE POUND
REPORT NO. 3923/21**

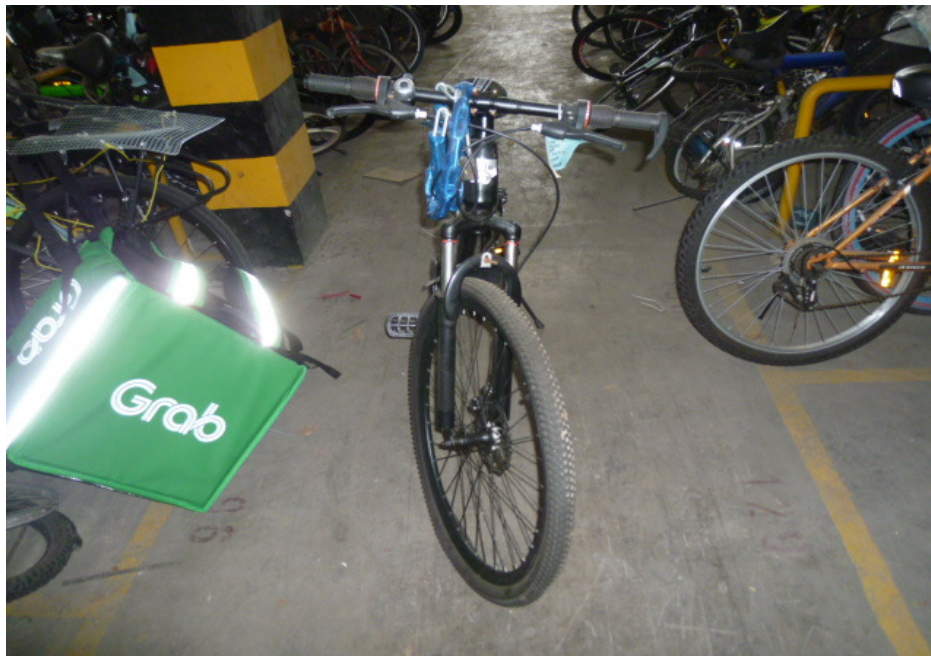
Photo 2 shows the frontal portion of the Bicycle at the time of our inspection. The Bicycle had sustained damages all around.

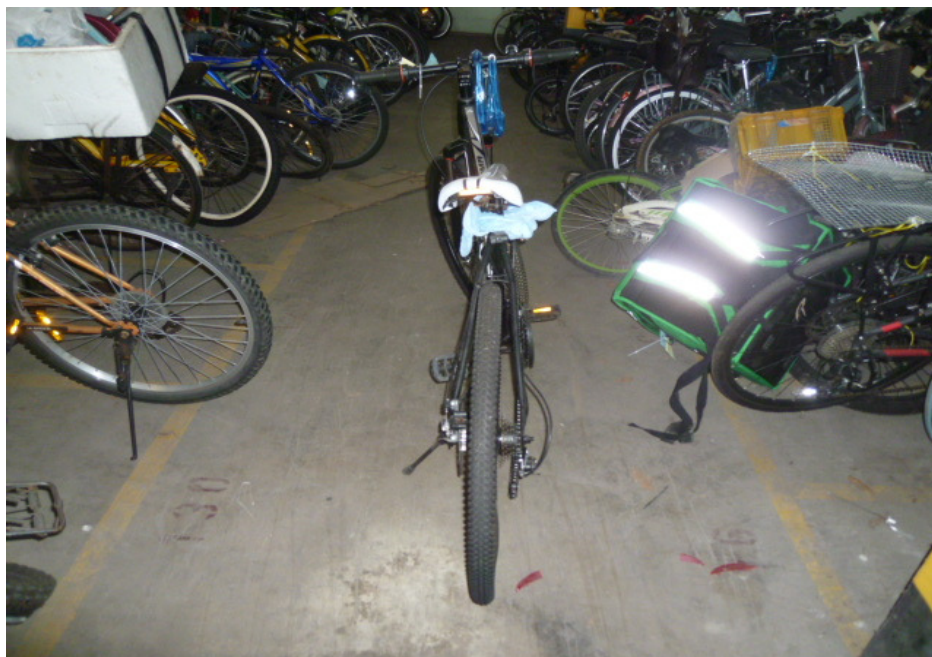
Photo 3 shows the rear portion of the Bicycle at the time of our inspection. The Bicycle had sustained damages all around.

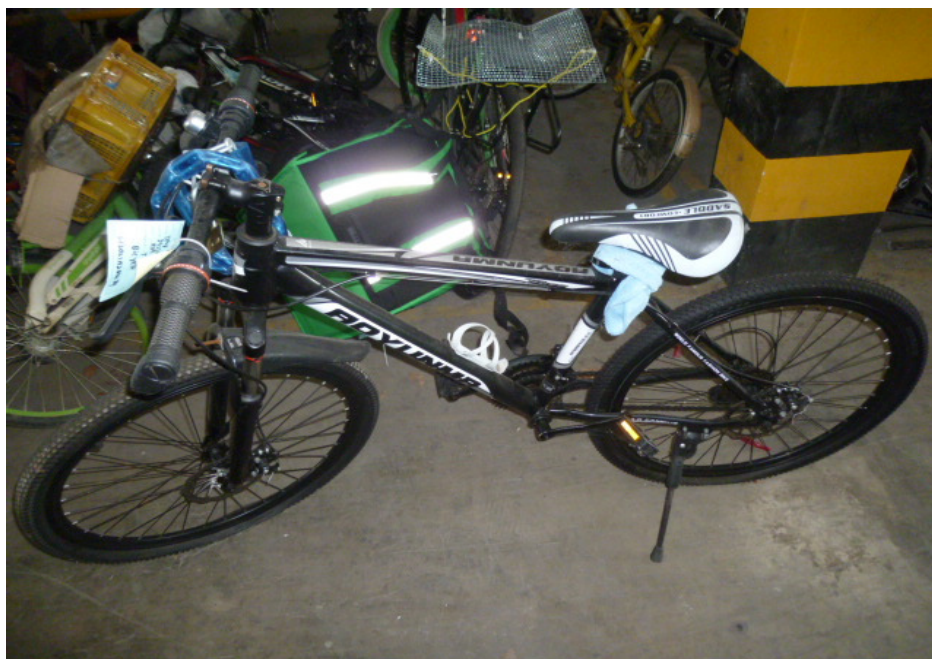
4. The Bicycle was observed to have sustained damages all around. The body parts that were found to have been damaged include its front mudguard, handlebar, left hand brake lever guard, right hand brake lever, right handlebar end and left pedal, amongst others as a result of the accident. See photos 1 – 10 below.

Photo 4 shows the left body of the Bicycle at the time of our inspection. The Bicycle had sustained damages all around. The front mudguard, handlebar, left hand brake lever guard, right hand brake lever, right handlebar end and left pedal, amongst others as a result of the accident.

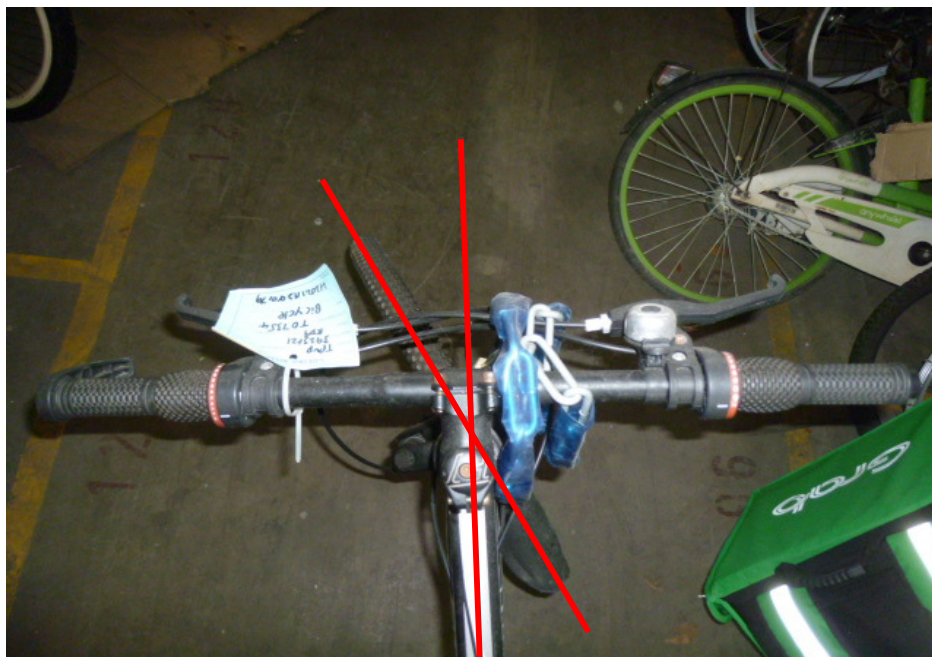
Photo 5 shows the frontal portion of the Bicycle (top view) at the time of our inspection. There was a misalignment of the handlebar & front tyre observed.

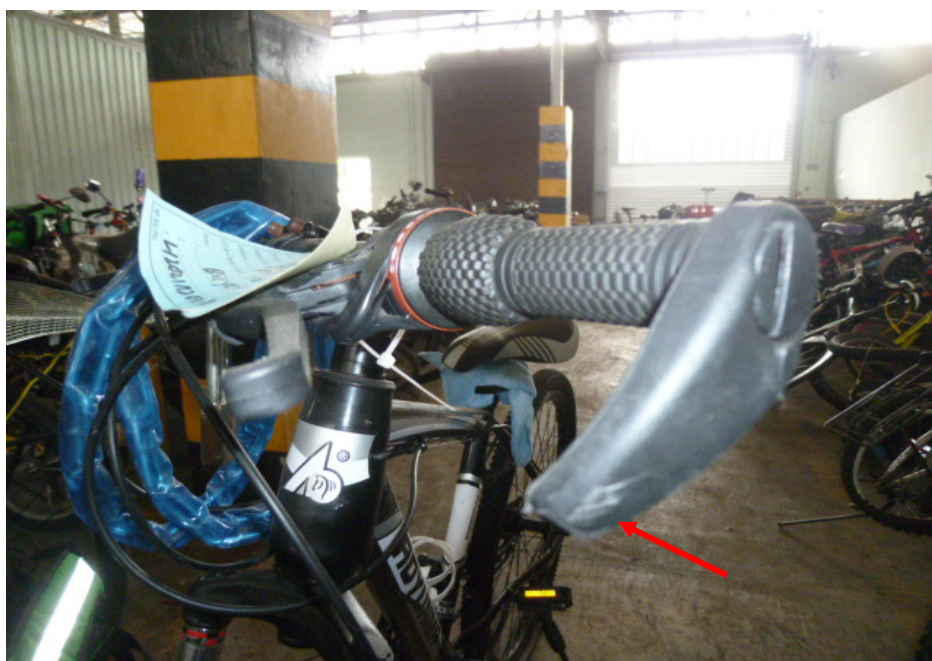
Photo 6 shows the damaged left hand brake lever guard (arrowed) of the Bicycle at the time of our inspection.

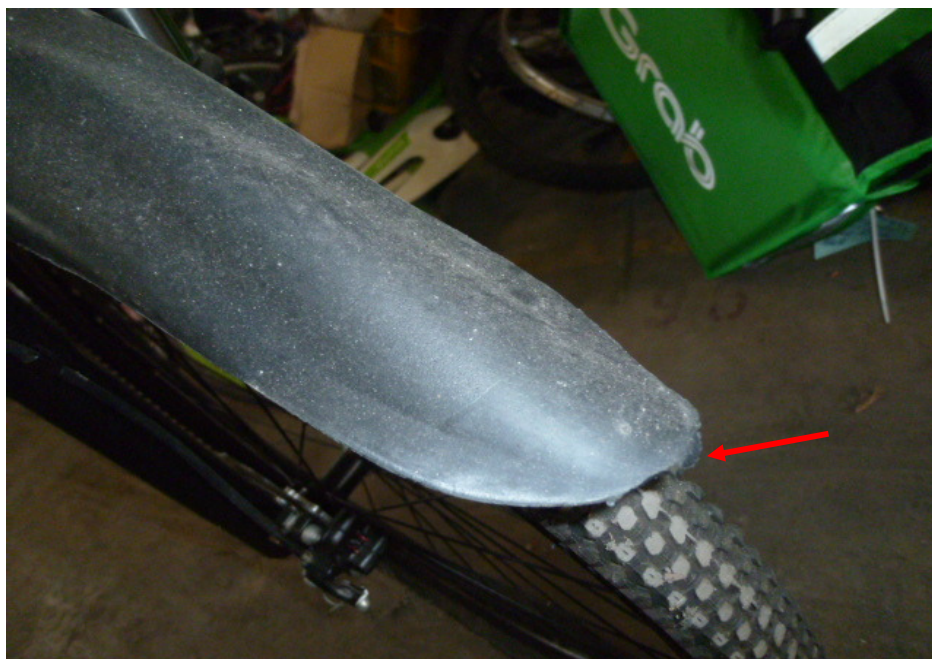
Photo 7 shows the damages of grazing nature on the front mudguard (arrowed) of the Bicycle at the time of our inspection.

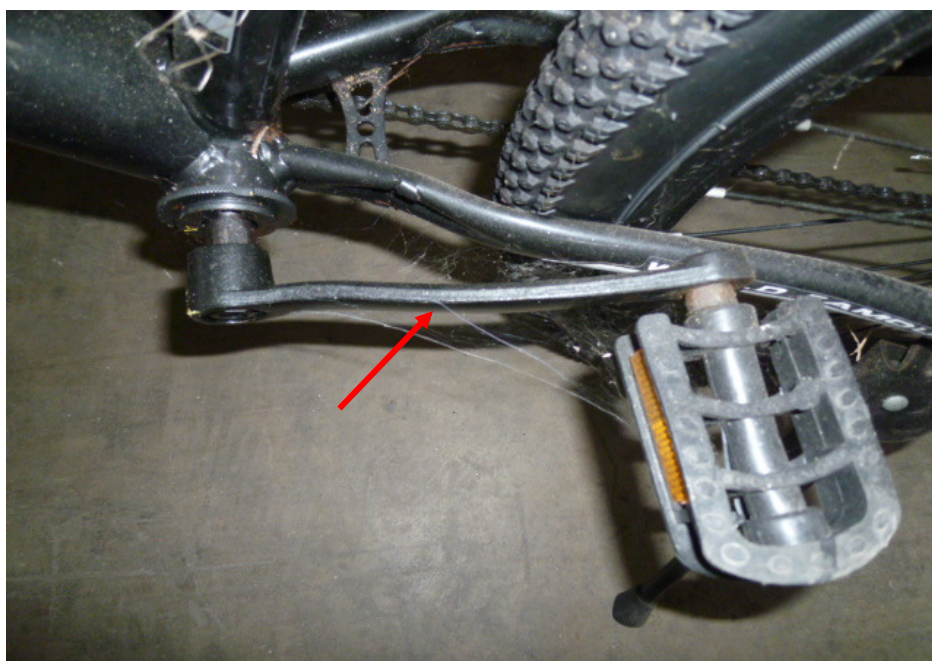
Photo 8 shows the deformed left pedal of the Bicycle at the time of our inspection (arrowed).

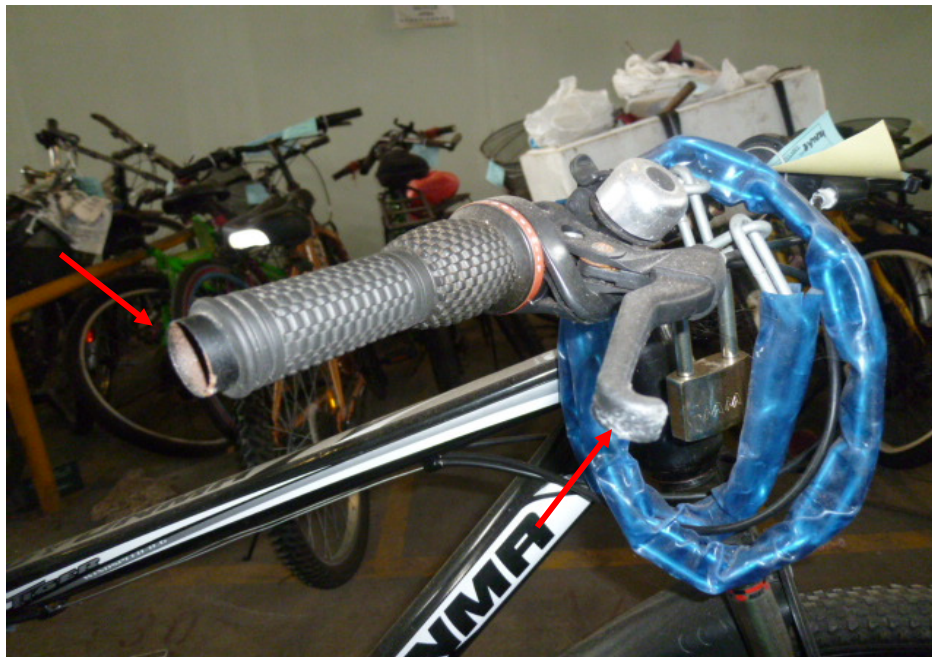
Photo 9 shows the damages of grazing nature on the right hand brake lever and right handlebar end of the Bicycle at the time of our inspection (arrowed).

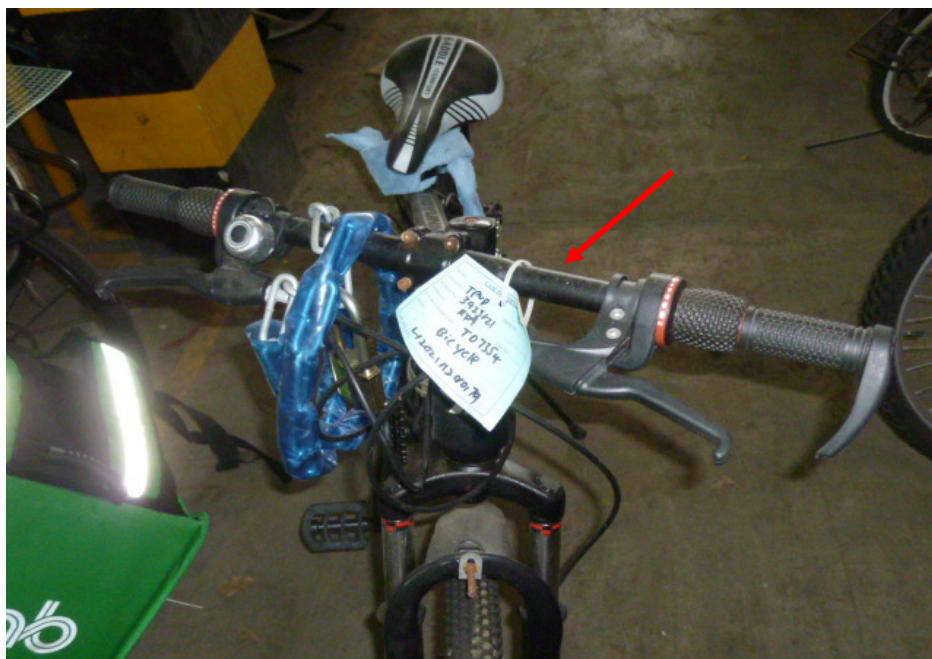
Photo 10 shows a close-up view of the deformed handlebar of the Bicycle as a result of the accident (arrowed).

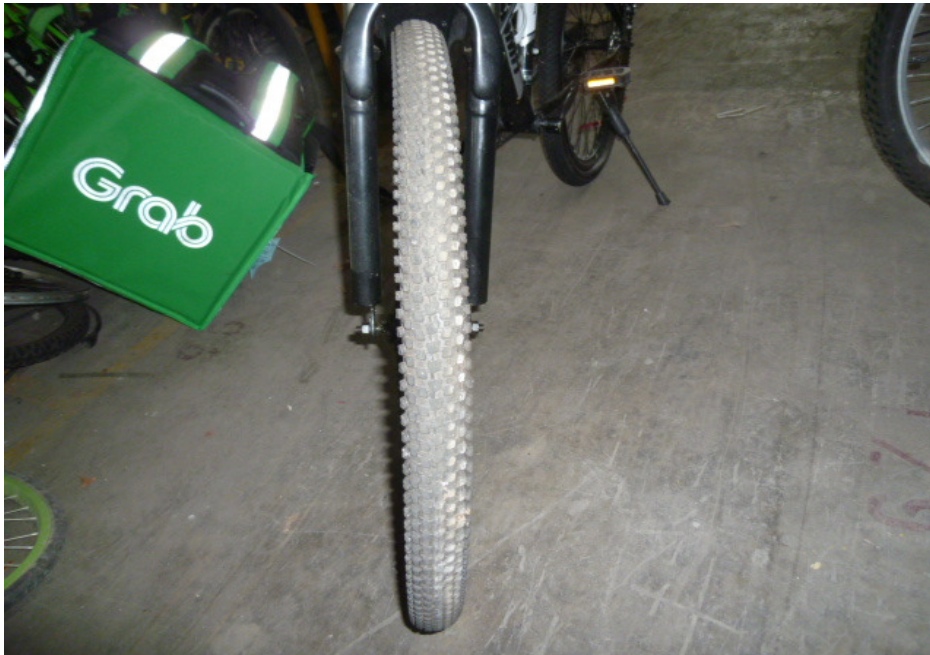
Photo 11 shows the front tyre of the Bicycle. The pattern of the tread was clearly visible. There was no tear, burst mark(s) and/or punctured hole(s) on the sidewalls as well as across the tread of the front tyre. However the front tyre was observed to be deflated.

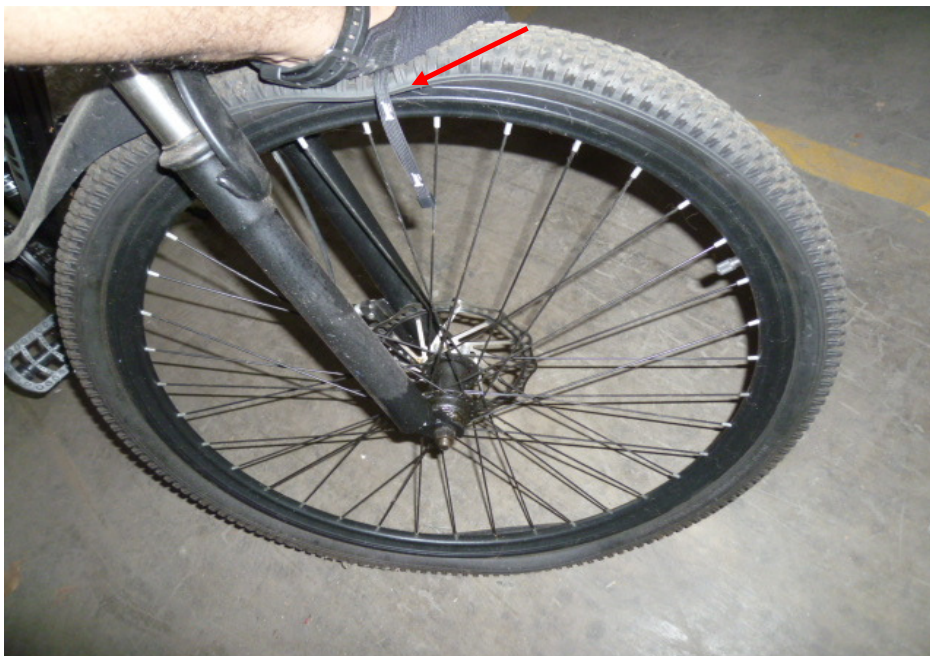
Photo 12 shows the deflated front tyre of the Bicycle (arrowed).

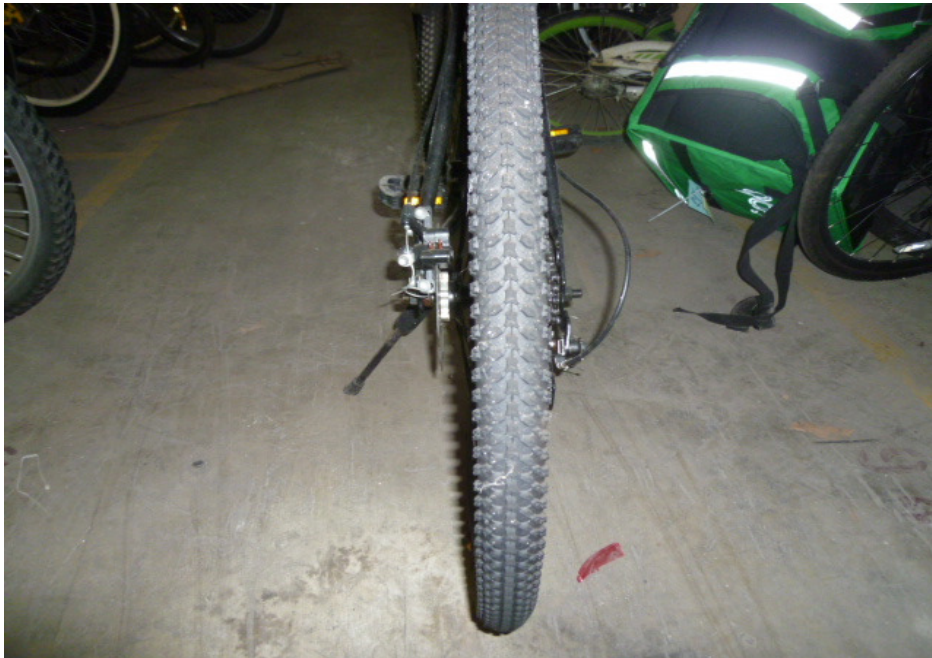
Photo 13 shows the rear tyre of the Bicycle. The pattern of the tread was clearly visible. There was no tear, burst mark(s) and/or punctured hole(s) on the sidewalls as well as across the tread of the rear tyre. However the rear tyre was observed to be deflated.

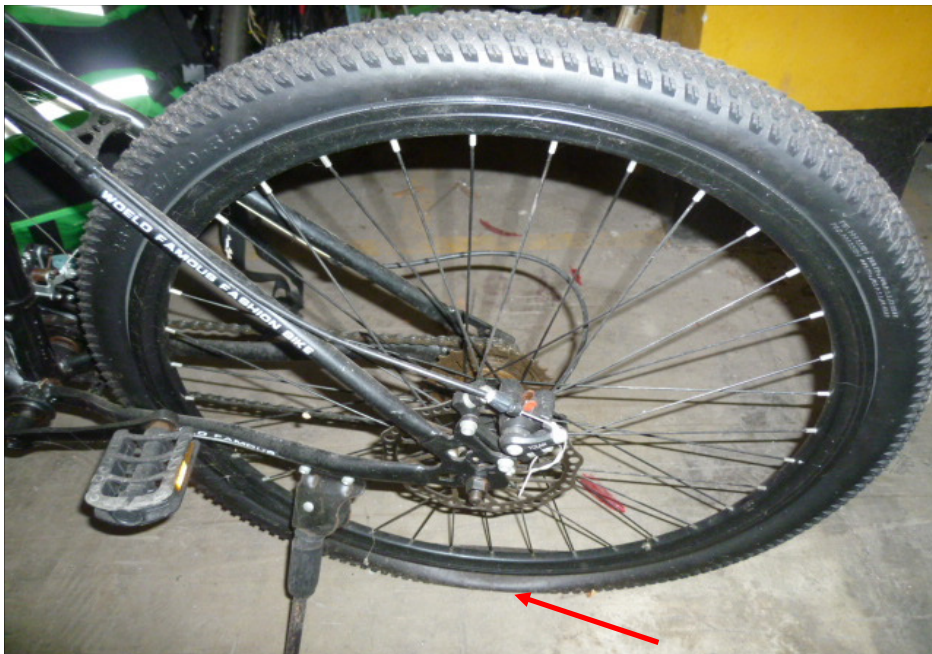
Photo 14 shows the deflated rear tyre of the Bicycle (arrowed).
