Your Ref: TP/IP/02791/2022
Our Ref : CI/TPD22004868/N

6 July 2022

Fatal Accident Investigation Team

INSPECTION REPORT OF MOTORCYCLE JLE 9028

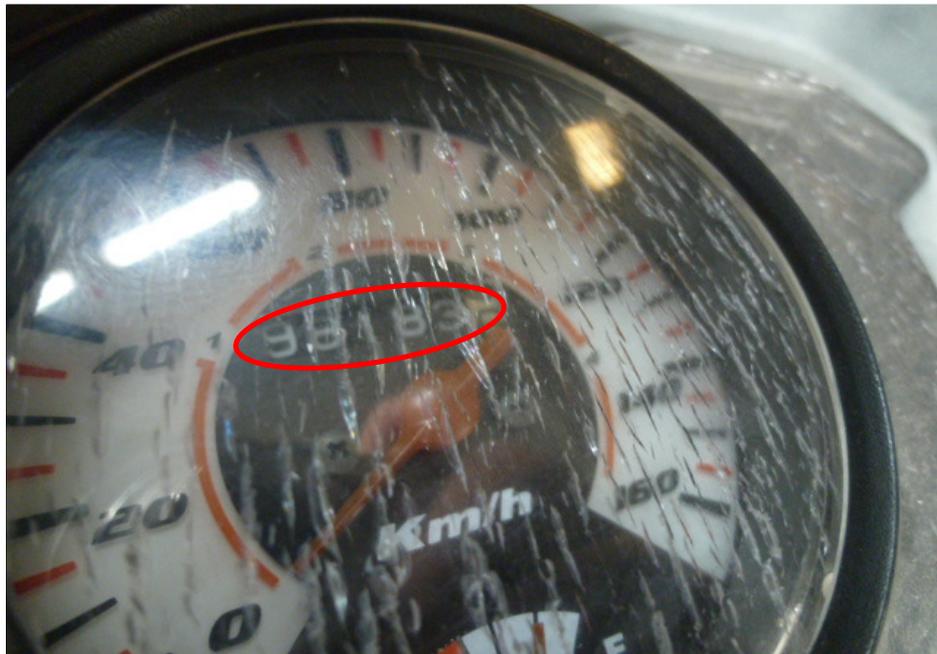
Photo 1 shows the speedometer gauge of the Motorcycle. The mileage of the Motorcycle at the time of our inspection was 98, 183km (circled).

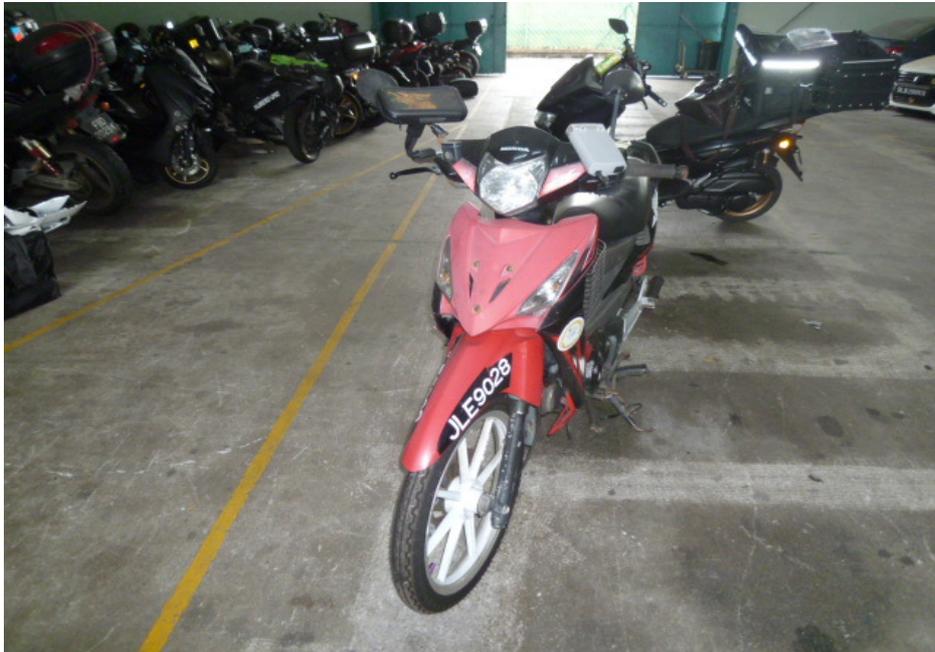
Photo 2 shows a general view of the frontal portion of the Motorcycle at the time of our inspection. The Motorcycle was observed to have sustained damages at its frontal portion and left body.

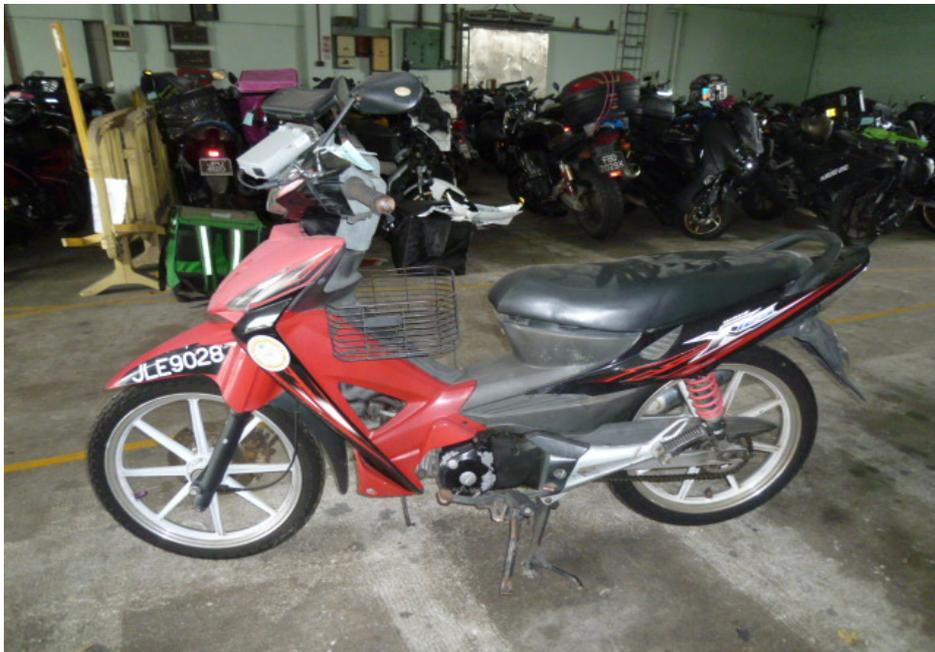
Photo 3 shows a general view of the left body of the Motorcycle at the time of our inspection. The Motorcycle was observed to have sustained damages at its frontal portion and left body. The body parts that were found to have been damaged include its headlight assembly, front mudguard, left cowling, left handlebar end, left side mirror, IU unit, left front footrest, left pillion foot peg, pillion grab rail, left rear side cover and rear number plate, amongst others.

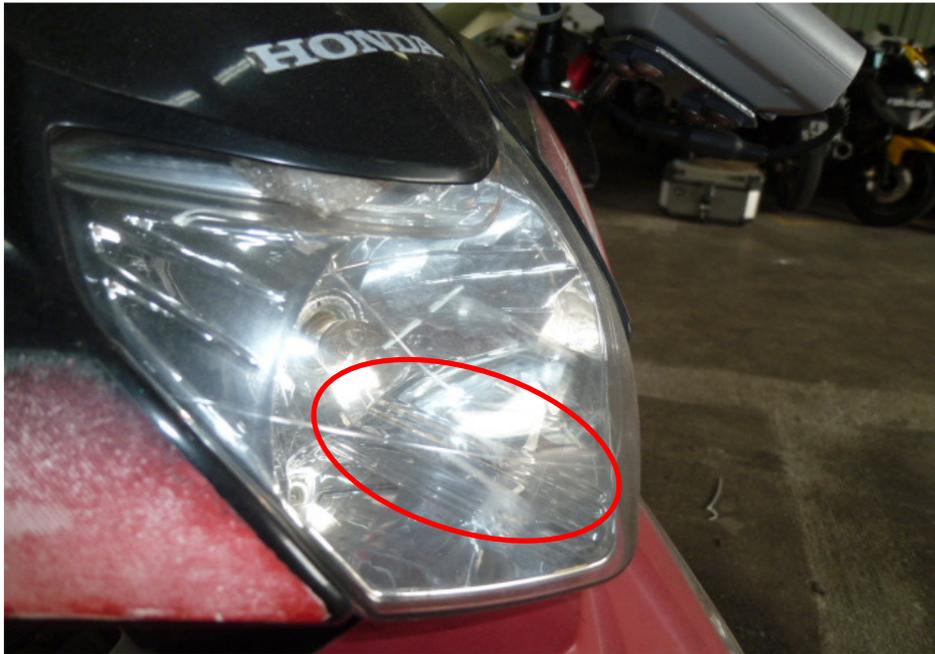
Photo 4 shows a close up view of the headlight assembly which was amongst the body parts at the front of the Motorcycle that had sustained damage as a result of the accident (circled).

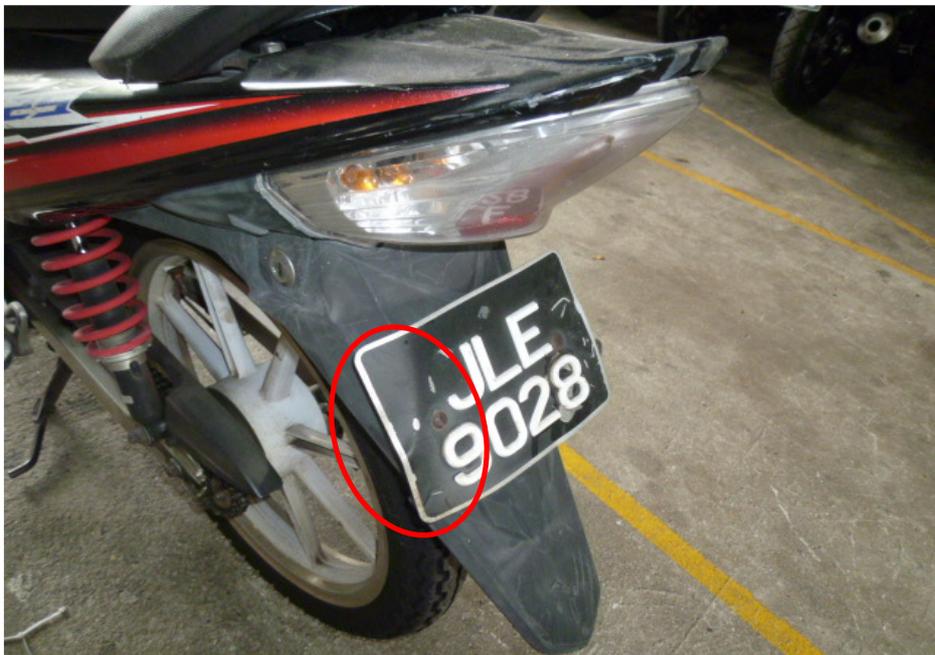
Photo 5 shows the rear number plate (circled) which was amongst the body parts of the Motorcycle that had sustained damage as a result of the accident.

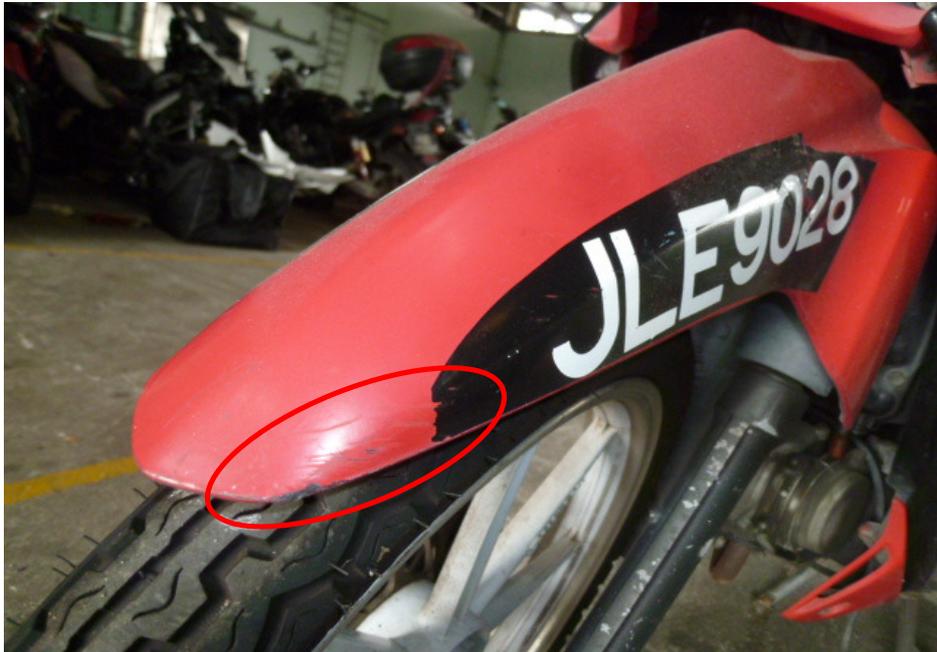
Photo 6 shows a closer view of the front mudguard (circled) which was amongst the body parts of the Motorcycle that had sustained damage as a result of the accident.

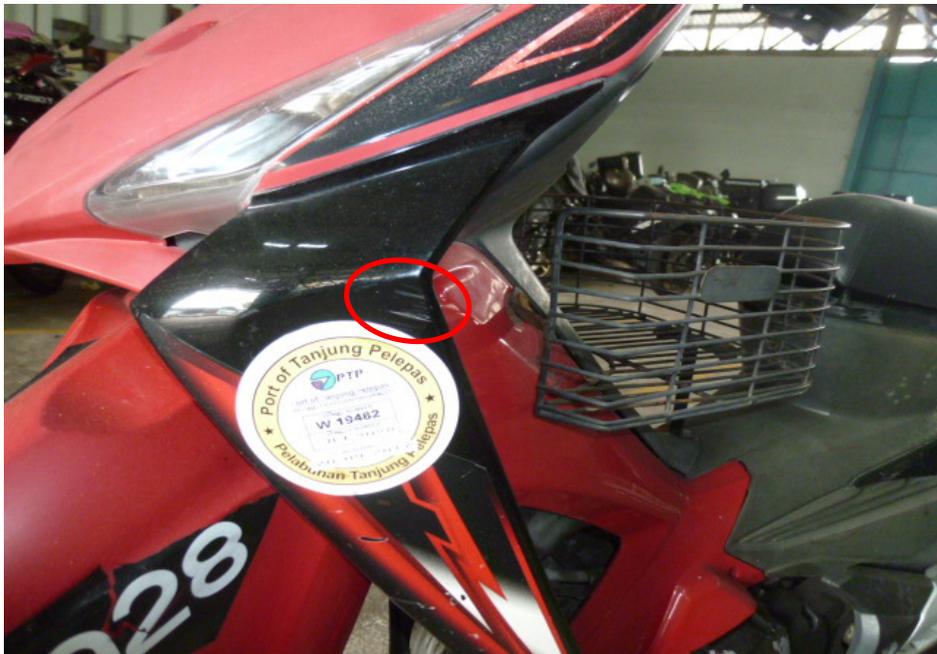
Photo 7 shows a closer view of the left cowling which was amongst the body parts of the Motorcycle that had sustained damage as a result of the accident (circled).

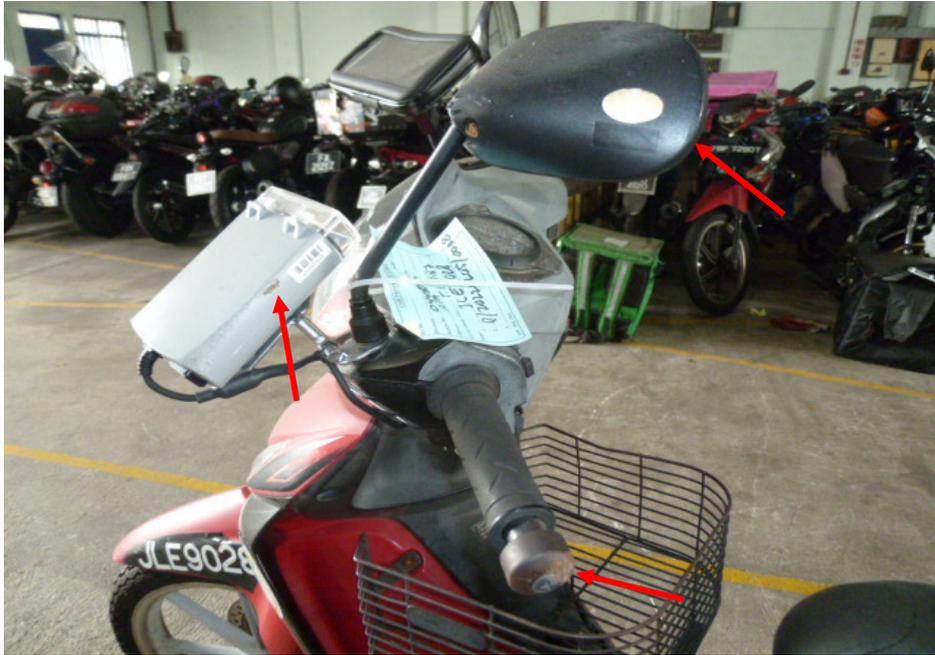
Photo 8 shows the left handlebar grip, left side mirror and IU unit (arrowed), which were amongst the body parts of the Motorcycle that had sustained damage as a result of the accident.

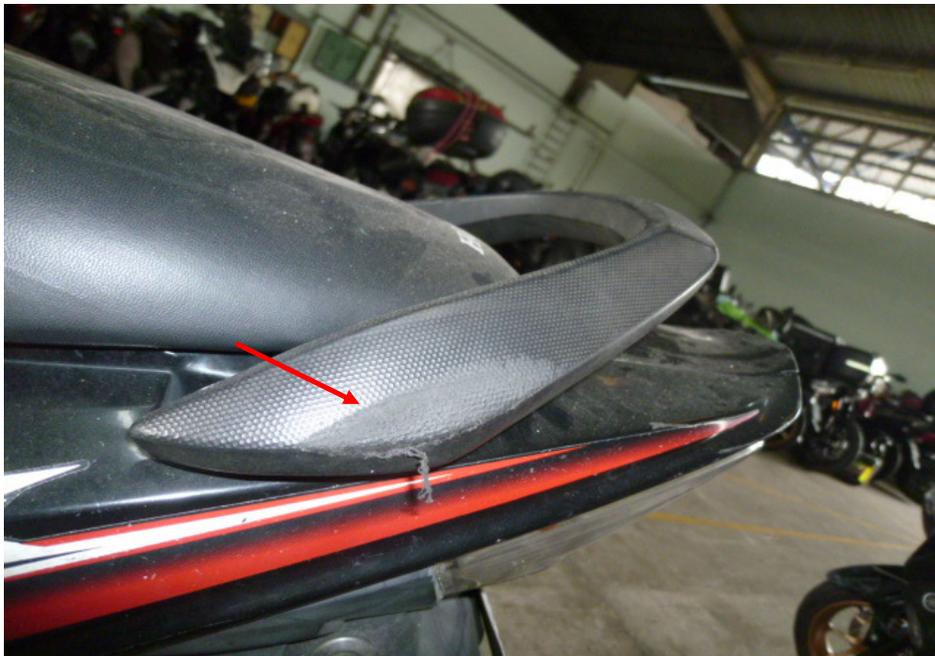
Photo 9 shows a closer view of the pillion grab rail which was amongst the body parts of the Motorcycle that had sustained damages of grazing nature as a result of the accident (arrowed).

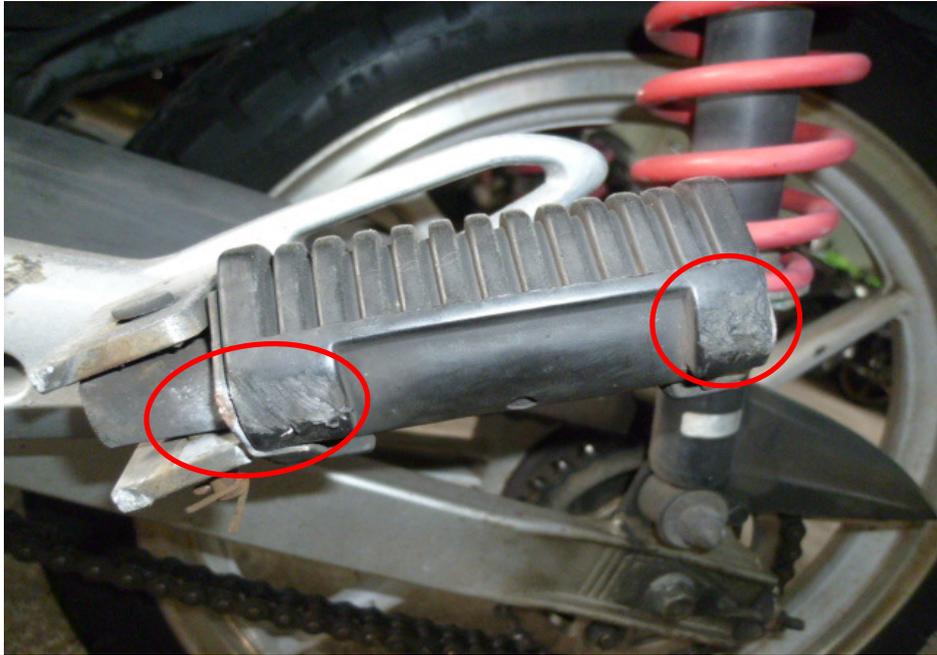
Photo 10 shows a closer view of the left pillion foot peg which was amongst the body parts of the Motorcycle that had sustained damages of grazing nature as a result of the accident (circled).

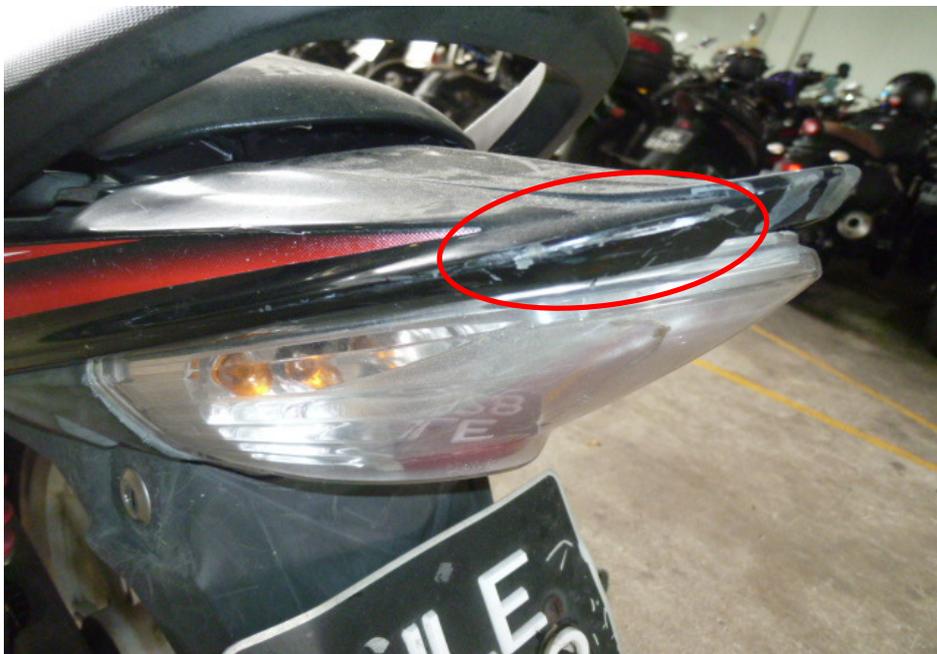
Photo 11 shows the left rear side cover of the Motorcycle that had sustained damage as a result of the accident (circled).

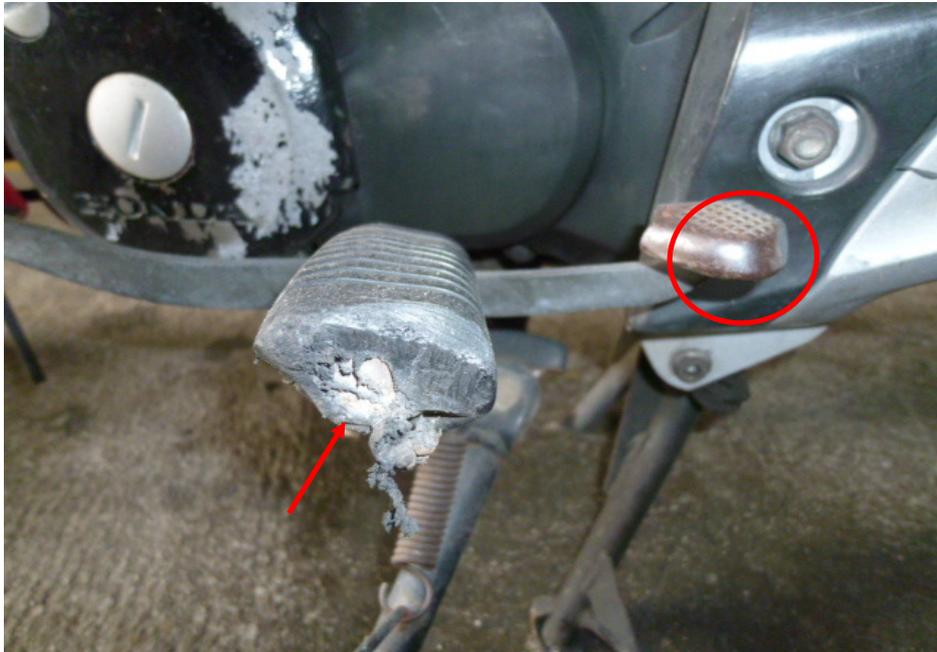
Photo 12 shows the gear shift pedal (circled) and left front footrest (arrowed) of the Motorcycle that had sustained damage as a result of the accident.

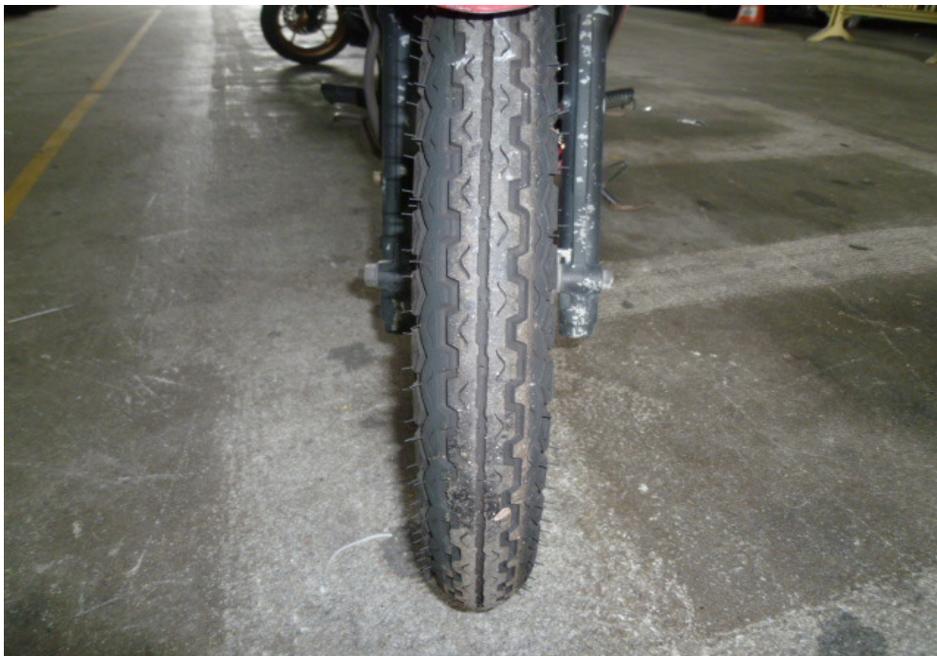
Photo 13 shows the front tyre of the Motorcycle at the time of our inspection. The front tyre was observed to be in serviceable condition with remaining tread depth of approximately 5mm. The pattern of the tread was also clearly visible. There was no tear, burst mark(s) and/or punctured hole(s) on the sidewalls as well as across the tread of the front tyre.

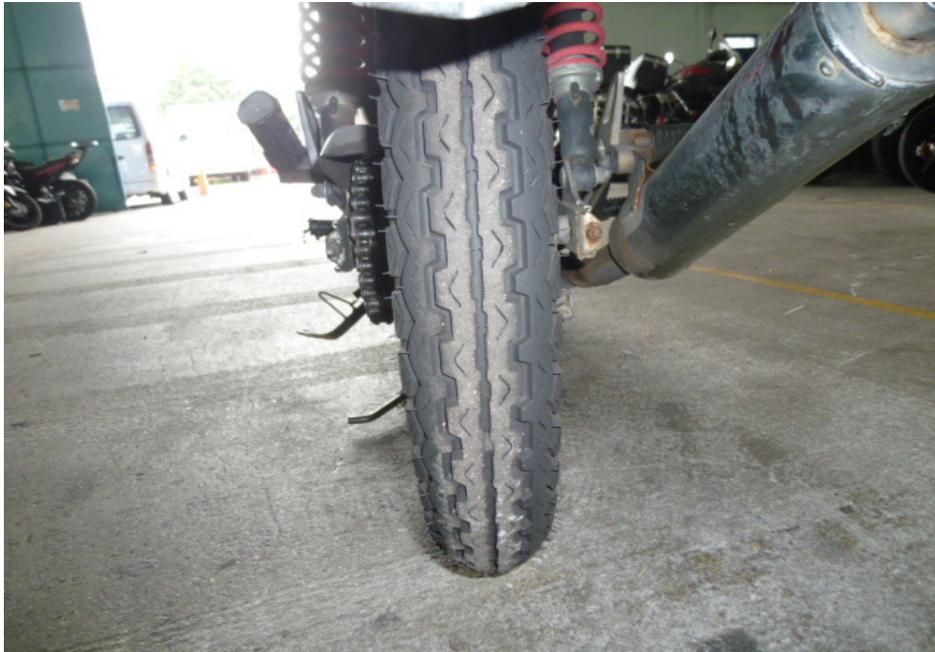
Photo 14 shows the condition of the Motorcycle's rear tyre. The rear tyre was observed to be in serviceable condition with remaining tread depth of approximately 6mm. The tyre was also observed to be sufficiently inflated for vehicular operation. We did not observe any tear, burst mark(s) and/or punctured hole(s) on the sidewalls as well as across the tread of the rear tyre.

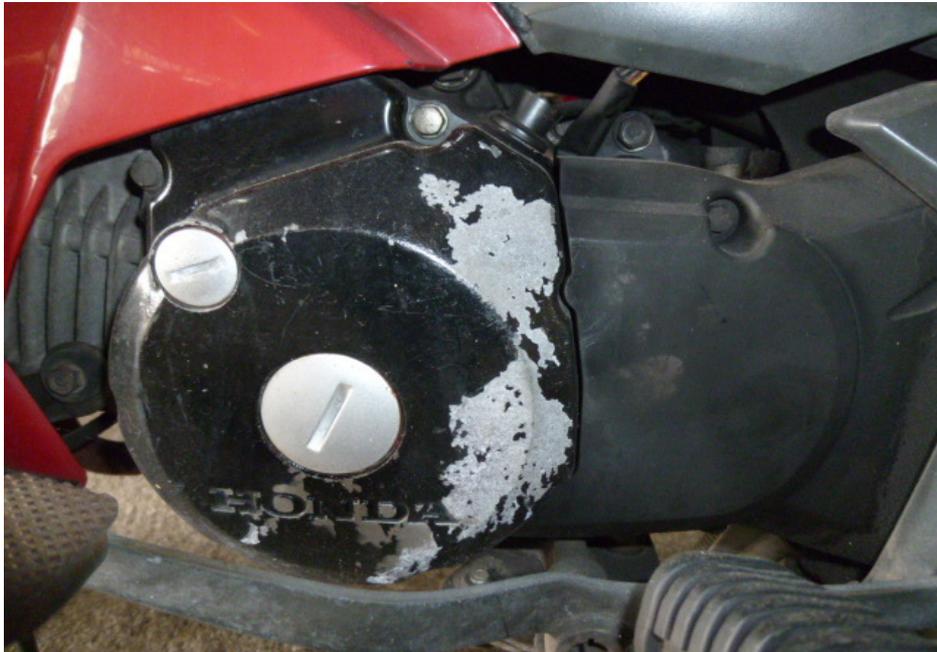
Photo 15 shows the left side of the engine of the Motorcycle at the time of our inspection. The various engine related parts and components were found to be intact with no visible damage. There was also no sign(s) or indication(s) of fluid leak observed around the left engine area of the Motorcycle.

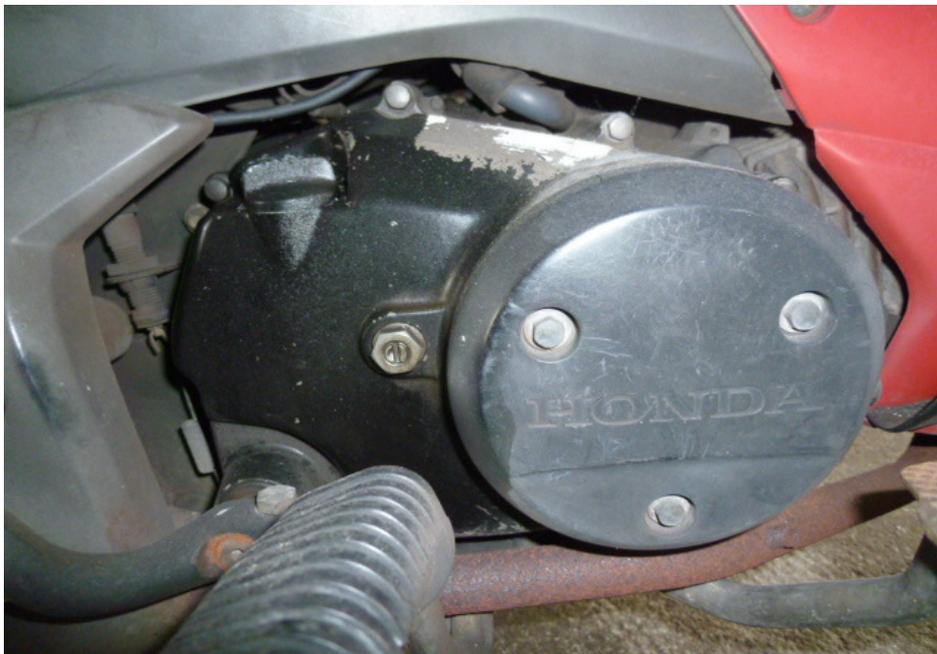
Photo 16 shows the right side of the engine of the Motorcycle at the time of our inspection. The various engine related parts and components were found to be intact with no visible damage. There was also no sign(s) or indication(s) of fluid leak observed around the right engine area of the Motorcycle.

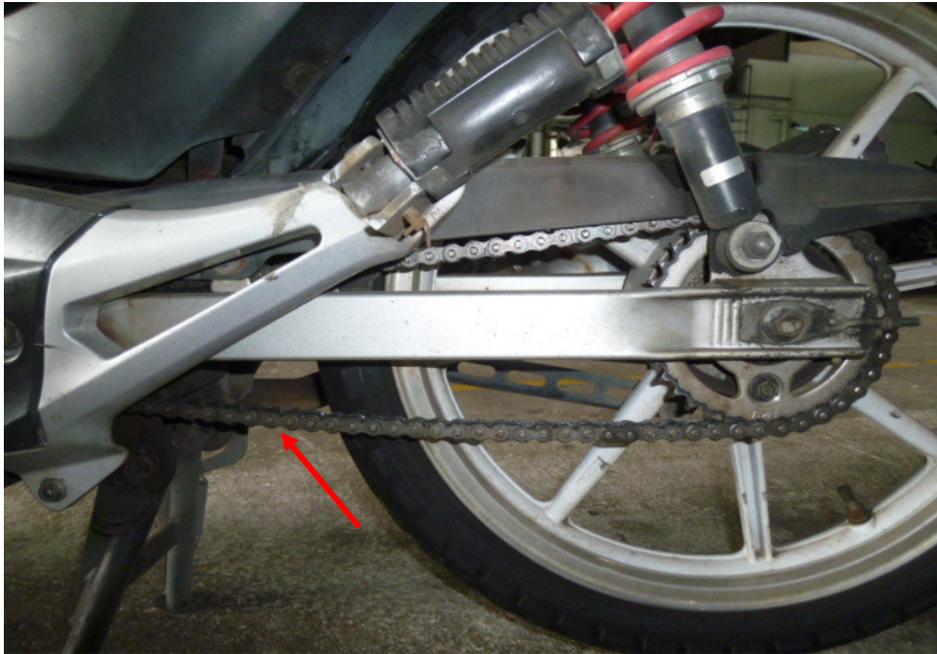
Photo 17 shows the general view of the gear train (arrowed) of the Motorcycle, which was observed to be intact with no misalignment. It was also adequately lubricated for operating purposes.

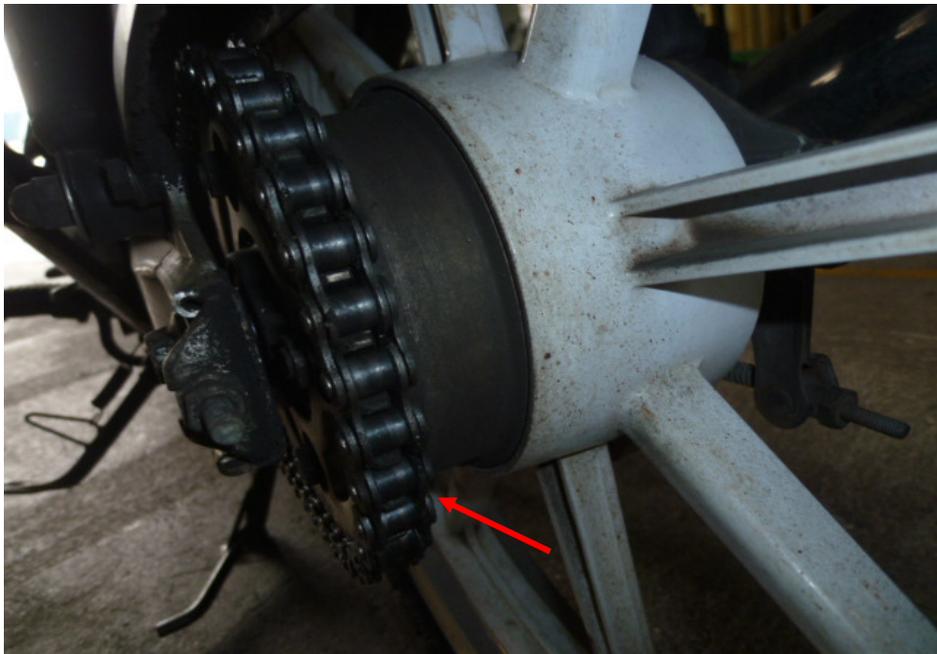
Photo 18 shows a closer view of the gear train (arrowed) of the Motorcycle, which was observed to be intact with no misalignment. It was also adequately lubricated for operating purposes.

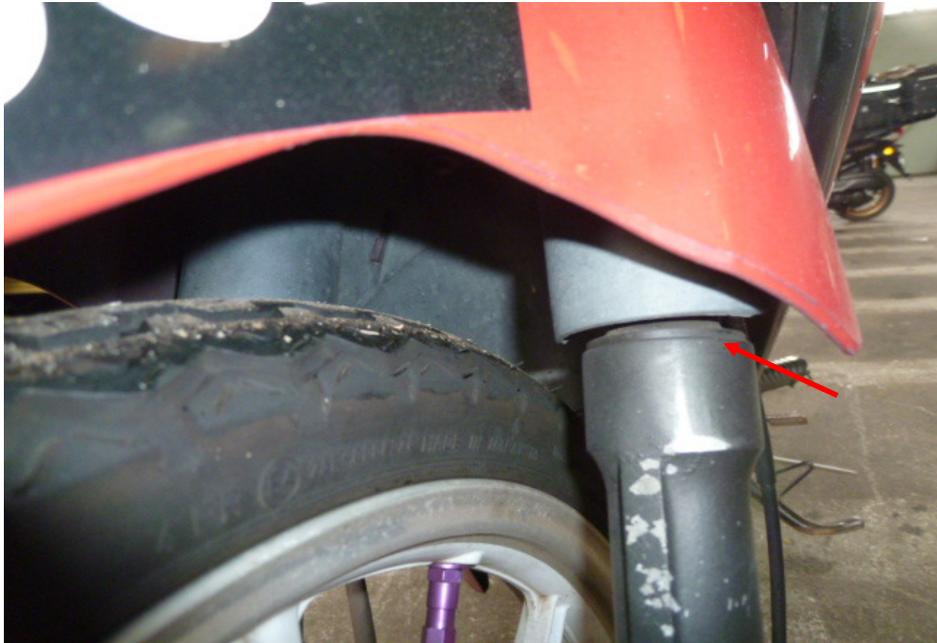
Photo 19 shows the left front fork of the Motorcycle (arrowed). The front fork and fork bracket of the Motorcycle were both found to be intact and undamaged. Turning the Motorcycle's handle bar towards the left and right did not produce any abnormal free play and/or resistance. The steering system of the Motorcycle was in serviceable condition at the time of our inspection.

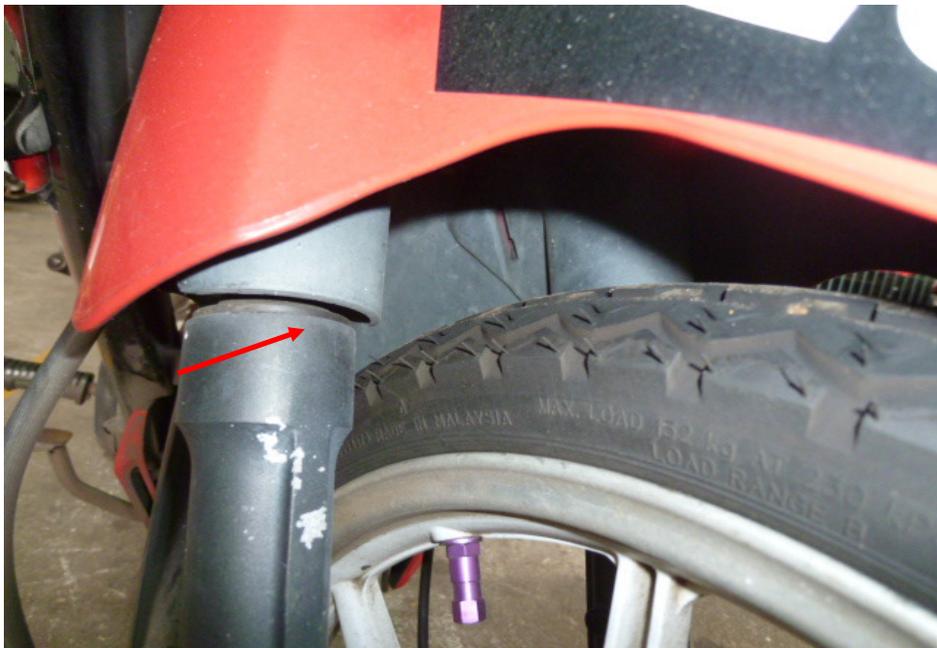
Photo 20 shows the right front fork of the Motorcycle (arrowed). The front fork and fork bracket of the Motorcycle were both found to be intact and undamaged. Turning the Motorcycle's handle bar towards the left and right did not produce any abnormal free play and/or resistance. The steering system of the Motorcycle was in serviceable condition at the time of our inspection.

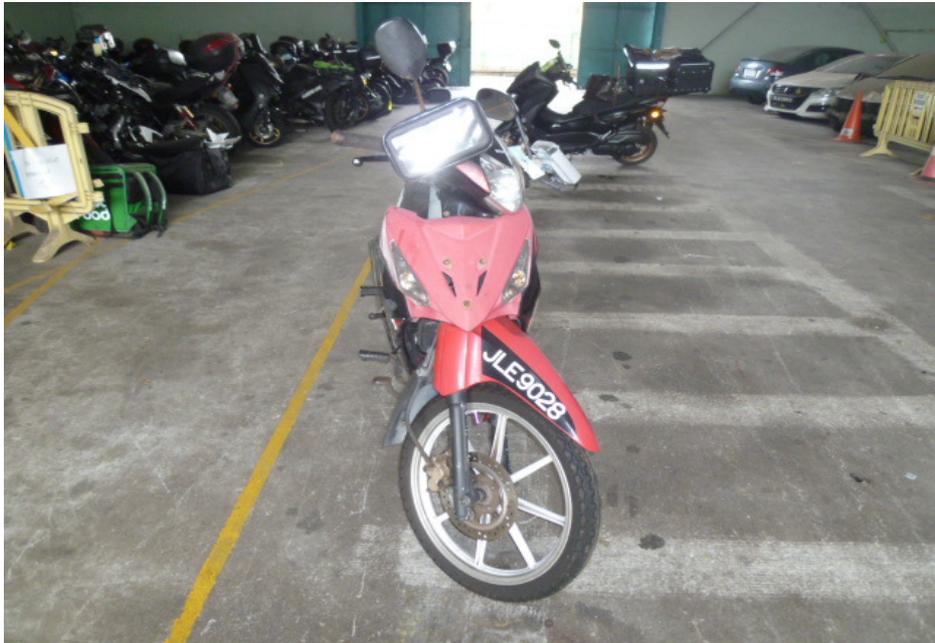
Photo 21 shows the front wheel of the Motorcycle turned towards its full left. Turning the Motorcycle's handle bar towards the left and right did not produce any abnormal free play and/or resistance. This would indicate that the steering system of the Motorcycle was in serviceable condition at the time of our inspection.

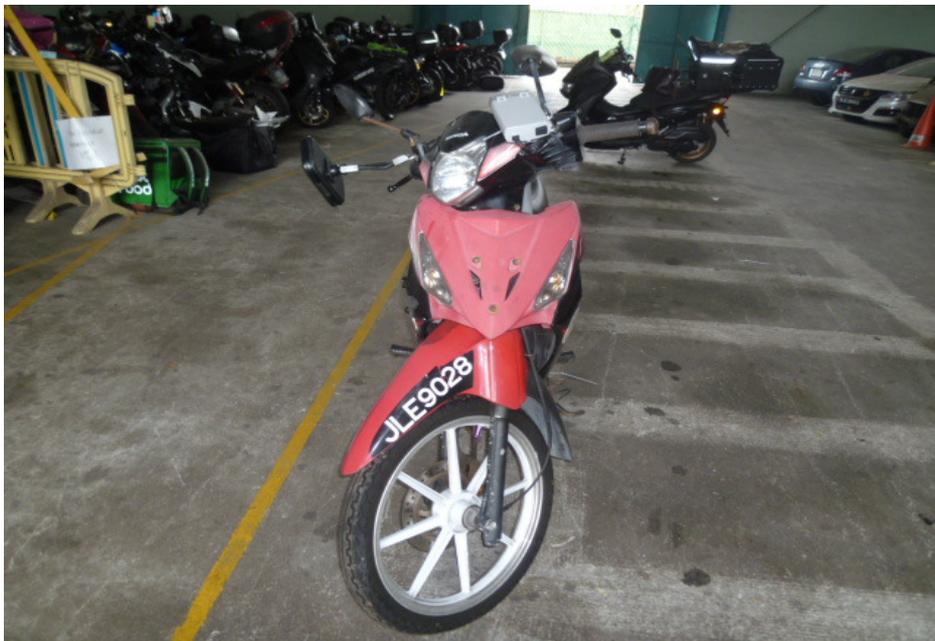
Photo 22 shows the front wheel of the Motorcycle turned towards its full right. Turning the Motorcycle's handle bar towards the left and right did not produce any abnormal free play and/or resistance. This would indicate that the steering system of the Motorcycle was in serviceable condition at the time of our inspection.

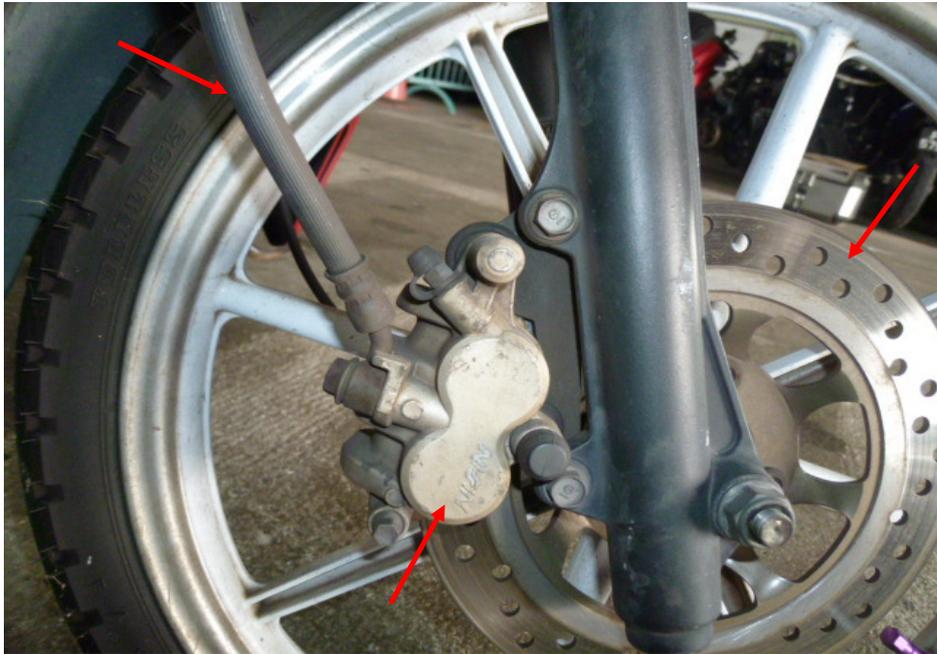
Photo 23 shows a close up view of the front brake caliper, front brake disc and front brake hose (arrowed) of the Motorcycle, which are all part of the components in the hydraulic front brake system of the Motorcycle. Our visual checks of these various components had revealed all to be intact with no visible damage. No leakage of brake fluid was also observed.

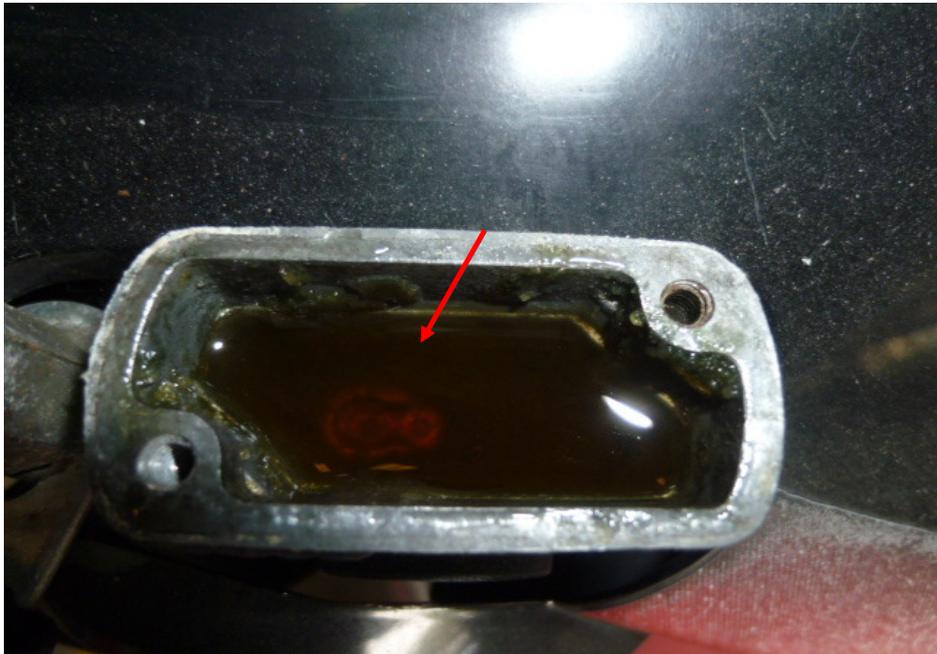
Photo 24 shows the brake fluid reservoir for the front brake of the Motorcycle. The brake fluid was observed to be of sufficient level for operating purposes. However it was found to be slightly contaminated (arrowed).

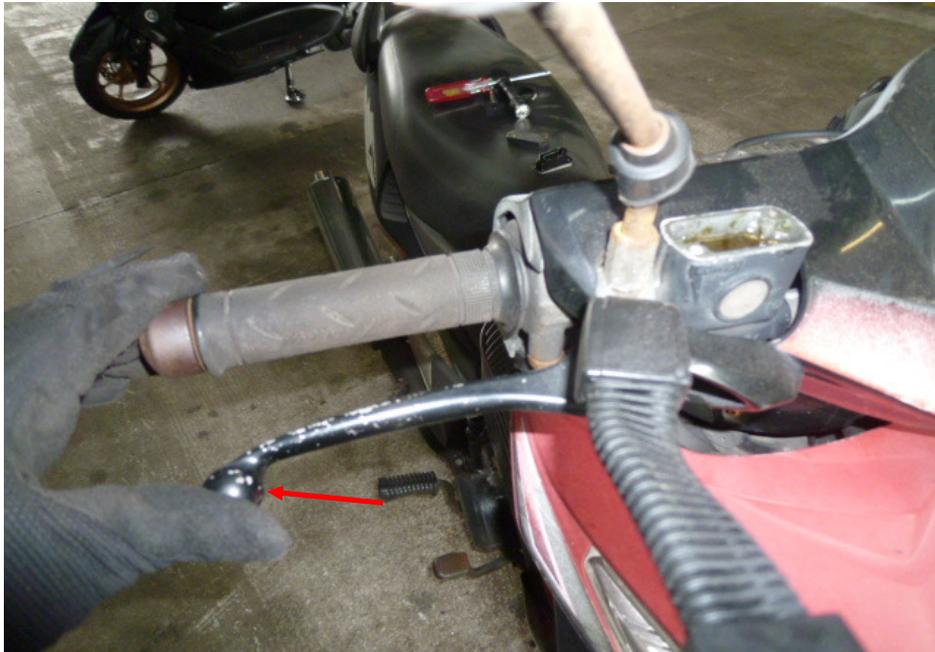
13. Static brake tests conducted on the Motorcycle had appeared to indicate that the brake system of the Motorcycle was in serviceable condition. There was some resistance felt (spongy like feel) upon pressing the front brake lever. This would indicate that there's no leakage of pressure/vacuum in the front brake system.

Photo 25 shows the front brake lever being depressed. There was some resistance felt (spongy like feel) upon pressing the front brake lever (arrowed). This would indicate that there is no leakage of pressure/vacuum in the brake system.

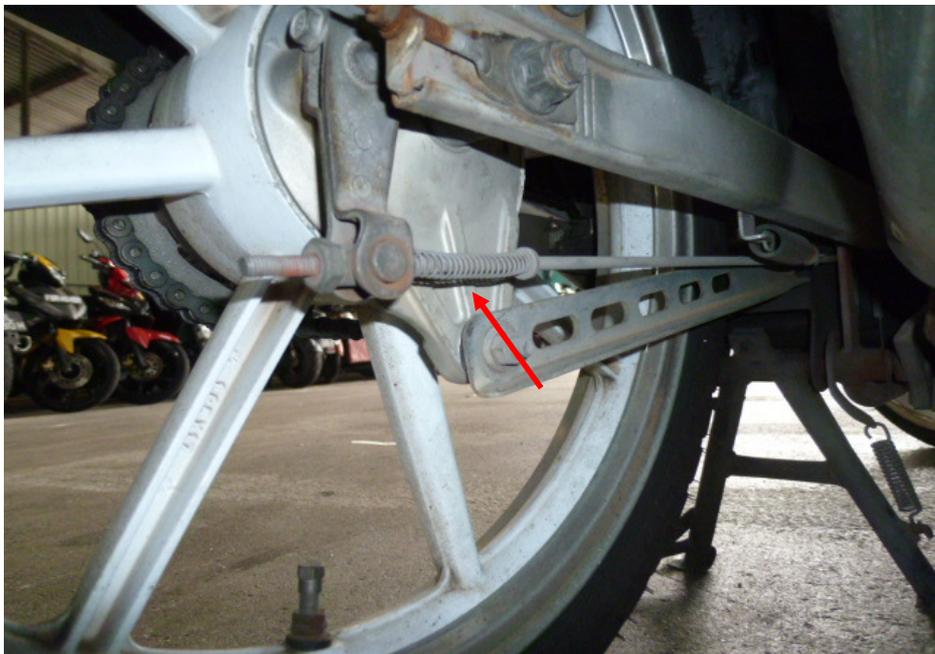
Photo 26 shows the rear wheel of the Motorcycle. The type of brake system for the rear wheel was of a mechanical type, controlled by the brake foot pedal of the Motorcycle. Our checks of the cable (arrowed), spring and drum which are all part of the components in the rear brake system of the Motorcycle reveal all to be intact and without damage.
