Your Ref: TP/IP/04366/2022  
Our Ref : CI/TPD22004869/N

**Fatal Accident Investigation Team**

**INSPECTION REPORT OF MOTORCYCLE JTQ 2476**

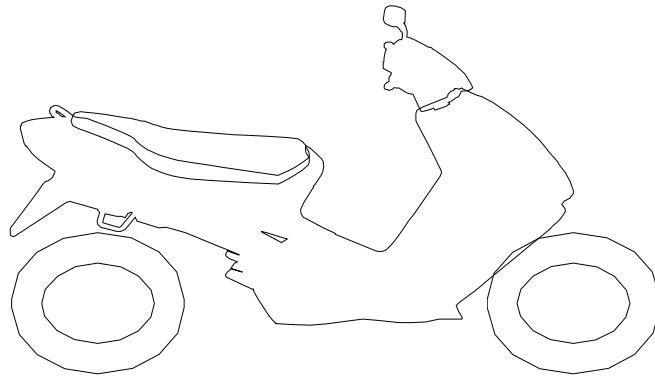
7. The front tyre was both observed to be sufficiently inflated for vehicular operation. However the rear tyre was observed to be deflated. The tyre brand, tyre size and remaining tread depth of the 2 tyres were recorded as follows:-

Timsum 80/80 - 17 (4mm)  
(Deflated)

Timsum 80/80 - 17 (5mm)

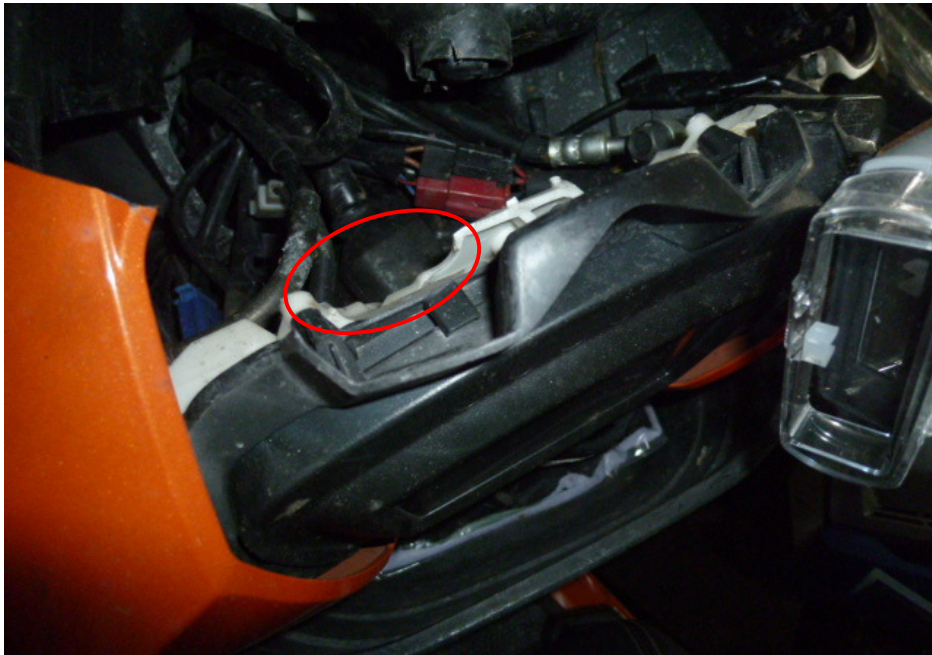
4. The mileage of the Motorcycle could not be recorded at the time of our inspection due to the damages sustained to the speedometer gauge.
5. The Motorcycle was observed to have sustained damages all around. The body parts that were found to have been damaged include its steering stem, headlight assembly, front cowling, front mudguard, side cowlings, side mirrors, front brake lever and right rear side cover, amongst others.

**Photo 1** shows the damaged speedometer gauge of the Motorcycle as a result of the accident (circled). Hence the mileage of the Motorcycle could not be recorded at the time of our inspection.

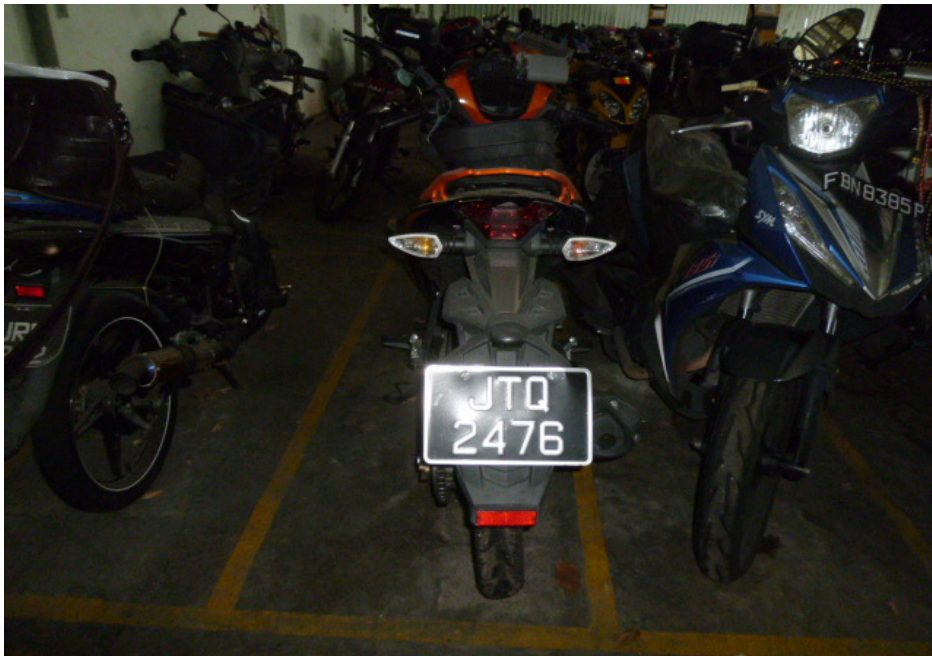
**Photo 2** shows a general view of the rear portion of the Motorcycle at the time of our inspection. The Motorcycle was observed to have sustained damages all around.

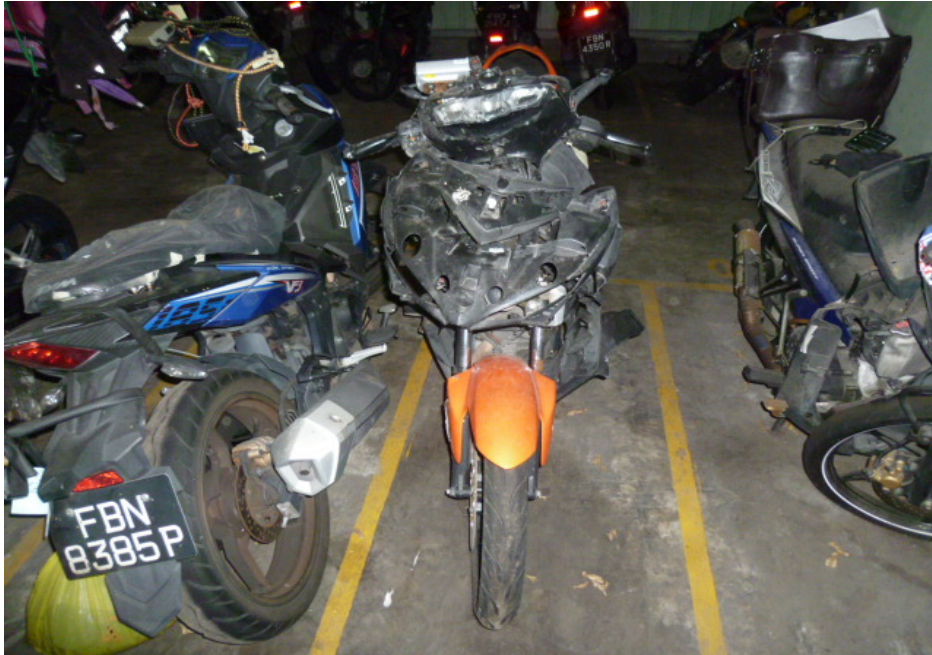
**Photo 3** shows a general view of the frontal portion of the Motorcycle at the time of our inspection. The Motorcycle was observed to have sustained damages all around.

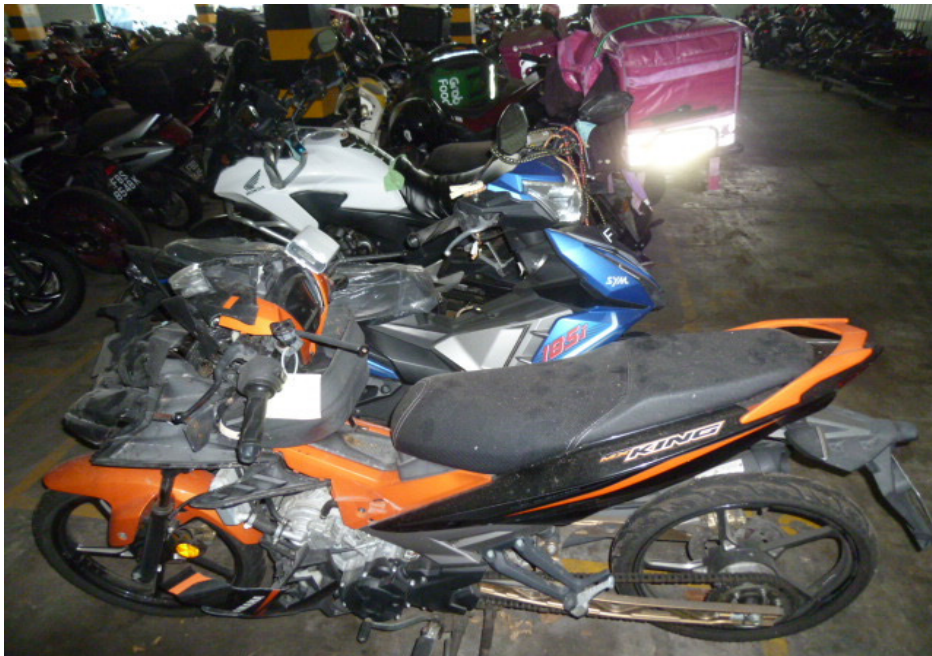
**Photo 4** shows a general view of the left body of the Motorcycle at the time of our inspection. The Motorcycle was observed to have sustained damages all around.

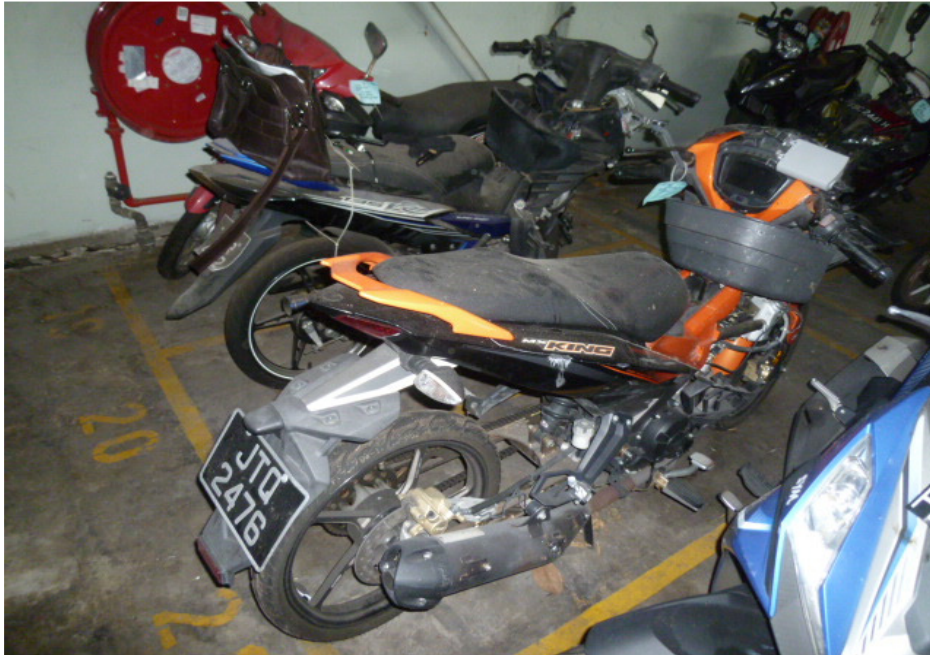
**Photo 5** shows a general view of the right rear body of the Motorcycle at the time of our inspection. The Motorcycle was observed to have sustained damages all around. The body parts that were found to have been damaged include its steering stem, headlight assembly, front cowling, front mudguard, side cowlings, side mirrors, front brake lever and right rear side cover, amongst others.

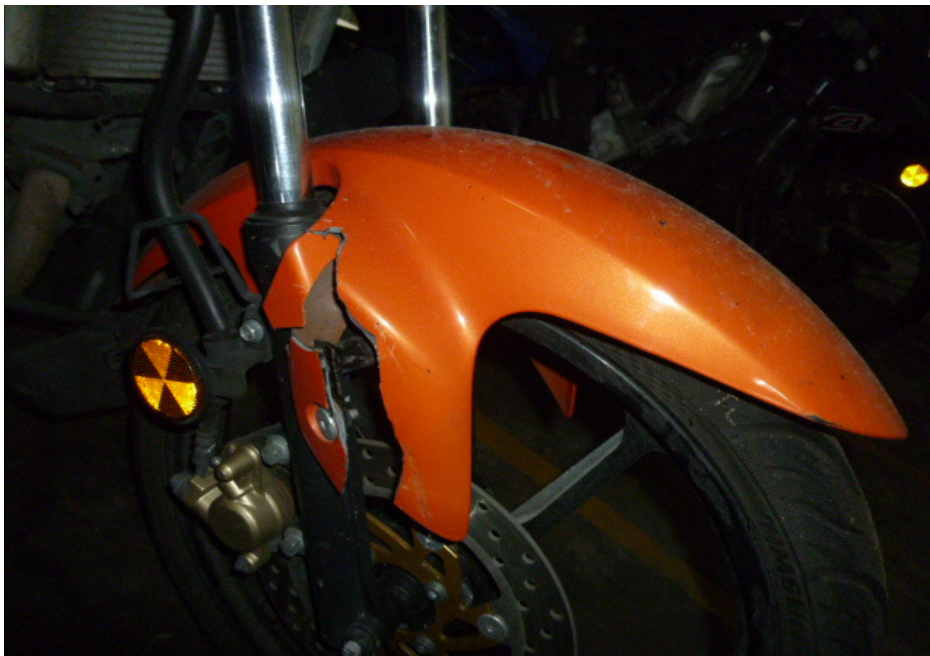
**Photo 6** shows a closer view of the cracked front mudguard which was amongst the body parts of the Motorcycle that had sustained damage as a result of the accident.

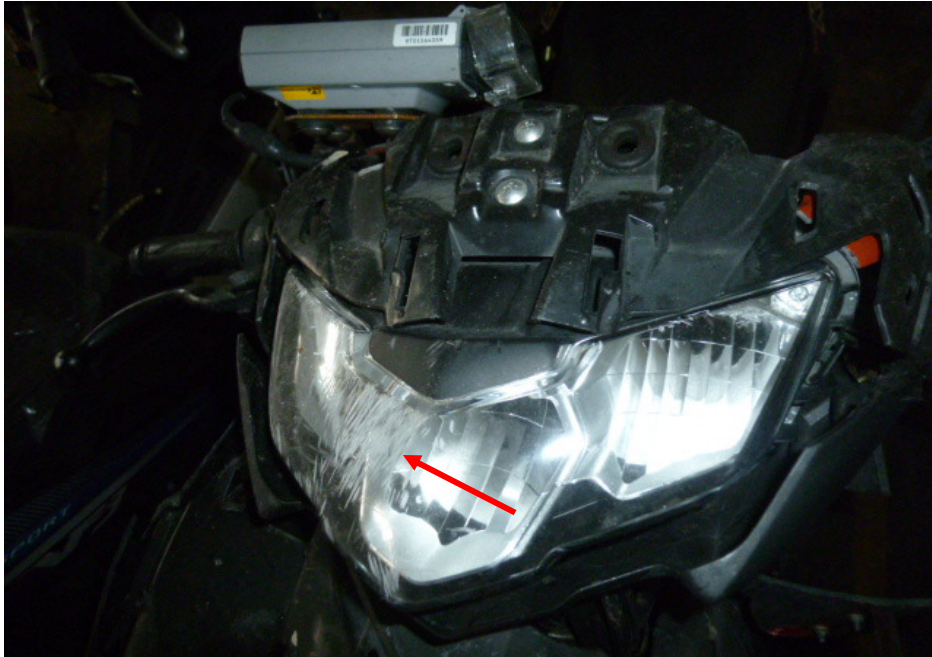
**Photo 7** shows the grazed headlight assembly (arrowed), which was amongst the body parts of the Motorcycle that had sustained damage as a result of the accident.

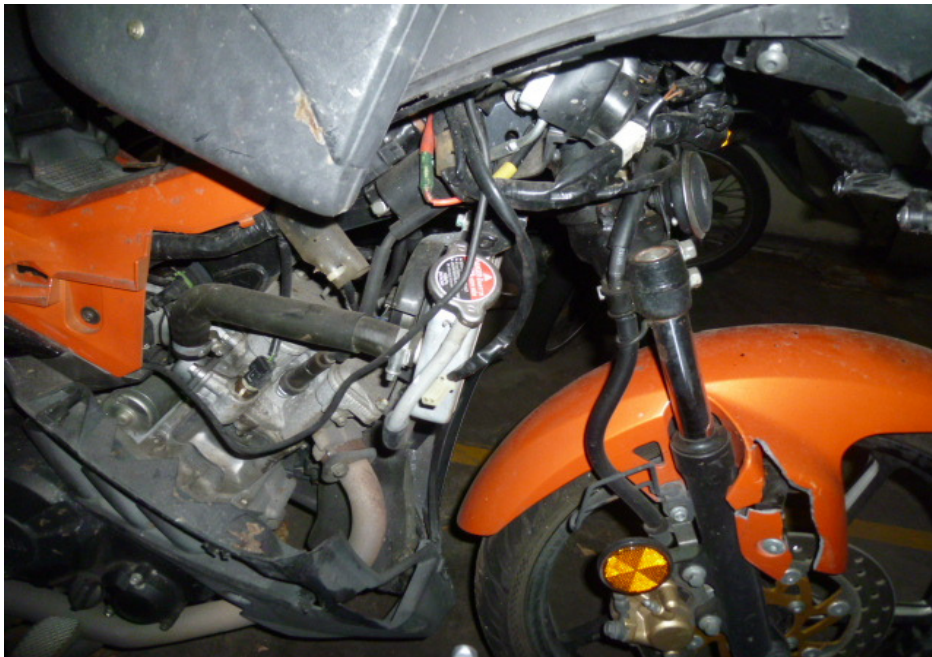
**Photo 8** shows a closer view of the missing right cowling of the Motorcycle as a result of the accident.

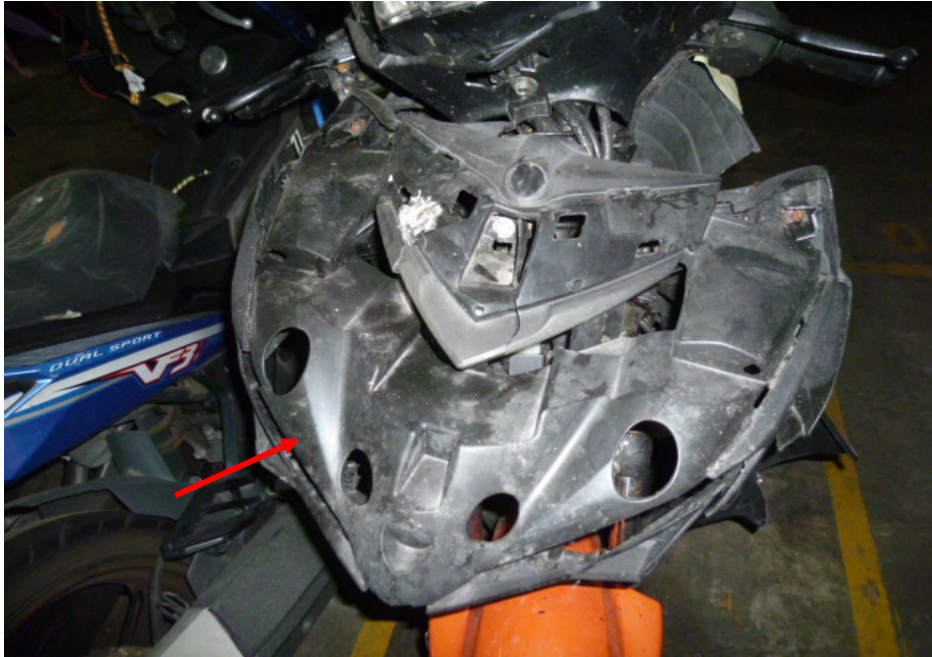
**Photo 9** shows a closer view of the missing front cowling of the Motorcycle as a result of the accident (arrowed).

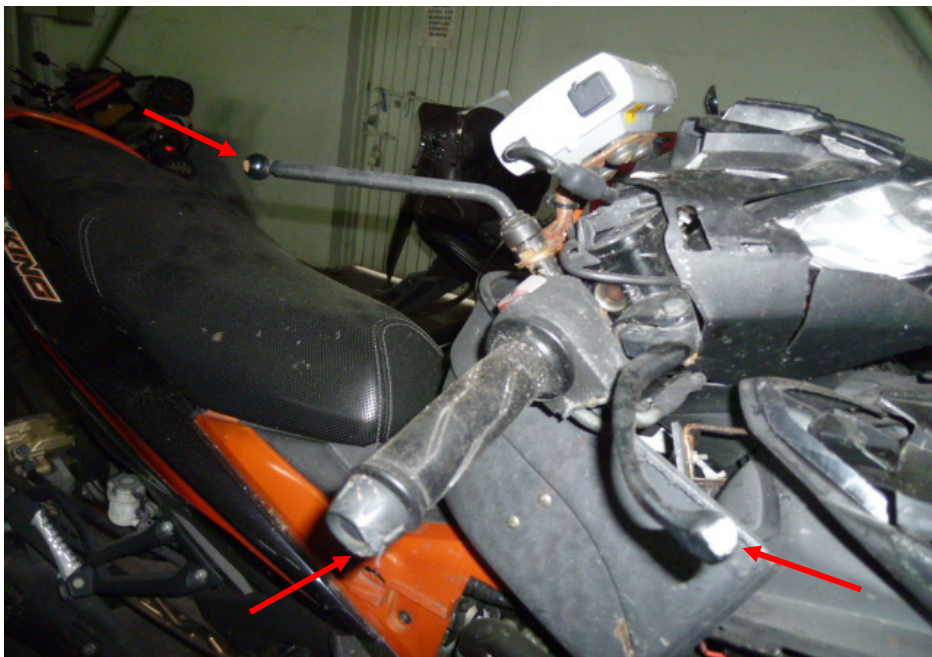
**Photo 10** shows the right handlebar end, front brake lever and right side mirror (arrowed), which were amongst the body parts of the Motorcycle that had sustained damage as a result of the accident.

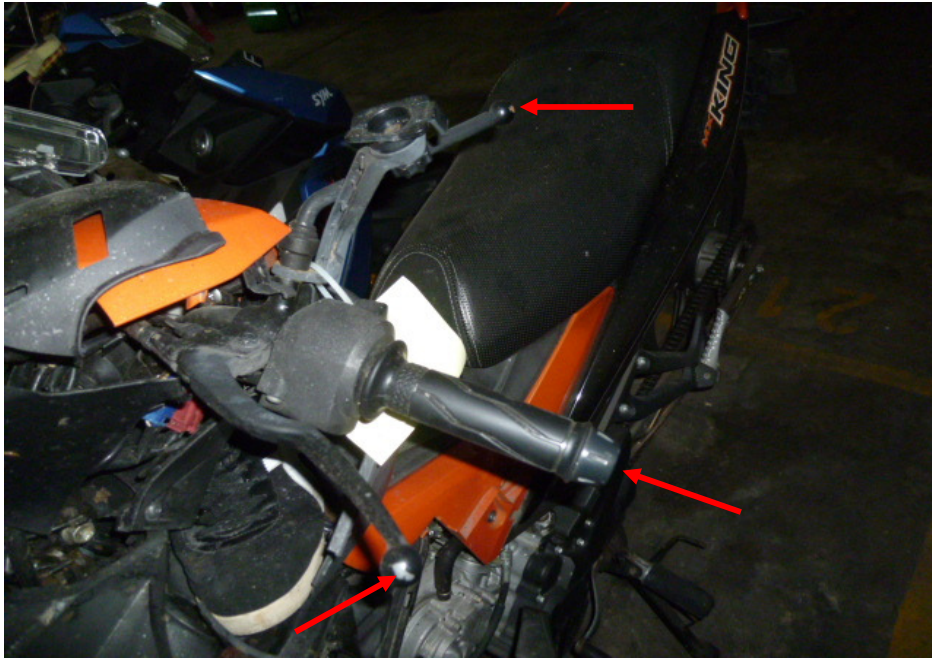
**Photo 11** shows the left handlebar end, clutch brake lever and left side mirror (arrowed), which were amongst the body parts of the Motorcycle that had sustained damage as a result of the accident.

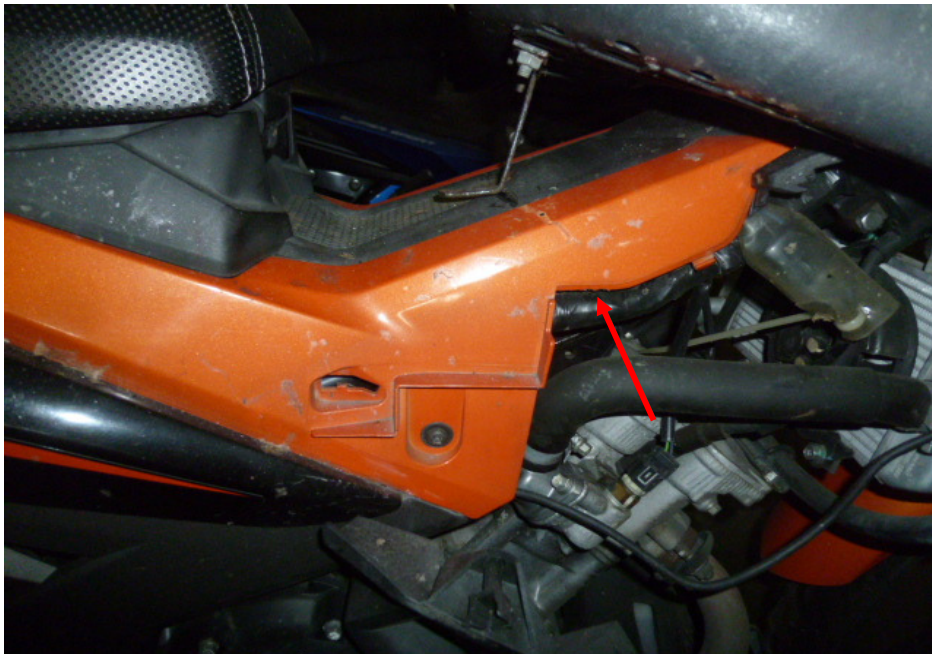
**Photo 12** shows a closer view of the cracked right centre cover (arrowed) which was amongst the body parts of the Motorcycle that had sustained damage as a result of the accident.

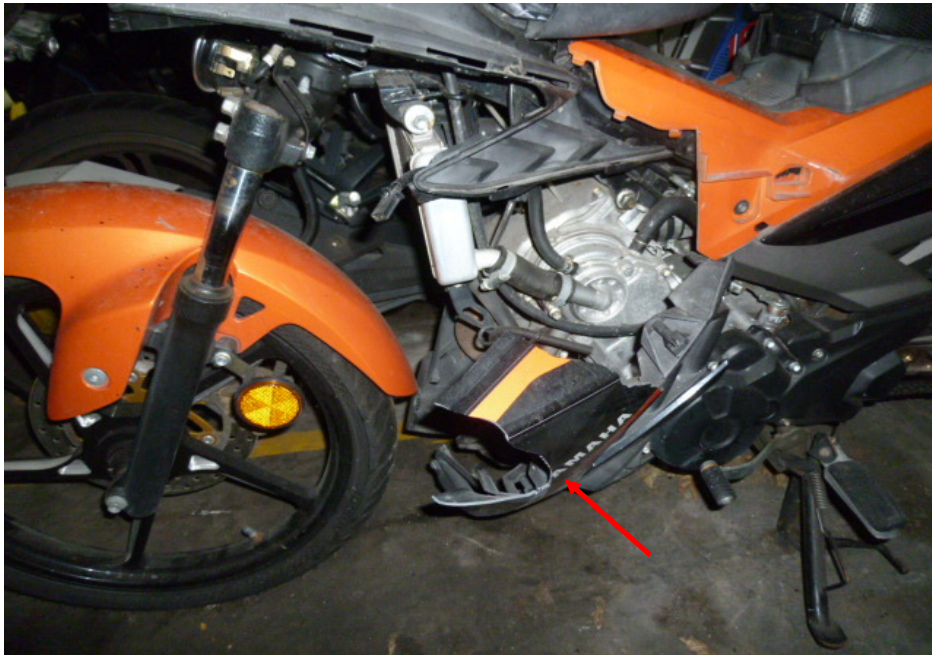
**Photo 13** shows a closer view of the cracked left cowling of the Motorcycle as a result of the accident (arrowed).

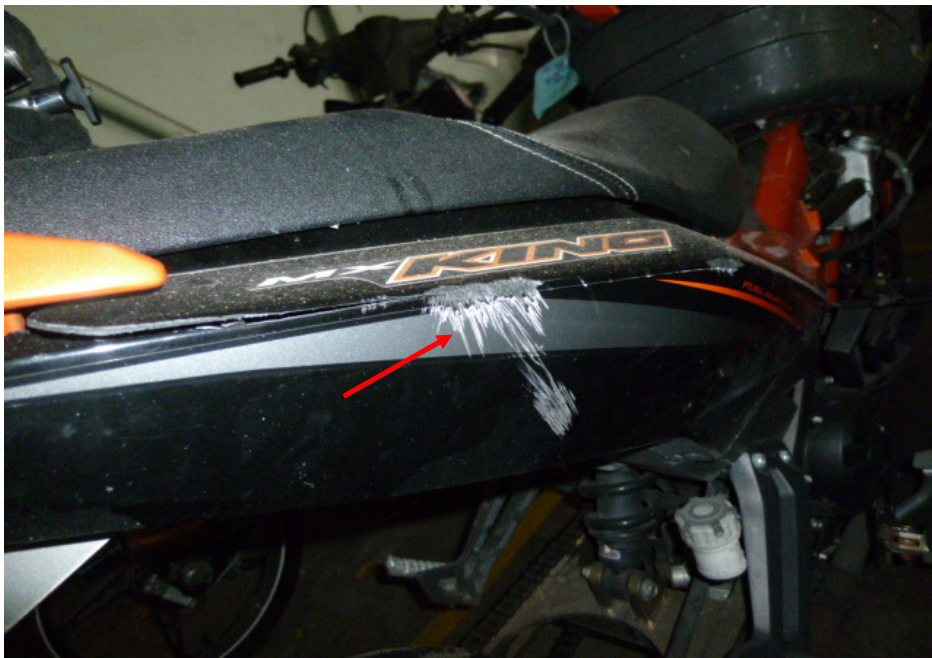
**Photo 14** shows a closer view of the grazed right rear side cover of the Motorcycle as a result of the accident (arrowed).

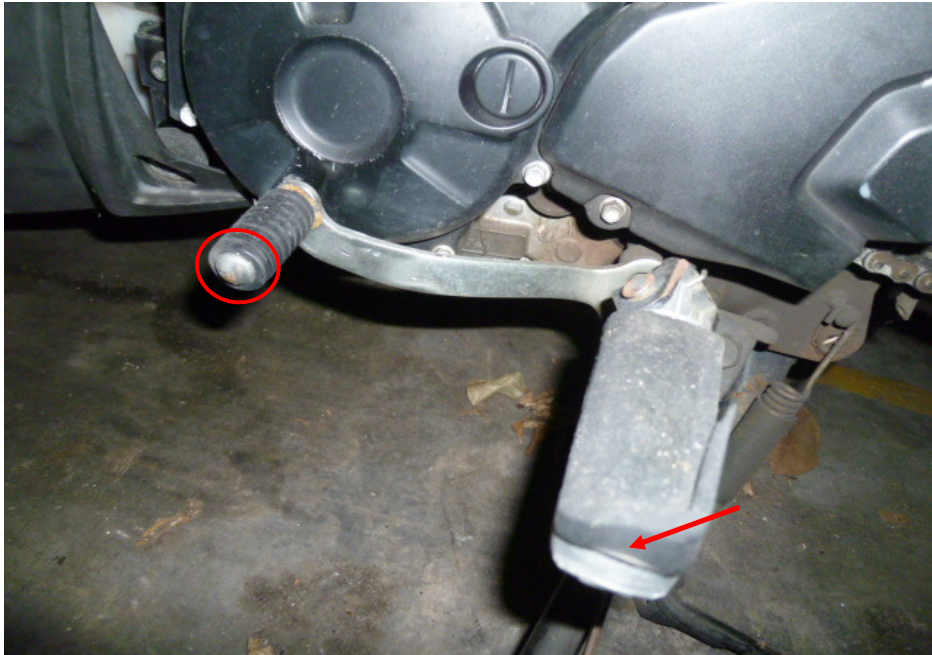
**Photo 15** shows the gear shift pedal (circled) and left front footrest (arrowed) of the Motorcycle that had sustained damage as a result of the accident.

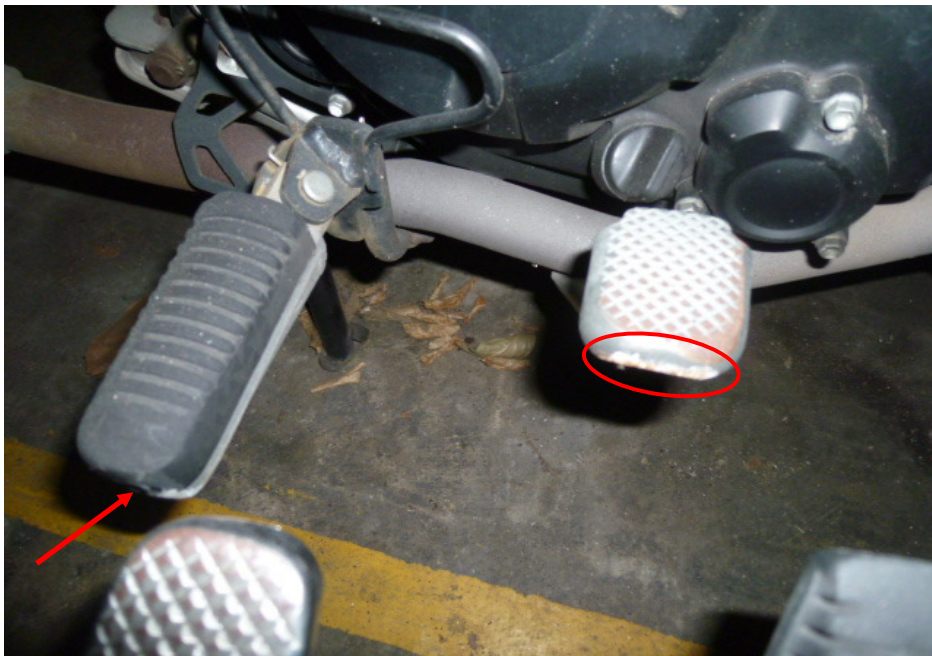
**Photo 16** shows the rear brake pedal (circled) and right front footrest (arrowed) of the Motorcycle that had sustained damage as a result of the accident.

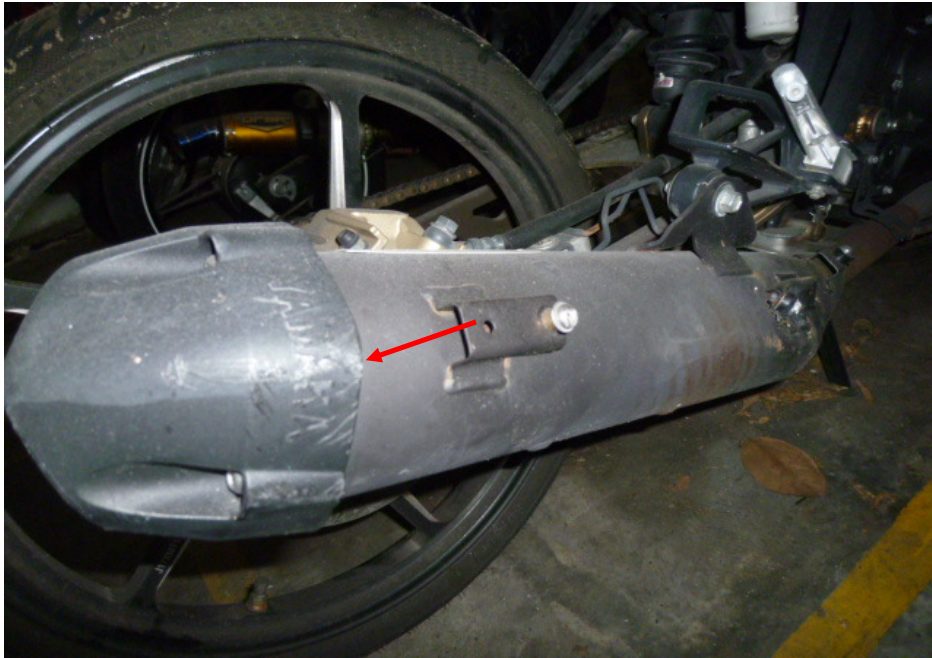
**Photo 17** shows the grazed exhaust muffler heat shield of the Motorcycle as a result of the accident (arrowed).

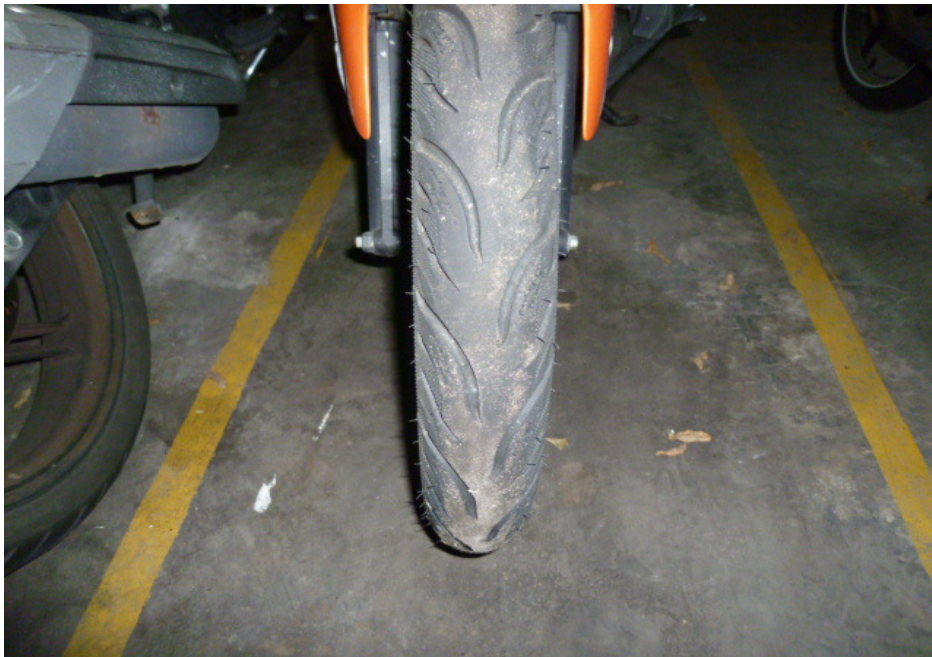
**Photo 18** shows the condition of the Motorcycle's front tyre. The front tyre was observed to be in serviceable condition with remaining tread depth of approximately 5mm. The tyre was also observed to be sufficiently inflated for vehicular operation. We did not observe any tear, burst mark(s) and/or punctured hole(s) on the sidewalls as well as across the tread of the front tyre.

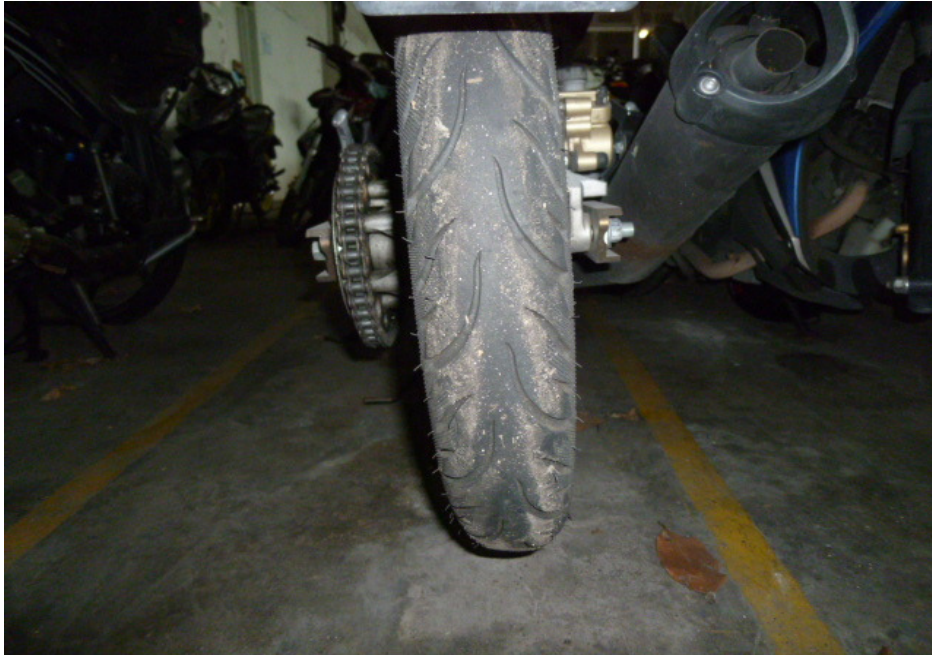
**Photo 19** shows the condition of the Motorcycle's rear tyre. The rear tyre was observed to be in serviceable condition with remaining tread depth of approximately 4mm. There was no tear, burst mark(s) and/or punctured hole(s) on the sidewalls as well as across the tread of the rear tyre. However the rear tyre was observed to be deflated.

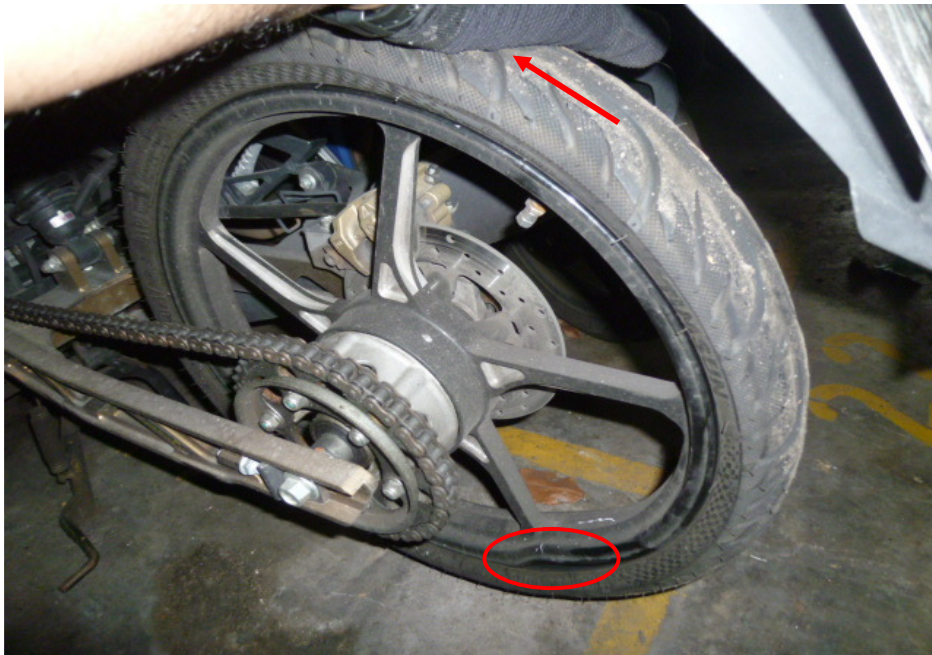
8. The 2 tyres were wrapped around alloy wheel rims. At the time of our inspection, we did not observe any visible damage on the front wheel rim of the Motorcycle. However we did observe that the rear wheel rim was bent. See photos 1 – 20 below.

**Photo 20** shows the bent rear wheel rim (circled) and deflated rear tyre (arrowed) of the Motorcycle at the time of our inspection.

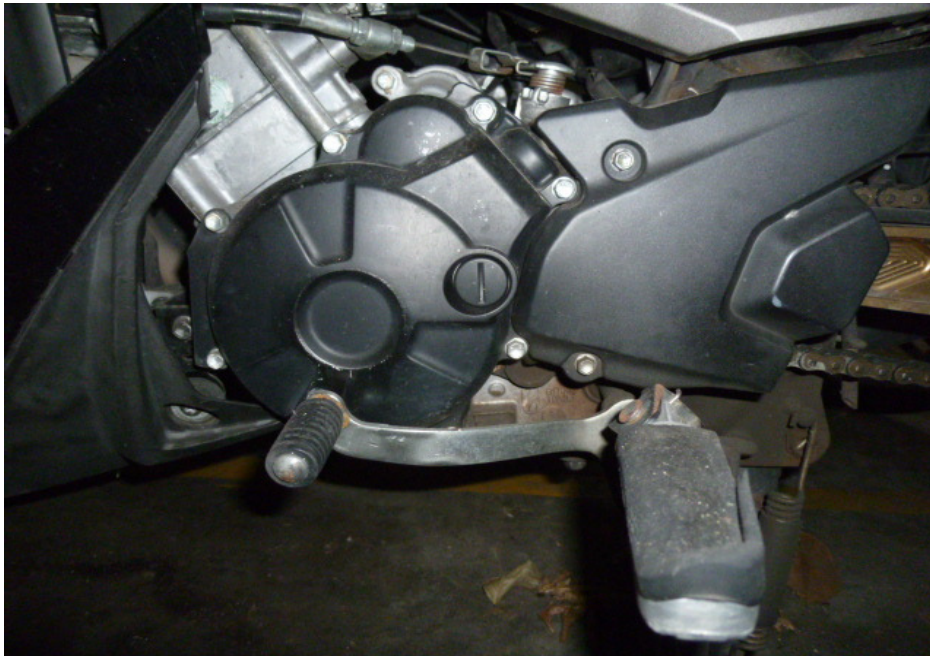
**Photo 21** shows the left side of the engine of the Motorcycle at the time of our inspection. The various engine related parts and components were found to be intact with no visible damage. There was also no sign(s) or indication(s) of fluid leak observed around the left engine area of the Motorcycle.

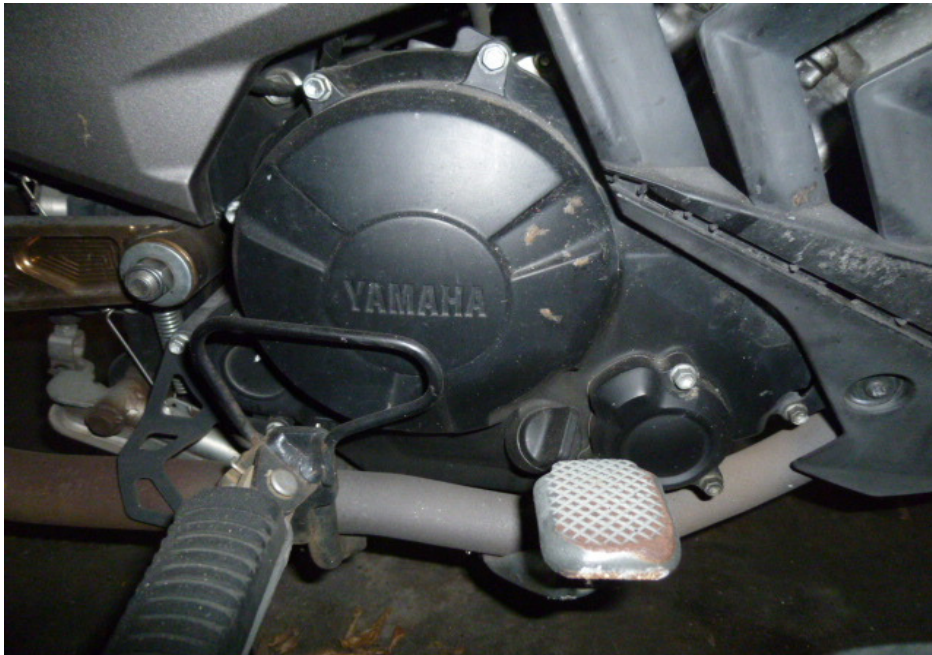
**Photo 22** shows the right side of the engine of the Motorcycle at the time of our inspection. The various engine related parts and components were found to be intact with no visible damage. There was also no sign(s) or indication(s) of fluid leak observed around the right engine area of the Motorcycle.

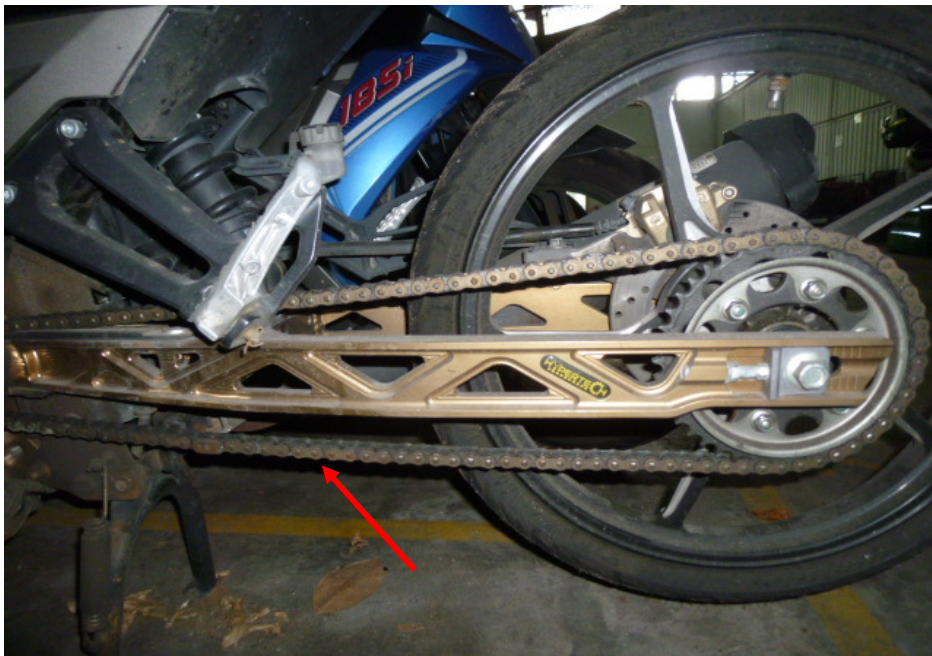
**Photo 23** shows the general view of the gear train (arrowed) of the Motorcycle, which was observed to be intact with no misalignment. It was also adequately lubricated for operating purposes.

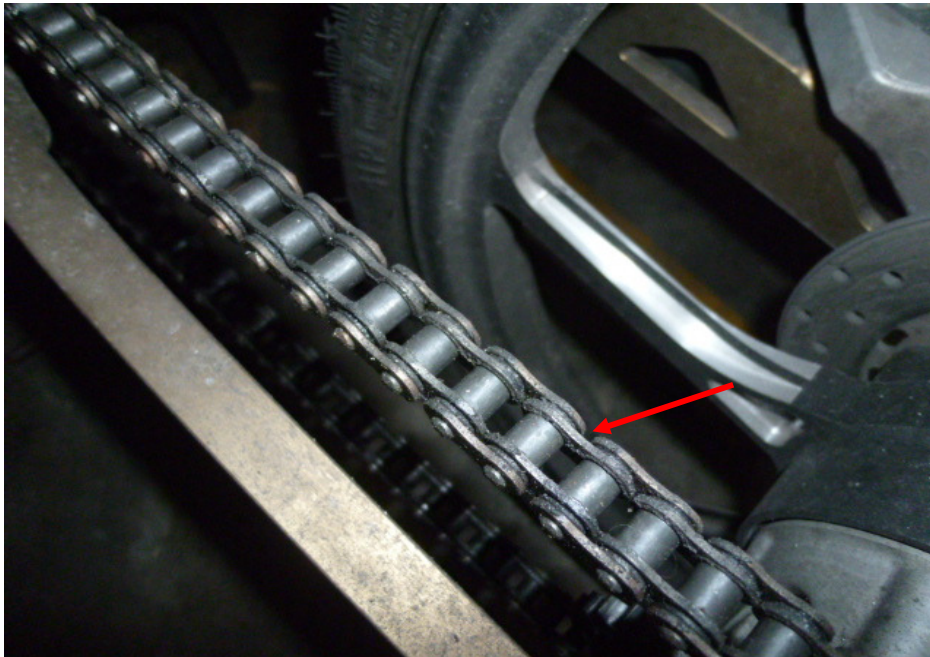
**Photo 24** shows a closer view of the gear train (arrowed) of the Motorcycle, which was observed to be intact with no misalignment. It was also adequately lubricated for operating purposes.

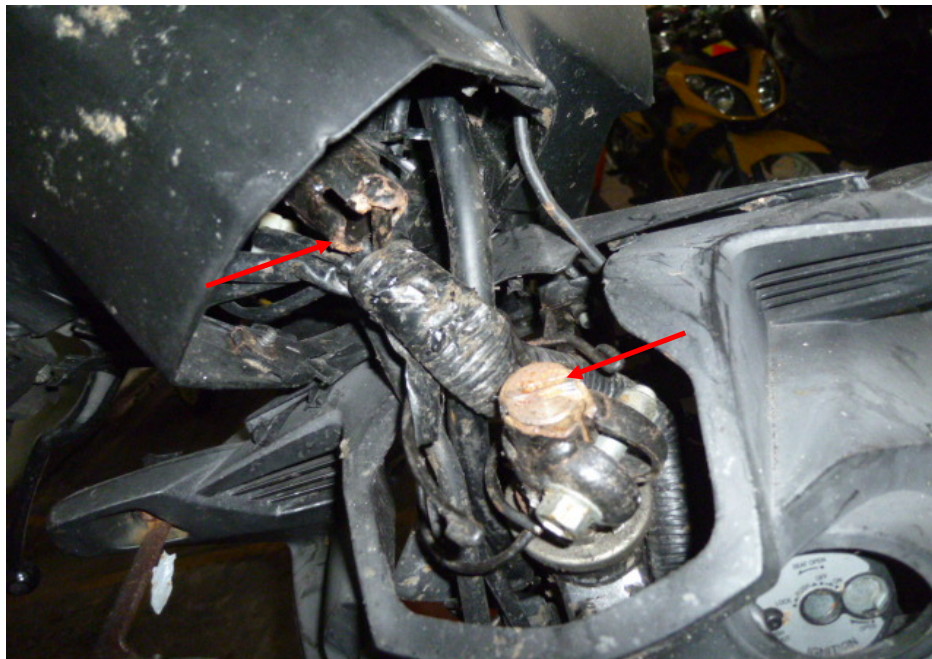
11. For this case, we were not able to conduct any test(s) on the steering system of the Motorcycle due to the damage to its steering stem. The steering stem was observed to be broken as a result of the accident.

**Photo 25** shows the steering stem of the Motorcycle. The steering stem was observed to be broken as a result of the accident (arrowed). We were hence not able to conduct any tests on the steering system of the Motorcycle.

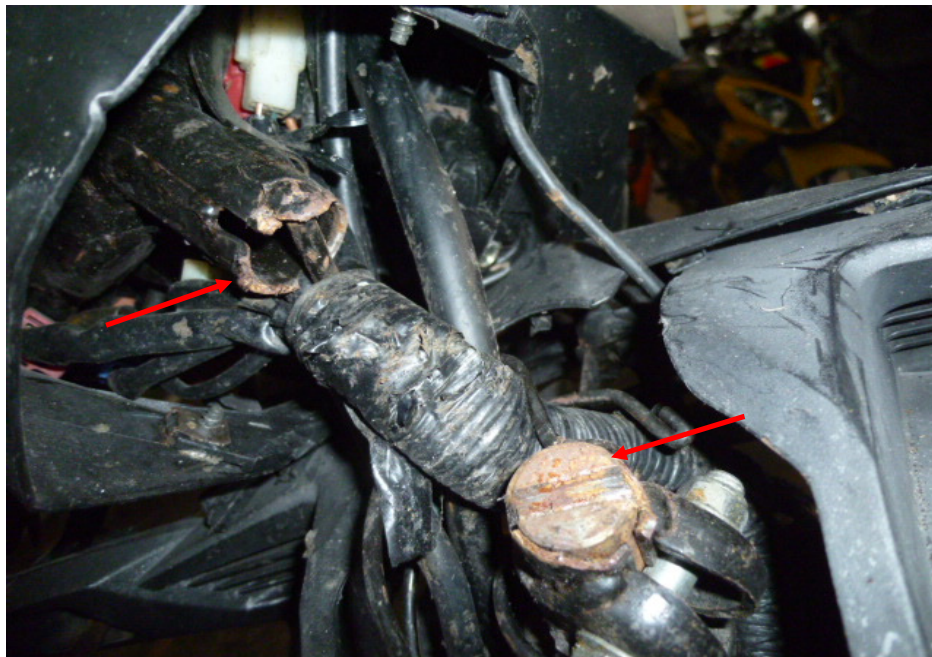
**Photo 26** shows a close up view of the steering stem of the Motorcycle. The steering stem was observed to be broken as a result of the accident (arrowed). We were hence not able to conduct any tests on the steering system of the Motorcycle.

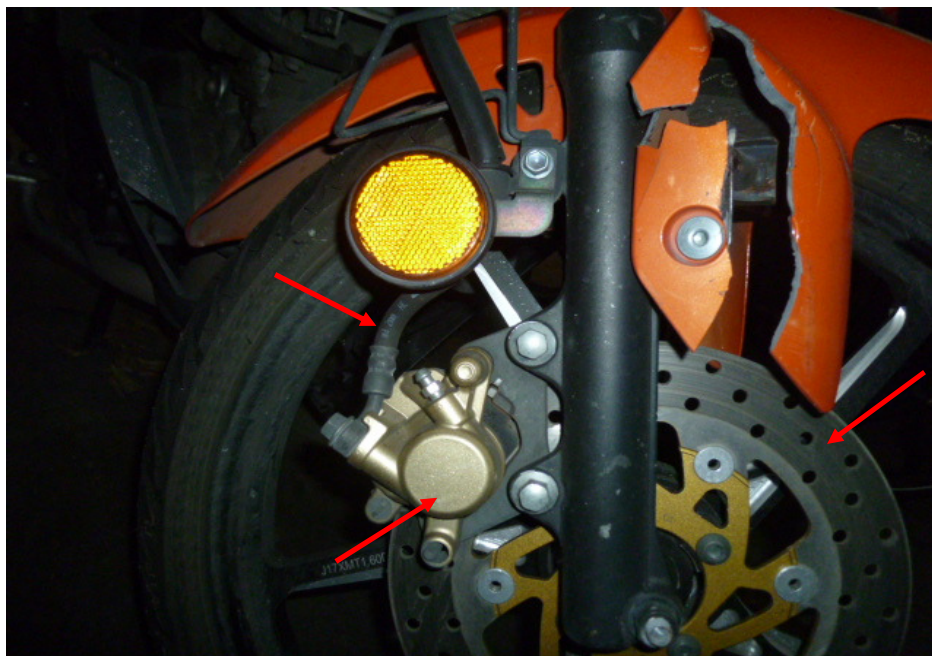
**Photo 27** shows a close up view of the front brake caliper, front brake disc and front brake hose (arrowed) of the Motorcycle, which are all part of the components in the hydraulic front brake system of the Motorcycle. Our visual checks of these various components had revealed all to be intact with no visible damage. No leakage of brake fluid was also observed.

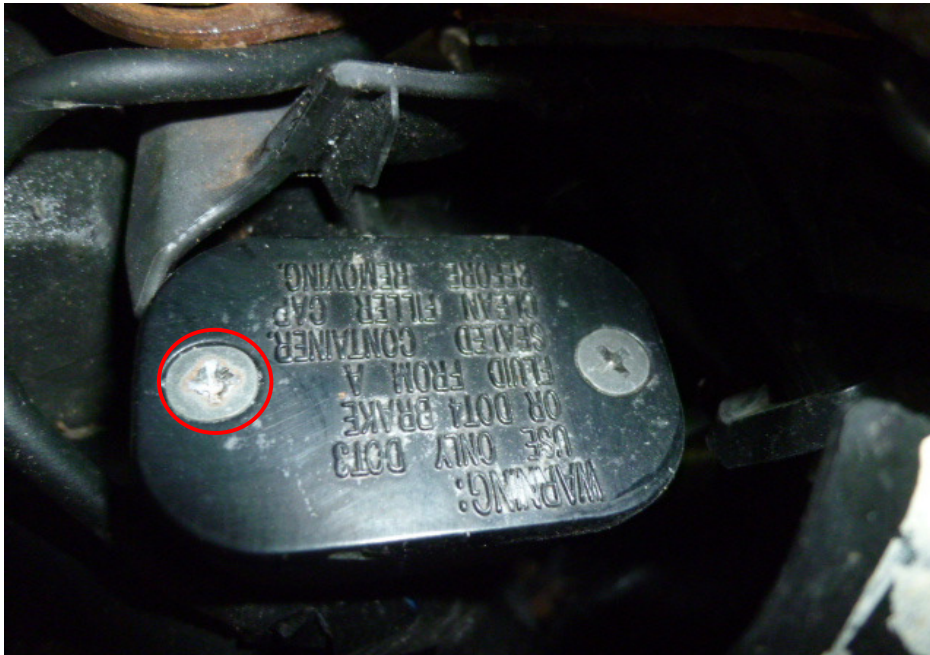
14. We were unable remove the front brake reservoir cover to examine whether the front brake fluid was without contamination due to a worn out screw. However the front brake fluid was observed to be of sufficient level for operational purposes.

**Photo 28** shows the brake fluid reservoir cover for the front brake of the Motorcycle. We were unable to examine whether the front brake fluid was without contamination due to the worn out screw (circled).

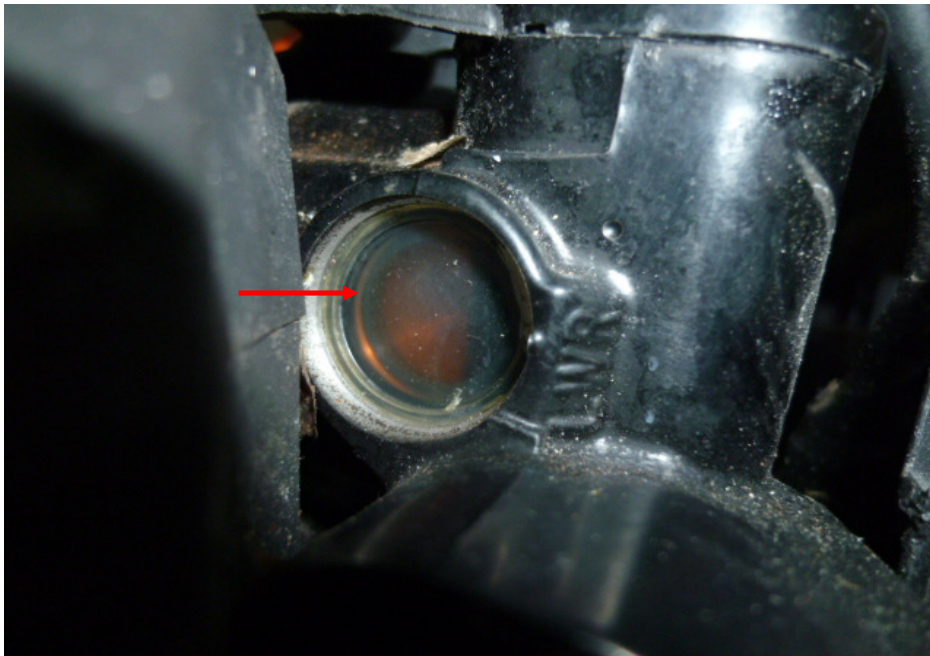
**Photo 29** shows a close up view of the brake fluid reservoir for the front brake of the Motorcycle. The brake fluid was observed to be of sufficient level for operational purposes (arrowed).

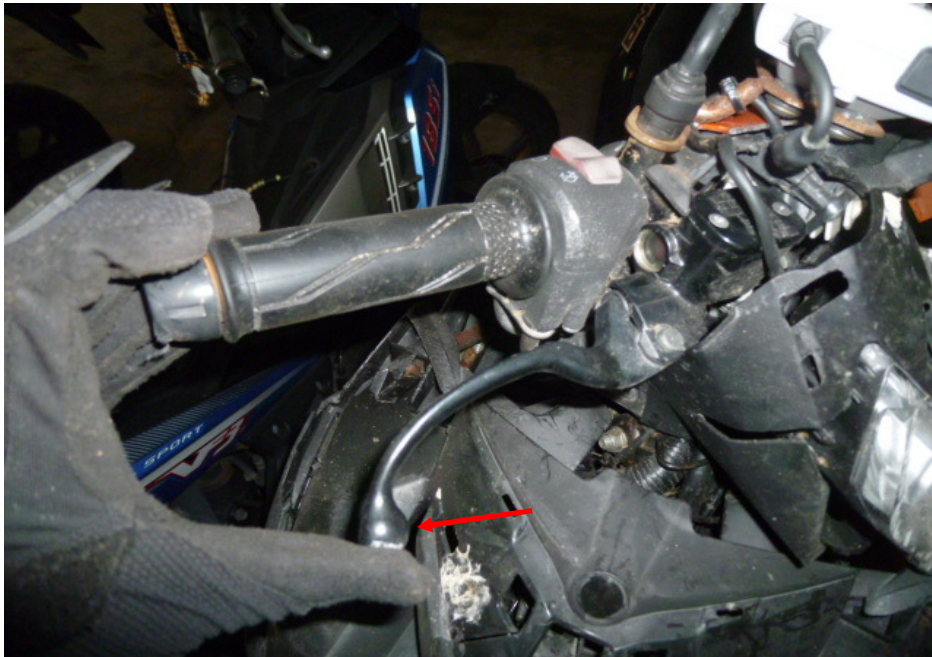
16. Static brake tests conducted on the Motorcycle had appear to indicate that the braking system of the Motorcycle was in serviceable condition. There was some resistance felt (spongy like feel) upon pressing the brake lever and upon stepping on the brake pedal. This would indicate that there was no leakage of pressure/vacuum in the brake system.

**Photo 30** shows the front brake lever being depressed. There was some resistance felt (spongy like feel) upon pressing the front brake lever (arrowed). This would indicate that there is no leakage of pressure/vacuum in the front brake system.

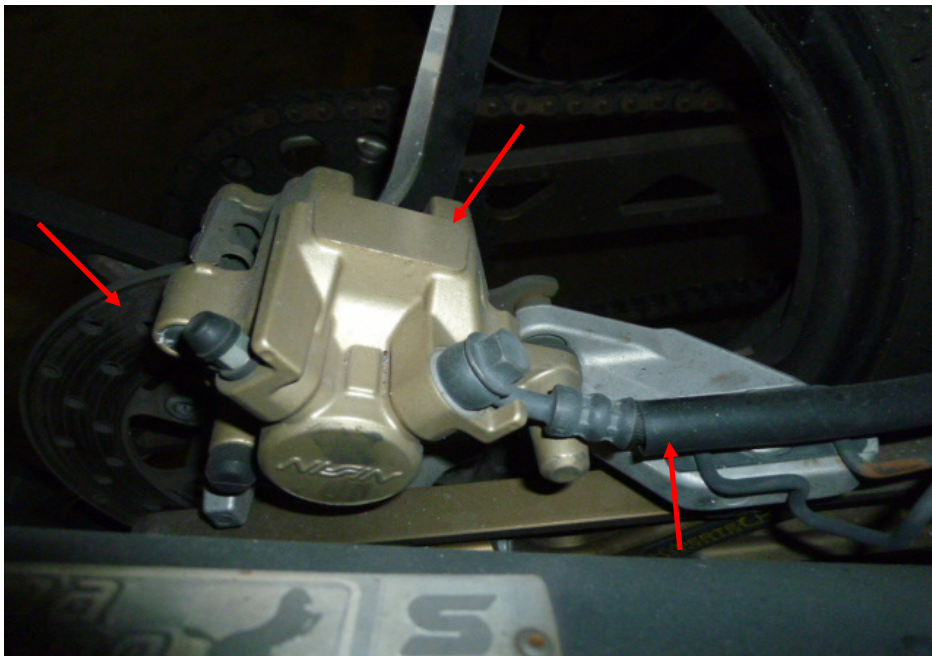
**Photo 31** shows a close up view of the rear brake caliper, rear brake disc and rear brake hose (arrowed) of the Motorcycle, which are all part of the components in the hydraulic rear brake system of the Motorcycle. Our visual checks of these various components had revealed all to be intact with no visible damage. No leakage of brake fluid was also observed.

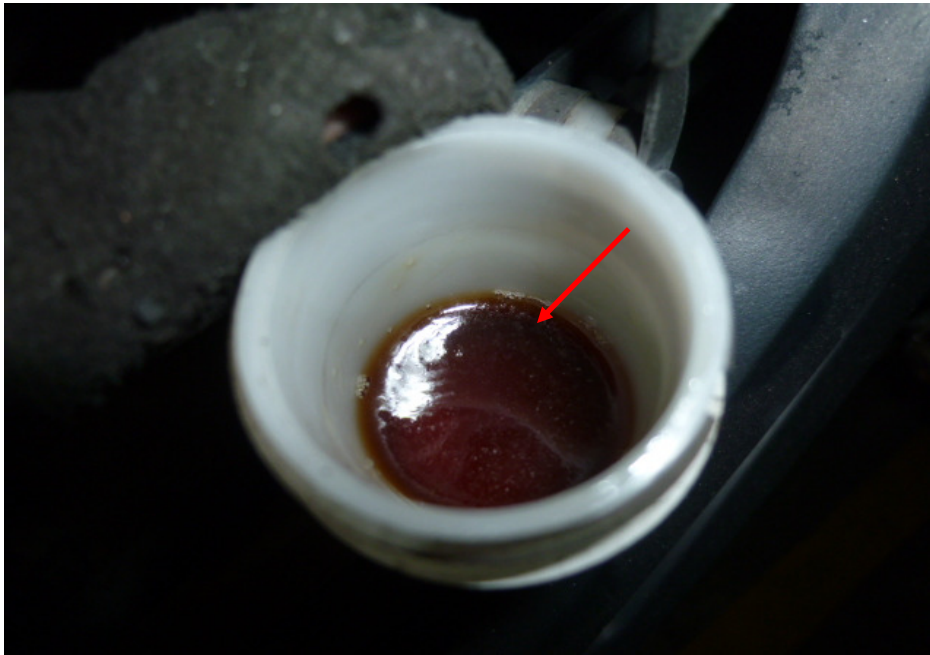
15. The brake fluid for the rear brake was observed to be of sufficient level for operating purposes. However it was found to be slightly contaminated.

**Photo 32** shows the brake fluid reservoir for the rear brake of the Motorcycle. The brake fluid was observed to be of sufficient level for operating purposes. However it was found to be slightly contaminated (arrowed).
