Your Ref: TP/IP/04581/2022
Our Ref : CI/TPD22004870/N

Fatal Accident Investigation Team

**INSPECTION REPORT OF BICYCLE (ORANGE) - TRAFFIC POLICE POUND
REPORT NO. 0720/22**

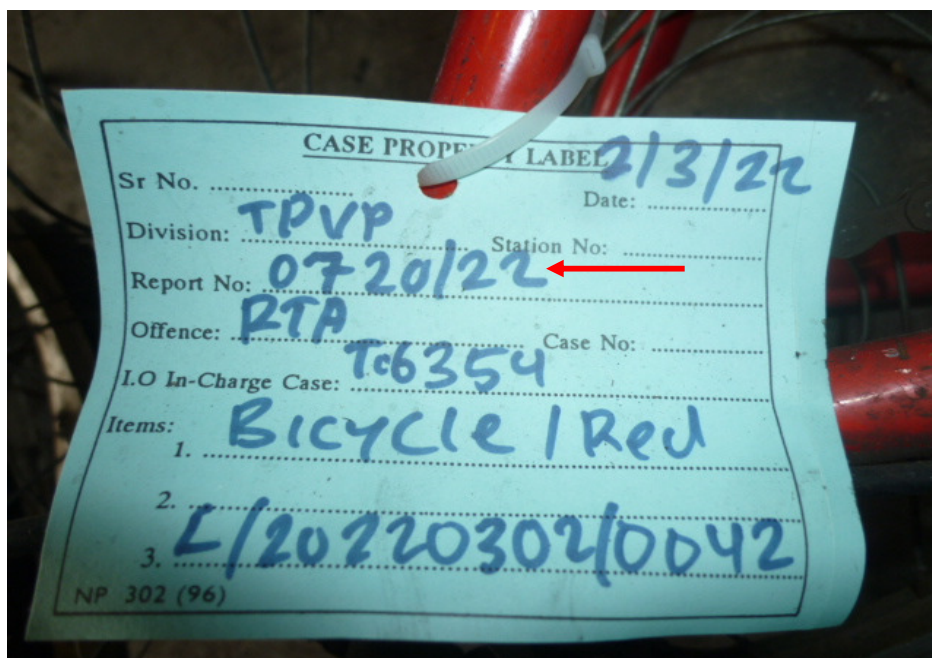
Photo 1 shows the identification of the Bicycle with reference to Traffic Police Pound Report No. 0720/22 (arrowed).

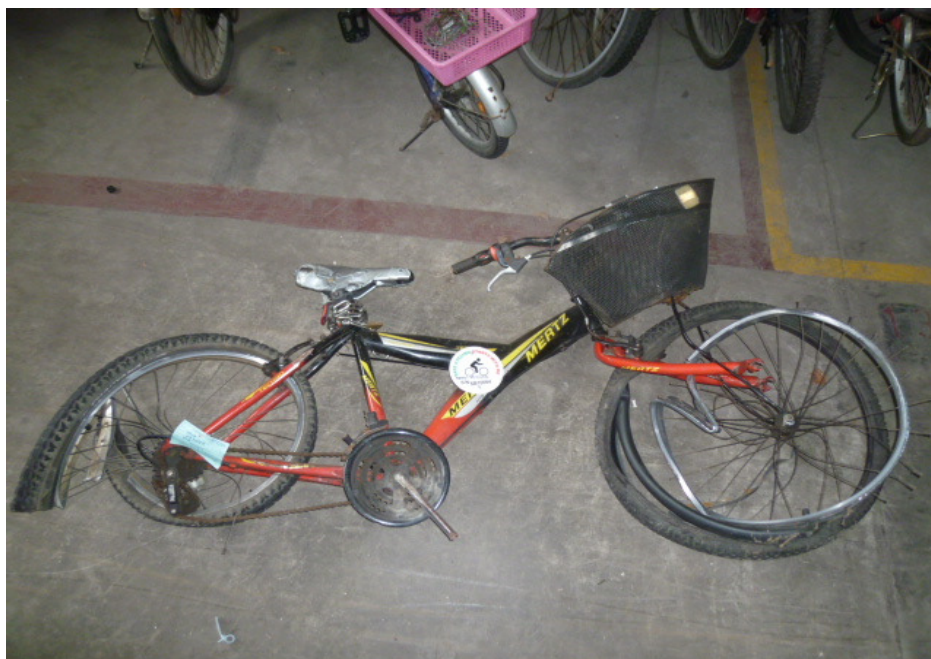
Photo 2 shows the right body of the Bicycle at time of our inspection. The Bicycle had sustained damages all around. The body parts that were found to have been damaged include its front basket, rear sub frame, pedals, braking components, gear train and rack, amongst others as a result of the accident.

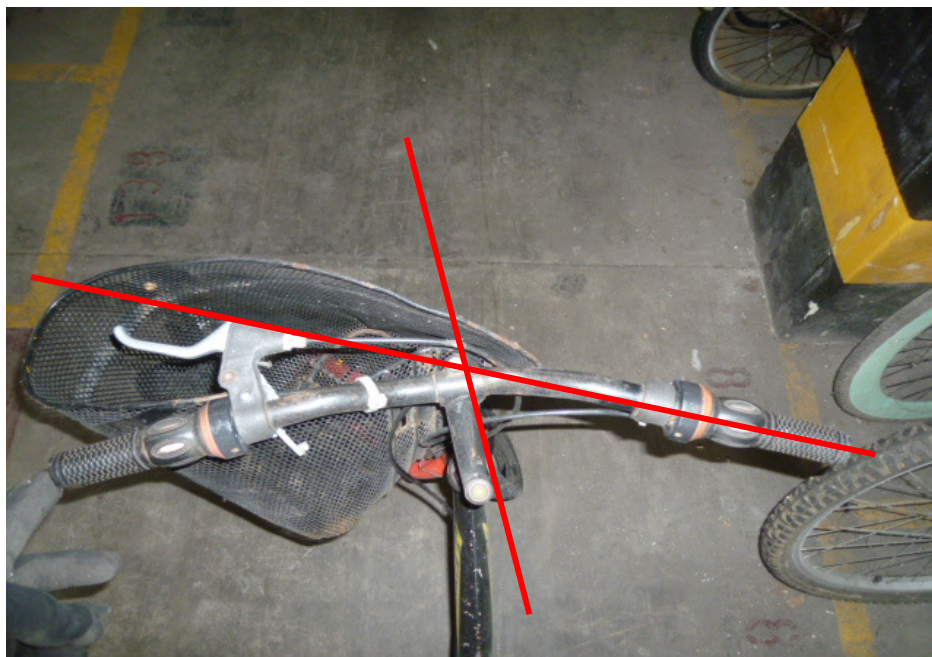
Photo 3 shows the frontal portion of the Bicycle (top view) at the time of our inspection. A misalignment of the handle bar & front tyre was observed.

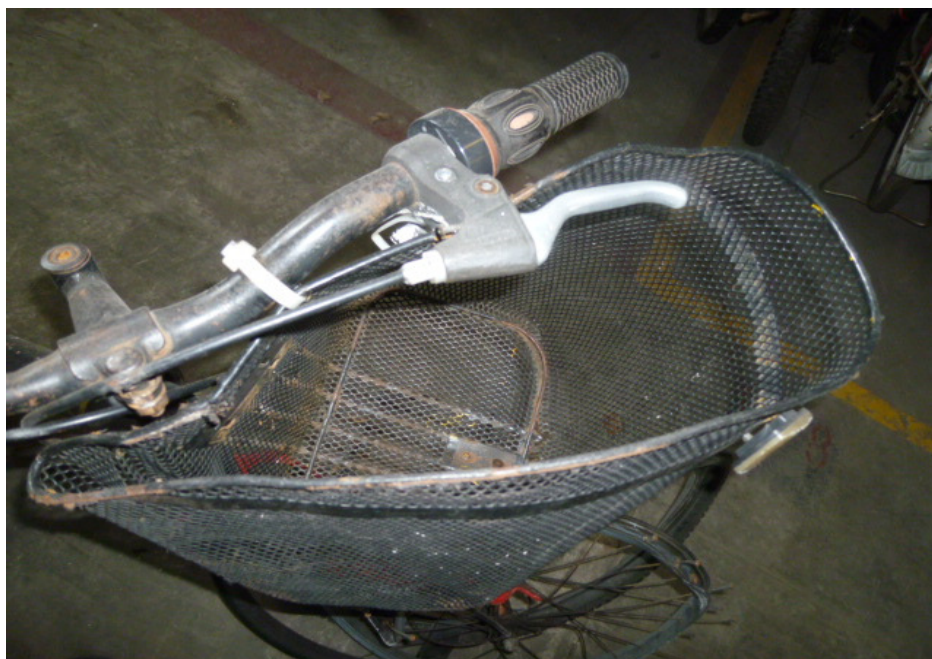
Photo 4 shows the damaged front basket of the Bicycle at the time of our inspection.

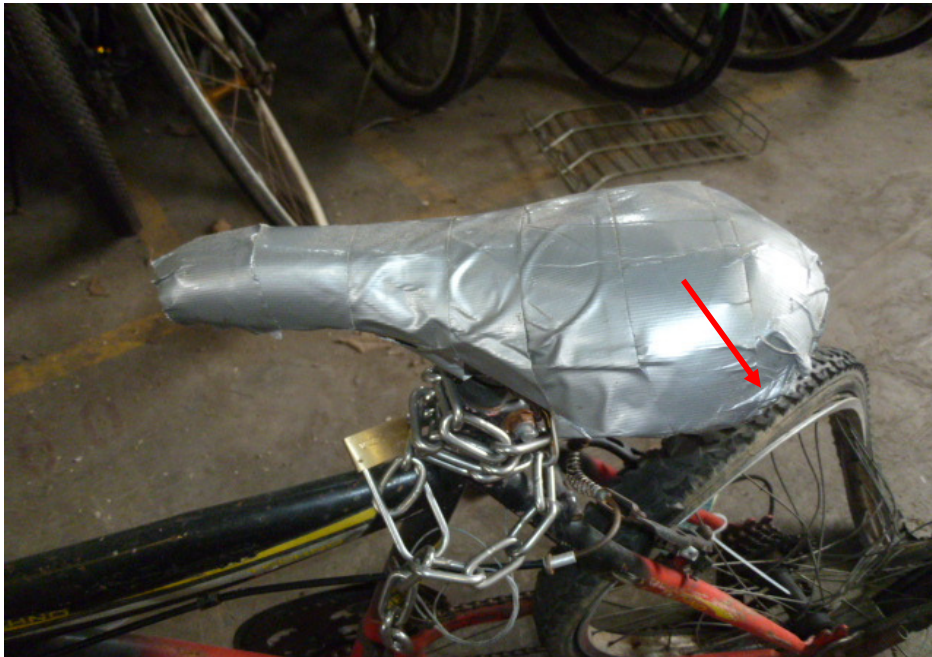
Photo 5 shows the grazed seat of the Bicycle at the time of our inspection (arrowed).

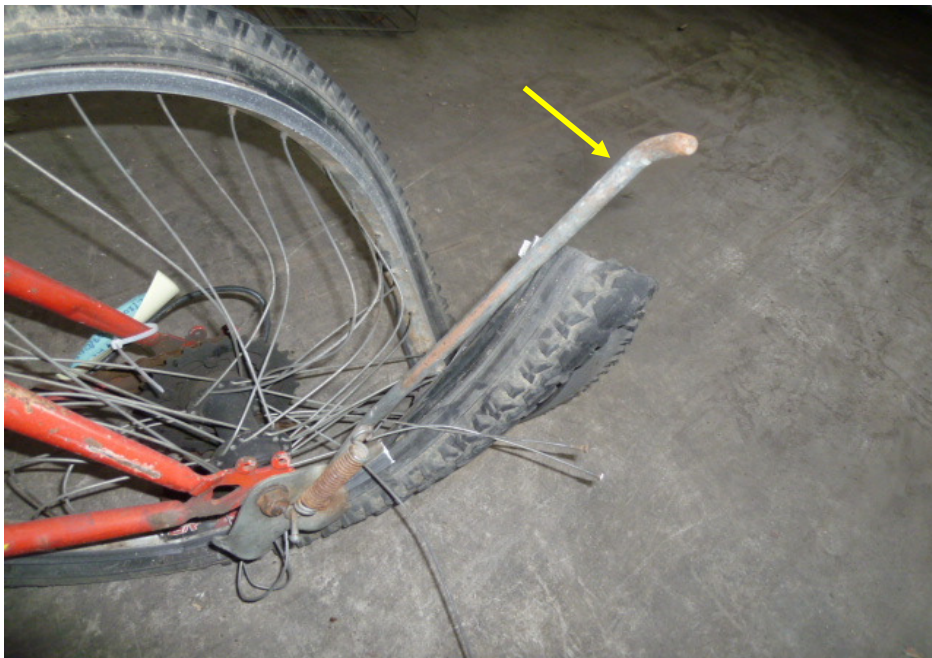
Photo 6 shows a close-up view of the bent side stand of the Bicycle due to the accident (arrowed).

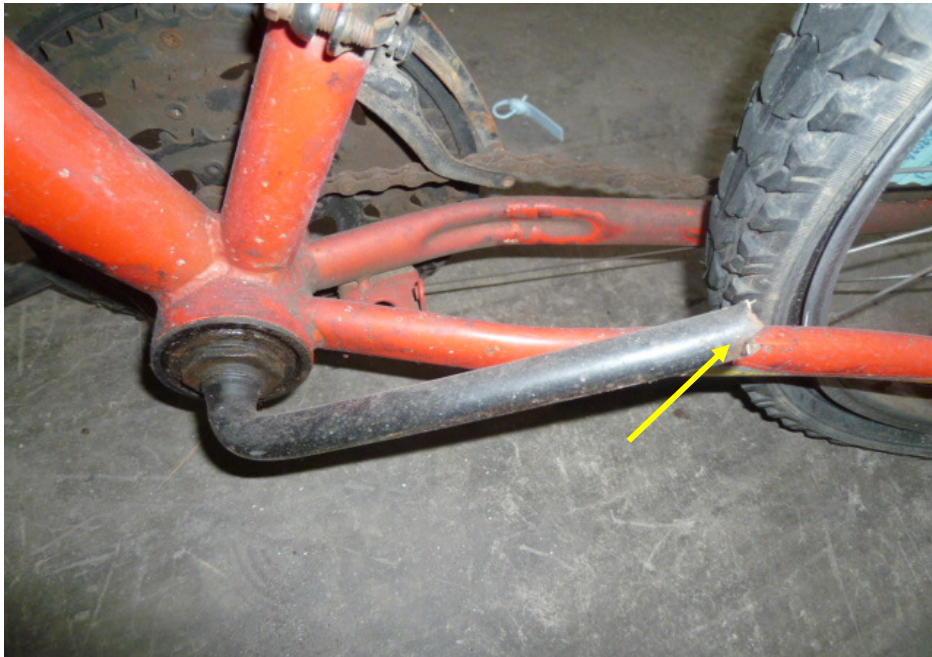
Photo 7 shows the broken left pedal of the Bicycle as a result of the accident (arrowed).

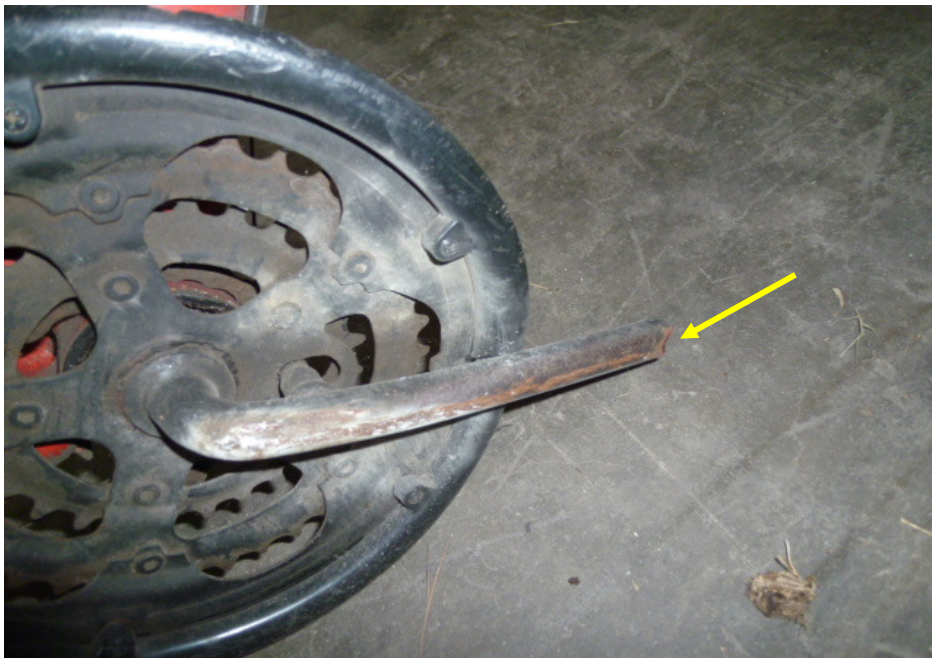
Photo 8 shows a close-up view of the broken right pedal of the Bicycle as a result of the accident (arrowed).

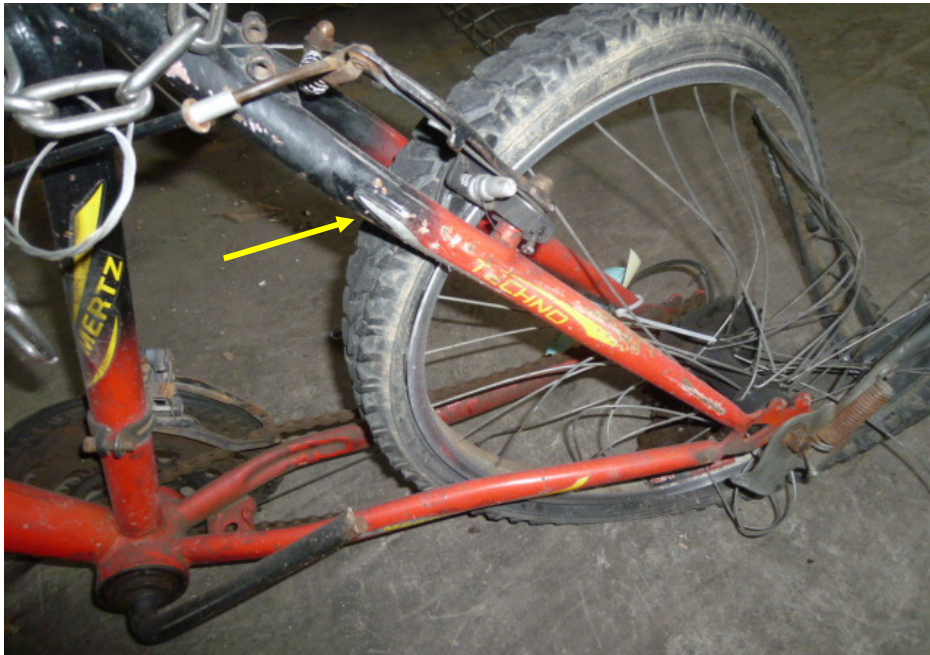
Photo 9 shows the grazed rear sub frame of the Bicycle as a result of the accident (arrowed).

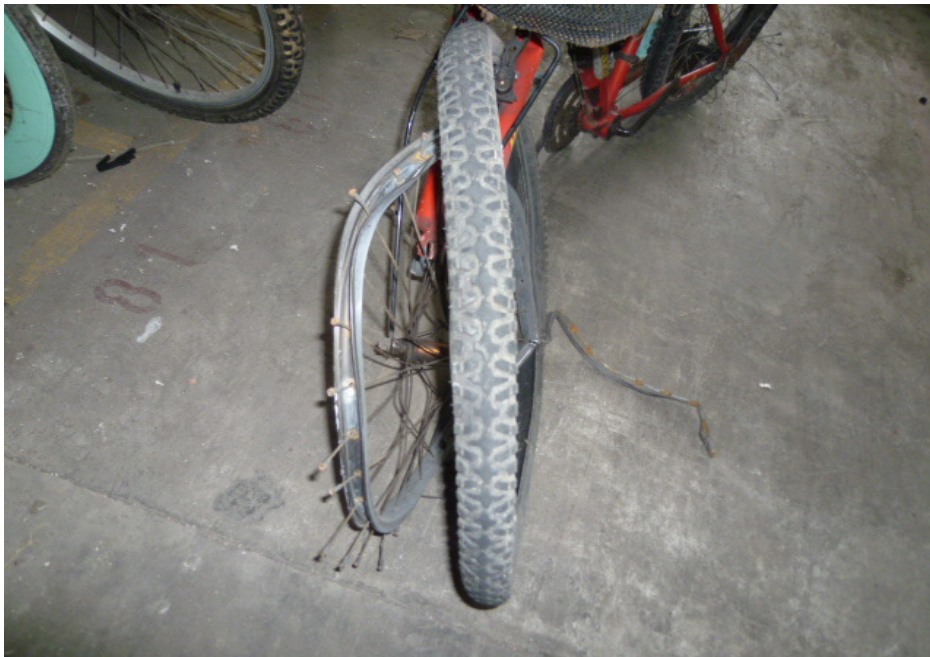
5. The condition of the Bicycle's front & rear tyres was observed to be in serviceable condition. The tread pattern of the 2 tyres was clearly visible. We did not observe any tear, burst mark(s) and/or punctured hole(s) on the sidewalls as well as across the tread of the 2 tyres. The front tyre was observed to be sufficiently inflated for vehicular operation. However the rear tyre was observed to be deflated as a result of the accident. The tyre brand, tyre size and remaining tread depth of the 2 tyres were recorded as follows:-

Photo 10 shows the deflated front tyre of the Bicycle most likely as a result of the accident. The pattern of the tread was clearly visible. There was no tear, burst mark(s) and/or punctured hole(s) on the sidewalls as well as across the tread of the front tyre.

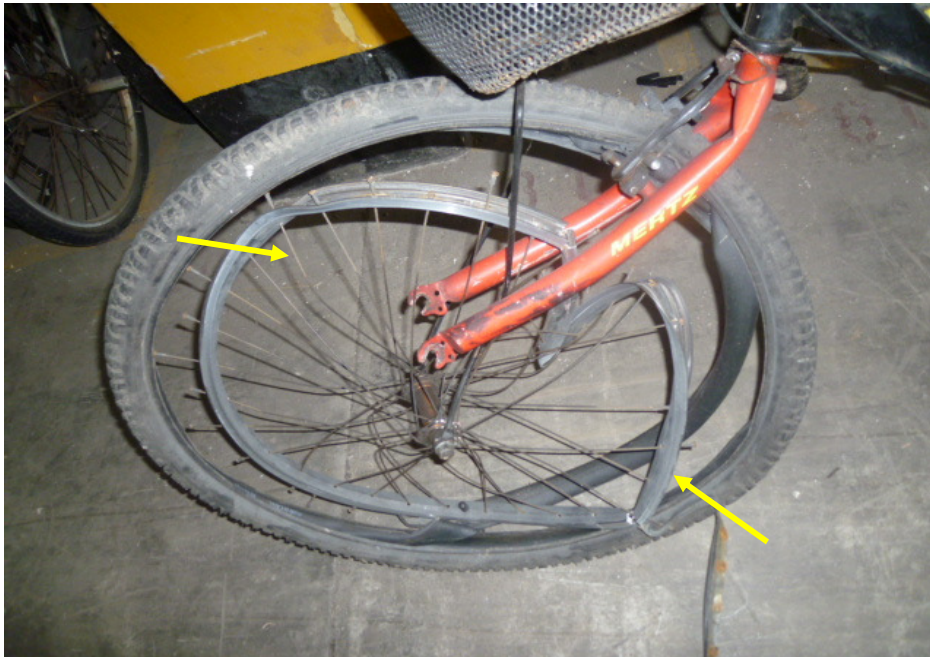
Photo 11 shows the bent spokes and bent front wheel rim of the Bicycle at the time of our inspection (arrowed).

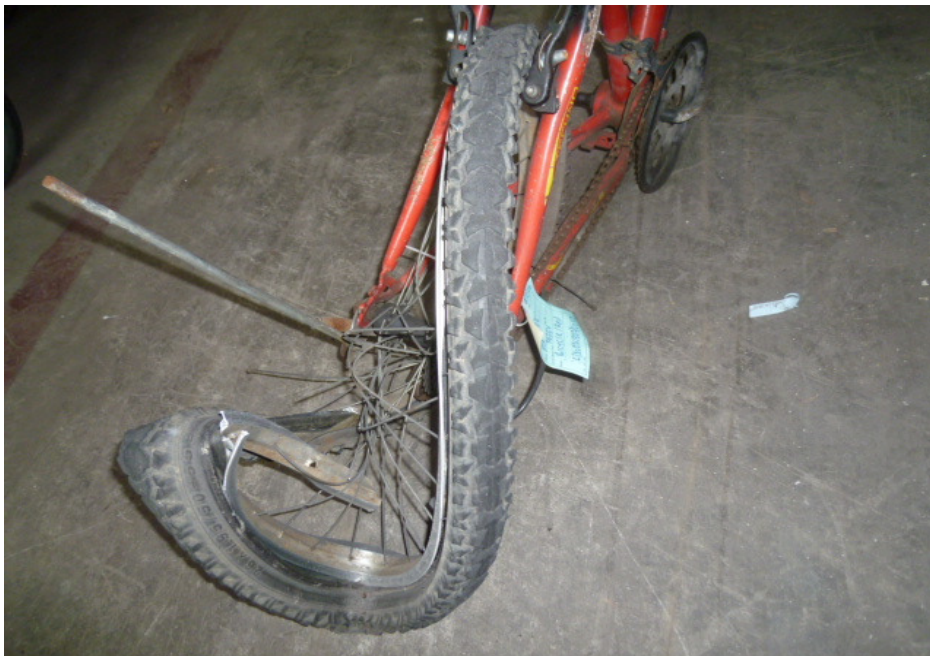
Photo 12 shows the deflated rear tyre of the Bicycle most likely as a result of the accident. The pattern of the tread was clearly visible. There was no tear, burst mark(s) and/or punctured hole(s) on the sidewalls as well as across the tread of the rear tyre.

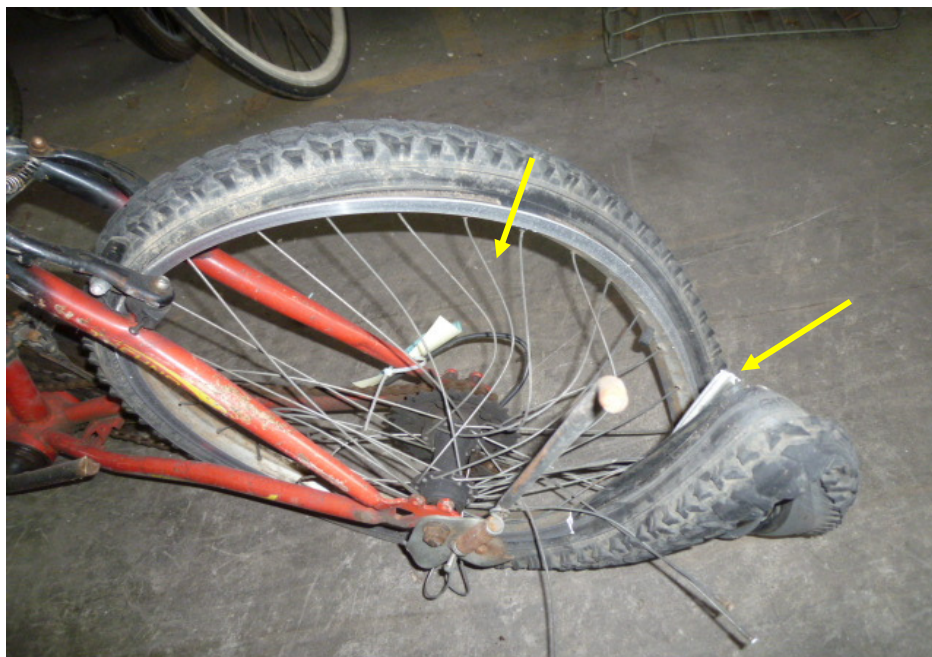
6. Both tyres were wrapped around alloy spoke wheel rims. At the time of our inspection, we did not observe any visible damage on the front wheel rim of the Bicycle. However we did observe that the rear wheel rim was bent and the spokes on the rear wheel rim were bent as a result of the accident. See photos 10 - 13 below.

Photo 13 shows the bent spokes and bent rear wheel rim of the Bicycle at the time of our inspection (arrowed).

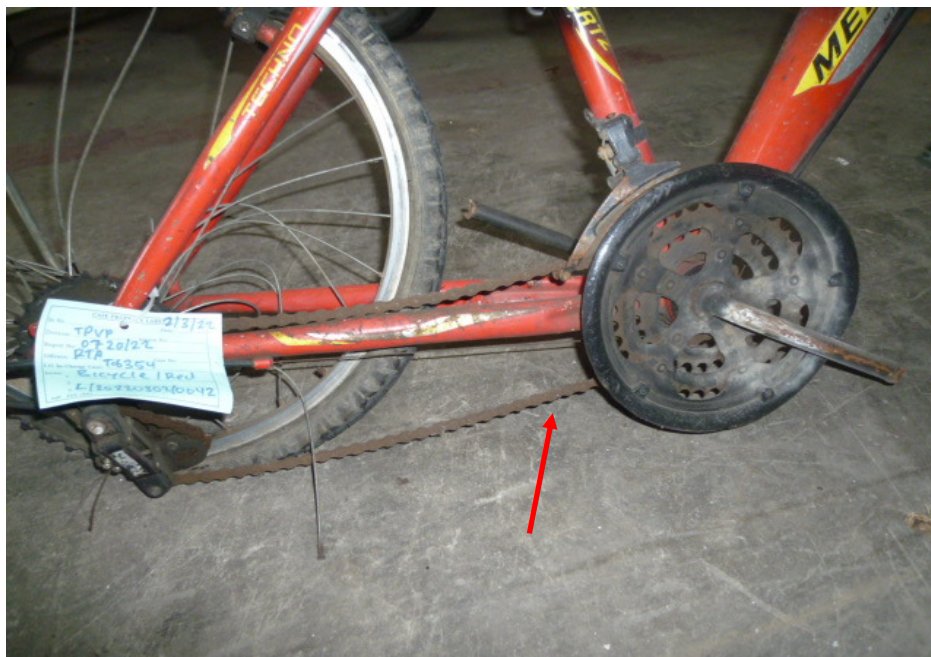
7. The gear train of the Bicycle was found to be severely damaged as a result of the accident. The chain was also observed to be dislodged from the gear train most likely as a result of the accident. No free play tension test can be conducted due to the extensive damages. See photos 14 & 15 below.

Photo 14 shows the general view of the gear train of the Bicycle which was found to be severely damaged as a result of the accident. The chain was also observed to be dislodged from the gear train most likely as a result of the accident (arrowed).

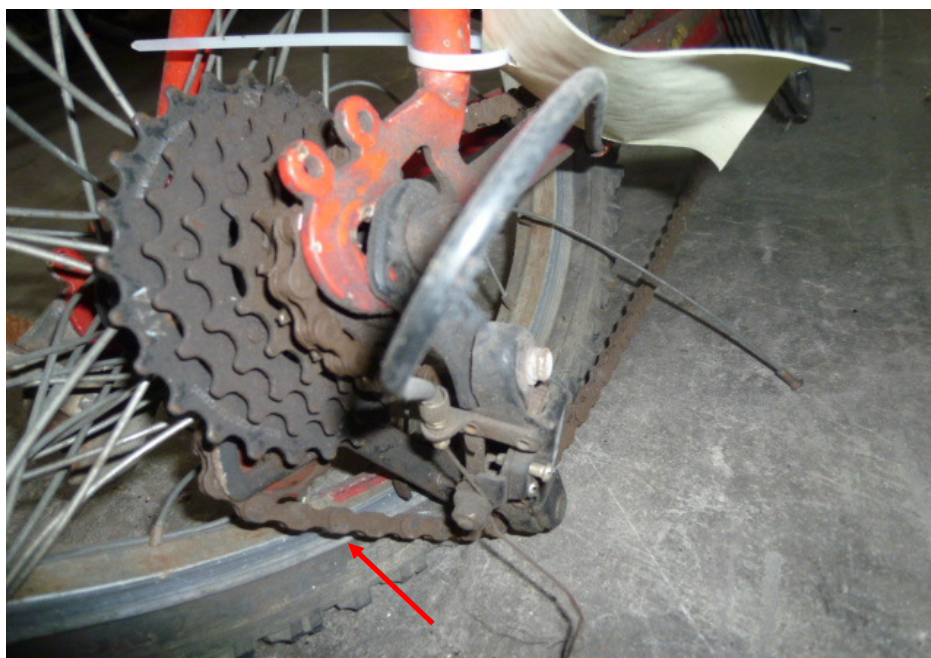
Photo 15 shows a close up view of the gear train of the Bicycle, which was observed to have sustained severe damages as a result of the accident (arrowed). No free play tension test can be conducted due to the extensive damages.

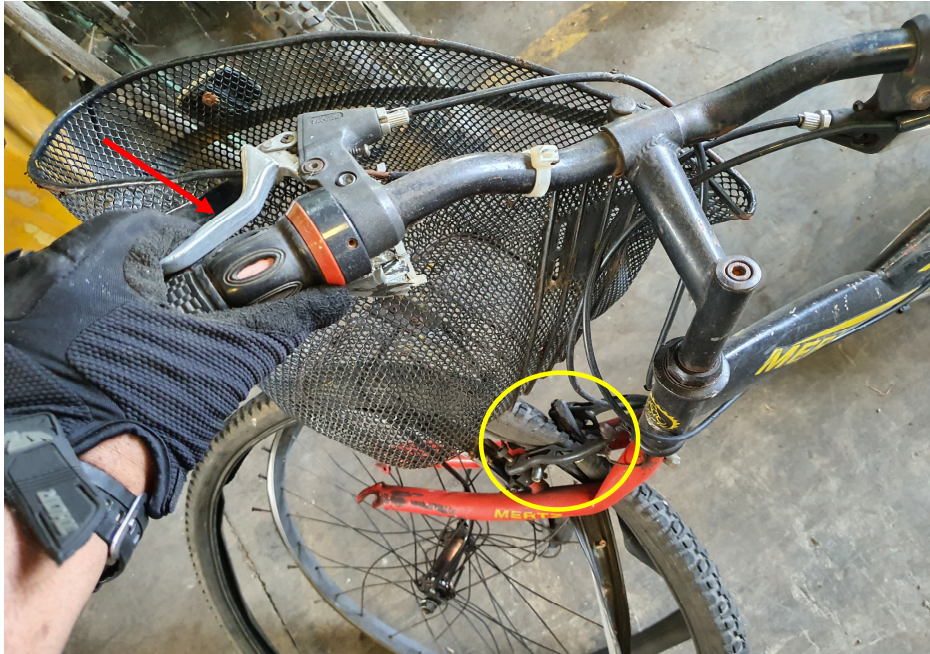
10. A static brake test was conducted on the front brake of the Bicycle. There was some resistance felt upon pressing the left hand brake lever. This was further confirmed by looking at the front brake clamps while we pressed the left hand brake lever. It shows that the front brake clamps responded to the gripping action. However due to the misalignment of the front brake clamp assembly as a result of the accident, the rubber brake blocks pressed against the front tyre instead of the front wheel rim.

Photo 16 shows a static brake test conducted on the Bicycle's front brake. There was some resistance felt upon pressing the left hand brake lever (arrowed). It also shows that the front brake clamps responded to the gripping action (circled) after depressing the left hand brake lever.

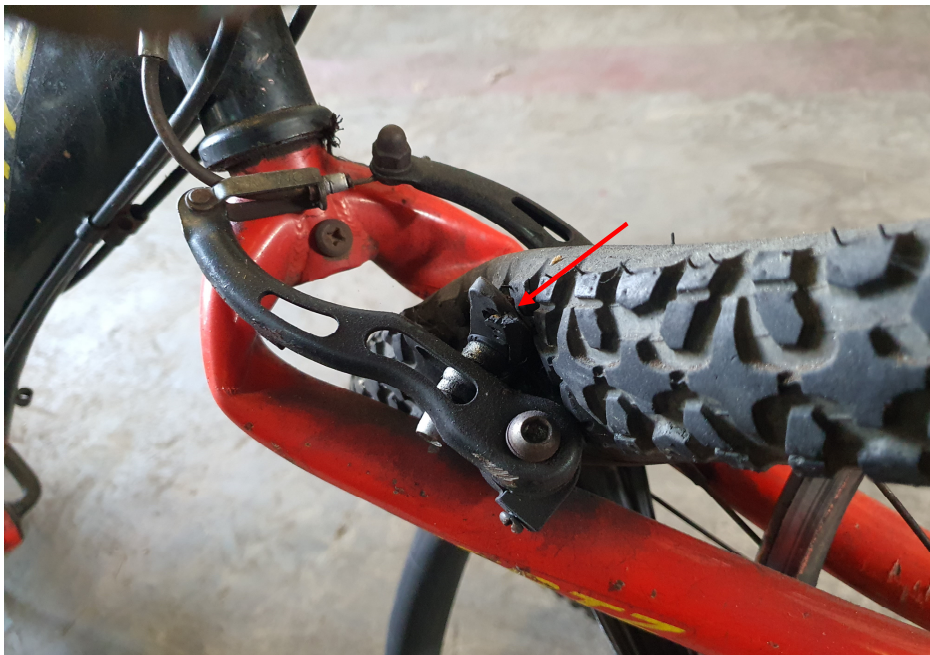
Photo 17 shows a close up view of the front brake clamps responding to the gripping action. The rubber brake blocks pressed against the front wheel rim upon depressing the left hand brake lever. However due to the misalignment of

the front brake clamp assembly as a result of the accident, the rubber brake blocks pressed against the front tyre instead of the front wheel rim (arrowed).

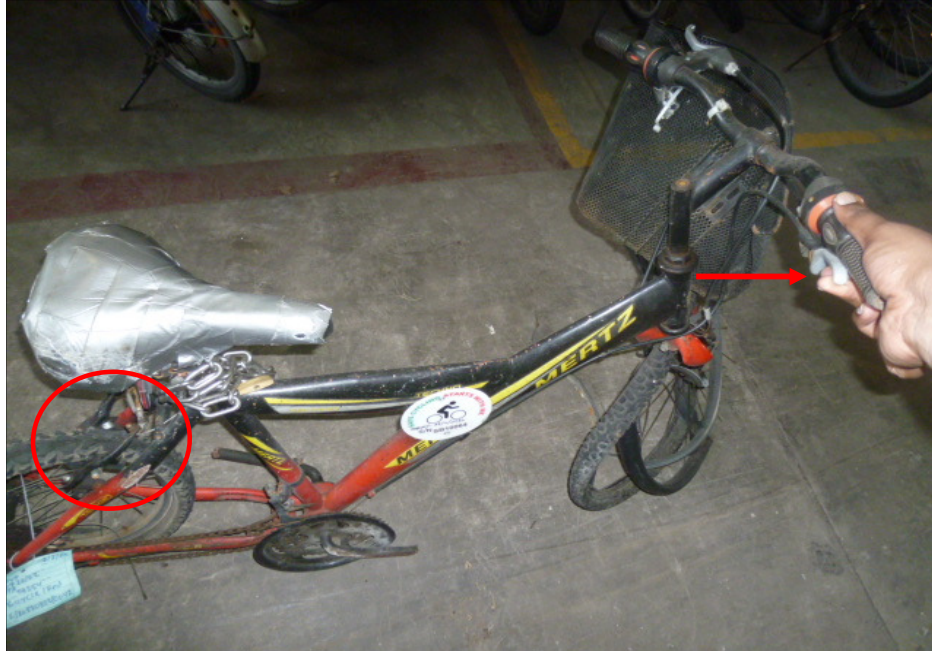
11. A static brake test was conducted on the rear brake of the Bicycle. There was some resistance felt upon pressing the right hand brake lever. This was further confirmed by looking at the rear brake clamps while we pressed the right hand brake lever. It shows that the rear brake clamps responded to the gripping action. However due to the misalignment of the rear brake clamp assembly as a result of the accident, the rubber brake blocks pressed against the rear tyre instead of the rear wheel rim.

Photo 18 shows a static brake test conducted on the Bicycle's rear brake. There was some resistance felt upon pressing the right hand brake lever (arrowed). It also shows that the rear brake clamps responded to the gripping action (circled) after depressing the right hand brake lever.

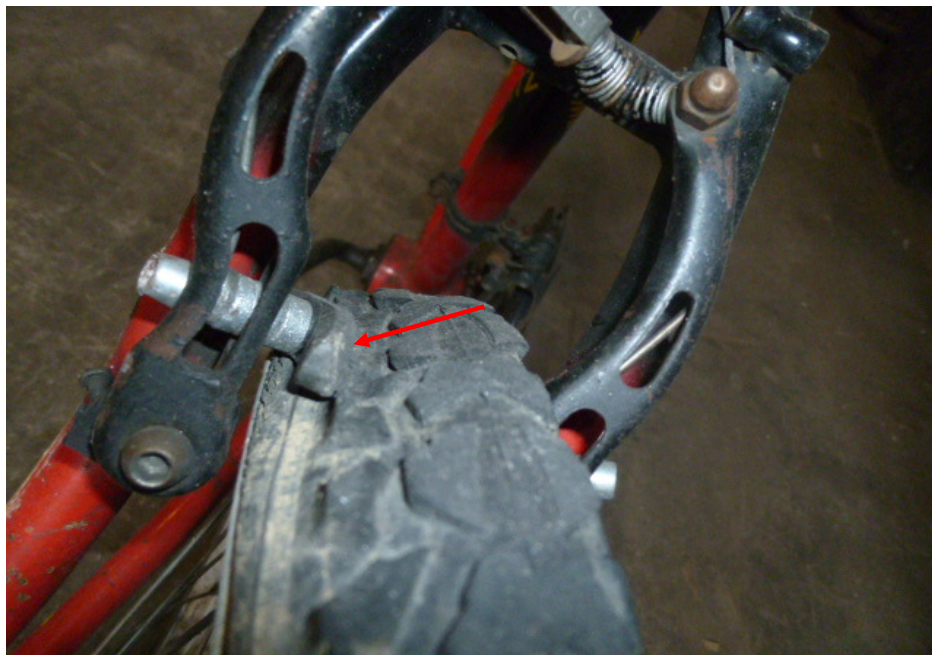
Photo 19 shows a close up view of the rear brake clamps responding to the gripping action. The rubber brake blocks pressed against the rear wheel rim upon depressing the right hand brake lever. However due to the misalignment of the

rear brake clamp assembly as a result of the accident, the rubber brake blocks pressed against the rear tyre instead of the rear wheel rim (arrowed).
