Your Ref: TP/IP/02266/2022
Our Ref : CI/TPD22004871/N

Fatal Accident Investigation Team

INSPECTION REPORT OF MOTORCYCLE JSQ 1480

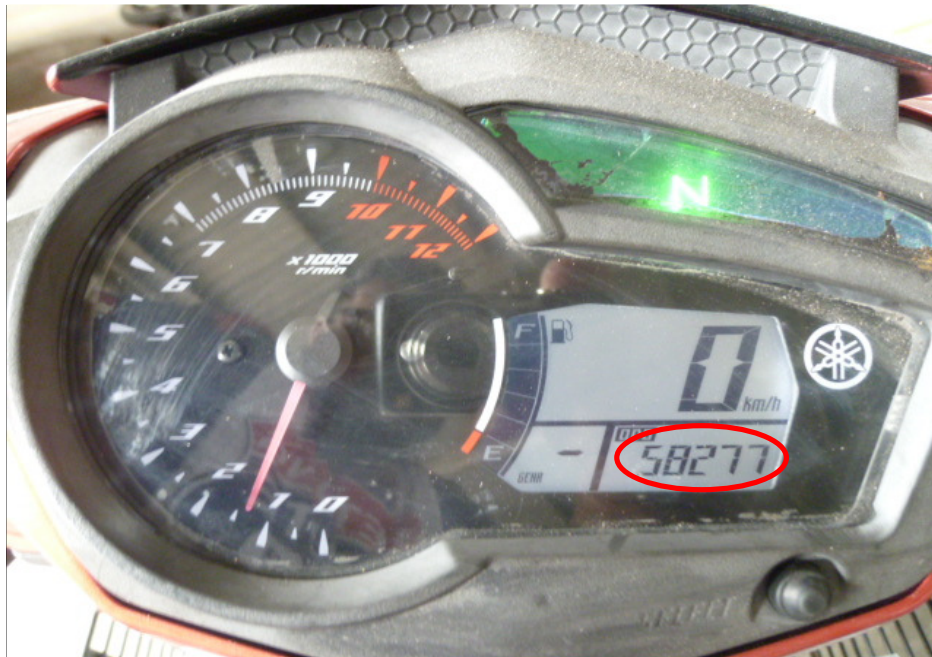
Photo 1 shows the speedometer gauge of the Motorcycle. The mileage of the Motorcycle at the time of our inspection was 58, 277km (circled).

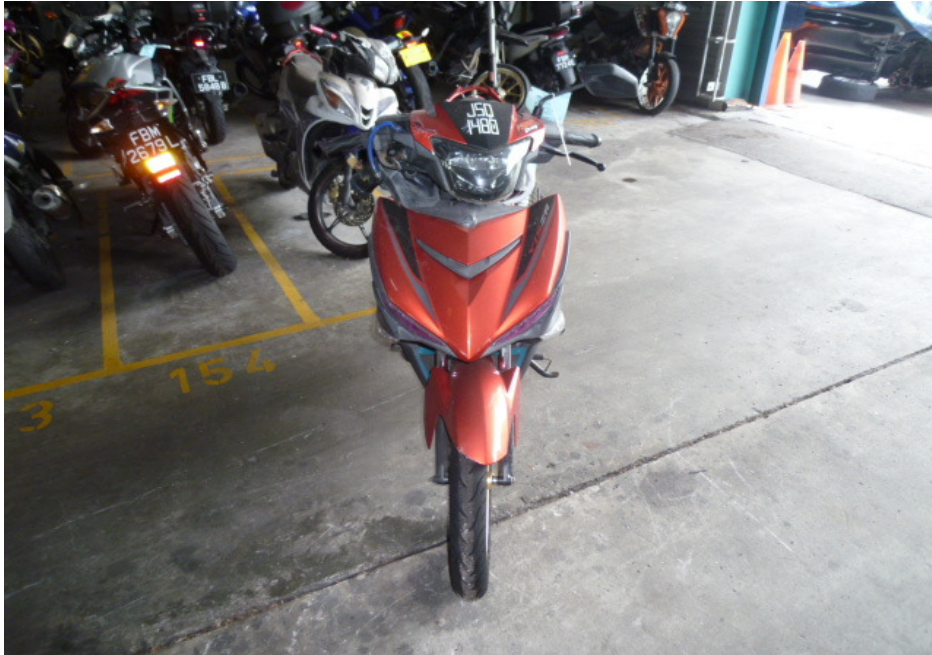
Photo 2 shows a general view of the frontal portion of the Motorcycle at the time of our inspection. The Motorcycle was observed to have sustained damages all around.

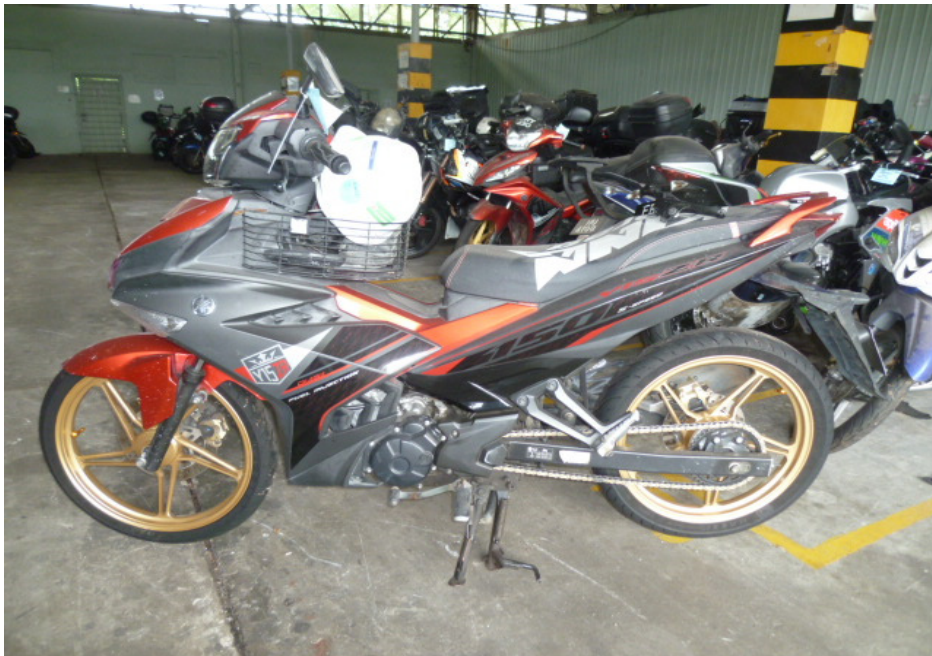
Photo 3 shows a general view of the left body of the Motorcycle at the time of our inspection. The Motorcycle was observed to have sustained damages all around.

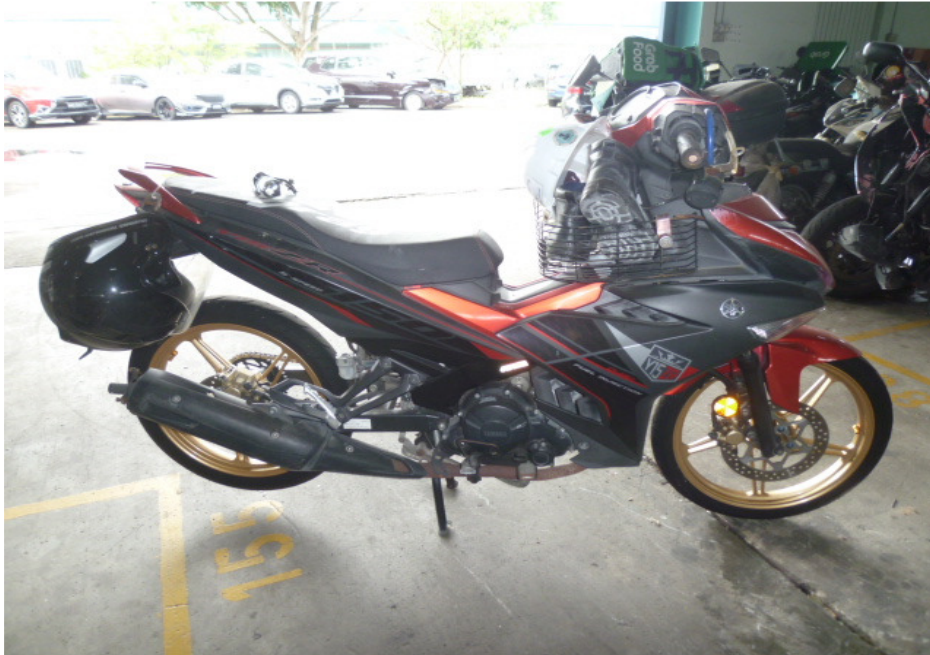
Photo 4 shows a general view of the right body of the Motorcycle at the time of our inspection. The Motorcycle was observed to have sustained damages all around. The body parts that were found to have been damaged include its front fork assembly, head cowling, front cowling, front mudguard, right cowling, right side mirror, front brake lever, rear brake pedal, right front footrest, rear side covers, exhaust muffler heat shield and left pillion footpeg

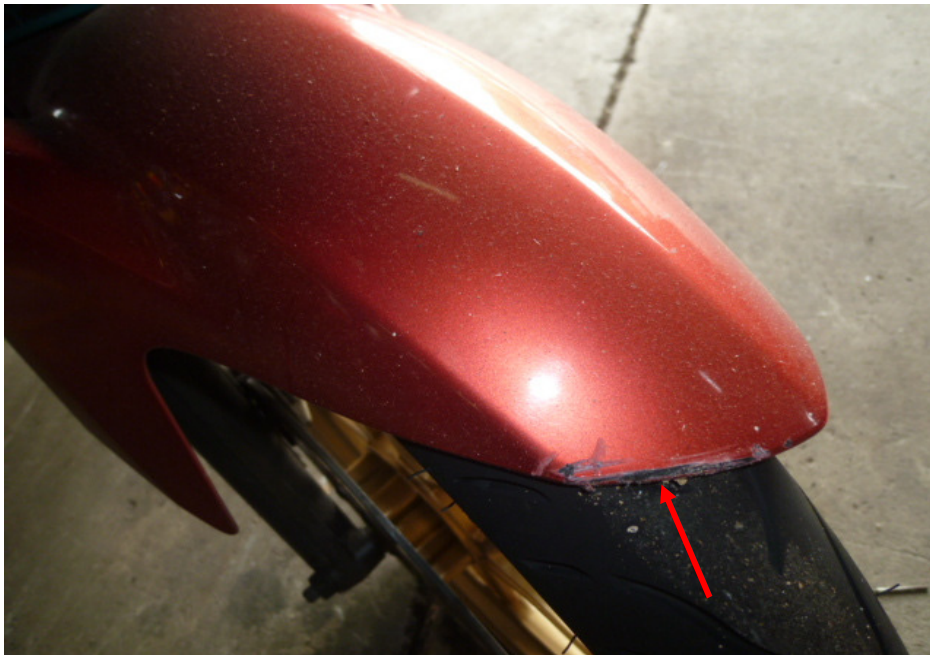
Photo 5 shows a closer view of the front mudguard (arrowed) which was amongst the body parts of the Motorcycle that had sustained damage as a result of the accident.

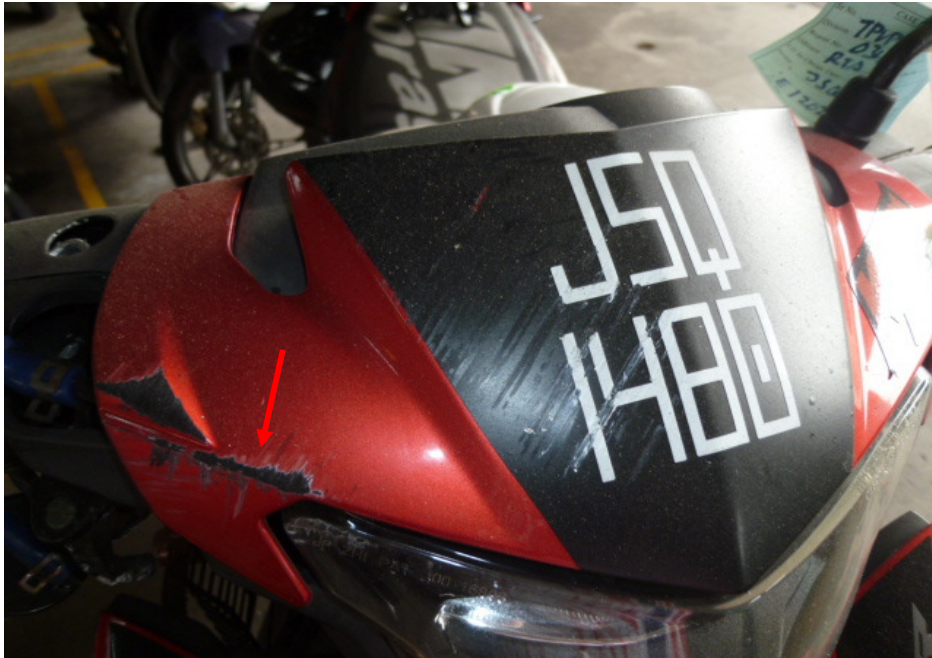
Photo 6 shows the grazed head cowling (arrowed) which was amongst the body parts of the Motorcycle that had sustained damage as a result of the accident.

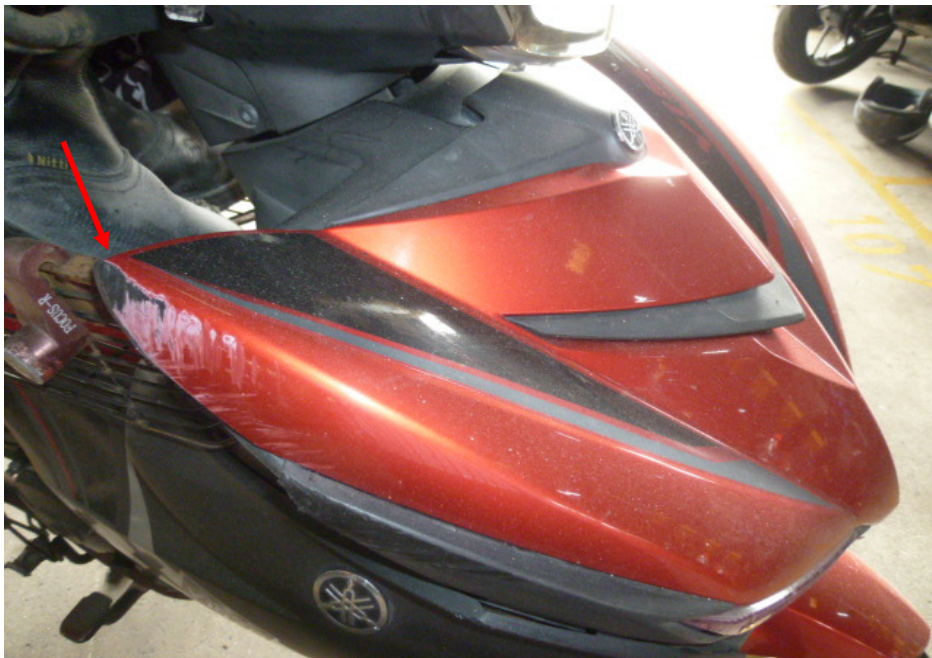
Photo 7 shows a closer view of the grazed front cowling (arrowed) of the Motorcycle as a result of the accident.

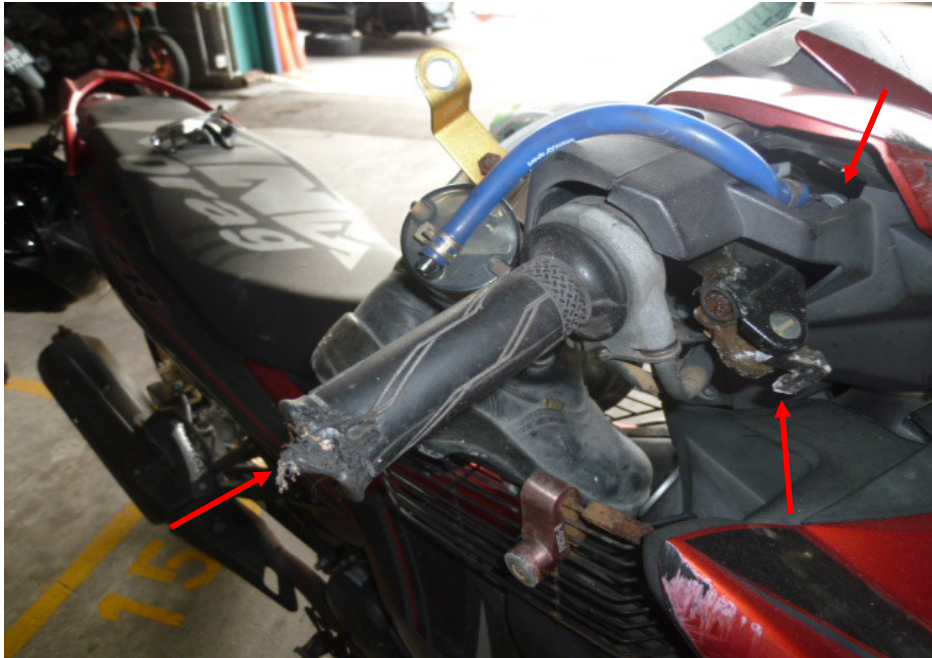
Photo 8 shows the right handlebar end, front brake lever and right side mirror (arrowed), which were amongst the body parts of the Motorcycle that had sustained damage as a result of the accident.

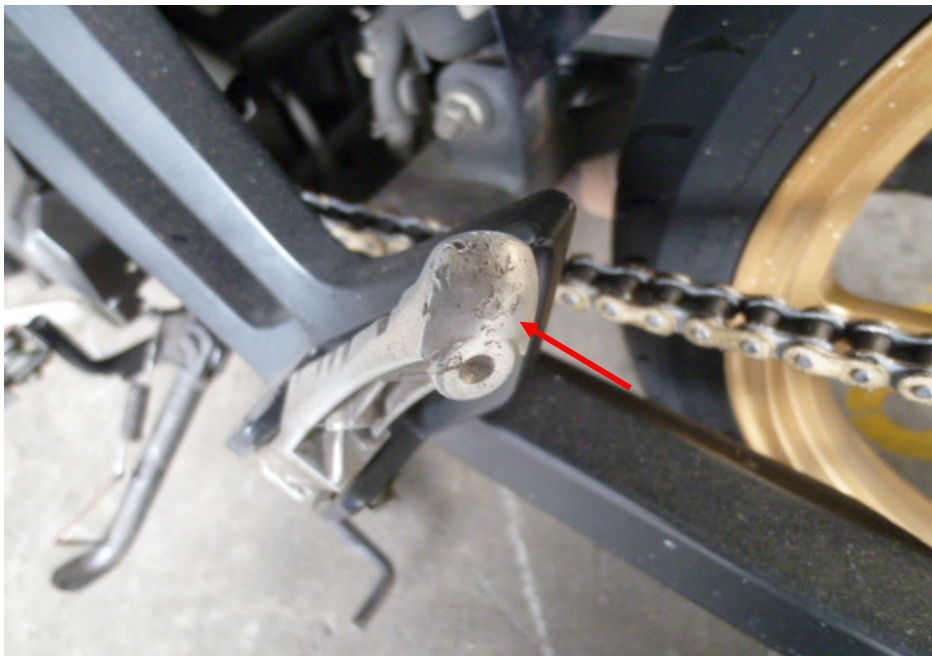
Photo 9 shows a closer view of the grazed left pillion footpeg of the Motorcycle as a result of the accident (arrowed).

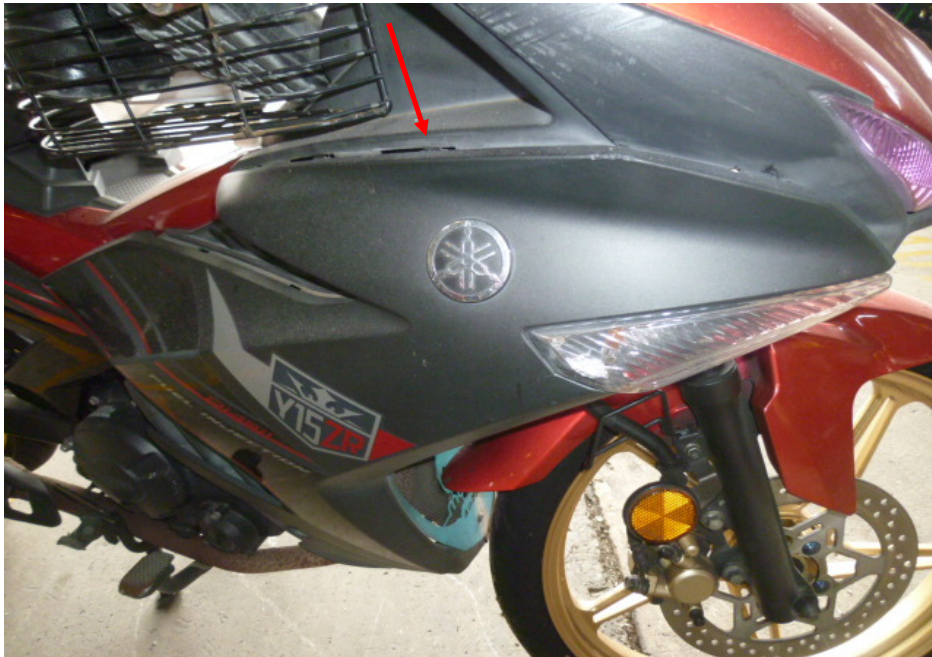
Photo 10 shows a closer view of the deformed right cowling of the Motorcycle as a result of the accident (arrowed).

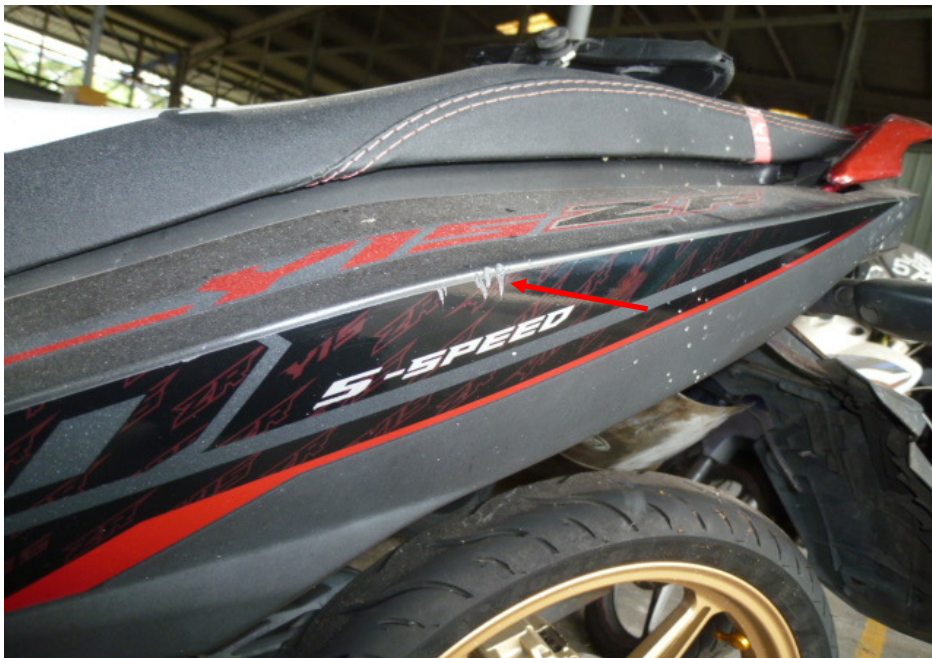
Photo 11 shows a closer view of the grazed left rear side cover of the Motorcycle as a result of the accident (arrowed).

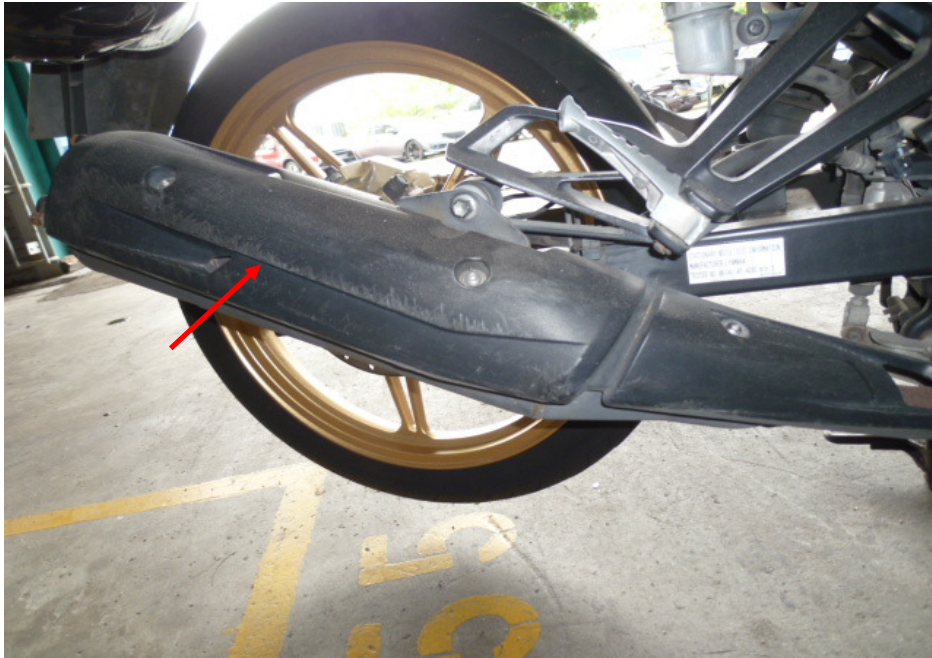
Photo 12 shows a closer view of the grazed exhaust muffler heat shield (arrowed) of the Motorcycle as a result of the accident.

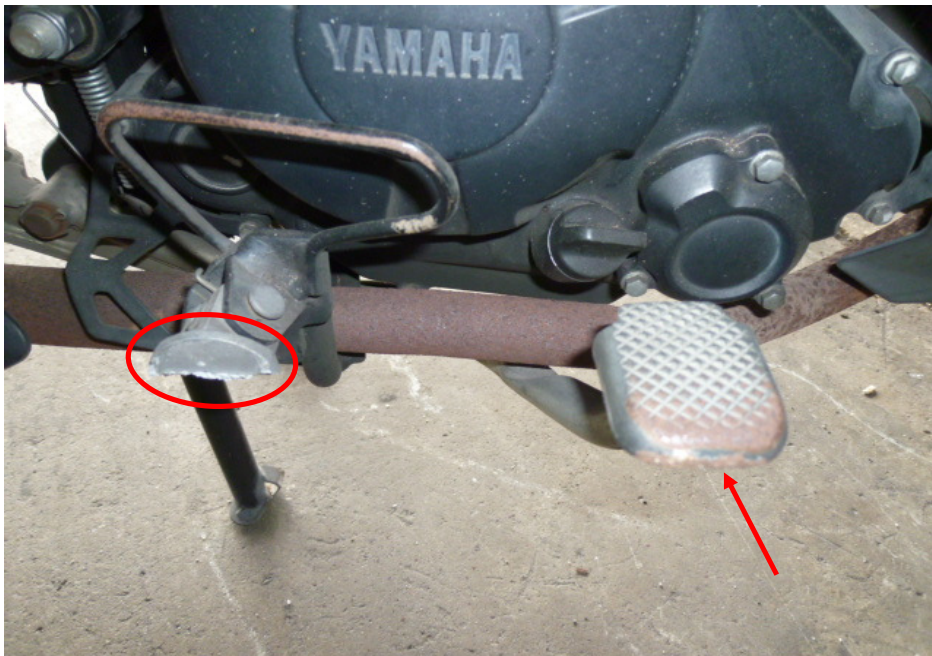
Photo 13 shows the rear brake pedal (arrowed) and broken right front footrest (circled) of the Motorcycle that had sustained damage as a result of the accident.

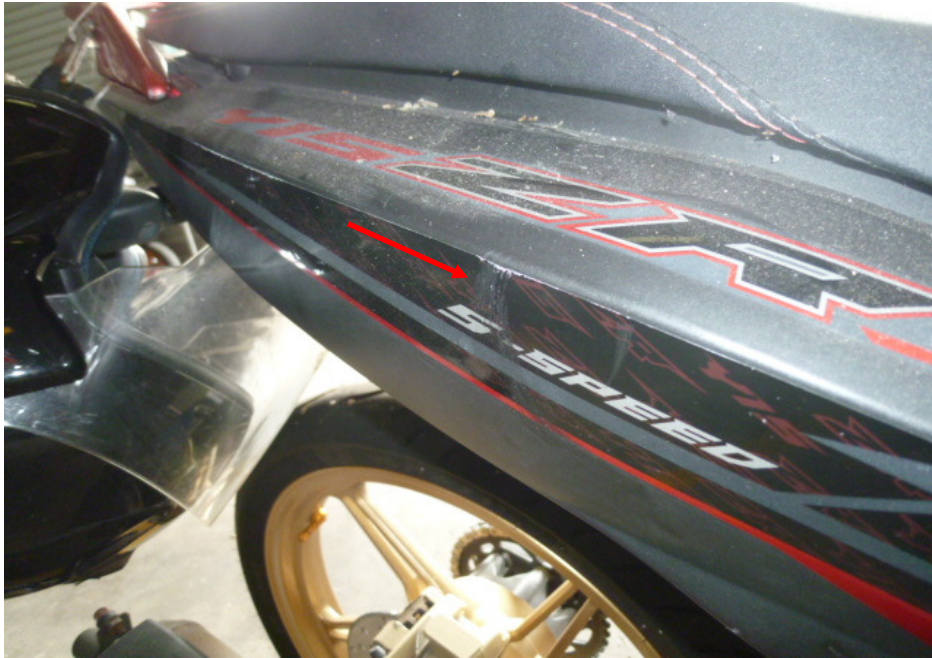
Photo 14 shows the grazed right rear side cover of the Motorcycle as a result of the accident (arrowed).

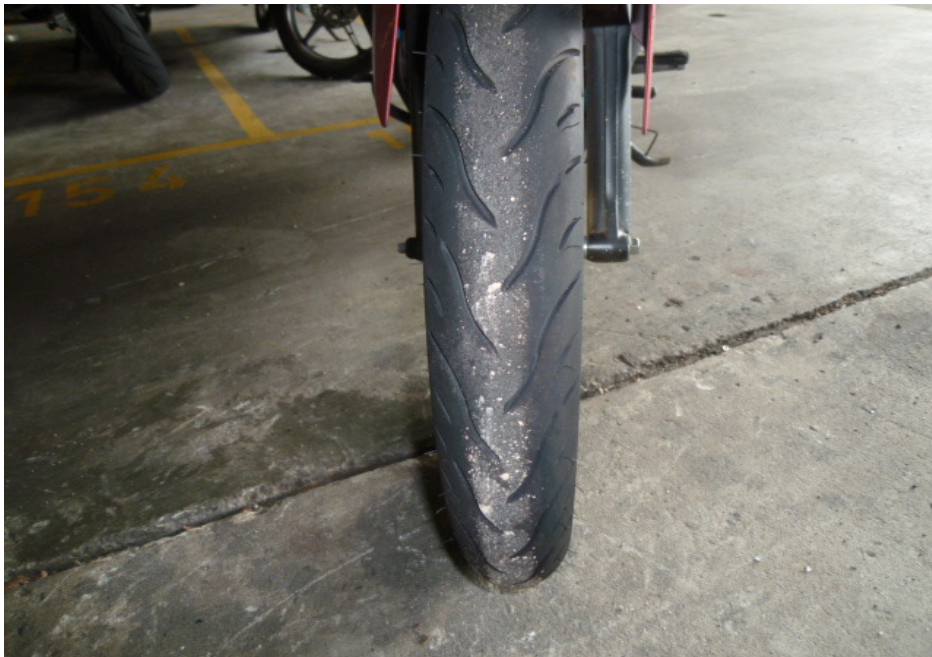
Photo 15 shows the front tyre of the Motorcycle at the time of our inspection. The front tyre was observed to be in serviceable condition with remaining tread depth of approximately 4mm. The pattern of the tread was also clearly visible. There was no tear, burst mark(s) and/or punctured hole(s) on the sidewalls as well as across the tread of the front tyre.

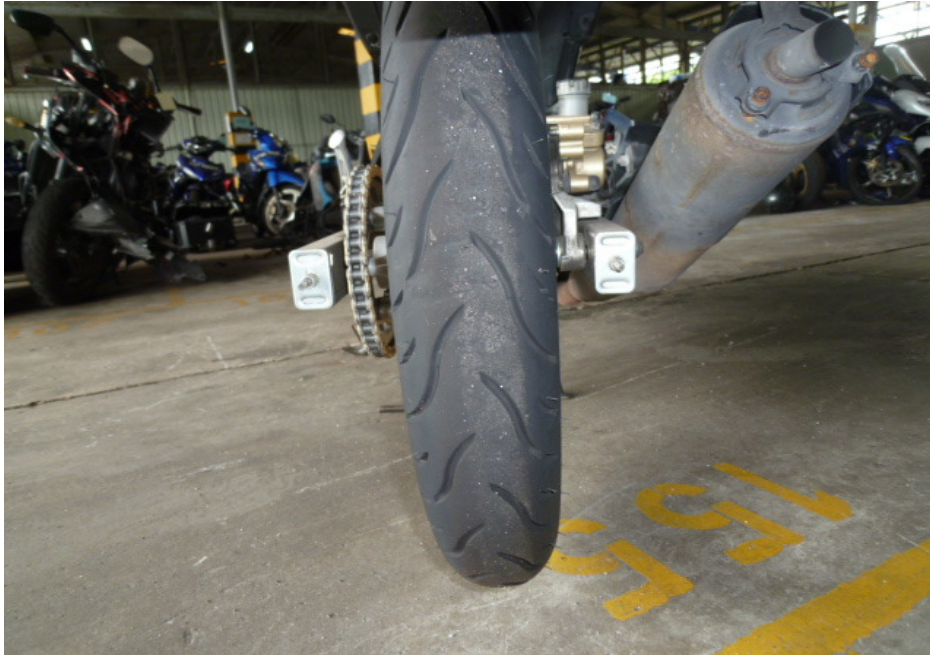
Photo 16 shows the condition of the Motorcycle's rear tyre. The rear tyre was observed to be in serviceable condition with remaining tread depth of approximately 5mm. The tyre was also observed to be sufficiently inflated for vehicular operation. We did not observe any tear, burst mark(s) and/or punctured hole(s) on the sidewalls as well as across the tread of the rear tyre.

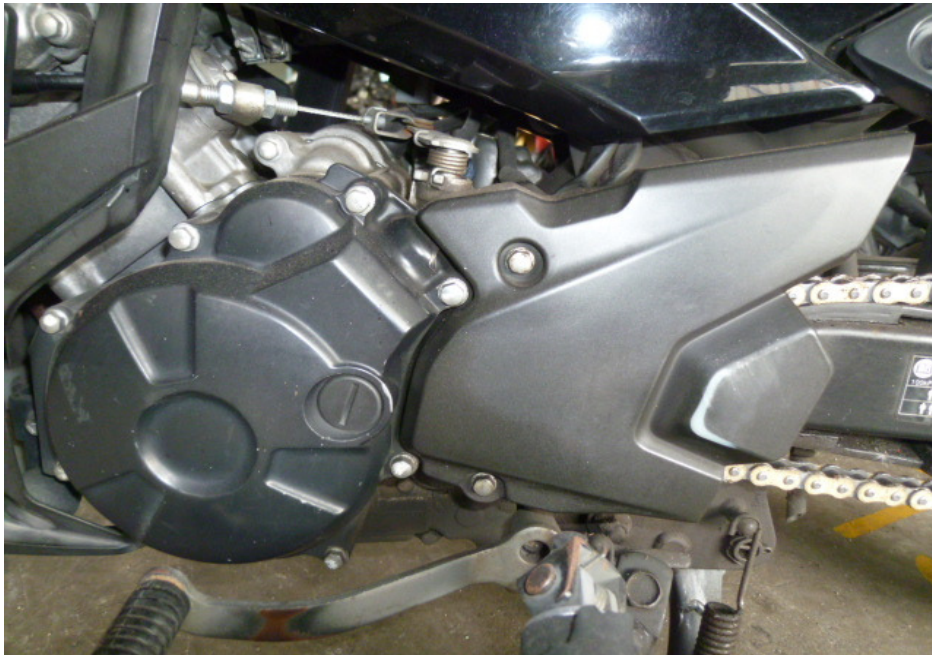
Photo 17 shows the left side of the engine of the Motorcycle at the time of our inspection. The various engine related parts and components were found to be intact with no visible damage. There was also no sign(s) or indication(s) of fluid leak observed around the left engine area of the Motorcycle.

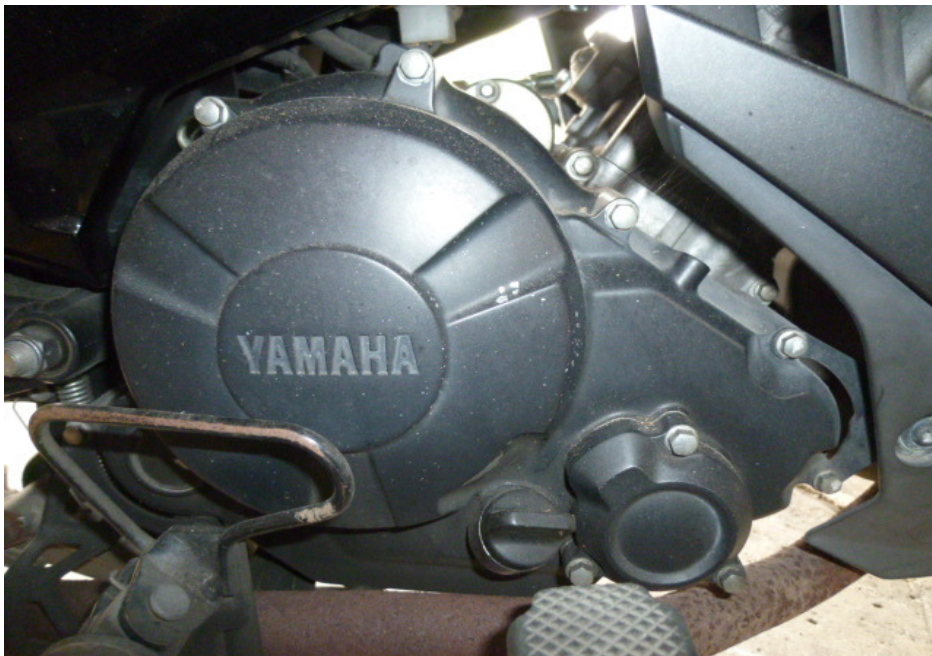
Photo 18 shows the right side of the engine of the Motorcycle at the time of our inspection. The various engine related parts and components were found to be intact with no visible damage. There was also no sign(s) or indication(s) of fluid leak observed around the right engine area of the Motorcycle.

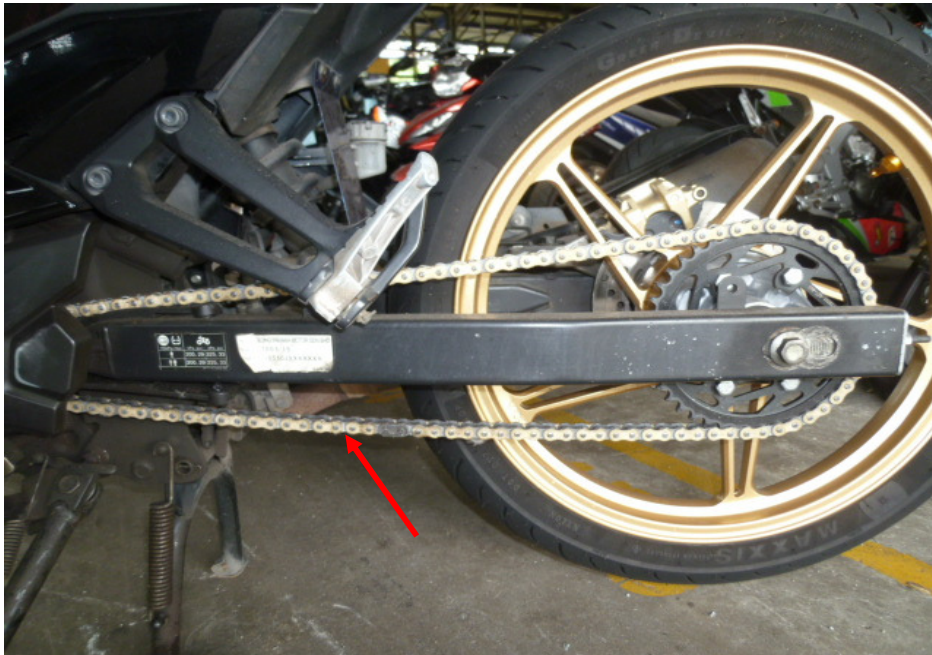
Photo 19 shows the general view of the gear train (arrowed) of the Motorcycle, which was observed to be intact with no misalignment. It was also adequately lubricated for operating purposes.

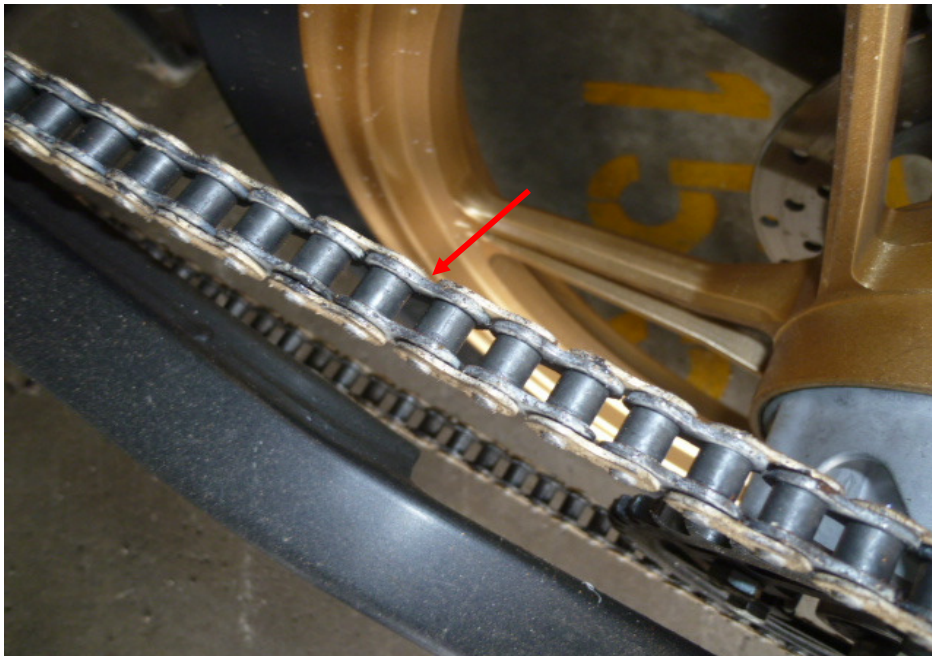
Photo 20 shows a closer view of the gear train (arrowed) of the Motorcycle, which was observed to be intact with no misalignment. It was also adequately lubricated for operating purposes.

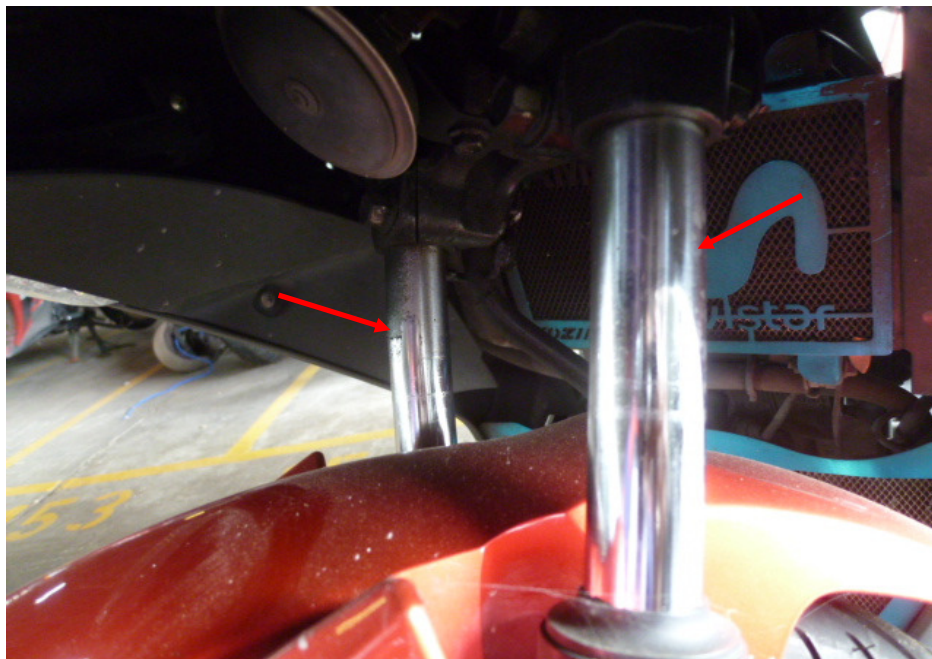
11. For this case, we were not able to conduct any test(s) on the steering system of the Motorcycle due to the damage of its front fork assembly. The front forks and were found to be bent as a result of the accident.

Photo 21 shows the front forks of the Motorcycle. The front forks were observed to be bent (arrowed) as a result of the accident. We were hence not able to conduct any tests on the steering system of the Motorcycle.

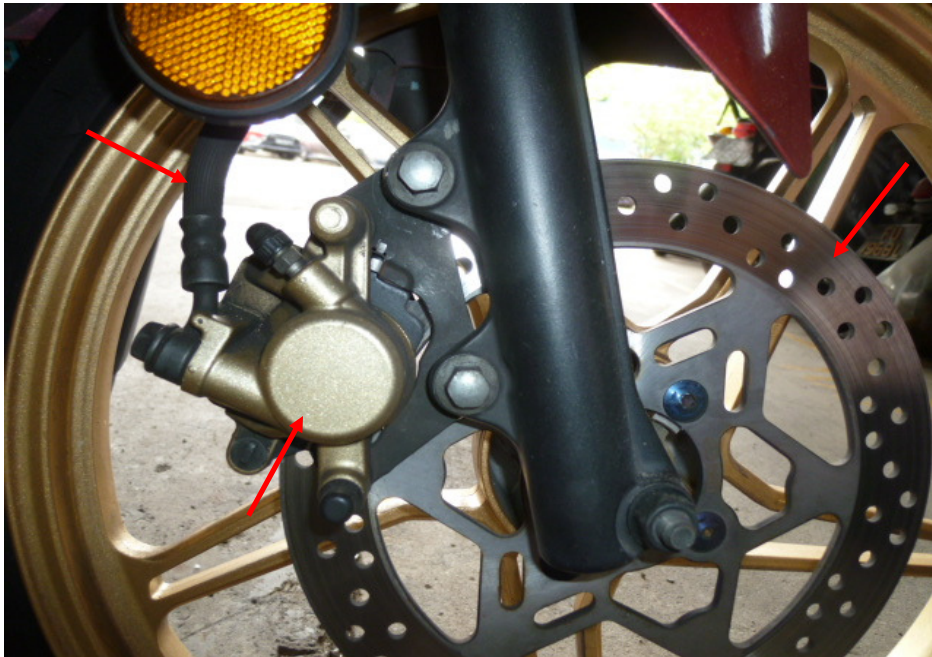
Photo 22 shows a close up view of the front brake caliper, front brake disc and front brake hose (arrowed) of the Motorcycle, which are all part of the components in the hydraulic front brake system of the Motorcycle. Our visual checks of these various components had revealed all to be intact with no visible damage. No leakage of brake fluid was also observed.

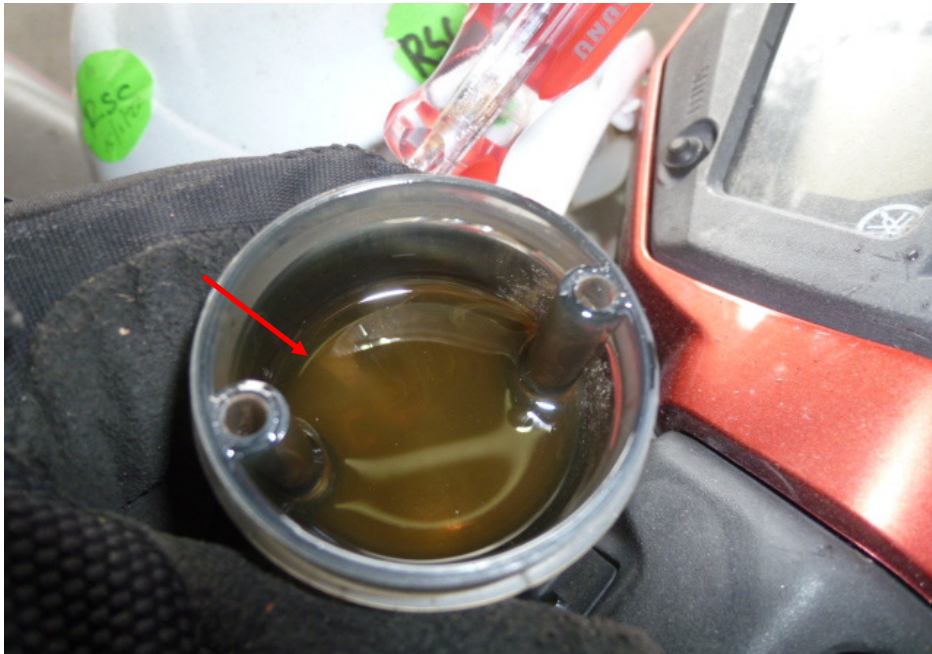
14. The brake fluid for the front brake and rear brake was observed to be of sufficient level for operational purposes. However the brake fluid for the front brake and rear brake was found to be slightly contaminated.

Photo 23 shows a close up view of the brake fluid reservoir for the front brake of the Motorcycle. The front brake fluid was observed to be of sufficient level for operational purposes. However it was found to be slightly contaminated (arrowed).

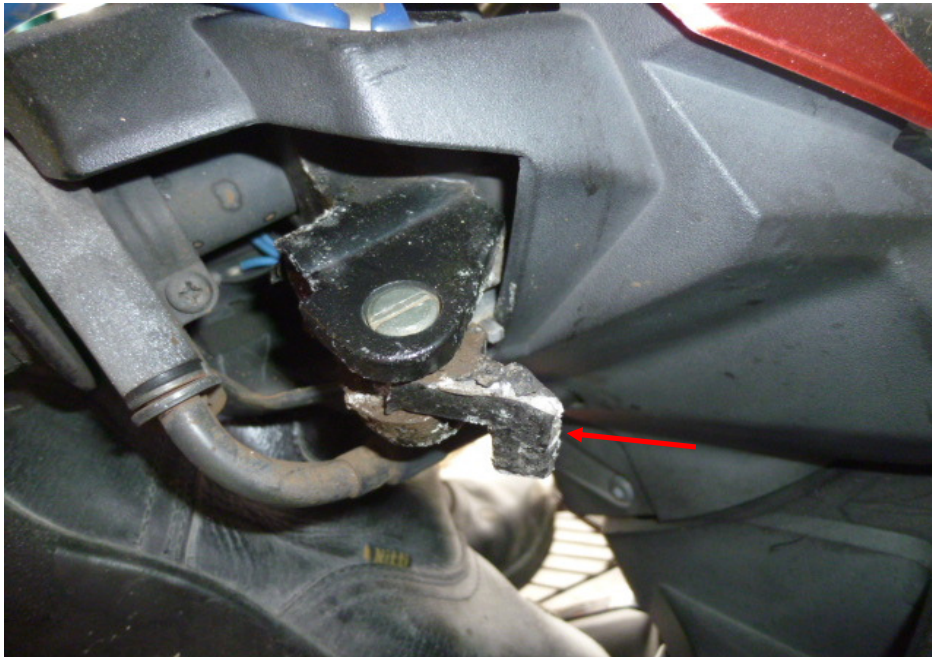
15. However we observed that part of the front brake lever had broken off as a result of the accident. Hence static as well as operational brake tests could not be conducted on the Motorcycle's front braking system. We were unable to determine if there was any leakage of pressure/vacuum in the front brake system.

Photo 24 shows the front brake reservoir. We were unable to depress the front brake lever as part of it had broken off as a result of the accident (arrowed). Hence we were unable to determine if there was any leakage of pressure/vacuum in the front brake system.

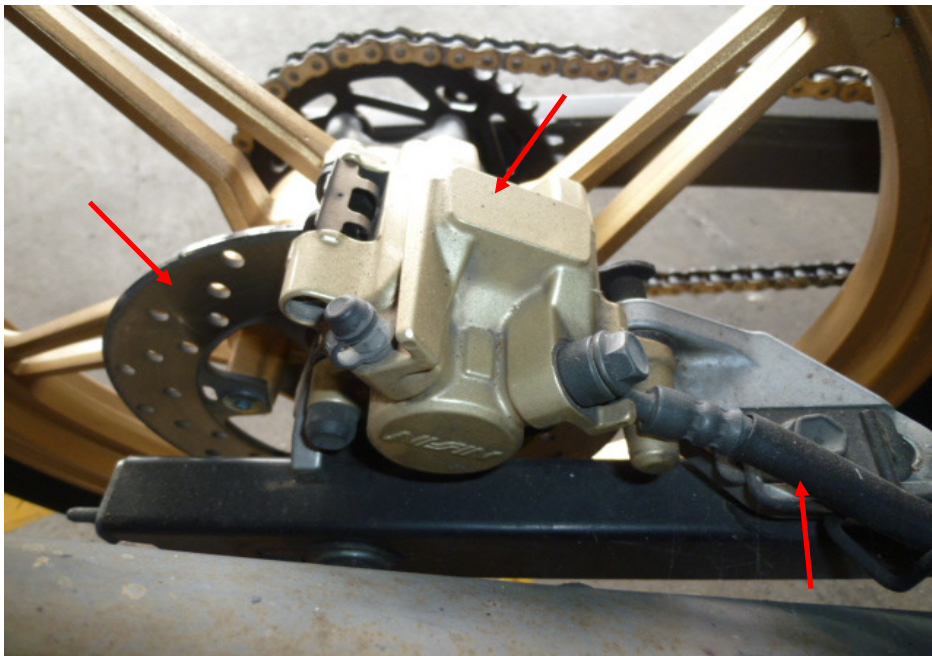
Photo 25 shows a close up view of the rear brake caliper, rear brake disc and rear brake hose (arrowed) of the Motorcycle, which are all part of the components in the hydraulic rear brake system of the Motorcycle. Our visual checks of these various components had revealed all to be intact with no visible damage. No leakage of brake fluid was also observed.

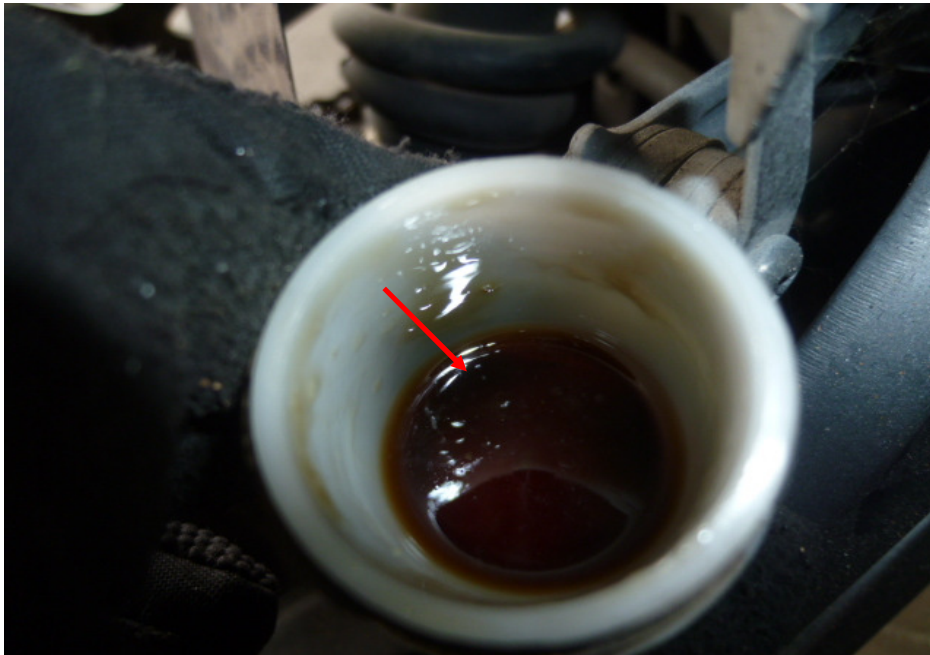
Photo 26 shows a close up view of the brake fluid reservoir for the rear brake of the Motorcycle. The rear brake fluid was observed to be of sufficient level for operational purposes. However it was found to be slightly contaminated (arrowed).
