Your Ref: 6E6jYCtICM  
Our Ref : CI/III22004956/P

**TECHNICAL INVESTIGATION REPORT OF WARRANTY CLAIM INVOLVING  
THE INSURED VEHICLE SKL 831A ON 19<sup>th</sup> April 2022**

Vehicle Registration No.	: SKL 831A
Make / Model	: MERCEDES BENZ GLS-CLASS GLS400D AMG LINE PREMIUM
Chassis No	: W1N1679232A215394
Year of Registration	: SEP 2020
Mileage	: 15,443KM

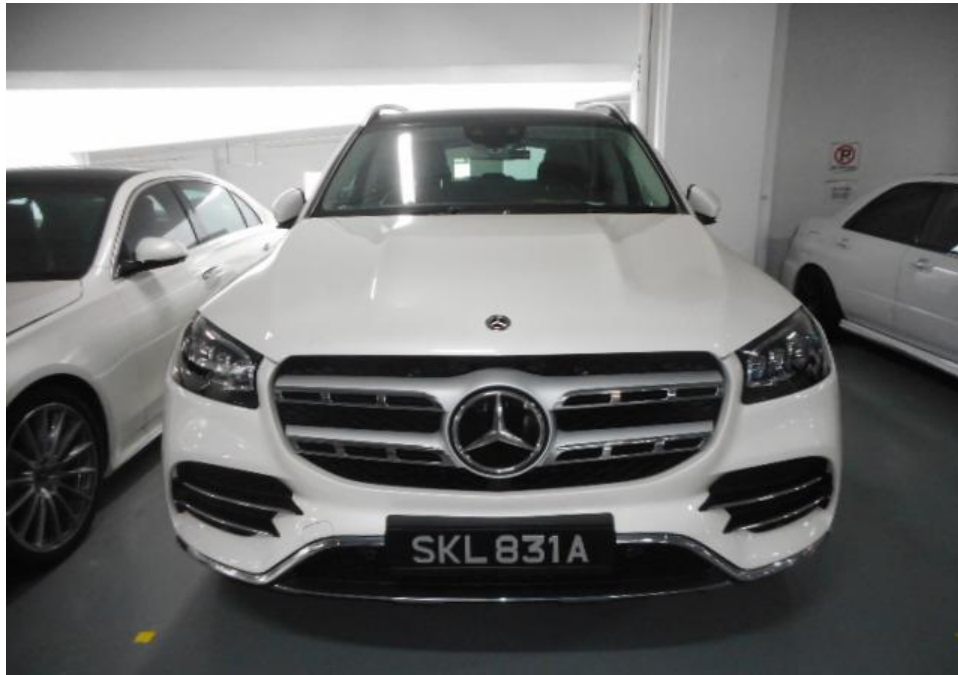
**Photo 2** shows the general view of the front portion of the Insured Vehicle at the time of our inspection. The Insured Vehicle is observed to be unaffected by any signs of accident.

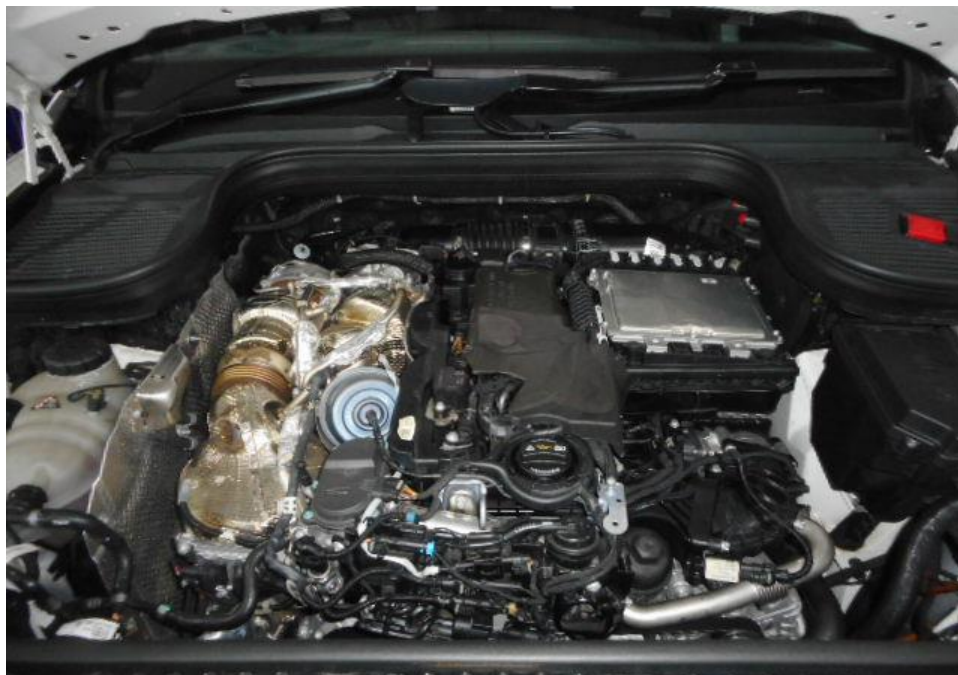
**Photo 3** shows the general view of the engine portion of the Insured Vehicle at the time of our inspection. The engine compartment is observed to be unaffected by any signs of accident.
