Your Ref: Mercedes Benz C63s  
(chassis number WDD2050872F944317)  
Our Ref : CI/TP22004965/D

25 May 2022

**INSPECTION REPORT OF AN UNREGISTERED MERCEDES BENZ C63s  
MOTOR CAR WITH CHASSIS NUMBER WDD2050872F944317**

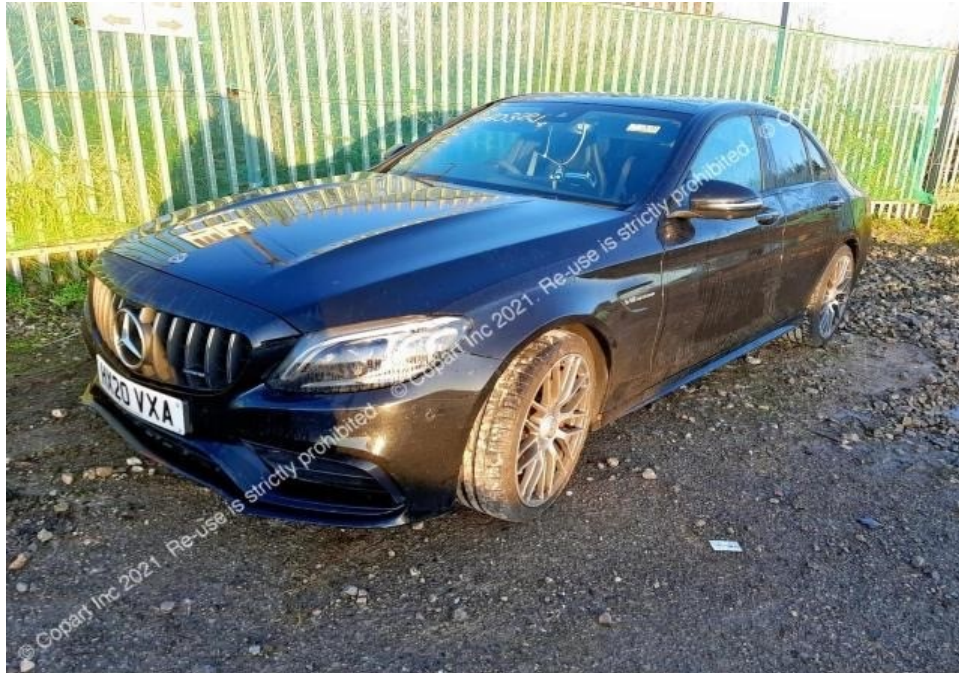
**Photo 1** shows the front left body of the Motor Car (photograph provided to me). There was no physical damage seen to the Motor Car from the photographs that were provided to me.

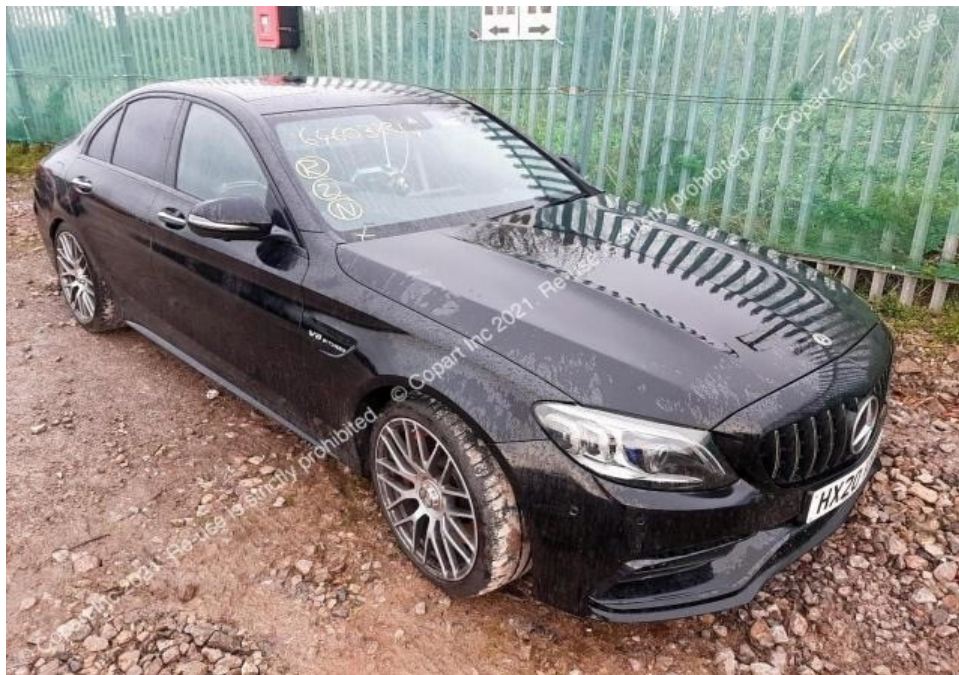
**Photo 2** shows the front right body of the Motor Car (photograph provided to me). There was no physical damage seen to the Motor Car from the photographs that were provided to me.

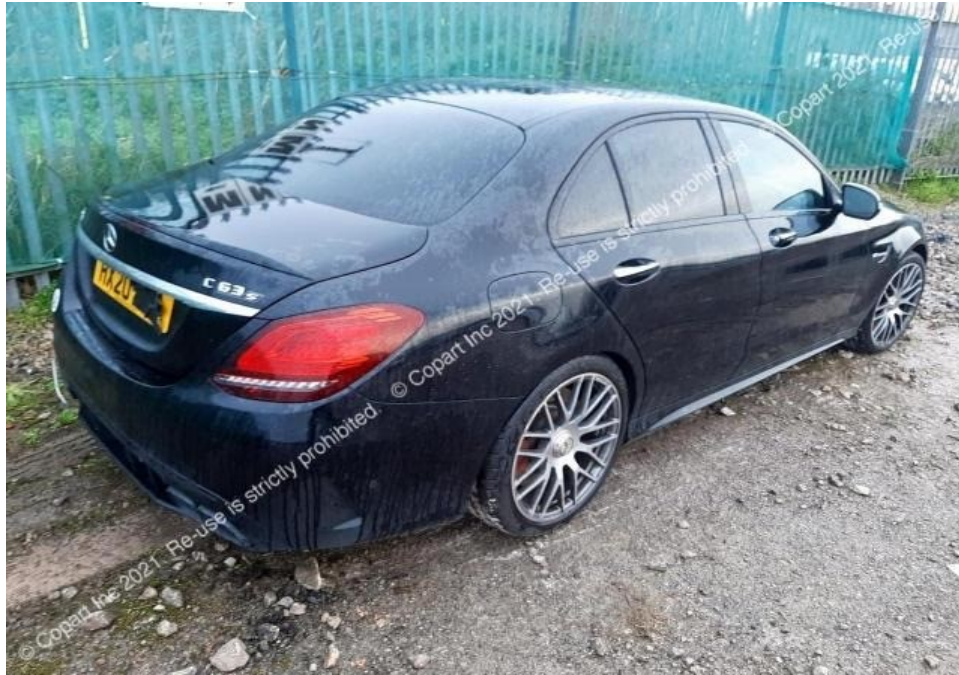
**Photo 3** shows the rear right body of the Motor Car (photograph provided to me). There was no physical damage seen to the Motor Car from the photographs that were provided to me.

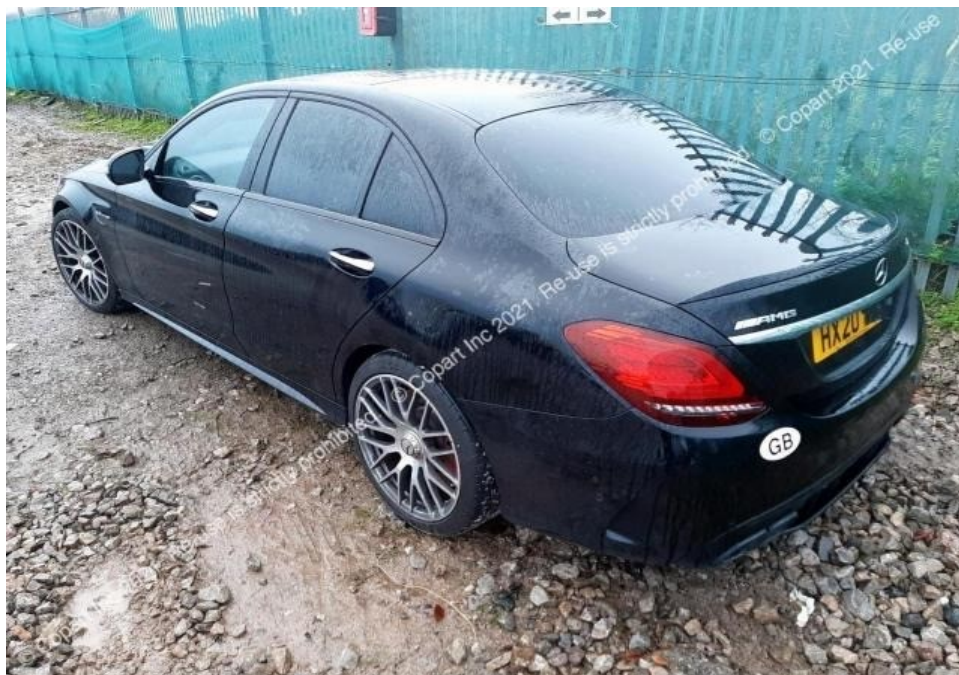
**Photo 4** shows the rear left body of the Motor Car (photograph provided to me). There was no physical damage seen to the Motor Car from the photographs that were provided to me.

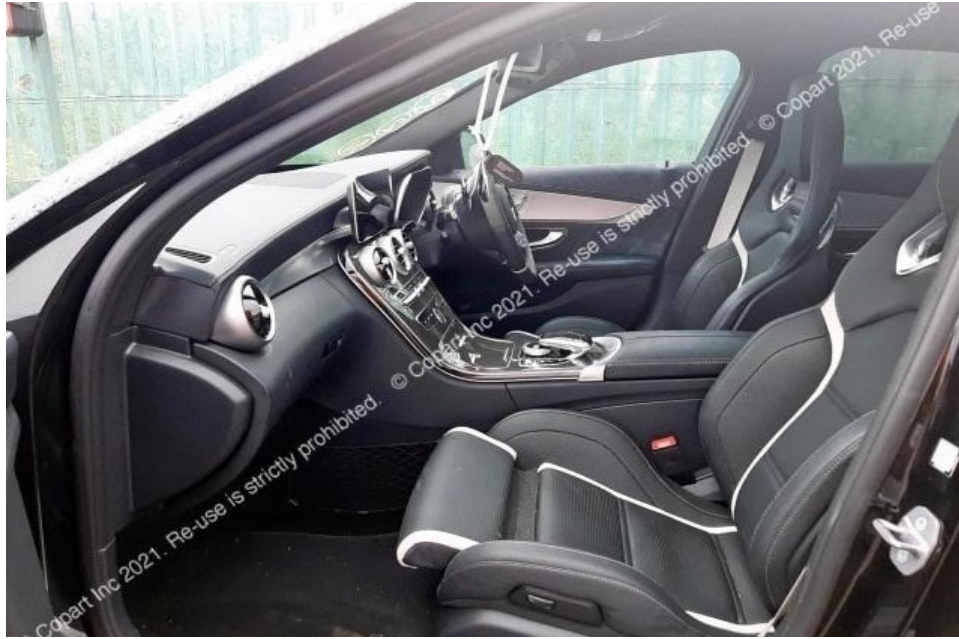
**Photo 5** shows the interior compartment of the Motor Car (photograph provided to me). The various parts and components within the interior compartment were all intact and unaffected. The airbag(s) was not deployed as seen from the photographs that were provided to me.

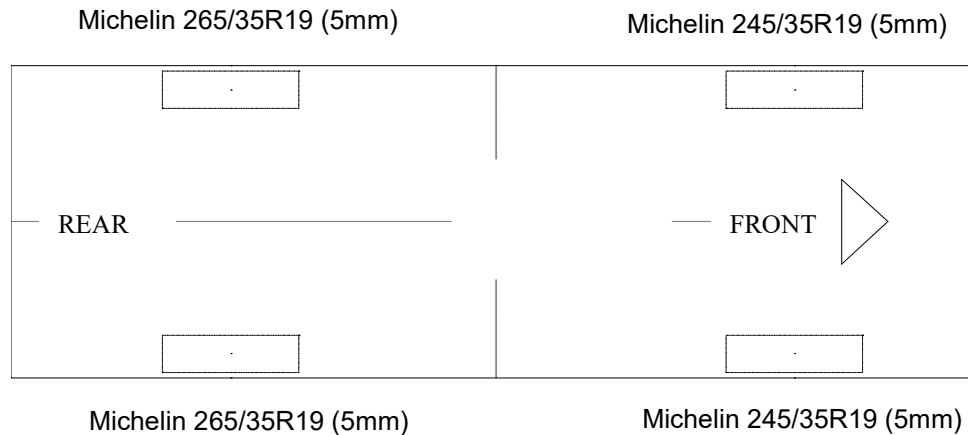
7. It was fitted with 19inch sport wheel rims that were wrapped with tyres that were observed to be of serviceable condition. The tyres were also sufficiently inflated for vehicular operation. The tyre brand, tyre size and approximate remaining tread depth of the 4 tyres of the Motor Car were recorded as follows: -

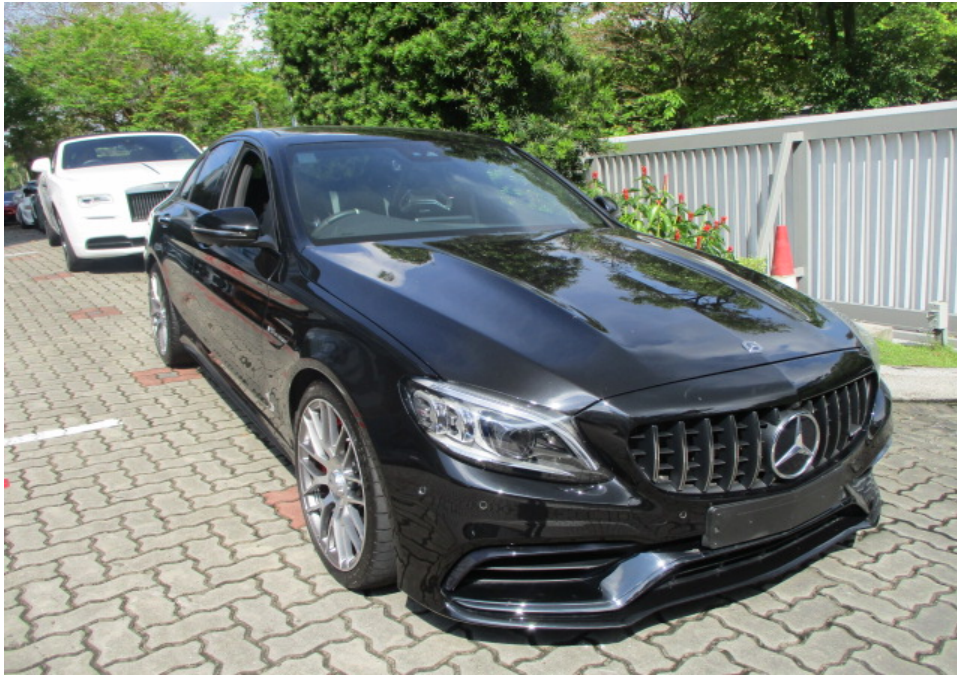
**Photo 6** shows a general view of the front right body of the Motor Car at the time of my inspection. The Motor Car was observed to be in a relatively good general condition with no loose exterior fittings observed. The mileage of the Motor Car recorded at the time of my inspection was 15,114km.

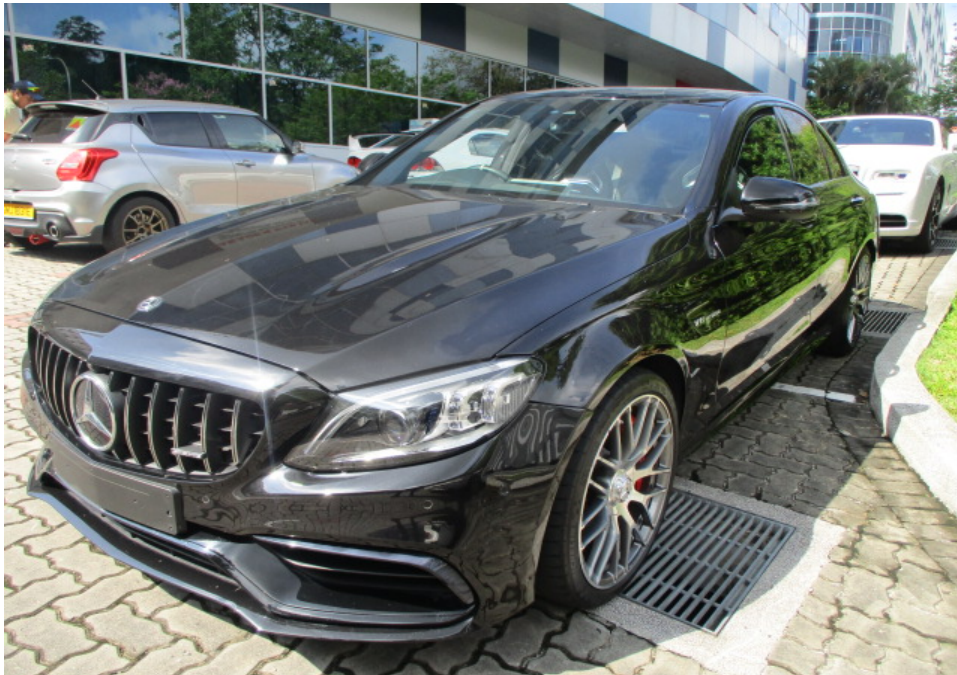
**Photo 7** shows a general view of the front left body of the Motor Car at the time of my inspection. The Motor Car was observed to be in a relatively good general condition with no loose exterior fittings observed. The mileage of the Motor Car recorded at the time of my inspection was 15,114km.

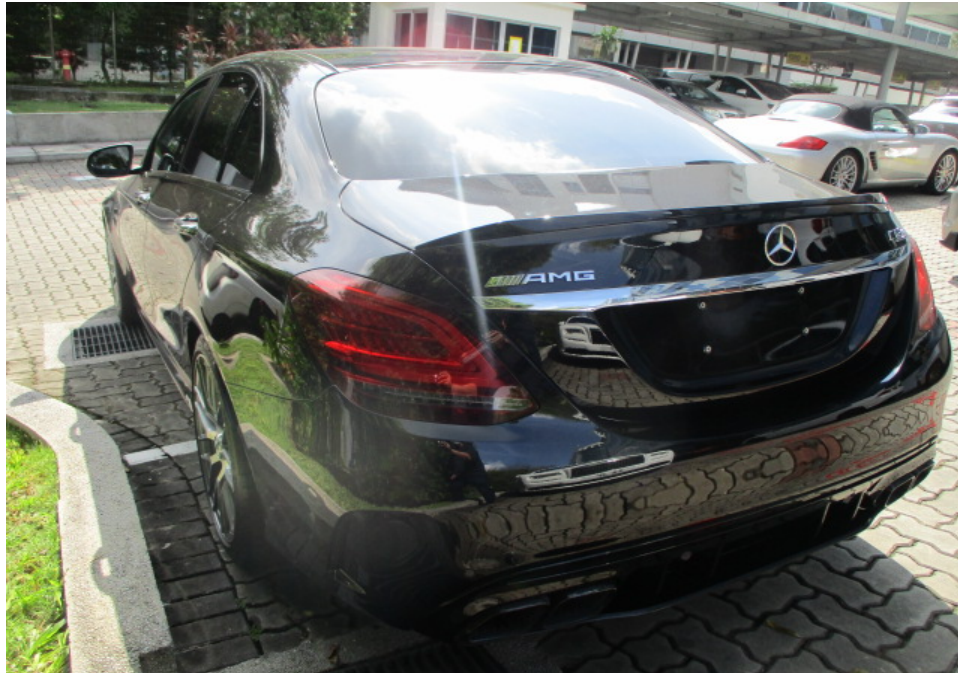
**Photo 8** shows a general view of the rear left body of the Motor Car at the time of my inspection. The Motor Car was observed to be in a relatively good general condition with no loose exterior fittings observed. The mileage of the Motor Car recorded at the time of my inspection was 15,114km.

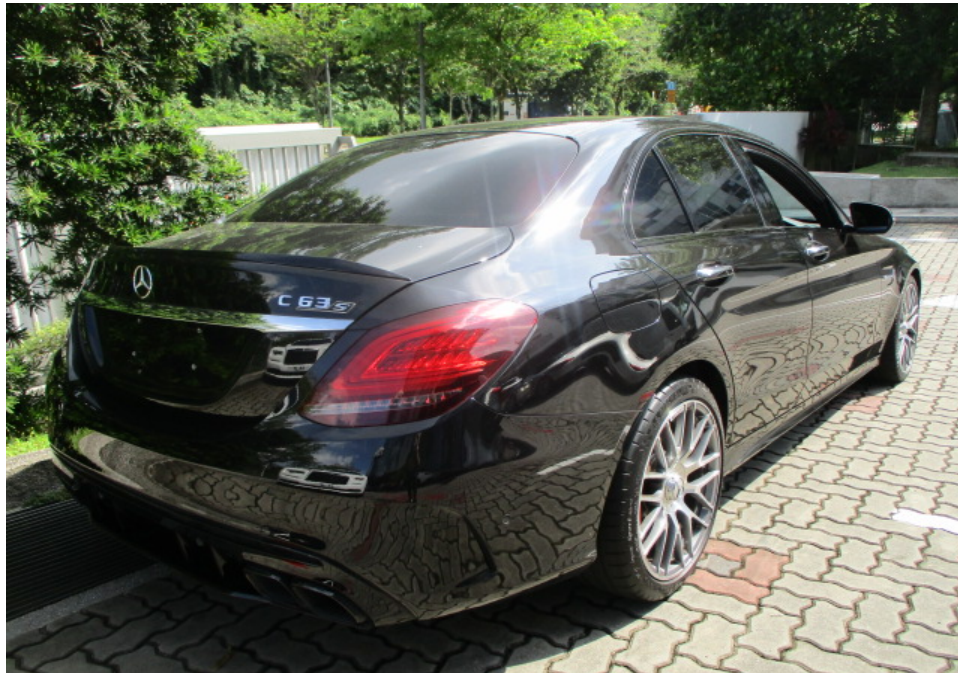
**Photo 9** shows a general view of the rear right body of the Motor Car at the time of my inspection. The Motor Car was observed to be in a relatively good general condition with no loose exterior fittings observed. The mileage of the Motor Car recorded at the time of my inspection was 15,114km.

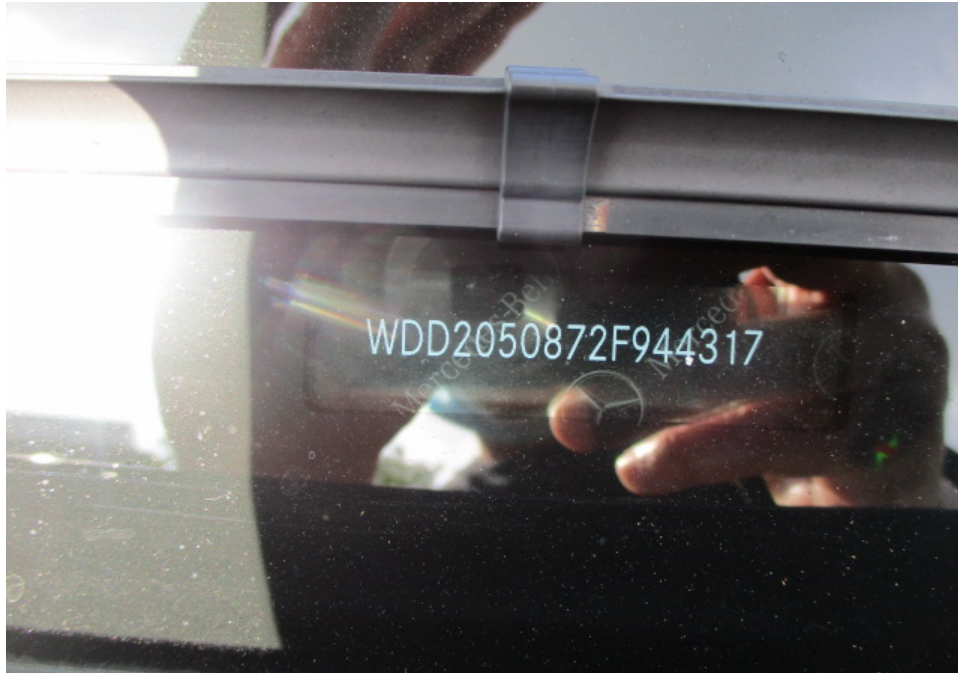
**Photo 10** shows the chassis number of the Motor Car. The chassis number recorded was WDD2050872F944317.

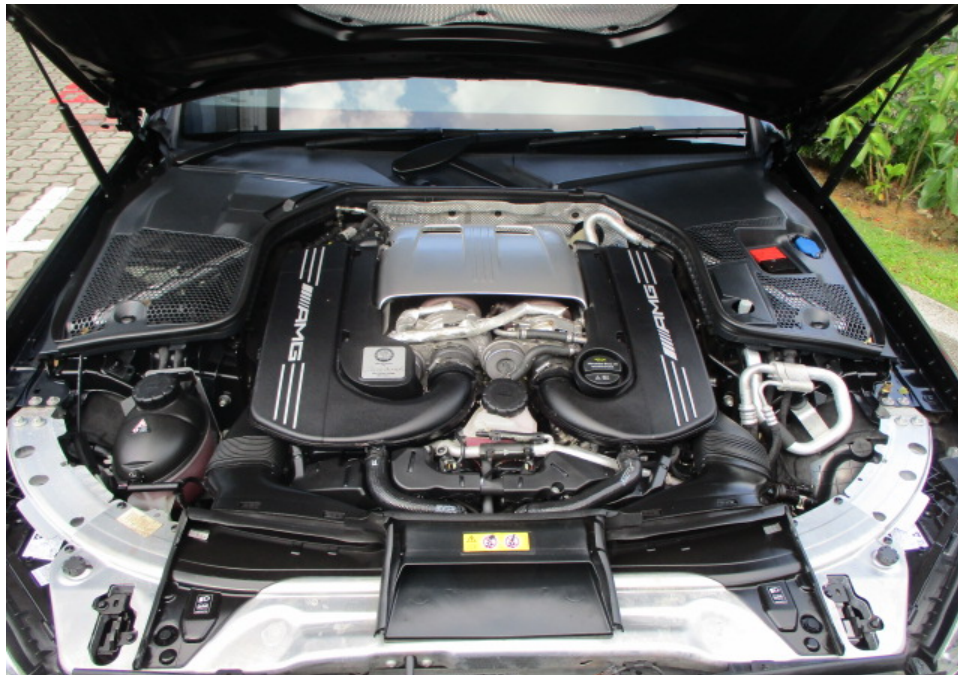
**Photo 11** shows a general view of the engine compartment of the Motor Car at the time of my inspection. The various parts and components inside the engine compartment were all observed to be intact and properly fitted. There was also no sign(s) or indication(s) of fluid leak and/or fluid stain found inside the engine compartment.

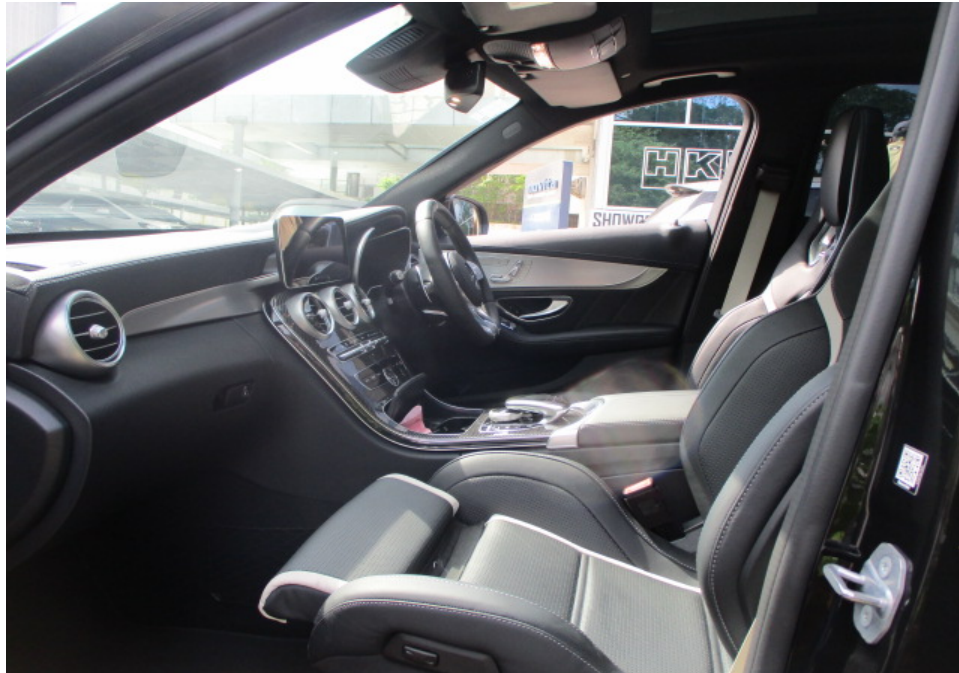
**Photo 12** shows the interior compartment of the Motor Car at the time of my inspection. The various parts and components, trims, carpet, and upholstery inside the interior compartment were all observed to be intact and properly fitted.

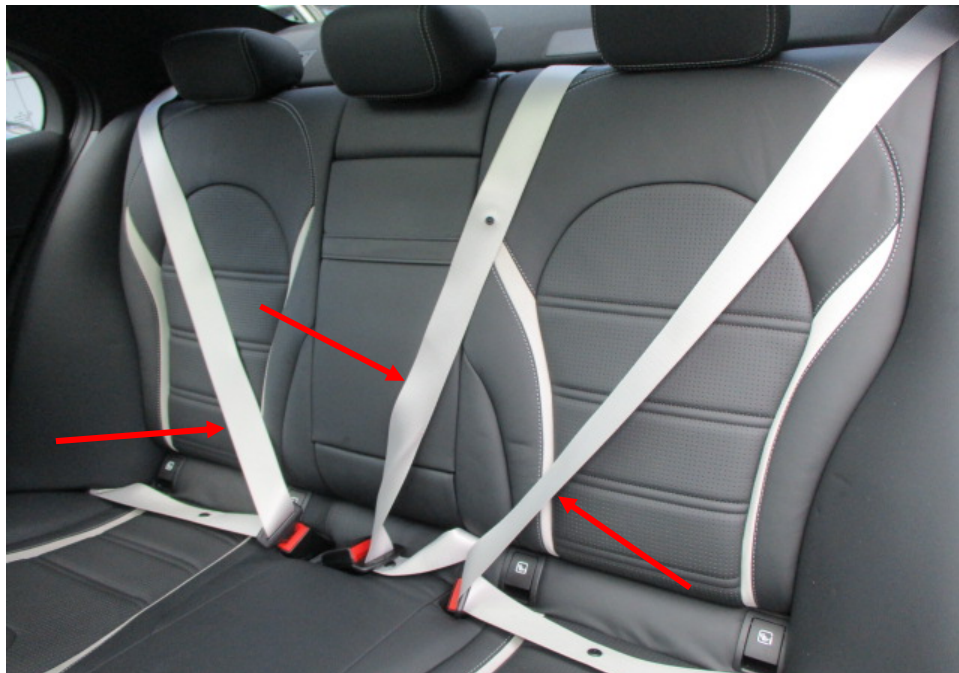
**Photo 13** shows the rear seats of the Motor Car. All the seats of the Motor Car were secured via seat rails to the floorboard. They were also fitted with a retractable seat belt reel and a pre-tensioner. The seat belts (arrowed) were tested and were able to be fastened into the respective pre-tensions that were fitted on the side of each individual seat.

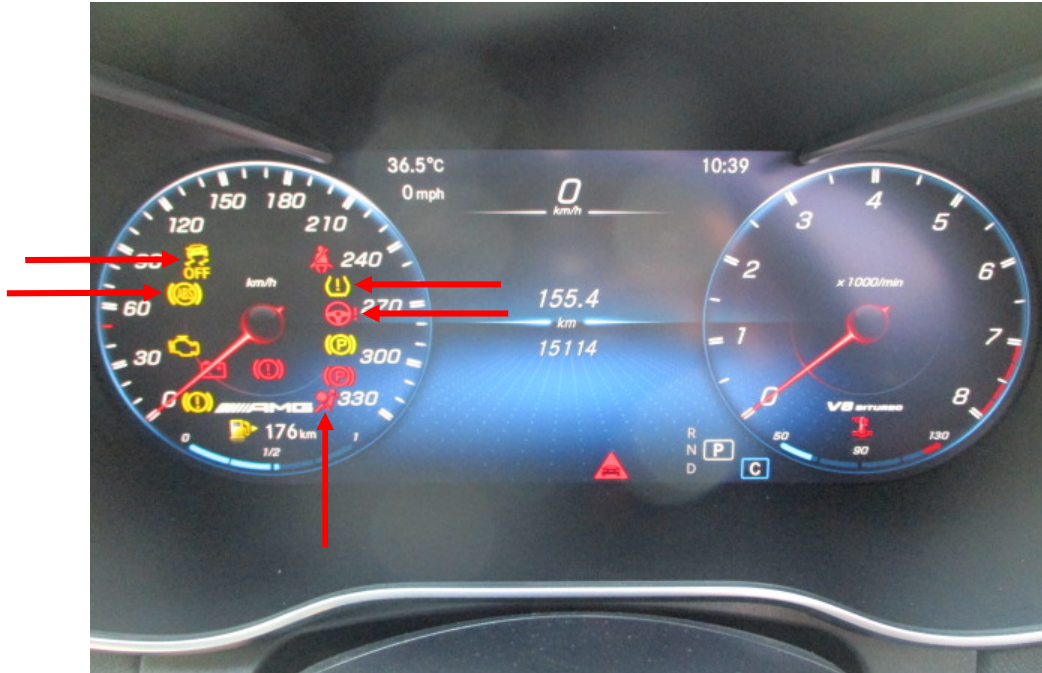
**Photo 14** shows the warning lights for the various electronic safety features appearing on the instrument panel of the Motor Car during its self-test when the engine is cranked, in particular the ABS, SRS, EPS, TPM and TCS lights (arrowed).

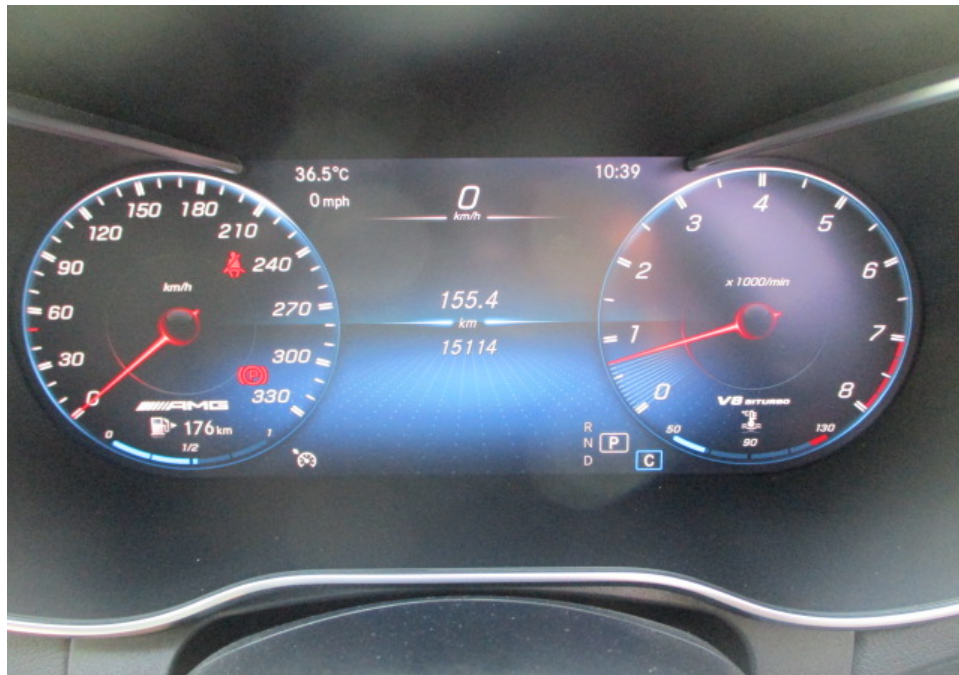
**Photo 15** shows the respective warning lights no longer illuminated, indicating that there is no fault detected to the ABS, SRS, EPS, TPM and TCS systems of the Motor Car during the self-test. These electronic systems were hence in working condition at the time of my inspection.

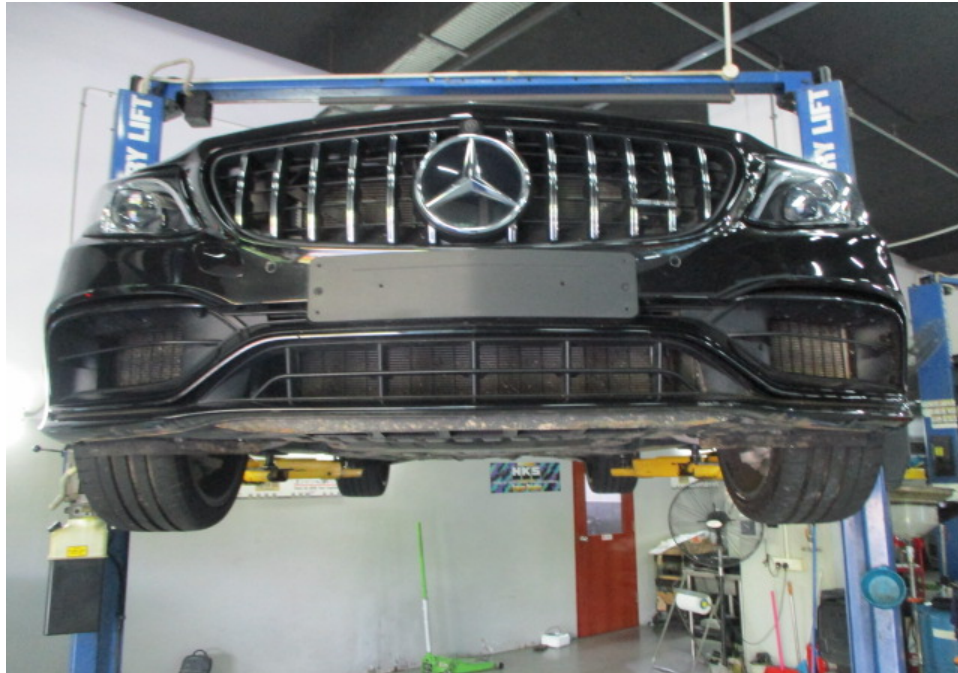
**Photo 16** shows the Motor Car hoisted up for checks on its undercarriage. There was no sign(s) or indication(s) of fluid leakage and/or fluid stain(s) on the underside of the Motor Car. The undercarriage components of the Motor Car were also all observed to be intact and secured in an appropriate manner.

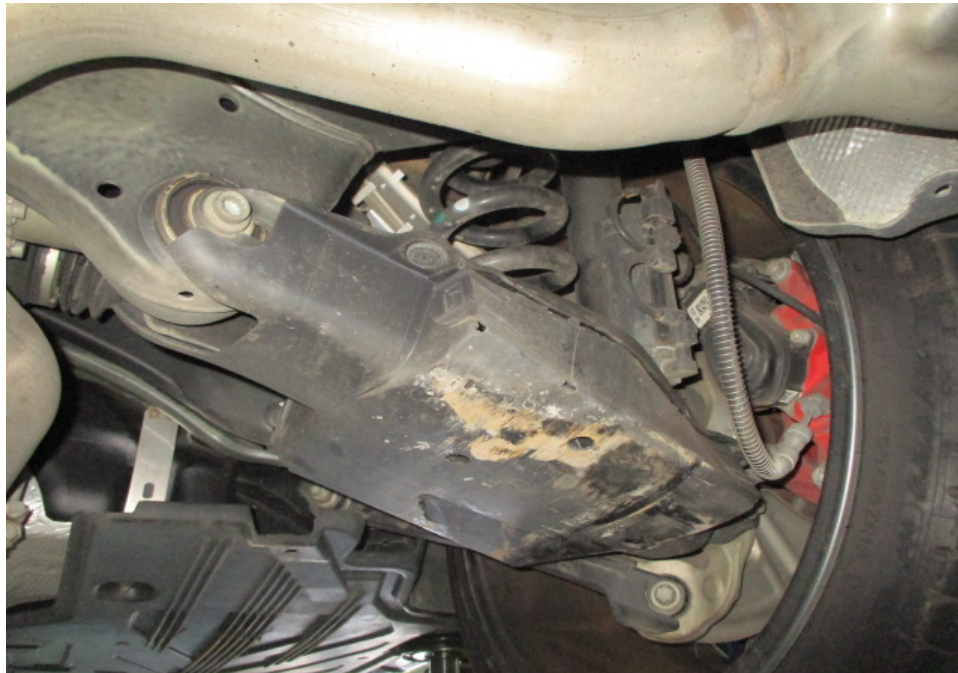
**Photo 17** shows a general view of the control arms and linkages at the rear right wheel of the Motor Car. I did not observe any fluid leak and/or fluid stain on the underside of the Motor Car. All of the Motor Car's undercarriage components were observed to be intact and secured in an appropriate manner.

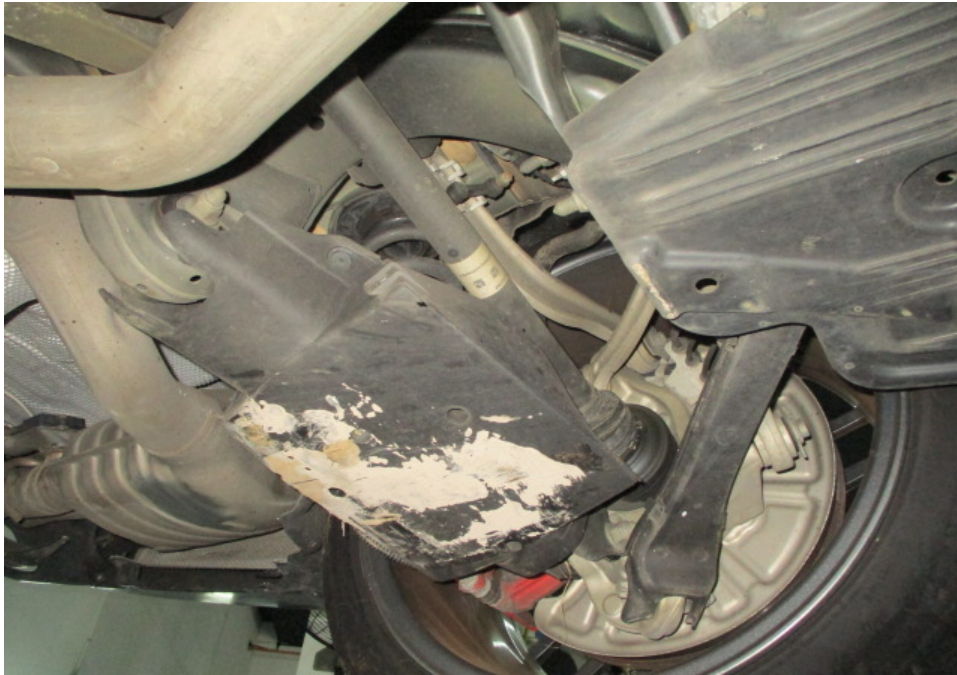
**Photo 18** shows a general view of the control arms and linkages at the rear left wheel of the Motor Car. I did not observe any fluid leak and/or fluid stain on the underside of the Motor Car. All of the Motor Car's undercarriage components were observed to be intact and secured in an appropriate manner.

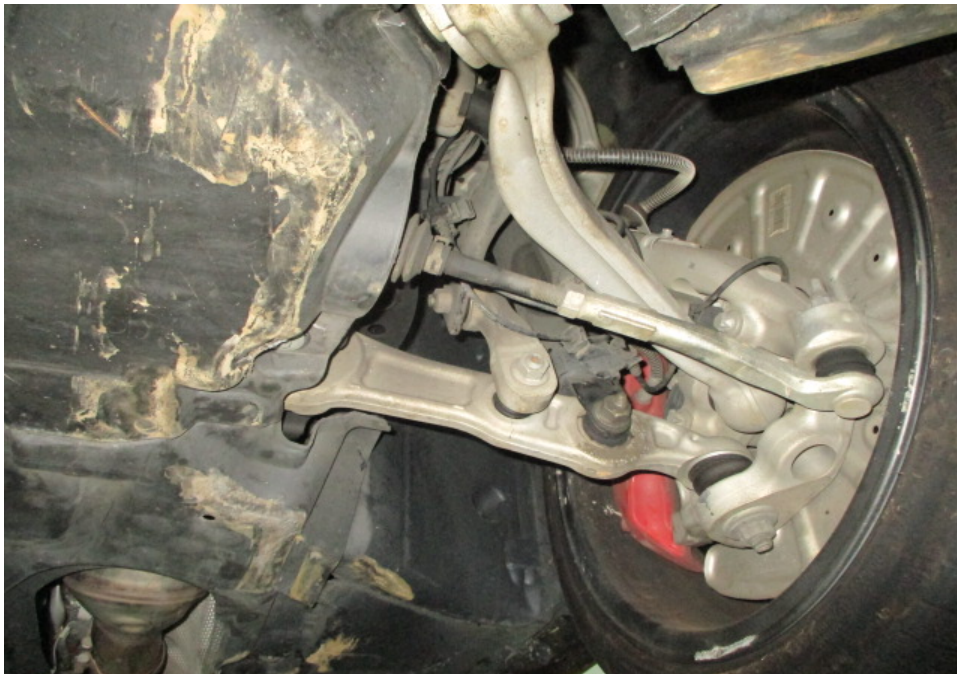
**Photo 19** shows the various undercarriage components at the front left wheel of the Motor Car. The mechanical components, control arms and linkages were all found to be intact and secured in an appropriate manner.

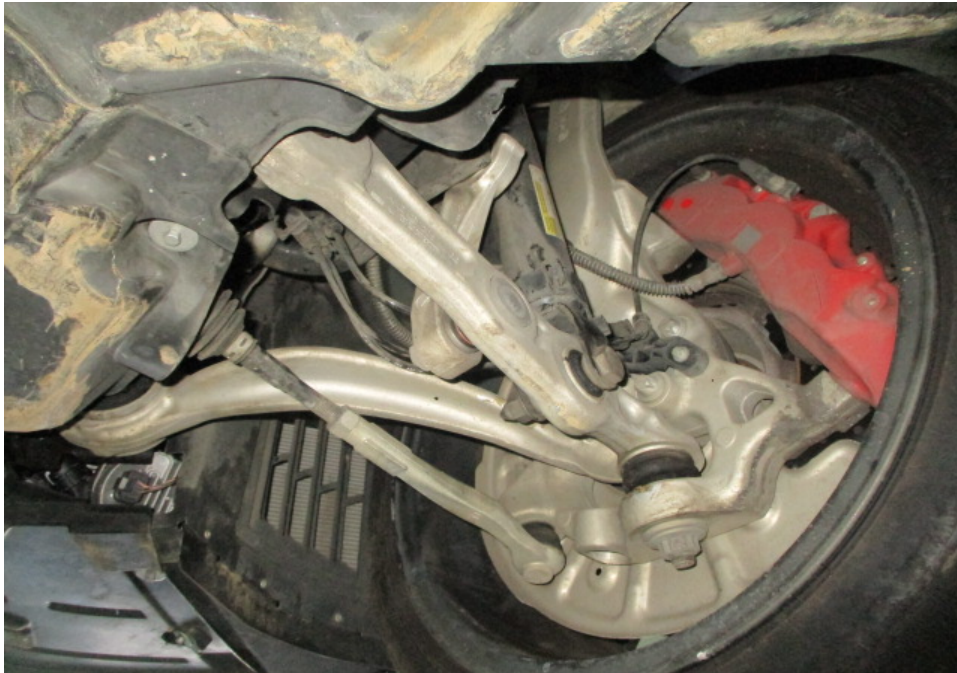
**Photo 20** shows the various undercarriage components at the front right wheel of the Motor Car. The mechanical components, control arms and linkages were all found to be intact and secured in an appropriate manner. I also did not observe any fluid leak and/or fluid stain on the underside of the Motor Car.

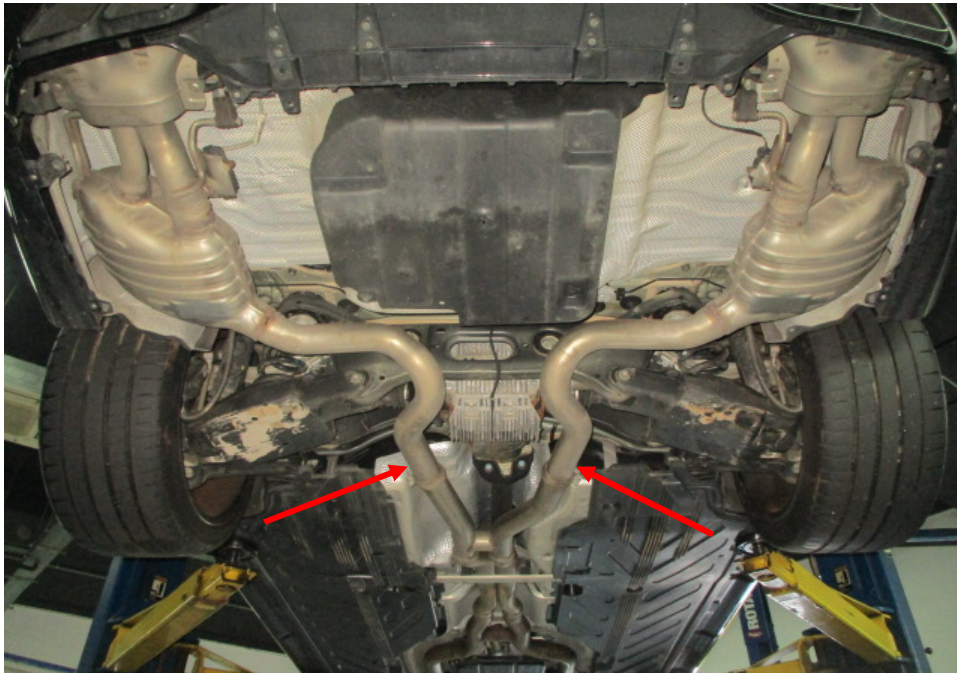
**Photo 21** shows the rear section of the Motor Car's exhaust system. My examination of the Motor Car's exhaust system revealed no sign(s) or indication(s) of any cut or weld marks along its exhaust pipes (arrowed), on its rear mufflers and on its catalytic converters.

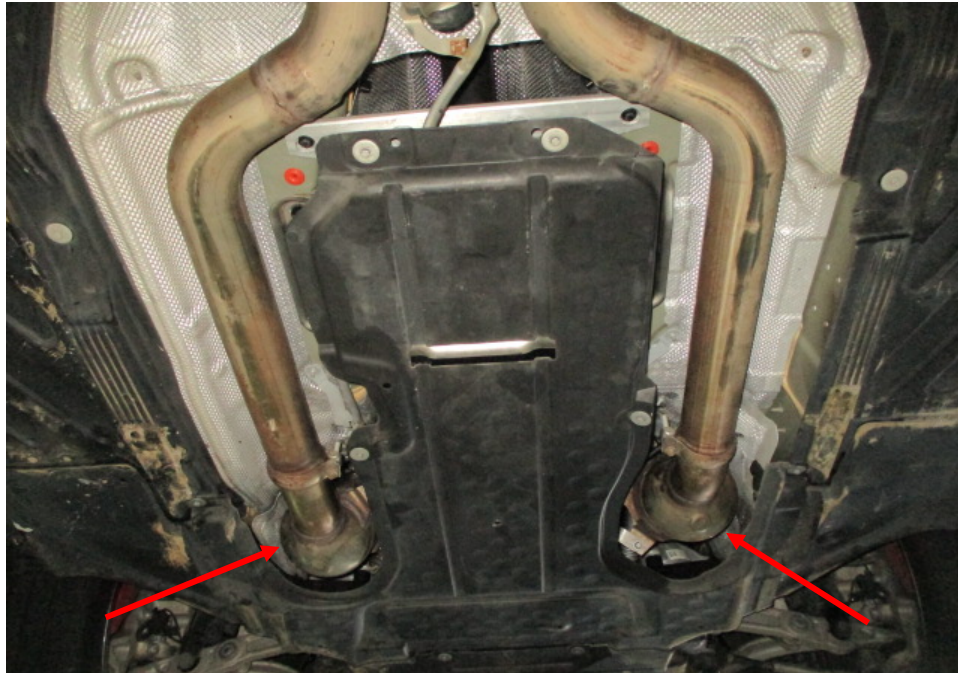
**Photo 22** shows the front section of the Motor Car's exhaust system. My examination of the Motor Car's exhaust system revealed no sign(s) or indication(s) of any cut or weld marks along its exhaust pipes, on its rear mufflers, and on its catalytic converters (arrowed).

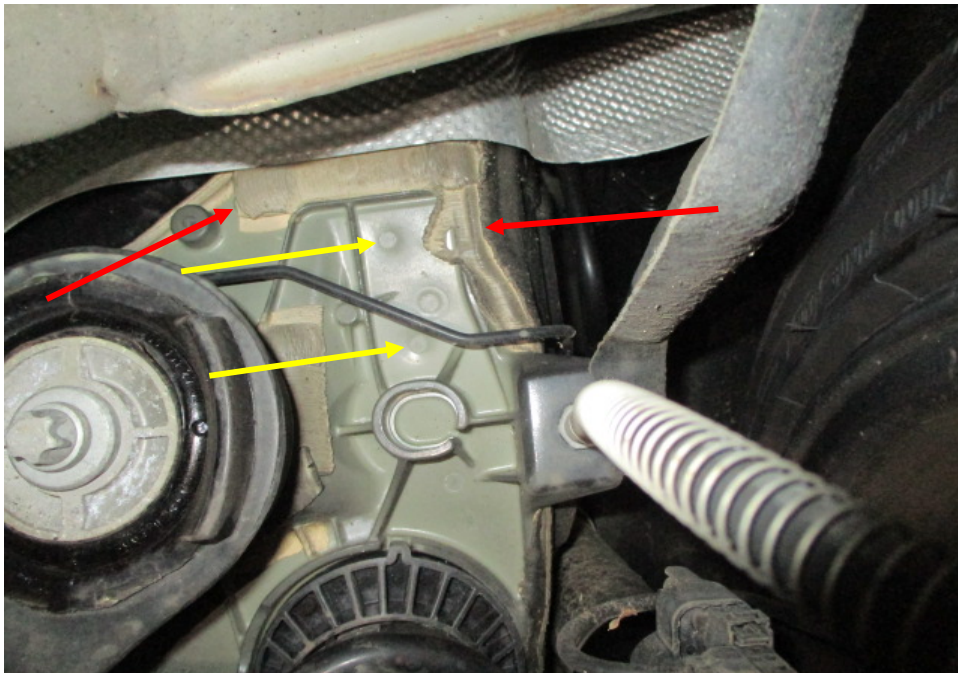
**Photo 23** shows the chassis/structural body at the underside rear right of the Motor Car. I did not find any weld marks other than original spot weld marks (yellow arrow) on the chassis/structural body of the Motor Car. The original factory sealant (red arrow) at the joints along the chassis/structural body was untouched, indicating no work was done on the chassis/structural body of the Motor Car and that the chassis/structural body was originally fitted.

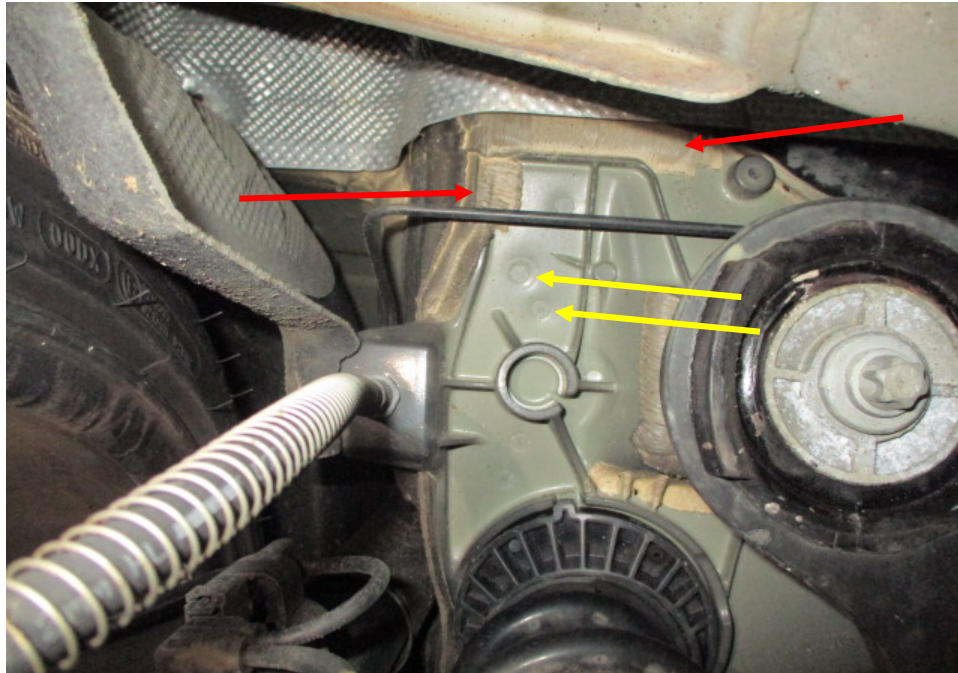
**Photo 24** shows the chassis/structural body at the underside rear left of the Motor Car. I did not find any weld marks other than original spot weld marks (yellow arrow) on the chassis/structural body of the Motor Car. The original factory sealant (red arrow) at the joints along the chassis/structural body was untouched, indicating no work was done on the chassis/structural body of the Motor Car and that the chassis/structural body was originally fitted.

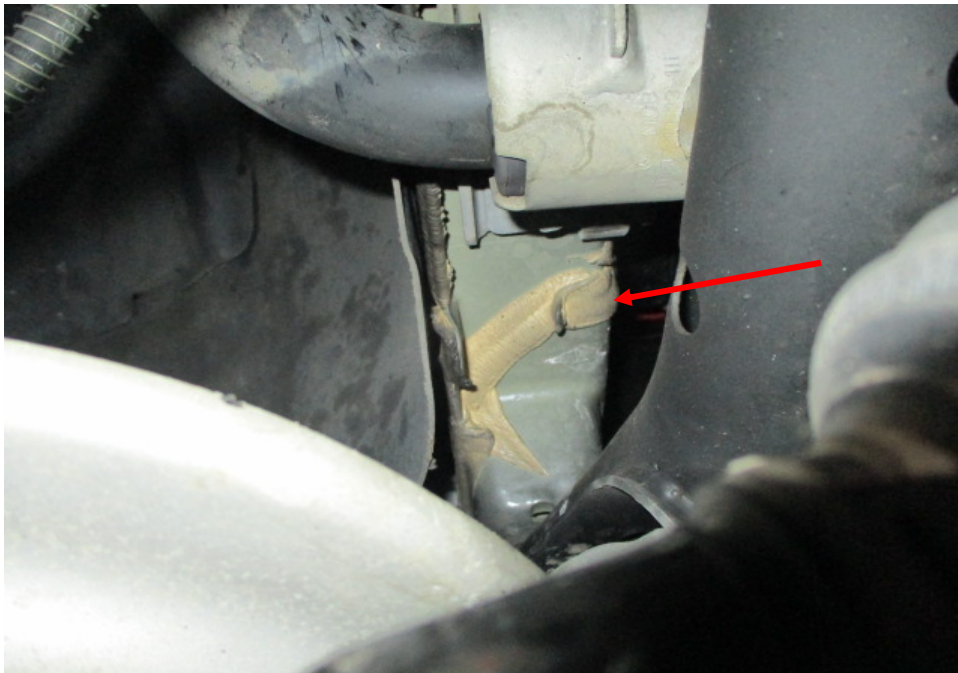
**Photo 25** shows the chassis/structural body at the underside front left of the Motor Car. The original factory sealant (arrowed) at the joints along the chassis/structural body was observed to be untouched. In general, I had found no work was carried out on the chassis/structural body of the Motor Car. The chassis/structural body of the Motor Car was originally fitted.

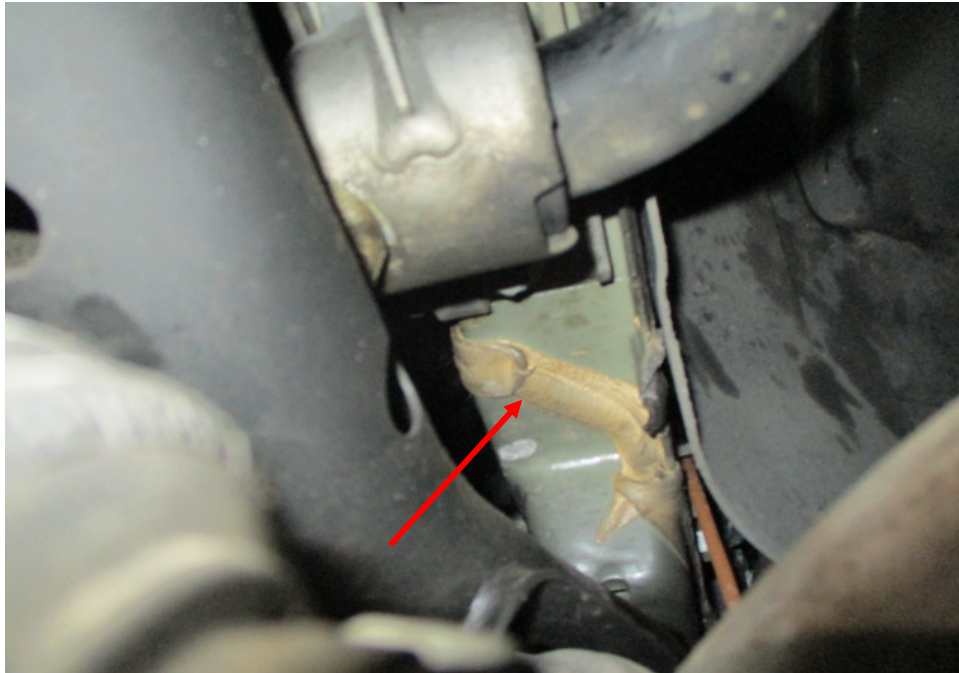
**Photo 26** shows the chassis/structural body at the underside front right of the Motor Car. The original factory sealant (arrowed) at the joints along the chassis/structural body was observed to be untouched. In general, I had found no work was carried out on the chassis/structural body of the Motor Car. The chassis/structural body of the Motor Car was originally fitted.

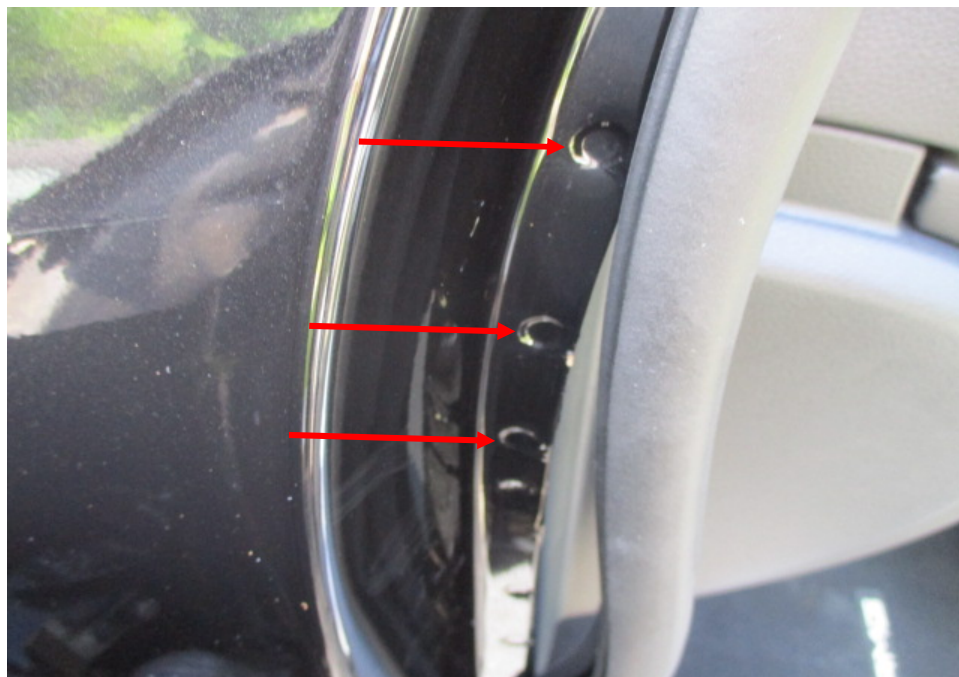
**Photo 27** shows the left side "A" pillar of the Motor Car. I did not find any weld marks other than original spot weld marks (arrowed) on the left side "A" pillar of the Motor Car which, indicates that there was no re-welding works carried out. In general, I had found all the non-detachable body panels of the Motor Car to be originally fitted at the time of my inspection.

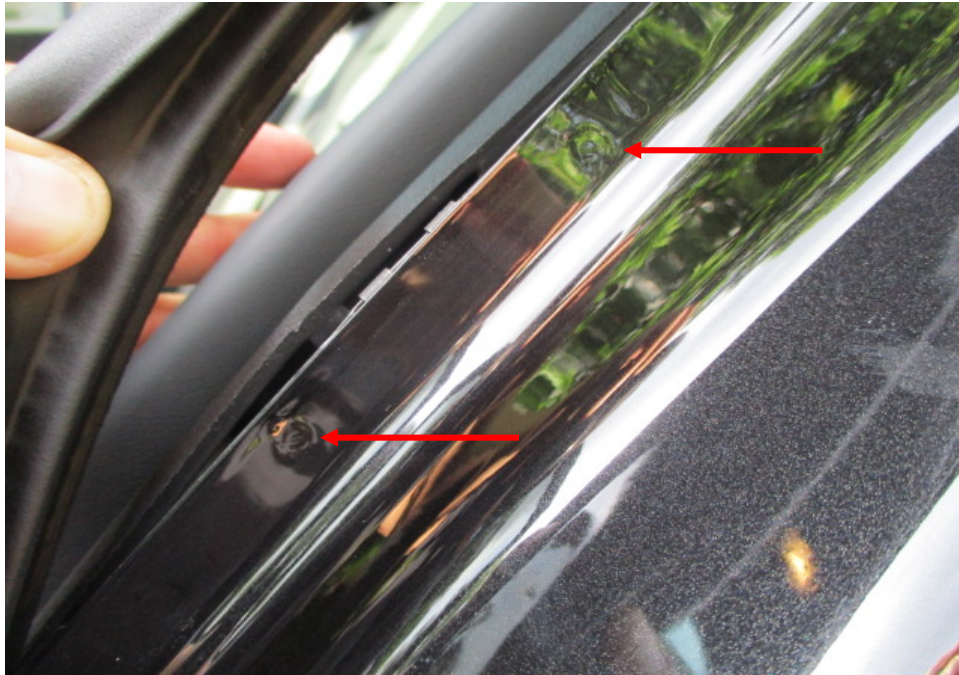
**Photo 28** shows the left side “C” pillar of the Motor Car. I did not find any weld marks other than original spot weld marks (arrowed) on the left side “C” pillar of the Motor Car, which indicates that there was no re-welding works carried out. In general, I had found all the non-detachable body panels of the Motor Car to be originally fitted at the time of my inspection.

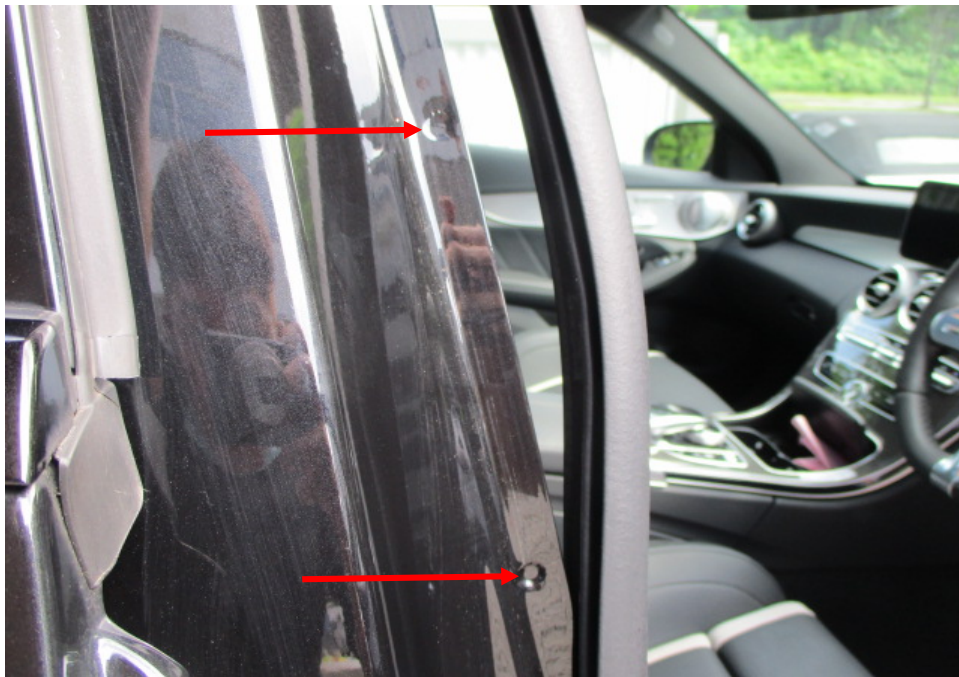
**Photo 29** shows the right side “B” pillar of the Motor Car. I did not find any weld marks other than original spot weld marks (arrowed) on the right side “B” pillar of the Motor Car, which indicates that there was no re-welding works carried out. In general, I had found all the non-detachable body panels of the Motor Car to be originally fitted at the time of my inspection.

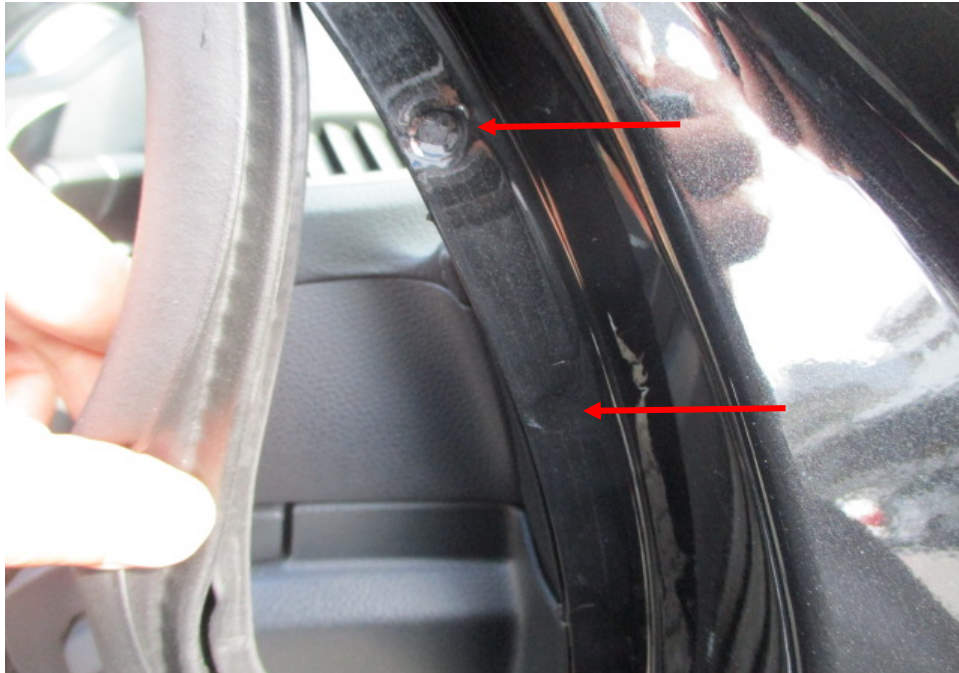
**Photo 30** shows the right side “A” pillar of the Motor Car. I did not find any weld marks other than original spot weld marks (arrowed) on the right side “A” pillar of the Motor Car which, indicates that there was no re-welding works carried out. In general, I had found all the non-detachable body panels of the Motor Car to be originally fitted at the time of my inspection.
