Your Ref: Porsche Cayenne S
(chassis number WP1ZZZ9YZKDA65124)
Our Ref : CI/TP22004967/D

25 May 2022

**INSPECTION REPORT OF AN UNREGISTERED PORSCHE CAYENNE S
MOTOR CAR WITH CHASSIS NUMBER WP1ZZZ9YZKDA65124**

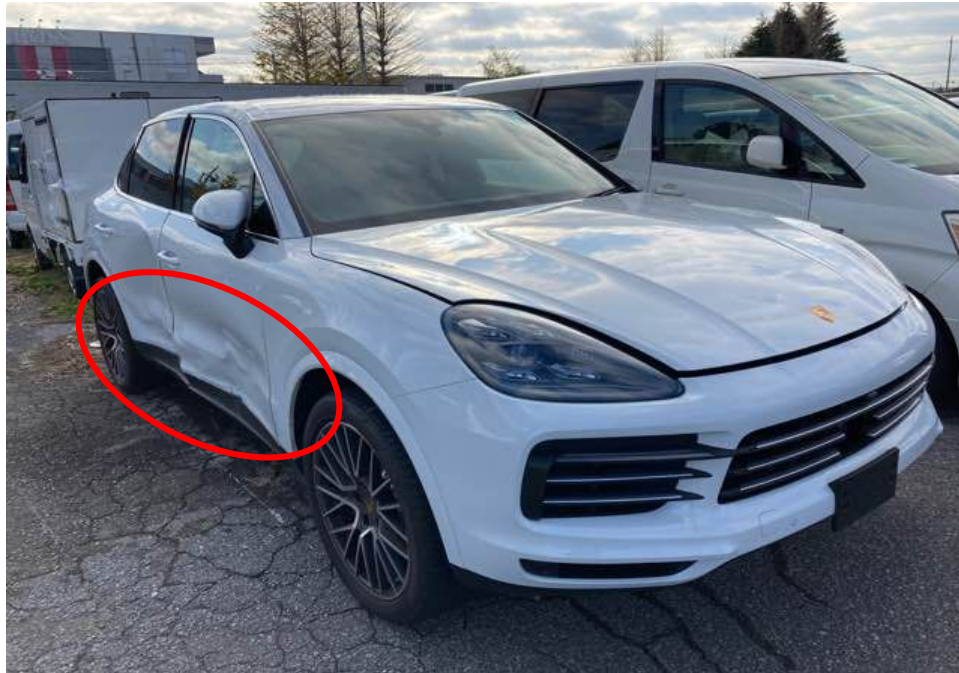
3. The photographs provided to me had showed damage to the right side centre portion of the Motor Car. Body parts damaged include the front right door, rear right door and right side rocker panel garnish amongst others.
4. Apart for the right side centre portion, there was no physical damage observed to other areas of the Motor Car. The airbag(s) was also not deployed as seen from the photographs that were provided to me. See photo 1 – 4 below.

Photo 1 shows the front right body of the Motor Car (photograph provided to me). The photographs provided to me had showed damage to the right side centre portion (circled) of the Motor Car. The front right door, rear right door and right side rocker panel garnish were amongst the body parts that were observed to have been damaged.

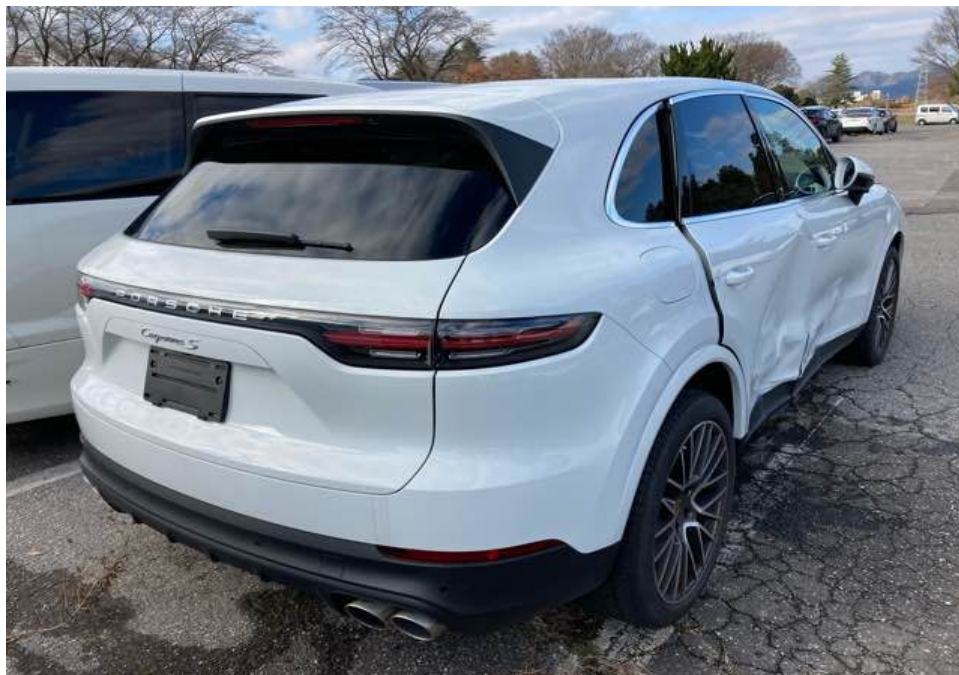
Photo 2 shows the rear right body of the Motor Car (photograph provided to me). The photographs provided to me had showed damage to the right side centre portion of the Motor Car. The front right door, rear right door and right side rocker panel garnish were amongst the body parts that were observed to have been damaged.

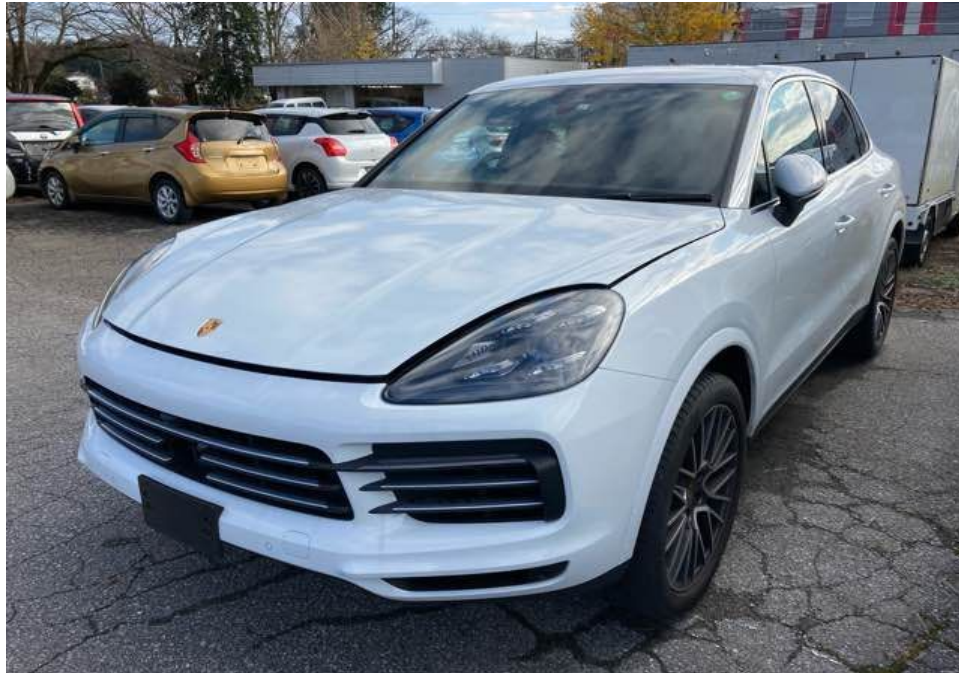
Photo 3 shows the front left body of the Motor Car (photograph provided to me). Apart for the right side centre portion, there was no physical damage observed to other areas of the Motor Car. The airbag(s) was not deployed as seen from the photographs that were provided to me.

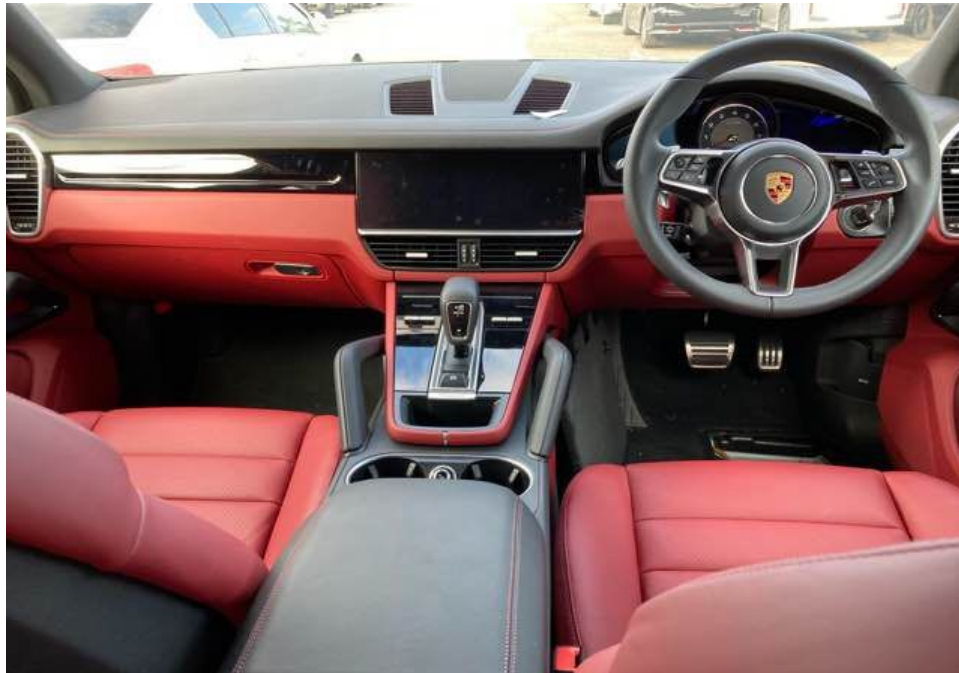
Photo 4 shows the interior compartment of the Motor Car (photograph provided to me). The various parts and components within the interior compartment were all intact and unaffected. The airbag(s) was not deployed as seen from the photographs that were provided to me.

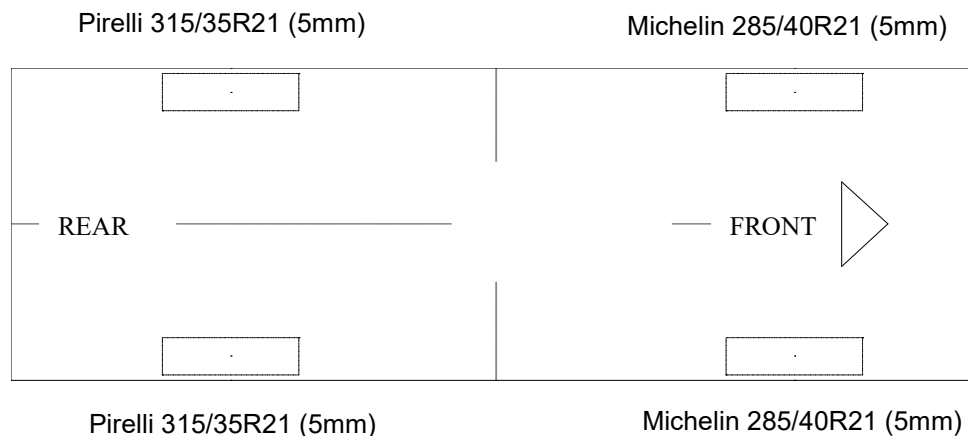
8. It was fitted with 21inch sport wheel rims that were wrapped with tyres that were observed to be of serviceable condition. The tyres were also sufficiently inflated for vehicular operation. The tyre brand, tyre size and approximate remaining tread depth of the 4 tyres of the Motor Car were recorded as follows: -

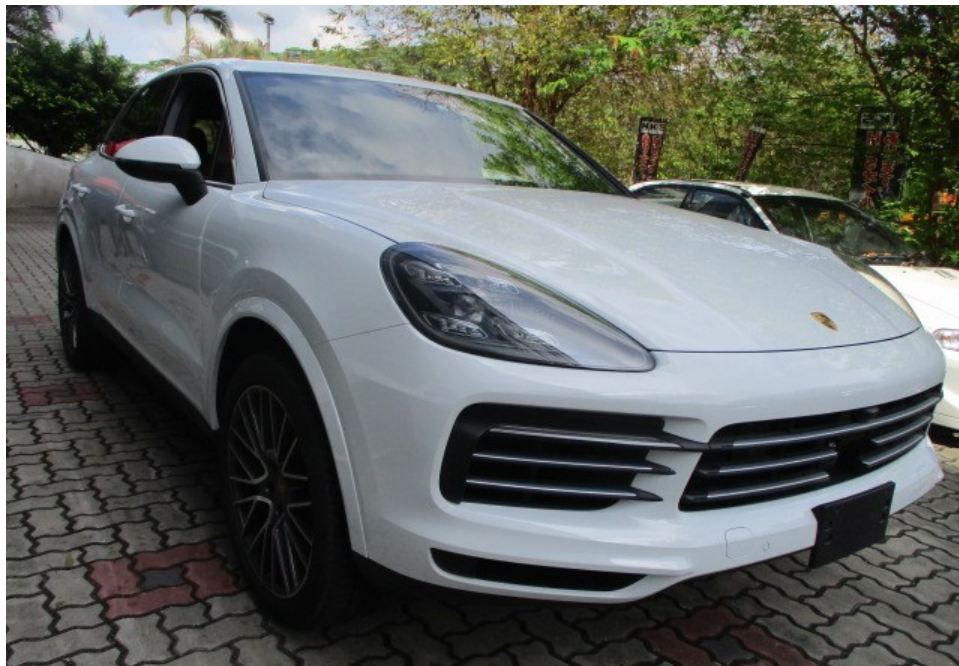
Photo 5 shows a general view of the front right body of the Motor Car at the time of my inspection. The Motor Car was observed to be in a relatively good general condition with no loose exterior fittings observed. The body parts at the right side centre portion of the Motor Car were visually examined and it was observed that the repair/restoration works carried out to the damaged area of the Motor Car (refer to photograph 1 & 2 above) were reasonably adequate and in order.

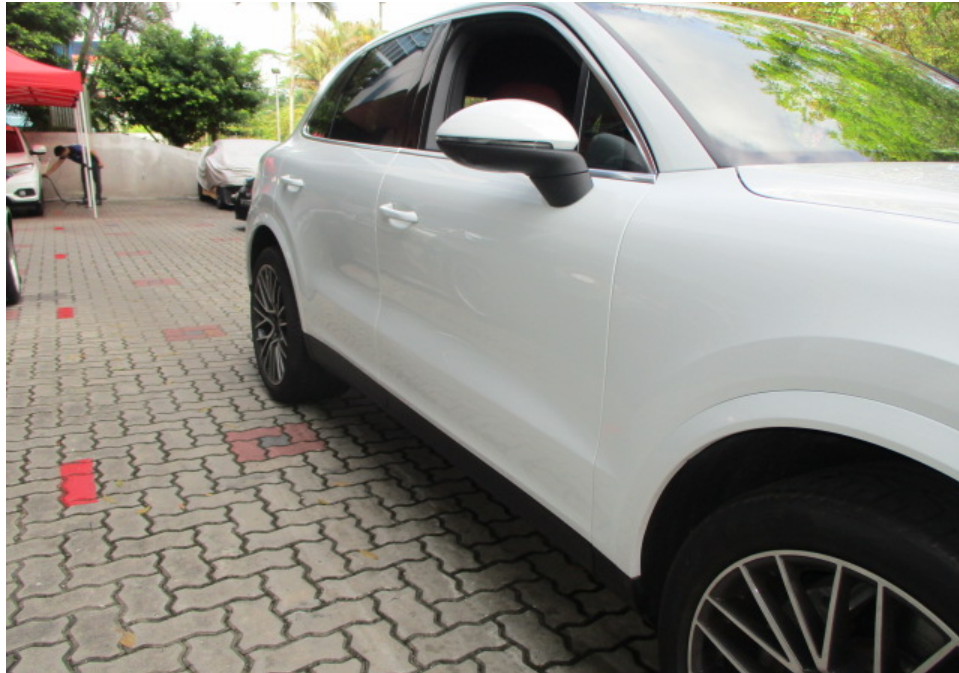
22. The body parts at the right side centre portion of the Motor Car were visually examined and it was noted that the repair/restoration works carried out to the damaged area of the Motor Car (refer to photograph 1 & 2 above) were reasonably adequate and in order.

Photo 6 shows a closer view of the Motor Car's front right fender, front right door, right side wing mirror and right side rocker panel garnish. The body parts at the right side centre portion of the Motor Car were visually examined and it was observed that the repair/restoration works carried out to the damaged area of the Motor Car (refer to photograph 1 & 2 above) were reasonably adequate and in order.

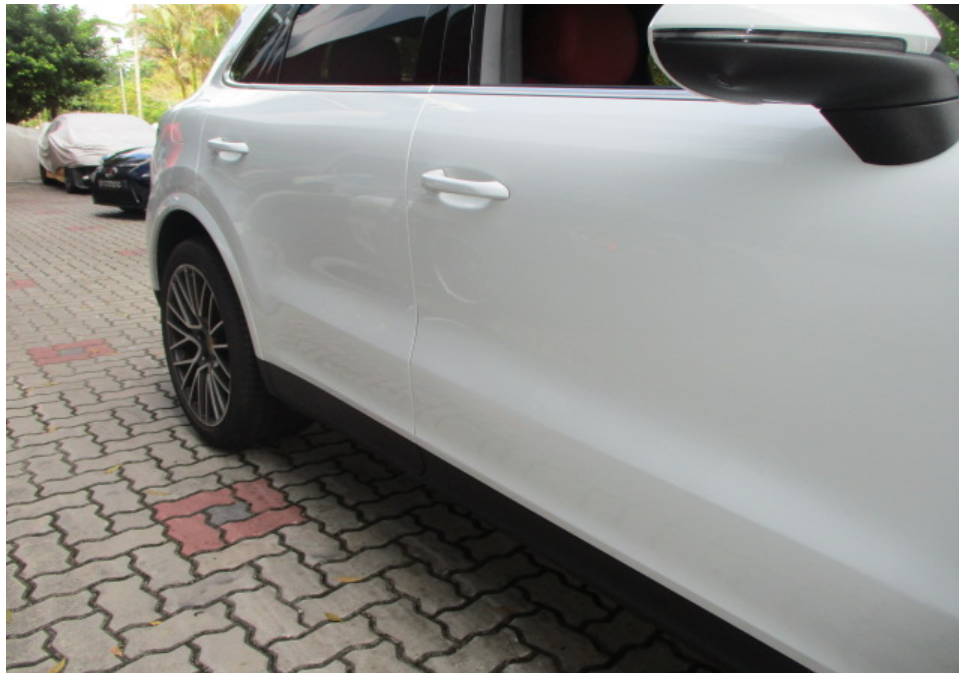
Photo 7 shows a closer view of the Motor Car's front right door, right side wing mirror and right side rocker panel garnish. The body parts at the right side centre portion of the Motor Car were visually examined and it was observed that the repair/restoration works carried out to the damaged area of the Motor Car (refer to photograph 1 & 2 above) were reasonably adequate and in order.

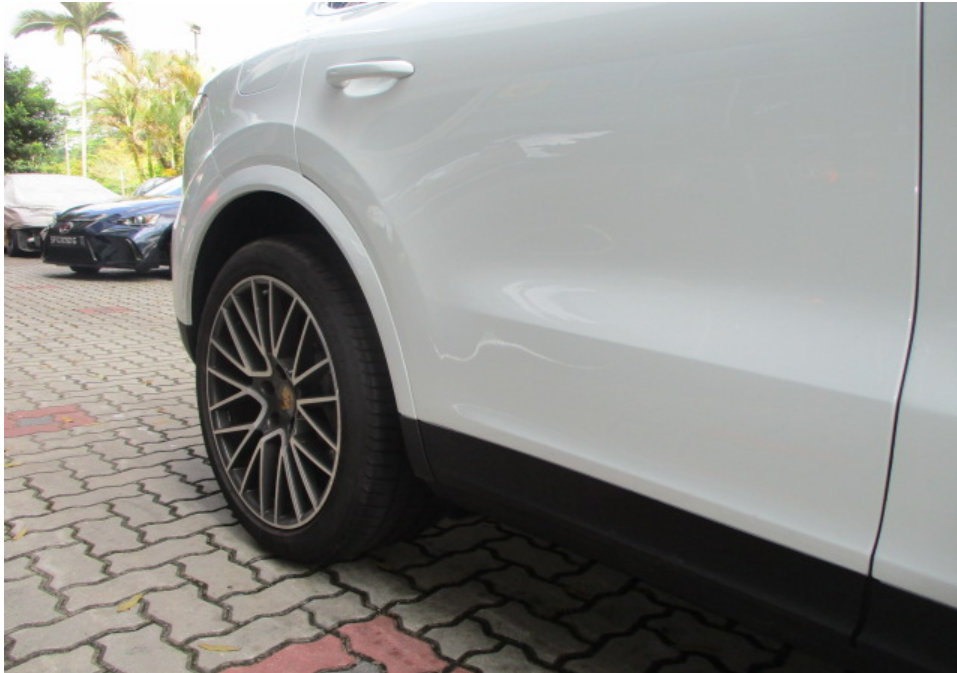
Photo 8 shows a closer view of the Motor Car's rear right door and right side rocker panel garnish. The body parts at the right side centre portion of the Motor Car were visually examined and it was observed that the repair/restoration works carried out to the damaged area of the Motor Car (refer to photograph 1 & 2 above) were reasonably adequate and in order.

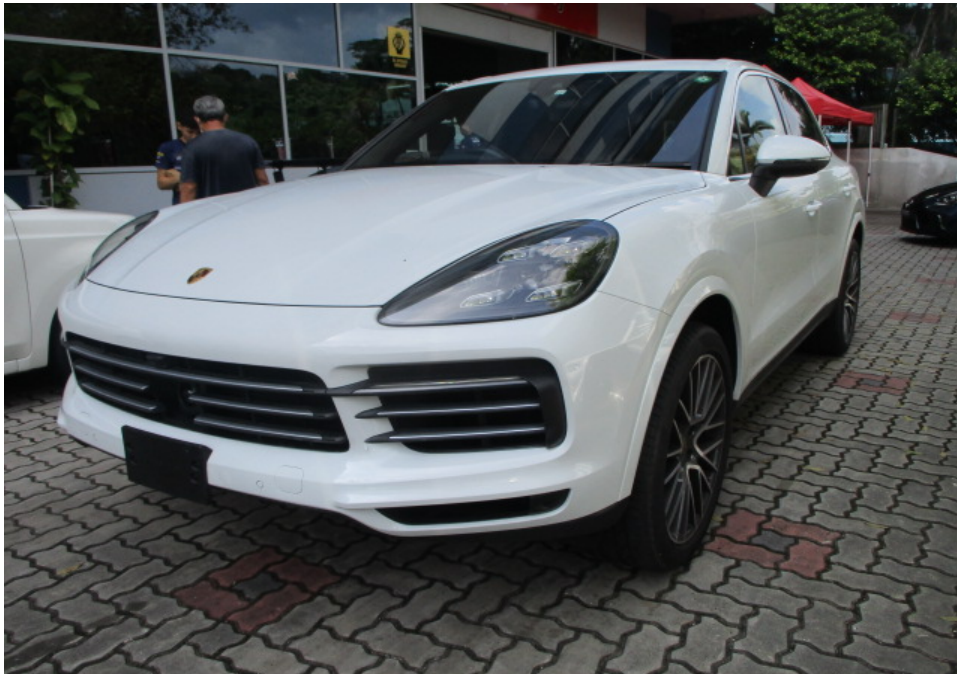
Photo 9 shows a general view of the front left body of the Motor Car at the time of my inspection. The Motor Car was observed to be in a relatively good general condition with no loose exterior fittings observed. The mileage of the Motor Car recorded at the time of my inspection was 8,257km.

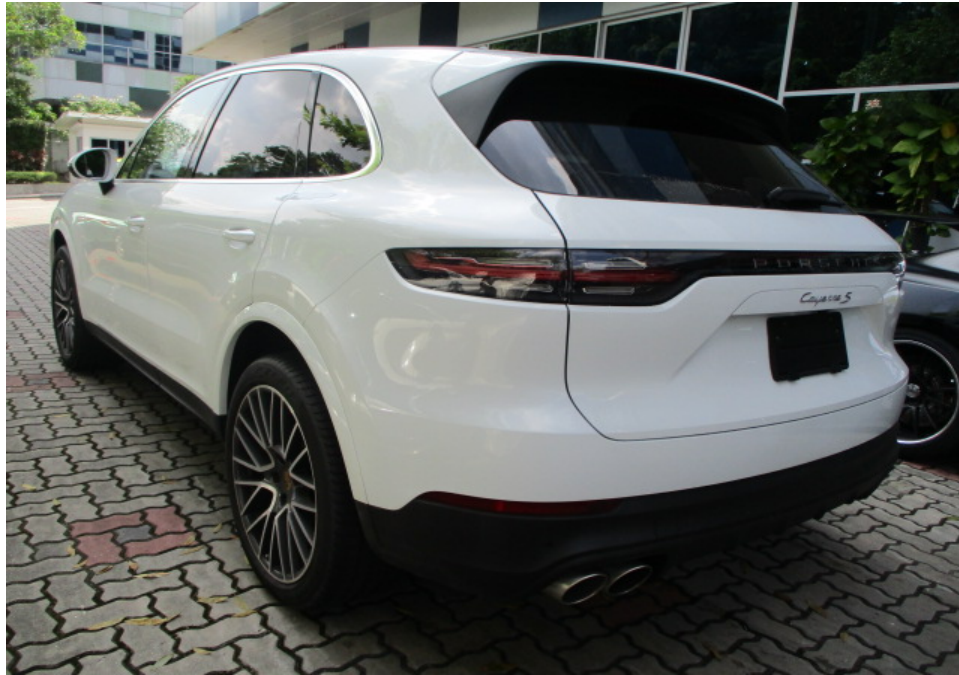
Photo 10 shows a general view of the rear left body of the Motor Car at the time of my inspection. The Motor Car was observed to be in a relatively good general condition with no loose exterior fittings observed. The mileage of the Motor Car recorded at the time of my inspection was 8,257km.

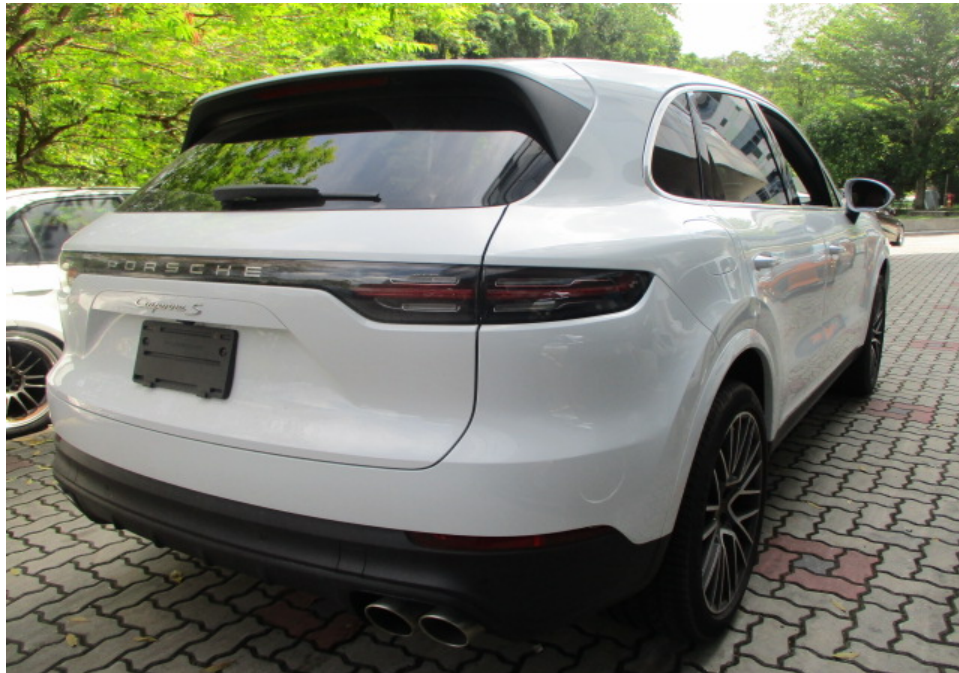
Photo 11 shows a general view of the rear right body of the Motor Car at the time of my inspection. The Motor Car was observed to be in a relatively good general condition with no loose exterior fittings observed. The mileage of the Motor Car recorded at the time of my inspection was 8,257km.

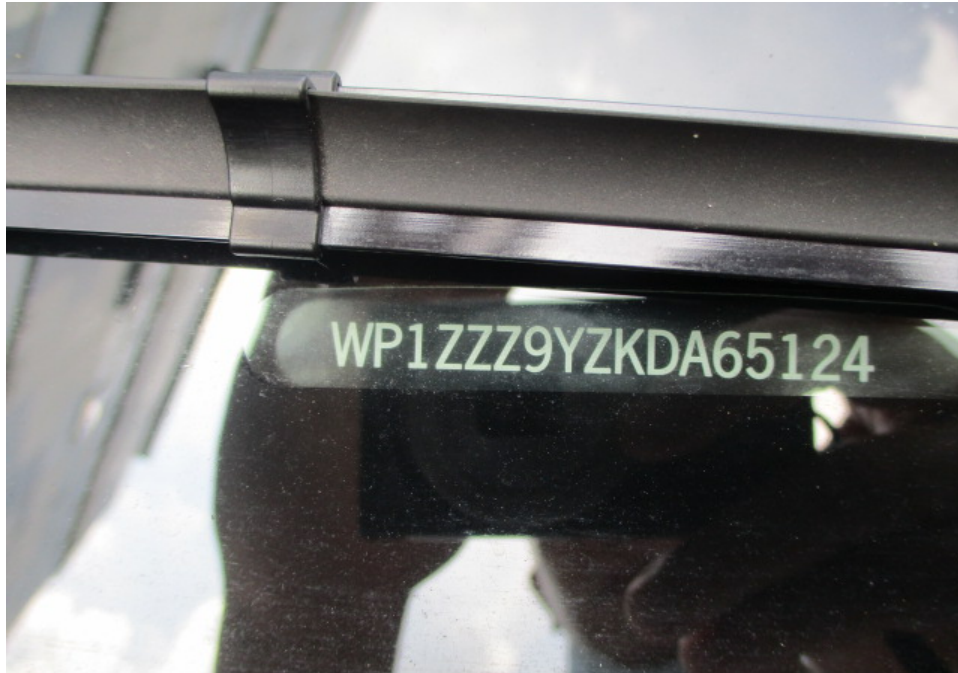
Photo 12 shows the chassis number of the Motor Car. The chassis number recorded was WP1ZZZ9YZKDA65124.

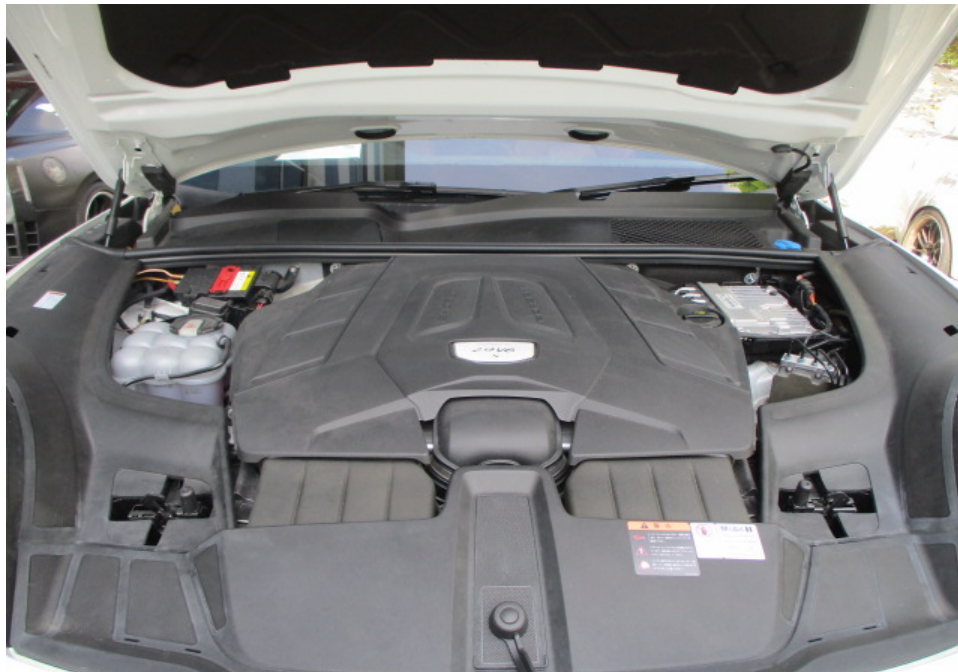
14. My examination of the engine compartment of the Motor Car revealed that the various parts and components inside the engine compartment were all intact and properly fitted. The engine oil, brake fluid and engine coolant were all found to be of sufficient level for operating purposes. Visually, there was also no contamination found to these fluids.

Photo 13 shows a general view of the engine compartment of the Motor Car at the time of my inspection. The various parts and components inside the engine compartment were all observed to be intact and properly fitted. There was also no sign(s) or indication(s) of fluid leak and/or fluid stain found inside the engine compartment.

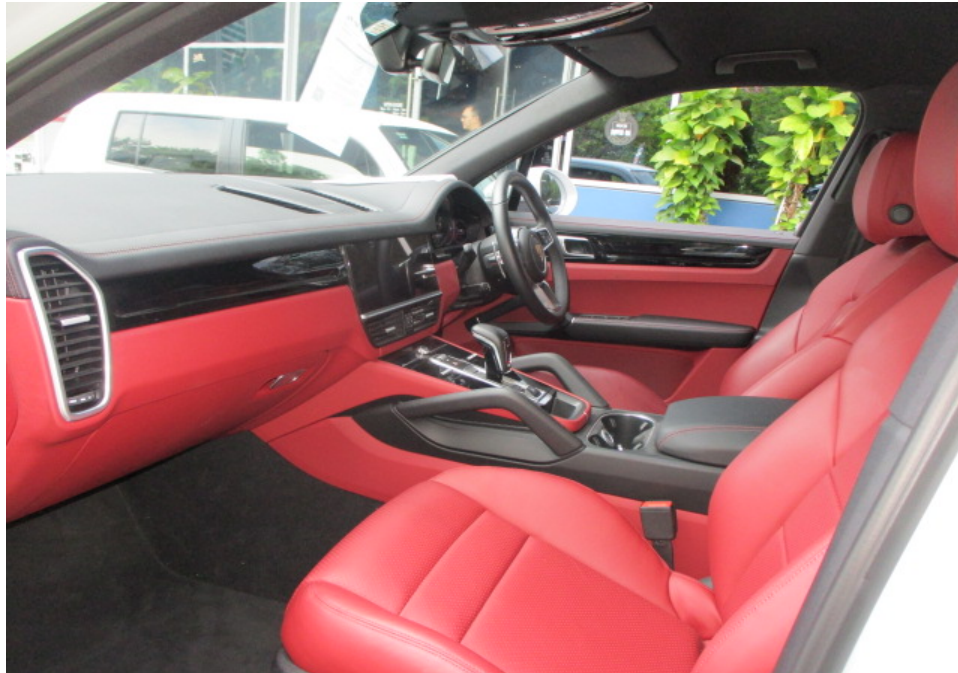
Photo 14 shows the interior compartment of the Motor Car at the time of my inspection. The various parts and components, trims, carpet, and upholstery inside the interior compartment were all observed to be intact and properly fitted.

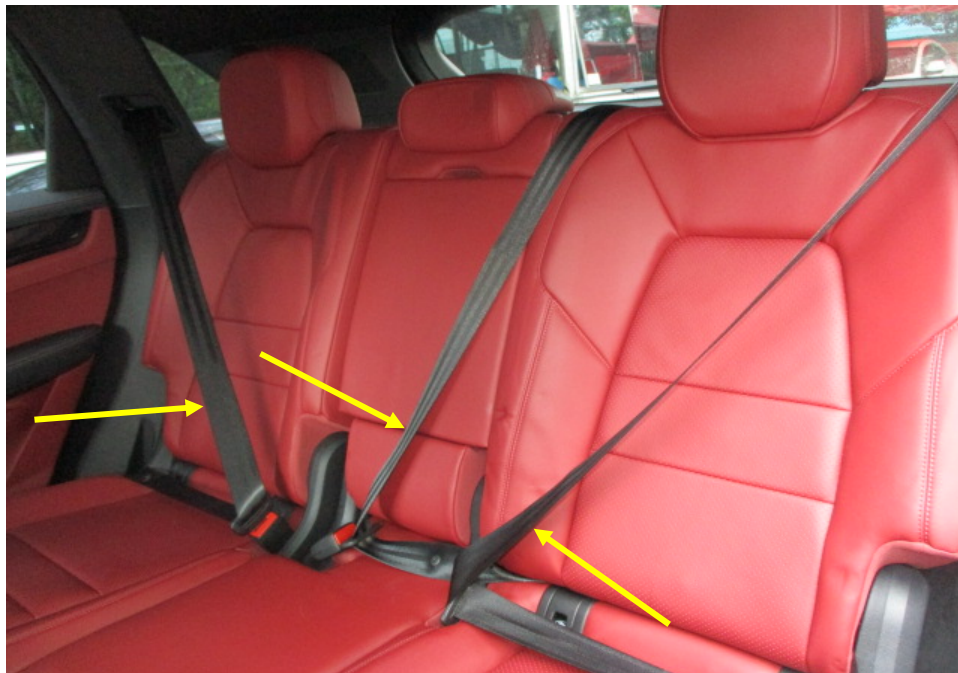
12. The seats of the Motor Car were found to be secured to the floorboard of the Motor Car via seat rails bolted onto the floorboard. Retractable seat belt reels and pre-tensioners were fitted on all seats of the Motor Car. The seat belts were tested and were able to be fastened securely into the respective pre-tensioners that were fixed to the side of all the seats.

Photo 15 shows the rear seats of the Motor Car. All the seats of the Motor Car were secured via seat rails to the floorboard. They were also fitted with a retractable seat belt reel and a pre-tensioner. The seat belts (arrowed) were tested and were able to be fastened into the respective pre-tensions that were fitted on the side of each individual seat.

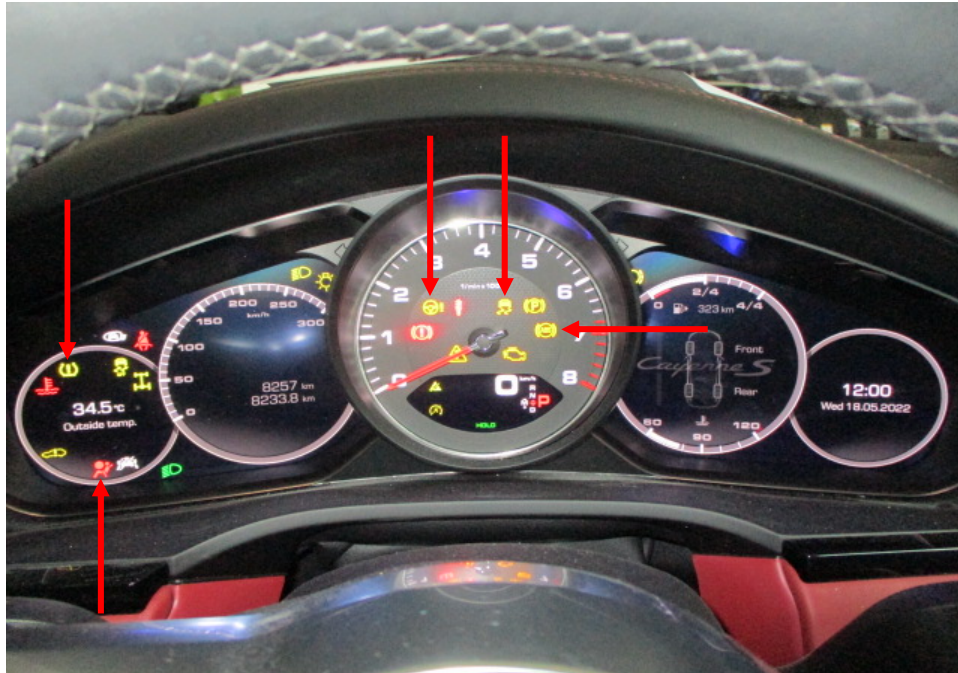
Photo 16 shows the warning lights for the various electronic safety features appearing on the instrument panel of the Motor Car during its self-test when the engine is cranked, in particular the ABS, SRS, EPS, TPM and TCS lights (arrowed).

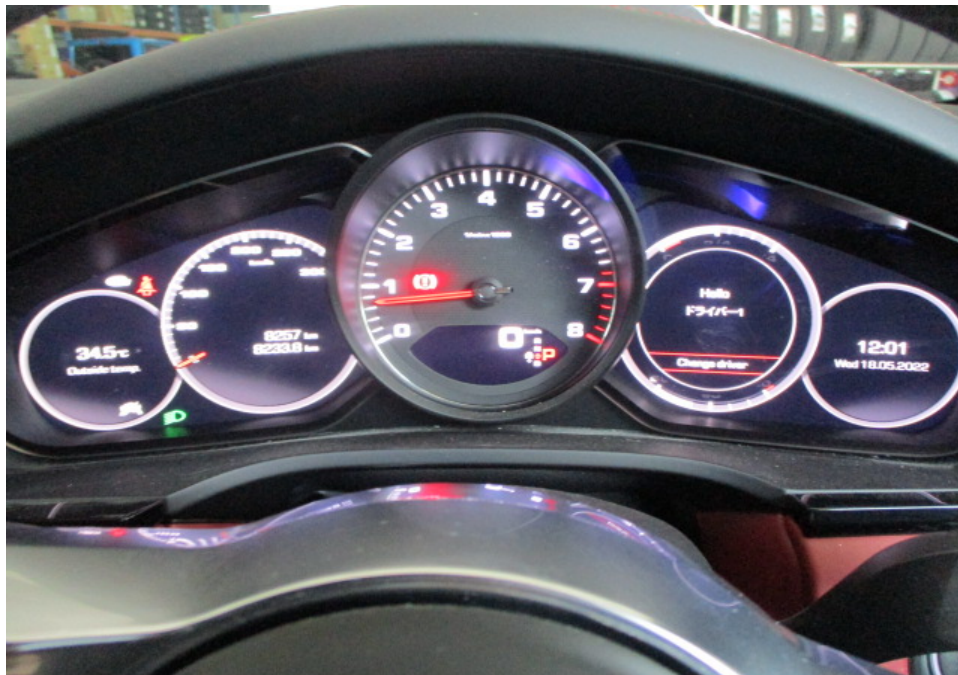
13. The Motor Car's automatic self-test of the functionality of its various electronic safety features like the Anti-Lock Brake System (ABS), Supplemental Restraint System (SRS), Electric Power Steering (EPS), Tyre Pressure Monitor (TPM) and Traction Control System (TCS) during cranking of the engine had indicated that these electronic systems were in working condition. This was determined from the respective warning lights disappearing from the instrument panel after the self-test.

Photo 17 shows the respective warning lights no longer illuminated, indicating that there is no fault detected to the ABS, SRS, EPS, TPM and TCS systems of the Motor Car during the self-test. These electronic systems were hence in working condition at the time of my inspection.

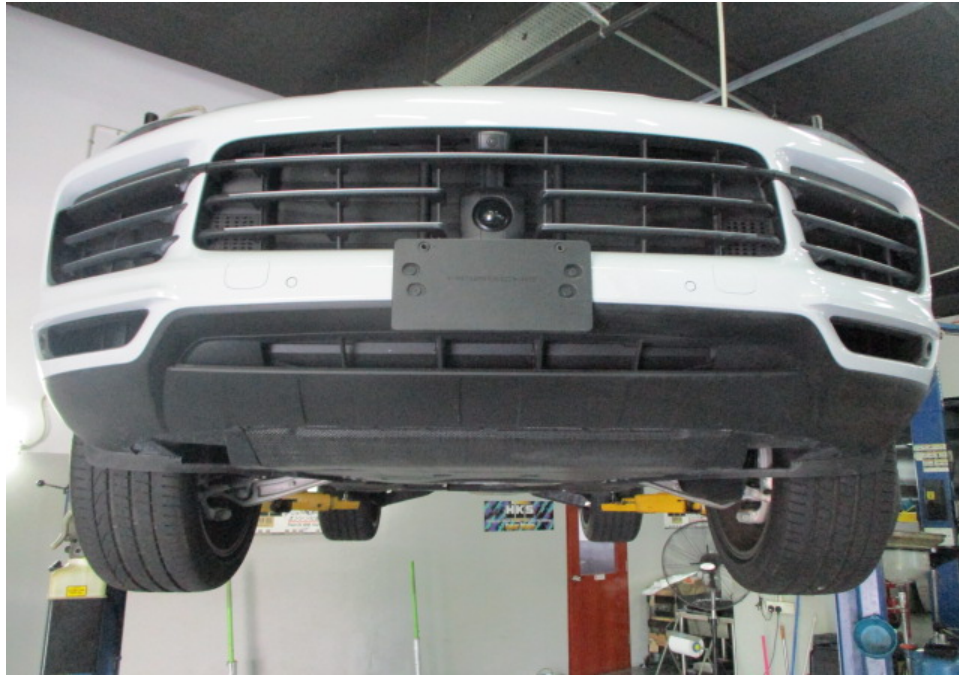
15. My checks on the underside of the Motor Car revealed no sign(s) or indication(s) of fluid leakage and/or fluid stain(s). The engine block and automatic transmission assembly were both secured properly. All undercarriage components of the Motor Car were also observed to be intact and secured in an appropriate manner.

Photo 18 shows the Motor Car hoisted up for checks on its undercarriage. There was no sign(s) or indication(s) of fluid leakage and/or fluid stain(s) on the underside of the Motor Car. The undercarriage components of the Motor Car were also all observed to be intact and secured in an appropriate manner.

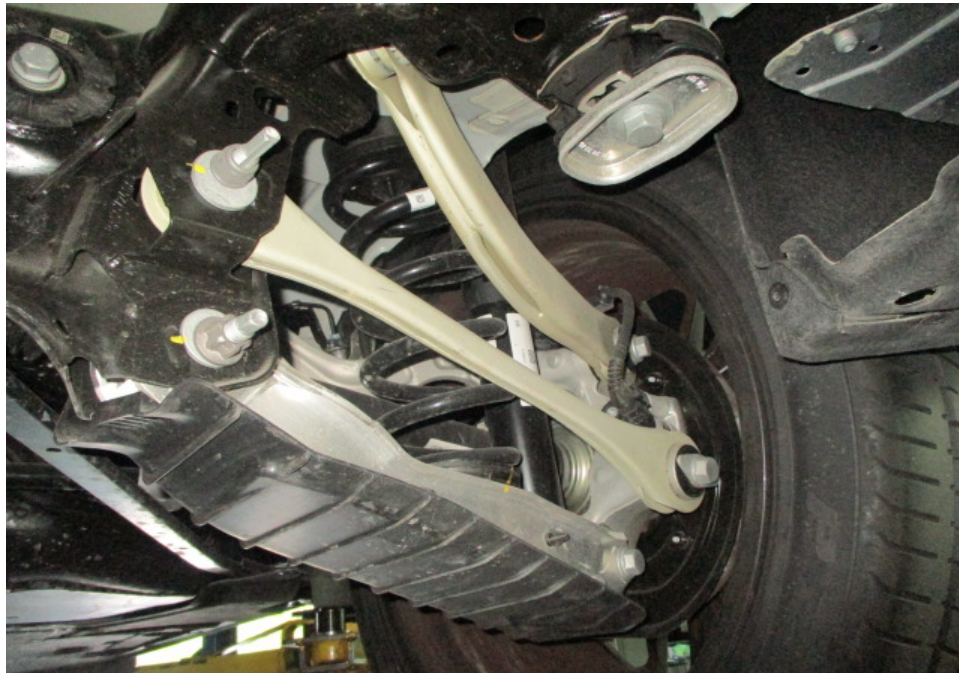
Photo 19 shows a general view of the control arms and linkages at the rear right wheel of the Motor Car. I did not observe any fluid leak and/or fluid stain on the underside of the Motor Car. All of the Motor Car's undercarriage components were observed to be intact and secured in an appropriate manner.

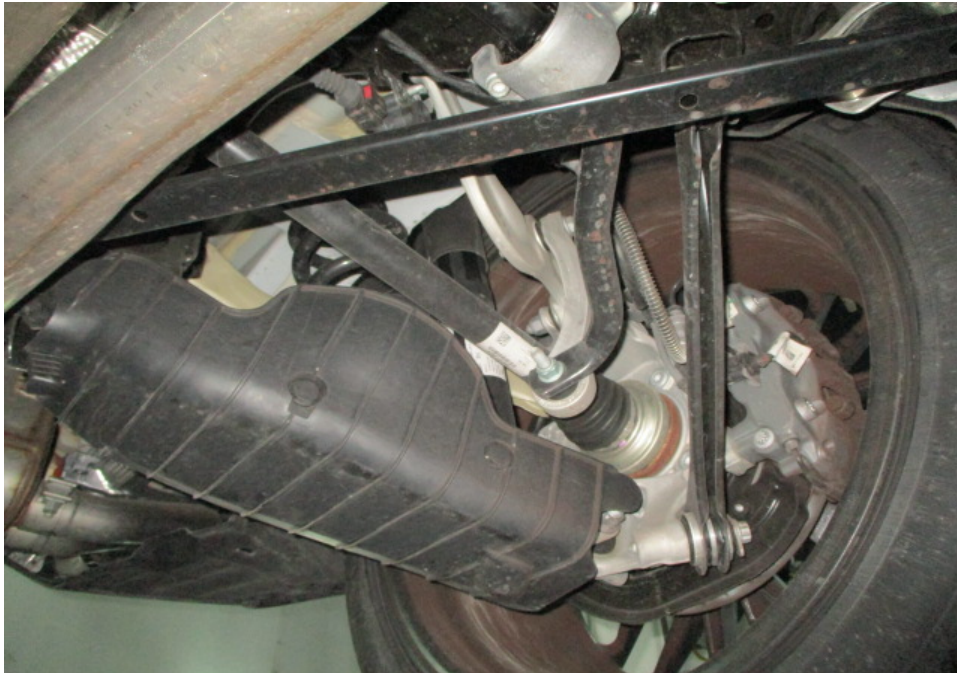
Photo 20 shows a general view of the control arms and linkages at the rear left wheel of the Motor Car. I did not observe any fluid leak and/or fluid stain on the underside of the Motor Car. All of the Motor Car's undercarriage components were observed to be intact and secured in an appropriate manner.

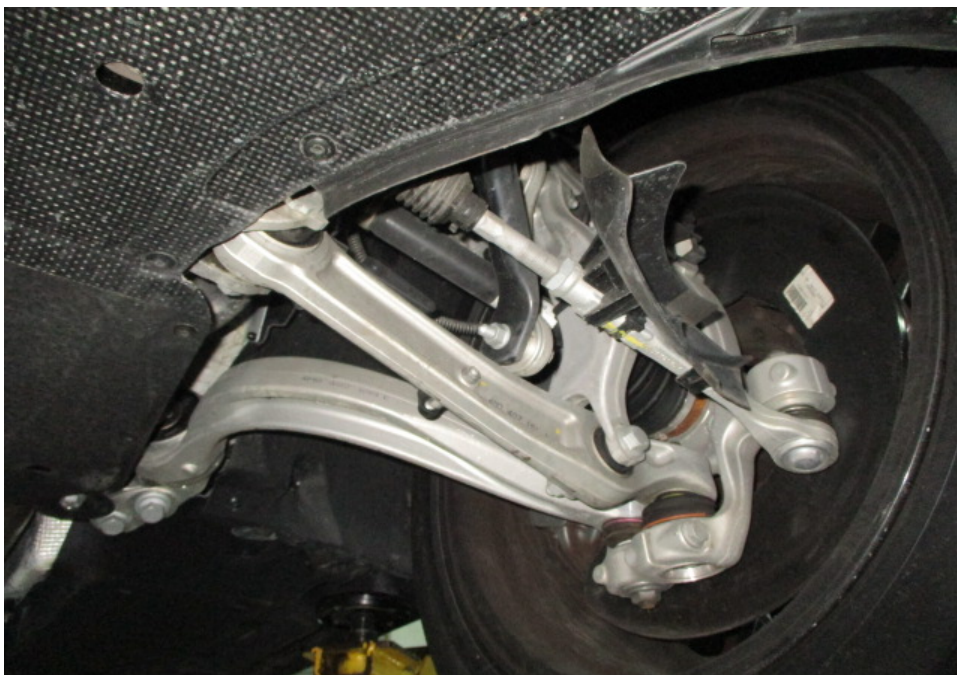
Photo 21 shows the various undercarriage components at the front left wheel of the Motor Car. The mechanical components, control arms and linkages were all found to be intact and secured in an appropriate manner.

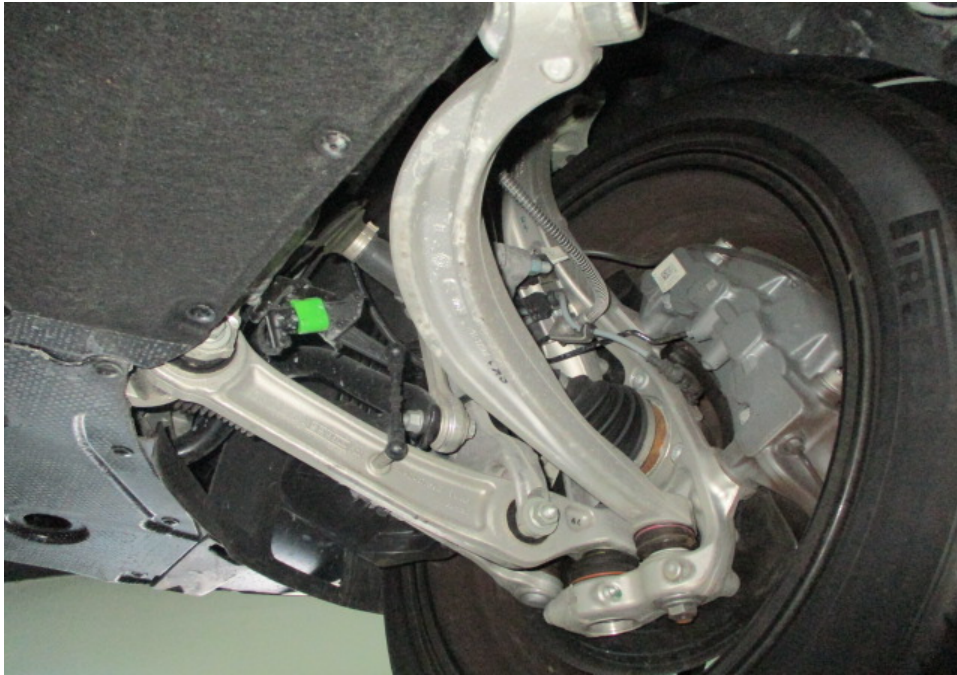
Photo 22 shows the various undercarriage components at the front right wheel of the Motor Car. The mechanical components, control arms and linkages were all found to be intact and secured in an appropriate manner. I also did not observe any fluid leak and/or fluid stain on the underside of the Motor Car.

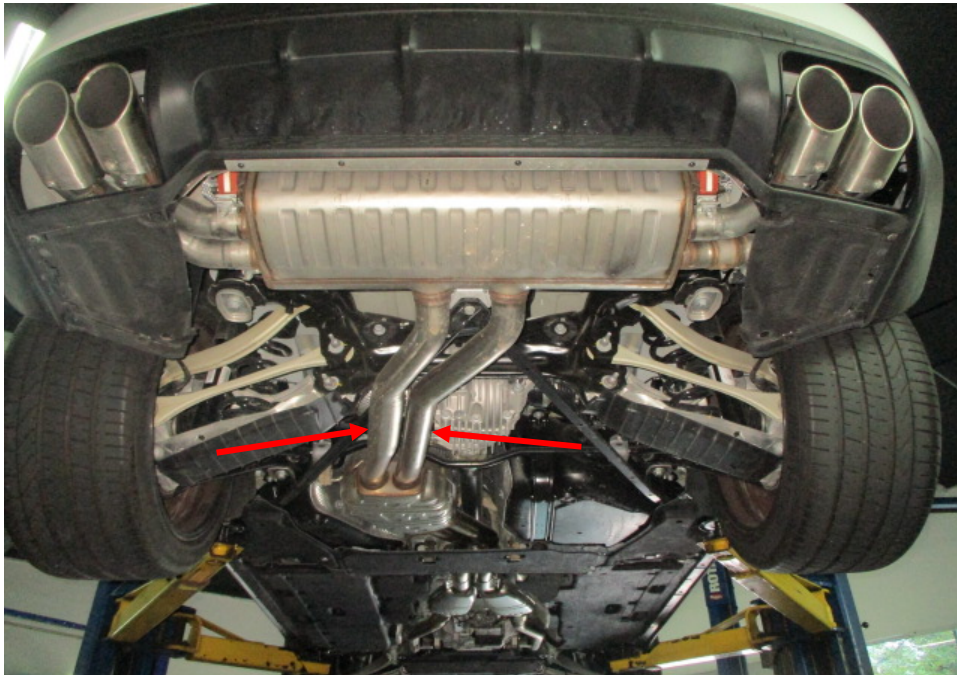
Photo 23 shows the rear section of the Motor Car's exhaust system. My examination of the Motor Car's exhaust system revealed no sign(s) or indication(s) of any cut or weld marks along its exhaust pipes (arrowed), on its rear muffler, on its centre resonator boxes and on its catalytic converters.

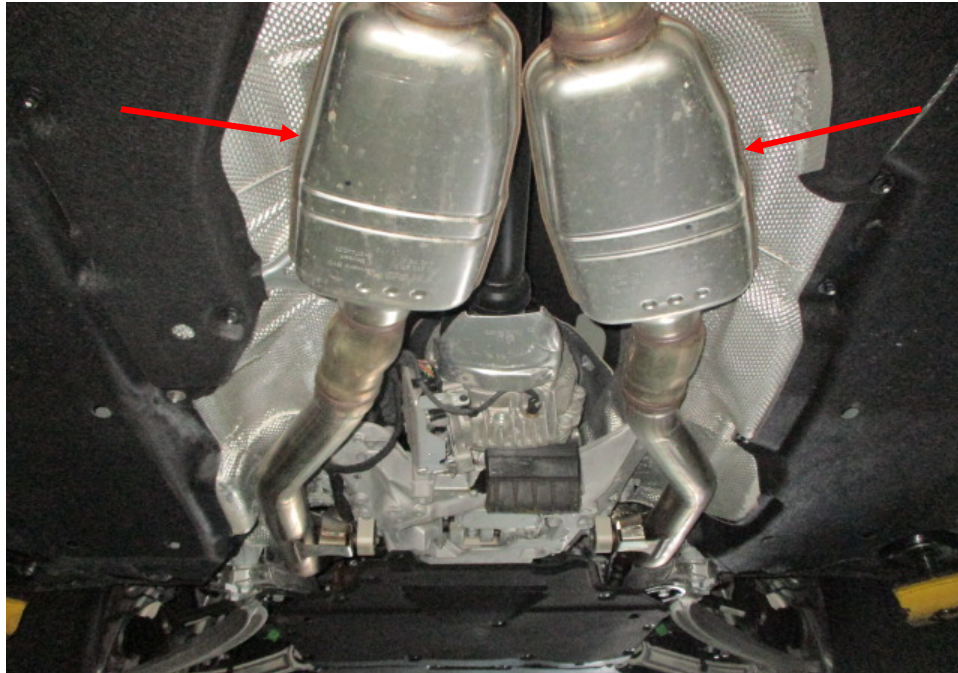
Photo 24 shows the front section of the Motor Car's exhaust system. My examination of the Motor Car's exhaust system revealed no sign(s) or indication(s) of any cut or weld marks along its exhaust pipes, on its rear mufflers, on its centre resonator boxes (arrowed) and on its catalytic converters.

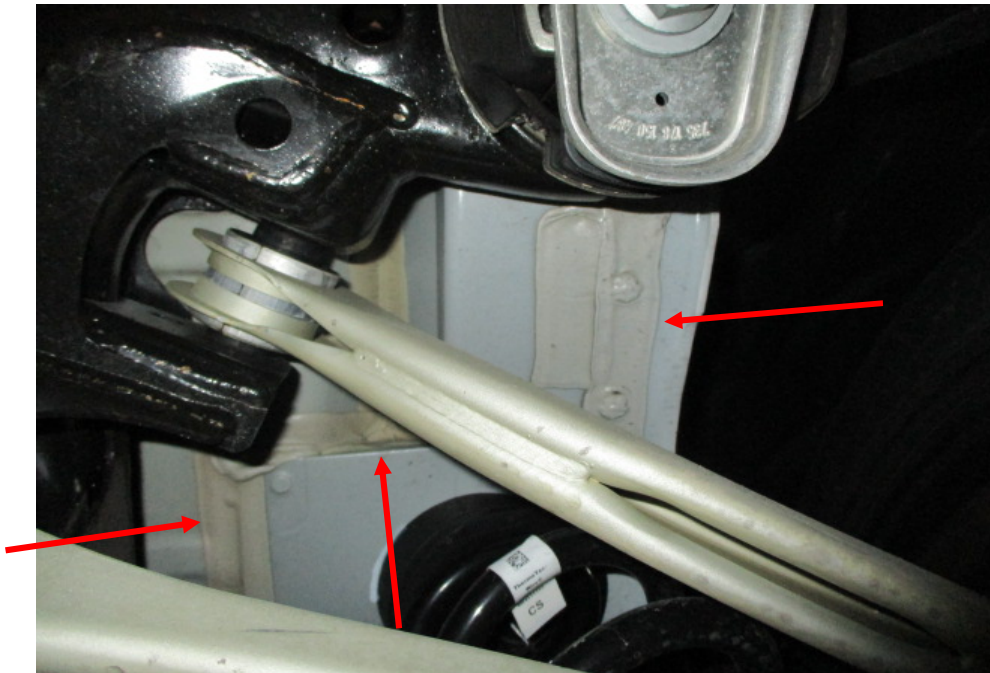
11. Visually, I did not find any weld marks, other than the original spot weld marks, on the chassis/structural body of the Motor Car. The original factory sealant at the joints along the chassis/structural body was also untouched, again indicating that no replacement of the chassis/structural body was carried out; and that the chassis/structural body was originally fitted.

Photo 25 shows the chassis/structural body at the underside rear right of the Motor Car. I did not find any weld marks other than original spot weld marks on the chassis/structural body of the Motor Car. The original factory sealant (arrowed) at the joints along the chassis/structural body was untouched, indicating no work was done on the chassis/structural body of the Motor Car and that the chassis/structural body was originally fitted.

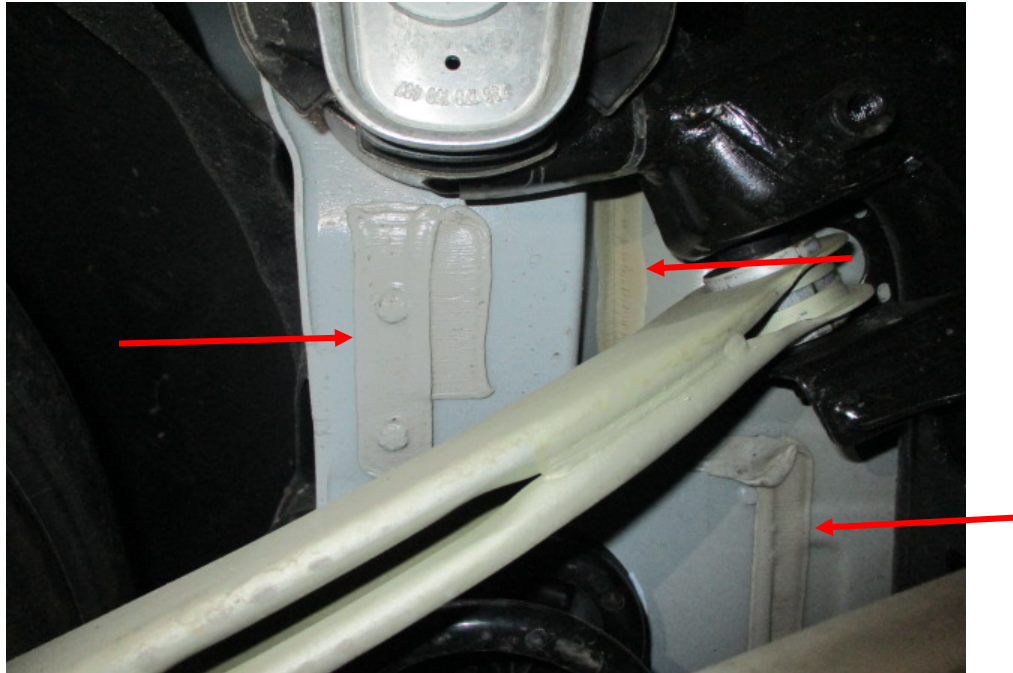
Photo 26 shows the chassis/structural body at the underside rear left of the Motor Car. I did not find any weld marks other than original spot weld marks on the chassis/structural body of the Motor Car. The original factory sealant (arrowed) at the joints along the chassis/structural body was untouched, indicating no work was done on the chassis/structural body of the Motor Car and that the chassis/structural body was originally fitted.

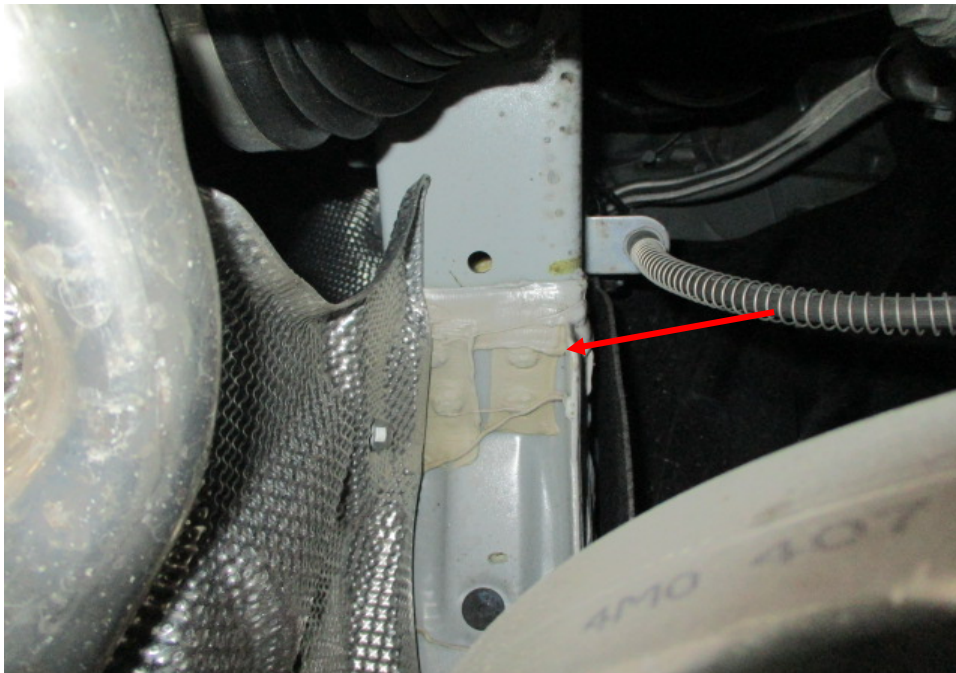
Photo 27 shows the chassis/structural body at the underside front left of the Motor Car. The original factory sealant (arrowed) at the joints along the chassis/structural body was observed to be untouched. In general, I had found no work was carried out on the chassis/structural body of the Motor Car. The chassis/structural body of the Motor Car was originally fitted.

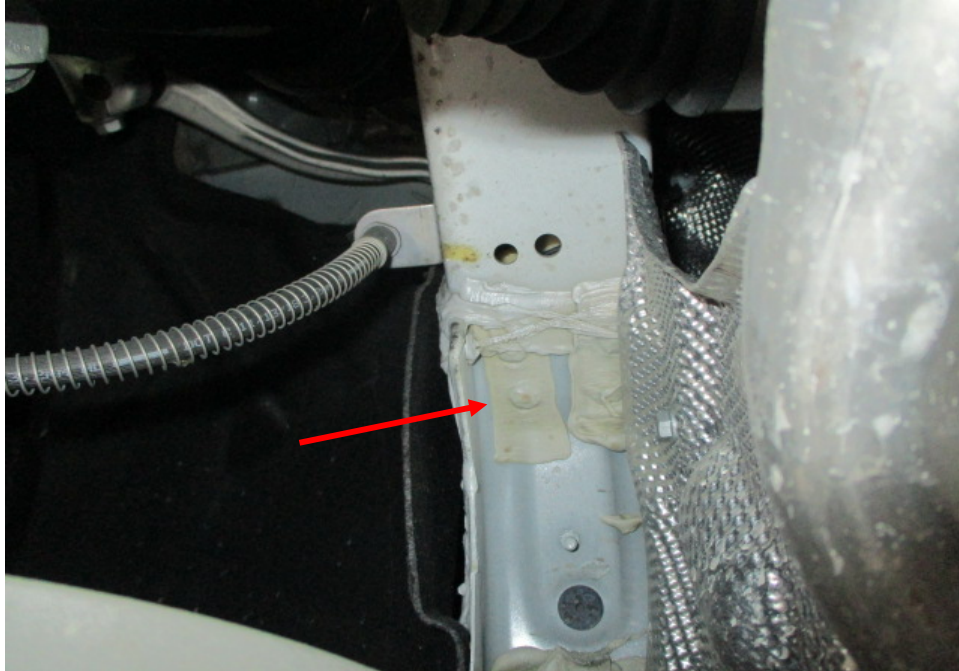
Photo 28 shows the chassis/structural body at the underside front right of the Motor Car. The original factory sealant (arrowed) at the joints along the chassis/structural body was observed to be untouched. In general, I had found no work was carried out on the chassis/structural body of the Motor Car. The chassis/structural body of the Motor Car was originally fitted.
