ASS. REC. BY: (234) REF: CS (CT) 22-	505055/Rty3 819H
	SIGNMENT WEXPIRE 2023 APR
From: Date:	Veh No: SK35963E Yr Regn: 20(3 APL Type: Mc A M.Cycle / Bus / Van / Lorry / Taxl / Prime Mover /
Estimated Cost: OD / TP / WS / TP RES / OD RES / EVA / INV / MV	Truck / Trailer or
To Inspect Vehicle No: SKJ 5963E	Make: ToyorA corolly MINS 1.6 A c.c 1598
at Workshop m/s Ann the succ	Colour CREY A/C: Insured / Std / NI / NA

Full Report Registration: SKJ5963E

Summary Information

Report on Accident on Tuesday 24/5/2022

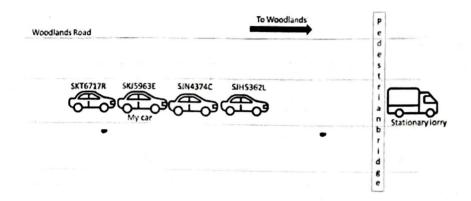
I was driving on the middle lane (SKJ5963E) along Woodlands Road towards Woodlands in the afternoon of Tuesday, 24 May. It was a sunny day. At about 2.13pm shortly after crossing the 10th Mile Junction/Choa Chu Kang flyover, I noticed that the car in front was slowing down, I too also slowed down (around 30km/hr) and kept a safe distance from the car in front. All of a sudden, a white 8MW car (SKT6717R) speeded from the back (appeared to be from left lane) and knocked on the left rear side of my car. The impact was so forceful that I couldn't react on time to stop my car. As a result of the impact, my car rushed forward and it hit on the rear of the car in front of me (SJN4374C) before it came to a stop. As a result, the car in front of my car also rushed forward and knocked on another car (SIH5362L) producing minor damage. The exact location of the accident was just after Bt Panjang Telephone Exchange and outside West View Primary School, just before the pedestrian bridge. The slowing down of the vehicles in front was due to a breakdown of a small lorry in the middle of the road, just below the pedestrian bridge. Both the front and rear of my car was damaged. The rear of my car (left side) was badly damaged and part of the fallen piece (underneath plastic part of the rear bumper) was touching the tyre (causing friction) when I tried to drive my car to the side of the road. I had to use force to pull it out so that it no longer touched the tyre so that I could drive home. The piece is still there but no longer touching the tyre. The car trunk is also unable to close properly.

A= 8KJ 5963E B= SKT6717R C=SJN4374C O=SJH5362L
