You're Ref: TP/IP/08470/2022
Our Ref: CI/TPD22005074/P

Fatal Accident Investigation Team

MECHANICAL INSPECTION REPORT OF MOTOR TAXI SH 9985G

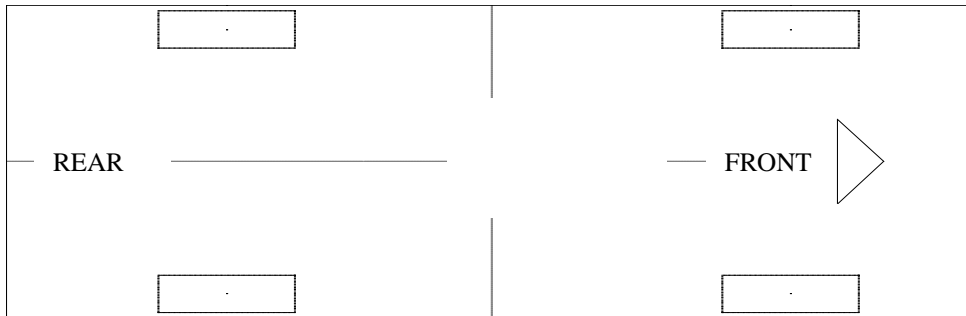
Duraturun 195/65R15 (7.8mm)

Duraturun 195/65R15 (5.7mm)
(deflated) (slip off)

Duraturun 195/65R15 (8mm)

Duraturun 195/65R15 (5.5mm)
(deflated) (slip off)

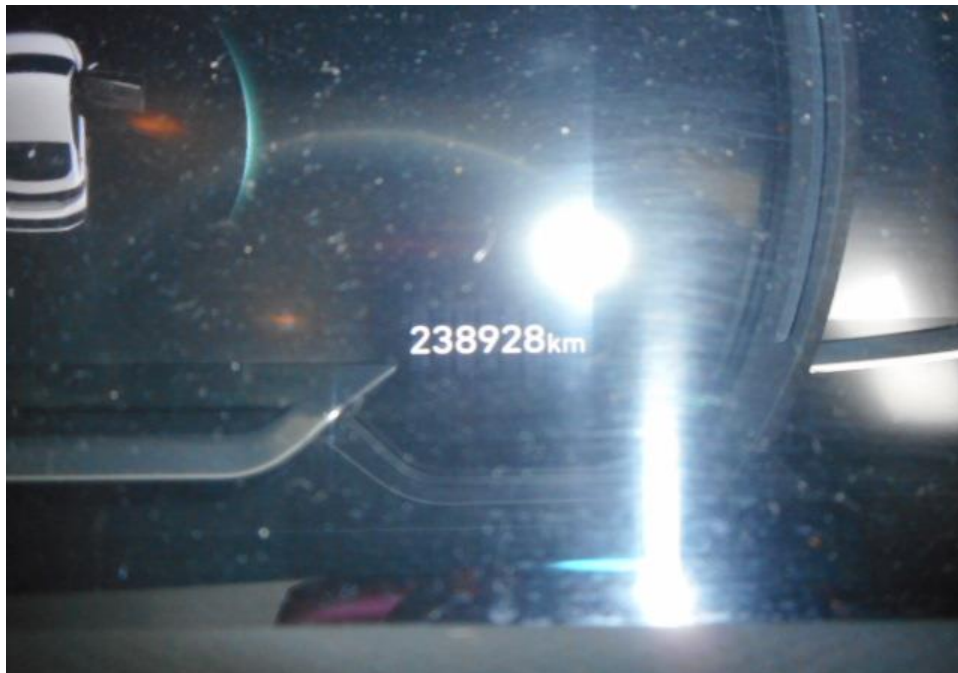
Photo 1 shows the mileage of the Motor Taxi at the time of my inspection. The mileage observed was 238,928km.

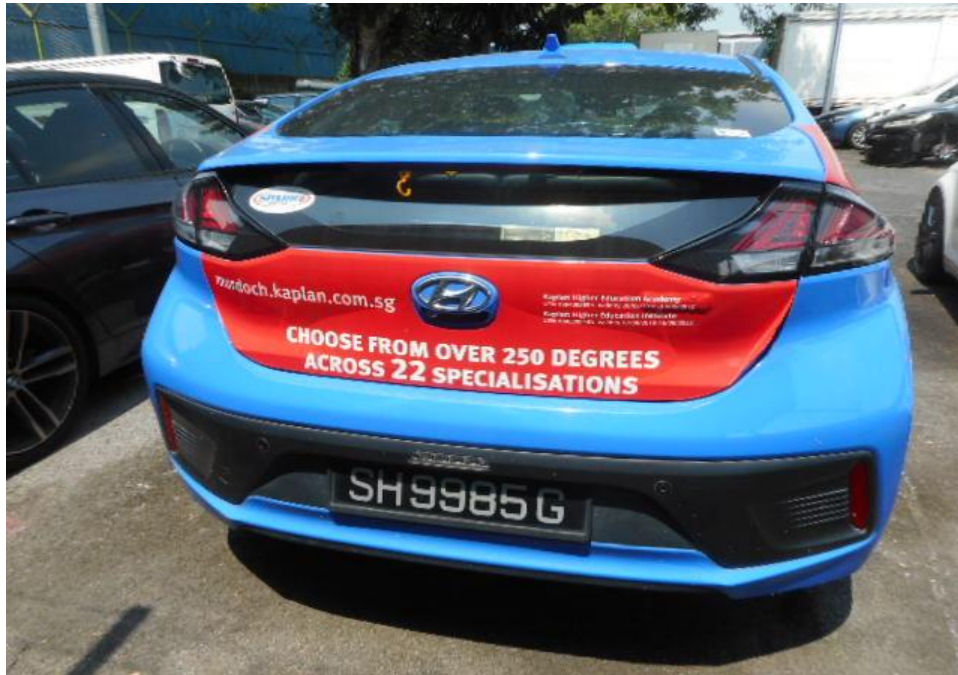
Photo 2 shows the general view of the Motor Taxi's rear body at the time of my inspection. The Motor Taxi rear was observed to be unaffected by the accident.

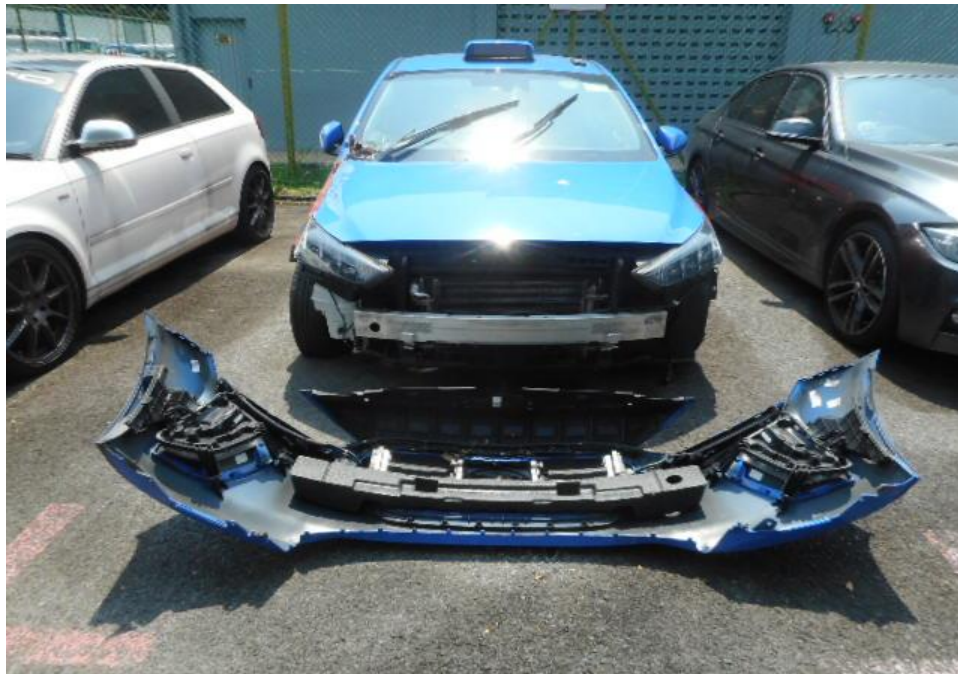
Photo 3 shows a general view of the Motor Taxi's front body at the time of my inspection. The front portion of the Motor Taxi was observed to have sustained damage. Its front windscreen, front bonnet, front bumper and front right fender was the body parts and various engine components were also damaged as a result of the accident.

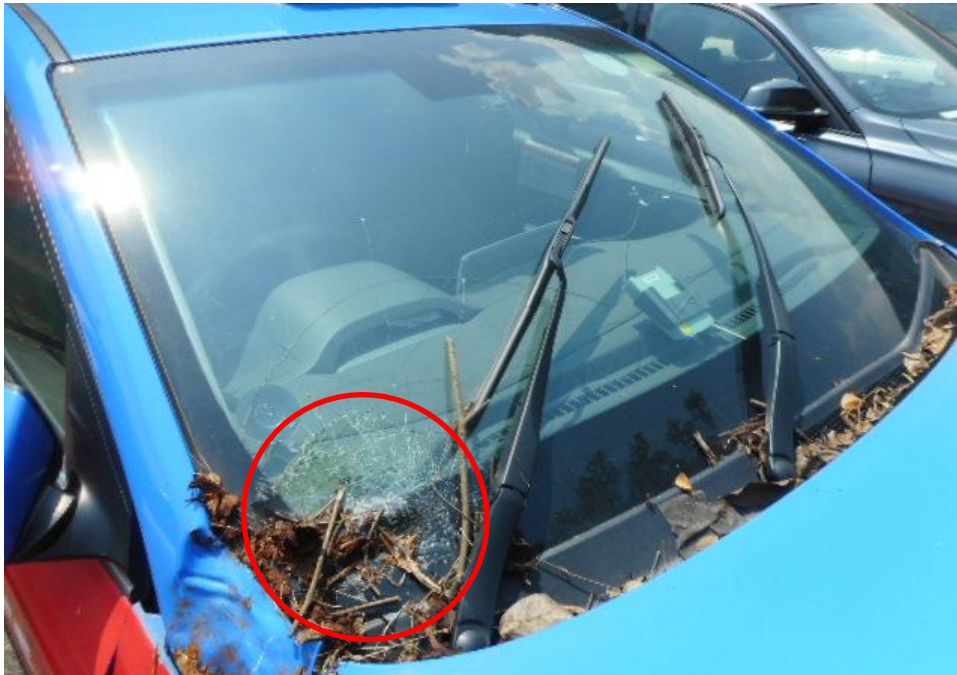
Photo 4 shows the close up view of the Motor Taxi's front body at the time of my inspection. The Motor Taxi was observed to have sustained damage at its front windscreen (circled) as a result of the accident.

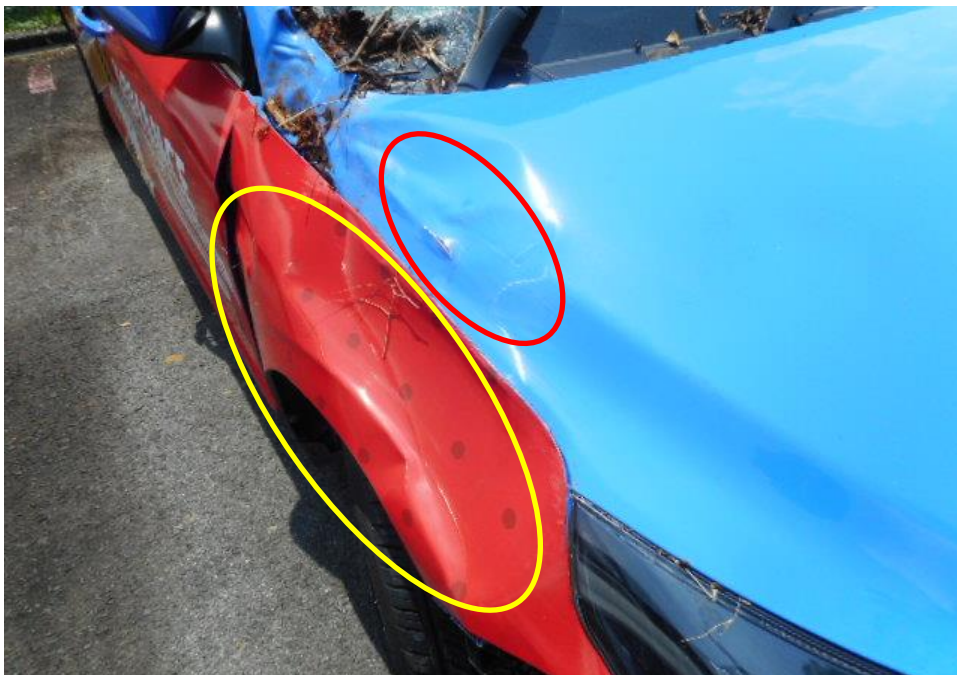
Photo 5 shows the close up view of the Motor Taxi's front body at the time of my inspection. The Motor Taxi was observed to have sustained damage at its front bumper (red circle) and front right fender (yellow circle) as a result of the accident.

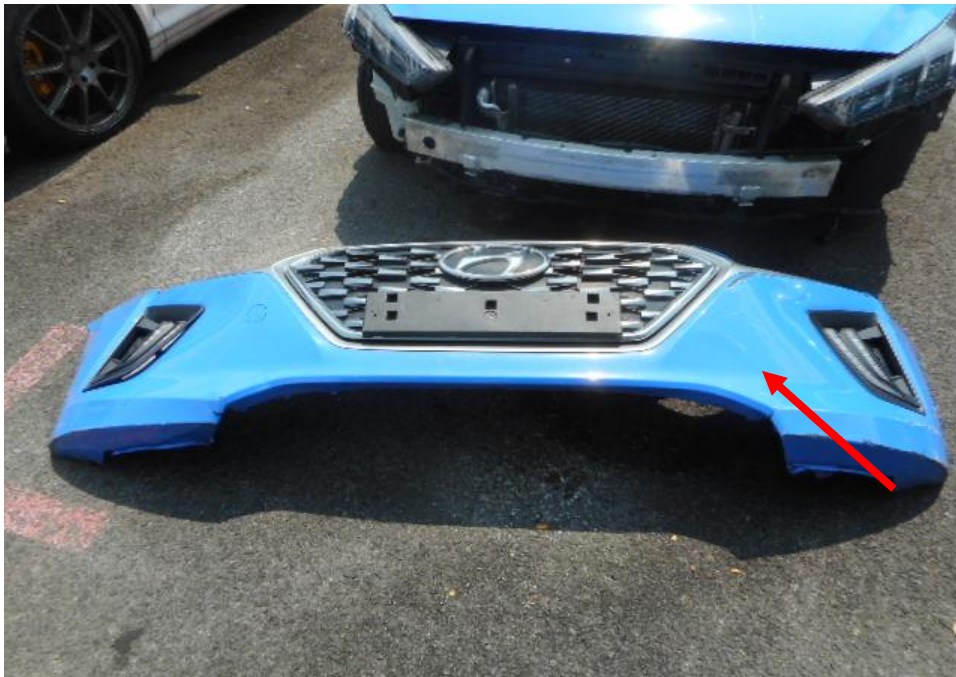
Photo 6 shows the close up view of the Motor Taxi's front body at the time of my inspection. The Motor Taxi was observed to have sustained damage at its front bumper (circled) and front left fender (arrowed) as a result of the accident.

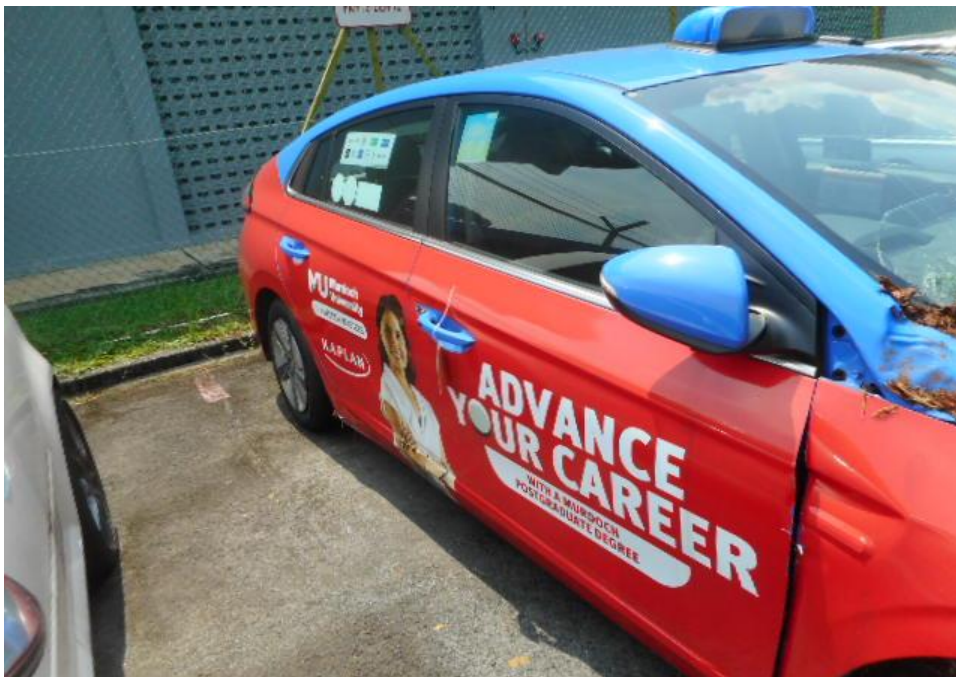
Photo 7 shows a general view of the Motor Taxi's right body at the time of my inspection. The right portion of the Motor Taxi was observed to have been unaffected by the accident.

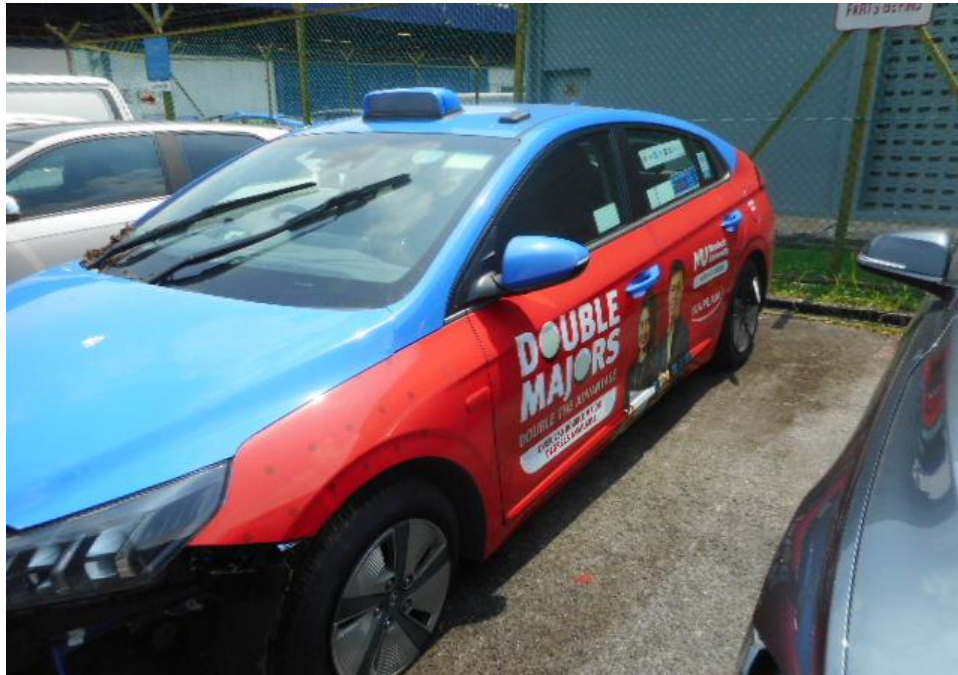
Photo 8 shows a general view of the Motor Taxi's left body at the time of my inspection. The left portion of the Motor Taxi was observed to have been unaffected by the accident.

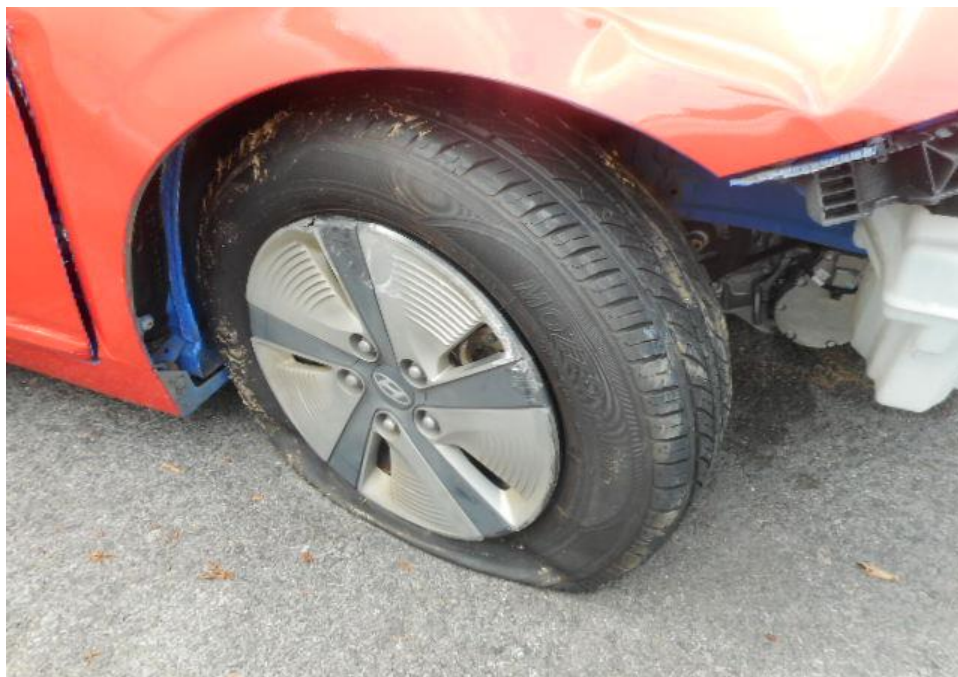
Photo 9 shows the condition of the front right tyre of the Motor Taxi, which was observed to be in unserviceable condition with remaining tread depth of approximately 5.5mm. The tyre was deflated and slip off the wheel rim as a result of the accident. There was no tear, cut or burst mark(s) on the outer and the inner sidewalls as well as across the tread.

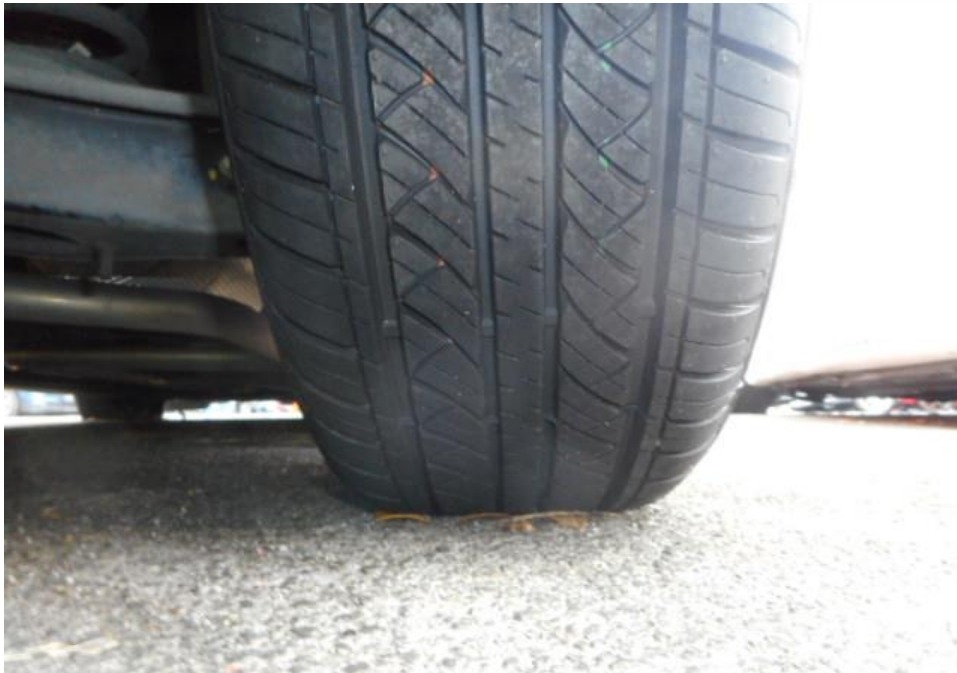
Photo 10 shows the condition of the rear right tyre of the Motor Taxi, which was observed to be in serviceable condition with remaining tread depth of approximately 8mm. The tyre was also observed to be sufficiently inflated for vehicular operation with no tear, cut or burst mark(s).

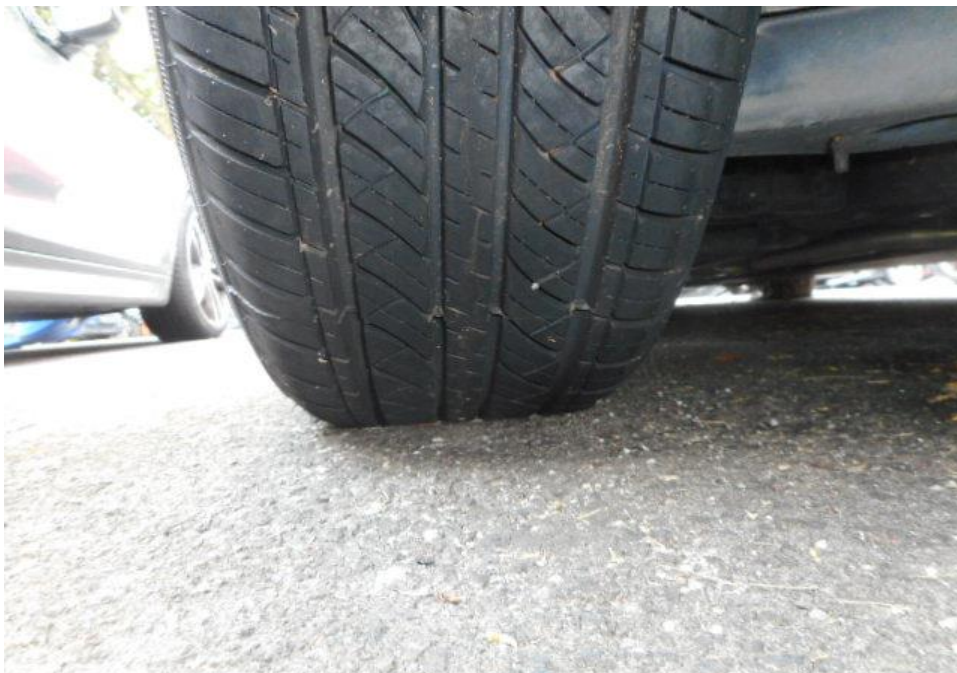
Photo 11 shows the condition of the rear left tyre of the Motor Taxi, which was observed to be in serviceable condition with remaining tread depth of approximately 7.8mm. The tyre, which was wrapped around steel wheel rim, was also observed to be sufficiently inflated for vehicular operation. The 4 tyres of the Motor Taxi were wrapped around standard steel wheel rims.

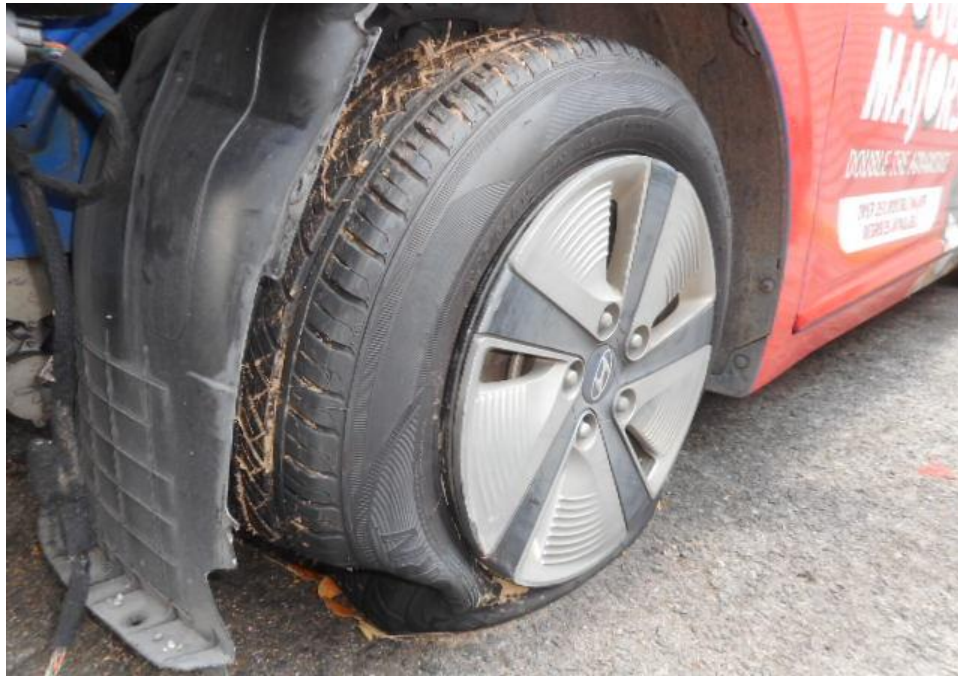
Photo 12 shows the condition of the front left tyre of the Motor Taxi, which was observed to be in unserviceable condition with remaining tread depth of approximately 5.7mm. The tyre was deflated and slip off the wheel rim as a result of the accident. There was no tear, cut or burst mark(s) on the outer and the inner sidewalls as well as across the tread.

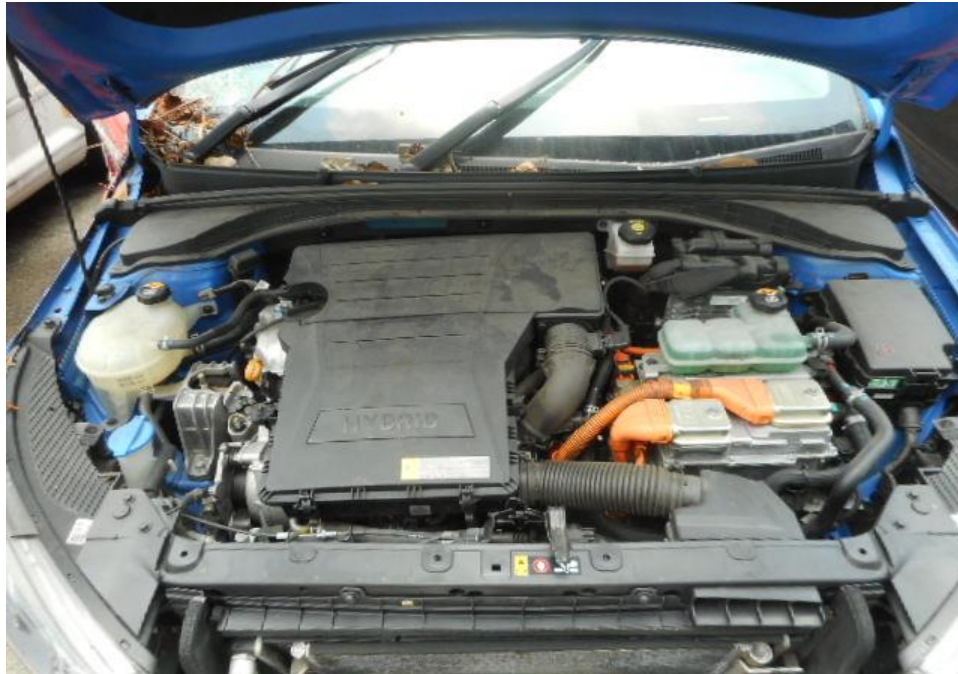
8. Upon examination of the engine compartment of the Motor Taxi, I had observed that the right side engine mounting and the engine coolant hose had been damaged as a result of the accident. The brake fluid, engine oil and were all found to be of sufficient level for operating purposes. Visually, there was also no contamination found to these fluids. However, the engine coolant was observed to be insufficient as the engine coolant hose was damaged by the accident.

Photo 13 shows a general view of the Motor Taxi's engine compartment, I had observed that the right side engine mounting and the engine coolant hose had been damaged as a result of the accident.

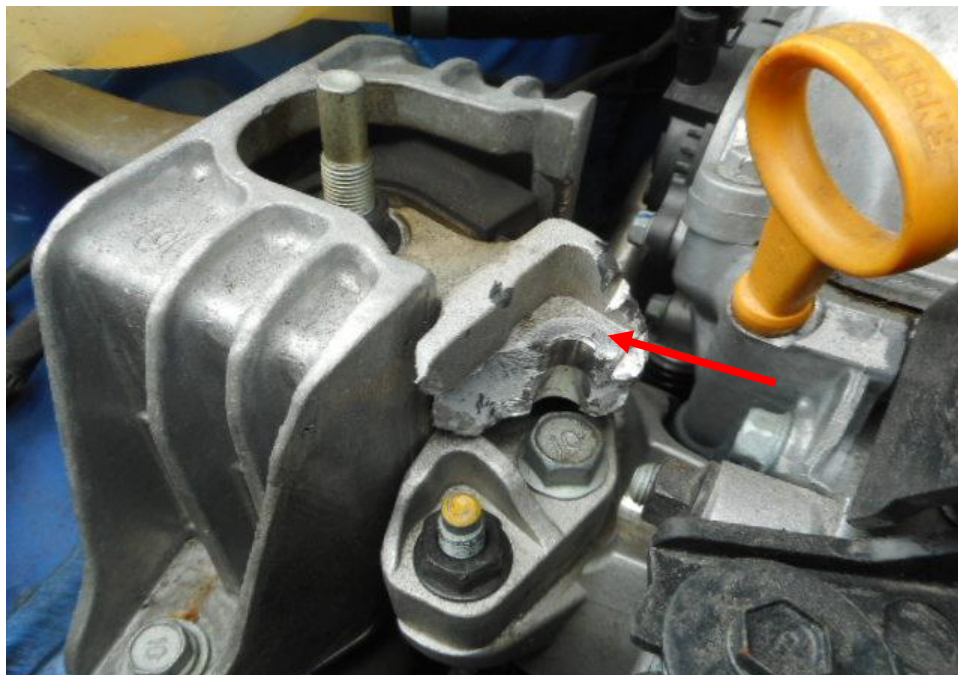
Photo 14 shows the close up view of the right side engine mounting of the Motor Taxi at the time of my inspection. The right side engine mounting (arrowed) of the Motor Taxi was damaged as a result of the accident.

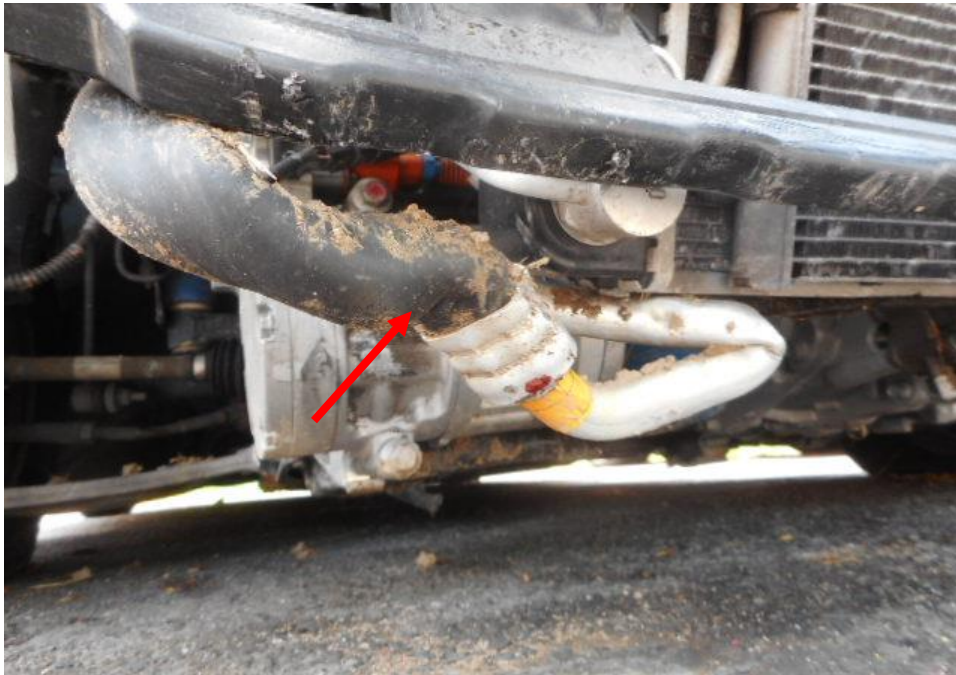
Photo 15 shows the close up view of the engine coolant hose of the Motor Taxi at the time of my inspection. The engine coolant hose (arrowed) of the Motor Taxi was damaged as a result of the accident.

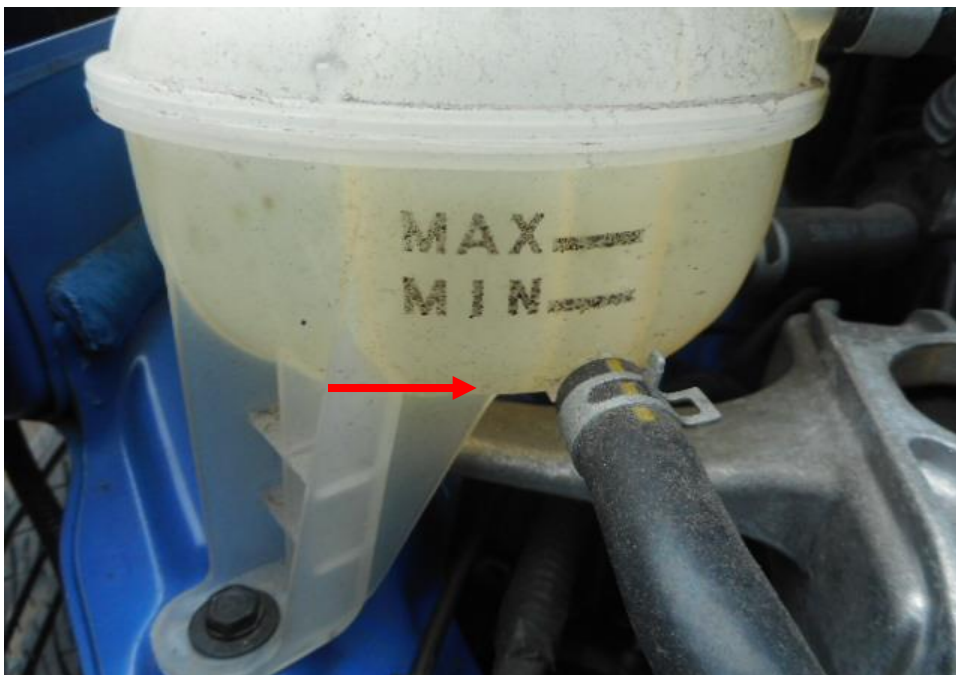
Photo 16 shows checks being carried out to the engine coolant of the Motor Taxi at the time of my inspection. The engine coolant was observed to be of insufficient level (arrowed) as the damage to the engine coolant hose has caused a leakage.

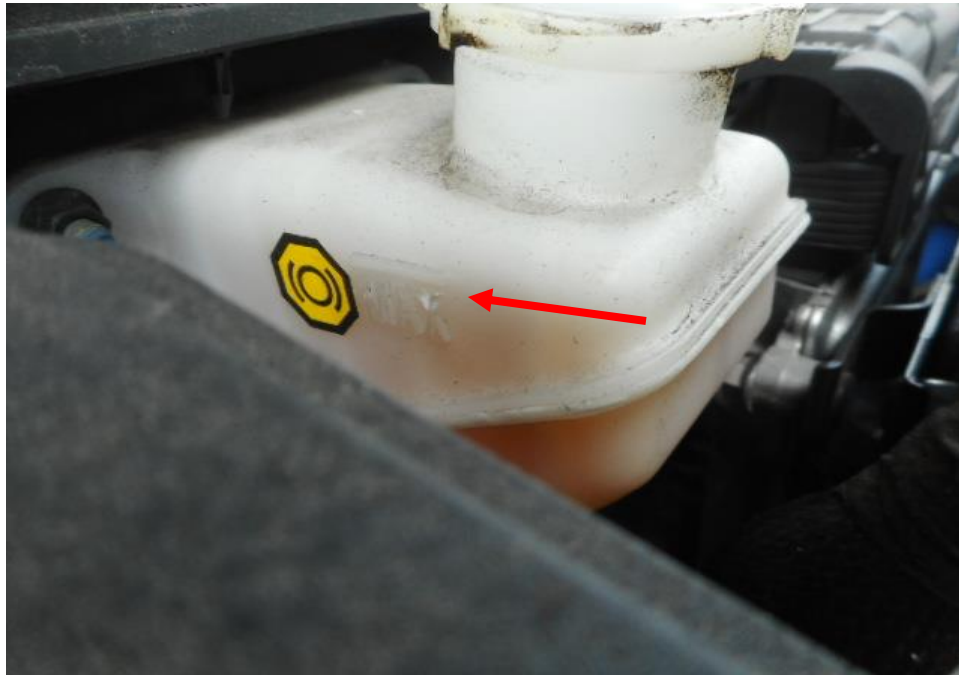
Photo 17 shows the brake fluid reservoir of the Motor Taxi at the time of my inspection. The brake fluid was observed to be of sufficient level (arrowed) and without any visible contamination.

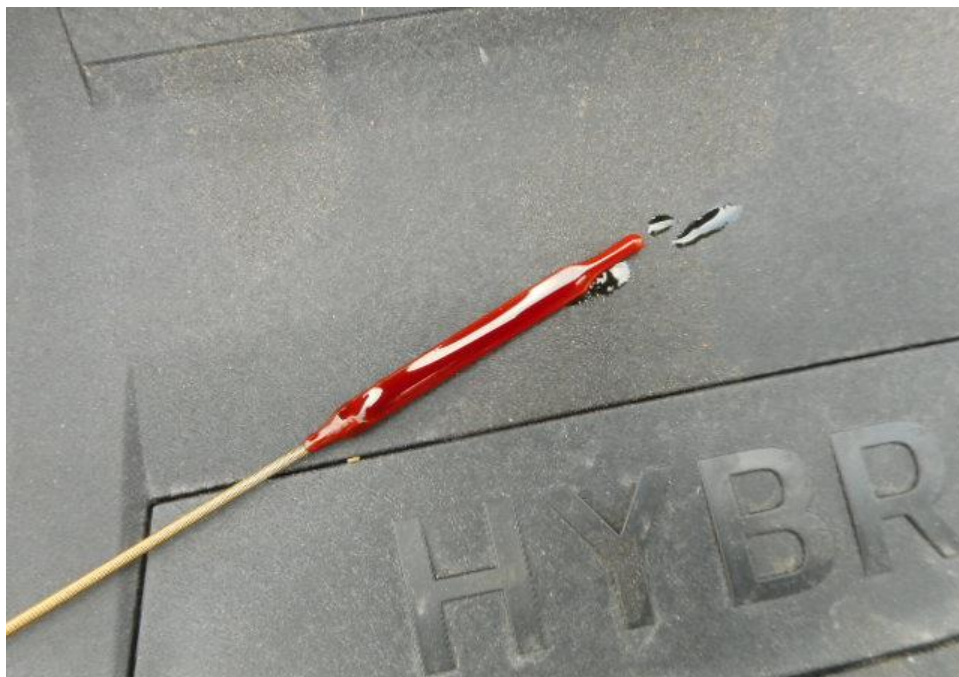
Photo 18 shows the engine oil dip stick of the Motor Taxi at the time of my inspection. The engine oil was observed to be of sufficient level and without any visible contamination.

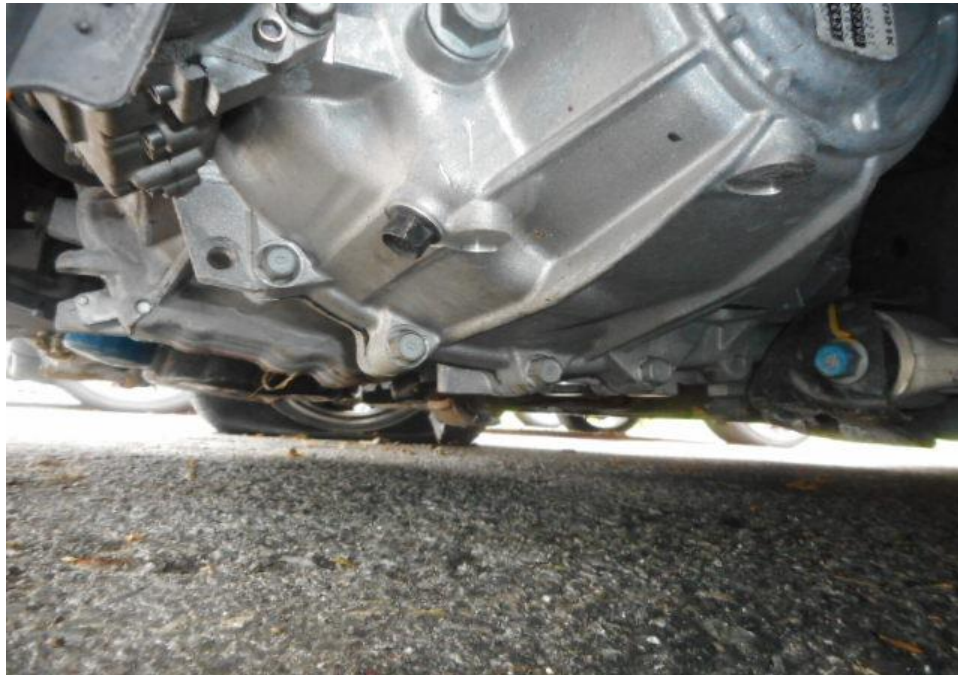
Photo 19 shows the undercarriage of the Motor Taxi, at the area where the engine housing and transmission housing are located. I did not find any sign(s) or indication(s) of fluid leak and/or fluid stain(s) on the underside of the Motor Taxi.

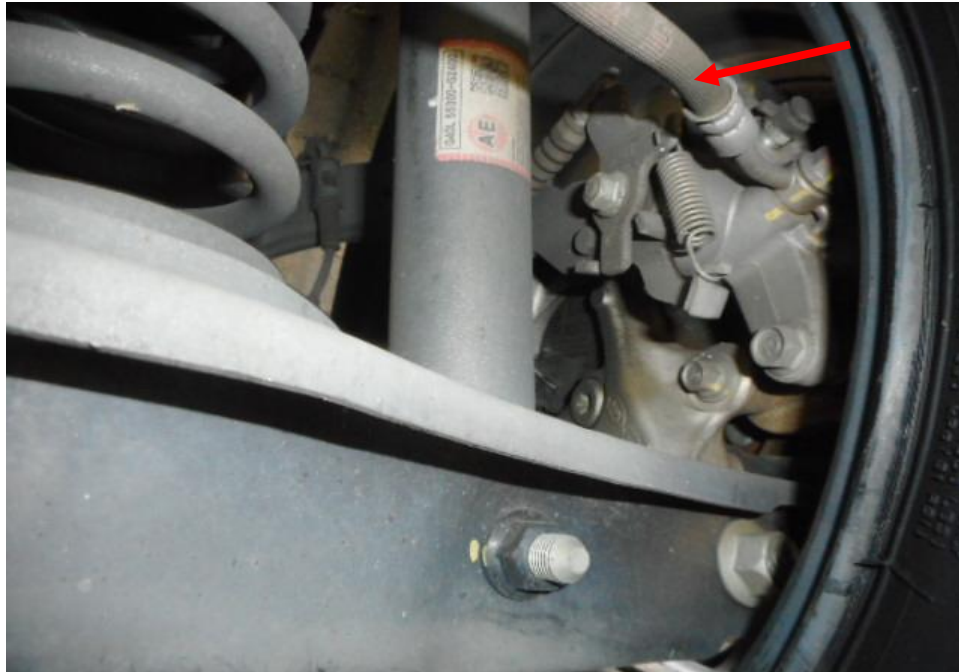
Photo 20 shows the brake hose/pipe (arrowed) at the rear right wheel of the Motor Taxi. No leakage of brake fluid was observed. Visual examination of the various components of the braking system like the drum brake, brake booster, brake pedal etc. had revealed all to be intact and without visible damage.

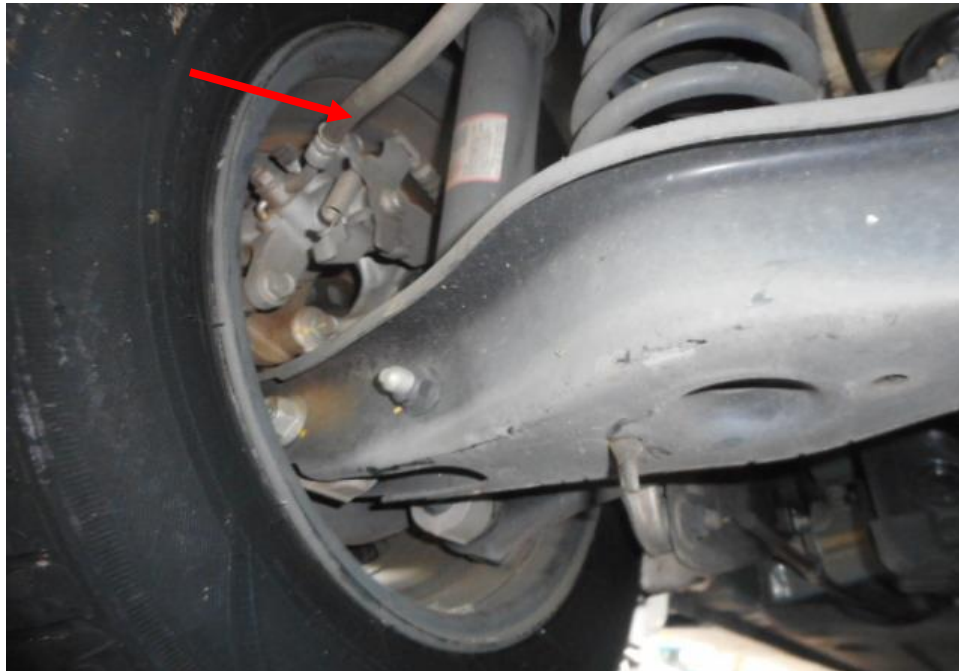
Photo 21 shows the brake hose/pipe (arrowed) at the rear left wheel of the Motor Taxi. I did not observe any leakage of brake fluid at the time of my inspection of the Motor Taxi. Static tests of the Motor Taxi's braking system had indicated that there was no internal leakage of pressure/vacuum. The undercarriage components of the Motor Taxi were also all found to be intact and without any visible damage.

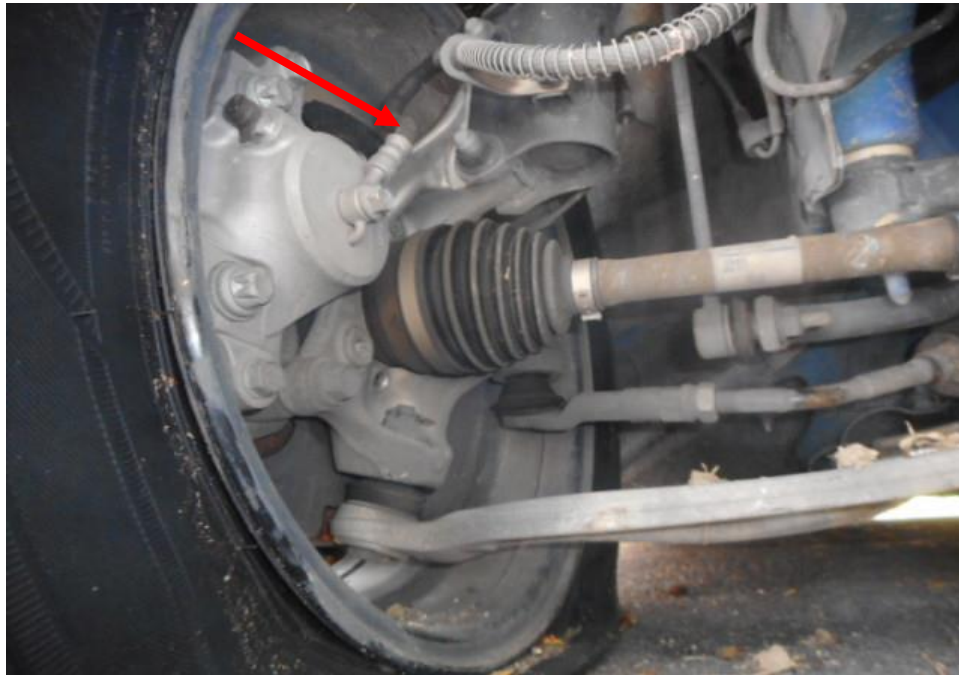
Photo 22 shows the brake hose/pipe (arrowed) at the front right wheel of the Motor Taxi. I did not observe any leakage of brake fluid at the time of my inspection of the Motor Taxi. Static tests of the Motor Taxi's braking system had indicated that there was no internal leakage of pressure/vacuum. The undercarriage components of the Motor Taxi were also all found to be intact and without any visible damage.

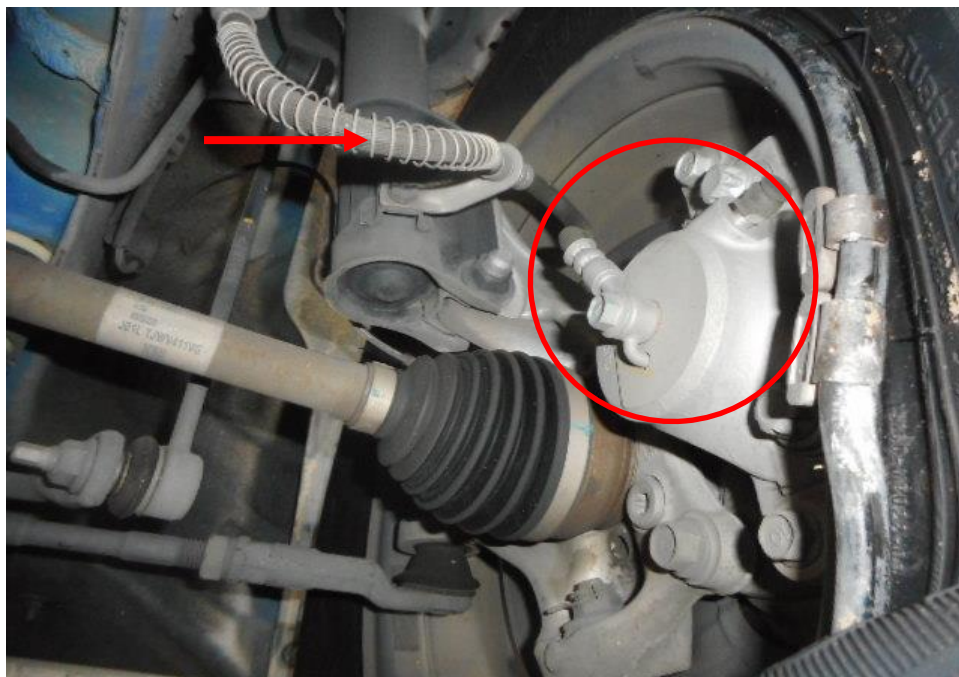
Photo 23 shows the brake hose/pipe (arrowed) at the front left wheel of the Motor Taxi. No leakage of brake fluid was observed. Visual examination of the various components of the braking system like the brake caliper (circled), brake booster, brake pedal etc had revealed all to be intact and without visible damage.

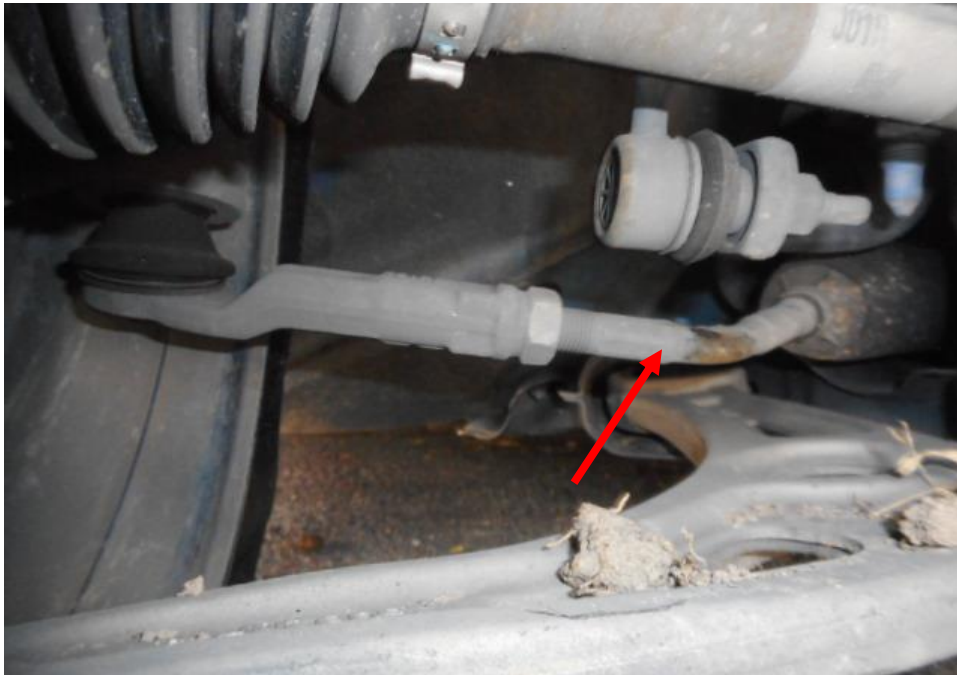
12. Static test on the steering system of the Motor Taxi also revealed abnormality to the steering system. I experienced resistance when turning the steering wheel left and right to full lock positions as my visual examination of the various steering components had revealed that the front right tie rod had sustained damaged as a result of the accident. However, the other components such as the steering rack and pinion, tie rod of the left side, tie rod ends and ball joints revealed that these components were all generally in good condition. See photo 20 - 25 below.

Photo 24 shows the various undercarriage components at the front right wheel of the Motor Taxi, in particular the steering tie rod (arrowed) was observed to be damaged as a result of the accident.

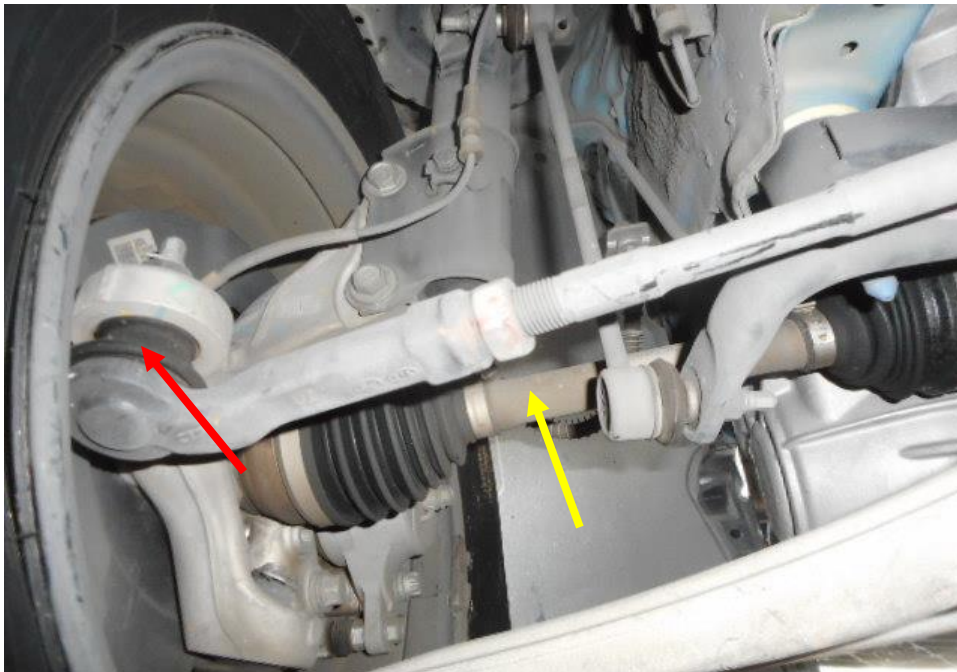
Photo 25 shows the various undercarriage components at the front left wheel of the Motor Taxi, which had included the steering tie rod (arrowed) and drive shaft (yellow arrow). The various undercarriage components of the Motor Taxi were all found to be intact without any visible damage.

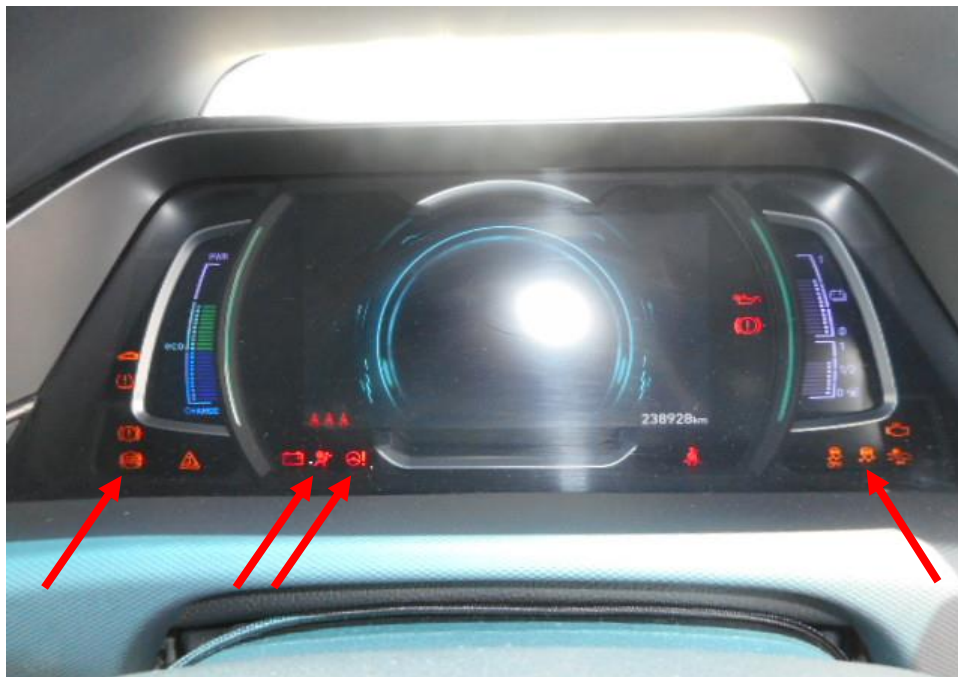
Photo 26 shows the warning light for Anti-Lock Brake System (ABS) and Power Steering System (EPS), Supplemental Restraint System (SRS) and Traction Control (TC) (arrowed) appearing on the instrument panel of the Motor Taxi during the self-test of its various electronic operating systems when its engine was cranked.

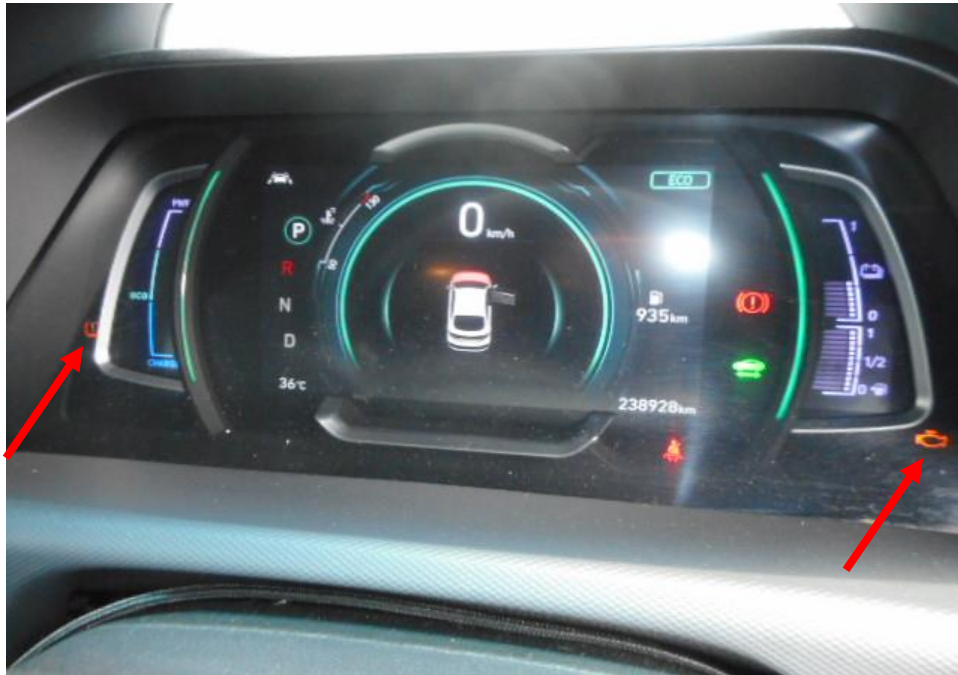
Photo 27 shows no warning lights illuminated on the instrument panel of the Motor Taxi after the engine was cranked. This would suggest that there was no abnormality to the electronic operating system of the Motor Taxi, like the ABS, EPS, SRS, and TC etc. However, only the engine and Tyre Pressure Monitoring System (TPMS) (arrowed) light remained illuminated as a result of the insufficient coolant in the engine as a result of the damaged coolant hose and the deflated front left and right tyres caused by the accident.
