Your Ref: TP/IP/08326/2022  
Our Ref: CI/TPD22005077/P

**Fatal Accident Investigation Team**

**MECHANICAL INSPECTION REPORT OF MOTOR LORRY YN 7543J**

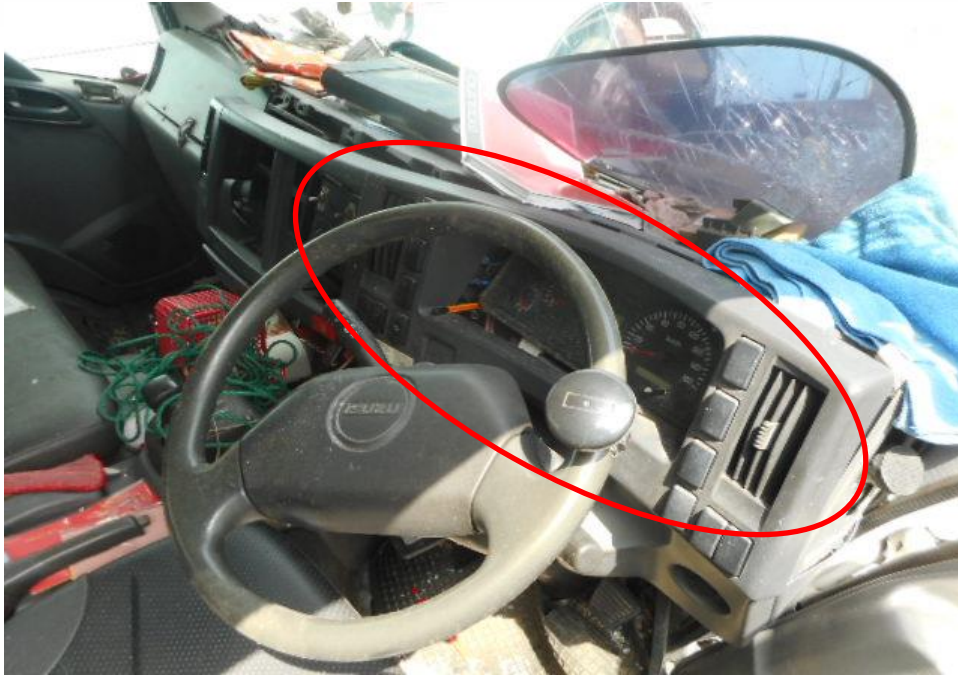
**Photo 1** shows the close up view of the front portion of the Motor Lorry at the time of our inspection. The Motor Lorry was observed to have sustained major damages to its dashboard (circled) that was crushed due to the accident's impact.

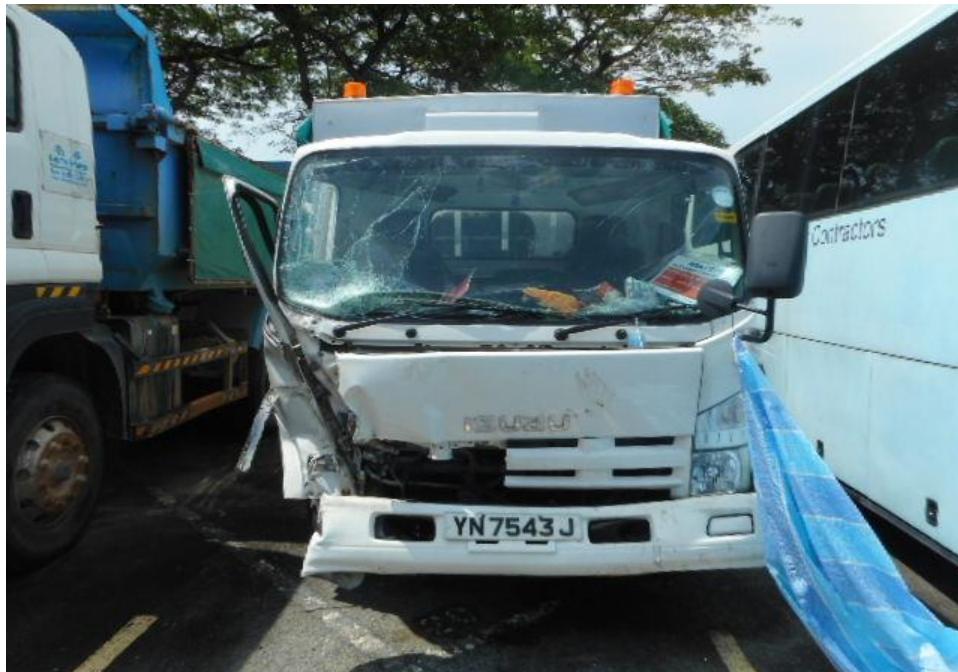
**Photo 2** shows a general view of the front portion of the Motor Lorry at the time of our inspection. The Motor Lorry was observed sustained major damages to its front windscreen, front body panel and front bumper portion as well as its right door as a result of the accident.

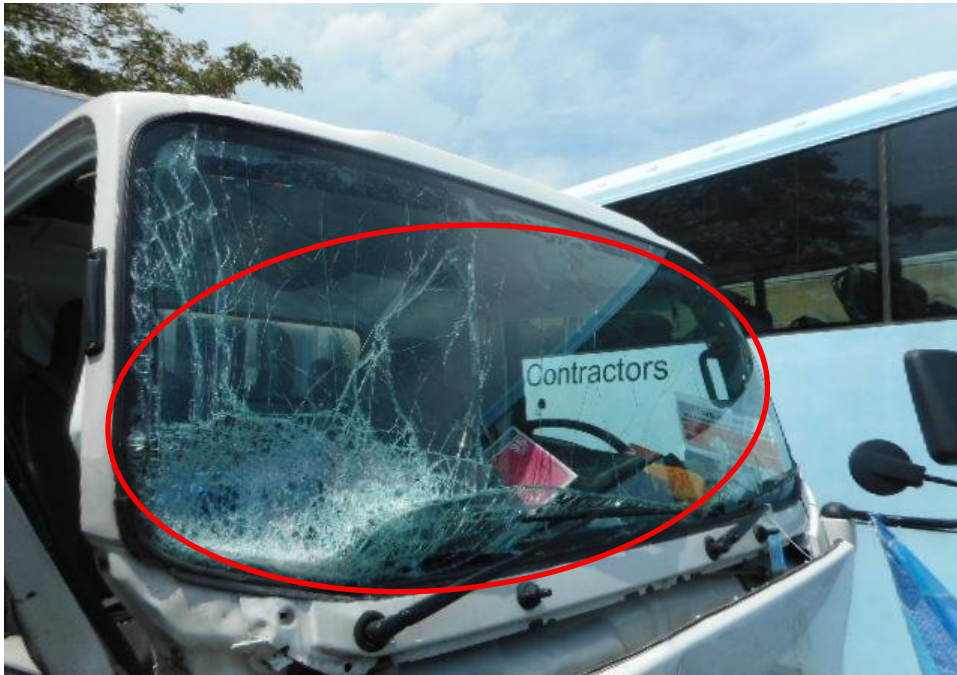
**Photo 3** shows the close up view of the front portion of the Motor Lorry at the time of our inspection. The Motor Lorry was observed to have sustained major damages to its front windscreen (circled) as a result of the accident.

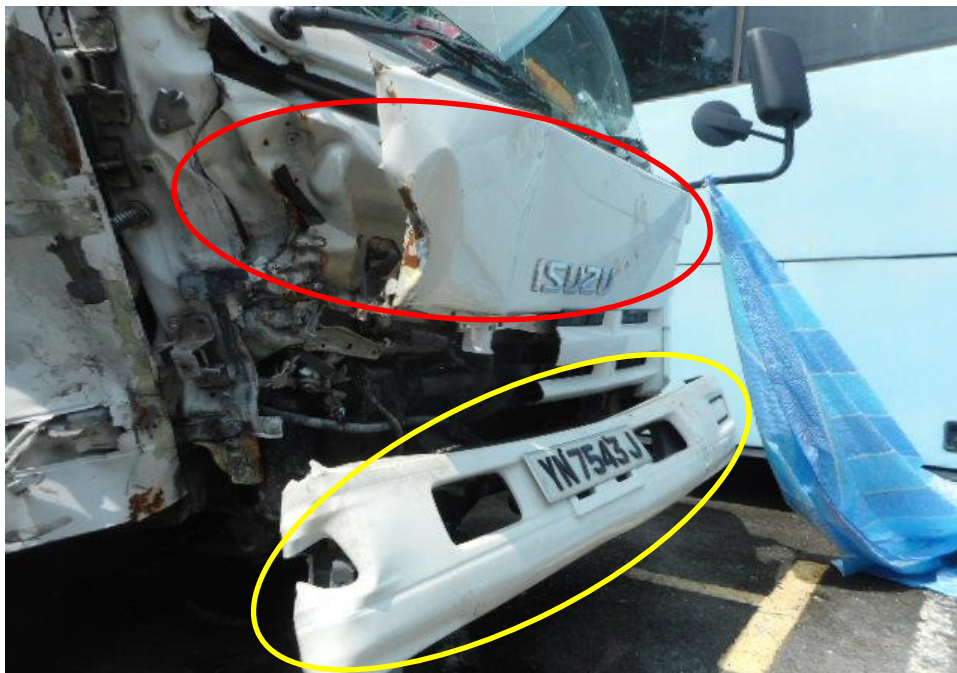
**Photo 4** shows the close up view of the front portion of the Motor Lorry at the time of our inspection. The Motor Lorry was observed to have sustained major damages to its front body panel (red circle) and front bumper (yellow circle) that was damaged as a result of the accident's impact.

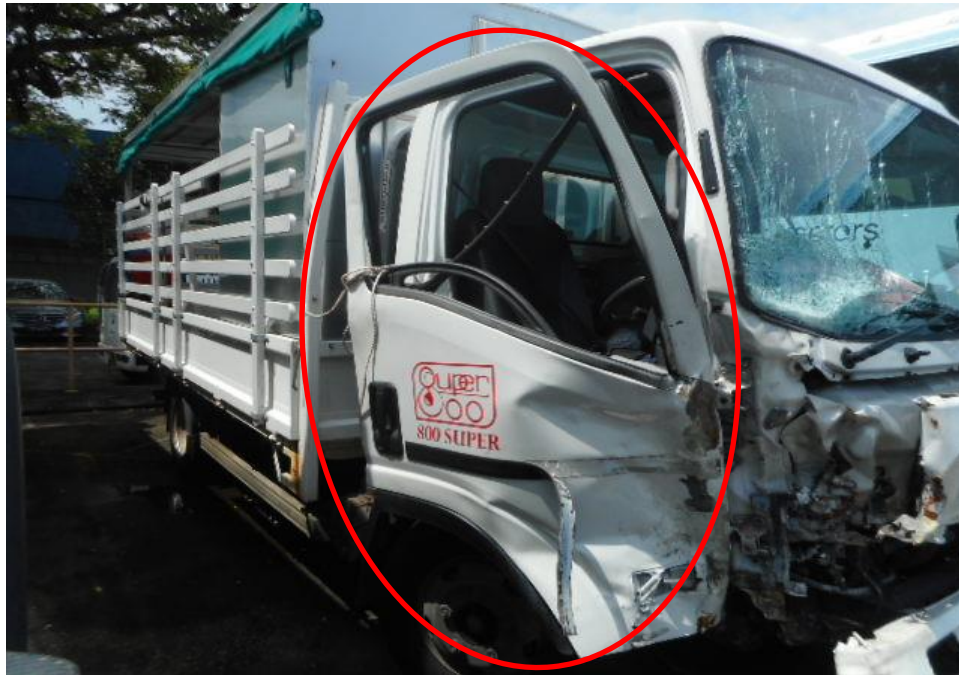
**Photo 5** shows the close up view of the right door of the Motor Lorry at the time of our inspection. The Motor Lorry was observed to have sustained damages to its left door (circled) as a result of the accident.

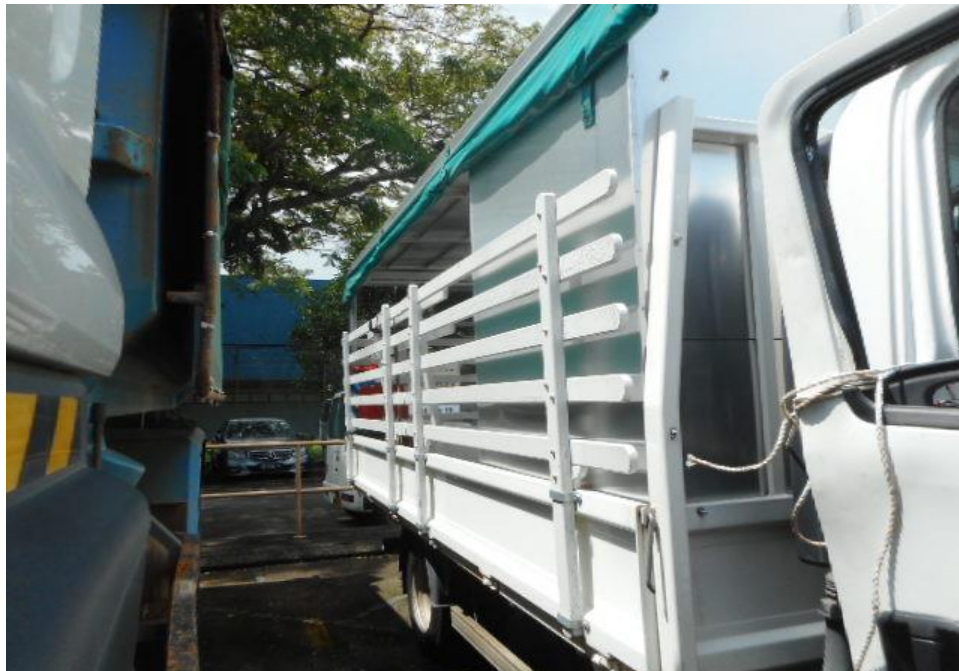
**Photo 6** shows a general view of the Motor Lorry's right body at the time of my inspection. The right portion of the Motor Lorry was observed to have been unaffected by the accident.

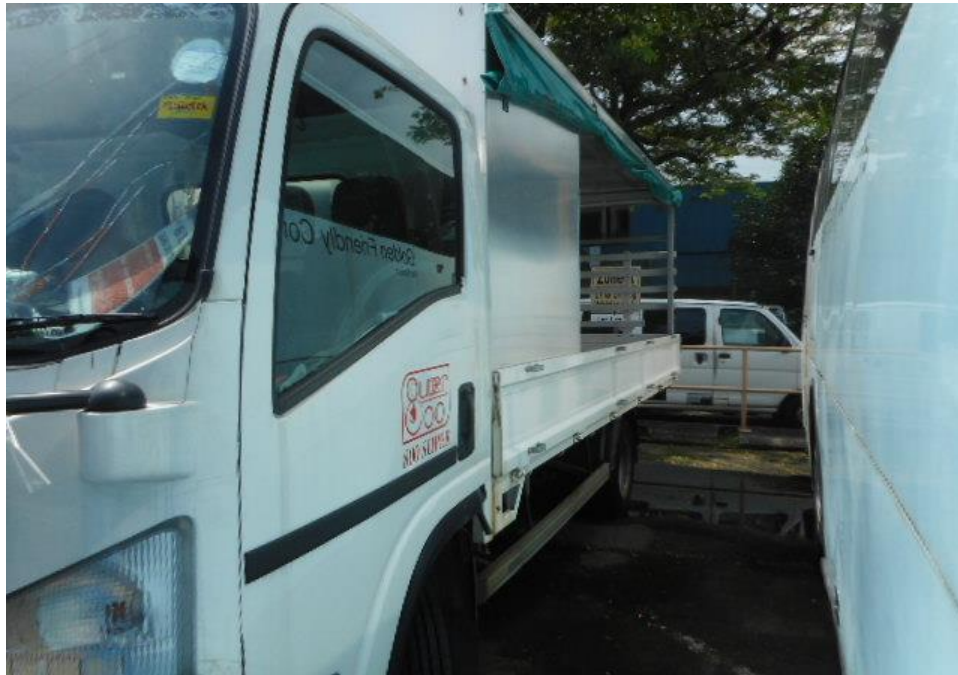
**Photo 7** shows a general view of the Motor Lorry's left body at the time of my inspection. The left portion of the Motor Lorry was observed to have been unaffected by the accident.

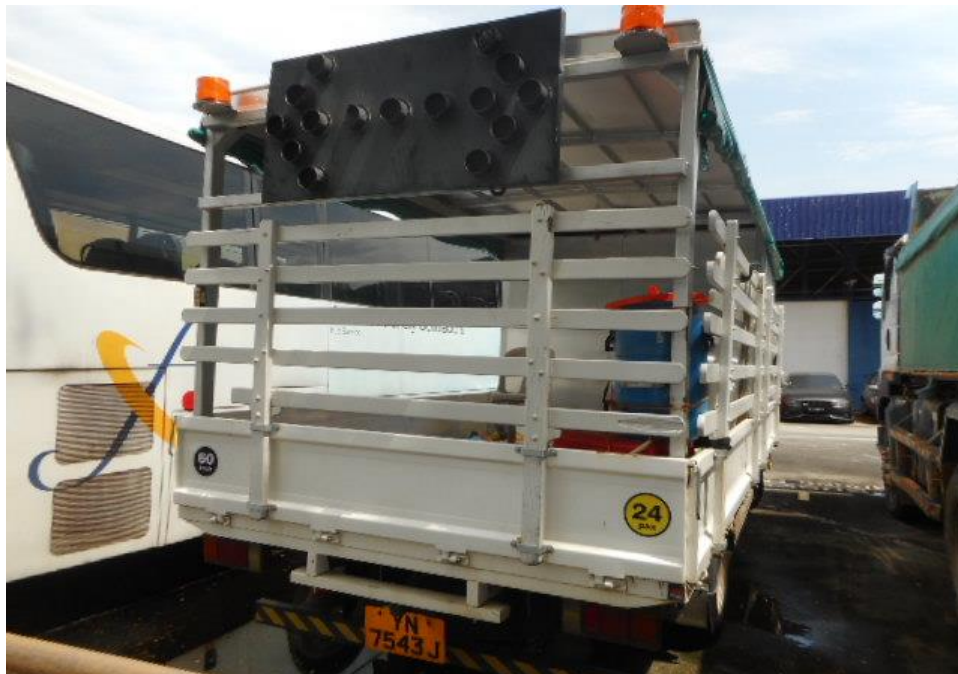
**Photo 8** shows the general view of the Motor Lorry's rear body at the time of my inspection. The Motor Lorry rear was observed to be unaffected by the accident.

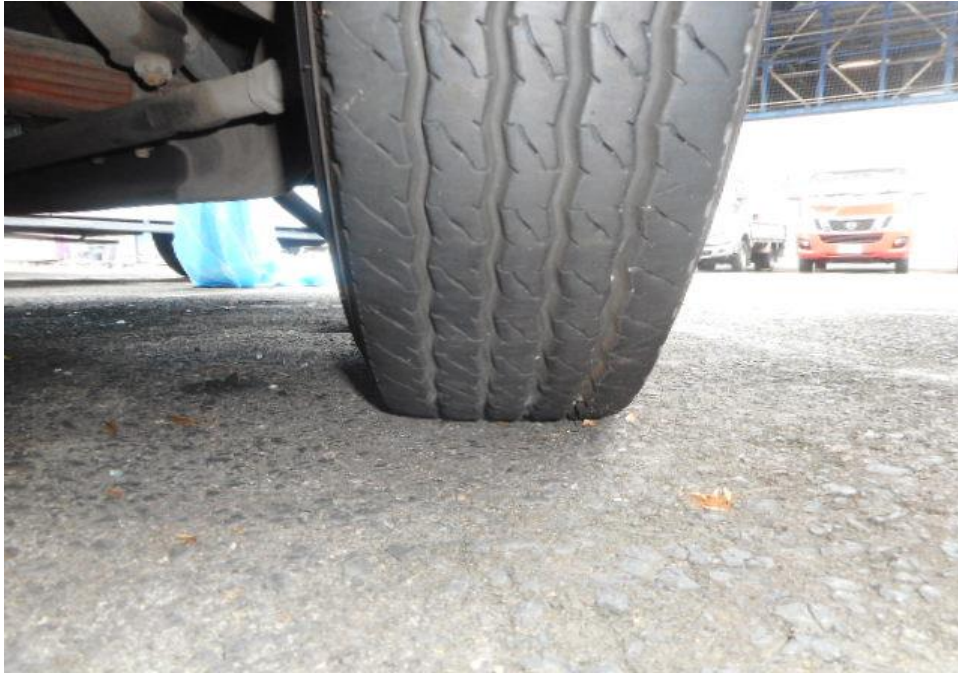
**Photo 9** shows the condition of the front right tyre of the Motor Lorry, which were observed to be in serviceable condition with remaining, tread depth of approximately 7.8mm. The tyre, which was wrapped around standard steel wheel rim, it was observed to be sufficiently inflated for vehicular operation.

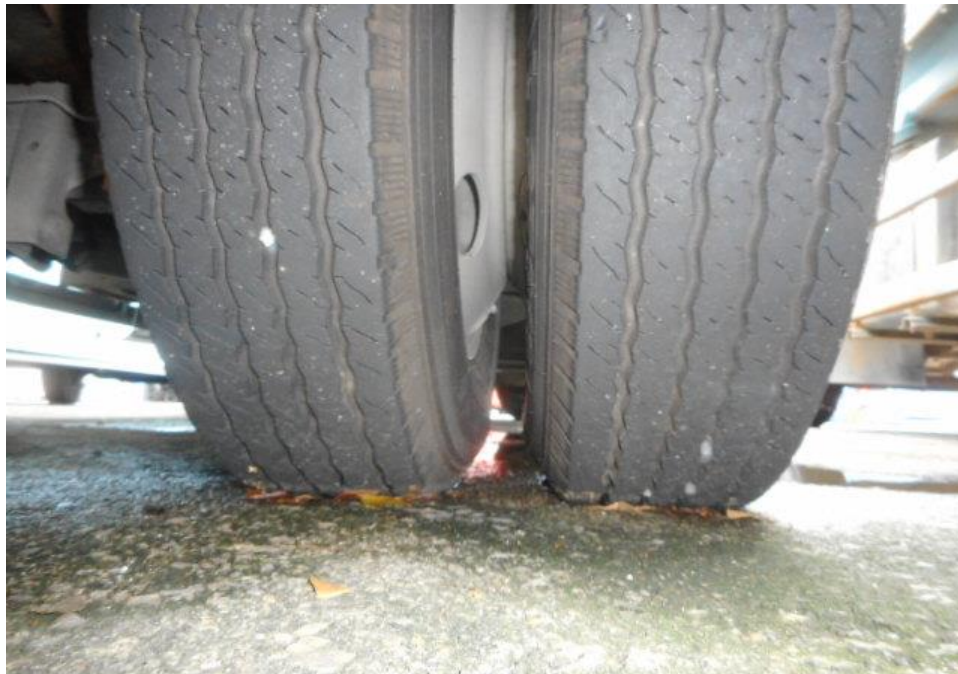
**Photo 10** shows the condition of the rear right tyres of the Motor Lorry, which were observed to be in serviceable condition with remaining, tread depth of approximately 4.1mm. The tyre, which was wrapped around standard steel wheel rim, it was observed to be sufficiently inflated for vehicular operation.

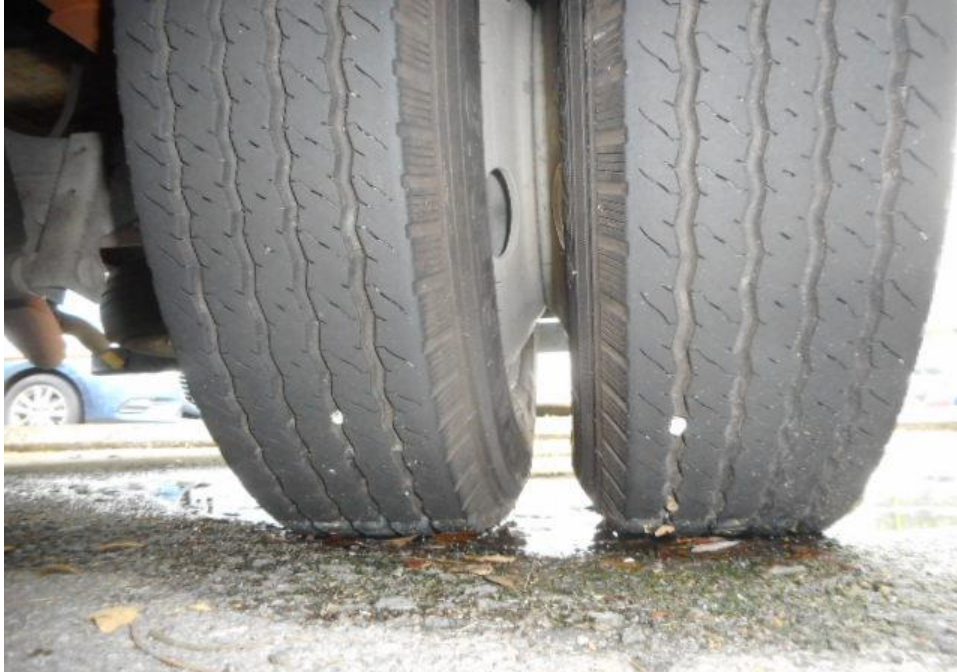
**Photo 11** shows the condition of the rear left tyres of the Motor Lorry, which were observed to be in serviceable condition with remaining, tread depth of approximately 5.5mm.

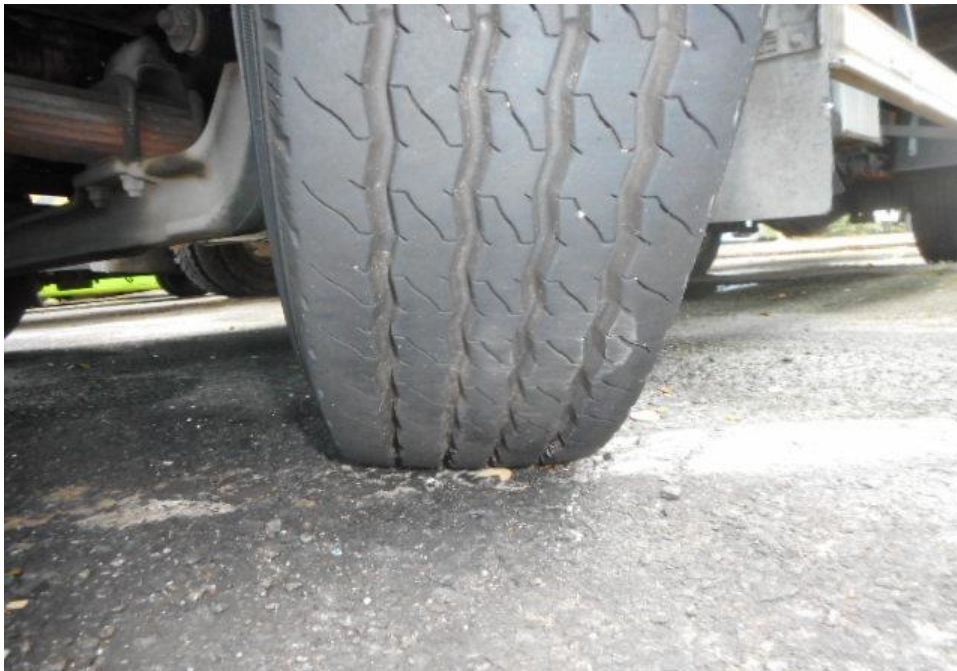
**Photo 12** shows the condition of the front left tyre of the Motor Lorry, which were observed to be in serviceable condition with remaining, tread depth of approximately 9.3mm. There was also no tear, cut or burst mark(s) on the outer and the inner sidewalls as well as across the tread of the 6 tyres that were fitted on the Motor Lorry.

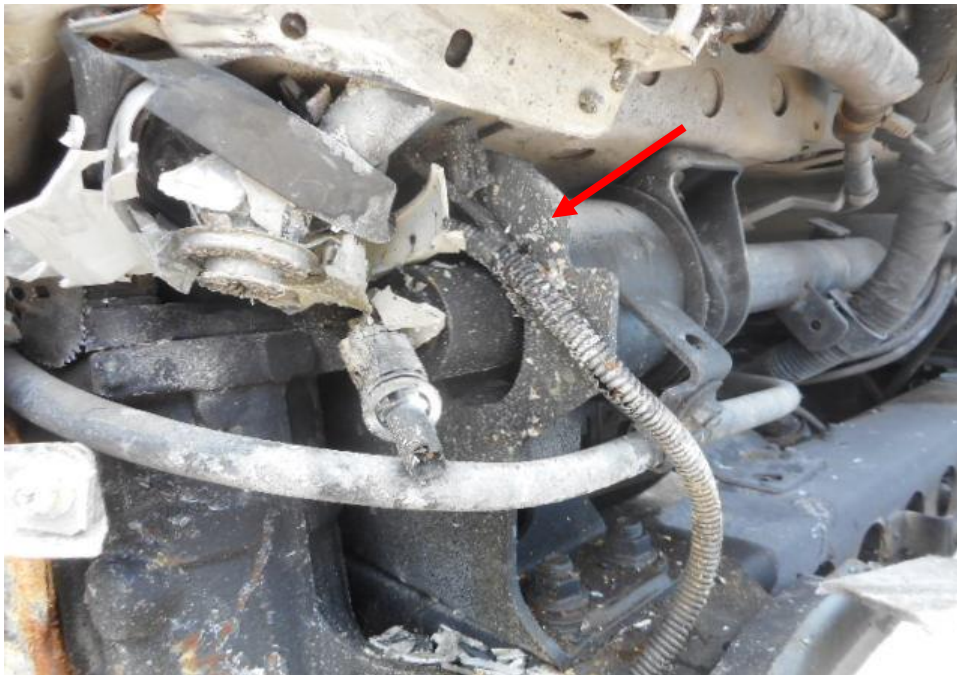
7. Upon examination of the Motor Lorry's engine compartment, we had observed that all the parts, components and fluids could not be inspection as due to the damage induced has crushed and deformed the cabin of the Motor Lorry which immobilized its opening and viewing.
8. However, we were been to inspect the engine coolant, power steering fluid and the brake fluid as they were located outside of the Motor Lorry's engine compartment and they were all found to be of sufficient level for operating purposes. Visually, there was also no contamination found to these fluids.
9. Our subsequent checks on the underside of the Motor Lorry visually, the various undercarriage components of the Motor Lorry were observed to be intact and without any visible damage. See photos 13- 17 below.

**Photo 13** shows the induced damage to the lifter of the front cabin (arrowed) of the Motor Lorry's which had immobilised the opening and viewing of the various parts and components inside the engine compartment a result of the accident.

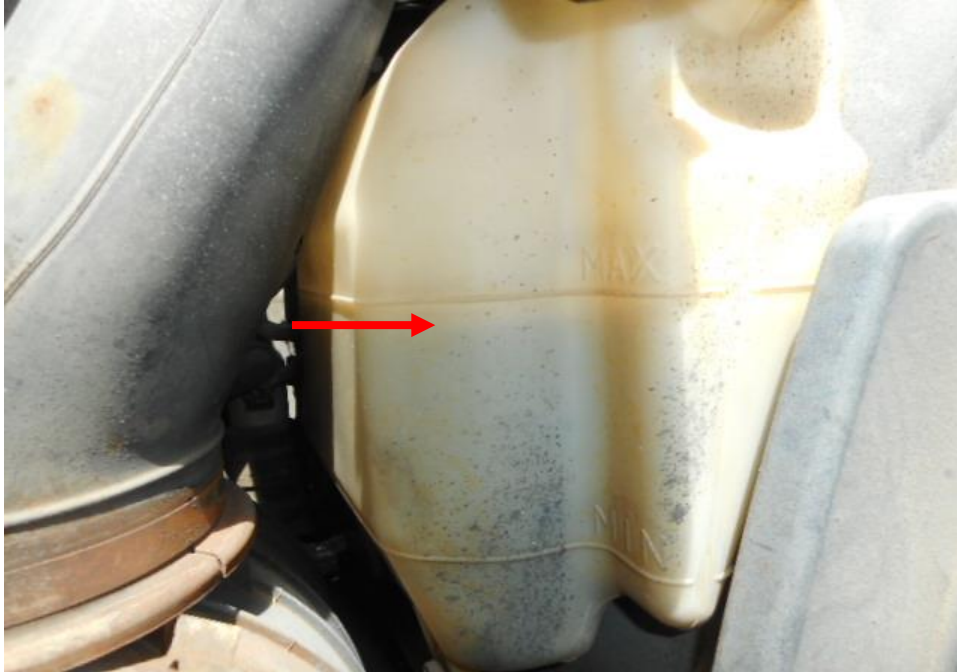
**Photo 14** shows checks being carried out to the engine coolant of the Motor Lorry at the time of my inspection. The engine coolant was observed to be of sufficient level and without any visible contamination.

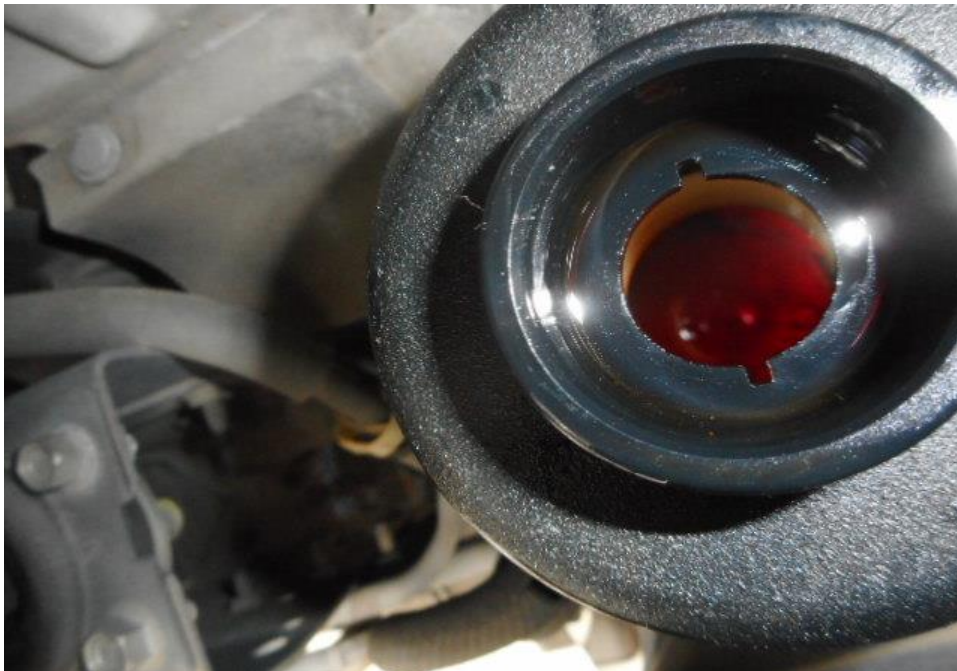
**Photo 15** shows the power steering fluid reservoir of the Motor Lorry at the time of my inspection. The power steering fluid was observed to be of sufficient level and without any visible contamination.

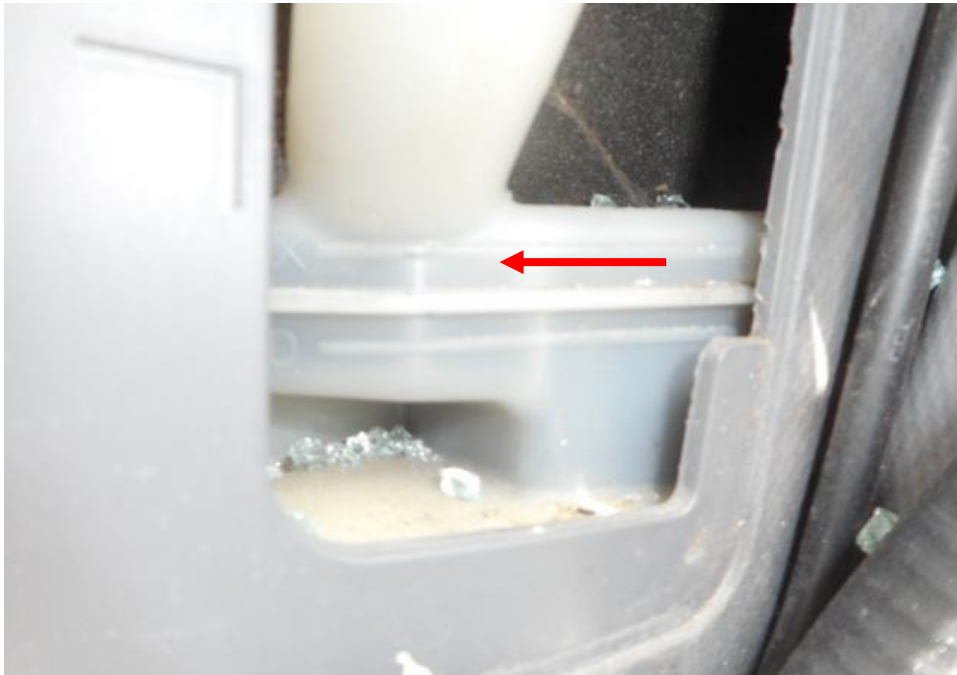
**Photo 16** shows the brake fluid reservoir of the Motor Lorry at the time of my inspection. The brake fluid was observed to be of sufficient level (arrowed) and without any visible contamination.

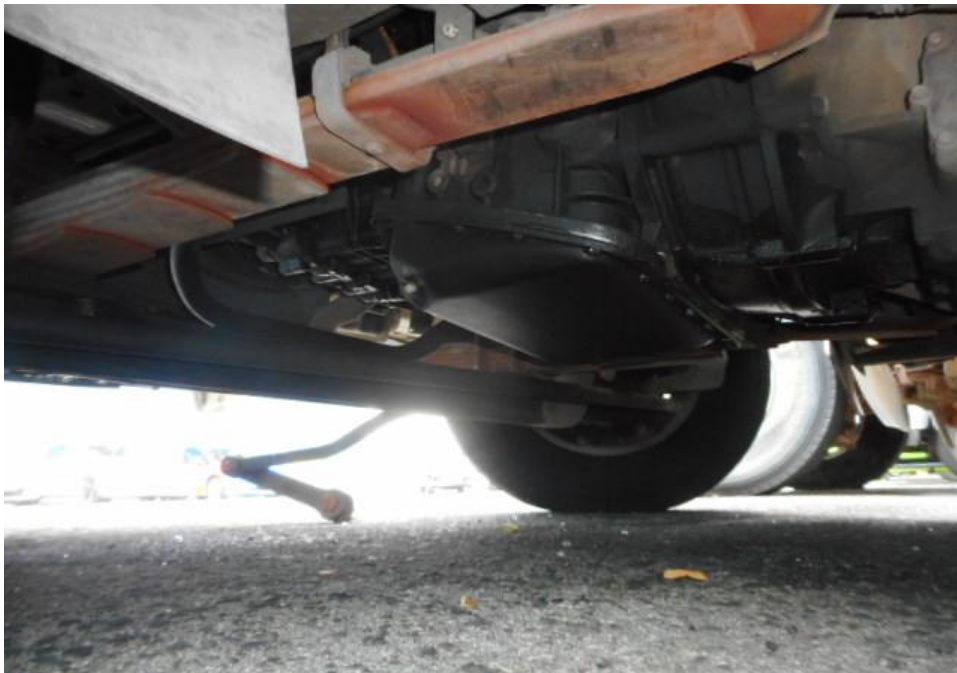
**Photo 17** shows the undercarriage of the Motor Lorry, at the area where the engine housing and transmission housing are located. I did not find any sign(s) or indication(s) of fluid leak and/or fluid stain(s) on the underside of the Motor Lorry.

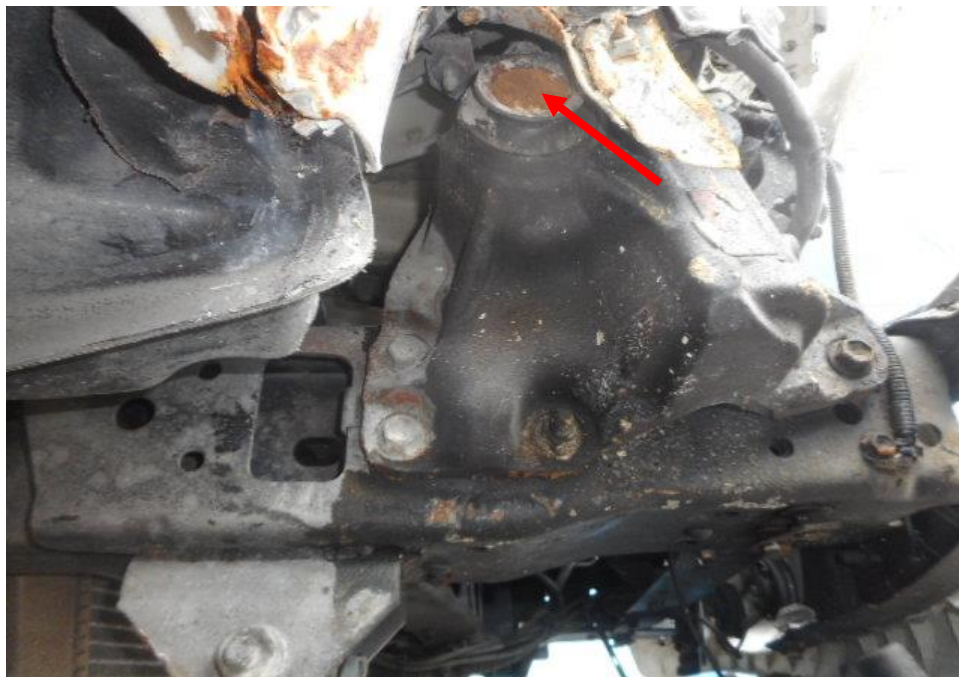
**Photo 18** shows the steering box (arrowed) of the Motor Lorry's steering system. The steering box was observed to sustained damages a result of the accident.

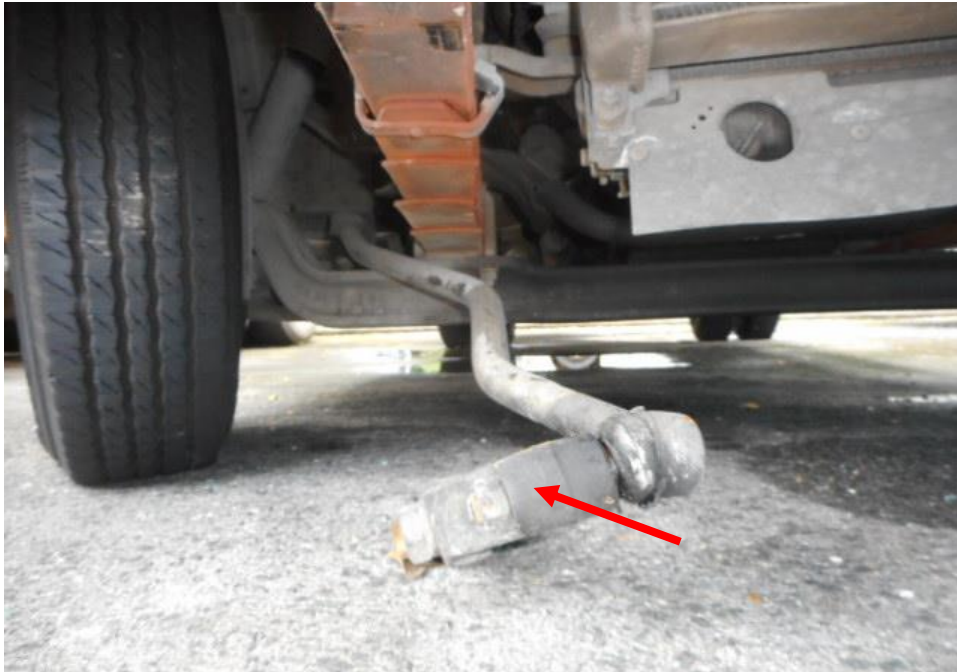
**Photo 19** shows the steering box arm (arrowed) of the Motor Lorry's steering system. The steering box arm was observed to sustained damages a result of the accident.

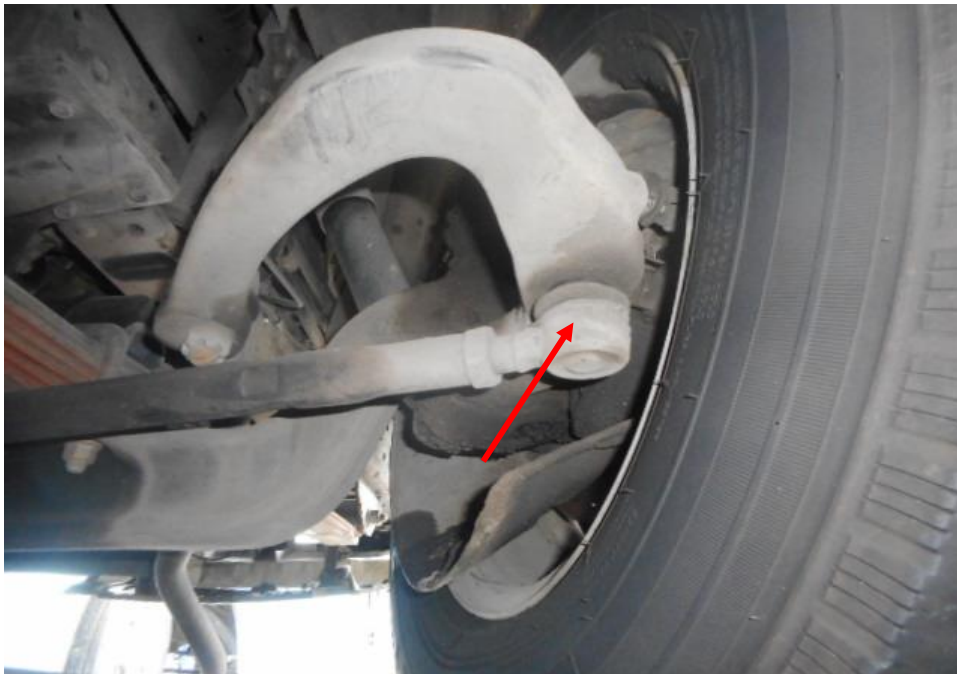
**Photo 20** shows the various undercarriage components at the front right wheel of the Motor Lorry, in particular the steering tie rod end (arrowed). The various steering components were all found to be intact, suggesting that the steering system of the Motor Lorry was likely to be in serviceable condition at the material time of accident. There was also no sign of fluid stain(s) observed on the various undercarriage components.

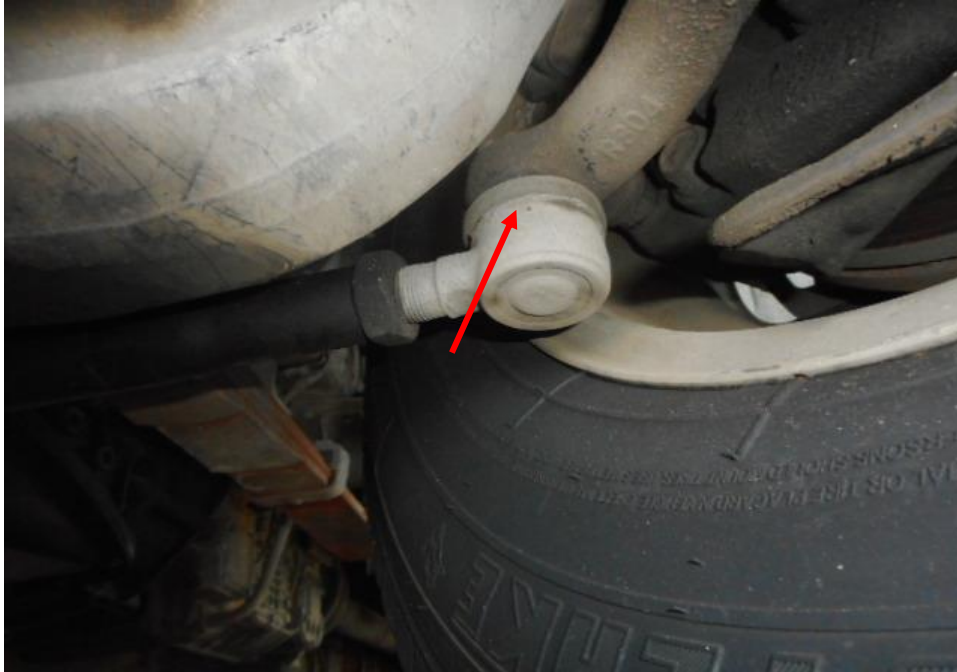
**Photo 21** shows the various undercarriage components at the front left wheel of the Motor Lorry, in particular the steering tie rod end (arrowed). The various undercarriage components of the Motor Lorry were all found to be intact without any visible damage. There was also no sign of fluid stain(s) observed on the various undercarriage components.

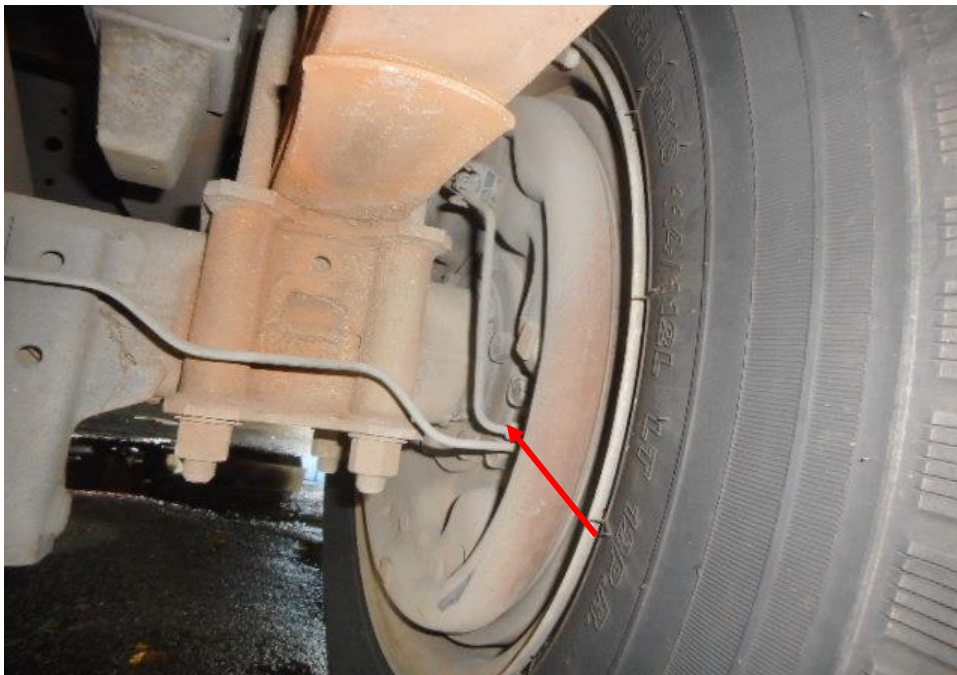
**Photo 22** shows the brake pipe (arrowed) at the rear right wheel of the Motor Lorry. I did not observe any leakage of brake fluid at the time of my inspection of the Motor Lorry. My static tests of the Motor Lorry's braking system, along with my visual examination of the various mechanical components in the braking system, had indicated that there was no internal leakage of pressure/vacuum.

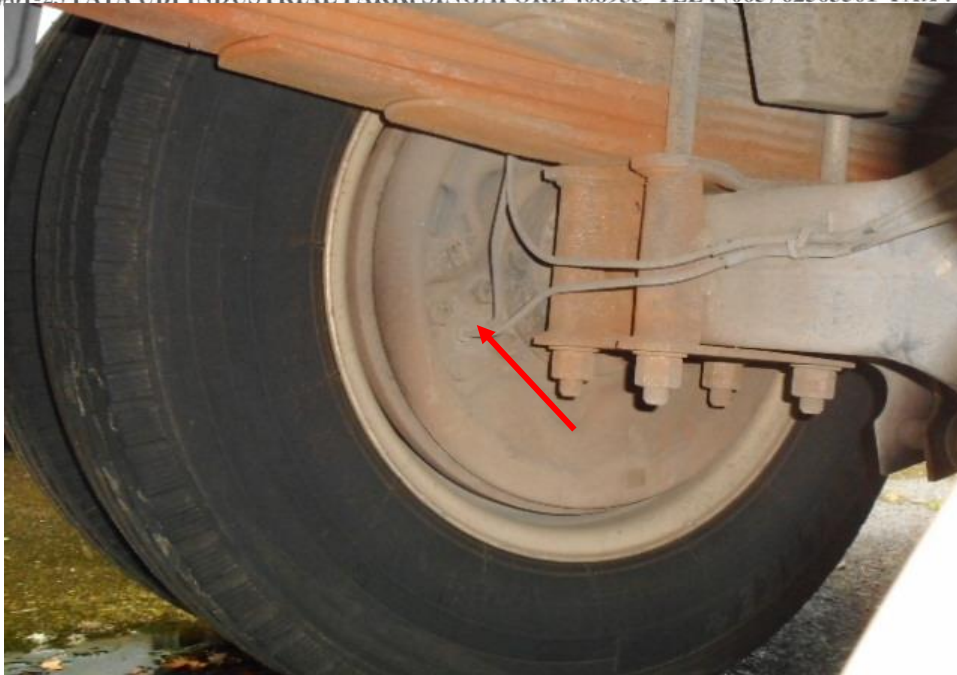
**Photo 23** shows the brake pipe (arrowed) at the rear left wheel of the Motor Lorry. I did not observe any leakage of brake fluid at the time of my inspection of the Motor Lorry. My static tests of the Motor Lorry's braking system, along with my visual examination of the various mechanical components in the braking system had indicated that there was no internal leakage of pressure/vacuum. Hence the braking system of the Motor Lorry was likely to be in serviceable condition at the material time of accident.

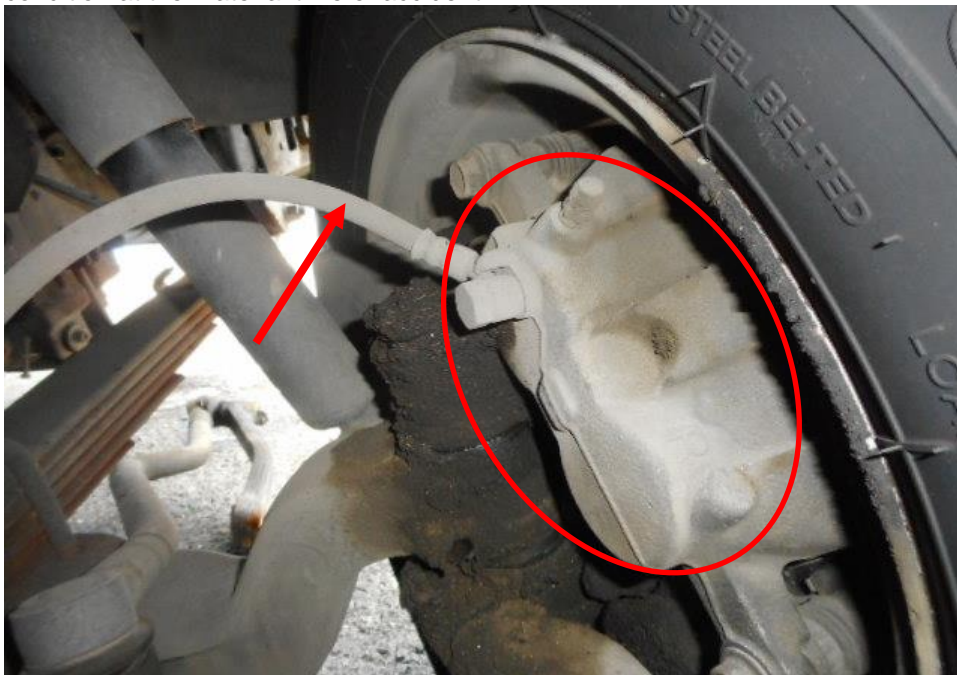
**Photo 24** shows the brake hose/pipe (arrowed) at the front right wheel of the Motor Lorry. No leakage of brake fluid was observed. Visual examination of the various components of the braking system like the brake caliper (circled), brake booster, brake pedal etc had revealed all to be intact and without visible damage at the time of accident. There was also no sign of fluid stain(s) observed on the various undercarriage components.

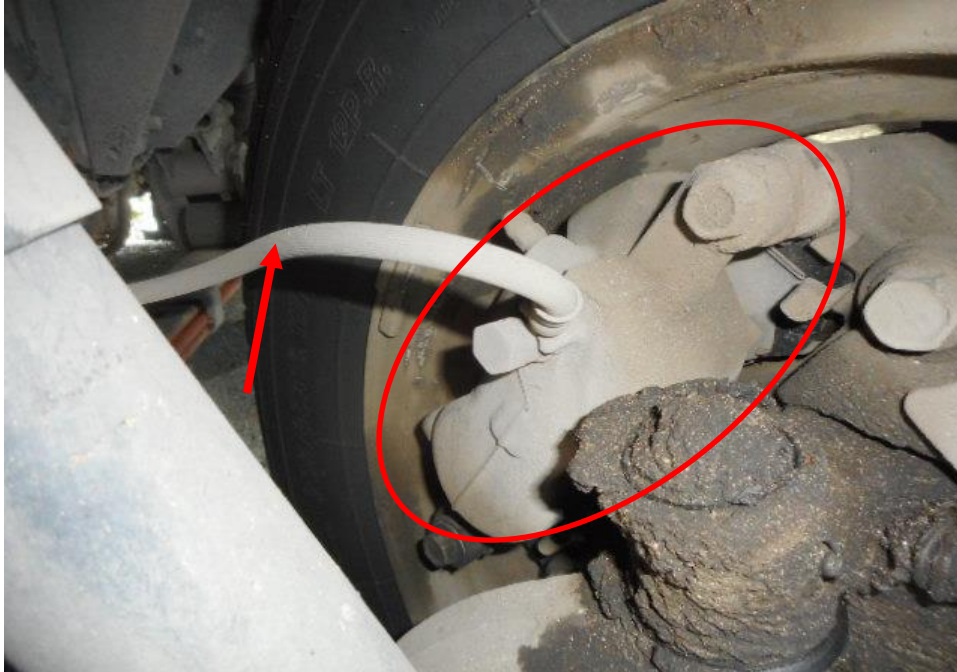
**Photo 25** shows the brake hose/pipe (arrowed) at the front left wheel of the Motor Lorry. No leakage of brake fluid was observed. Visual examination of the various components of the braking system like the brake caliper (circled), brake booster, brake pedal etc had revealed all to be intact and without visible damage at the time of accident. There was also no sign of fluid stain(s) observed on the various undercarriage components.
