Your Ref: TP/IP/10567/2022
Our Ref : CI/TPD22005080/P

Fatal Accident Investigation Team

MECHANICAL INSPECTION REPORT OF MOTOR BUS SG 6122E

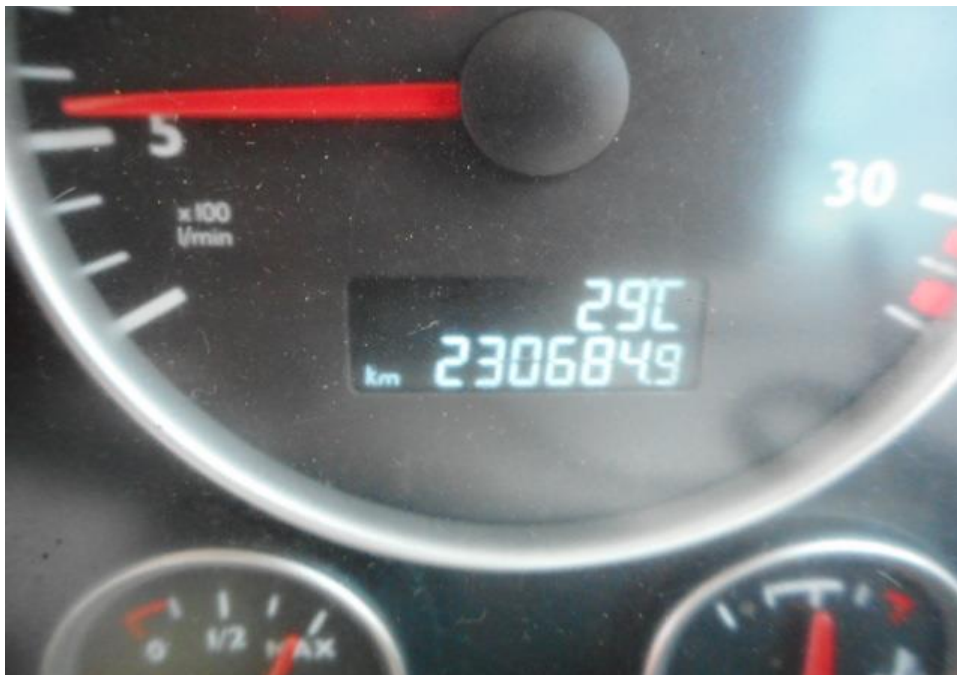
4. The mileage of the Motor Bus at the time of my inspection was 230,684km.
5. The Motor Bus was observed to have sustained damage at its front portion. Its front bumper was the body part that were damaged at the time of inspection.

Photo 1 shows a general view of the instrument cluster of the Motor Bus at the time of my inspection. The mileage of the Motor Bus was 230,684km

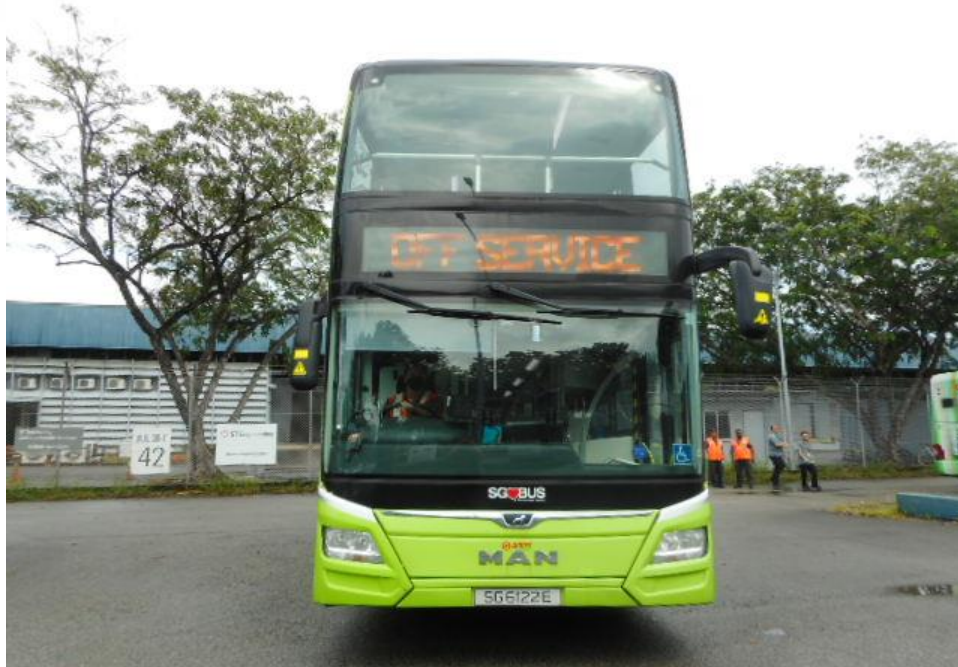
Photo 2 shows a general view of the front body of the Motor Bus at the time of my inspection. The Motor Bus was observed to have sustained damages at its front bumper was observed to be damaged at time of our inspection.

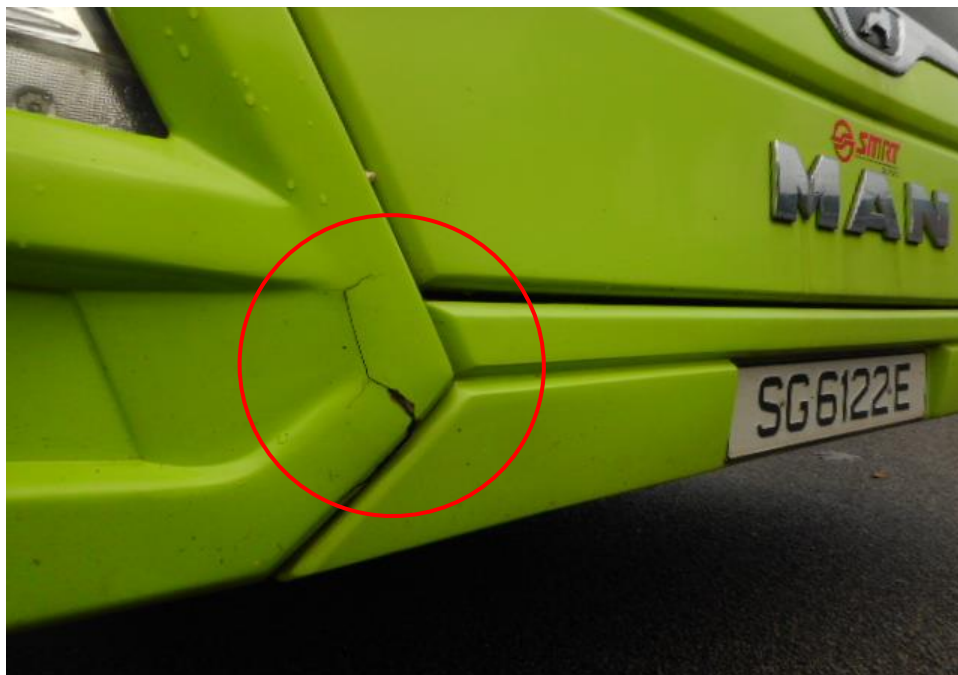
Photo 3 shows a close up view of the front body of the Motor Bus at the time of our inspection. The Motor Bus was observed to have sustained damages at its front bumper (circled) as a result of the accident.

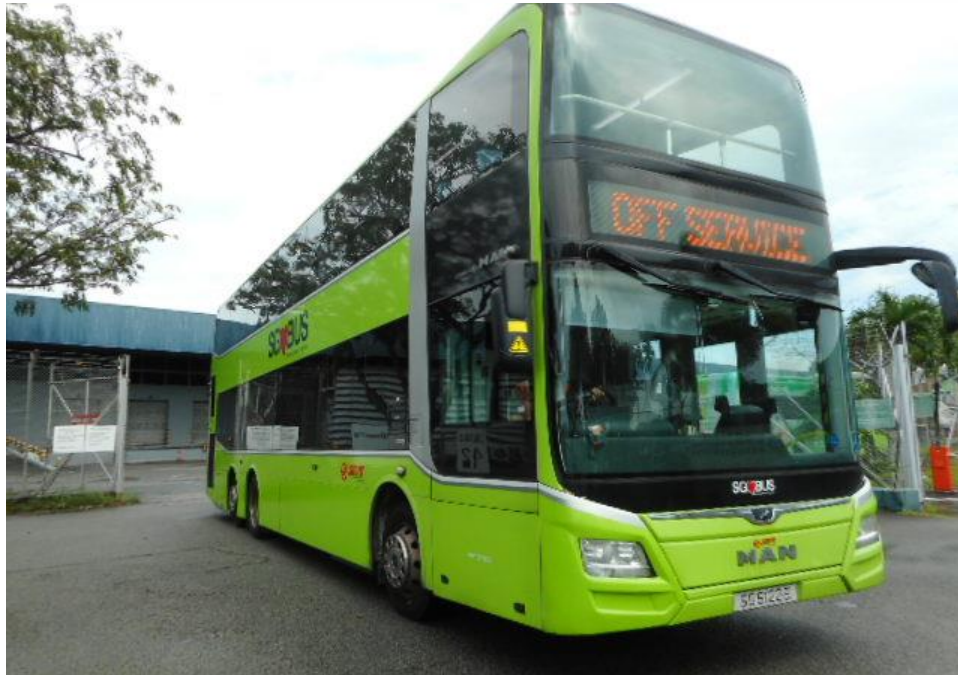
Photo 4 shows a general view of the right body of the Motor Bus at the time of my inspection. The Motor Bus was observed to be intact and unaffected by the accident.

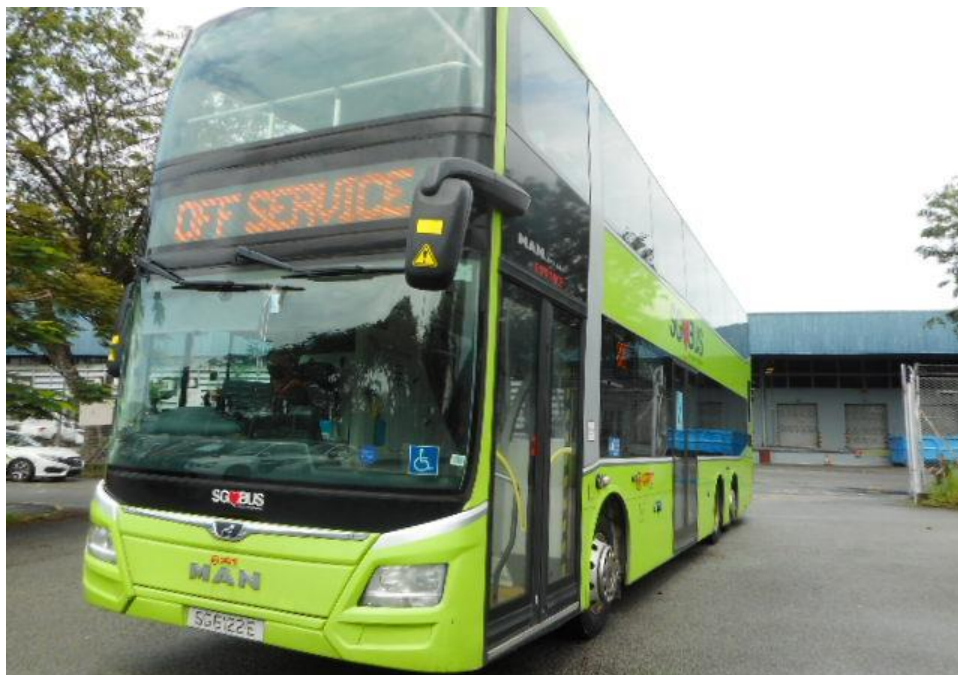
Photo 5 shows a general view of the left body of the Motor Bus at the time of my inspection. The Motor Bus was observed to be intact and unaffected by the accident.

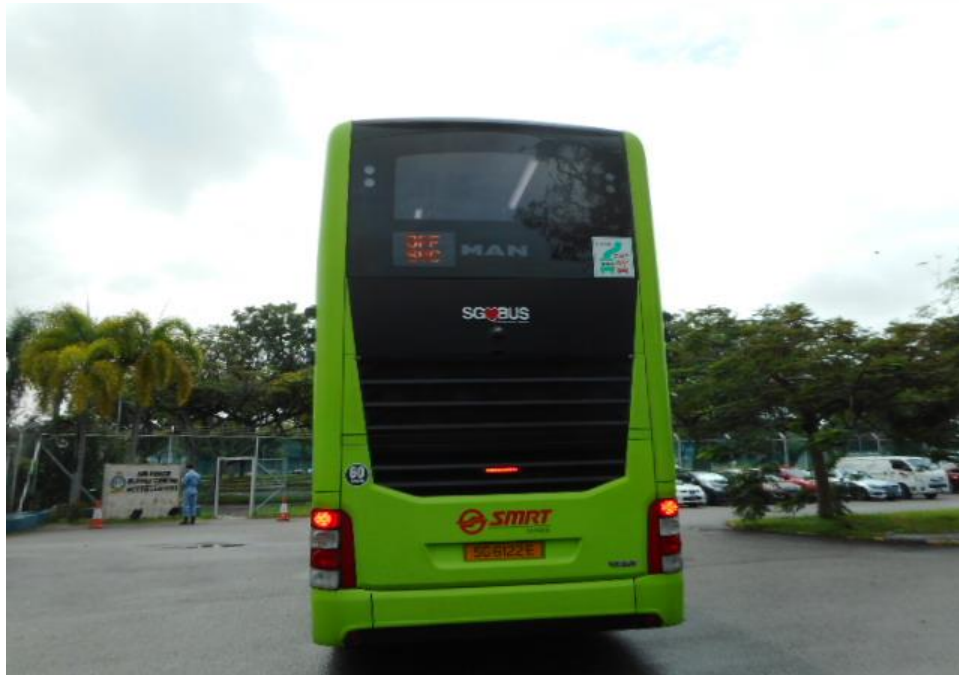
Photo 6 shows a general view of the rear body of the Motor Bus at the time of my inspection. The Motor Bus was observed to be intact and unaffected by the accident.

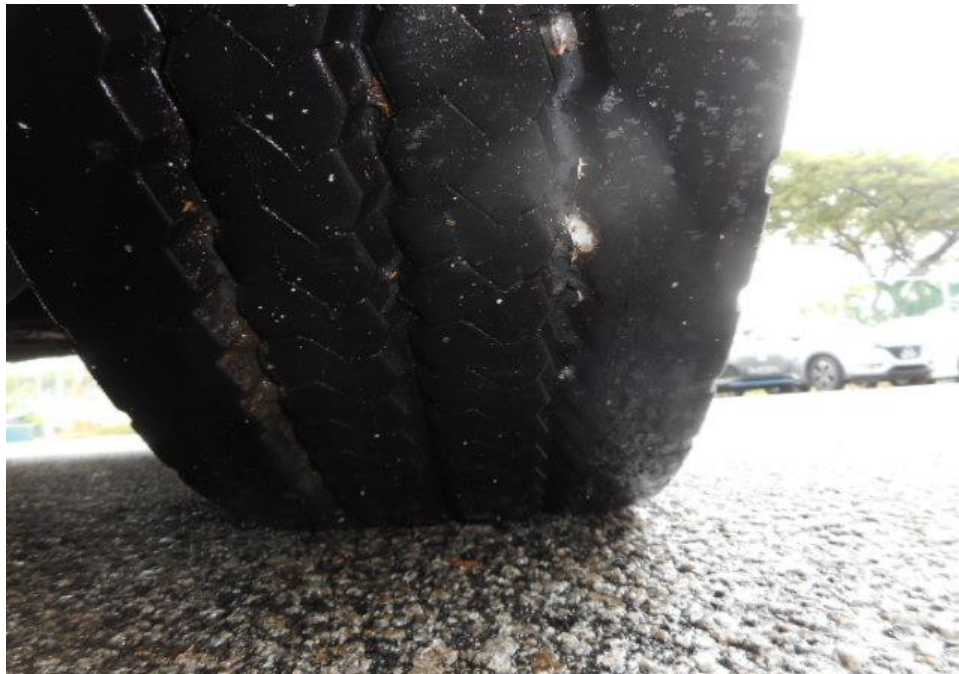
Photo 7 shows the condition of the front right tyre of the Motor Bus, which was observed to be in serviceable condition with remaining tread depth of approximately 14mm. The tyre, which was wrapped around standard steel wheel rim, was also observed to be sufficiently inflated for vehicular operation. There was no tear, cut or burst mark(s) on the outer and the inner sidewalls as well as across the tread of the 8 tyres that were fitted on the Motor Bus.

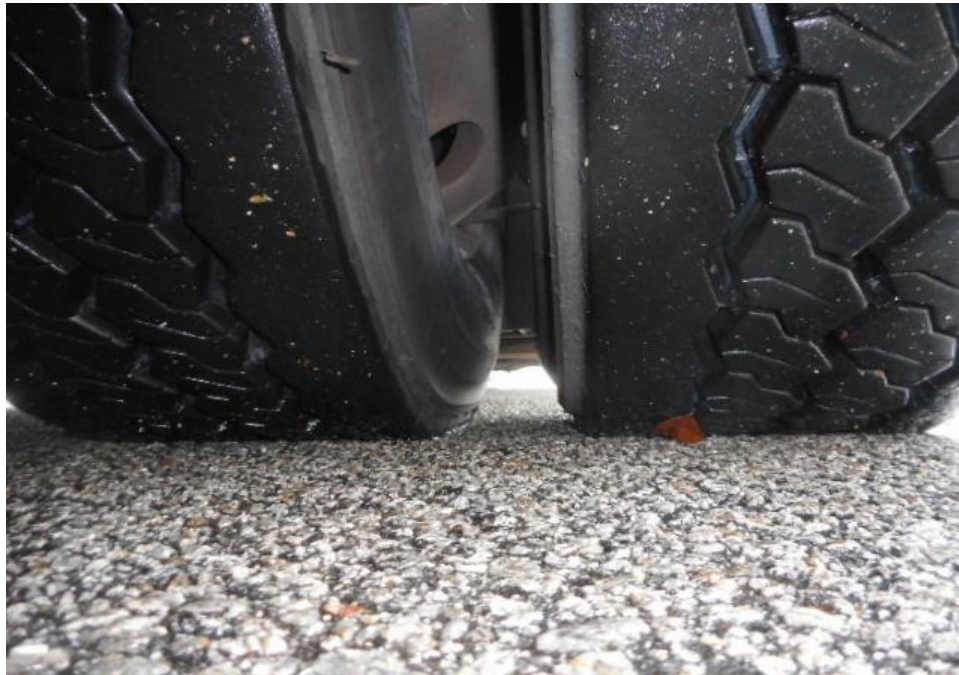
Photo 8 shows the condition of the rear right tyre of the Motor Bus, which was observed to be in serviceable condition with remaining tread depth of approximately 14mm. The tyre, which was wrapped around standard steel wheel rim, was also observed to be sufficiently inflated for vehicular operation.

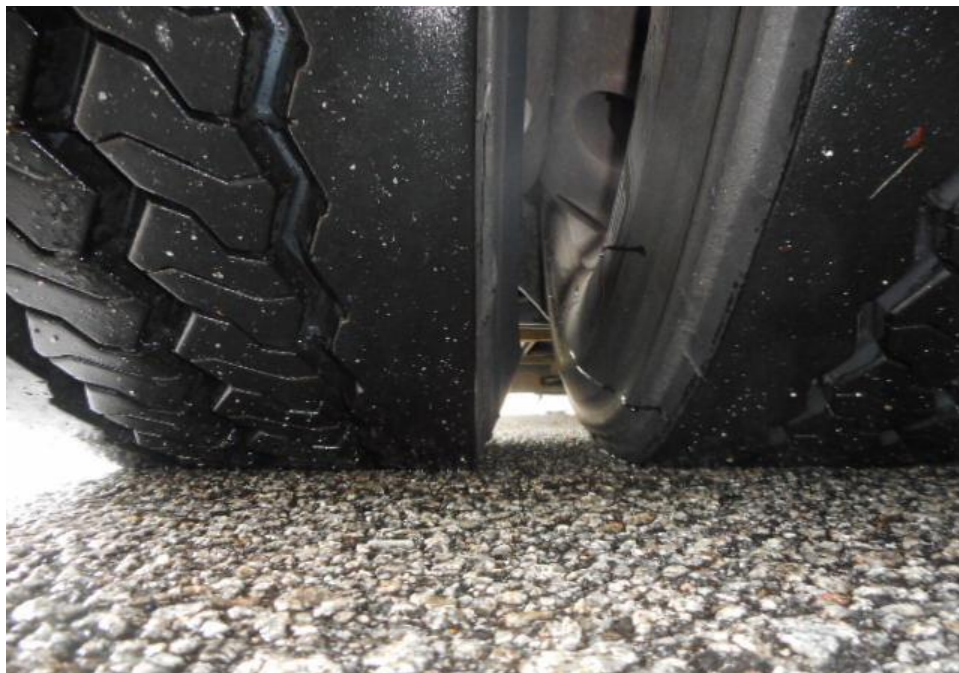
Photo 9 shows the condition of the rear left tyres of the Motor Bus, which was observed to be in serviceable condition with remaining tread depth of approximately 14.4mm. The tyres, which were wrapped around standard steel wheel rim, were also observed to be sufficiently inflated for vehicular operation. There was also no damage found on all 8 steel wheel rims of the Motor Bus.

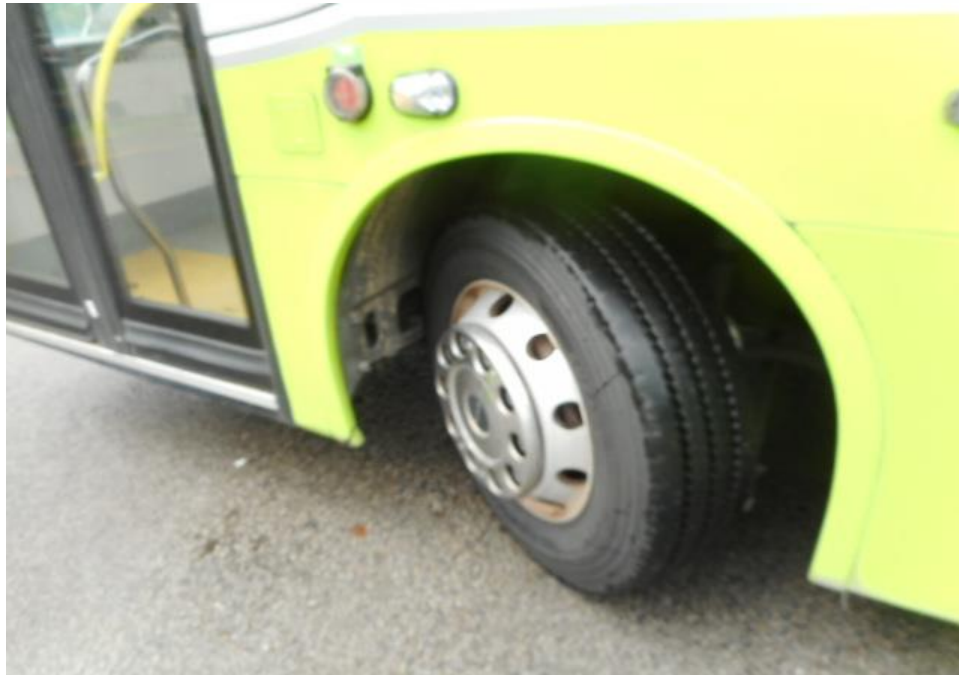
Photo 10 shows the condition of the front left tyres of the Motor Bus, which were observed to be in serviceable condition with remaining tread depth of approximately 14.4mm. There was also no tear, cut or burst mark(s) on the outer and the inner sidewalls as well as across the tread of the 8 tyres that were fitted on the Motor Bus.

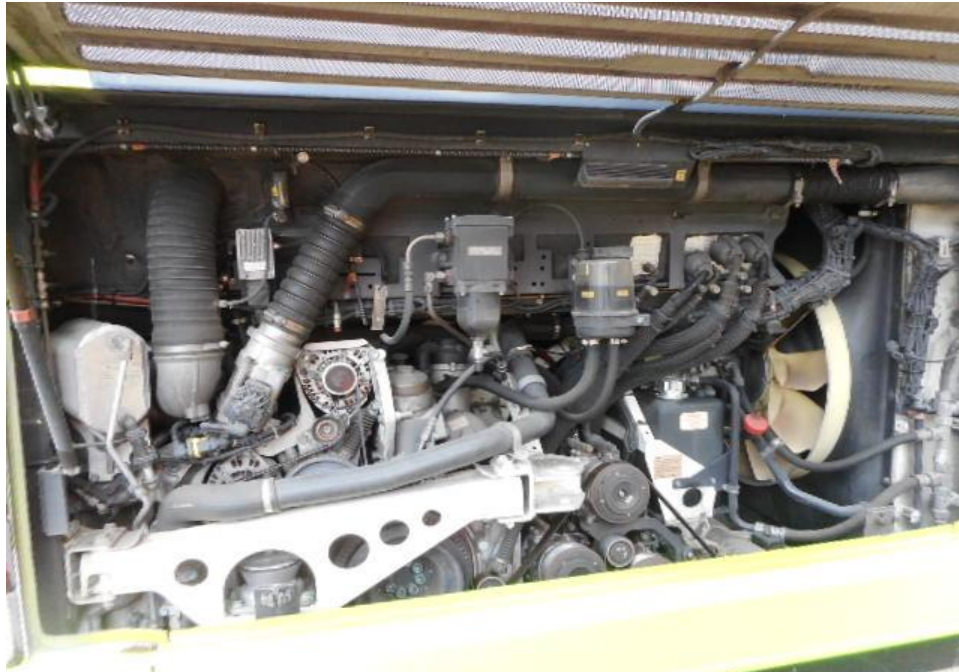
Photo 11 shows a general view of the Motor Bus's engine compartment, which was accessed by lifting the rear of the Motor Bus. The various parts and components inside the engine compartment were unaffected by the accident. There was also no sign(s) or indication(s) of fresh fluid leakage and/or fluid stain within the engine compartment

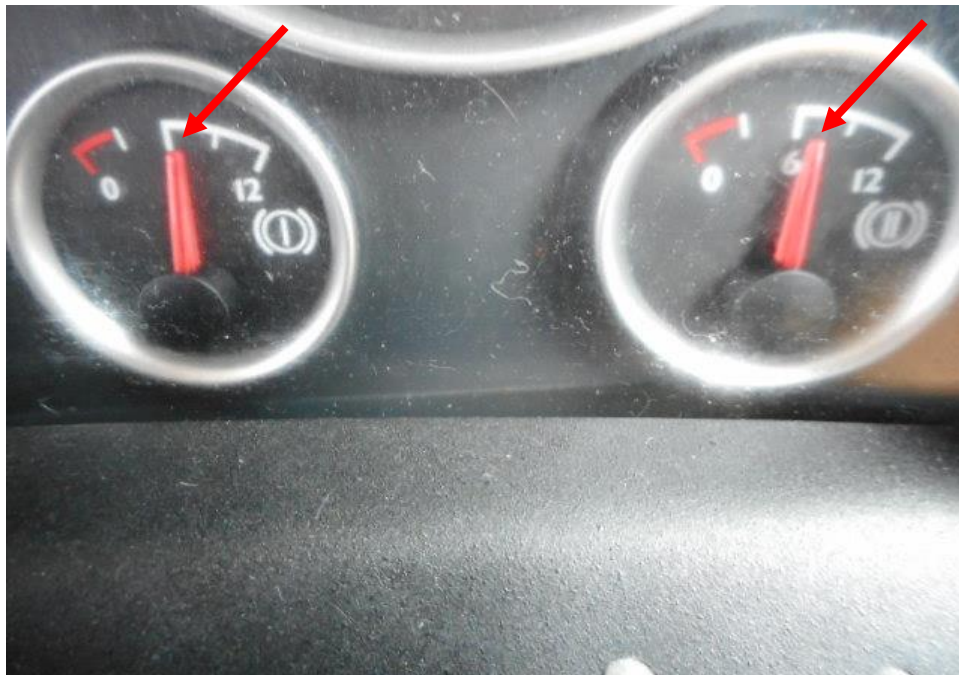
Photo 12 shows the air in the air brake cylinder of the Motor Bus at the time of my inspection. The air in the cylinder was observed to be of sufficient level & serviceable at the time of the accident.

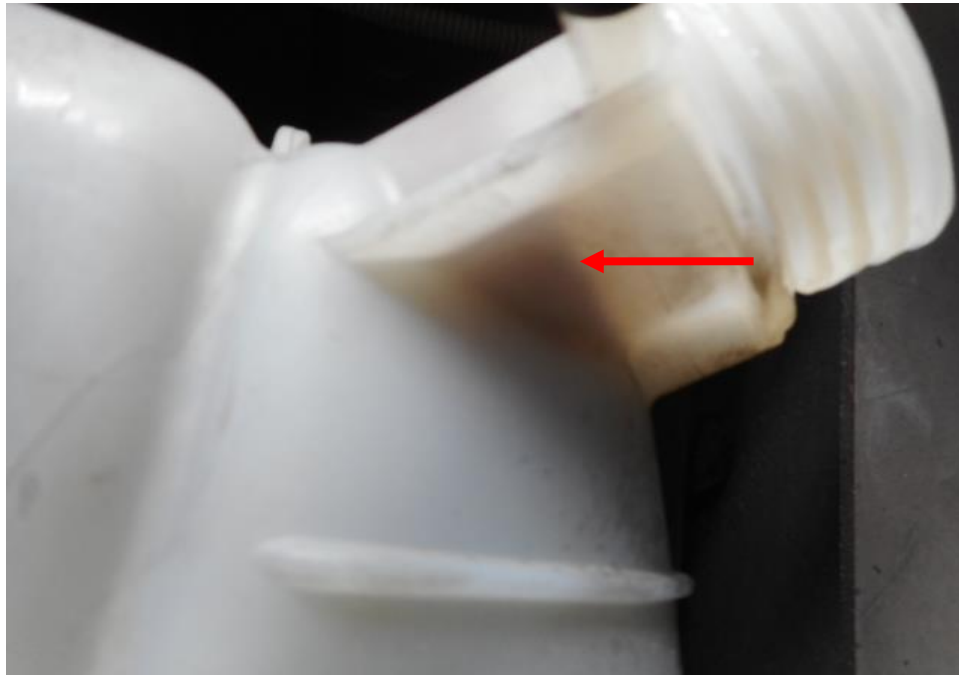
Photo 13 shows the engine coolant reservoir of the Motor Bus at the time of my inspection. The engine coolant was observed to be of sufficient level (arrowed) and without any visible contamination.

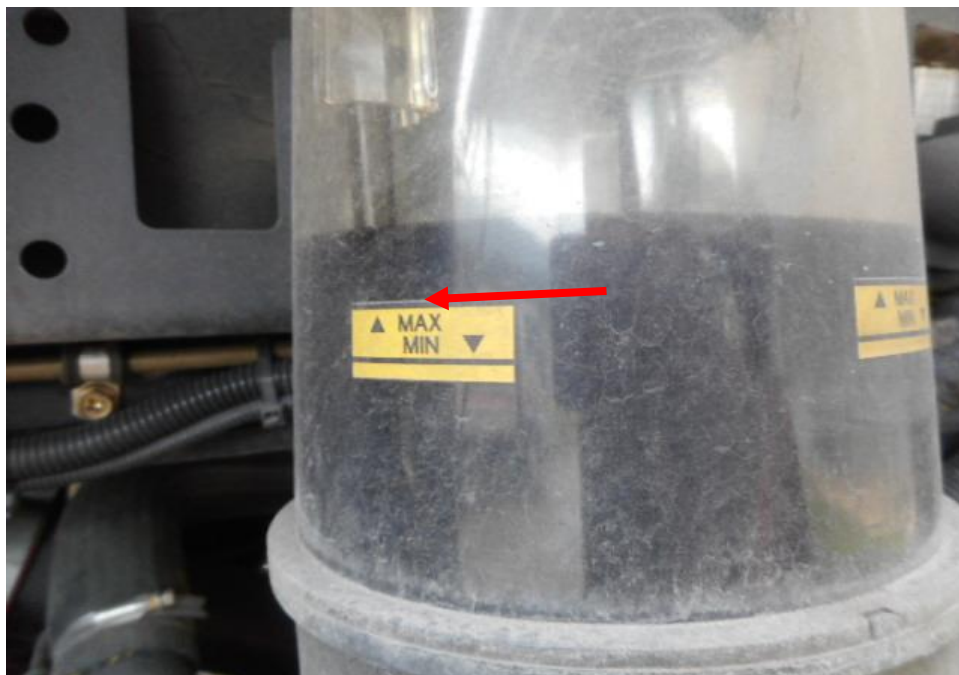
Photo 14 shows the power steering fluid reservoir of the Motor Bus at the time of my inspection. The power steering fluid was observed to be of sufficient level and without any visible contamination.

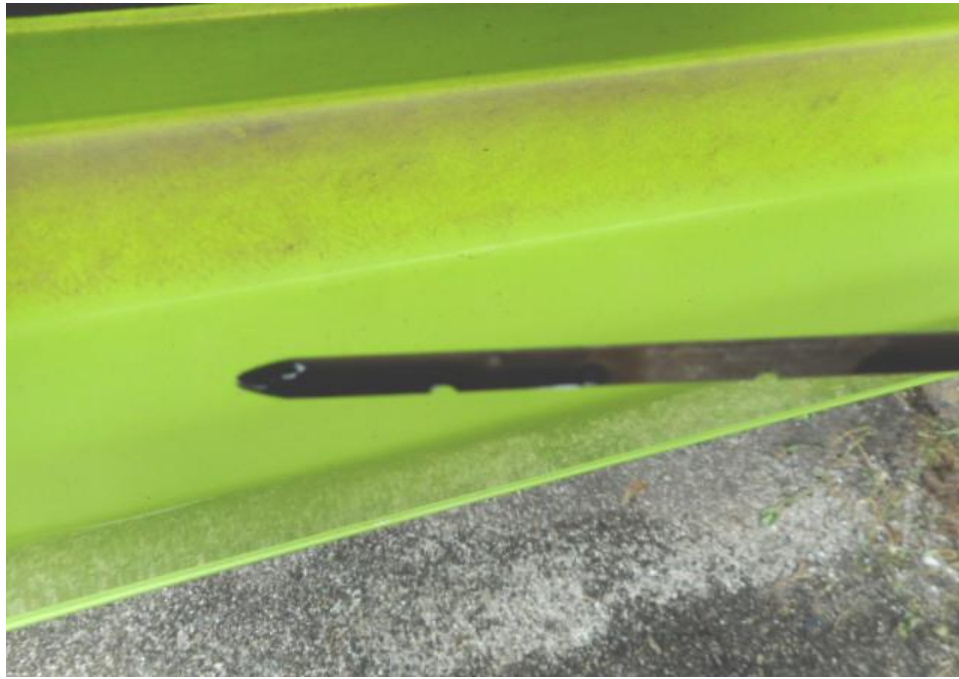
Photo 15 shows the engine oil dip stick system of the Motor Bus at the time of my inspection. The engine oil was observed to be sufficient for operation and without any visible contamination.

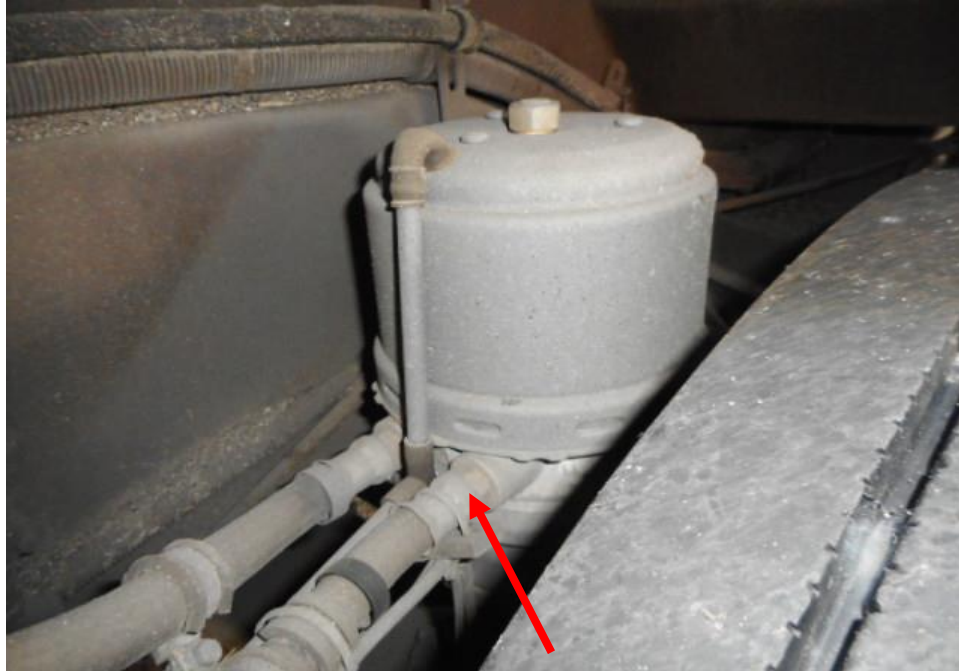
Photo 16 shows the brake pipe (arrowed) at the rear right wheel of the Motor Bus. I did not observe any leakage of brake fluid at the time of my inspection of the Motor Bus. My static tests of the Motor Bus's braking system, along with my visual examination of the various mechanical components in the braking system, had indicated that there was no internal leakage of pressure/vacuum. Hence the braking system of the Motor Bus was likely to be in serviceable condition at the material time of accident.

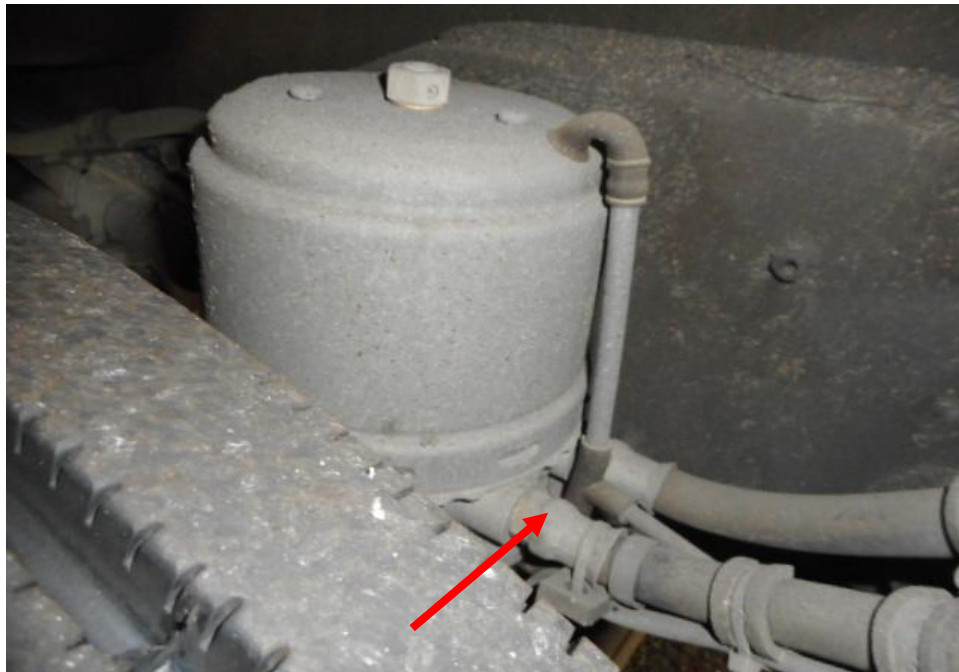
Photo 17 shows the brake pipe (arrowed) at the rear left wheel of the Motor Bus. I did not observe any leakage of brake fluid at the time of my inspection of the Motor Bus. My static tests of the Motor Bus's braking system, along with my visual examination of the various mechanical components in the braking system, had indicated that there was no internal leakage of pressure/vacuum. Hence the braking system of the Motor Bus was likely to be in serviceable condition at the material time of accident.

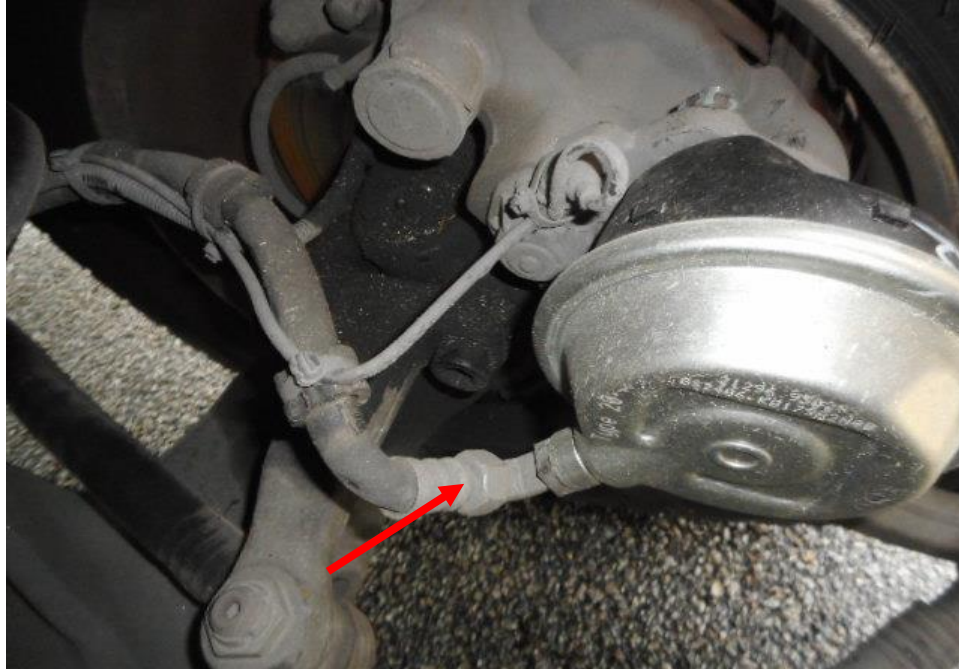
Photo 18 shows the brake pipe (arrowed) at the front right wheel of the Motor Bus. I did not observe any leakage of brake fluid at the time of my inspection of the Motor Bus. My static tests of the Motor Bus's braking system, along with my visual examination of the various mechanical components in the braking system, had indicated that there was no internal leakage of pressure/vacuum. Hence the braking system of the Motor Bus was likely to be in serviceable condition at the material time of accident.

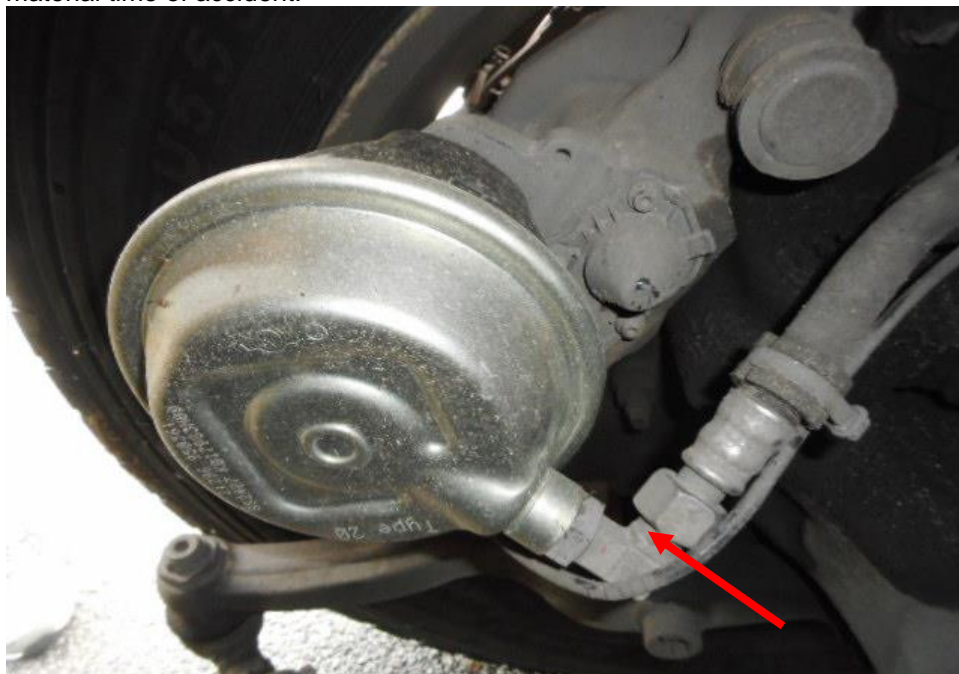
Photo 19 shows the brake pipe (arrowed) at the front left wheel of the Motor Bus. I did not observe any leakage of brake fluid at the time of my inspection of the Motor Bus. My static tests of the Motor Bus's braking system, along with my visual examination of the various mechanical components in the braking system had indicated that there was no internal leakage of pressure/vacuum. Hence the braking system of the Motor Bus was likely to be in serviceable condition at the material time of accident.

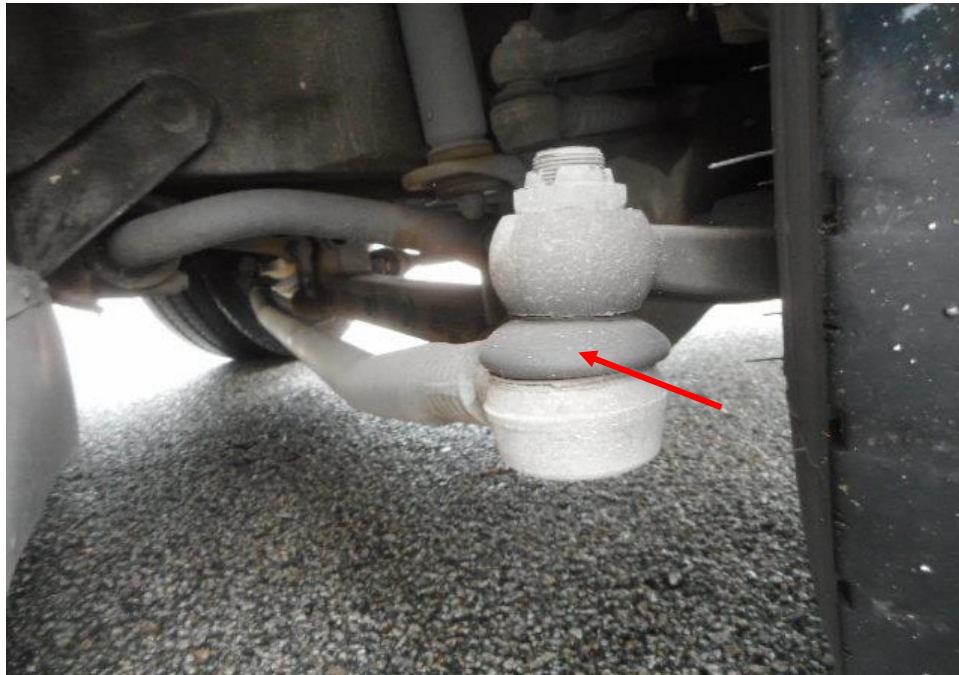
Photo 20 shows the various undercarriage components at the front right wheel of the Motor Bus, in particular the steering tie rod end (arrowed). The various steering components were all found to be intact, suggesting that the steering system of the Motor Bus was likely to be in serviceable condition at the material time of accident. There was also no sign of fluid stain(s) observed on the various undercarriage components.

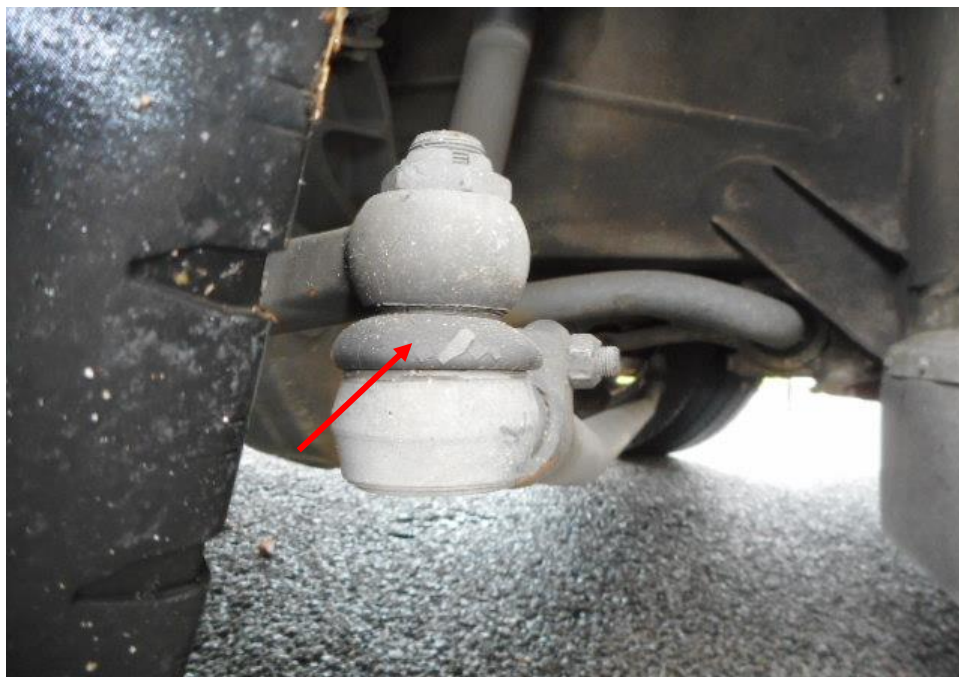
Photo 21 shows the various undercarriage components at the front left wheel of the Motor Bus, in particular the steering tie rod end (arrowed). The various undercarriage components of the Motor Bus were all found to be intact without any visible damage. There was also no sign of fluid stain(s) observed on the various undercarriage components.

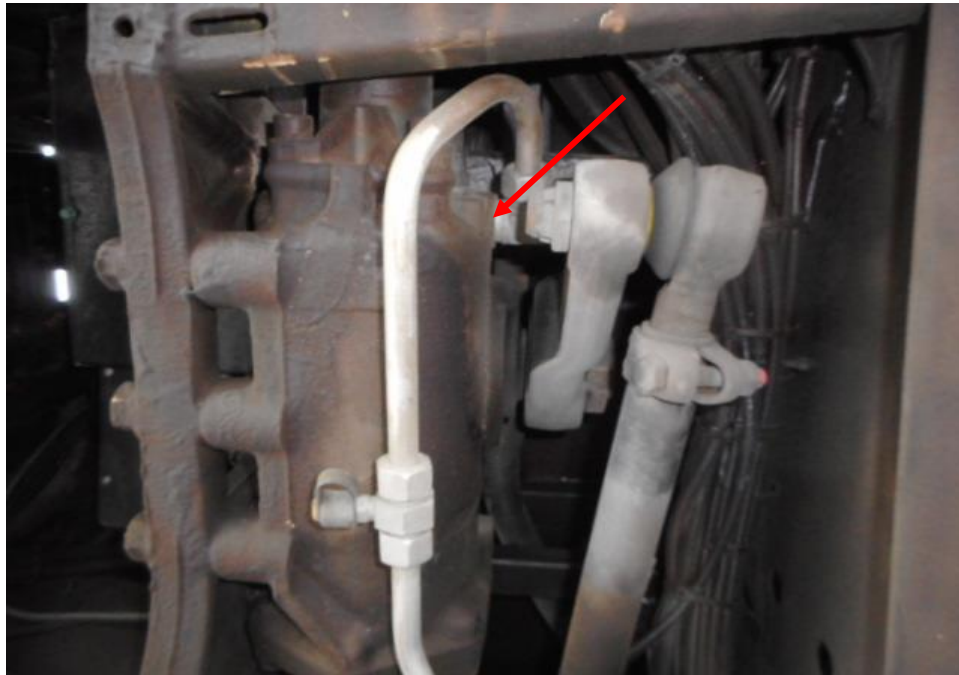
Photo 22 shows the steering box component (arrowed) at the undercarriage of the Motor Bus was found to be intact without any visible damage. There was also no sign of fluid stain(s) observed on the various undercarriage components.

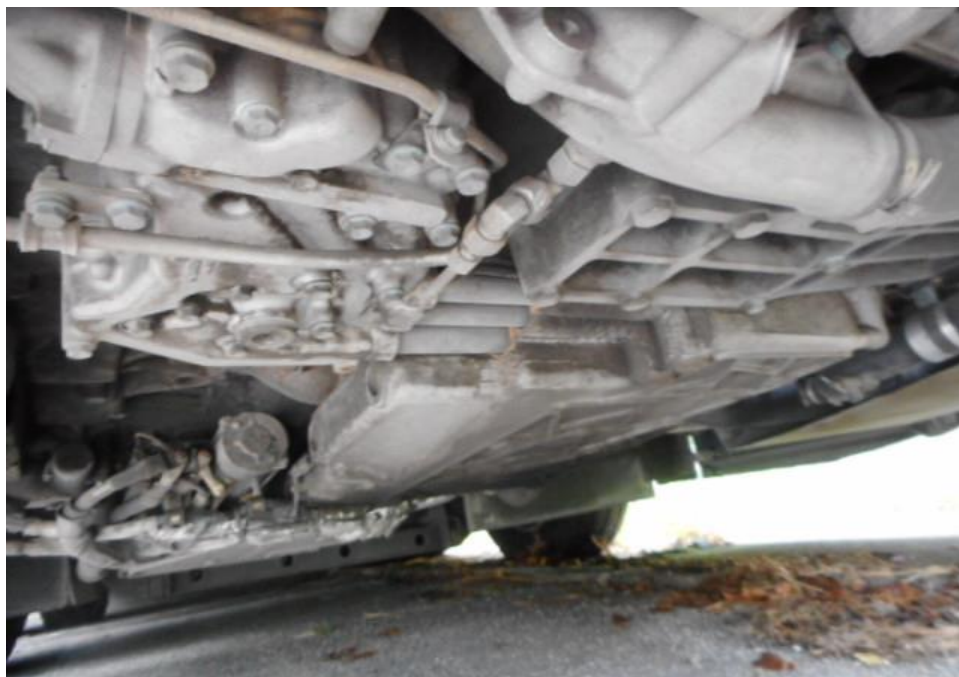
Photo 23 shows the undercarriage of the Motor Bus, at the area where the engine housing and transmission housing are located. I did not find any sign(s) or indication(s) of fluid leak and/or fluid stain(s) on the underside of the Motor Bus.

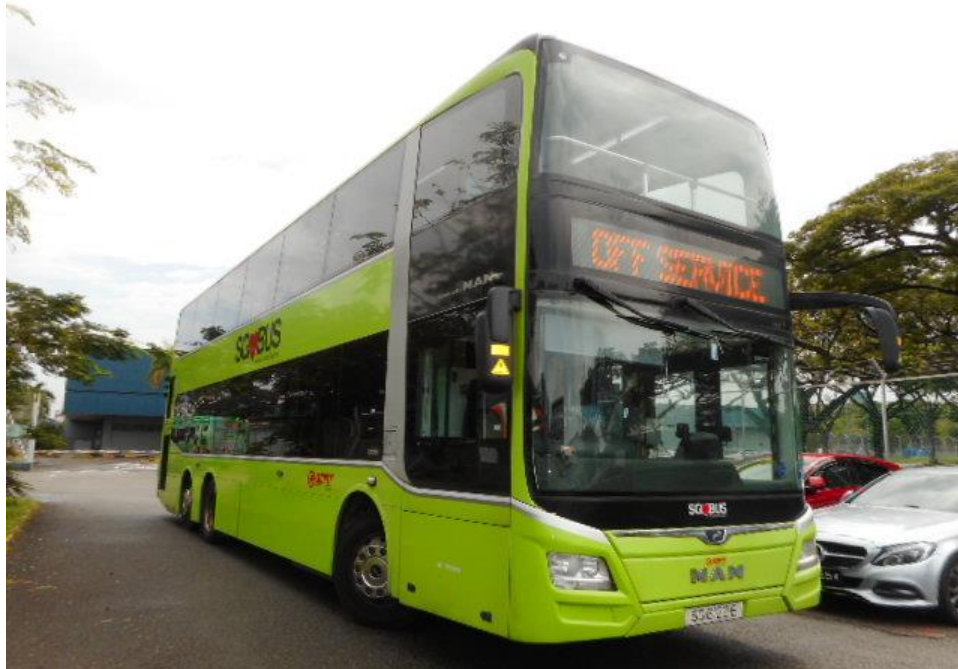
Photo 24 shows the front right wheel of the Motor Bus turned to its full left. During my steering system test, I did not experience any abnormal free play and/or resistance when I had turned the steering wheel towards full left and full right. This would suggest that the steering system of the Motor Bus was likely to be in serviceable condition at the material time of accident.

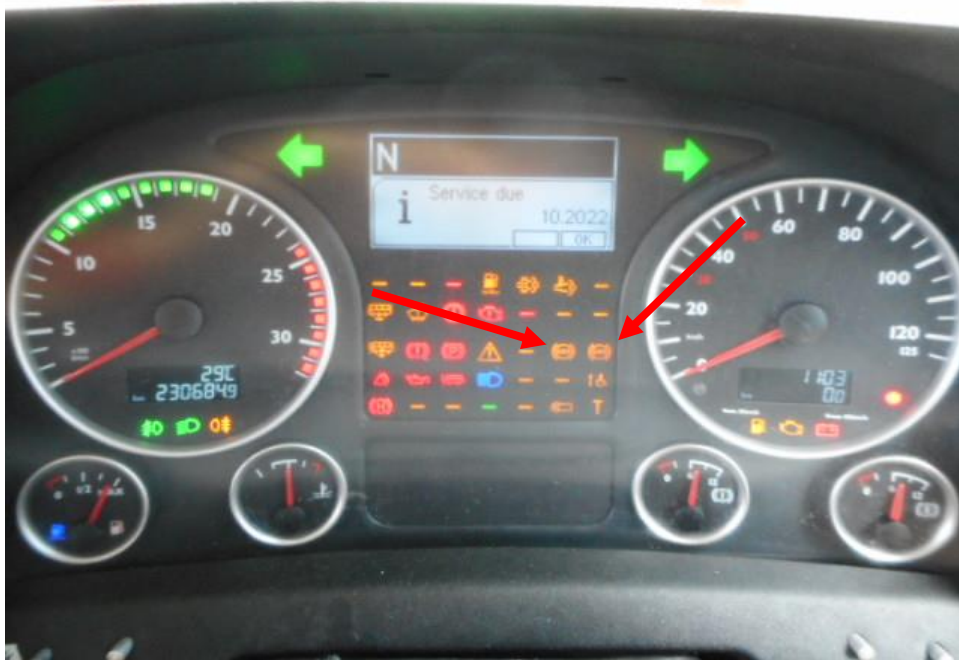
Photo 25 shows the warning light for Traction Control System (TCS) and Anti-Lock Braking System (ABS) appearing on the instrument panel of the Motor Bus during the self-test of its various electronic operating systems when its engine was cranked.

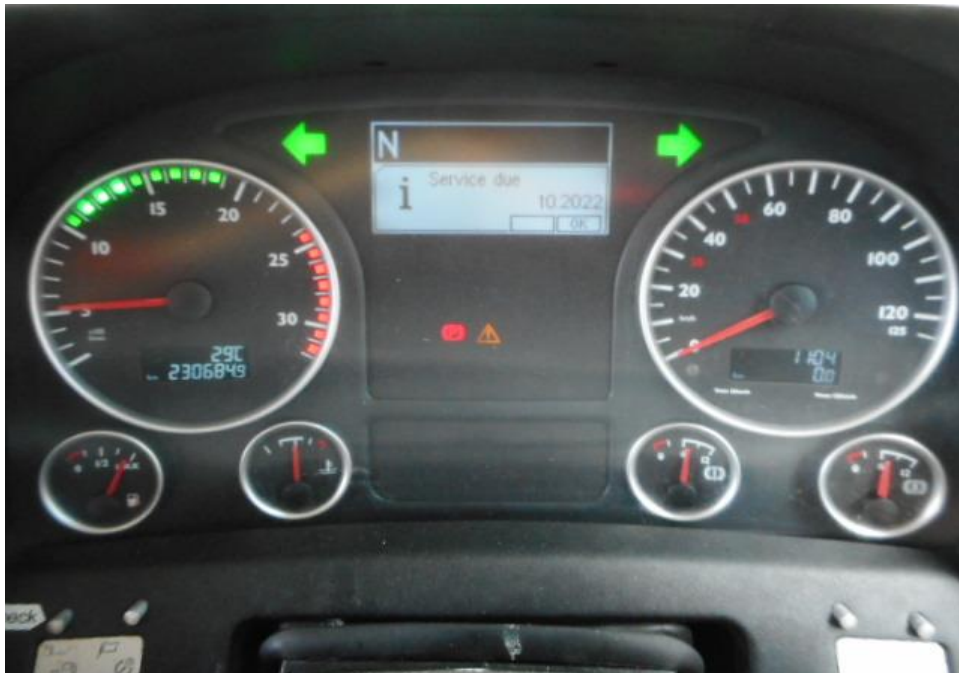
Photo 26 shows no warning lights illuminated on the instrument panel of the Motor Bus after the engine was cranked. This would suggest that there was no abnormality to the various electronic operating systems of the Motor Bus, like the TCS, ABS and etc.
