You're Ref: TP/IP/08448/2022  
Our Ref: CI/TPD22005082/P

31<sup>st</sup> May 2022

**Fatal Accident Investigation Team**

**MECHANICAL INSPECTION REPORT OF MOTOR CAR SLJ 8418G**

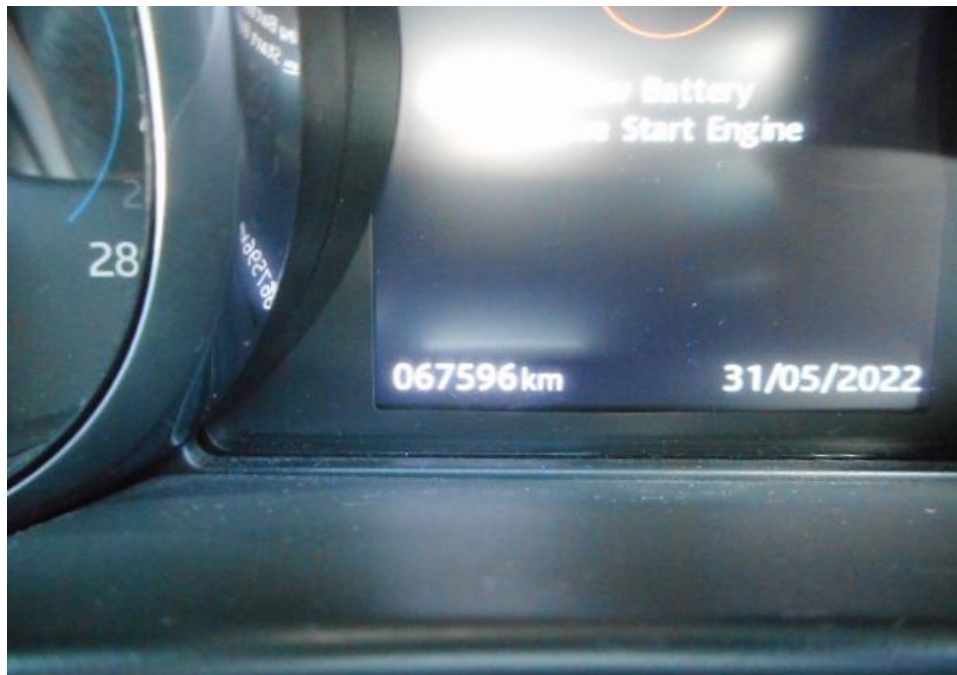
**Photo 1** shows the mileage of the Motor Car at the time of my inspection. The mileage observed was 67,596km.

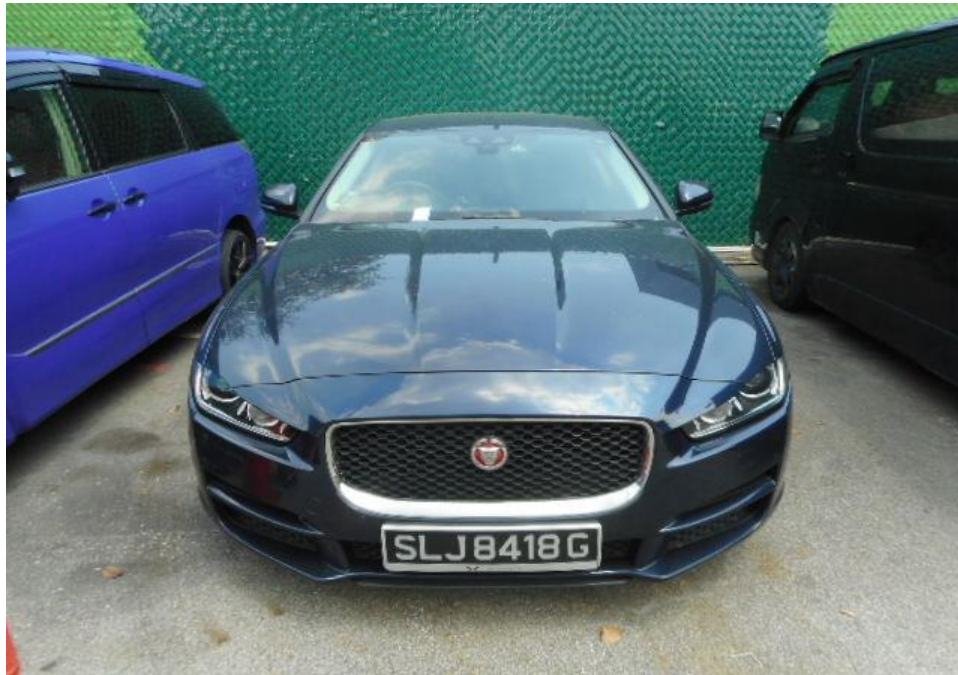
**Photo 2** shows a general view of the Motor Car's front body at the time of my inspection. The front portion of the Motor Car was observed to have been unaffected by the accident.

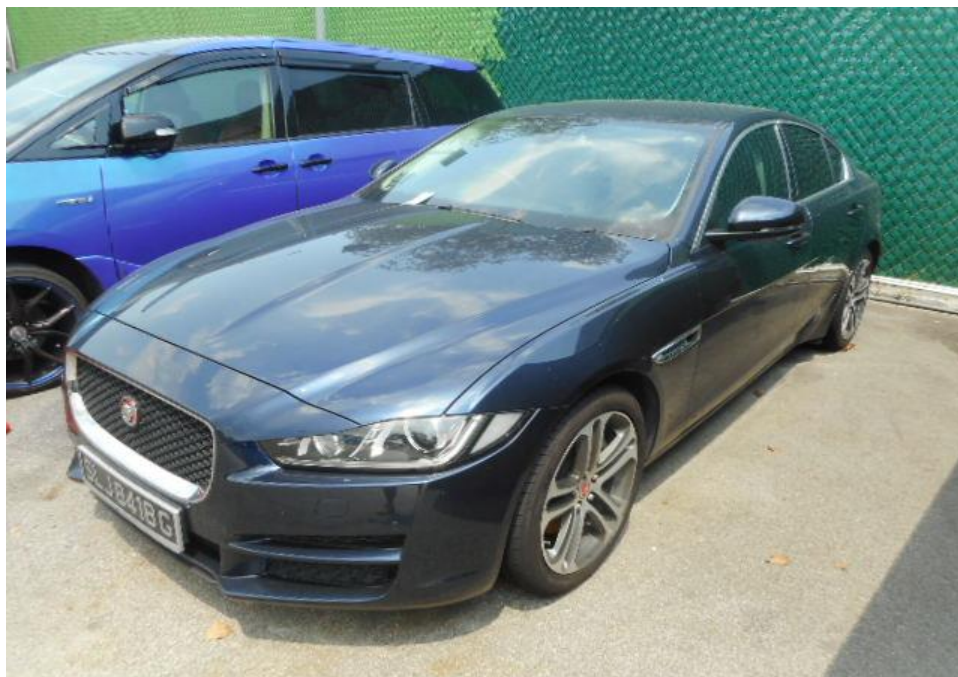
**Photo 3** shows a general view of the Motor Car's left body at the time of my inspection. The Motor Car was observed to have sustained damage at its left portion. Its left rear door panel was the body part that were damaged as a result of the accident.

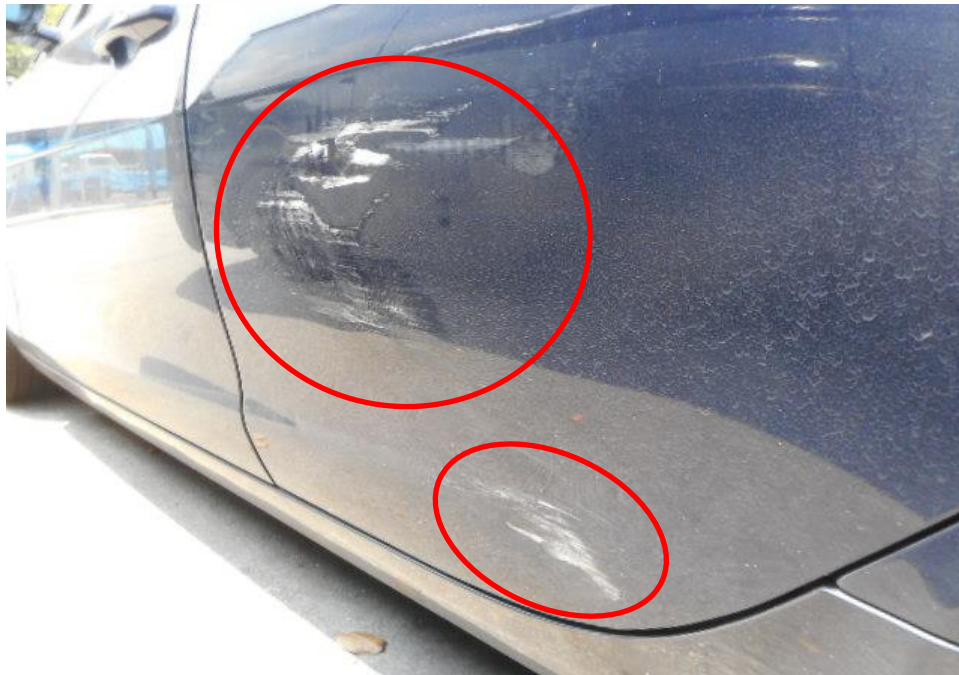
**Photo 4** shows a close up view of the Motor Car's left body at the time of my inspection. The rear portion of the Motor Car was observed to have sustained damage. Its left rear door panel (circled) was the body part that were damaged as a result of the accident.

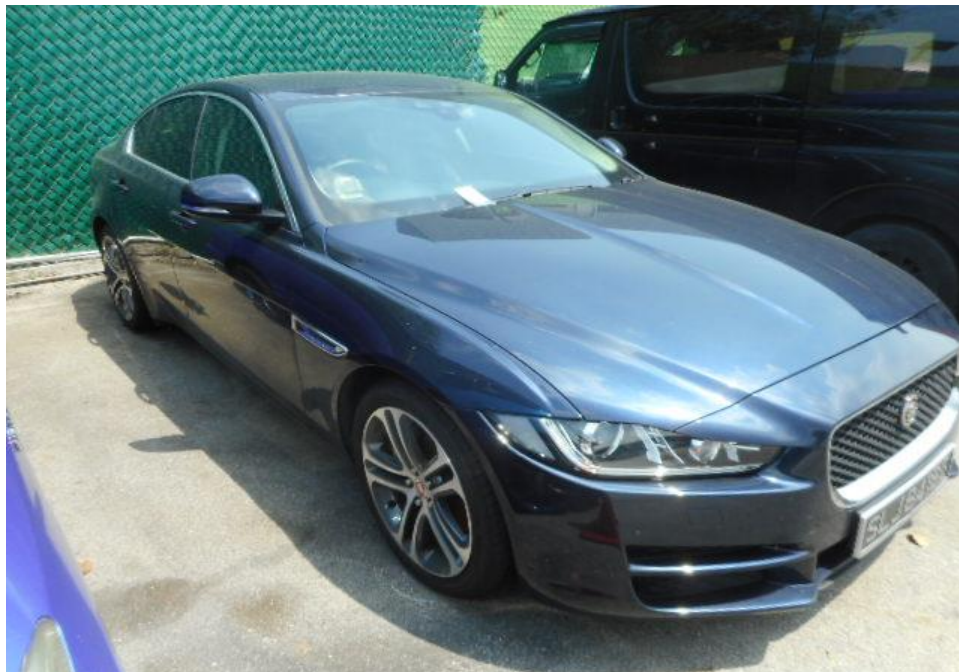
**Photo 5** shows a general view of the Motor Car's right body at the time of my inspection. The right portion of the Motor Car was observed to have been unaffected by the accident.

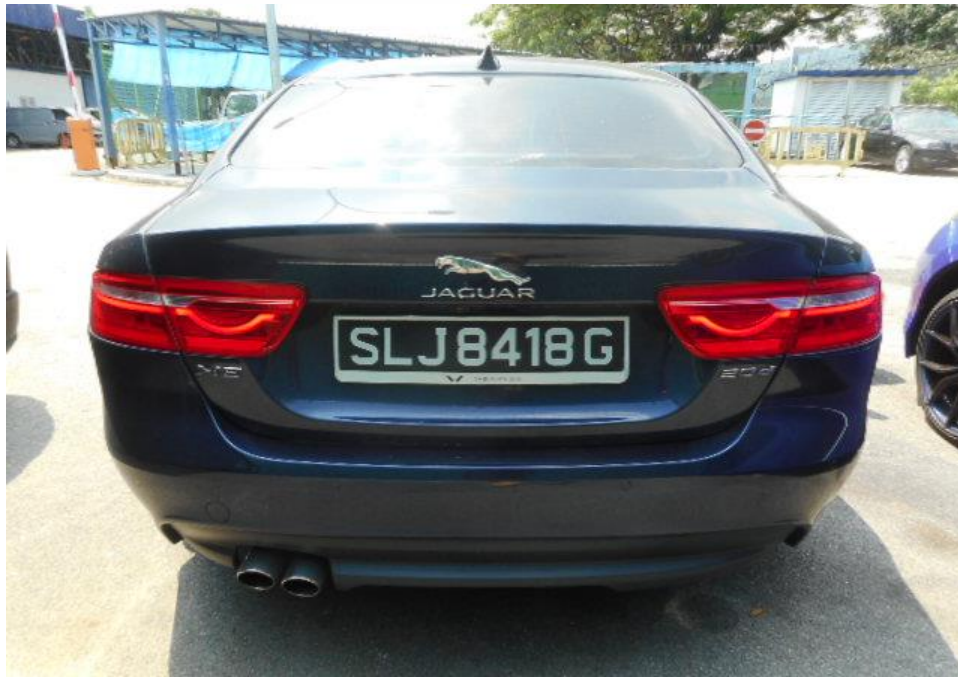
**Photo 6** shows the general view of the Motor Car's rear body at the time of my inspection. The rear portion of the Motor Car was observed to have been unaffected by the accident.

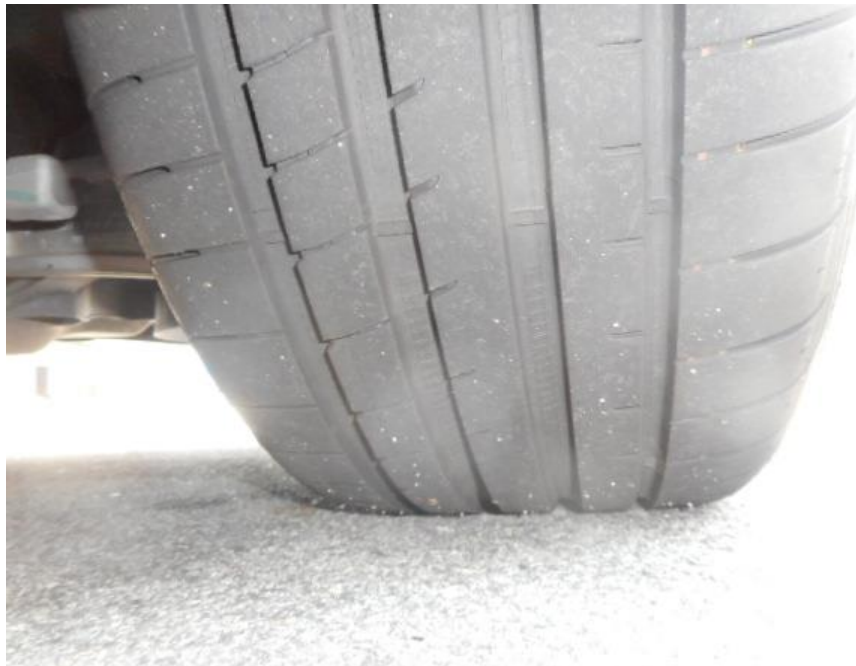
**Photo 7** shows the condition of the front right tyre of the Motor Car, which was observed to be in serviceable condition with remaining tread depth of approximately 6.8mm. The tyre was sufficiently inflated for vehicular operation with no tear, cut or burst mark(s) on the outer and the inner sidewalls as well as across the tread. The 4 tyres of the Motor Car were wrapped around standard steel wheel rims without any damage.

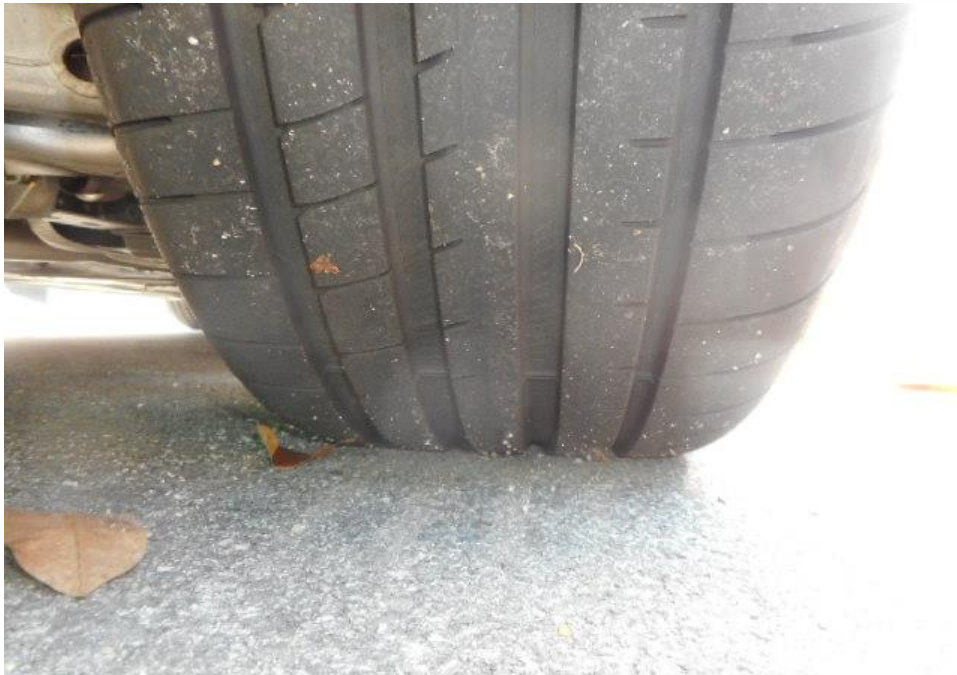
**Photo 8** shows the condition of the rear right tyre of the Motor Car, which was observed to be in serviceable condition with remaining tread depth of approximately 6.6mm. The tyre was also observed to be sufficiently inflated for vehicular operation with no tear, cut or burst mark(s).

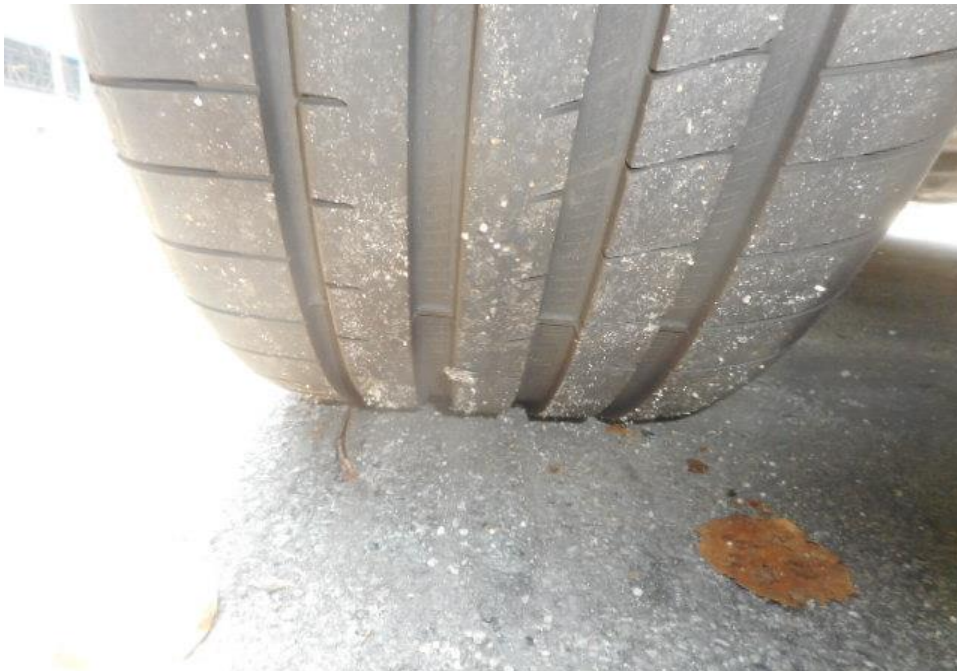
**Photo 9** shows the condition of the rear left tyre of the Motor Car, which was observed to be in serviceable condition with remaining tread depth of approximately 6.9mm. The tyre, which was wrapped around steel wheel rim, was also observed to be sufficiently inflated for vehicular operation. The 4 tyres of the Motor Car were wrapped around standard steel wheel rims.

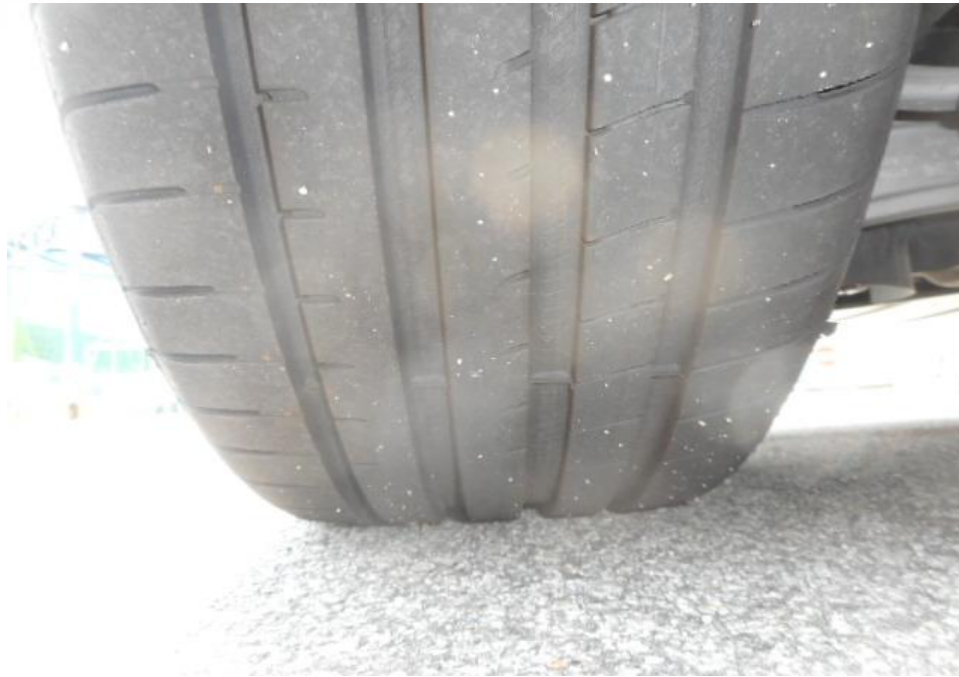
**Photo 10** shows the condition of the front left tyre of the Motor Car, which was observed to be in serviceable condition with remaining tread depth of approximately 6.4mm. There was also no tear, cut or burst mark(s) on the outer and the inner sidewalls as well as across the tread of the Motor Car's 4 tyres.

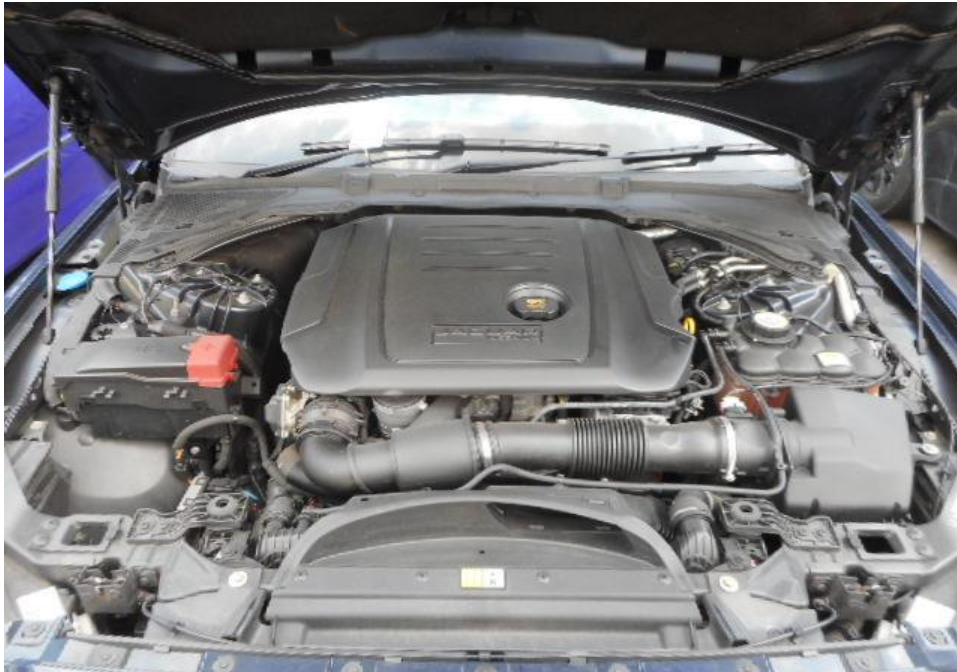
**Photo 11** shows a general view of the Motor Car's engine compartment. The various parts and components inside the engine compartment were unaffected by the accident. There was also no sign(s) or indication(s) of fluid leakage and/or fluid stain within the engine compartment.

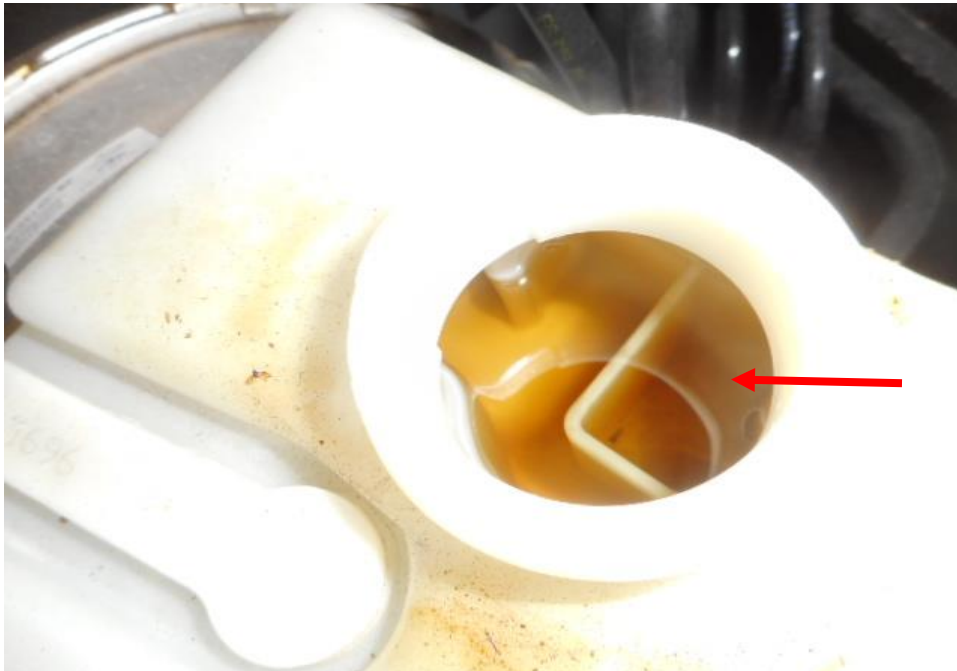
**Photo 12** shows the brake fluid reservoir of the Motor Car at the time of my inspection. The brake fluid was observed to be of sufficient level (arrowed) and without any visible contamination.

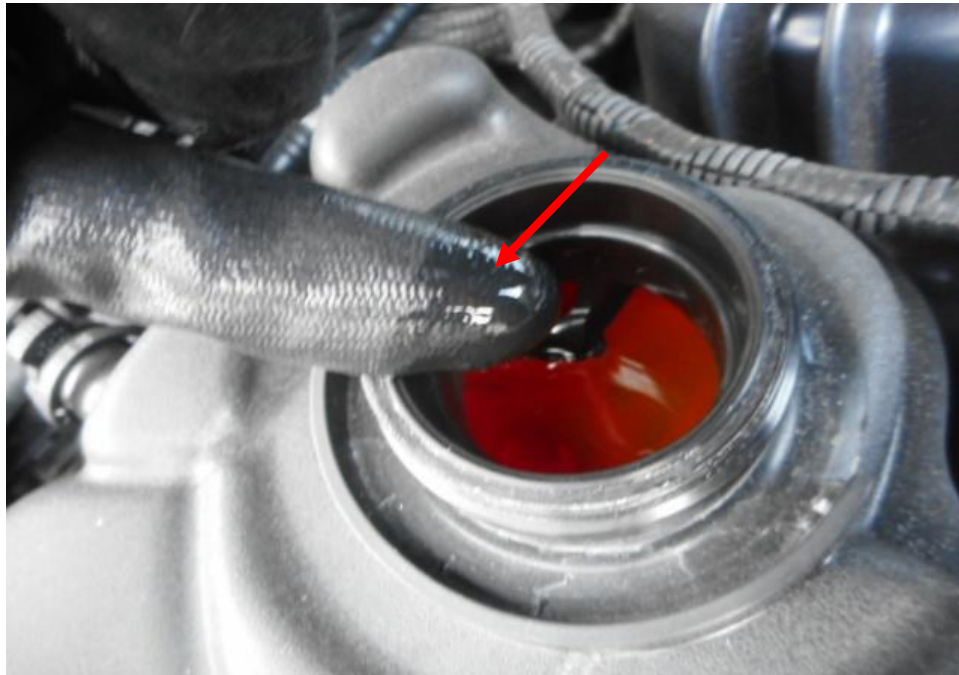
**Photo 13** shows checks being carried out to the engine coolant of the Motor Car at the time of my inspection. The engine coolant was observed to be of sufficient level (arrowed) and without any visible contamination.

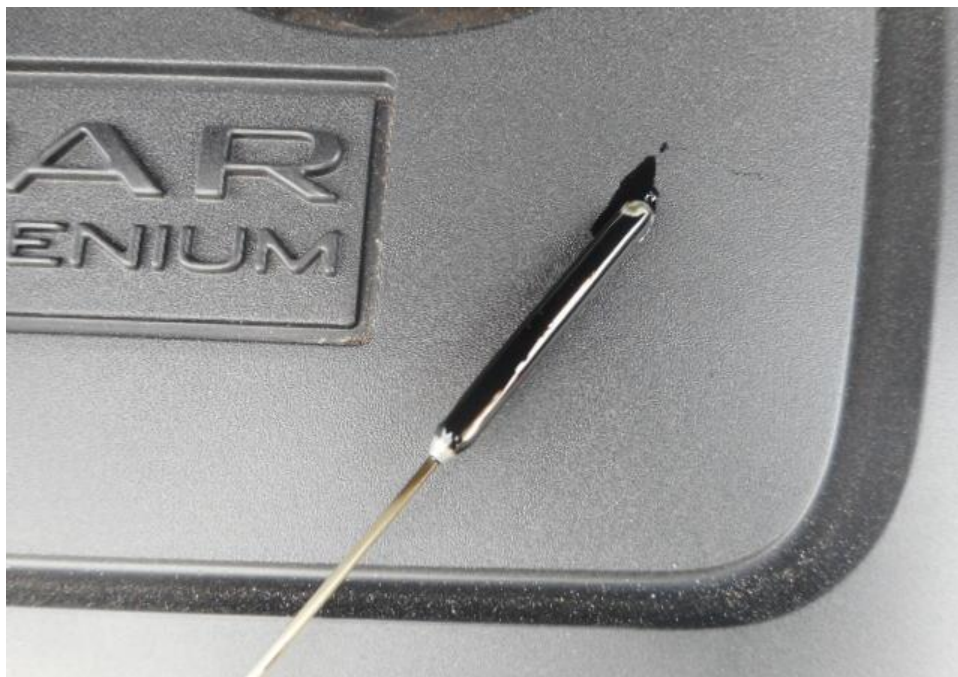
**Photo 14** shows the engine oil dipstick of the Motor Car at the time of my inspection. The engine oil was observed to be of sufficient level and without any visible contamination.

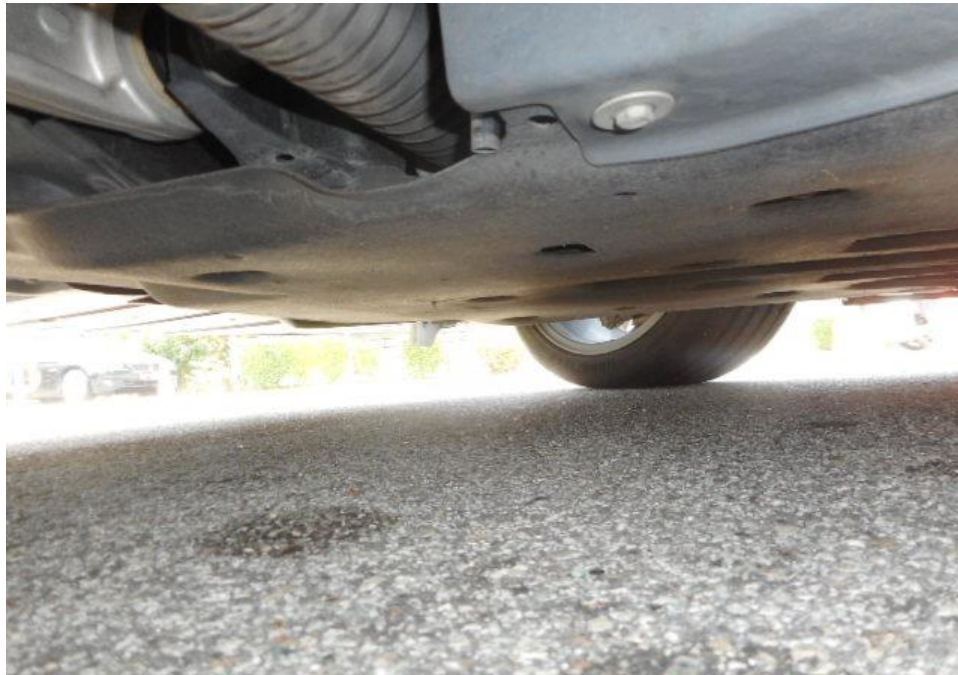
**Photo 15** shows the undercarriage of the Motor Car, at the area where the engine housing and transmission housing are located. I did not find any sign(s) or indication(s) of fluid leak and/or fluid stain(s) on the underside of the Motor Car.

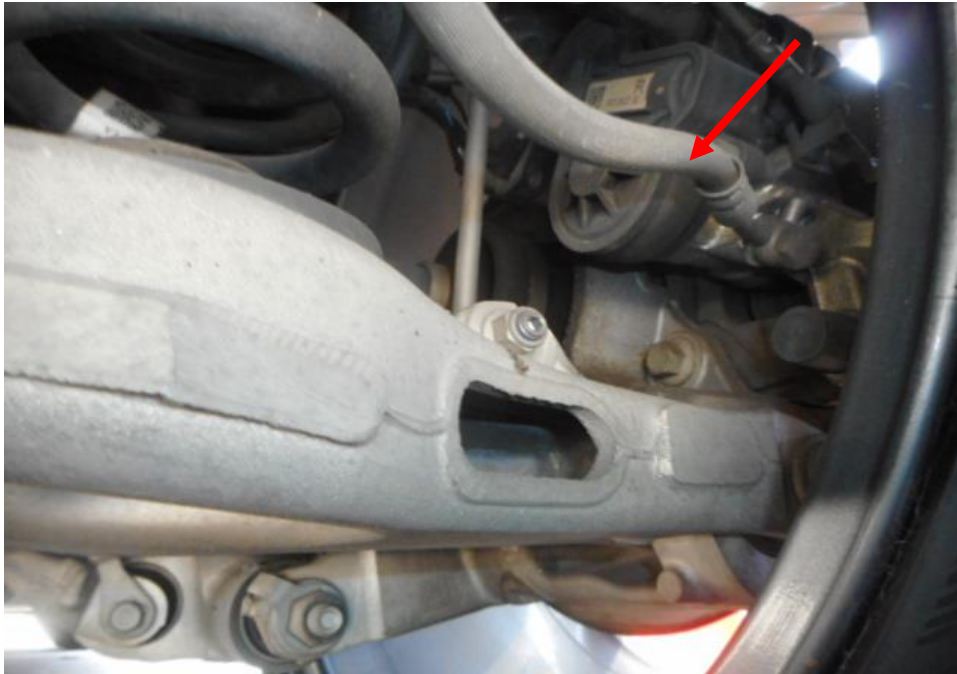
**Photo 16** shows the brake hose/pipe (arrowed) at the rear right wheel of the Motor Car. No leakage of brake fluid was observed. Visual examination of the various components of the braking system like the drum brake, brake booster, brake pedal etc. had revealed all to be intact and without visible damage.

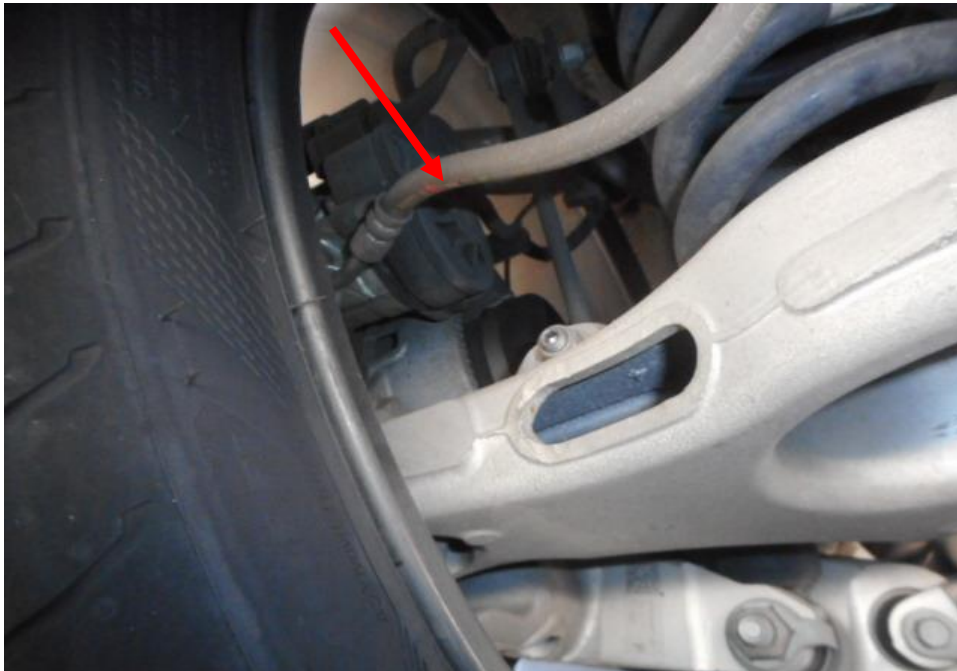
**Photo 17** shows the brake hose/pipe (arrowed) at the rear left wheel of the Motor Car. I did not observe any leakage of brake fluid at the time of my inspection of the Motor Car. Static tests of the Motor Car's braking system had indicated that there was no internal leakage of pressure/vacuum. The undercarriage components of the Motor Car were also all found to be intact and without any visible damage.

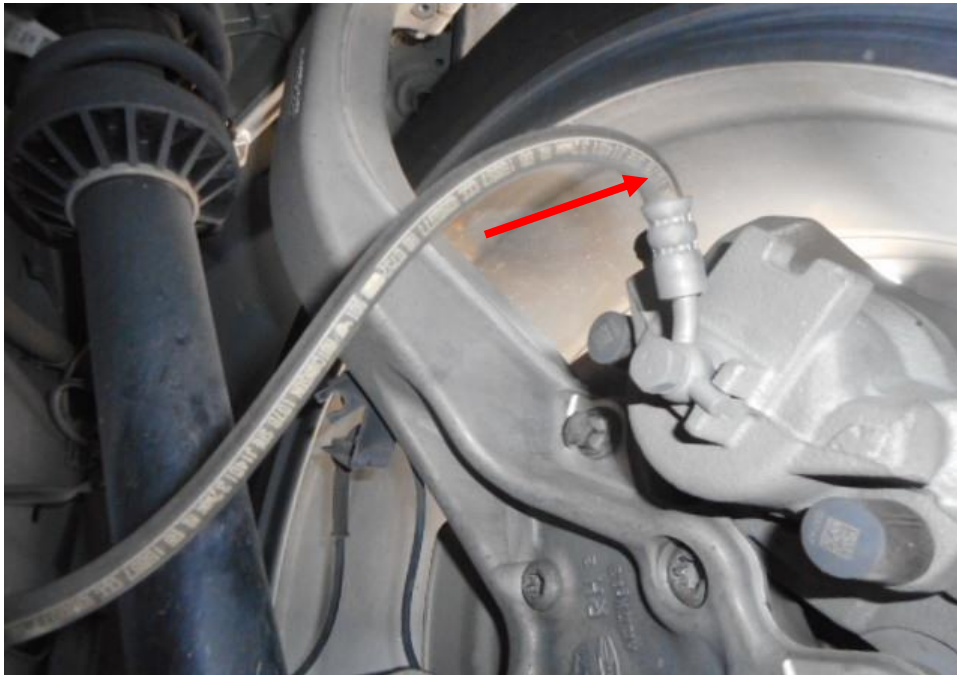
**Photo 18** shows the brake hose/pipe (arrowed) at the front right wheel of the Motor Car. I did not observe any leakage of brake fluid at the time of my inspection of the Motor Car. Static tests of the Motor Car's braking system had indicated that there was no internal leakage of pressure/vacuum.

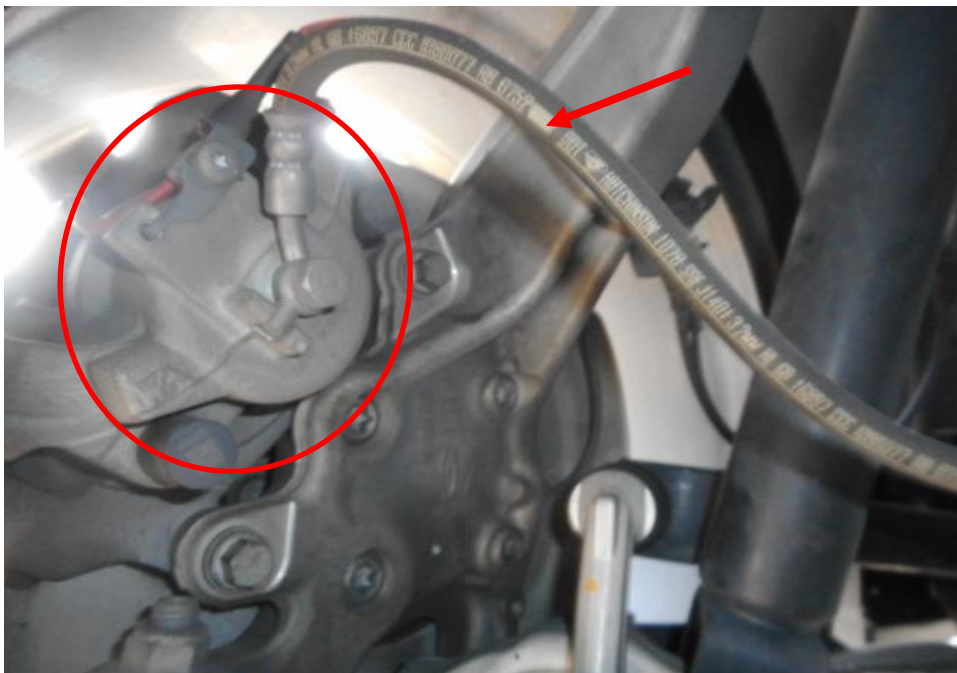
**Photo 19** shows the brake hose/pipe (arrowed) at the front left wheel of the Motor Car. No leakage of brake fluid was observed. Visual examination of the various components of the braking system like the brake caliper (circled), brake booster, brake pedal etc had revealed all to be intact and without visible damage.

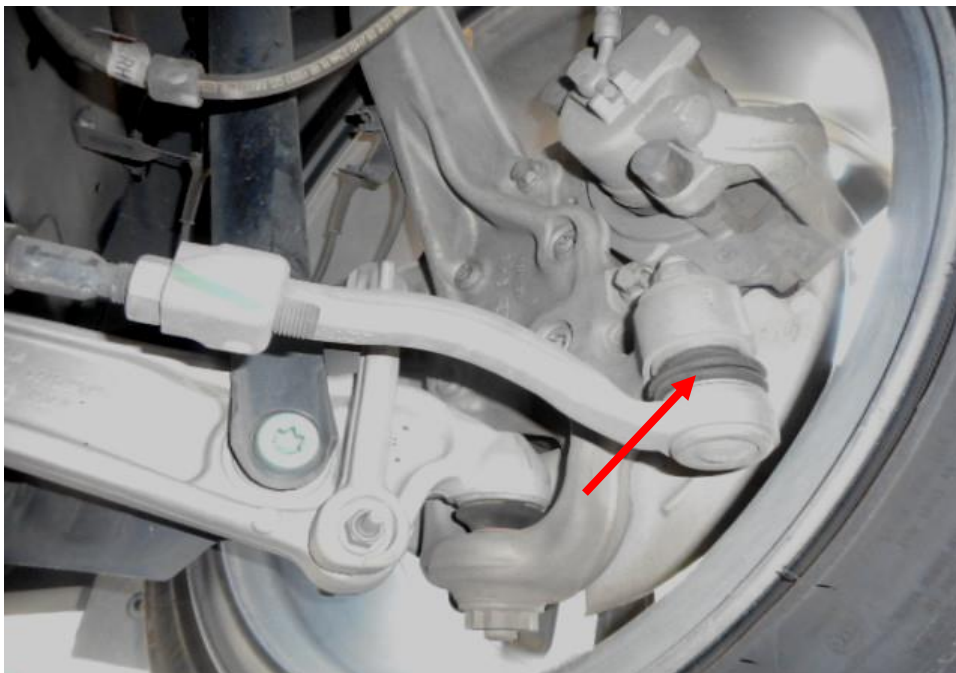
**Photo 21** shows the various undercarriage components at the front right wheel of the Motor Car, in particular the steering tie rod (red arrow). The various steering components were all found to be intact, suggesting that the steering system of the Motor Car was likely to be in serviceable condition at the material time of accident. There was also no sign of fluid stain observed on the various undercarriage components at the front right wheel of the Motor Car.

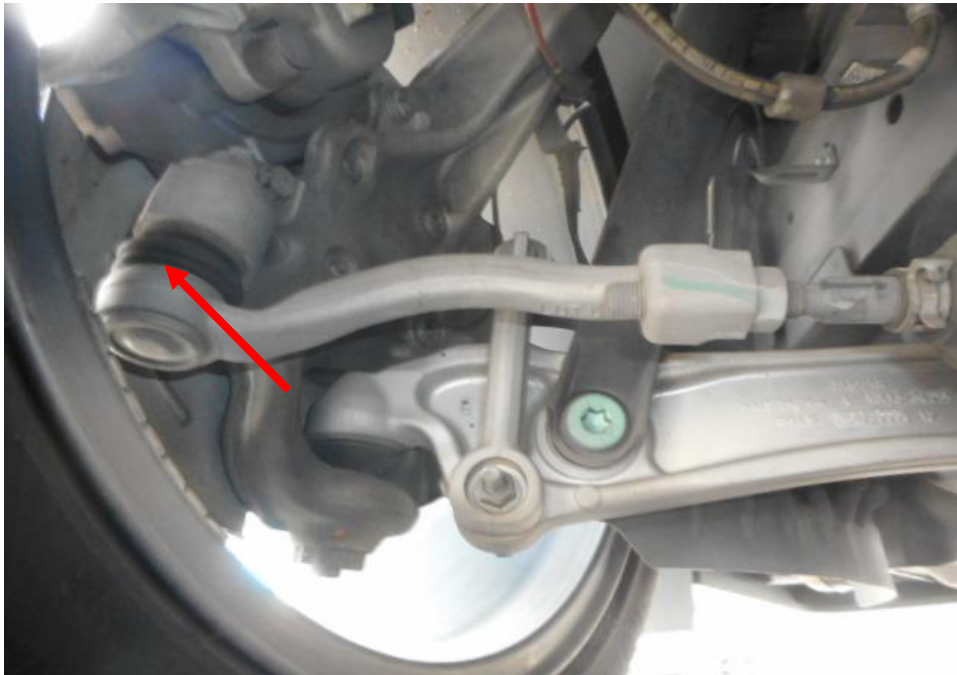
**Photo 22** shows the various undercarriage components at the front left wheel of the Motor Car, which had included the steering tie rod (red arrow). The various undercarriage components of the Motor Car were all found to be intact without any visible damage.

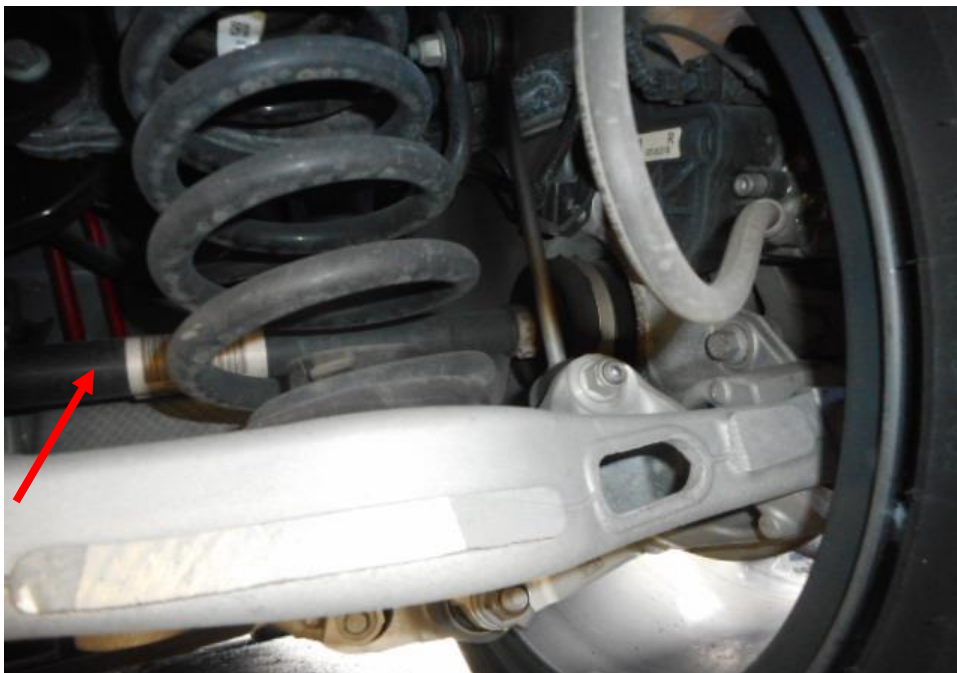
**Photo 23** shows the various undercarriage components at the rear right wheel of the Motor Car, in particular the drive shaft (arrowed). The various components were all found to be intact, suggesting that the driveshaft of the Motor Car was likely to be in serviceable condition at the material time of accident. There was also no sign of fluid stain observed on the various undercarriage components at the rear right wheel of the Motor Car.

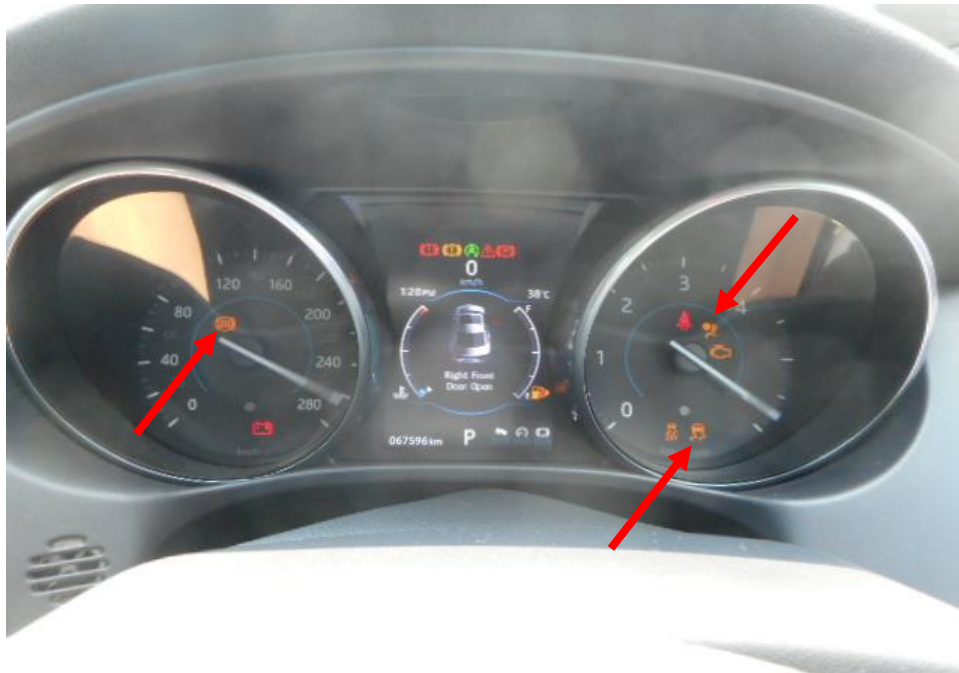
**Photo 24** shows the warning light for Anti-Lock Brake System (ABS), Traction Control System (TCS), and Supplemental Restraint System (SRS) (arrowed) appearing on the instrument panel of the Motor Car during the self-test of its various electronic operating systems when its engine was cranked.

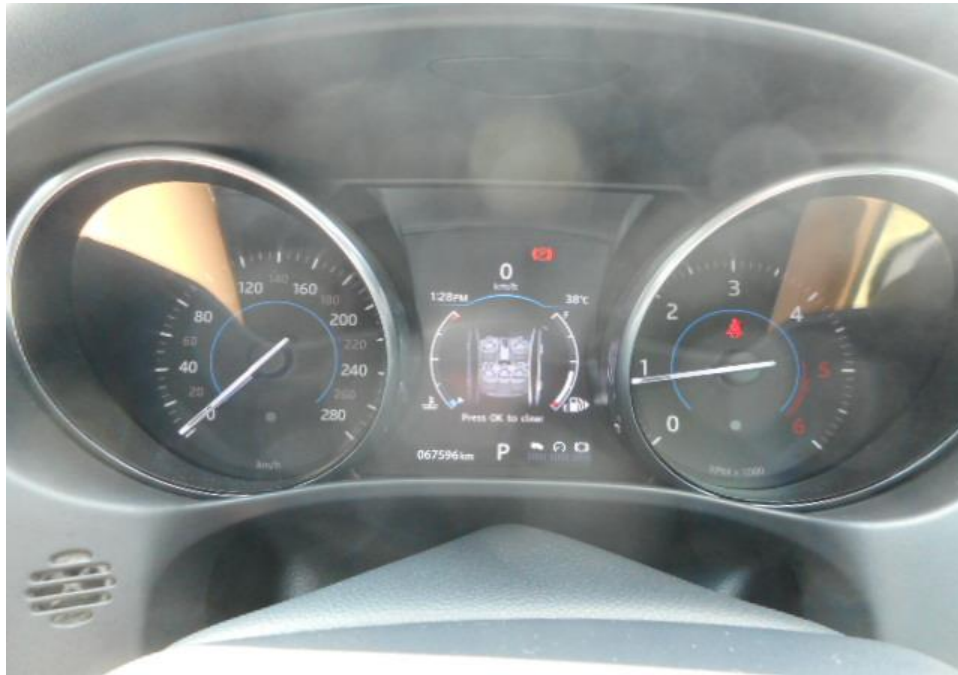
**Photo 25** shows no warning lights illuminated on the instrument panel of the Motor Car after the engine was cranked. This would suggest that there was no abnormality to the electronic operating system of the Motor Car, like the ABS, TCS and SRS etc.
