Your Ref: TP/IP/05078/2022  
Our Ref : CI/TPD22005083/P

### **Fatal Accident Investigation Team**

### **MECHANICAL INSPECTION REPORT OF MOTOR CAR SFF 319D**

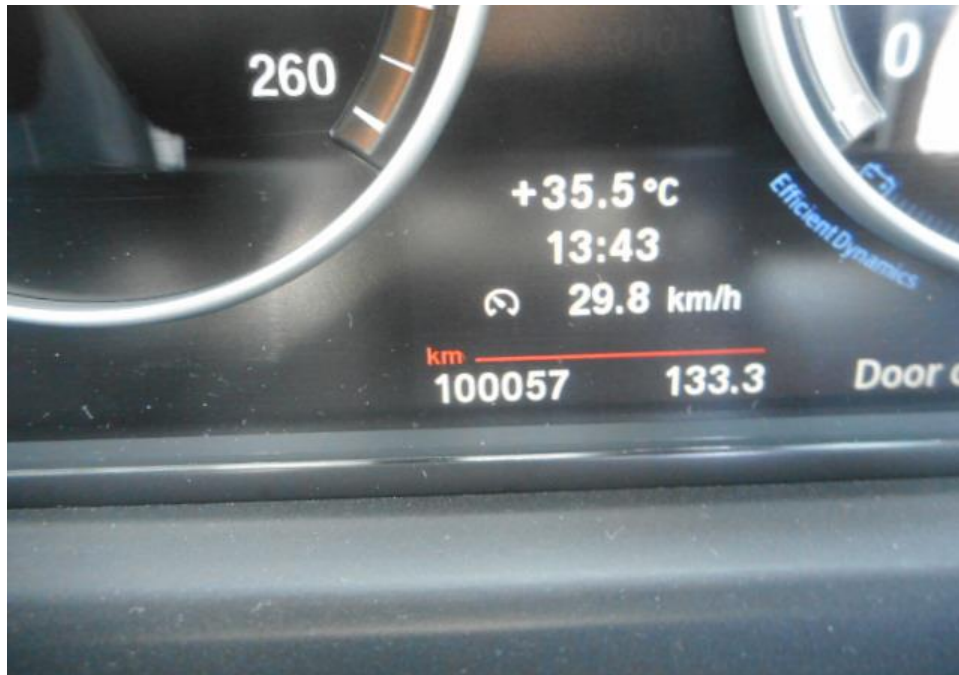
**Photo 1** shows a general view of the instrument cluster of the Motor Car at the time of my inspection. The mileage of the Motor Car was 100,057km

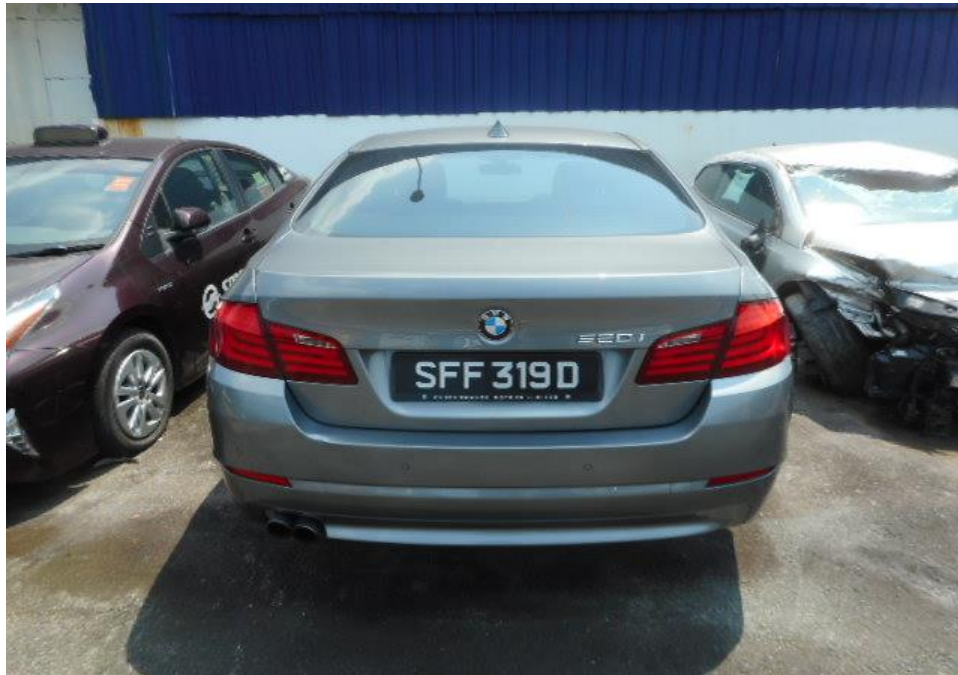
**Photo 2** shows a general view of the rear body of the Motor Car at the time of my inspection. The Motor Car was observed to be intact and unaffected by the accident.

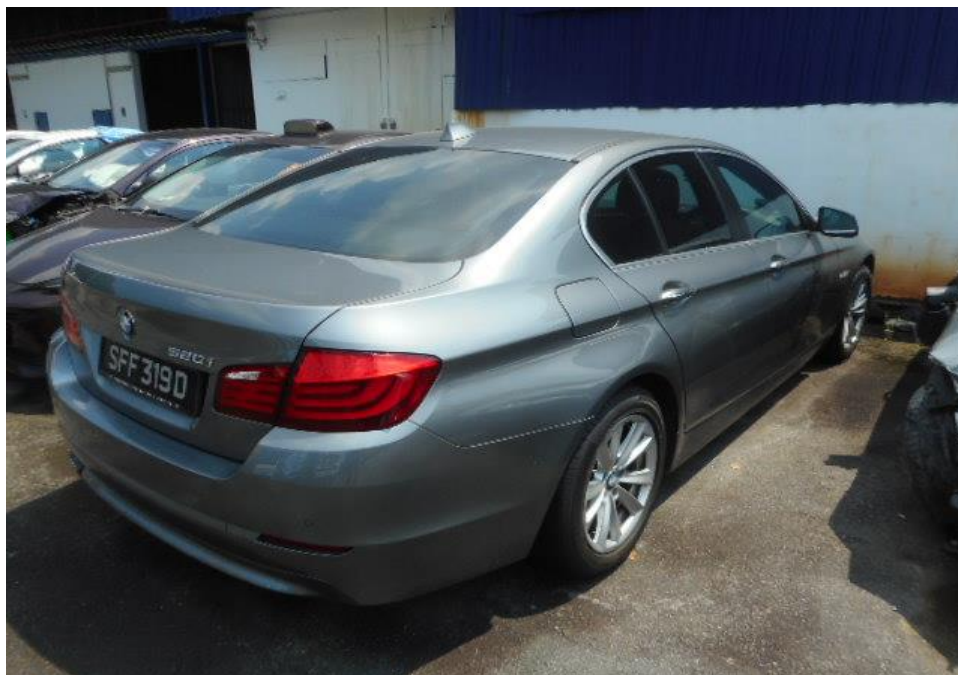
**Photo 3** shows a general view of the right body of the Motor Car at the time of my inspection. The Motor Car was observed to be intact and unaffected by the accident.

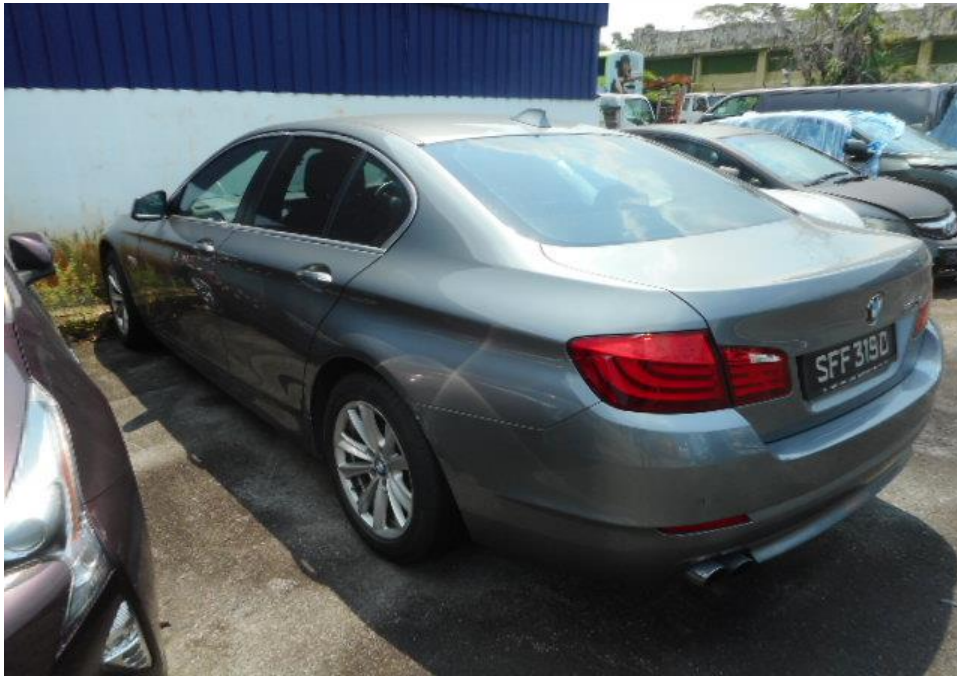
**Photo 4** shows a general view of the left body of the Motor Car at the time of my inspection. The Motor Car was observed to be intact and unaffected by the accident.

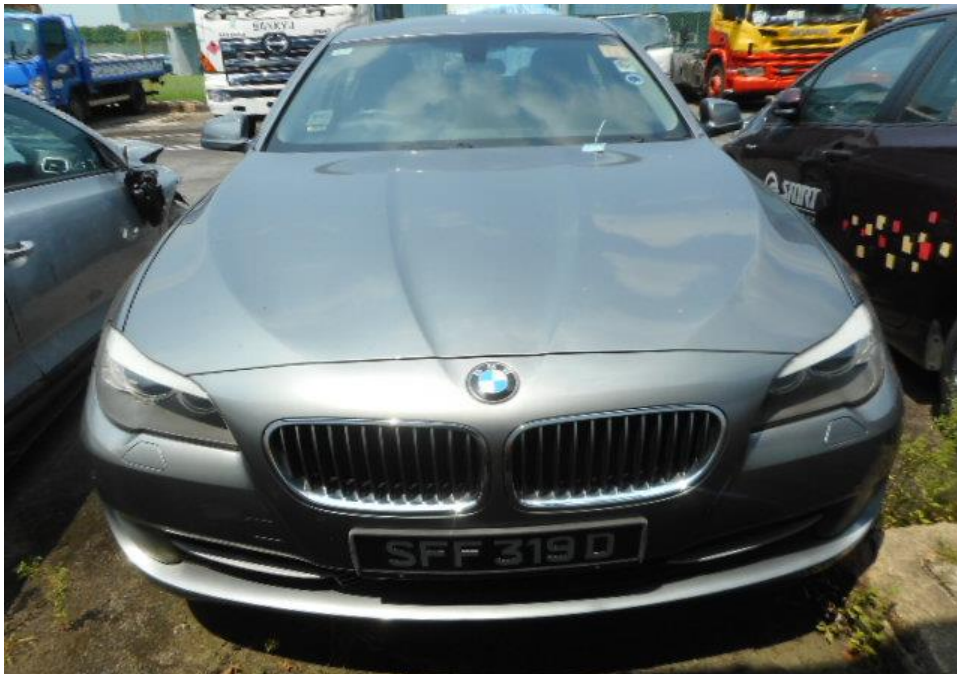
**Photo 5** shows a general view of the Motor Car at the time of my inspection. The Motor Car was observed to be intact and unaffected by the accident.

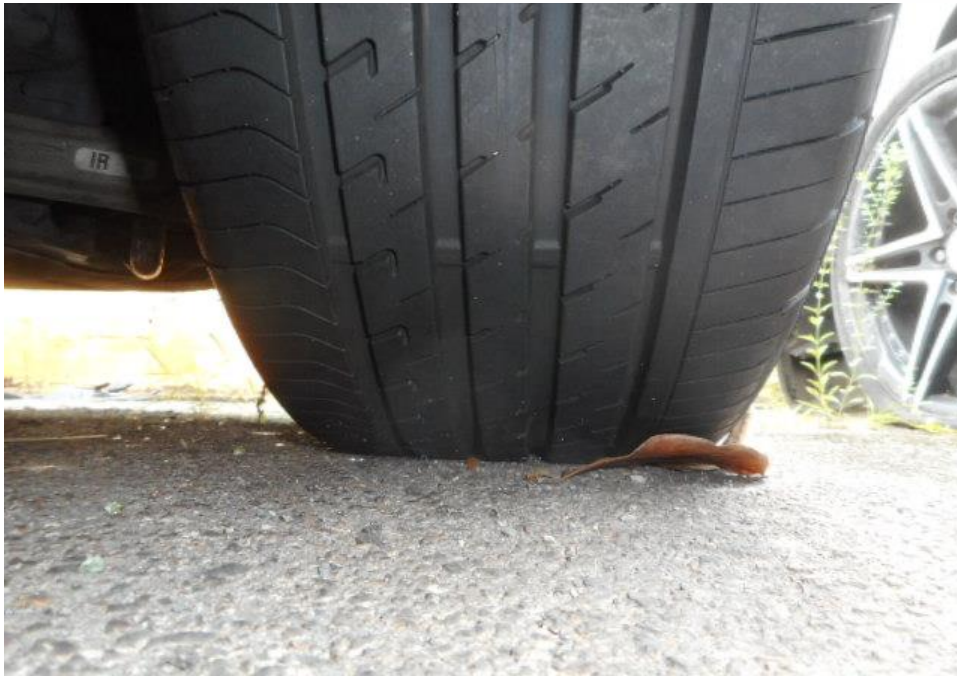
**Photo 6** shows the condition of the front right tyre of the Motor Car, which was observed to be in serviceable condition with remaining tread depth of approximately 7.2mm. The tyre, which was wrapped around standard alloy wheel rim, was also observed to be sufficiently inflated for vehicular operation. There was no tear, cut or burst mark(s) on the outer and the inner sidewalls as well as across the tread of the 4 tyres that were fitted on the Motor Car.

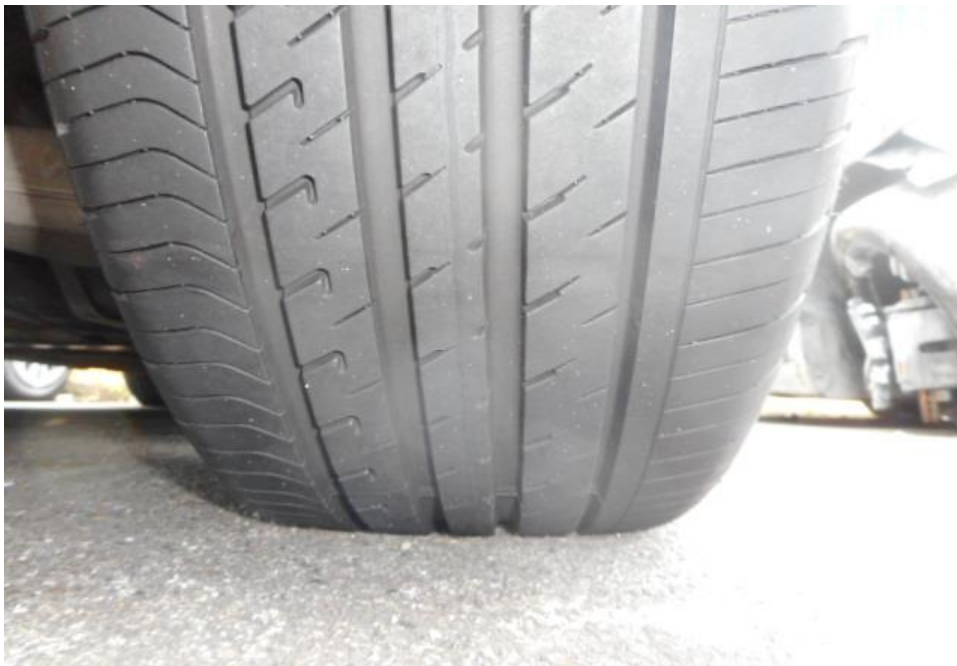
**Photo 7** shows the condition of the rear right tyre of the Motor Car, which was observed to be in serviceable condition with remaining tread depth of approximately 7.1mm. The tyre, which was wrapped around standard alloy wheel rim, was also observed to be sufficiently inflated for vehicular operation.

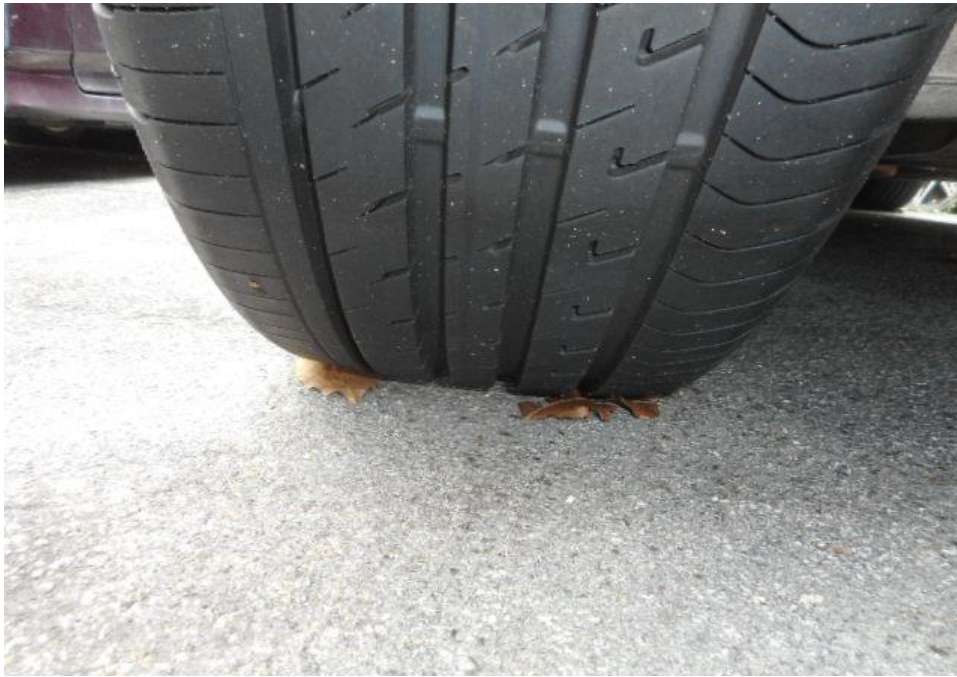
**Photo 8** shows the condition of the rear left tyres of the Motor Car, which was observed to be in serviceable condition with remaining tread depth of approximately 6.9mm. The tyres, which were wrapped around standard alloy wheel rim, were also observed to be sufficiently inflated for vehicular operation. There was also no damage found on all 4 alloy wheel rims of the Motor Car.

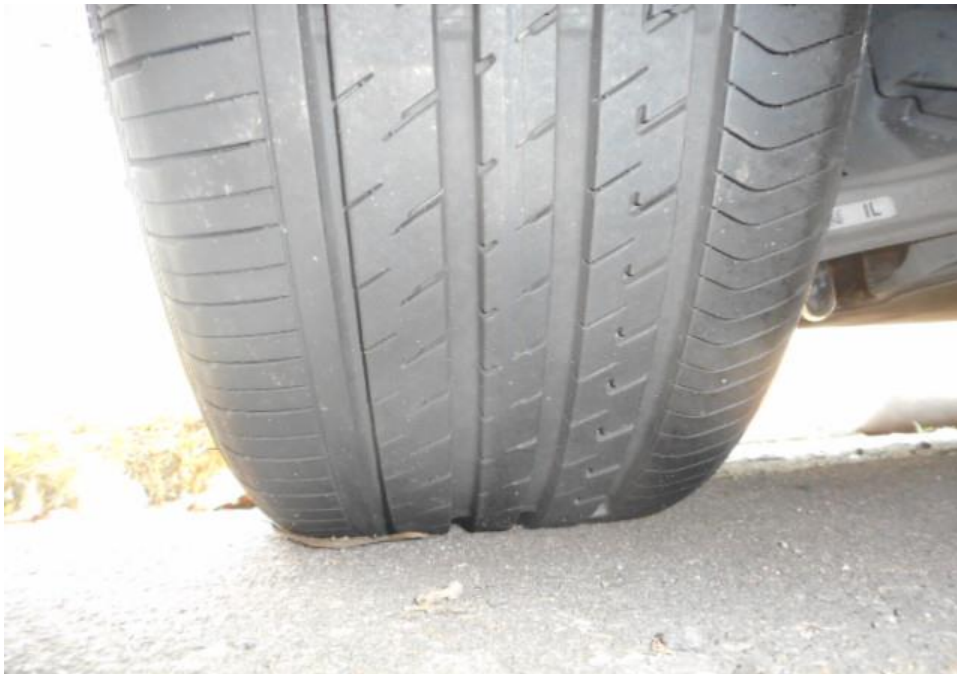
**Photo 9** shows the condition of the rear right tyres of the Motor Car, which were observed to be in serviceable condition with remaining, tread depth of approximately 7.3mm. There was also no tear, cut or burst mark(s) on the outer and the inner sidewalls as well as across the tread of the 4 tyres that were fitted on the Motor Car.

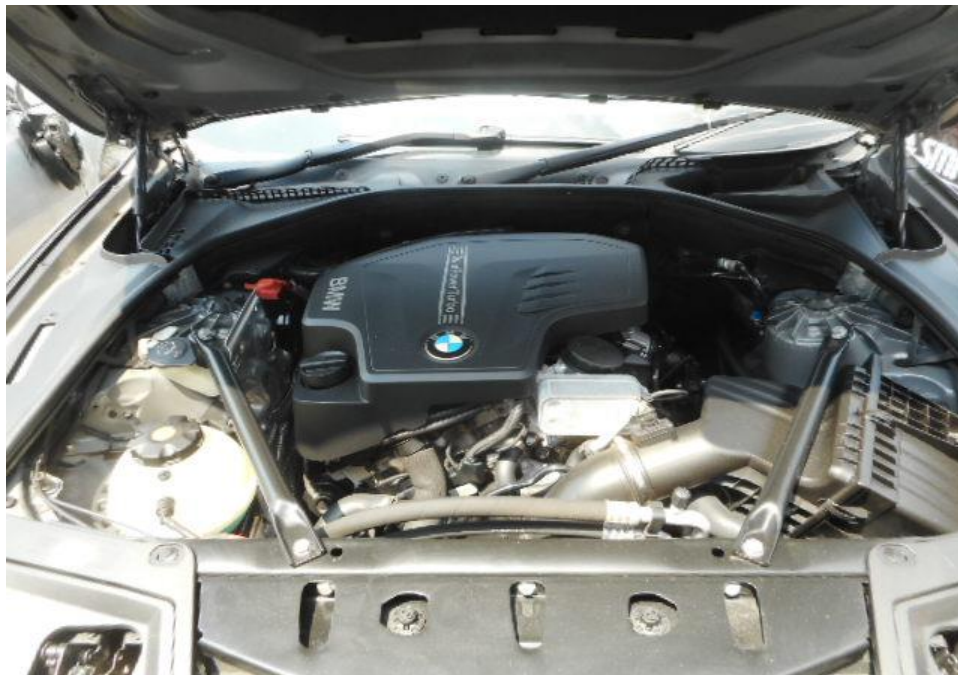
**Photo 10** shows a general view of the Motor Car's engine compartment, which was accessed by lifting the front cabin of the Motor Car. The various parts and components inside the engine compartment were unaffected by the accident. There was also no sign(s) or indication(s) of fresh fluid leakage and/or fluid stain within the engine compartment

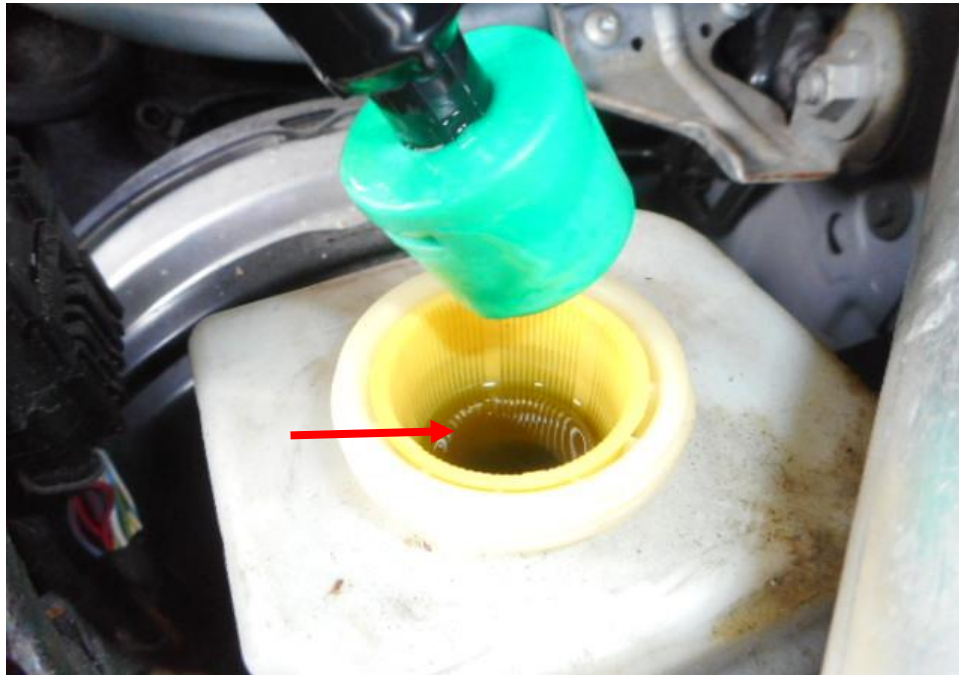
**Photo 11** shows the brake fluid reservoir of the Motor Car at the time of my inspection. The brake fluid was observed to be of sufficient level (arrowed) and without any visible contamination.

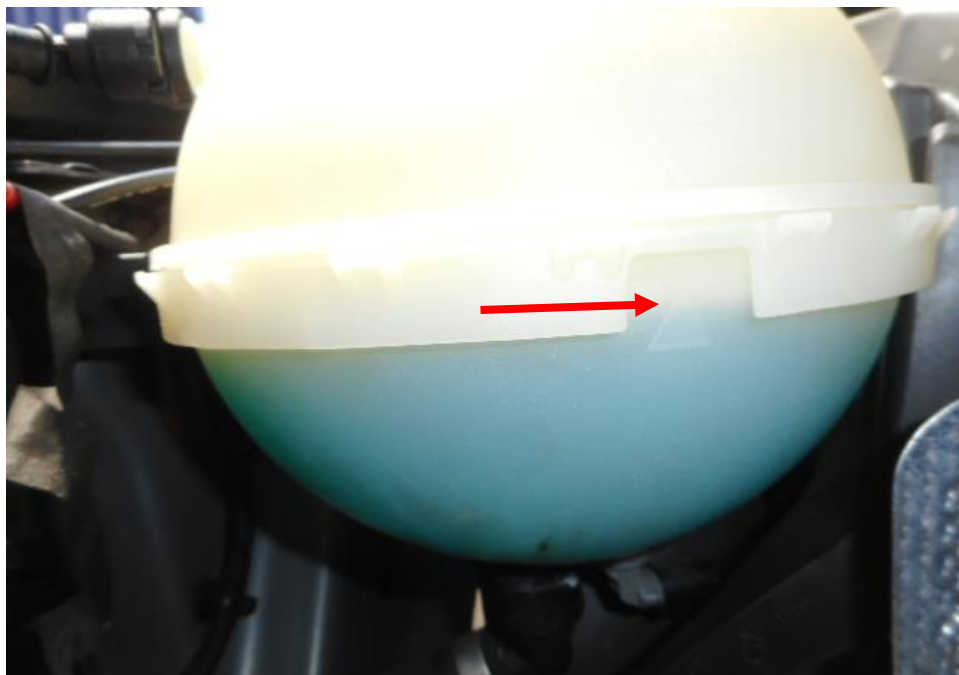
**Photo 12** shows the engine coolant reservoir of the Motor Car at the time of my inspection. The engine coolant was observed to be of sufficient level (arrowed) and without any visible contamination.

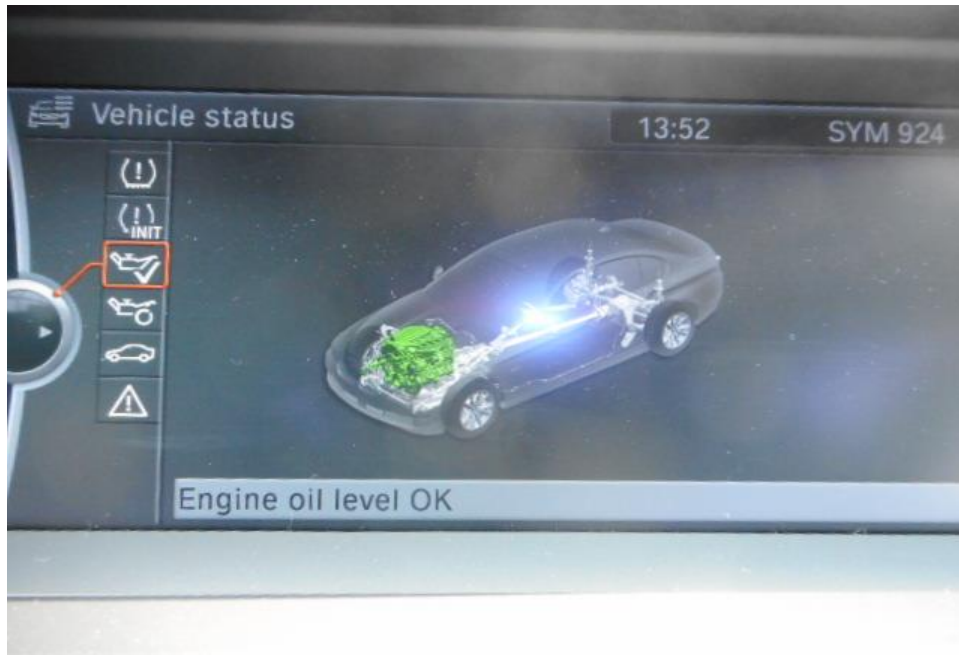
**Photo 13** shows the engine oil level of the Motor Car at the time of my inspection. The engine oil was observed to be of sufficient level and without any visible contamination.

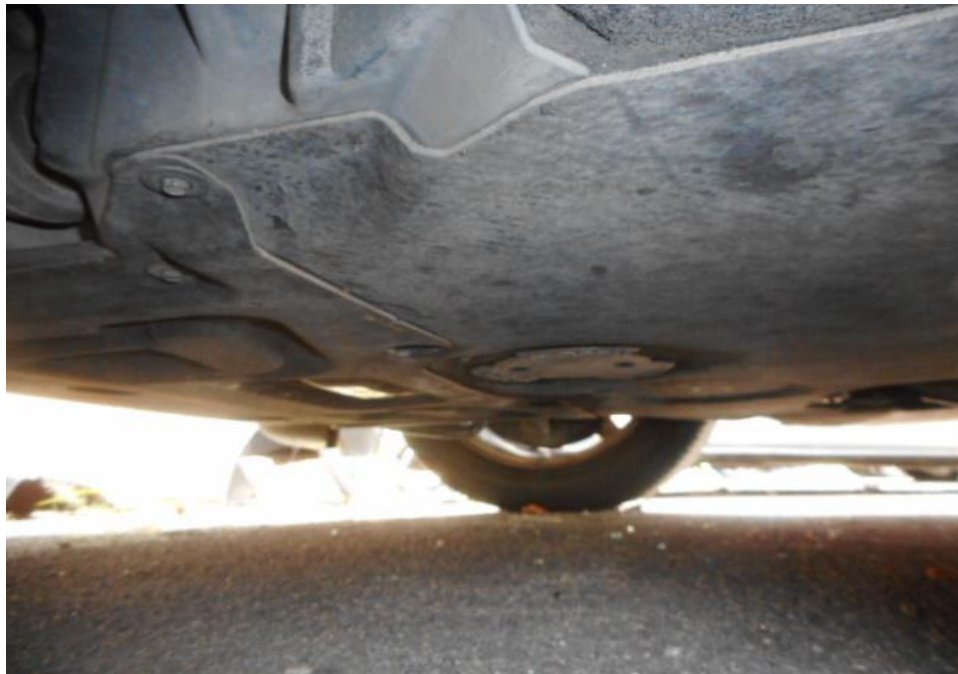
**Photo 14** shows the undercarriage of the Motor Car, at the area where the engine housing and transmission housing are located. . I did not find any sign(s) or indication(s) of fluid leak and/or fluid stain(s) on the underside of the Motor Car.

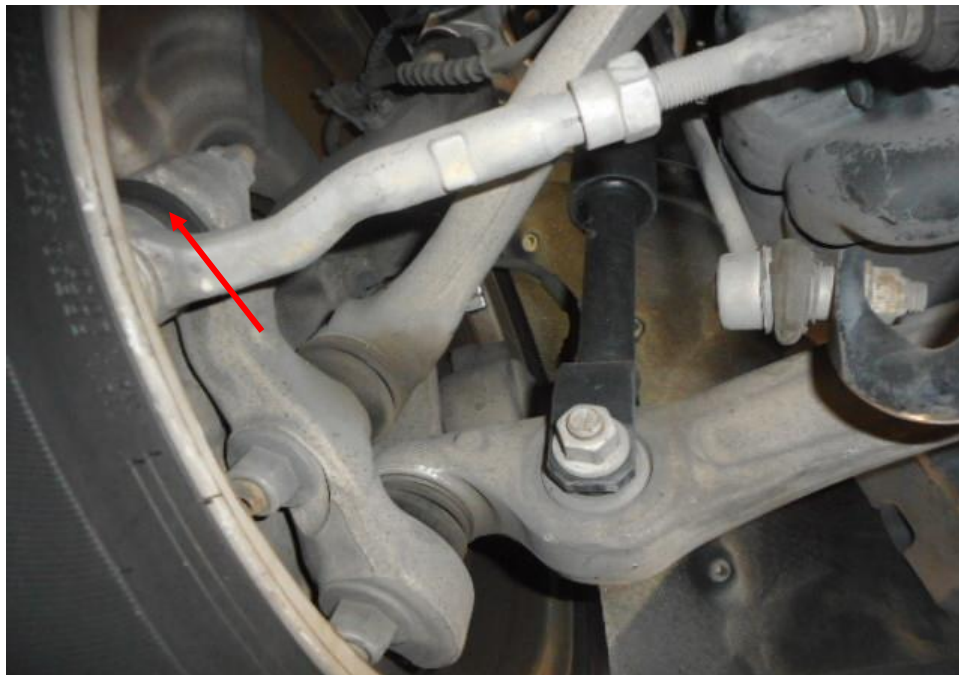
**Photo 15** shows the various undercarriage components at the front right wheel of the Motor Car, in particular the steering tie rod end (arrowed). The various steering components were all found to be intact, suggesting that the steering system of the Motor Car was likely to be in serviceable condition at the material time of accident. There was also no sign of fluid stain(s) observed on the various undercarriage components.

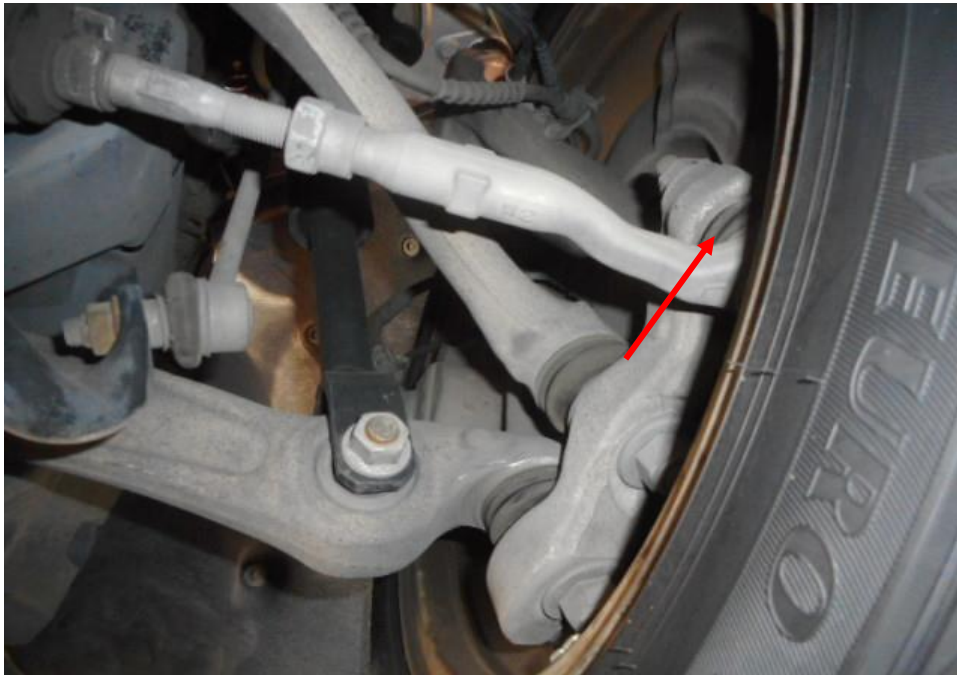
**Photo 16** shows the various undercarriage components at the front left wheel of the Motor Car, in particular the steering tie rod end (arrowed). The various Undercarriage components of the Motor Car were all found to be intact without any visible damage. There was also no sign of fluid stain(s) observed on the various undercarriage components.

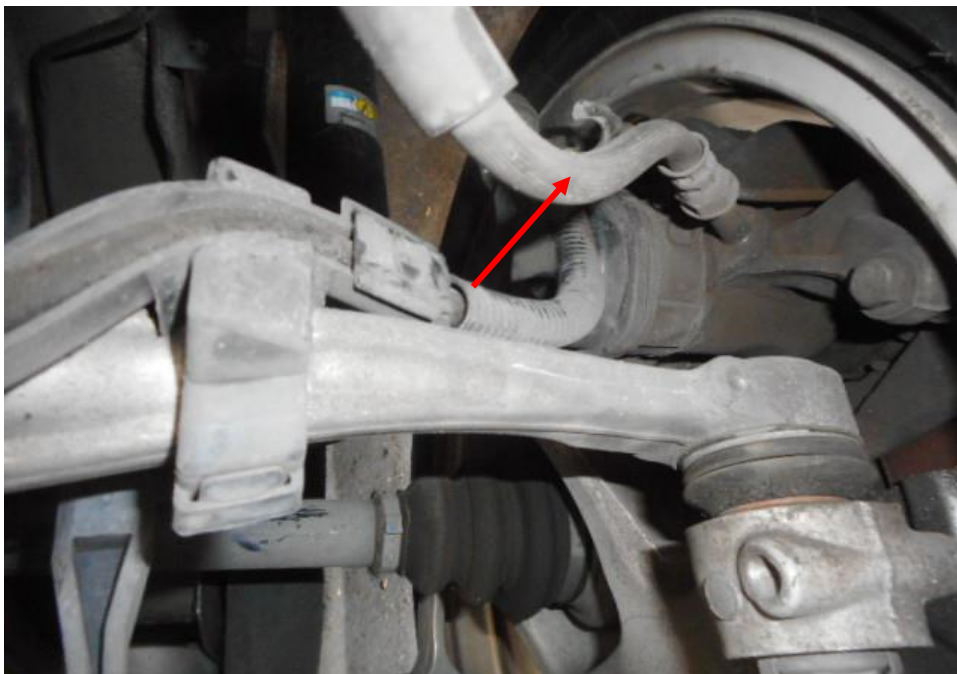
**Photo 17** shows the brake pipe (arrowed) at the rear right wheel of the Motor Car. I did not observe any leakage of brake fluid at the time of my inspection of the Motor Car. My static tests of the Motor Car's braking system, along with my visual examination of the various mechanical components in the braking system, had indicated that there was no internal leakage of pressure/vacuum. Hence the braking system of the Motor Car was likely to be in serviceable condition at the material time of accident.

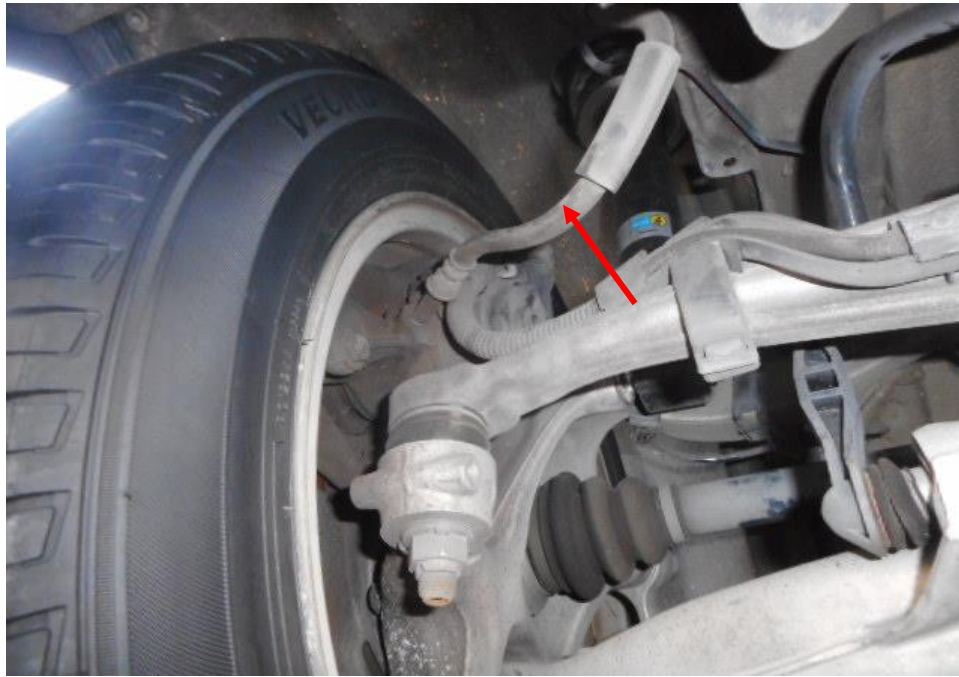
**Photo 18** shows the brake pipe (arrowed) at the rear left wheel of the Motor Car. I did not observe any leakage of brake fluid at the time of my inspection of the Motor Car. My static tests of the Motor Car's braking system, along with my visual examination of the various mechanical components in the braking system had indicated that there was no internal leakage of pressure/vacuum. Hence the braking system of the Motor Car was likely to be in serviceable condition at the material time of accident.

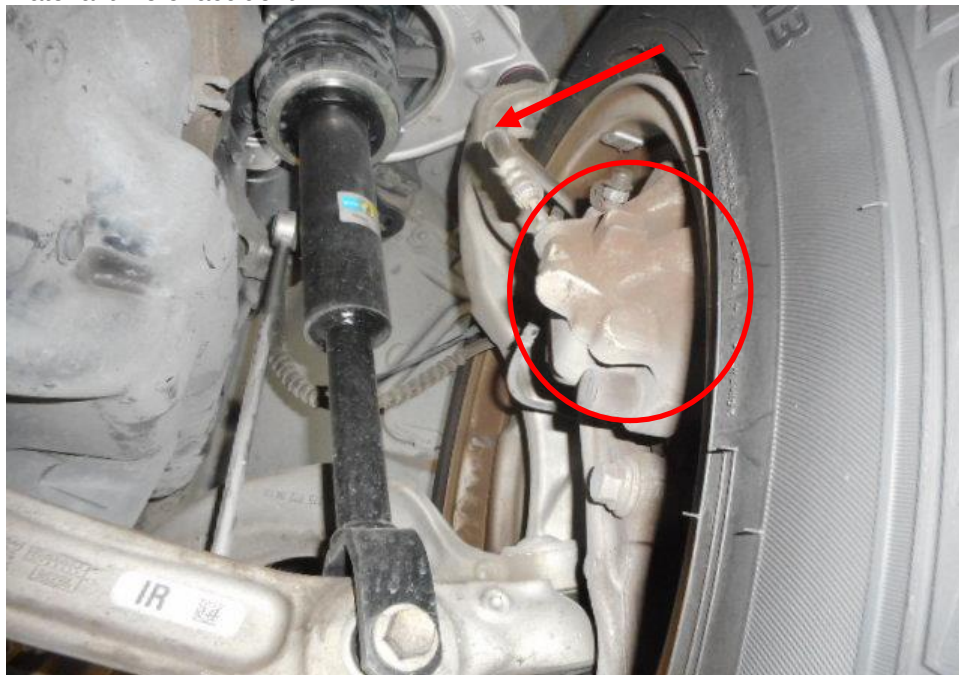
**Photo 19** shows the brake hose/pipe (arrowed) at the front right wheel of the Motor Car. No leakage of brake fluid was observed. Visual examination of the various components of the braking system like the brake caliper (circled), brake booster, brake pedal etc had revealed all to be intact and without visible damage at the time of accident. There was also no sign of fluid stain(s) observed on the various undercarriage components.

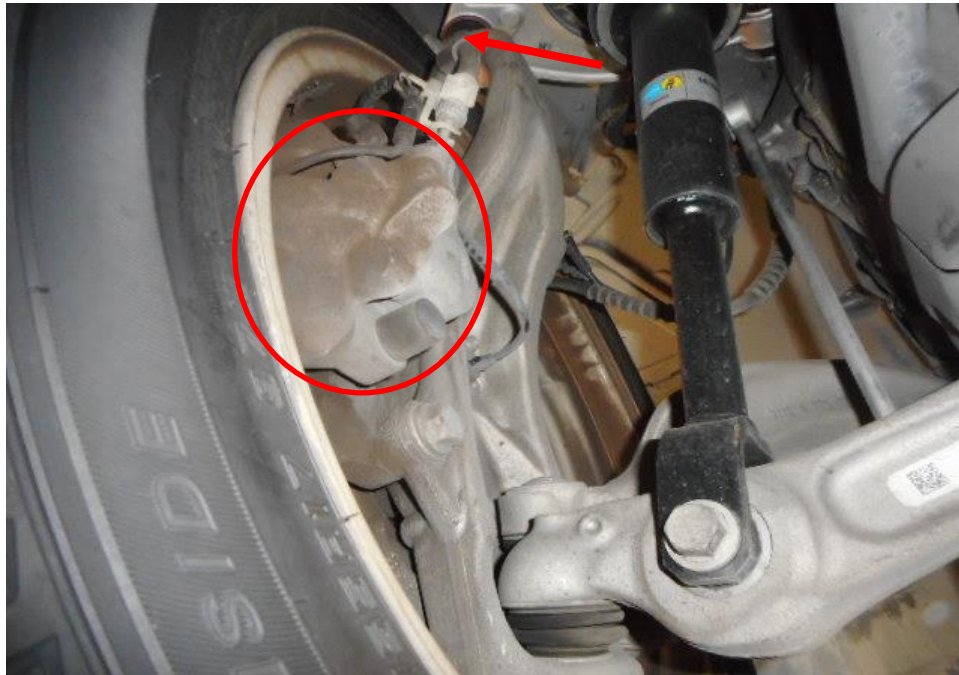
**Photo 20** shows the brake hose/pipe (arrowed) at the front left wheel of the Motor Car. No leakage of brake fluid was observed. Visual examination of the various components of the braking system like the brake caliper (circled), brake booster, brake pedal etc had revealed all to be intact and without visible damage at the time of accident. There was also no sign of fluid stain(s) observed on the various undercarriage components.

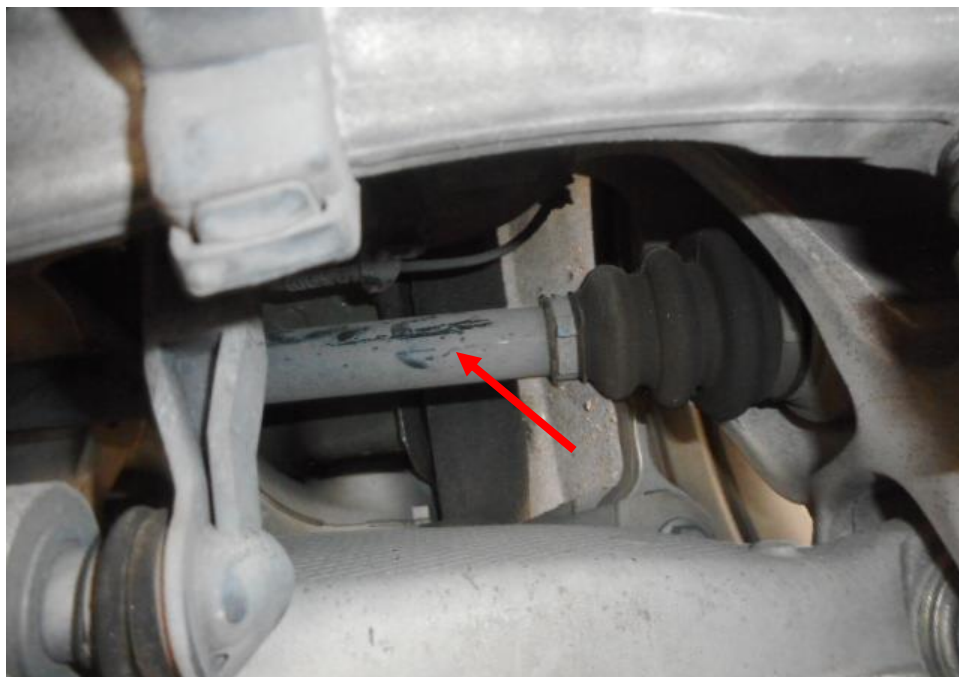
**Photo 21** shows the various undercarriage components at the rear right wheel of the Motor Car, in particular the drive shaft (arrowed). The various steering components were all found to be intact, suggesting that the steering system of the Motor Car was likely to be in serviceable condition at the material time of accident. There was also no sign of fluid stain(s) observed on the various undercarriage components.

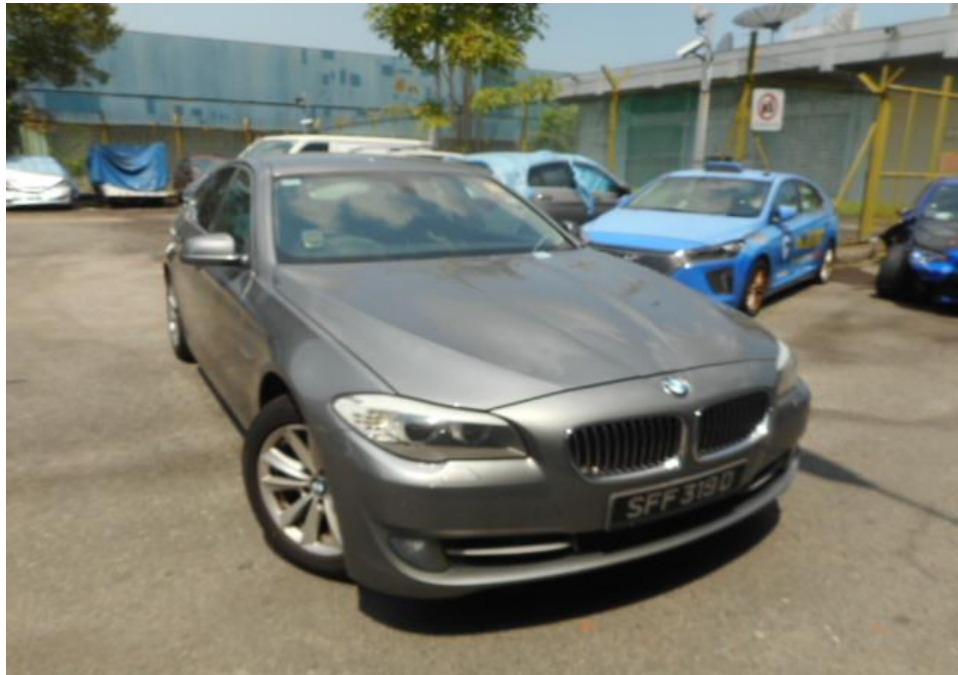
**Photo 22** shows the front right wheel of the Motor Car turned to its full left. During my steering system test, I did not experience any abnormal free play and/or resistance when I had turned the steering wheel towards full left and full right. This would suggest that the steering system of the Motor Car was likely to be in serviceable condition at the material time of accident.

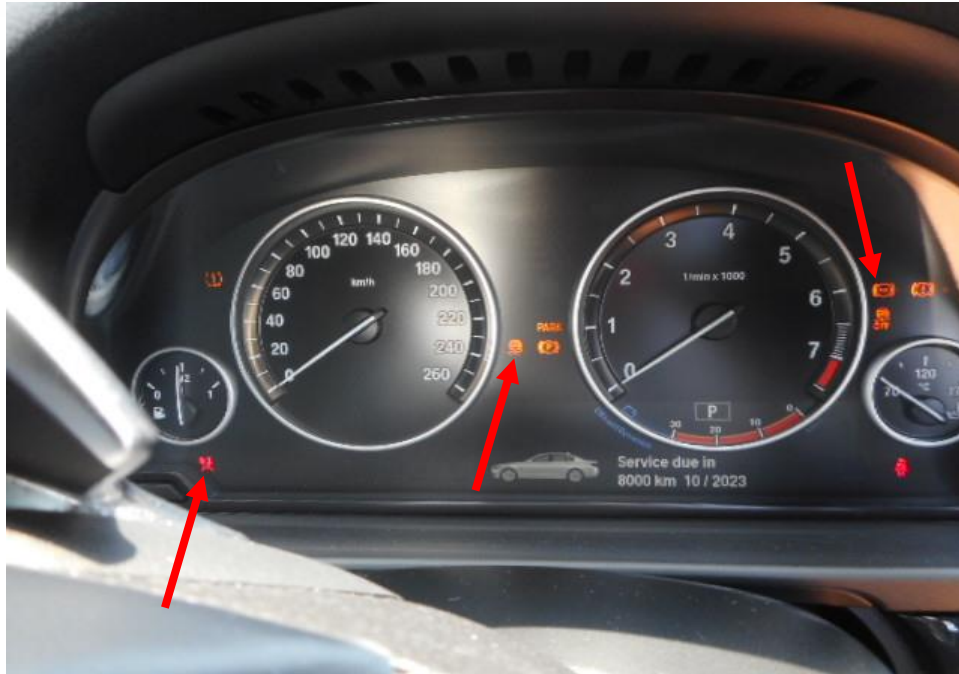
**Photo 23** shows the warning light for Anti-Lock Brake System (ABS), Traction Control System (TCS), and Supplemental Restraint System (SRS) appearing on the instrument panel of the Motor Car during the self-test of its various electronic operating systems when its engine was cranked.

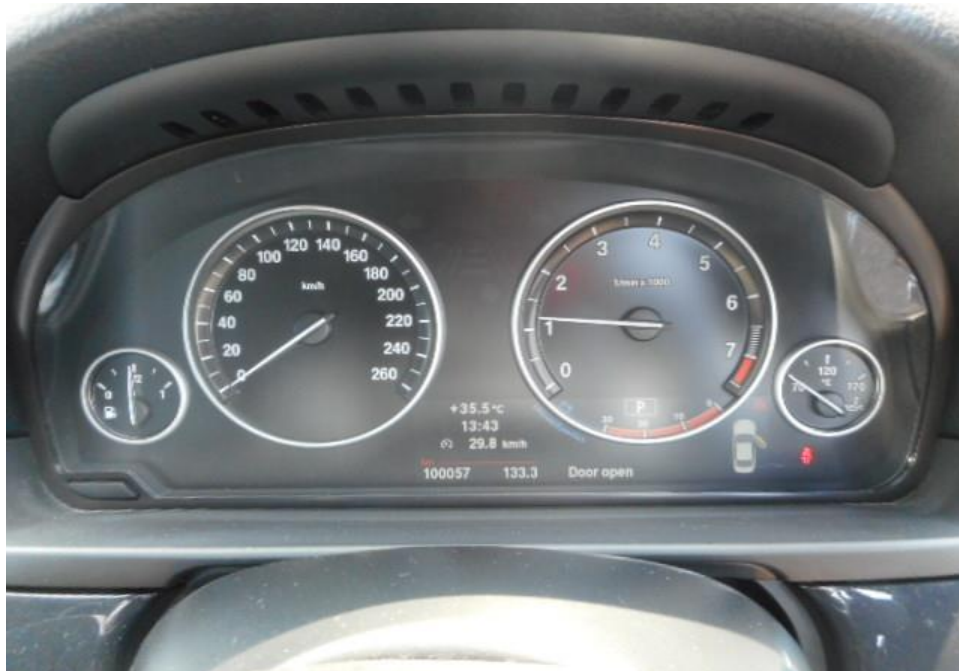
**Photo 24** shows no warning lights illuminated on the instrument panel of the Motor Car after the engine was cranked. This would suggest that there was no abnormality to the various electronic operating systems of the Motor Car, like the ABS, TCS, and SRS.
