Your Ref: TP/IP/09095/2022
Our Ref : CI/TPD22005084/P

Fatal Accident Investigation Team

MECHANICAL INSPECTION REPORT OF MOTOR CAR SLE 6014C

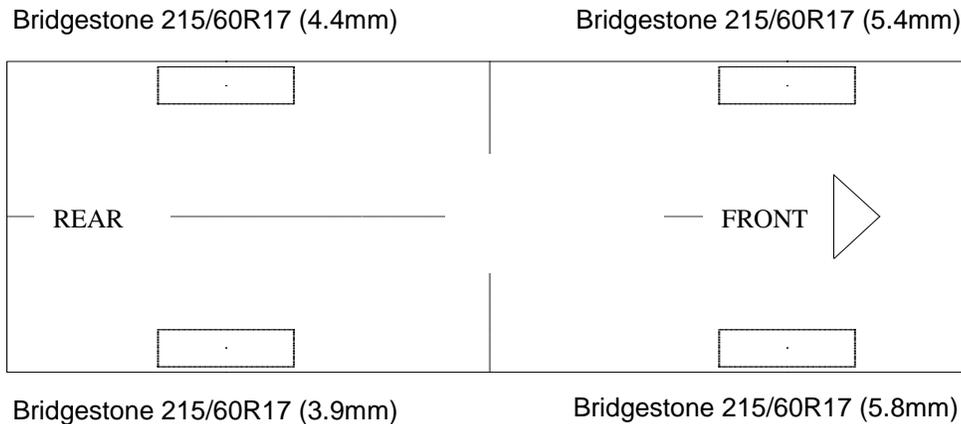
6. The condition of the Motor Car's 4 tyres was observed to be in serviceable condition. I did not find any tear, cut or burst mark(s) on the outer and the inner sidewalls as well as across the tread of the 4 tyres. The 4 tyres were also observed to be sufficiently inflated for vehicular operation. The tyre brand, tyre size and remaining tread depth of the 4 tyres were recorded as follows:-

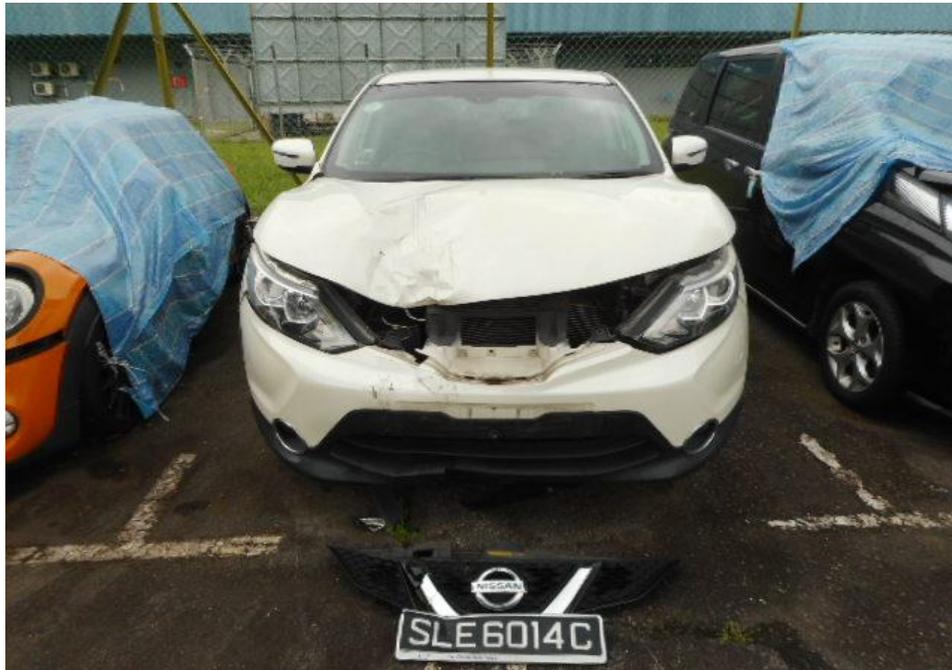
Photo 1 shows a general view of the Motor Car's front body at the time of my inspection. The Motor car was observed to have sustained damage at its front portion. Its front windscreen, front bonnet, front bumper, front grille was amongst the body parts and various engine components were also damaged as a result of the accident.

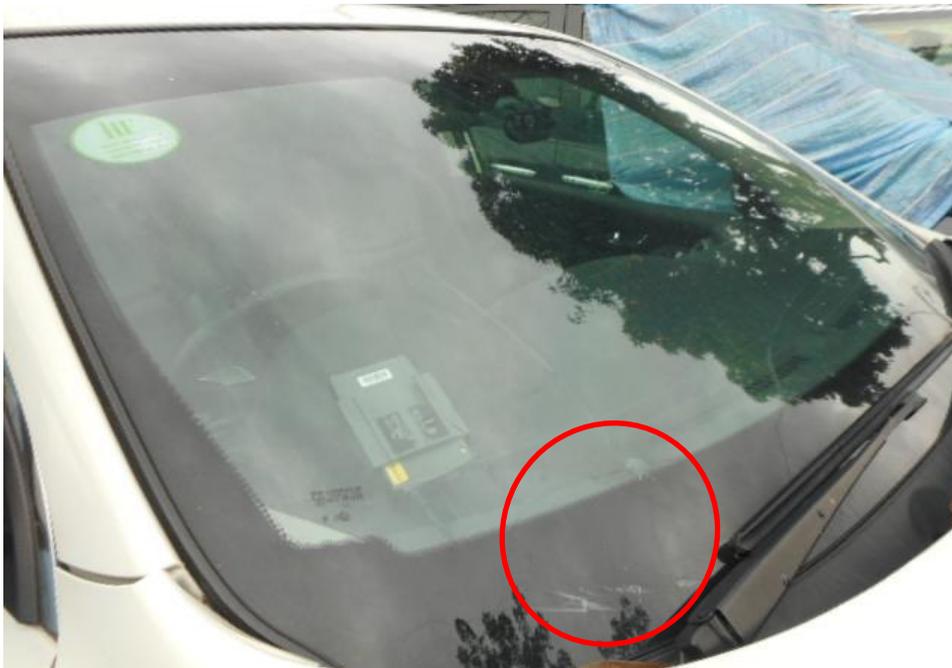
Photo 2 shows the close up view of the Motor Car's front body at the time of my inspection. The Motor car was observed to have sustained damage at its front portion. Its front windscreen (circled) was damaged as a result of the accident.

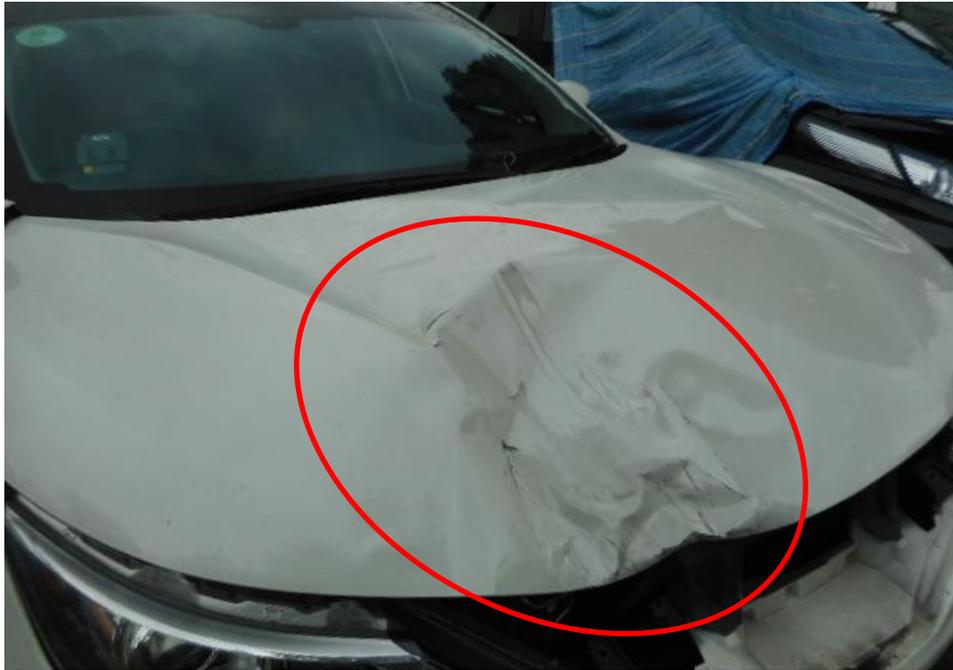
Photo 3 shows the close up view of the Motor Car's front body at the time of my inspection. The Motor car was observed to have sustained damage at its front portion. Its front bonnet (circled) was damaged as a result of the accident.

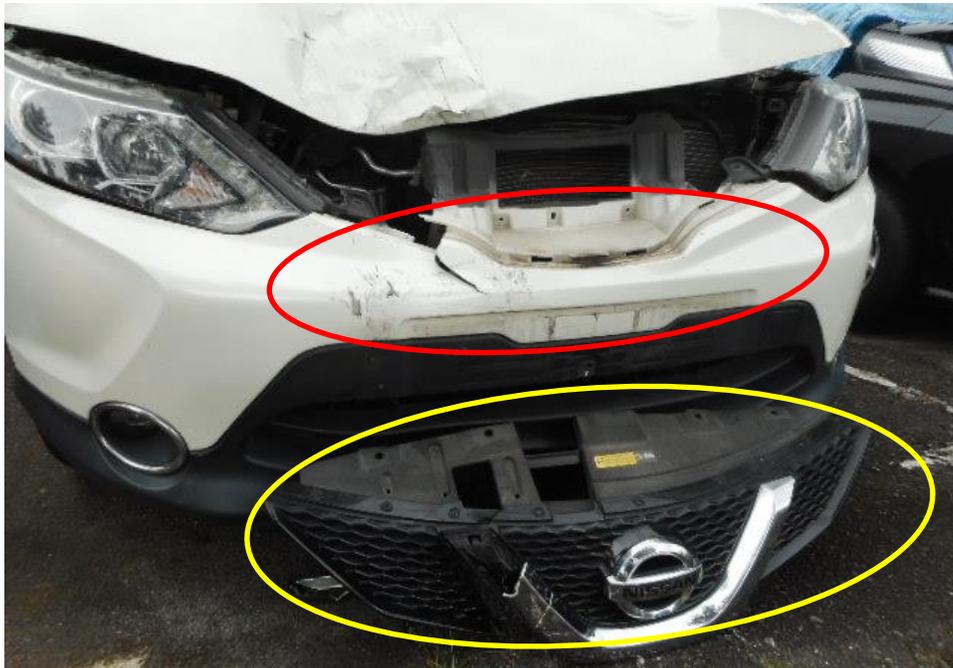
Photo 4 shows the close up view of the Motor Car's front body at the time of my inspection. The Motor car was observed to have sustained damage at its front portion. Its front bumper (red circle) and front grille (yellow circle) was damaged as a result of the accident.

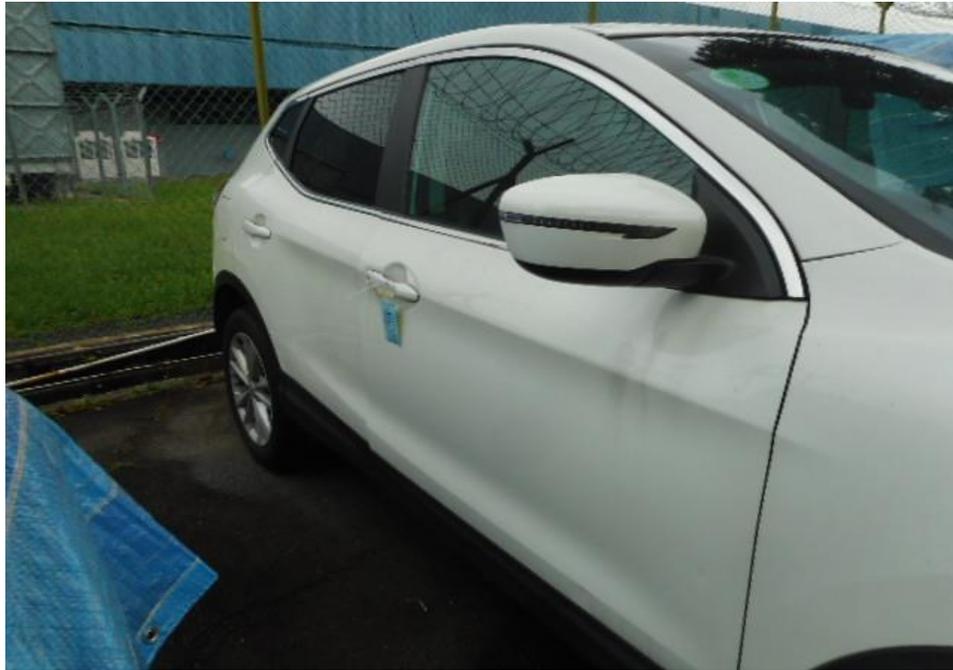
Photo 5 shows a general view of the Motor Car's right body at the time of my inspection. The right portion of the Motor Car was observed to have been undamaged by the accident.

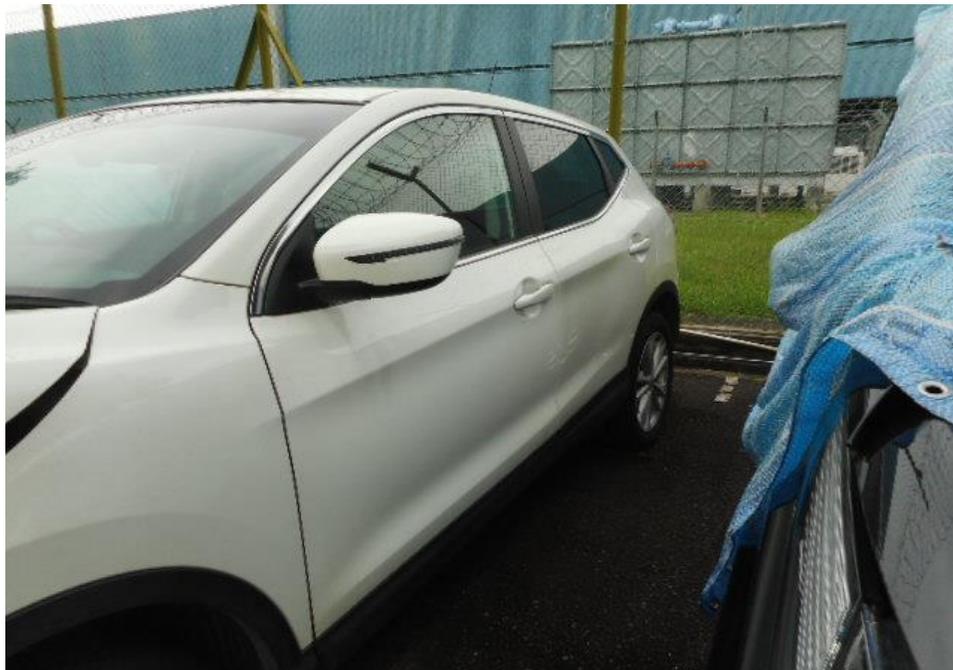
Photo 6 shows a general view of the Motor Car's left body at the time of my inspection. The left portion of the Motor Car was observed to have been undamaged by the accident.

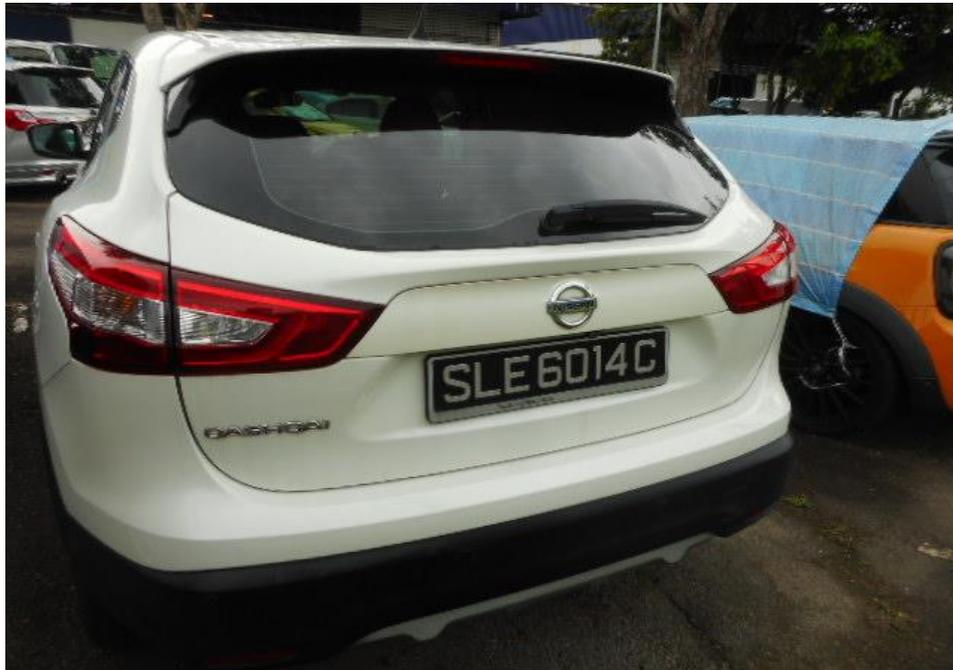
Photo 7 shows a general view of the Motor Car's rear body at the time of my inspection. The rear portion of the Motor Car was observed to have been undamaged by the accident.

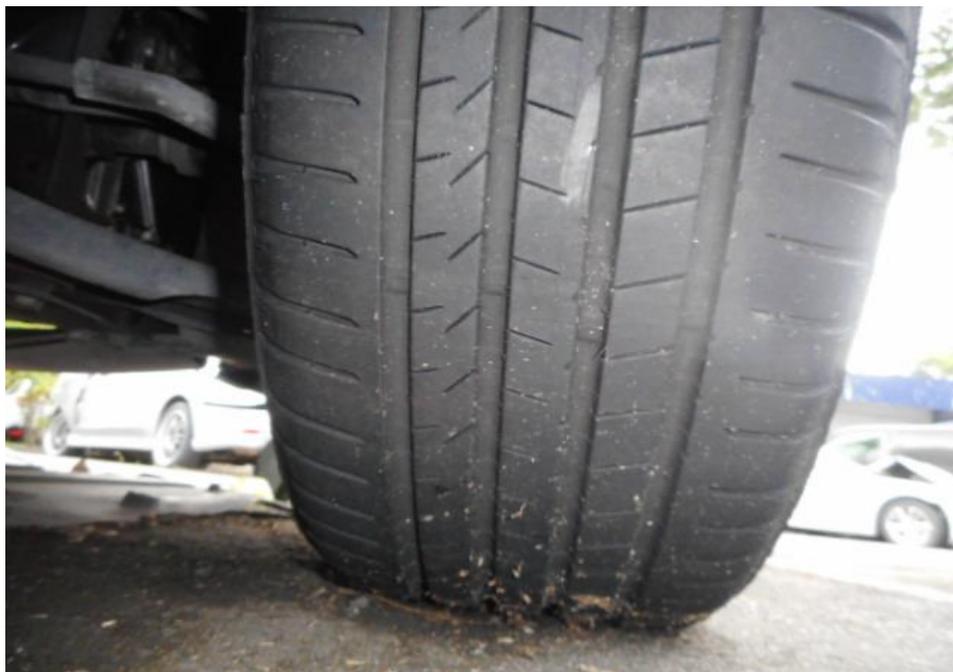
Photo 8 shows the condition of the front right tyre of the Motor Car, which was observed to be in serviceable condition with remaining tread depth of approximately 5.8mm. The tyre, which was wrapped around alloy wheel rim, was also observed to be sufficiently inflated for vehicular operation.

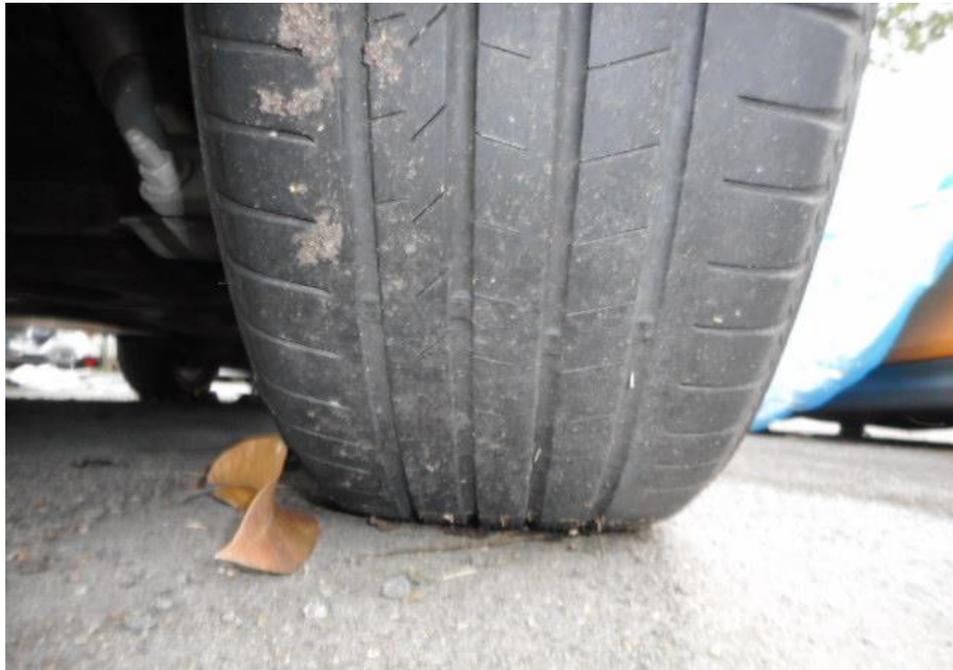
Photo 9 shows the condition of the rear right tyre of the Motor Car, which was observed to be in serviceable condition with remaining tread depth of approximately 3.9mm. The tyre was also observed to be sufficiently inflated for vehicular operation with no tear, cut or burst mark(s).

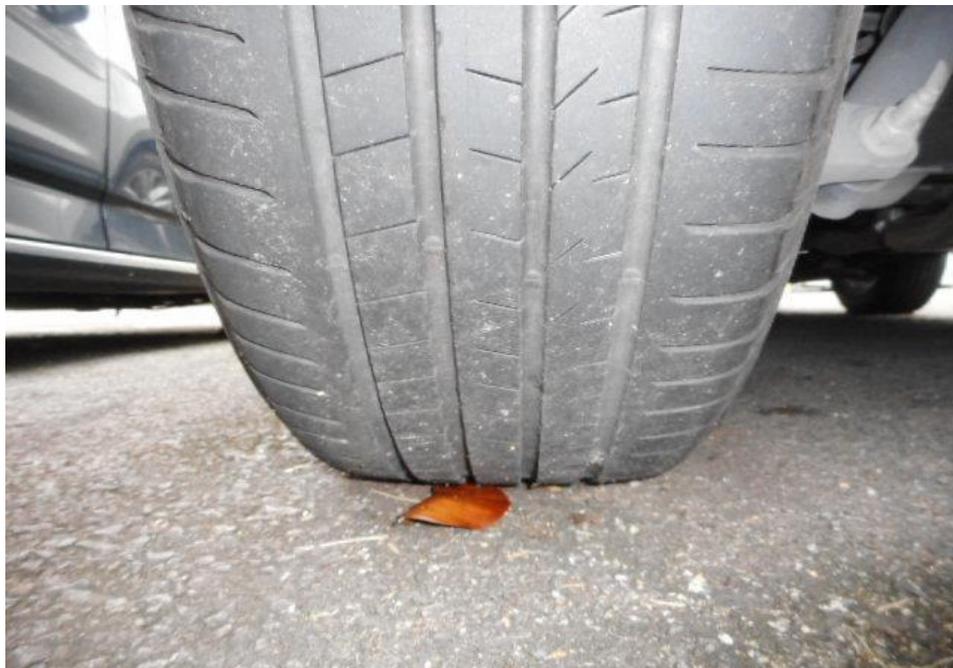
Photo 10 shows the condition of the rear left tyre of the Motor Car, which was observed to be in serviceable condition with remaining tread depth of approximately 4.4mm. The tyre was also observed to be sufficiently inflated for vehicular operation with no tear, cut or burst mark(s).

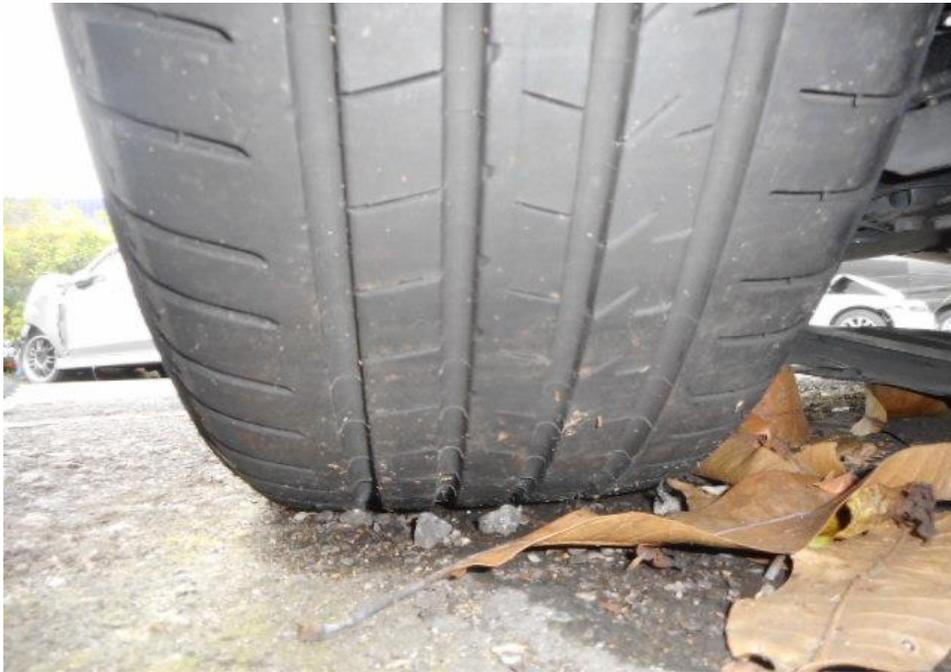
Photo 11 shows the condition of the front left tyre of the Motor Car, which was observed to be in serviceable condition with remaining tread depth of approximately 5.4mm. The tyre was also observed to be sufficiently inflated for vehicular operation with no tear, cut or burst mark(s).

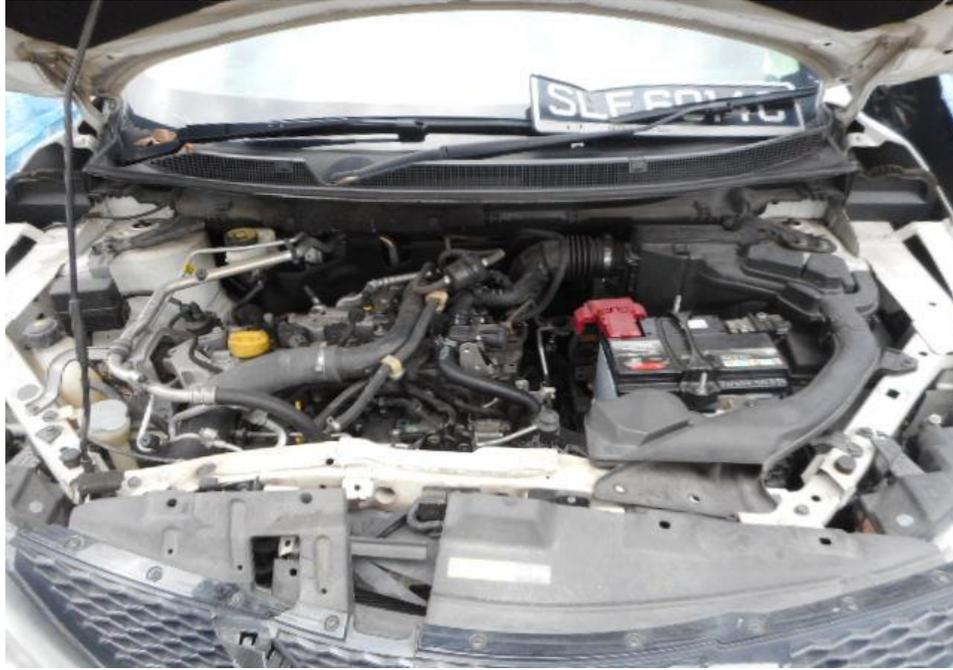
8. Upon examination of the engine compartment of the Motor Car, I had observed the engine radiator, engine radiator fan, and engine throttle body inside the engine compartment to be damaged as a result of the accident.

9. The brake fluid and engine oil was found to be of sufficient level for operating purposes and there was also no contamination found to the fluid. However, the engine coolant was observed to be insufficient due to the damaged engine radiator as a result of the accident.

Photo 12 shows a general view of the Motor Car's engine compartment. I had observed the engine radiator, engine radiator fan, and engine throttle body inside the engine compartment to be damaged as a result of the accident. The brake fluid and engine oil was found to be of sufficient level for operating purposes and there was also no contamination found to the fluid. However, the coolant was observed to be insufficient due to the damaged engine radiator as a result of the accident.

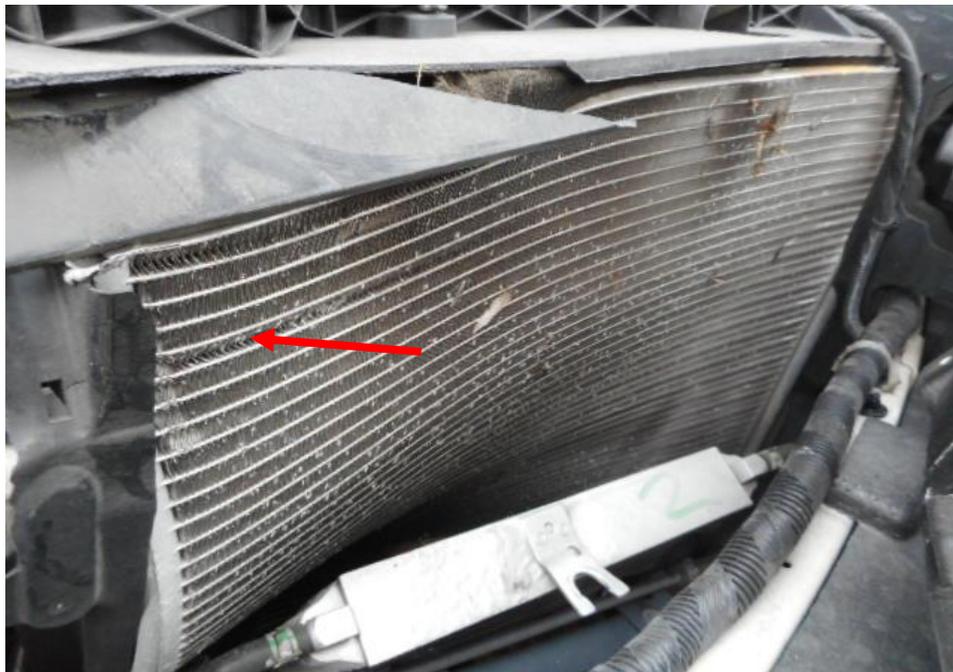
Photo 13 shows the coolant radiator of the Motor Car at the time of my inspection. The coolant radiator (arrowed) was observed to be damaged as a result of the accident.

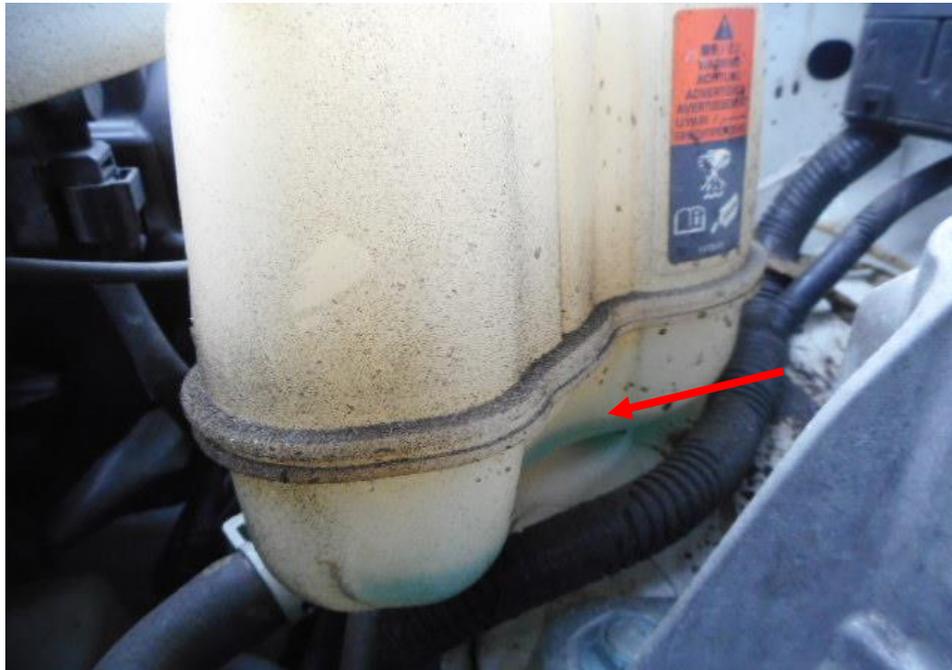
Photo 14 shows the coolant reservoir of the Motor Car at the time of my inspection. The coolant fluid was observed to be of insufficient level (arrowed) due to the damaged radiator as a result of the accident.

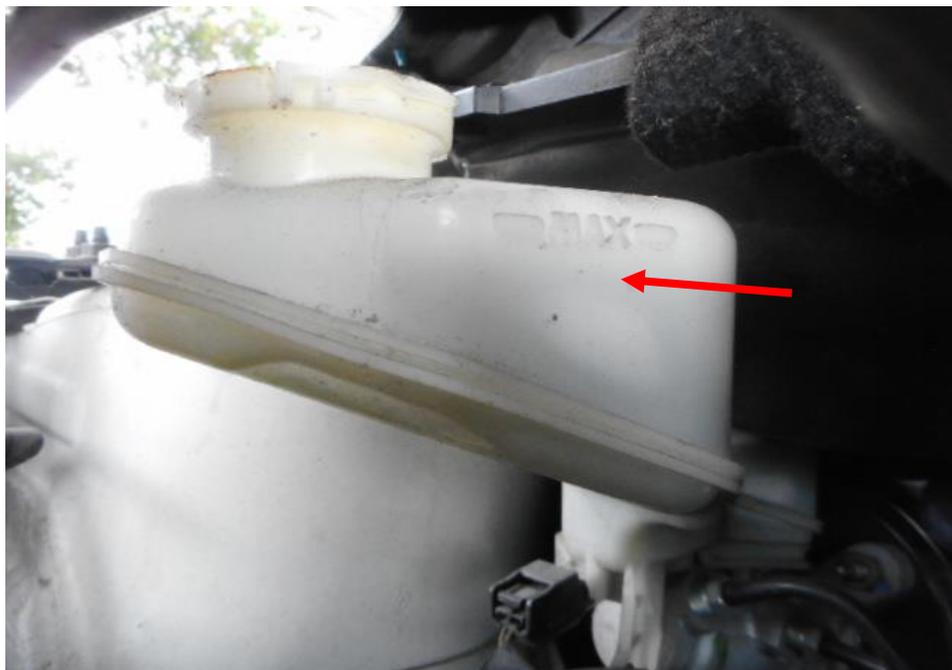
Photo 15 shows the brake fluid reservoir of the Motor Car at the time of my inspection. The brake fluid was observed to be of sufficient level (arrowed) and without any visible contamination.

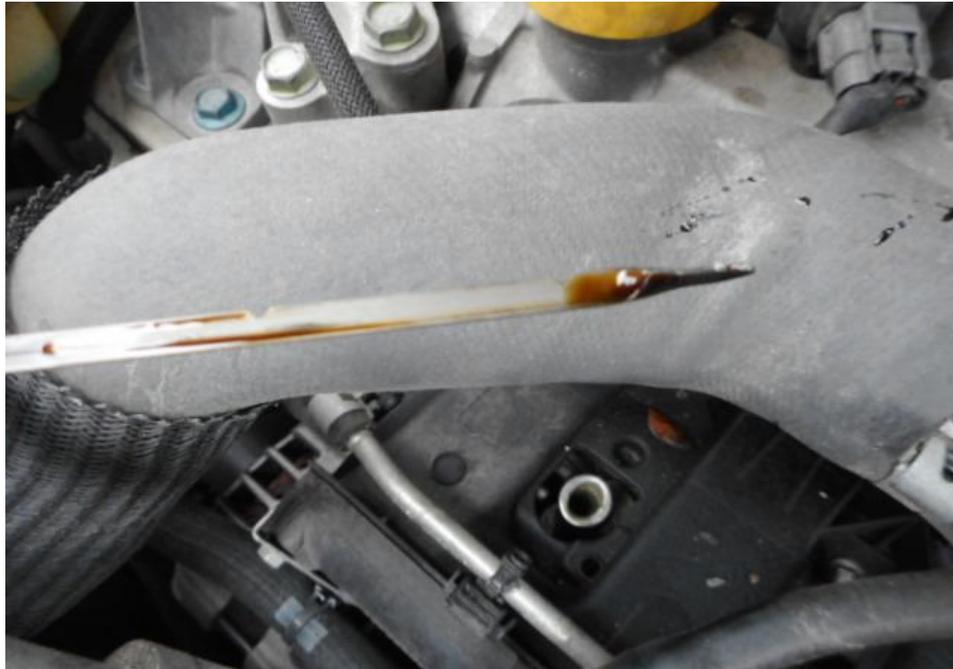
Photo 16 shows the engine oil dip stick of the Motor Car at the time of my inspection. The engine oil was observed to be of sufficient level and without any visible contamination.

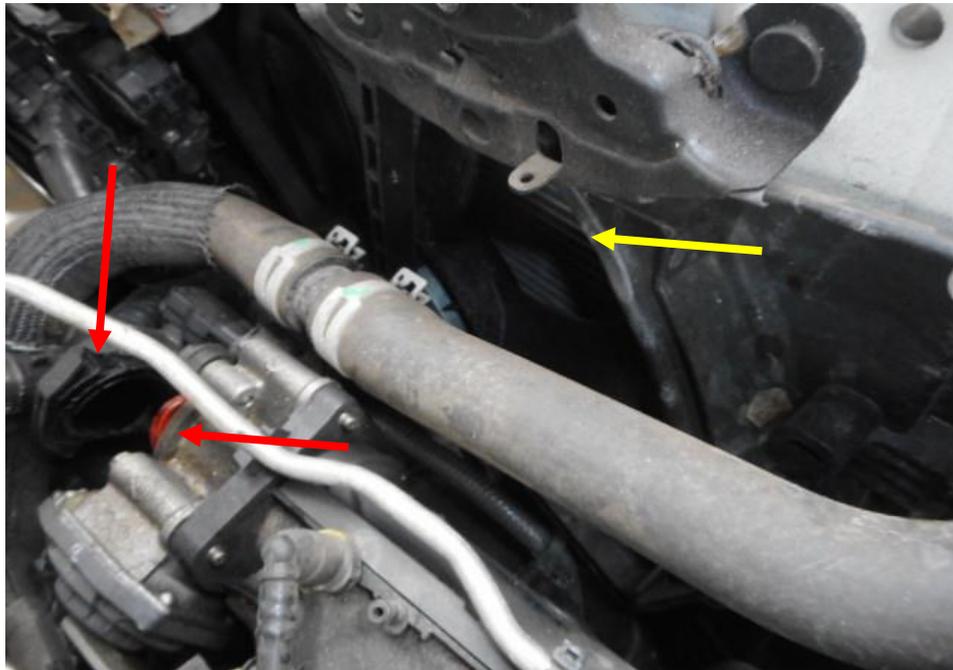
10. The Motor Car was unable to be started up due to the damaged to the engine throttle body as a result of the accident.
11. My subsequent checks on the underside of the Motor Car also revealed no sign(s) or indication(s) of fluid leak and/or fluid stain(s). Visually, the various undercarriage components of the Motor Car were all observed to be intact and without any visible damage. See photo 12 -18 below.

Photo 17 shows the radiator fan and the engine throttle body of the Motor Car at the time of my inspection. The radiator fan (yellow arrow) and the engine throttle body (red arrow) was observed to be damaged as a result of the accident.

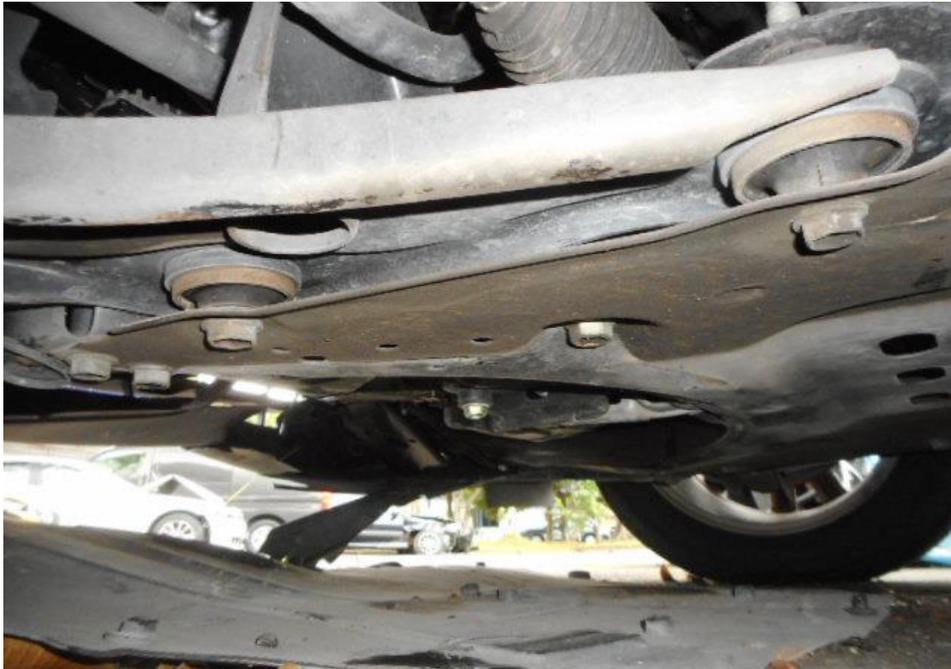
Photo 18 shows the undercarriage of the Motor Car, at the area where the engine housing and transmission housing are located. I did not find any sign(s) or indication(s) of fluid leak and/or fluid stain(s) on the underside of the Motor Car.

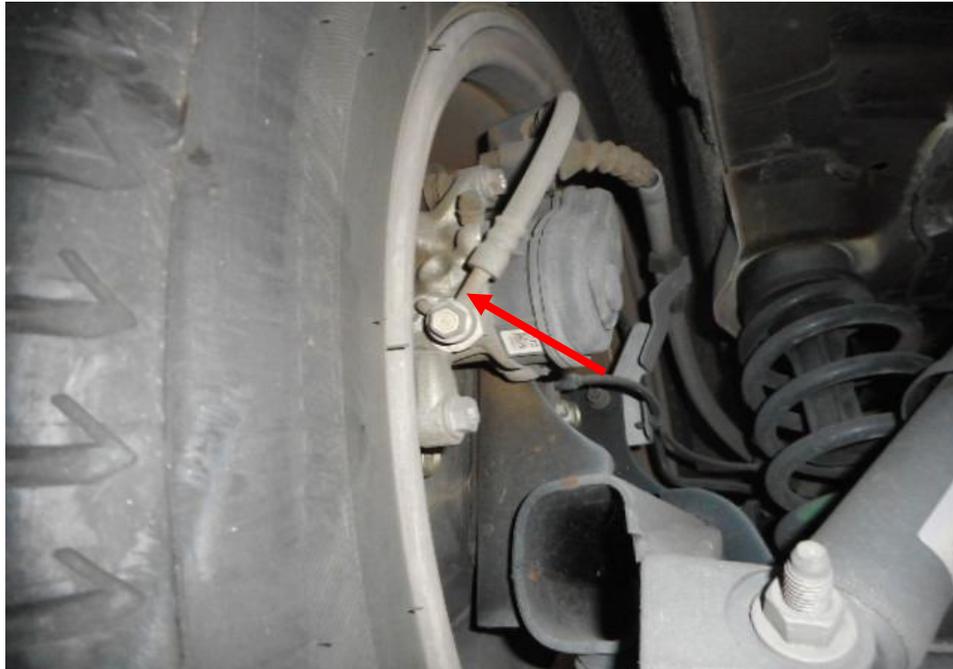
Photo 19 shows the brake hose/pipe (arrowed) at the rear left wheel of the Motor Car. No leakage of brake fluid was observed. Visual examination of the various components of the braking system like the drum brake, brake booster, brake pedal etc. had revealed all to be intact and without visible damage.

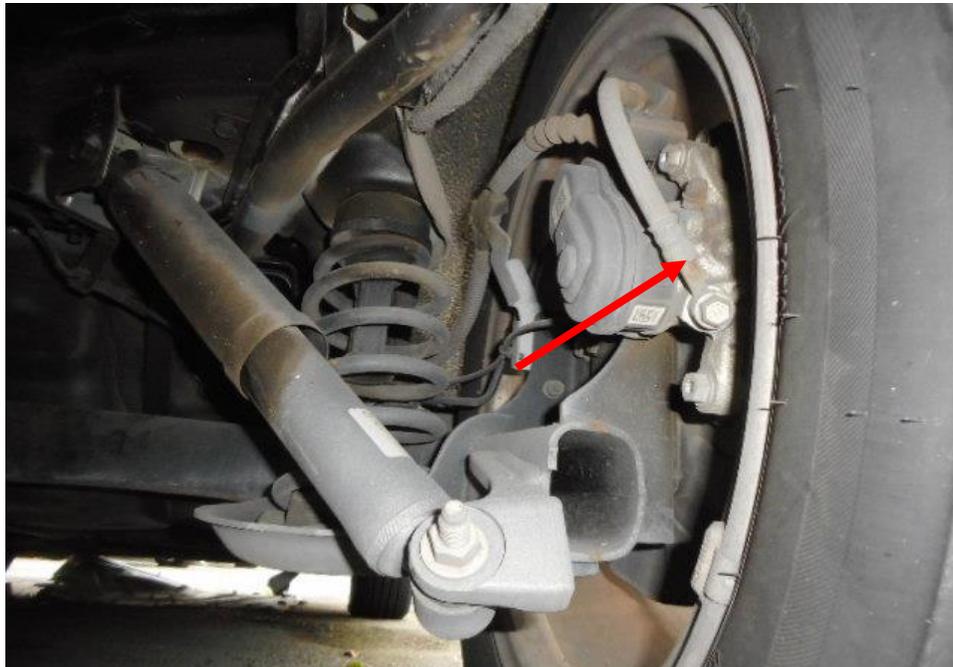
Photo 20 shows the brake hose/pipe (arrowed) at the rear right wheel of the Motor Car. No leakage of brake fluid was observed. Visual examination of the various components of the braking system like the drum brake, brake booster, brake pedal etc. had revealed all to be intact and without visible damage.

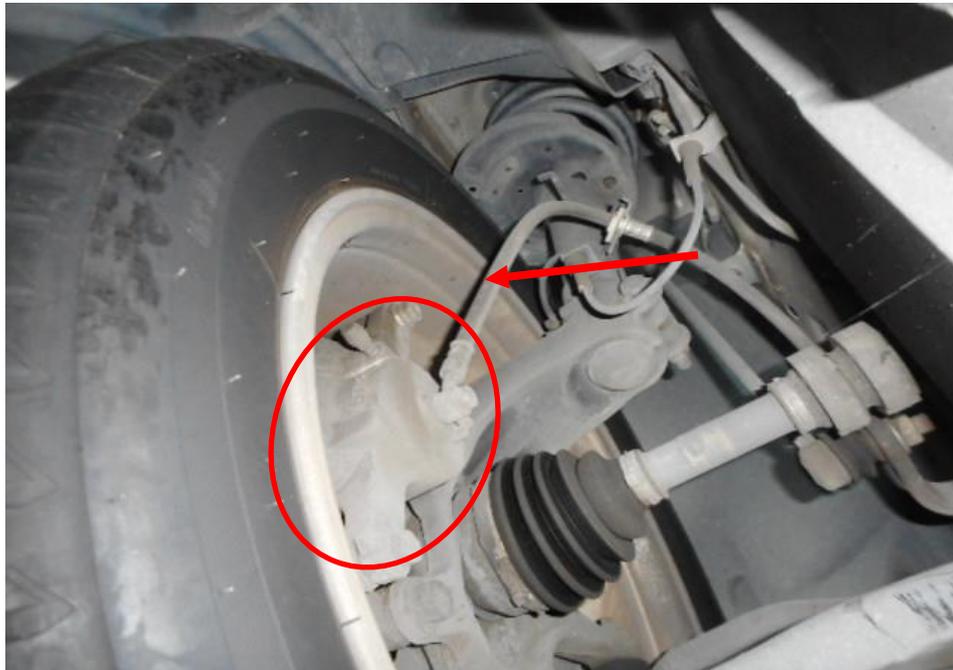
Photo 21 shows the brake hose/pipe (arrowed) at the front right wheel of the Motor Car. I did not observe any leakage of brake fluid at the time of my inspection of the Motor Car. Static tests of the Motor Car's braking system had indicated that there was no internal leakage of pressure/vacuum.

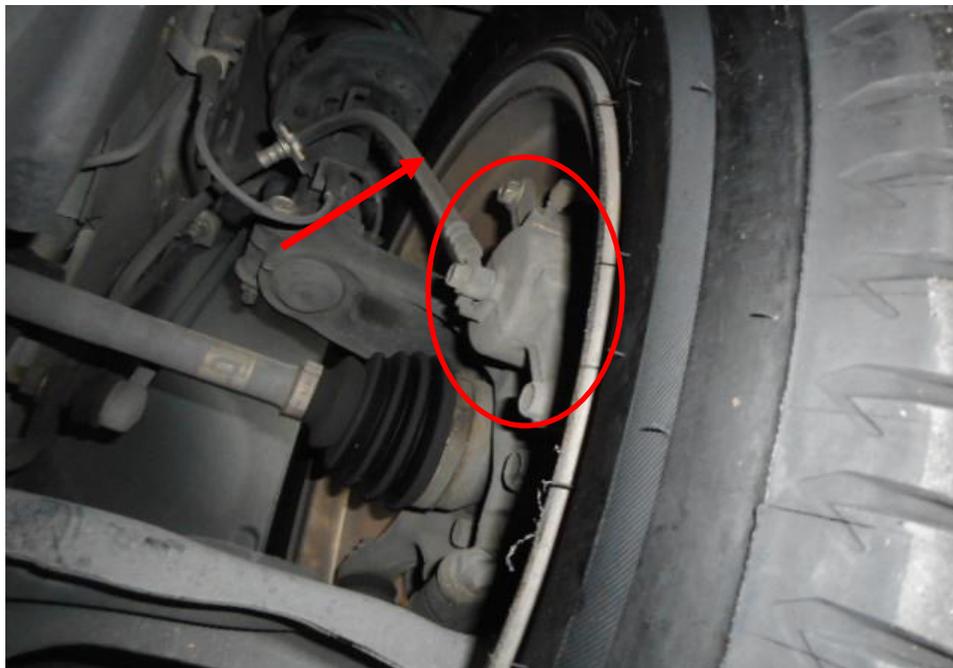
Photo 22 shows the brake hose/pipe (arrowed) at the front left wheel of the Motor Car. No leakage of brake fluid was observed. Visual examination of the various components of the braking system like the brake caliper (circled), brake booster, brake pedal etc had revealed all to be intact and without visible damage.

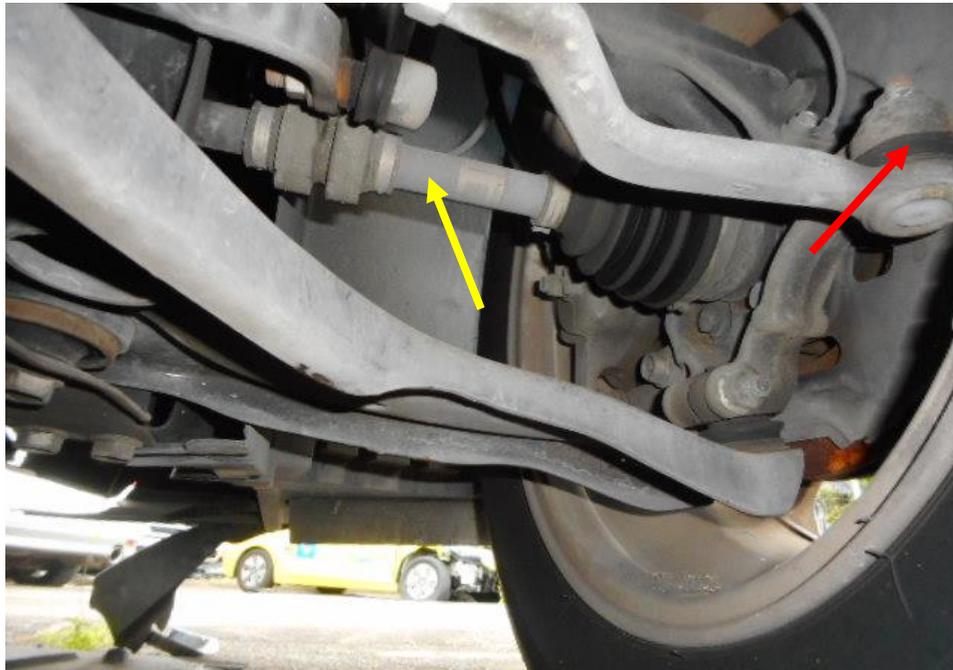
Photo 23 shows the various undercarriage components at the front right wheel of the Motor Car, in particular the steering tie rod (red arrow) and the driveshaft (yellow arrow). The various steering components were all found to be intact, suggesting that the steering system of the Motor Car was likely to be in serviceable condition at the material time of accident. There was also no sign of fluid stain observed on the various undercarriage components at the front right wheel of the Motor Car.

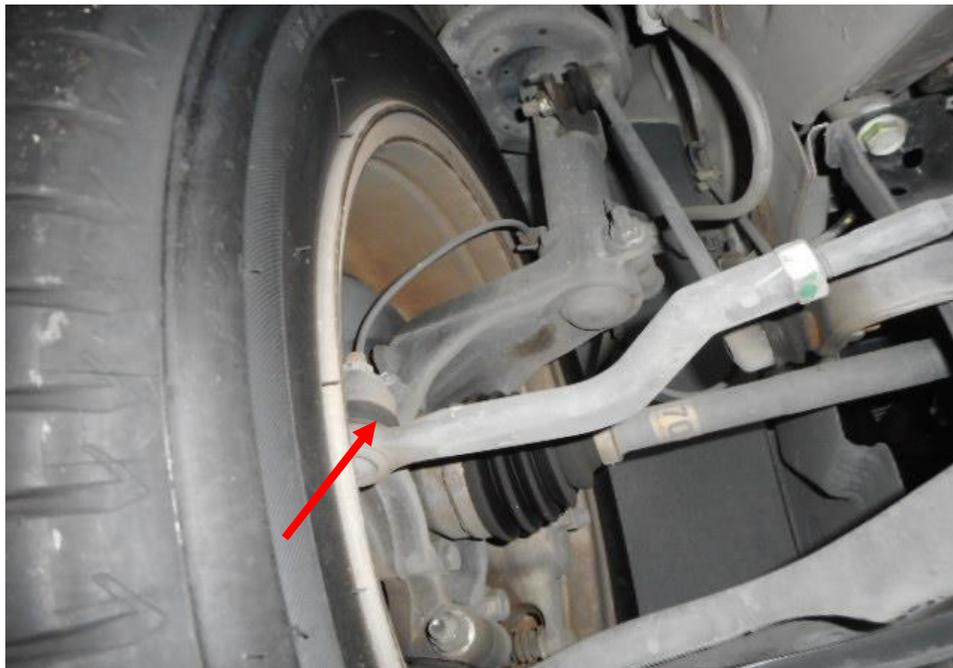
Photo 24 shows the various undercarriage components at the front left wheel of the Motor Car, in particular the steering tie rod end (arrowed). The various undercarriage components of the Motor Car were all found to be intact without any visible damage. There was also no sign of fluid stain(s) observed on the various undercarriage components.
