**發 福 摩 哆 車 房**  
**HUAT HOCK MOTOR WORKSHOP**

**REPAIR COST FOR VEHICLE NO. GBG 9344 M**

## VEHICLE INSPECTION REPORT

Registration no.	: GBG9344M	Odometer	: 76083 KM
Make	: TOYOTA	Chassis no.	: KDH2015029134
Model	: HIACE	Transmission	: Manual
Regn. date	: 30 Nov 2017	Engine no.	: 1KD2738885
Body colour	: White	Engine cap.	: 2982 CC

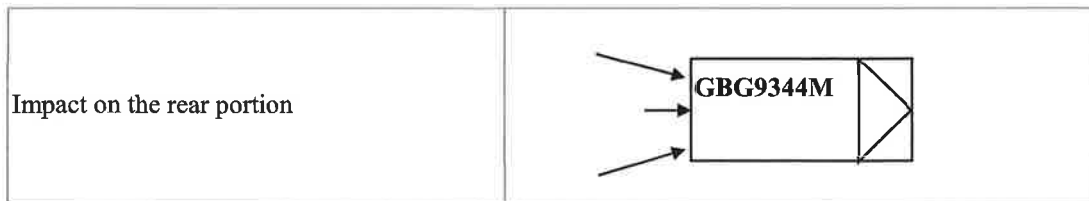
## POINT OF IMPACT

The impact of the collision has damaged / affected the tailgate assy, rear windscreen glass assy, rear bumper assy, rear end panel assy, rear floorpanel, both taillamps and etc...
