SURVEY OF VEHICLE NO. SLP 9803P

AUTOMOBILE ASSESSMENT REPORT

Assessment of Vehicle No : **SLP 9803P**
Date of Accident : **15-January-2019**
Date of Inspection : **17-January-2019**
Address of Inspection : **68 Kaki Bukit Ave 6 #02-05 ARK @KB S'417896**

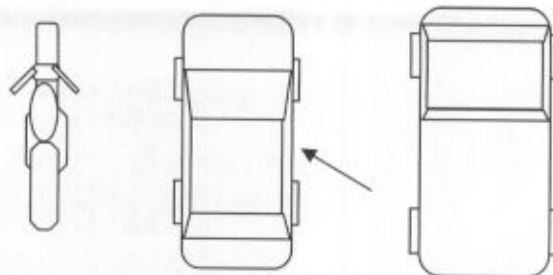
At the time of inspection, this vehicle sustained damages to the **RHS** portion. Please see attached scheduled for details.
