Your Ref: BMW M4 Coupe
(chassis number WBS4Y92050FH67671)
Our Ref : CI/TP22005189/D

INSPECTION REPORT OF AN UNREGISTERED BMW M4 COUPE MOTOR CAR WITH CHASSIS NUMBER WBS4Y92050FH67671

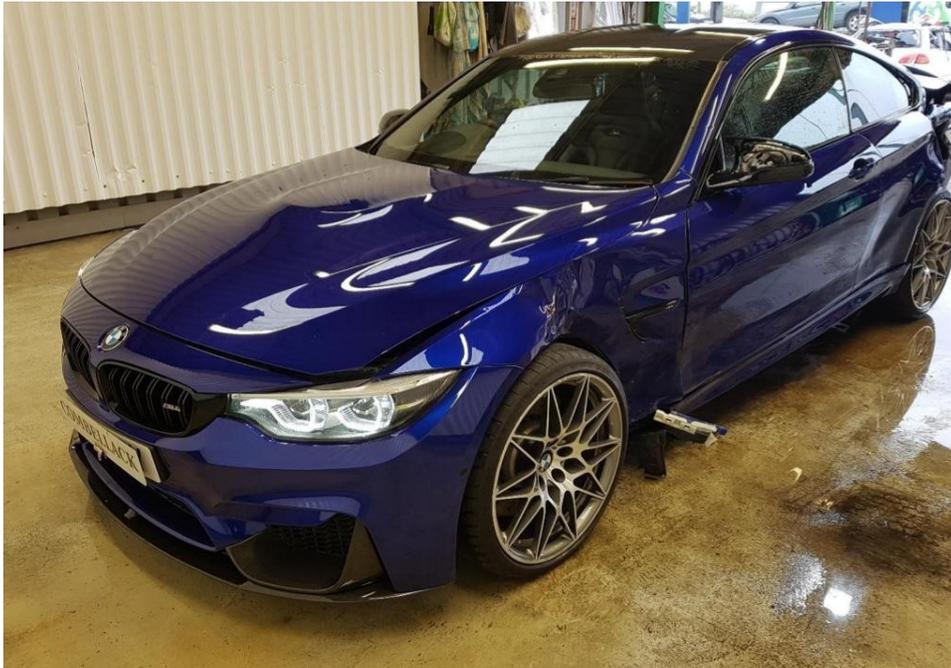
Photo 1 shows the front left body of the Motor Car (photograph provided to me). The Motor Car was observed to have sustained damage along its entire left side portion. The front bonnet, front left fender, front left fender inner shield, front left door, left wing mirror and left rocker panel garnish were amongst the body parts that were observed to have been damaged.

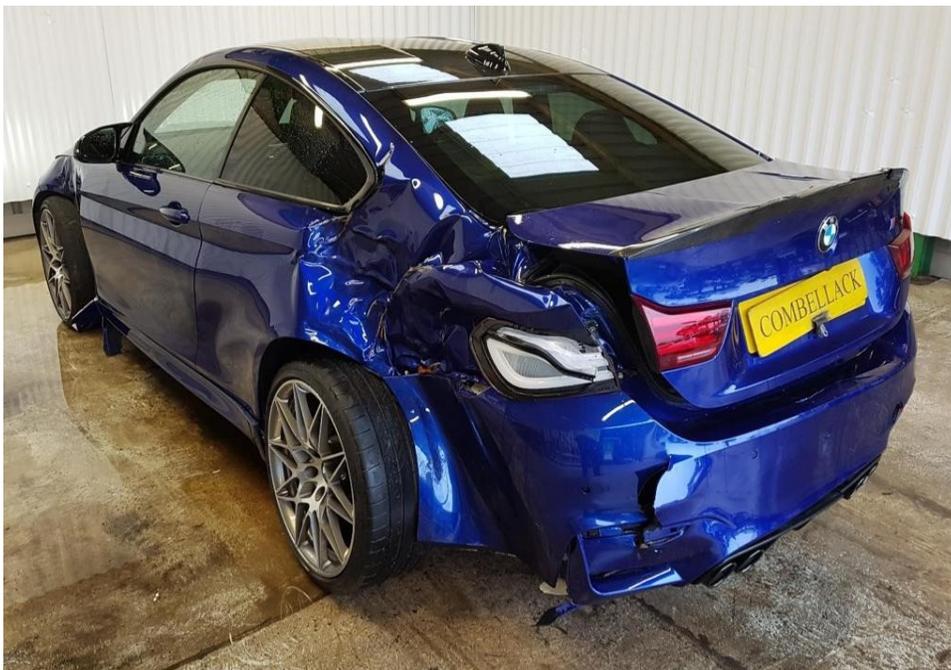
Photo 2 shows the rear left body of the Motor Car (photograph provided to me). The Motor Car was observed to have sustained damage along its entire left side portion. The rear left body panel, rear left taillamp, rear bootlid, rear bumper, rear bumper left reflector and left rocker panel garnish were amongst the body parts that were observed to have been damaged.

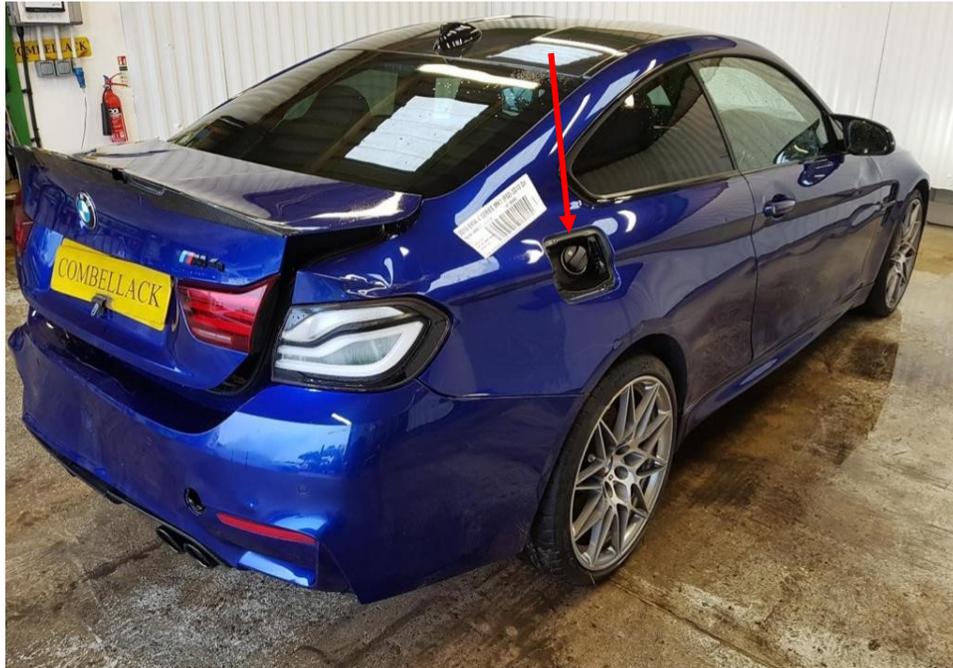
Photo 3 shows the rear right body of the Motor Car (photograph provided to me). Apart for the entire left side portion, I had also observed damage at the right side rear portion of the Motor Car. The rear right body panel and rear right taillamp were amongst other body parts that were observed to have been damaged. The outer cover for the petrol filler hose (arrowed) was also observed to be dislodged/missing/damaged.

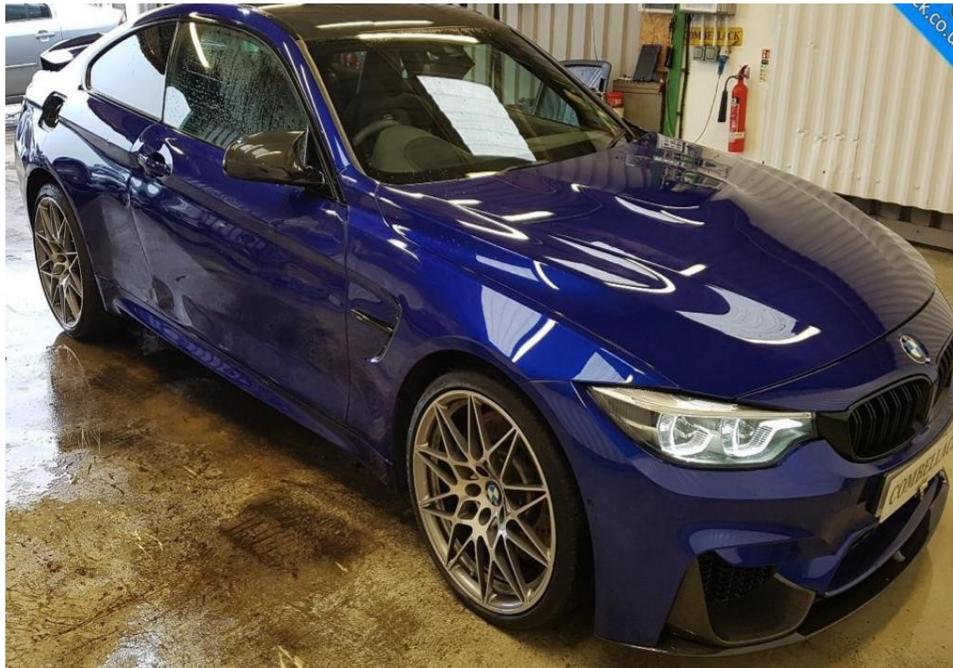
Photo 4 shows the front right body of the Motor Car (photograph provided to me). No physical damage was observed to the front right portion of the Motor Car. The airbag(s) of the Motor Car was not deployed as seen from the photographs that were provided to me.

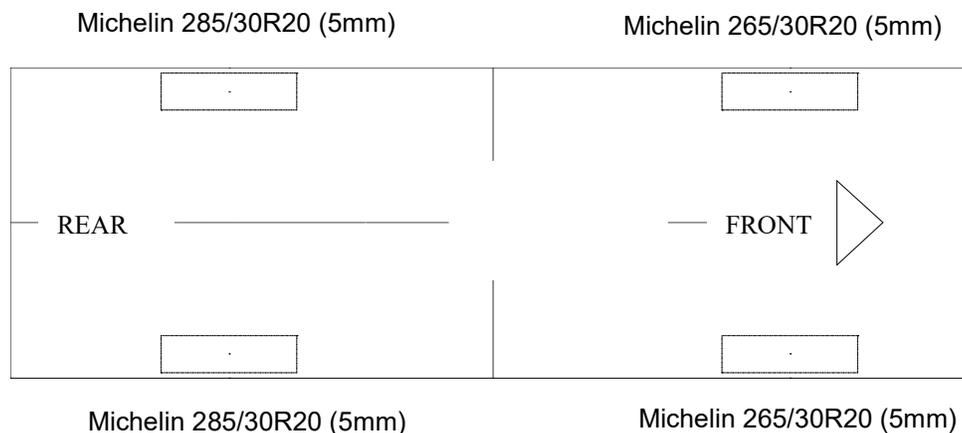
9. It was fitted with 20inch sport wheel rims that were wrapped with tyres that were observed to be of serviceable condition. The tyres were also sufficiently inflated for vehicular operation. The tyre brand, tyre size and approximate remaining tread depth of the 4 tyres of the Motor Car were recorded as follows: -

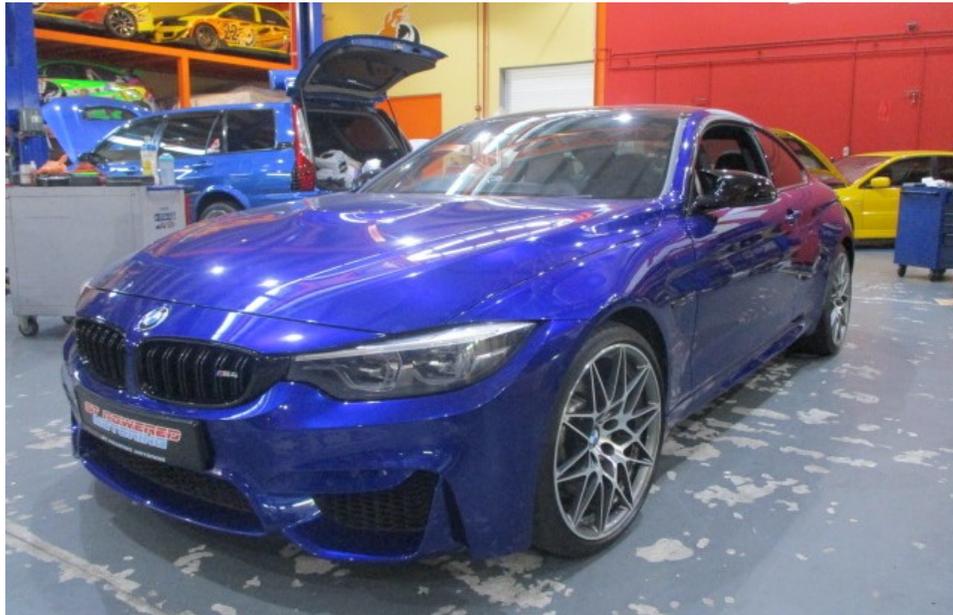
Photo 5 shows a general view of the front left body of the Motor Car at the time of my inspection. The Motor Car was observed to be in a relatively good general condition with no loose exterior fittings observed. The body parts along the entire left side portion of the Motor Car were visually examined and it was observed that the repair/restoration works carried out to the damaged area of the Motor Car (refer to photograph 1 above) were reasonably adequate and in order.

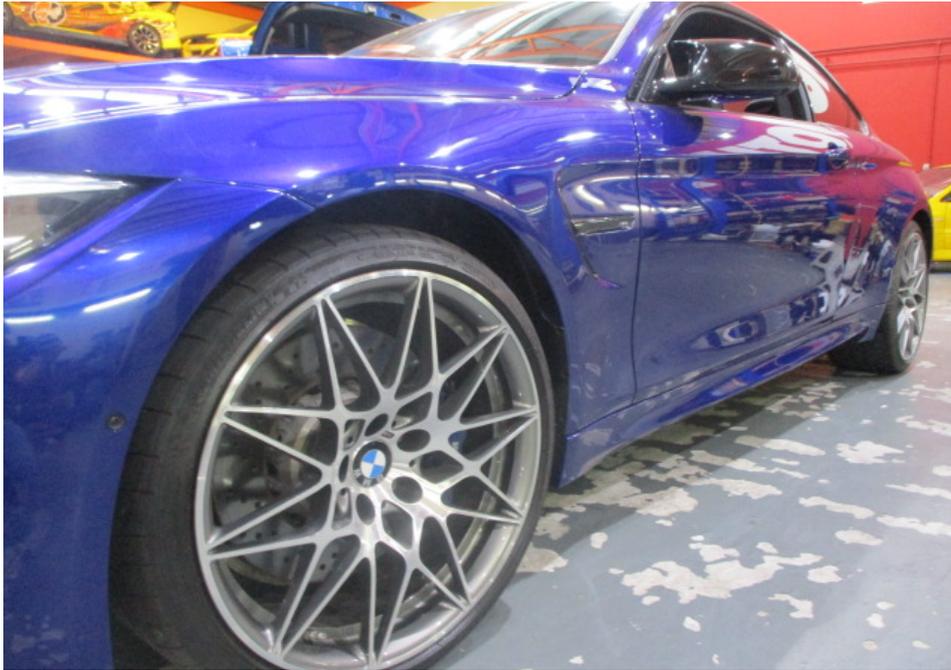
Photo 6 shows a closer view of the Motor Car's front bonnet, front left fender and front left wheel rim at the time of my inspection. The body parts along the entire left side portion of the Motor Car were visually examined and it was observed that the repair/restoration works carried out to the damaged area of the Motor Car (refer to photograph 1 above) were reasonably adequate and in order.

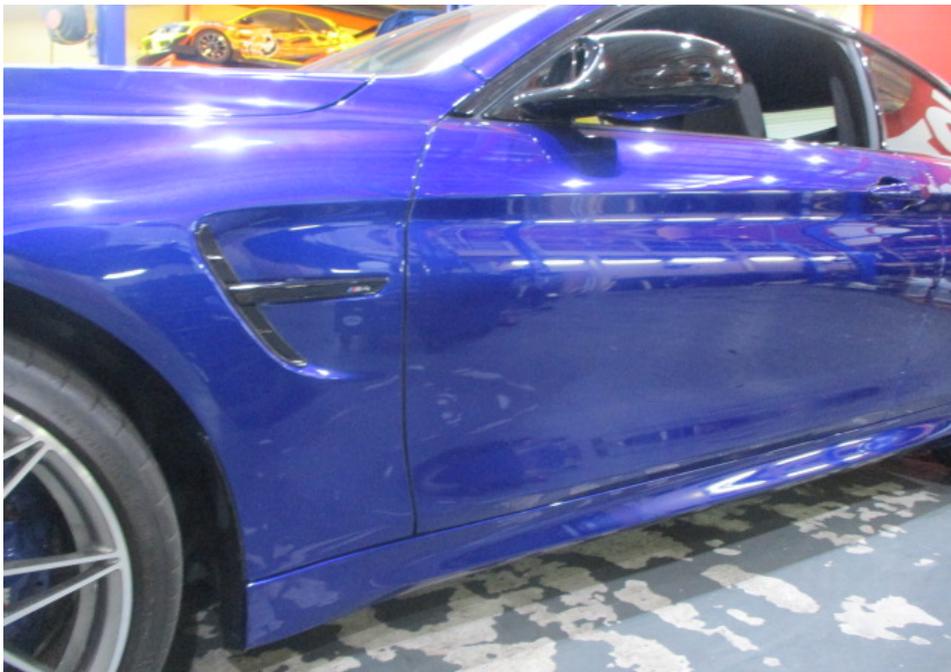
Photo 7 shows a closer view of the Motor Car's front left fender, front left door, left side wing mirror and left side rocker panel garnish at the time of my inspection. The body parts along the entire left side portion of the Motor Car were visually examined and it was observed that the repair/restoration works carried out to the damaged area of the Motor Car (refer to photograph 1 above) were reasonably adequate and in order.

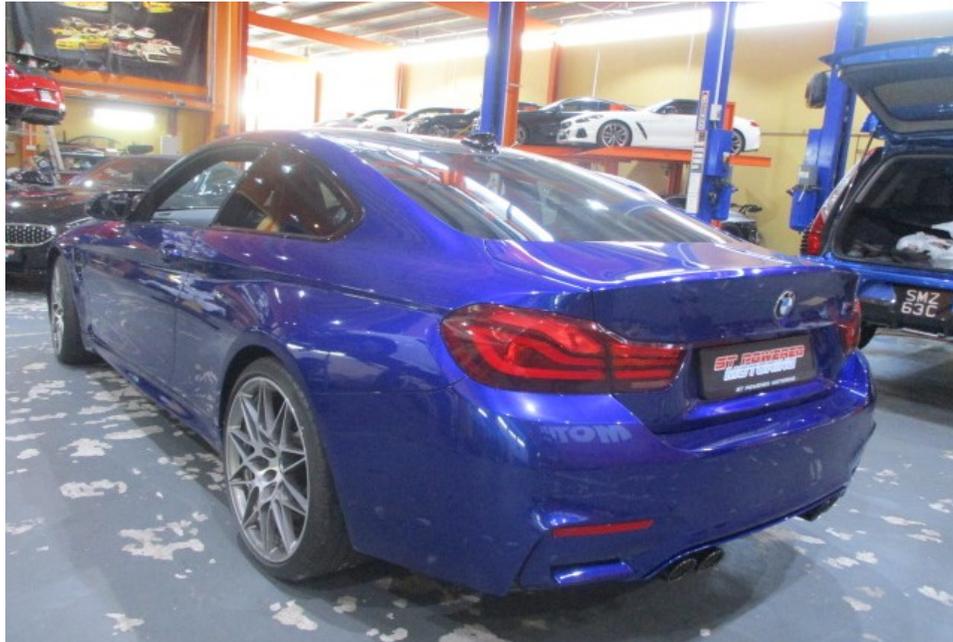
Photo 8 shows a general view of the rear left body of the Motor Car at the time of my inspection. The Motor Car was observed to be in a relatively good general condition with no loose exterior fittings observed. The body parts along the entire left side portion of the Motor Car were visually examined and it was observed that the repair/restoration works carried out to the damaged area of the Motor Car (refer to photograph 2 above) were reasonably adequate and in order.

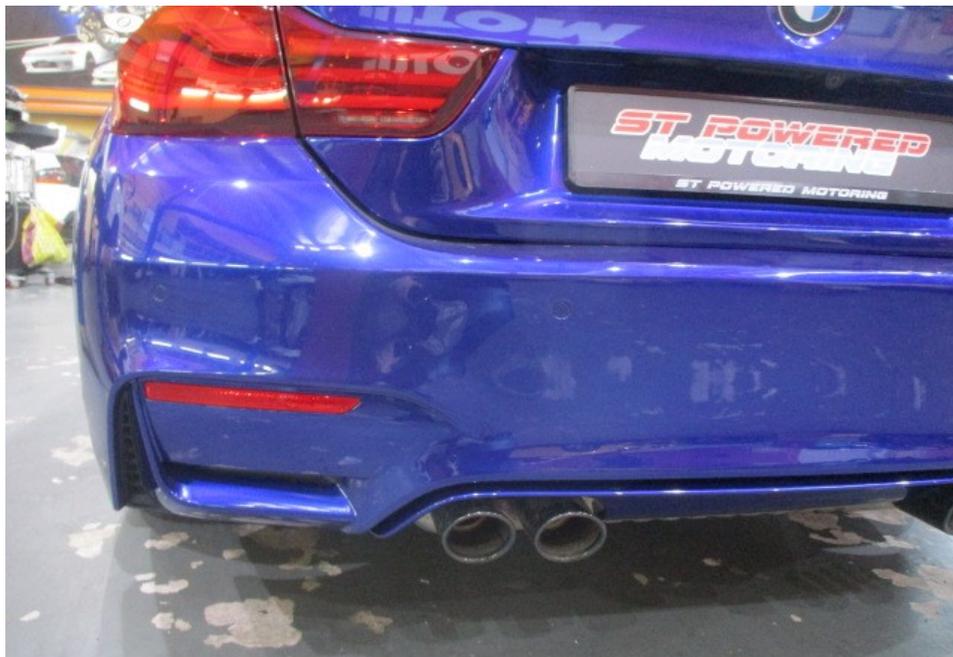
Photo 9 shows a closer view of the Motor Car's rear bumper, rear bumper left reflector, rear bumper centre lower cover and rear bootlid at the time of my inspection. The body parts at the rear portion of the Motor Car were visually examined and it was observed that the repair/restoration works carried out to the damaged area of the Motor Car (refer to photograph 2 above) were reasonably adequate and in order.

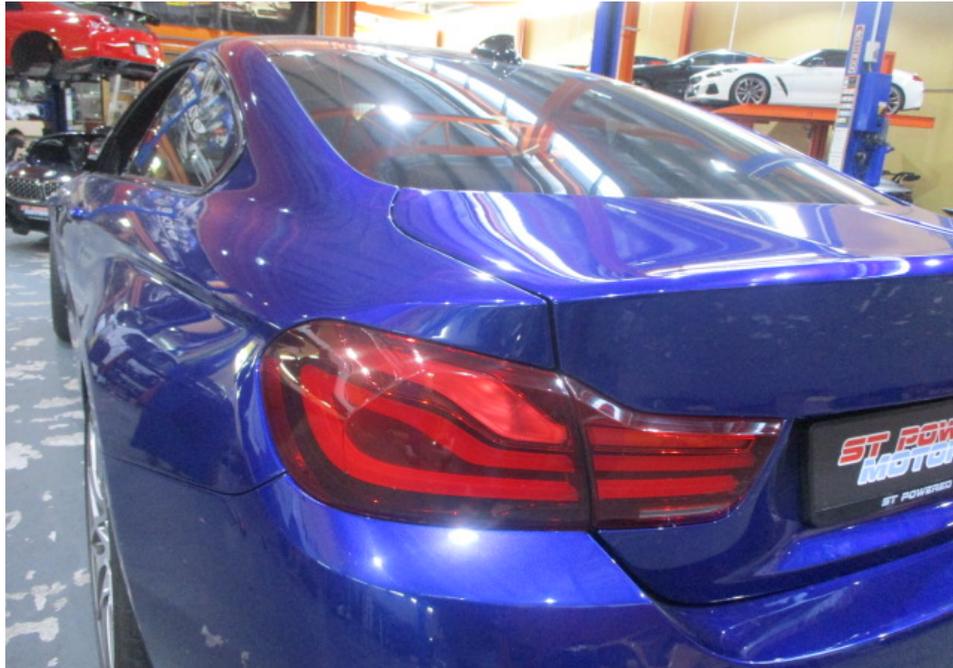
Photo 10 shows a closer view of the Motor Car's rear bootlid, rear left bootlid lamp, rear left taillamp and rear left body panel at the time of my inspection. The body parts along the entire left side portion of the Motor Car were visually examined and it was observed that the repair/restoration works carried out to the damaged area of the Motor Car (refer to photograph 2 above) were reasonably adequate and in order.

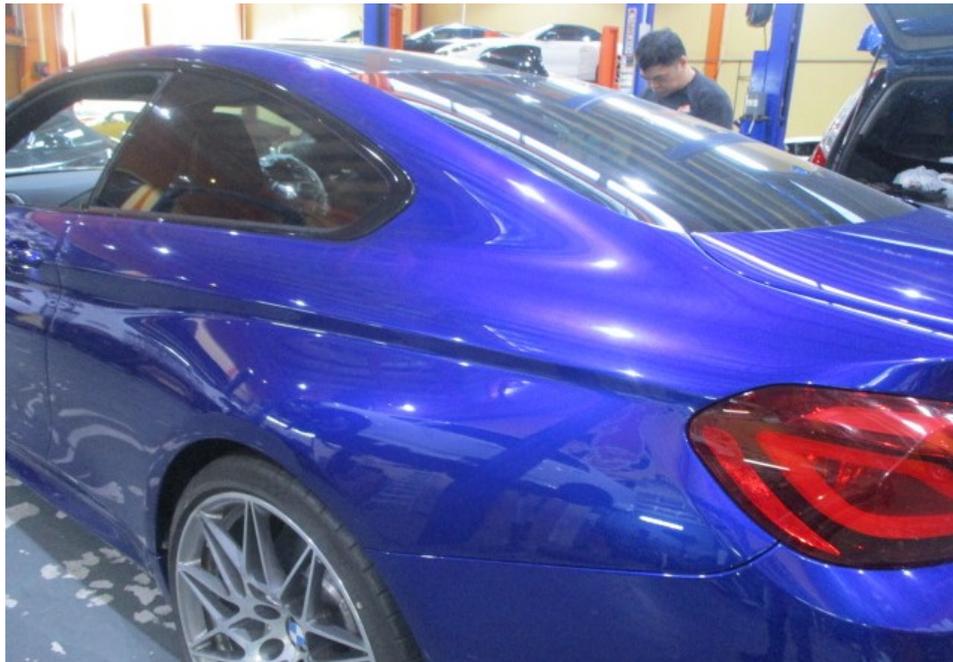
Photo 11 shows a closer view of the Motor Car's rear left taillamp and rear left body panel at the time of my inspection. The body parts along the entire left side portion of the Motor Car were visually examined and it was observed that the repair/restoration works carried out to the damaged area of the Motor Car (refer to photograph 2 above) were reasonably adequate and in order.

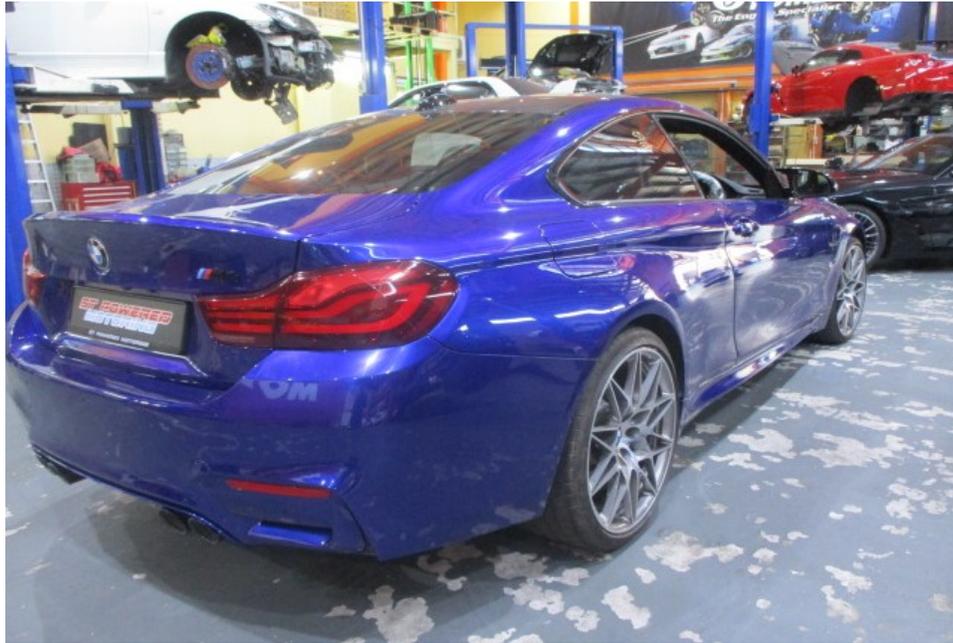
Photo 12 shows a general view of the rear right body of the Motor Car at the time of my inspection. The Motor Car was observed to be in a relatively good general condition with no loose exterior fittings observed. The body parts at the right side rear portion of the Motor Car were visually examined and it was observed that the repair/restoration works carried out to the damaged area of the Motor Car (refer to photograph 3 above) were reasonably adequate and in order.

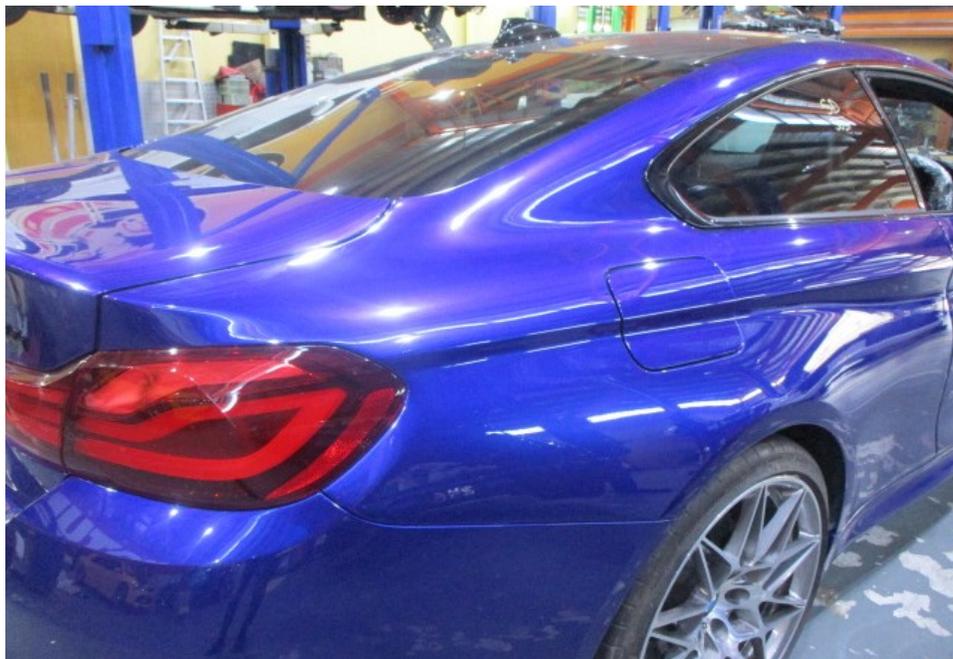
Photo 13 shows a closer view of the Motor Car's rear right taillamp, rear right body panel and the outer cover for the petrol filler hose and at the time of my inspection. The body parts at the right side rear portion of the Motor Car were visually examined and it was observed that the repair/restoration works carried out to the damaged area of the Motor Car (refer to photograph 3 above) were reasonably adequate and in order.

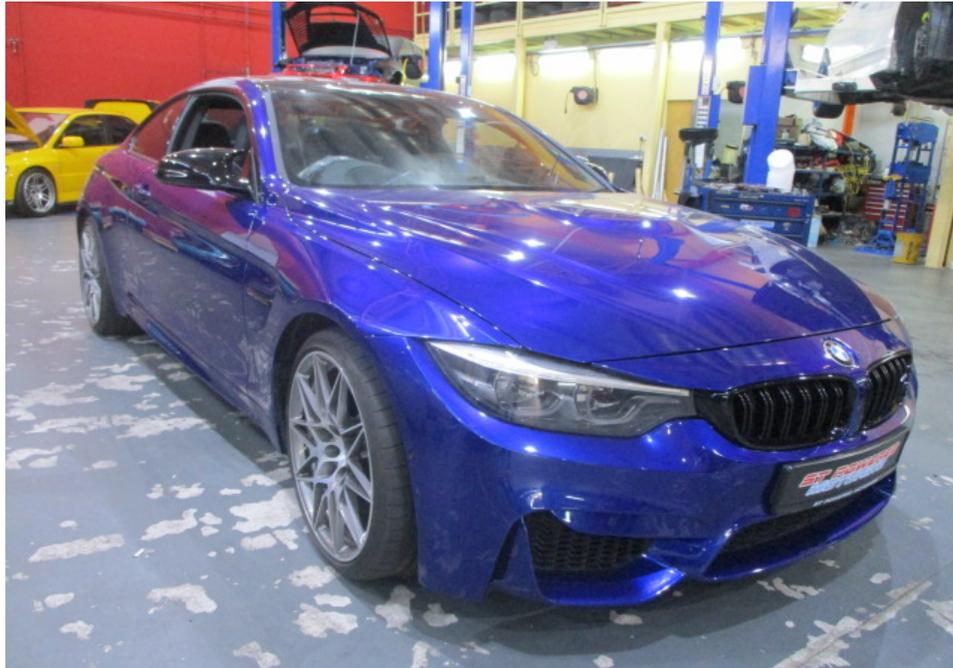
Photo 14 shows a general view of the front right body of the Motor Car at the time of my inspection. The Motor Car was observed to be in a relatively good general condition with no loose exterior fittings observed. The mileage of the Motor Car recorded at the time of my inspection was 19,634km.

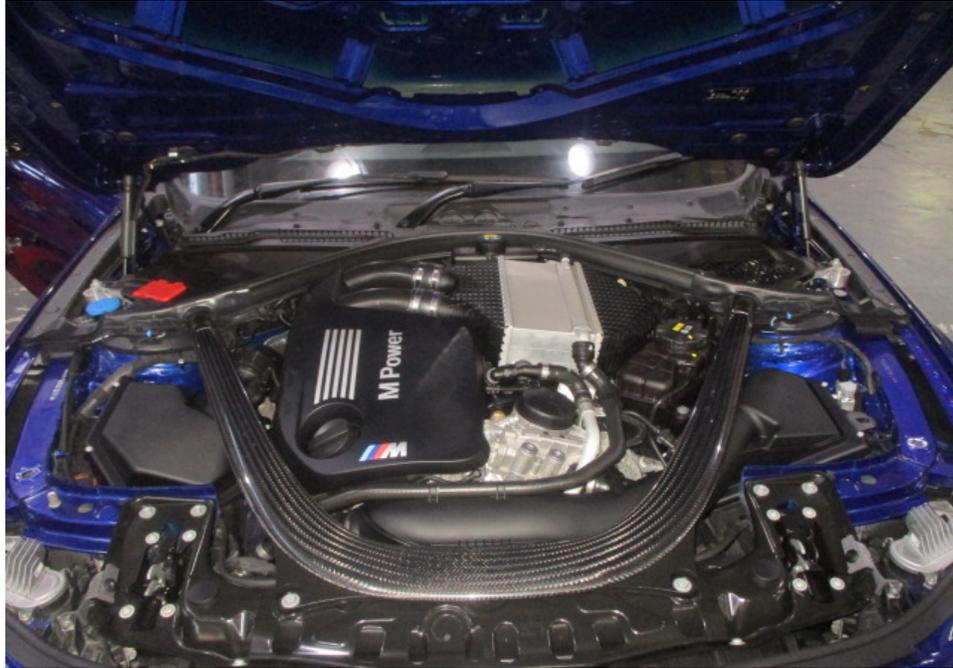
Photo 16 shows a general view of the engine compartment of the Motor Car at the time of my inspection. The various parts and components inside the engine compartment were all observed to be intact and properly fitted. There was also no sign(s) or indication(s) of fluid leak and/or fluid stain found inside the engine compartment.

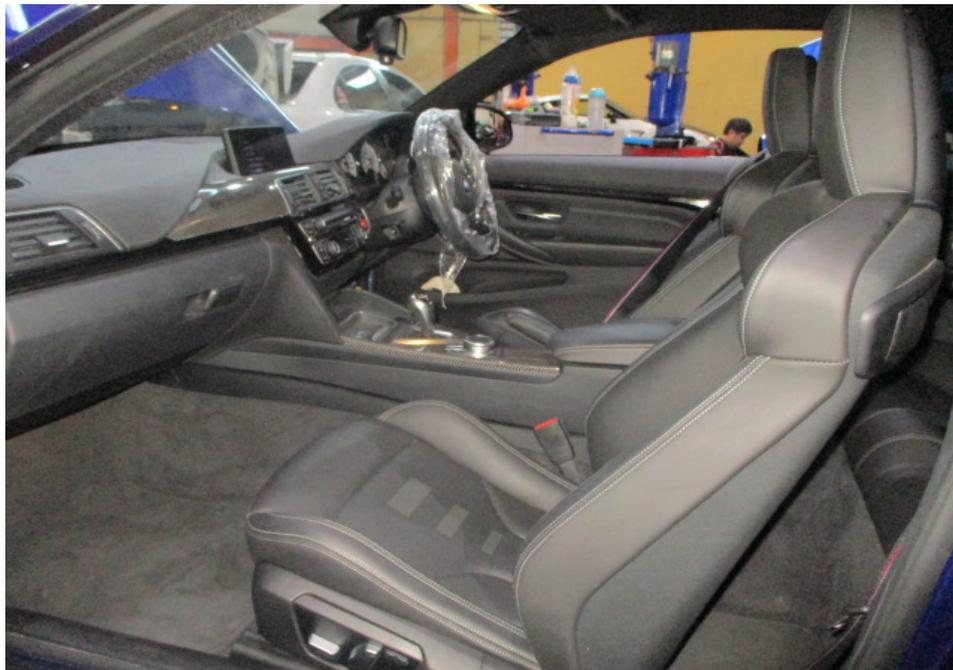
Photo 17 shows the interior compartment of the Motor Car at the time of my inspection. The various parts and components, trims, carpet, and upholstery inside the interior compartment were all observed to be intact and properly fitted.

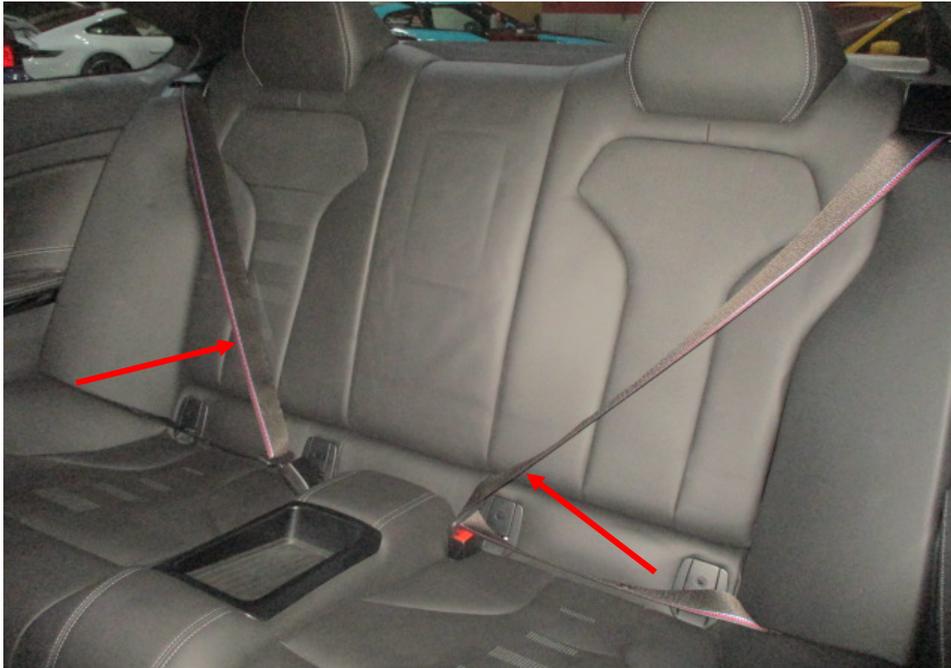
Photo 18 shows the rear seats of the Motor Car. All the seats of the Motor Car were secured via seat rails to the floorboard. They were also fitted with a retractable seat belt reel and a pre-tensioner. The seat belts (arrowed) were tested and were able to be fastened into the respective pre-tensions that were fitted on the side of each individual seat.

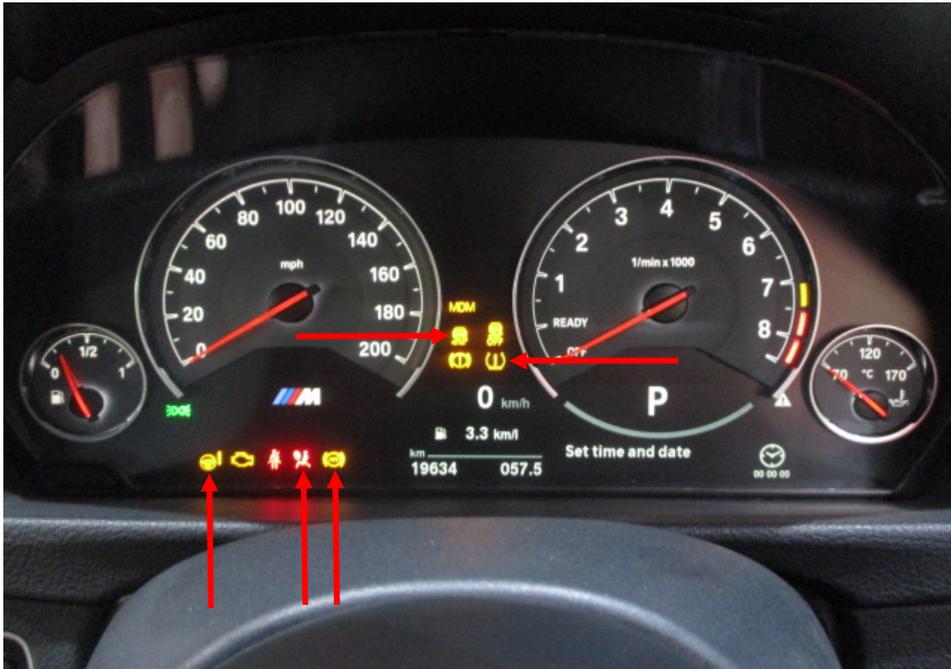
Photo 19 shows the warning lights for the various electronic safety features appearing on the instrument panel of the Motor Car during its self-test when the engine is cranked, in particular the ABS, SRS, IAS, TPM and DSC lights (arrowed).

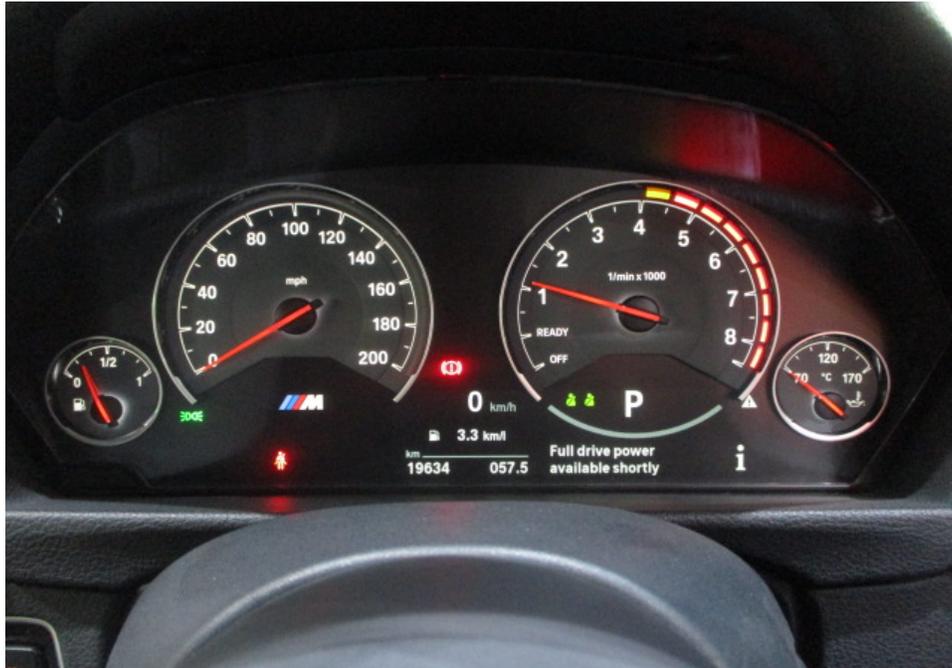
Photo 20 shows the respective warning lights no longer illuminated, indicating that there is no fault detected to the ABS, SRS, IAS, TPM and DSC systems of the Motor Car during the self-test. These electronic systems were hence in working condition at the time of my inspection.

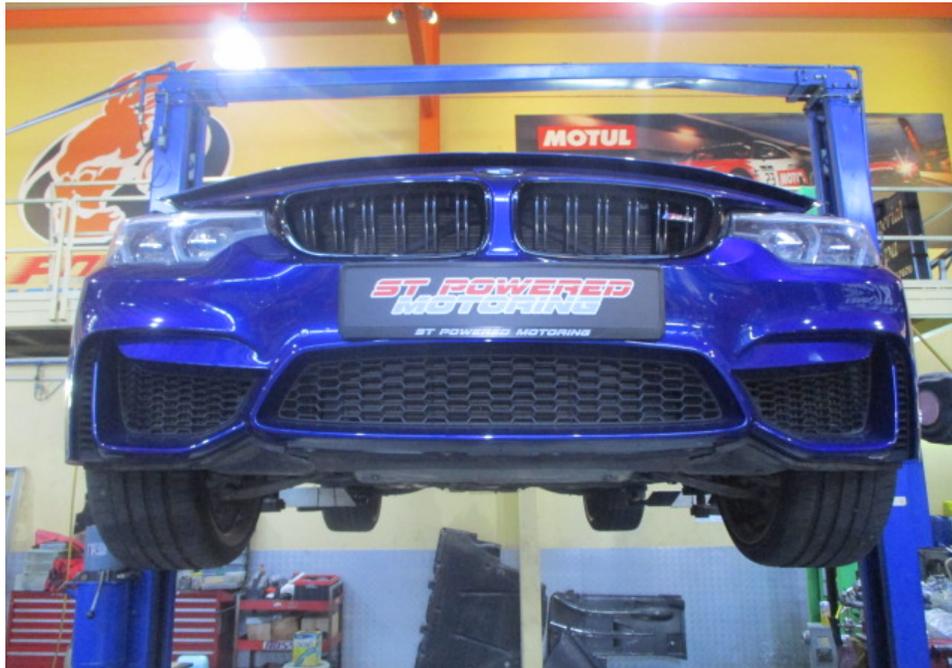
Photo 21 shows the Motor Car hoisted up for checks on its undercarriage. There was no sign(s) or indication(s) of fluid leakage and/or fluid stain(s) on the underside of the Motor Car. The undercarriage components of the Motor Car were also all observed to be intact and secured in an appropriate manner.

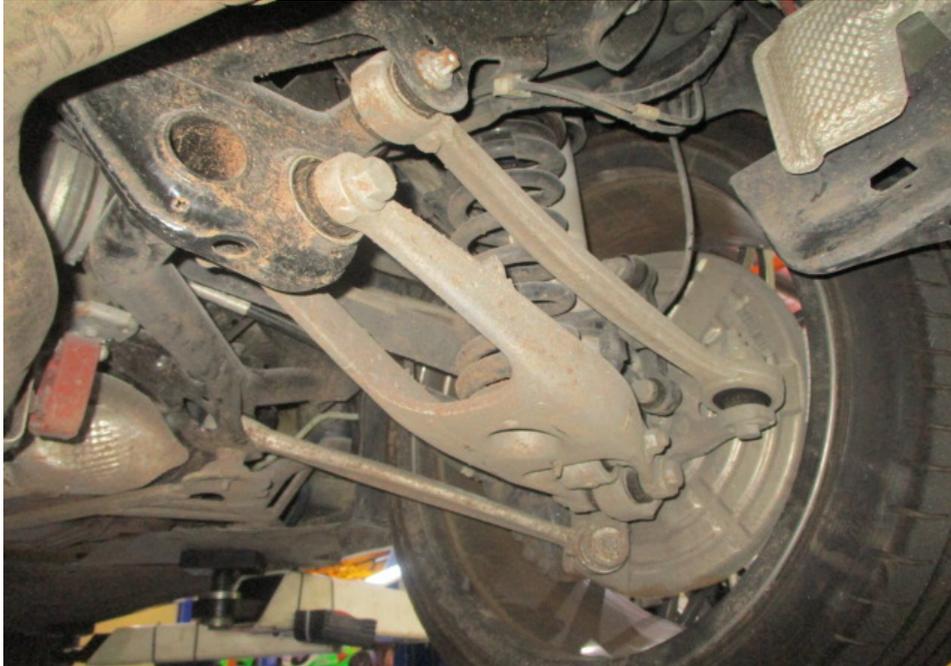
Photo 22 shows a general view of the control arms and linkages at the rear right wheel of the Motor Car. I did not observe any fluid leak and/or fluid stain on the underside of the Motor Car. All of the Motor Car's undercarriage components were observed to be intact and secured in an appropriate manner.

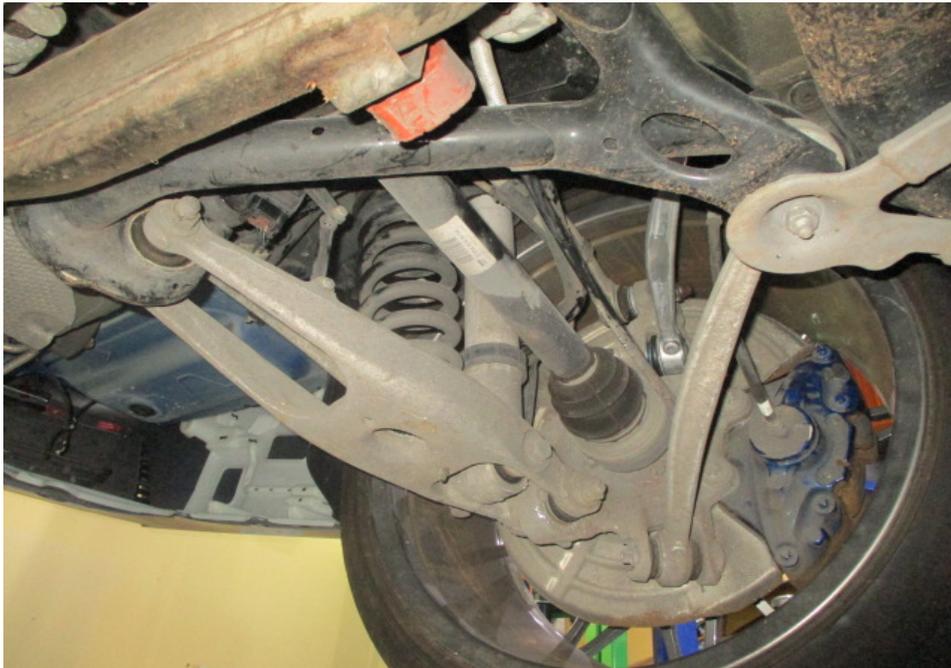
Photo 23 shows a general view of the control arms and linkages at the rear left wheel of the Motor Car. I did not observe any fluid leak and/or fluid stain on the underside of the Motor Car. All of the Motor Car's undercarriage components were observed to be intact and secured in an appropriate manner.

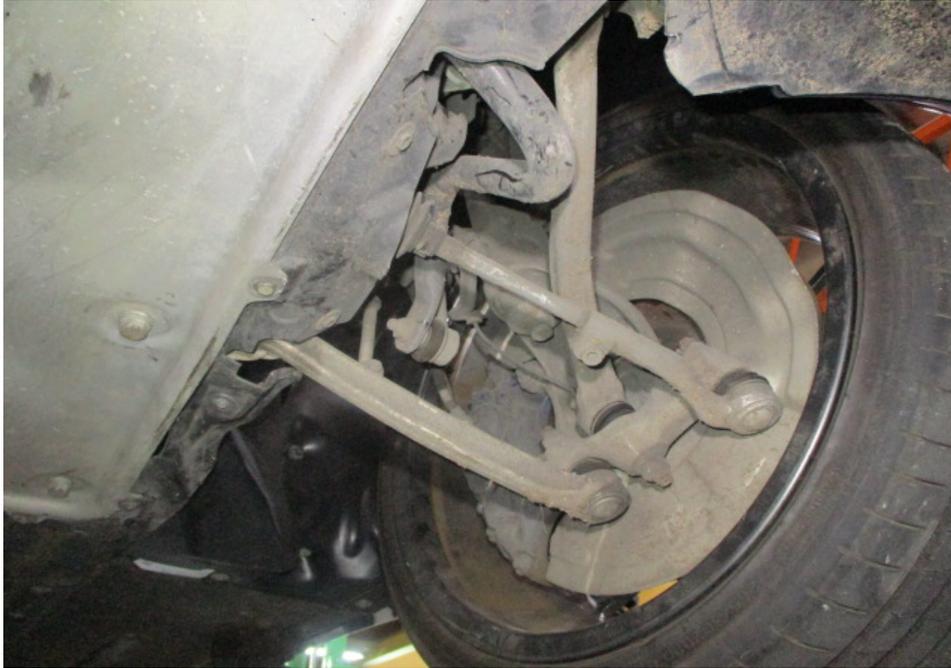
Photo 24 shows the various undercarriage components at the front left wheel of the Motor Car. The mechanical components, control arms and linkages were all found to be intact and secured in an appropriate manner.

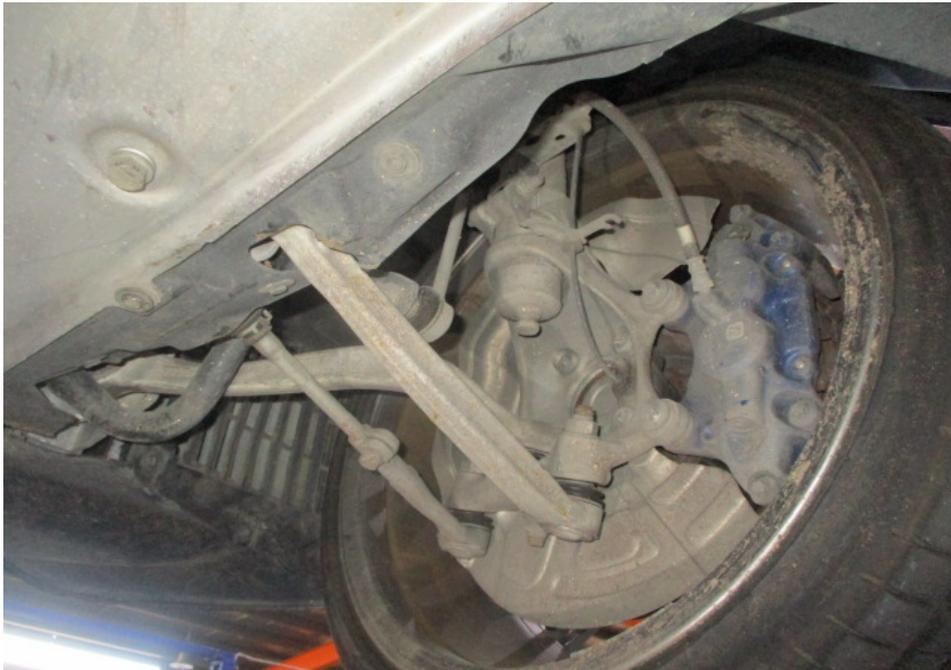
Photo 25 shows the various undercarriage components at the front right wheel of the Motor Car. The mechanical components, control arms and linkages were all found to be intact and secured in an appropriate manner. I also did not observe any fluid leak and/or fluid stain on the underside of the Motor Car.

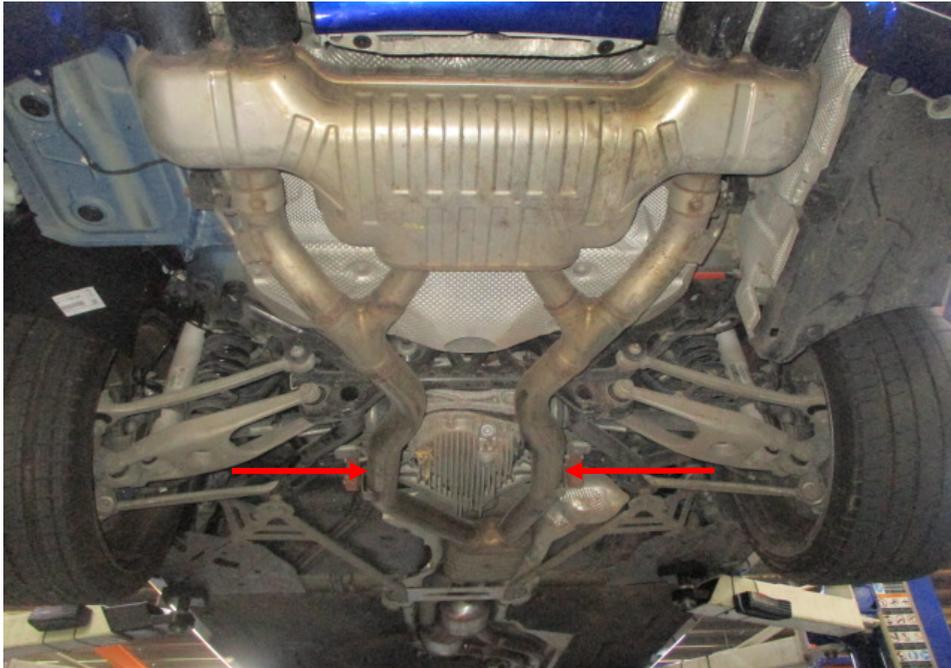
Photo 26 shows the rear section of the Motor Car's exhaust system. My examination of the Motor Car's exhaust system revealed no sign(s) or indication(s) of any cut or weld marks along its exhaust pipes (arrowed), on its rear muffler, on its centre resonator boxes and on its catalytic converters.

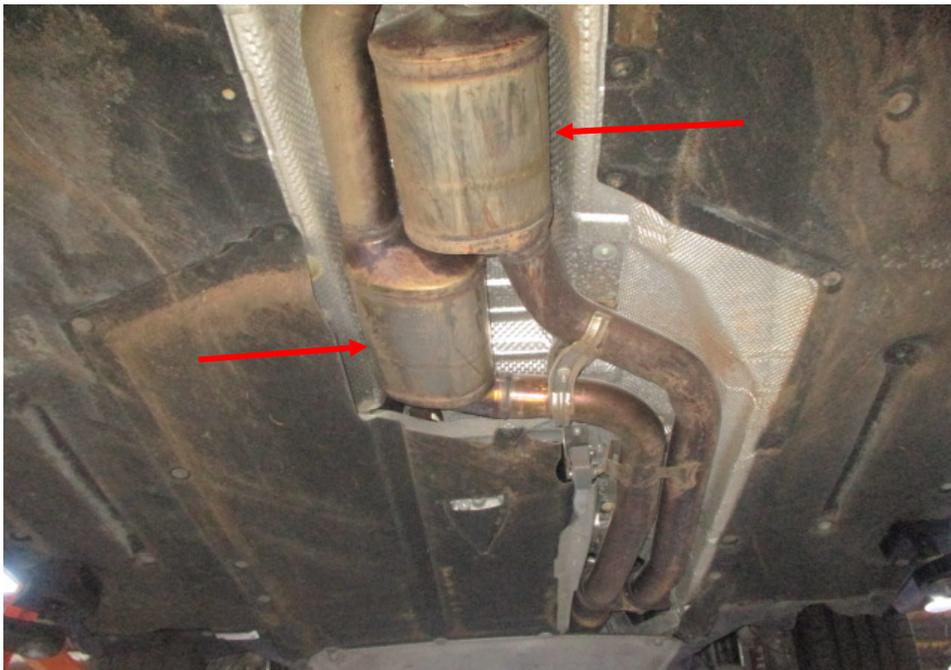
Photo 27 shows the front section of the Motor Car's exhaust system. My examination of the Motor Car's exhaust system revealed no sign(s) or indication(s) of any cut or weld marks along its exhaust pipes, on its rear muffler, on its centre resonator boxes (arrowed) and on its catalytic converters.

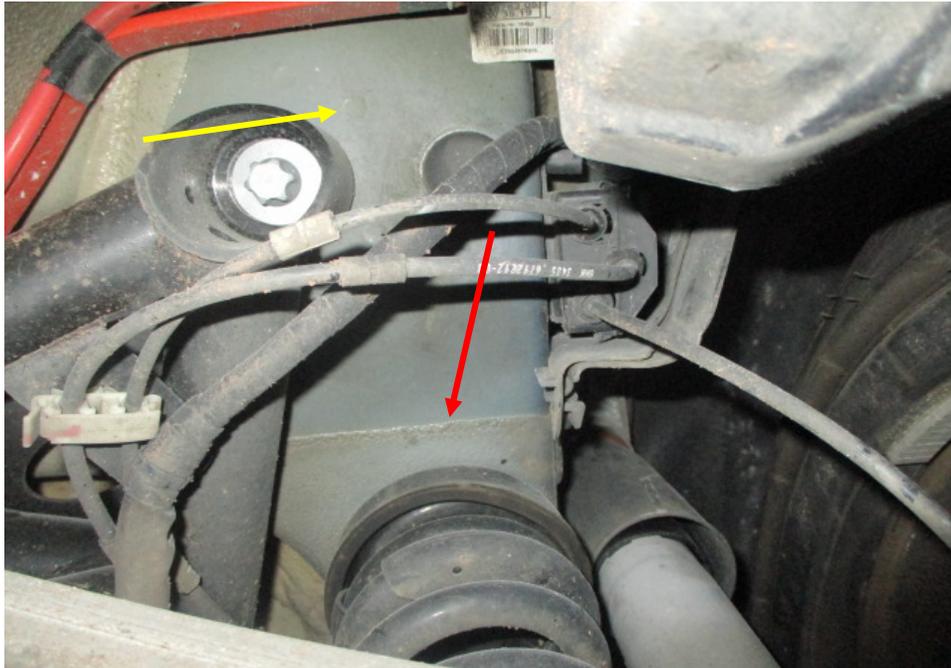
Photo 28 shows the chassis/structural body at the underside rear right of the Motor Car. I did not find any weld marks other than original spot weld marks (yellow arrow) on the chassis/structural body of the Motor Car. The original factory sealant (red arrow) at the joints along the chassis/structural body was untouched, indicating no work was done on the chassis/structural body of the Motor Car and that the chassis/structural body was originally fitted.

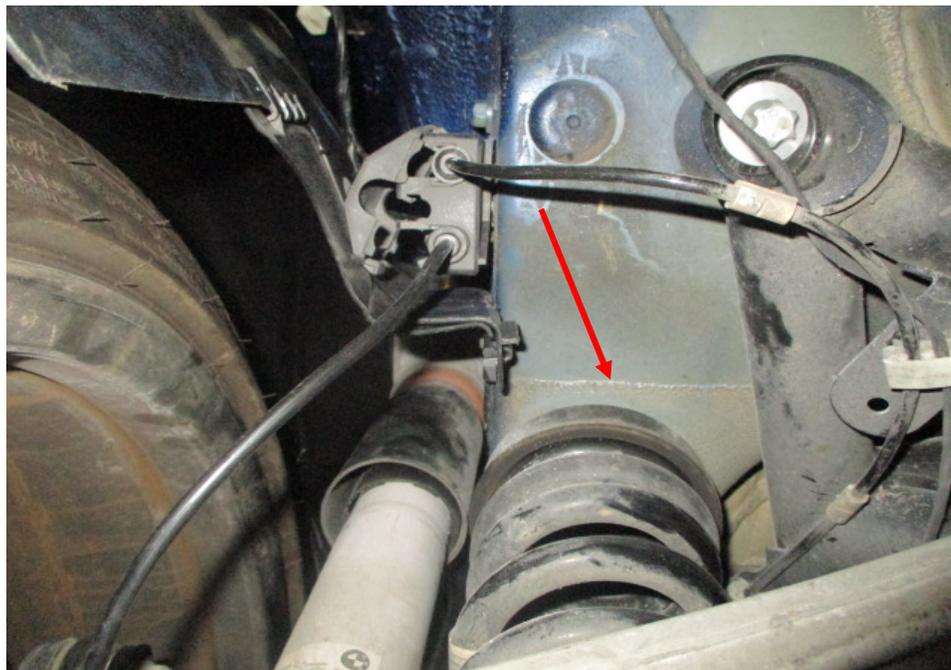
Photo 29 shows the chassis/structural body at the underside rear left of the Motor Car. The original factory sealant (arrowed) at the joints along the chassis/structural body was observed to be untouched. In general, I had found no work was carried out on the chassis/structural body of the Motor Car. The chassis/structural body of the Motor Car was originally fitted.

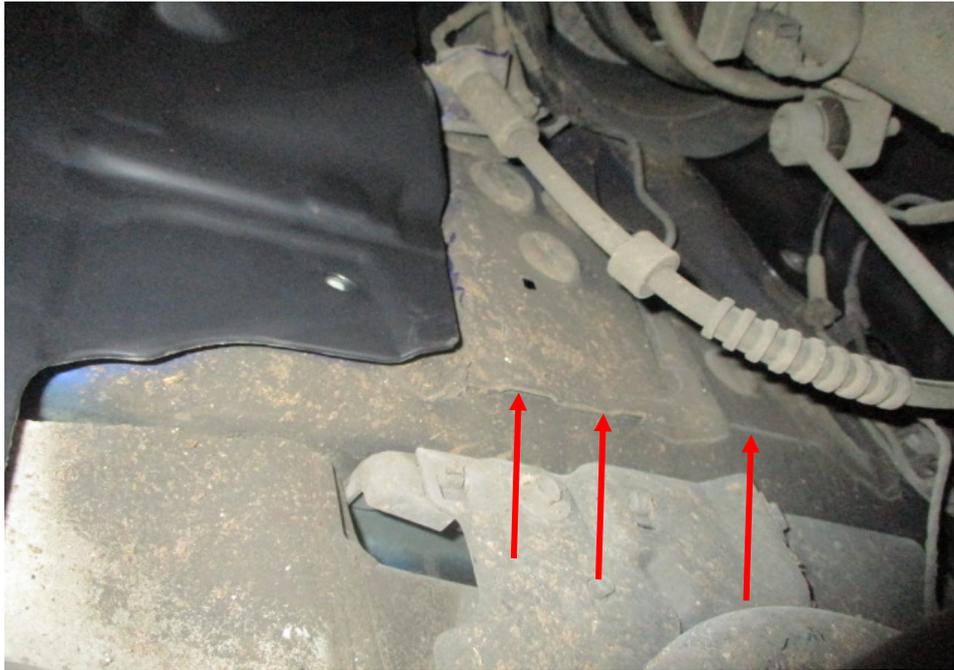
Photo 30 shows the chassis/structural body at the underside front left of the Motor Car. The original factory sealant (arrowed) at the joints along the chassis/structural body was observed to be untouched. In general, I had found no work was carried out on the chassis/structural body of the Motor Car. The chassis/structural body of the Motor Car was originally fitted.

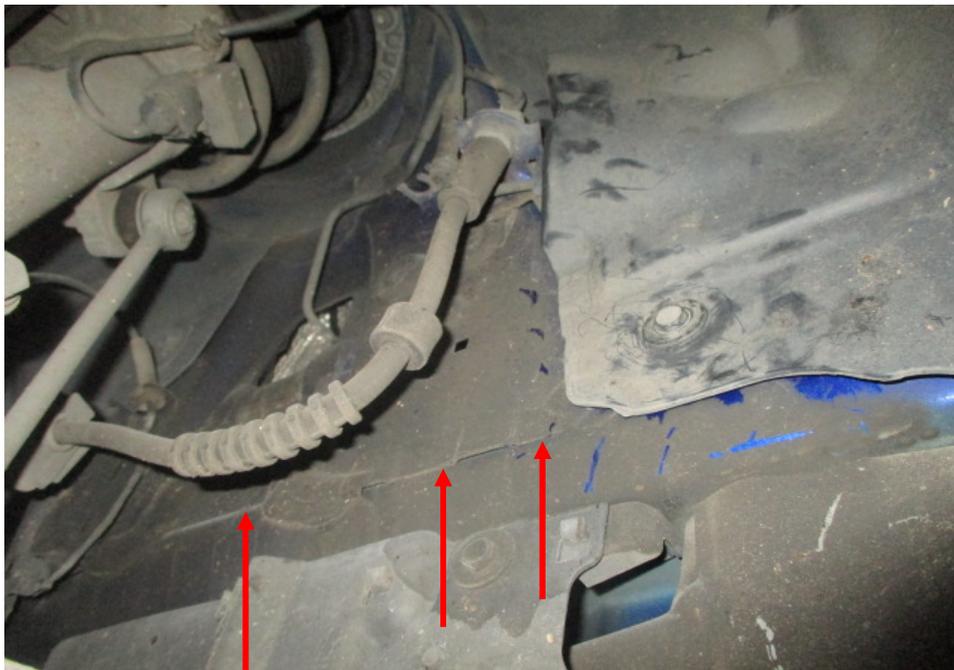
Photo 31 shows the chassis/structural body at the underside front right of the Motor Car. The original factory sealant (arrowed) at the joints along the chassis/structural body was observed to be untouched. In general, I had found no work was carried out on the chassis/structural body of the Motor Car. The chassis/structural body of the Motor Car was originally fitted.
