Your Ref: BMW M4 Coupe
(chassis number WBS4Y92050FH67671)
Our Ref : CI/TP22005189/D

INSPECTION REPORT OF AN UNREGISTERED BMW M4 COUPE MOTOR CAR WITH CHASSIS NUMBER WBS4Y92050FH67671

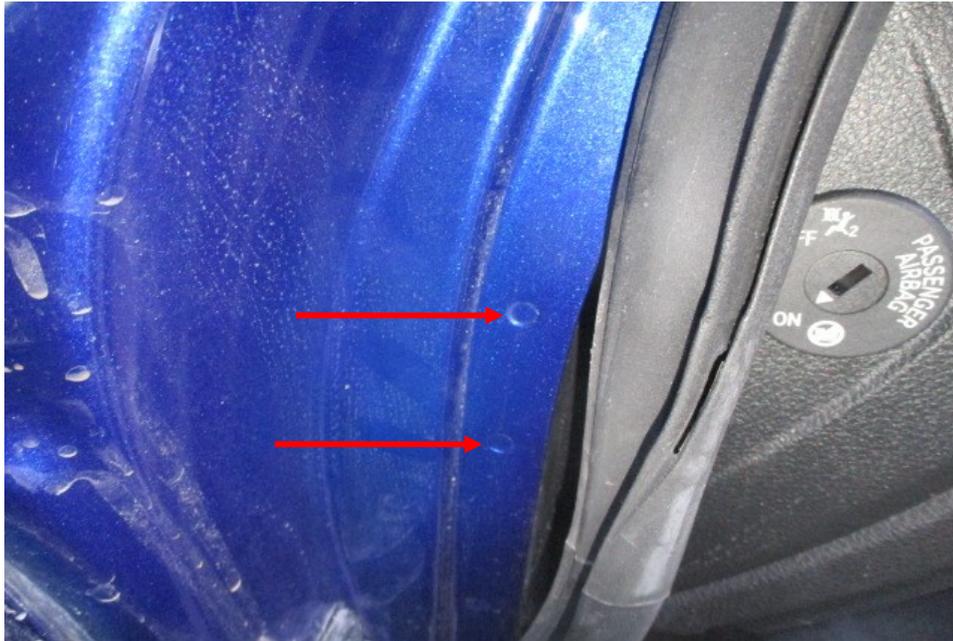
Photo 32 shows the left side "A" pillar of the Motor Car. I did not find any weld marks other than original spot weld marks (arrowed) on the left side "A" pillar of the Motor Car which, indicates that there was no re-welding works carried out. In general, I had found all the non-detachable body panels of the Motor Car to be originally fitted at the time of my inspection, except for the rear left body panel.

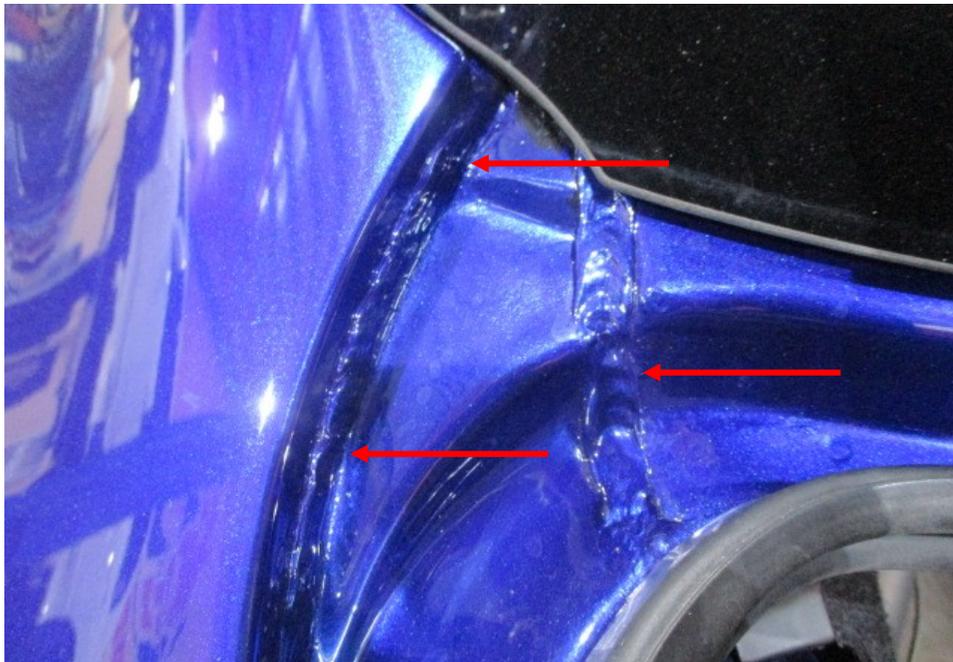
11. Checks on the non-detachable body panels like the rear body panels, floorboard, roof panel, pillars and rocker panels amongst others, revealed that these body panels were spot welded onto the chassis/structural body of the Motor Car. The original factory sealant at the joints of the non-detachable body panels was all untouched indicating no replacement of the non-detachable body panels was carried out; and that these body panels were all originally fitted, except for the rear left body panel, which was found to be replaced. Refer to photograph 33 below.

Photo 33 shows the area where the rear left body panel of the Motor Car is welded onto the rear speaker panel. The sealant (arrowed) joining the body panels was observed to be not original factory sealant, indicating that the rear left body panel of the Motor Car was replaced. The lack of original weld marks seen on the rear left body panel was also due to replacement work when the replaced rear left body panel was re-welded onto the Motor Car and smoothen for re-spraying work. Refer to photograph 34 below for comparison.

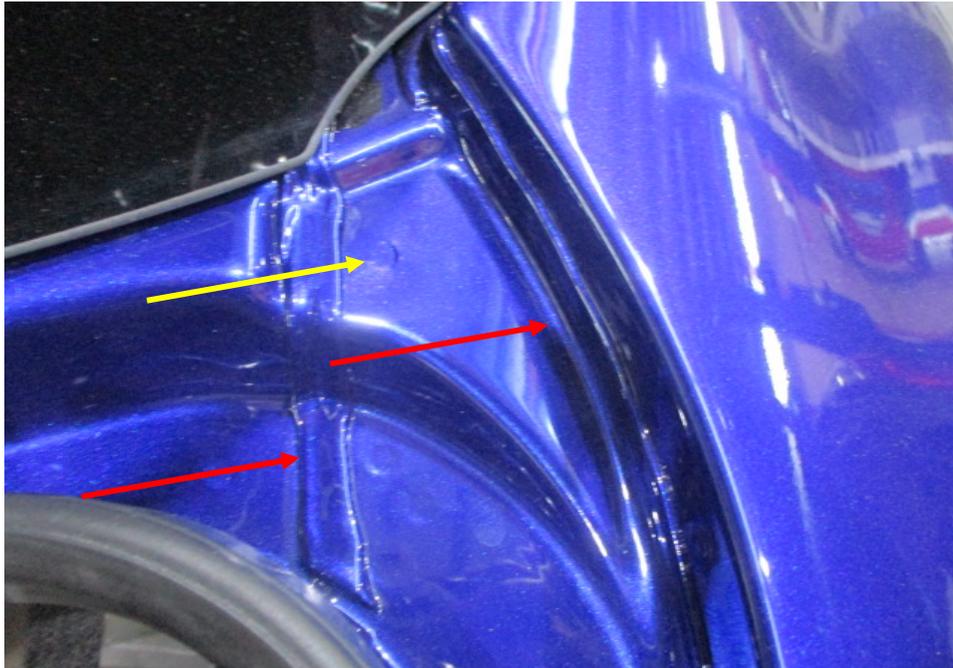
Photo 34 shows the area where the rear right body panel of the Motor Car is welded onto the rear speaker panel (for comparison purposes with photograph 33 above). The sealant (red arrow) joining the body panels was original factory sealant. Original spot weld marks (yellow arrow) were also seen on the rear right body panel of the Motor Car.

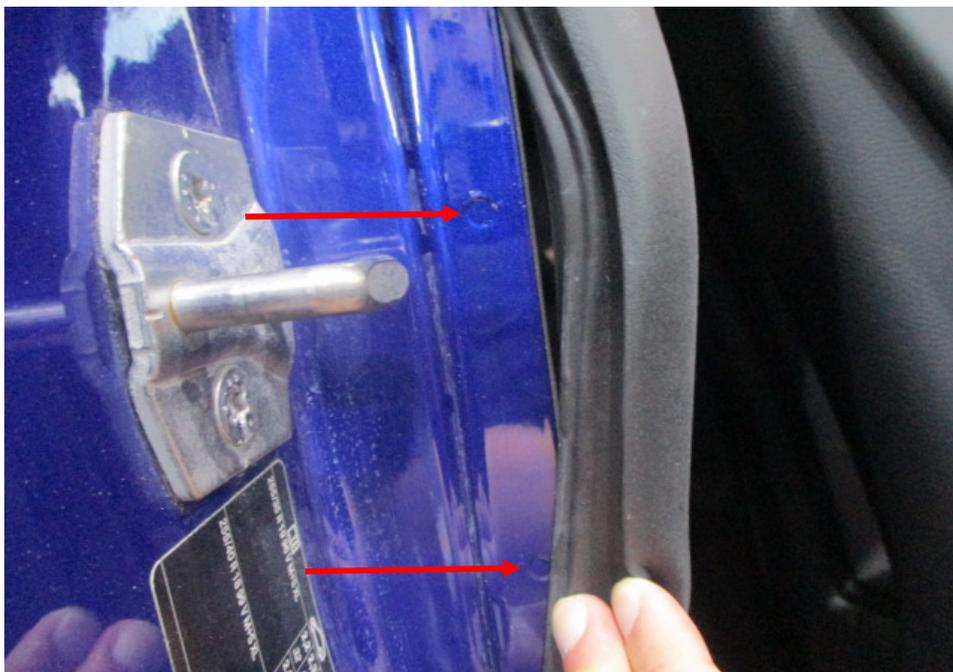
Photo 35 shows the rear right body panel of the Motor Car. I did not find any weld marks other than original spot weld marks (arrowed) on the rear right body panel of the Motor Car, which indicates that there was no re-welding works carried out. In general, I had found all the non-detachable body panels of the Motor Car to be originally fitted at the time of my inspection, except for the rear left body panel.

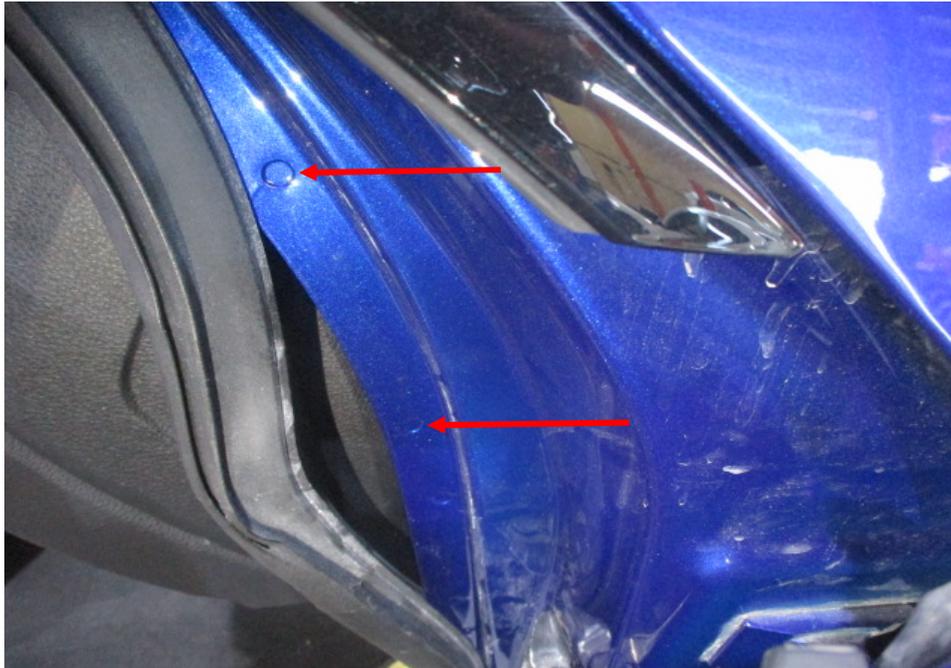
Photo 36 shows the right side "A" pillar of the Motor Car. I did not find any weld marks other than original spot weld marks (arrowed) on the right side "A" pillar of the Motor Car, which indicates that there was no re-welding works carried out. In general, I had found all the non-detachable body panels of the Motor Car to be originally fitted at the time of my inspection, except for the rear left body panel.
