Your Ref: BMW 420i Coupe
(chassis number WBA12AP040CH50994)
Our Ref : CI/TP22005190/D

INSPECTION REPORT OF AN UNREGISTERED BMW 420i COUPE MOTOR CAR WITH CHASSIS NUMBER WBA12AP040CH50994

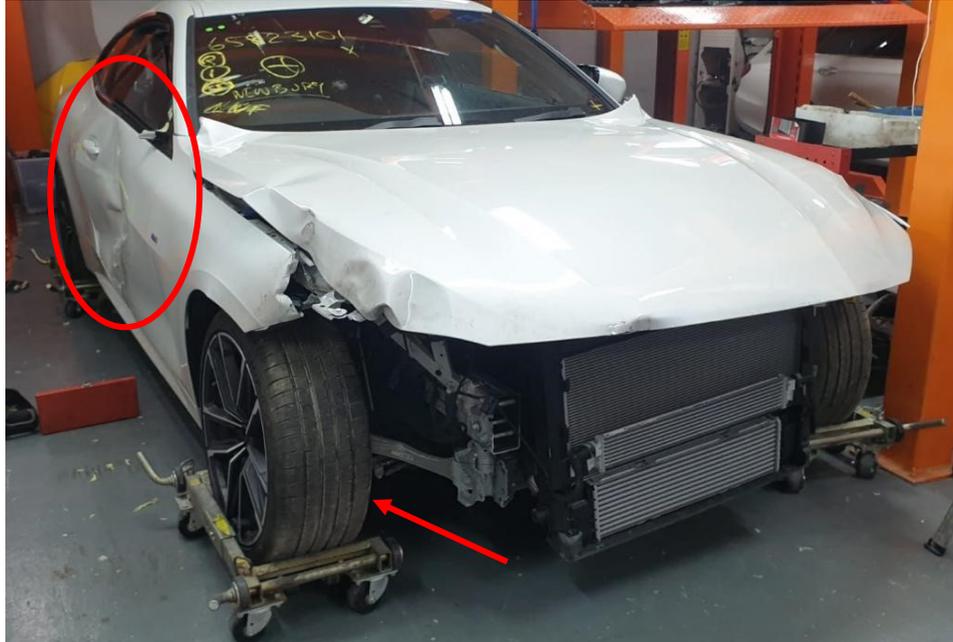
3. The photographs provided to me had showed damage at the frontal portion and right side centre portion of the Motor Car. Body parts damaged at the frontal portion include the front bonnet, front left fender and front right fender amongst others. The front headlamps, front day lights, radiator grilles, front bumper and all its related parts and components like the front bumper centre lower grille, front bumper right lower grille, front bumper left lower grille, front bumper sponge, front bumper reinforcement and front bumper sensors amongst others were observed to be missing/dislodged/damaged.

4. As for the Motor Car's right side centre portion, I had observed damage to its right side wing mirror and right side front door.
5. The photographs provided to me had also showed the Motor Car's front wheels orientation in different directions. This would indicate damage to the undercarriage parts at the Motor Car's front wheel(s).

Photo 1 shows the front right body of the Motor Car (photograph provided to me). The Motor Car was observed to have sustained damage at its frontal portion and right side centre portion (circled). The front bonnet, front right fender, right side wing mirror and right side front door were amongst the body parts that were observed to have been damaged. The front right wheel (arrowed) and front left wheel (refer to photograph 3 below) were both orientated in different directions, indicating damage to the undercarriage parts at the Motor Car's front wheel(s).

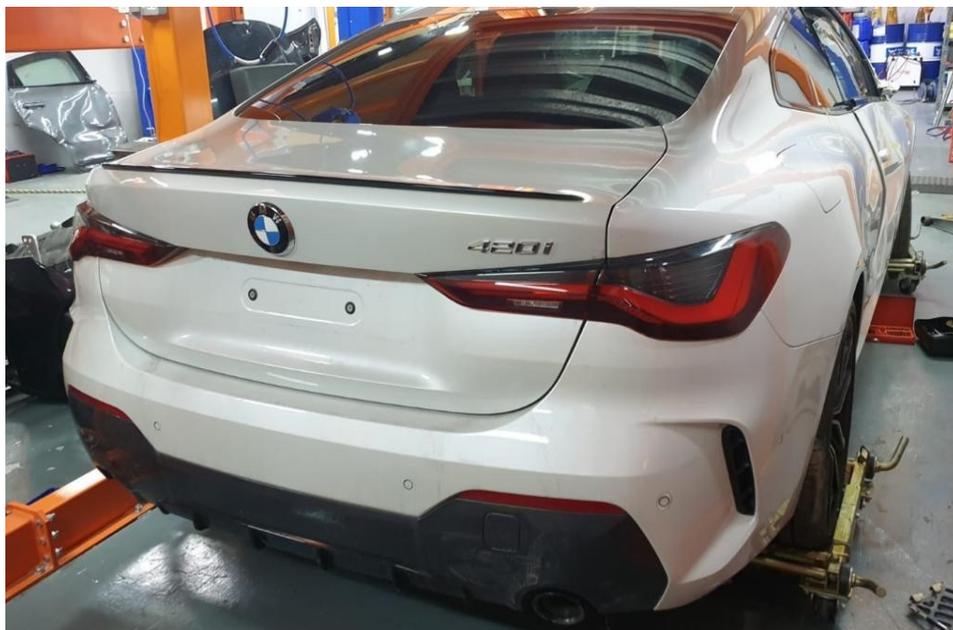
Photo 2 shows the rear right body of the Motor Car (photograph provided to me). No physical damage was observed to the rear right portion of the Motor Car.

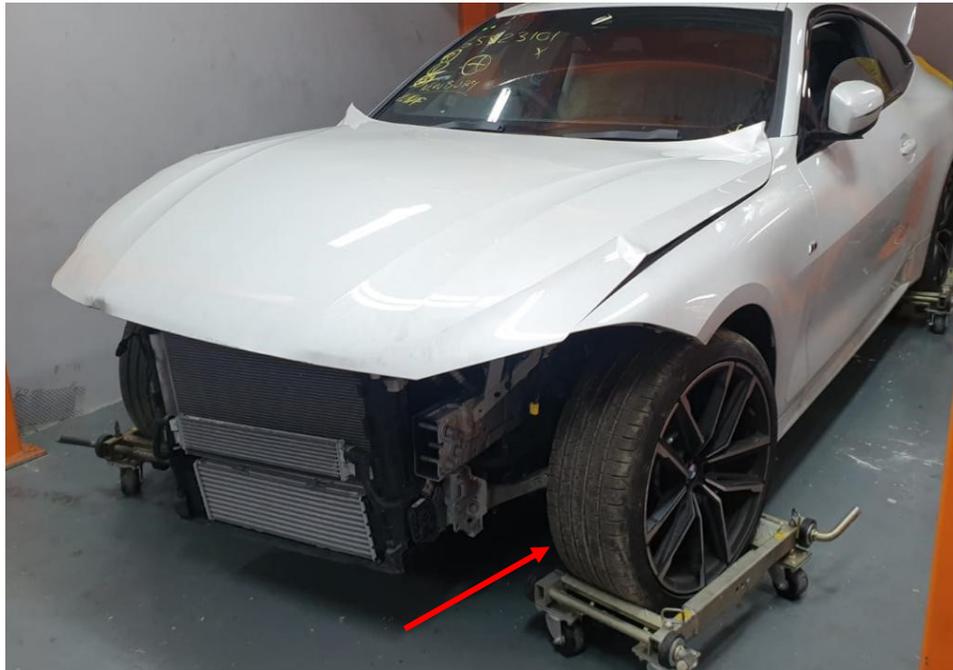
6. The Motor Car's airbag(s) was not deployed as seen from the photographs that were provided to me. See photo 1 – 4 below.

Photo 3 shows the front left body of the Motor Car (photograph provided to me). The Motor Car was observed to have sustained damage at its frontal portion. The front bonnet and front left fender were amongst the body parts that were observed to have been damaged. The front headlamps, front day lights, radiator grilles, front bumper and all its related parts and components were also observed to be missing/dislodged/damaged. The front left wheel (arrowed) and front right wheel (refer to photograph 1 above) were both orientated in different directions, indicating damage to the undercarriage parts at the Motor Car's front wheel(s). The airbag(s) of the Motor Car was not deployed as seen from the photographs that were provided to me.

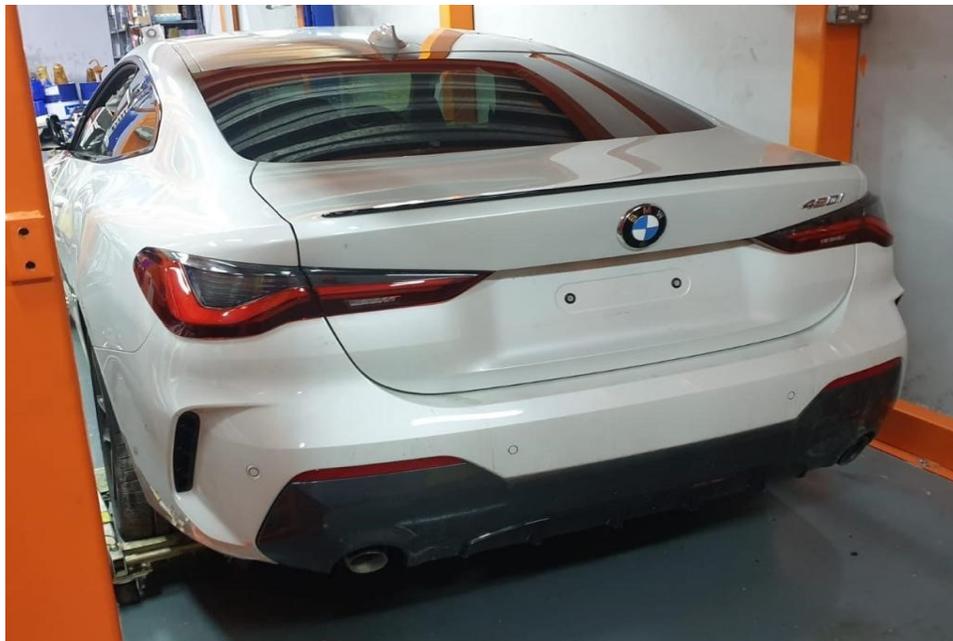
Photo 4 shows the rear left body of the Motor Car (photograph provided to me). No physical damage was observed to the rear left portion of the Motor Car.

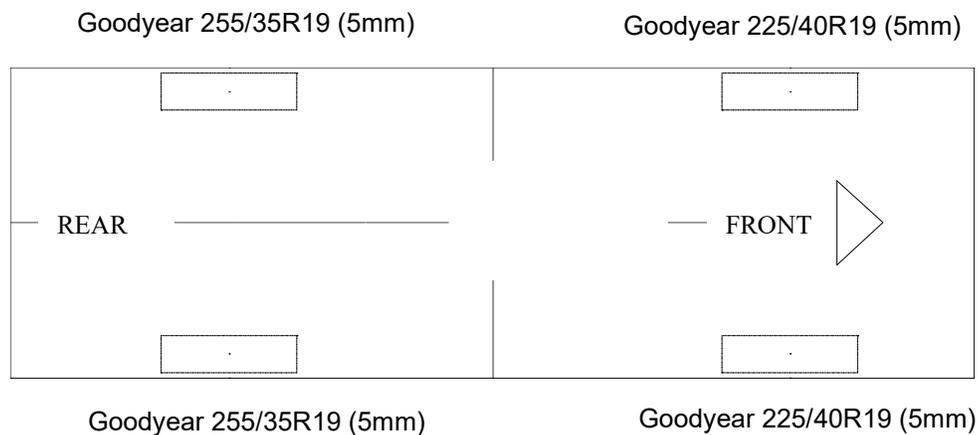
10. It was fitted with 19inch sport wheel rims that were wrapped with tyres that were observed to be of serviceable condition. The tyres were also sufficiently inflated for vehicular operation. The tyre brand, tyre size and approximate remaining tread depth of the 4 tyres of the Motor Car were recorded as follows: -

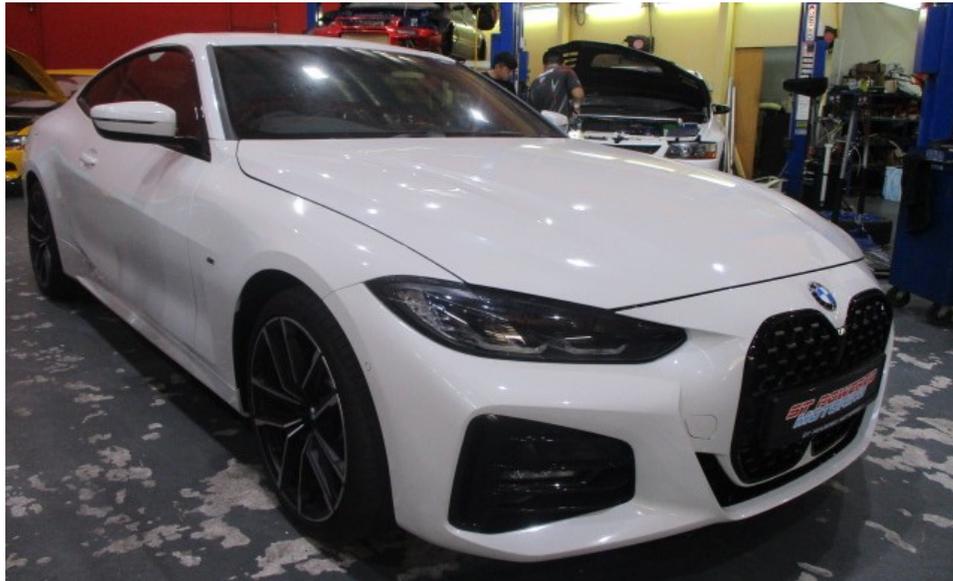
Photo 5 shows a general view of the front right body of the Motor Car at the time of my inspection. The Motor Car was observed to be in a relatively good general condition with no loose exterior fittings observed. The body parts at the frontal portion and right side centre portion of the Motor Car were visually examined and it was observed that the repair/restoration works carried out to the damaged area of the Motor Car (refer to photograph 1 above) were reasonably adequate and in order.

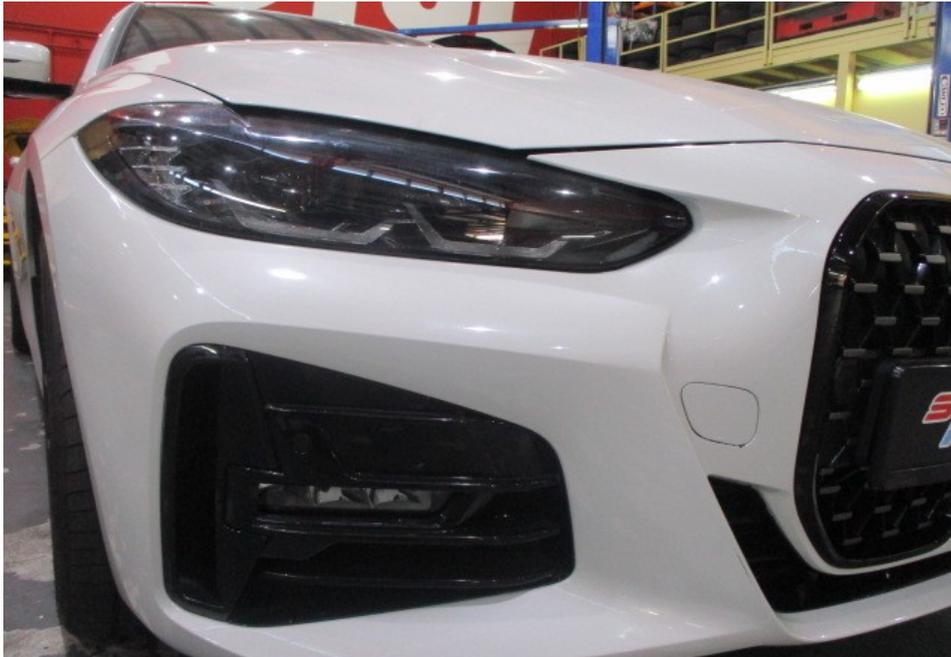
Photo 6 shows a closer view of the Motor Car's front bumper, front bumper right lower grille, front right day light and front right headlamp at the time of my inspection. The body parts at the frontal portion of the Motor Car were visually examined and it was observed that the repair/restoration works carried out to the damaged area of the Motor Car (refer to photograph 1 above) were reasonably adequate and in order.

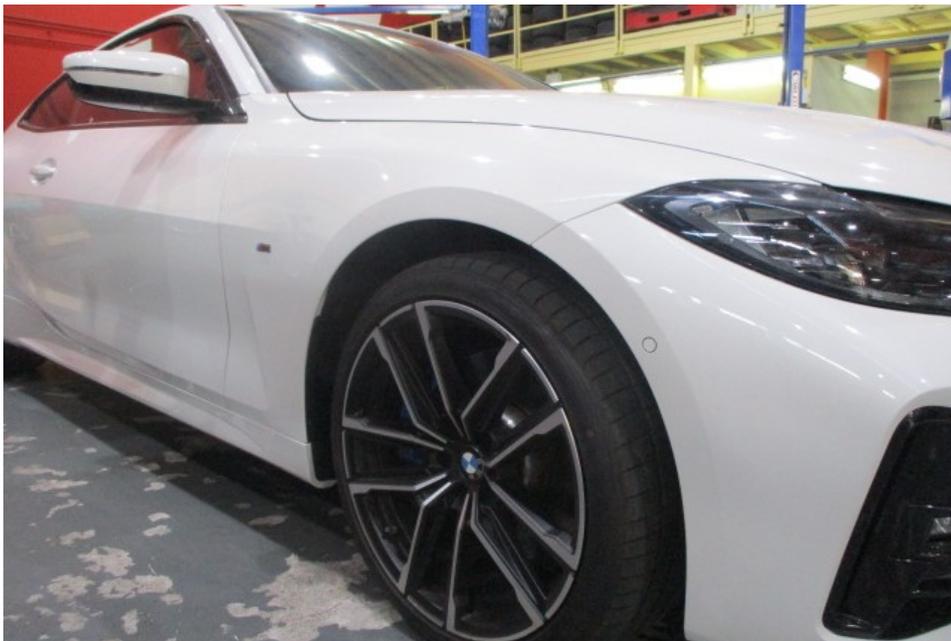
Photo 7 shows a closer view of the Motor Car's front bonnet, front right fender, front right wheel rim and right side wing mirror at the time of my inspection. The body parts at the frontal portion of the Motor Car were visually examined and it was observed that the repair/restoration works carried out to the damaged area of the Motor Car (refer to photograph 1 above) were reasonably adequate and in order.

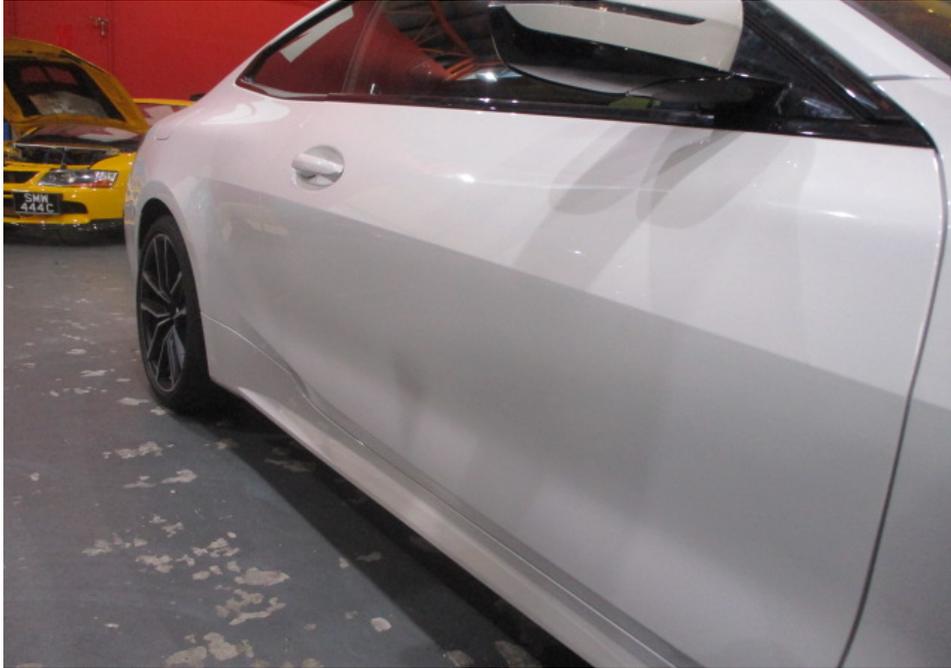
Photo 8 shows a closer view of the Motor Car's front right door and right side rocker panel at the time of my inspection. The body parts at the right side centre portion of the Motor Car were visually examined and it was observed that the repair/restoration works carried out to the damaged area of the Motor Car (refer to photograph 1 above) were reasonably adequate and in order.

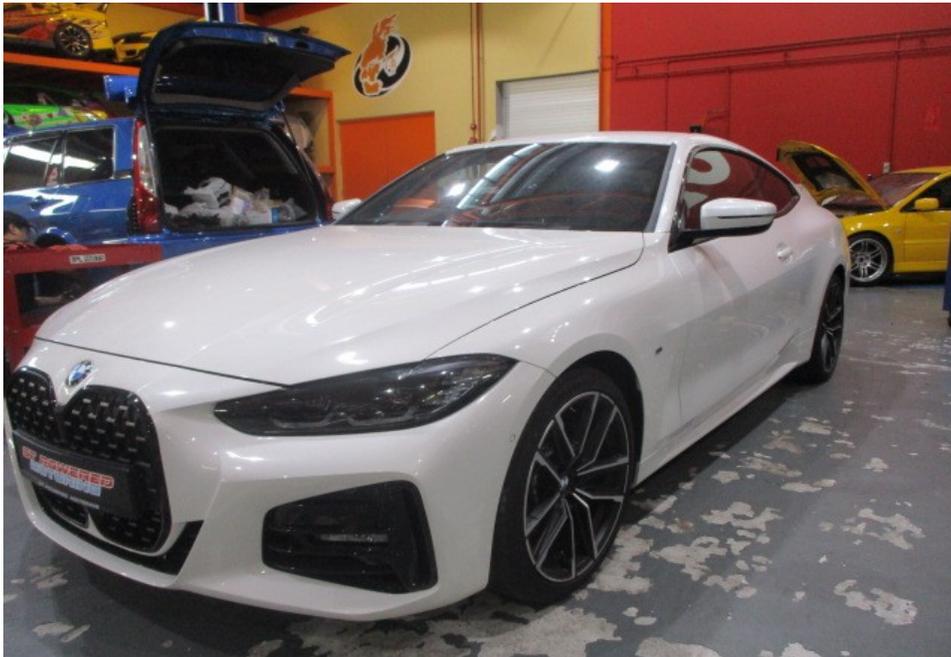
Photo 9 shows a general view of the front left body of the Motor Car at the time of my inspection. The Motor Car was observed to be in a relatively good general condition with no loose exterior fittings observed. The body parts at the frontal portion of the Motor Car were visually examined and it was observed that the repair/restoration works carried out to the damaged area of the Motor Car (refer to photograph 3 above) were reasonably adequate and in order.

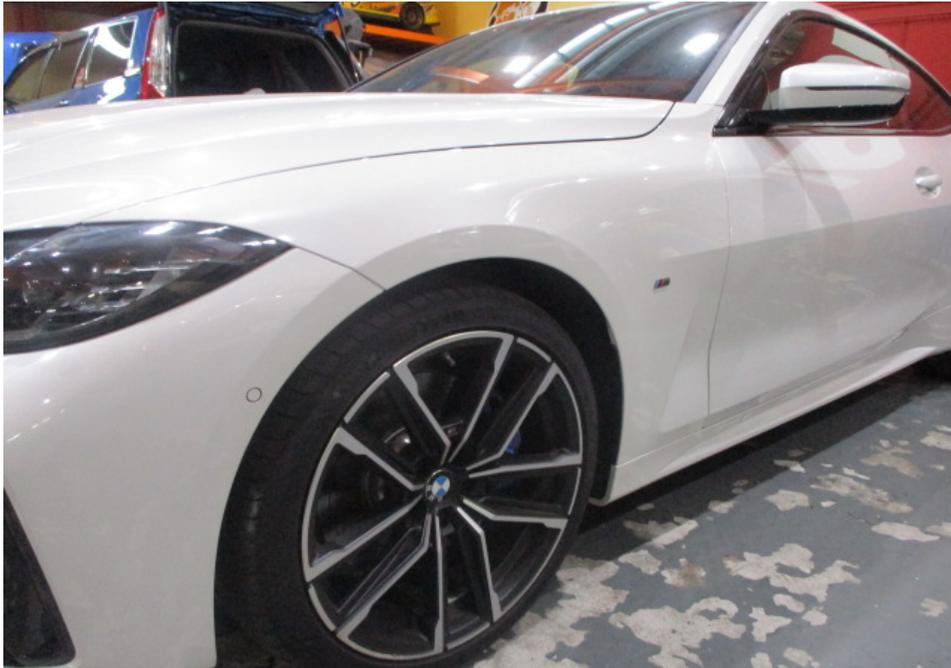
Photo 10 shows a closer view of the Motor Car's front bonnet, front left fender and front left wheel rim at the time of my inspection. The body parts at the frontal portion of the Motor Car were visually examined and it was observed that the repair/restoration works carried out to the damaged area of the Motor Car (refer to photograph 3 above) were reasonably adequate and in order.

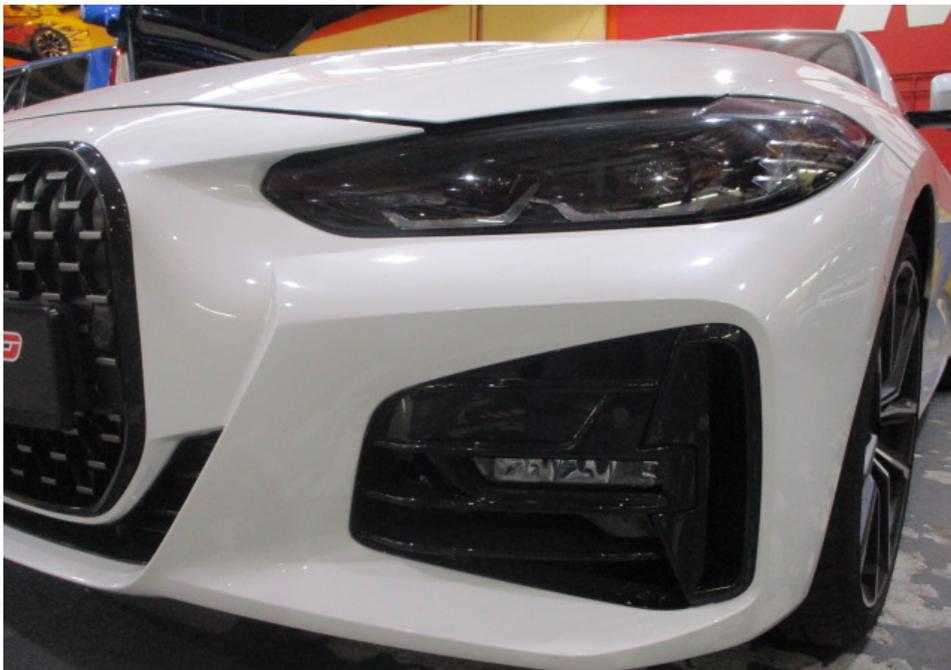
Photo 11 shows a closer view of the Motor Car's front bumper, front bumper left lower grille, front left day light and front left headlamp at the time of my inspection. The body parts at the frontal portion of the Motor Car were visually examined and it was observed that the repair/restoration works carried out to the damaged area of the Motor Car (refer to photograph 3 above) were reasonably adequate and in order.

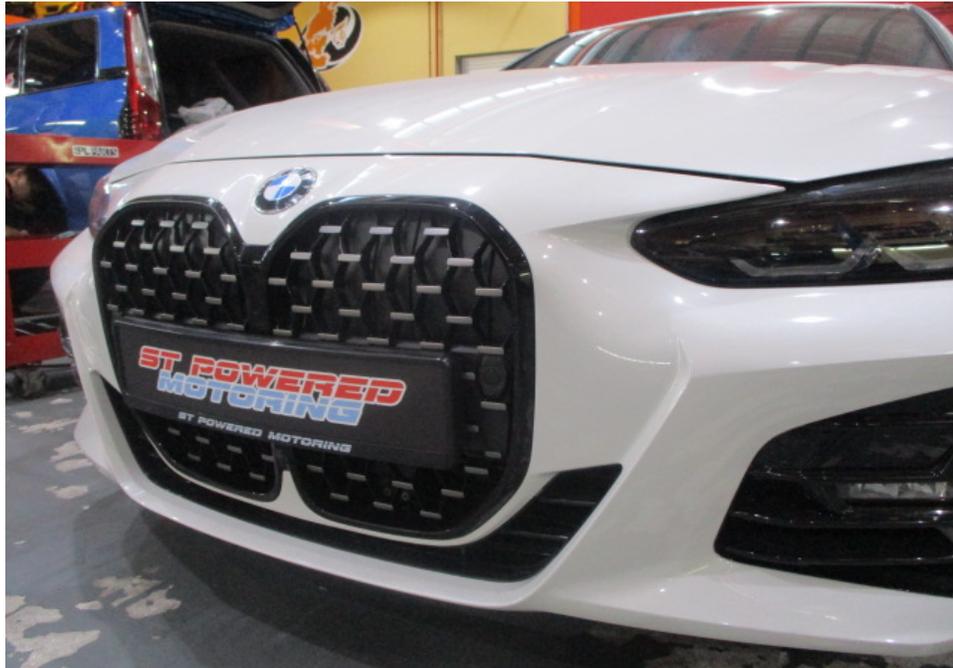
Photo 12 shows a closer view of the Motor Car's front bumper, front bumper centre lower grille and radiator grilles at the time of my inspection. The body parts at the frontal portion of the Motor Car were visually examined and it was observed that the repair/restoration works carried out to the damaged area of the Motor Car (refer to photograph 3 above) were reasonably adequate and in order.

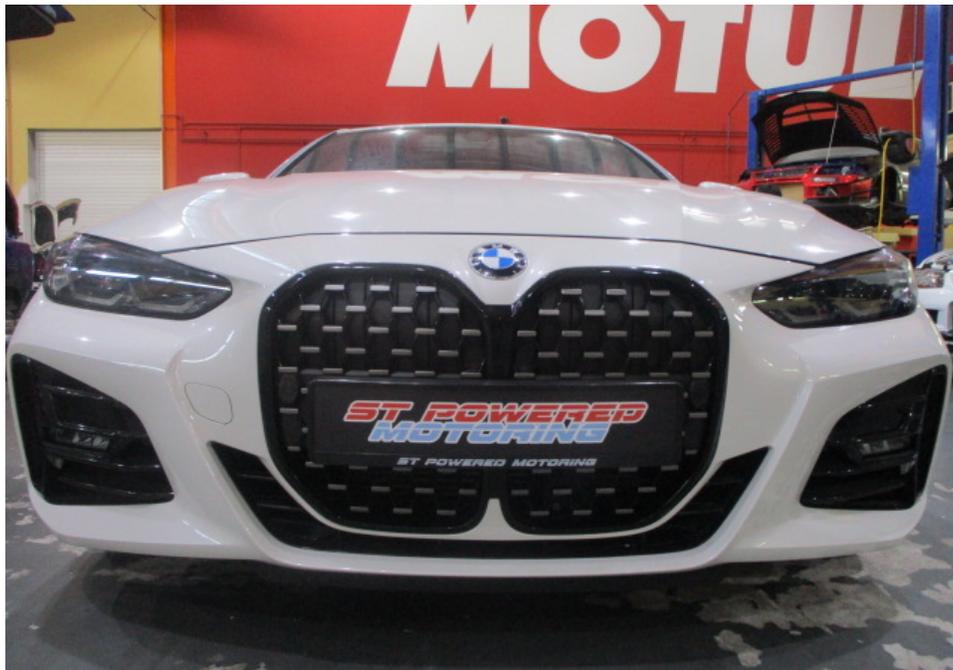
Photo 13 shows a closer view of the Motor Car's frontal portion at the time of my inspection. The body parts at the frontal portion of the Motor Car were visually examined and it was observed that the repair/restoration works carried out to the damaged area of the Motor Car (refer to photograph 1 & 3 above) were reasonably adequate and in order.

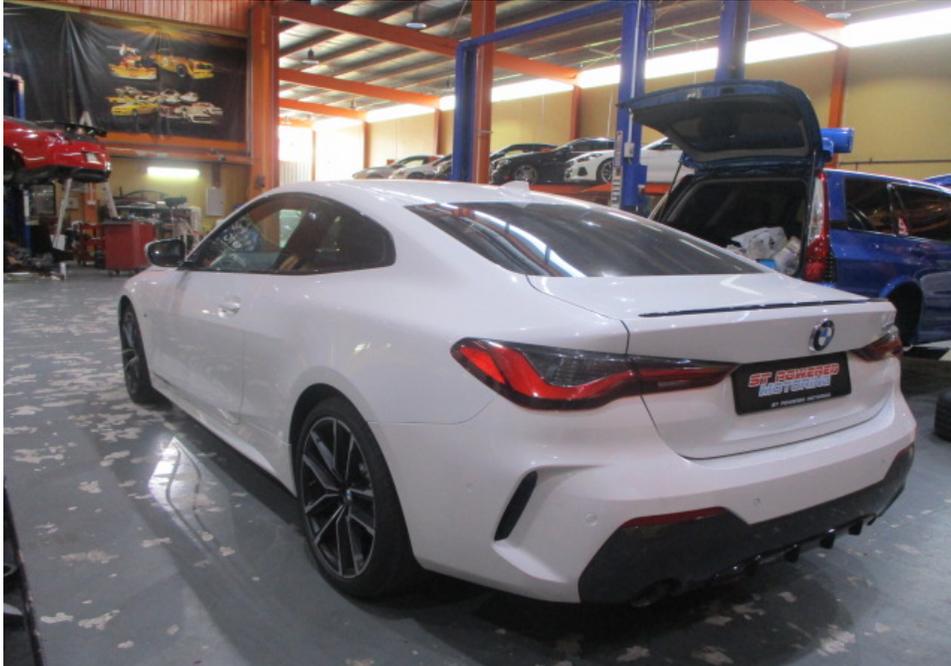
Photo 14 shows a general view of the rear left body of the Motor Car at the time of my inspection. The Motor Car was observed to be in a relatively good general condition with no loose exterior fittings observed. The mileage of the Motor Car recorded at the time of my inspection was 911km.

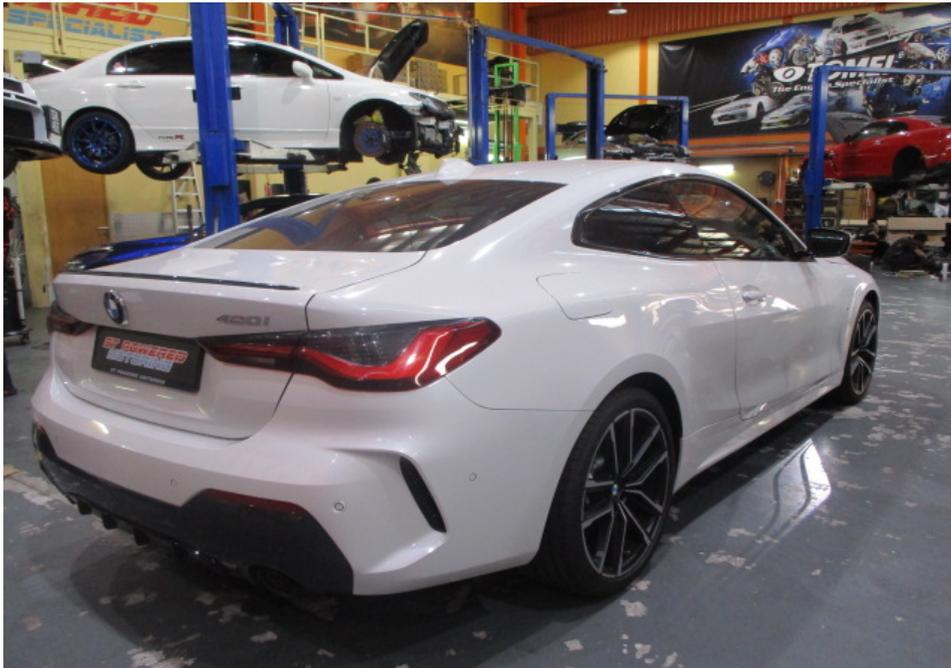
Photo 15 shows a general view of the rear right body of the Motor Car at the time of my inspection. The Motor Car was observed to be in a relatively good general condition with no loose exterior fittings observed. The mileage of the Motor Car recorded at the time of my inspection was 911km.

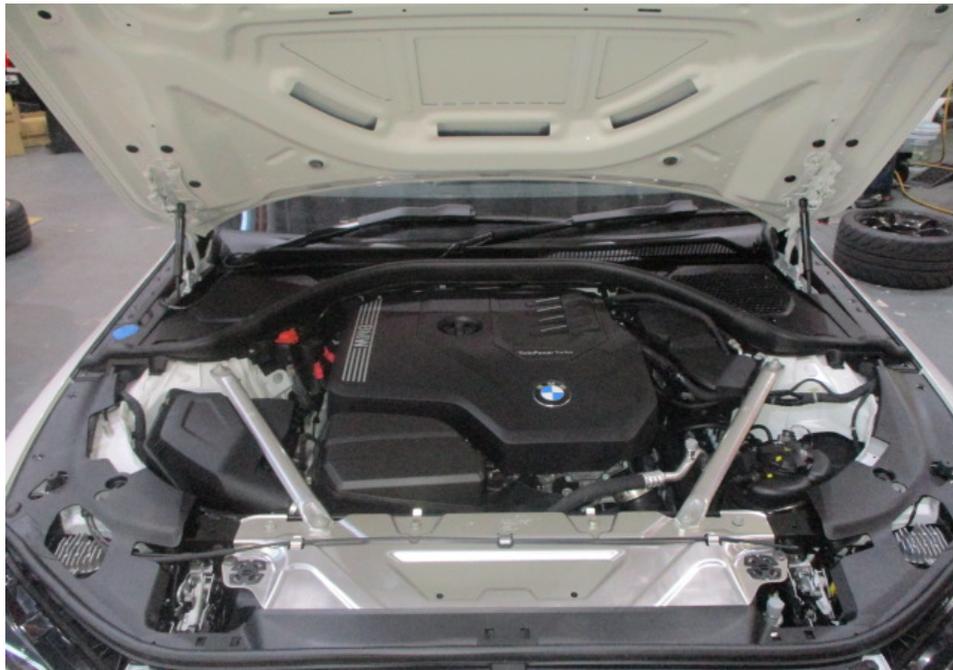
Photo 17 shows a general view of the engine compartment of the Motor Car at the time of my inspection. The various parts and components inside the engine compartment were all observed to be intact and properly fitted. There was also no sign(s) or indication(s) of fluid leak and/or fluid stain found inside the engine compartment.

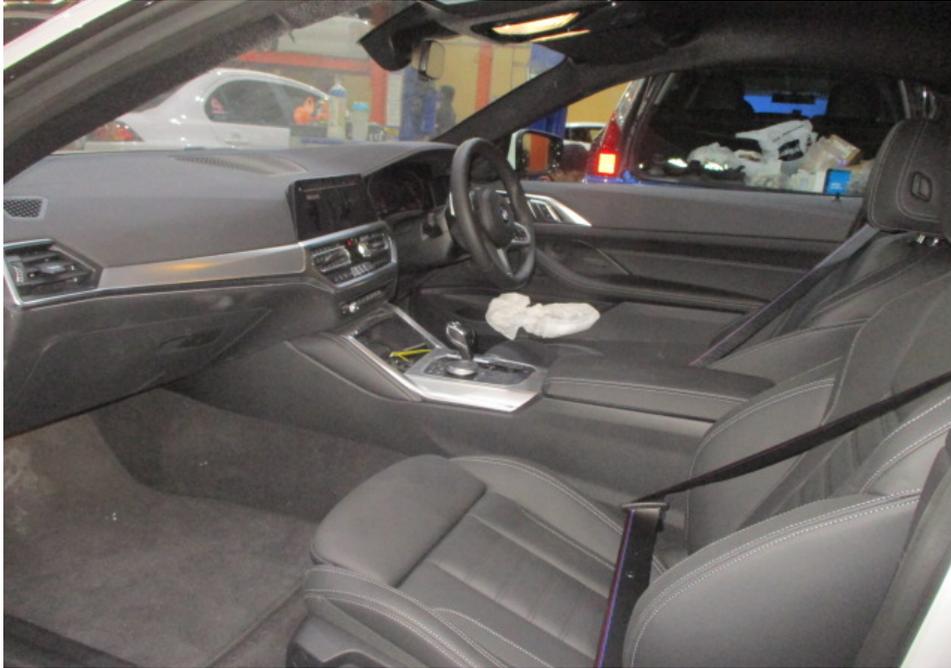
Photo 18 shows the interior compartment of the Motor Car at the time of my inspection. The various parts and components, trims, carpet, and upholstery inside the interior compartment were all observed to be intact and properly fitted.

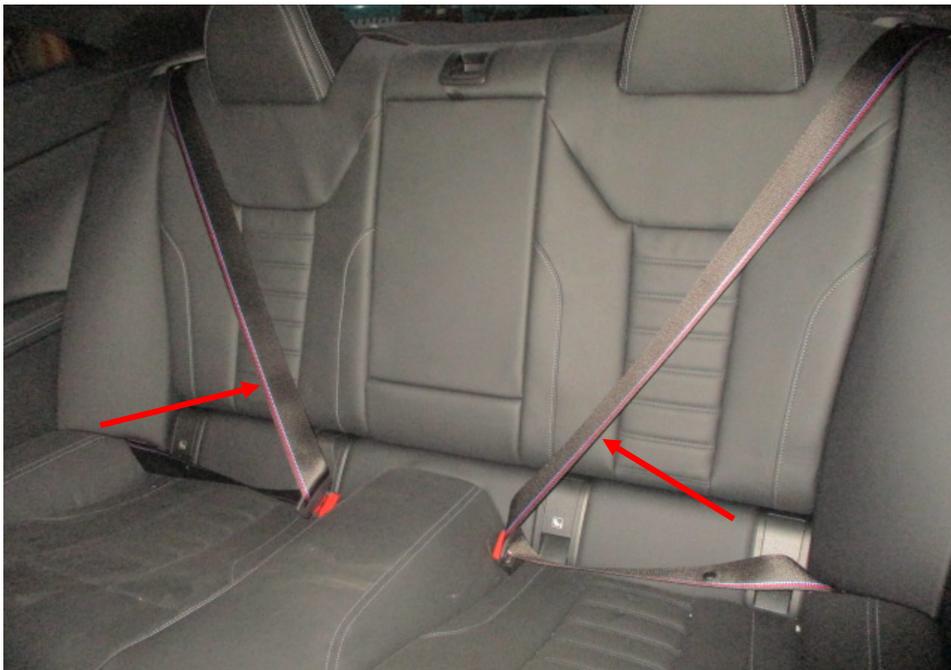
Photo 19 shows the rear seats of the Motor Car. All the seats of the Motor Car were secured via seat rails to the floorboard. They were also fitted with a retractable seat belt reel and a pre-tensioner. The seat belts (arrowed) were tested and were able to be fastened into the respective pre-tensions that were fitted on the side of each individual seat.

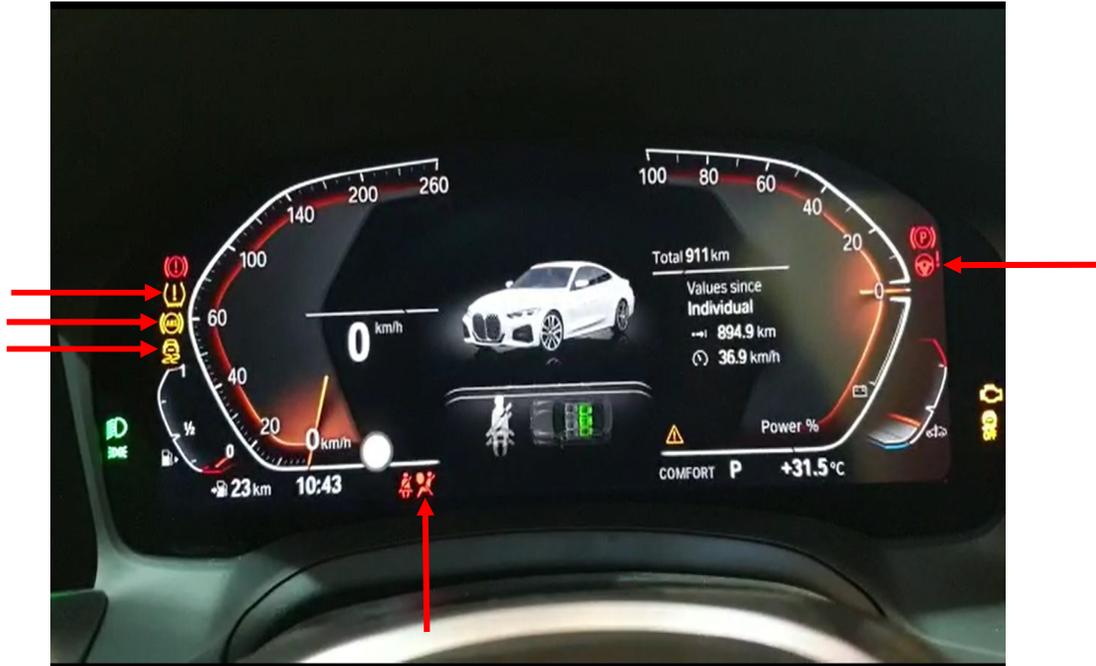
Photo 20 shows the warning lights for the various electronic safety features appearing on the instrument panel of the Motor Car during its self-test when the engine is cranked, in particular the ABS, SRS, IAS, TPM and DSC lights (arrowed).

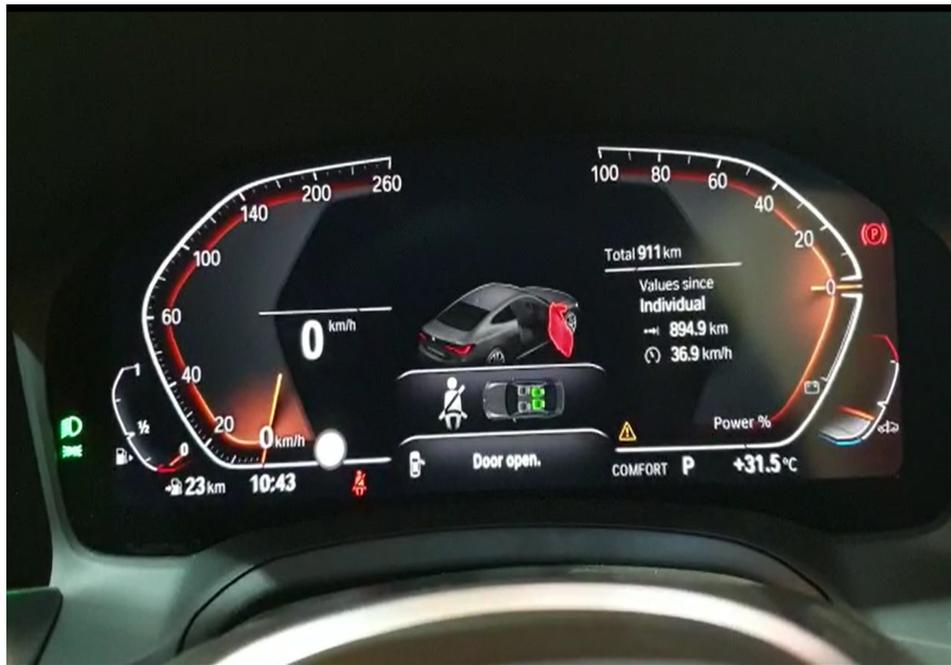
Photo 21 shows the respective warning lights no longer illuminated, indicating that there is no fault detected to the ABS, SRS, IAS, TPM and DSC systems of the Motor Car during the self-test. These electronic systems were hence in working condition at the time of my inspection.

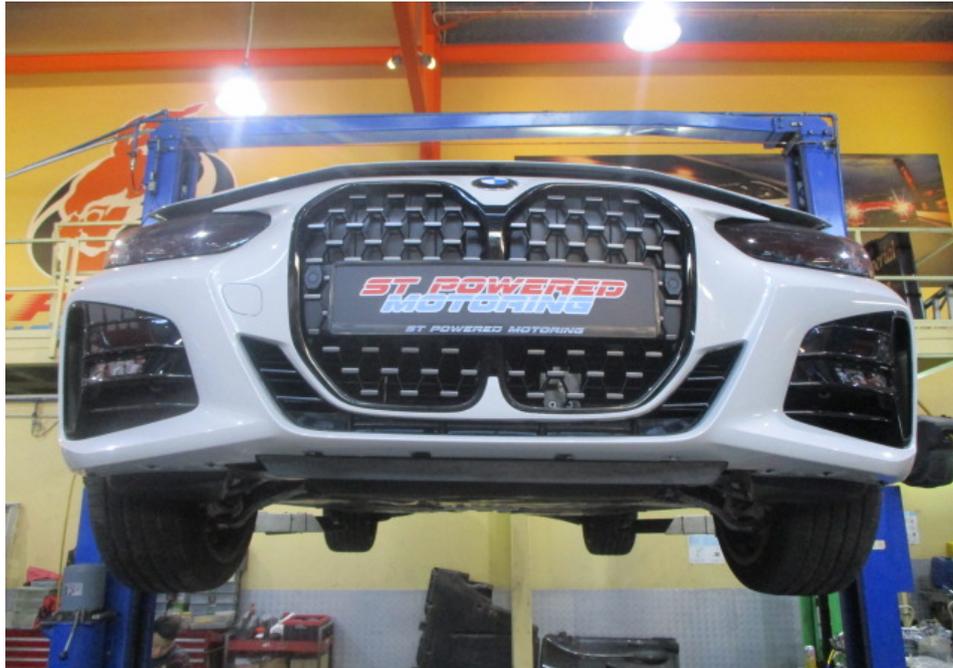
Photo 22 shows the Motor Car hoisted up for checks on its undercarriage. There was no sign(s) or indication(s) of fluid leakage and/or fluid stain(s) on the underside of the Motor Car. The undercarriage components of the Motor Car were also all observed to be intact and secured in an appropriate manner.

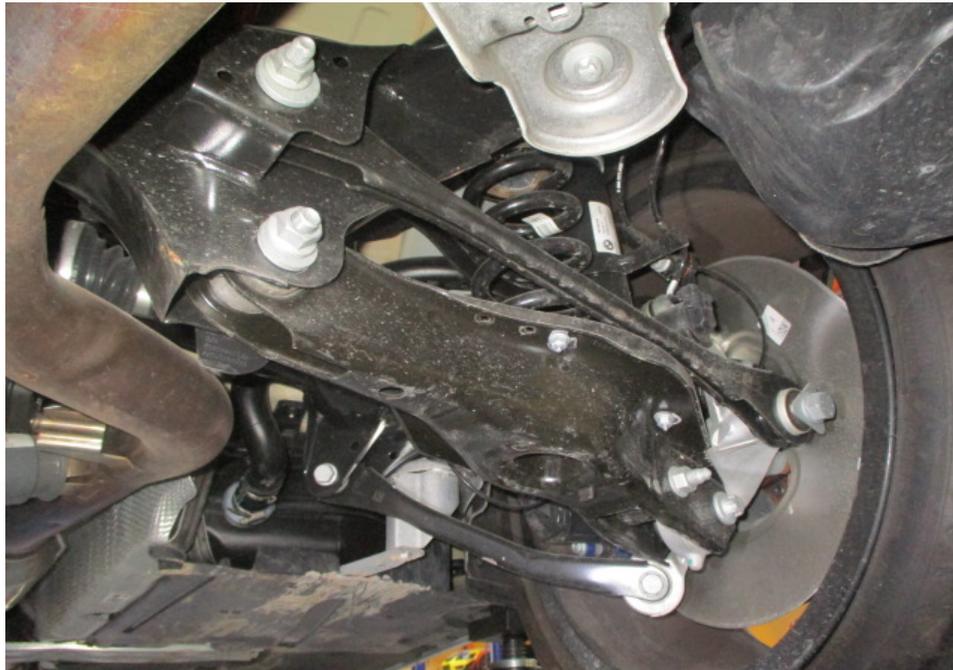
Photo 23 shows a general view of the control arms and linkages at the rear right wheel of the Motor Car. I did not observe any fluid leak and/or fluid stain on the underside of the Motor Car. All of the Motor Car's undercarriage components were observed to be intact and secured in an appropriate manner.

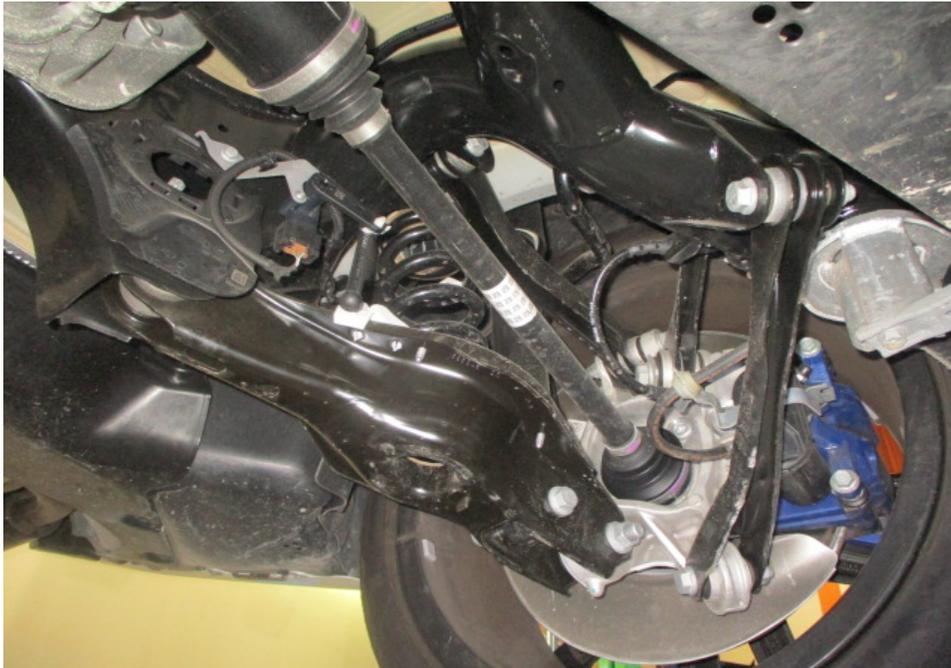
Photo 24 shows a general view of the control arms and linkages at the rear left wheel of the Motor Car. I did not observe any fluid leak and/or fluid stain on the underside of the Motor Car. All of the Motor Car's undercarriage components were observed to be intact and secured in an appropriate manner.

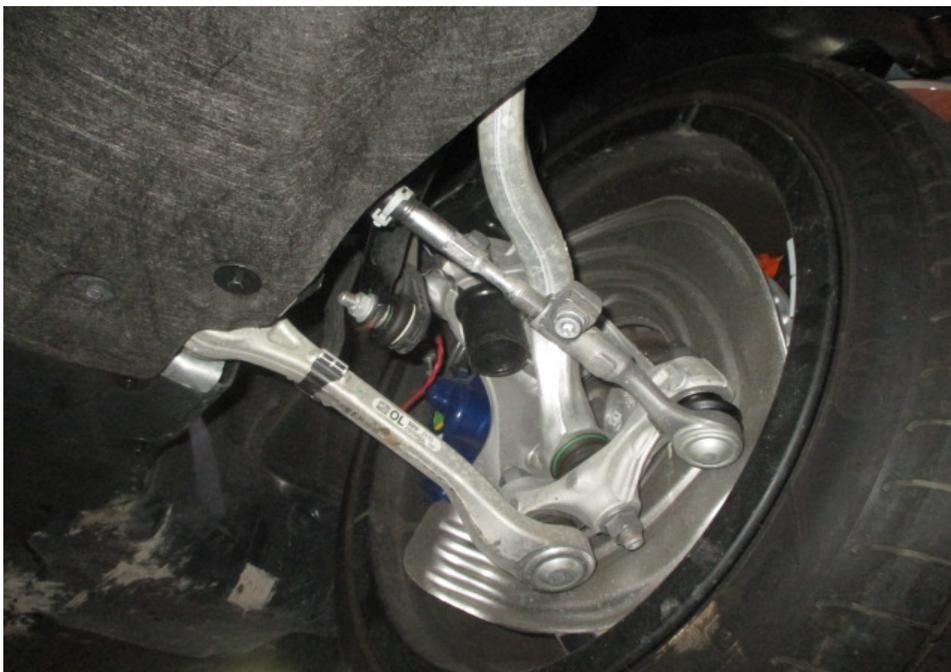
Photo 25 shows the various undercarriage components at the front left wheel of the Motor Car. The mechanical components, control arms and linkages were all found to be intact and secured in an appropriate manner.

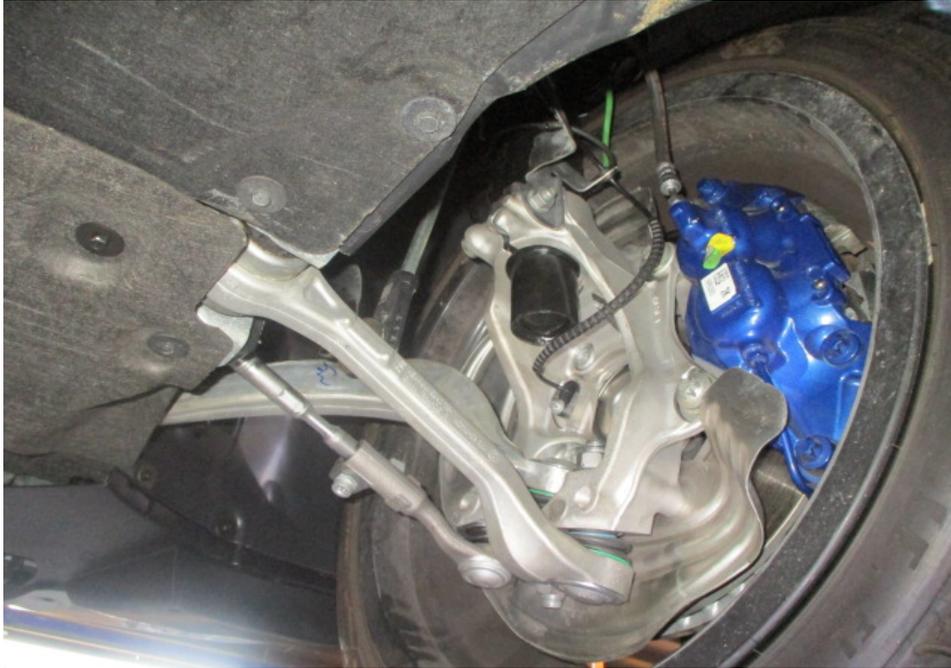
Photo 26 shows the various undercarriage components at the front right wheel of the Motor Car. The mechanical components, control arms and linkages were all found to be intact and secured in an appropriate manner. I also did not observe any fluid leak and/or fluid stain on the underside of the Motor Car.

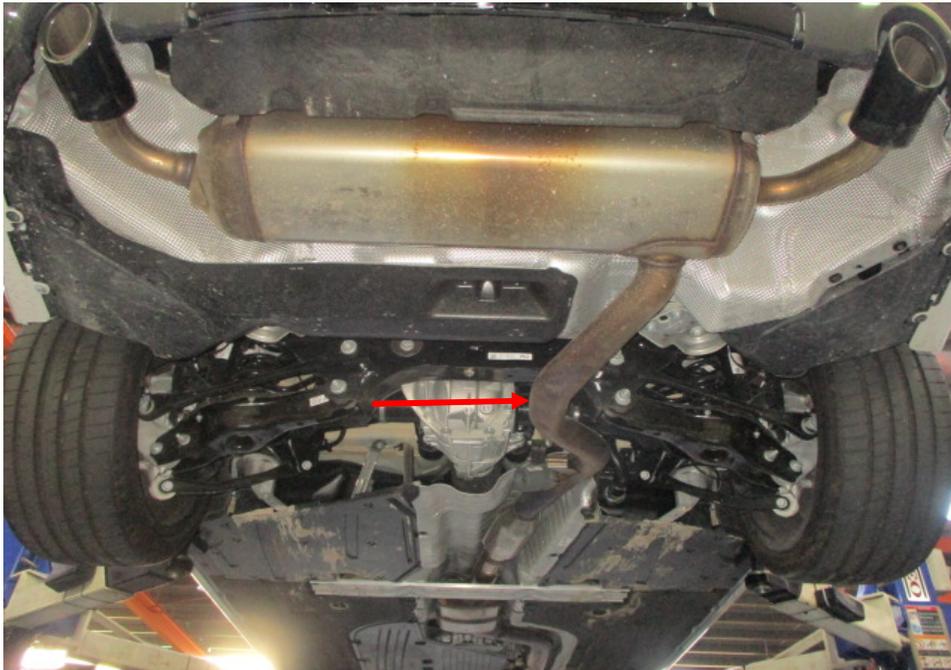
Photo 27 shows the rear section of the Motor Car's exhaust system. My examination of the Motor Car's exhaust system revealed no sign(s) or indication(s) of any cut or weld marks along its exhaust pipes (arrowed), on its rear muffler, on its centre resonator boxes and on its catalytic converter.

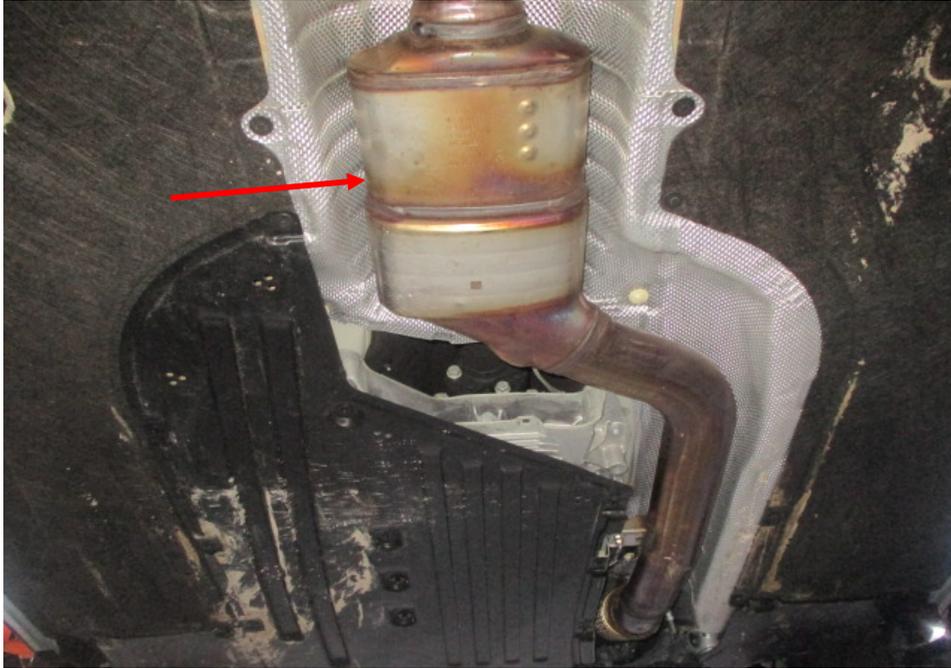
Photo 28 shows the front section of the Motor Car's exhaust system. My examination of the Motor Car's exhaust system revealed no sign(s) or indication(s) of any cut or weld marks along its exhaust pipes, on its rear muffler, on its centre resonator boxes (arrowed) and on its catalytic converter.

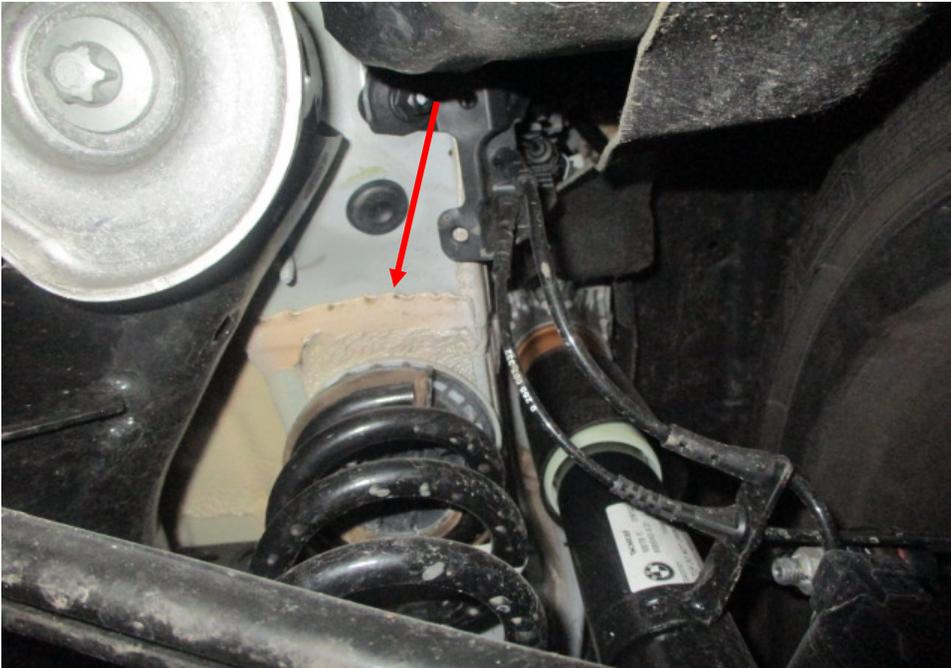
Photo 29 shows the chassis/structural body at the underside rear right of the Motor Car. I did not find any weld marks other than original spot weld marks on the chassis/structural body of the Motor Car. The original factory sealant (arrowed) at the joints along the chassis/structural body was untouched, indicating no work was done on the chassis/structural body of the Motor Car and that the chassis/structural body was originally fitted.

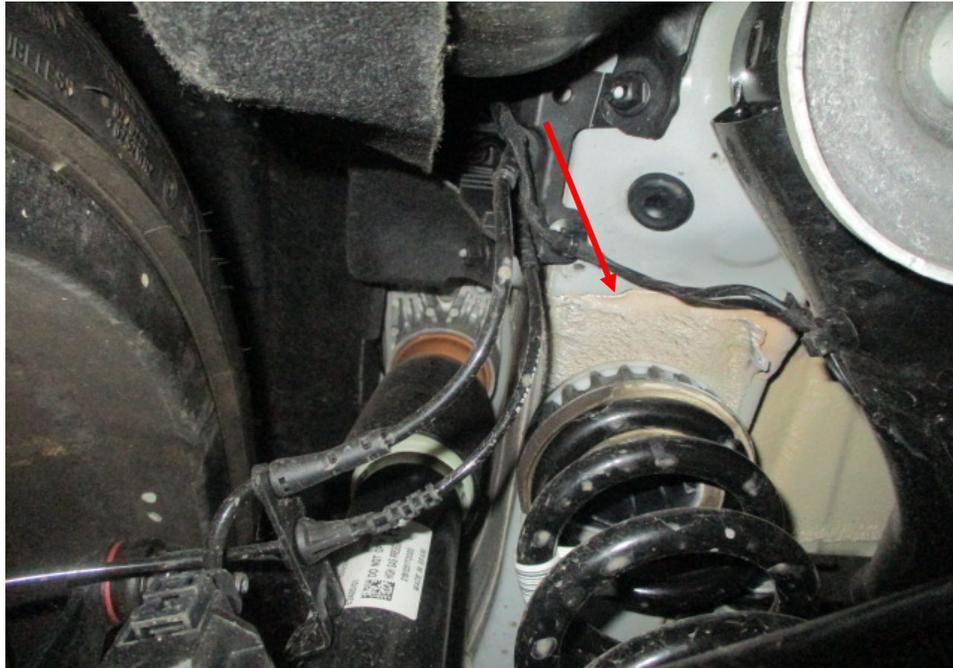
Photo 30 shows the chassis/structural body at the underside rear left of the Motor Car. The original factory sealant (arrowed) at the joints along the chassis/structural body was observed to be untouched. In general, I had found no work was carried out on the chassis/structural body of the Motor Car. The chassis/structural body of the Motor Car was originally fitted.

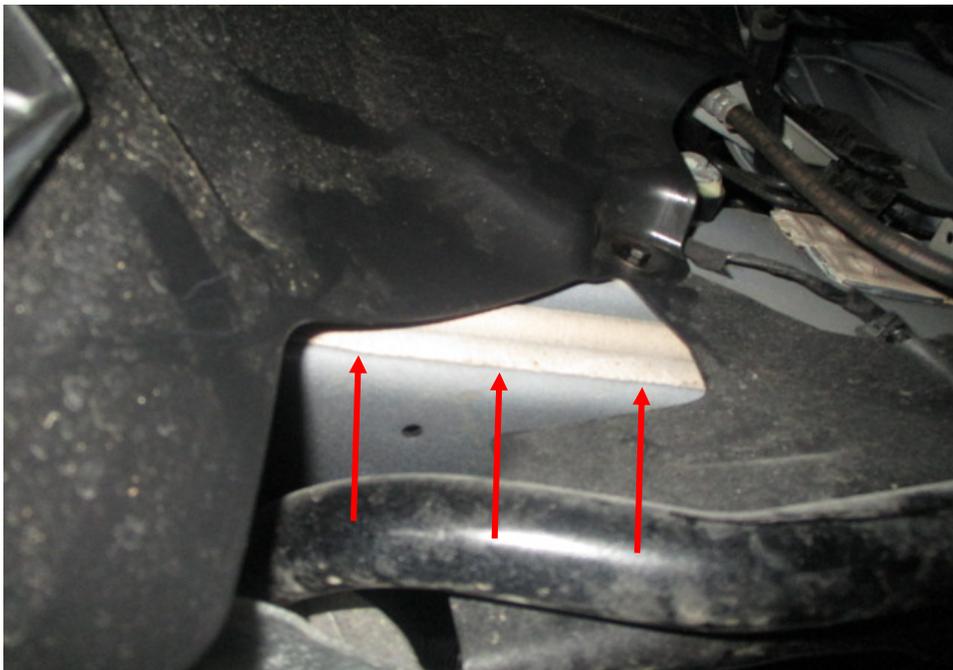
Photo 31 shows the chassis/structural body at the underside front left of the Motor Car. I did not find any weld marks other than original spot weld marks on the chassis/structural body of the Motor Car. The original factory sealant (arrowed) at the joints along the chassis/structural body was untouched, indicating no work was done on the chassis/structural body of the Motor Car and that the chassis/structural body was originally fitted.
