Your Ref: BMW 420i Coupe
(chassis number WBA12AP040CH50994)
Our Ref : CI/TP22005190/D

INSPECTION REPORT OF AN UNREGISTERED BMW 420i COUPE MOTOR CAR WITH CHASSIS NUMBER WBA12AP040CH50994

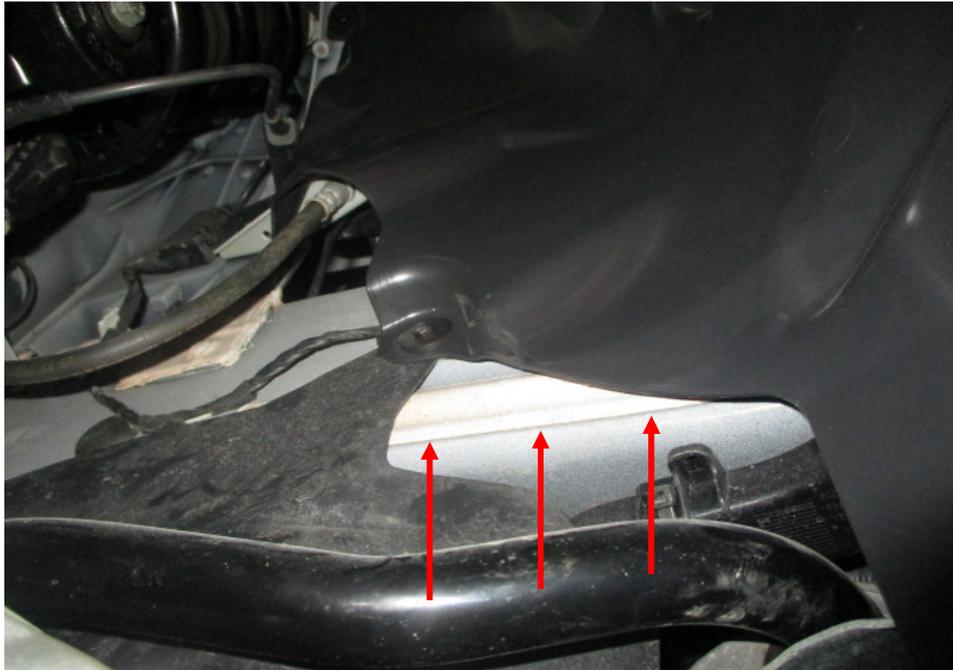
Photo 32 shows the chassis/structural body at the underside front right of the Motor Car. The original factory sealant (arrowed) at the joints along the chassis/structural body was observed to be untouched. In general, I had found no work was carried out on the chassis/structural body of the Motor Car. The chassis/structural body of the Motor Car was originally fitted.

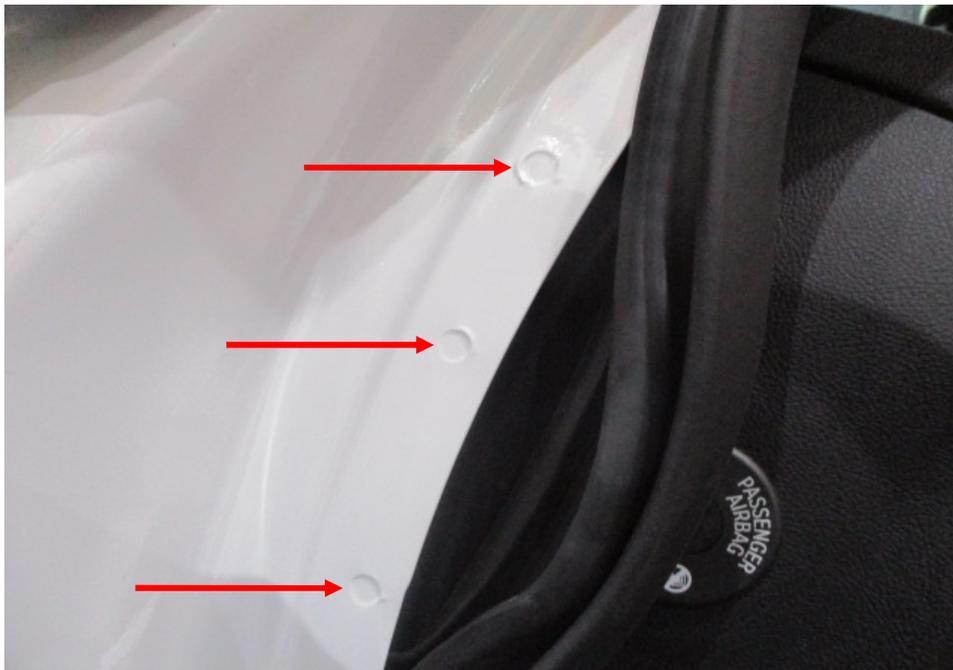
Photo 33 shows the left side "A" pillar of the Motor Car. I did not find any weld marks other than original spot weld marks (arrowed) on the left side "A" pillar of the Motor Car which, indicates that there was no re-welding works carried out. In general, I had found all the non-detachable body panels of the Motor Car to be originally fitted at the time of my inspection, except for the rear left body panel.

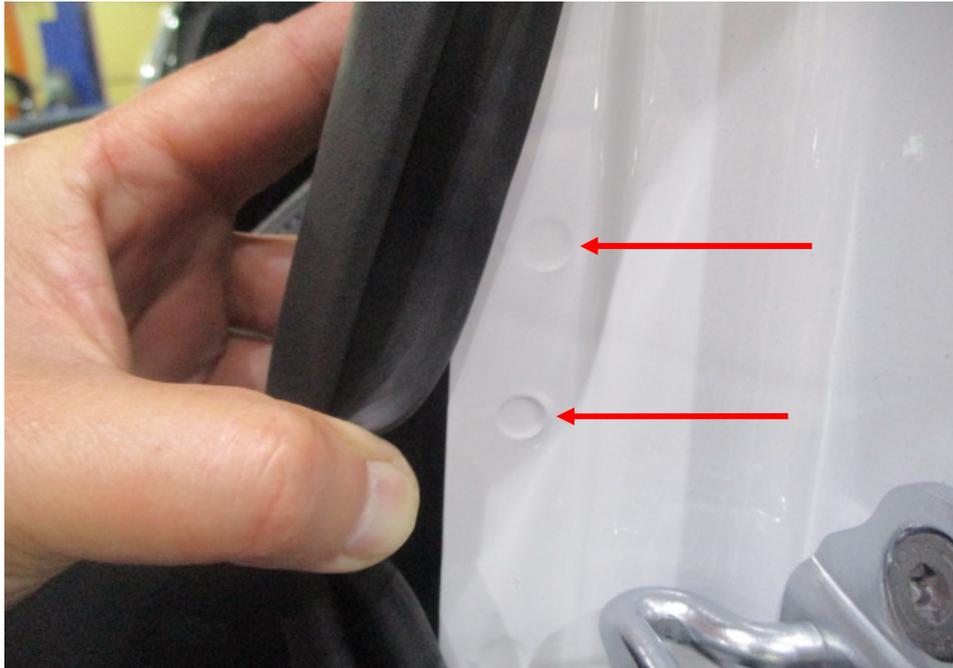
Photo 34 shows the rear left body panel of the Motor Car. I did not find any weld marks other than original spot weld marks (arrowed) on the rear left body panel of the Motor Car, which indicates that there was no re-welding works carried out. In general, I had found all the non-detachable body panels of the Motor Car to be originally fitted at the time of my inspection, except for the rear left body panel.

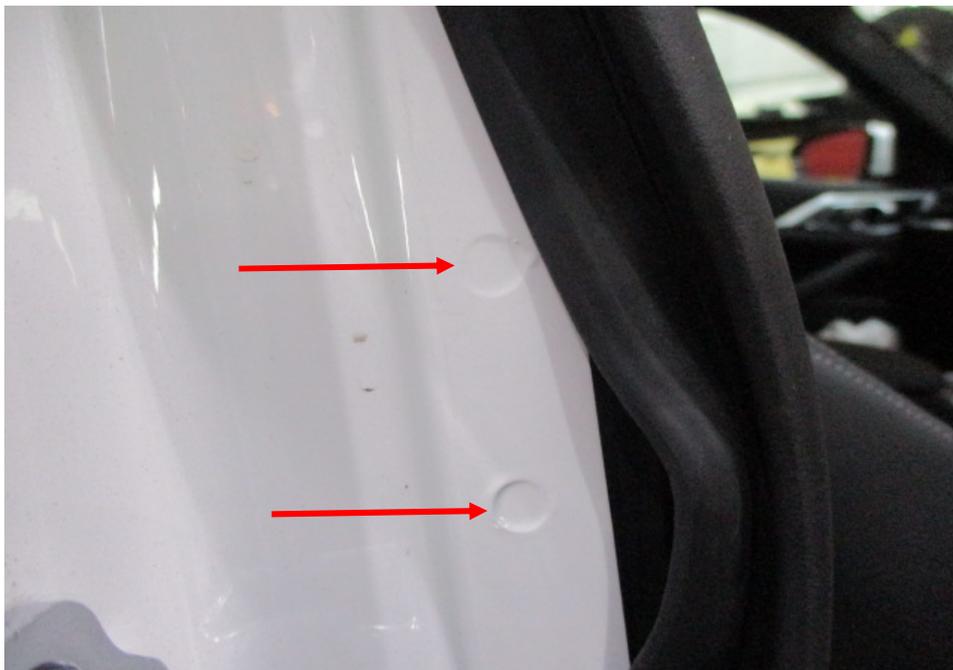
Photo 35 shows the rear right body panel of the Motor Car. I did not find any weld marks other than original spot weld marks (arrowed) on the rear right body panel of the Motor Car, which indicates that there was no re-welding works carried out. In general, I had found all the non-detachable body panels of the Motor Car to be originally fitted at the time of my inspection, except for the rear left body panel.

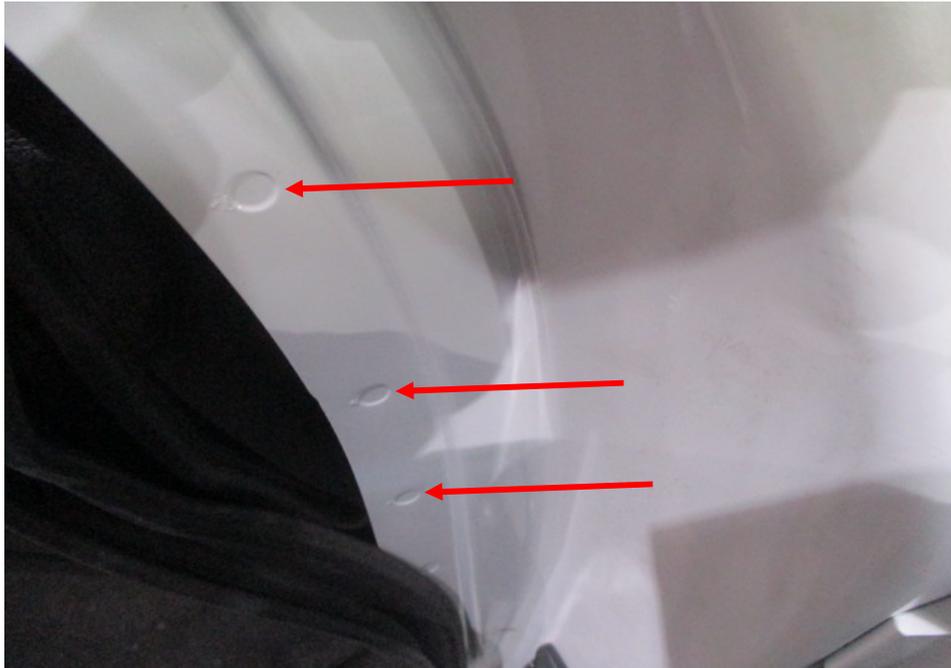
Photo 36 shows the right side "A" pillar of the Motor Car. I did not find any weld marks other than original spot weld marks (arrowed) on the right side "A" pillar of the Motor Car, which indicates that there was no re-welding works carried out. In general, I had found all the non-detachable body panels of the Motor Car to be originally fitted at the time of my inspection, except for the rear left body panel.
