Reference : TY5/TA/10088/3565/TP/04.22

VEHICLE INSPECTION REPORT

Registration No.	;	GBF 3565	L,	Chassis Frame No.	:	JN1SC2F24Z0858935
Make / Model	;	Nissan	Cabstar 3.0 5MT Euro5	Engine No.	:	ZD30013949N
Year of Registration	:	2016		Odometer Reading	:	308,414 KM
Class / Tyne	•	Lorry		Colour	:	Blue

ASSESSMENT SUMMARY

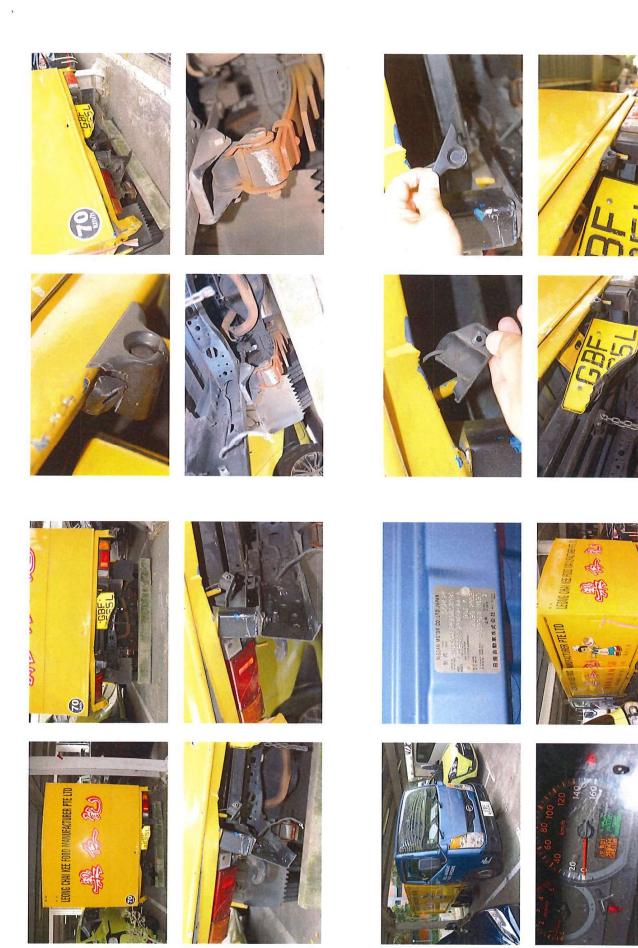
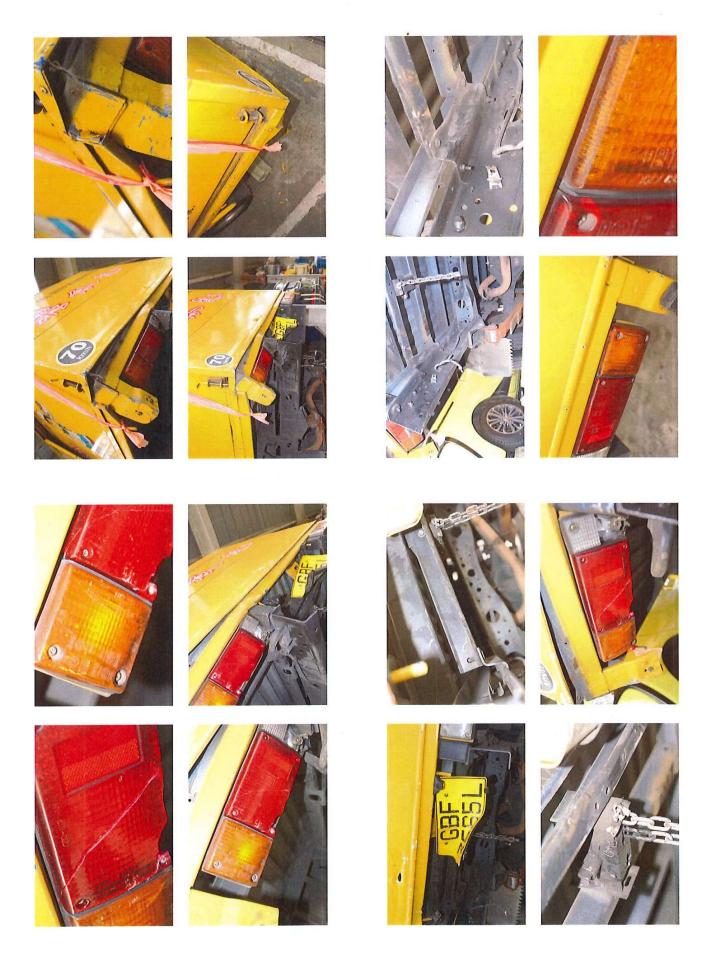
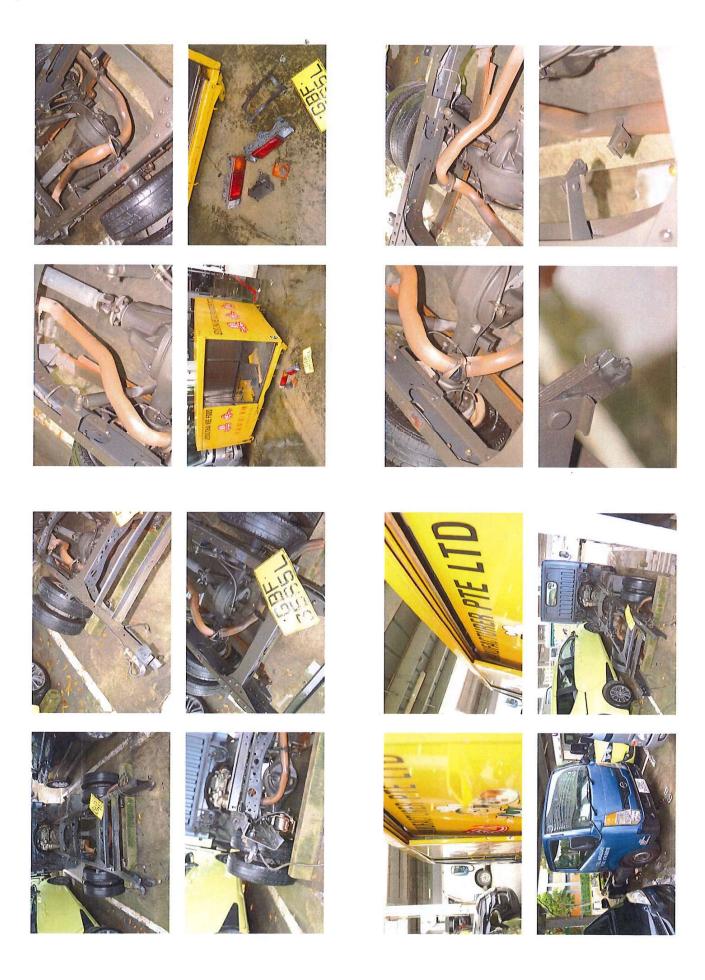
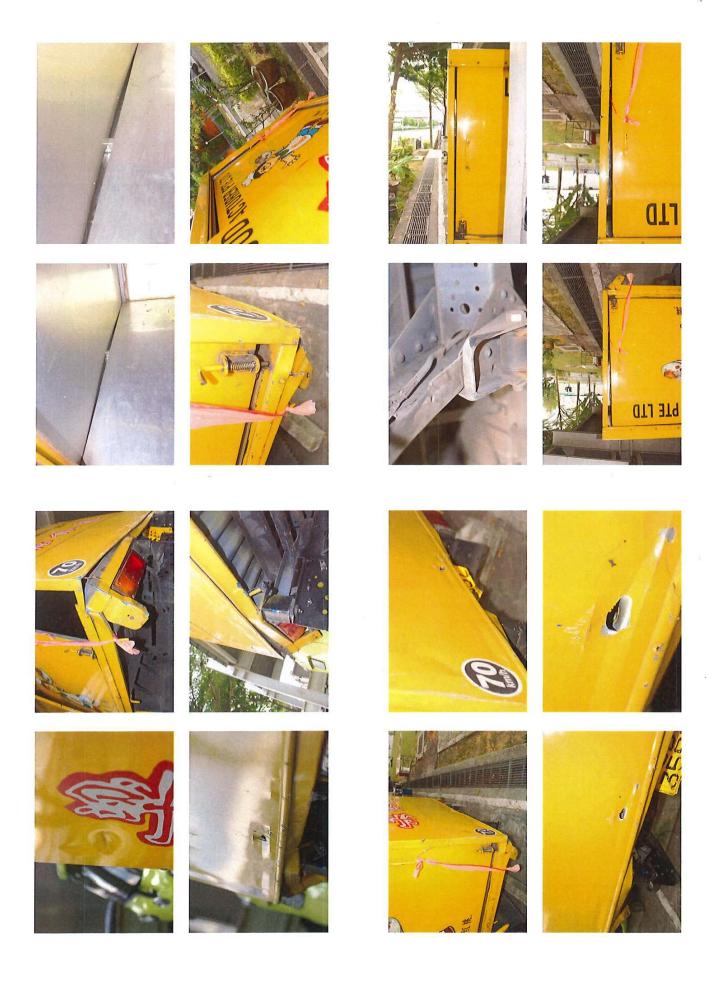
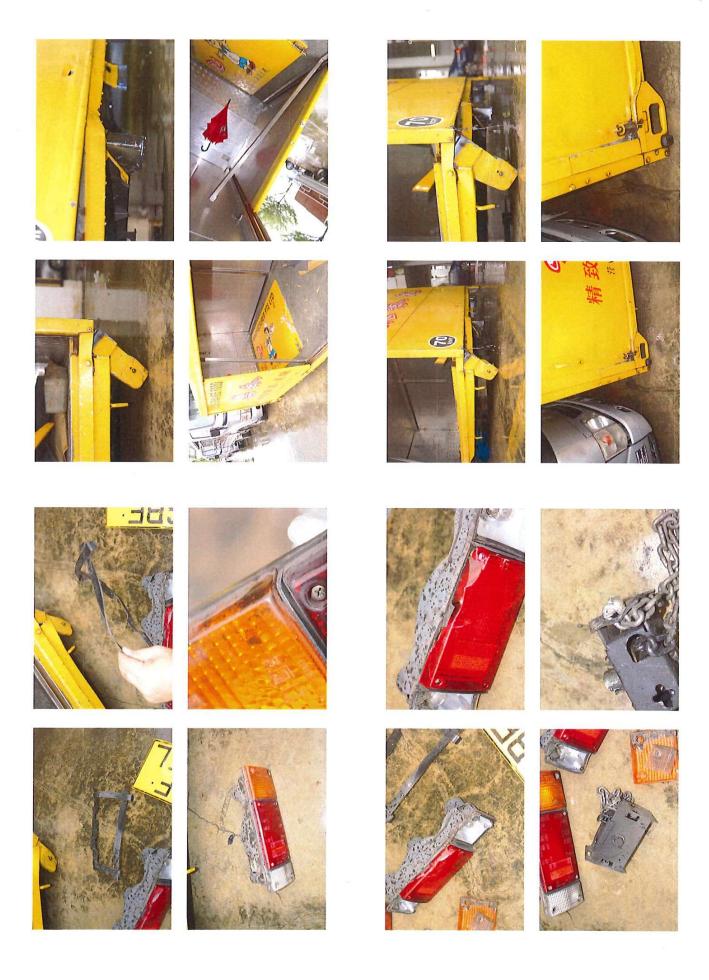
Damages sustained were consistent with the subject vehicle being involved in a collision with another vehicle and the impact of the collision was delivered Squarely to the Rear portion of the vehicle.

Our attached assessment schedule has been checked throughly by us against the actual damages sustained on the vehicle, and we recommend the replacement of parts and repair accordingly. We have adjusted the cost and the repairer has agreed to undertake the repair at the recommended sum to a acceptable quality and standards. We have not given authorization and instruction to the repairer to proceed with the repairs.
