Your Ref: TP/IP/59820/2021
Our Ref : CI/TPD22005244/N

Fatal Accident Investigation Team

INSPECTION REPORT OF MOTORCYCLE FBQ 839J

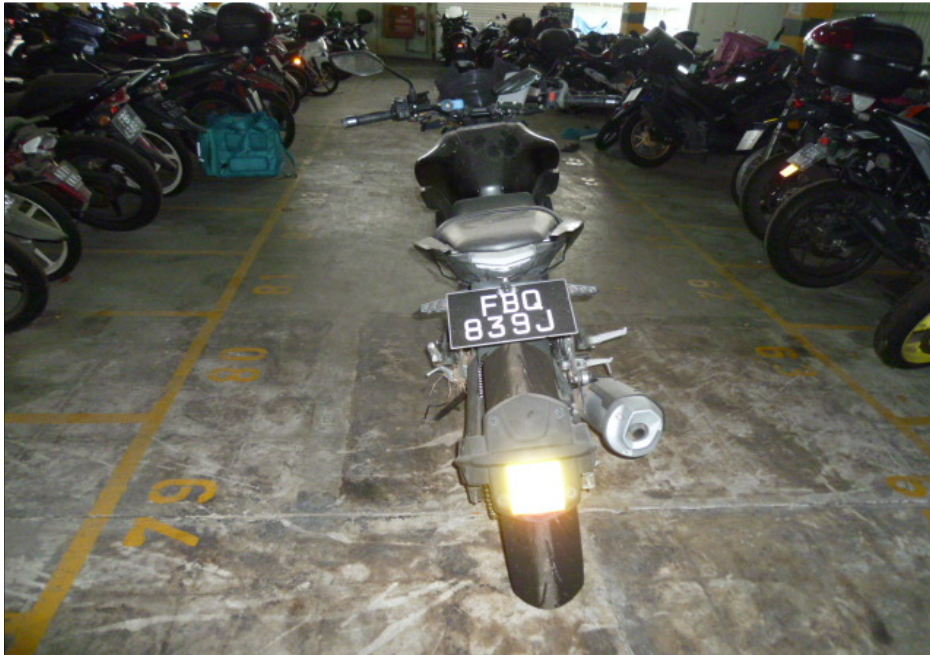
Photo 1 shows a general view of the rear portion of the Motorcycle at the time of our inspection. The Motorcycle was observed to have sustained damages all around.

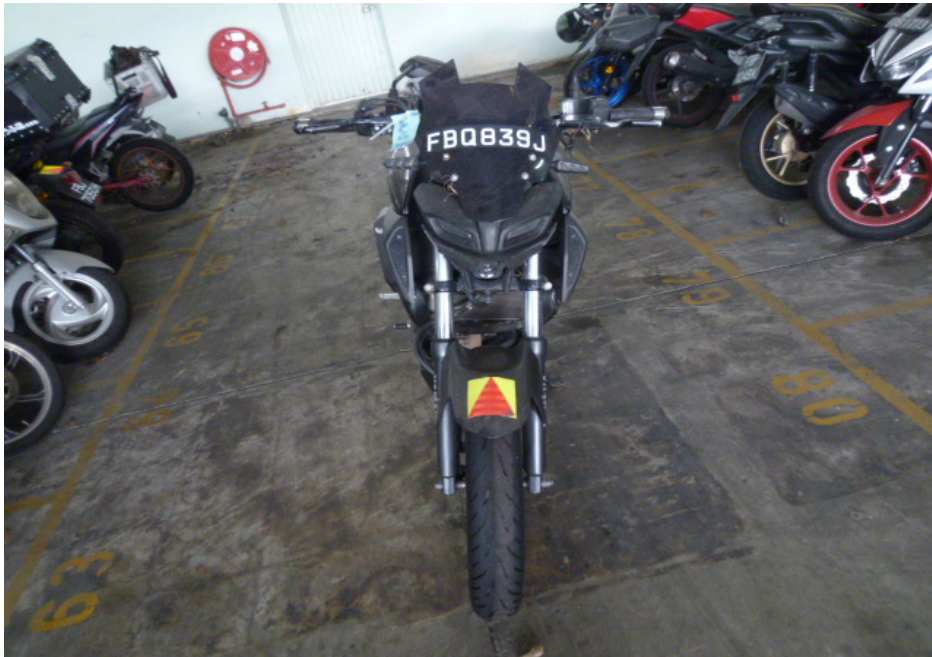
Photo 2 shows a general view of the frontal portion of the Motorcycle at the time of our inspection. The Motorcycle was observed to have sustained damages all around.

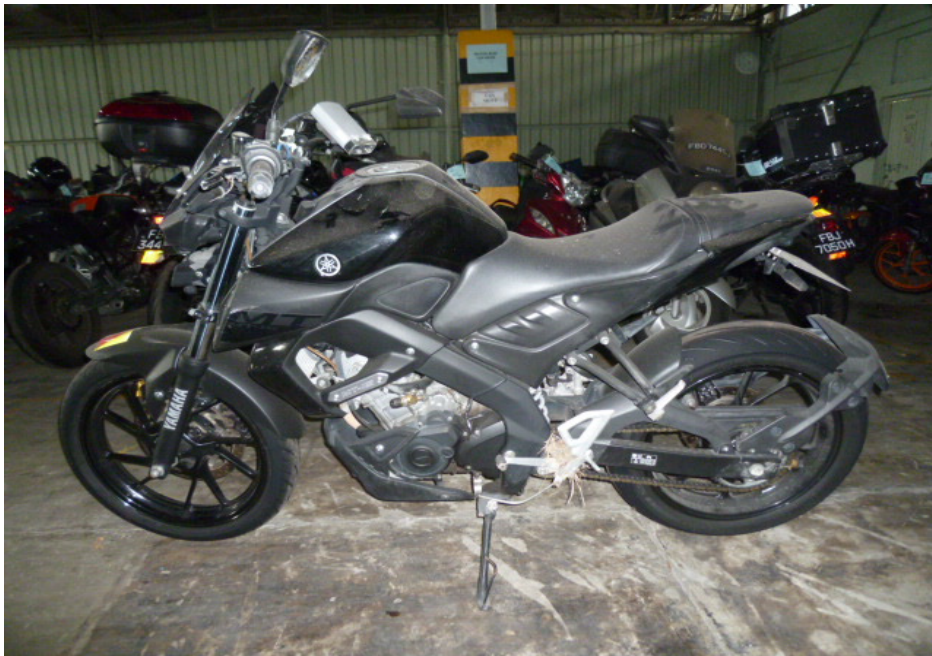
Photo 3 shows a general view of the left body of the Motorcycle at the time of our inspection. The Motorcycle was observed to have sustained damages all around.

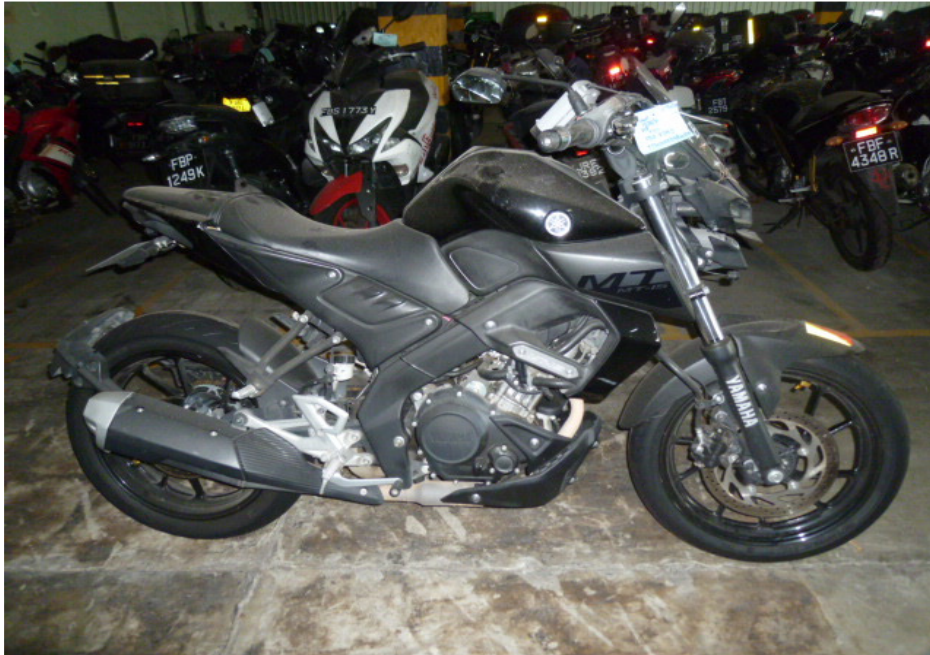
4. The mileage of the Motorcycle could not be recorded at the time of our inspection due to the unavailability of the ignition key.
5. The Motorcycle was observed to have sustained damages all around. The body parts that were found to have been damaged include its head cowling, front mudguard, left cowling, right side mirror, front brake lever, gear shift pedal, right front footrest and rear sprocket nut, amongst others.

Photo 4 shows a general view of the right body of the Motorcycle at the time of our inspection. The Motorcycle was observed to have sustained damages all around. The body parts that were found to have been damaged include its head cowl, front mudguard, left cowl, right side mirror, front brake lever, gear shift pedal, right front footrest and rear sprocket nut, amongst others.

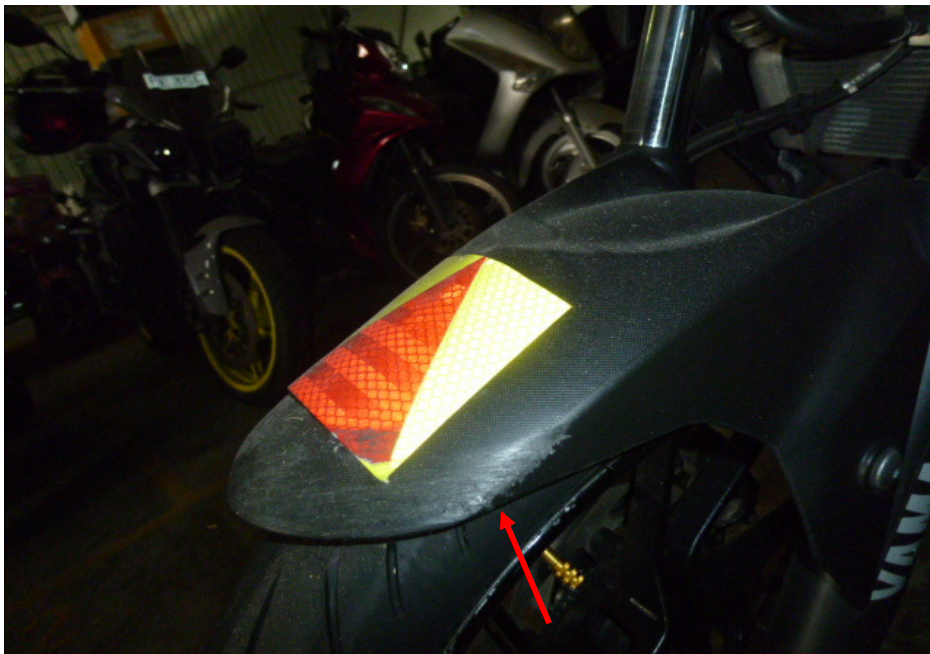
Photo 5 shows a closer view of the front mudguard (arrowed) which was amongst the body parts of the Motorcycle that had sustained damage as a result of the accident.

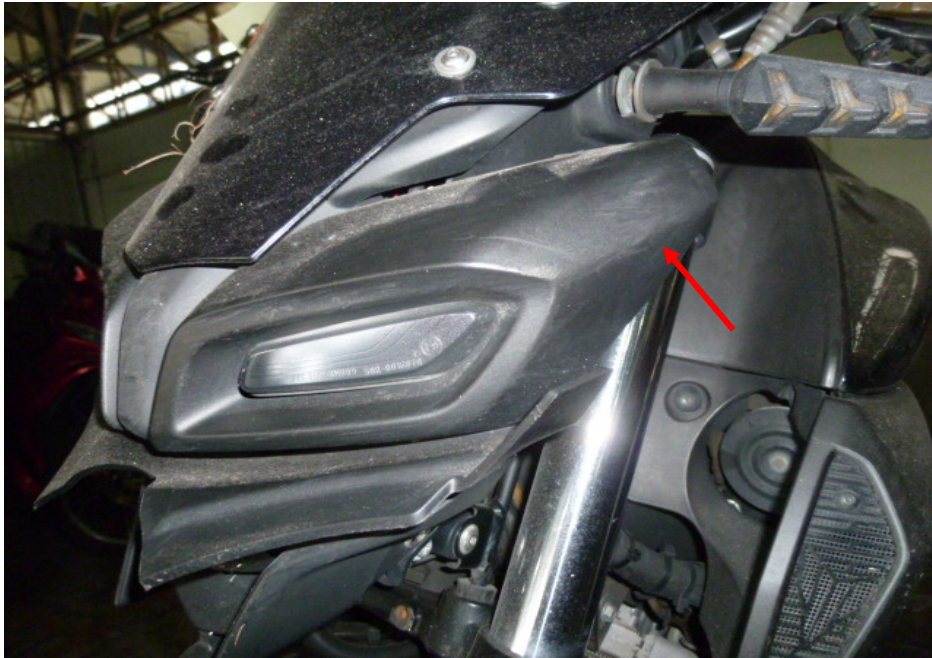
Photo 6 shows the grazed head cowling (arrowed), which was amongst the body parts of the Motorcycle that had sustained damage as a result of the accident.

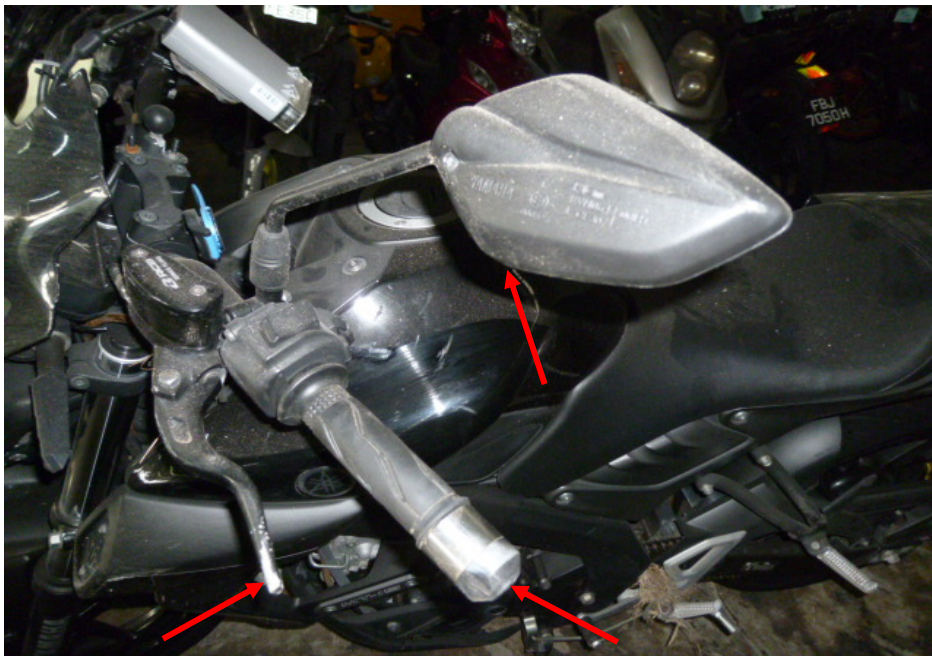
Photo 7 shows the left handlebar end, clutch lever and left side mirror (arrowed), which were amongst the body parts of the Motorcycle that had sustained damage as a result of the accident.

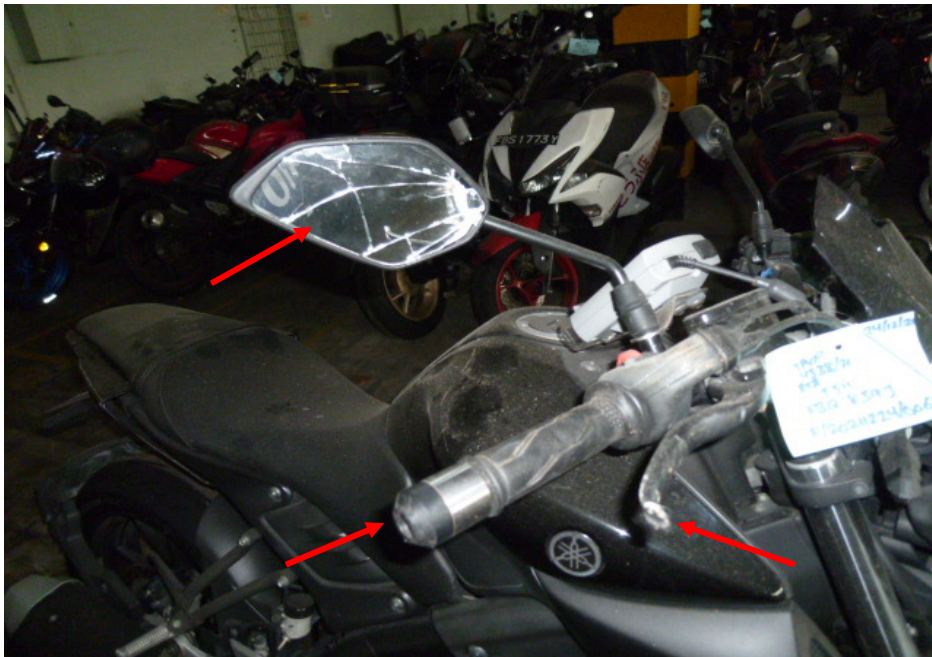
Photo 8 shows the right handlebar end, front brake lever and right side mirror (arrowed), which were amongst the body parts of the Motorcycle that had sustained damage as a result of the accident.

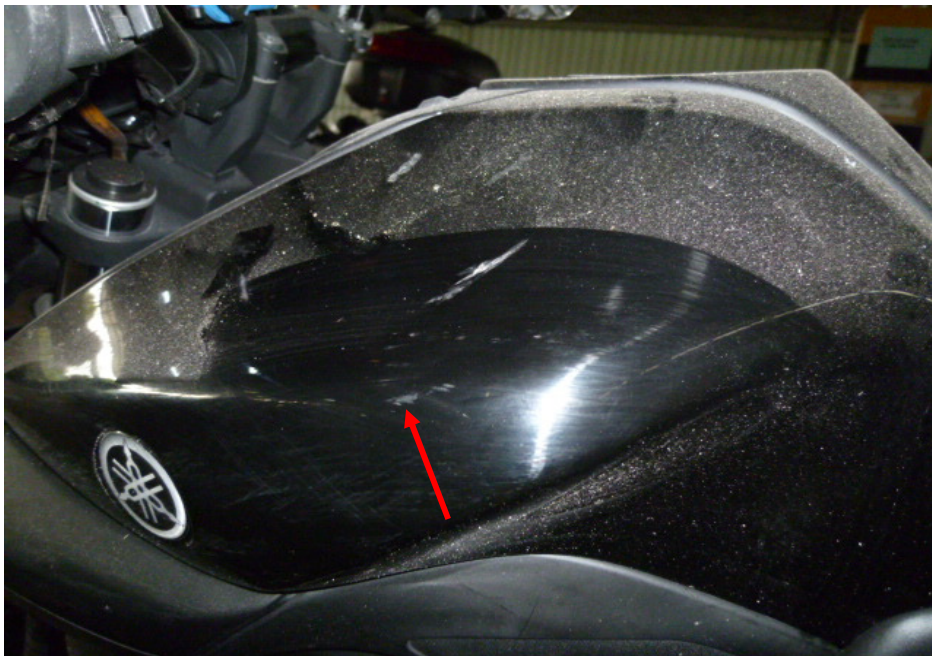
Photo 9 shows a closer view of the petrol tank of the Motorcycle as a result of the accident (arrowed).

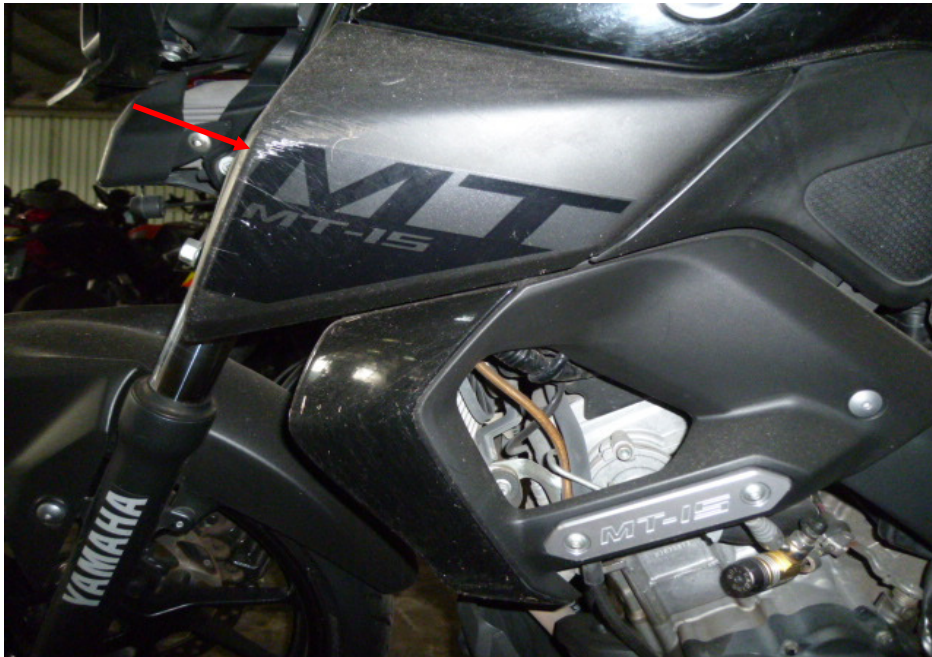
Photo 10 shows a closer view of the grazed left cowling of the Motorcycle as a result of the accident (arrowed).

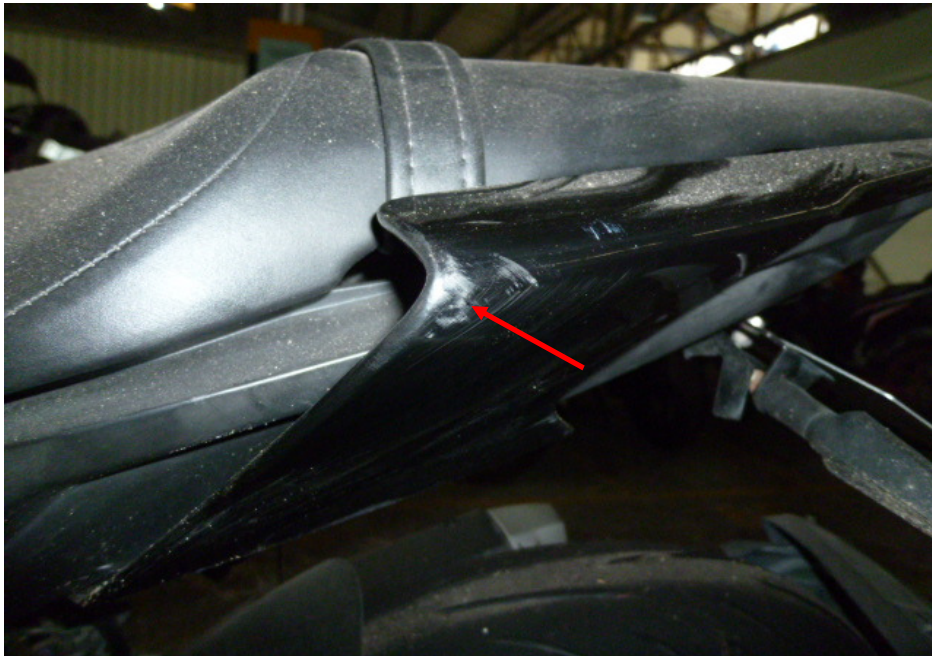
Photo 11 shows a closer view of the grazed left rear side cover of the Motorcycle as a result of the accident (arrowed).

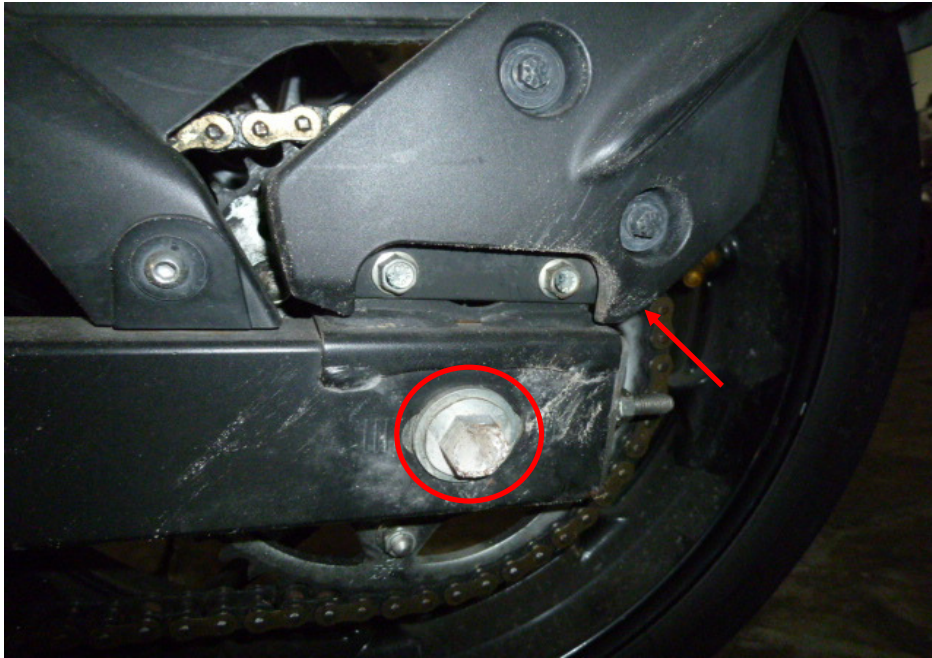
Photo 12 shows a closer view of the grazed rear sprocket nut (circled) and grazed rear wheel splash guard (arrowed) of the Motorcycle as a result of the accident.

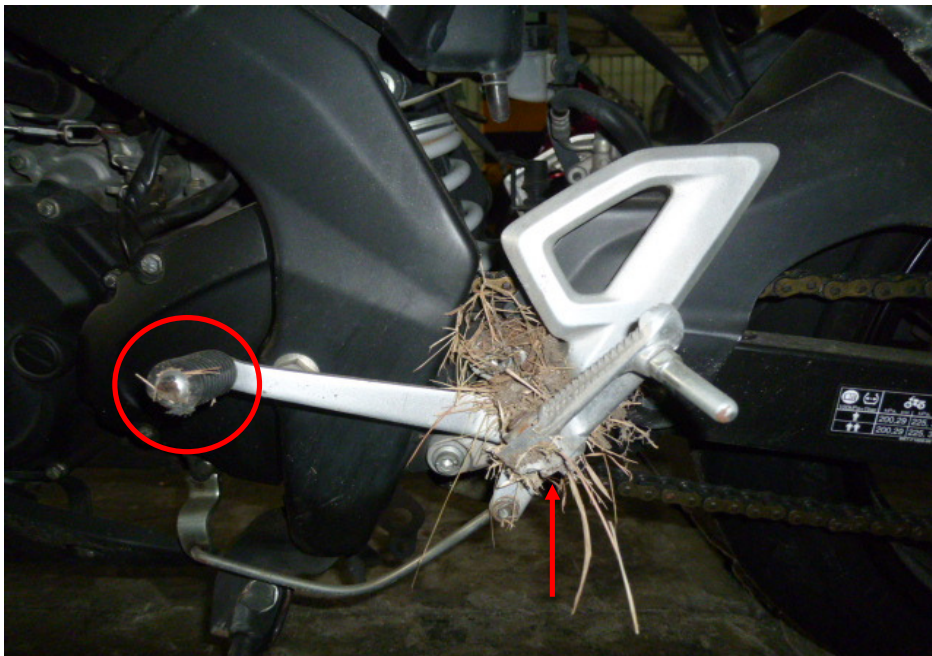
Photo 13 shows the grazed gear shift pedal (circled) and deformed left front footrest (arrowed) of the Motorcycle as a result of the accident.

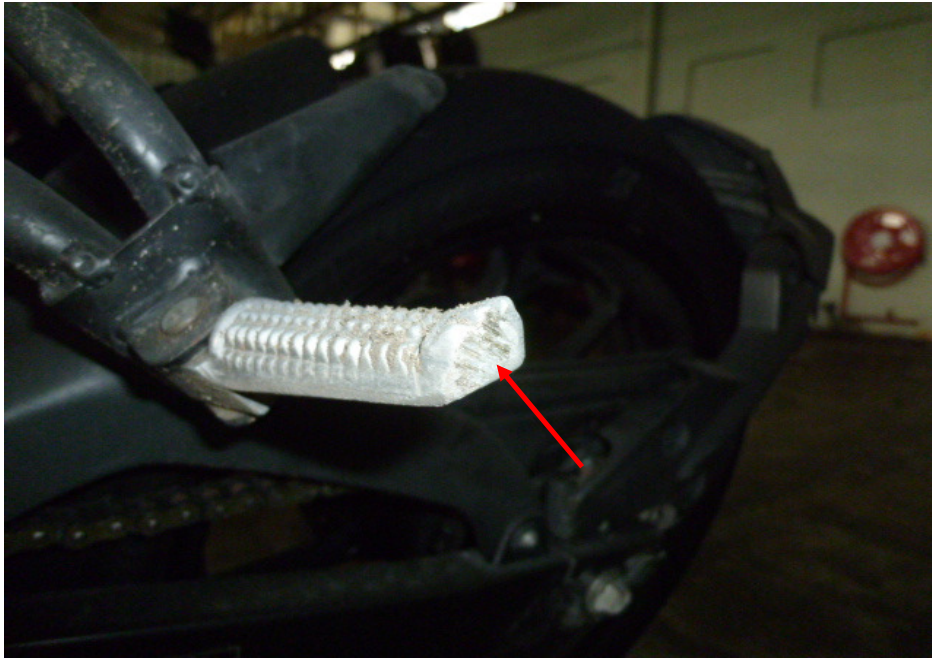
Photo 14 shows the grazed left pillion foot peg of the Motorcycle as a result of the accident (arrowed).

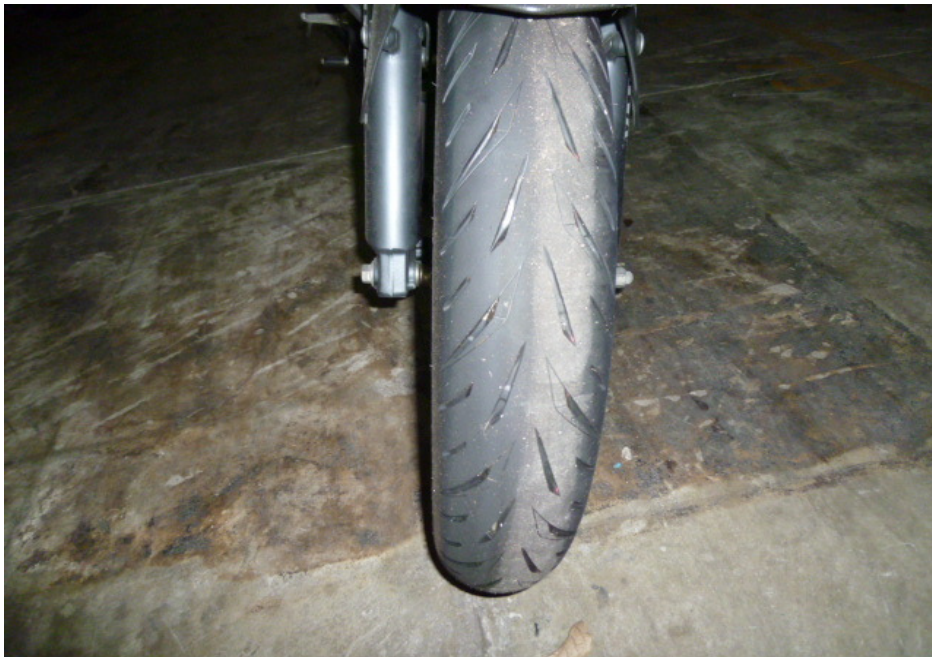
Photo 15 shows the front tyre of the Motorcycle at the time of our inspection. The front tyre was observed to be in serviceable condition with remaining tread depth of approximately 5mm. The pattern of the tread was also clearly visible. There was no tear, burst mark(s) and/or punctured hole(s) on the sidewalls as well as across the tread of the front tyre.

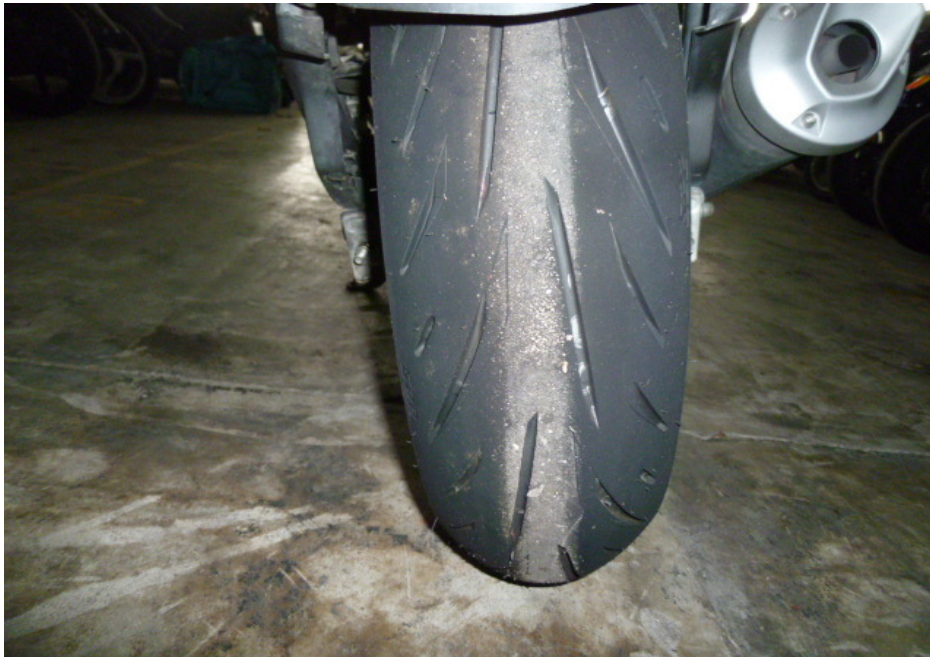
Photo 16 shows the condition of the Motorcycle's rear tyre. The rear tyre was observed to be in serviceable condition with remaining tread depth of approximately 8mm. The tyre was also observed to be sufficiently inflated for vehicular operation. We did not observe any tear, burst mark(s) and/or punctured hole(s) on the sidewalls as well as across the tread of the rear tyre.

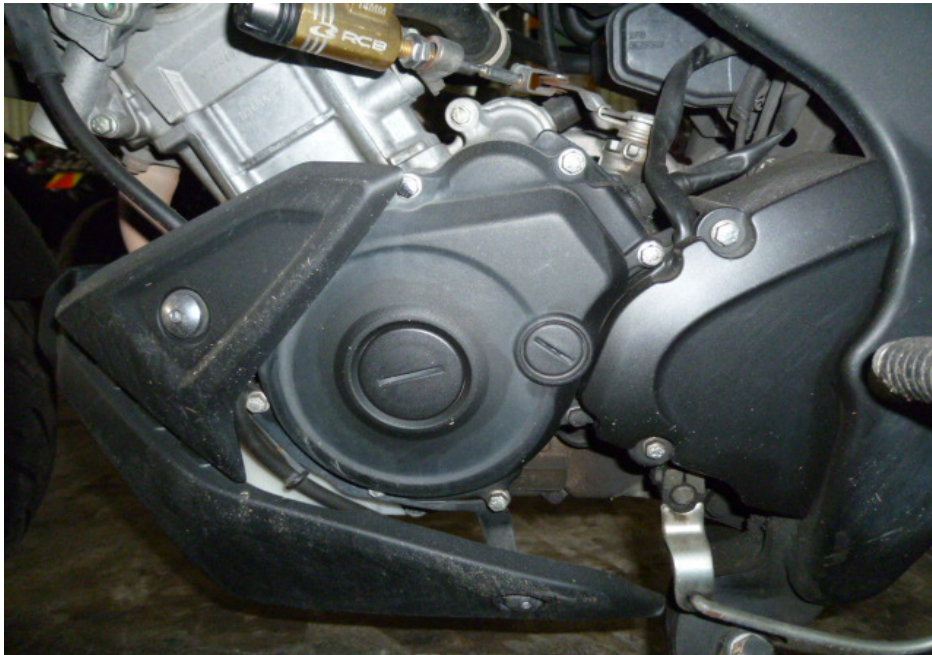
Photo 17 shows the left side of the engine of the Motorcycle at the time of our inspection. The various engine related parts and components were found to be intact with no visible damage. There was also no sign(s) or indication(s) of fluid leak observed around the left engine area of the Motorcycle.

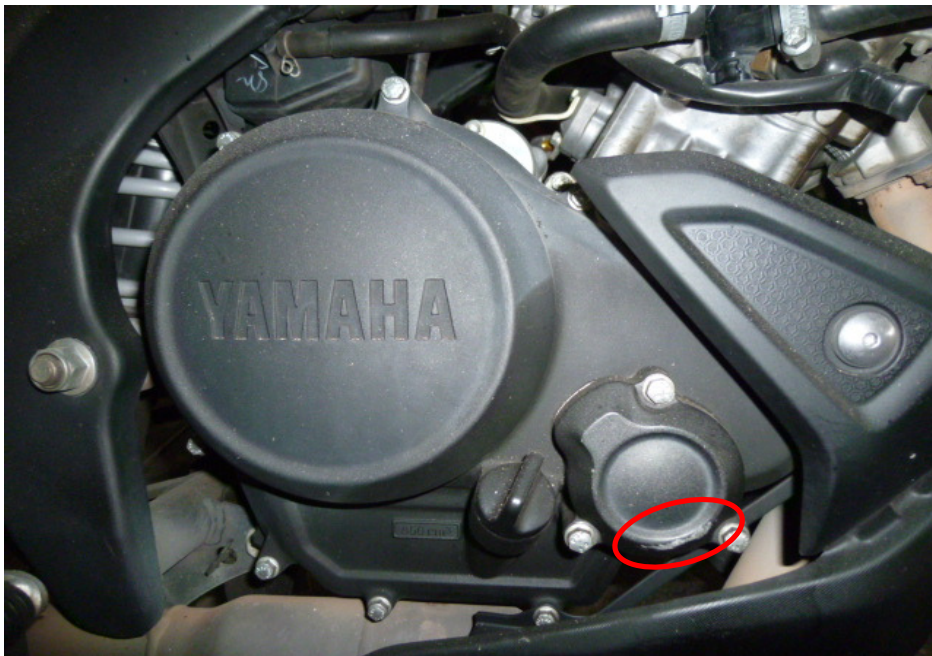
Photo 18 shows the right side of the engine of the Motorcycle at the time of our inspection. The various right engine components had sustained damage of grazing nature as a result of the accident (circled) however the engine components were still intact. There was also no fluid leak and/or fluid stain found around the right engine area of the Motorcycle.

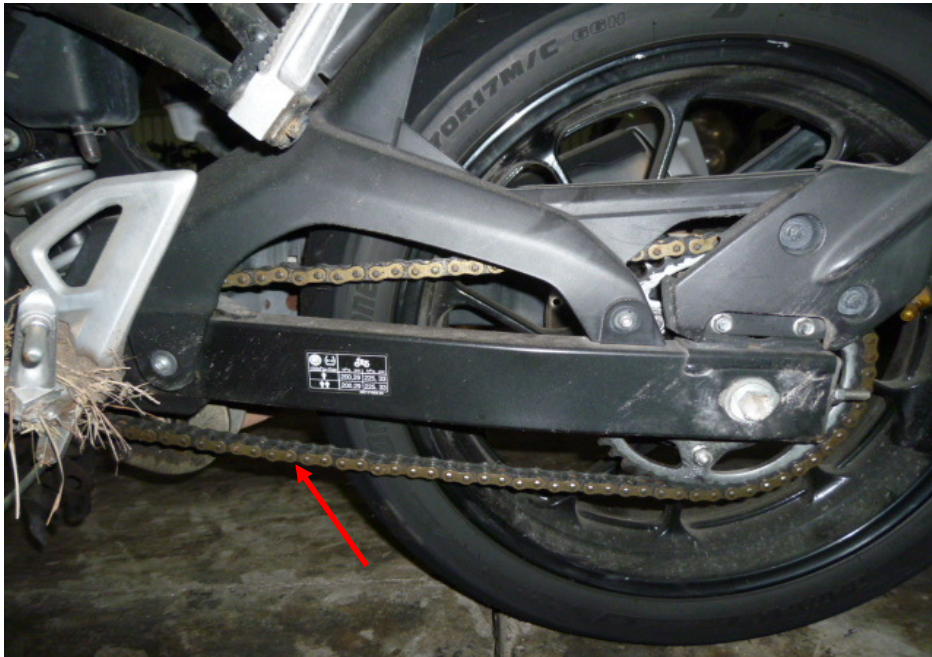
Photo 19 shows the general view of the gear chain (arrowed) of the Motorcycle, which was observed to be intact with no misalignment. It was also adequately lubricated for operating purposes. The gear chain rotates the rear wheel of the Motorcycle

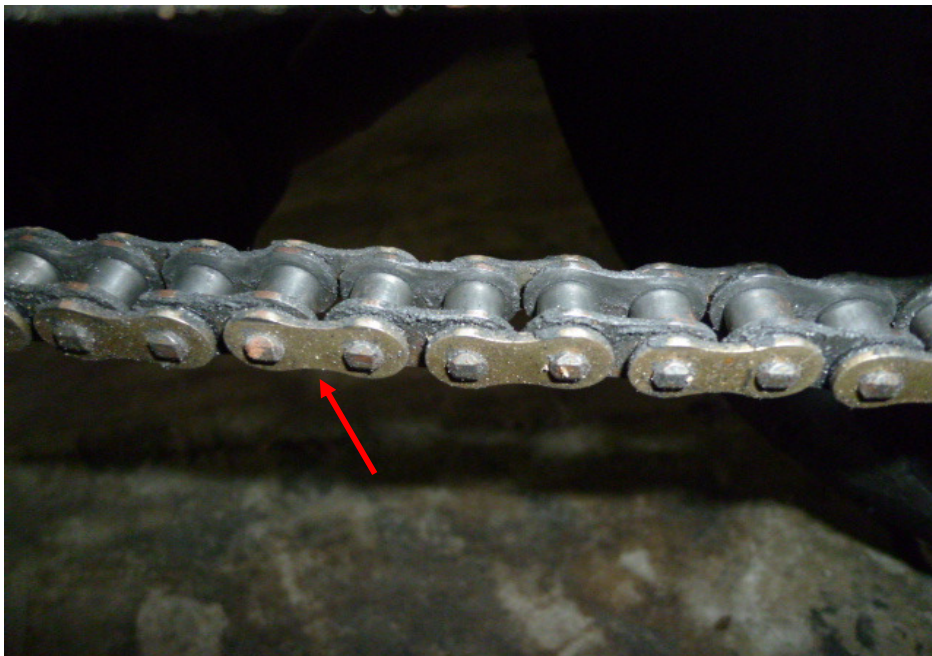
Photo 20 shows a closer view of the gear chain (arrowed) of the Motorcycle, which was observed to be intact with no misalignment. It was also adequately lubricated for operating purposes.

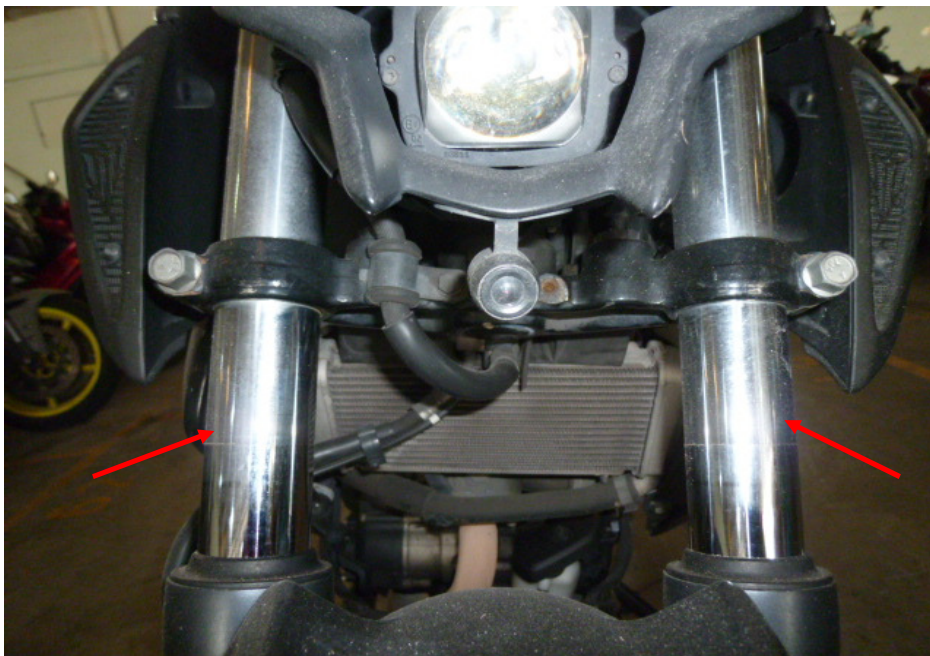
Photo 21 shows the front forks (arrowed) of the Motorcycle. The front forks and fork bracket of the Motorcycle were both found to be intact and undamaged. Turning the Motorcycle's handle bar towards the left and right did not produce any abnormal free play. The steering system of the Motorcycle was in serviceable condition at the time of our inspection.

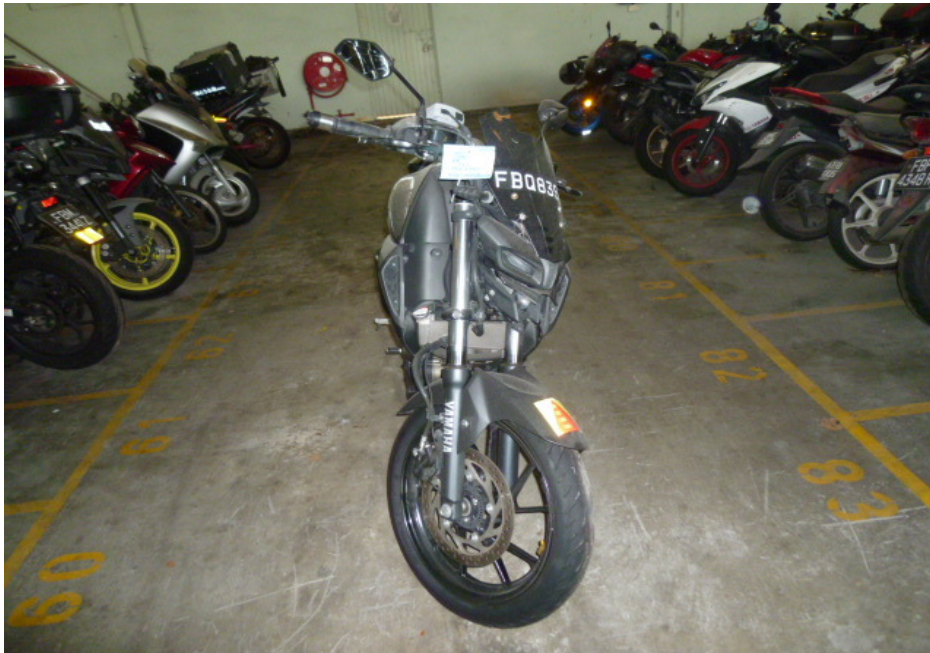
Photo 22 shows the front wheel of the Motorcycle turned towards its full left. Turning the Motorcycle's handle bar towards the left did not produce any abnormal free play and/or resistance. This would indicate that the steering system of the Motorcycle was in serviceable condition at the time of our inspection.

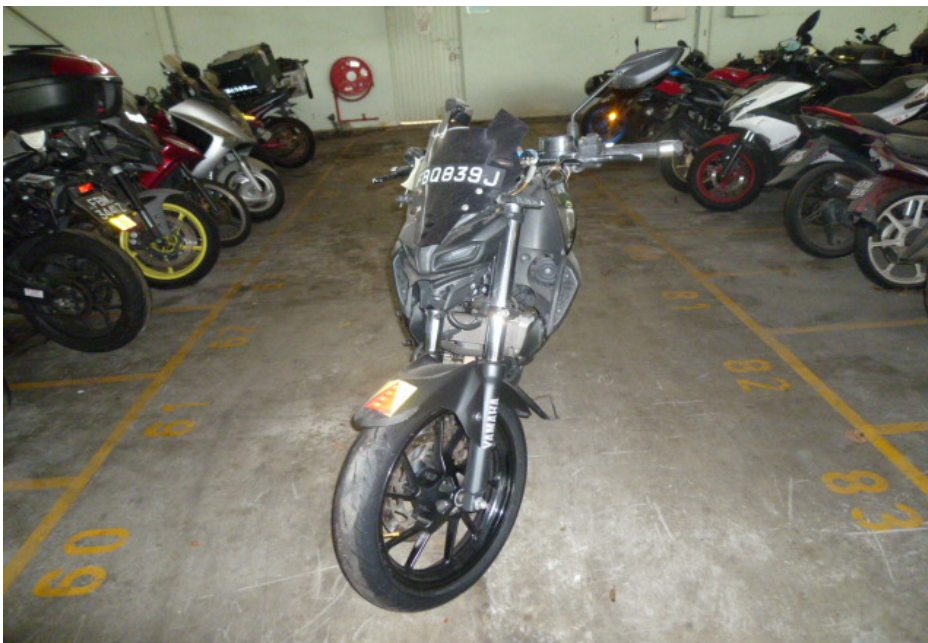
Photo 23 shows the front wheel of the Motorcycle turned towards its full right. Turning the Motorcycle's handle bar towards the right did not produce any abnormal free play and/or resistance. This would indicate that the steering system of the Motorcycle was in serviceable condition at the time of our inspection.

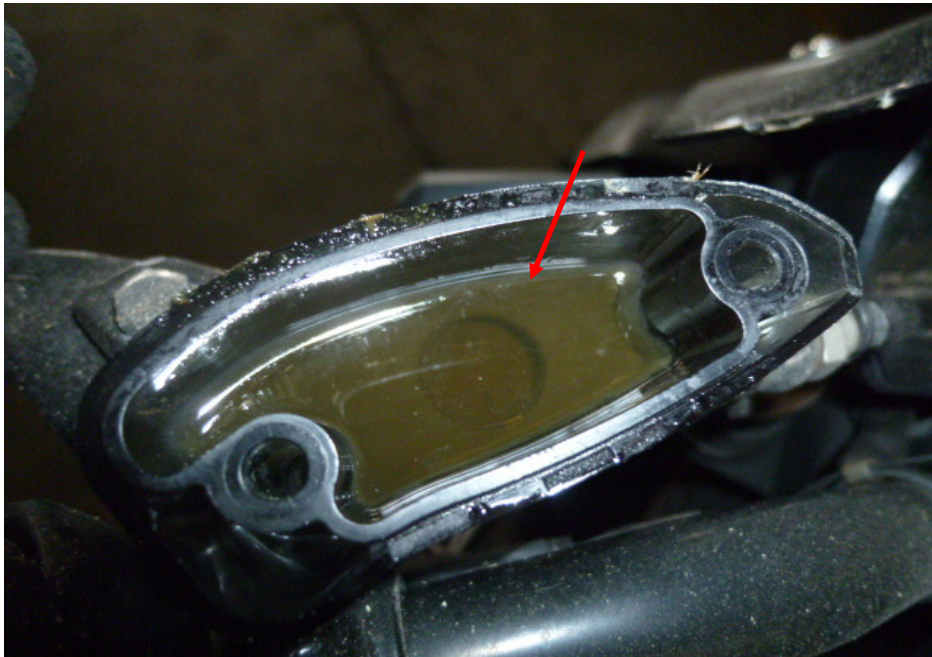
13. Our visual examination of the various components in the Motorcycle's hydraulic clutch system like the clutch lever and clutch hoses revealed all to be intact and without damage. There was also no leakage of clutch fluid observed along the clutch hoses. This was from the respective clutch fluid reservoir at the left handlebar of the Motorcycle. The clutch fluid was found to be of sufficient level for operating purposes. However it was found to be slightly contaminated.

Photo 24 shows the hydraulic clutch fluid reservoir for the hydraulic clutch system of the Motorcycle. The hydraulic clutch fluid was observed to be of sufficient level for operational purposes. However it was found to be slightly contaminated (arrowed).

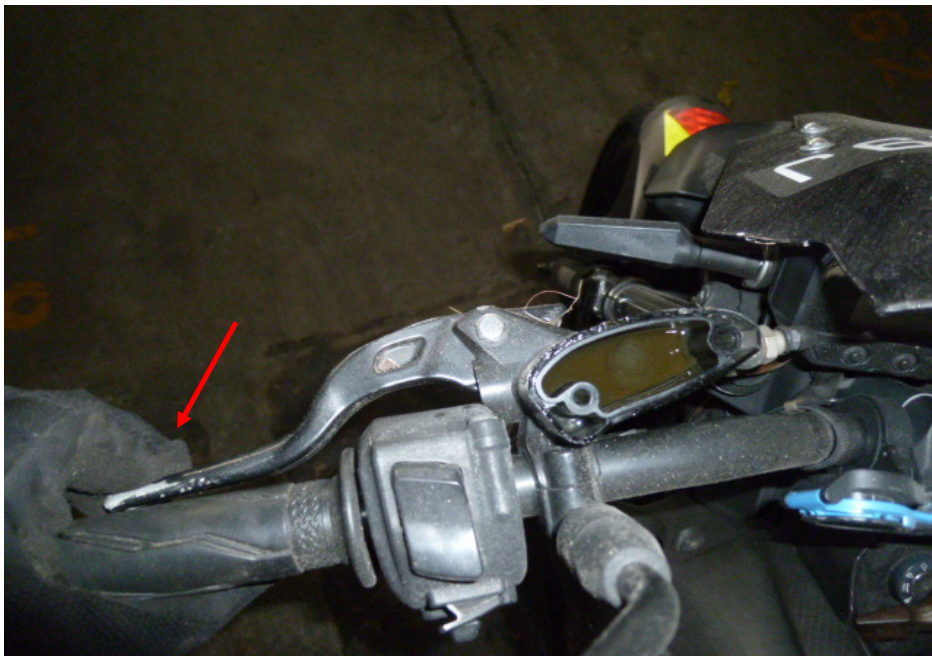
Photo 25 shows the clutch lever being depressed. There was some resistance felt (spongy like feel) upon pressing the clutch lever (arrowed). This would indicate that there is no leakage of pressure/vacuum in the hydraulic clutch system.

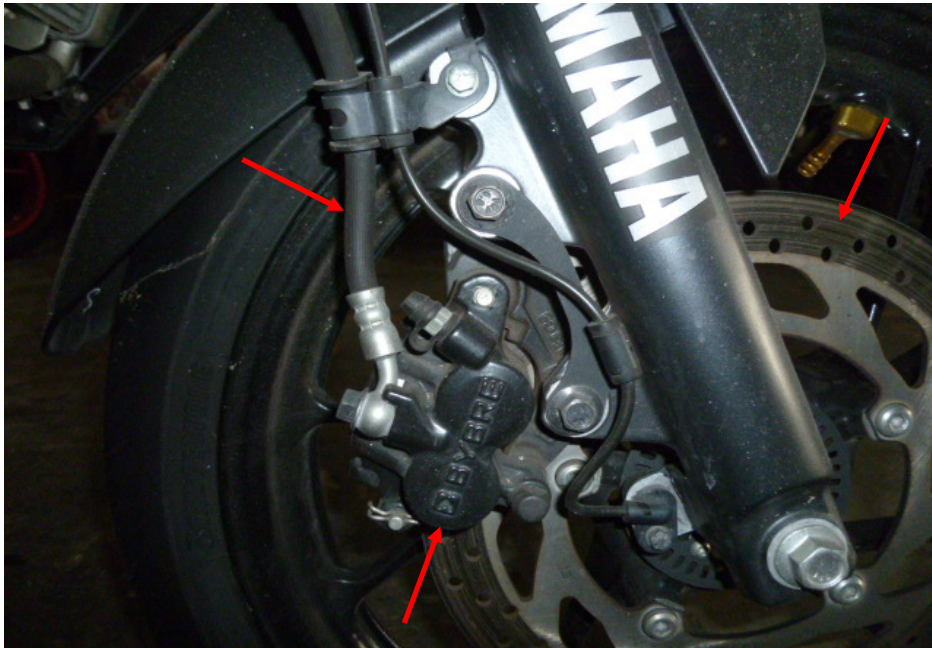
Photo 26 shows a close up view of the front brake caliper, front brake disc and front brake hose (arrowed) of the Motorcycle, which are all part of the components in the hydraulic front brake system of the Motorcycle. Our visual checks of these various components had revealed all to be intact with no visible damage. No leakage of brake fluid was also observed.

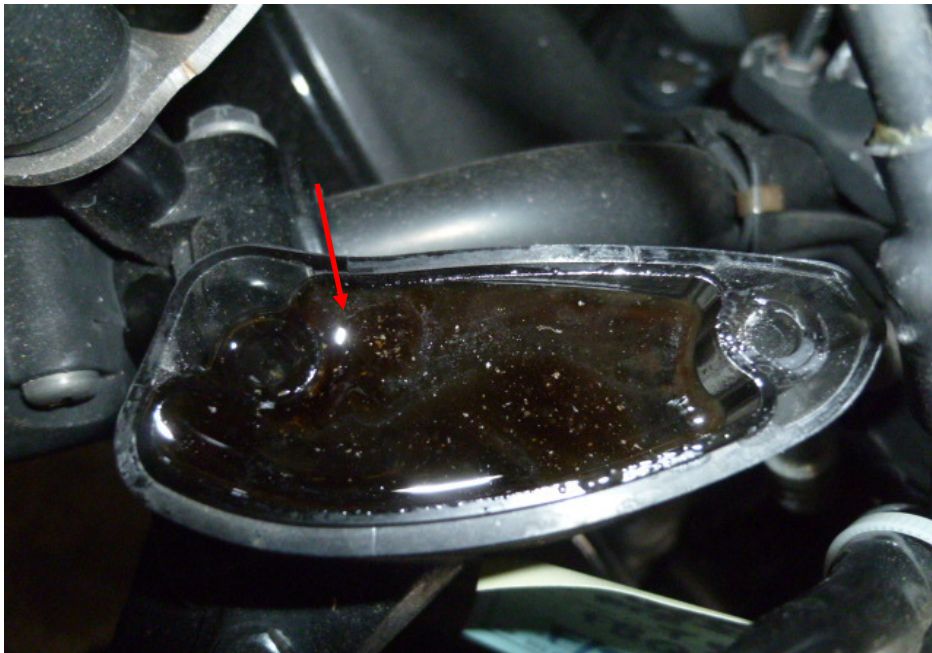
17. The brake fluid for the front brake and rear brake was observed to be of sufficient level for operational purposes. However the brake fluid for the front brake and rear brake was found to be slightly contaminated.

Photo 27 shows a close up view of the brake fluid reservoir for the front brake of the Motorcycle. The front brake fluid was observed to be of sufficient level for operational purposes. However it was found to be slightly contaminated (arrowed).

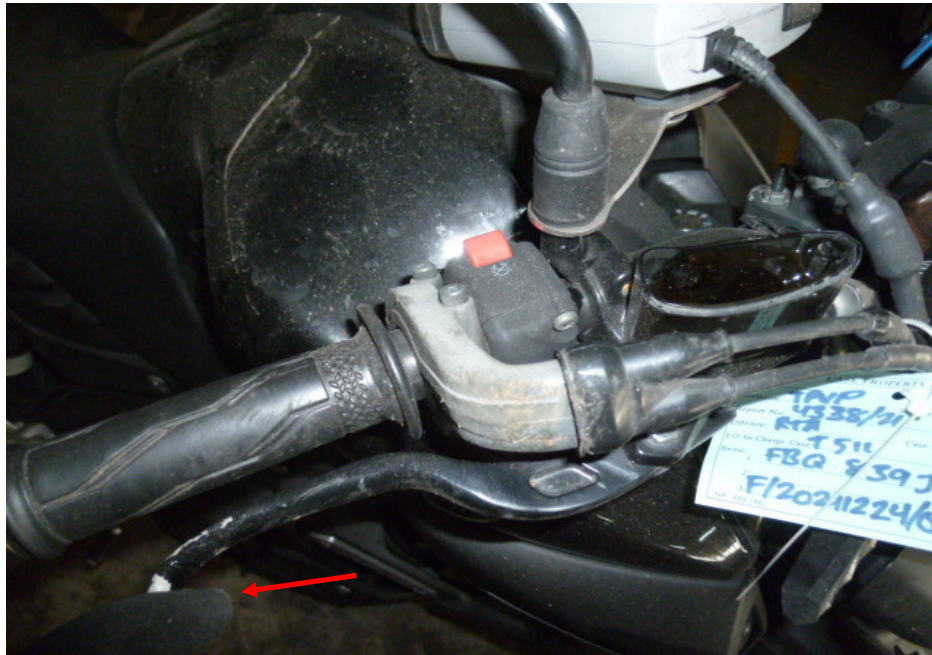
Photo 28 shows the front brake lever being depressed. There was some resistance felt (spongy like feel) upon pressing the front brake lever (arrowed). This would indicate that there is no leakage of pressure/vacuum in the front brake system.

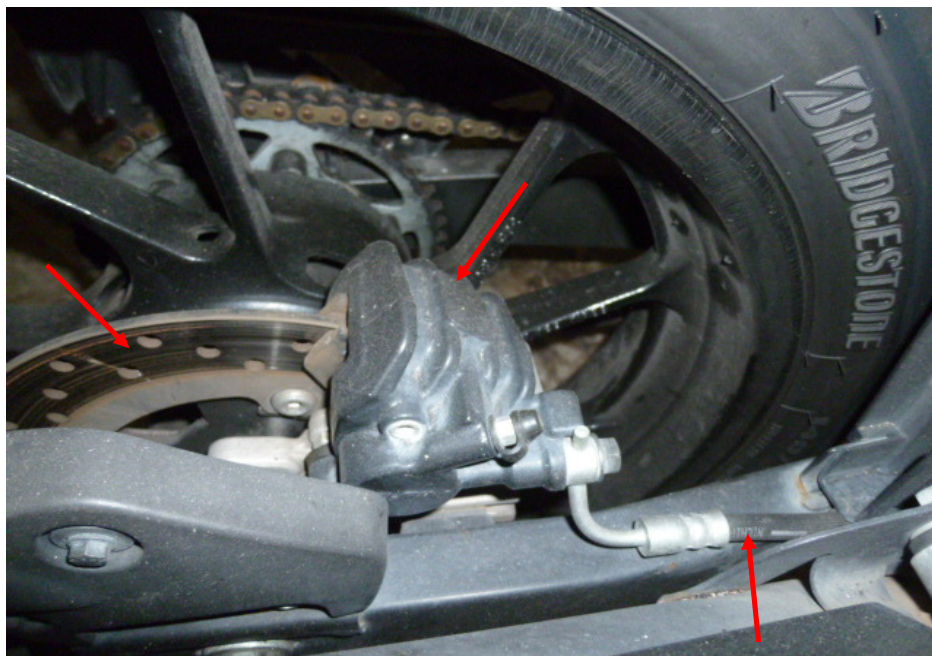
Photo 29 shows a close up view of the rear brake caliper, rear brake disc and rear brake hose (arrowed) of the Motorcycle, which are all part of the components in the hydraulic rear brake system of the Motorcycle. Our visual checks of these various components had revealed all to be intact with no visible damage. No leakage of brake fluid was also observed.

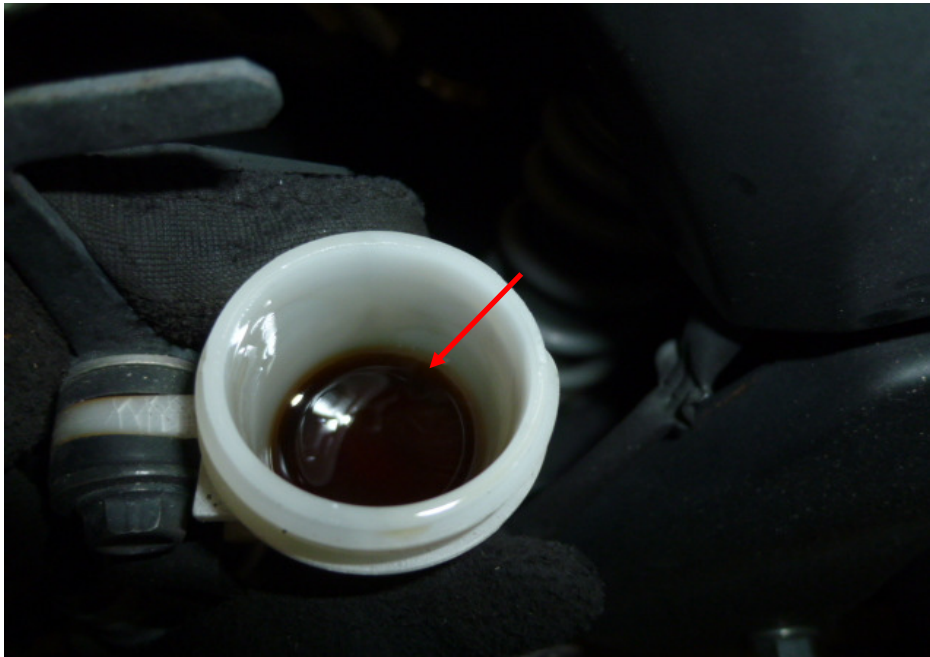
Photo 30 shows a close up view of the brake fluid reservoir for the rear brake of the Motorcycle. The rear brake fluid was observed to be of sufficient level for operational purposes. However it was found to be slightly contaminated (arrowed).
